HISTORIC RESOURCES INVENTORY - BUILDING AND STRUCTURES

Building Name (Common) Henry's Trees LLC Record No. 18120
 Building Name (Historic) Sanford, Jesse, Farmstead / Oakwood Farm
 Street Address or Location 613 Lovely Street
 Town/City Avon Village West Avon County Hartford
 Owner(s) Becker, Henry J., III and Elizabeth D., 613 Lovely Street, Avon CT 06001 Public Private

HISTORIC RESOURCES INVENTORY FORM – BUILDING AND STRUCTURES continuation sheet

613 Lovely Street, Avon CT

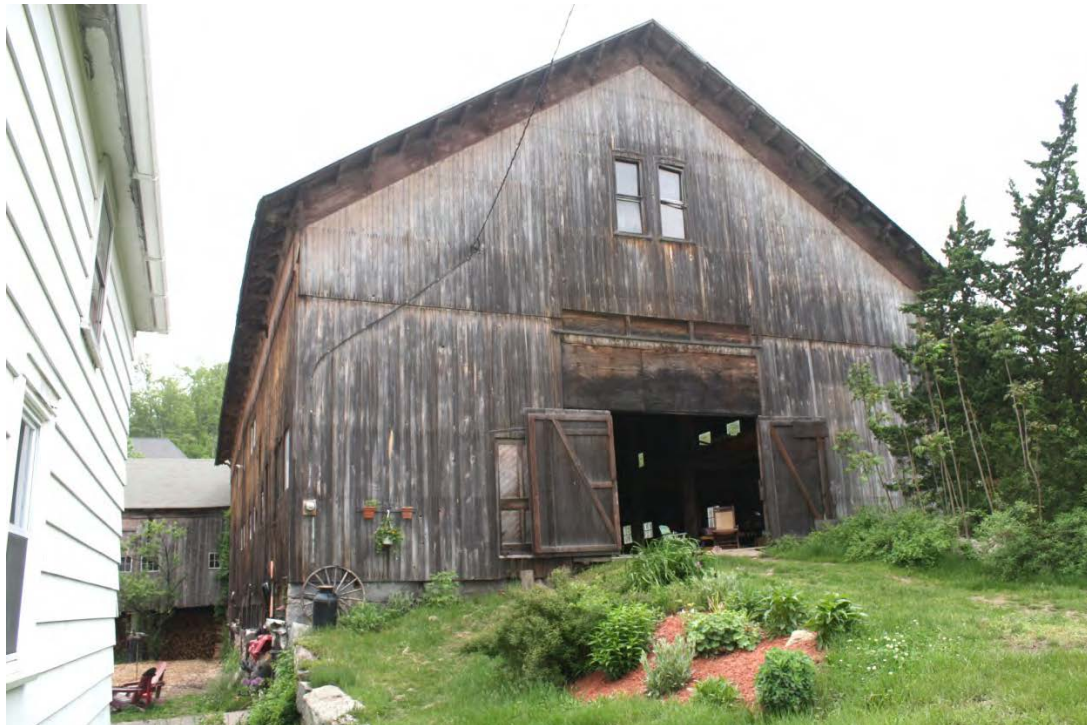
The main entrance is a tall opening in the east gable-end. A historic photograph c. 1900 shows the original pair of interior-mounted six-paneled doors with a three-part multi-paned transom light and beveled lintel trim above. These doors opened by sliding vertically, with a system of pulleys and counterweights. Currently a pair of hinged doors opens outward in a smaller opening framed into the original and the transom is boarded over, with just a trace outline of the trim visible on the siding. To the left (south) a pass-through door has the original diagonal board infill panels and beveled head trim. A pair of one-over-one double-hung windows is centered in the attic gable and has finished surround trim with tapered head casings. The originals appear to have been four-over-four.

6. East view of Barn I, camera facing west. Barn III-House is at left.

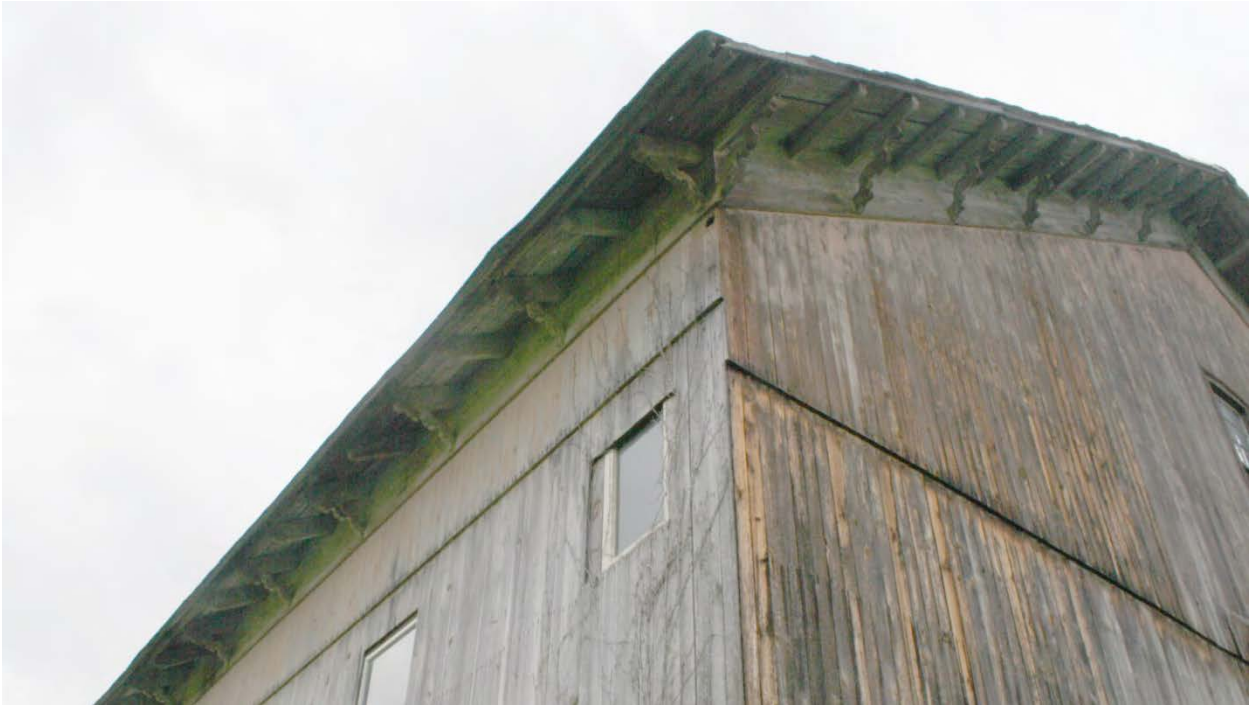
The deep roof overhang has a series of scroll-sawn brackets on the rake as well as at the eaves, and a wide trim board at the head of the wall surfaces. The brackets are mounted below every second rafter tail along the eaves and on alternate projecting outriggers on the rakes. The brackets are intact and appear in fairly good condition; they are an unusual and distinctive feature. Siding is vertical tongue-and-groove flush-boards, originally painted a light color with dark trim, per the historic photograph, but now unpainted. The base of a cupola sits on the center of the ridge; in the historic photo the cupola had windows on all sides and a low-slope hipped roof with a weather vane. According to the owner, the cupola blew off in a past hurricane. Roofing is asphalt shingles.

9. Northwest view of Barn I eave and rake details, camera facing southeast.

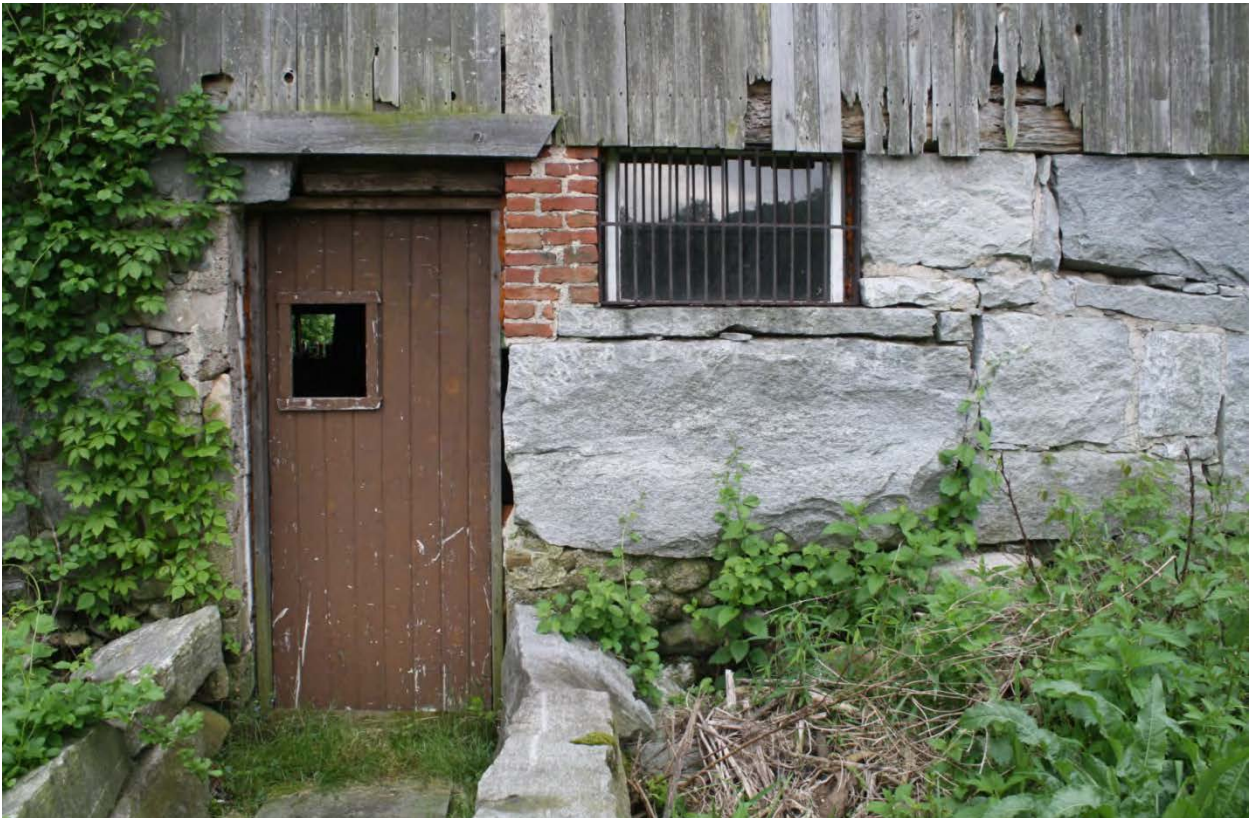
The north eave-side has a foundation of massive granite random ashlar with a series of window openings in the topmost course. The basement is exposed on this side and a pass-through door is located off-center toward the right (west). Above at the main level there are eleven stable-window openings, ten filled with six-pane windows and one boarded up; these are irregularly distributed. At the second floor level there are eight six-pane stable-type windows irregularly placed. Above the second-level windows is a siding divide. The upper part, sheltered by the eave overhang, has traces of a pinkish-tan paint color which can also be seen elsewhere.

10. North detail view of Barn I stone foundation, camera facing south.

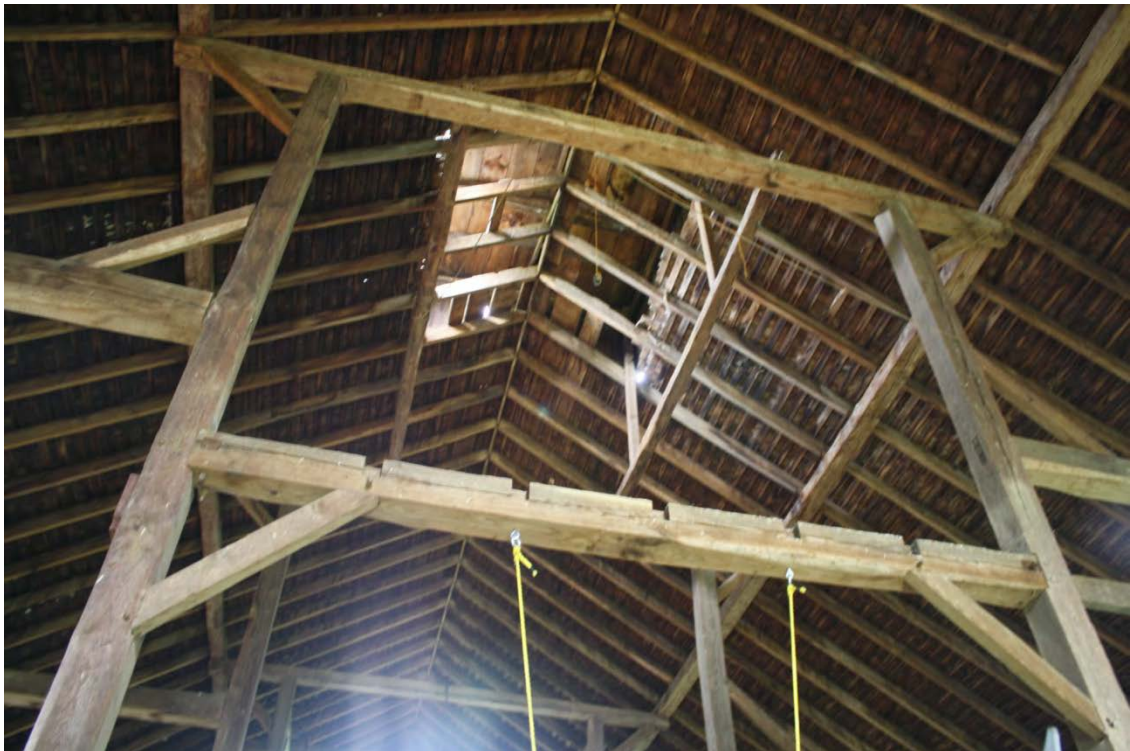
The square rule post and beam frame of Barn I consists of eight bents each with three aisles, the center aisle being the drive bay which extends the full length of the structure and has doors at both ends. The bents are spaced more closely near the ends, with the west and east bays being 10 feet wide, the second and sixth bays 8 feet, and the center three bays 14 feet. The height at the ridge is more than 32 feet above the main drive bay floor. The framing system is an unusual arrangement. The center aisle is framed by posts 14 feet apart which extend well beyond the height of the eave line. At the top of each pair of posts, a cross tie member cantilevers beyond the posts and supports longitudinal purlins at the center of the rafter span. Angle braces connect the cantilevered ends to the main posts. Each of the main interior posts is braced by a dropped tie girt out to the exterior wall post, a lower tie girts supporting a side loft floor, and the interior posts are braced across the center aisle by a girt a few feet below the upper tie girts. Bents two and three are tied longitudinally by a girt slightly below the top cantilevered member, as are bents six and seven.

12. Interior view of Barn I main level, camera facing west, with cantilevered top tie girls supporting purlin plates.

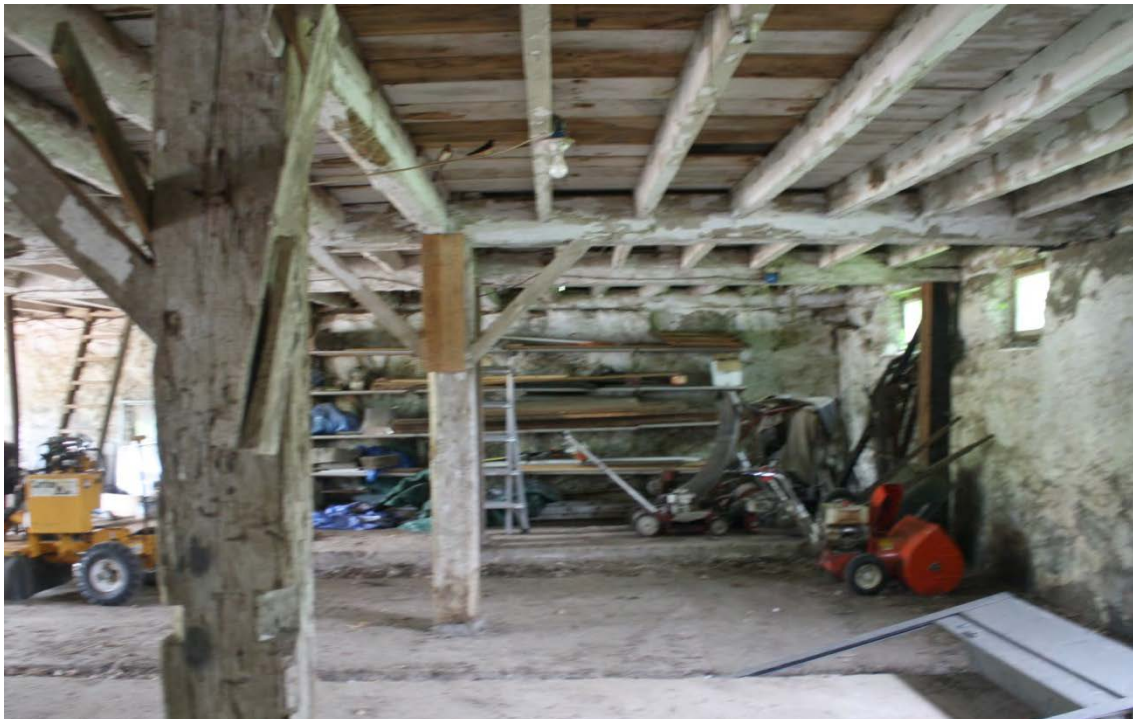
The basement level is constructed with massive 10 inch square posts and lateral girders forming the seven bays, and gigantic granite block random ashlar perimeter walls at the west, north, and east sides. The wood members are hand-hewn timbers. Floor joists above are a mix of hewn and rounded pole members. At the first framing line in from the west end wall the wood posts have been replaced by iron or steel columns. The floor is concrete with manure gutters running north-south extant in several locations; others have been filled in level with newer concrete. A stair along the north wall, in the third bay from the east end, connects to the main level.

14. Interior view of Barn I, Basement level, camera facing west.

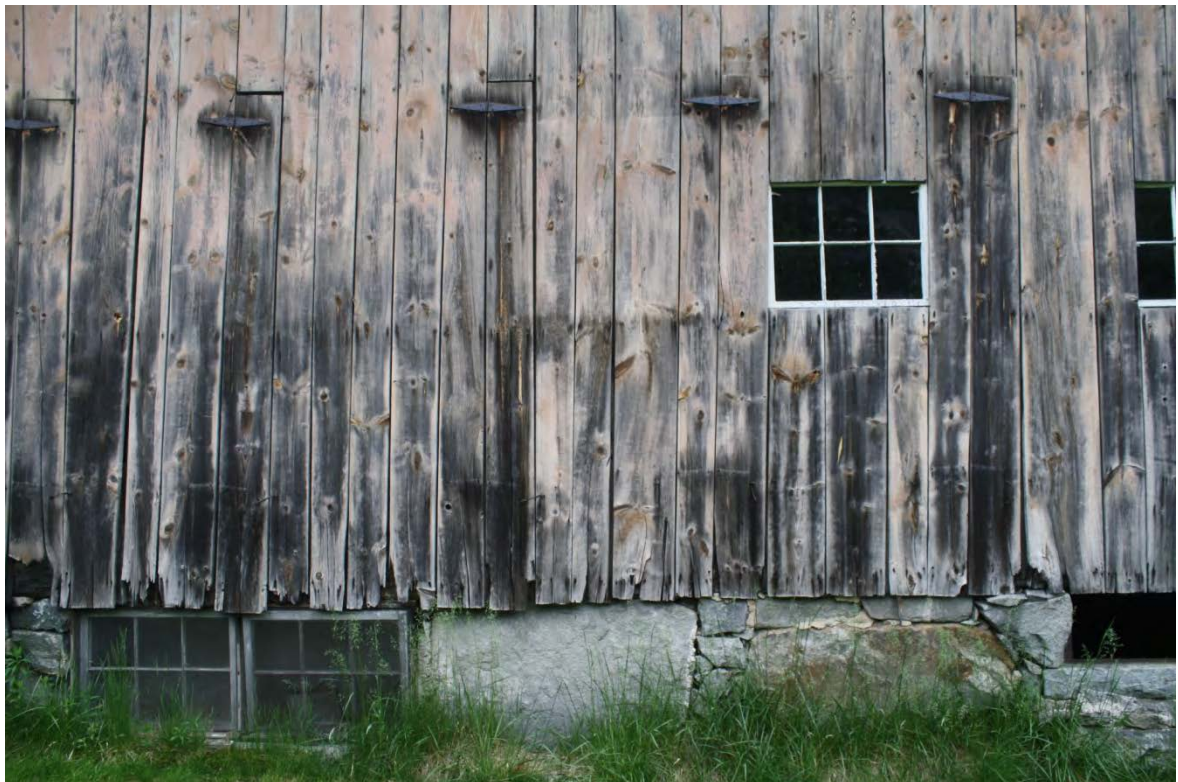
The main level is a typical tobacco shed frame with vented siding. This is erected over a banked foundation of massive granite random ashlar masonry. The tobacco shed type is normally found on level ground with drive-in access at the gable-ends; this is an unusual configuration. It seems possible that this barn was moved from elsewhere onto this foundation.

16. North detail view of Barn II, camera facing south; showing stone foundation and tobacco shed venting.

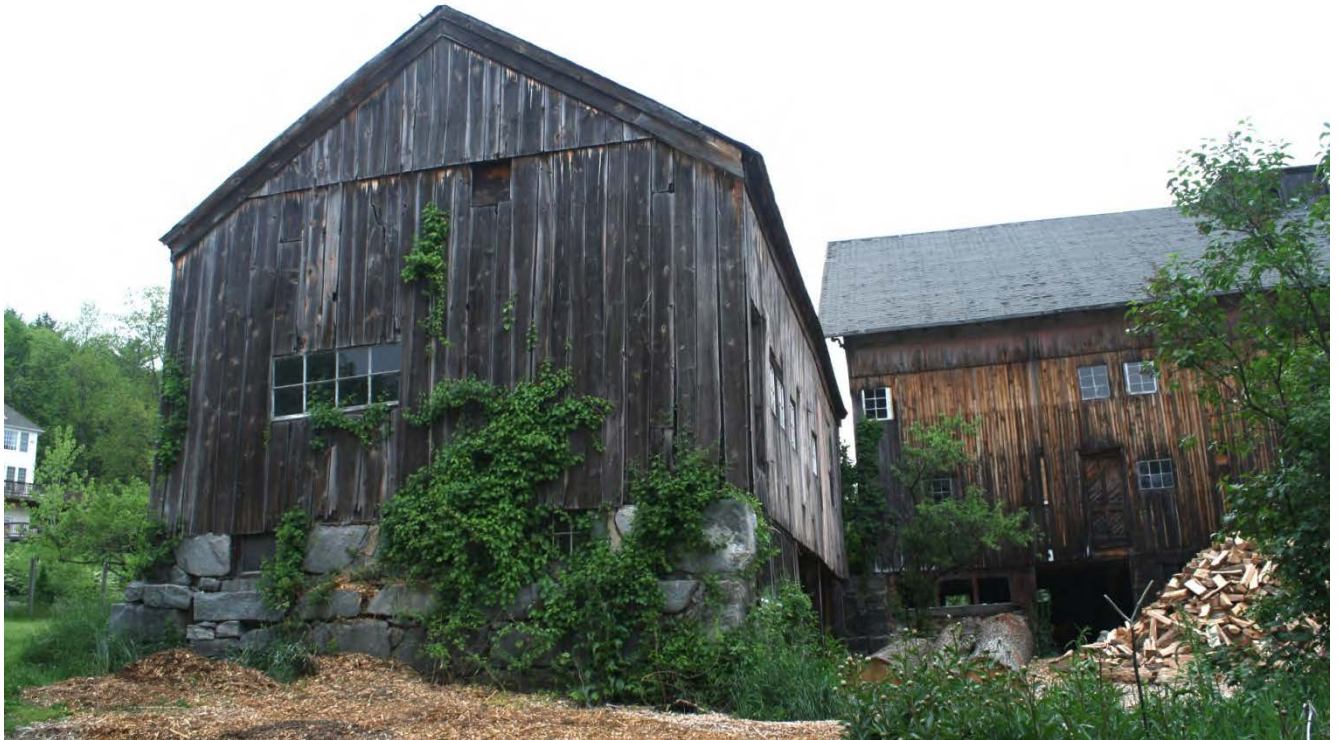
The north gable-end and west eave-side have their main level slightly above grade, and the south gable-end has exposed stone foundation half-height along the grade which slopes down toward the east. The north gable-end has a vertical eight-pane window at the center and a filled-in opening at the right (west) corner. The west eave-side has from left (north) to right, an area covered with tar-paper, an area of tobacco-vent siding with two six-pane stable windows, and a pass-through door at the right corner. There are four window openings in the foundation wall lighting the basement level. The south gable-end has one eight-pane stable window off-center toward the left.

17. South view of Barn II, camera facing north.

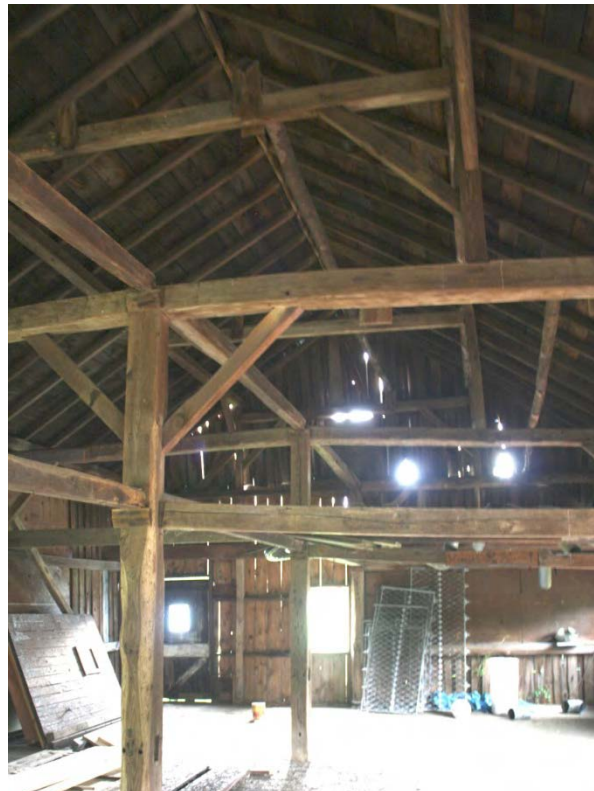
The interior is a square rule post and beam framed structure with five lateral bents, some of hand-hewn timbers. Each bent has one center post below a dropped tie-girt, forming a two-aisle tobacco shed layout. There are lower cross girts just above head height and longitudinal beams at a similar height, suitable for the poles that support hanging tobacco. At the attic level a pair of queen posts in each bent are tied by an angle-braced cross tie and support longitudinal purlins at the mid-span of the rafters. Some repairs have been sistered on at the joint between the dropped girt and wall post. Rafters are sawn dimension lumber.

18. Interior view of upper level, Barn II, camera facing north.

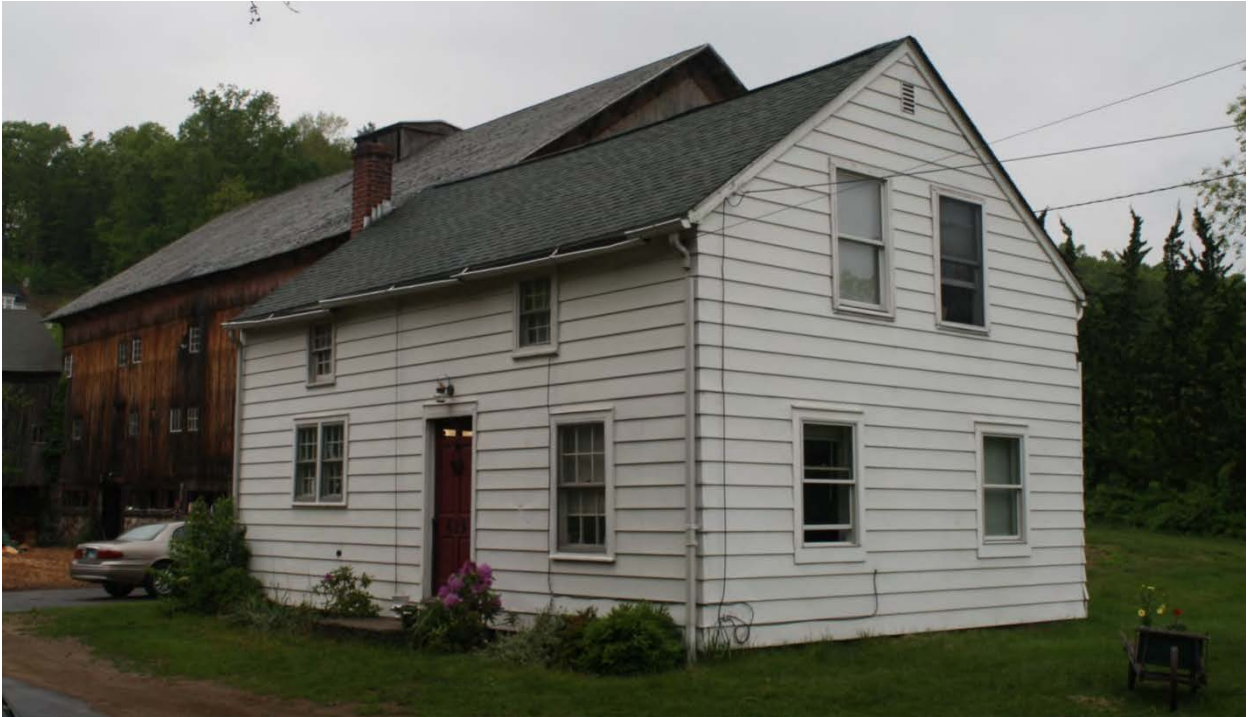
Today the south wing is gone and what remains is a 1 ½-story cape-style house with an entrance in the south eave-side and another in the west gable-end. The gable roof is oriented east-west. The house has double-hung windows with a mix of six-over-six and one-over-one sash, aluminum clapboard siding and asphalt roofing. A brick chimney is attached to the exterior along the west gable-end.

19. Southeast view of Barn III-House, camera facing northwest.
