HISTORIC RESOURCES INVENTORY - BUILDING AND STRUCTURES

Building Name (Common) Eisenman Farm / Cranberry Hollow Record No. 4995
 Building Name (Historic) Bishop, Lewis / Tuttle, Charles and Lydia / Megin, Sarah and Dennis, Farmstead
 Street Address or Location 163 Carrington Road
 Town/City Bethany Village _____ County New Haven
 Owner(s) Eisenman, Hope, 163 Carrington Road, Bethany CT 06524 Public Private

163 Carrington Road, Bethany CT

Record No. 4995

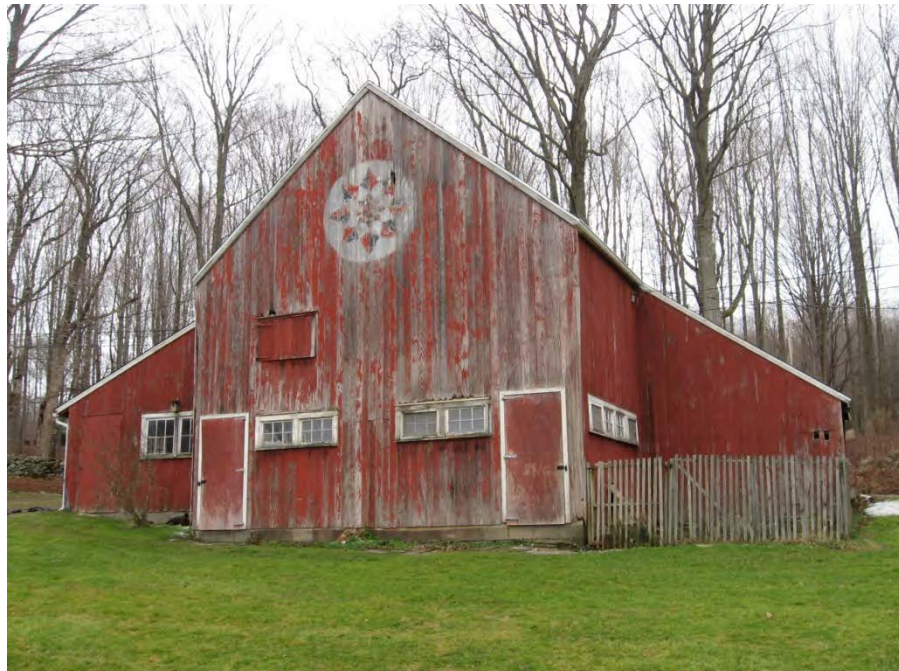
The entrances to the ground level of the main block are located at the opposite ends of the west gable-end. There is a pair of horizontally-oriented, multi-pane hopper windows to the interior side of each door. These have six panes each and painted white trim. An outward swinging hay door, measuring roughly 3' x 2', can be found off-center toward the left (north) above the windows. A painted hex detail, approximately 4' in diameter, is located in the gable-end of the west elevation. The detail is of Pennsylvania Dutch origin and is inspired by the owner's Western Pennsylvania heritage.

9. West and south elevations of Barn I, camera facing northeast. Note hay door and geometric detail in gable end.

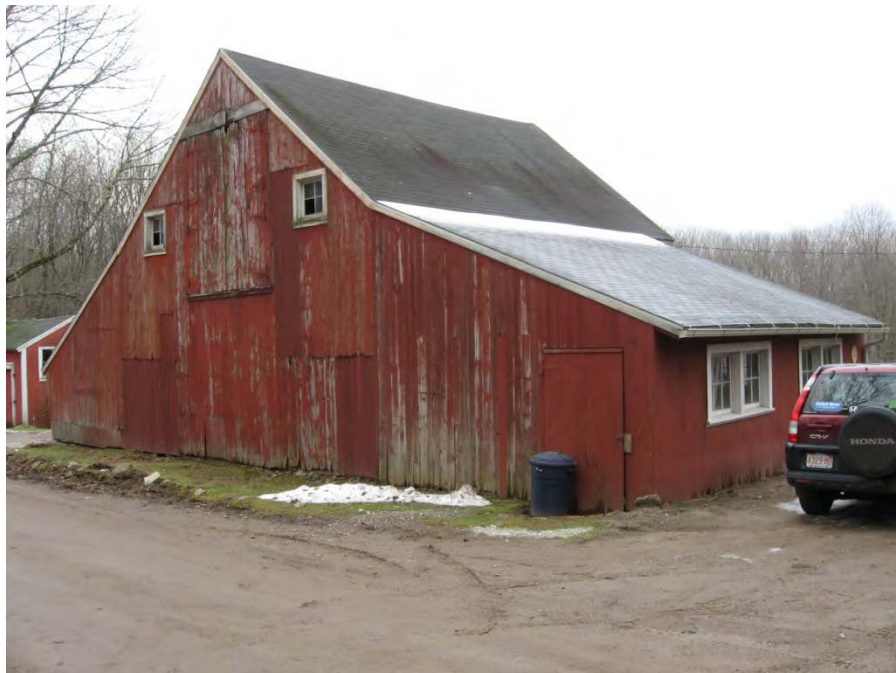
The east gable-end of the main block has a pair of hinged doors in its gable, these providing access to an area originally used for hay storage. A wood block has been placed over the opening where a hay fork once extended beyond the plane of the building, the cantilevered support having since been removed. Two small, four-pane hopper windows flank the hay doors just below the roof-line of the main block.

11. East and north elevations of Barn I, camera facing southwest. Note hay doors in gable end.

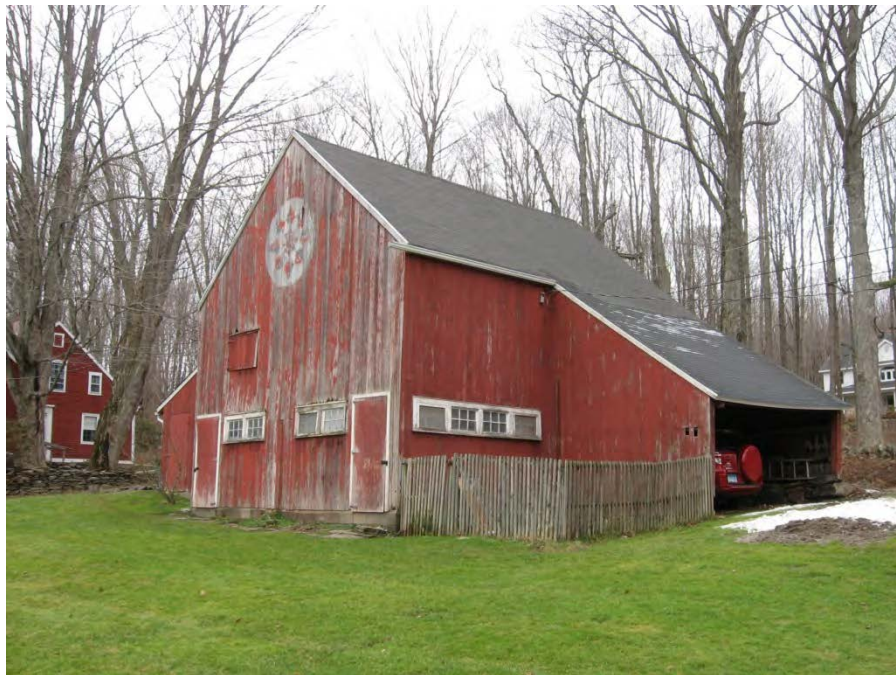
The shed-roofed addition on the barn's south eave-side has a full-width, one-bay opening leading to a covered storage area, dirt-floored, below the loft level of the main block. A fenced enclosure is located to the west of the addition, this forming a small rectangular yard currently used as a run for chickens. The south eave-side of the main block is broken by a small swing door leading from the chicken run into the building, above which are four horizontally-oriented, multi-pane hopper windows.

13. South and west elevations of Barn I, camera facing northeast. Note chicken run at southwest corner of barn.

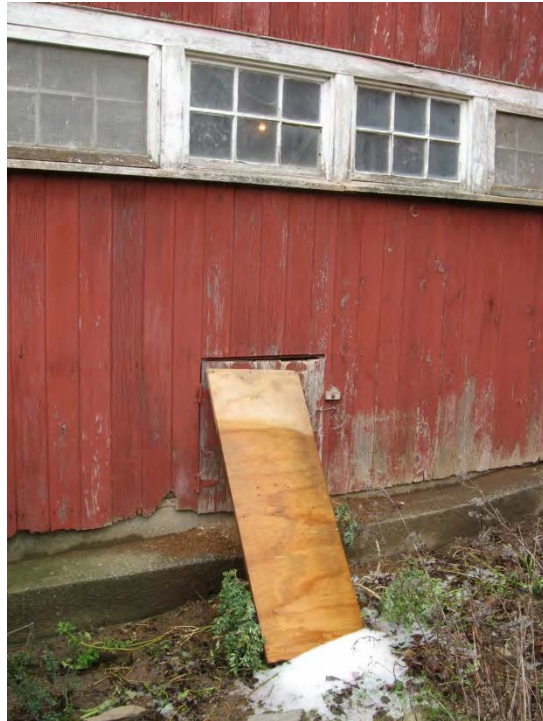
14. South elevation of Barn I, camera facing northeast. Detail of hopper windows and chicken run door.

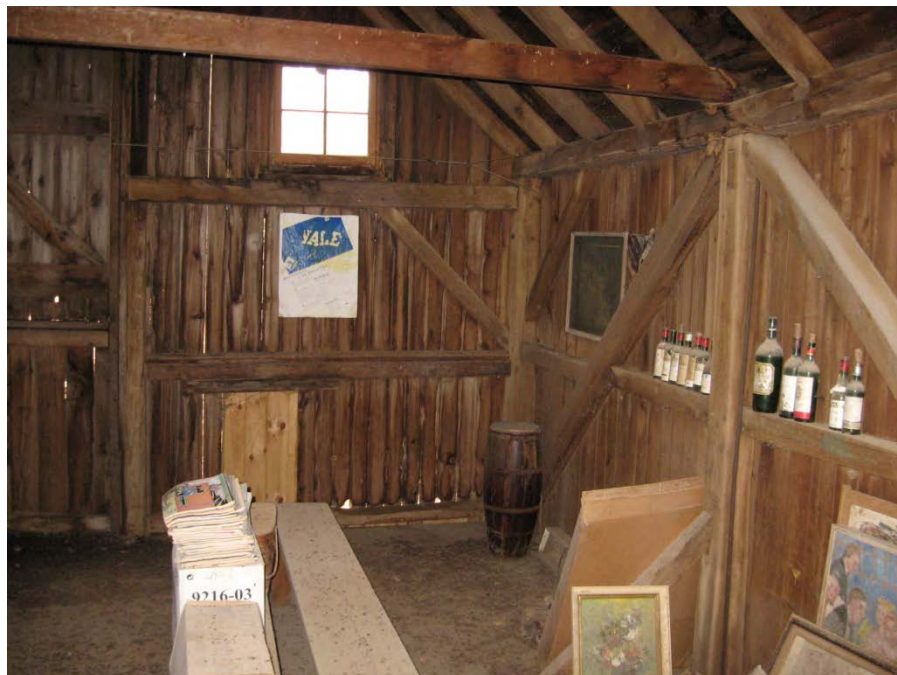
The interior of the main block's upper level reveals a three-bay, four-bent, square rule post and beam frame with dropped tie-girts and diagonal bracing. The original framing is circular sawn with the posts measuring 6" x 7" and the plates measuring 6" x 6". The common rafters are butted at the ridge. The original tie girts have been cut and removed at the plate, this to accommodate a hay track running the length of the building. A heavy cantilevered beam, tie girt, and purlins were added at the eastern end of the barn to support the hay fork. It appears that the alteration may have caused the barn to spread over time as a steel cable and two dimension lumber replacement ties were installed in order to support the first, second, and third bents, respectively. Long diagonal braces are visible in

the eastern bays of the south side of the barn, forming a triangular truss supporting a clear opening below where the storage space extends below. Steel rods have been added on either side of the post over the center of the opening, these bolted from above and below in order to further support the span.

15. Interior view of Barn I second floor level, showing framing detail, camera facing southeast. Note location of removed tie-girt and framing over south bay opening at right.

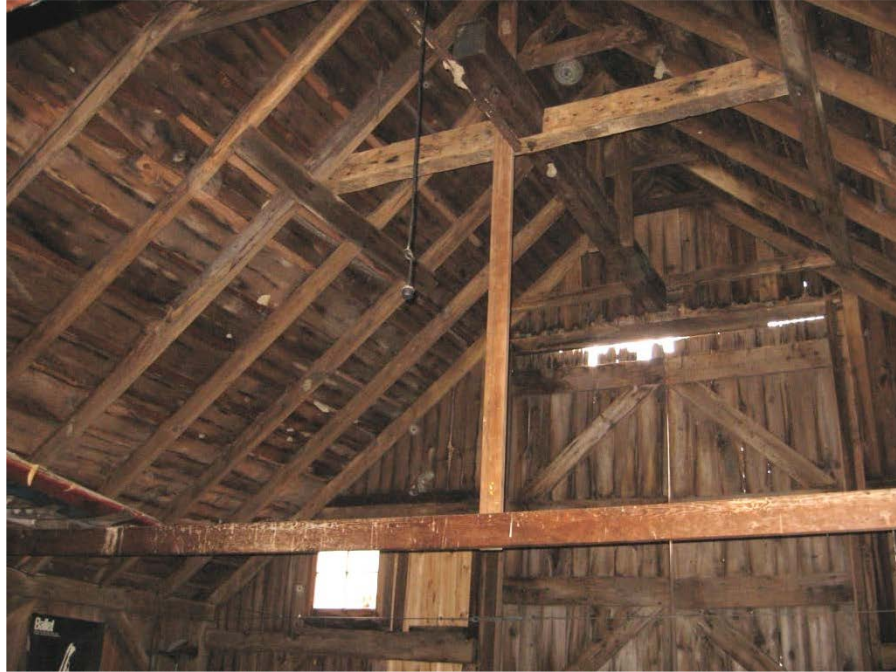
16. Interior view of Barn I second floor level, showing framing detail of hay track, camera facing northeast. Note replacement support framing and hay door at rear.

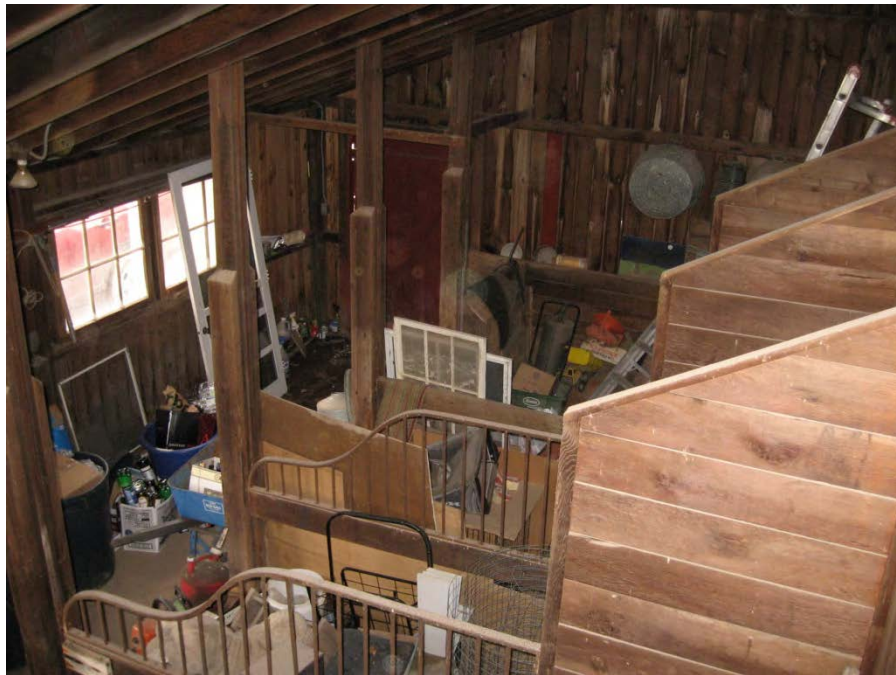
Five sliding hay doors are located just above floor level on the north eave-side of the hay loft. These correspond with five horse stalls which comprise the majority of the space within the north addition. A frame stair – the only access to the loft level of the main block – runs down to the west end of the north addition. A pass-through door leading into the yard is located directly to the west of the stair landing and the aforementioned horse stalls run along the north eave-side of the main block to the east. The addition is of balloon construction erected with dimensional lumber. Frame half-walls with iron stanchions divide the horse stalls, each stall having an iron hay bin suspended just below the hay door leading into the loft. The floor of the addition is poured concrete with wood boards lining the floor of the stalls.

17. Interior view of Barn I north addition, showing horse stalls, camera facing northeast. Note the iron stanchions.

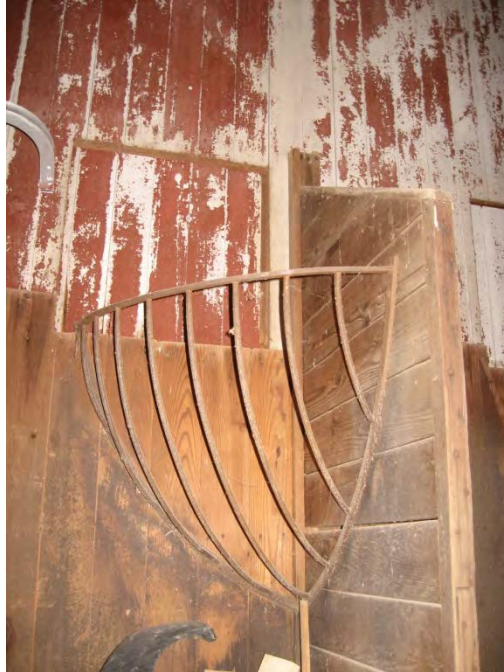
18. Interior view of Barn I north addition, showing horse stall hay catcher, camera facing south. Note hay door opening above.

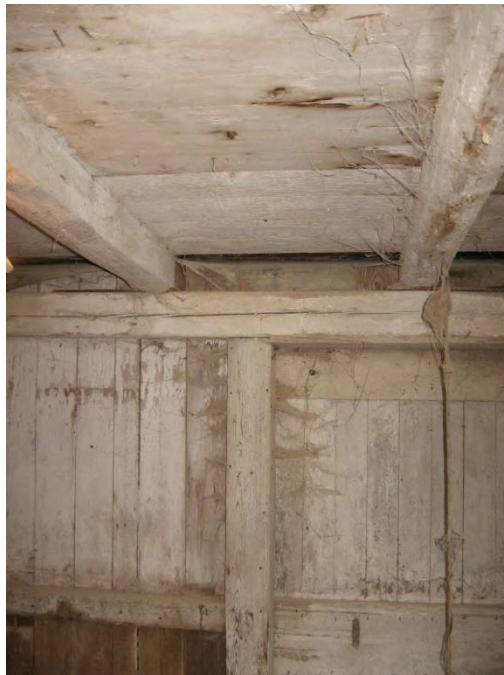
The two pass-through doors on the west gable-end of the main block's lower level each lead into small room, these divided from each other by a wall of vertical wood boards. The ceilings and portions of the exterior walls are whitewashed, suggesting that this space once housed dairy cows. Today the northern room is used for storage while the southern space houses a flock of chickens.

19. Interior view of Barn I lower level, showing whitewashed walls and ceiling, camera facing east.

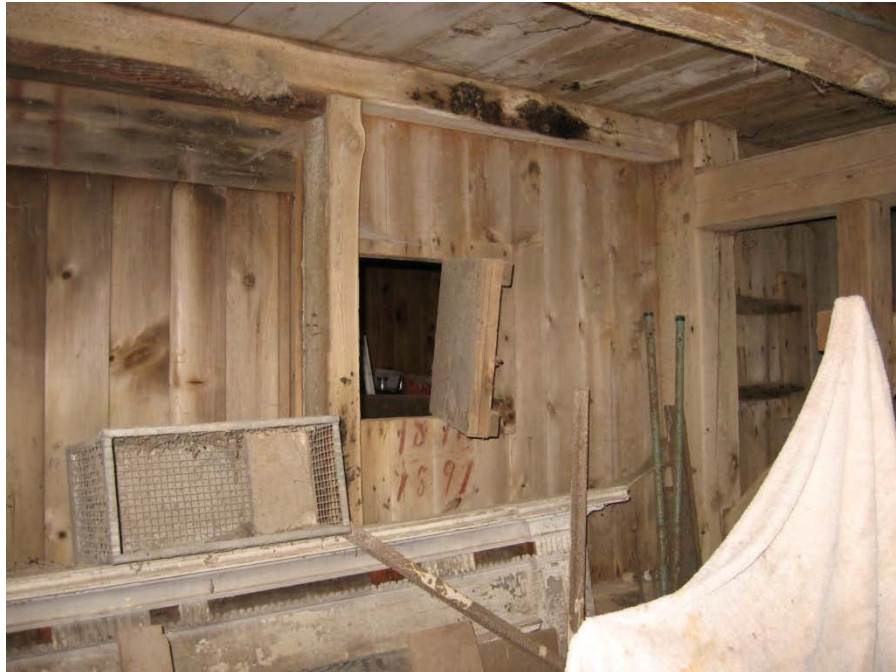
A sliding door in the southern room leads into the area below the eastern end of the main block. This consists of a bay perhaps once used for carriage or equipment storage. Part of the bay has since been framed out in order to store lumber. Small openings with swinging doors along the northern side of the space provide light and ventilation into the horse stalls beyond. The shed-roofed addition extending beyond the original one-bay opening consists of a mix of repurposed hand-hewn timbers and dimension lumber. Aerial photographs indicate that the addition was erected between 1934 and 1965, perhaps using framing materials reclaimed from the barn removed from the site during that same period.

20. Interior view of Barn I lower level, showing openings between carriage bay and horse stalls, camera facing northeast.

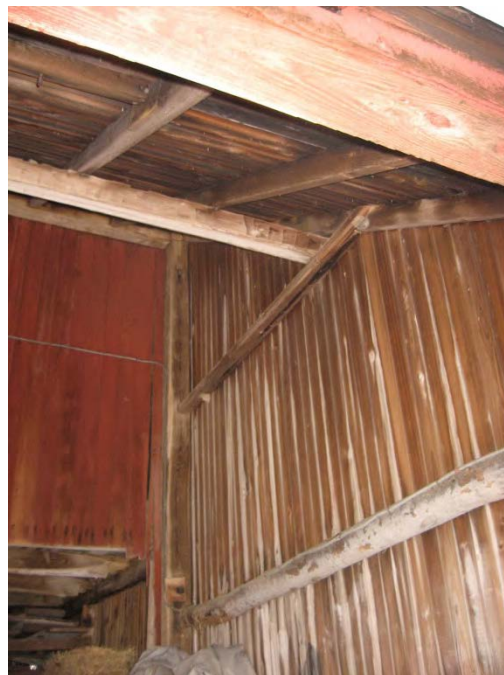
21. Interior view of Barn I south addition, showing recycled framing, camera facing northeast.
