HISTORIC RESOURCES INVENTORY - BUILDING AND STRUCTURES

Building Name (Common) Russell Farmstead / Hill Top Farm Record No. 5116
 Building Name (Historic) Russell, Daniel, Farmstead
 Street Address or Location 20 Round Hill Road
 Town/City Bethany Village _____ County New Haven
 Owner(s) Bethany Historical Society, 512 Amity Road, Bethany CT 06524 Public Private

HISTORIC RESOURCES INVENTORY FORM – BUILDING AND STRUCTURES continuation sheet

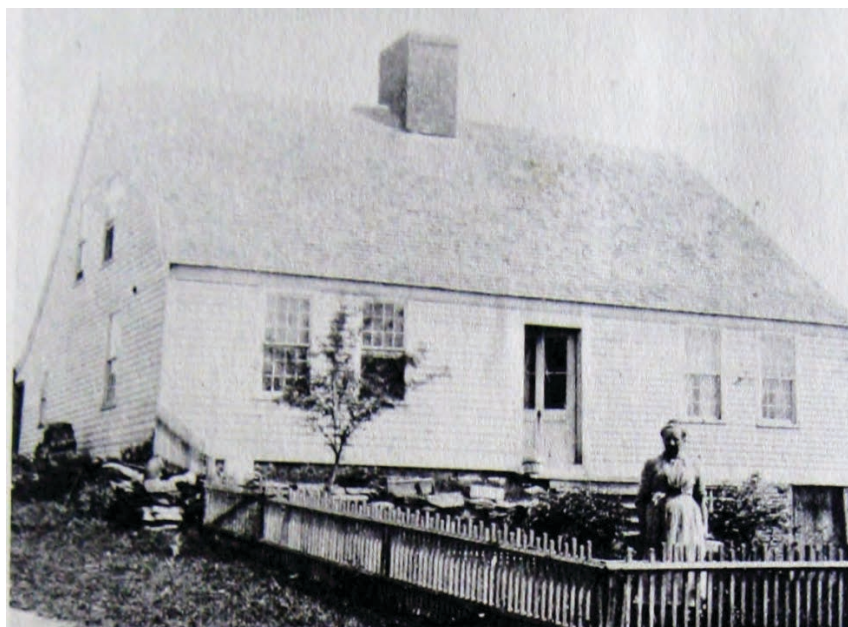
During Arthur and Olive's ownership, the central chimney mass was removed and the front door moved from the center to the present location. The original windows in the house were apparently replaced after 1900, as indicated by a historic photograph (Bunton). The replacement two-over-two sash are typically Italianate style 19th-century materials, and since some of the same windows appear in the bus garage bay of the barn, perhaps the Russells "modernized" with recycled second-hand windows, re-using them for the house and barn.

4. Southeast view, c. 1900 photograph (Bunton), showing original window sash, door, and center chimney.

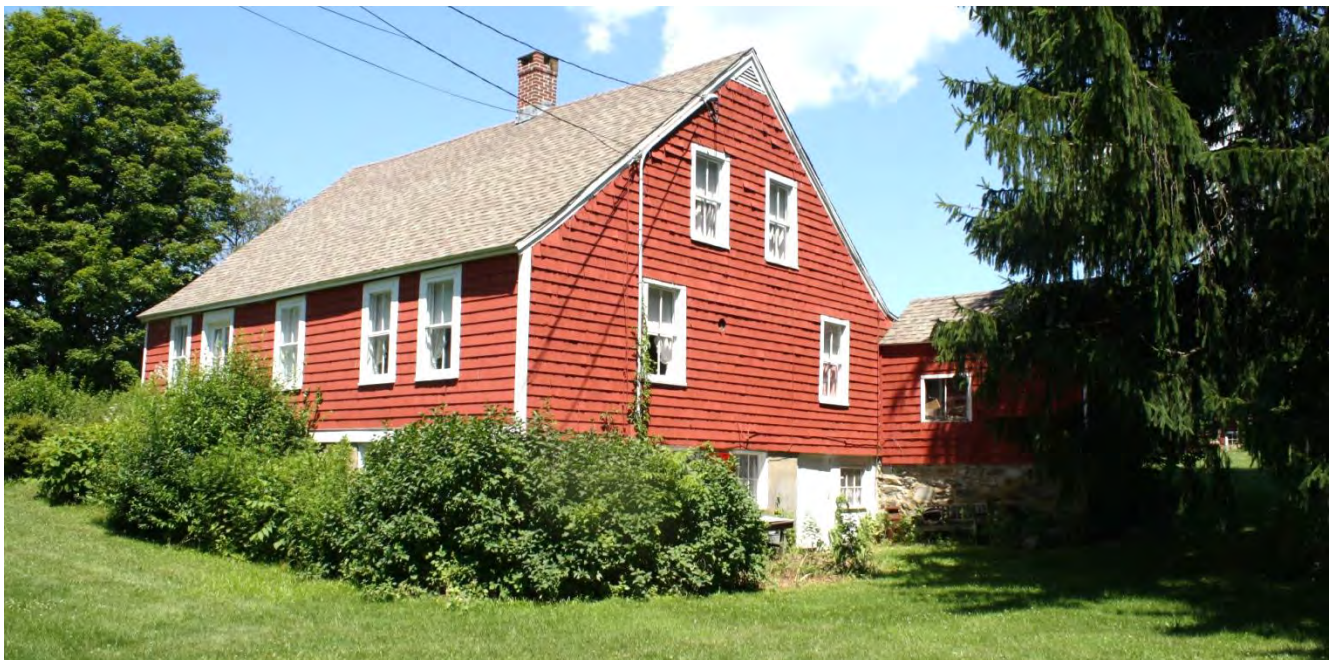
6. Southeast view of Farmhouse, camera facing northwest. Note basement access in east end and well room at right.

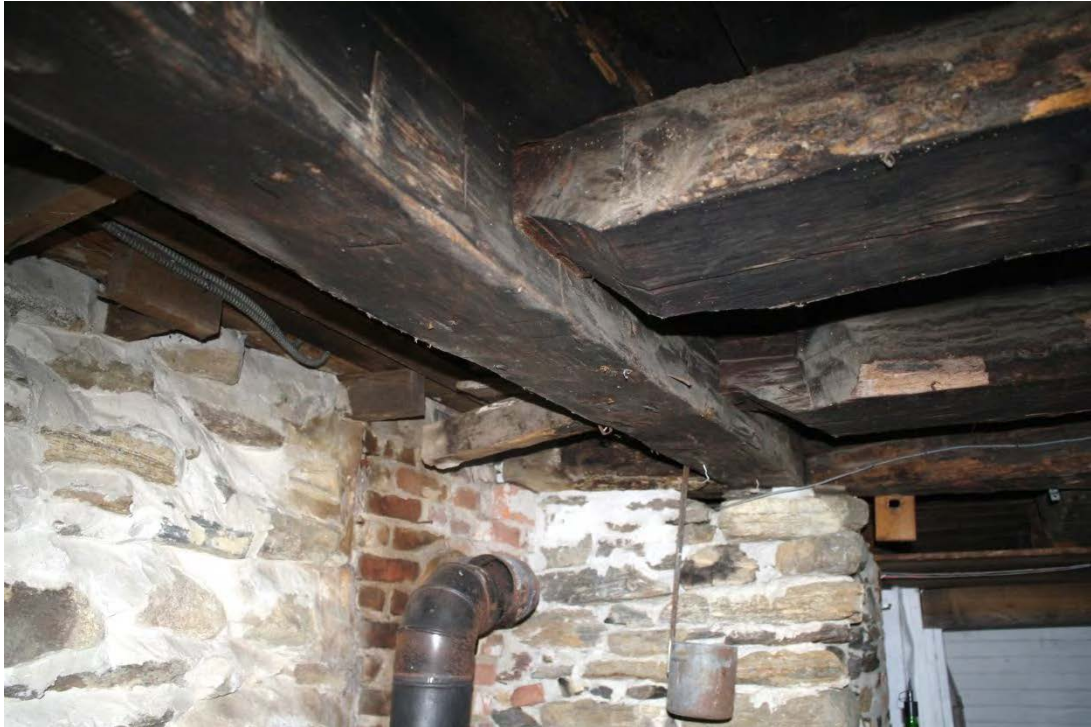
The Farmhouse interior formerly had a center chimney mass, but most of it was removed in the early- or mid-20th century. The interior layout consists of two parlors at the south side with a narrow room between, formerly the entry hall or porch. To the north, the northwest corner was historically a burning room, the northeast room is the kitchen, and a bathroom and pantry are located at the center. The house is of post-and-beam construction, though significantly modified by the removal of the chimney mass and installation of central heat. The eastern part of the basement was used as a summer kitchen and for canning. The current owners have been restoring it as a house museum, to a pre-World War II period.

9. Detail view of basement showing the east side of the remnant chimney base and first floor framing, camera facing northwest.

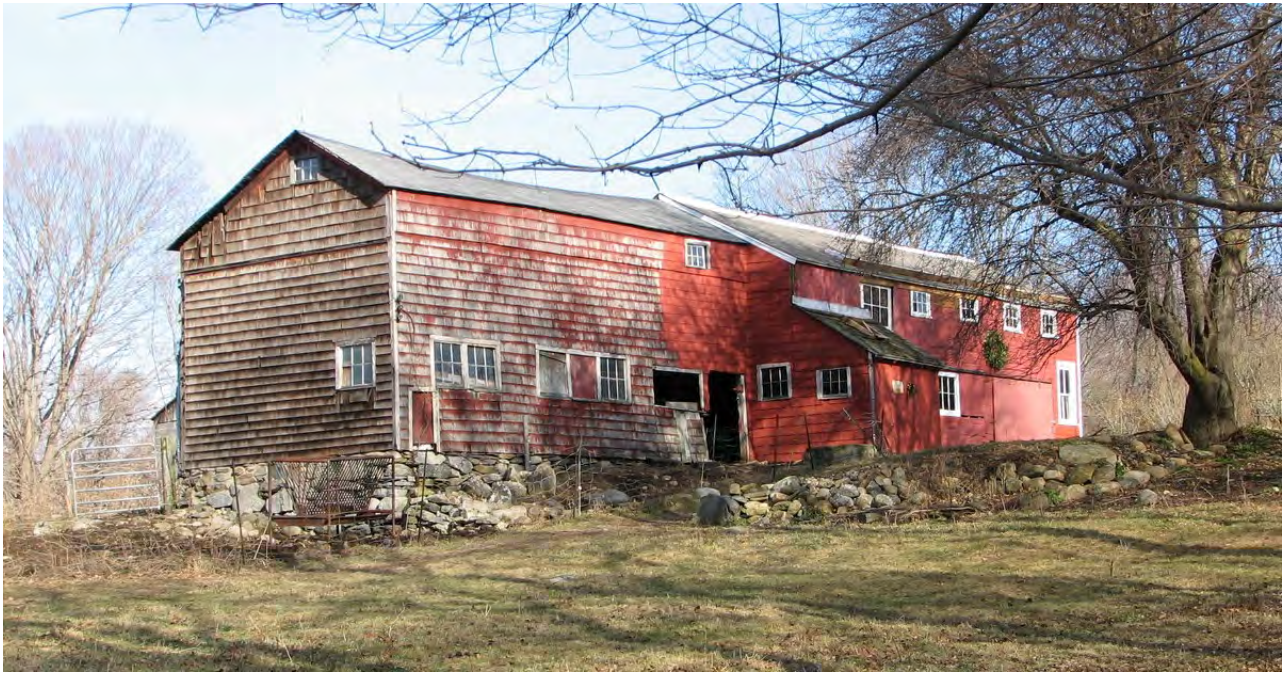
This is a 1 ½-story three-bay eave-entry English barn with several additional bays added to the east end, the easternmost being a school bus garage. The ground level of the western three-bay block has been adapted to use as a dairy cow stable, with the upper loft level remaining as a hay loft. The original frame is obscured on the interior but is visible from inside the hay loft.

15. Southwest view of Barn I, camera facing northeast. The shingled section is the three-bay English barn; to the right are later additions.

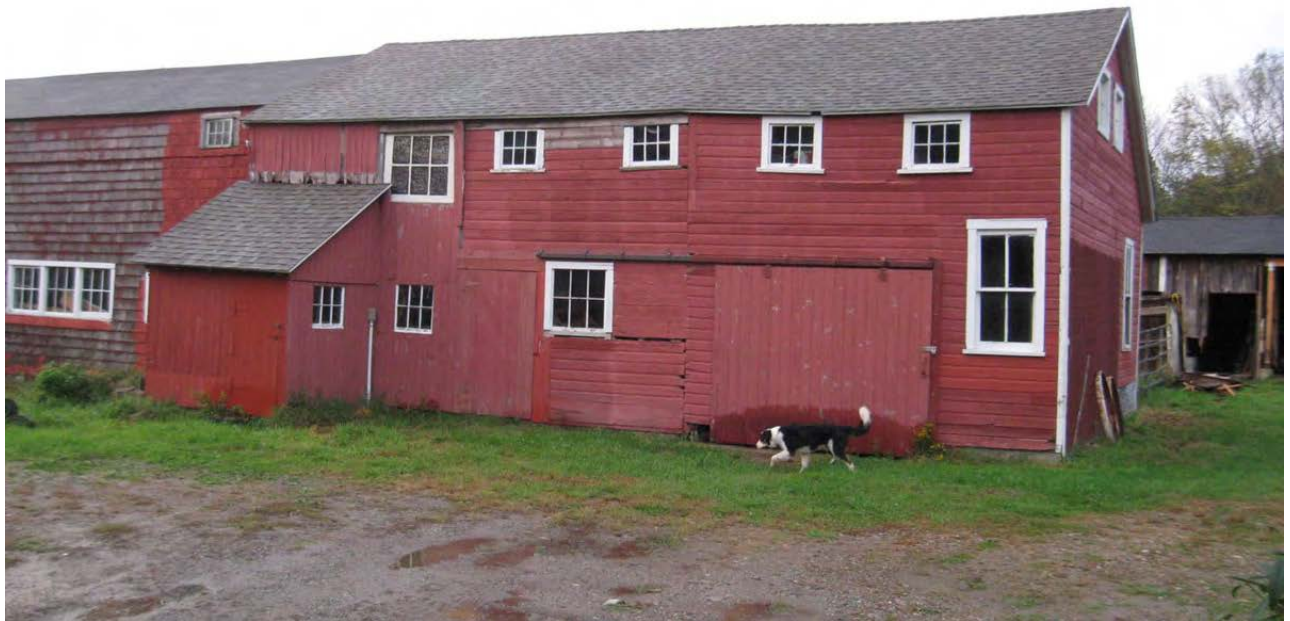
The east portion of the barn appears by the deflections in the roof line to consist of three bays. The left (west) bay is largely encompassed by the milk room addition but also had, prior to recent repairs, a small stable window at the ground level (replaced by a larger sash) and a large six-pane window at the loft level (removed). To the right the next bay has a hinged pass-through door and a six-pane stable window. The rightmost (eastern) bay has a sliding barn or garage door and to the right a two-over-two double-hung window matching those of the Farmhouse. The two righthand bays have at the loft level a row of four six-pane windows just under the eave line. Siding was formerly a mix of vertical boards on the milk room bay and horizontal lap siding on the right two bays. During rehabilitation horizontal siding has been installed across all three bays and the discontinuities that indicated construction of each bay as an addition, are less noticeable.

16. South view of Barn I, camera facing north. View prior to rehabilitation work shows different siding on each bay, indicating different times of construction. The projecting addition was the milk room.

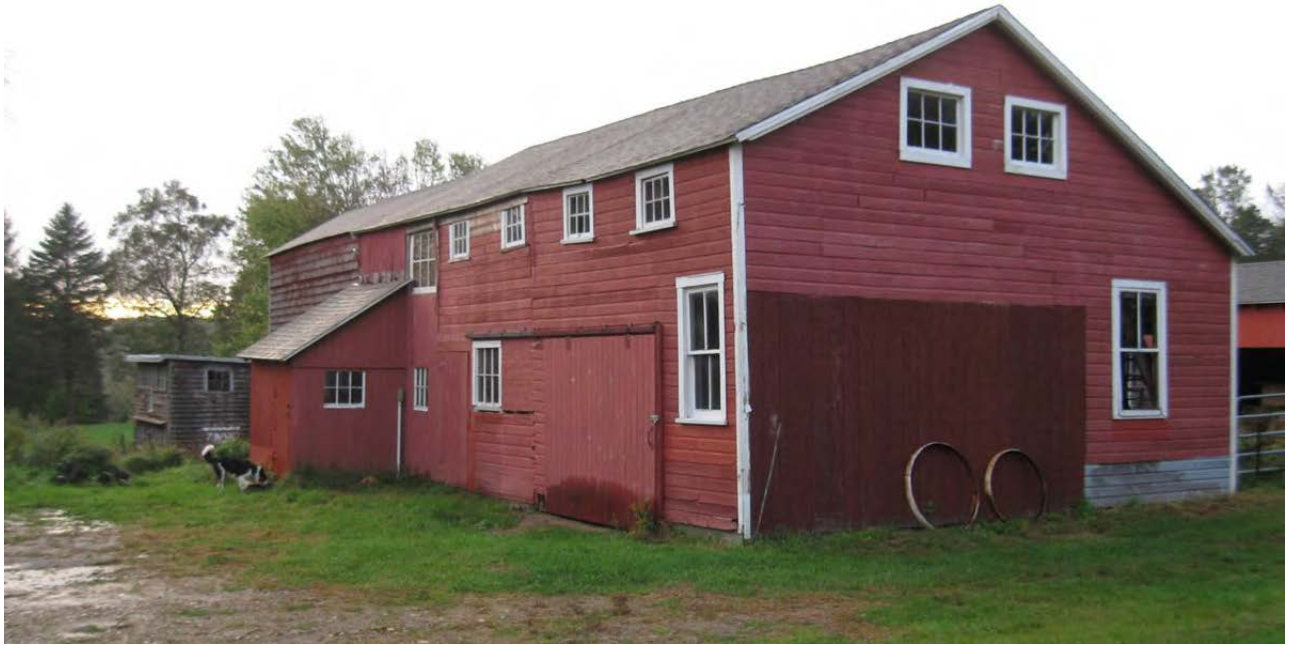
17. Southeast view of Barn I, camera facing northwest. View prior to rehabilitation work.

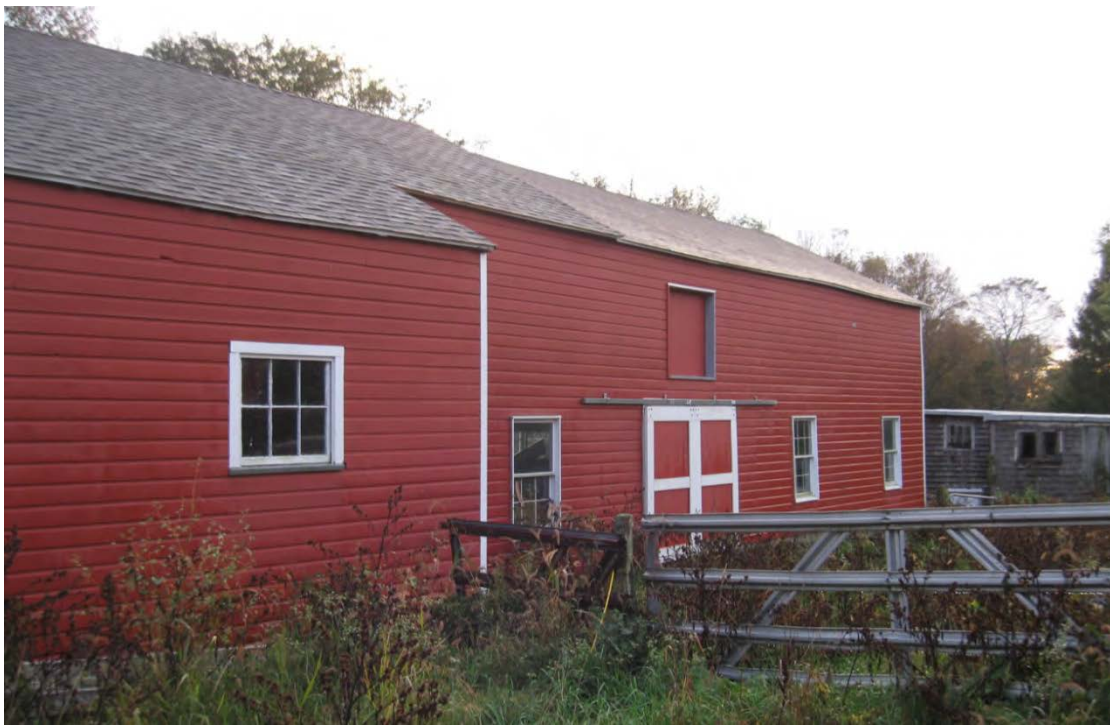
18. North view of Barn I, camera facing southwest. View after rehabilitation work. Coop III is at right rear.

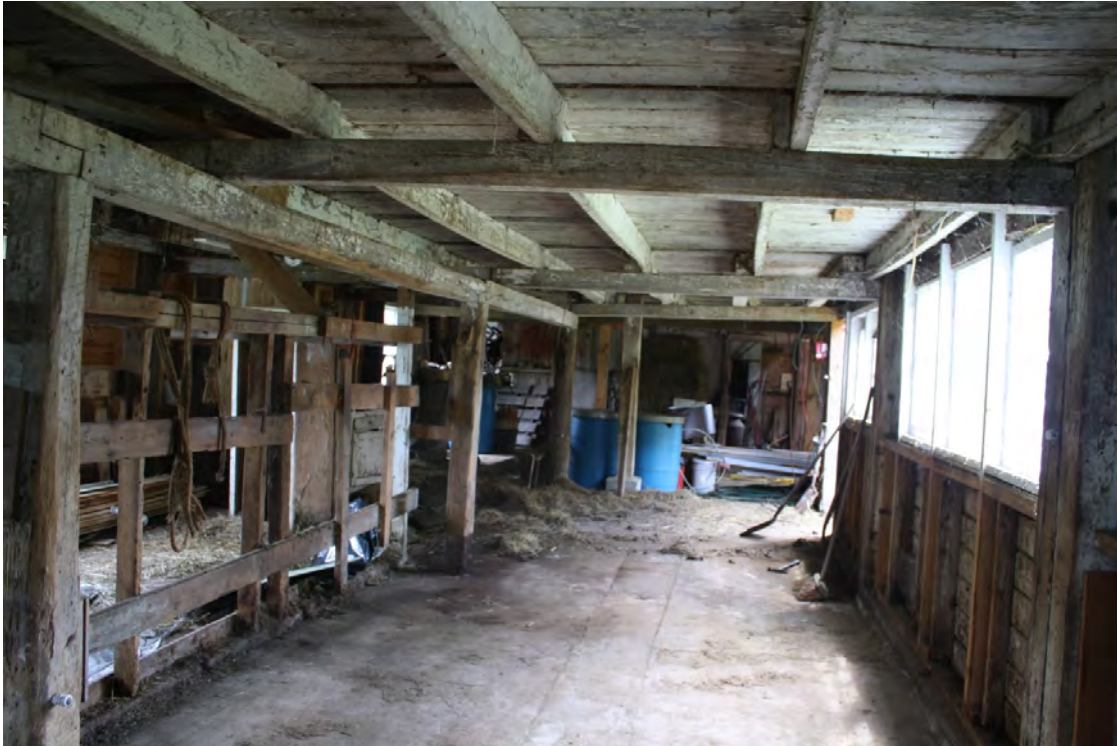
north and south walls. Floor joists for the loft level run longitudinally (east-west). The structure at the ground floor has traces of whitewash, the concrete floor indicates the location of a manure gutter running east-west parallel to the south wall, and there are remains of wood stanchions between the central posts – all indicate occupancy by dairy cows in a single row facing north.

19. Interior view of Barn I ground level, camera facing east, showing structural alterations for dairy stable use.

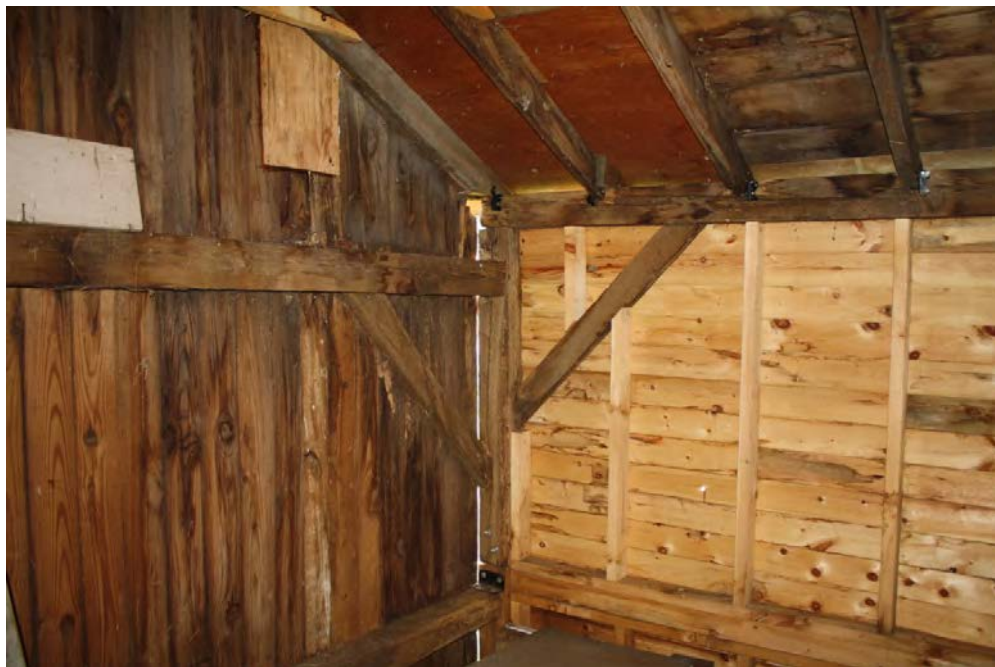
At the loft level older post-and-beam framing is visible, including square rule framing, dropped tie-girts with a single central post at each bent (truncated at the floor level and carried by the longitudinal girder below), and pegged mortise and tenon joints. Timbers bear the straight saw kerf marks of a water-powered sash saw. In the north wall at the northeast corner of the three-bay frame, a double post and discontinuous plate show that the western three-bay barn must have had another post-and-beam structure added on to extend it eastward. Further east, the added bays are constructed of balloon framing with sawn dimension lumber. Common rafters are of sawn dimension lumber. Recent repairs have been made with locally-sourced lumber sawn to match the dimensions of the old material. Structural reinforcement with modern technology including hurricane clips, has been inserted during rehabilitation work.

20. Interior view of Barn I loft level, camera facing northwest. View after rehabilitation work shows replacement framing, collar ties, and hurricane clips added to existing post and beam frame with dropped girt. Note left side has vertical board sheathing with wood shingle siding while right (north) wall has replacement horizontal lap siding.

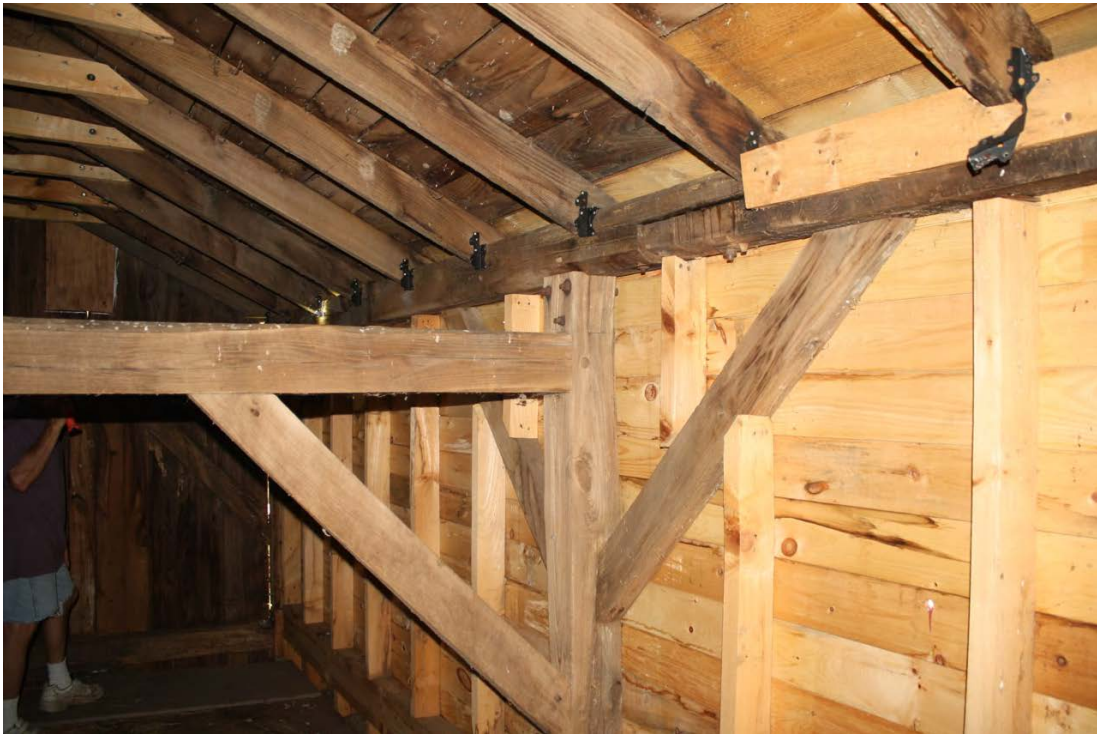
21. Interior view of Barn I loft level, camera facing northwest, showing interior bent with dropped tie girt.=.

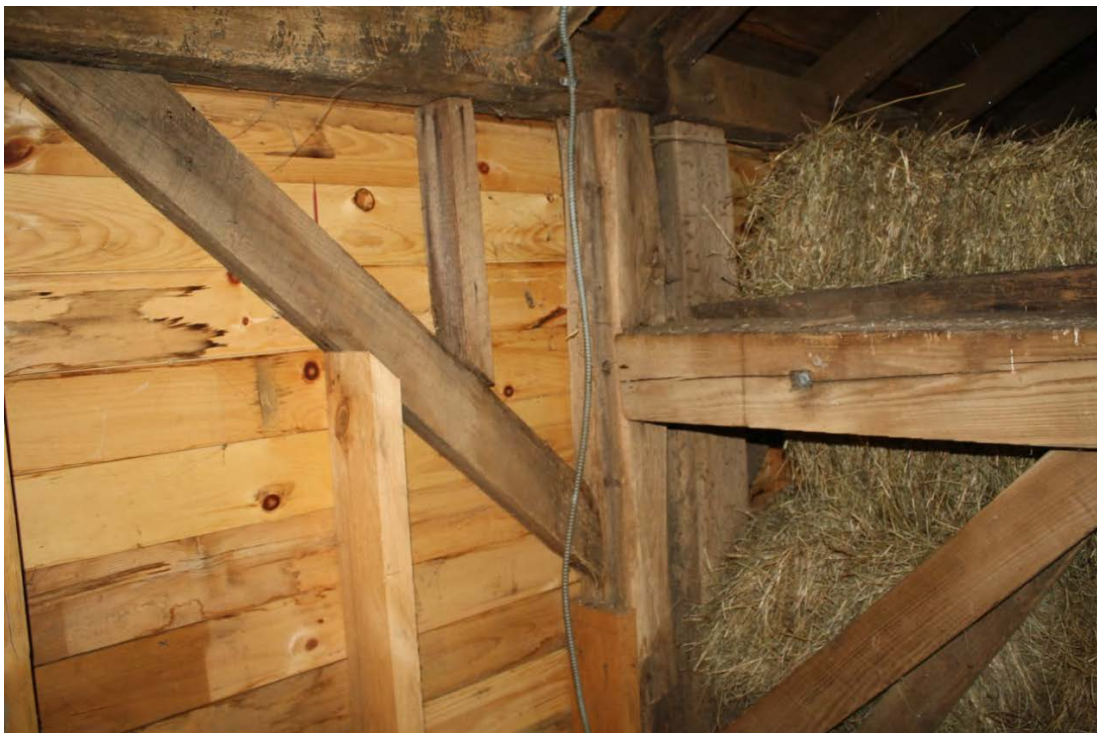
22. Interior view of Barn I loft level, camera facing northeast. This is the easternmost bent of the three-bay English barn frame; note the double post, evidence of a second post and beam frame erected adjacent to the east end of the first frame. Only part of this frame appears to be extant.

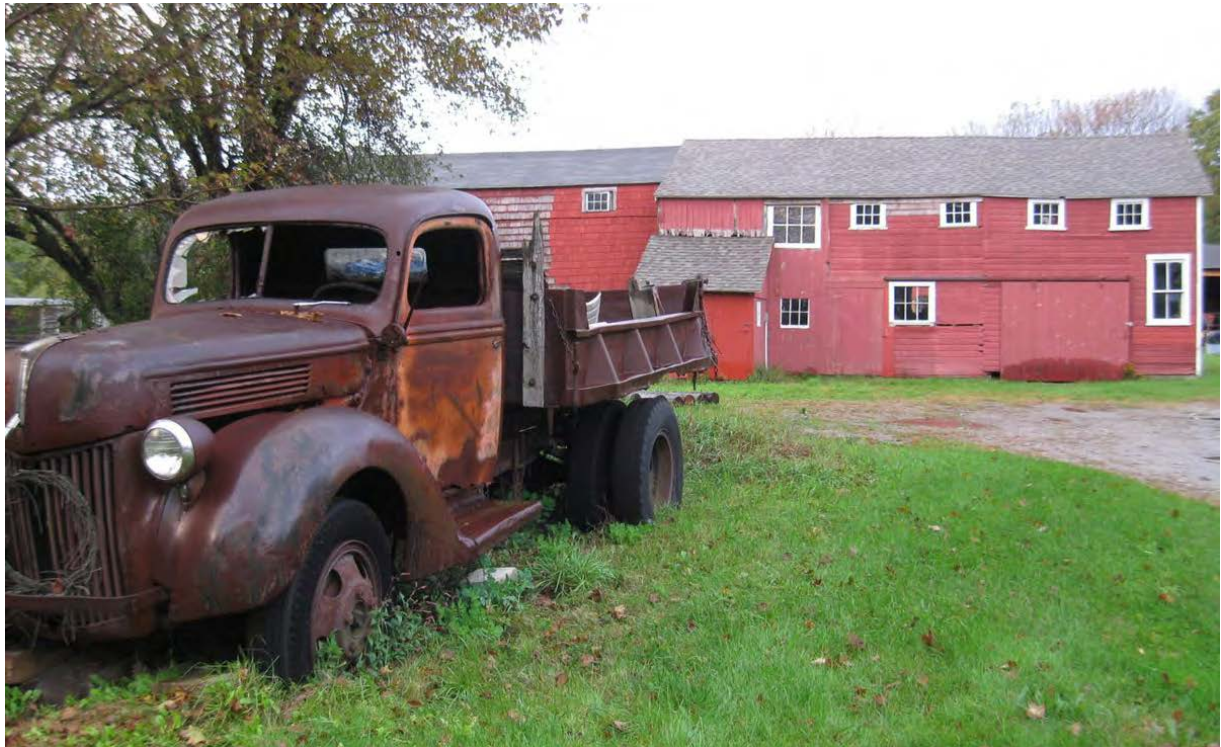
26. South view of Barn I from Round Hill Road, camera facing north, prior to rehabilitation work.
