HISTORIC RESOURCES INVENTORY - BUILDING AND STRUCTURES

Building Name (Common) Brooks, William, Farmstead Record No. 27966
 Building Name (Historic) Brooks, William, Farmstead
 Street Address or Location 376 Academy Road
 Town/City Cheshire Village _____ County New Haven
 Owner(s) Valerie Joyce, 376 Academy Road, Cheshire, CT 06410 Public Private

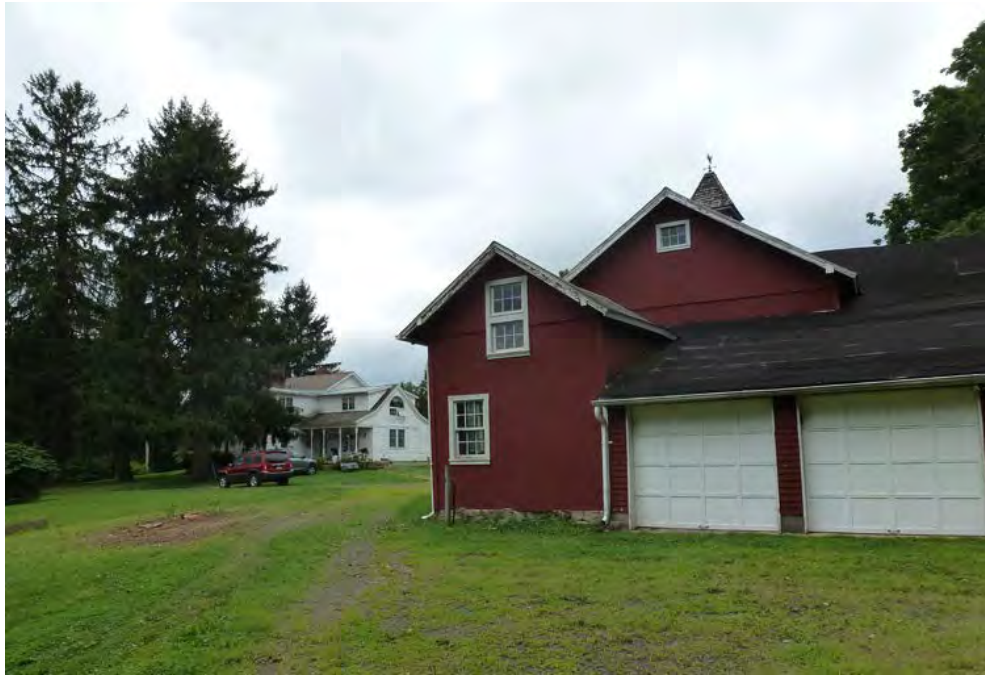
5. Northeast context view of Barn and Farmhouse, camera facing southwest.

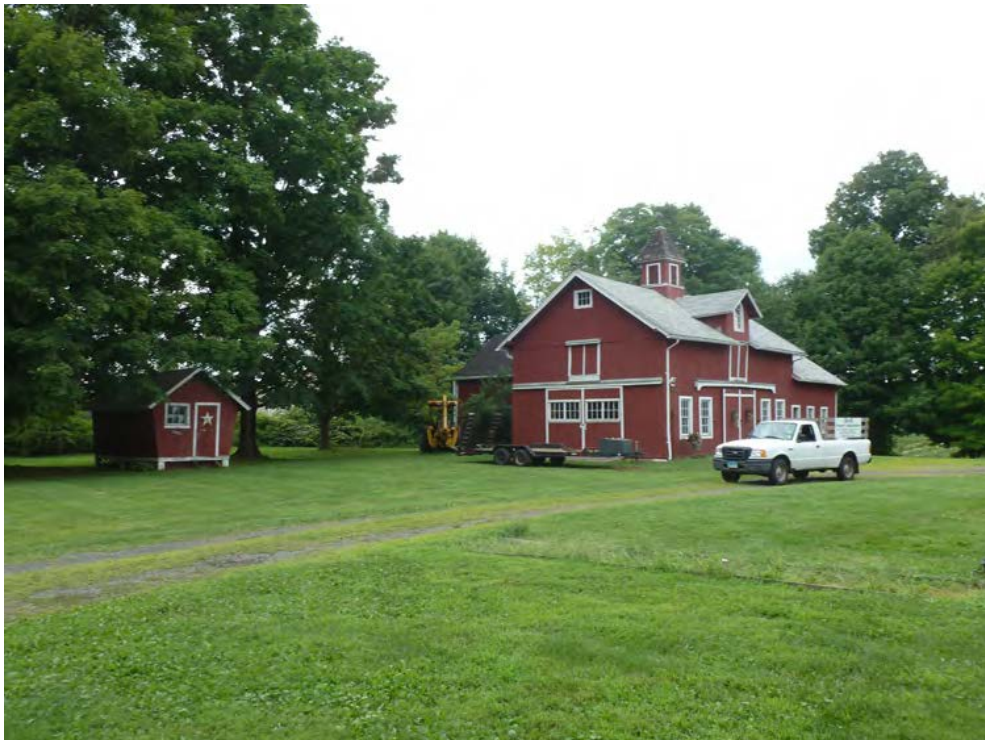
6. Southwest context view of the Corn crib and Barn, camera facing northeast.

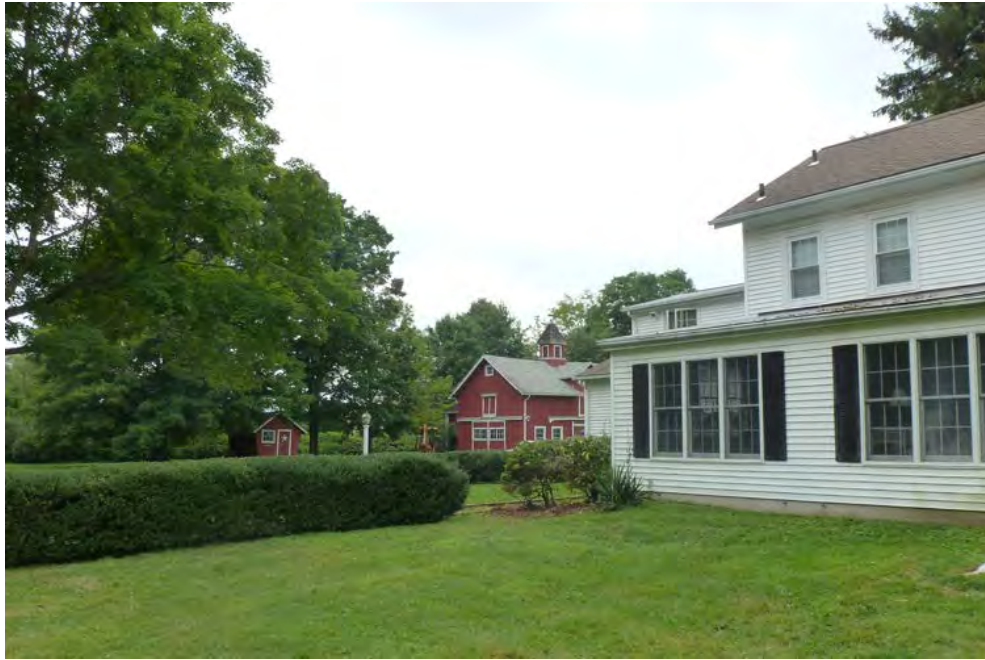
7. Southwest context view with the Farmhouse, Corn crib and Barn, camera facing northeast.

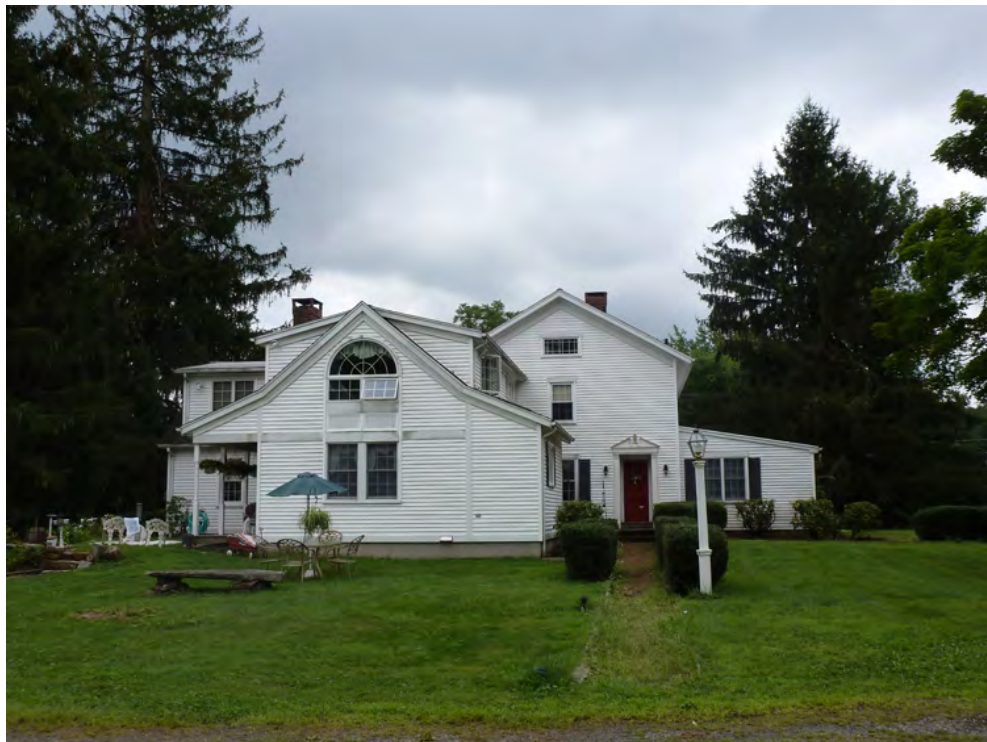
8. North gable-end (main façade) of the William Brooks Farmhouse, camera facing south.

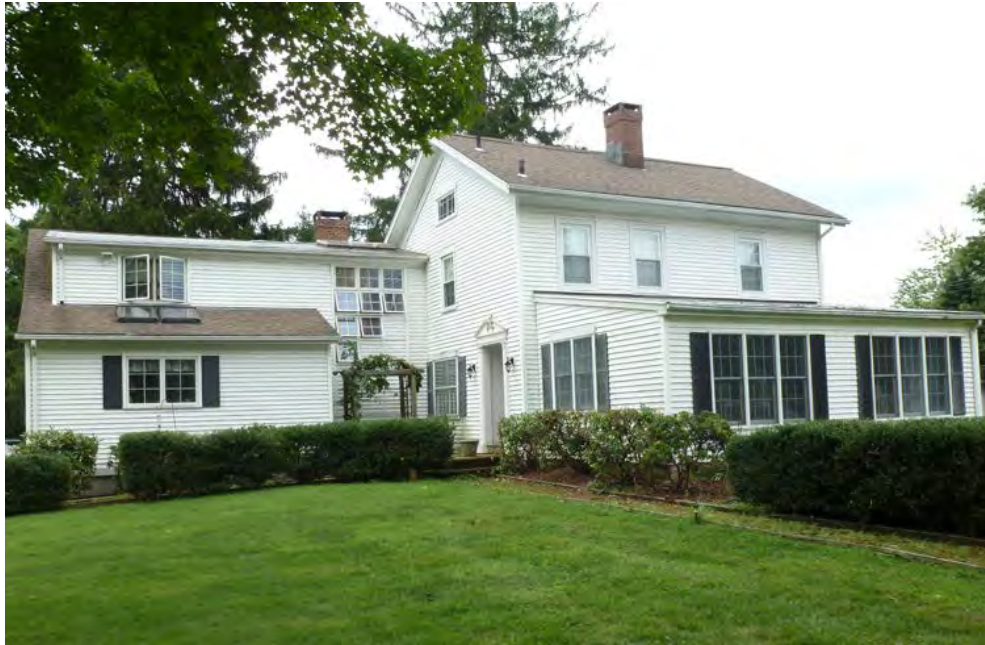
9. Northwest view of the north gable-end (main façade) and west eave-side of the William Brooks Farmhouse, camera facing southeast.

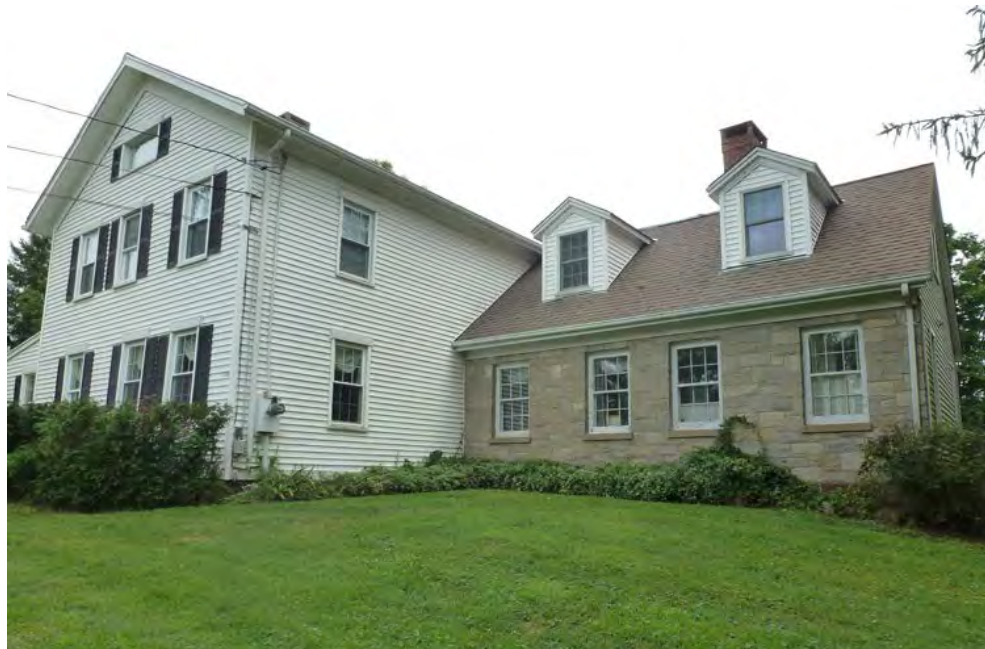
10. Southeast view of the south gable-end and east eave-side of the William Brooks Farmhouse; note the original c. 1790s wing of the house on the right. Camera facing northwest.

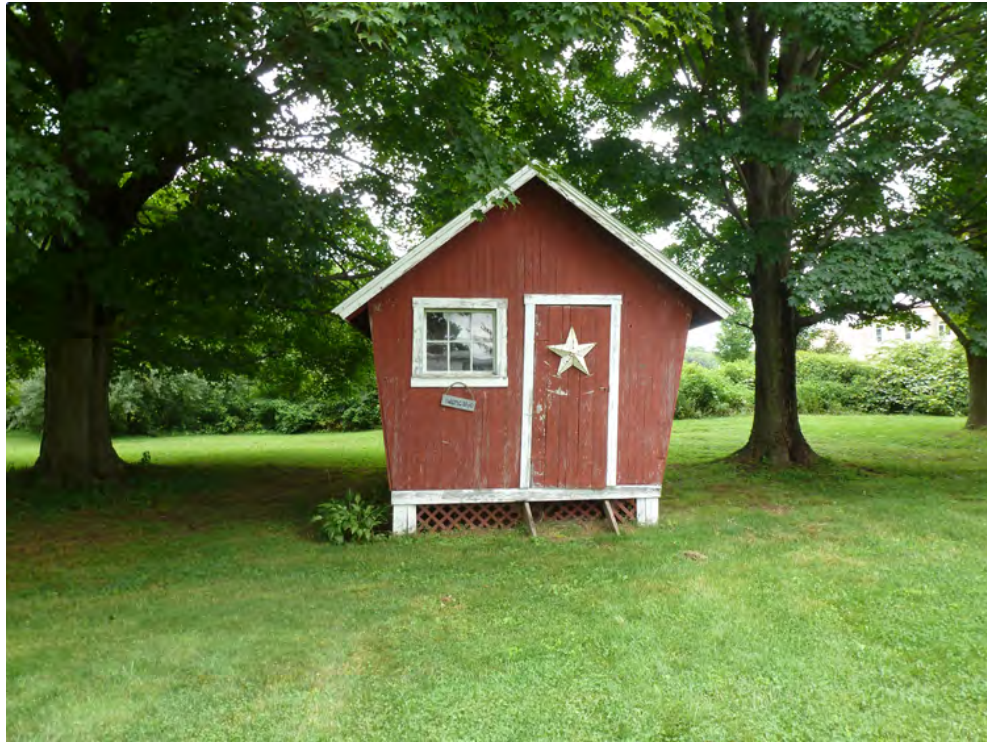
11. South gable-end of the Corn crib, camera facing north.

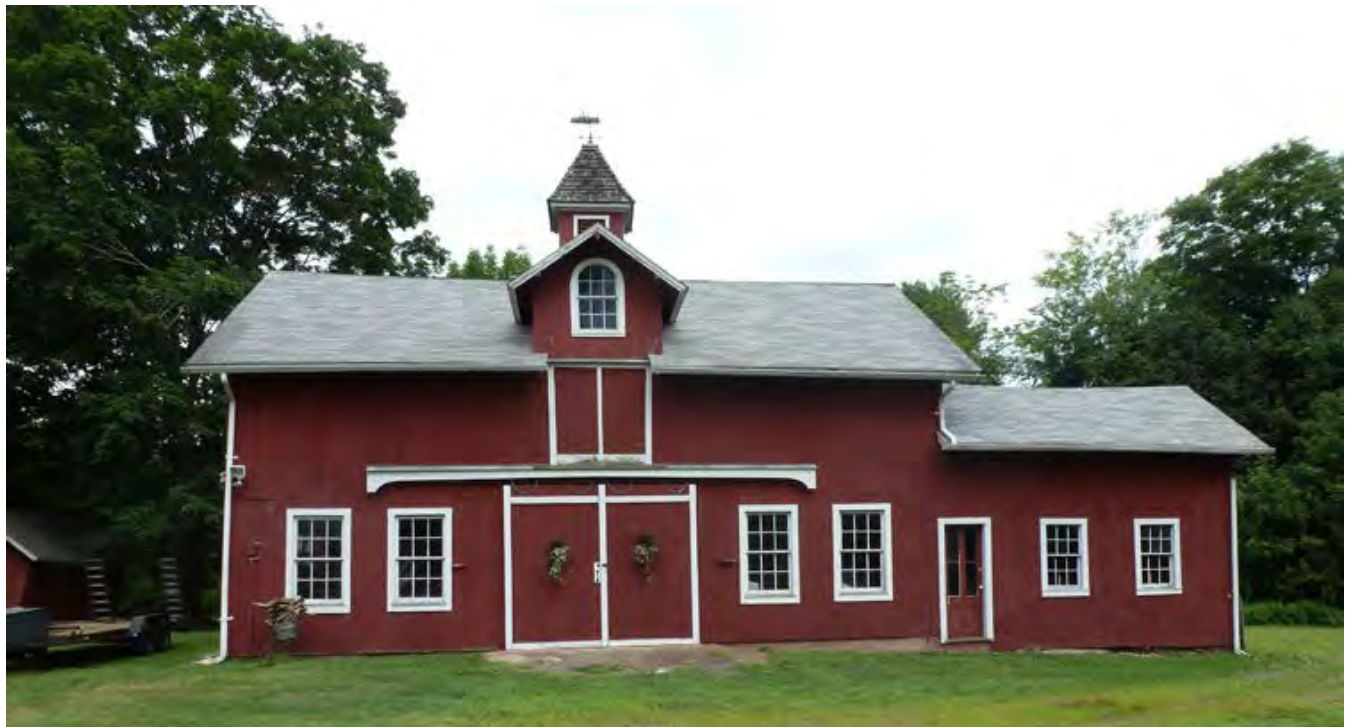
12. South eave-side (main façade) of the English barn and Addition I on the east, camera facing north.

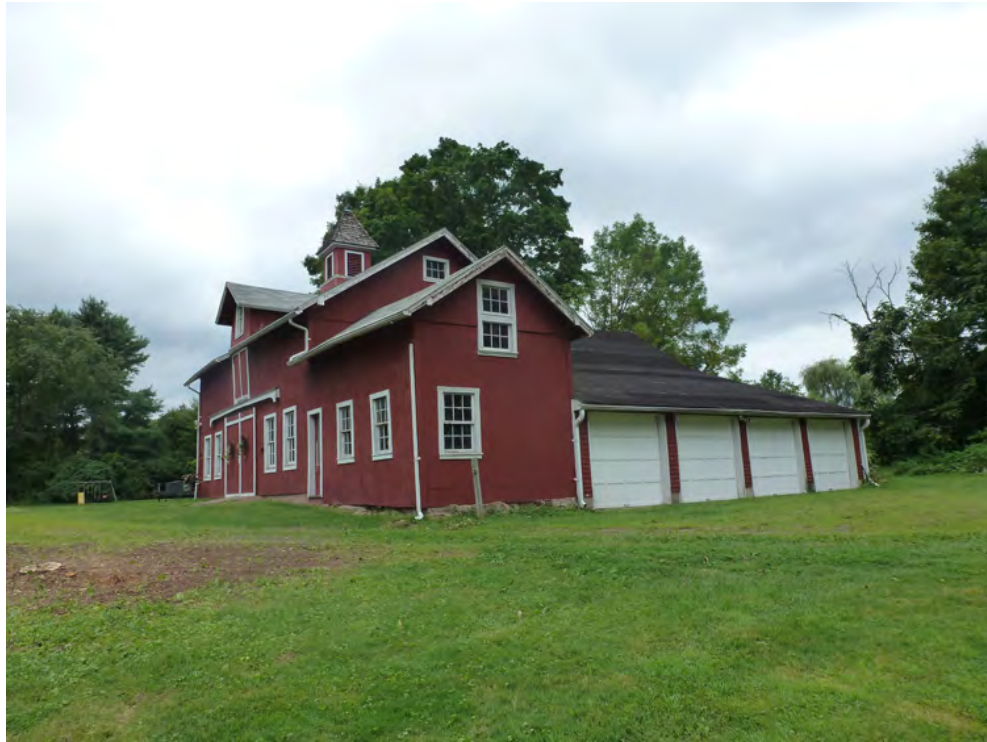
13. South eave-side of the barn and Addition I, east gable-end of the barn and Addition I and the east side of Addition II, camera facing northwest.

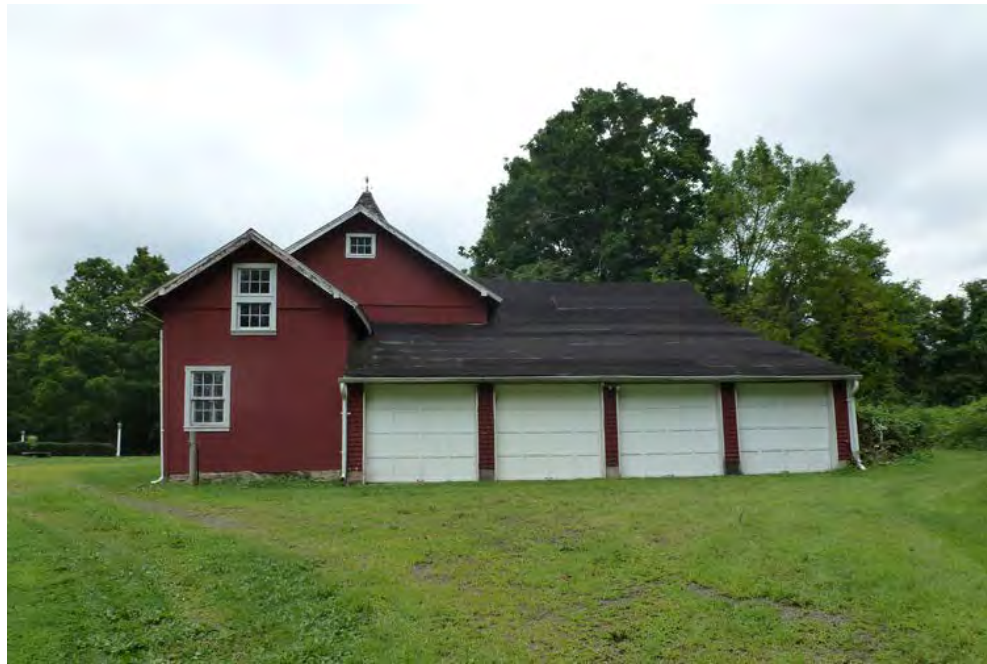
14. East gable-end of the barn and Addition I, east side of Addition II, camera facing west.

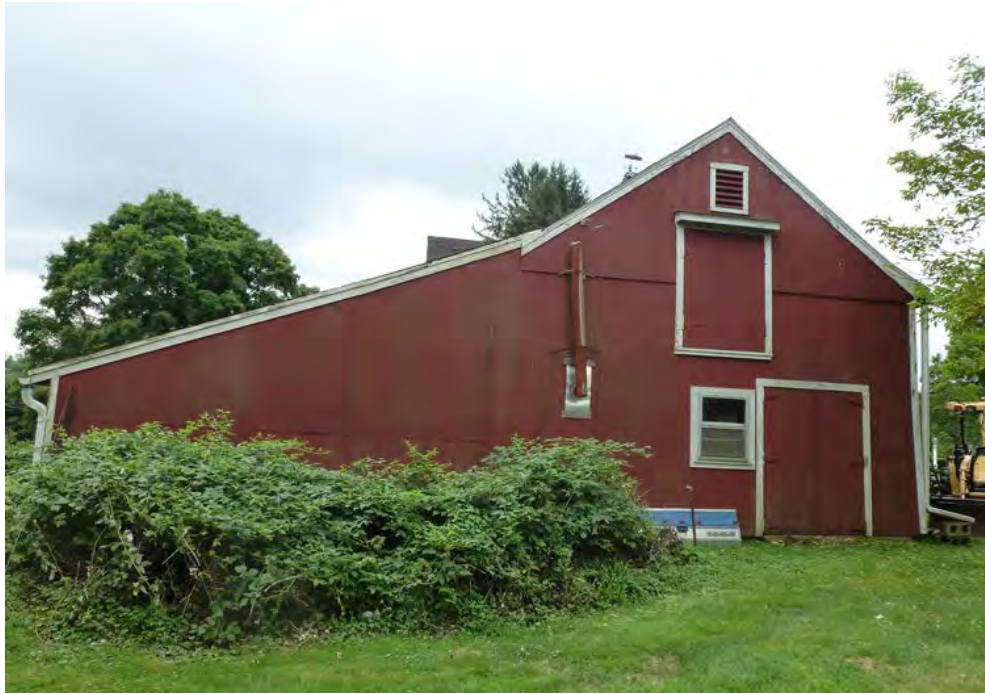
15. North side of Addition II and north gable-end of Addition III, camera facing south.

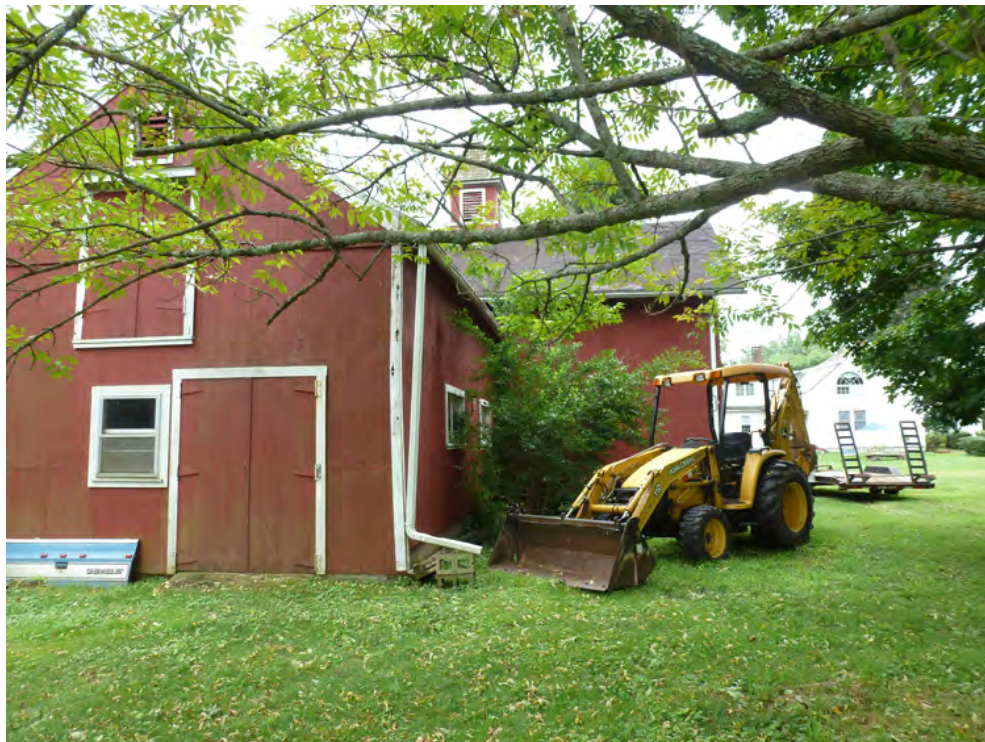
16. North gable-end and west eave-side of Addition III, north eave-side of the barn, camera facing south.

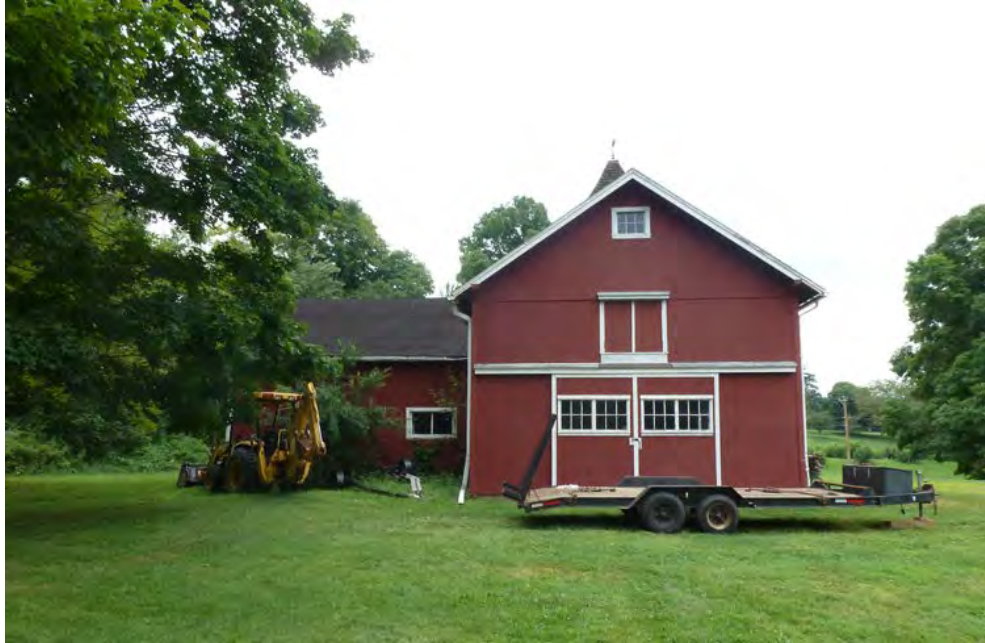
17. West eave-side of Addition III and west gable-end of the barn, camera facing east.

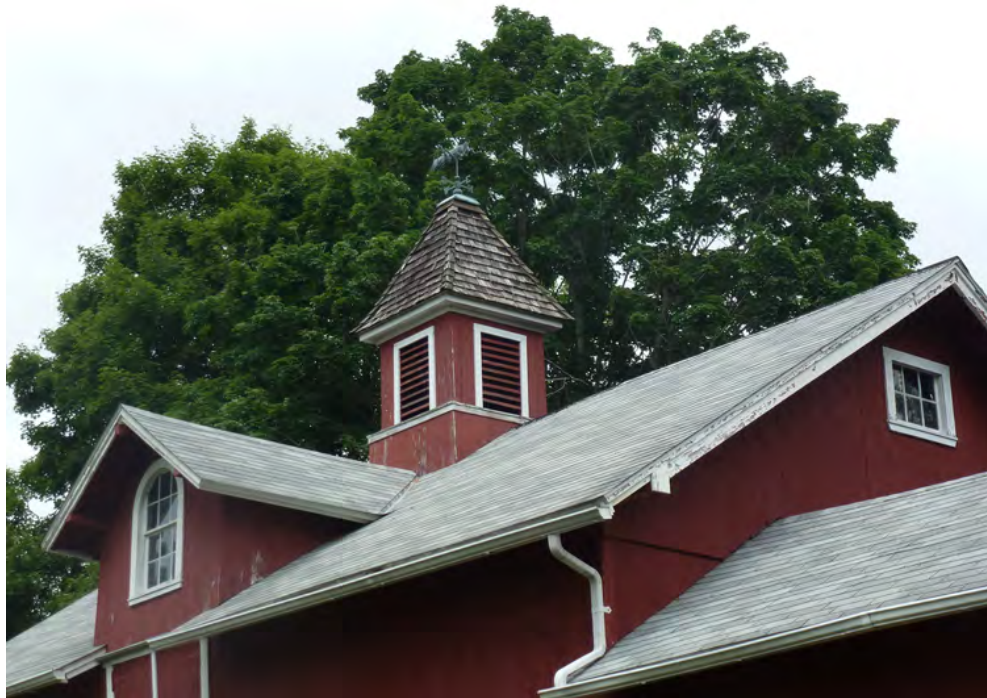
18. Detail view of the gable roof-dormer and the cupola, camera facing northwest.

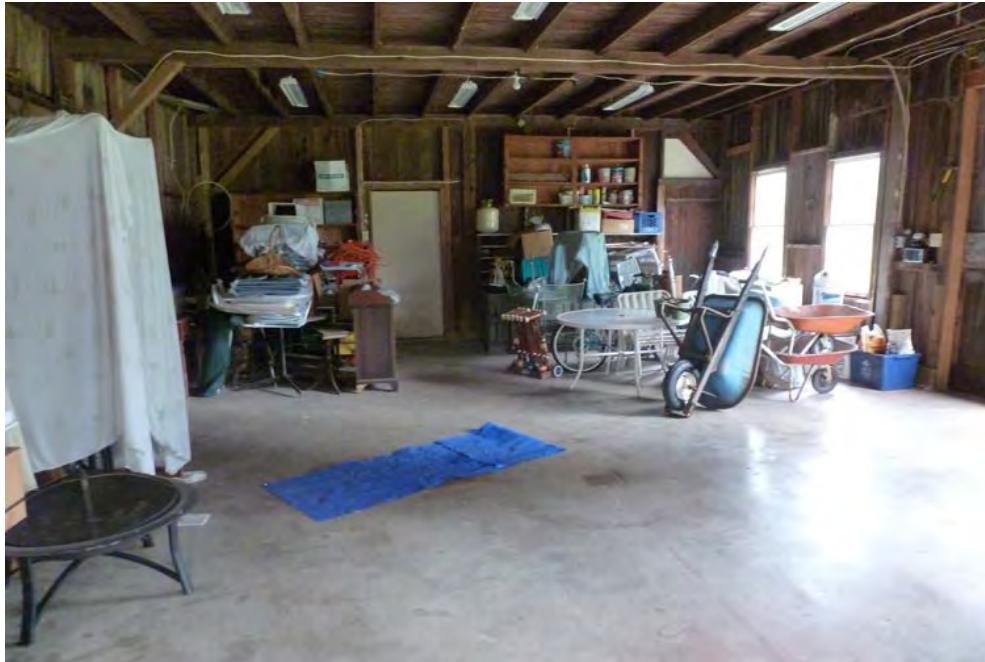
19. Interior view of the east half of the interior of the barn, camera facing east. Note the clear span without an interior post.

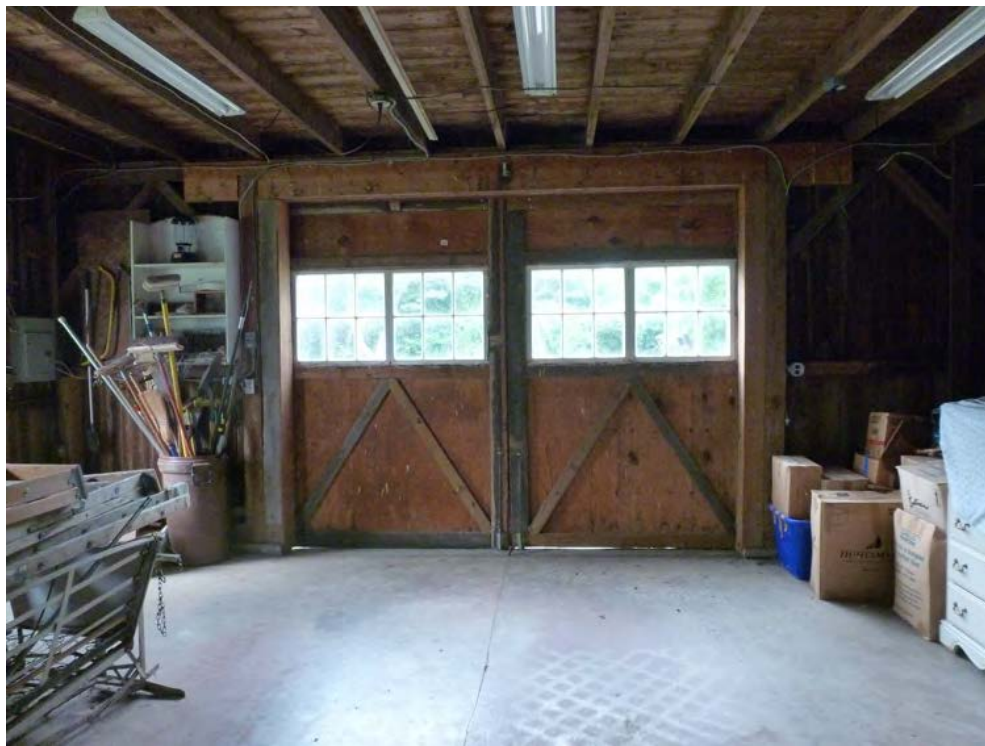
20. Interior view of the west half of the interior of the barn, camera facing west.

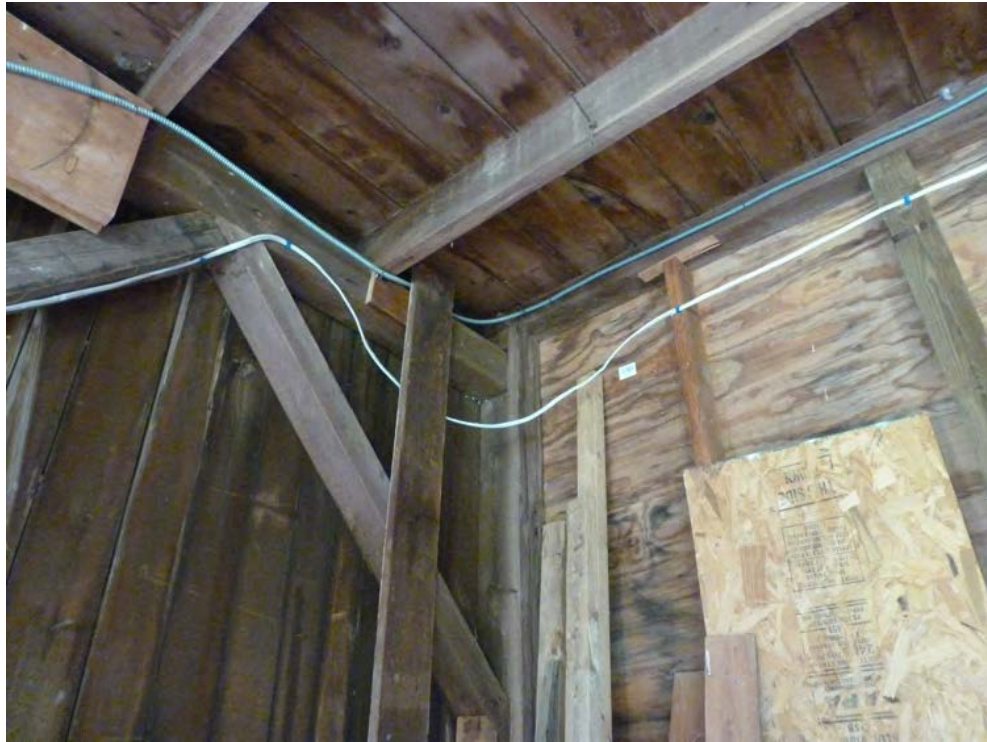
21. Interior view of the northwest corner of the barn, note the square rule post-and-beam framing, camera facing northwest.

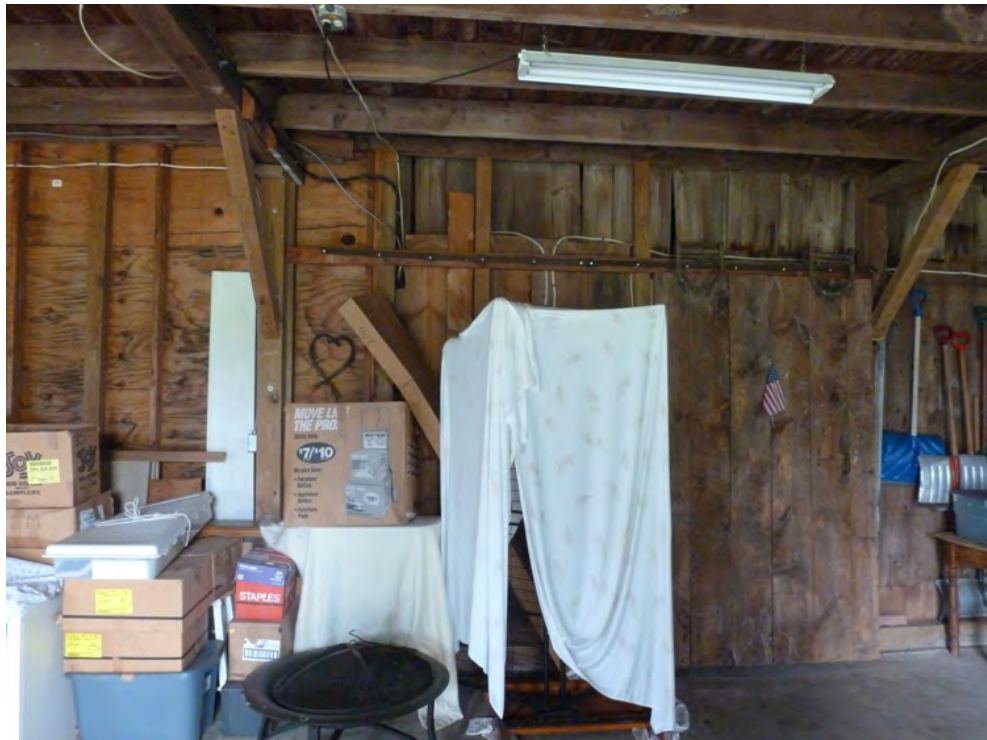
22. Interior view of the north wall of the barn, note the interior hung sliding door. Camera facing north.

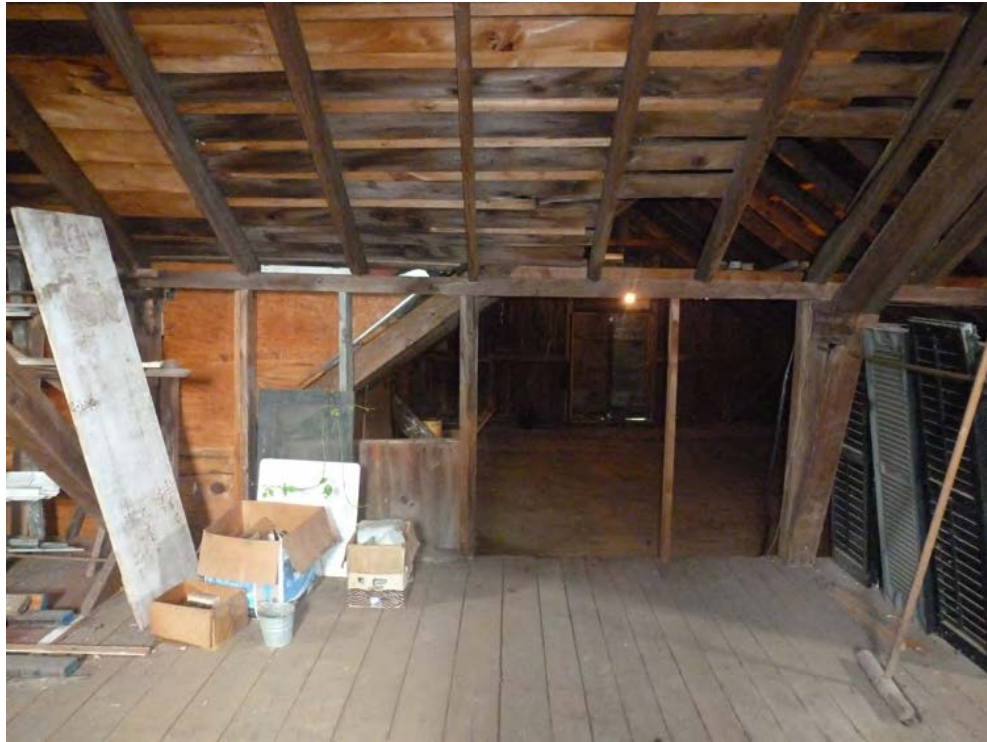
23. Interior view of the north side of the second floor of the barn, camera facing north.

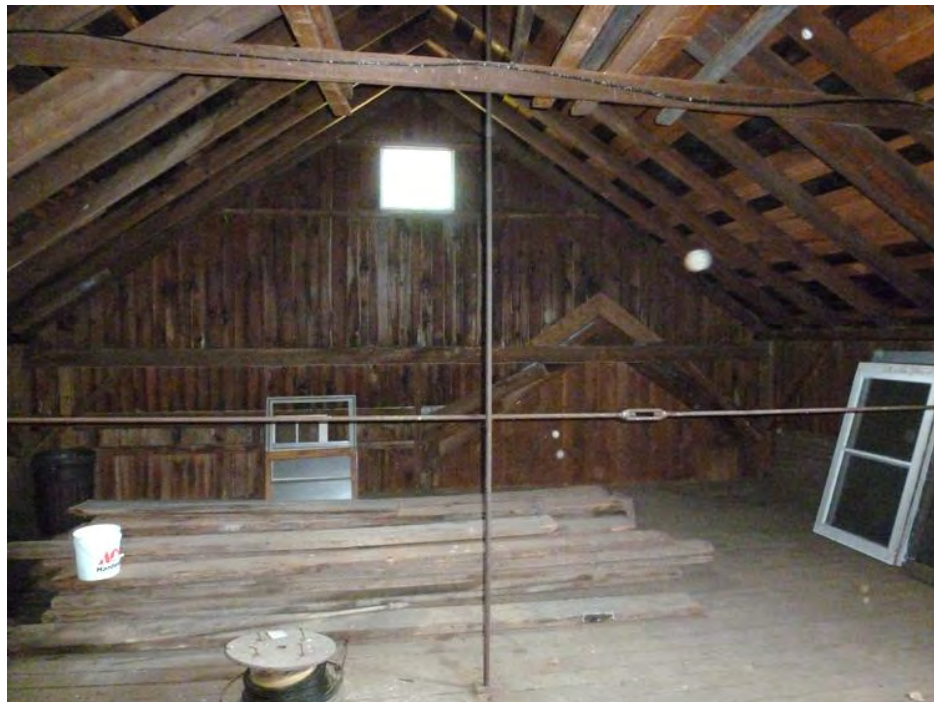
24. Interior view of the second floor east gable-end of the barn, camera facing east. Note the gable roof of Addition I intersection at far right rear.

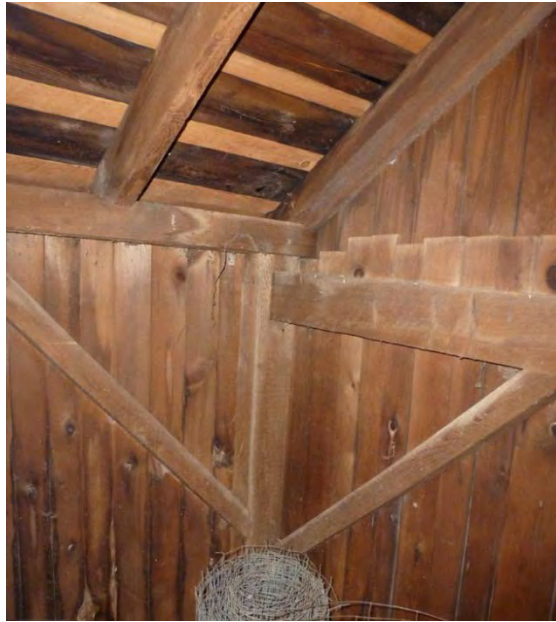
25. Interior view of the second floor northeast corner of the barn, note the post-and-beam framing. Camera facing northeast.

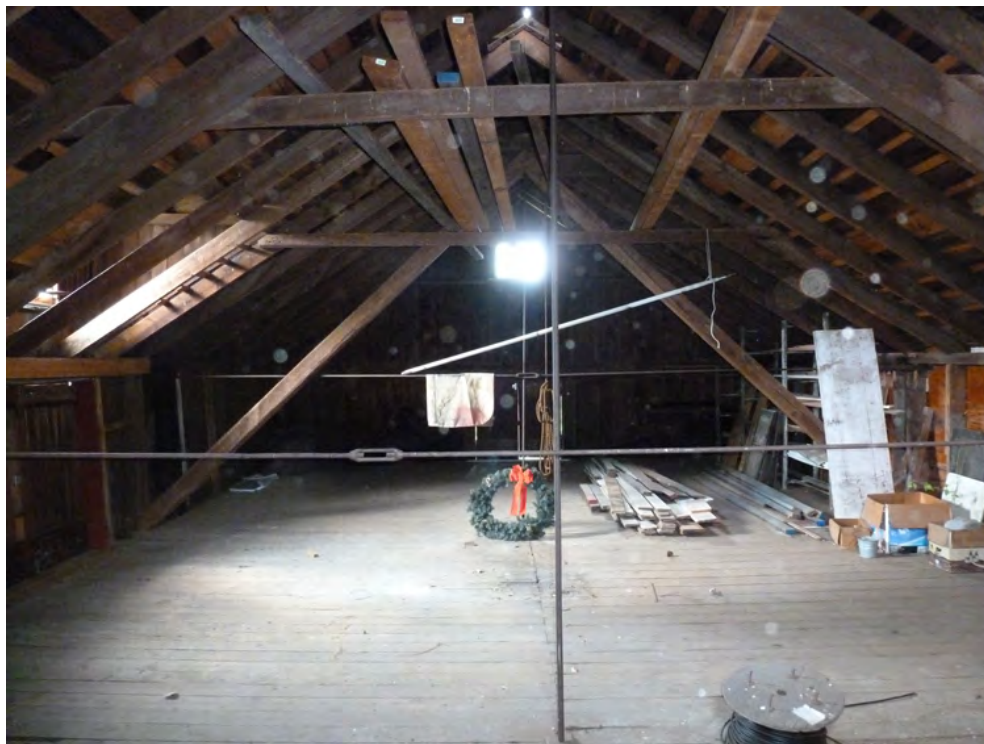
26. Interior view of the second floor west gable-end of the barn. Note the two sets of steel tension cables and the large diagonal truss frame helping to stabilize the barn and support the clear span below. Camera facing west.

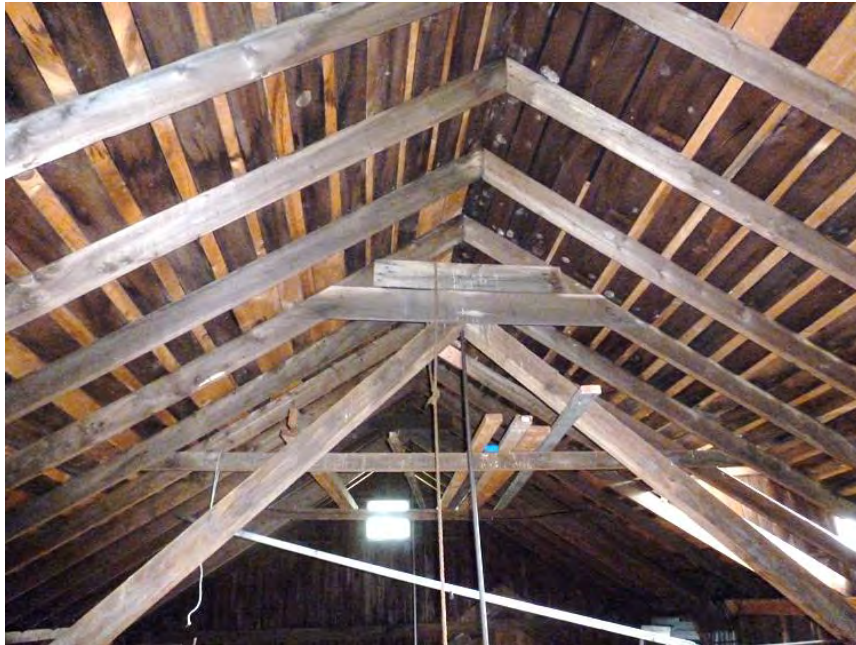
27. Interior view of the common rafters and roof deck of the barn, found on the second floor.

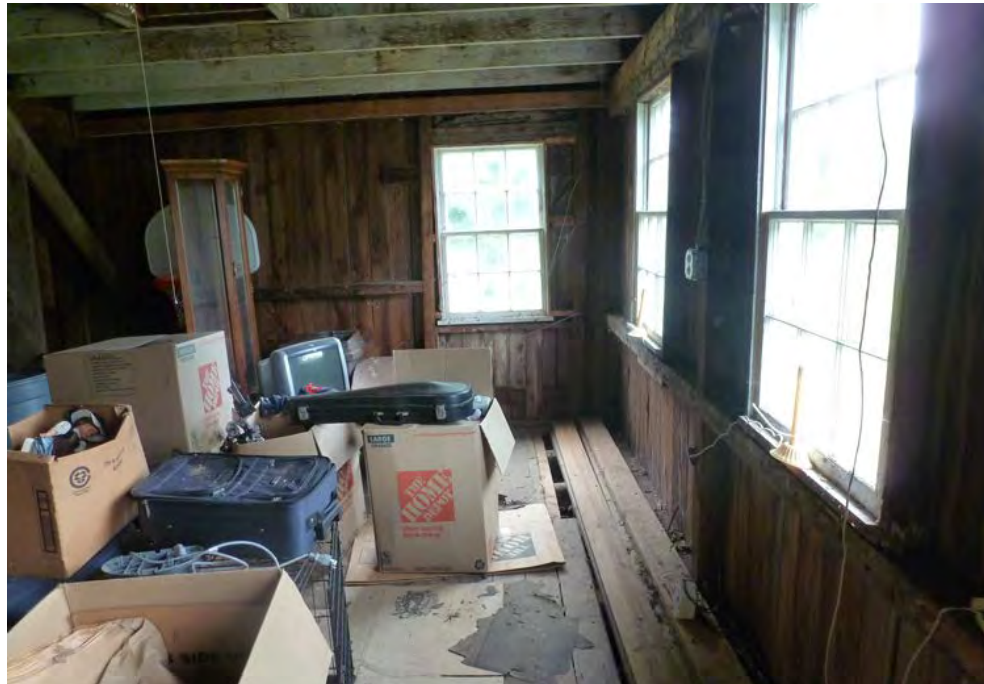
28. Interior view of the first floor of Addition I, camera facing east.

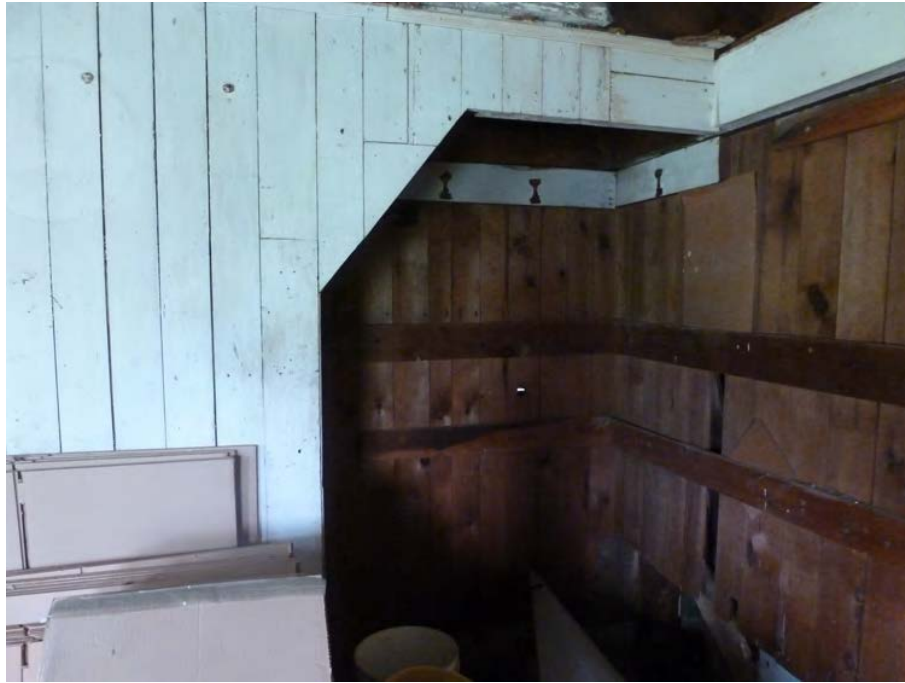
29. Interior view of the cubby behind the staircase in Addition I, camera facing northwest.

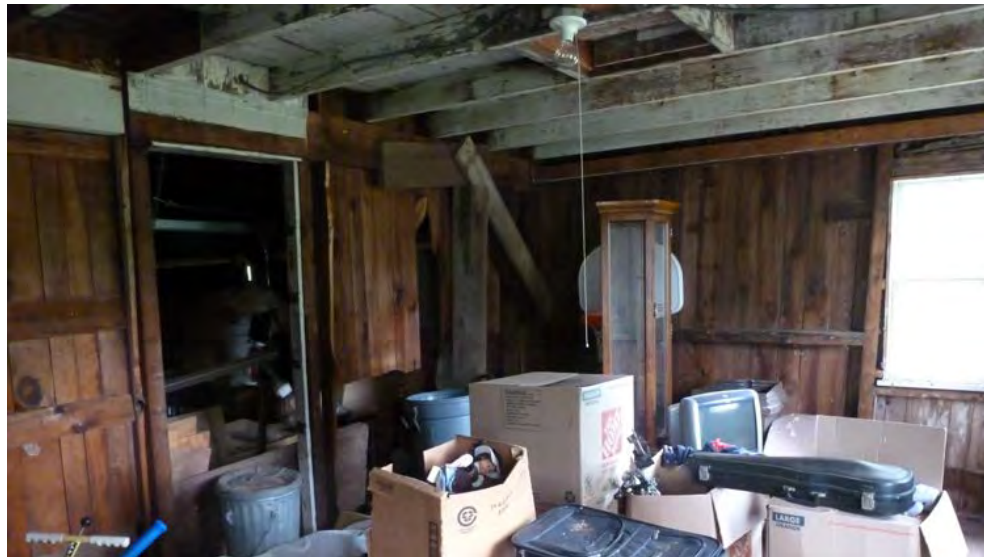
30. Interior view of Addition I, note the open doorway that leads into Addition II, camera facing northeast.

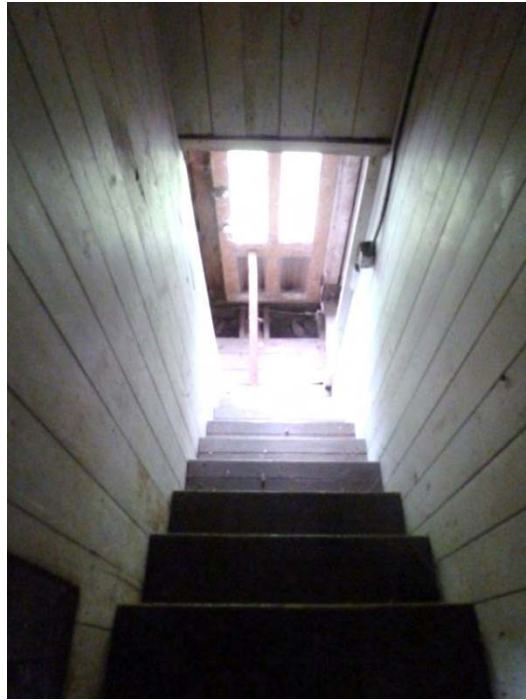
31. Interior view of the enclosed staircase that leads the second floor of Addition I.

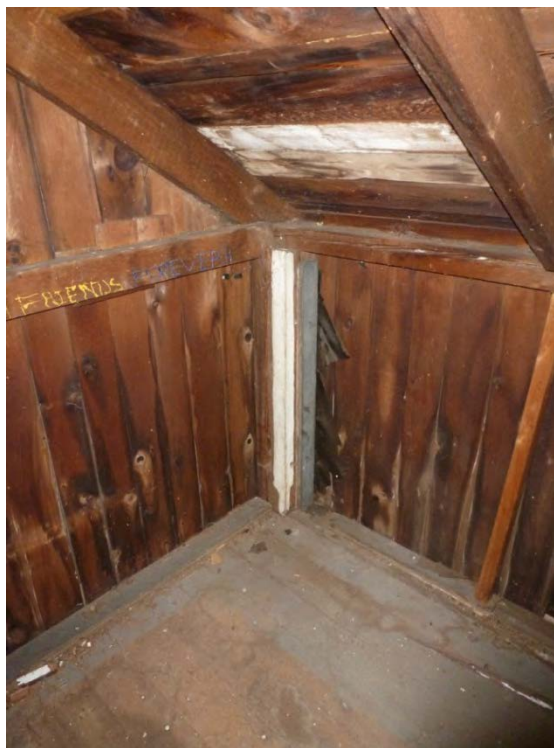
32. Interior view of the northeast corner of the second floor of Addition I, camera facing northeast.

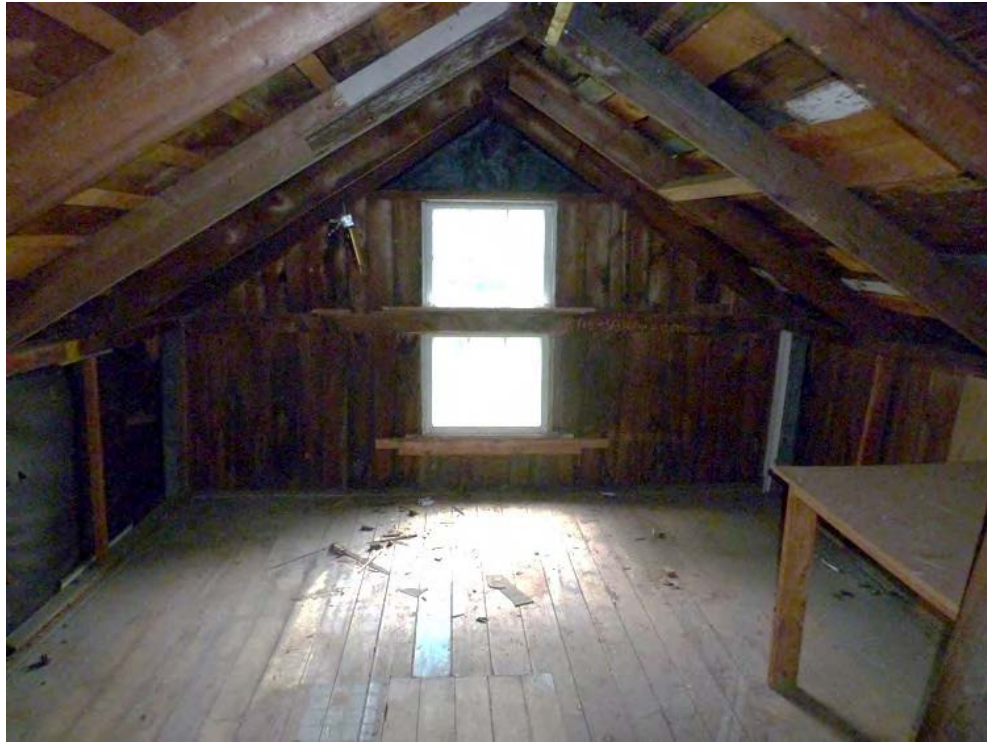
33. Interior view of the second floor east gable-end of Addition I, camera facing east.

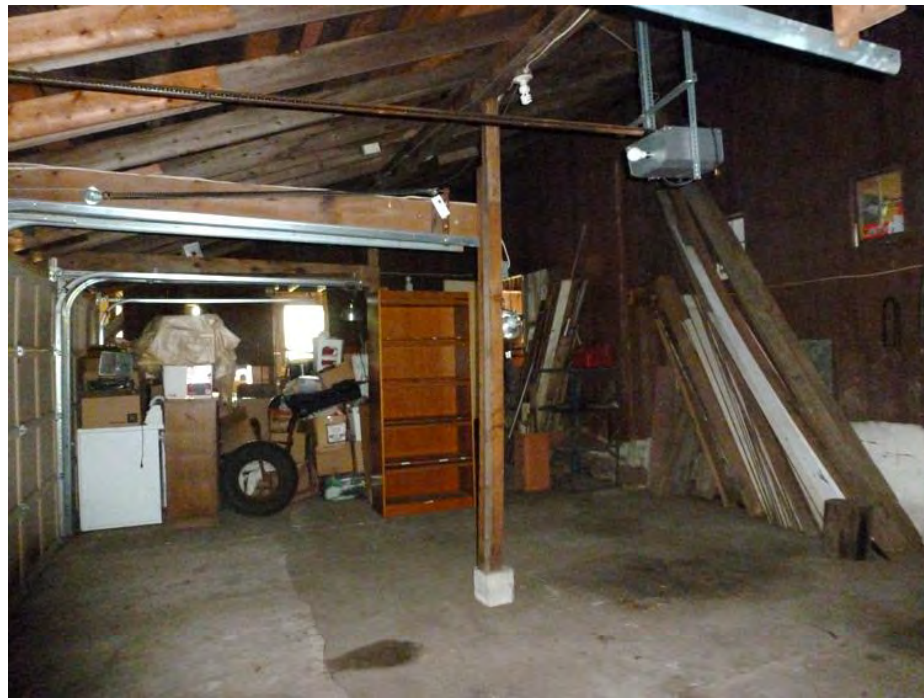
34. Interior view of Addition II, camera facing southwest.

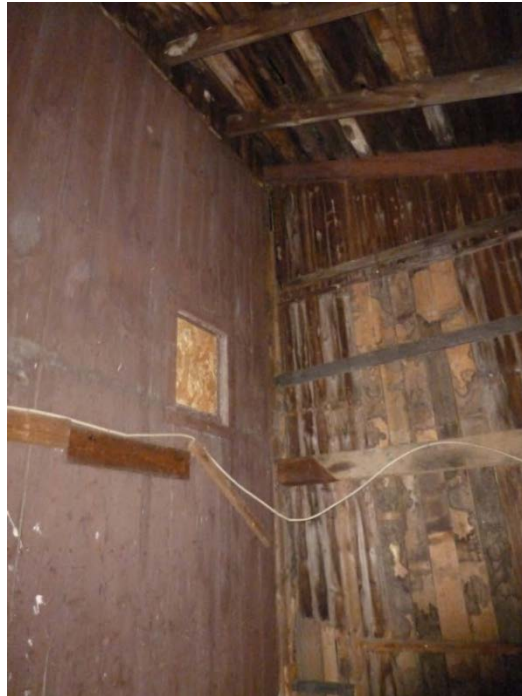
35. Interior view of the northwest corner of Addition II, note the rafters puncturing the wall and extending into Addition III. Also note the exterior siding of Addition III. Camera facing northwest.

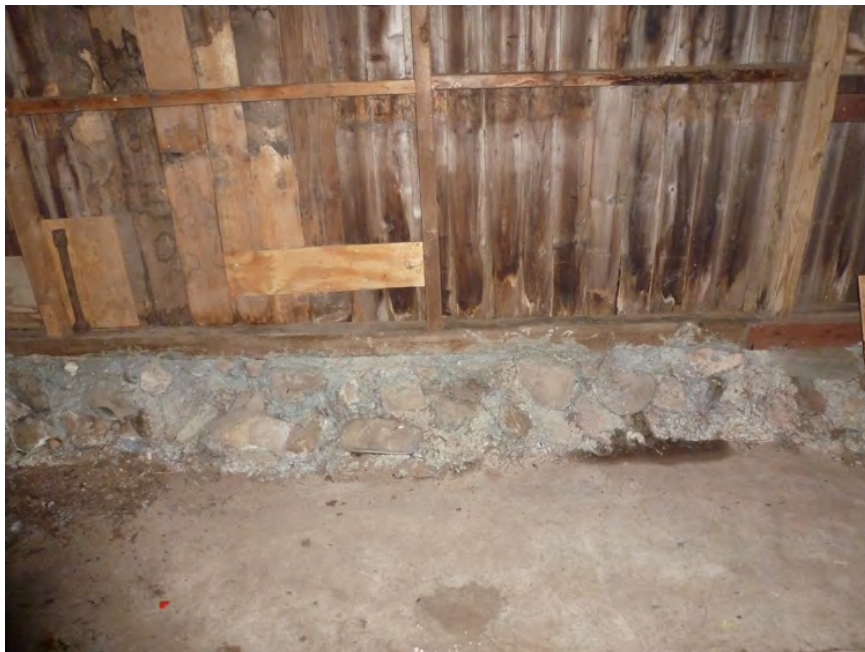
36. Interior view of the mortared fieldstone foundation along the north wall of Addition II, camera facing north.

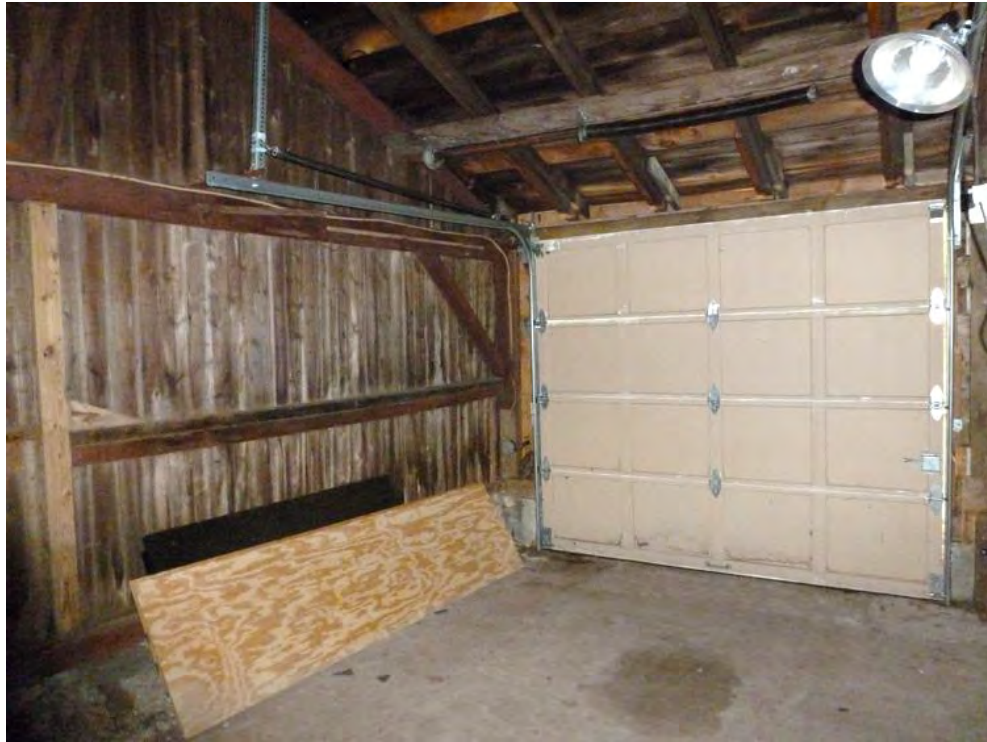
37. Interior view of the northeast corner of Addition II, camera facing northeast.

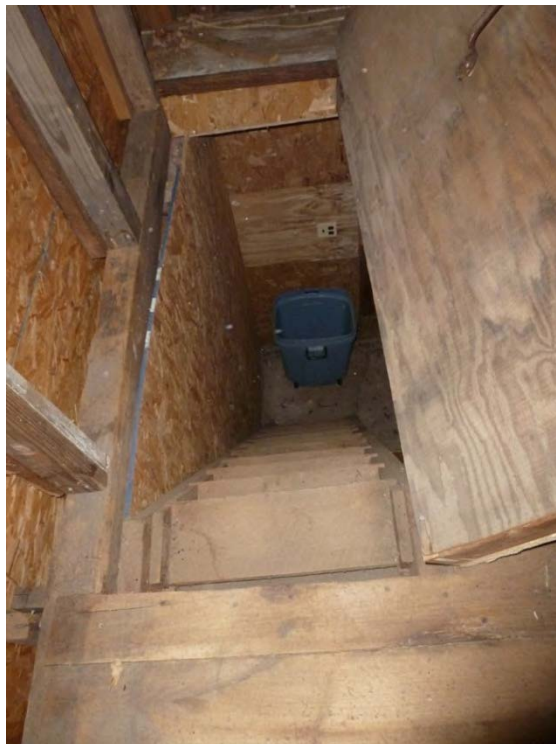
38. Interior view of the built in staircase in Addition III that leads to the second floor.
