HISTORIC RESOURCES INVENTORY - BUILDING AND STRUCTURES

Building Name (Common) Brooks, William, Farmstead Record No. 27966
 Building Name (Historic) Brooks, William, Farmstead
 Street Address or Location 376 Academy Road
 Town/City Cheshire Village _____ County New Haven
 Owner(s) Valerie Joyce, 376 Academy Road, Cheshire, CT 06410 Public Private

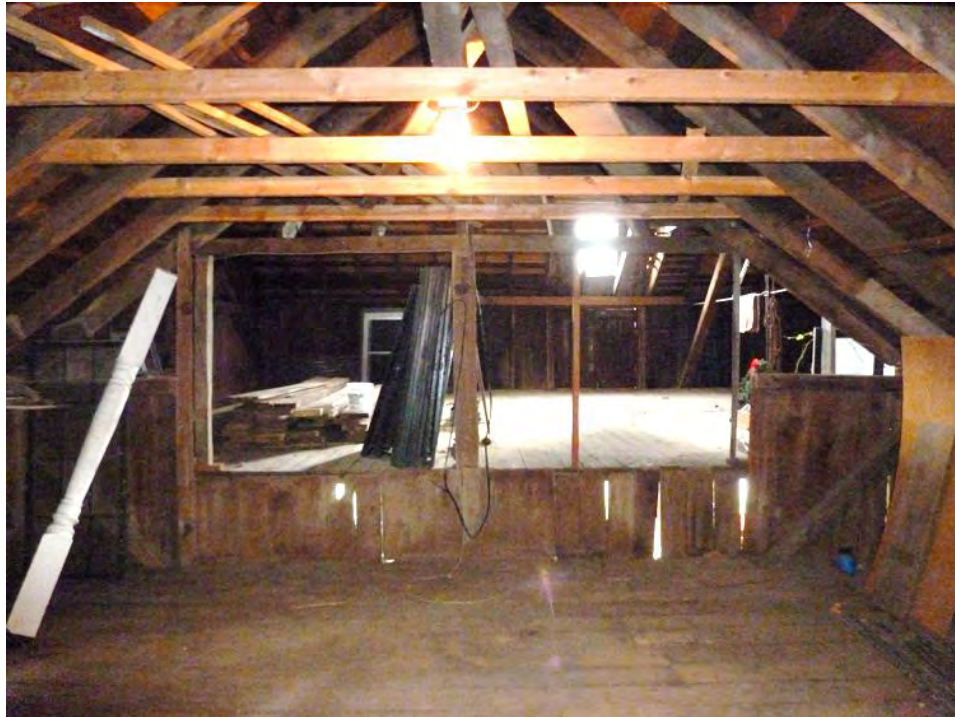
39. Interior view of the second floor of Addition III, note the rise in the floors and open bays that leads to the second floor of the main barn. Camera facing south.

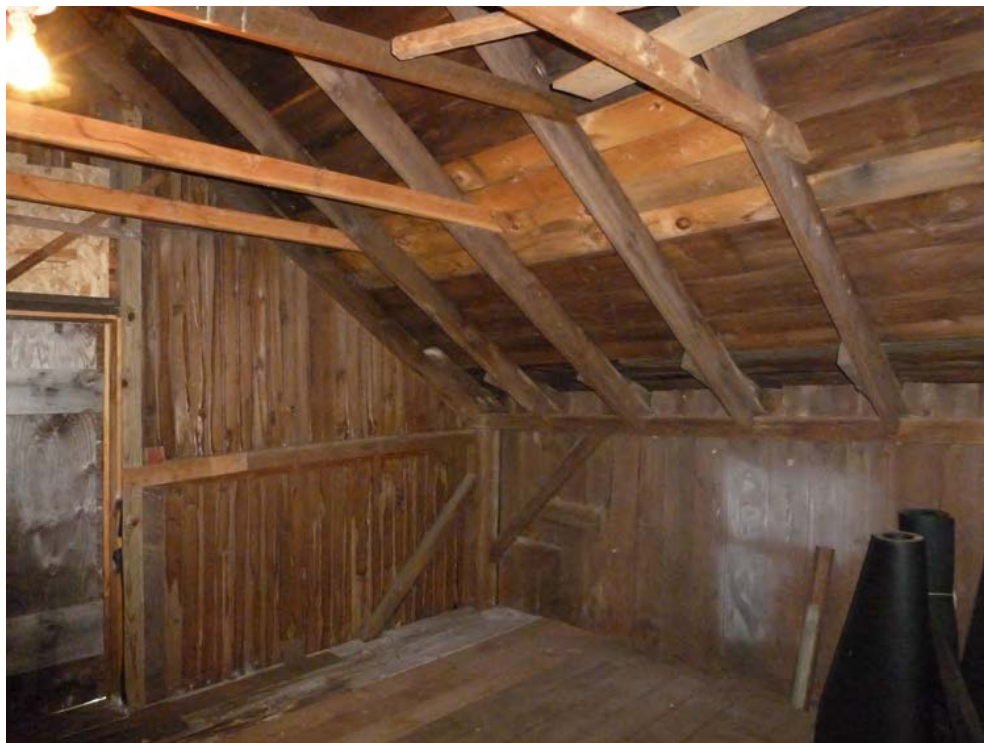
40. Interior view of the second floor northeast corner of Addition III, note the post-and-beam framing. Camera facing northeast.

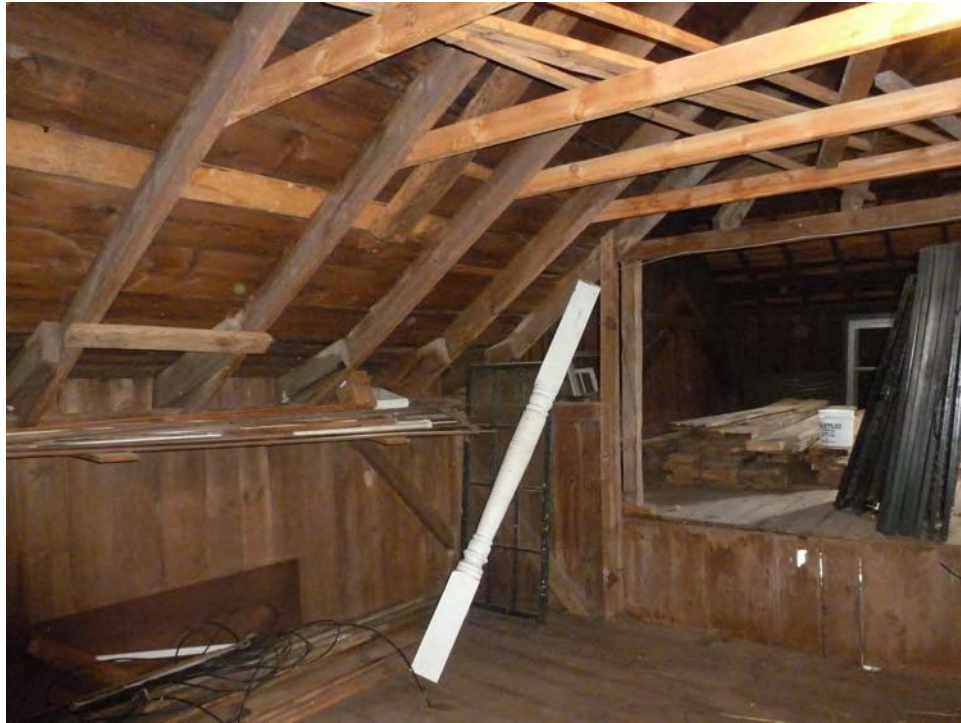
41. Interior view of the second floor southeast corner of Addition III, note the rafters from Addition II protruding through the wall, and collar ties helping to support the roof. Camera facing southeast.

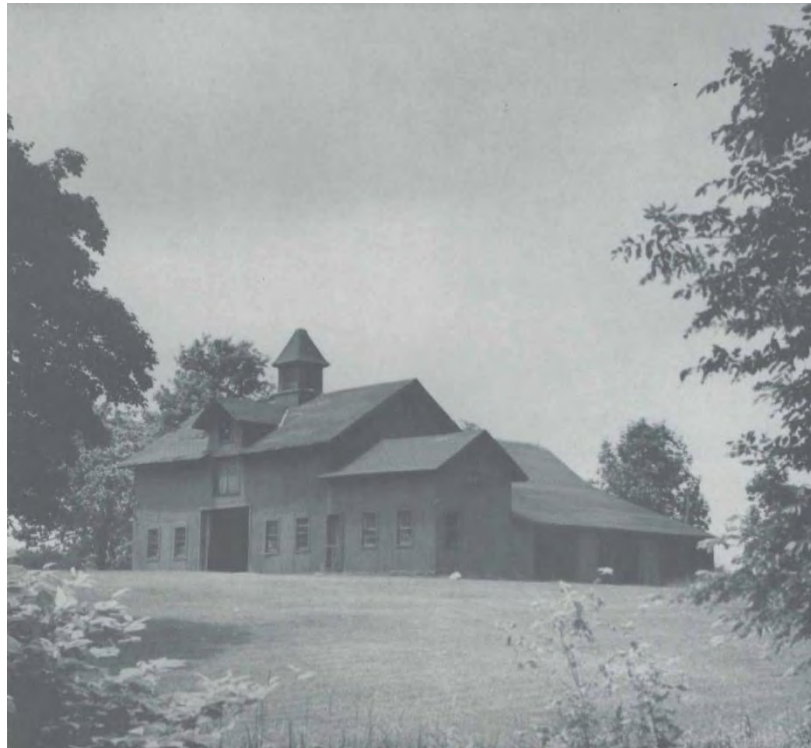
According to a photograph from the 1970s found in Klamkin, it is clear that the main entry was once an interior-hung sliding door. Also, Addition II only consisted of three open bays instead of four bays with garage doors.

42. Southeast view of the barn and additions, c. 1979. Camera facing northwest. (Klamkin, p. 38).
