## HISTORIC RESOURCES INVENTORY - BUILDING AND STRUCTURES

Building Name (Common) North, Susan, Farmstead Record No. 53329  
 Building Name (Historic) Ramutan, Joseph and Agnes, Farmstead  
 Street Address or Location 390 Kent Cornwall Road  
 Town/City Kent Village North Kent County Litchfield  
 Owner(s) Susan North, 390 Kent Cornwall Road, Kent CT 06757  Public  Private

Style of building English barn, Vernacular style Date of Construction 19th c.

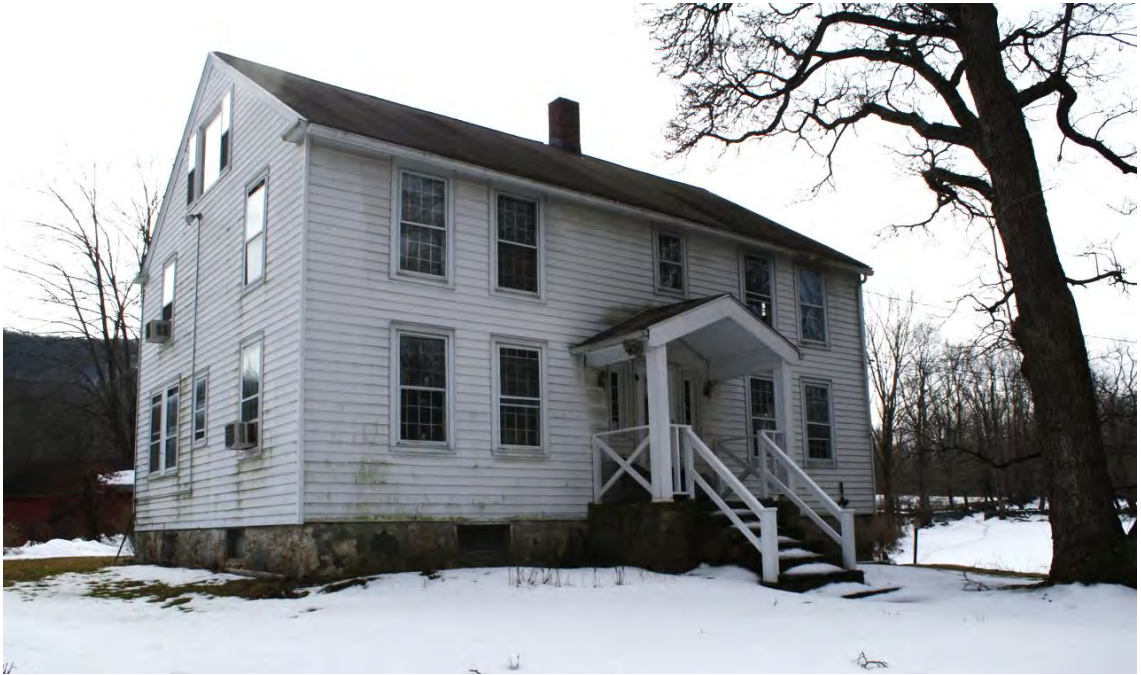
3. North view of Farmhouse, camera facing southwest. Note twelve-over-twelve sash, tripartite attic window, and marble foundation stone.

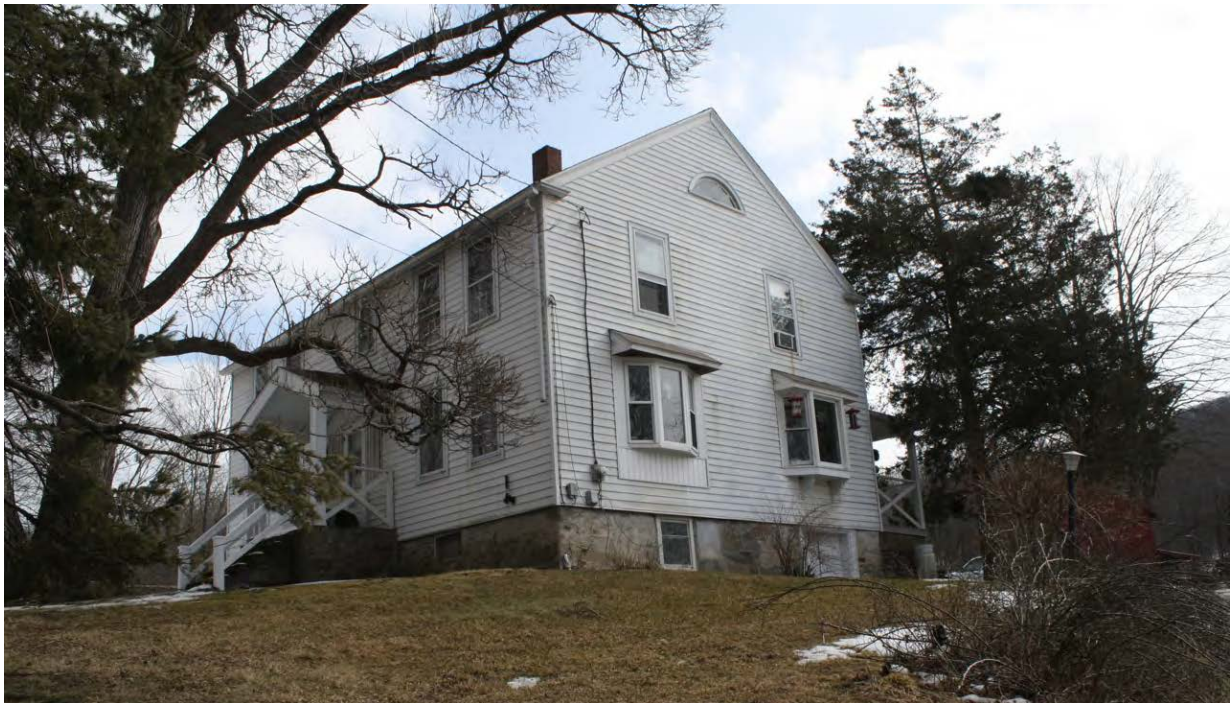
4. Northwest view of Farmhouse, camera facing southeast. Note attic lunette window and marble foundation stone.

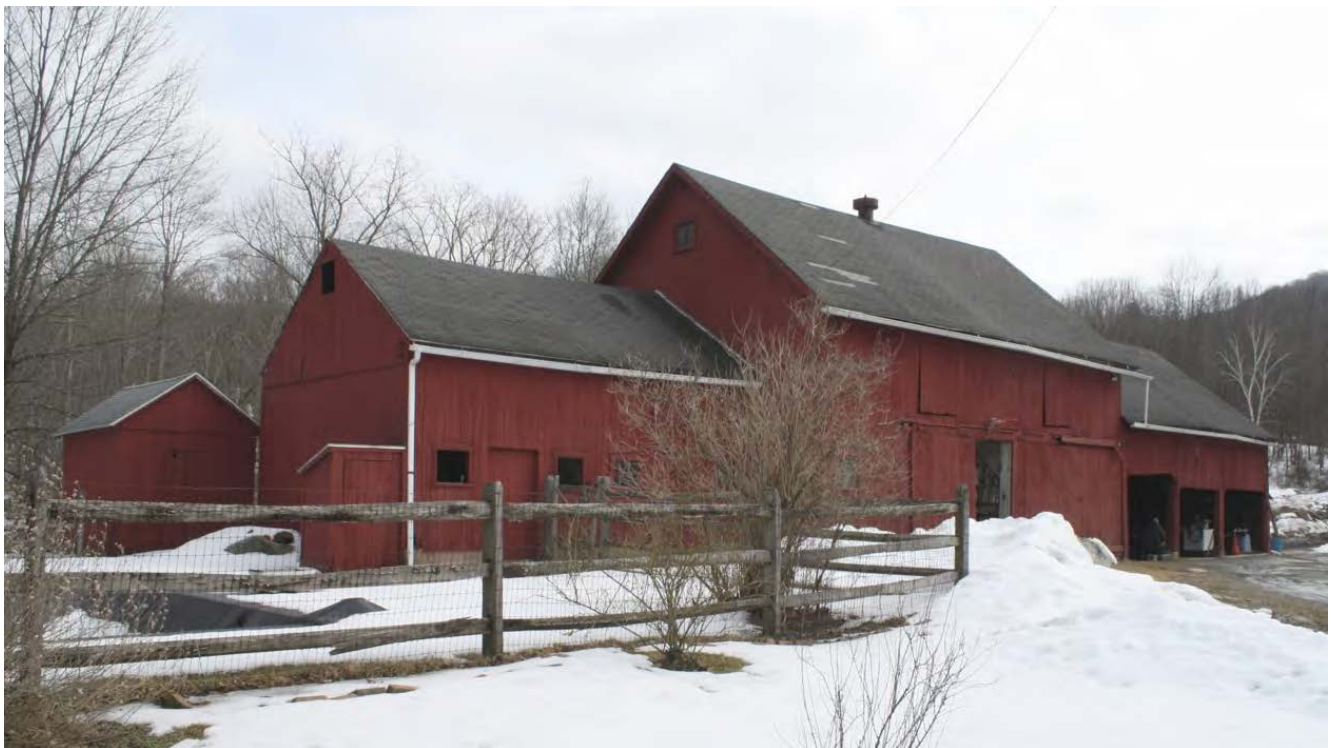
8. North view of Barn and Shed (at left), camera facing south.

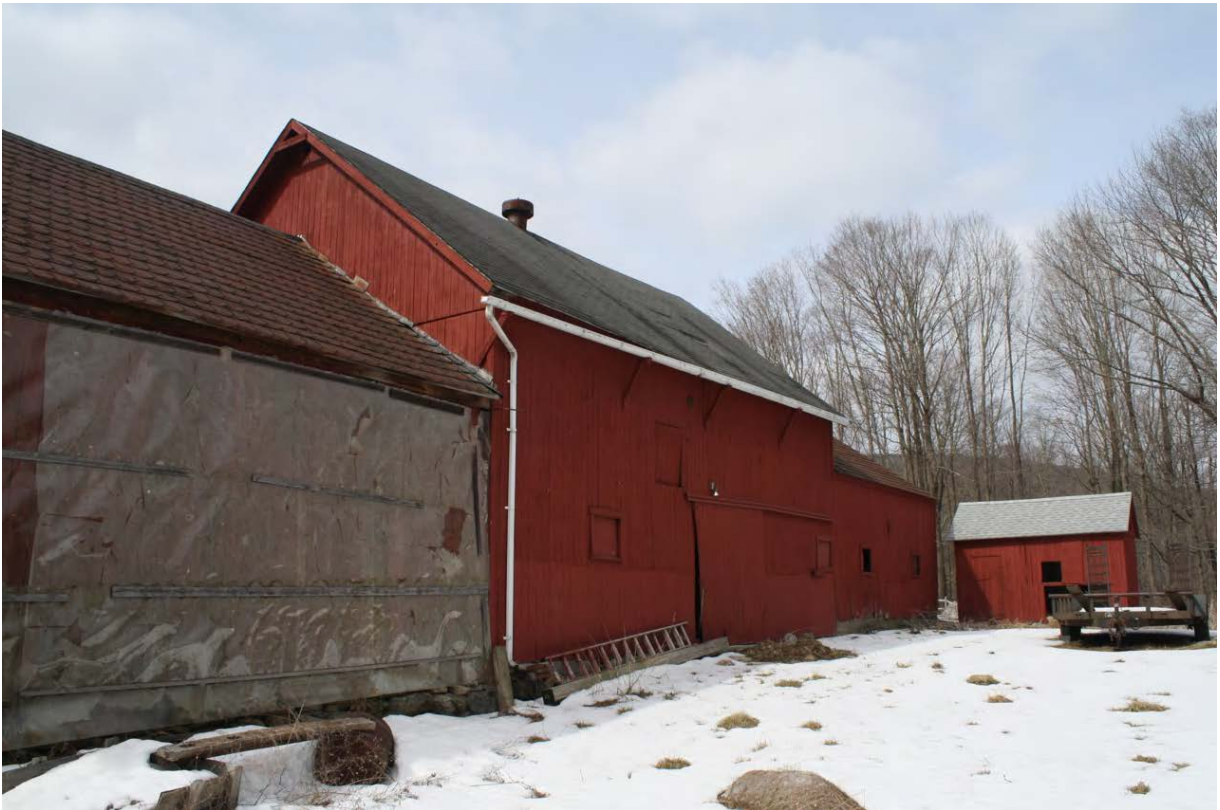
9. Southeast view of Barn and Shed (at right rear), camera facing north.

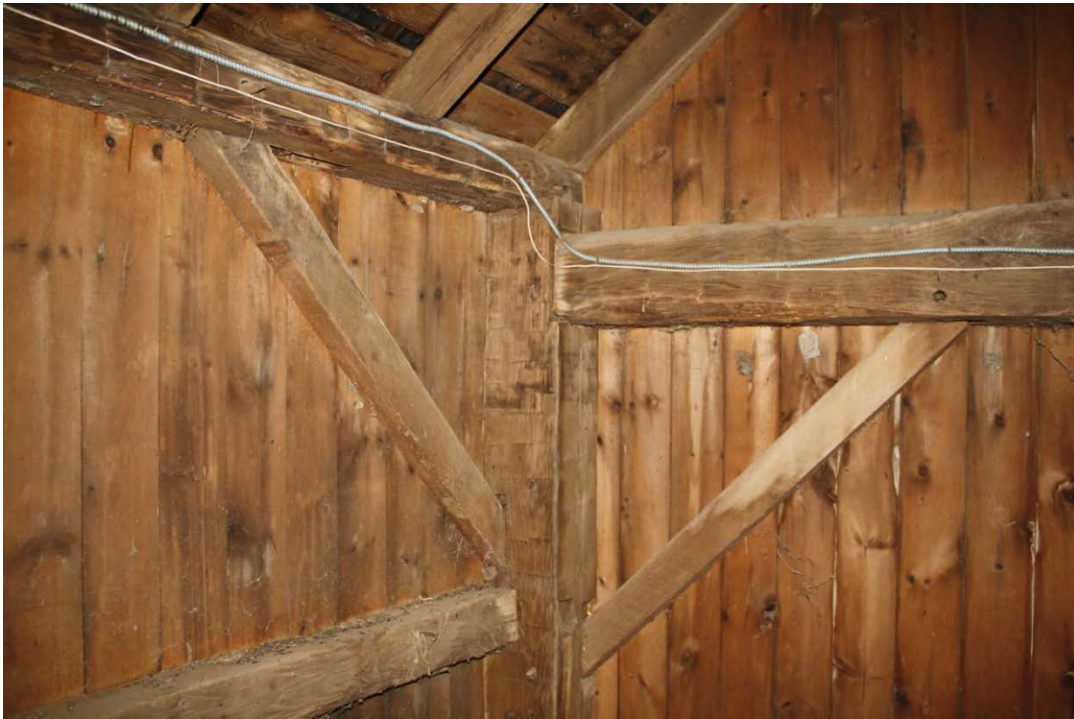
The central block of the barn is a two-bay square rule post and beam frame with dropped tie-girts. The common rafters are of sawn dimension lumber although the major timbers are mostly hand hewn. The rafters span from the plates to the peak without intermediate supports, although a few collar ties have been added in recent years. The interior tie-girt has an added steel tension cable installed below the girt. The loft floor, inserted approximately five feet below the plate elevation, is framed with sawn dimension lumber which has been painted or whitewashed; this appears to have been an addition to the original post and beam structure. The ground floor is fitted out as horse stalls.

11. Interior view of Barn framing, camera facing north at northwest corner of loft level. Note hand-hewn timbers, dropped tie-girt detail.

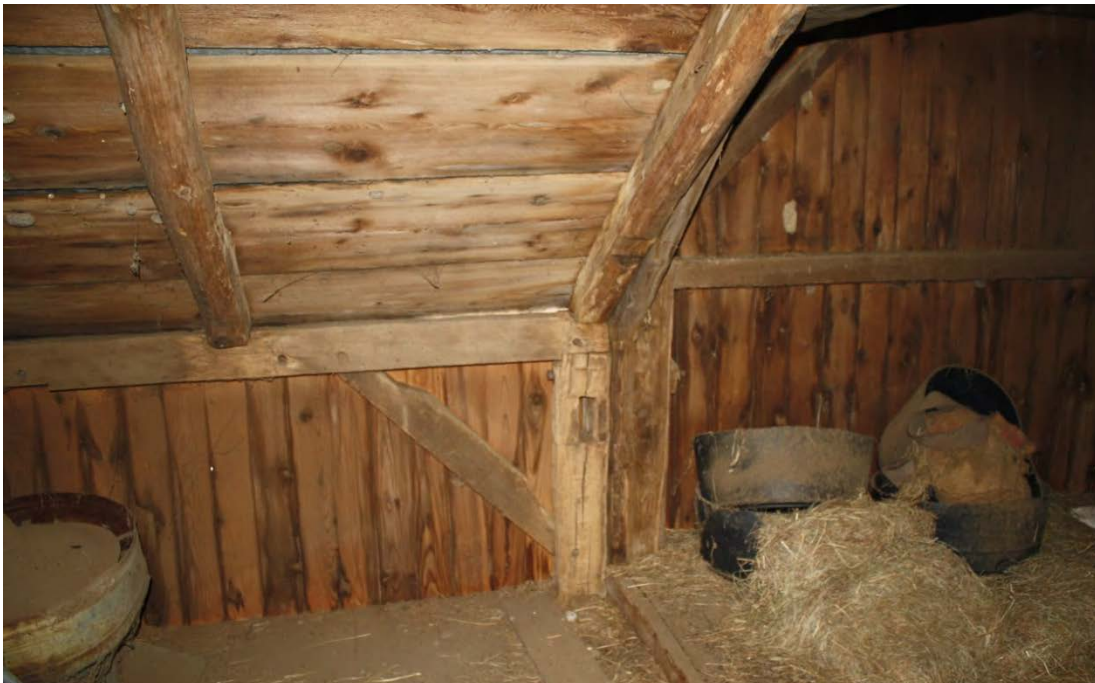
12. Interior view of Barn loft level, showing connection between central block and north addition, camera facing east. The double corner posts suggest that two complete barn structures were assembled abutting at the gable ends.

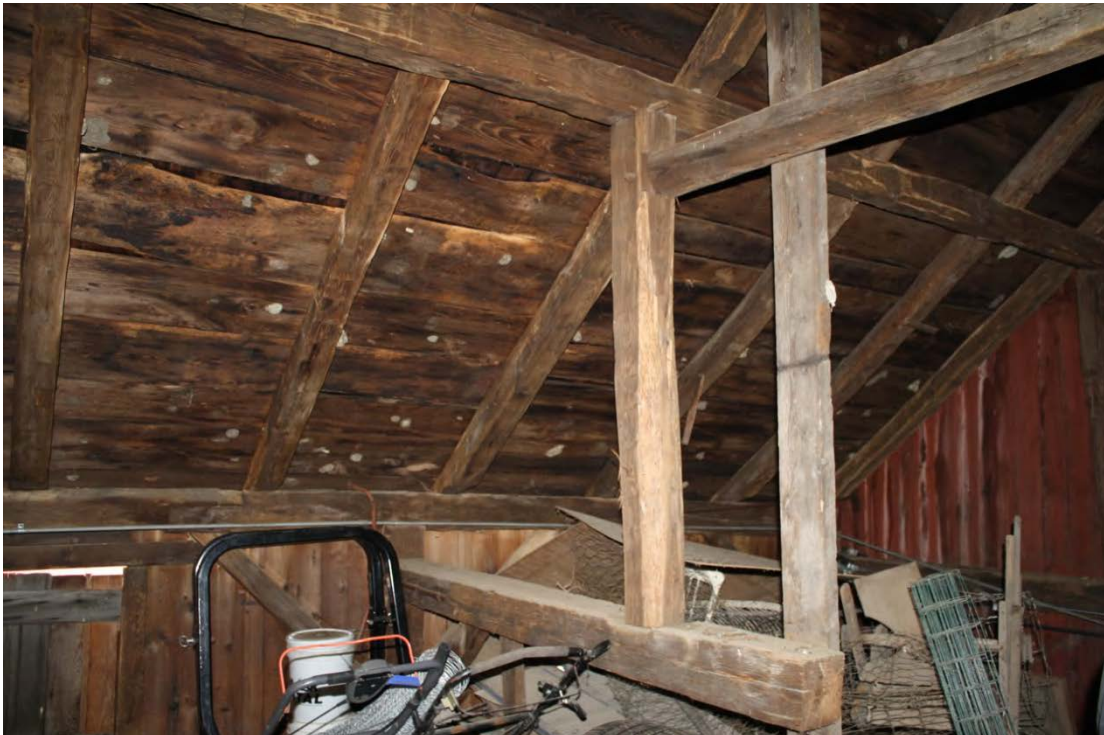
The southern wagon shed addition may be the oldest portion of the barn, being constructed with hand-hewn post and beam framing, dropped tie-girts, and hand-hewn rafters supported by a typical queen post and longitudinal purlin system. Here too a loft floor has been inserted at about four feet below the plate elevation. The tie-girts have been truncated, with a central section removed. Some steel cable reinforcement has been added in about 2011.

14. Interior view of Wagon Shed addition at south end of the Barn, loft level, camera facing northwest. Note the dropped tie-girt (center cut out for access), queen post, purlin plate, and hand-hewn rafters.

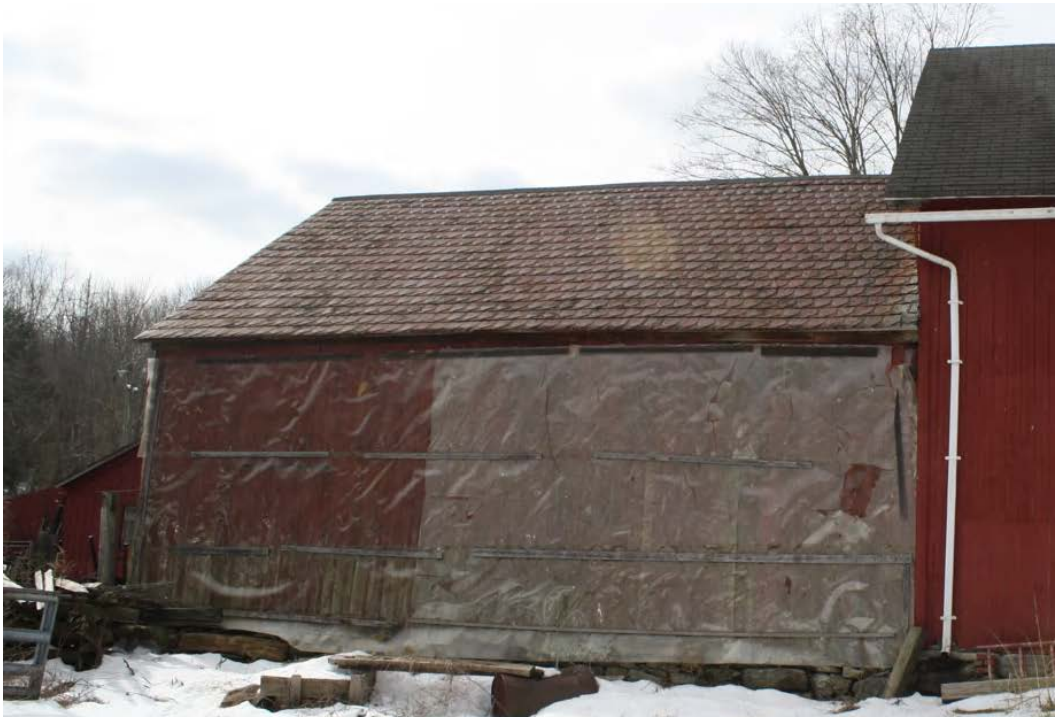
The house and barn together are significant as typical examples of their type in a rural setting along with adjacent properties that were formerly under a single ownership. They remain in a setting reflective of the earlier character of the agricultural landscape. The Farmhouse retains original window sash and some distinctive Federal-style details, although much is obscured by 20<sup>th</sup>-century siding. The Farmhouse and its barn sit on a prominent knoll, facing across the road to the main barn and tobacco barn in the floodplain of the Housatonic River, at a gateway location near the northern border of Kent. The barn has elements of hand-hewn post and beam framing, combined with later alterations to adapt it to a horse barn and wagon shed. The distinctive tin shingles remaining on the east pitch of the barn roofs are historic materials of interest.

15. Southeast view of Wagon Shed addition with metal shingle roof, camera facing north.
