HISTORIC RESOURCES INVENTORY - BUILDING AND STRUCTURES

Building Name (Common) Gault Energy & Stone Barns Record No. 51080
 Building Name (Historic) Gault Brothers Farmstead
 Street Address or Location 124 Compo Road South
 Town/City Westport Village _____ County Fairfield
 Owner(s) Sam Gault, L.H. Gault & Sons Inc., P.O. Box 2030, Westport, CT 06880 Public Private

HISTORIC RESOURCES INVENTORY FORM – BUILDING AND STRUCTURES continuation sheet

124 Compo Road South, Westport, CT

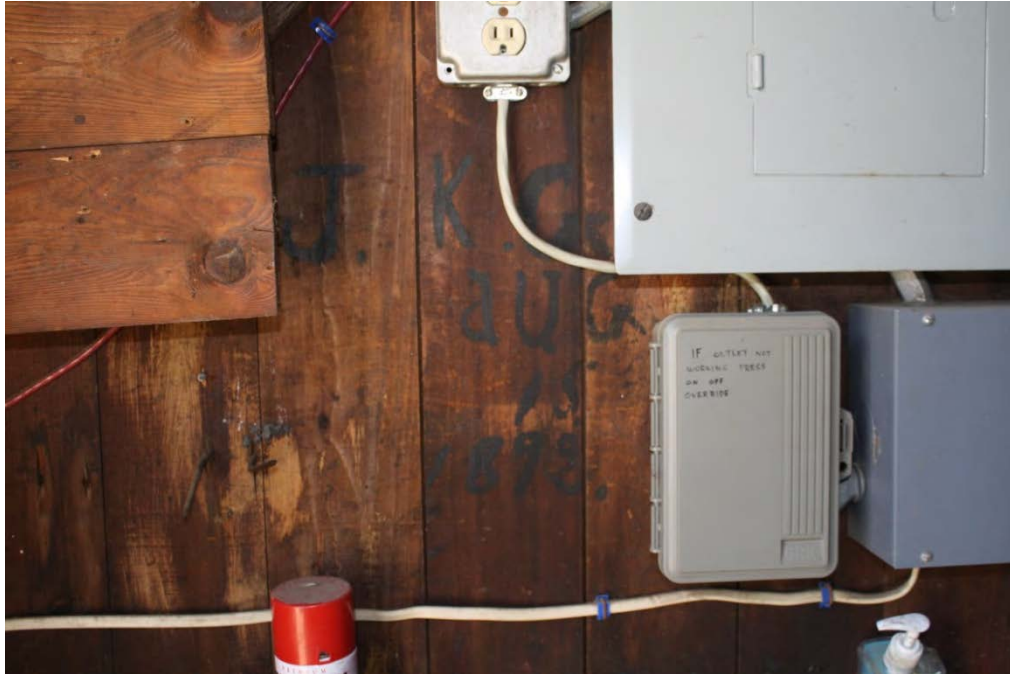
The south gable-end wall, which is a common wall with Barn II, has an electrical panel mounted on the wall and to the east (left) of the panel, in black paint or tar, is the following: J. K.G. AUG 15 1898. J.K.G. refers to John K. Gault. Although written in the older (1890) Barn I, the signature and date evidently refer to the construction of the second building, Barn II, located adjacent.

13. Detail at south gable-end wall of Barn I, with J.K.G. AUG 15 1898 in tar or black paint, camera facing south.

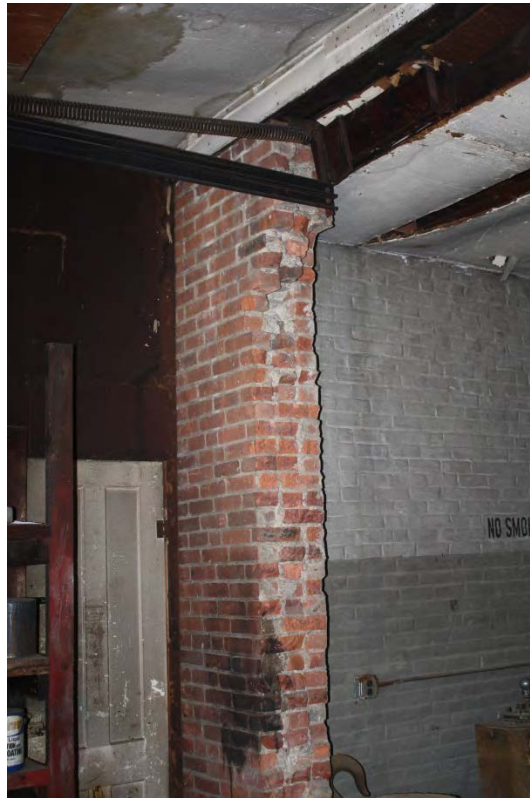
Alterations? Yes No If yes, explain: Interior top floor east eave-side original doors removed.

27. Detail of the damaged interior bays of the third and top level of Barn III, with the doors removed, camera facing east.

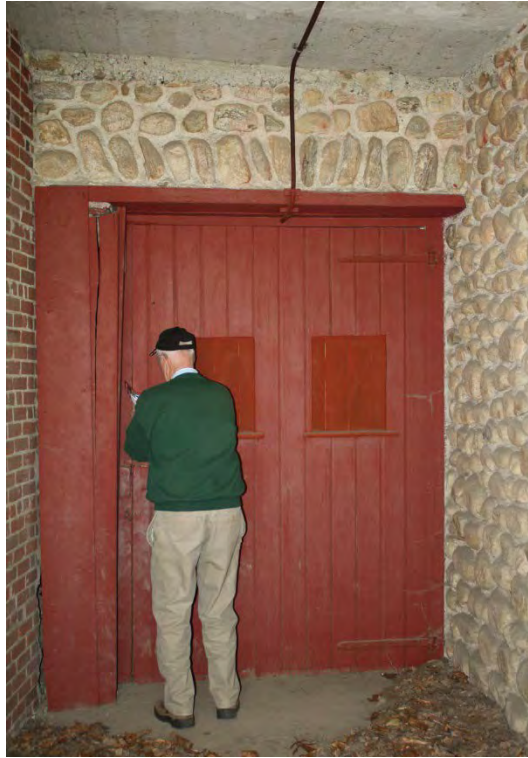
In 1945 after World War II, a local Chevrolet dealership hid cars on the second level because demand was so high. The south entry to the second level was enlarged and damaged to allow the room necessary for the cars to fit in the doorway.

29. Detail of the south main entry to the second (middle) level of Barn III, camera facing north. Note the left portion of the photo where the frame is damaged. That portion was altered to allow cars into the floor.
