HISTORIC RESOURCES

BUILDING AND STRUCTURES

Building Name (Common) Russell Farmstead / Hill Top Farm Record No. 5116
 Building Name (Historic) Russell, Daniel, Farmstead
 Street Address or Location 20 Round Hill Road
 Town/City Bethany Village _____ County New Haven
 Owner(s) Bethany Historical Society, 512 Amity Road, Bethany CT 06524 Public Private

HISTORIC RESOURCES INVENTORY FORM – BUILDING AND STRUCTURES continuation sheet

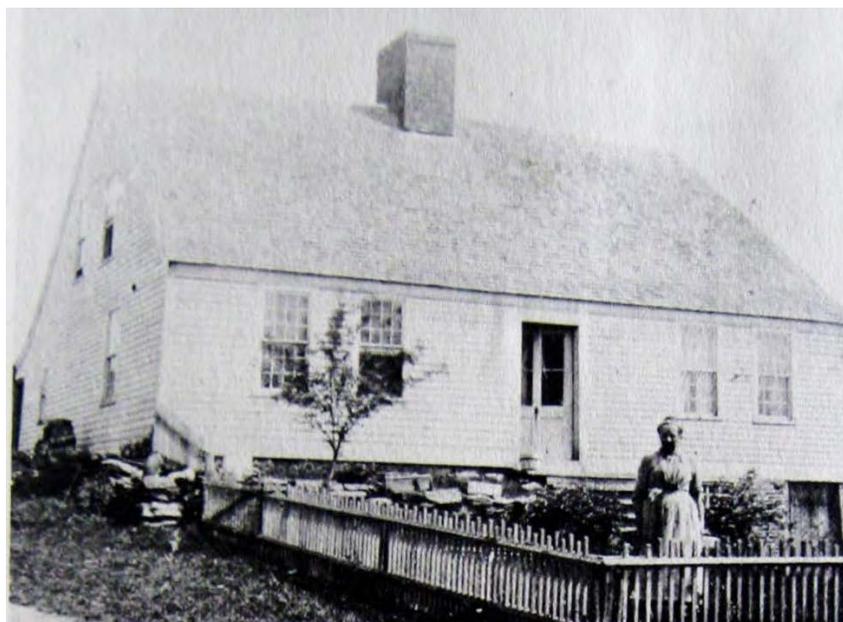
During Arthur and Olive's ownership, the central chimney mass was removed and the front door moved from the center to the present location. The original windows in the house were apparently replaced after 1900, as indicated by a historic photograph (Bunton). The replacement two-over-two sash are typically Italianate style 19th-century materials, and since some of the same windows appear in the bus garage bay of the barn, perhaps the Russells "modernized" with recycled second-hand windows, re-using them for the house and barn.

4. Southeast view, c. 1900 photograph (Bunton), showing original window sash, door, and center chimney.

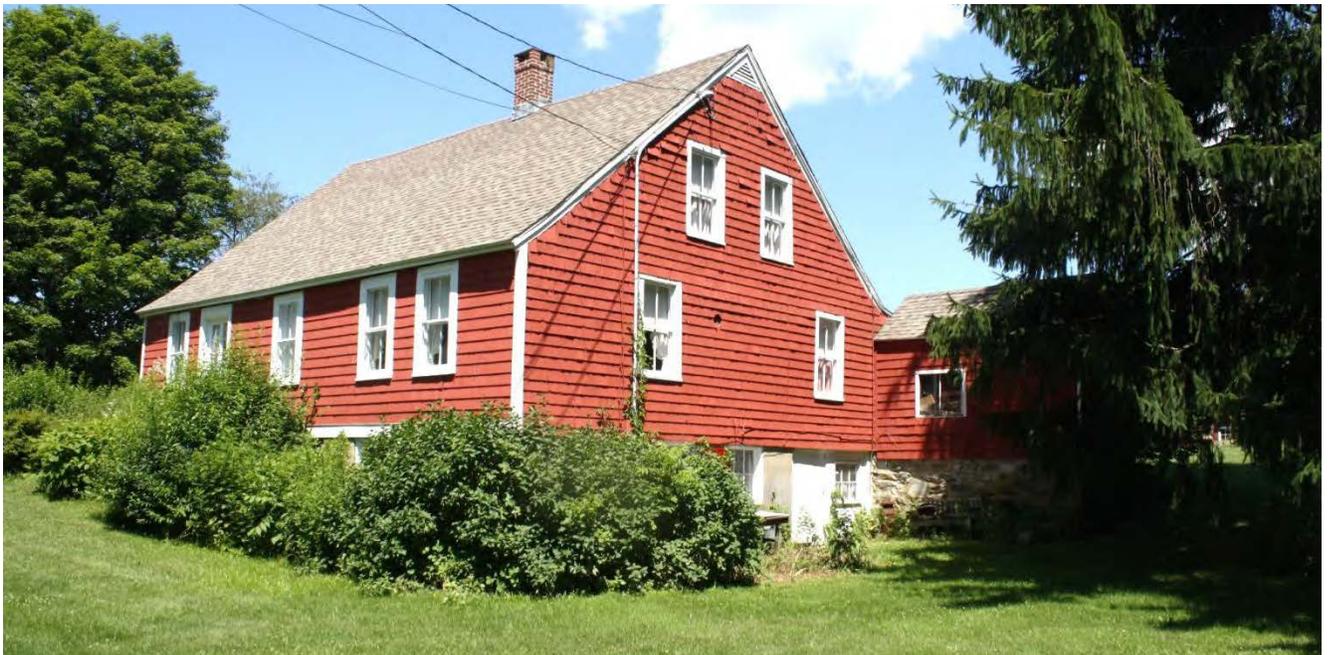
6. Southeast view of Farmhouse, camera facing northwest. Note basement access in east end and well room at right.

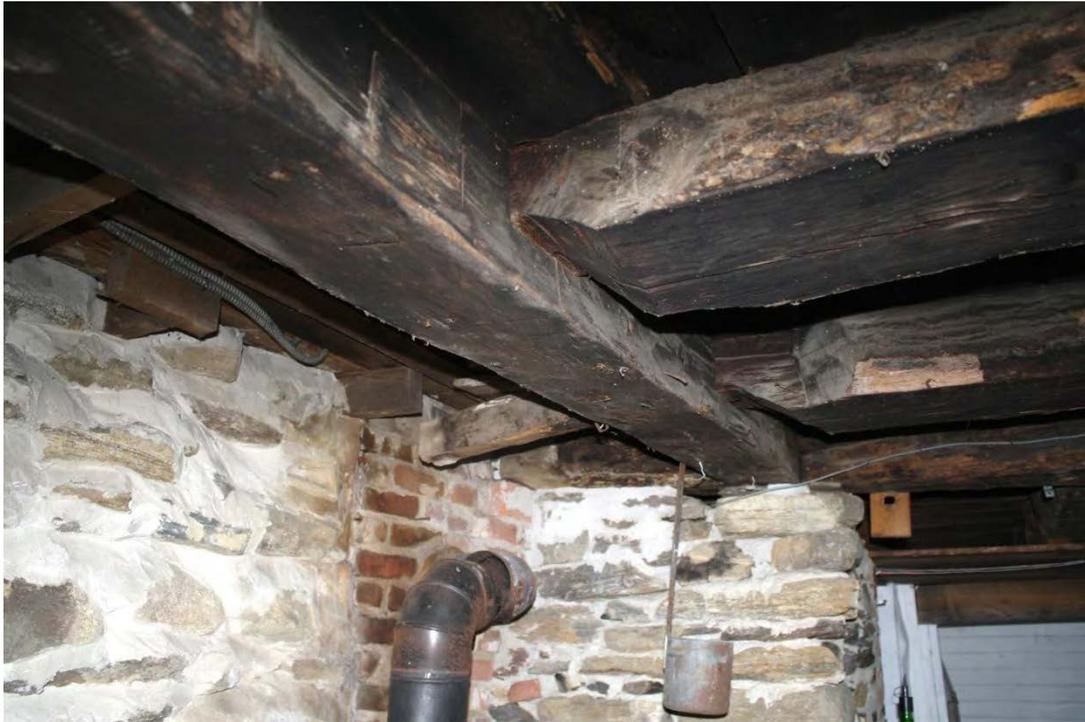
The Farmhouse interior formerly had a center chimney mass, but most of it was removed in the early- or mid-20th century. The interior layout consists of two parlors at the south side with a narrow room between, formerly the entry hall or porch. To the north, the northwest corner was historically a borning room, the northeast room is the kitchen, and a bathroom and pantry are located at the center. The house is of post-and-beam construction, though significantly modified by the removal of the chimney mass and installation of central heat. The eastern part of the basement was used as a summer kitchen and for canning. The current owners have been restoring it as a house museum, to a pre-World War II period.

9. Detail view of basement showing the east side of the remnant chimney base and first floor framing, camera facing northwest.

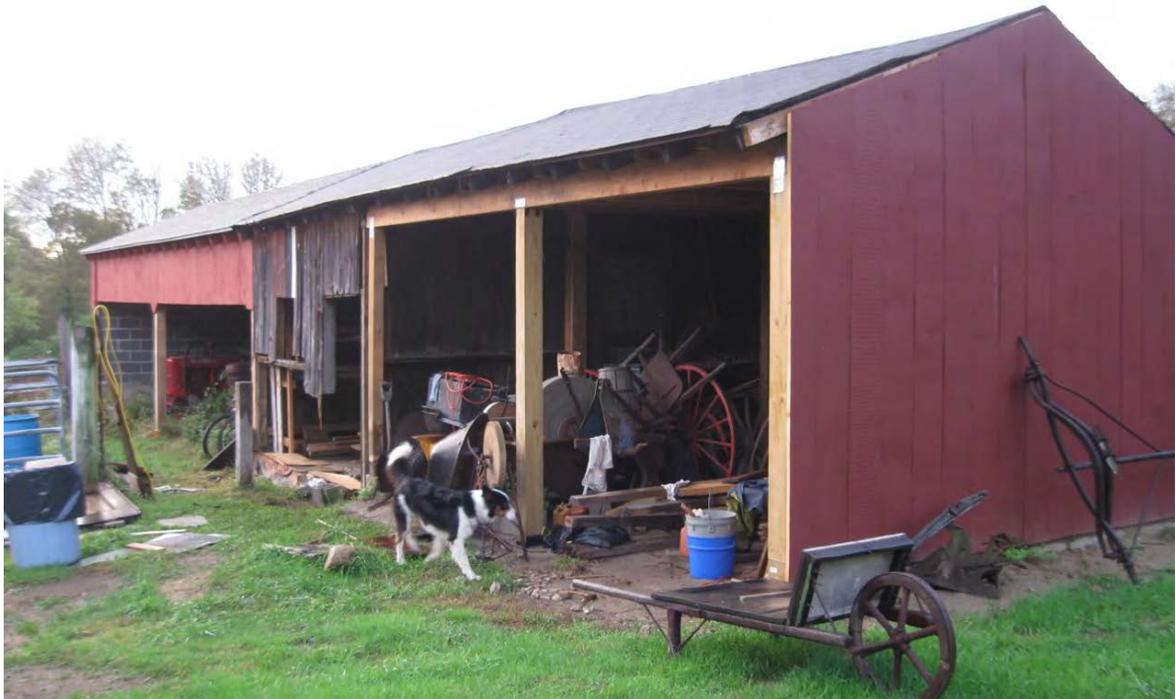
Shed II, the wagon shed, is a five-bay structure with its south side open. Much of it is wood construction, but the western gable-end wall is exposed concrete block masonry.

10. Southeast view of Wagon shed II, camera facing northwest.

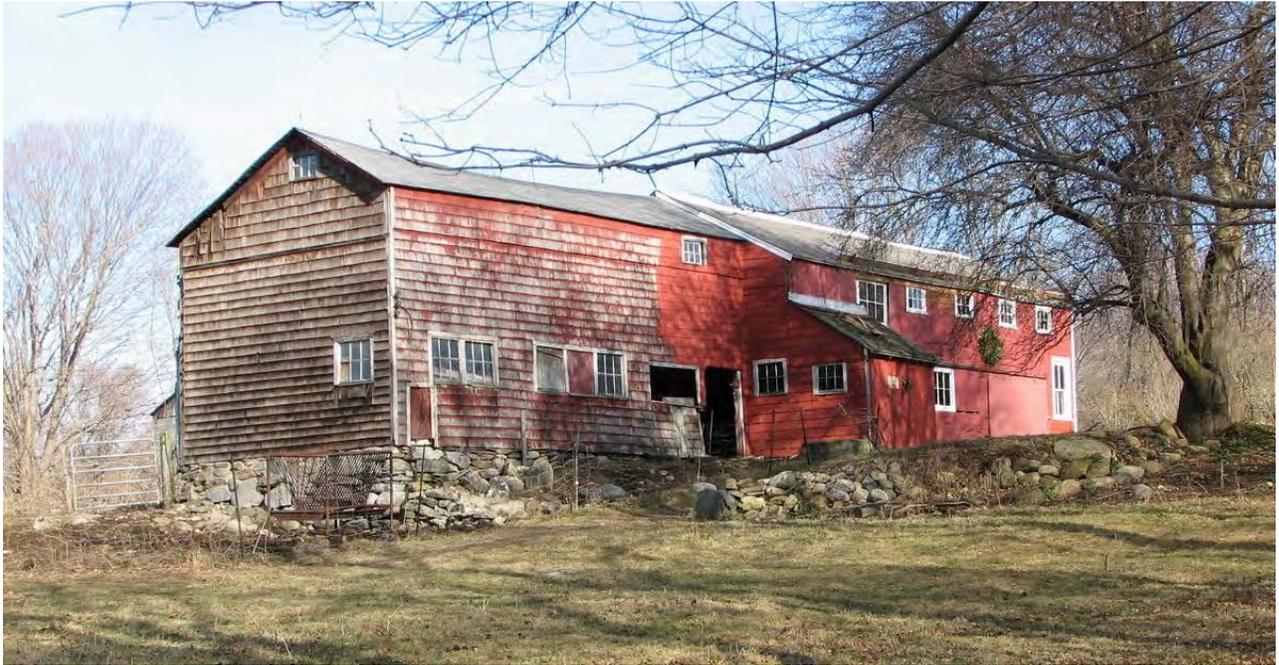
This is a 1 ½-story three-bay eave-entry English barn with several additional bays added to the east end, the easternmost being a school bus garage. The ground level of the western three-bay block has been adapted to use as a dairy cow stable, with the upper loft level remaining as a hay loft. The original frame is obscured on the interior but is visible from inside the hay loft.

15. Southwest view of Barn I, camera facing northeast. The shingled section is the three-bay English barn; to the right are later additions.

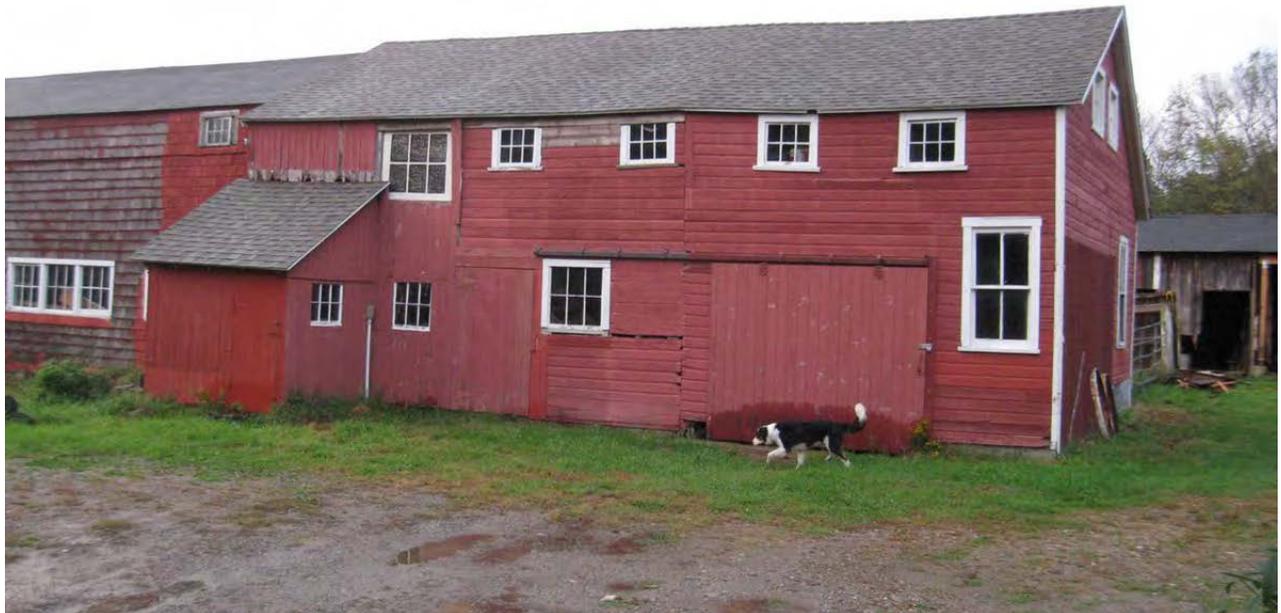
The east portion of the barn appears by the deflections in the roof line to consist of three bays. The left (west) bay is largely encompassed by the milk room addition but also had, prior to recent repairs, a small stable window at the ground level (replaced by a larger sash) and a large six-pane window at the loft level (removed). To the right the next bay has a hinged pass-through door and a six-pane stable window. The rightmost (eastern) bay has a sliding barn or garage door and to the right a two-over-two double-hung window matching those of the Farmhouse. The two righthand bays have at the loft level a row of four six-pane windows just under the eave line. Siding was formerly a mix of vertical boards on the milk room bay and horizontal lap siding on the right two bays. During rehabilitation horizontal siding has been installed across all three bays and the discontinuities that indicated construction of each bay as an addition, are less noticeable.

16. South view of Barn I, camera facing north. View prior to rehabilitation work shows different siding on each bay, indicating different times of construction. The projecting addition was the milk room.

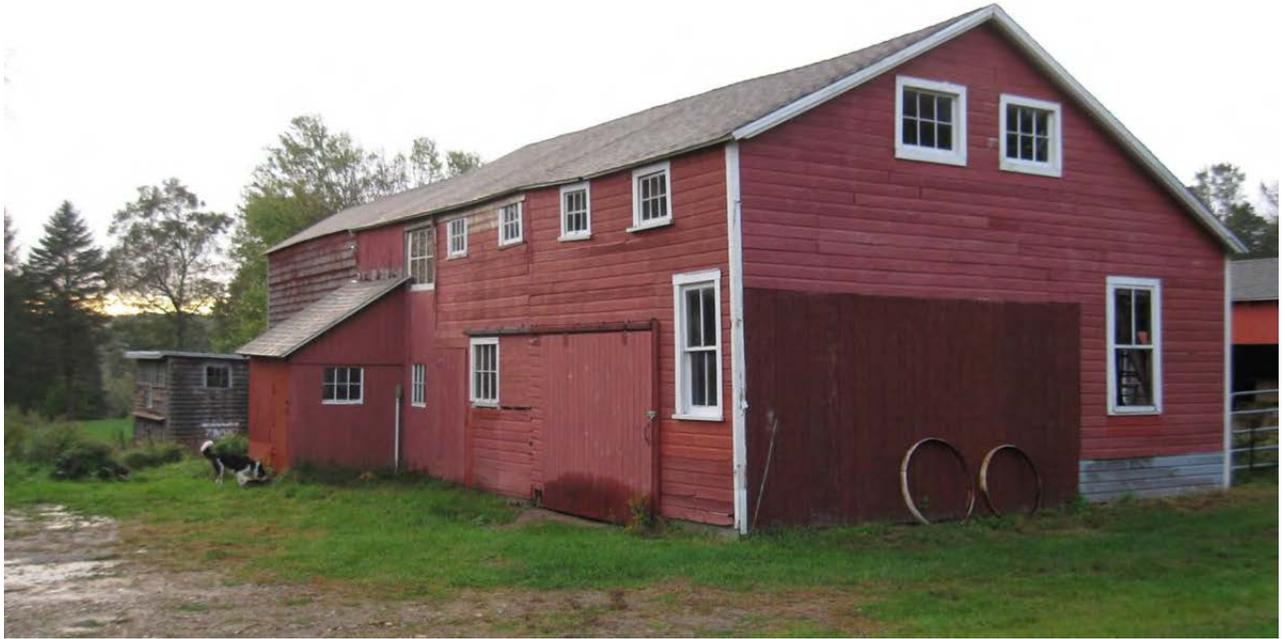
17. Southeast view of Barn I, camera facing northwest. View prior to rehabilitation work.

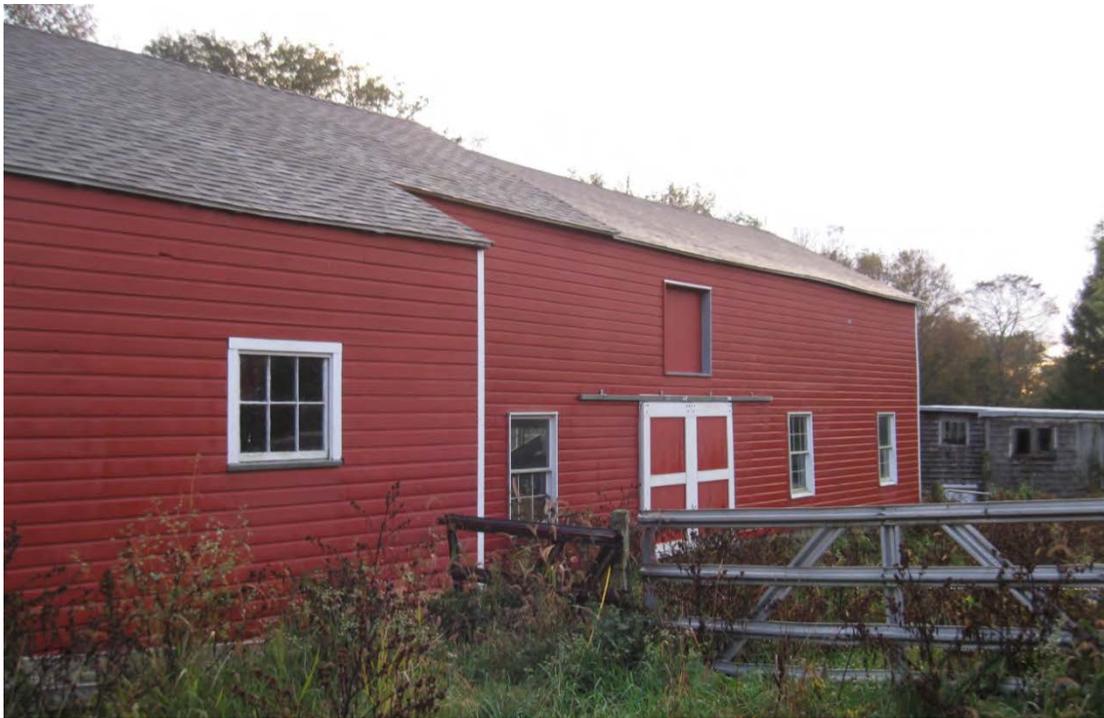
18. North view of Barn I, camera facing southwest. View after rehabilitation work. Coop III is at right rear.

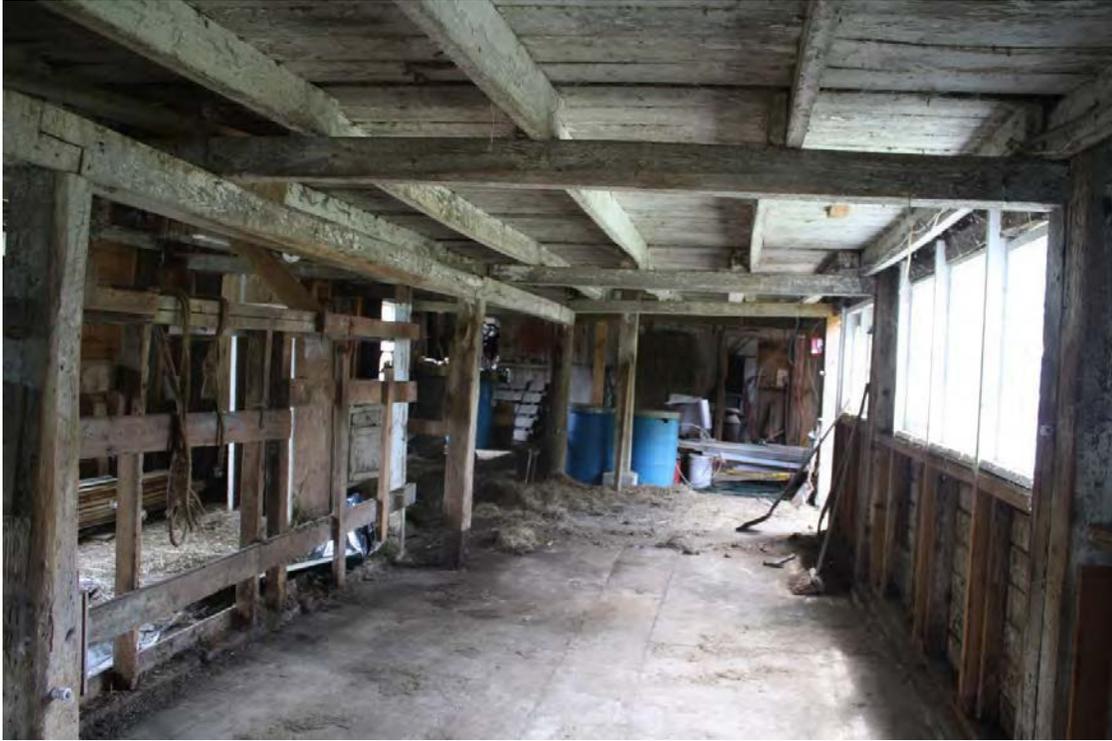
The western block is approximately 20' x 35'. The ground floor has a central row of posts supporting a longitudinal girder. The girder carries cross girders which appear to correspond to the three bays and terminate at posts in the north and south walls. Floor joists for the loft level run longitudinally (east-west). The structure at the ground floor

has traces of whitewash, the concrete floor indicates the location of a manure gutter running east-west parallel to the south wall, and there are remains of wood stanchions between the central posts – all indicate occupancy by dairy cows in a single row facing north.

19. Interior view of Barn I ground level, camera facing east, showing structural alterations for dairy stable use.

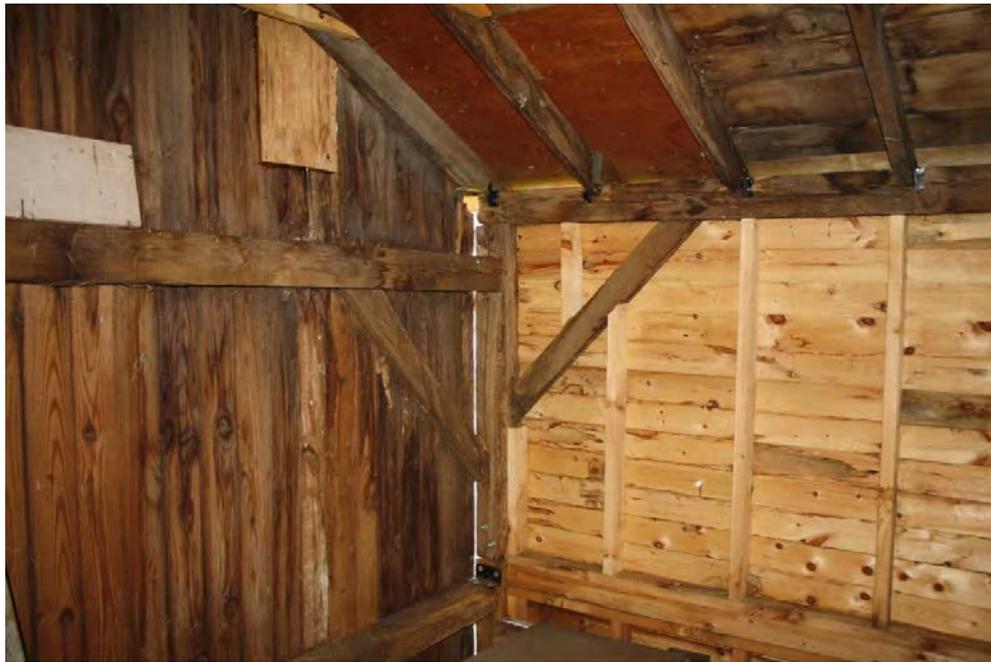
At the loft level older post-and-beam framing is visible, including square rule framing, dropped tie-girts with a single central post at each bent (truncated at the floor level and carried by the longitudinal girder below), and pegged mortise and tenon joints. Timbers bear the straight saw kerf marks of a water-powered sash saw. In the north wall at the northeast corner of the three-bay frame, a double post and discontinuous plate show that the western three-bay barn must have had another post-and-beam structure added on to extend it eastward. Further east, the added bays are constructed of balloon framing with sawn dimension lumber. Common rafters are of sawn dimension lumber. Recent repairs have been made with locally-sourced lumber sawn to match the dimensions of the old material. Structural reinforcement with modern technology including hurricane clips, has been inserted during rehabilitation work.

20. Interior view of Barn I loft level, camera facing northwest. View after rehabilitation work shows replacement framing, collar ties, and hurricane clips added to existing post and beam frame with dropped girt. Note left side has vertical board sheathing with wood shingle siding while right (north) wall has replacement horizontal lap siding.

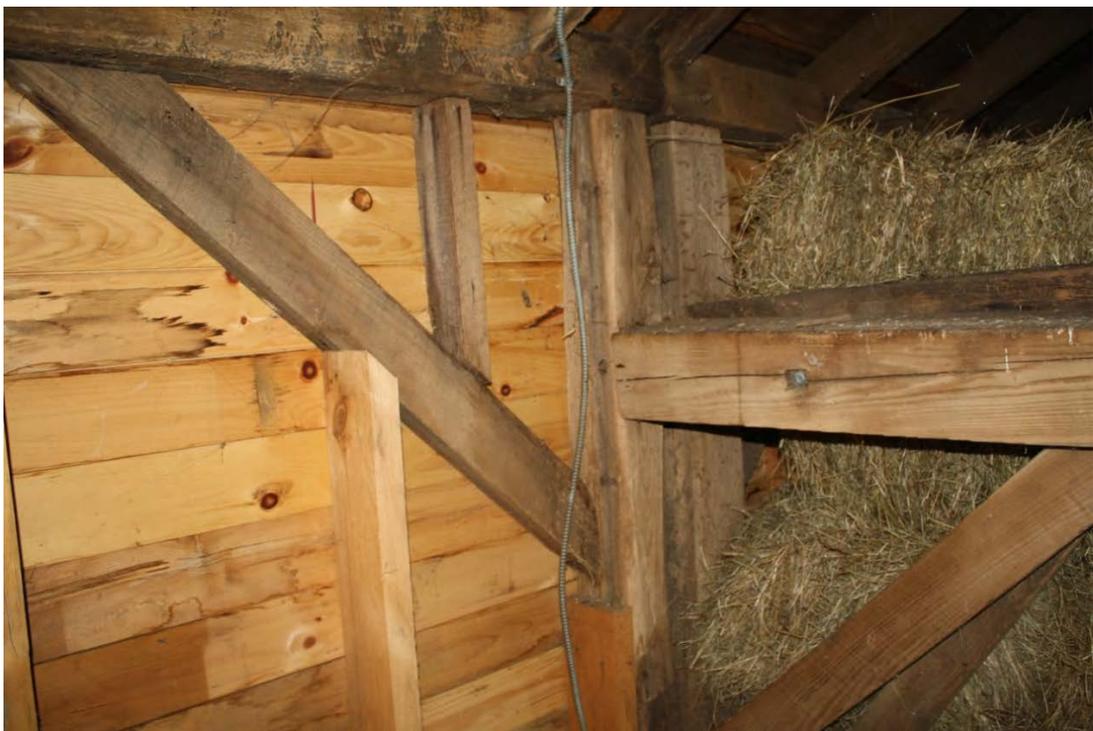
22. Interior view of Barn I loft level, camera facing northeast. This is the easternmost bent of the three-bay English barn frame; note the double post, evidence of a second post and beam frame erected adjacent to the east end of the first frame. Only part of this frame appears to be extant.

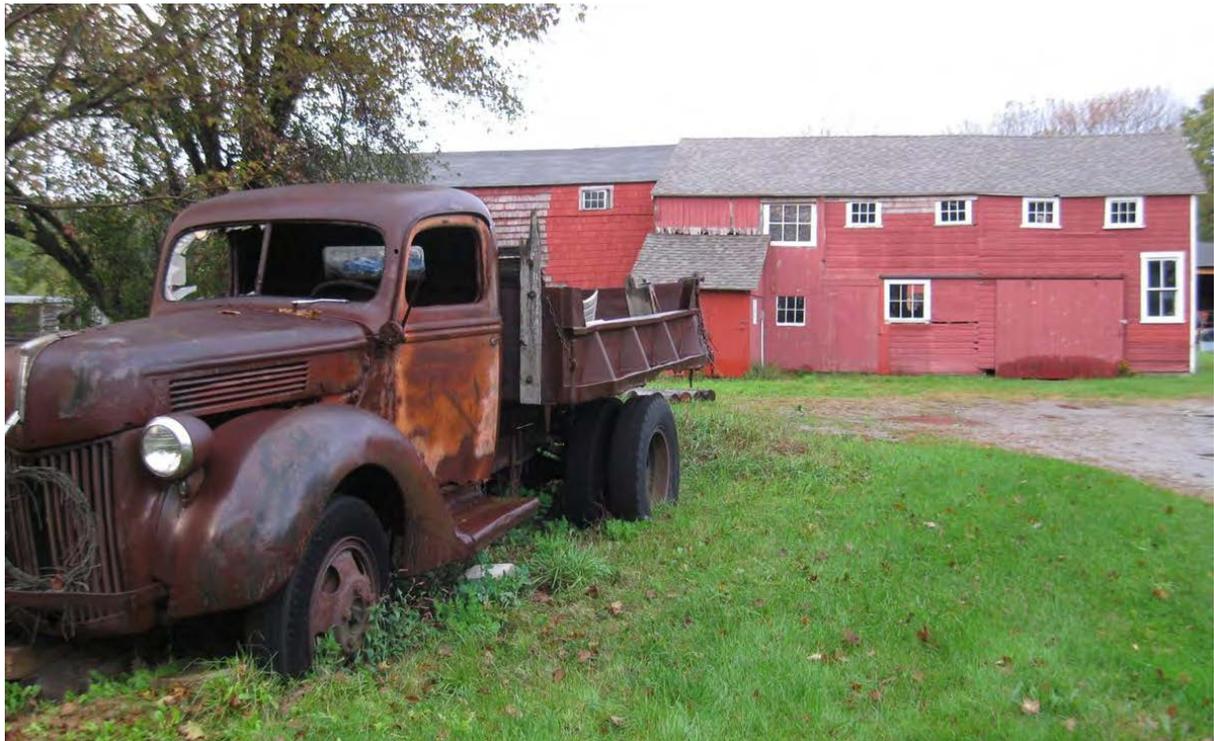
26. South view of Barn I from Round Hill Road, camera facing north, prior to rehabilitation work.
