**HISTORIC RESOURCES**

**BUILDING AND STRUCTURES**

Building Name (Common) Lawton, Stephen, Farmstead Record No. 28110  
 Building Name (Historic) Lawton, Stephen, Farmstead  
 Street Address or Location 803 West Main Street  
 Town/City Cheshire Village \_\_\_\_\_ County New Haven  
 Owner(s) Jill Rochford, 795 West Main Street, Cheshire CT 06410  Public  Private

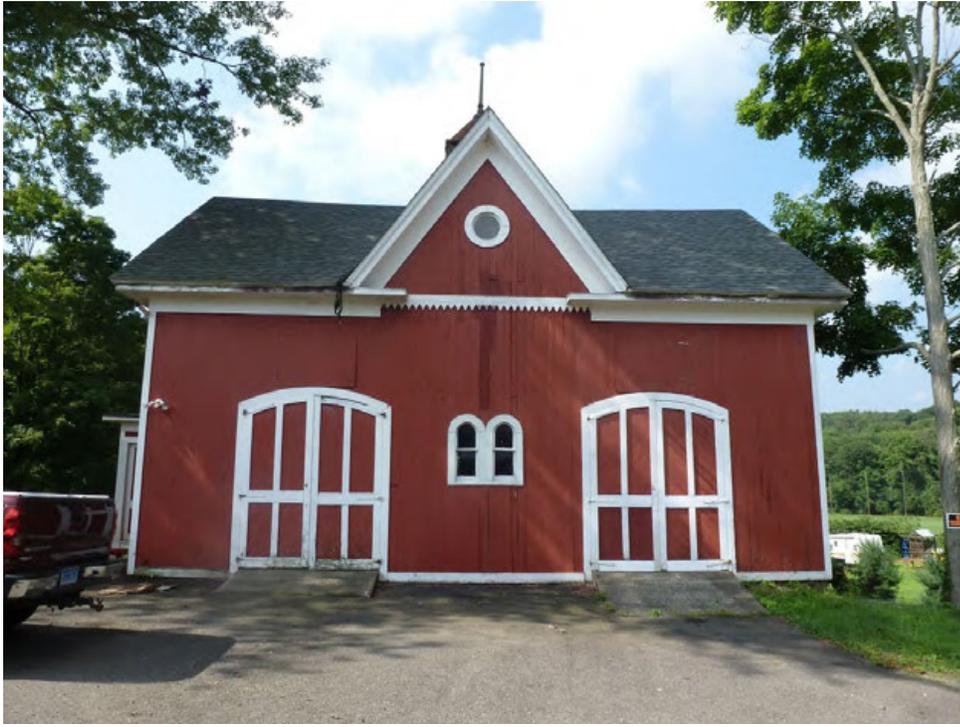
The two main entries are found on the north eave-side of this vernacular Italianate styled English bank barn. Each entry is reached by a concrete ramp that leads to a set of side-hinged, arched, panel doors with trim and original iron strap hinges. One set is located near the east corner while the other is near the west corner of the north eave-side of the barn. Found in the center of the façade, between the two sets of doors is a set of two-paned, arched windows with trim. Above each set of arched doors is a side-hinged hay door. The hay door found on the east half of the façade has the wrought iron hinges on the east, while the hay door on the west half of the façade has the wrought iron hinges on the west. This helps to create the symmetrical look of the main façade. A gable-roof wall dormer is found protruding above the eave, in the center of the façade. It has overhanging eaves with cornice returns and decorative saw-tooth trim on the bottom of the dormer. A round window with trim is found just below the peak of the gable of the dormer.

7. North eave-side of the English bank barn (main façade), camera facing south.

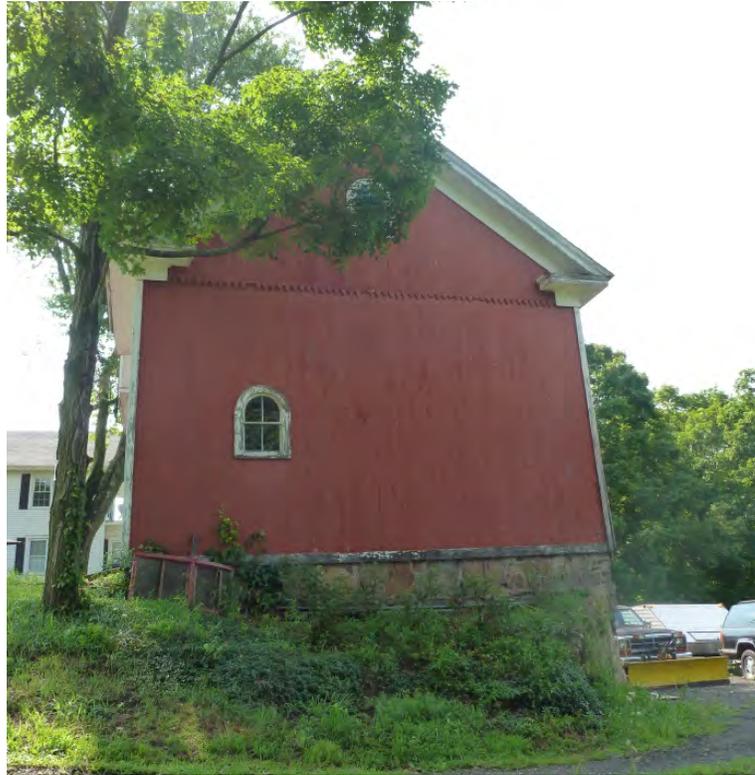
The grade drops along the west gable-end of the barn, revealing a basement level with a mortared fieldstone foundation. Near the north corner, on the main level of the barn, is a four-paned, arched window with trim. Above this, along the girt line siding divide, is a decorative saw-tooth trim. Found in the gable-attic is a four-paned, arched window with trim. A mortared fieldstone retaining wall extends off the south corner, towards the west for approximately 7 feet.

9. West gable-end of the Barn, camera facing east.

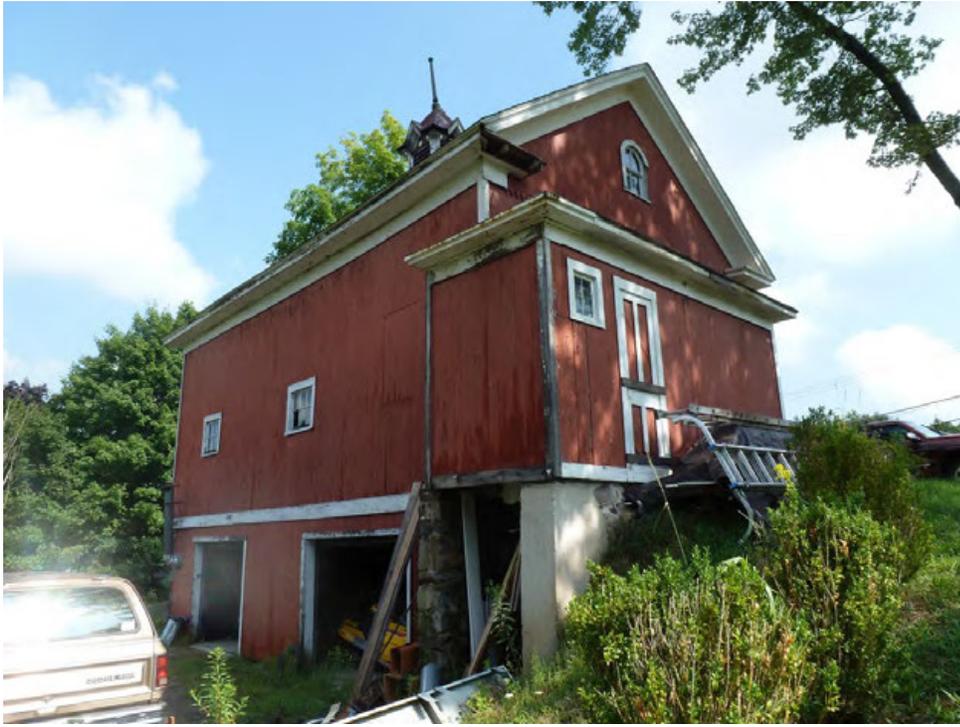
The grade rises along the east gable-end of the barn. A flat-roof addition is attached to the south half of the east-gable end of the barn, extending past the south corner of the barn, revealing a concrete foundation on the addition. A four-paned window with trim and a paneled pass-through door with trim are found on the south half of the addition. Located on the north side of the addition is a paneled pass-through door with trim. This addition is a three-hole privy that is now used for storage. Near the north corner of the east gable-end of the barn is a four-paned arched window with trim and paneled pass-through door with trim. Along the girt-line siding divide is a decorative saw-tooth trim, and above this in the gable-attic is a four-paned, arched window with trim.

11. South eave-side and east gable-end of the Barn with the addition, camera facing northwest.

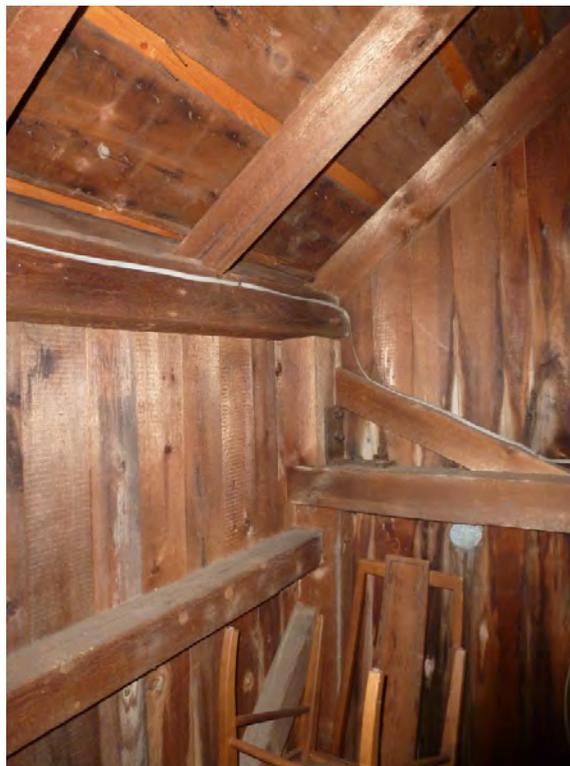
The attic is one open room with wood plank floors. In three of the four corners the tie girt rests on top of the posts, with a shorter post just above which the plate sits on. The tie girt is bolted to the shorter post with a wrought iron "L" shaped brace. However, in the south corner of the west side of the barn, the tie girt is attached to the post by tree nails in the mortise and tennon joint. In the center of the interior space is a tie girt sitting on top of posts with vertical and diagonal braces supporting the roof. Also running the length of this tie girt, just above it, is a steel tension cable attached to the posts on both the north and south walls. Attached to the plate, the common rafters meet at the ridge with no ridge board, and the roof deck consists of wood planks. Vertical support braces and collar ties have been added in the 21<sup>st</sup> century for additional stabilization. The framing of this barn appears to be a transitional hybrid between post-and-beam framing with heavy timbers with the lighter balloon framing.

20. Interior view of framing with the tie girt sitting upon the post with a shorter post just above, note the "L" shaped iron brace connecting the girt with the short post.

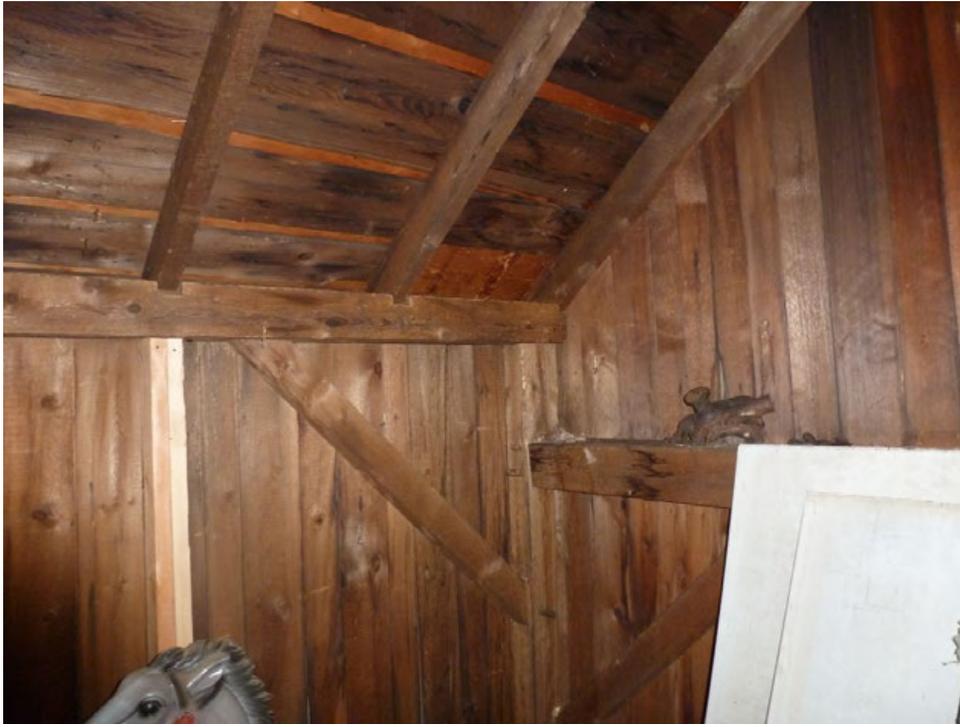
21. Interior view of the framing in the south corner on the west side of the barn, note the mortise and tenon joint with the tree nails.

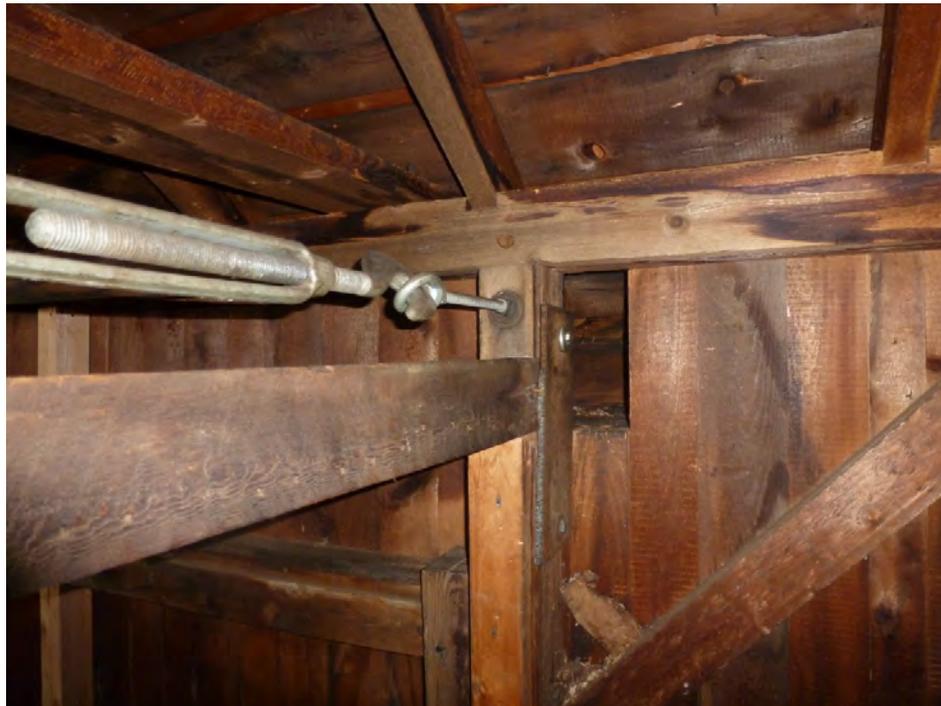
22. Interior view of the steel cable that runs along the top of the middle tie girt, attached to a post. Also note steel repair plate at the post.

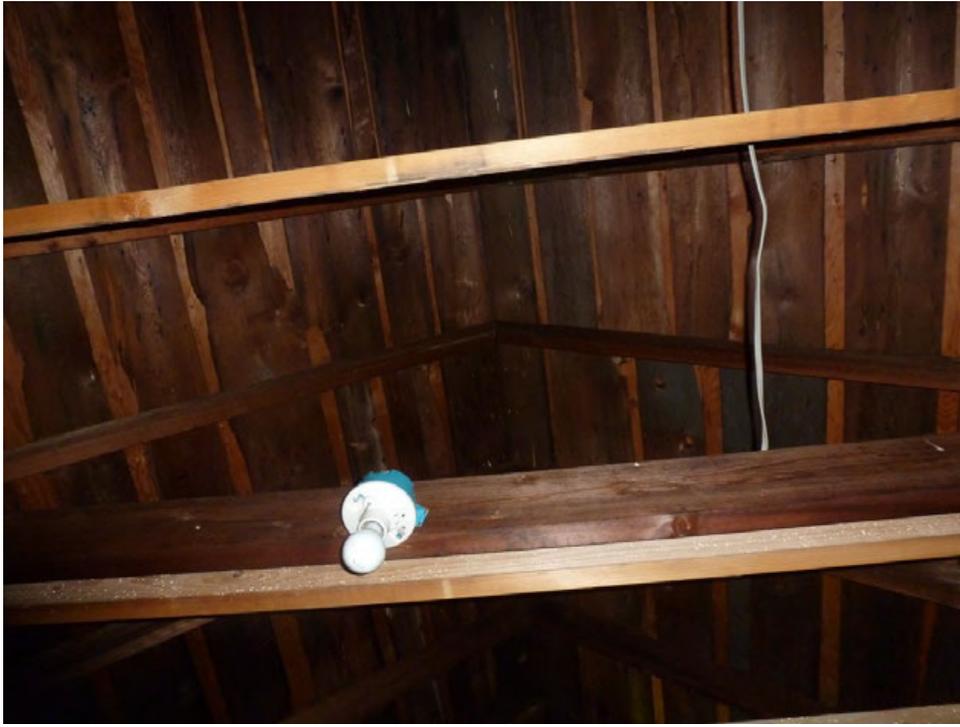
23. Interior view of the roof system; note the lack of a ridge-board and clear span of the rafters.

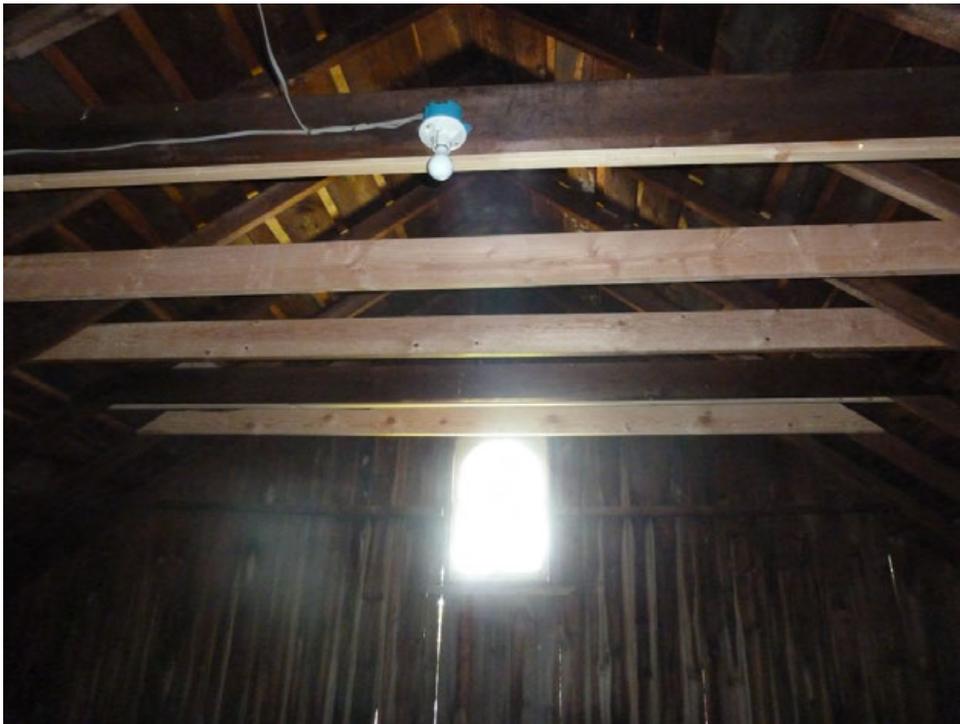
24. View of the collar ties that were added to prevent the roof from spreading.

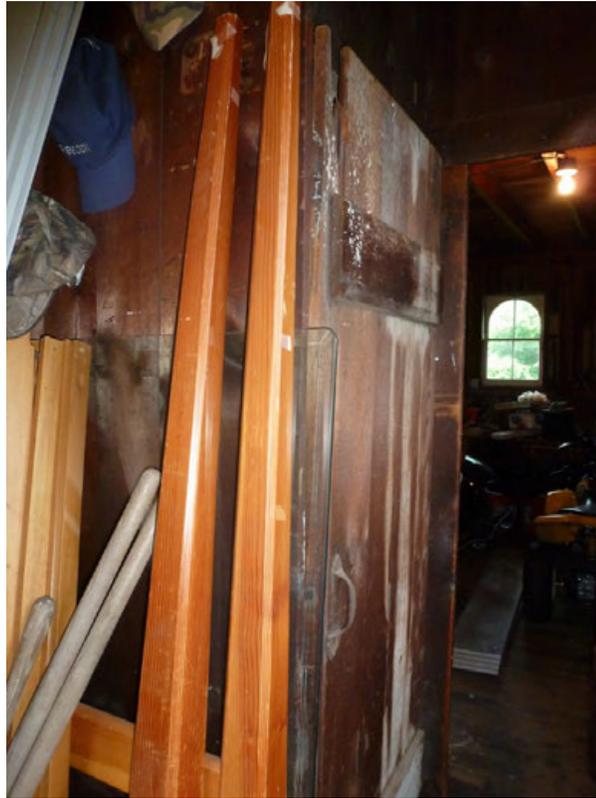
The basement level was once reached by a staircase located in the middle of the two bays on the main level of the barn. It has since been removed. The access to the basement is now only reached by the two entries found in the basement level of the barn on the south side. These entries lead to a large open room with concrete floors and mortared fieldstone walls. New support posts have been added down the center of the room, from north to south.

25. Interior view of the door that once lead to the staircase to the basement level of the barn. The staircase has since been removed, but the door remains.

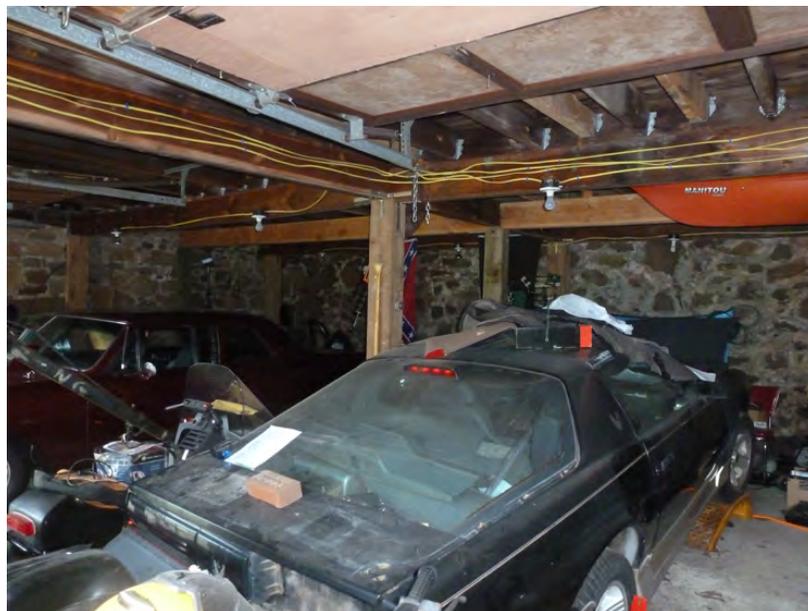
26. Interior view of the basement level of the barn; note the concrete floors and structural posts, camera facing northwest.
