HISTORIC RESOURCES

BUILDING AND STRUCTURES

Building Name (Common) Hunt, George F., Carriage House Record no. 42505
 Building Name (Historic) Hunt, George F., Carriage House
 Street Address or Location 62 Atwater Avenue
 Town/City Derby Village _____ County New Haven
 Owner(s) Tolmie, Harold, 62 Atwater Avenue, Derby CT 06418 Public Private

HISTORIC RESOURCES INVENTORY FORM – BUILDING AND STRUCTURES continuation sheet

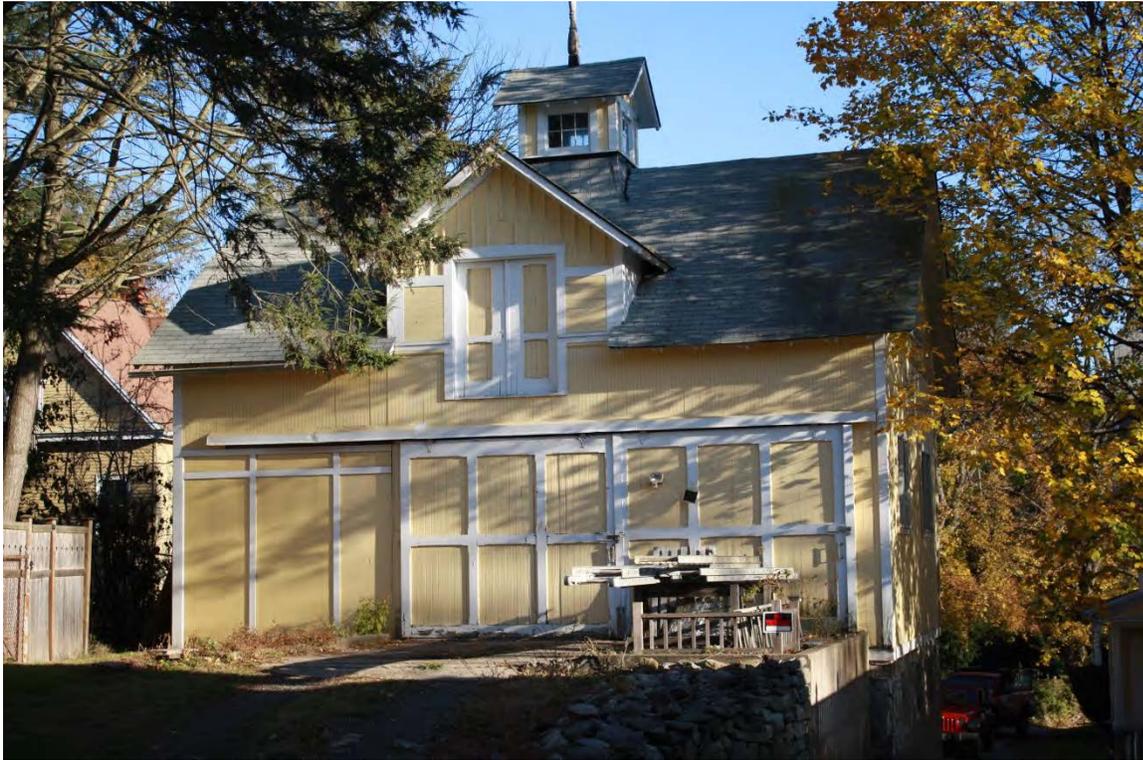
The main entries are located in the main level of the west eave-façade of the barn and consist of two exterior-hung sliding doors with a hooded track, each a bay wide, in the middle and south bay. Both doors slide to the north to open. The north bay is braced plywood that replaced the original features. As revealed by the interior framework, an opening was once there.

5. West eave-façade of carriage barn, camera facing east.

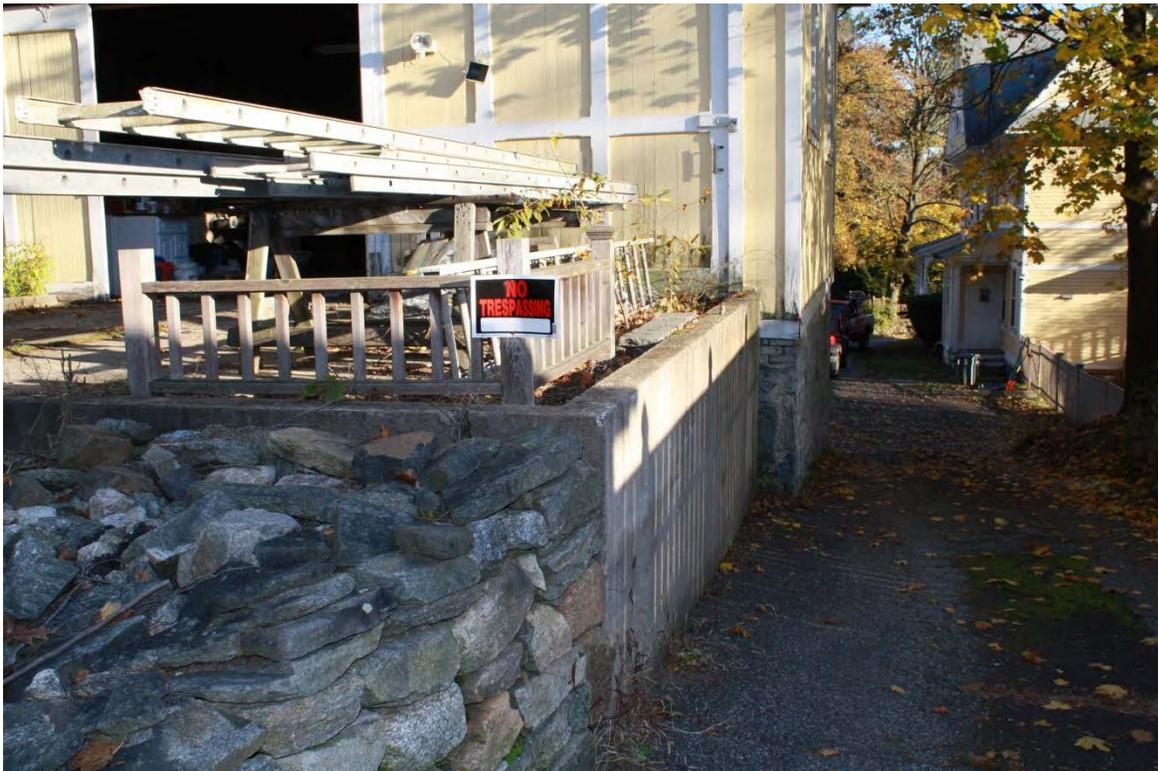
6. Detail of concrete block masonry platform, camera facing east.

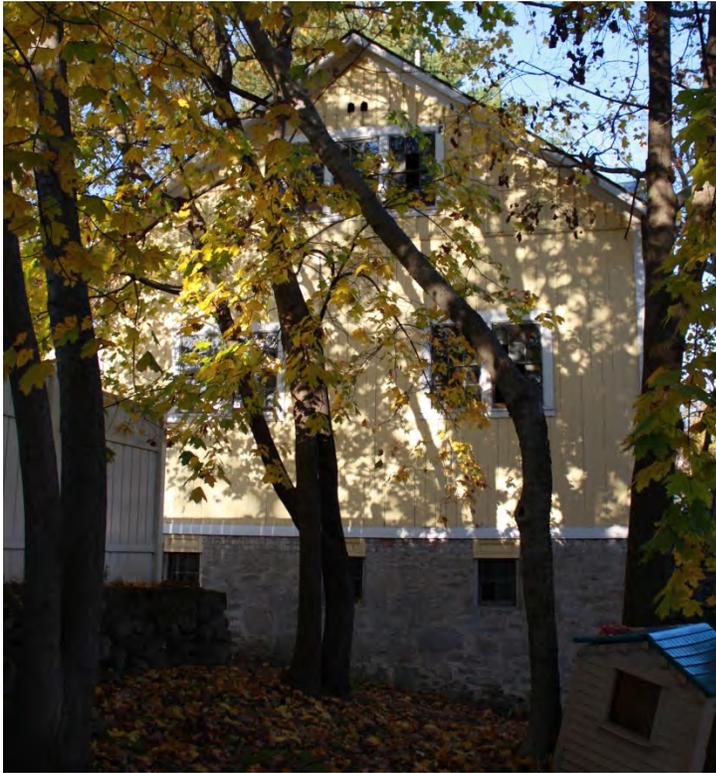
The grade declines along the south gable-end of the barn, revealing a full basement of mortared field stone topped with three courses of brick. Set within the basement wall and spaced evenly on the south gable-end of the barn are three four-pane windows with wood panels above each. On the main level, spaced evenly across the wall, are two pairs of six-over-six, double-hung windows with trim and pediments. In the gable attic on the south gable-end of the barn is a set of three, six-over-six, double-hung windows with trim. Above is a centered pair of pigeon holes.

7. South gable-end of the carriage barn, camera facing north.

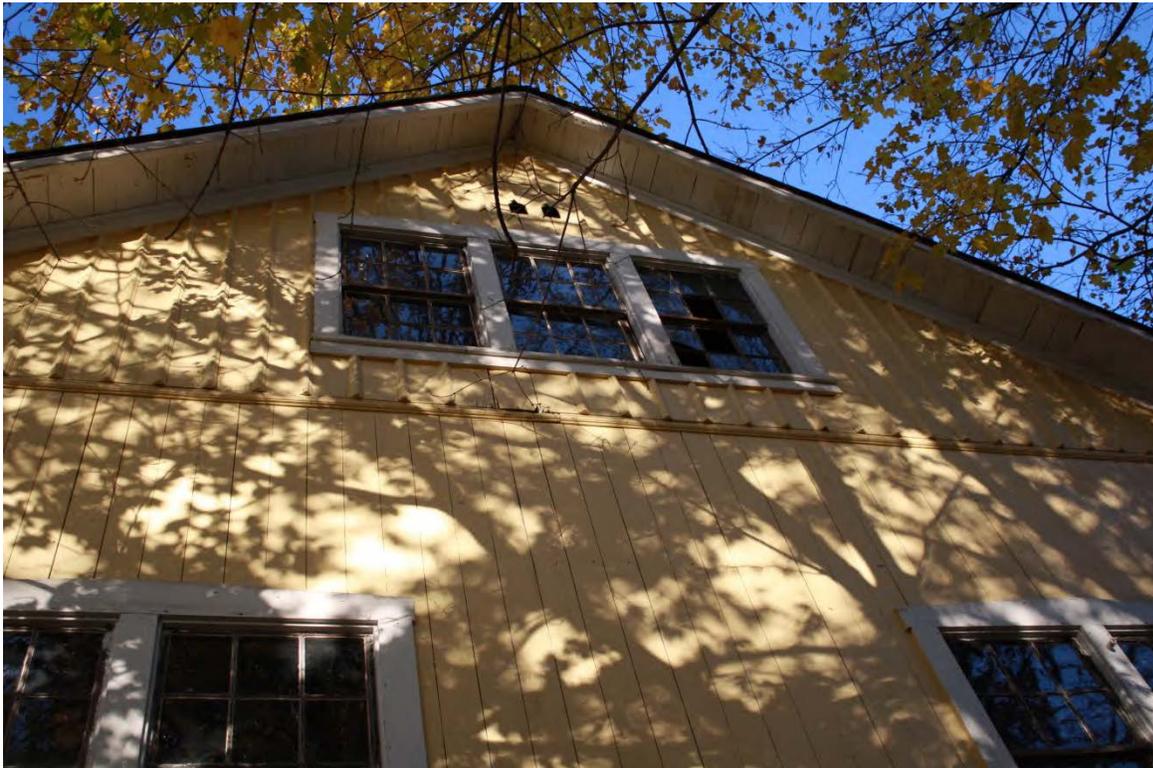
8. Detail of south gable, camera facing north. Note the pigeon holes.

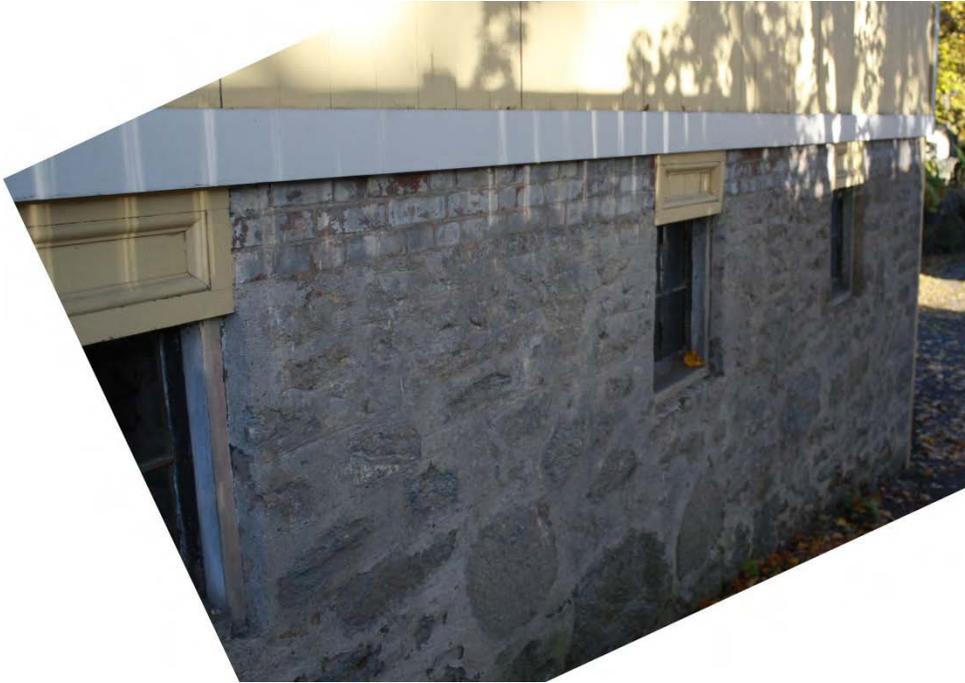
9. Detail of south gable-end foundation with brick layer, camera facing northeast.

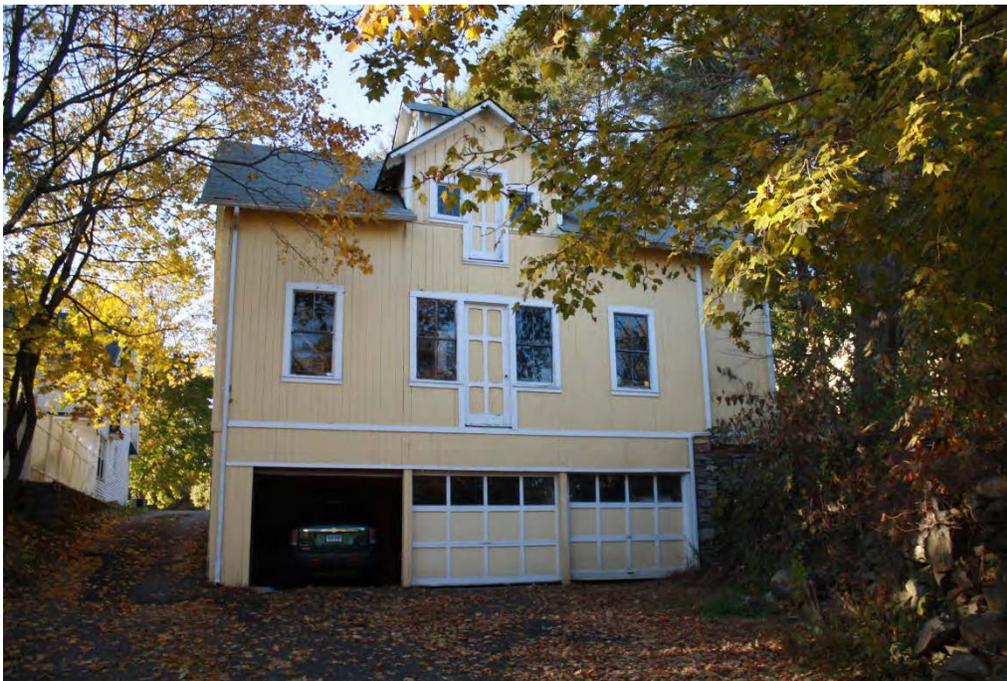
The grade levels off past the barn and towards the house, resuming its decline past the northwest corner of the house. The basement level of the east eave-side of the barn has three overhead, paneled garage doors. The north corner of the basement level of the east eave-side is constructed of field stone topped with three courses of brick, with a fieldstone retaining wall extending to the east off the north corner. Centered above the middle bay of the basement in the main level of the east eave-side of the barn is a paneled pass-through door flanked by two-over-two double-hung windows, sharing a single lintel. Centered above the north and south bay are two-over-two double-hung windows with trim. Centered in the cross gable wall dormer, intersecting the eave line, is a paneled pass-through door flanked by nine-pane fixed windows with trim. A 1-story gable-roof addition extends to the north from the north corner of the east eave-side of the barn.

10. East eave-side of carriage barn, camera facing west.

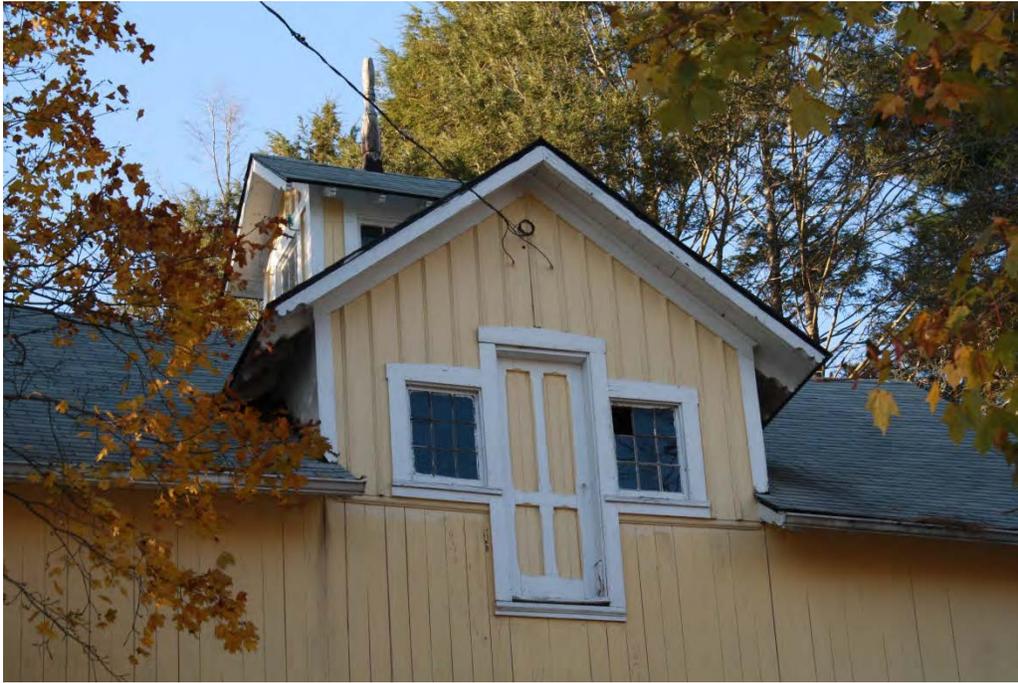
11. Detail of east eave-side wall dormer and cupola, camera facing west.

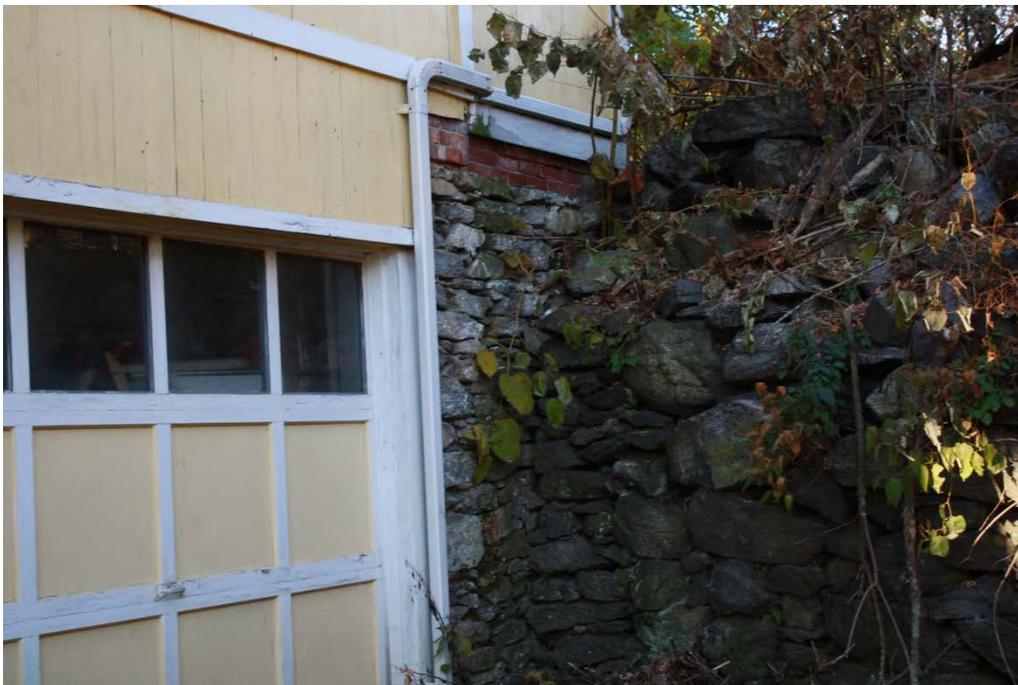
12. Detail of the cut stone and brick foundation at the northeast corner of the carriage barn, camera facing northwest.

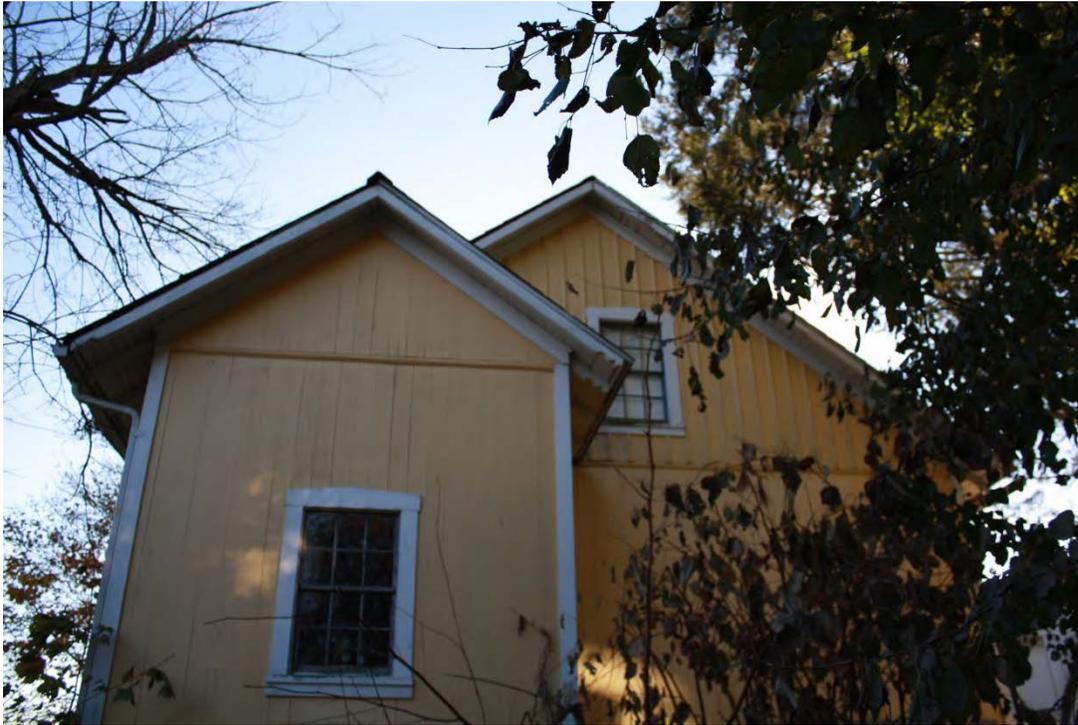
The grade inclines sharply at the north gable-end of the barn back to the main level elevation. The north gable-end of the barn has a gable-roof addition on the east half, encompassing about a third of the end. Its east eave-side is flush with the east eave-side of the barn and is accented with a vertical trim board. Centered in the north gable-end of the addition is a six-over-six, double-hung window with trim. The rest of the north gable-end of the barn is blank except for a six-over-six, double-hung window with trim centered in the gable attic.

13. North gable-end of the carriage barn, camera facing south.

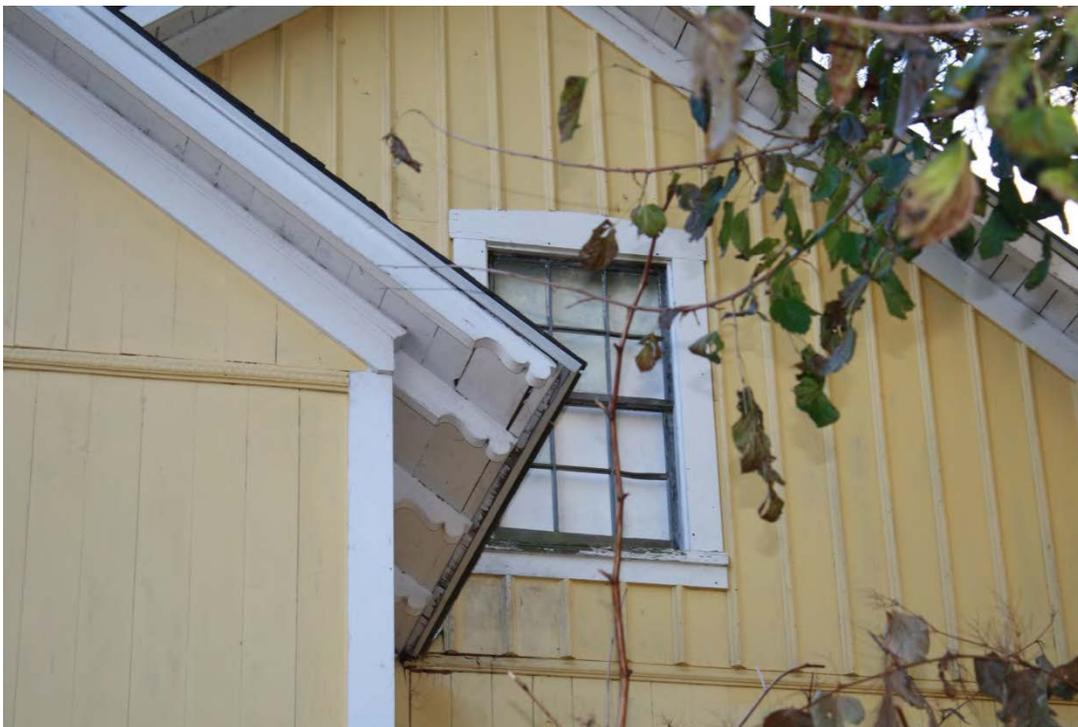
14. Detail of scroll-sawn brackets on the addition, camera facing south.

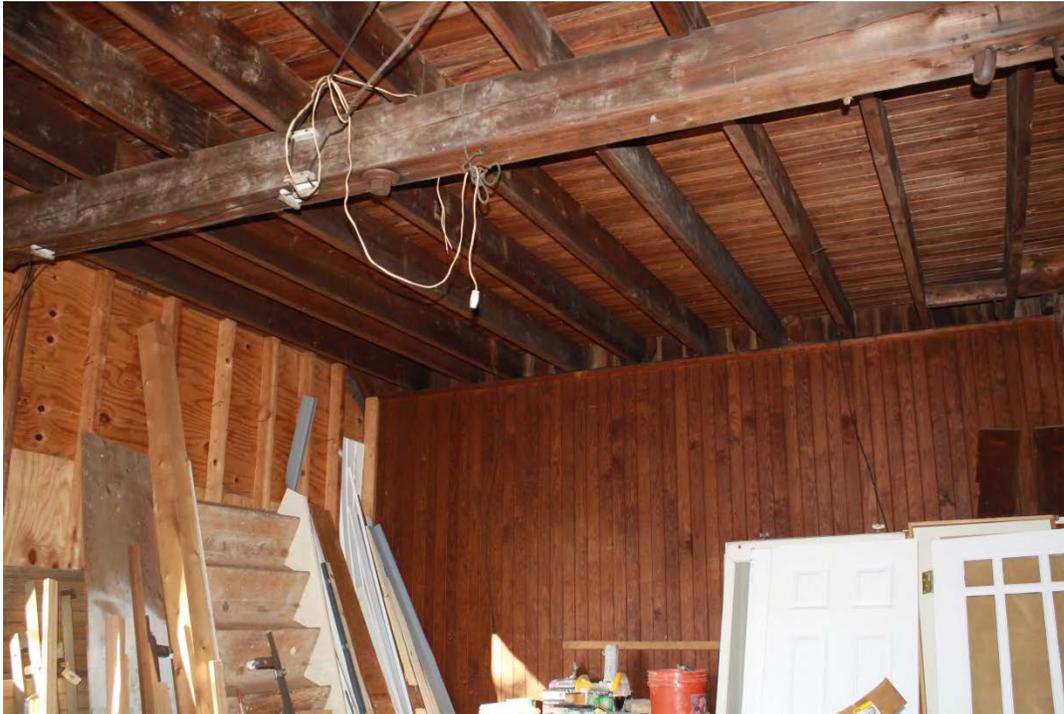
15. Interior of main level of carriage barn, camera facing northwest. Note the new balloon frame in the west eave-wall and the bent with bolt of metal tie-rod.

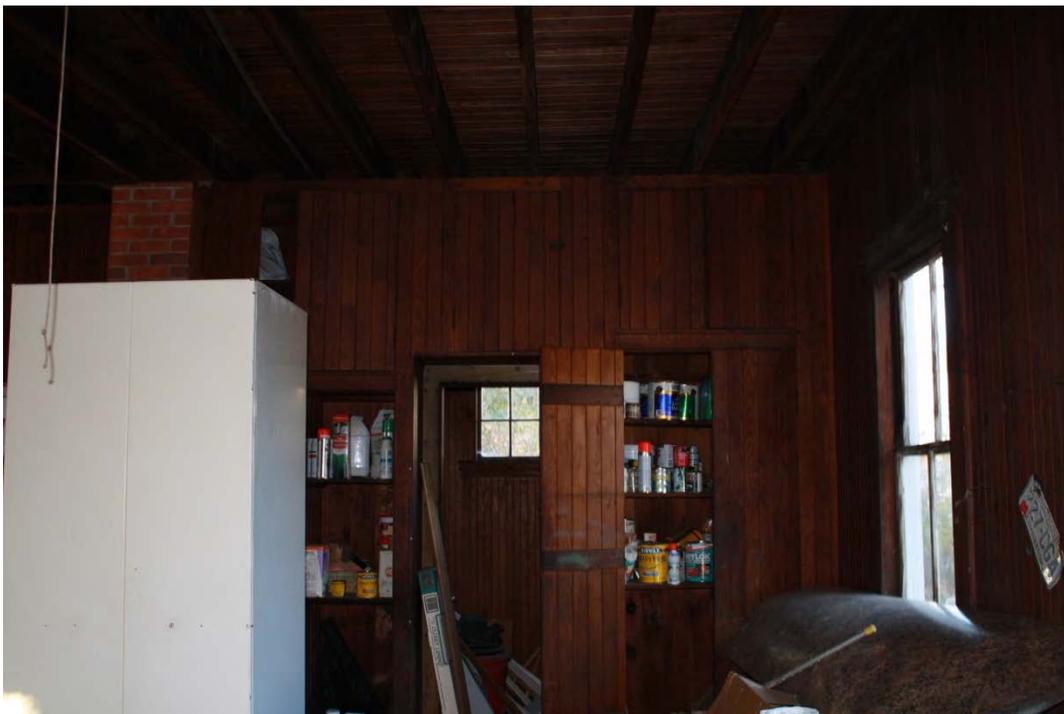
16. Interior of main level of carriage barn, camera facing north. Note the built-in cabinets and doorway to north addition.

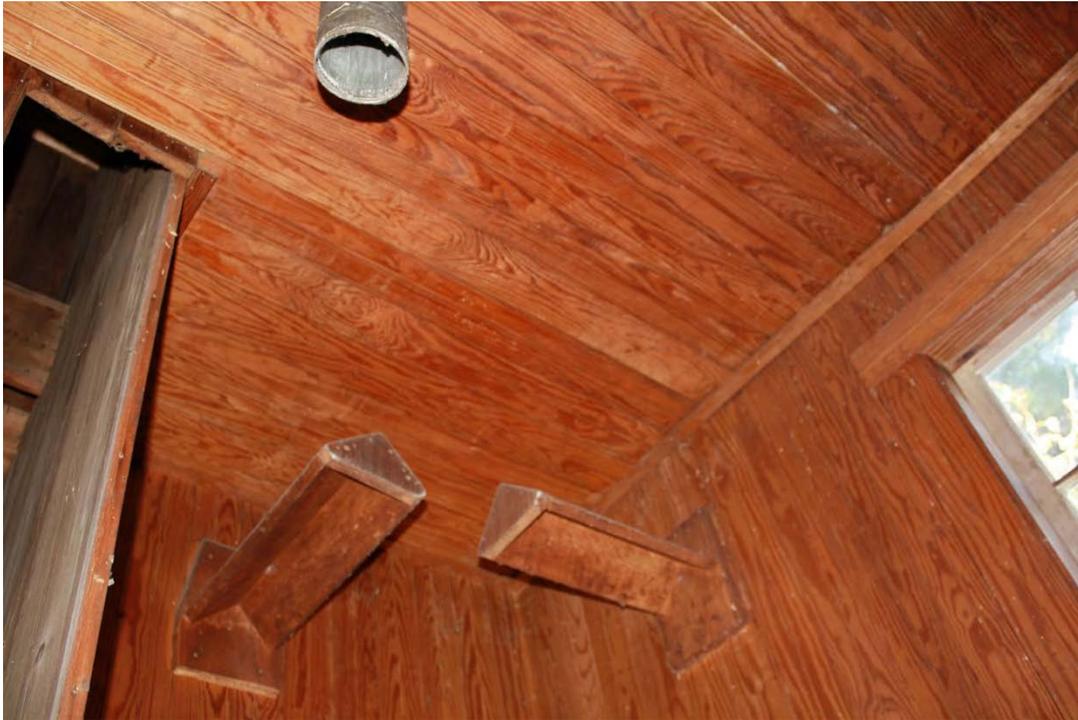
17. Detail of the interior of the addition, camera facing northeast. Note the saddle racks.

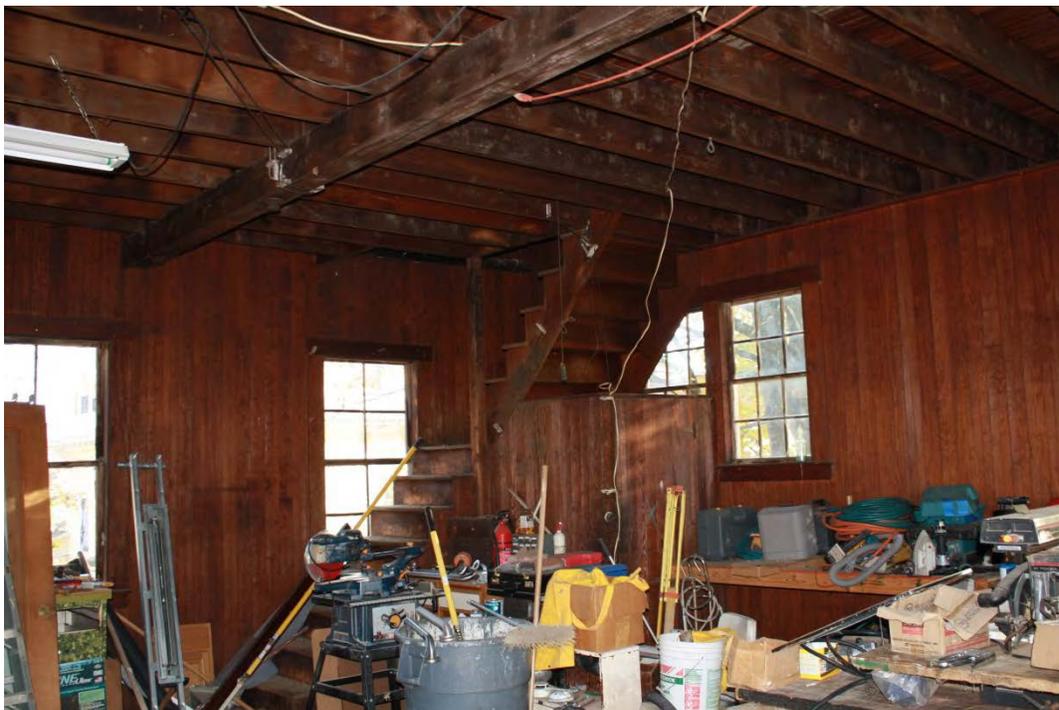
18. Interior of main level of carriage barn, camera facing southeast. Note the two-tier stairway to the second level with enclosed closet beneath.

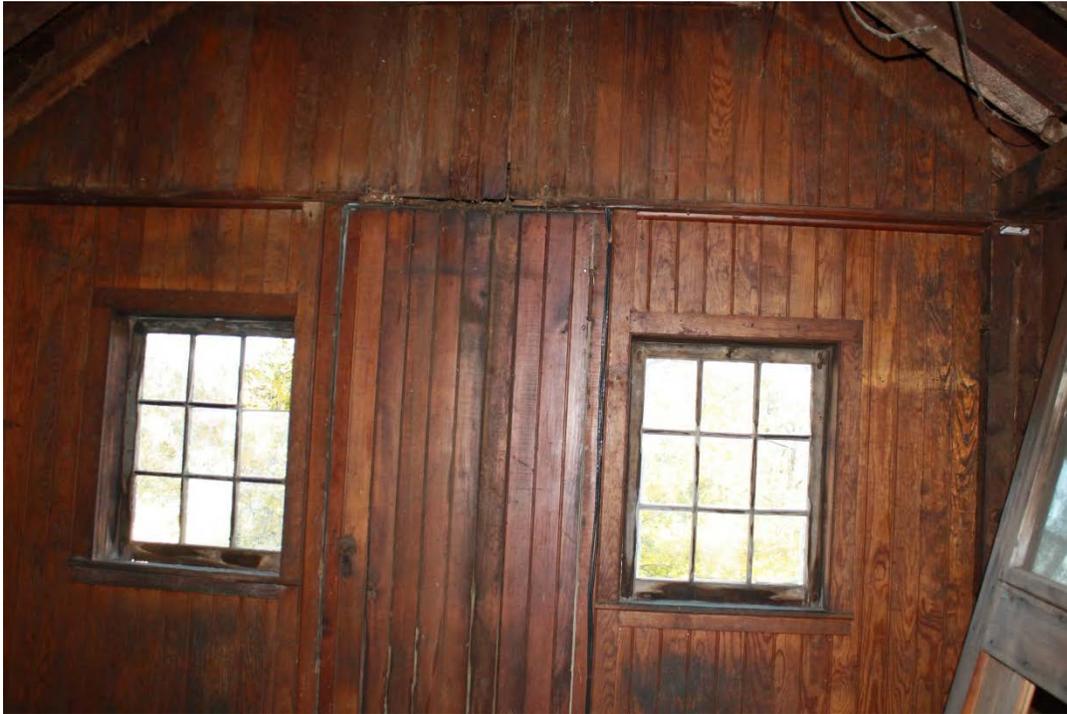
19. Detail of second level east wall dormer interior door, camera facing east.

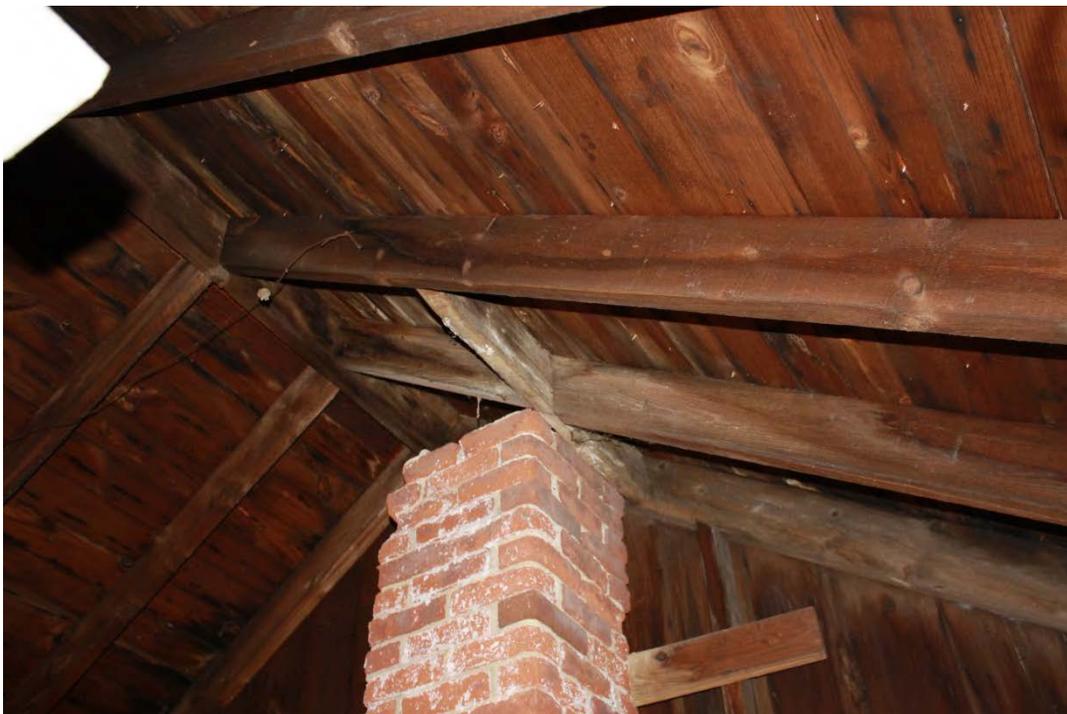
20. Detail of north wall in the second level, camera facing north. Note the chimney is terminated prior to exiting the roof.

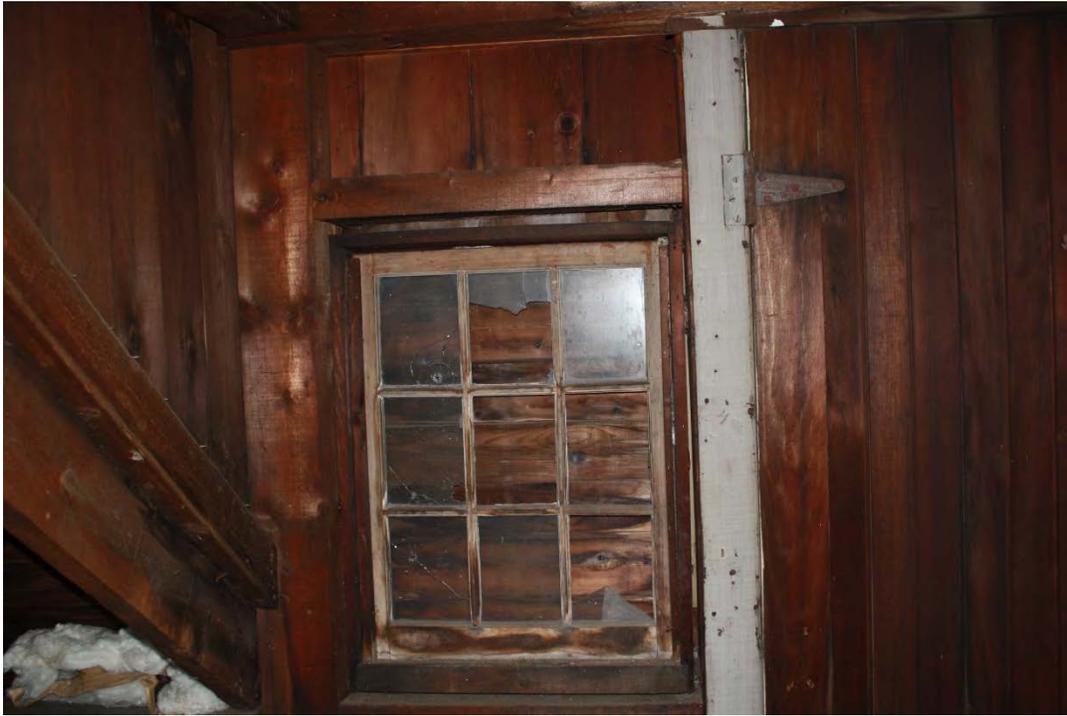
21. Detail of the west wall dormer in the second level, camera facing west. Note the boarded over nine-pane window.

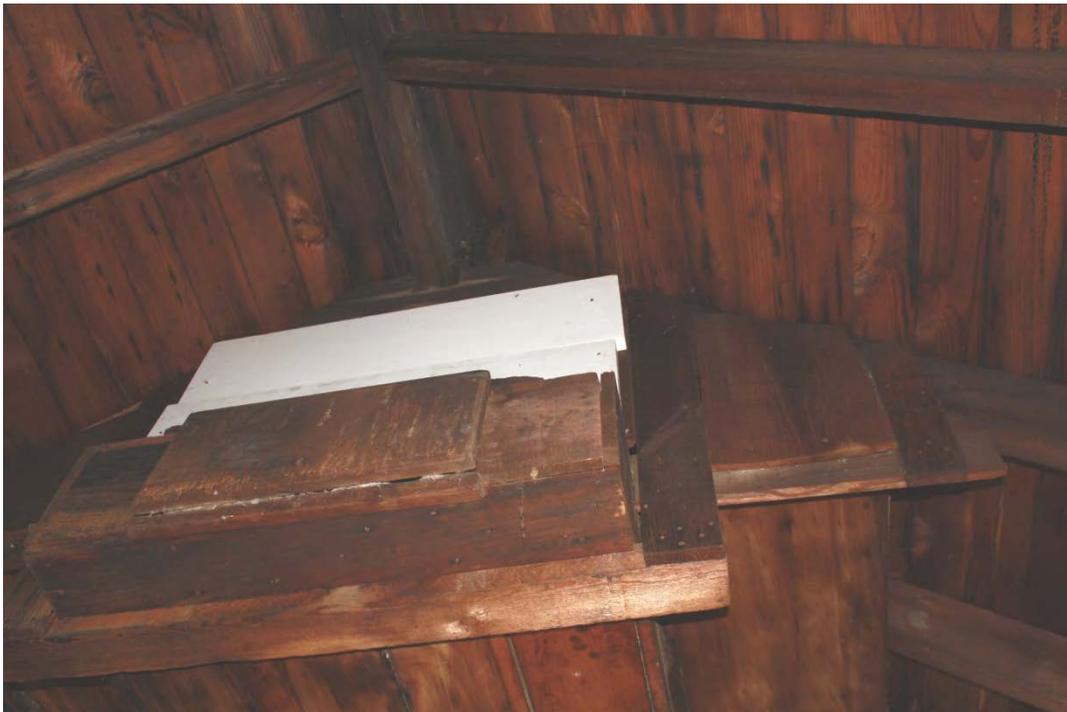
22. Detail of south gable-end pigeon coop, camera facing up & south.

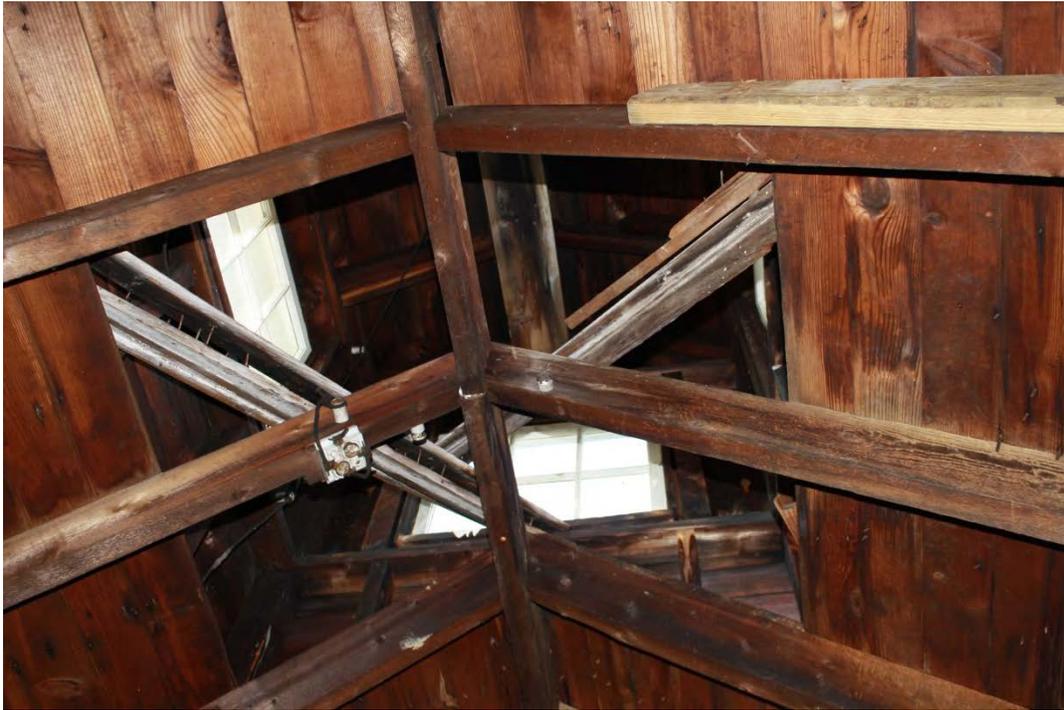
23. Detail of the interior of the cupola, camera facing upward.

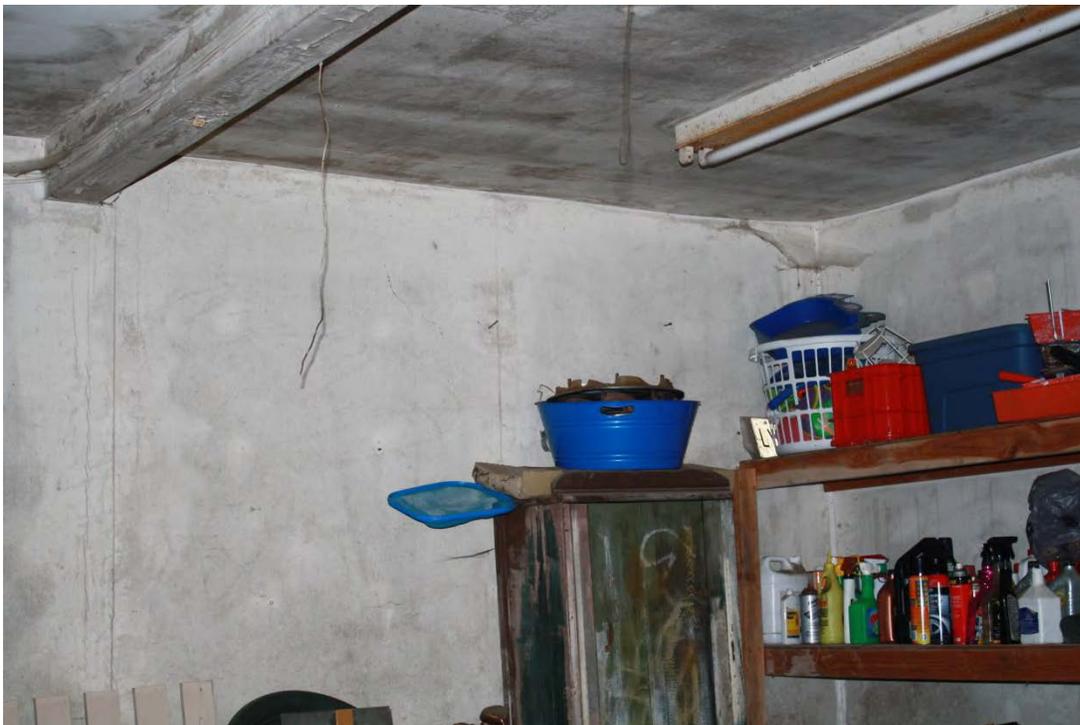
The basement level is accessible only from the exterior on the east side; the original stairway from the main level to the basement level has been covered with a closet on the main level and gypsum wall board on the basement level ceiling. The basement level is one room, formerly used for painting automobiles. It is accessed from the exterior by three modern overhead garage doors, one in each bay. The ceiling, south, west and north walls have been covered with gypsum painted white. Only the windows on the south side are uncovered, as well as a section in the ceiling of the middle bay and north bay, although it appears as if it were once covered. Two exposed 4" x 8" beams, each corresponding with the placement of the bents above, are also exposed. The floor of the basement is concrete.

24. Interior of basement level, camera facing northwest.

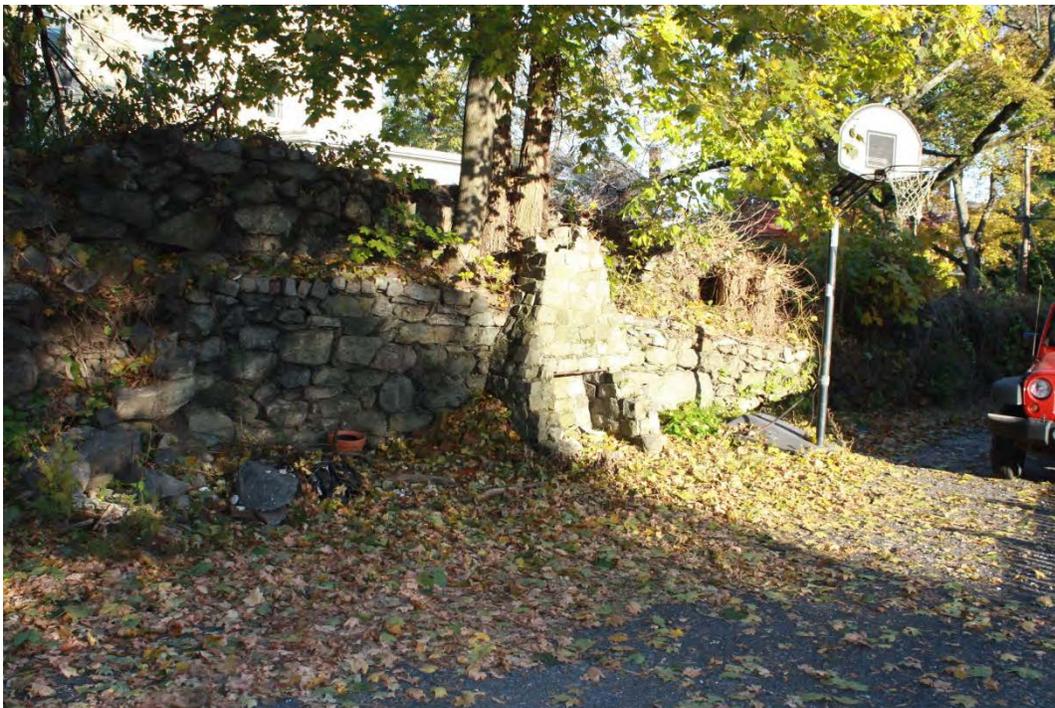
At the northeast corner of the barn, extending to the east, is an un-mortared field stone retaining wall that runs all the way to Atwater Avenue. The grade declines from west to east, resulting in the eastern portion of the retaining wall becoming a stone wall. A stone fireplace is facing south, slightly projecting from the stone wall, north of the point where the driveway and the area in front of the barn converge. To the east of the barn is automobile access from all three bays, converging on the driveway, north of the house.

28. Detail of north retaining/stone wall, camera facing northeast. Note the stone fireplace.
