HISTORIC RESOURCES

BUILDING AND STRUCTURES

Building Name (Common) Potter, Clare / Rossiter, Christopher Columbus, Farmstead Record No. 8125

Street Address or Location 594 County Road

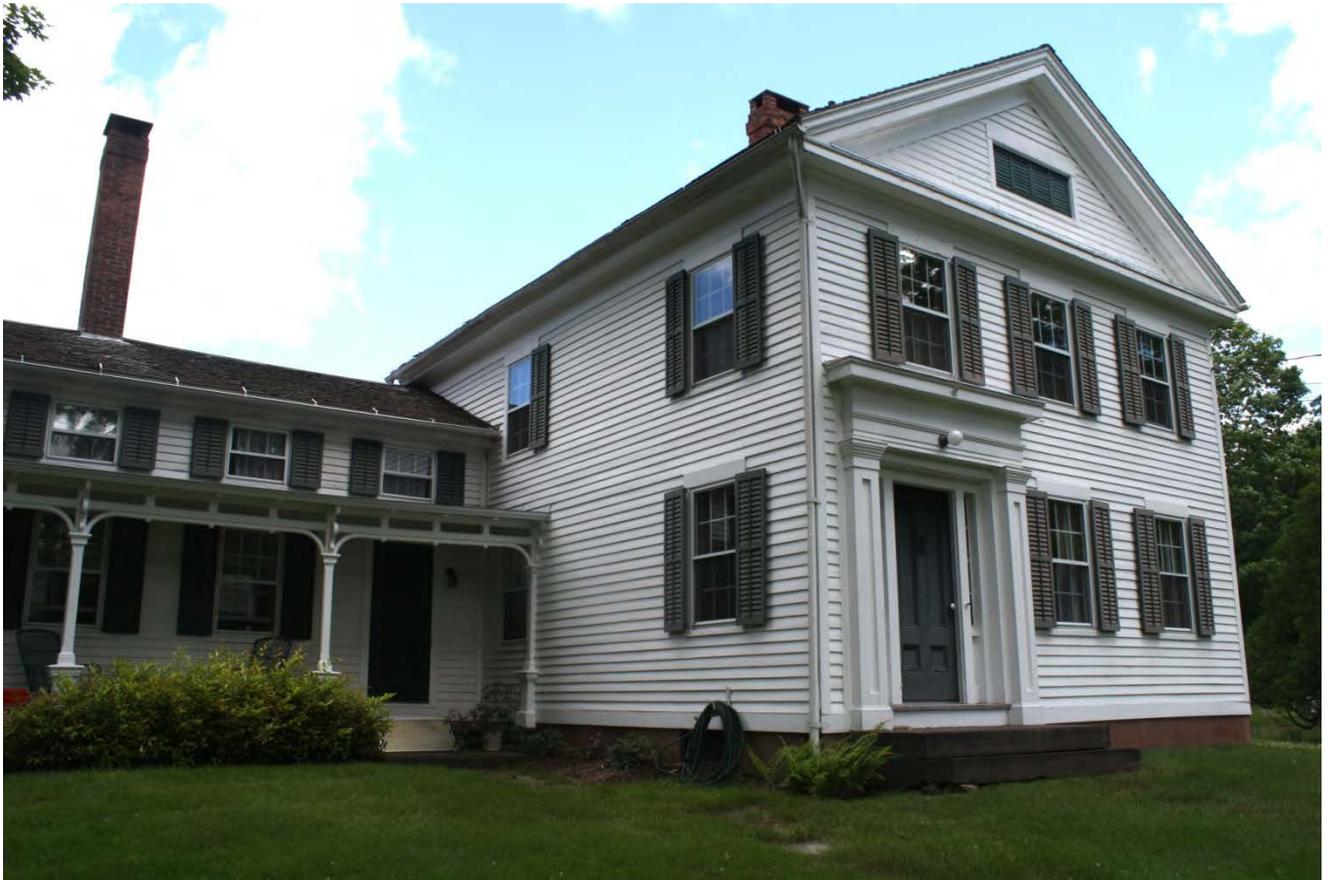
5. Southwest view of Farmhouse, camera facing northeast.

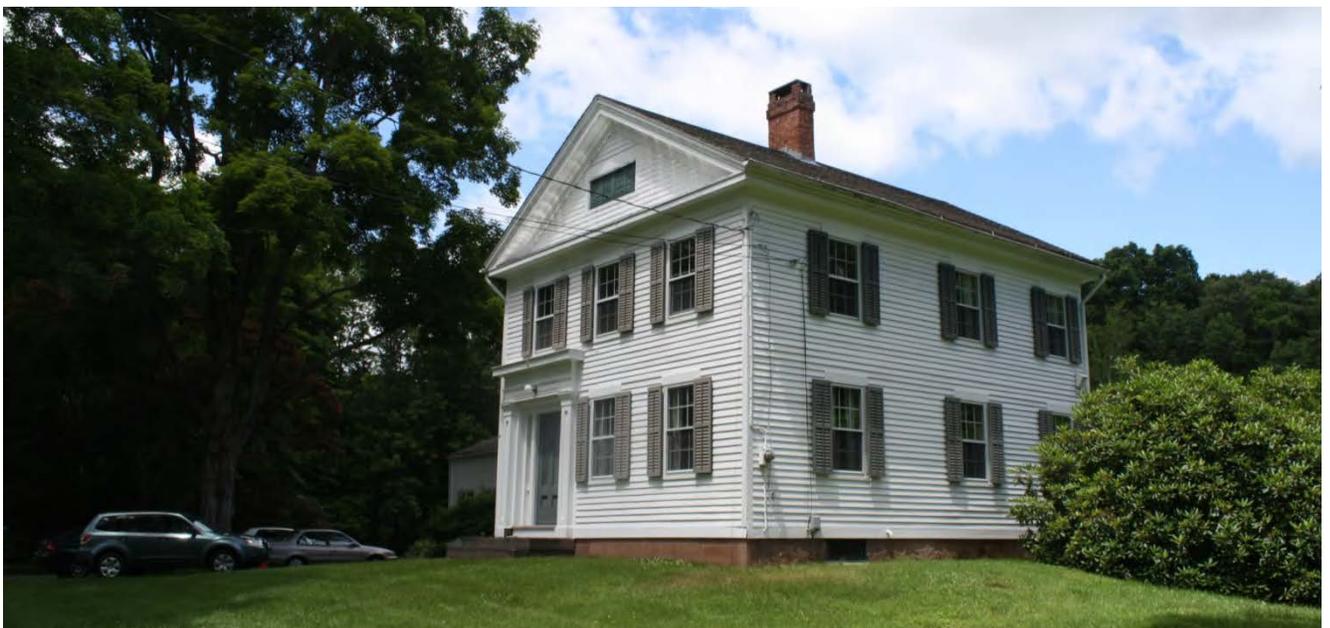
6. Southeast view of Farmhouse, camera facing northwest.

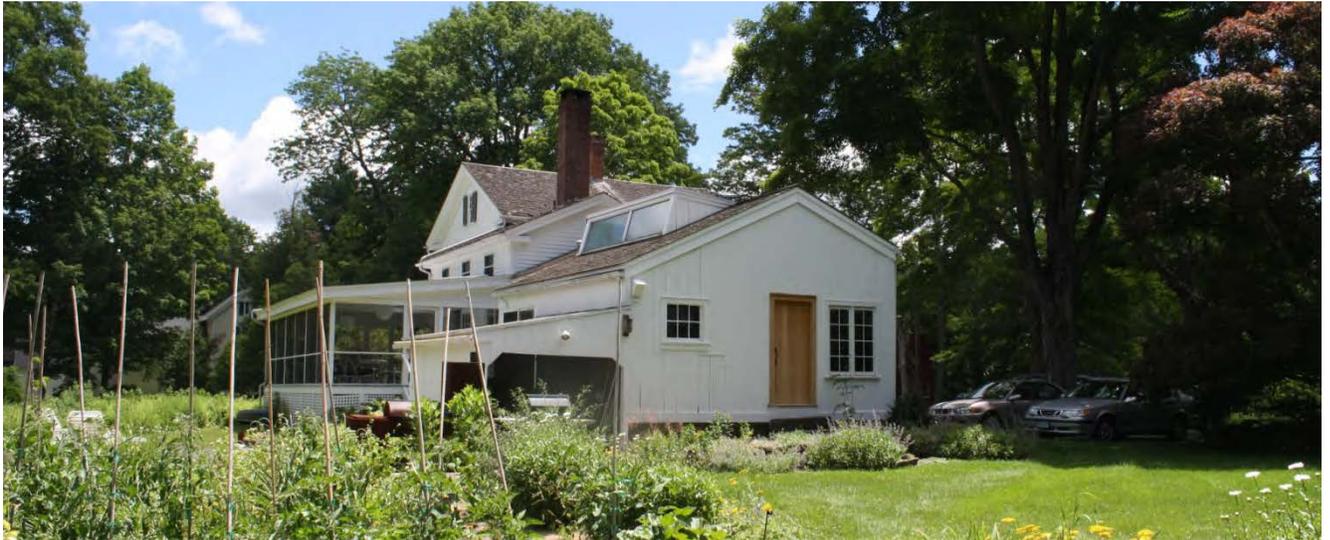
7. Northwest view of Farmhouse, camera facing southeast. Modern alterations include screened porch and conversion of the carriage shed to a studio with north-facing skylight.

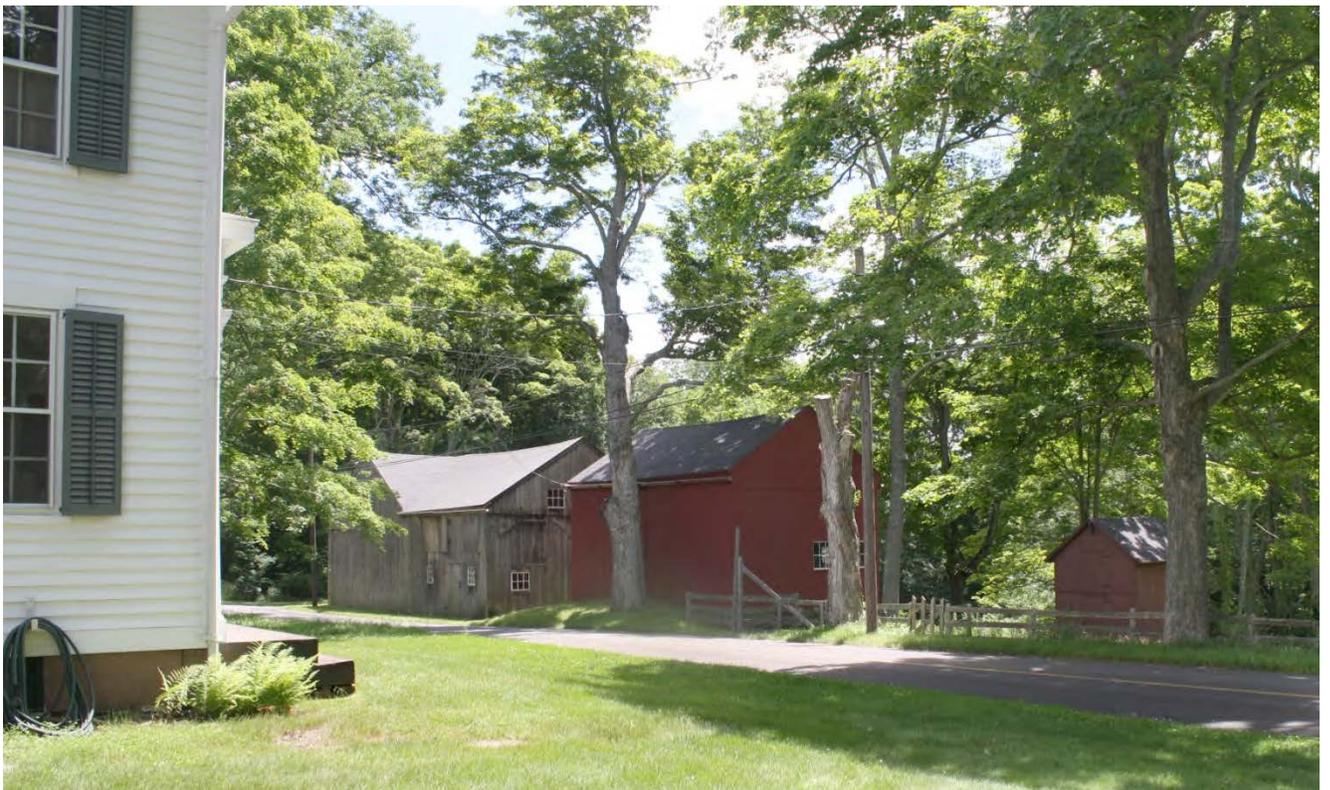
8. Northwest view of barns from the Farmhouse, camera facing southeast. From left to right: Barn I – Gray barn, Barn II – Red barn, Corncrib.

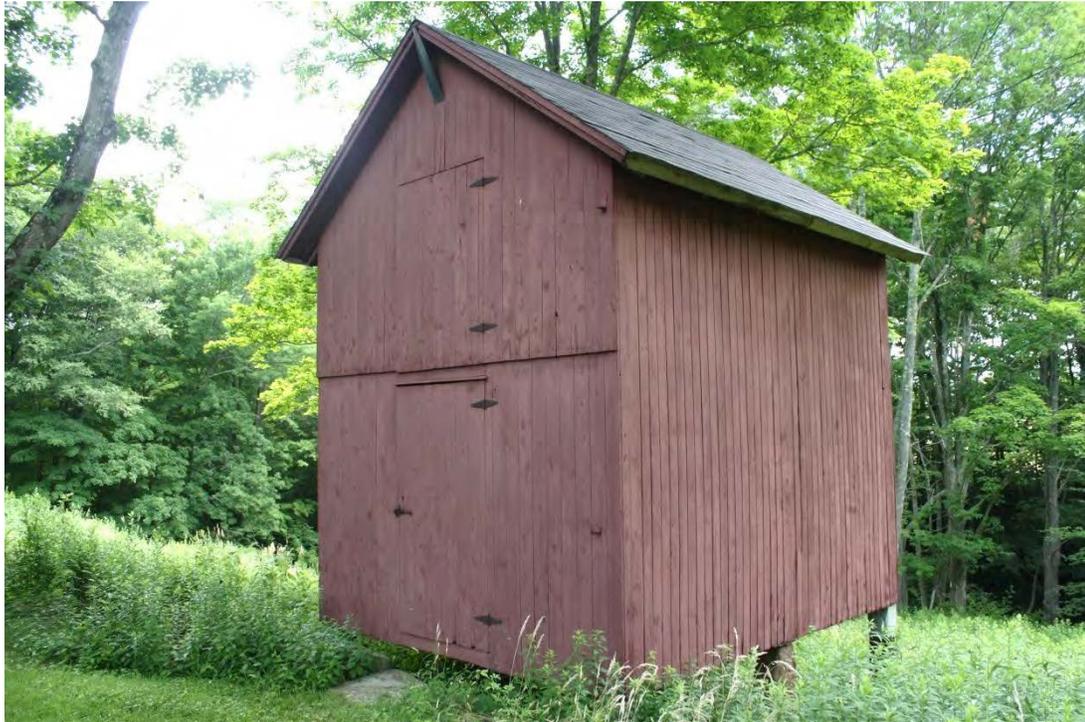
9. Northwest view of Corncrib, camera facing southeast.

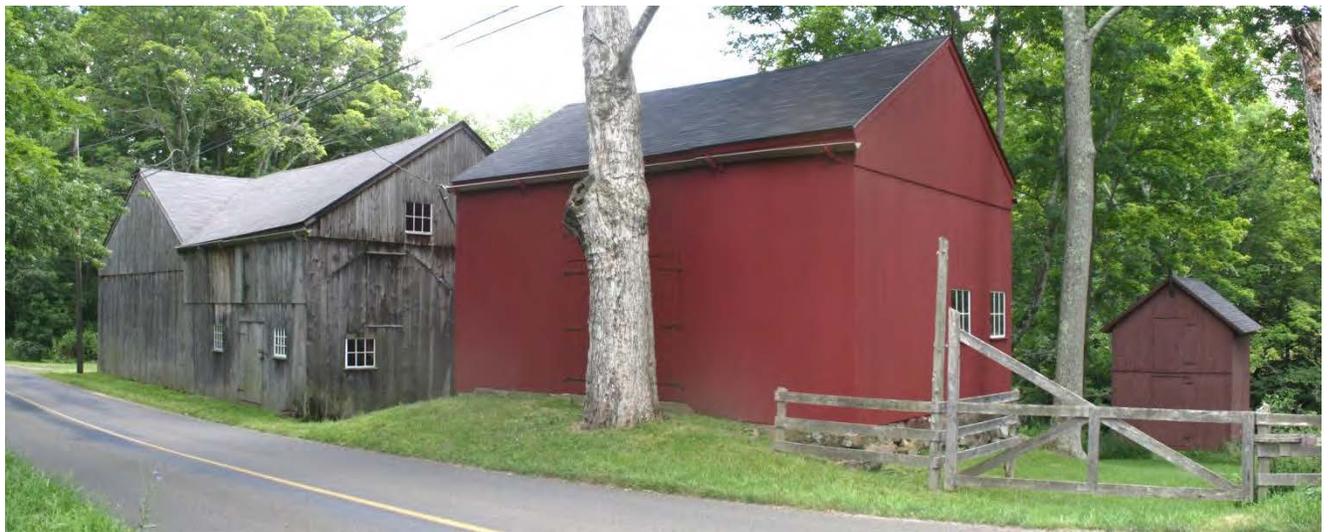
10. Northwest view of barns, camera facing southeast. Barn I – Gray barn at left, Barn II – Red barn at center, and Corncrib at right rear.

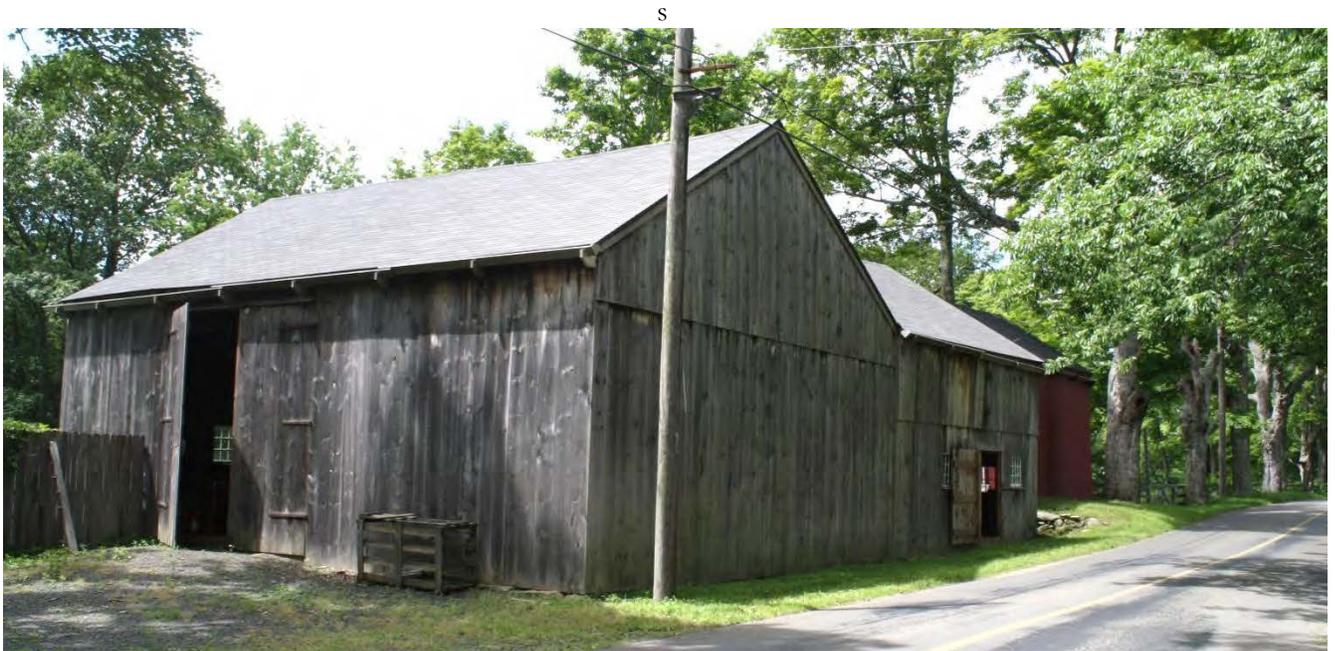
11. Northeast view of Barn I – Gray barn, camera facing southwest. Barn II is at right rear.

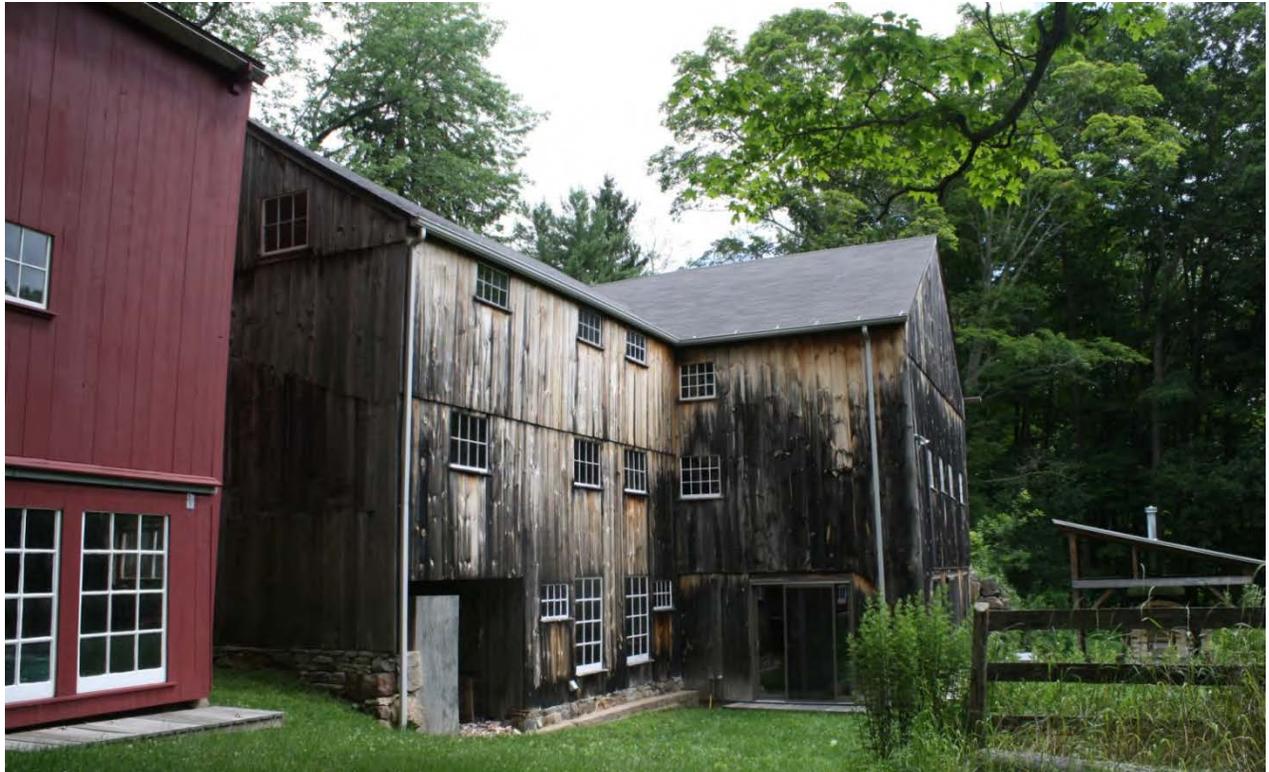
12. Southwest view of Barn I, camera facing east. Barn II is at left; the main block of Barn I is the projecting structure at right, with the west wing at left. This view shows additional windows added during renovation. Shed roof for the kiln is at the right rear.

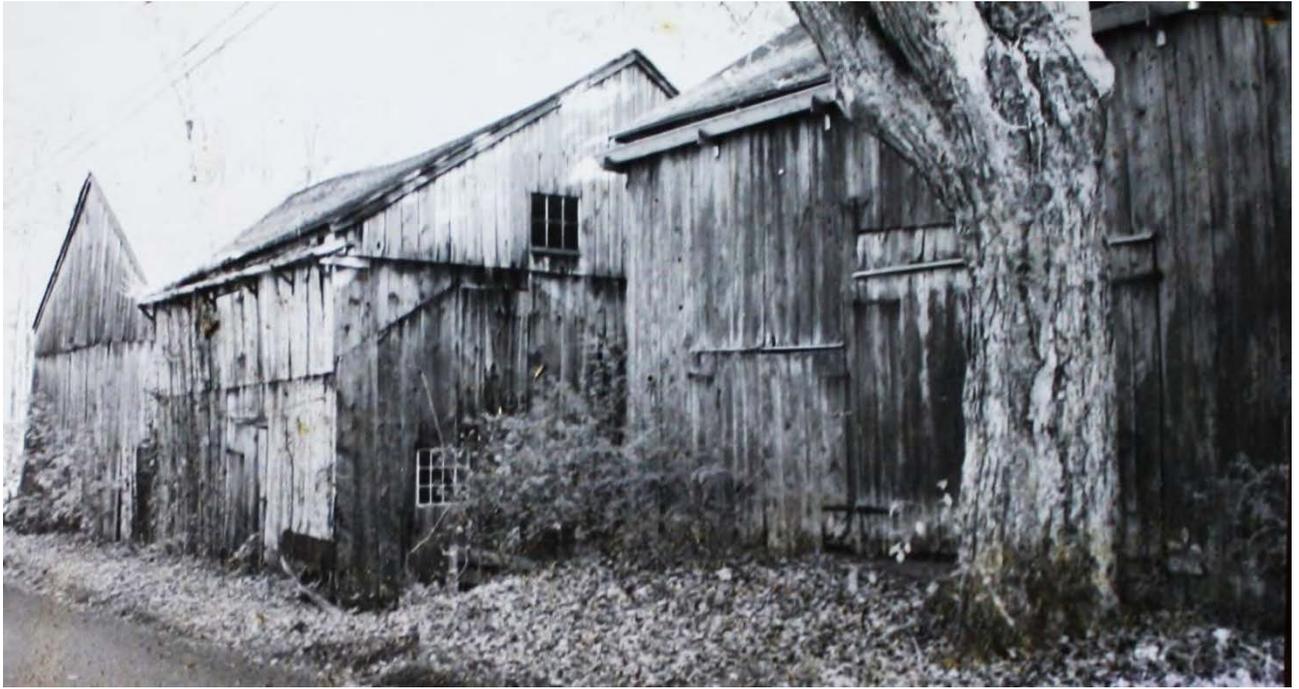
13. Northwest view of Barn I & II prior to restoration; courtesy of Caroline Chandler.

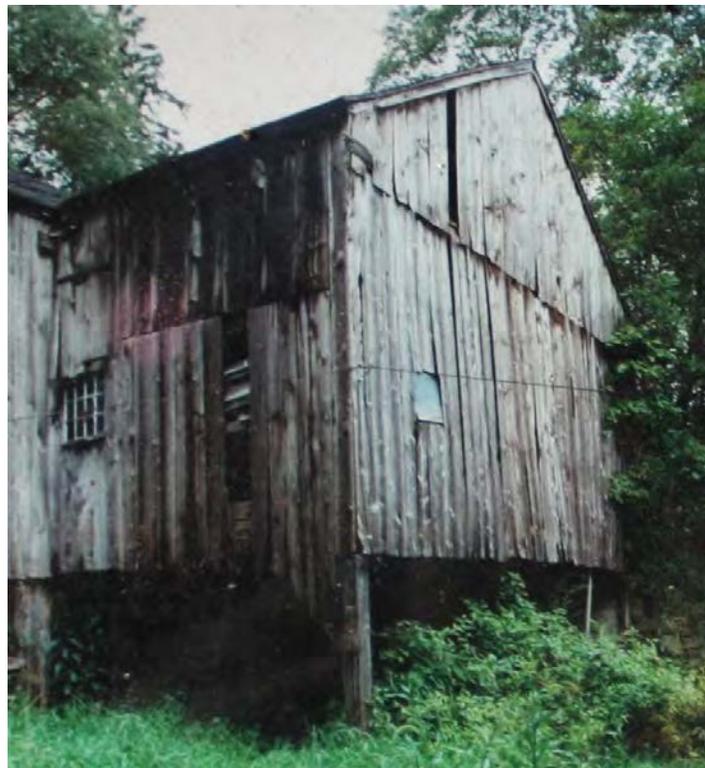
14. Southwest view of Barn I prior to restoration; courtesy of Caroline Chandler.

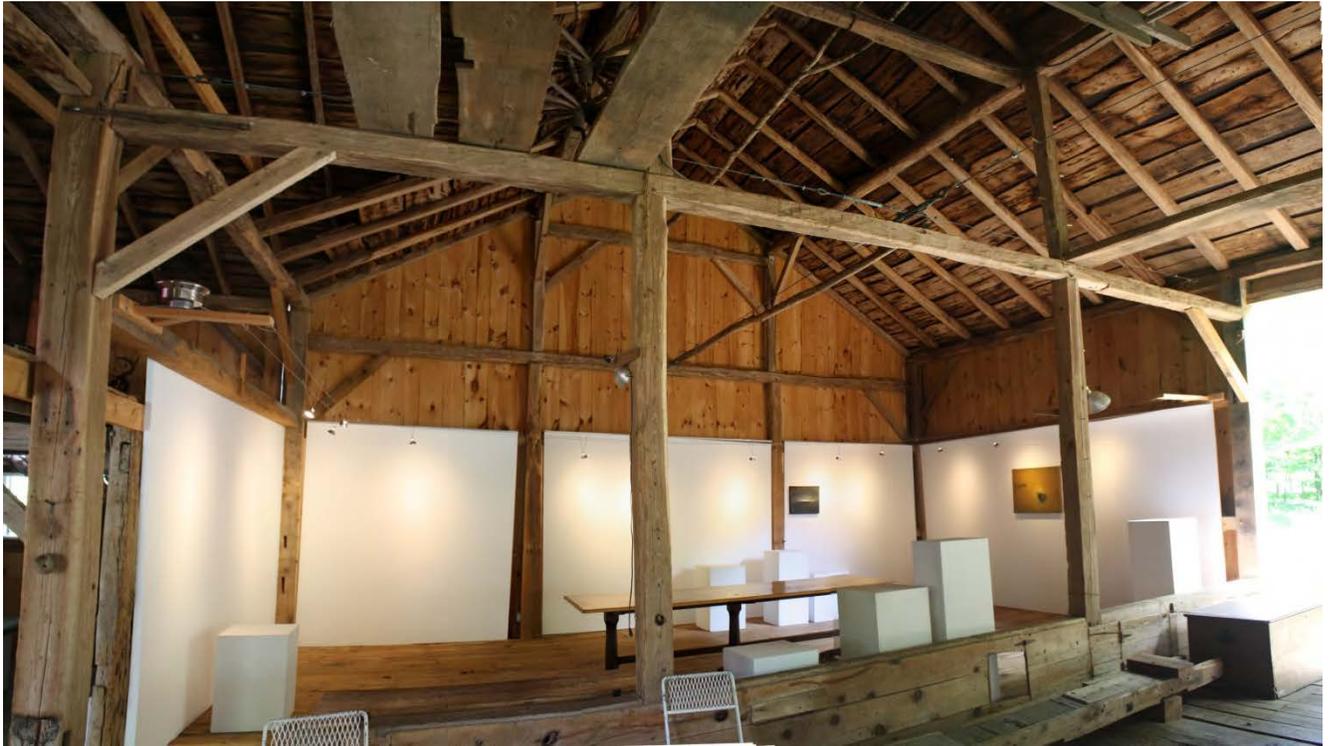
15. Interior view of Barn I main level, camera facing northeast; showing typical framing and art gallery. At lower right foreground is a bench made from a post “repaired” with concrete, an artifact of the barn’s history.

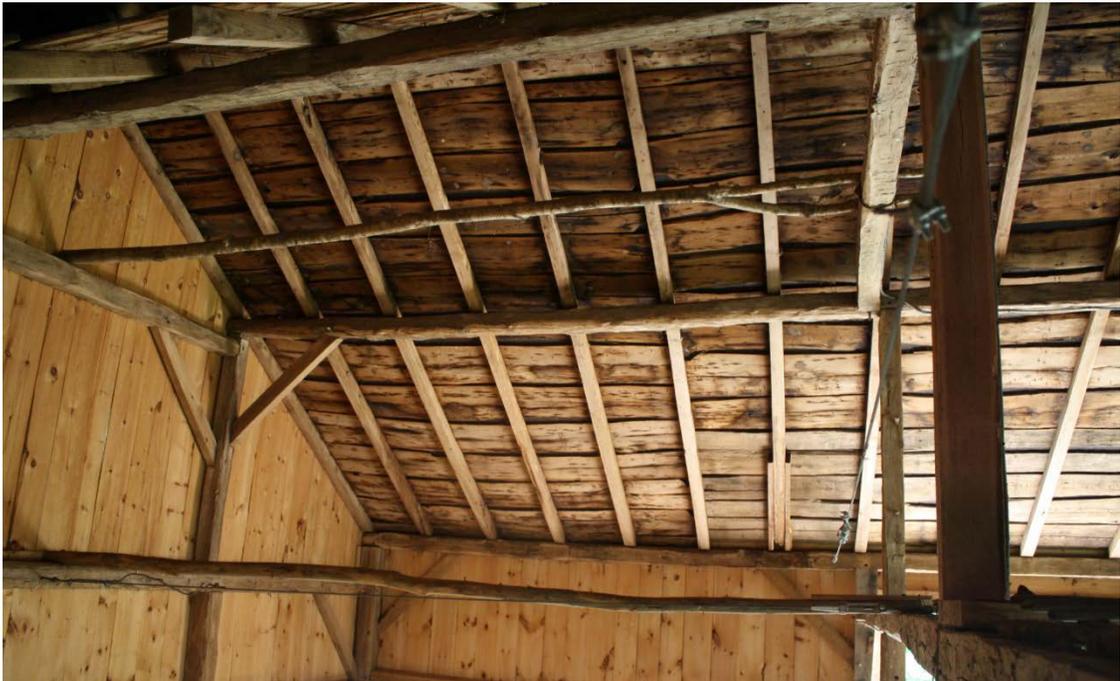
16. Interior view of Barn I framing at northeast corner, camera facing east.

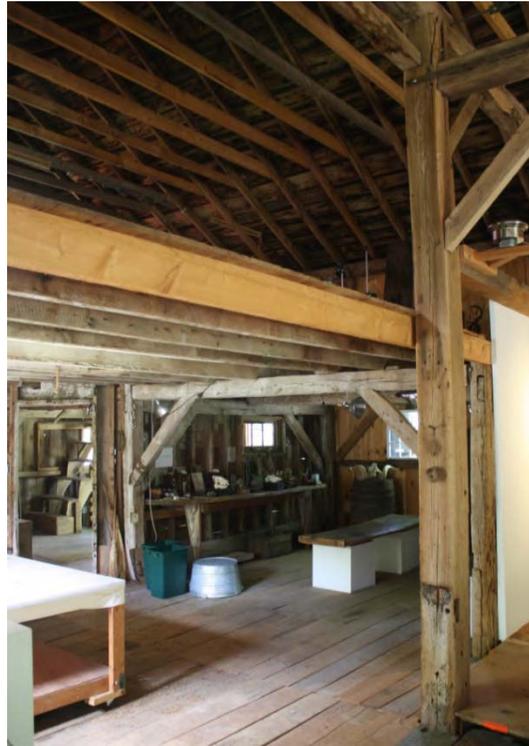
17. Interior view looking from the main block of Barn I northwest into the west wing. The light gray frame at rear is the material thought to be oldest.

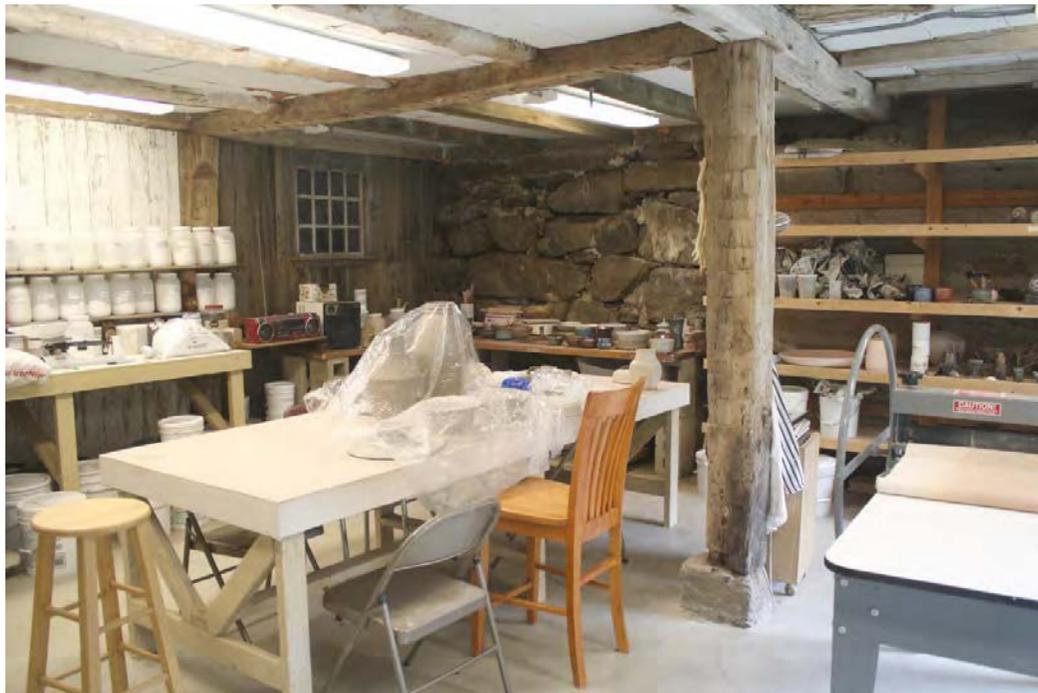
18. Interior view of basement level of Barn I, pottery studio; camera facing northeast. The east retaining wall is visible at rear.

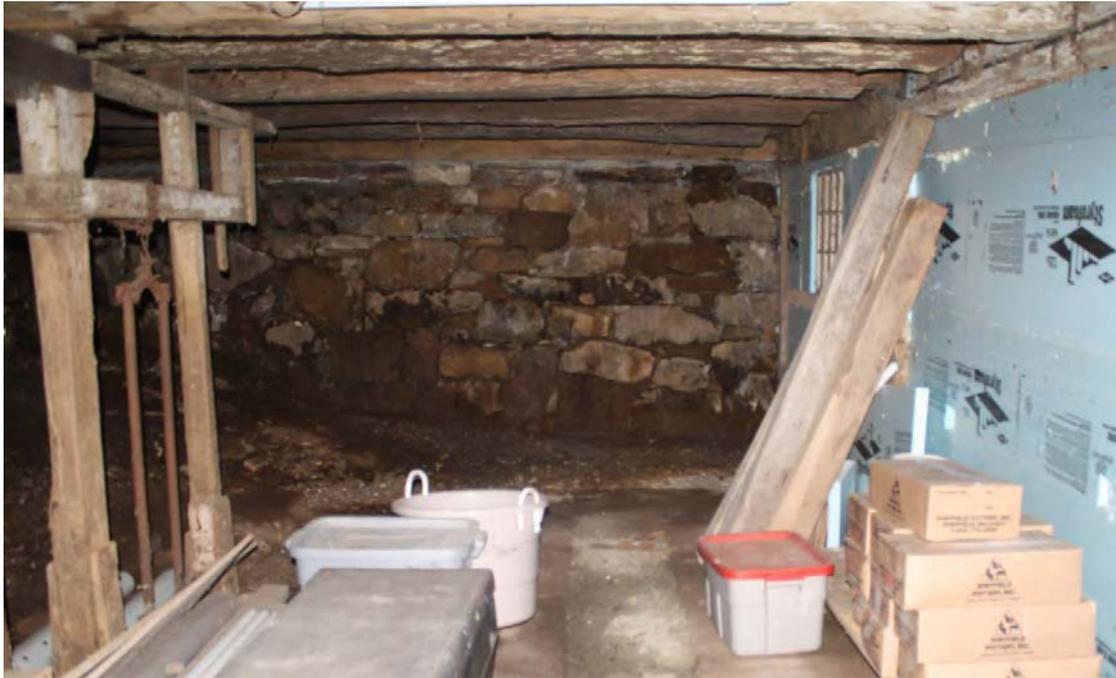
19. Interior view of basement level of Barn I, northeast corner; camera facing northeast. The east retaining wall is visible at rear and dairy cow stanchions are at left. The concrete floor has been filled in level; old location of manure gutter is visible at center.

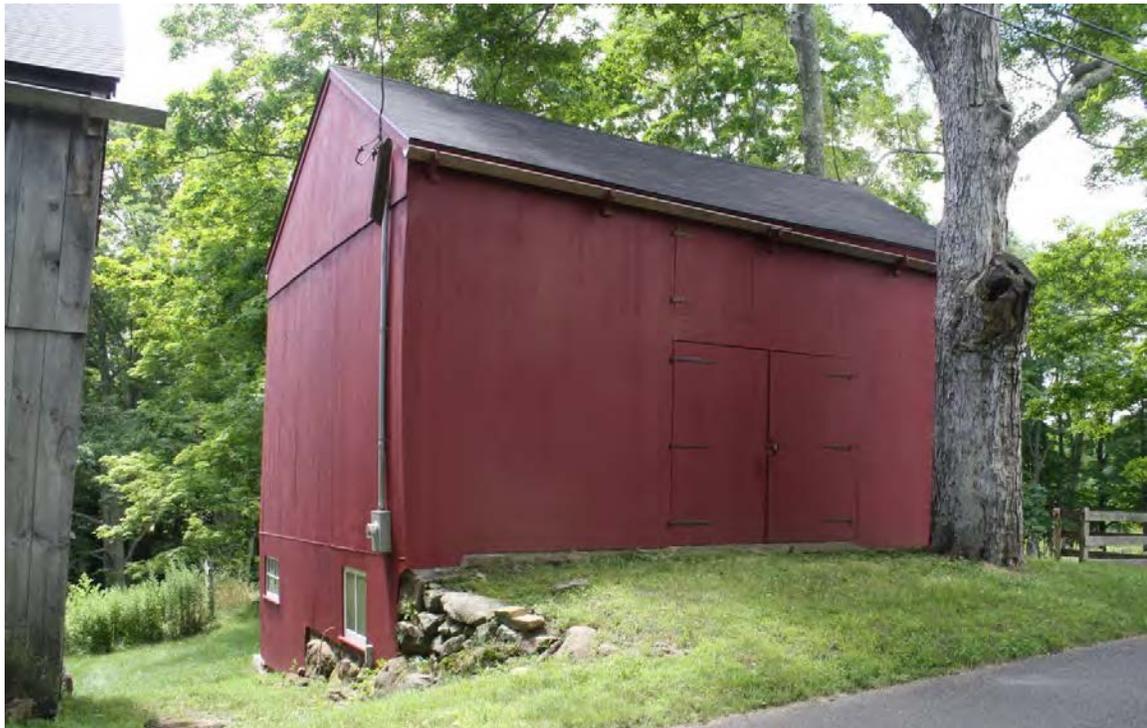
20. Northeast view of Barn II, camera facing southwest. The corner of Barn I is at left. View after renovation.

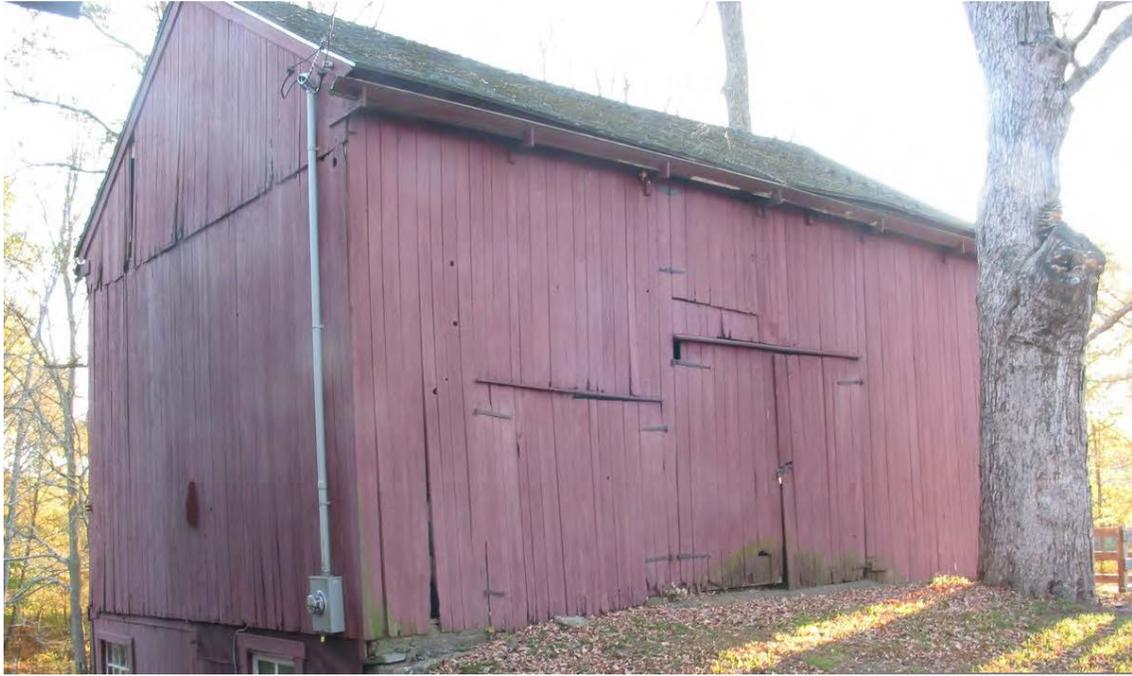
21. Northeast view of Barn II, camera facing southwest. View before renovation, courtesy of Caroline Chandler.

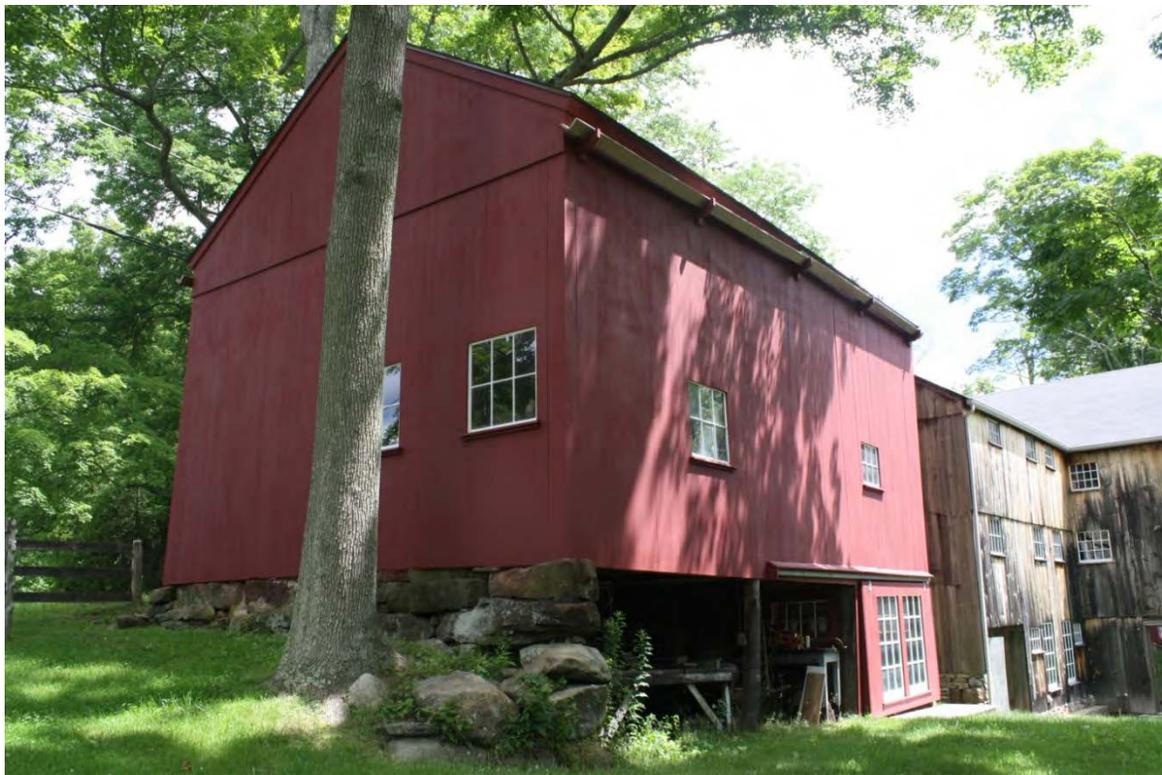
22. Southwest view of Barn II, camera facing northeast; Barn I at right rear.
