HISTORIC RESOURCES

BUILDING AND STRUCTURES

Building Name (Common) Botsford-Minor Farmstead Record No. 46821
 Building Name (Historic) Botsford-Minor Farmstead
 Street Address or Location 88 Old Roxbury Road
 Town/City Roxbury Village _____ County Litchfield
 Owner(s) Adams Office LLC, 88 Old Roxbury Road, Roxbury CT 06783 Public Private

88 Old Roxbury Road, Roxbury CT

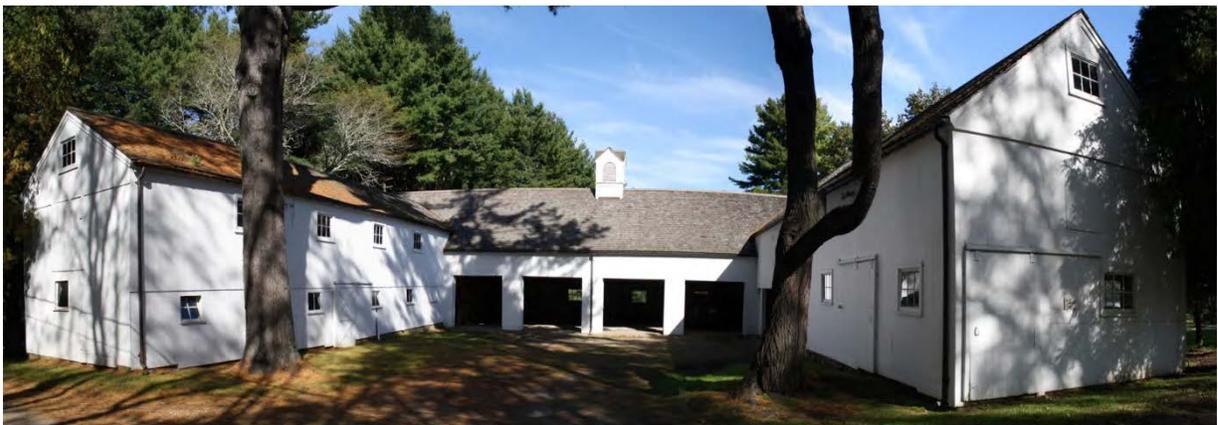
The central block, an extended English barn, has its current entrances via four overhead garage doors in the south eave-side, facing the former barnyard, now an entry court for vehicles. Three are of equal width, while the westernmost (left) opening is narrower.

5. South view of barn, camera facing north.

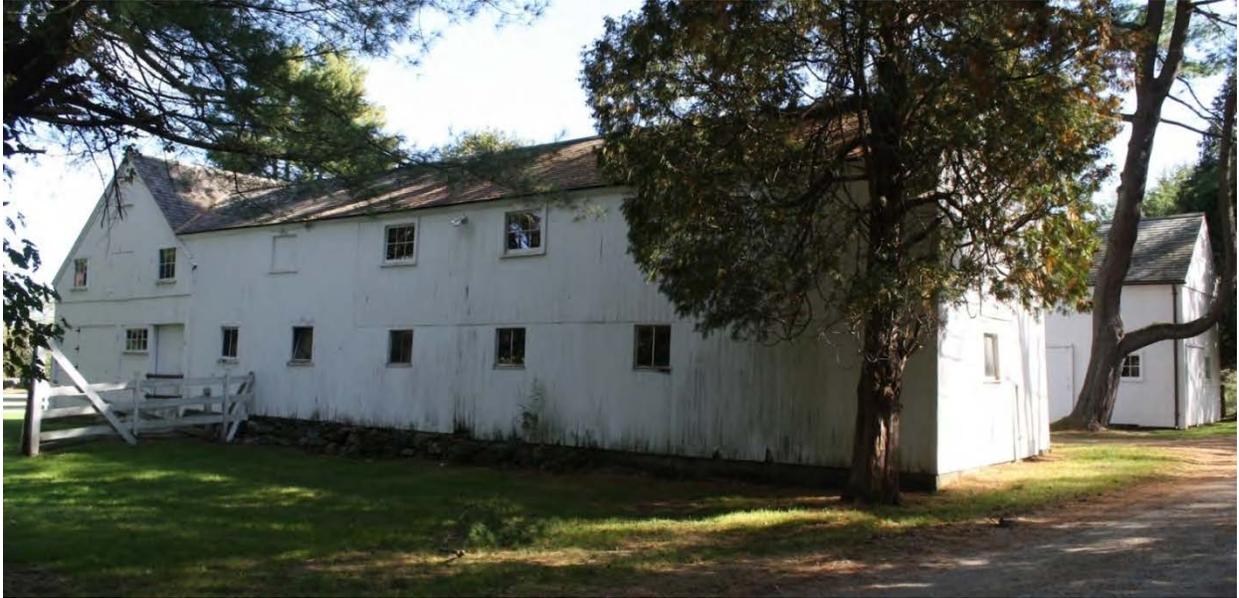
The west side consists of at the north (left) the gable-end of the west extension bay, and flush with it to the south (right) the west eave-side of the 2-story west wing. The gable-end roof, with simple rake trim, extends into the wall of the west wing as on the east side. The gable-end has two doors on the ground level. The left-most is a Dutch stall door set into the left side of a slight recess which may have formerly been open. To the right is an interior sliding door. Above is a centered hay door flanked by six-pane attic windows. Above at the peak is a shuttered opening. To the right the wall of the west wing has five two-pane stable windows in the ground floor and four windows in the upper level, of which one is boarded up and the rest are six-pane. The foundation of the west wing is stepped up from that of the north block; is fieldstone though an area at the south end is concrete. The south gable-end has a square hopper stable window at the center of the ground floor with a hinged door to the right (east). Above is a hay door and in the attic is a six-pane window. The east eave-side of the west wing has six two-pane hopper windows and a centered sliding exterior door at the ground level. There are four six-pane windows in the upper level.

6. West view of west wing, camera facing northeast.

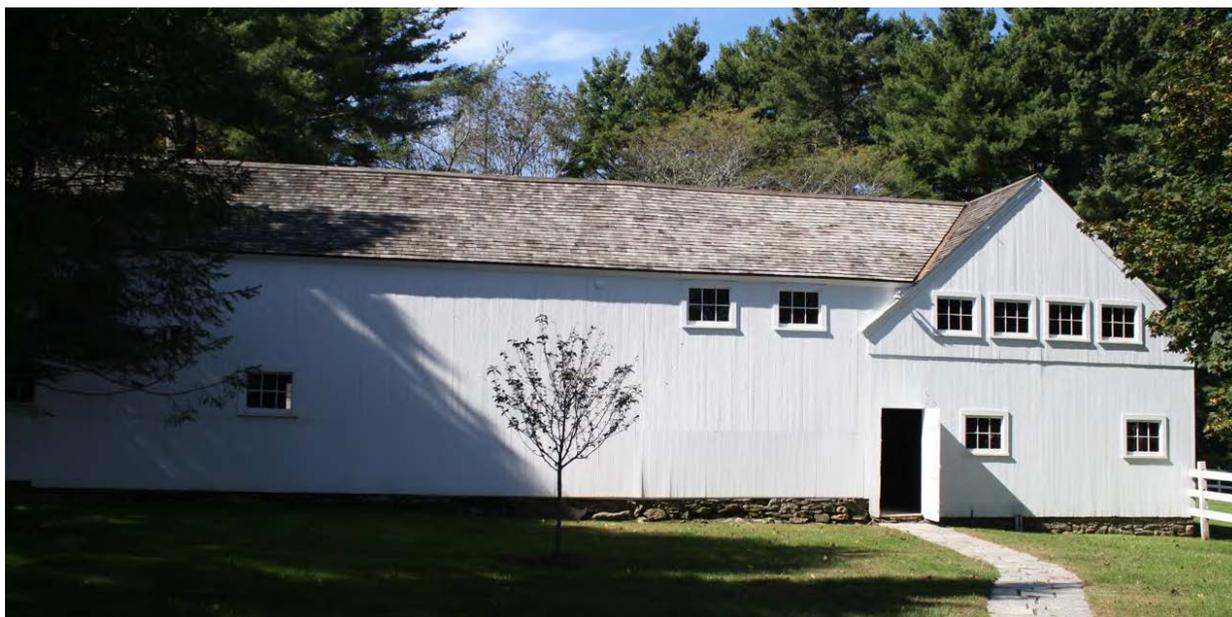
The gable-end wall of the northern block (the east extension bay) has at the ground level a wood plank pass-through door and two six-pane stable windows. Above in the upper loft level is a row of four six-pane windows. The rake of the roof has a slight projection and rake trim which extends across the overlapping wall of the east wing. The foundation is exposed above grade on the east side and steps down from a short concrete portion near the left corner, to a fieldstone portion for the remainder of the east wing, and again to the fieldstone of the north block.

9. East view of east wing, camera facing northwest.

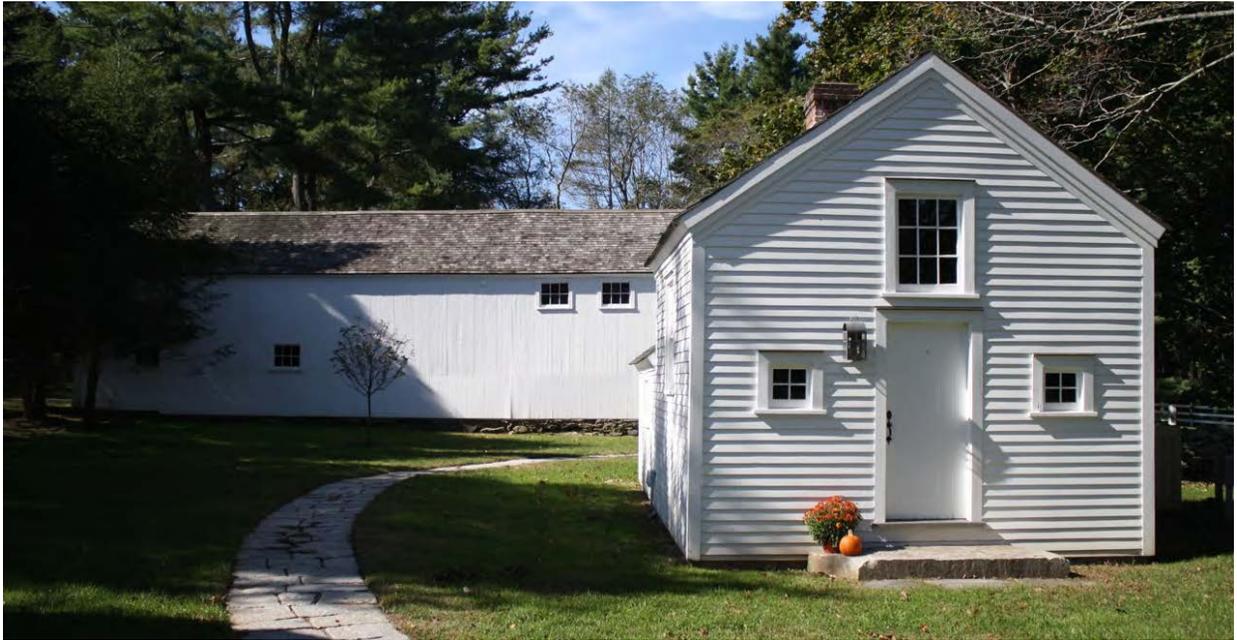
The smokehouse is a 12- x 26-foot 1 ½-story gable-roofed structure with its ridge-line oriented east-west, and is set between the house and barn. Local tradition is that this building was a smokehouse, possibly substantiated by the presence of a brick fireplace inside (Carley, p. 134). The western section is 1-story while the eastern portion is slightly taller. A central door is present on each gable-end, flanked by small four-pane windows; an attic window is above the door (six-pane on the west, nine-pane on the east). The eave-side elevations each have an eight-pane window in the lower part and a six-over-six double-hung window in the higher section. Roofing is wood shingles and there is a brick chimney projecting from the ridge at the west end of the higher section. Construction is post-and-beam framing with a fieldstone foundation.

10. East view of smokehouse, camera facing west. East side of east wing of the barn is at rear.

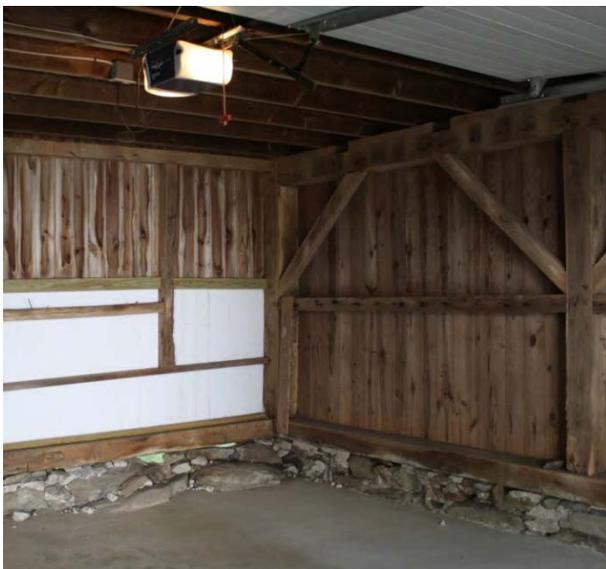
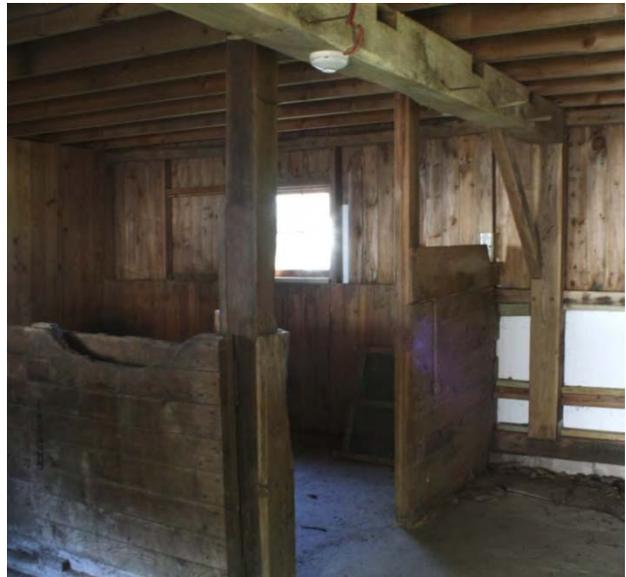
13a-b. Interior ground floor of east wing. Left: north garage bay, camera facing southeast; right south stall bay, camera facing northeast.

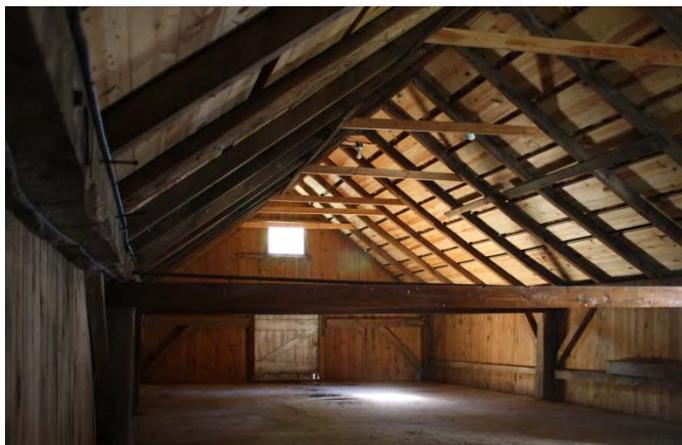
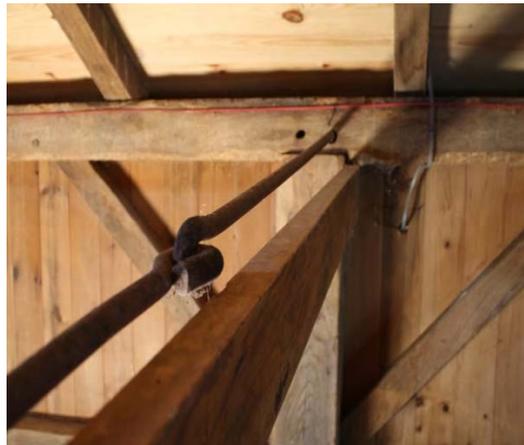
The east wing walls are constructed with wood-pegged post-and-beam framing using sawn timbers, with a dropped girt at the south gable-end eave. The joists and roof framing of the loft level are balloon framing with dimension lumber. A lateral girt at the center is reinforced with a wrought iron tension member. The loft level is open to the upper level of the east extension bay described above. Along with the similar construction detailing, this suggests a contemporary construction date for the two portions of the structure.

14a-b. Interior upper level of east wing. Left, interior view, camera facing south; right, detail view of tie beam with iron tension tie.

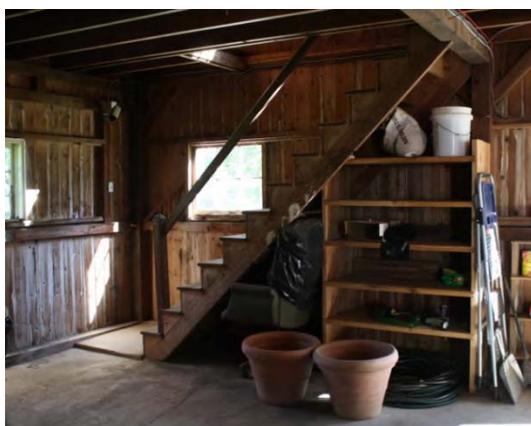
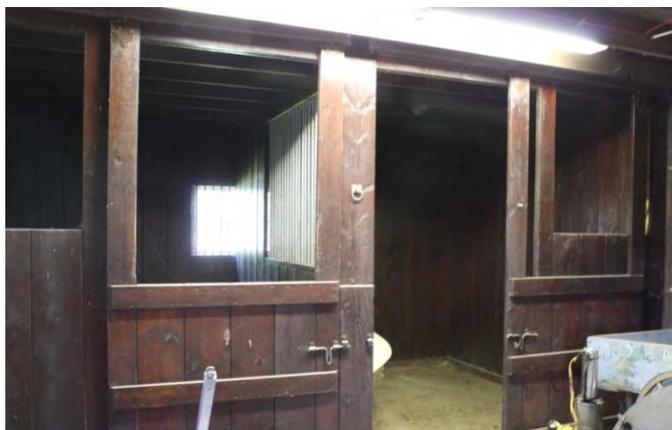
To the west of the central block is a one-bay extension framed with balloon framing and finished on the interior with vertical wood paneling. This space is fitted with two horse stalls with sliding doors. The floor is concrete slab.

15a-b. Left, interior ground floor of northeast corner, camera facing northeast. Right, interior ground floor stall area of northwest corner, camera facing north.

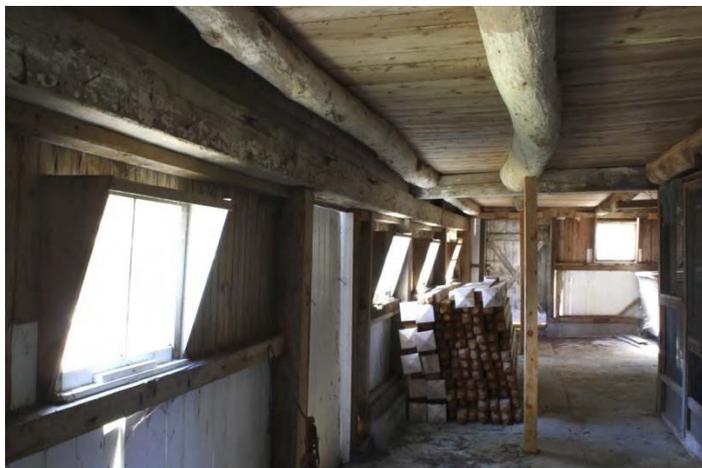
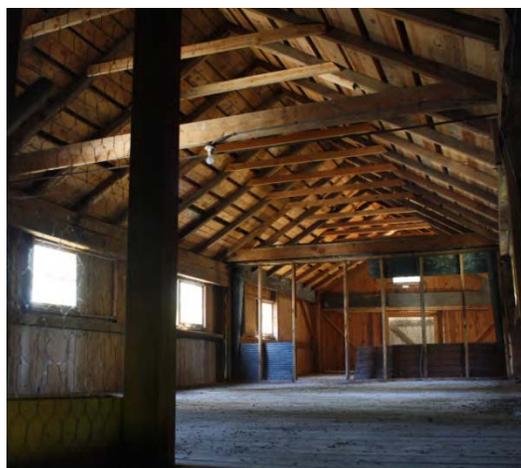
The west wing's ground floor is constructed with hewn timber framing. Some of the joists supporting the loft above are squared while others are round and uneven; joists are mortised into the girders. Although the structure is narrow, joists run the long direction north-south spanning between lateral girders. Windows are in-tilting hoppers with triangular cheek panels at the sides to support the open sash. Reinforcement has been added in some locations by sistering sawn timbers below the old members. Traces of whitewash suggest use for dairy cows. The foundation has been partially replaced with concrete including a raised curb at the perimeter, and changes of floor slab level are typical of dairy barns in the early 20th century. The loft level is constructed with a hybrid mix of heavy timber at walls and dimension lumber for roof rafters and nailed collar ties.

16a-b. West wing ground floor, east and south view, camera facing southeast; loft level, camera facing southeast.

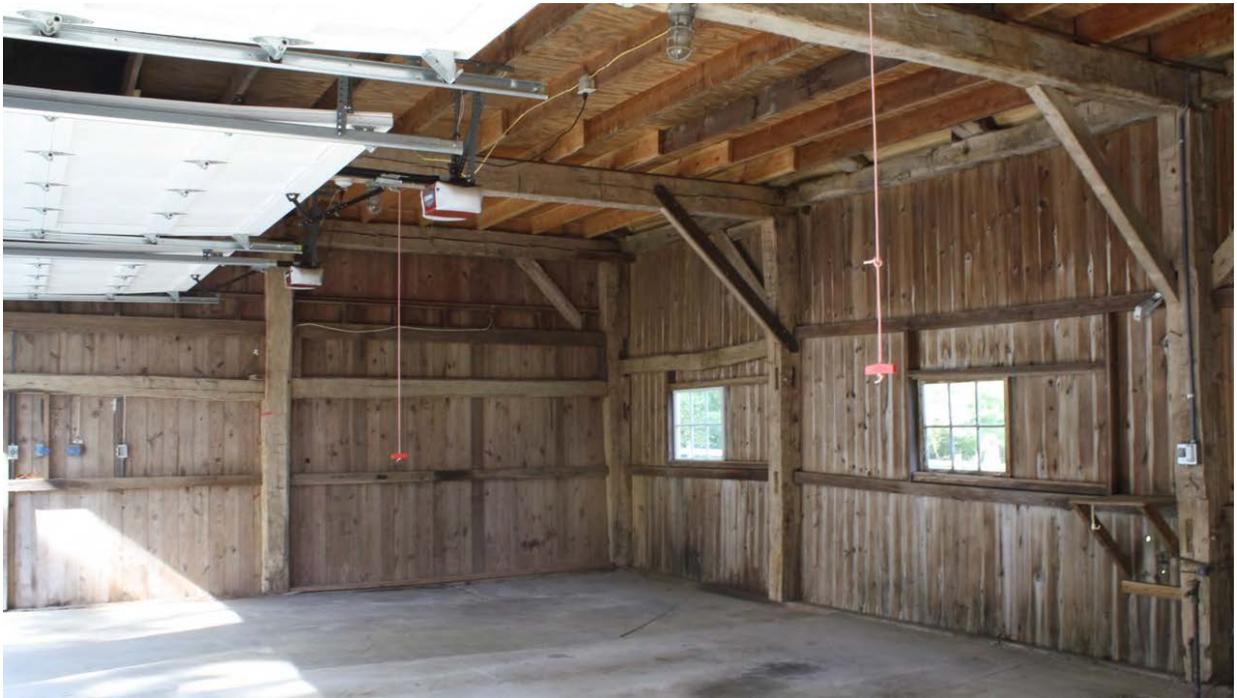
The central block has a heavy timber post-and-beam frame. The western bents have gunstock posts and cross girts in the plane of the plates, suggesting possible 18th-century construction. In contrast, the easternmost bent has straight posts and a dropped end girt, suggesting that this could have been a later extension to the more typical previous three-bay structure. The major timbers are hand-hewn square-rule construction; some of the diagonal braces are sawn. A number of the joints appear to have mortises larger than the tenons, and there are open mortises on the inside faces of the interior posts, suggesting alterations to the structural frame such as the removal of interior posts. Recent alterations include steel reinforcement of the braces along the north wall, steel substitute braces at the south wall between the garage door openings, and steel tension cables through the plates. Some of the posts between door openings have been replaced or reinforced with newer lumber. An attic loft floor of dimensional lumber and plywood had been inserted above the lateral girts; the toes of the hewn rafters can be seen along the north wall below the new floor. The floor is a concrete slab.

17. Interior of central block, camera facing northwest. Note gunstock posts and tie-girts at plate elevation.

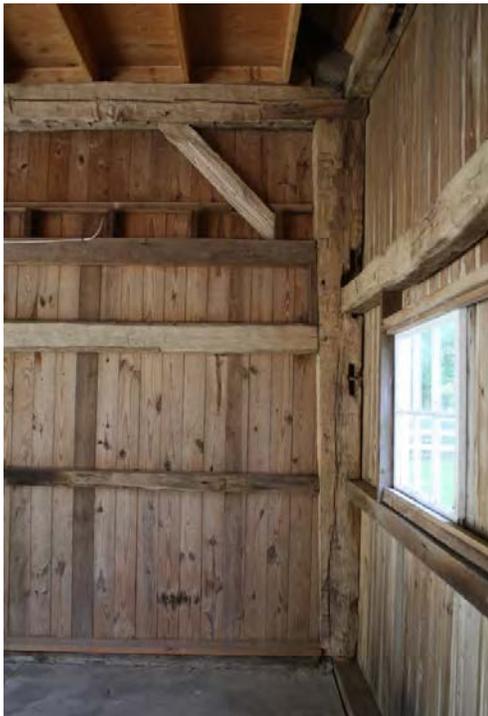
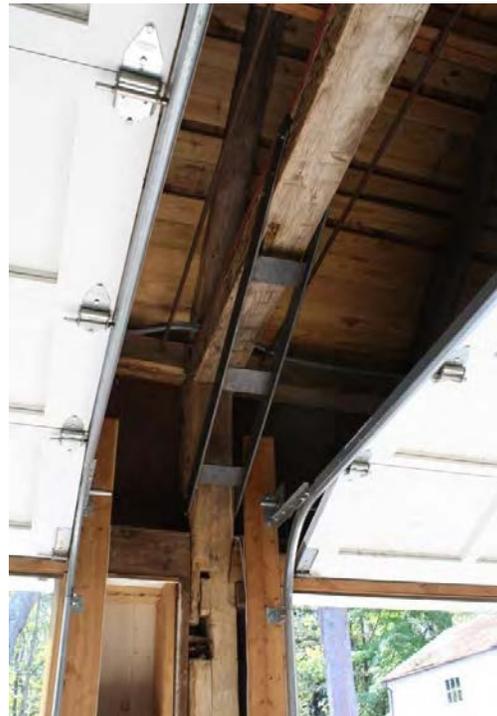
Later residents converted the working farm to an equestrian facility; evidence of stable use remains in the stalls at the northwest corner and southern bays of the east wing. The current use is for garage space. Structural modifications in the central block and north bays of the east wing have allowed for installation of power-operated overhead doors.

18a-b. Interior of central block. Left, detail of northwest corner showing gunstock post, camera facing northwest; right, detail of south wall reinforcing at garage door openings, camera facing south.

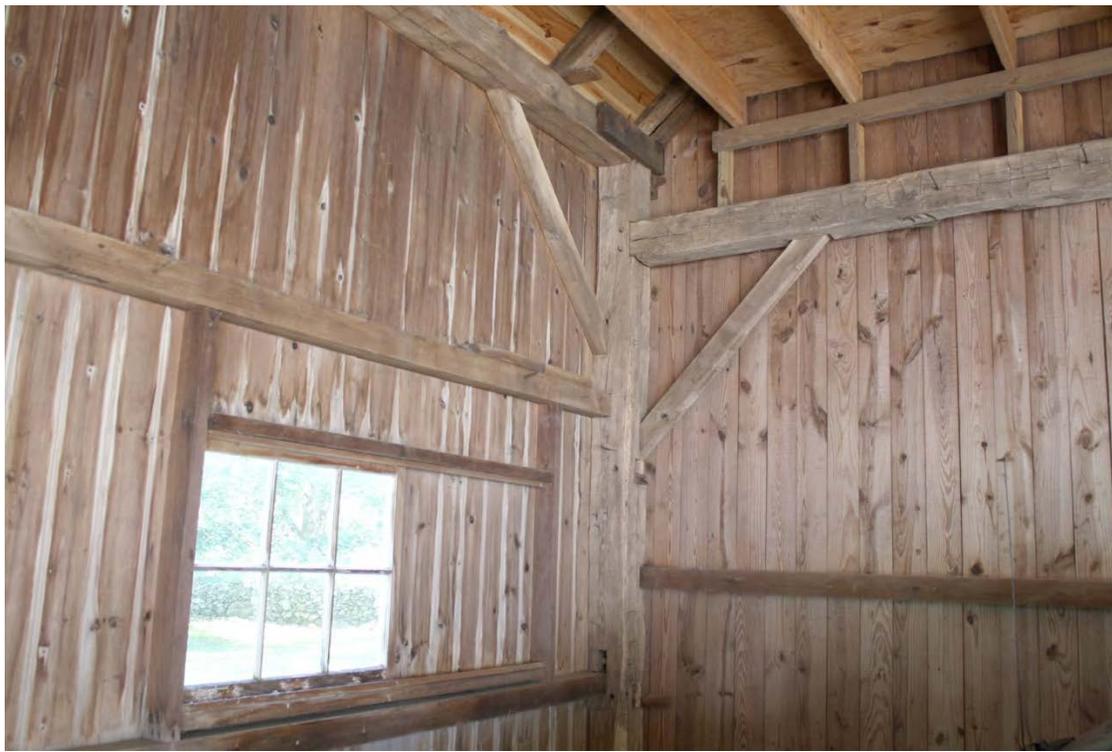
19. Interior of central block showing the dropped girt and square rule framing of the easternmost bent, camera facing northeast.

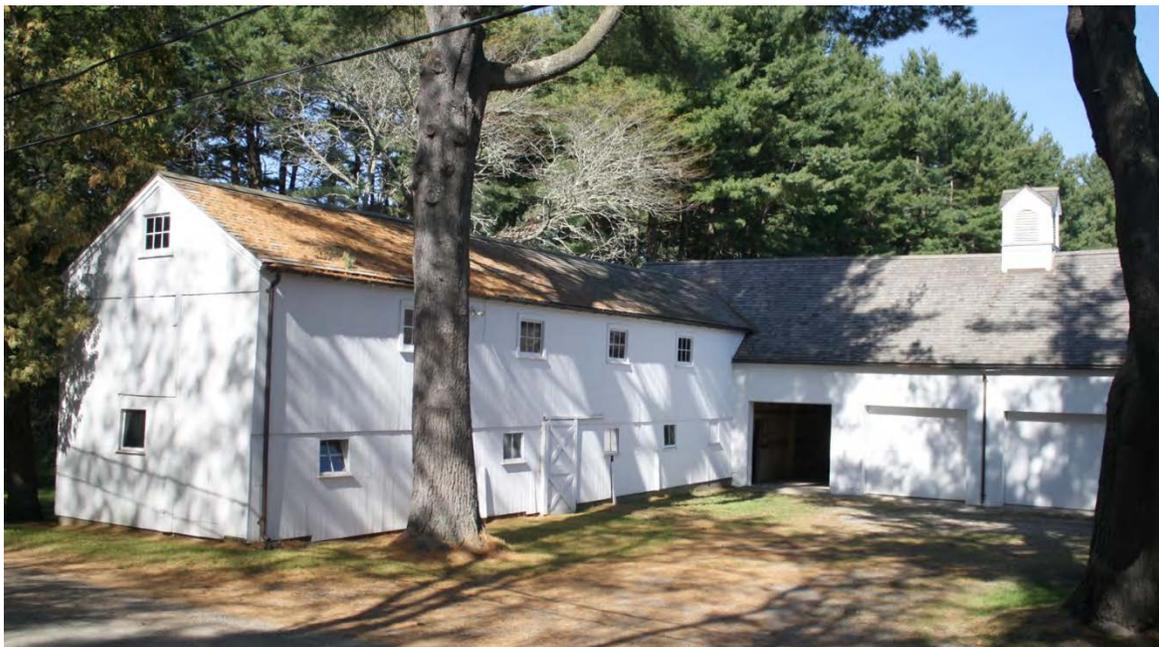
20. Southeast view of yard, showing modern overhead doors, camera facing northwest.
