HISTORIC RESOURCES

BUILDING AND STRUCTURES

Building Name (Common) Wike Brothers Farm Record No. 52563
 Building Name (Historic) Wike Farmstead
 Street Address or Location 38 White Hollow Road
 Town/City Sharon Village _____ County Litchfield
 Owner(s) Wike Brothers Farm LLC, 38 White Hollow Road, Sharon CT 06069 Public Private

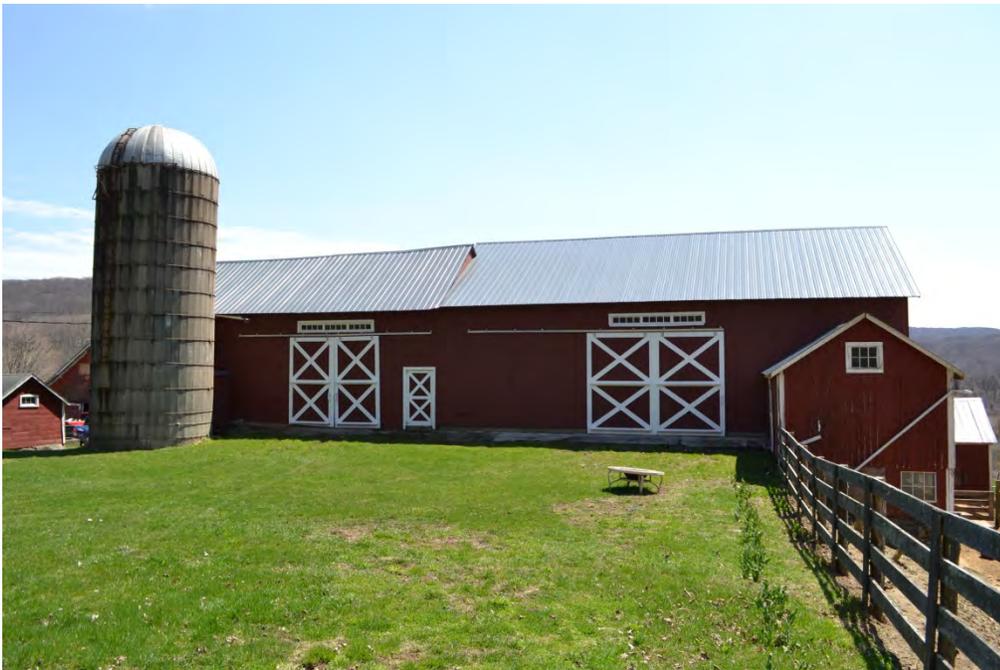
barn with entries in the second and fourth bays, the building's three southern bays collapsed in a storm in 1989 and were replaced with a three-bay tobacco barn transported from Ithaca, New York. The roof pitches of the two blocks vary slightly, with the tobacco barn addition having a lesser pitch but a higher ridge-line due to its greater width. The original northern block has a saltbox extension, with its 1-story east eave-side projecting beyond the east side of the tobacco barn block.

22. West eave-side of Barn I, camera facing southeast. Note roof-line divide between the original block and the rebuilt section to the right. Milk house at rear left, west eave-side ell at far right.

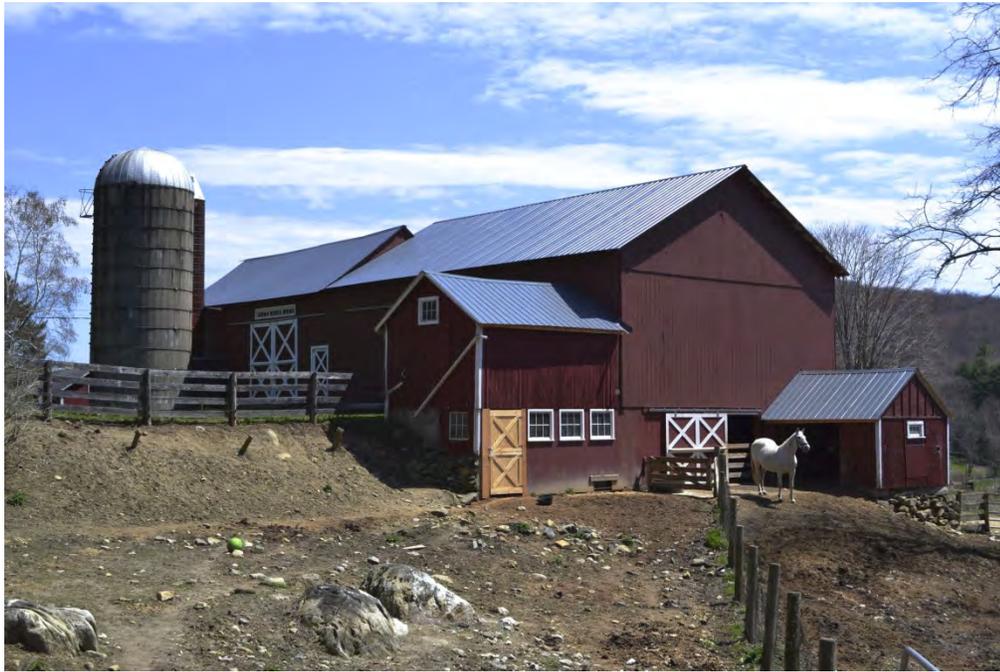
23. West eave-side and south gable-end of Barn I, camera facing northeast. Note west eave-side ell with basement level entry at center, south gable-end ell at far right.

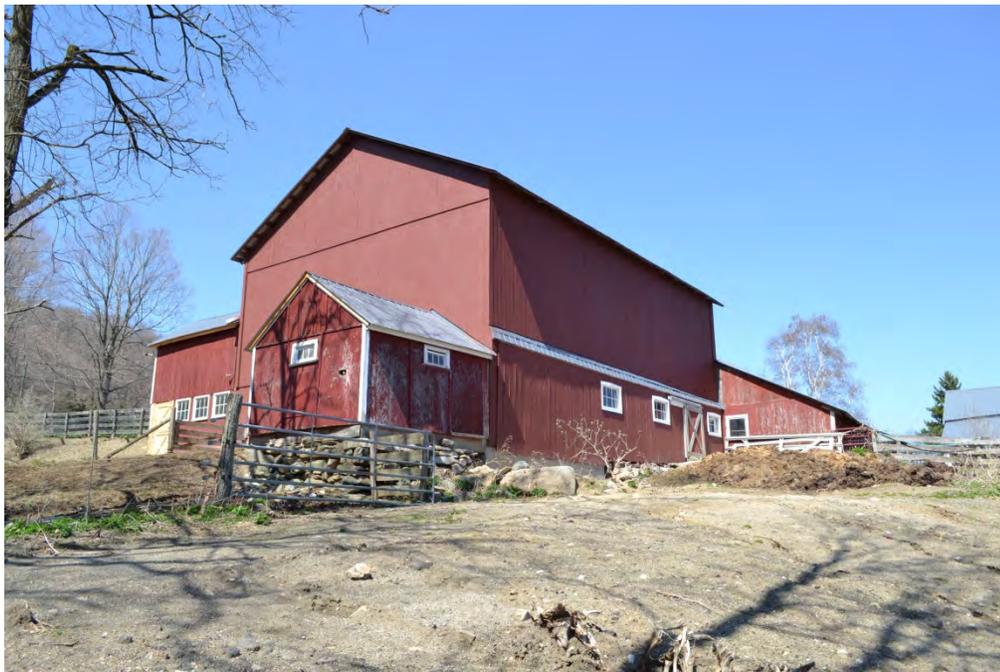
24. South gable-end and east eave-side of Barn I, camera facing north. Note west eave-side ell with basement level entry at left, south gable-end ell at center, original block rear lean-to at far right.

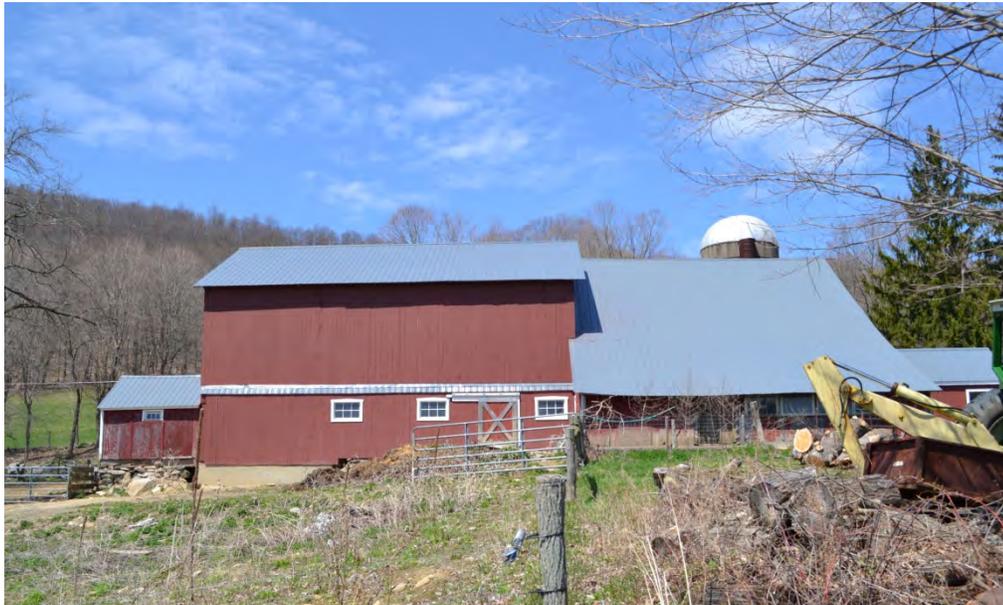
25. East eave-side of Barn I, camera facing west. Note basement level sliding door at center, original block rear lean-to at far right.

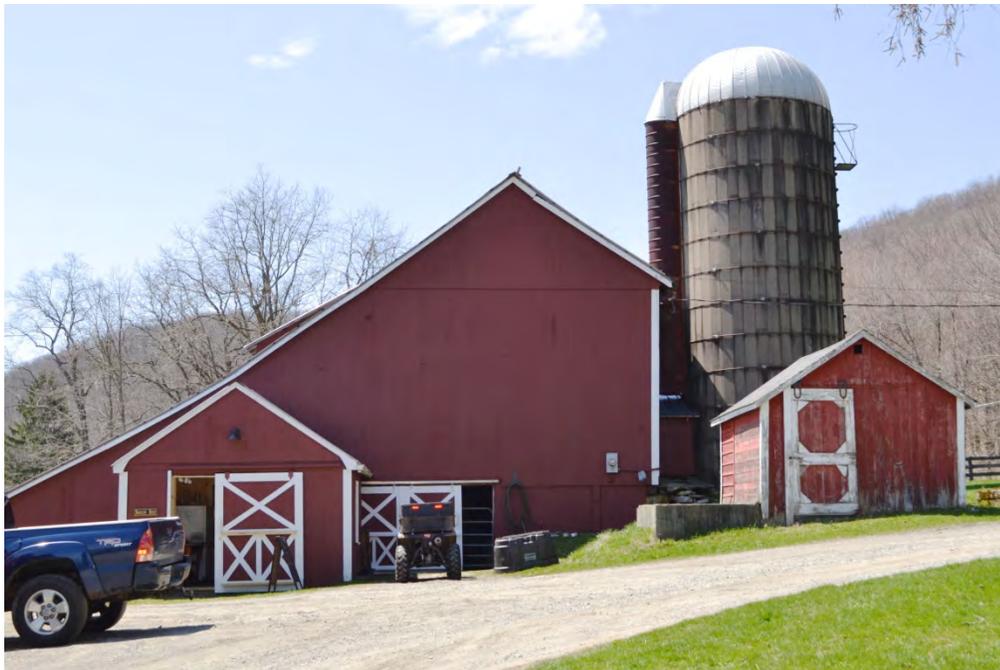
26. North view of the gable-end of Barn I, camera facing northwest. Note lean-to additions to original block at left, north gable-end ell at center left, Milk house and Silo at right.

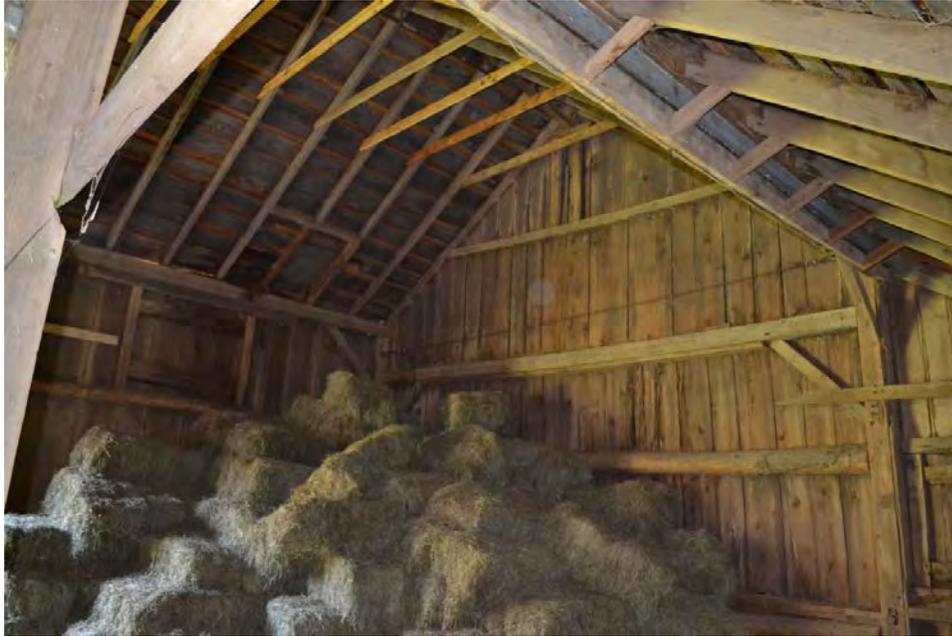
27. Interior view of Barn I main level original block, showing framing details, camera facing north. Note dropped girt, diagonal bracing, and common rafters.

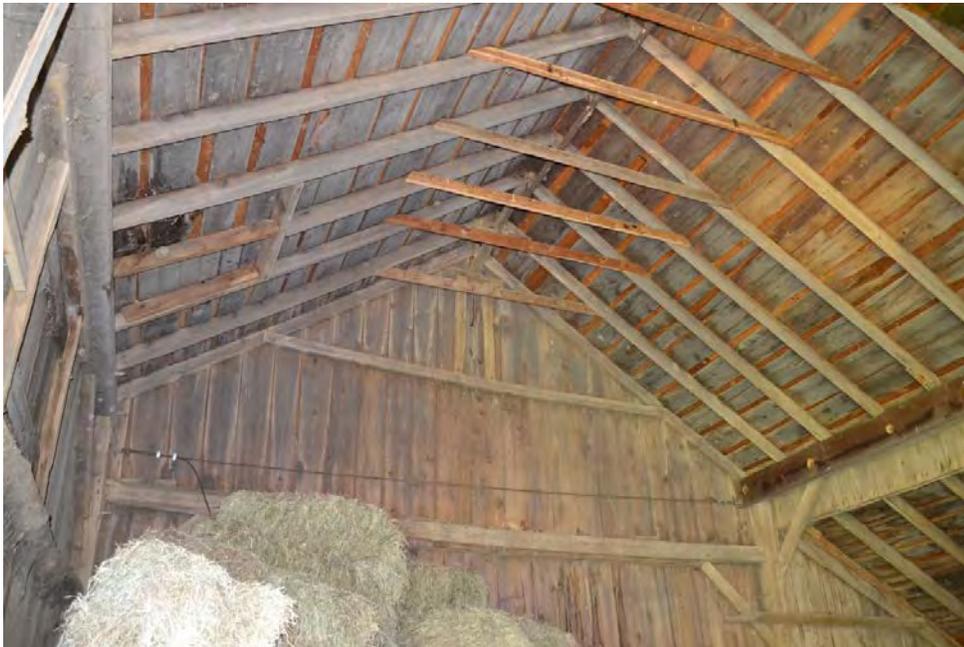
28. Interior view of Barn I main level original block, showing framing and roof details, camera facing east. Note dropped girt, diagonal bracing, and common rafters.

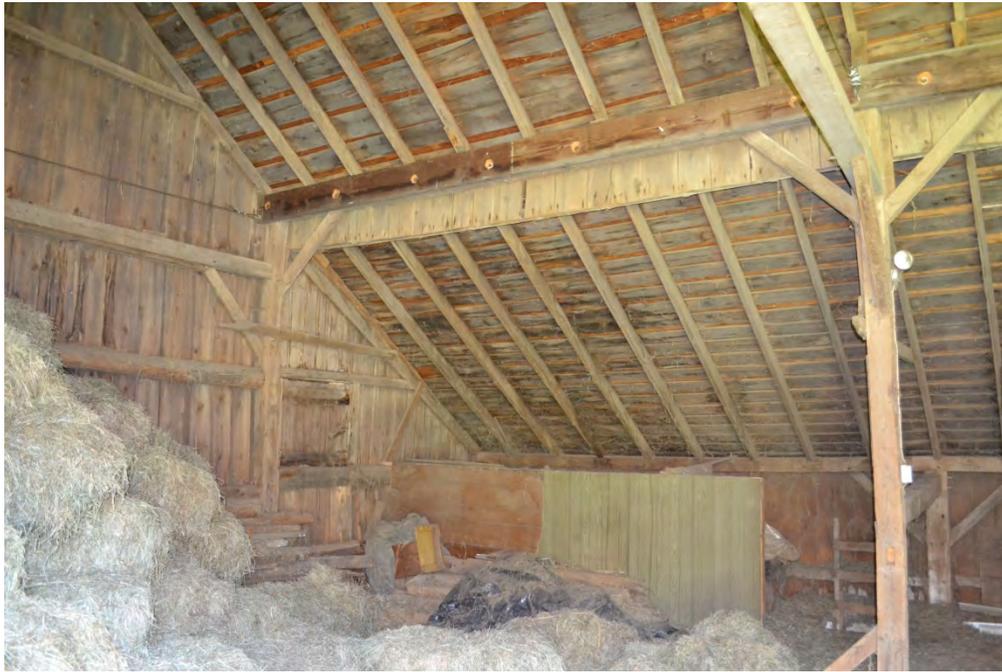
29. Interior view of Barn I main level original block, showing first rear lean-to framing details, camera facing east. Note dropped girts, diagonal bracing, and common rafters.

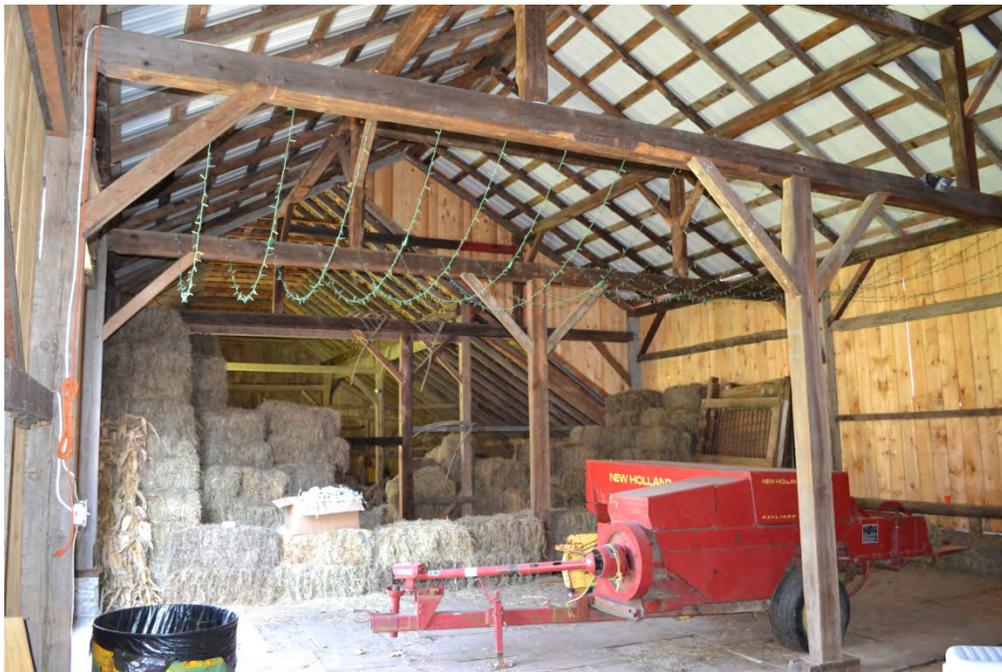
30. Interior view of Barn I main level rebuilt section (former Tobacco barn frame), showing framing details, camera facing northeast. Note dropped girts, diagonal bracing, and principal rafters.

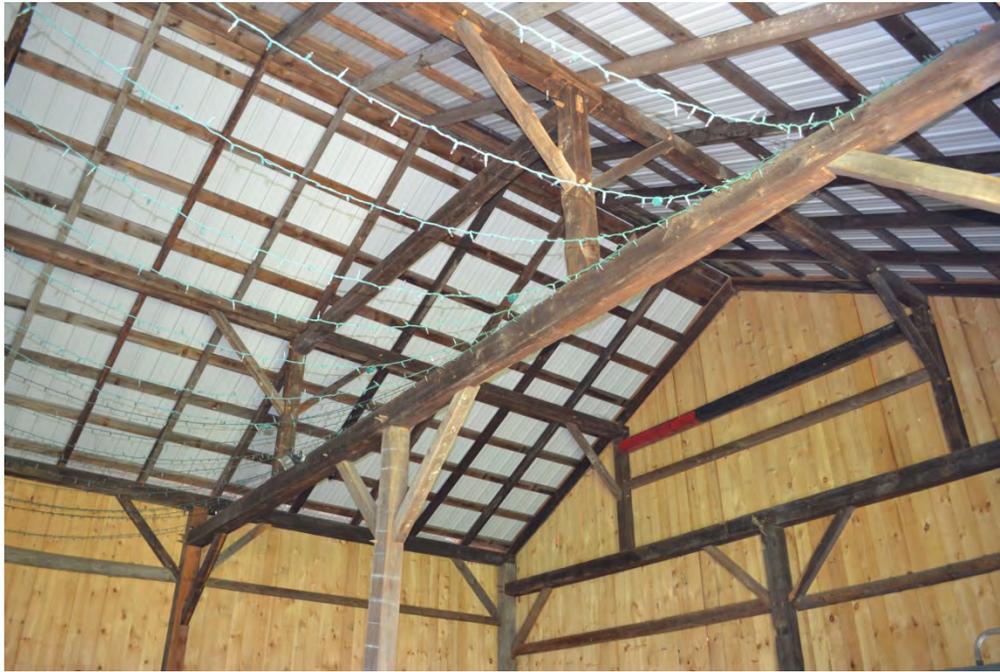
31. Interior view of Barn I main level rebuilt section, showing framing details, camera facing south. Note dropped girts, diagonal bracing, queen posts with cross-ties, and common rafters.

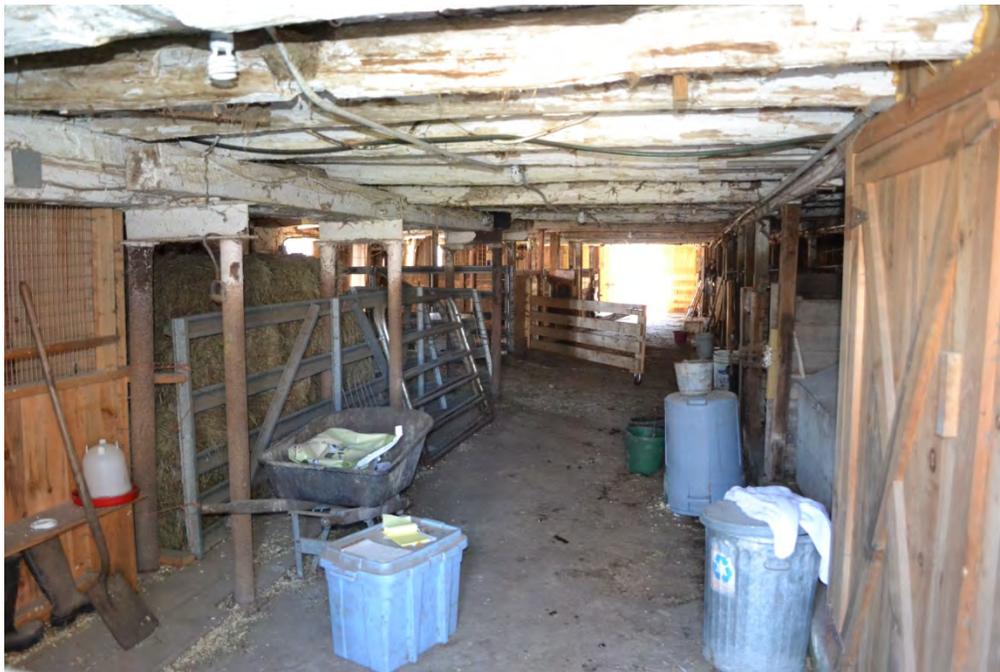
32. Interior view of Barn I basement level, showing framing center aisle details, camera facing southwest. Note lally columns with steel headers and half-round joists.

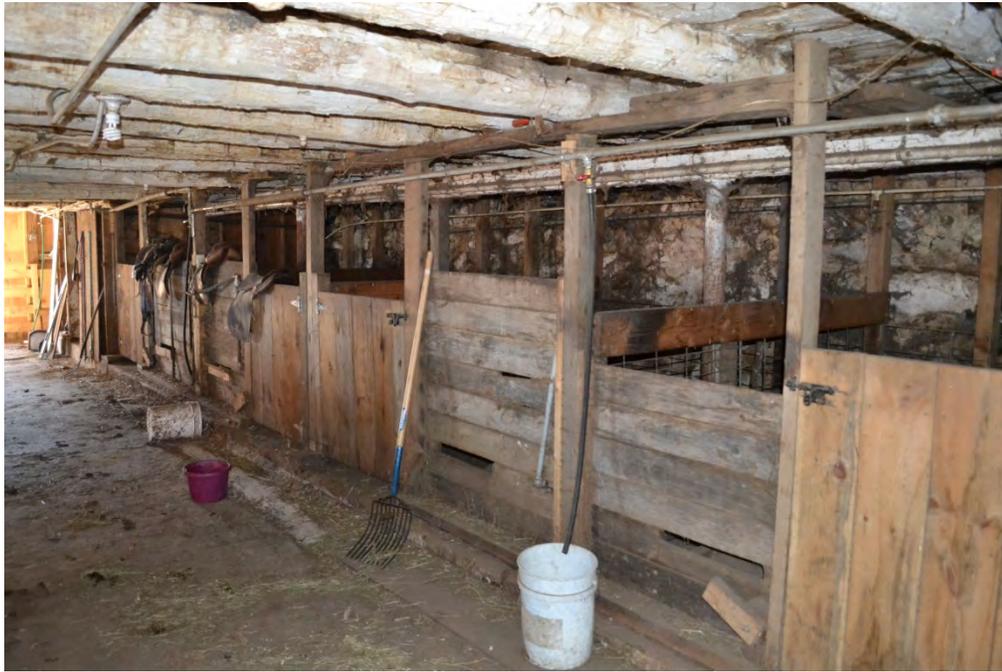
33. Interior view of Barn I basement level, showing stall details, camera facing northwest. Note frame stalls, half-round joists above.

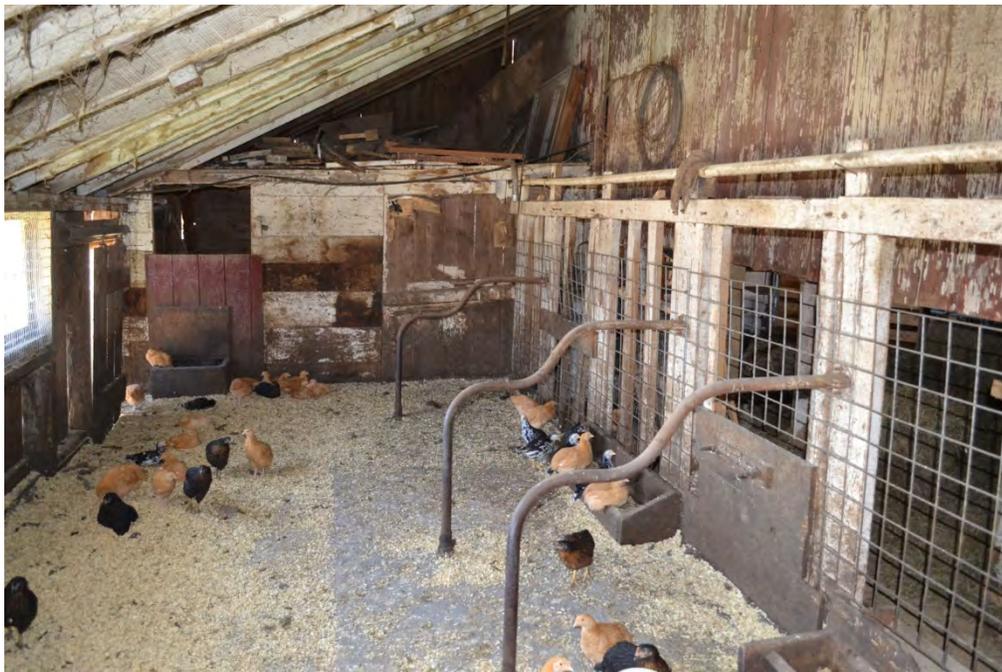
34. Interior view of Barn I basement level rear second lean-to, showing framing details, camera facing west. Note metal stanchions, former exterior wall at upper right.

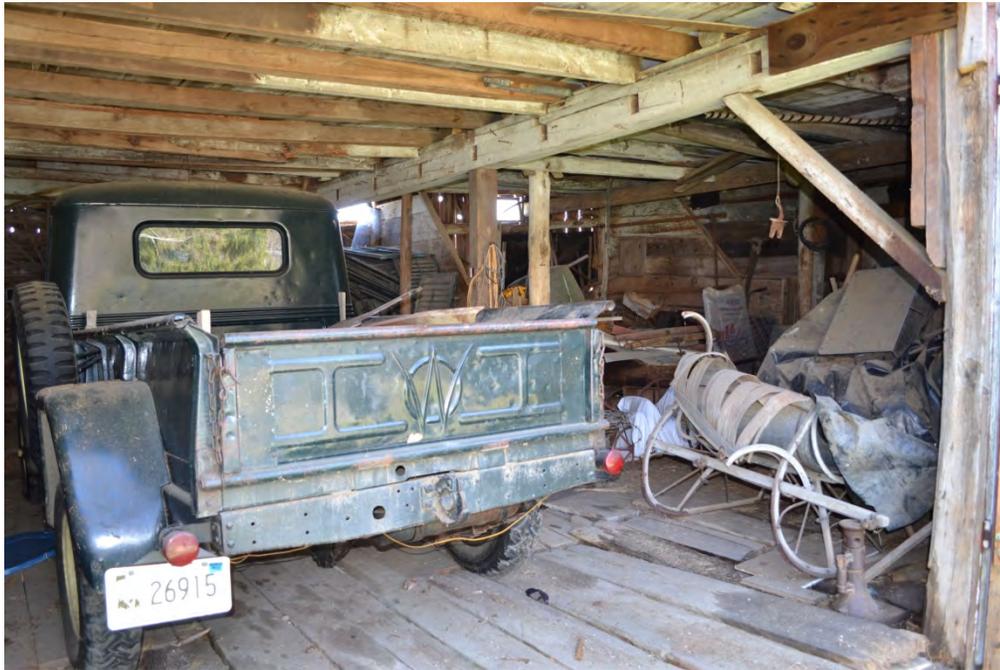
41. Interior view of Horse barn ell main level, showing framing details, camera facing south. Note wide board floor, empty mortise pockets in the recycled framing members.

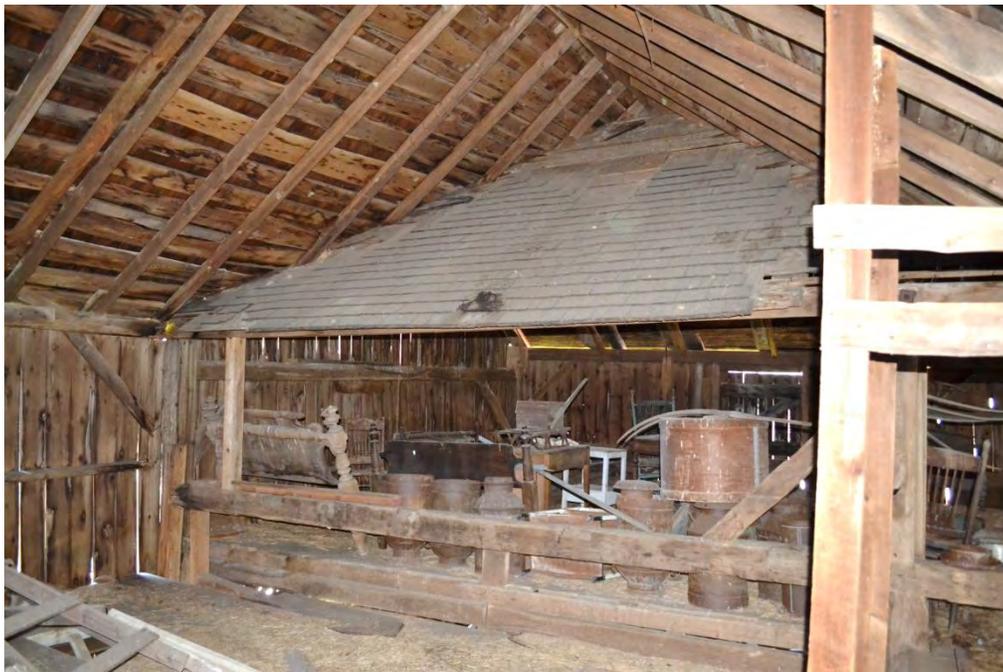
44. Interior view of Horse barn ell loft level, showing framing details, camera facing southwest. Note exposed framing and roof of primary block's north eave-side, indicating that the ell addition was attached to the primary block.
