HISTORIC RESOURCES

BUILDING AND STRUCTURES

Building Name (Common) Secchiaroli, Alessandro, Farmstead Record No. 33803
 Building Name (Historic) Secchiaroli, Alessandro, Farmstead
 Street Address or Location 61 Miner Lane
 Town/City Waterford Village _____ County New London
 Owner(s) Town of Waterford, 15 Rope Ferry Road, Waterford, CT 06385 Public Private

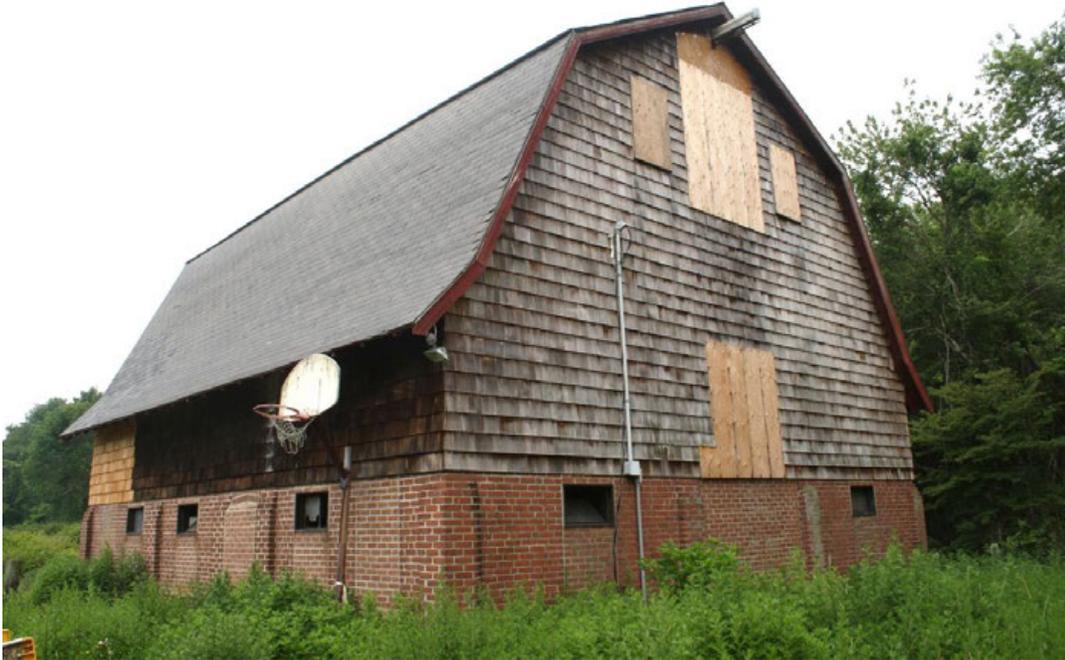
5. Southeast view of the corner of the barn, camera facing northwest.

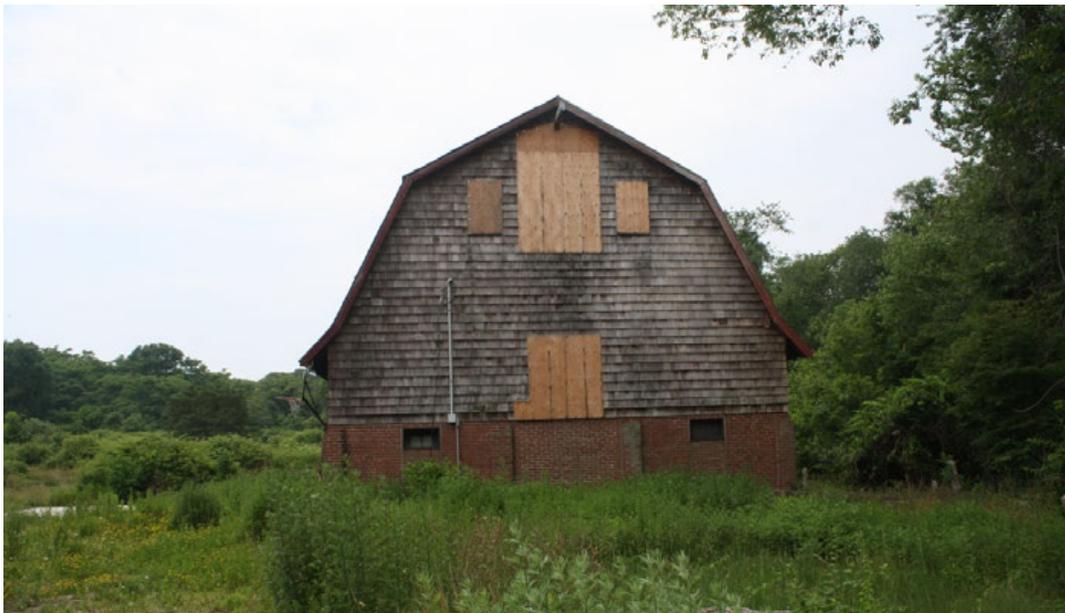
The original main entry of the barn is in the center of the east gable-end. The first level has three equal-sized bays and four brick buttresses. There is a buttress at each corner and buttresses that separate the bays from one another. The main entry has been filled in with a layer of brick backed by concrete block masonry. The flanking bays each have a centered two-pane hopper window, although the original windows were two-over-two double-hung sashes. The area beneath the hopper window has been filled in with a layer of brick over concrete block masonry. Original stone sills are still in place. The second level of the east gable-end of the barn is clad in wood shingles. There are four openings that are now boarded over with plywood; just above the first level was a centered pair of hay doors; centered just beneath the apex of the roof was a larger pair of hay doors; flanking the larger hay doors appear to have been either more hay doors, or as is the case for the west gable-end of the barn, one-over-one double-hung sashes.

6. East view of the east gable-end, camera facing west.

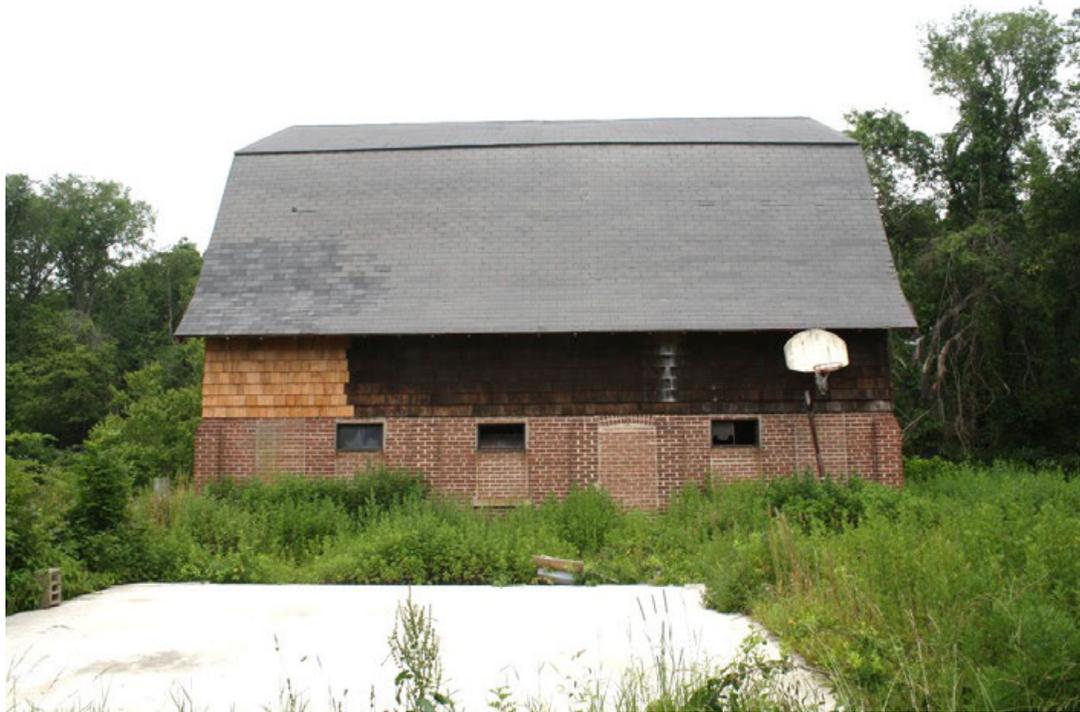
The south eave-side of the barn has three bays and four brick buttresses. There is a buttress at each corner and buttresses that separate the bays from one another. It appears as if there were four bays originally. The two middle bays are smaller than the corner bays and the second bay from the east appears to have been a bay-wide door opening, now bricked over. It appears that originally there were five two-over-two double-hung windows according to photographic evidence; two in the easternmost bay, two in the westernmost bay and a one in the second to the west bay. Today, the two windows closest to the corners have been filled in with a layer of brick entirely. The bottom portions of the remaining windows are similar to those on the east gable-end; they have been filled in with a layer of brick backed by concrete block masonry and have a hopper window at the top with stone lintels at the bottom and brick soldier course headers. The second level is blank except for the shingle sheathing.

7. South eave-side of barn, camera facing north. Note the concrete floor of the demolished garage in the foreground.

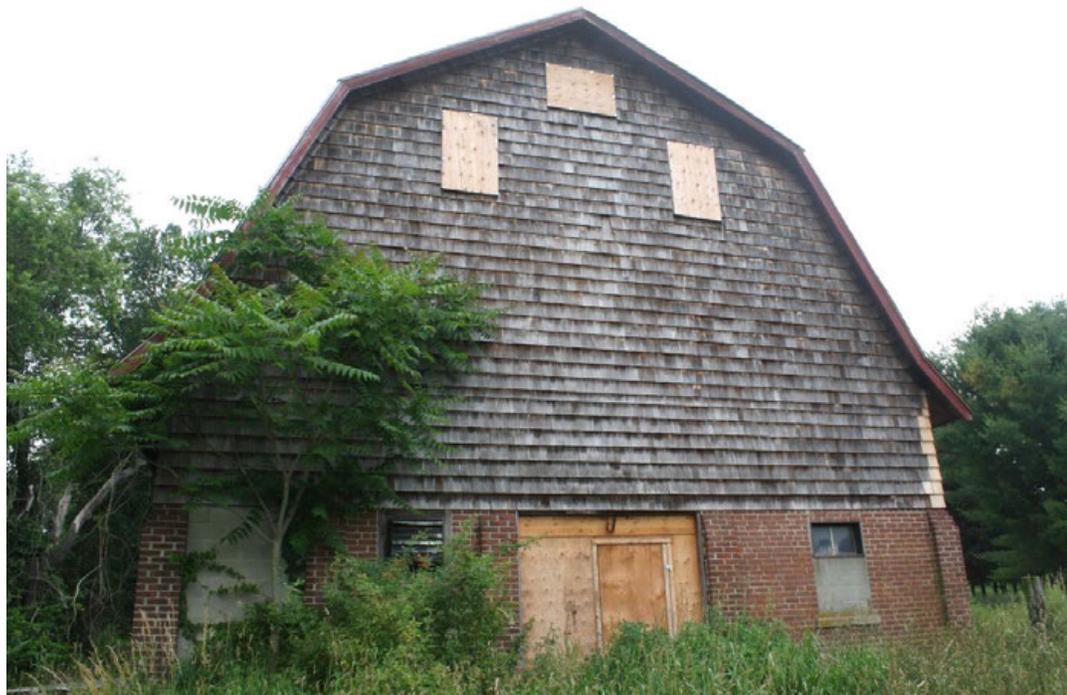
The first level of the west gable-end of the barn is nearly identical first level of the east gable-end; three equal-sized bays and four brick buttresses. There is a buttress at each corner and buttresses that separate the bays from one another. The main entry in the center bay of the west gable-end of the barn has been covered with plywood with a pass-through door to access the interior of the barn. The flanking bays have windows that have been filled in the concrete block masonry on the bottom portions. The south bay has a two-pane hopper window while the north bay

8. West gable-end of barn, camera facing east.

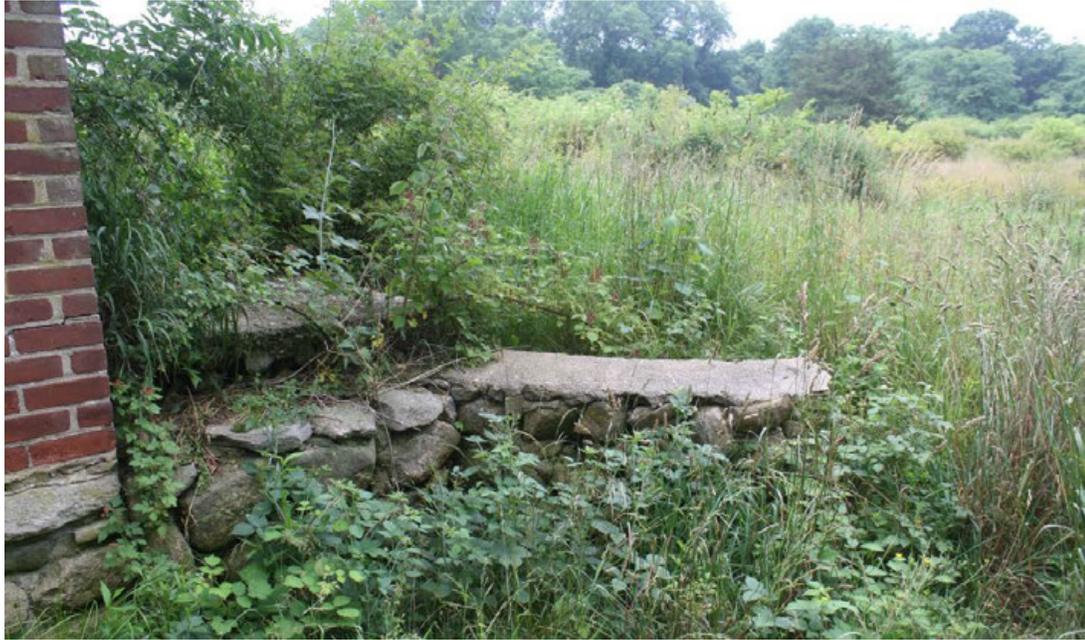
has a metal louvered vent. Both have stone sills. At the north corner of the west gable-end of the barn was a pass-through door, now filled in with concrete block masonry, accessed by a concrete step. The second level of the west gable-end of the barn is clad in wood shingles. There are three openings that are now boarded over with plywood; what appears to be a single-pane hopper window flanked by two-over-two double-hung sashes. Extending to the northwest from the northwest corner of the barn is a short mortared retaining wall that leads to the remains of the base of a silo, now gone.

9. Detail view of northwest corner of barn and remains of silo base, camera facing southwest.

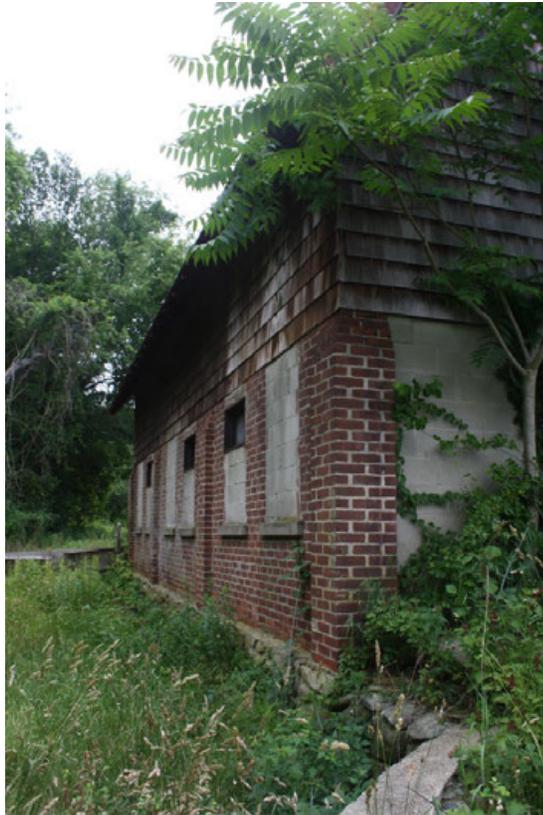
The north eave-side of the barn has three equal-sized bays and four brick buttresses. There is a buttress at each corner and buttresses that separate the bays from one another. Each bay originally had two two-over-two double-hung windows with stone sills. Today, both of the windows closest to the corners have been entirely filled in with concrete block masonry. The east window in the middle bay has also been entirely filled in with concrete block masonry. The remaining three windows, one in each bay, are two-pane hopper windows. The second level is blank except for the shingle sheathing.

10. Northeast corner and north eave-side of barn, camera facing east.

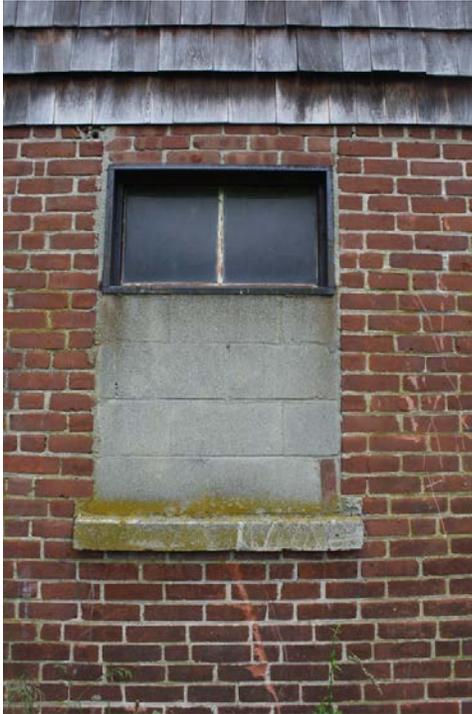
11. Detail of window on the north eave-side of barn, camera facing south.

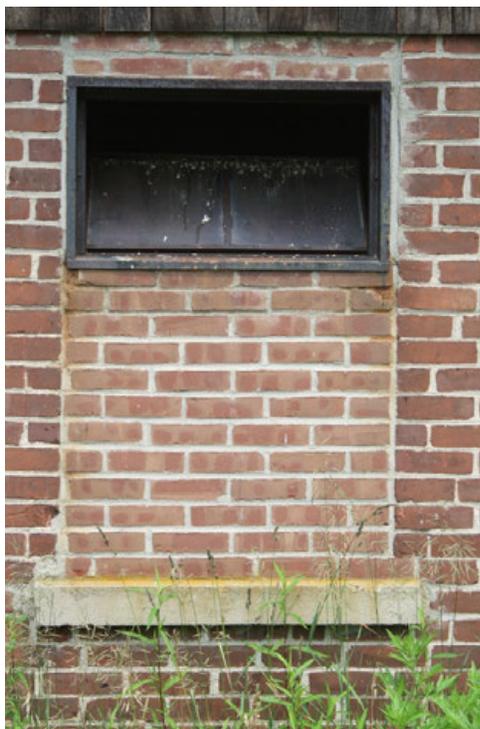
12. Detail of window on the south eave-side of barn, camera facing north. Note that the south side of barn is the 'public' view shed, hence the brick finish material.

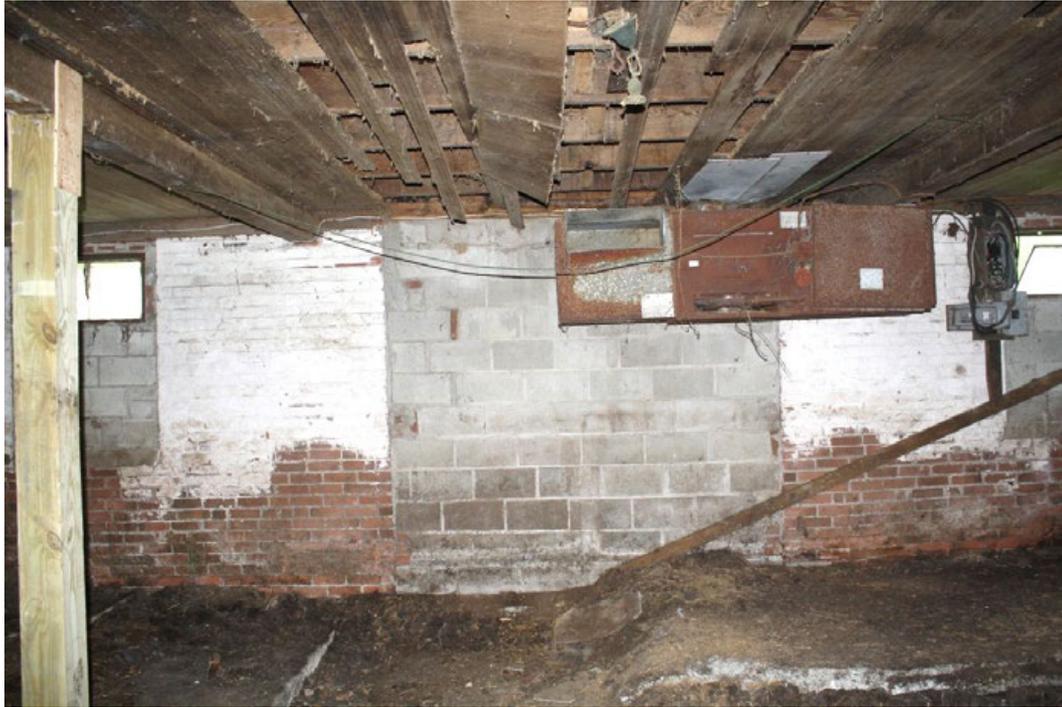
All of the original openings except for the middle bay opening in the west gable-end of the barn have been filled in with concrete block masonry. The south eave-side and the east gable-end of the barn also have exterior brick veneers. The north bay in the west gable-end of the barn with the metal louvered vent includes an interior metal electric fan. Just behind the original main entry in the east gable-end of the barn is a large mechanical venting system. Behind the second buttress from the west on the south eave-side of the barn in the interior is an opening (the only access point) into the second level.

13. Interior of barn first level original main entry, camera facing east. Note that the east end of barn is the 'public' view shed and has original brick bearing walls while later infill of door and window openings has brick veneer exterior and a concrete block masonry interior.

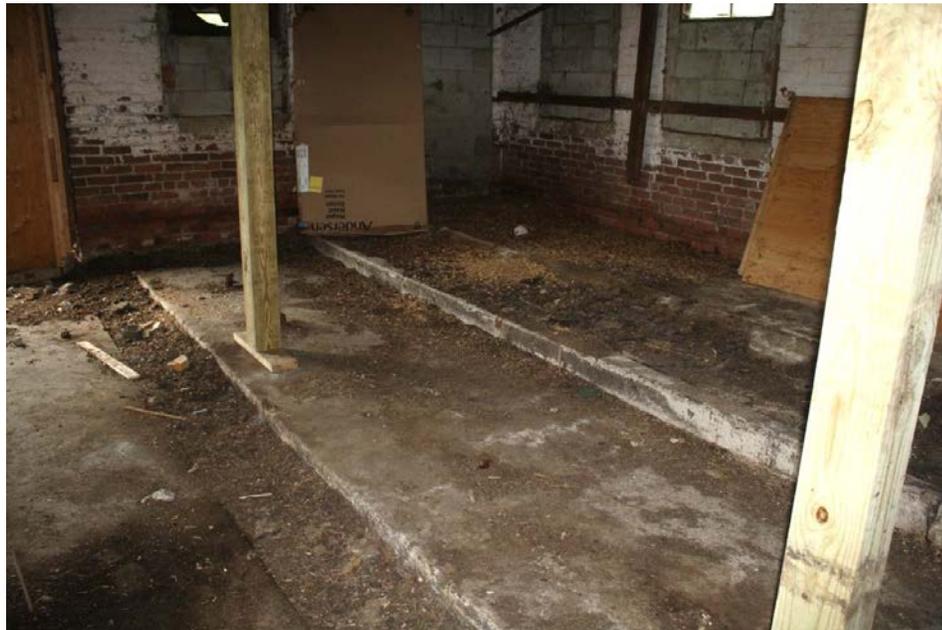
The floor is poured concrete with manure trenches for two rows of stanchions (no longer in place). There were ten stanchions per row for a total of twenty stanchions in the lower level. Automatic water cups were placed along the row of stanchions with one water cup for every two stanchions. A manure trolley was suspended from a track that ran from inside the barn approximately 100 feet to a cart or wagon in the field west of the gable end. The brick walls are whitewashed, and the ceiling is formed of tongue and groove beaded boards (milled so that each board gives the appearance of two) (Nelson).

14. Concrete floor used for dairy production, camera facing northwest. Note the manure gutter to the left and the white-washed walls.

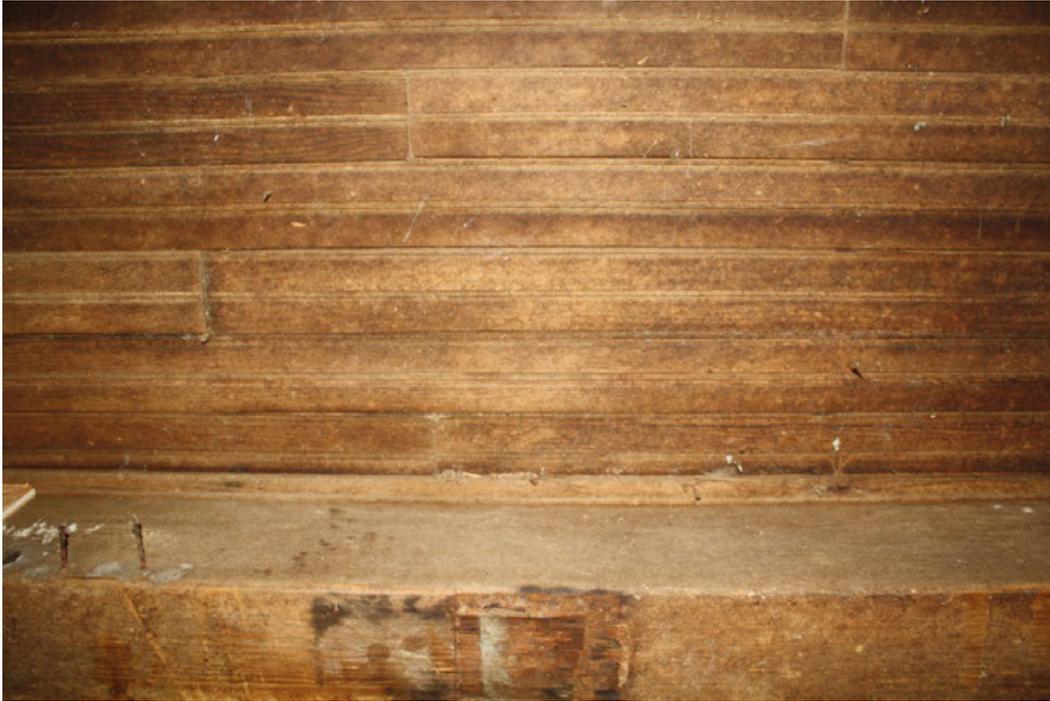
15. Detail of the first level ceiling bead-board.

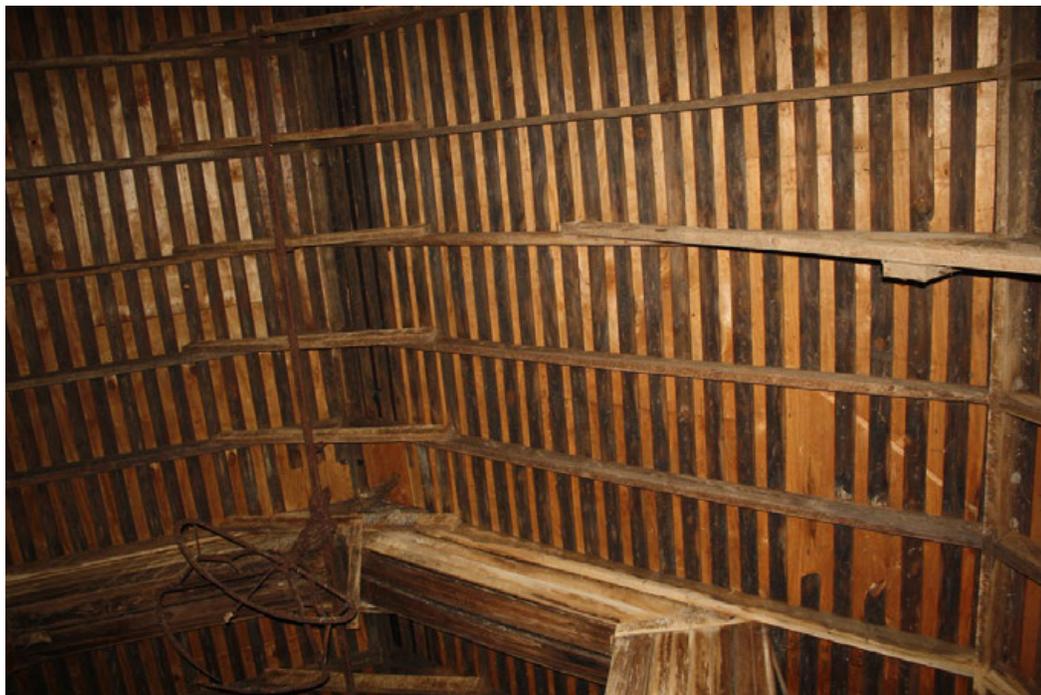
The loft area was constructed of wood frame walls with a modified braced-rafter gambrel roof set on top of wood-frame knee walls that rest on the masonry walls below. Two vertical wood clad ventilation shafts run from the loft floor level to the roof ridge where they met and terminated at a metal roof ventilator. The ventilator no longer survives but the ventilation shafts remain. The exterior of the rectangular-section shafts are formed of beaded boards; typical construction consisted of two layers of tongue-and-groove boards nailed to corner posts, with tarpaper in between the layers. The hinged door openings to the shafts in the ceiling of the lower level have been blocked off. The barn's framing is visible on the interior of the upper or loft level. Along the sides, there is a four-foot high knee wall, with diagonal braces to the floor joists every four feet and an unbraced intermediate stud.

16. Detail interior view of the second level roof structure. Note the hay hook and wood ventilation shafts.

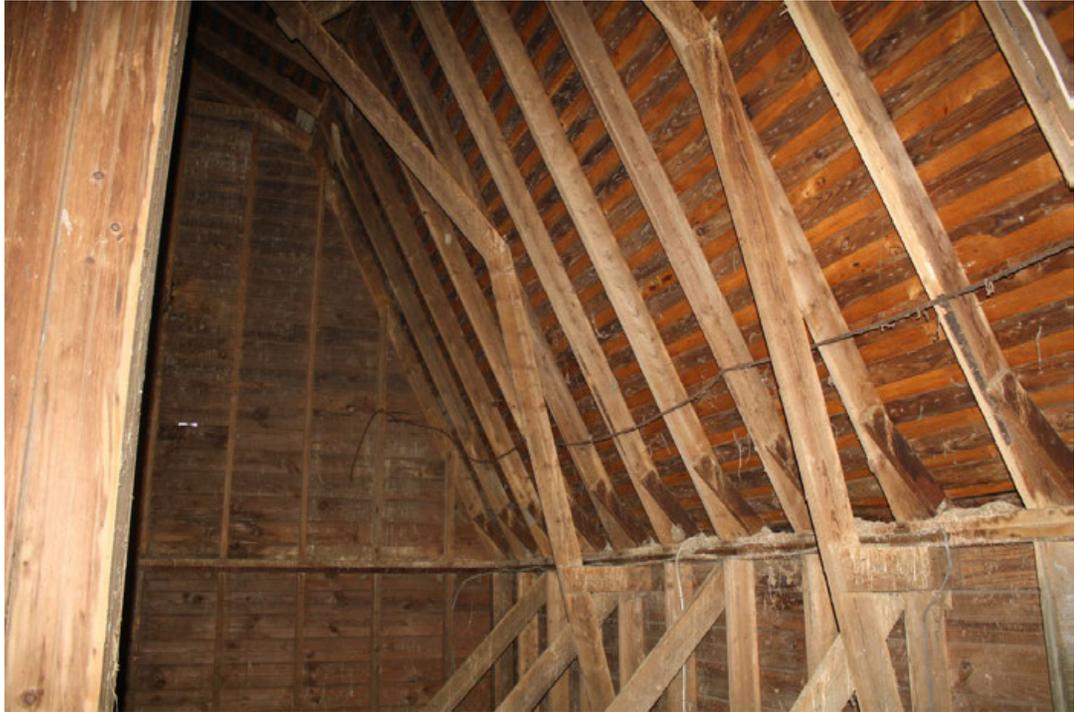
Resting on the knee wall are the rafters for the gambrel roof, spaced at two-foot intervals. Attached to the lower rafters, just above the knee wall, are the outriggers for the overhang. Purlin boards and a ridge board are found where the roof's slope changes. Every fourth set of rafters (not counting the end sets) are braced with two trusses: the upper trusses have a bottom chord connecting the midpoints of the rafters for the roof's top and bottom slopes and a king-post connecting the midpoint of the lower chord to the purlin. The lower trusses have the bottom chord running from the midpoint of the rafter for the lower slope to the base of the knee wall, with the kingpost nailed just below the top of the knee wall. All rafter pairs are connected by collar ties near the top of the roof, from which is suspended the rail for the hay fork. The roof forms a wide overhang at the ends,

17. Detail interior view of the upper level. Note that every fourth rafter is a braced-rafter truss, making the barn a modified braced-rafter barn.

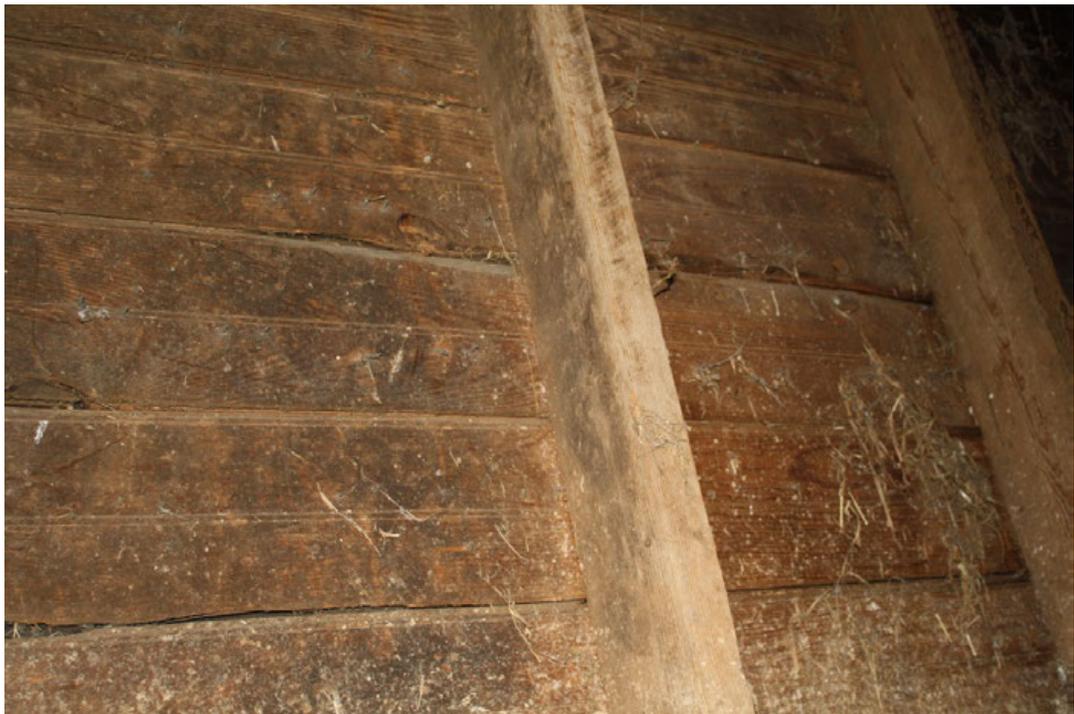
18. Detail interior view of the upper level. Note the bead-board wall sheathing.

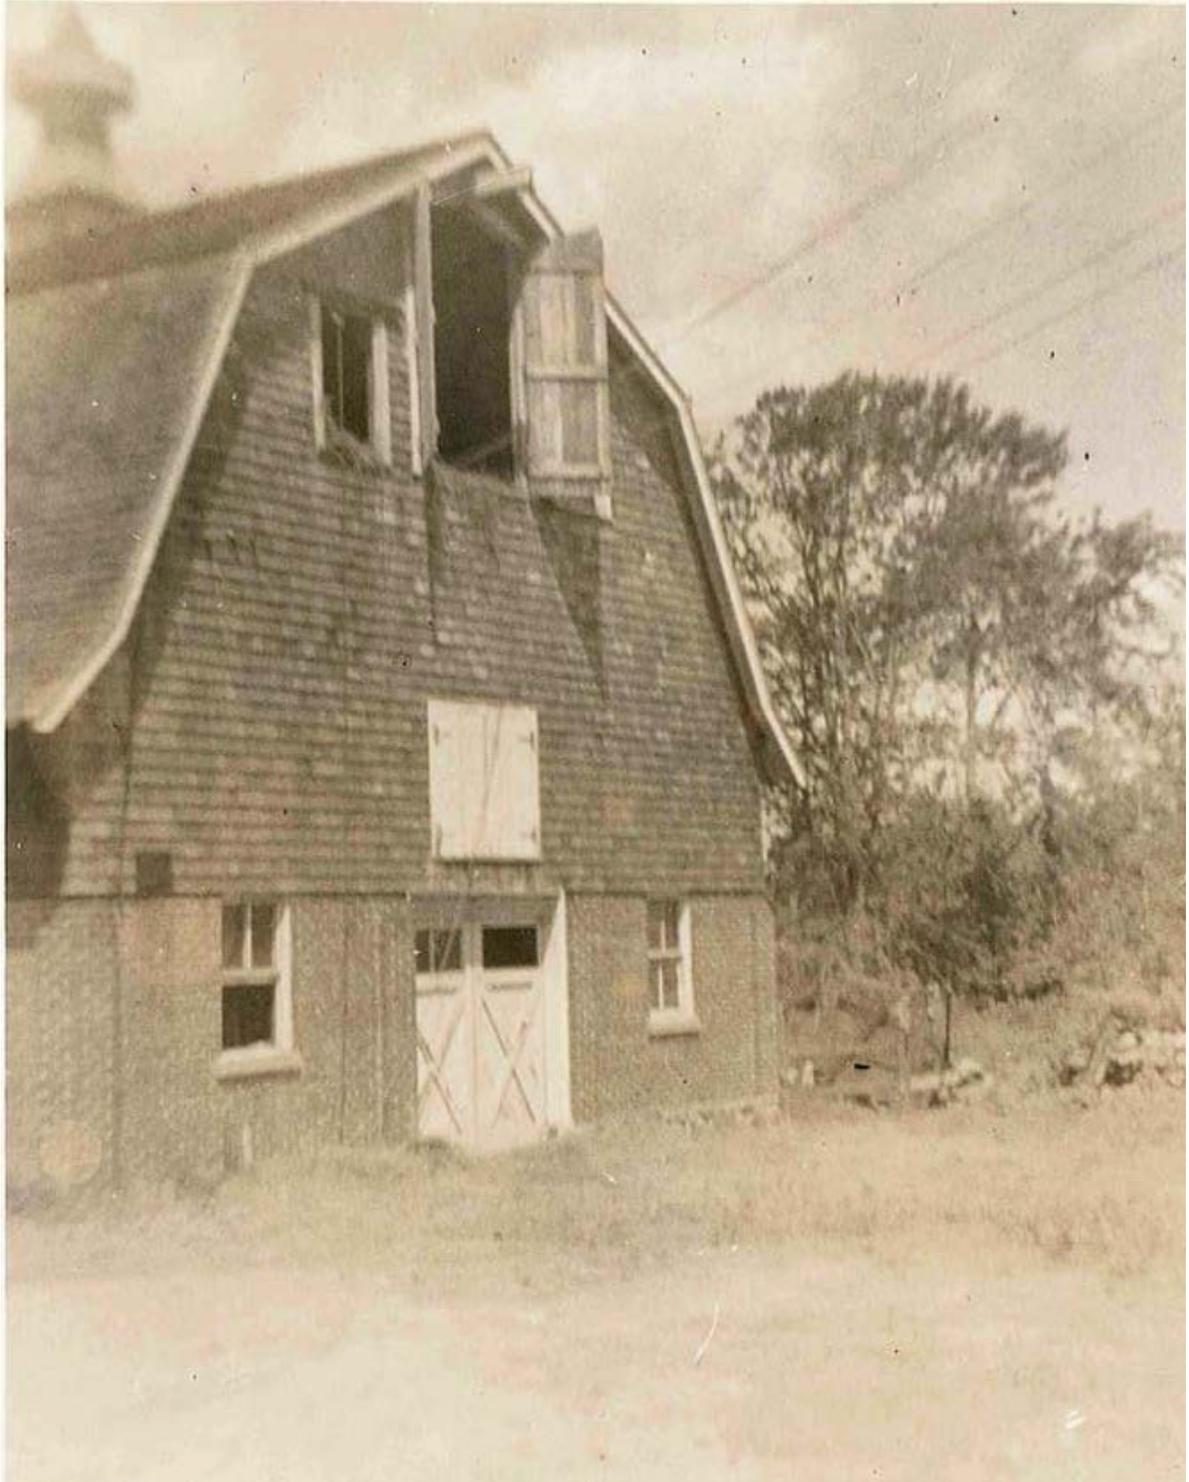
19. Historic photograph of the barn while still in dairy production, c. 1937. Courtesy of Sara Nelson. Note the ground level doors and windows, later infilled with masonry.
