**HISTORIC RESOURCES**

**BUILDING AND STRUCTURES**

Building Name (Common) Massaro Community Farm / Massaro Farm CSA, Inc. Record No. 6039

**HISTORIC RESOURCES INVENTORY FORM – BUILDING AND STRUCTURES** continuation sheet

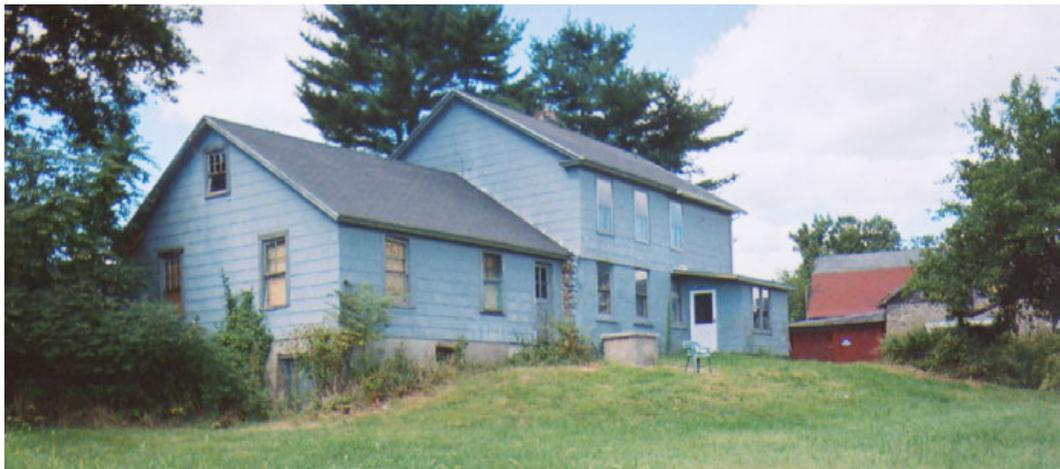
8. Southeast view of farmhouse prior to restoration, camera facing northwest.

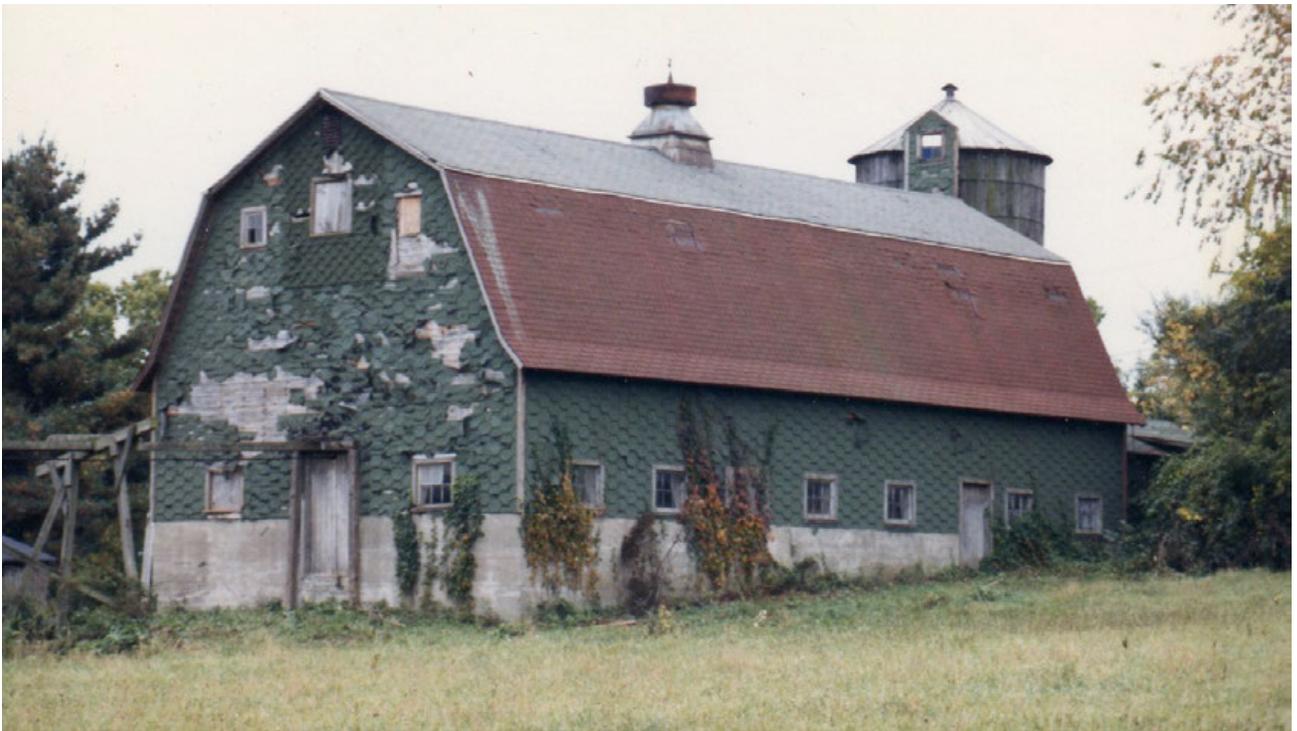
11. Northeast view of Barn I in 2008, camera facing southwest. Note patched area in upper gable-end, former location of a hay door.

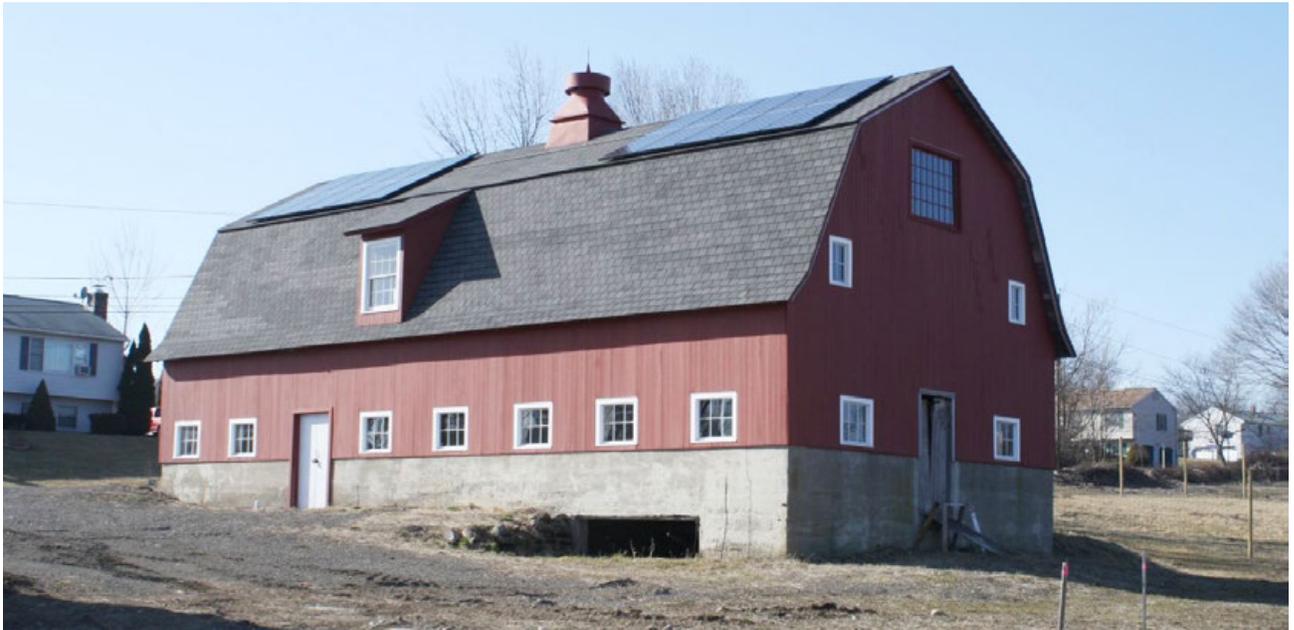
12. Southeast view of Barn I, camera facing northwest. Note photo-voltaic panels at roof.

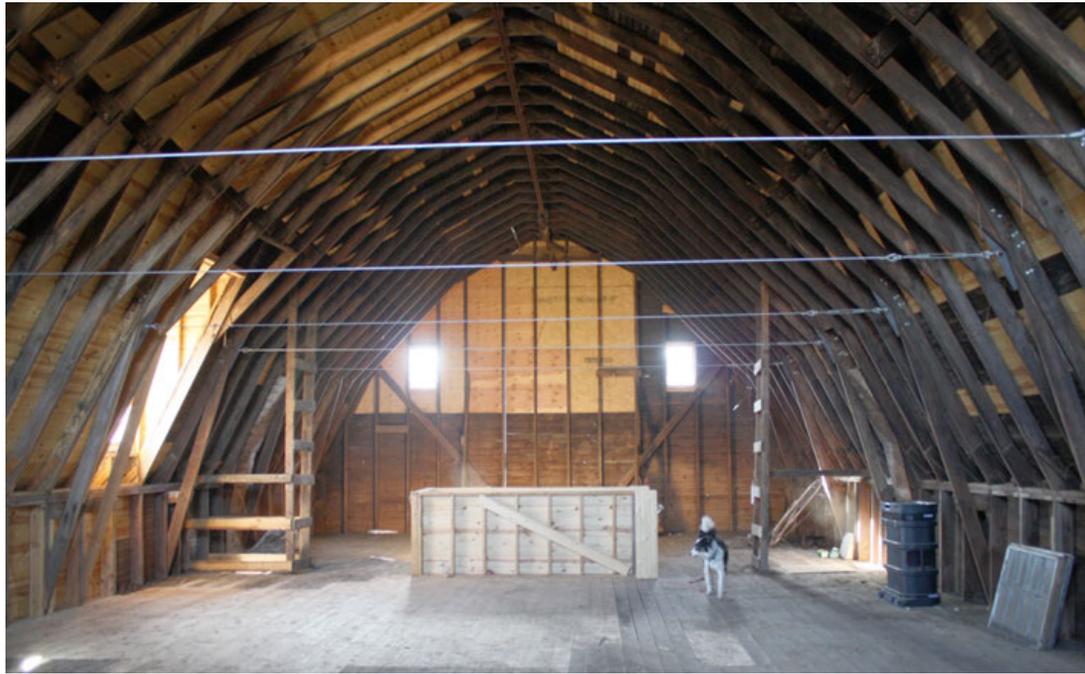
16. Interior view of loft level, Barn I, camera facing west. Note roof truss design incorporating 4' knee wall. Restoration work included cable ties at trusses, rebuilt dormer (left), patching of roof deck, west wall, floor. Half-height partition at center rear is new stair opening for access from lower level.

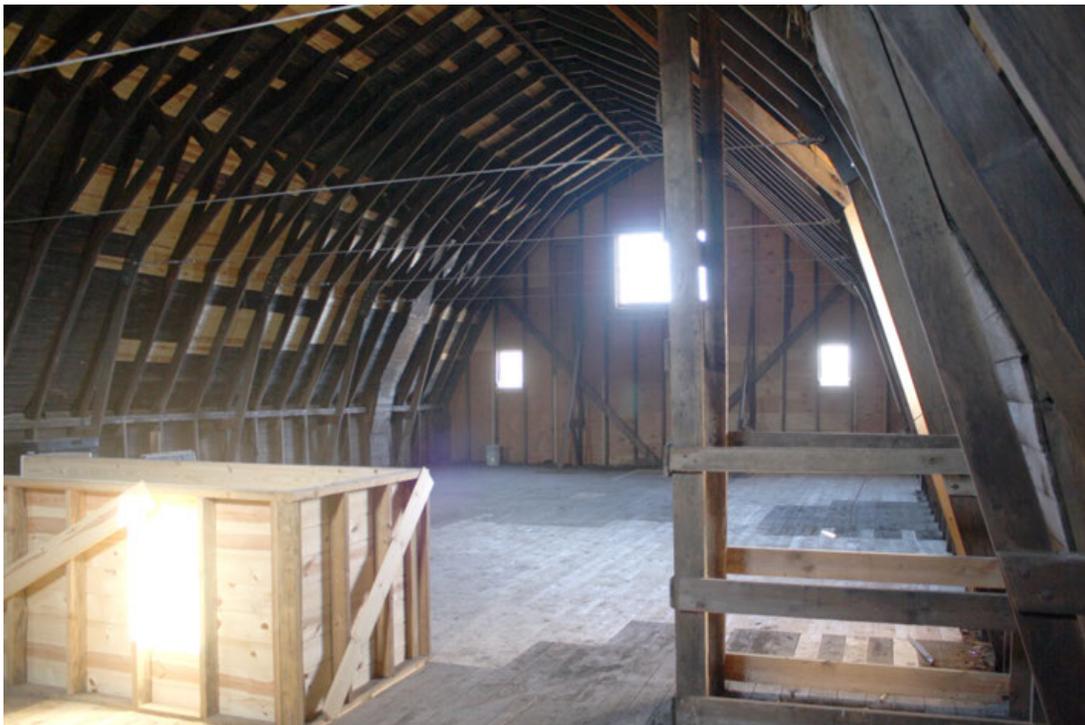
17. Interior view of loft level, Barn I, camera facing east. Large window at rear gable-end wall represents likely location of original hay door. Future plan is for this space to be finished as an event space, with addition of a second egress.

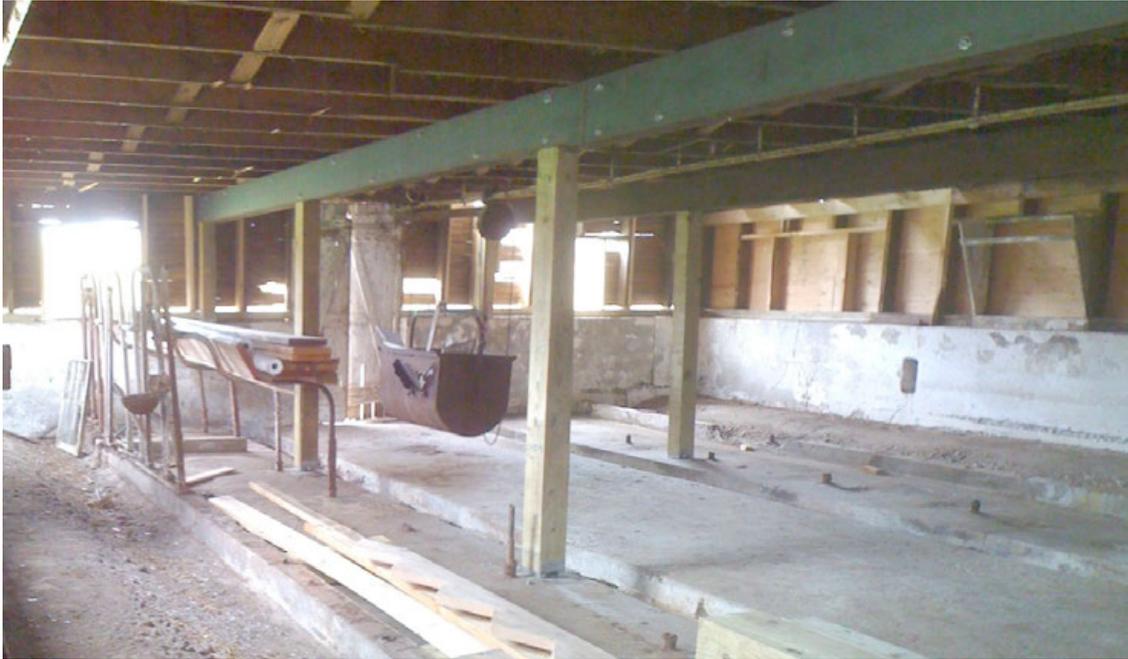
20. Interior view of lower level during renovation, camera facing west. Note preserved metal cow stanchions at left rear, suspended manure trolley at center, manure gutters cast into floor for cleaning, concrete perimeter wall.

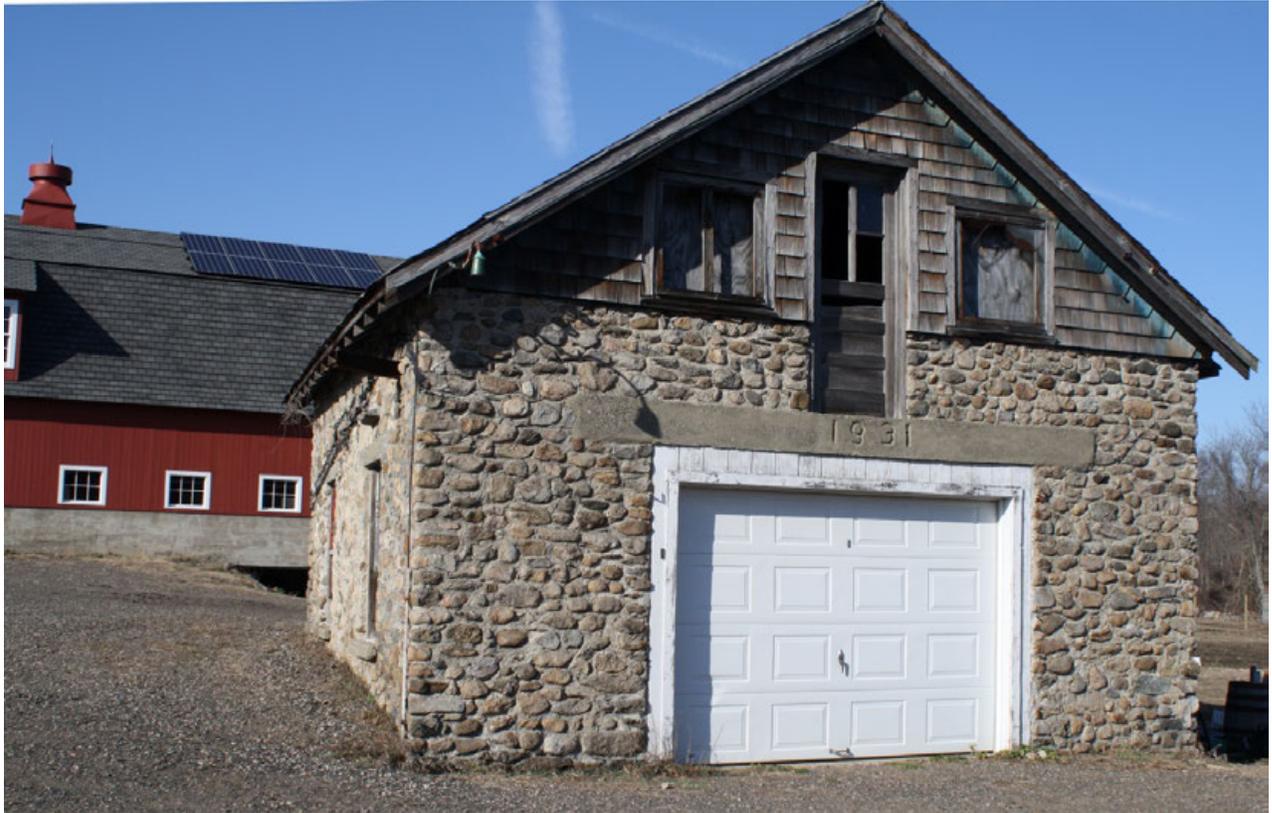
formed into the concrete. The attic gables have two two-pane windows in each of the north and south ends, while the south gable-end also has a pass-through or hay door at the center, extending down to the top elevation of the door lintel. The gable-ends are sided with wood shingle siding. The roof has overhangs at the eaves and rakes, with exposed rafter tails, and is asphalt shingles. The east and west exterior walls show marks where sheds were formerly attached. The windows and roof are deteriorated and awaiting planned renovations.

22. South view of Barn II – Stone barn, camera facing north.
