HISTORIC RESOURCES INVENTORY - BUILDING AND STRUCTURES

Building Name (Common) Larson Farm Record No. 52804
Building Name (Historic) Northrop, Isaac, Farmstead / Larson, Frank and Josephine, Farmstead
Street Address or Location 388 Danbury Road (US Route 7 & 202)
Town/City New Milford Village _____ County Litchfield
Owner(s) Town of New Milford, 10 Main Street, New Milford CT 06776 ☒ Public ☐ Private

HISTORIC RESOURCES INVENTORY FORM – BUILDING AND STRUCTURES continuation sheet

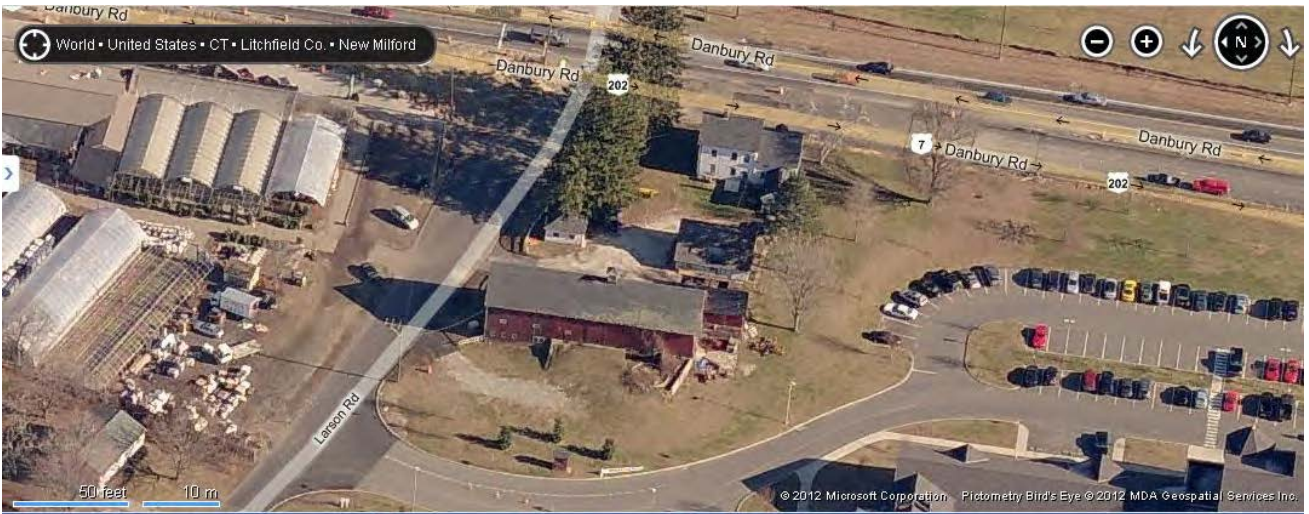
2. West view – aerial “bird’s-eye” map of 388 Danbury Road (US Route 7), New Milford CT – <http://www.bing.com/maps> accessed 11/27/2012. Note the cupola, now gone, and the circular silo base.

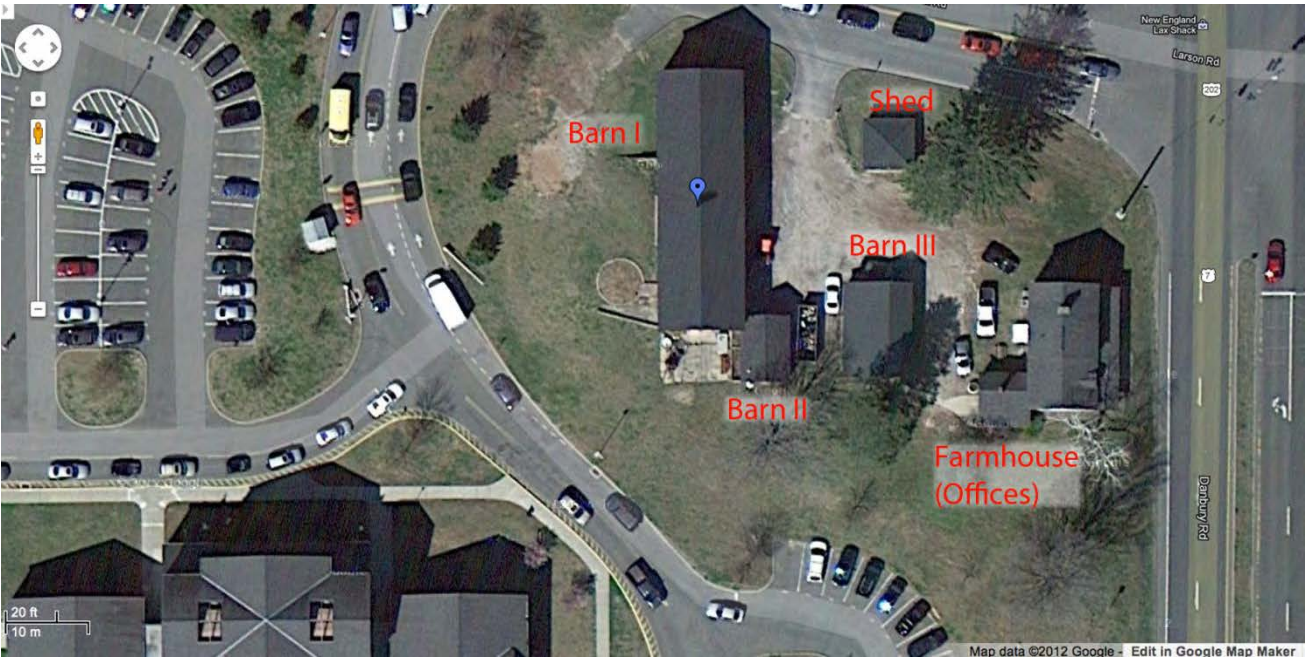
3. Detail Site Plan Sketch showing contributing resources. New Milford High School buildings are at lower left.

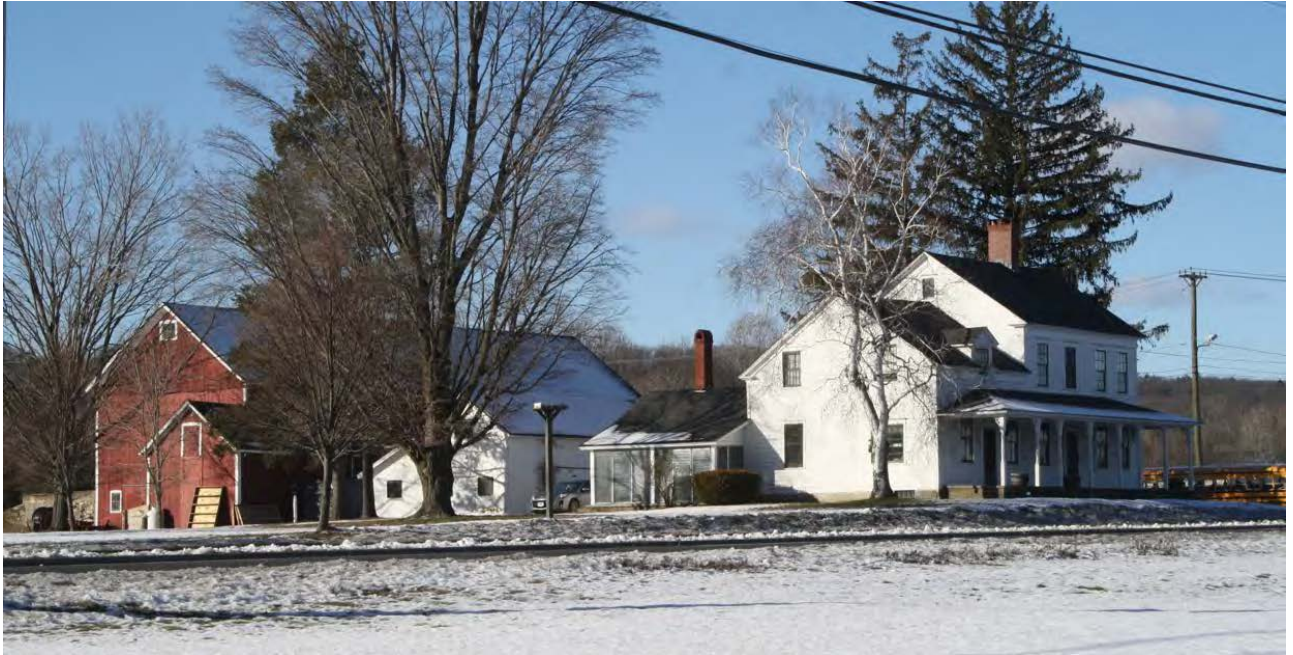
4. Southeast context view of Barns and Farmhouse (Offices), camera facing northwest.

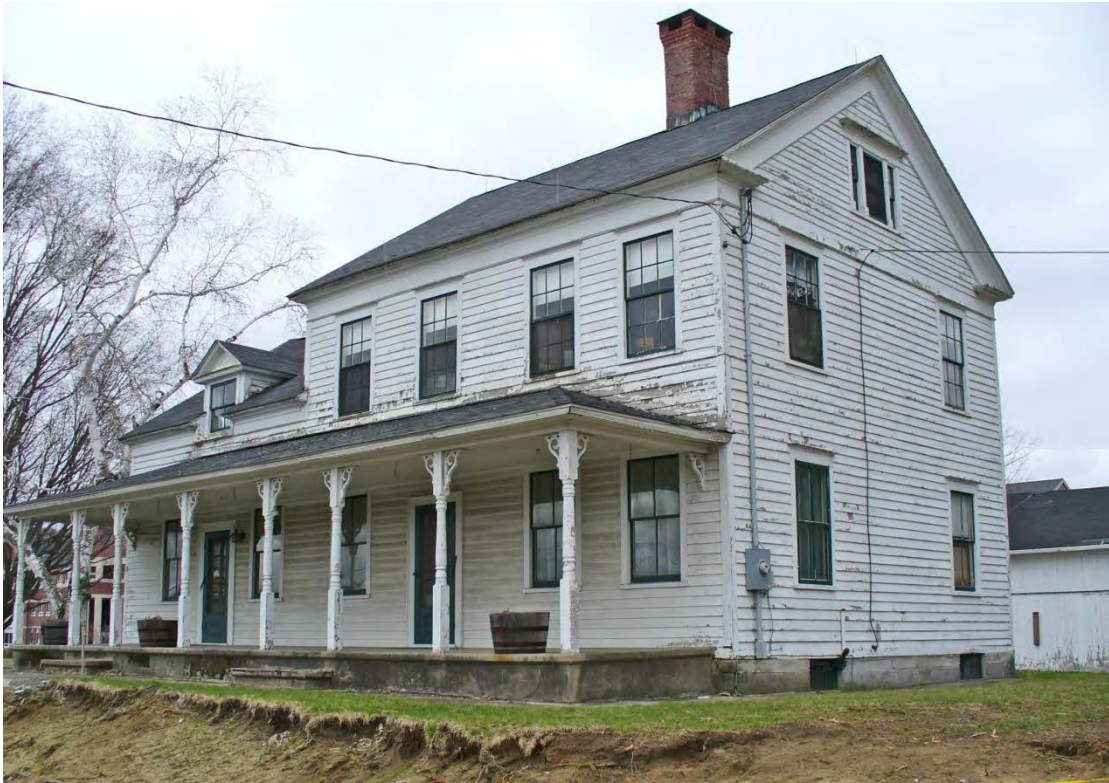
The Farmhouse is a 2 ½-story gable-roofed frame structure with its ridge-line oriented north-south, and its east eave-side facing east, now located close to the roadway of Danbury Road which has been widened repeatedly. The four-bay main block of the house has vernacular classical cornice returns and frieze under the eaves, and a three-part attic window with a cornice suggesting Federal-period style. To the south is a two-bay 1 ½-story wing with a single dormer in the attic; there is an entry door in both the main block and the south wing. A small 1-story ell projects west off the south wing. A full-width 1-story porch with Victorian-style turned posts and simple brackets extends across the east front. Windows are a mix of six-over-six and two-over-two sash, siding is narrow clapboards with corner-board trim, the foundation is cut marble masonry, and the roof is asphalt shingles. The building has been renovated for use as offices by the town department of education.

5. Northeast view of Farmhouse (Offices), camera facing southwest.

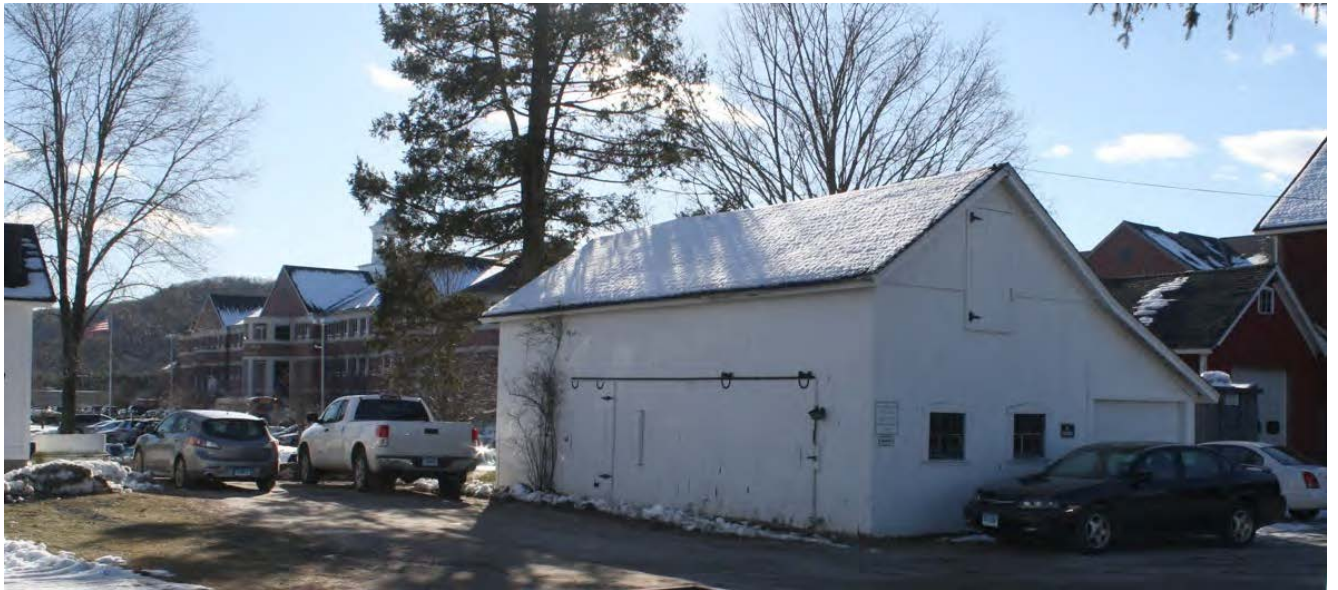
To the west of the house is Barn III, a 1 ½-story gable-roofed structure with its ridge-line oriented north-south and a shed extension across the west side giving it a saltbox profile. It appears to be a three-bay structure, and has a sliding door in the right (north) bay of the east eave-side. The north and south gable-ends have stable windows with beveled head trim at the ground floor and a hay door (north) or window (south) in the attic. The west shed portion is accessed by a garage door opening in the north end. Siding is vertical flush boards painted white, and roofing is asphalt shingles.

6. Northeast view of Barn III, camera facing southwest. New Milford High School is at left rear.

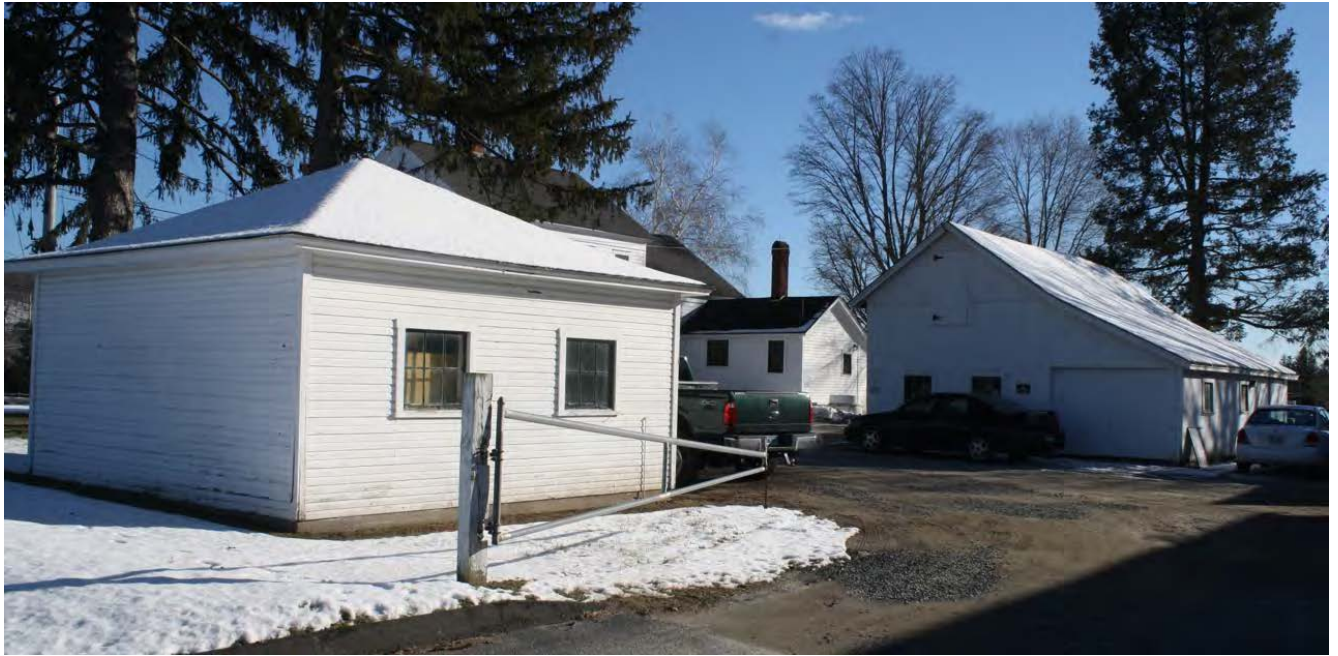
7. Northwest view of Shed/Milk room and Barn III, camera facing southeast. Farmhouse rear ell is at rear.

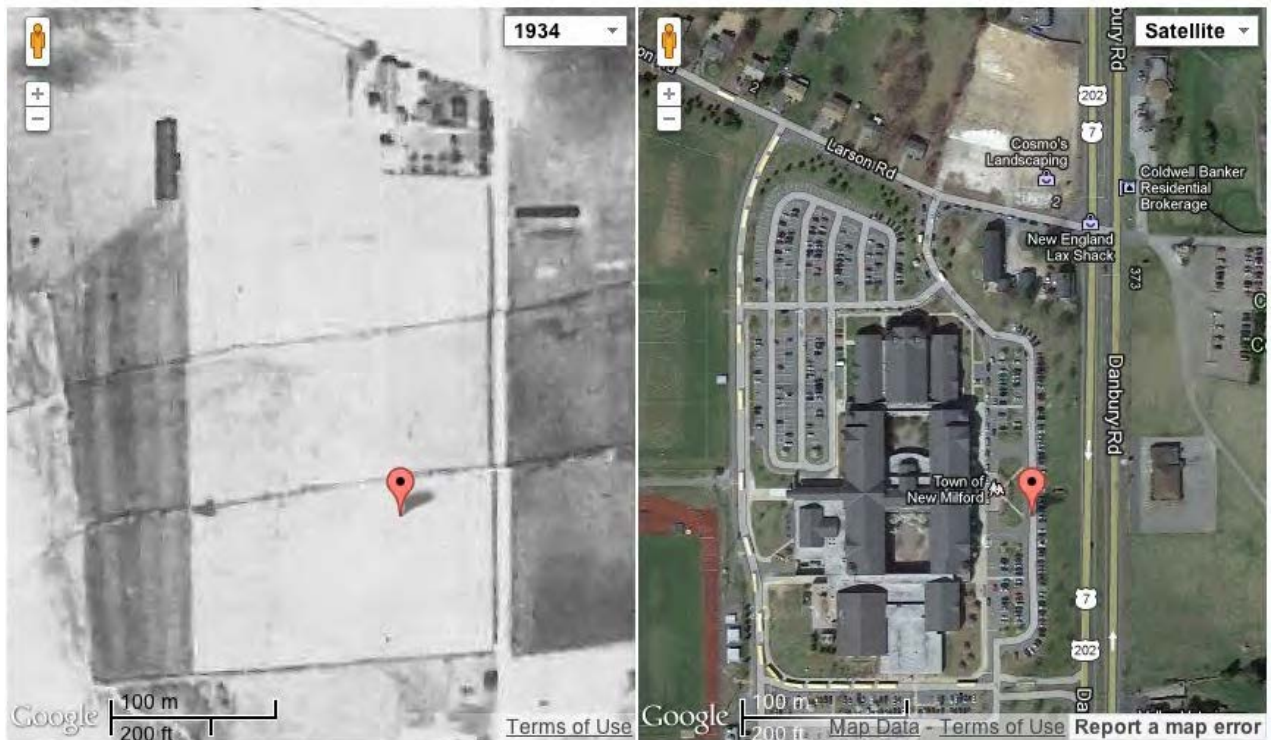
In the 1934 Fairchild aerial photograph, the farm's cleared land can be seen, with two large barns at a distance to the south and west from the main farm complex. These appear to have been tobacco sheds.

8. Fairchild aerial photograph, 1934, compared with 2012 Google Map aerial view – the farmhouse and barns are at the upper right. Note the tobacco sheds to the west (left) and across the road to the east (right); another larger tobacco shed is located to the south outside of this viewing area. Accessed 1/03/2012 at: <http://magic.lib.uconn.edu>.

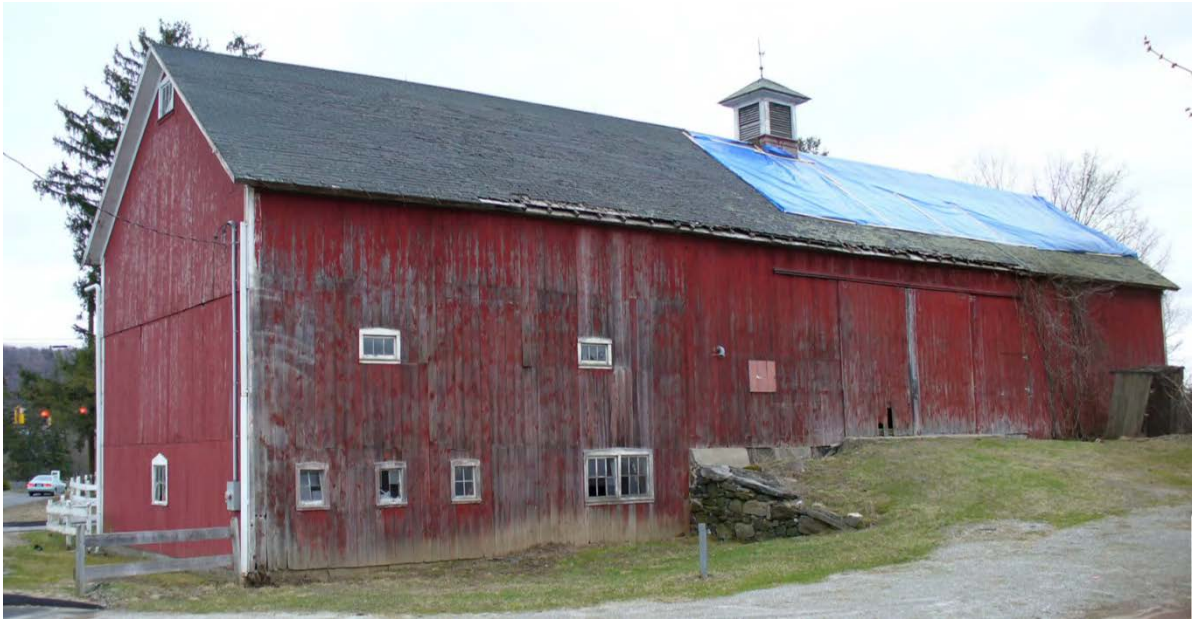
Alterations? ☒ Yes ☐ No If yes, explain: Cupola removed during re-roofing, 2007

9. Northwest view of Barn I, camera facing southeast, April 2007 photograph prior to repairs and painting. Note cupola, which was later removed.

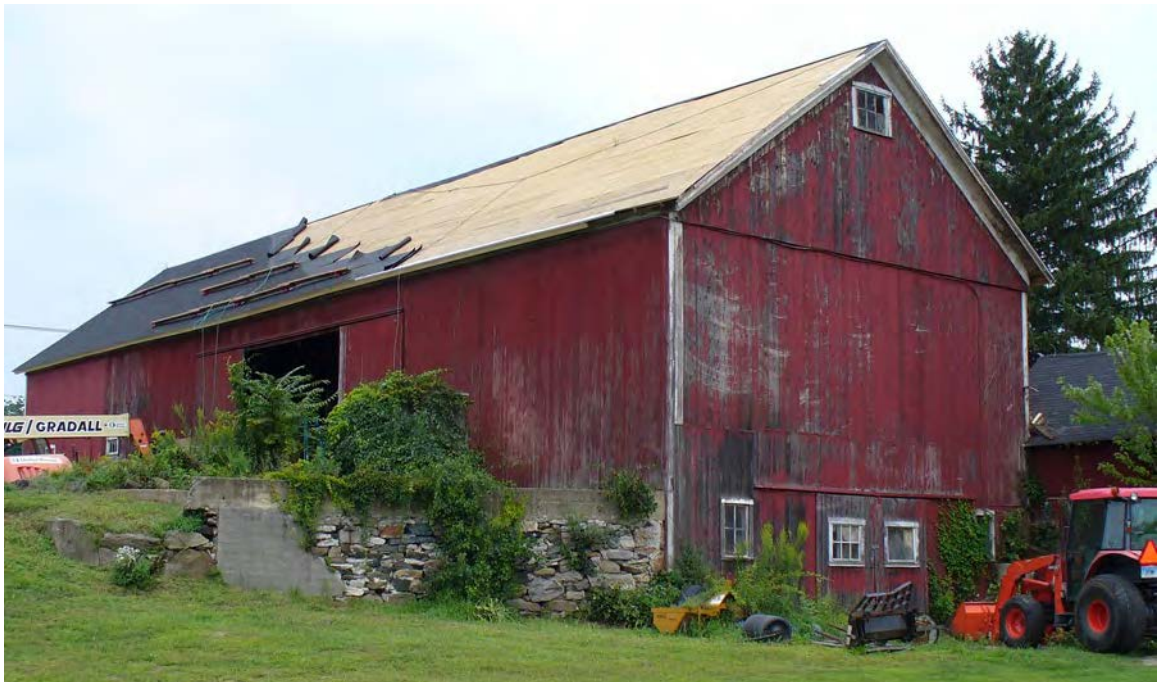
10. Southwest view of Barn I, camera facing northeast, August 2007 photograph during repairs.

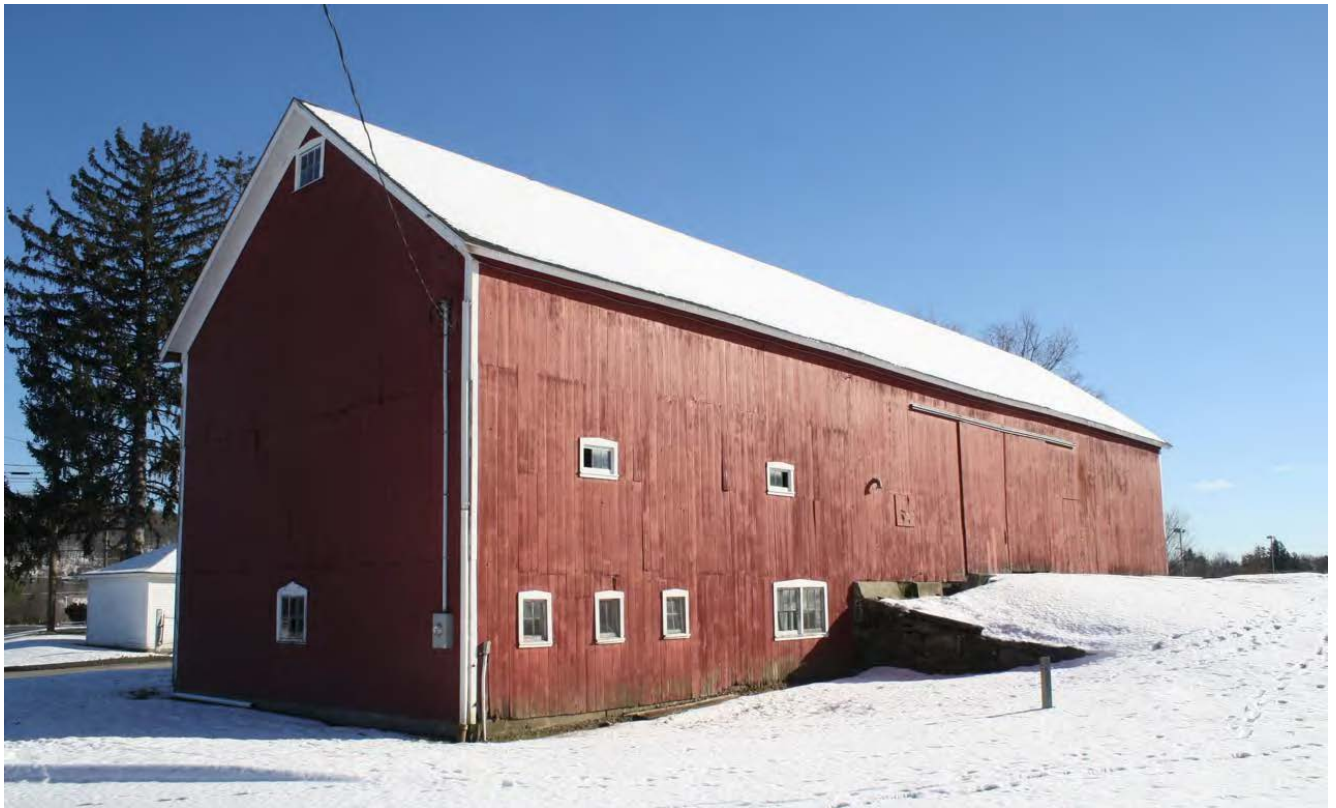
11. Northwest view of Barn I, camera facing southeast. Note the hip-roofed milk room or garage at far left.

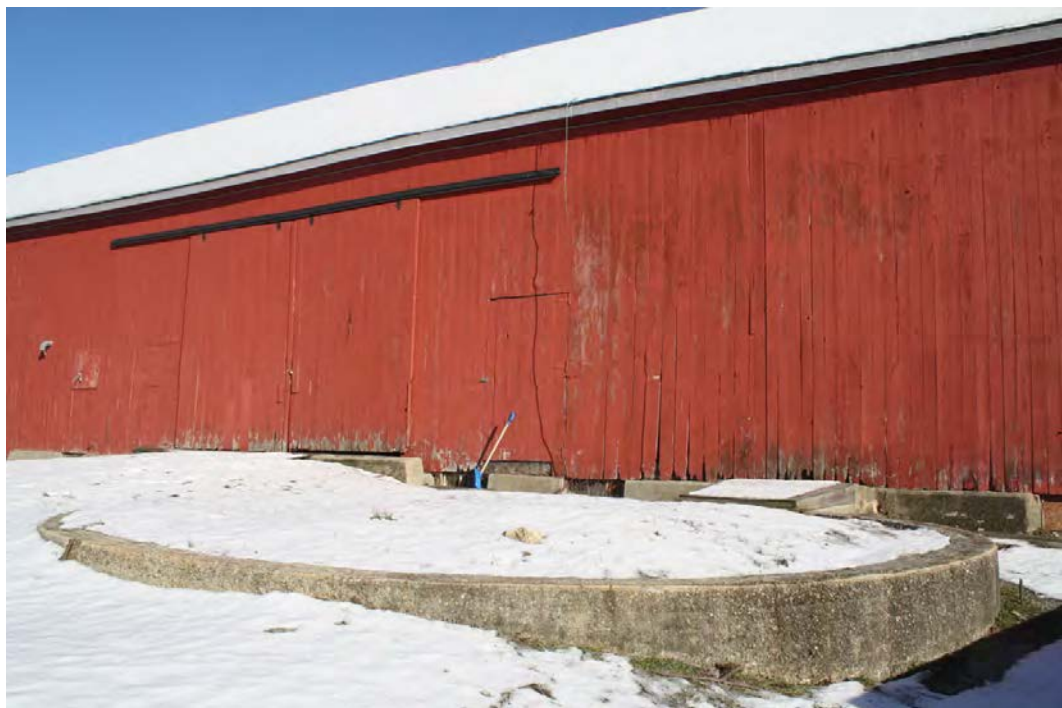
The west eave-side has the main entry into the upper loft level through a pair of full-height sliding doors in Bay 3. An earthen ramp with fieldstone retaining walls to the north and south, leads up to the door sill. There is a hinged pass-through door to the right (south) of the sliding doors. To the south of the doors, adjacent to Bay 1, there is the concrete foundation of a silo. The left (north) part of the west wall, Bays 5-6 has the basement level fully exposed, with a row of five six-pane stable windows at grade (the rightmost pair larger) and one three-pane window in the upper part of each bay. The upper walls of Bays 5-6 show jointing in the vertical siding which suggests possibly a former row of tall narrow operable vents for tobacco curing, later secured back in place.

12. West detail view of Barn I, camera facing northeast, showing the main entry doors and silo foundation.

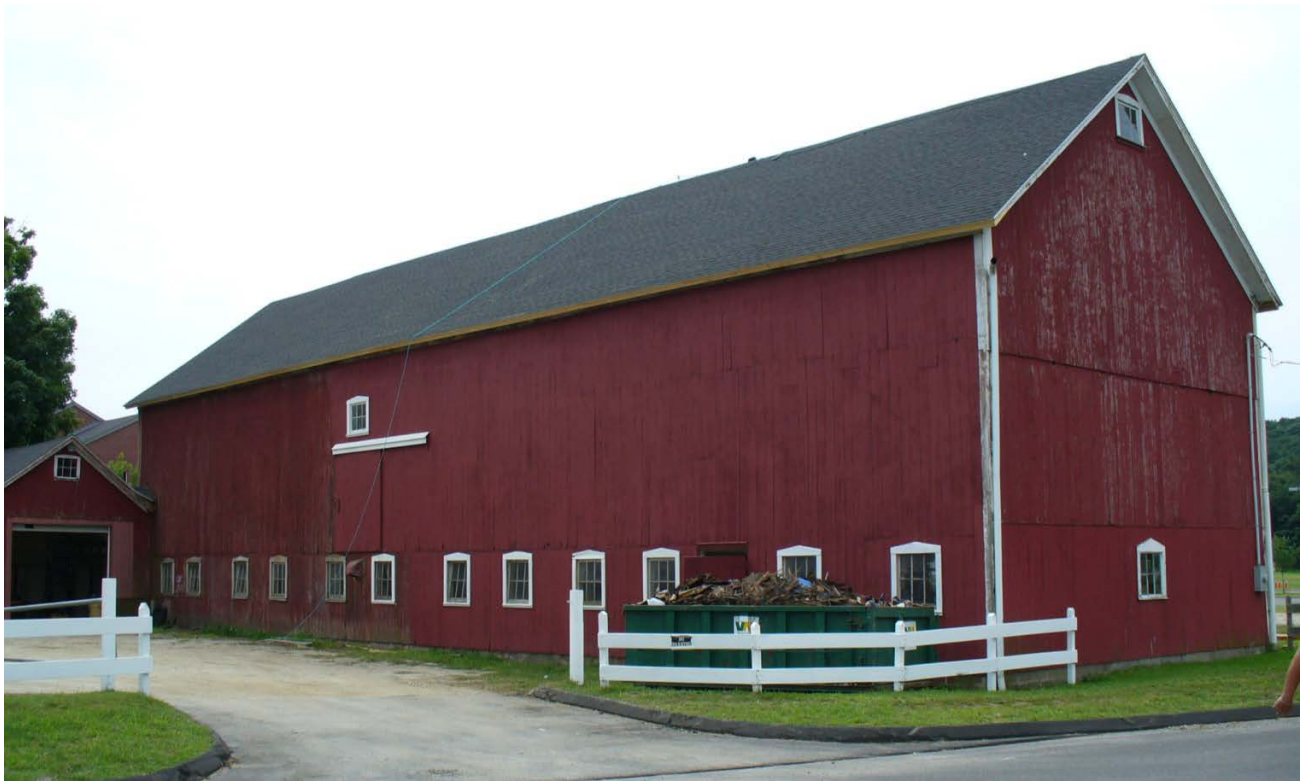
The north gable-end has one stable window centered at grade level, a six-pane sash with a beveled head trim. A course of concrete block masonry foundation is visible below the siding, which is vertical boards divided at the loft floor level and at an elevation roughly six feet below the eaves. There is a six-pane attic window very high in the peak. The east eave-side also has its basement grade level fully exposed has twelve six-pane hopper stable windows, two per bay, and a pass-through door in Bay 5. At the main level in Bay 3 there is a sliding hay door with a six-pane window above under the eaves. Barn II is attached to Barn I at the southeast corner, where the two structures overlap slightly; there is a cricket in the roof of Barn II at the connection.

13. Northeast view of Barn I, camera facing southwest.

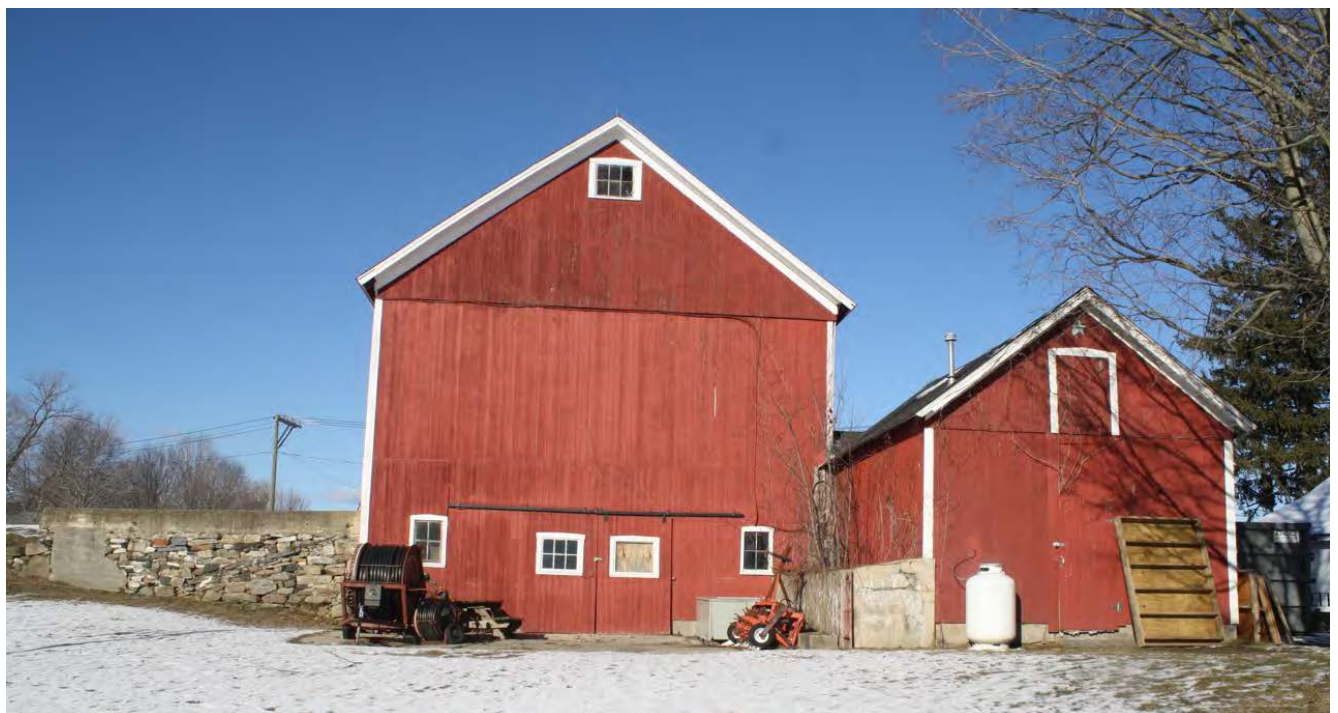
The south gable-end has its basement level exposed to grade. In the basement is a centered pair of sliding doors with a six-pane glazed panel in each leaf. The doors are flanked by a four-pane window in each side aisle. Above at the main level, there is a siding divide at the eave line (unlike the north end) and a six-pane attic window at the peak.

14. South view of Barn I, left, and Barn II, right, camera facing north.

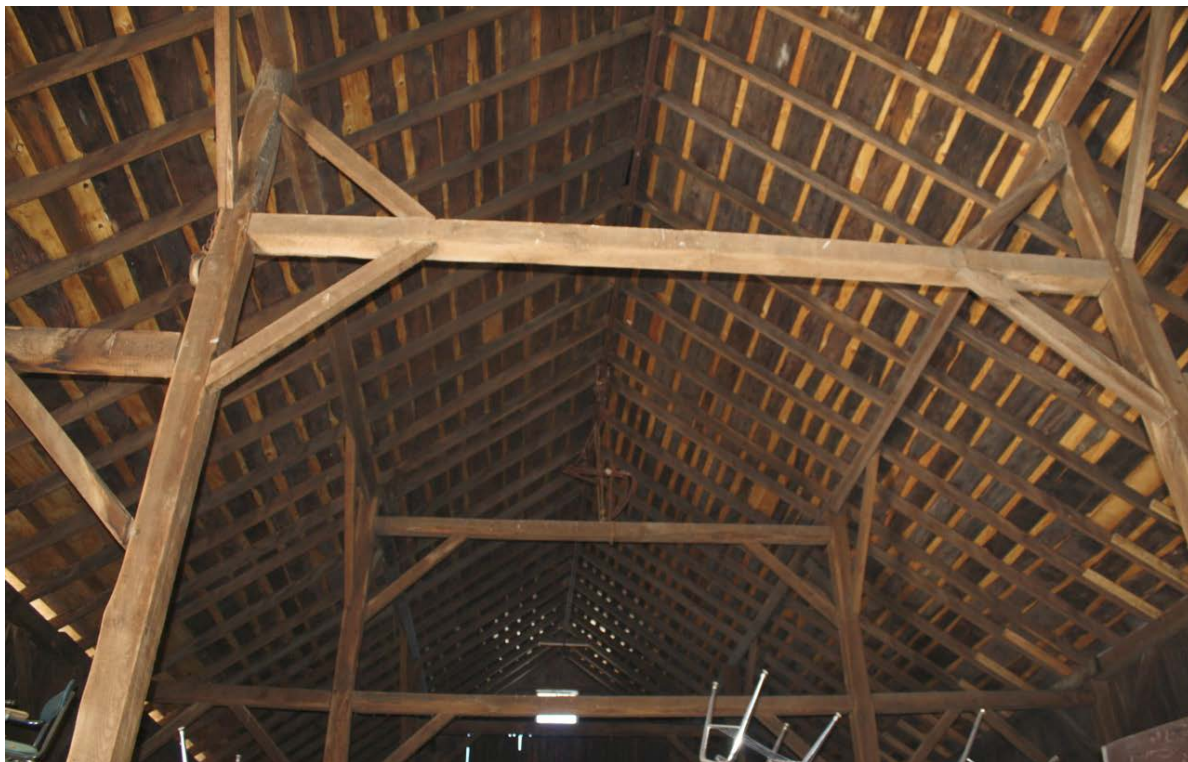
15. Interior view of Barn I upper level framing, camera facing north from Bay 3. Note the hay track and horse fork.

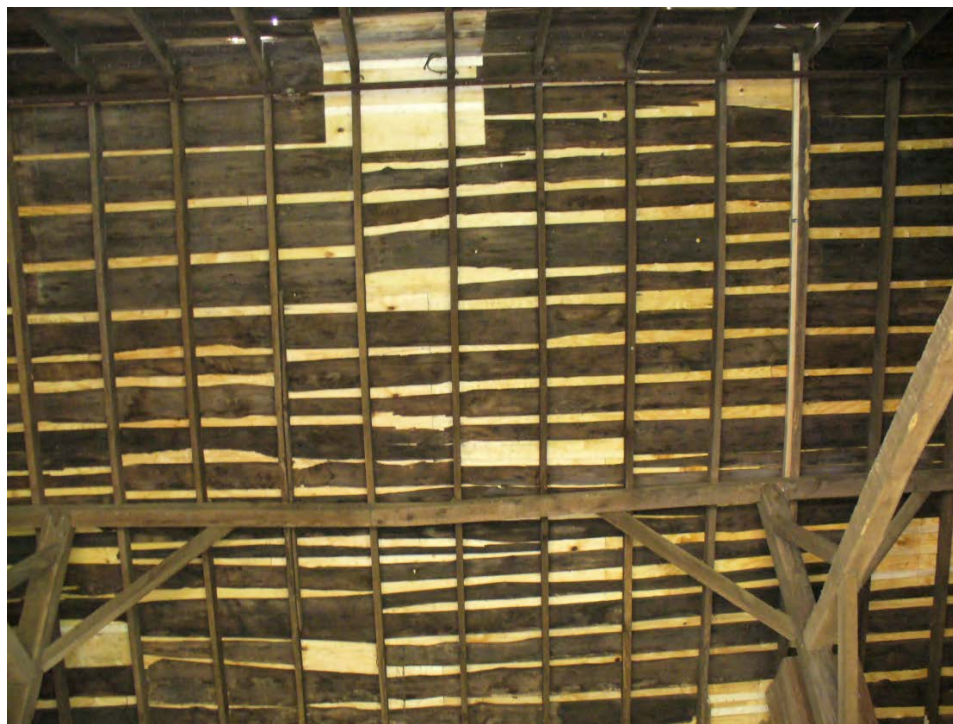
16. Interior view of Barn I upper level framing, camera facing east in Bay 3. Note the new plywood decking infilling the cupola location.

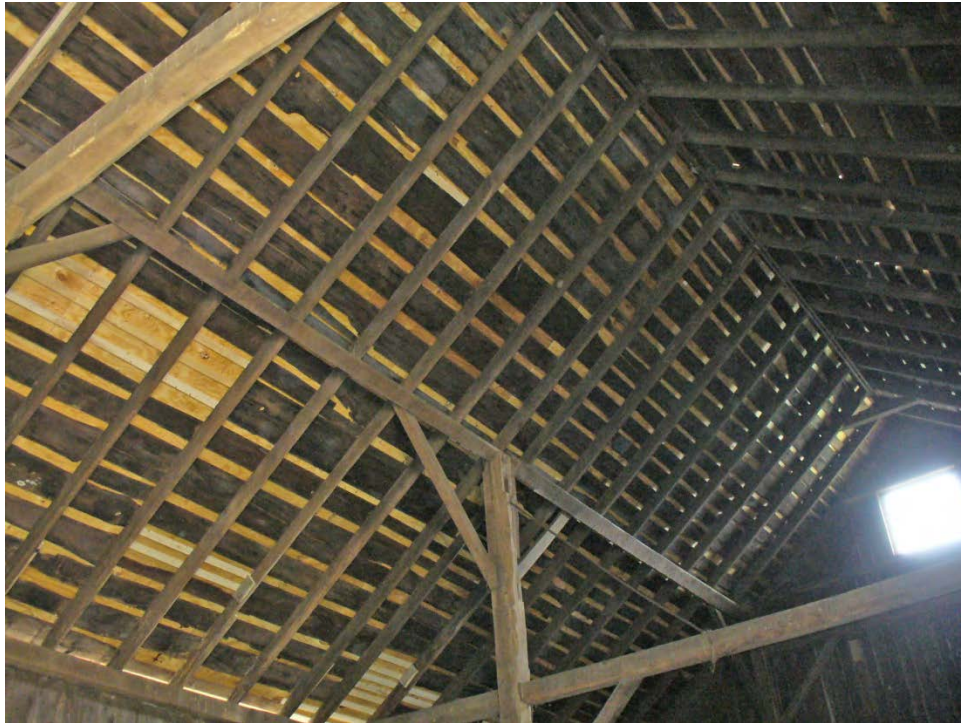
17. Interior view of Barn I upper level framing, camera facing southeast from Bay 3. Note metal diagonal brace, removed upper tie-girt (indicated by the empty mortise near the top of the post), close rafter spacing at the post.

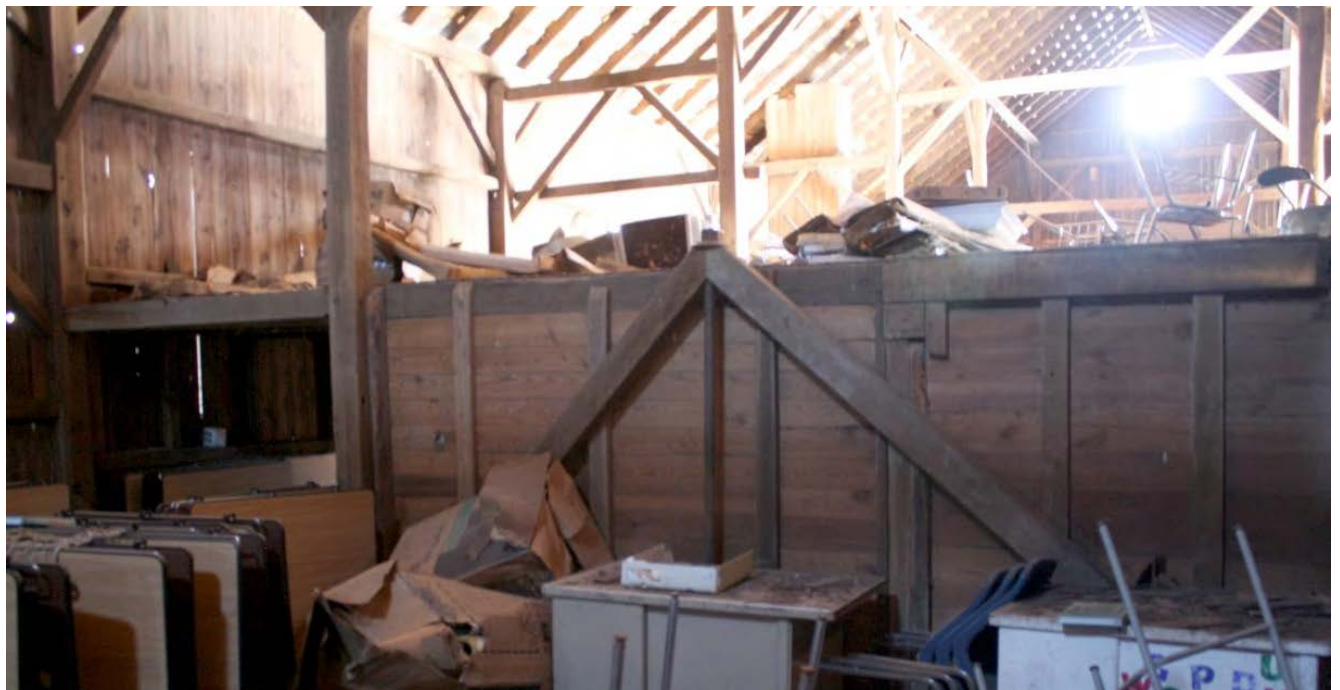
18. Interior view of Barn I, main level framing, camera facing south at the north bent of Bay 4. Note the triangular truss, which bolts through the center longitudinal girder below the floor, visible from basement. This truss occurs in the four bents of the original three-bay English barn.

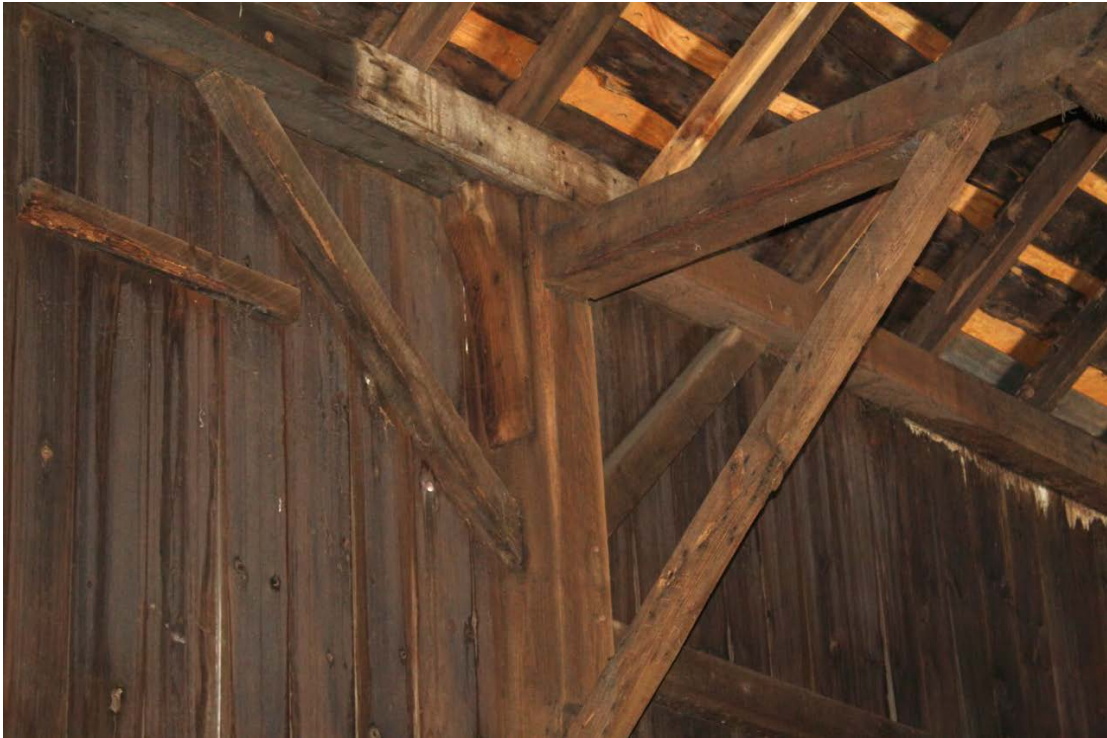
19. Interior view of Barn I, main level framing, camera facing southeast at the north bent of Bay 4 where the added Bay 5 is spliced on with a corbel block.

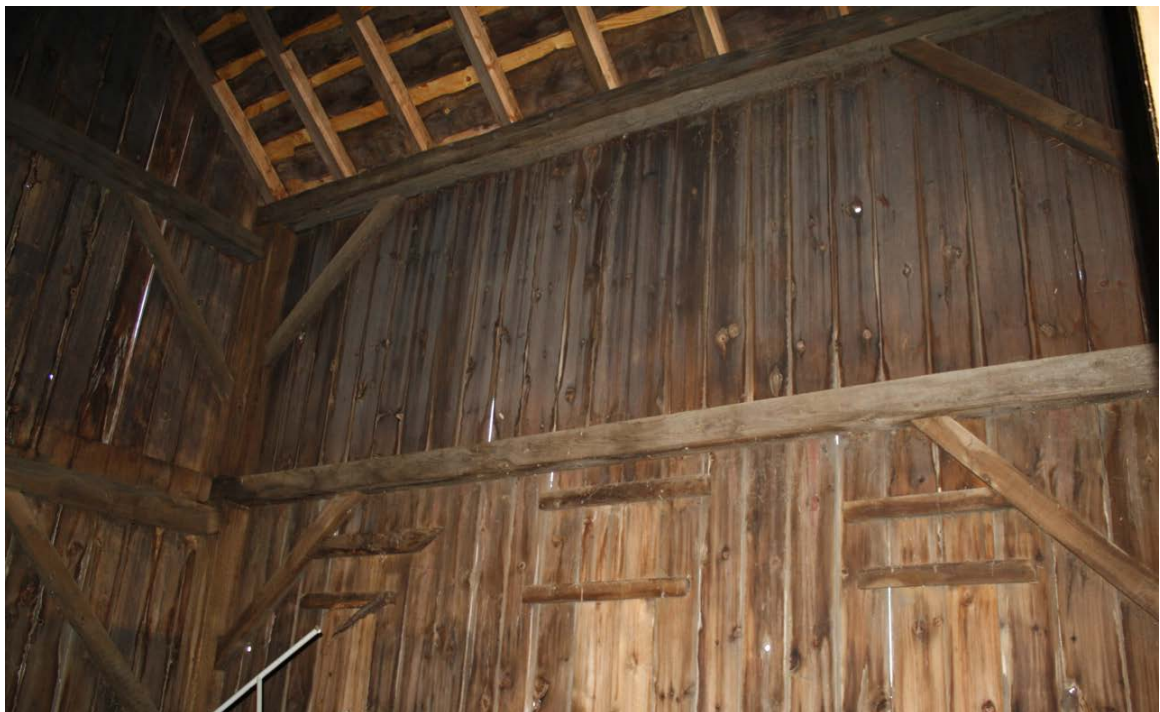
20. Interior view of Barn I, main level framing, camera facing northeast at Bay 6, showing formerly top-hinged vent openings, now nailed shut, dating from the use for tobacco curing.

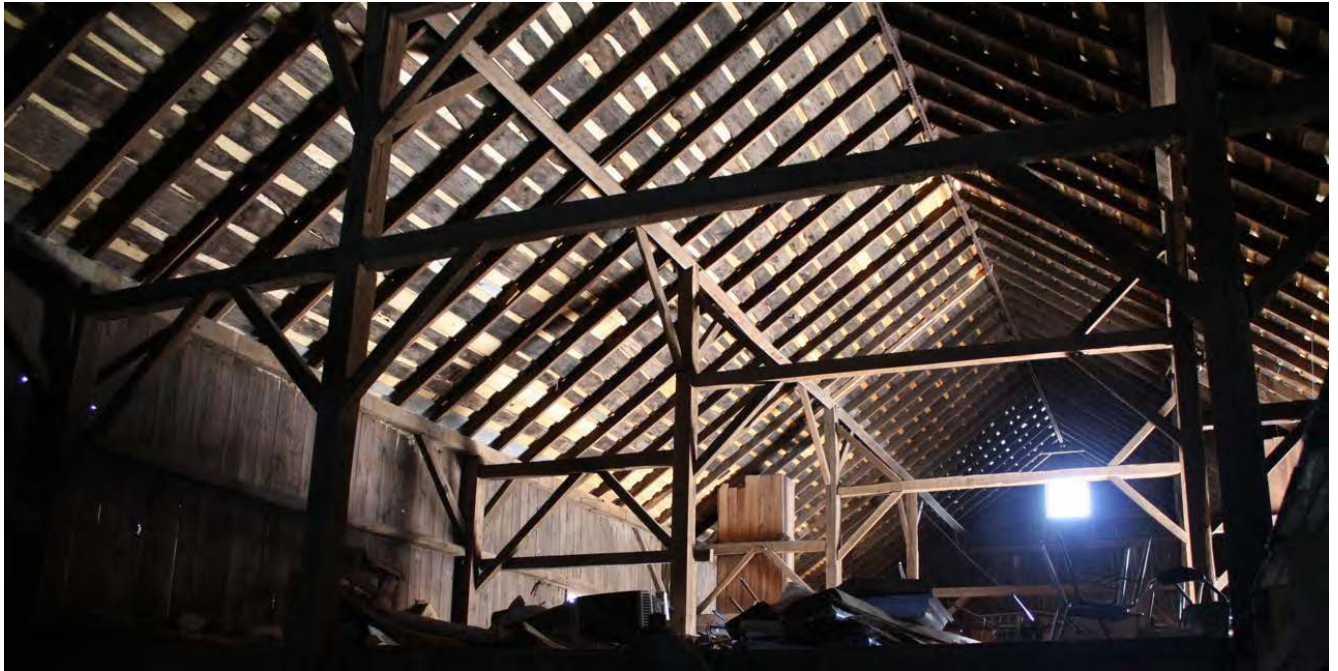
The interior of the main loft level is a series of seven bents forming six bays. The bents are all designed with a pair of full-height interior posts forming three aisles, and supporting canted purlin plates. The interior posts are braced to the outer wall posts with dropped tie-girts. The center aisle has a series of tie-girts in various configurations, some bents have one and others having two. In some places iron rods act as angle braces while in other locations wood angle braces are used. A hay track runs below the peak, with the horse fork still extant in the 2007 photographs. The rafters are of sawn lumber, as are the other structural timbers. The purlin plates can be seen to have joints at the bent between Bay 1 and 2, and between Bay 4 and 5. In addition, the rafter spacing around these bents is closer, additional clues indicating differences in construction.

21. Interior view of Barn I, main level framing, camera facing south from Bay 5. Note the typical full-height posts carrying the purling plates, braced to the outer walls, and the wide center aisle.

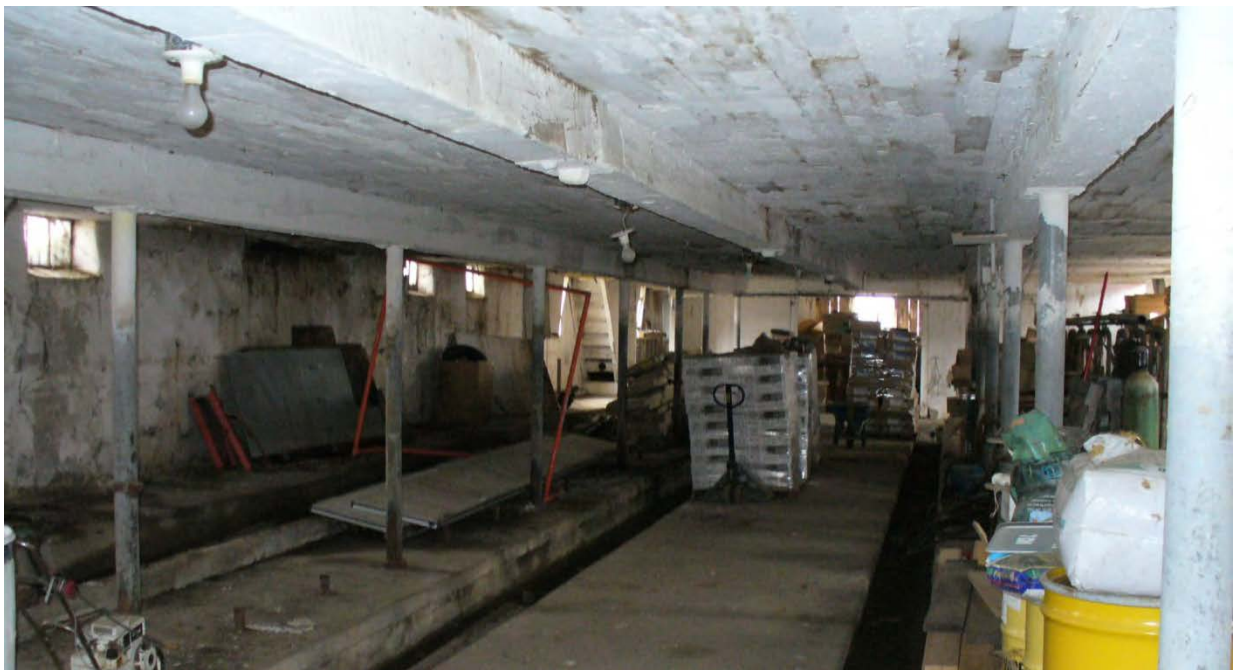
The basement or ground level is configured as a ground level stable barn for two rows of cows (stanchions removed for use as storage) facing outward. Two lines of cast iron columns support longitudinal wood girders which carry the floor joists above. The spacing of the steel columns is laid out for the convenience of the dairy operation and does not correspond to the bays of the upper frame. A third girder along the center appears to carry the ends of the floor joists at the center line, but is apparently supported by a truss system from above. The ceiling is a finished board surface, painted or whitewashed. According to the conditions assessment by the Archidesign Group, Bays 1-4 have floor joists oriented laterally, east-west, while Bays 5 and 6 have joists running north-south; these may be supported on lateral floor girders in the bents. The floor is concrete slab stepped for mangers, access aisles, and manure cleanout gutters.

22. Barn I basement level interior view, camera facing north. Note the two girders carried on metal posts and the third center girder suspended from above (through-bolts visible on lower face). Manure gutters in the center aisle formerly were cleaned by a mechanical gutter cleaner.

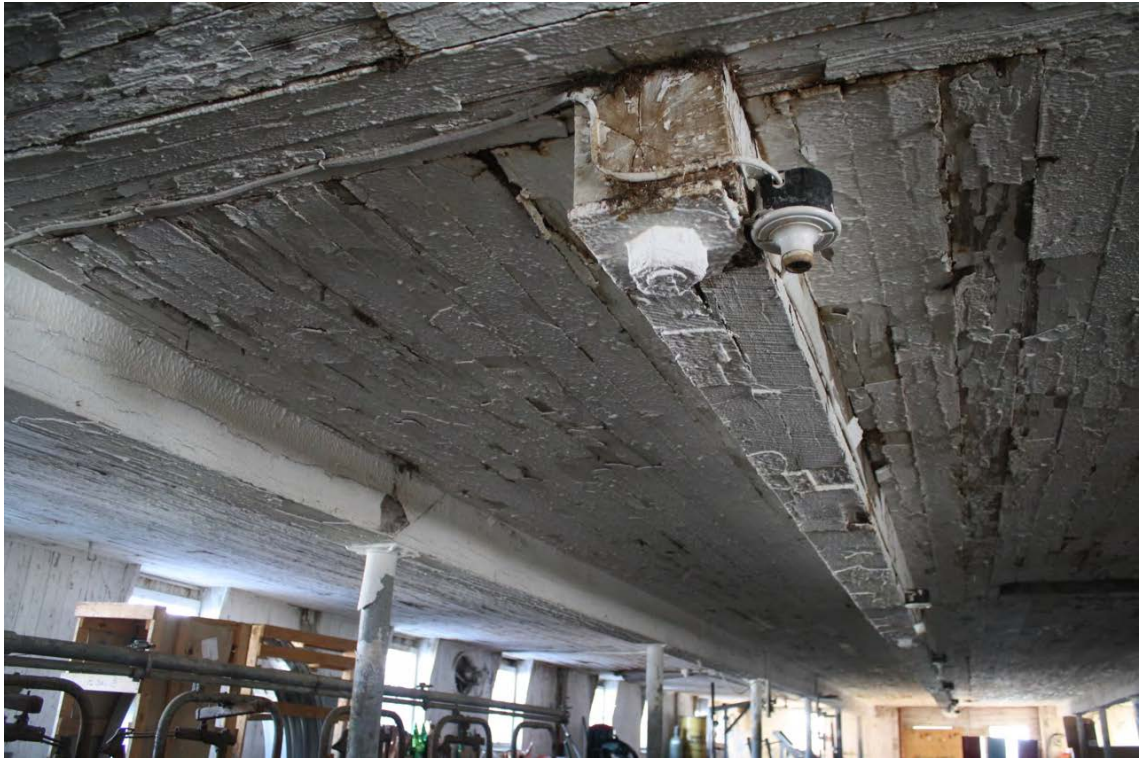
23. Barn I basement level interior view, camera facing south. Note the two girders carried on metal posts and the third center girder suspended from above (through-bolts visible on lower face). Dairy stanchions remain in the east aisle.

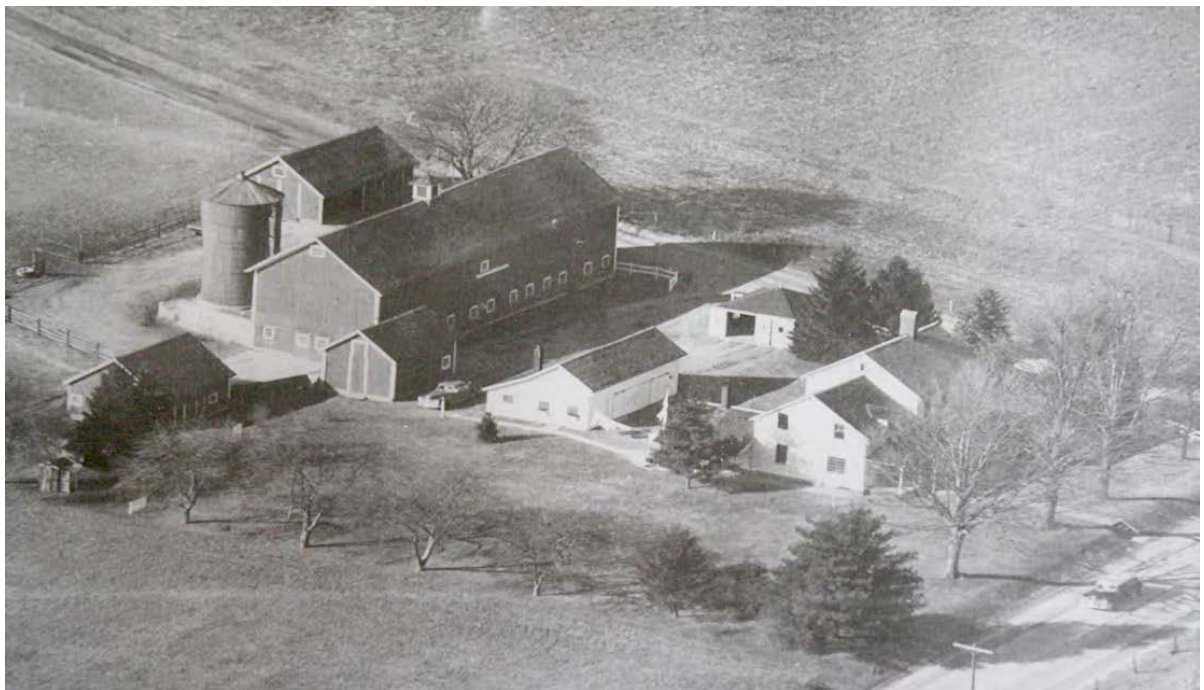
24. Southeast aerial view of Larson Farm, courtesy of New Milford Board of Education. The barn at the upper left was relocated to the Sullivan Farm, 140 Park Lane Road, and re-used as a maple sugar house.
