HISTORIC RESOURCES INVENTORY - BUILDING AND STRUCTURES

Building Name (Common) Botsford-Minor Farmstead Record No. 46821
 Building Name (Historic) Botsford-Minor Farmstead
 Street Address or Location 88 Old Roxbury Road
 Town/City Roxbury Village _____ County Litchfield
 Owner(s) Adams Office LLC, 88 Old Roxbury Road, Roxbury CT 06783 Public Private

88 Old Roxbury Road, Roxbury CT

Record No. 46821

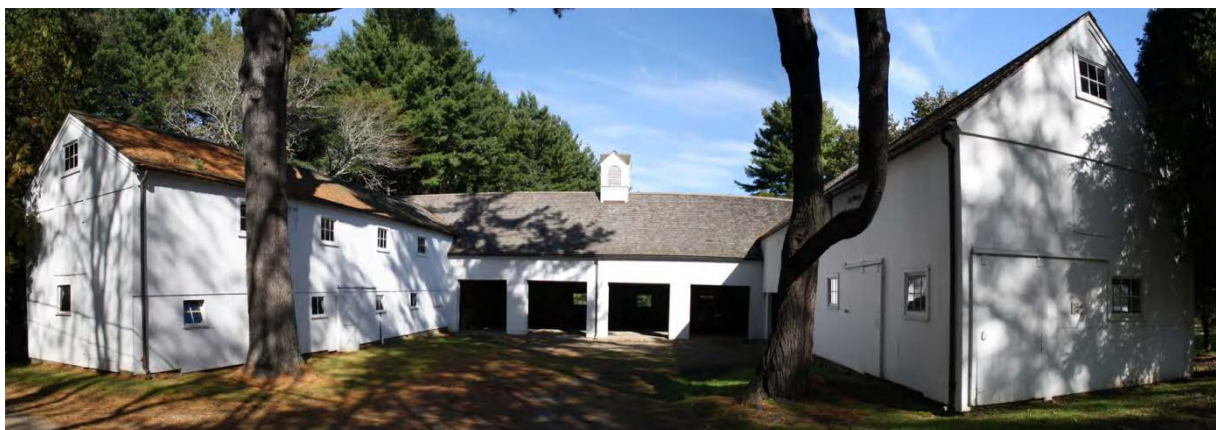
The central block, an extended English barn, has its current entrances via four overhead garage doors in the south eave-side, facing the former barnyard, now an entry court for vehicles. Three are of equal width, while the westernmost (left) opening is narrower.

5. South view of barn, camera facing north.

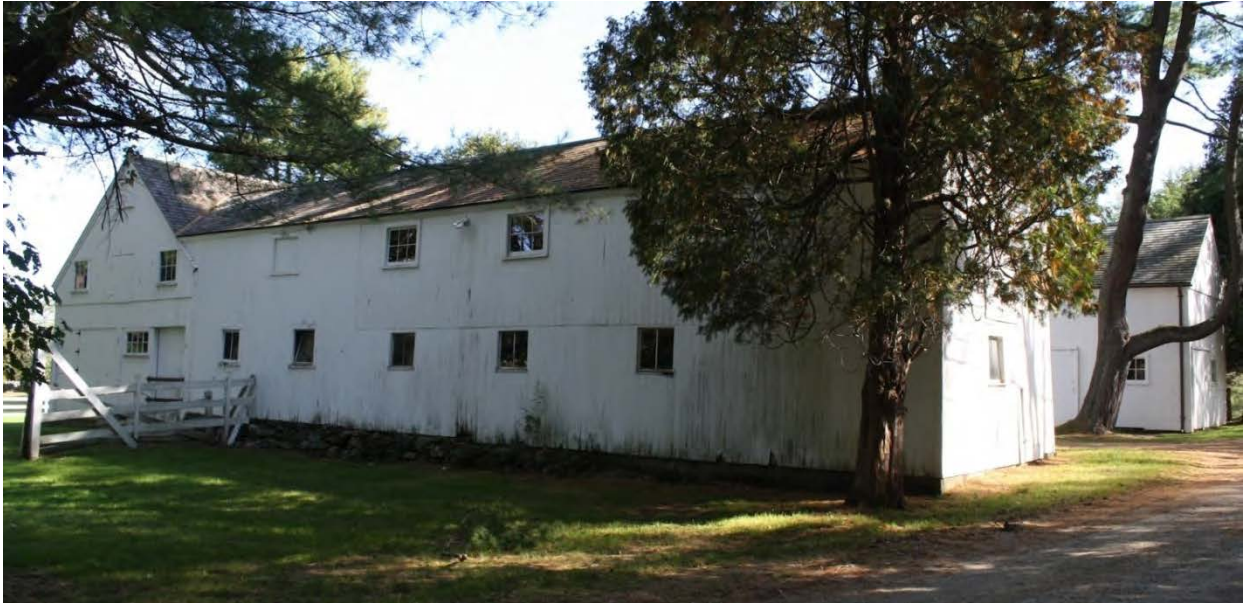
The west side consists of at the north (left) the gable-end of the west extension bay, and flush with it to the south (right) the west eave-side of the 2-story west wing. The gable-end roof, with simple rake trim, extends into the wall of the west wing as on the east side. The gable-end has two doors on the ground level. The left-most is a Dutch stall door set into the left side of a slight recess which may have formerly been open. To the right is an interior sliding door. Above is a centered hay door flanked by six-pane attic windows. Above at the peak is a shuttered opening. To the right the wall of the west wing has five two-pane stable windows in the ground floor and four windows in the upper level, of which one is boarded up and the rest are six-pane. The foundation of the west wing is stepped up from that of the north block; is fieldstone though an area at the south end is concrete. The south gable-end has a square hopper stable window at the center of the ground floor with a hinged door to the right (east). Above is a hay door and in the attic is a six-pane window. The east eave-side of the west wing has six two-pane hopper windows and a centered sliding exterior door at the ground level. There are four six-pane windows in the upper level.

6. West view of west wing, camera facing northeast.

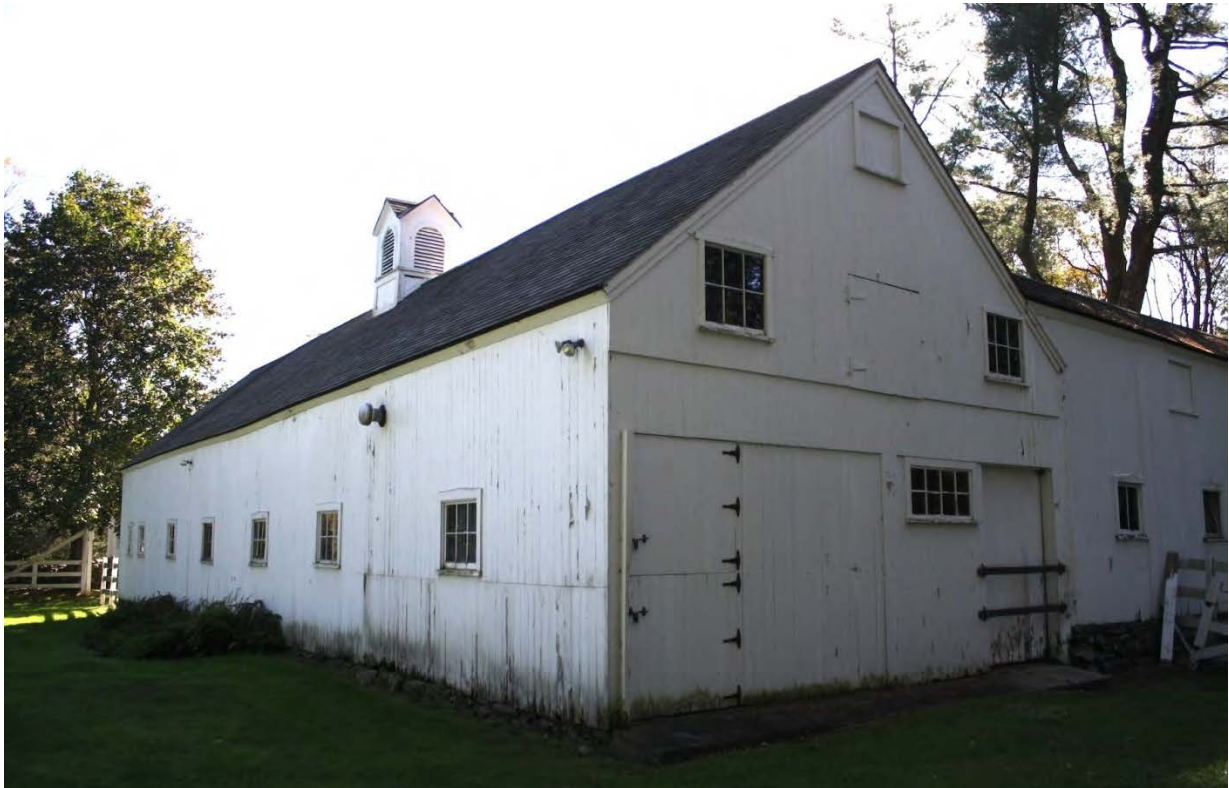
7. Northwest view, camera facing southeast.

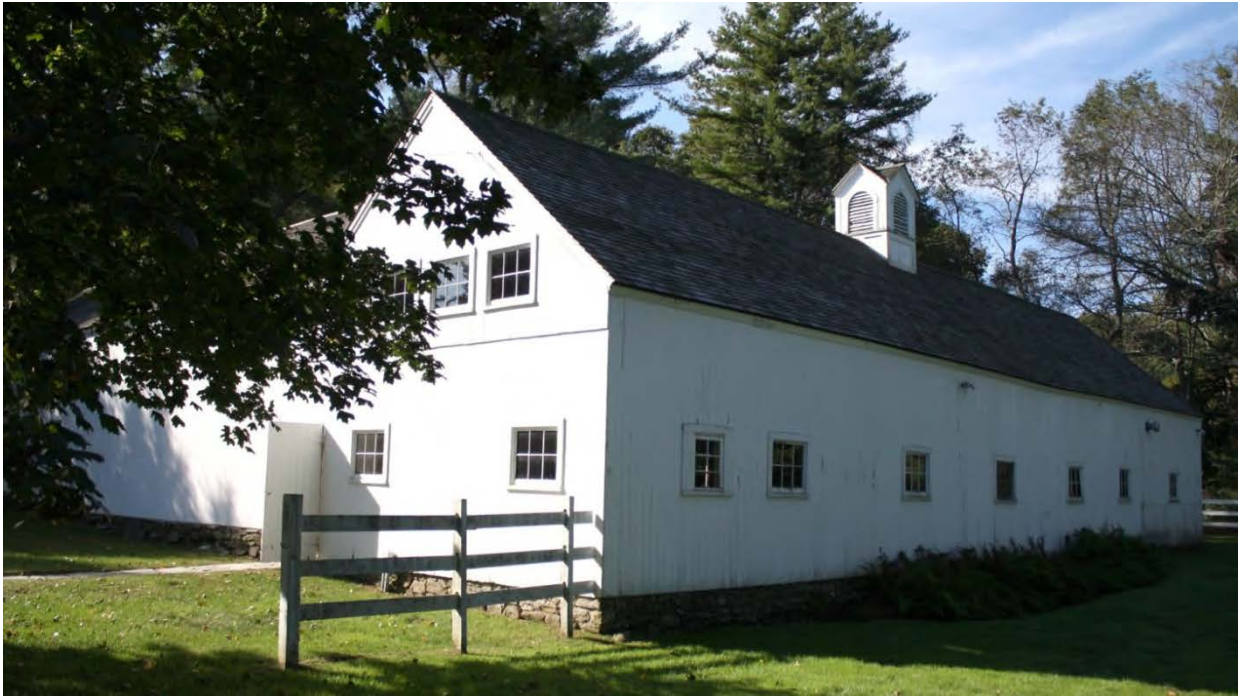
8. Northeast view, camera facing southwest.

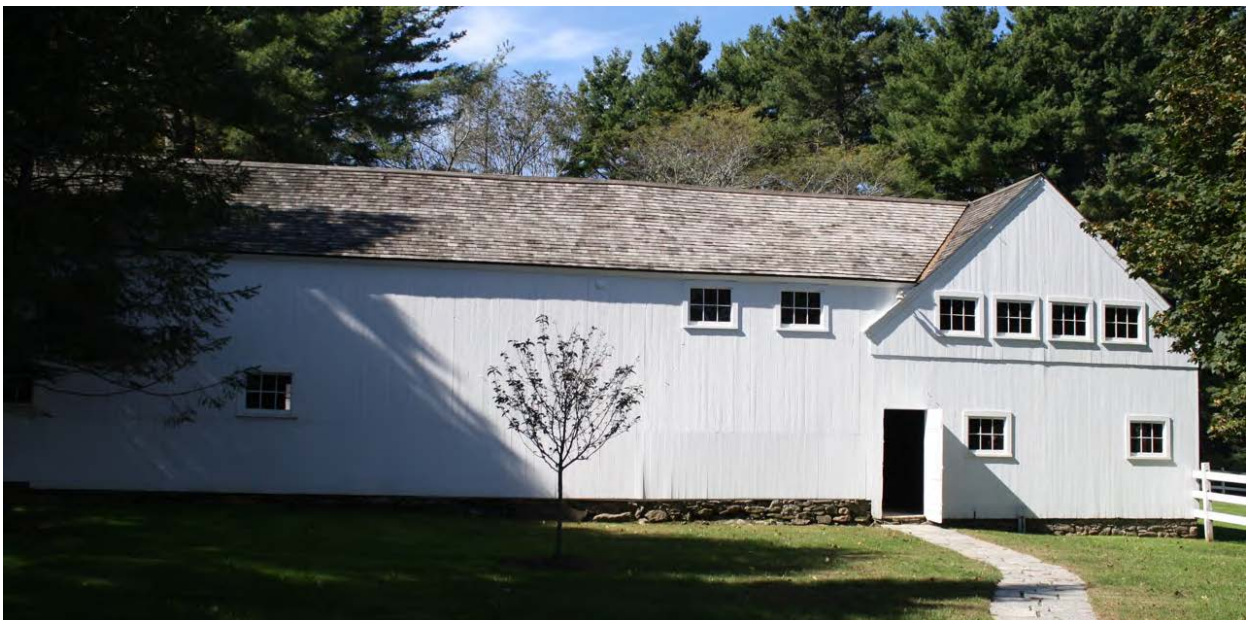
9. East view of east wing, camera facing northwest.

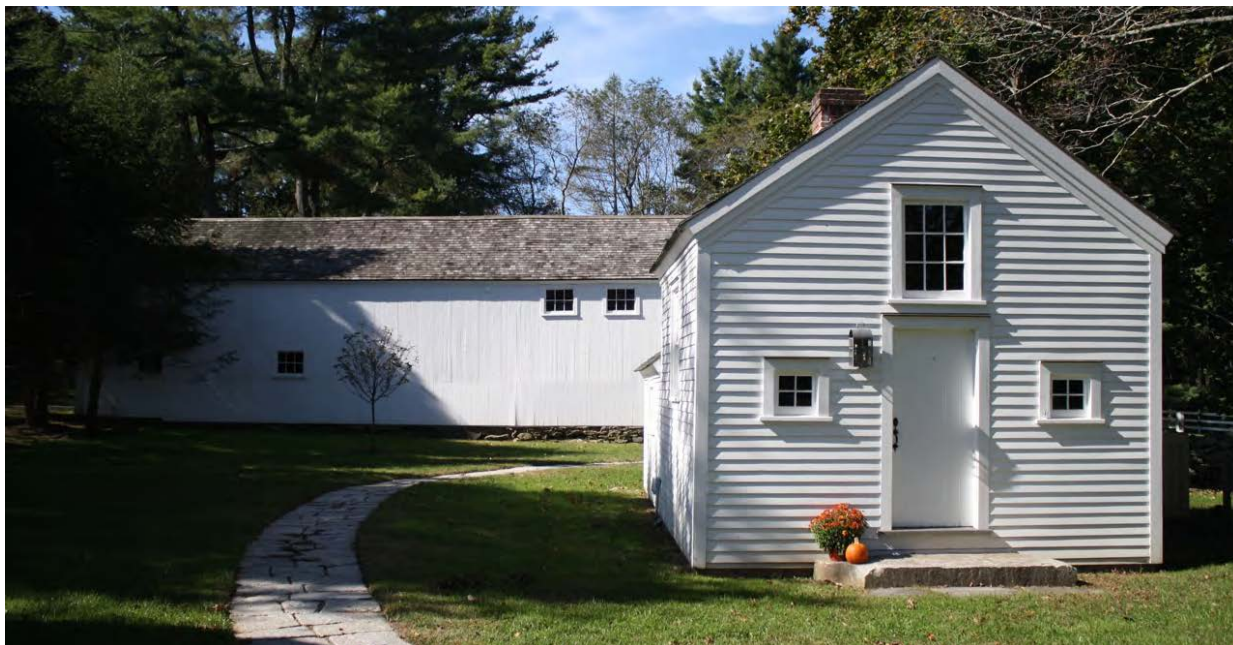
10. East view of smokehouse, camera facing west. East side of east wing of the barn is at rear.

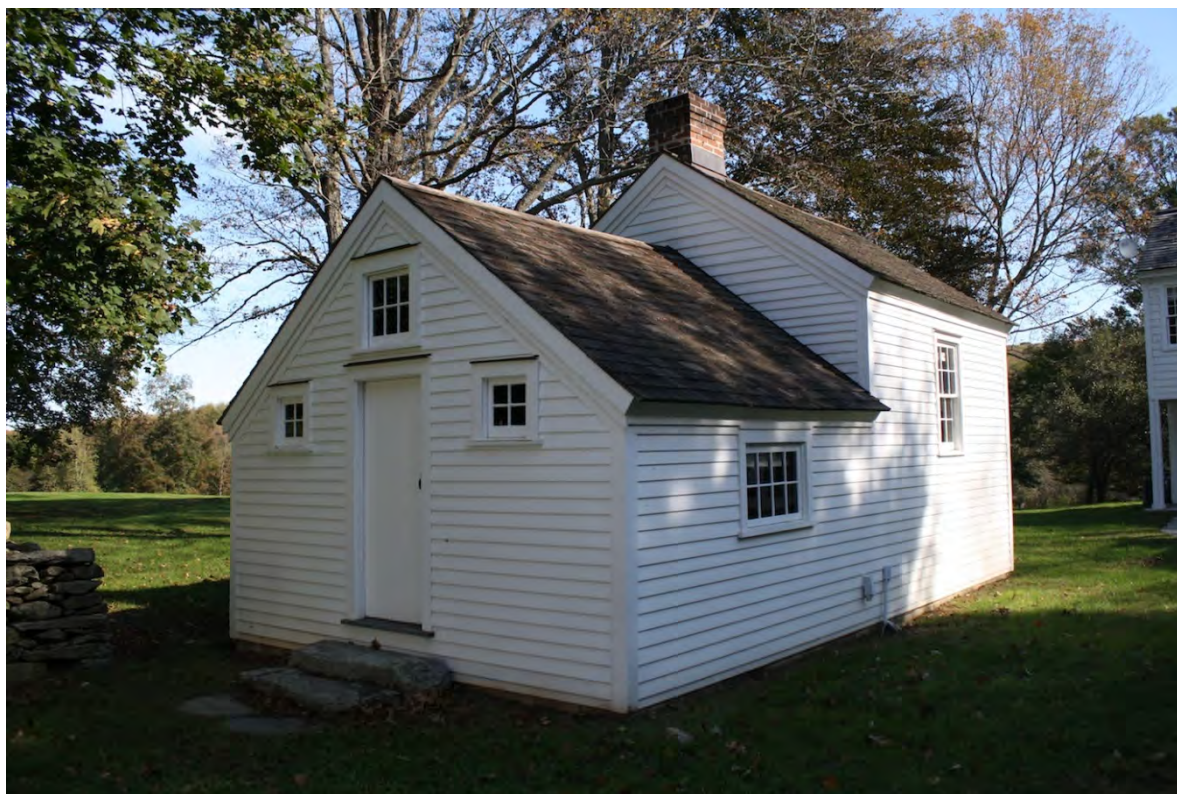
The smokehouse is a 12- x 26-foot 1 ½-story gable-roofed structure with its ridge-line oriented east-west, and is set between the house and barn. Local tradition is that this building was a smokehouse, possibly substantiated by the presence of a brick fireplace inside (Carley, p. 134). The western section is 1-story while the eastern portion is slightly taller. A central door is present on each gable-end, flanked by small four-pane windows; an attic window is above the door (six-pane on the west, nine-pane on the east). The eave-side elevations each have an eight-pane window in the lower part and a six-over-six double-hung window in the higher section. Roofing is wood shingles and there is a brick chimney projecting from the ridge at the west end of the higher section. Construction is post-and-beam framing with a fieldstone foundation.

11. Southwest view of smokehouse, camera facing northeast. House is at right rear.

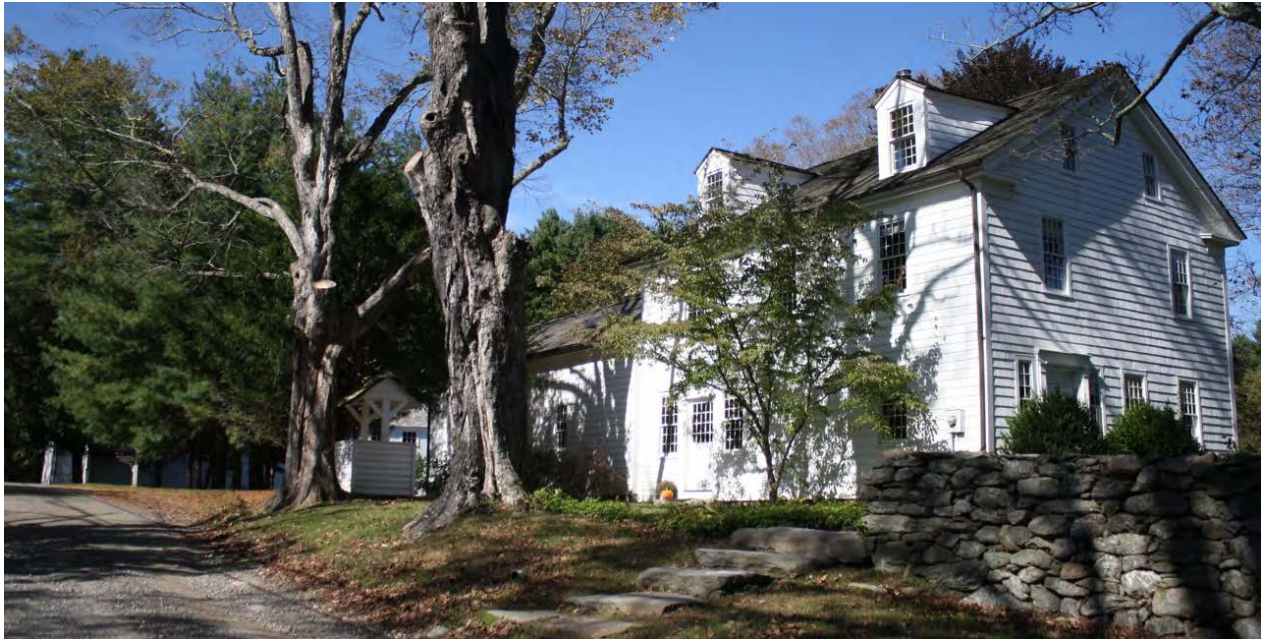
12. Southeast view of farmhouse, camera facing northwest.

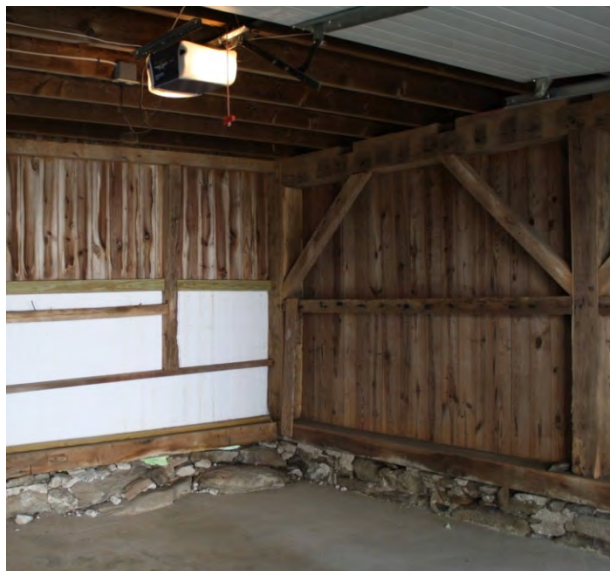
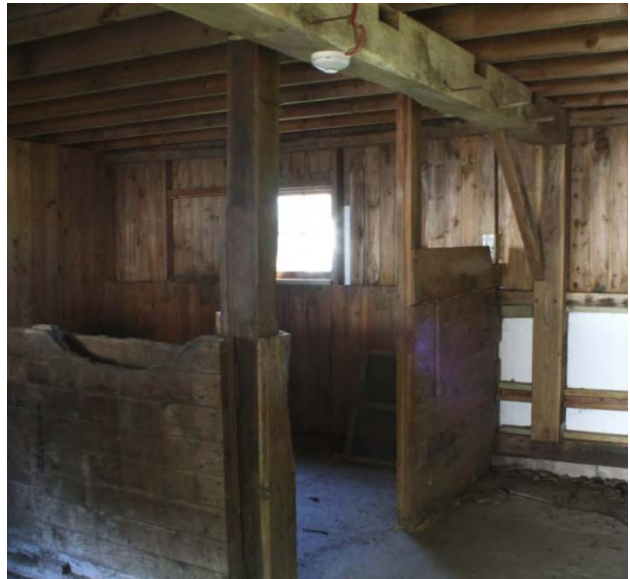
13a-b. Interior ground floor of east wing. Left: north garage bay, camera facing southeast; right south stall bay, camera facing northeast.

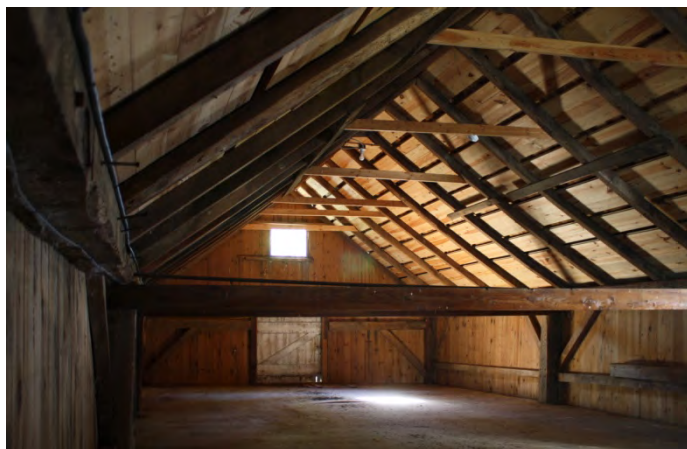
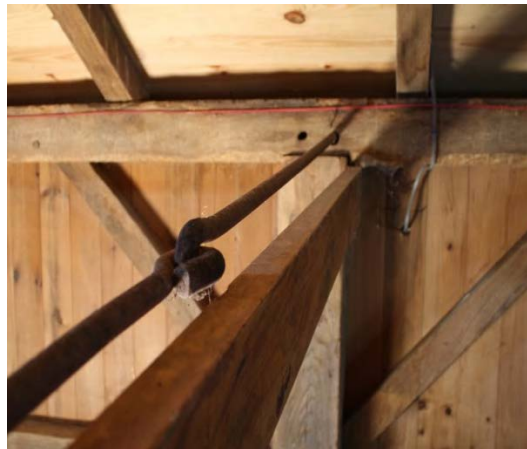
The east wing walls are constructed with wood-pegged post-and-beam framing using sawn timbers, with a dropped girt at the south gable-end eave. The joists and roof framing of the loft level are balloon framing with dimension lumber. A lateral girt at the center is reinforced with a wrought iron tension member. The loft level is open to the upper level of the east extension bay described above. Along with the similar construction detailing, this suggests a contemporary construction date for the two portions of the structure.

14a-b. Interior upper level of east wing. Left, interior view, camera facing south; right, detail view of tie beam with iron tension tie.

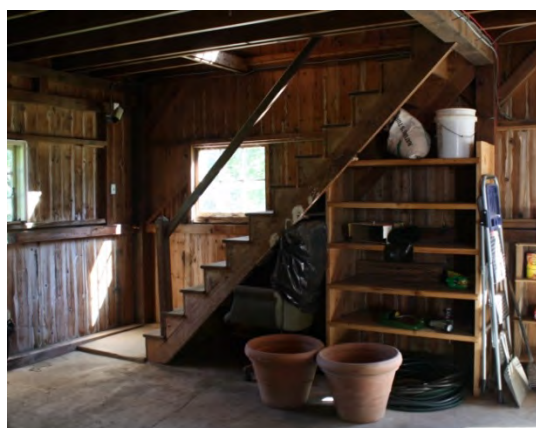
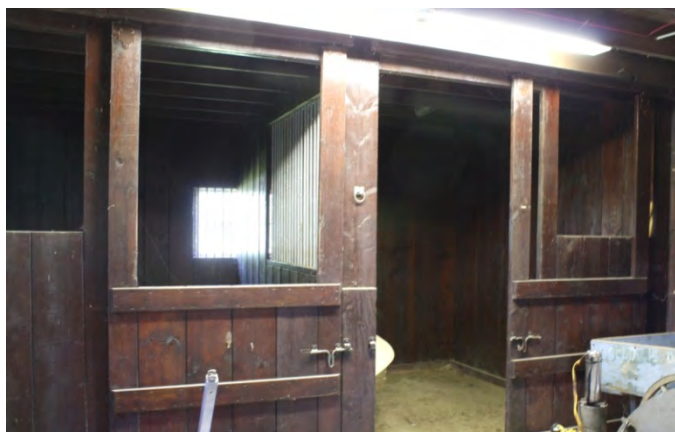
To the west of the central block is a one-bay extension framed with balloon framing and finished on the interior with vertical wood paneling. This space is fitted with two horse stalls with sliding doors. The floor is concrete slab.

15a-b. Left, interior ground floor of northeast corner, camera facing northeast. Right, interior ground floor stall area of northwest corner, camera facing north.

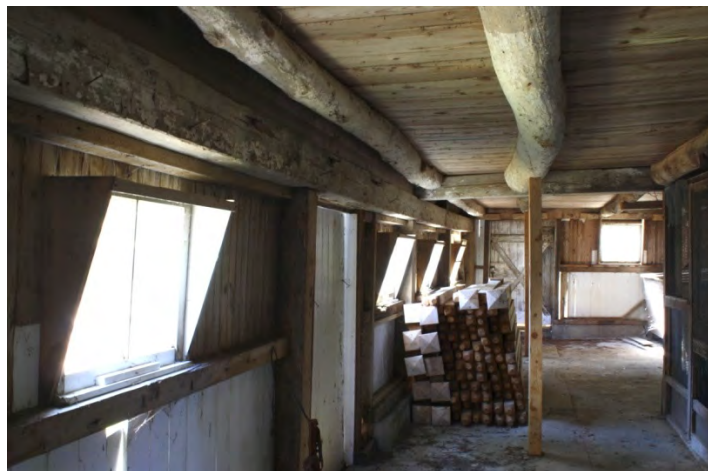
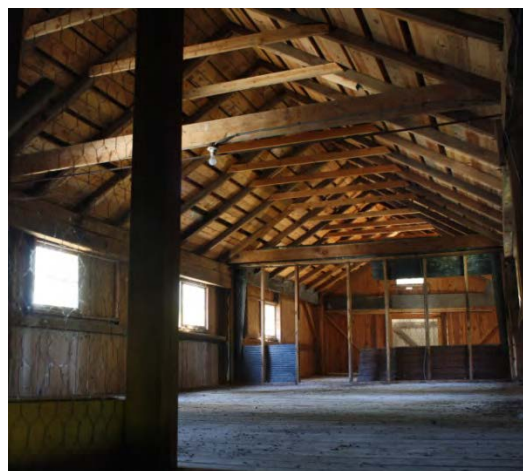
The west wing's ground floor is constructed with hewn timber framing. Some of the joists supporting the loft above are squared while others are round and uneven; joists are mortised into the girders. Although the structure is narrow, joists run the long direction north-south spanning between lateral girders. Windows are in-tilting hoppers with triangular cheek panels at the sides to support the open sash. Reinforcement has been added in some locations by sistering sawn timbers below the old members. Traces of whitewash suggest use for dairy cows. The foundation has been partially replaced with concrete including a raised curb at the perimeter, and changes of floor slab level are typical of dairy barns in the early 20th century. The loft level is constructed with a hybrid mix of heavy timber at walls and dimension lumber for roof rafters and nailed collar ties.

16a-b. West wing ground floor, east and south view, camera facing southeast; loft level, camera facing southeast.

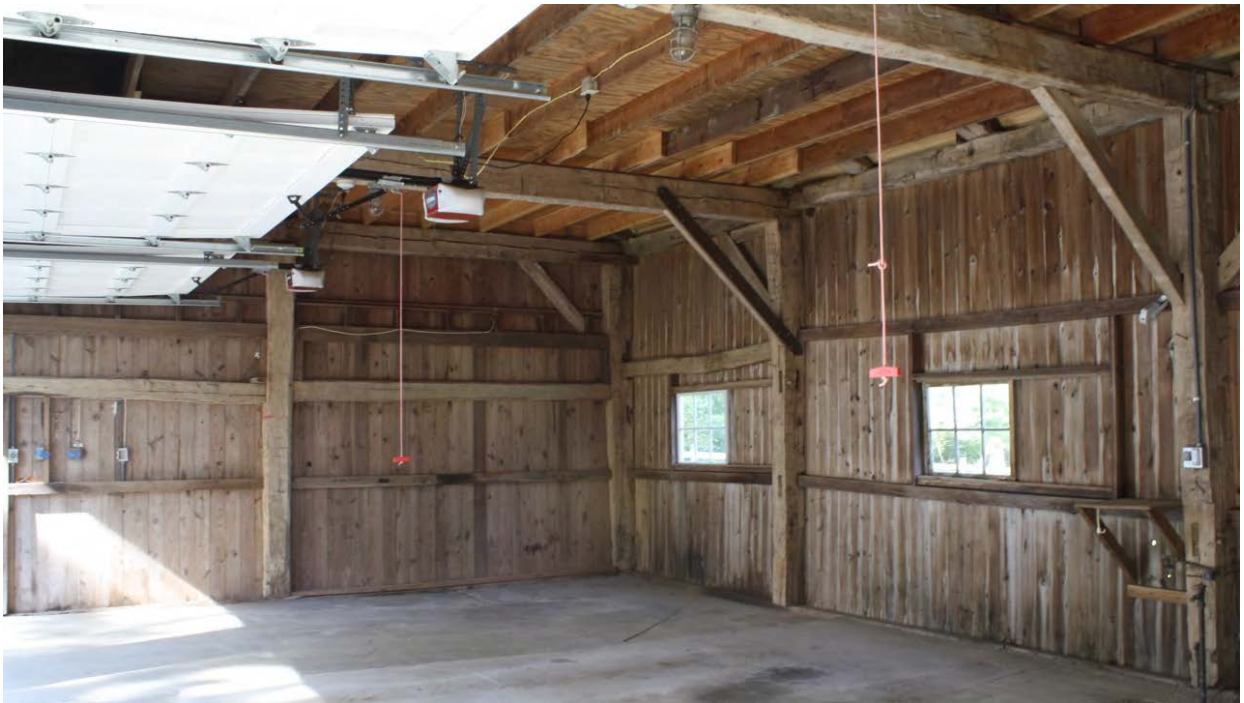
The central block has a heavy timber post-and-beam frame. The western bents have gunstock posts and cross girts in the plane of the plates, suggesting possible 18th-century construction. In contrast, the easternmost bent has straight posts and a dropped end girt, suggesting that this could have been a later extension to the more typical previous three-bay structure. The major timbers are hand-hewn square-rule construction; some of the diagonal braces are sawn. A number of the joints appear to have mortises larger than the tenons, and there are open mortises on the inside faces of the interior posts, suggesting alterations to the structural frame such as the removal of interior posts. Recent alterations include steel reinforcement of the braces along the north wall, steel substitute braces at the south wall between the garage door openings, and steel tension cables through the plates. Some of the posts between door openings have been replaced or reinforced with newer lumber. An attic loft floor of dimensional lumber and plywood had been inserted above the lateral girts; the toes of the hewn rafters can be seen along the north wall below the new floor. The floor is a concrete slab.

17. Interior of central block, camera facing northwest. Note gunstock posts and tie-girts at plate elevation.

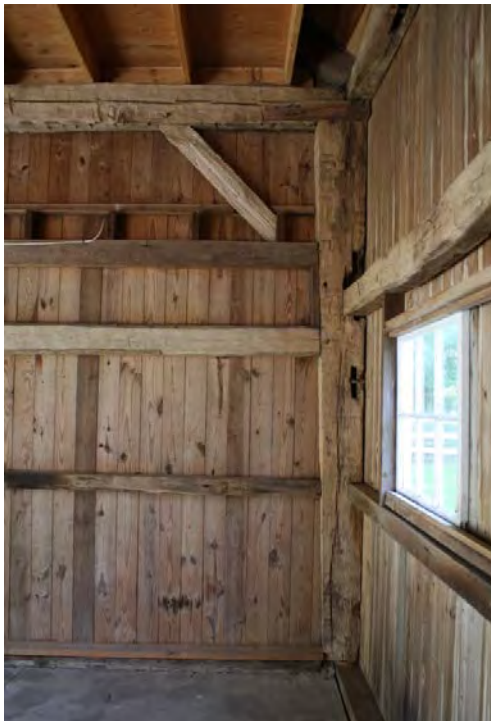
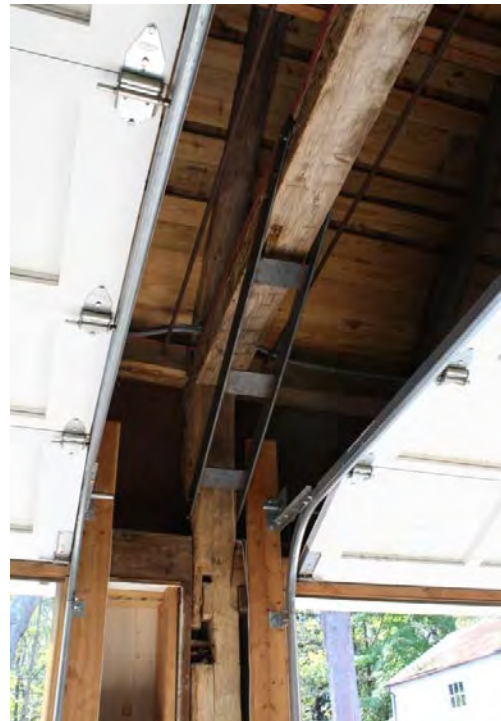
Later residents converted the working farm to an equestrian facility; evidence of stable use remains in the stalls at the northwest corner and southern bays of the east wing. The current use is for garage space. Structural modifications in the central block and north bays of the east wing have allowed for installation of power-operated overhead doors.

18a-b. Interior of central block. Left, detail of northwest corner showing gunstock post, camera facing northwest; right, detail of south wall reinforcing at garage door openings, camera facing south.

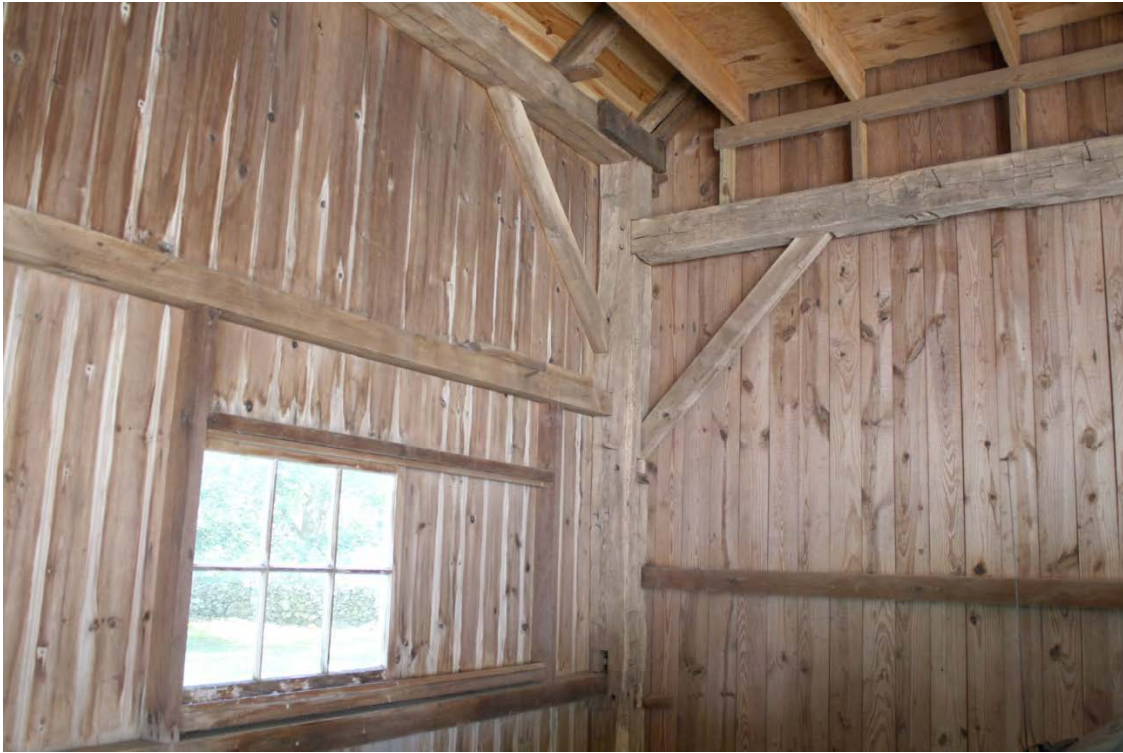
19. Interior of central block showing the dropped girt and square rule framing of the easternmost bent, camera facing northeast.

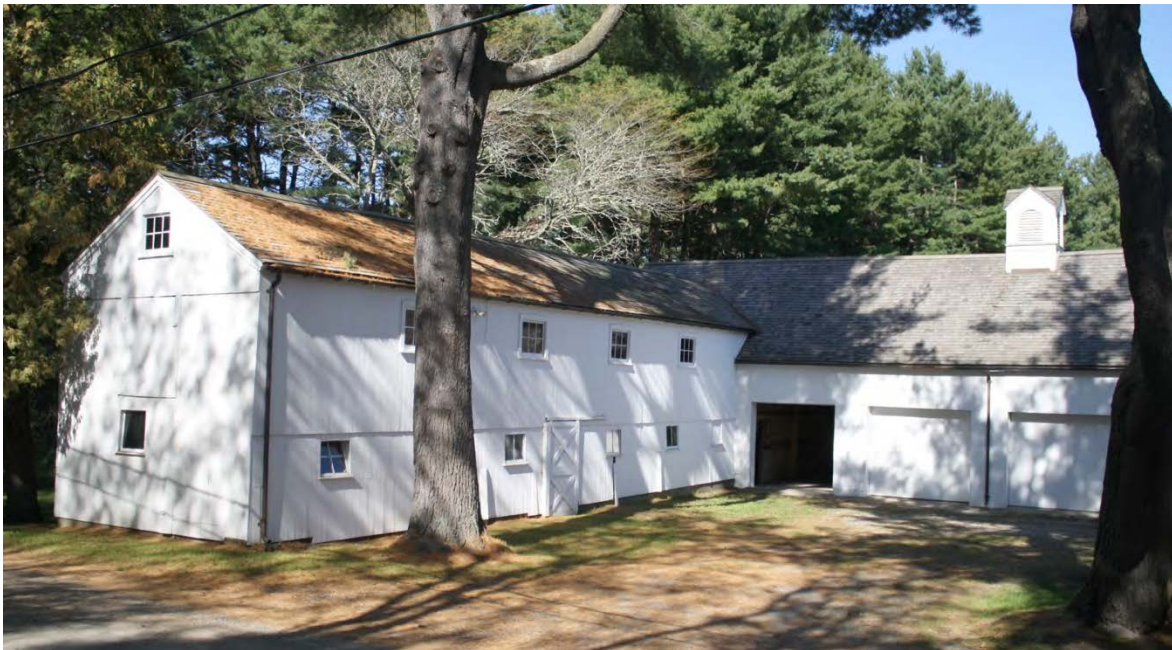
20. Southeast view of yard, showing modern overhead doors, camera facing northwest.
