## HISTORIC RESOURCES INVENTORY - BUILDING AND STRUCTURES

Building Name (Common) Allen-Thompson Homestead Record No. 14483  
 Building Name (Historic) Spicer, Benjamin, Farmstead  
 Street Address or Location 7 Allen Road  
 Town/City Lisbon Village \_\_\_\_\_ County New London  
 Owner(s) Wayne and Elizabeth Thompson, 7 Allen Road, Lisbon CT 06330  Public  Private

Style of building English bank barn, vernacular style Date of Construction c.1880

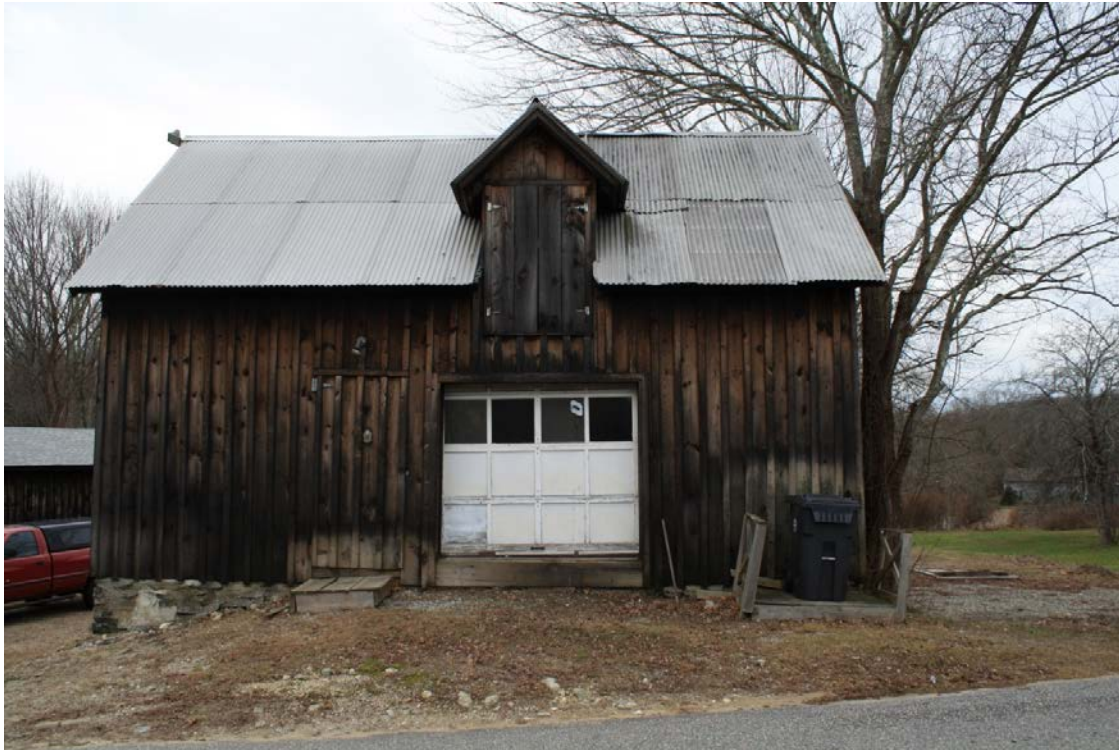
5. Main northeast-eave façade of barn, camera facing southwest.

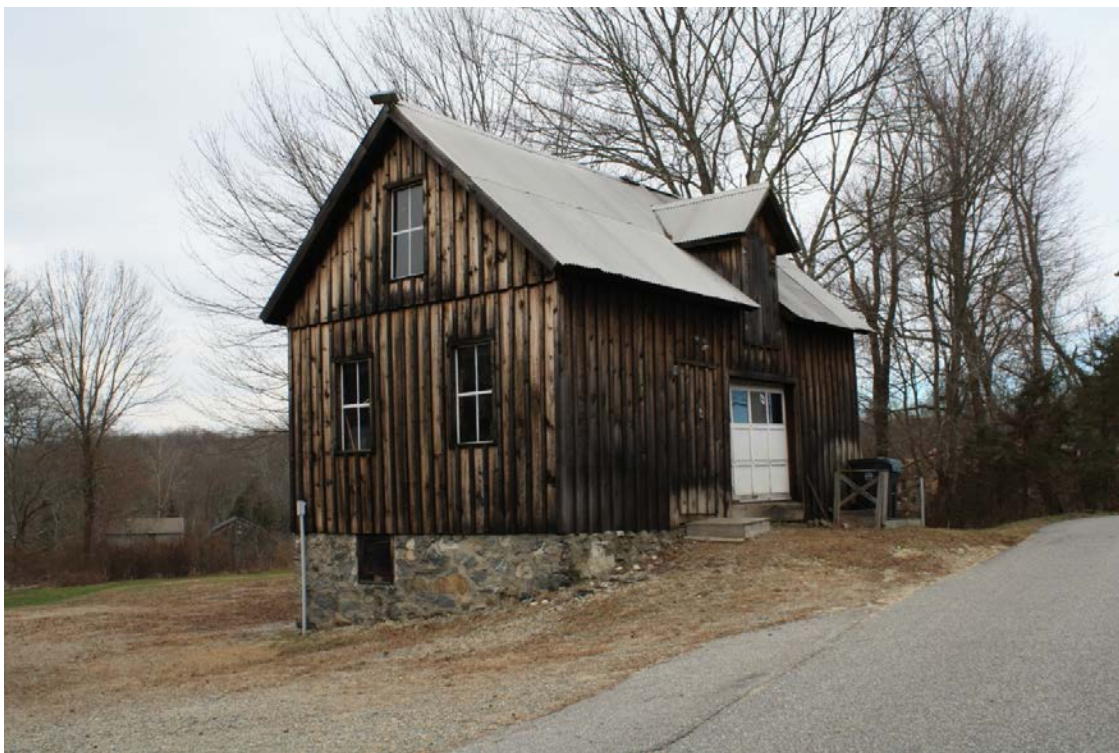
6. Southeast corner of barn, camera facing west.

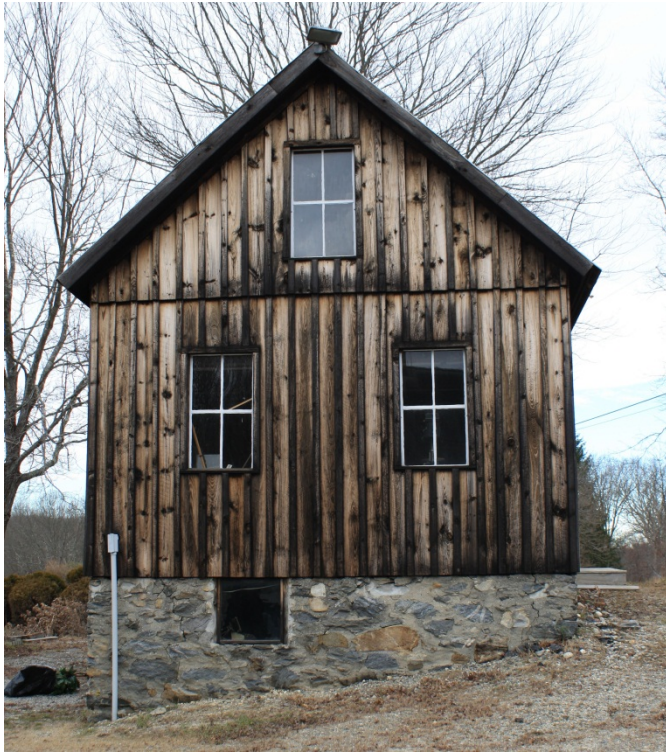
The grade at the south gable-end of the barn declines from east to west, resulting in an exposed foundation and basement level. The foundation is mortared fieldstone with a square inset single-pane window off center to the west. The main level has two identical fixed, four-pane windows. Centered above the girt line siding divide in the gable attic is a fixed, four-pane window.

7. South gable-end of barn, camera facing northwest.

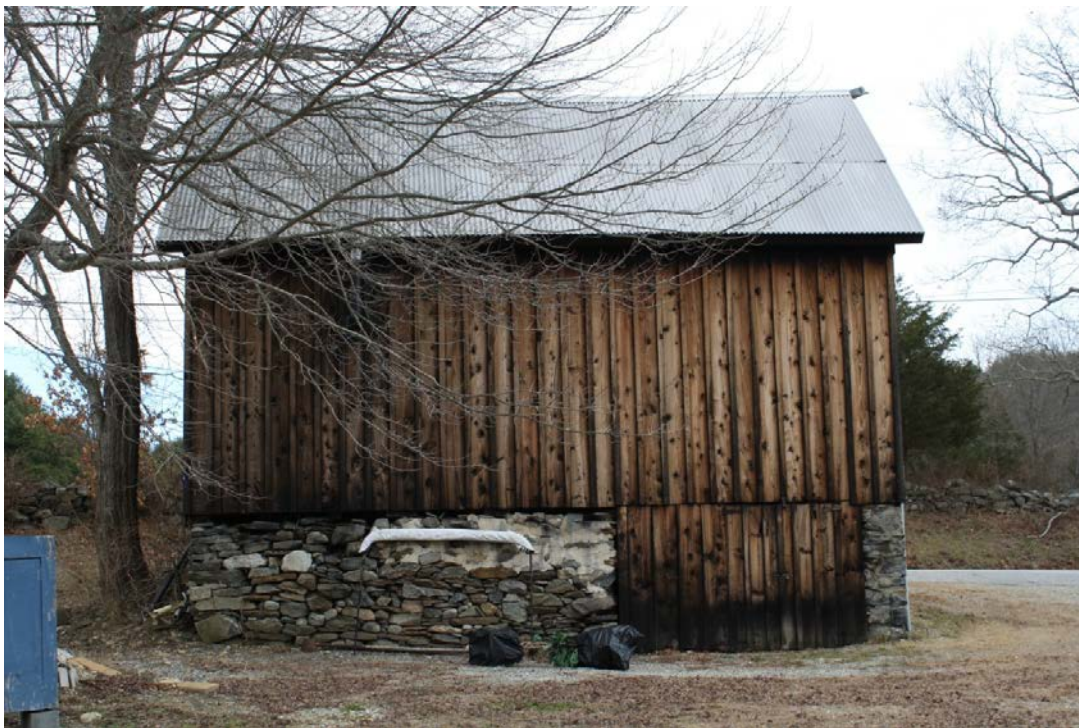
The west eave-side of the barn has a pair of swinging hinged doors in the south half of the basement level. The foundation is mostly mortared fieldstone on the north half of basement level. The rest of the side is blank. The grade inclines at the north corner.

8. West eave-side of barn, camera facing northeast.

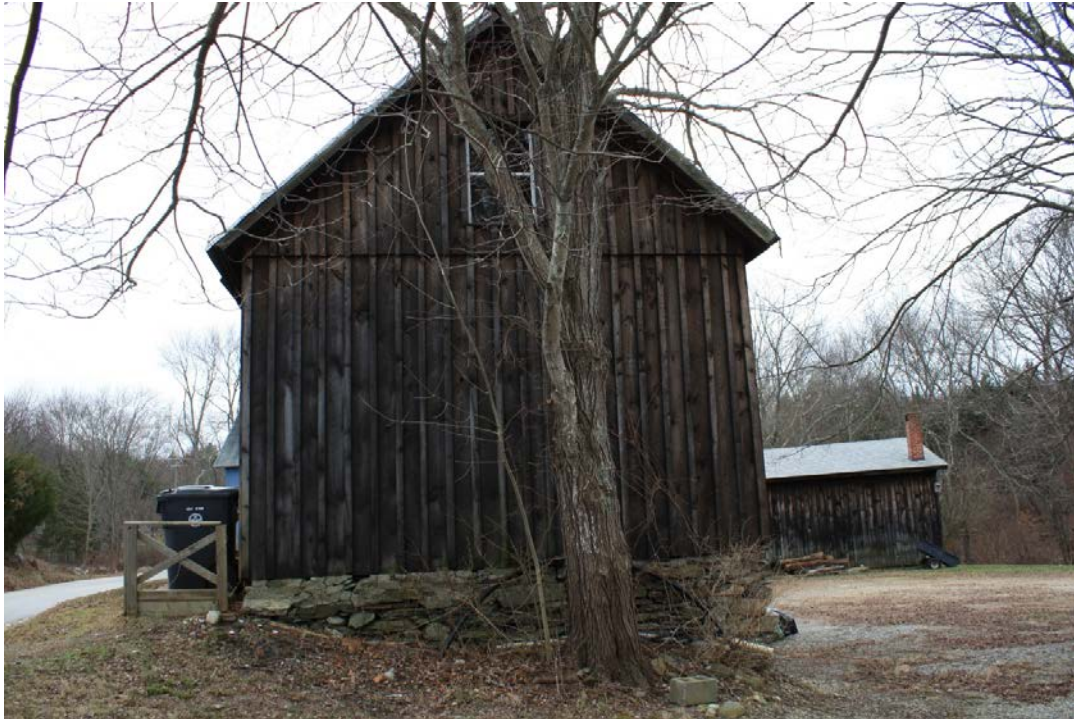
The grade at the north gable-end of the barn inclines to the east back to the grade of the east-façade. Centered above the girt line siding divide in the gable attic is a fixed, four-pane window. The rest of the north gable-end of the barn is blank.

9. North gable-end of barn, camera facing southeast. A portion of the summer kitchen/garage is visible at the right rear.

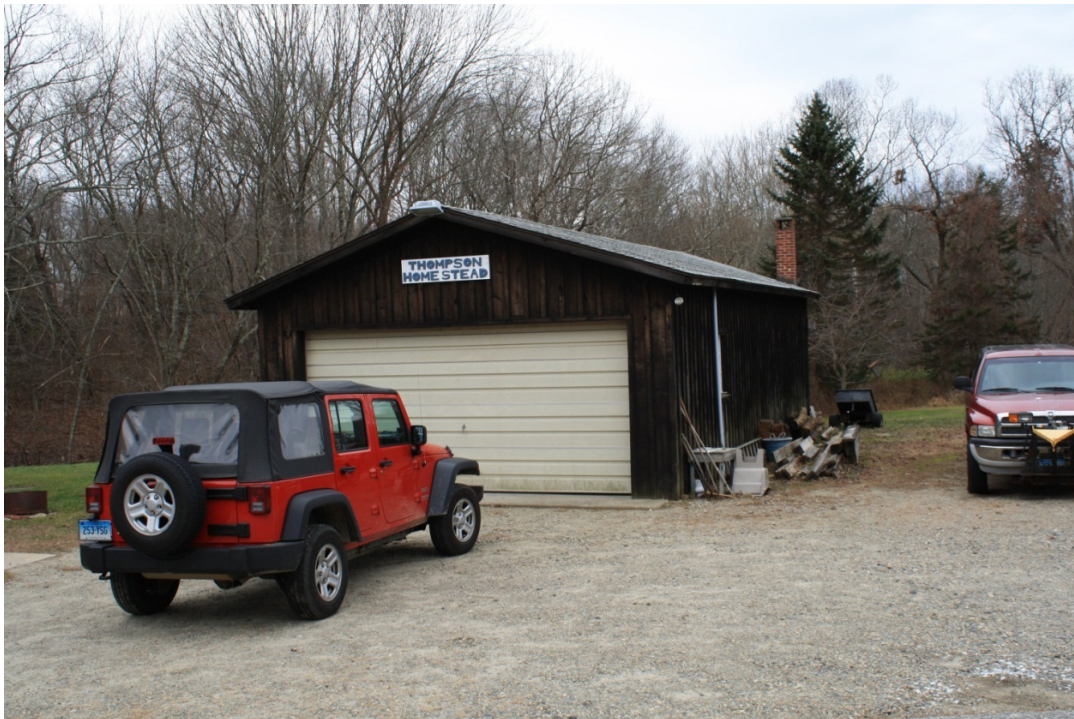
10. East gable-end of the summer kitchen/garage, camera facing west.

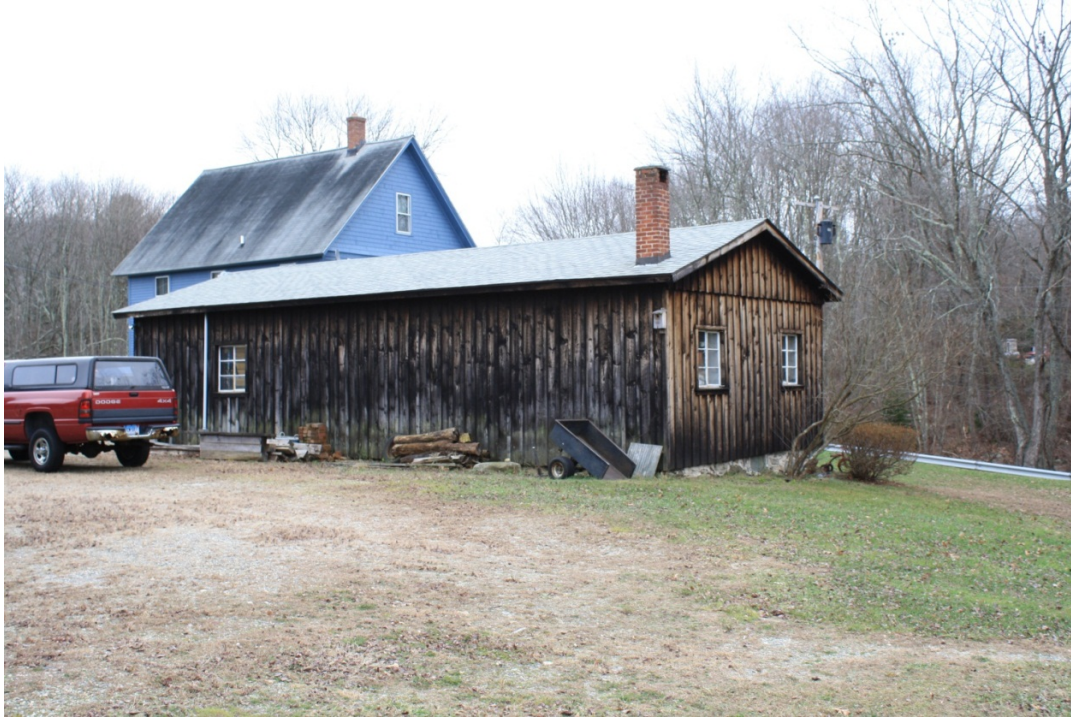
11. West corner of summer kitchen/garage, camera facing east. A portion of the main house is visible.

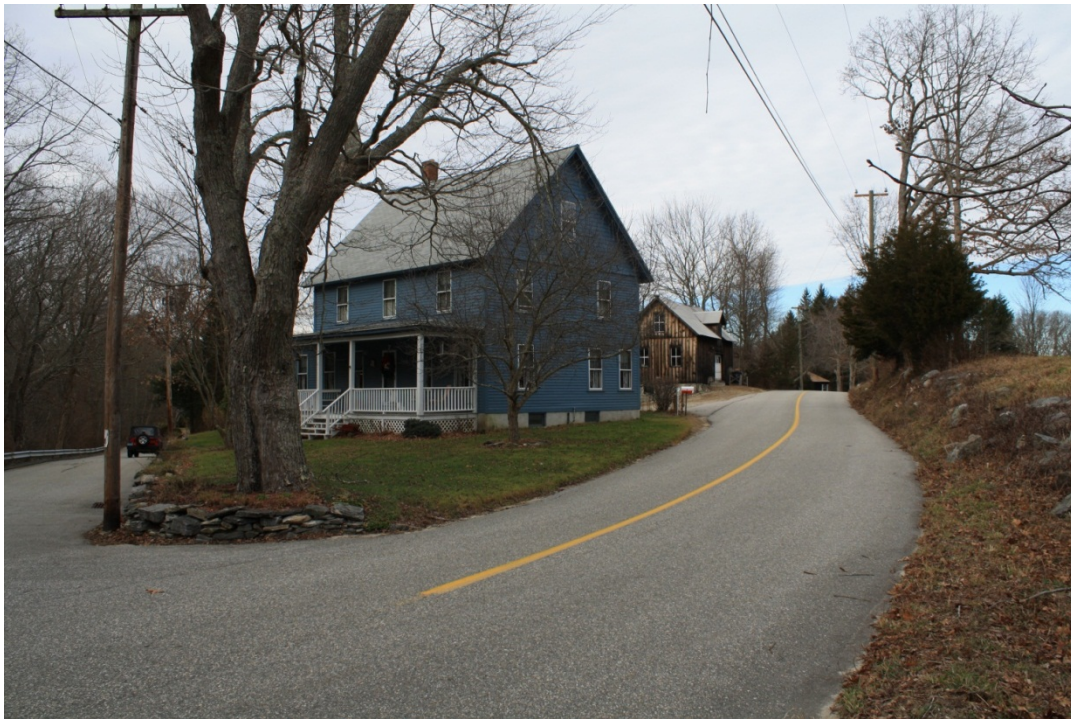
12. East corner of house, with barn to the north, camera facing west.

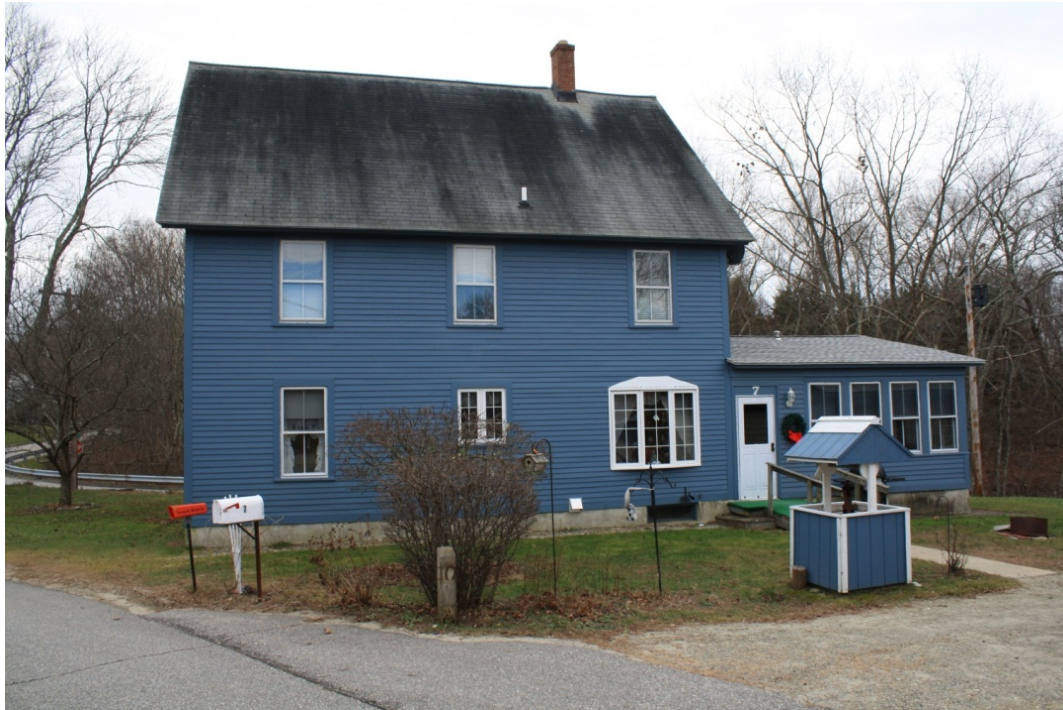
13. Northwest eave-side of house, camera facing southeast, well at right front.

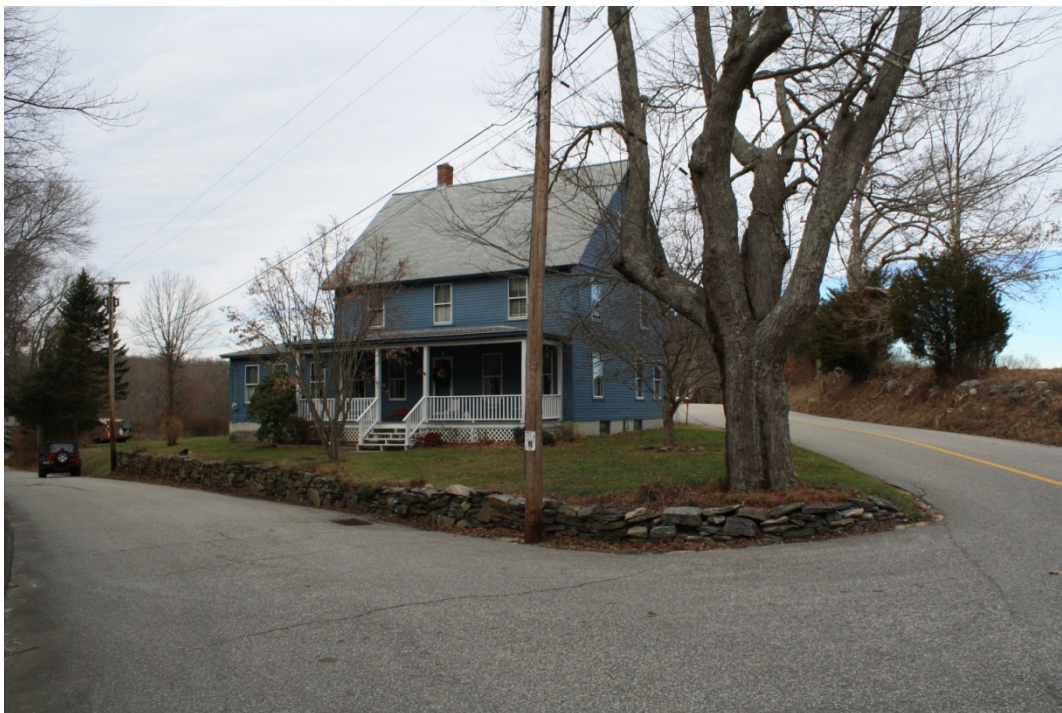
14. Main southeast façade of house, camera facing northwest.

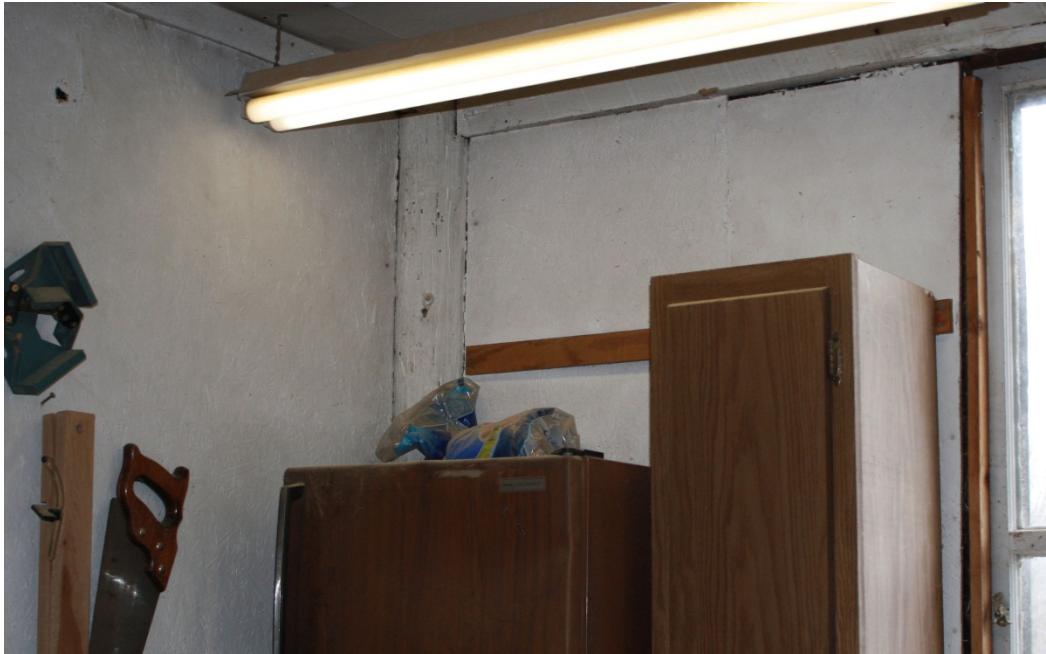
15. Southwest corner of the interior first level of barn, camera facing south.

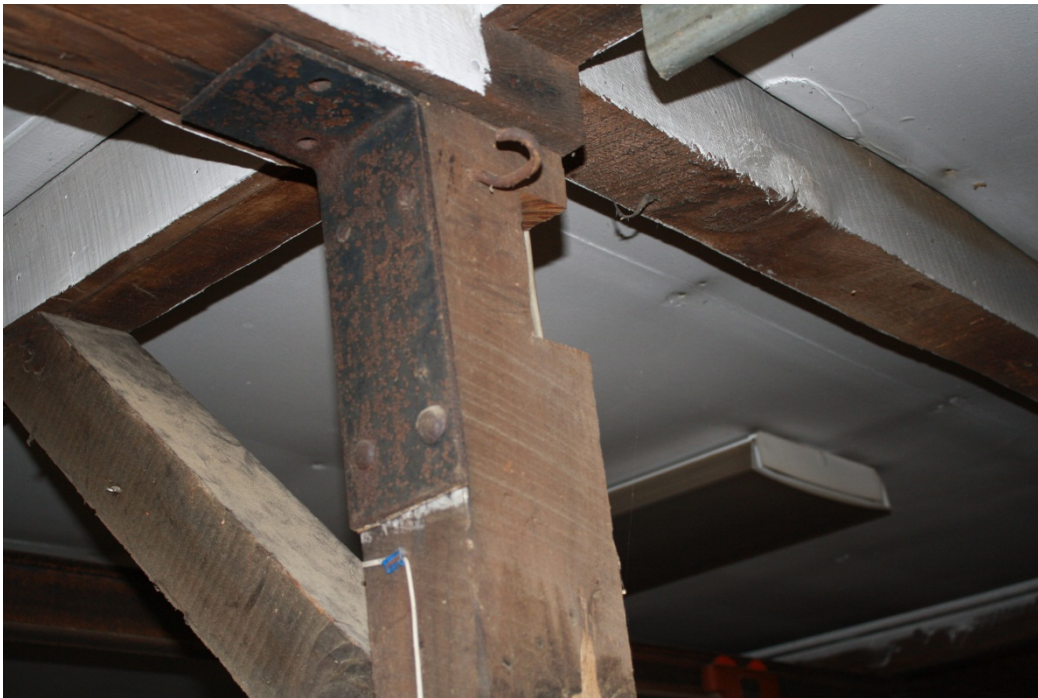
16. Barn interior view, detail of middle bent and L-brace on the first level, camera facing northwest.
