HISTORIC RESOURCES

BUILDING AND STRUCTURES

Building Name (Common) Pierce, Colonel Dwight Wellington, Farmstead Record No. 22055
 Building Name (Historic) Pierce, Colonel Dwight Wellington, Farmstead
 Street Address or Location 12 Popple Swamp Road
 Town/City Cornwall Village Cornwall Bridge County Litchfield
 Owner(s) Barton & Deborah Jones, 12 Popple Swamp Rd, Cornwall Bridge CT 06754 Public Private

HISTORIC RESOURCES INVENTORY FORM – BUILDING AND STRUCTURES continuation sheet

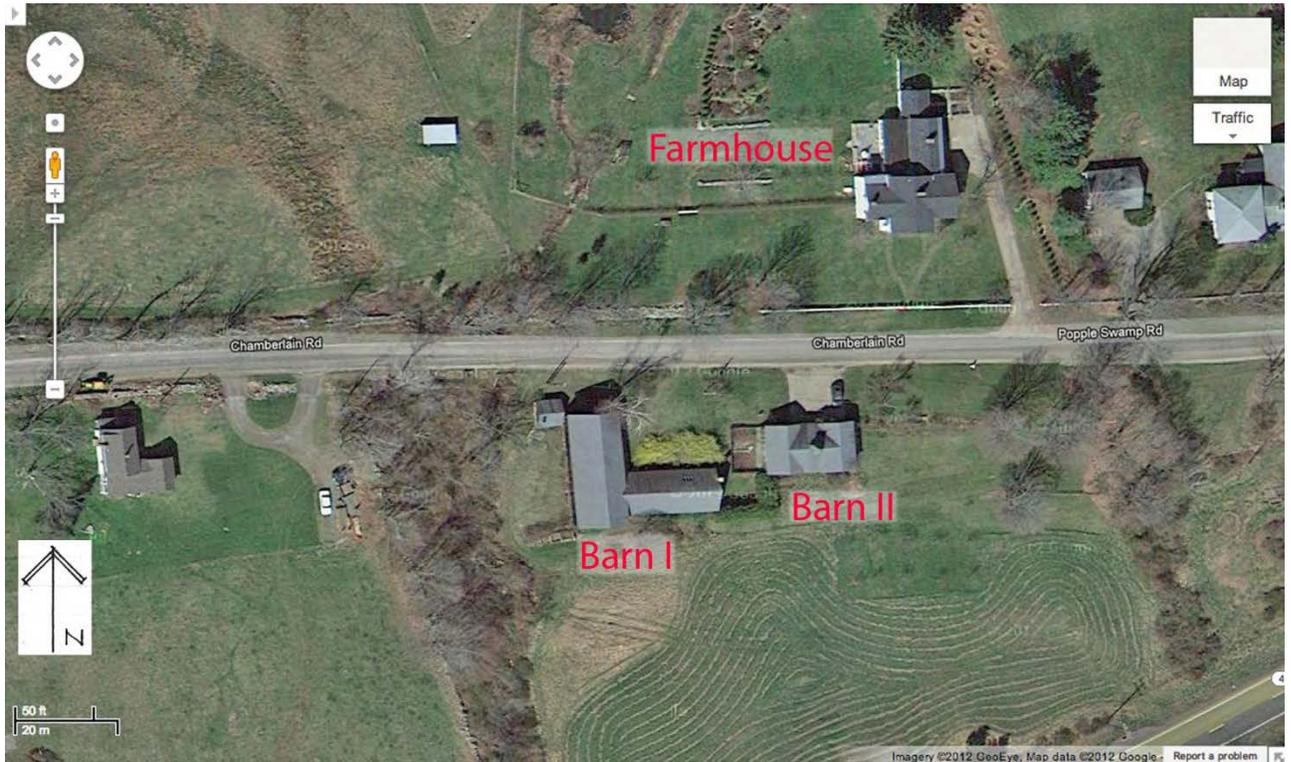
3. Detail Site Plan Sketch 12 Popple Swamp Road, Cornwall CT identifying contributing resources.

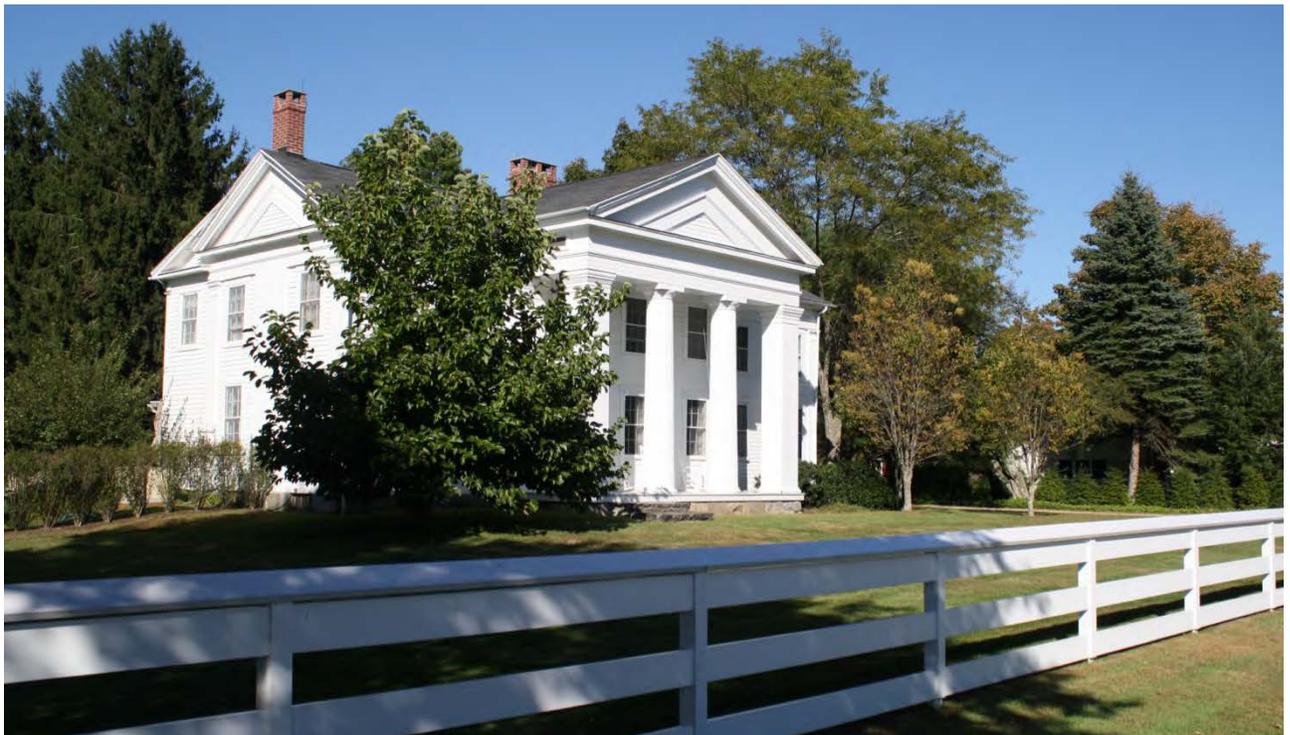
4. Southwest view of house, camera facing northeast.

The house is an elegantly-detailed Greek Revival-style frame building of 2 ½ stories with a cross-gable plan. A long block is oriented with its ridge-line east-west parallel to the road, and a cross-gable wing at the center projects southward with a formal temple portico. The structure rests on a stone slab foundation. The portico consists of a full pediment over an entablature supported by a pair of gigantic fluted Doric columns flanked by massive square piers with matching Doric capitals. The body of the house has pilasters at the corners, a wide entablature below the eaves, and full pediments at the west and east gable-ends. Behind the central portico the body of the house has a three-bay gable-end with the main entry door in the left (west) bay, a paneled door with a transom above and a lintel with Greek key motif. Windows at the first and second floors are six-over-six double-hung with surrounds having the same Greek key motif on the lintels. The side wings of the south façade have two bays each, with six-over-six double-hung windows on the first and second floors. The east and west gable-ends are three-bays with the window omitted at the center where there is a chimney in the west façade. Siding is narrow horizontal wood clapboards. The north façade matches the east and west except where partially covered by a 1 ½-story ell extending north. Other additions have extended the main block northward. Roofing is asphalt shingles.

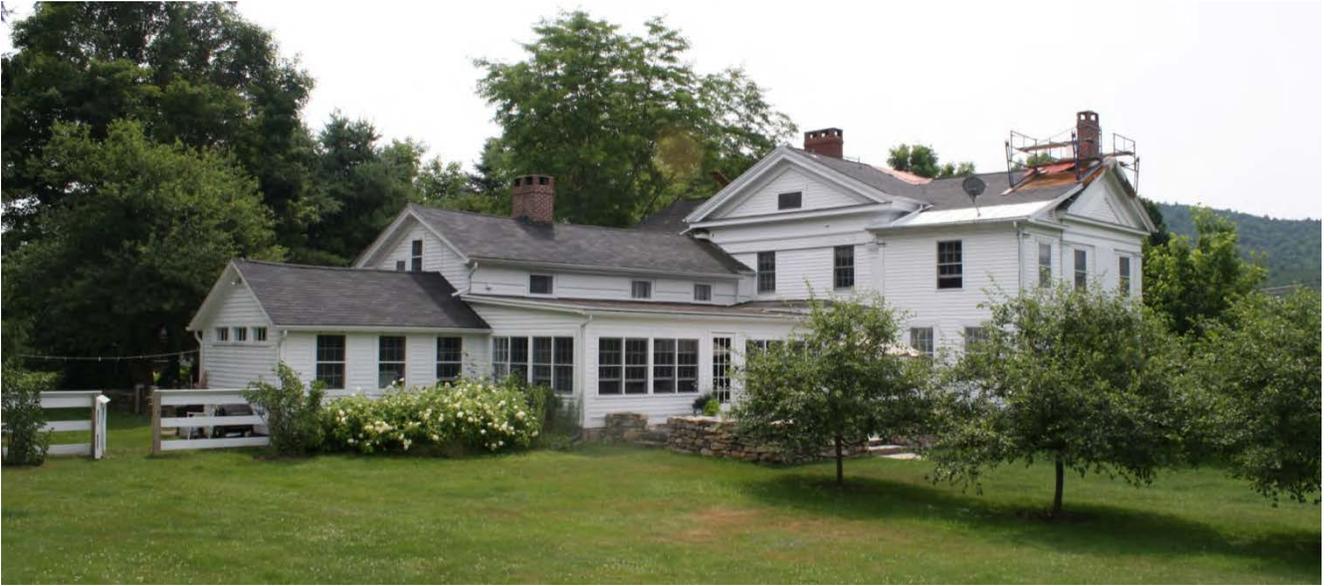
5. Northwest view of house, camera facing southeast, showing original rear gable pediment, west gable pediment, and rear additions.

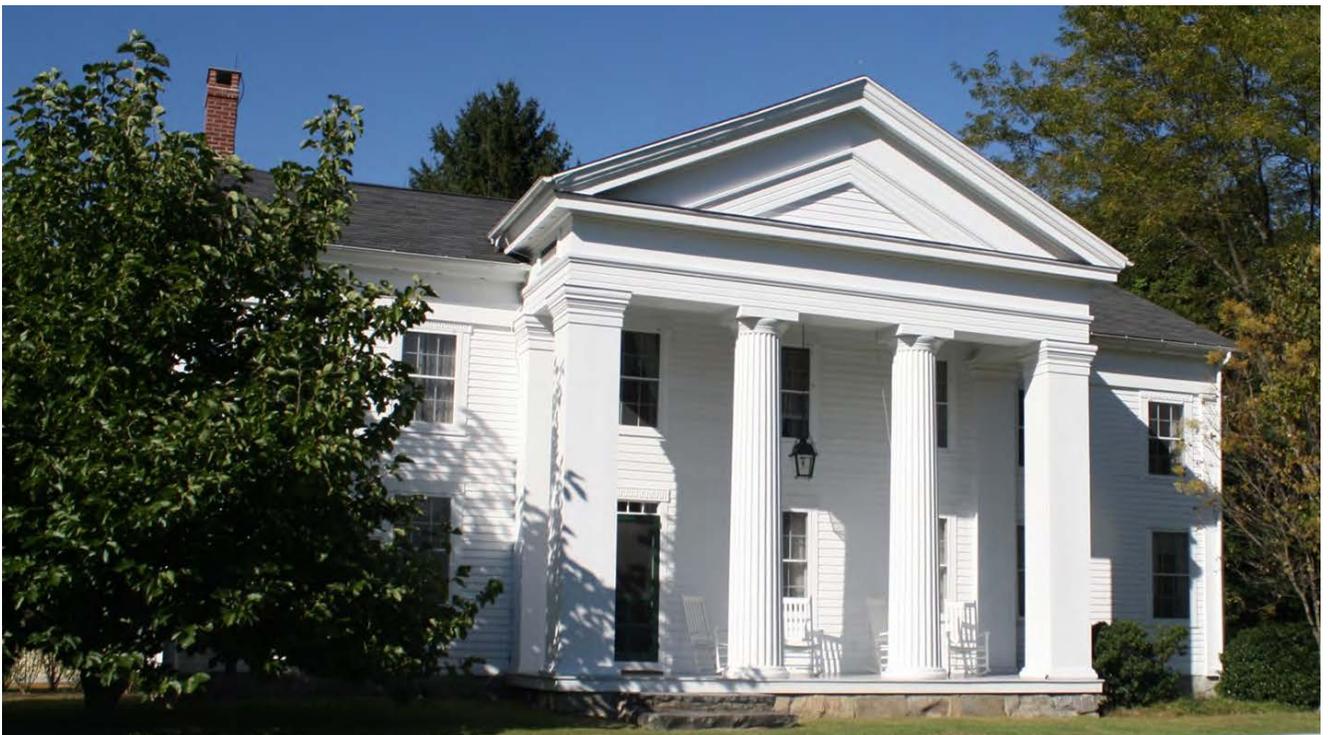
6. South view of house, camera facing northeast, showing entry door and portico.

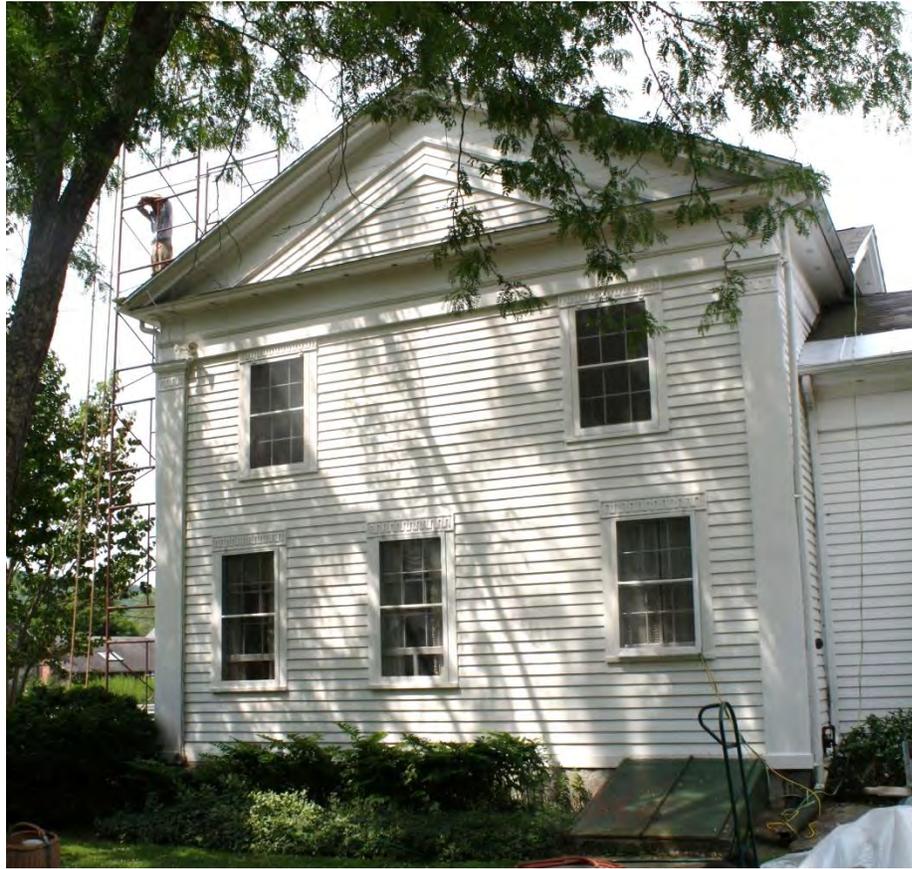
7. East detail view of house, camera facing west, showing window surround, corner pilasters, and pediment.

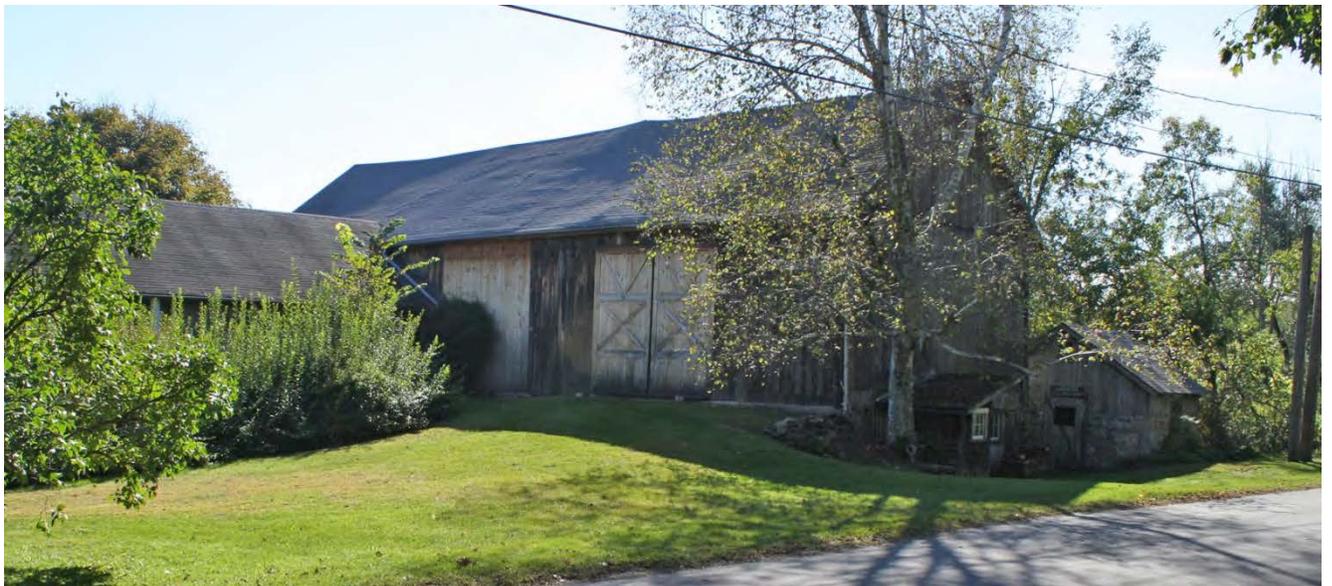
8. Northeast view of Barn I, camera facing southwest. Note the deformation in the ridge-line; the high point at the center indicates the joint between the two three-bay frames.

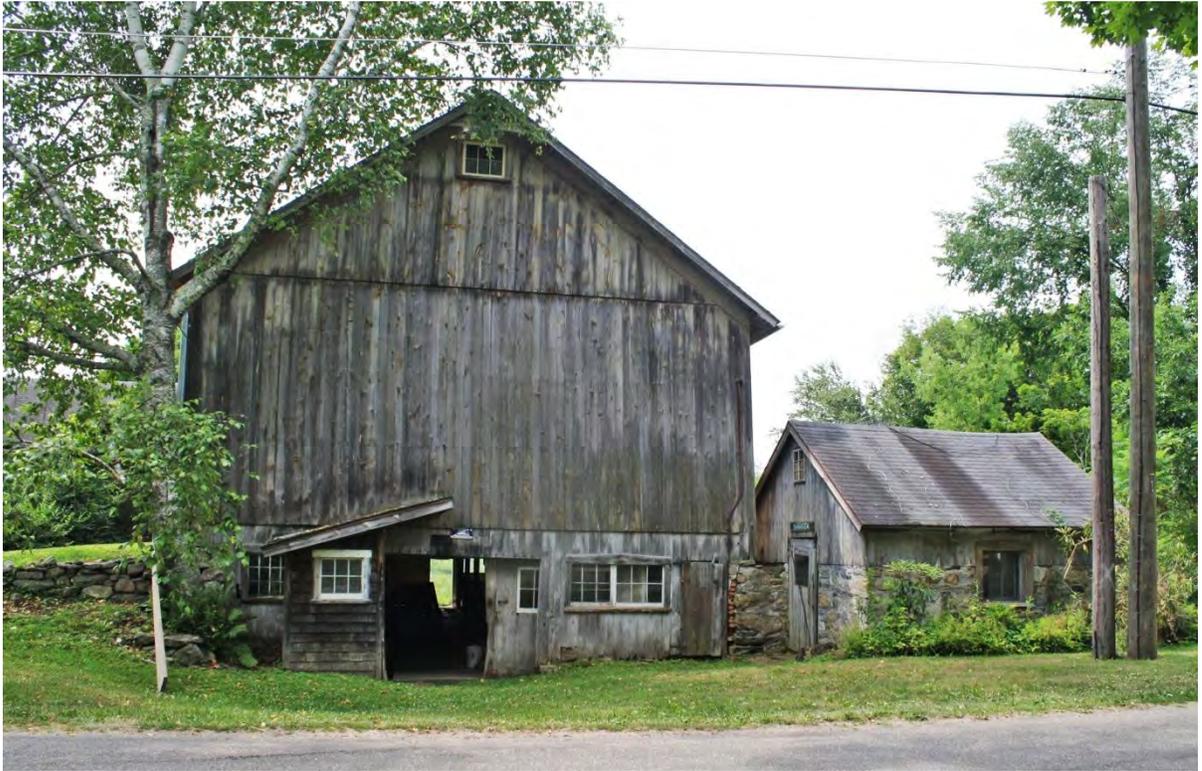
9. North view of Barn I, camera facing south. Milk room is at right.

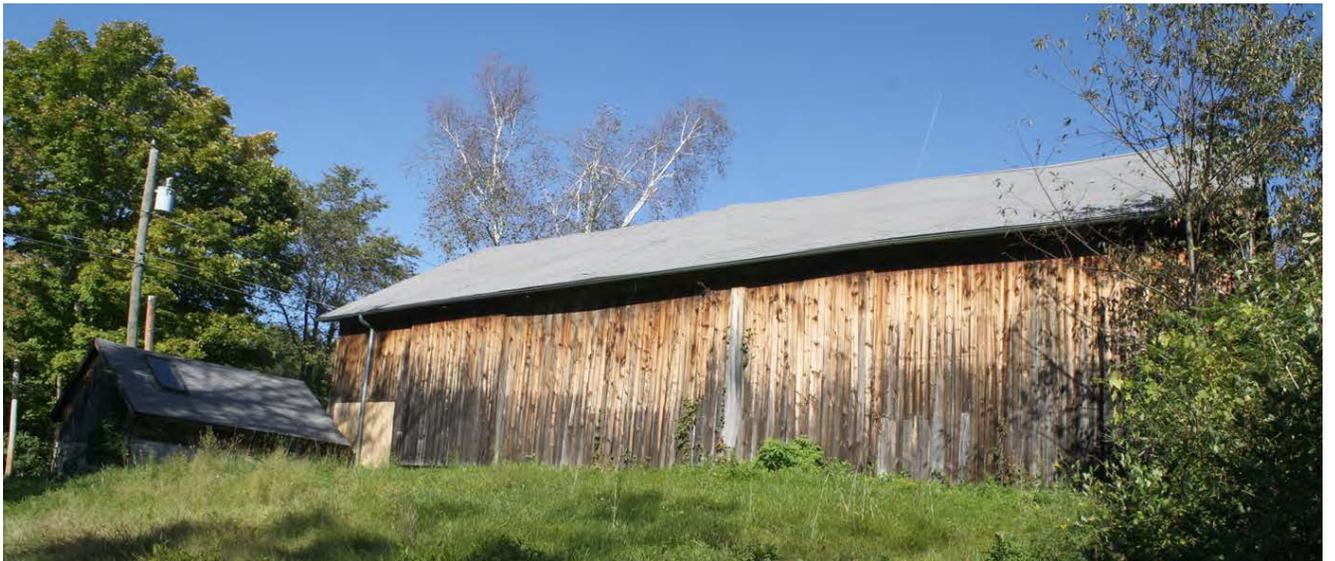
10. West view of Barn I, camera facing northeast. Milk room is at left; note how earth is bermed up to the main level.

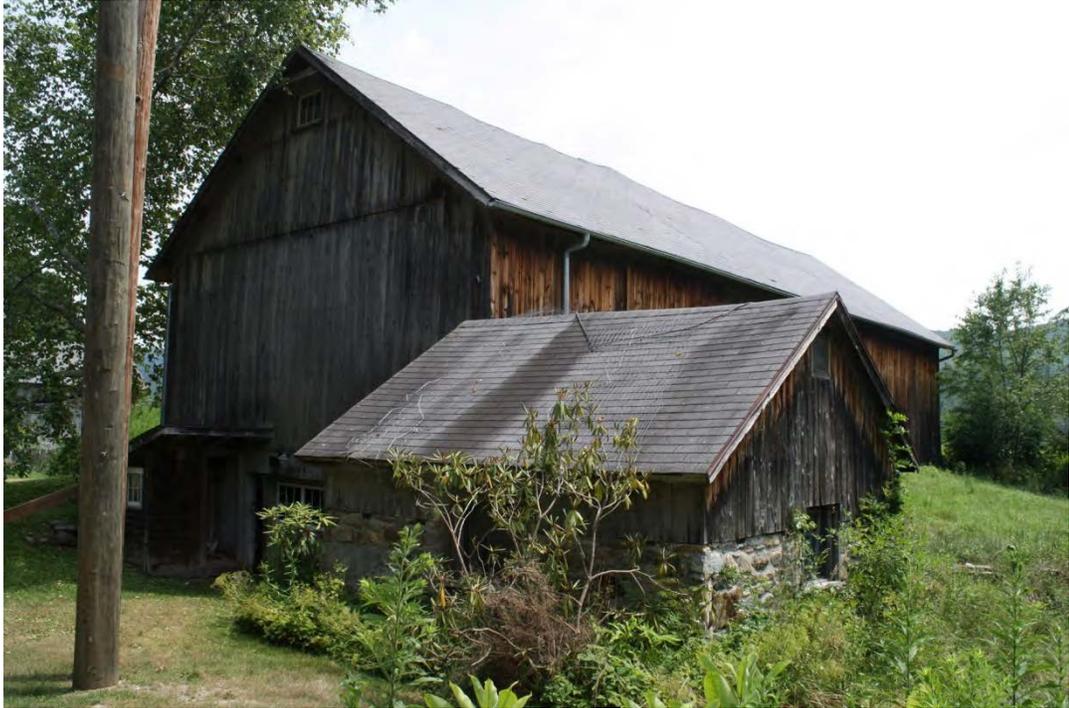
11. Northwest view of Barn I, camera facing southeast. Milk room is in foreground.

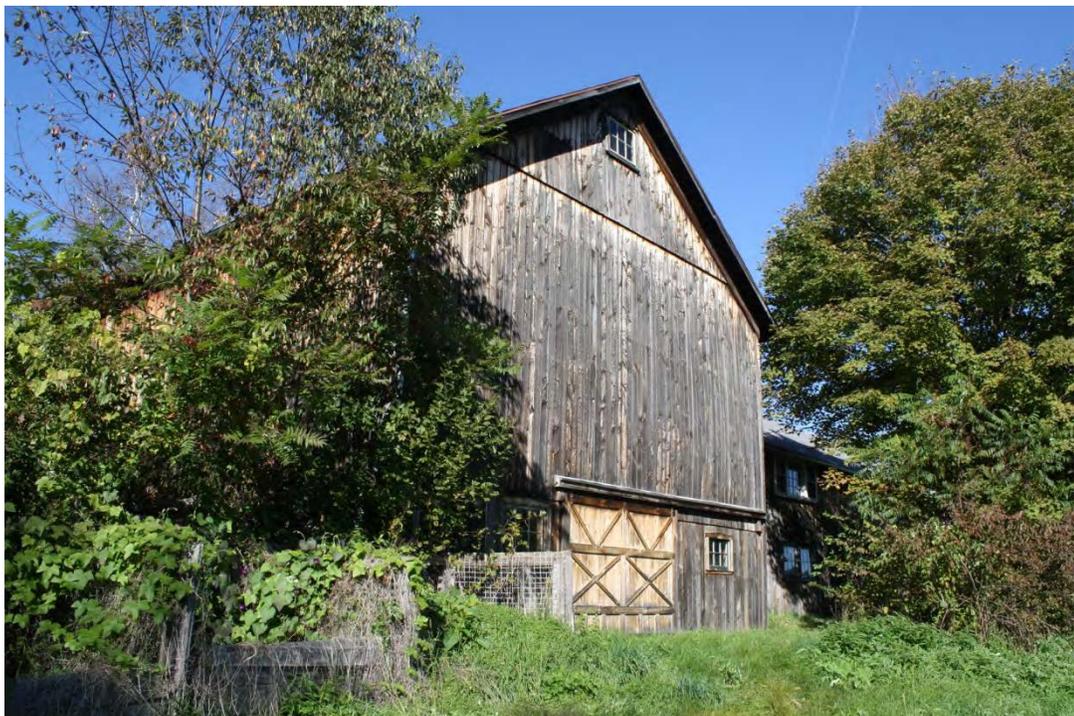
12. South view of Barn I, camera facing northeast. Addition is at right, with its basement level exposed at the lower grade elevation.

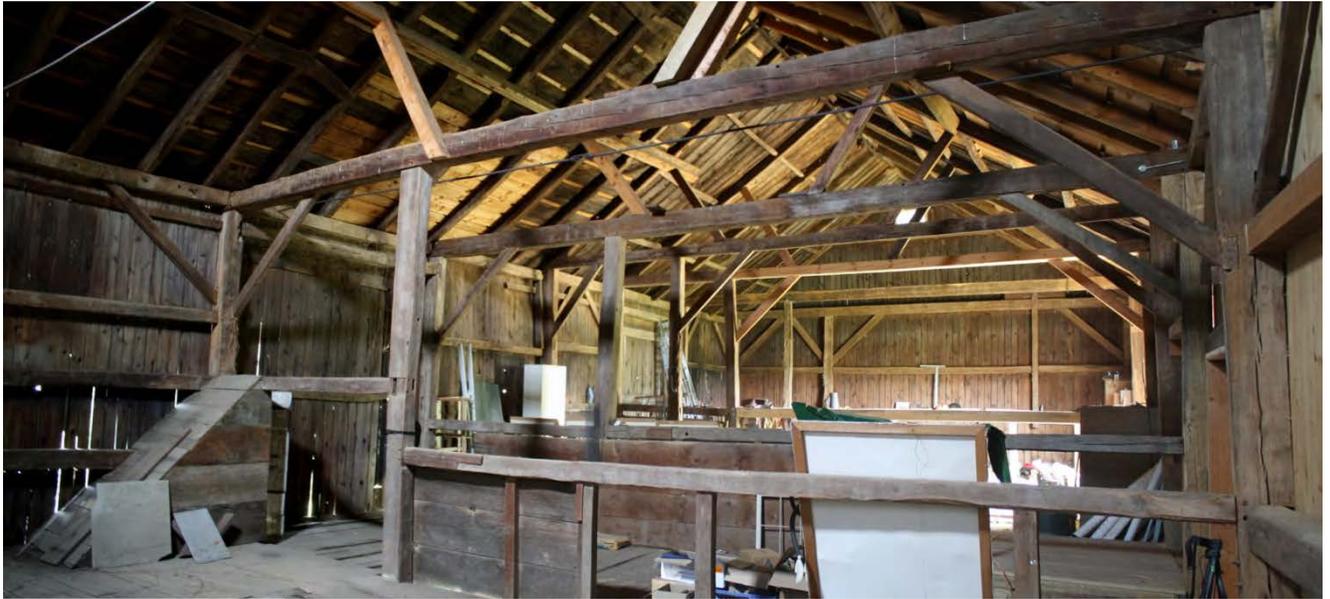
13. Interior view of Barn I upper level, camera facing north, from the south bay. Note the southern bays have canted queen posts with purlin plates and common rafters. The northern three bays have principal rafters, minor purlins, and vertically-laid roof sheathing boards. The interior posts are off-center throughout.

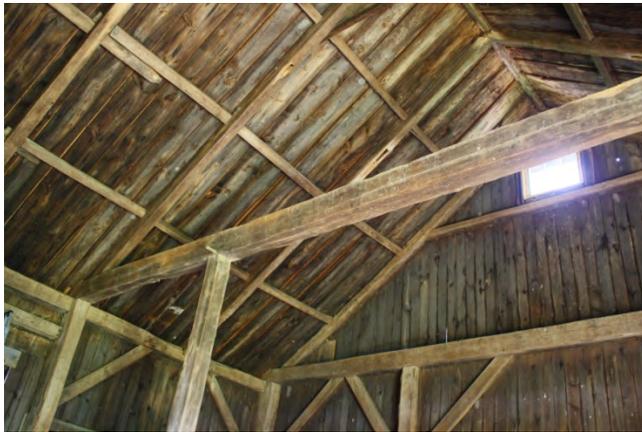
14. Northwest interior view of Barn I, camera facing northwest, showing tie girts above the plate, principal rafters and minor purlins.

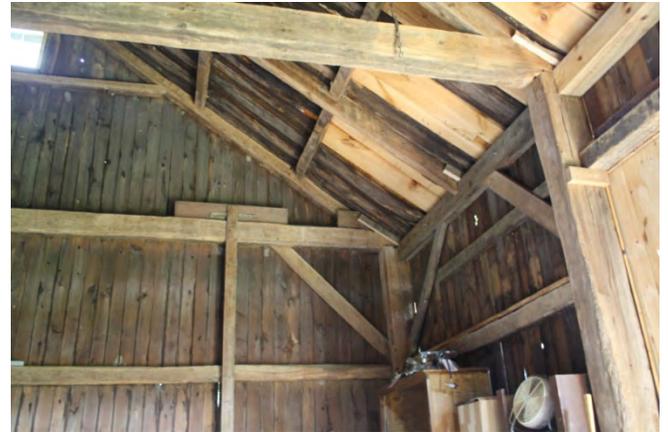
15. Northeast interior view of Barn I, camera facing northeast, showing tie girt above the plate, gunstock posts.

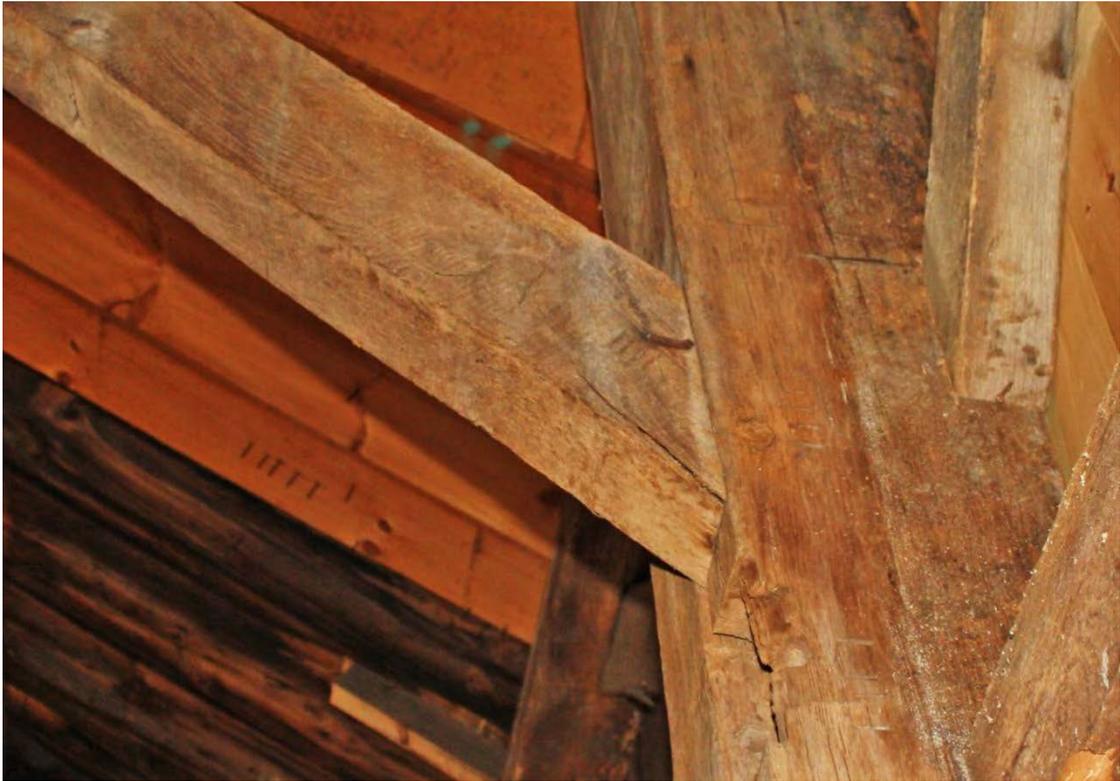
16. Interior view of Barn I, south end bent of the northern three-bay frame, camera facing north. Note the scribe rule marriage marks “IIII.”

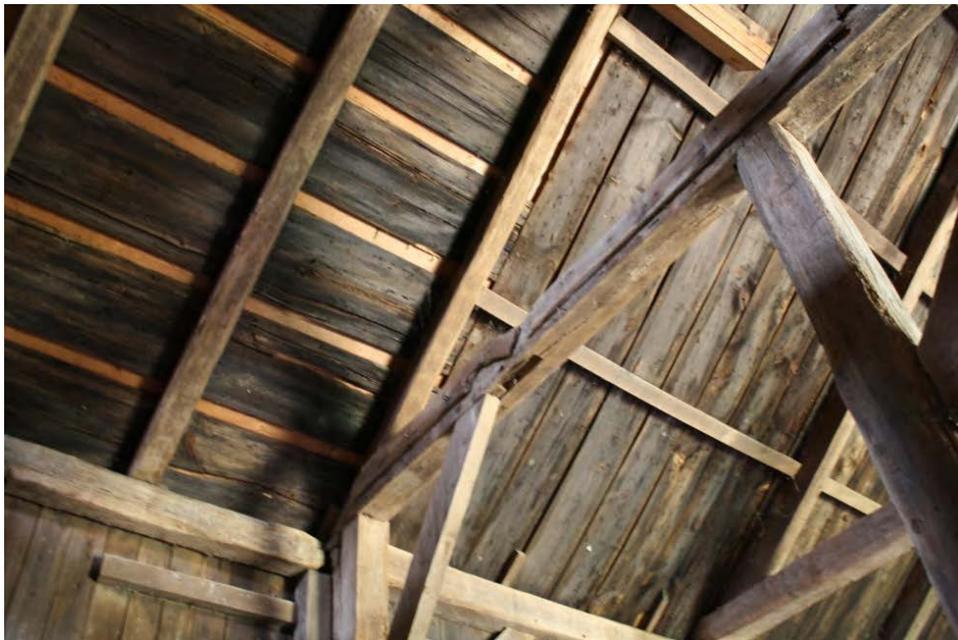
17. Interior view of Barn I, camera facing west, showing southernmost bent of the northern three-bay frame and the southern frame at left. Note change in rafters and roof sheathing.

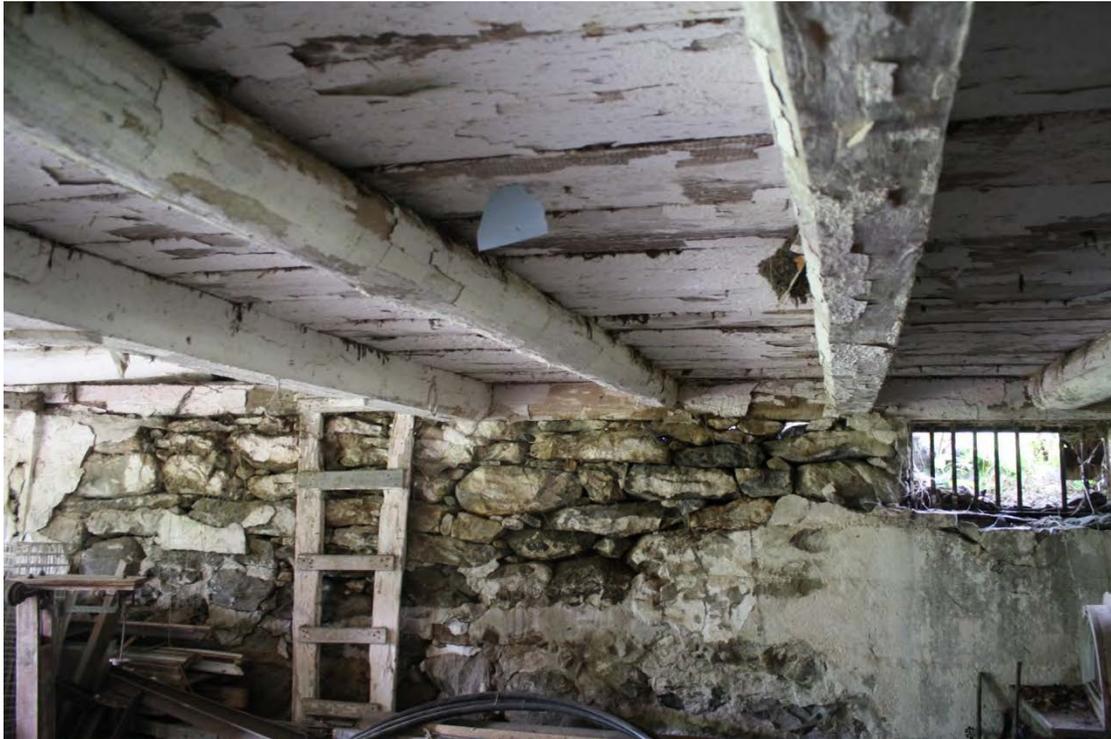
18. Interior view of Barn I basement level, camera facing west at center bay of the southern three-bay block. Note loft floor joists running east-west in center “threshing” bay and north-south in other bays, west foundation wall of fieldstone.

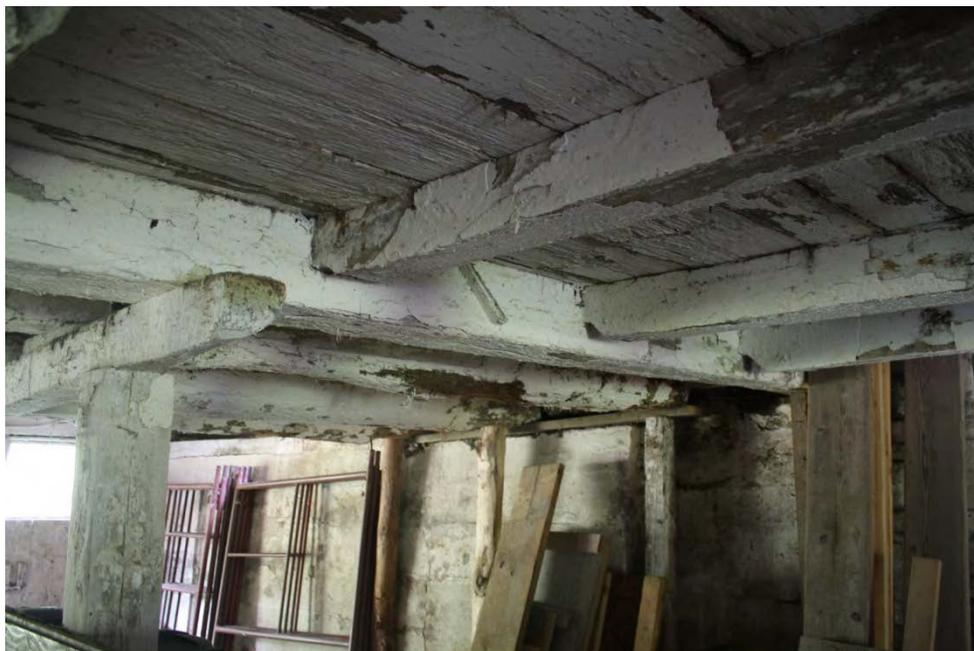
19. Interior view of Barn I basement level, camera facing northeast at southern bay of northern three-bay block. Note in foreground the north-south joist of the side bay and beyond, the east-west joists of the center “threshing” bay; east foundation wall of concrete.

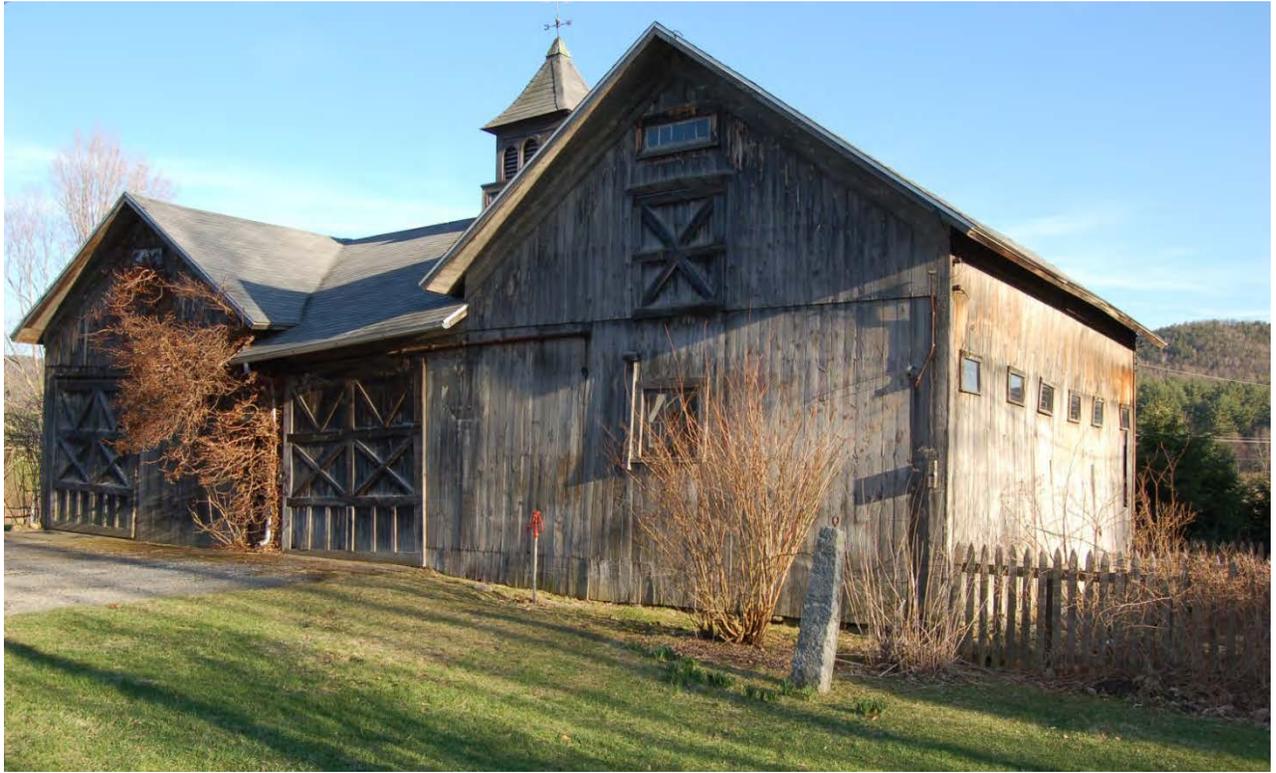
20. Northwest view of Barn II, camera facing southeast, photograph courtesy of Alec Frost.

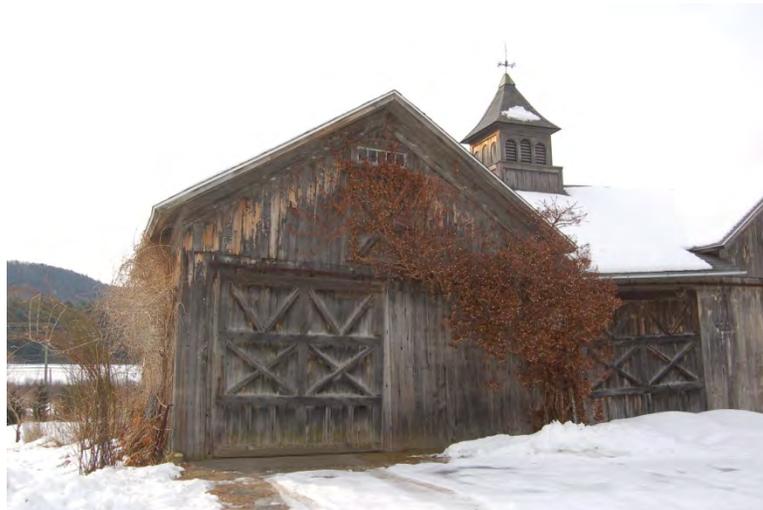
21. North view of Barn II, camera facing south, photograph courtesy of Alec Frost.

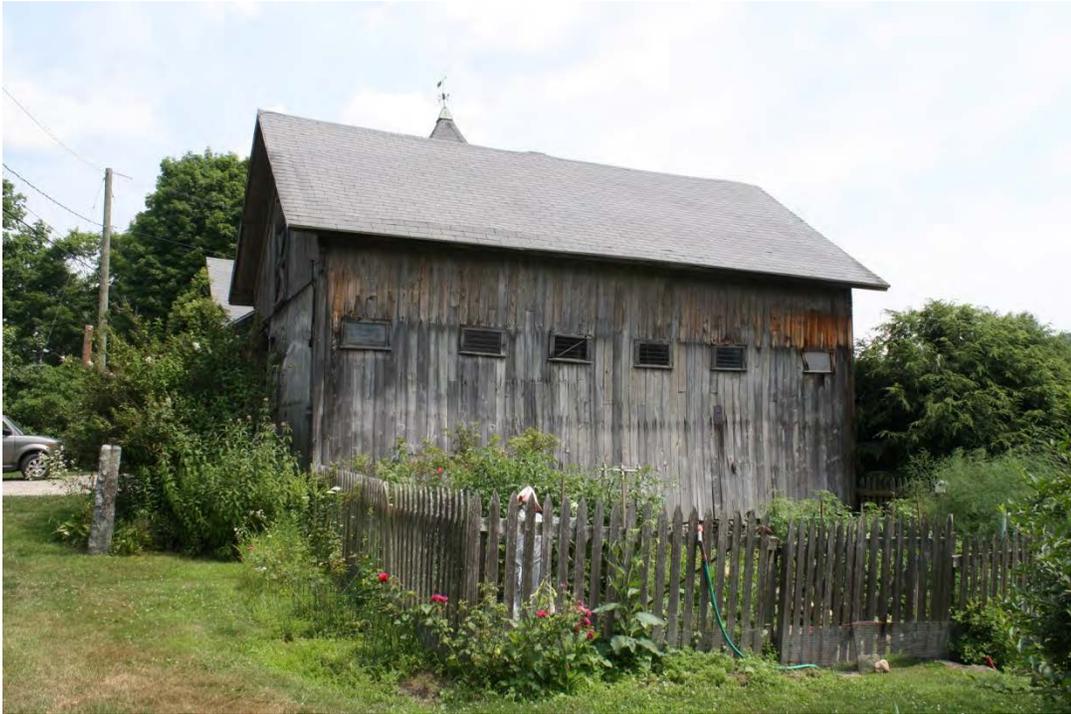
22. West view of Barn II, camera facing east.

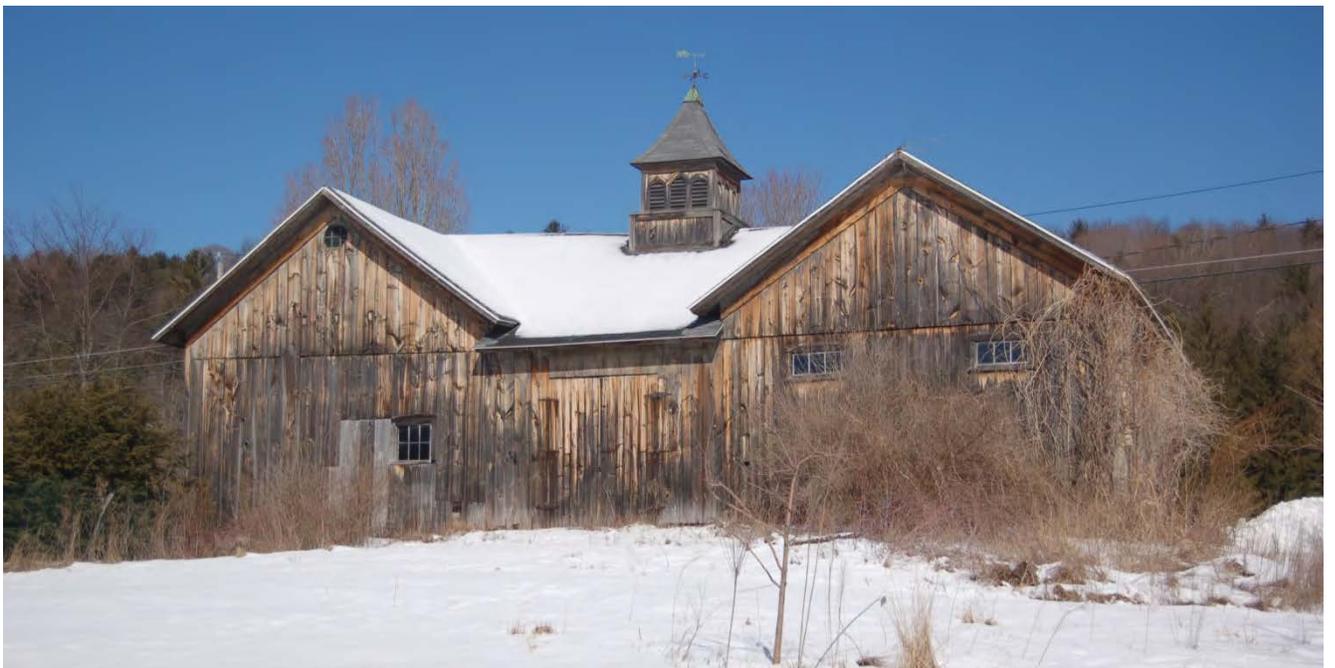
23. South view of Barn II, camera facing north, photograph courtesy of Alec Frost. House is at right rear.

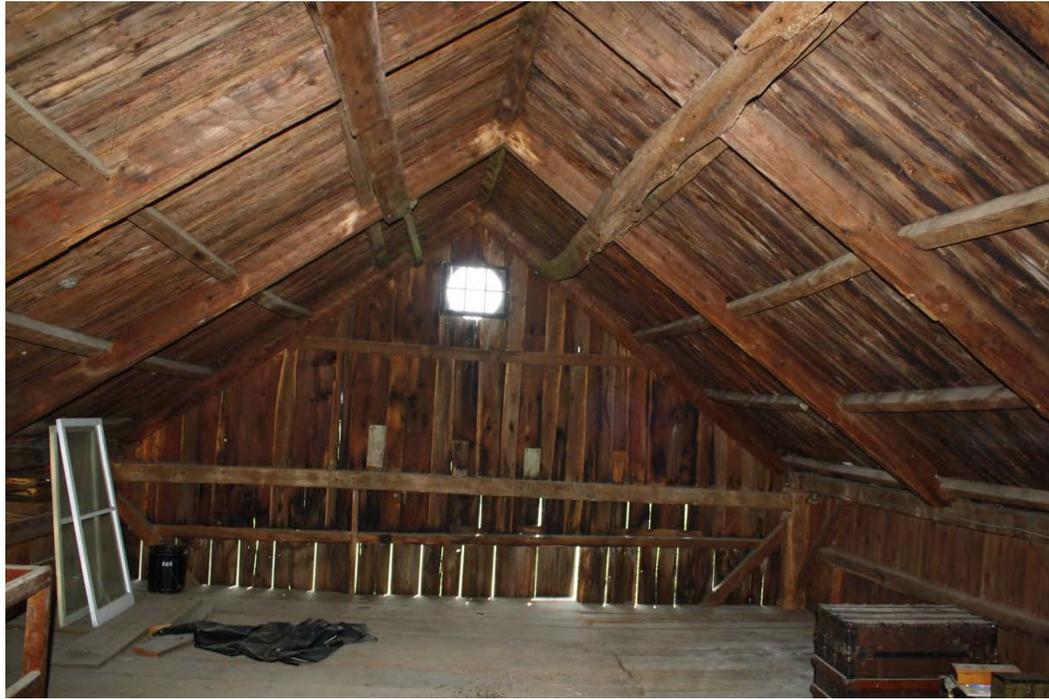
24. Interior view of Barn II west block loft level, camera facing south. Note major rafter / minor purlin layout of roof framing with sheathing boards oriented vertically. At rear (south) wall, dropped girt is in place but siding divide is fastened to a secondary wall girt below. Rafters meet at a ridge-pole.

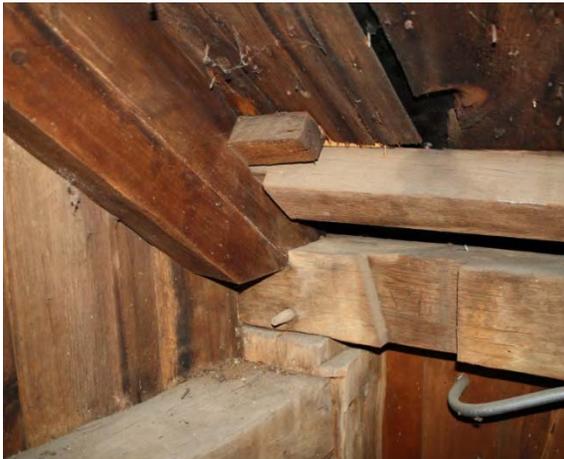
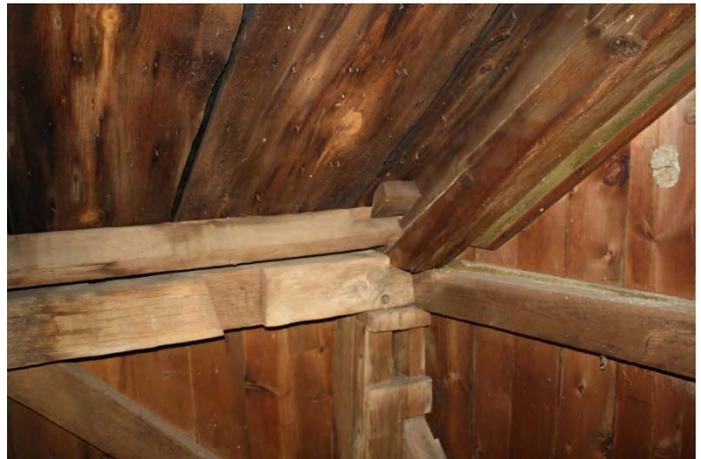
25 a-b. Interior views of Barn II, west block loft level, west plate at rafter toes, camera facing west. Note empty dovetail notches in the plate, indications of re-use. At left, dropped girt in place, at right an empty setting for a similar dropped girt.

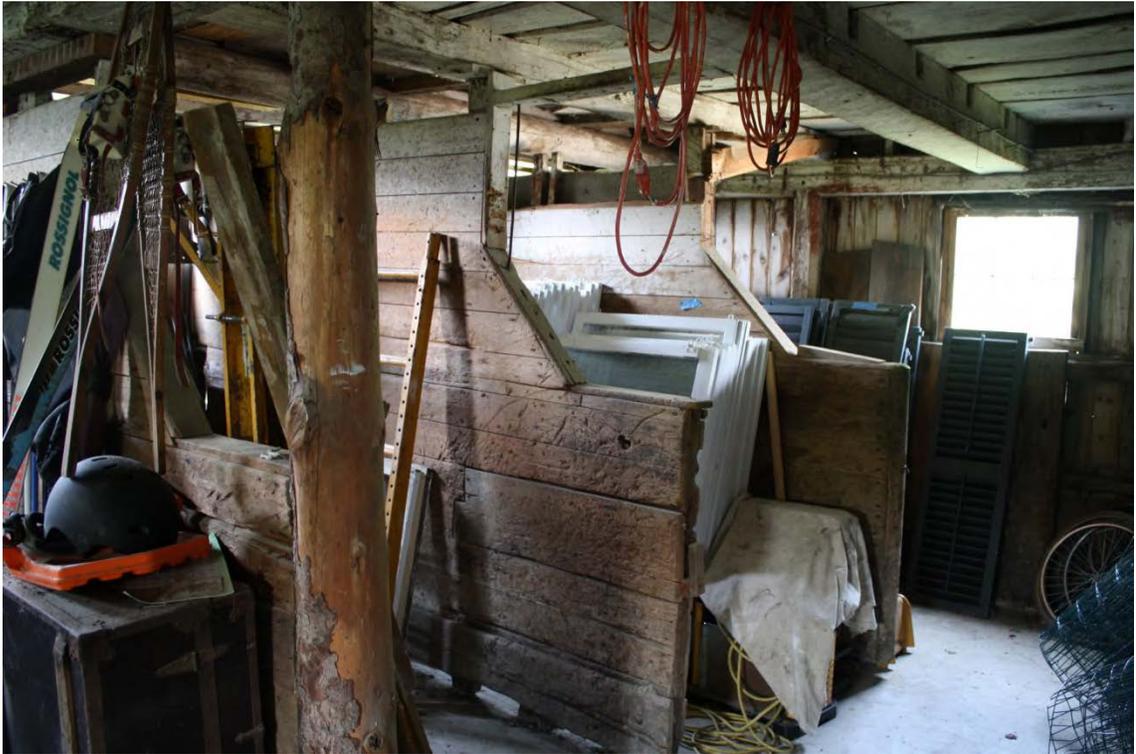
26. Interior view of Barn II, west block ground level horse stall area, camera facing northwest. Note stall dividers, whitewashed ceiling

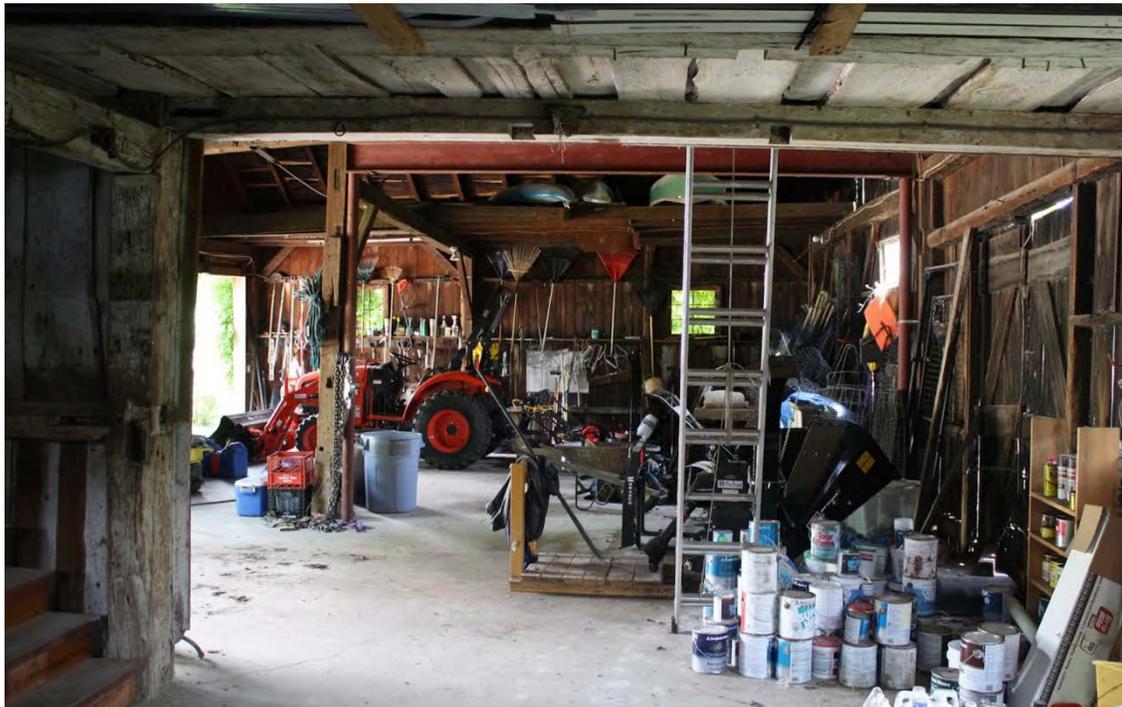
27. Interior view of Barn II, ground level, camera facing east from the west block looking through the center connector to the east block.

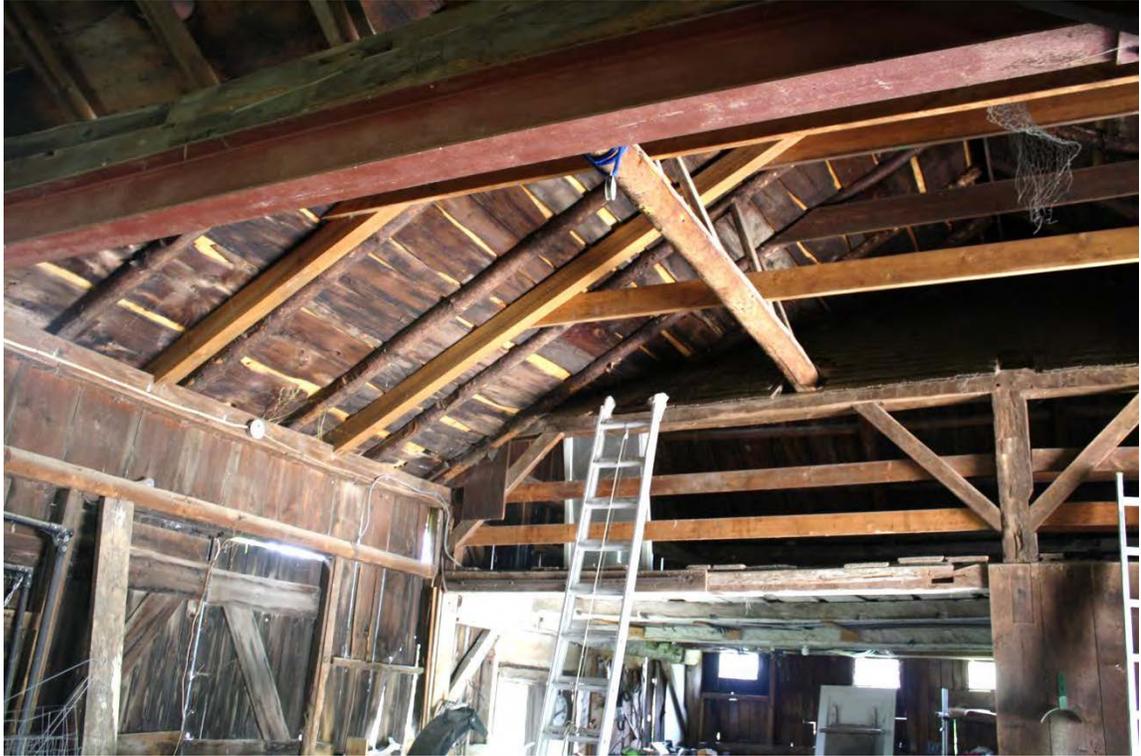
28. Interior view of Barn II, ground level, camera facing west from the east block looking through the center connector to the west block.

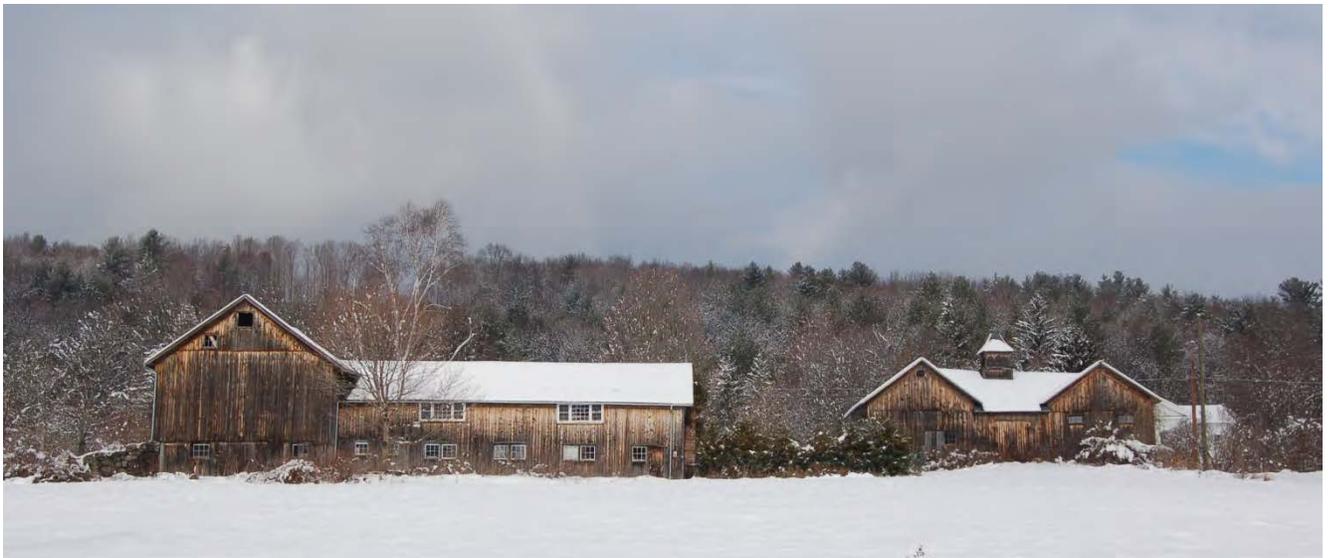
31. South view of Barn I at left and Barn II at right, house at right rear, camera facing north; courtesy of Alec Frost.
