Agricultural Heritage Multiple Property Submission - State Register

HISTORIC RESOURCES

BUILDING AND STRUCTURES

Building Name (Common) Windy Ridge Farm Record No. 44792
Building Name (Historic) Carter, Ward / Carter, Benjamin and Amelia, Farmstead
Street Address or Location 183 Melius Road
Town/City Warren Village County Litchfield
Owner(s) Gertrude Hill, 183 Melius Road, Warren CT 06754 Public Private

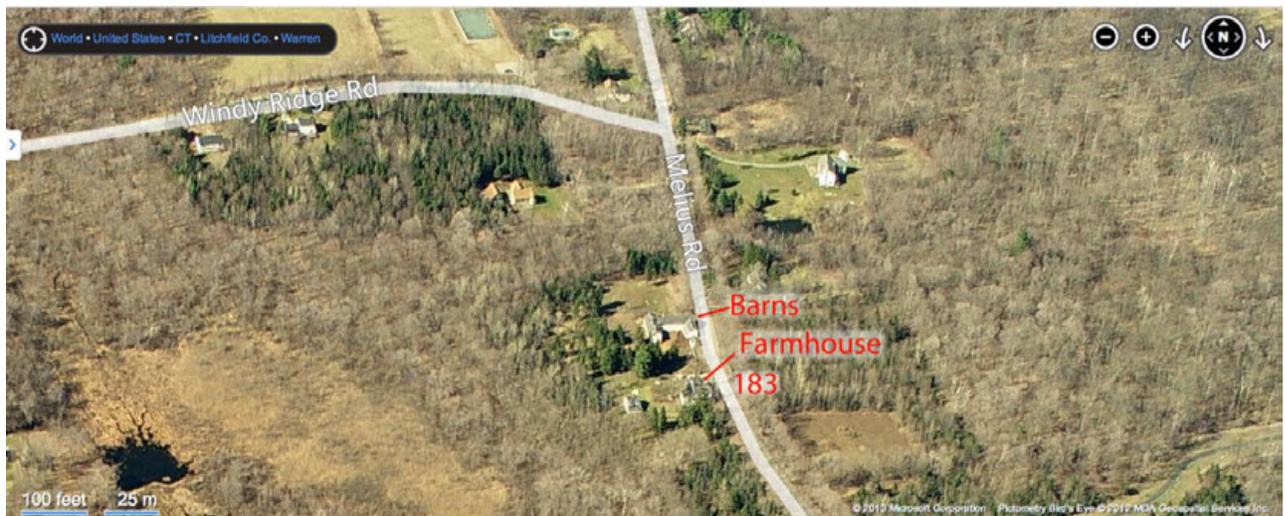
2. Southwest view – aerial “bird’s-eye” map of 183 Melius Road, Warren CT – base image from <http://www.bing.com/maps> accessed 8/25/2013.

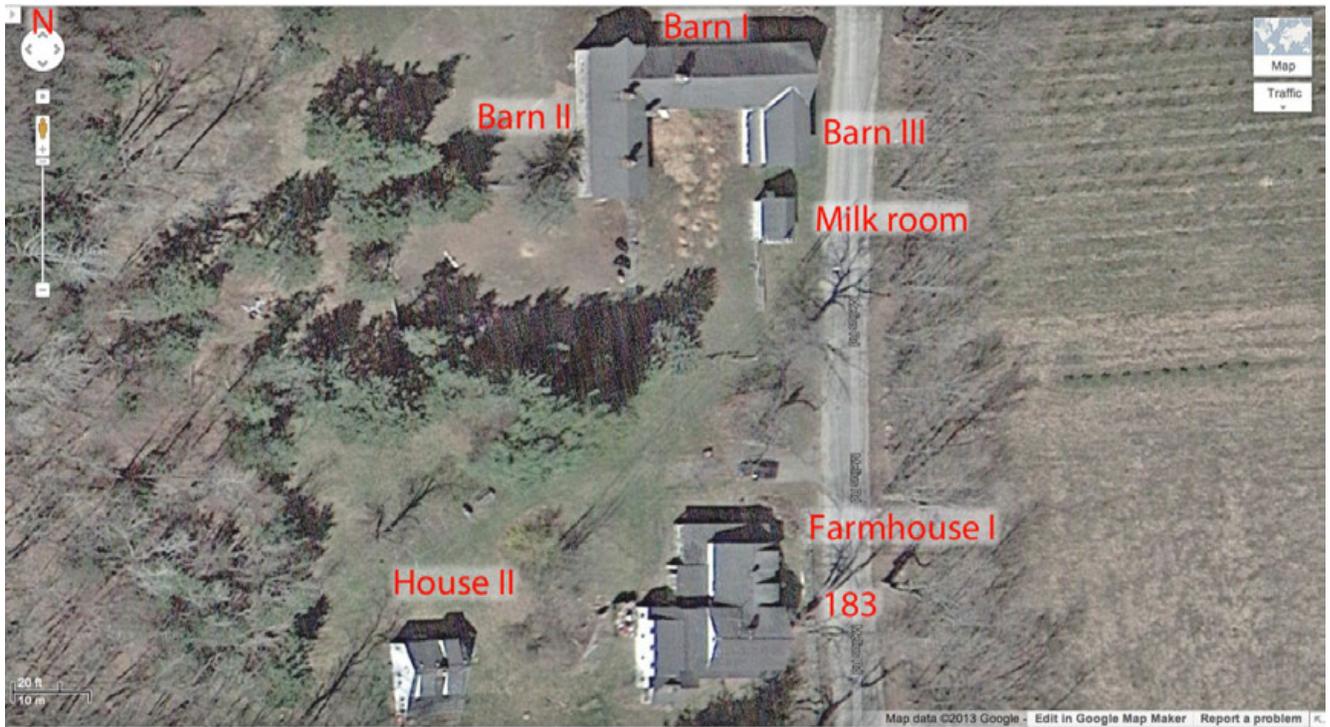
3. Detail Site Plan Sketch showing contributing resources – base image from Google Maps.

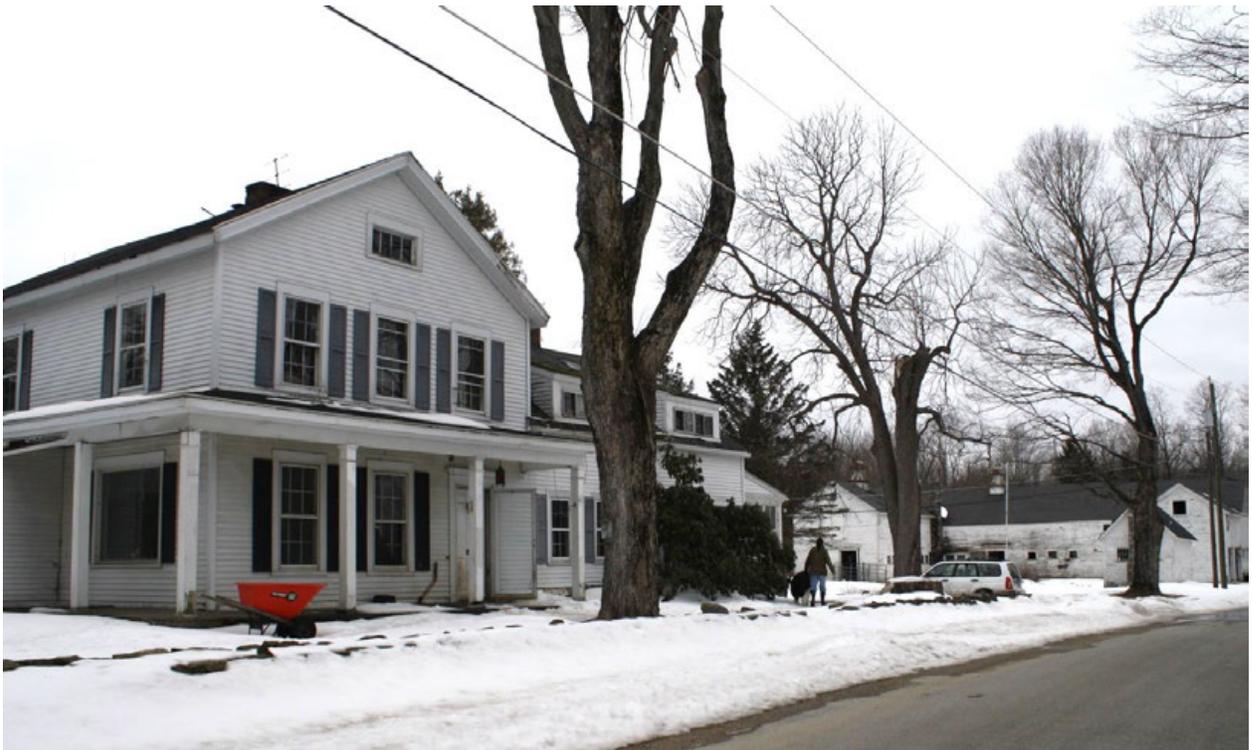
4. East context view, camera facing northwest. The Farmhouse is at left with the barn complex at right rear.

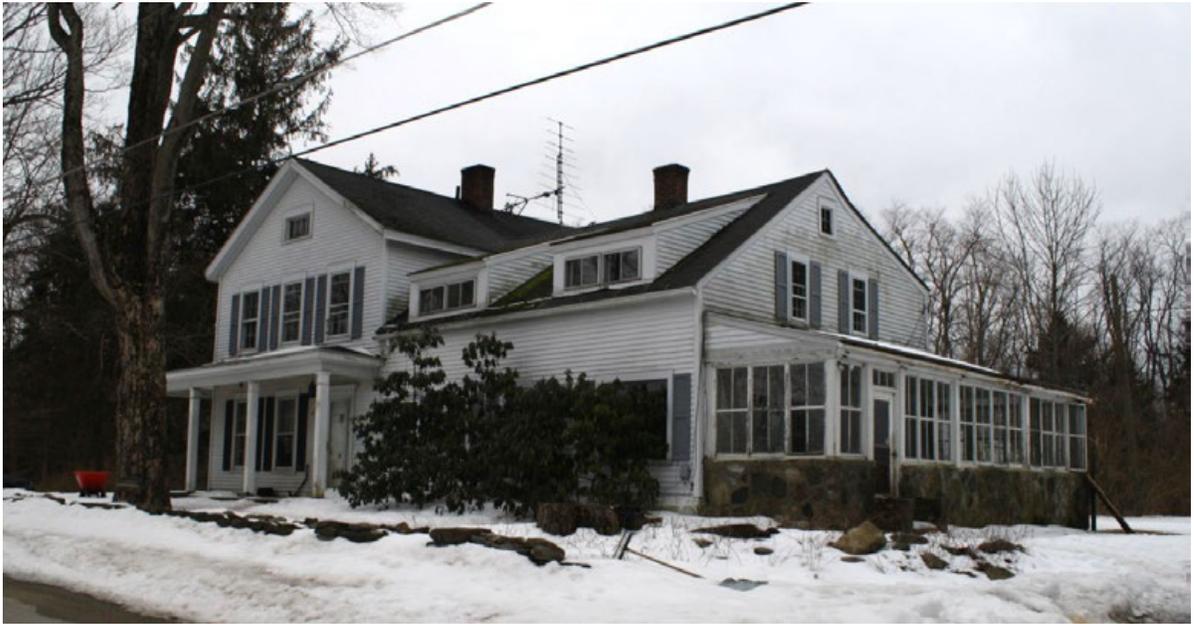
5. Northeast view of Farmhouse, camera facing southwest. The Cape-style block is at right, the vernacular Greek Revival-style block at left.

The Farmhouse is located adjacent to the road south of the barn complex. The house, its earliest portion dating from c. 1790, has two blocks. The north wing is a 1 ½-story Cape-style structure, 28' x 26', with its ridge-line oriented north-south and its east eave-side facing the road. Although clad in aluminum siding, the massing implies that it may be a raised-plate Cape type, originally with eyebrow attic windows below the eaves. Shed dormers have been added, as well as a screened porch along the north side. Windows in the attic on the north gable-end are nine-over-six, consistent with the 18th-century date given by the Assessor's record. The southern block, attached to the first, is a 2 ½-story structure, 24' x 30', with its ridge-line oriented east-west and its east gable-end facing the road. This has a three-bay façade with the entry door in the right (north) bay. This portion has six-over-six double hung windows and a four-pane horizontal attic window, vernacular Greek Revival-style in character. This appears likely to have been an addition in the first half of the 19th century. A full-width hip-roofed porch extends across this gable-end façade and wraps around the south side. At the rear (west) there are multiple additions.

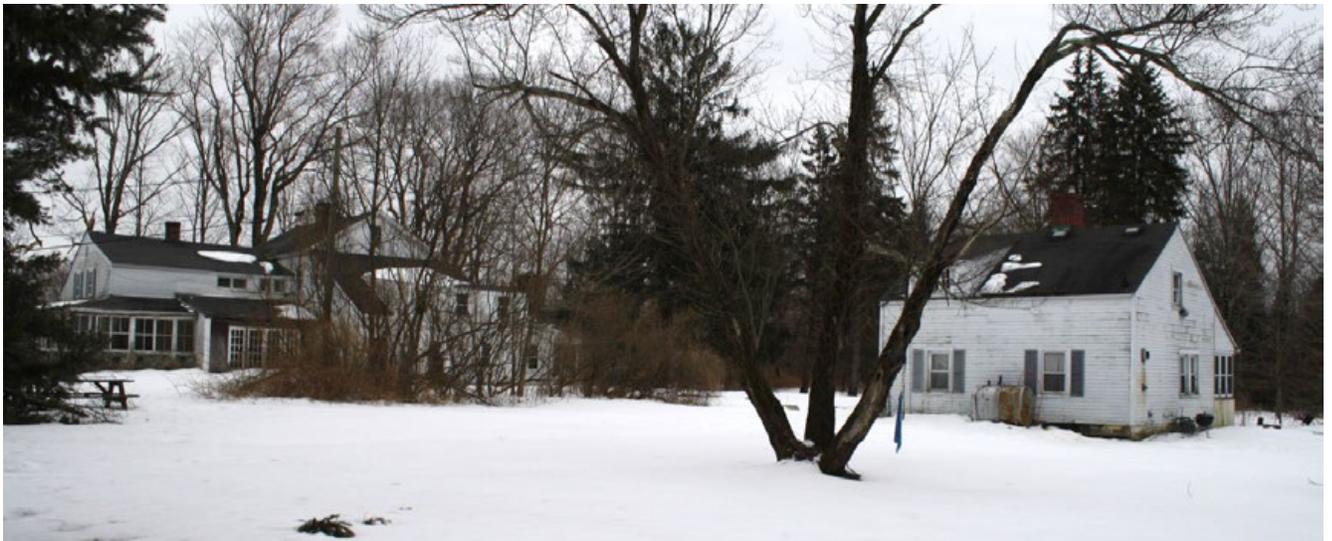
6. Northwest view of rear of Farmhouse (at left) and House II at right, camera facing southeast.

West of the Farmhouse is a Cape-style secondary dwelling, c. 1930, oriented with its ridge-line east-west and its primary façade the north eave-side. An extension to the south gives it a saltbox profile.

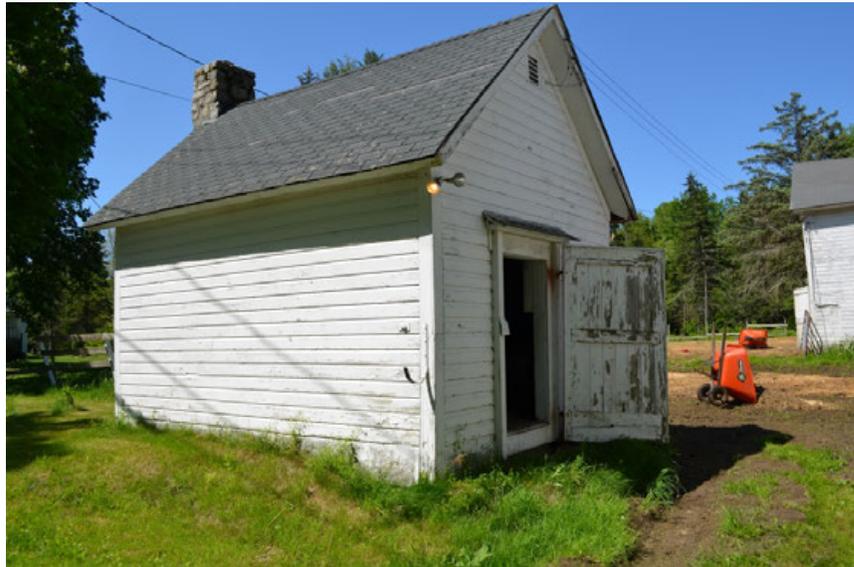
7. Northeast view of Milk house, camera facing southwest. Barn II is at right rear.

A small free-standing Milk room structure sits south of Barn III. It is a 1-story gable-roofed structure with its ridge-line oriented north-south. It is entered by a door in the north gable-end, facing toward the barns; a mortared fieldstone exterior chimney is centered on the south gable-end flanked by eight-pane windows. The eave-sides are blank. The walls are clad in wood clapboards painted white and the roof is asphalt shingles.

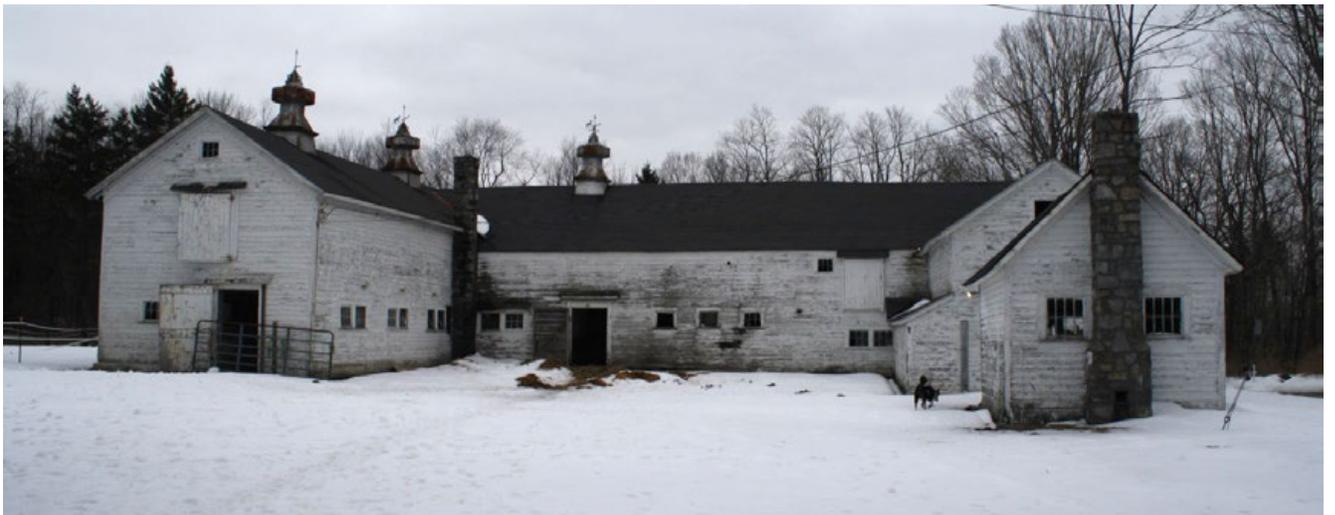
8. South view of barn complex, camera facing north. At left is the gable-end of Barn II; at center rear is Barn I. Barn III is behind the Milk house on the right. Note the fieldstone chimneys of the Milk house and in the corner between Barn I and Barn II.

The barns at 183 Melius Road are attached in a U-shaped plan forming a sheltered barnyard open on its south side. This complex is made up of several connected barn structures, which will be described as Barn I, the northern leg of the U (and earliest structure), Barn II, the southwestern block, and Barn III, the southeastern section.

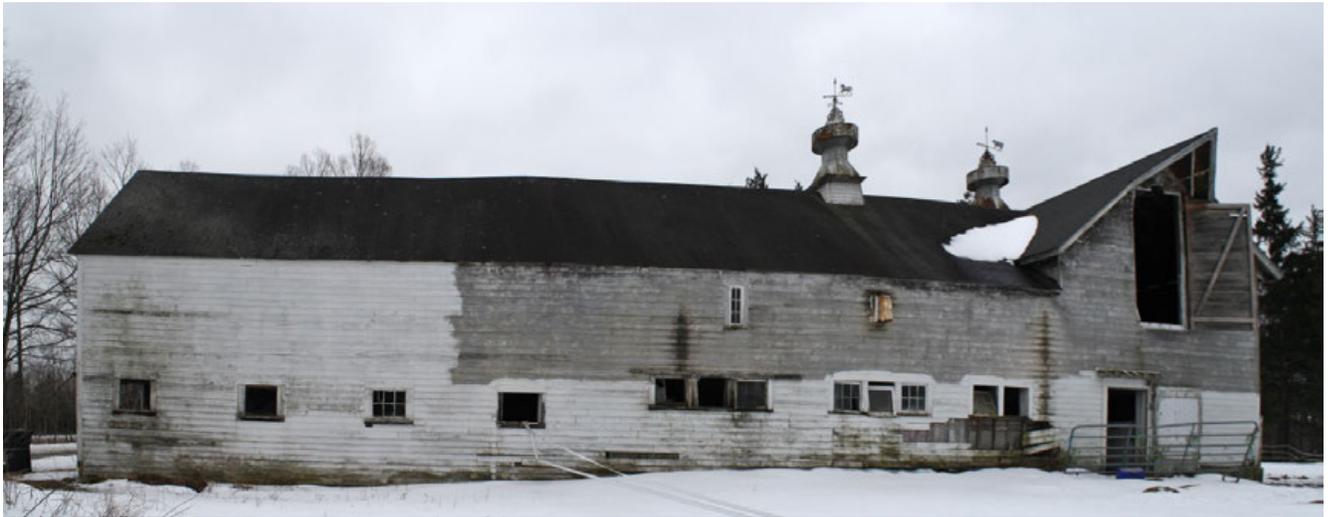
9. North view of barn complex, camera facing south. Barn I is at center and the north end of Barn II is at right.

This is a 25' x 34' three-bay 1 ½-story English barn with a post and beam frame. It forms the north side of the barnyard and has been incorporated into the complex by re-siding with early-20th-century horizontal siding. The south eave-side has a hinged pass-through door flanked by six-pane stable windows – a pair to the left and three to the right. The north eave-side has a group of stable windows in each bay – a panel of three in the left (east) and center bays and a pair in the right bay. A metal ventilator, with weathervane, sits on the roof, and matches two other ventilators on Barn II. The roof is continuous with an addition that extends eastward another 32' and contains garage space at the ground level, with two garage doors at grade and a hay door above. This extension has four stable windows in the north eave-side, which is flush and continuous with the side of Barn I.

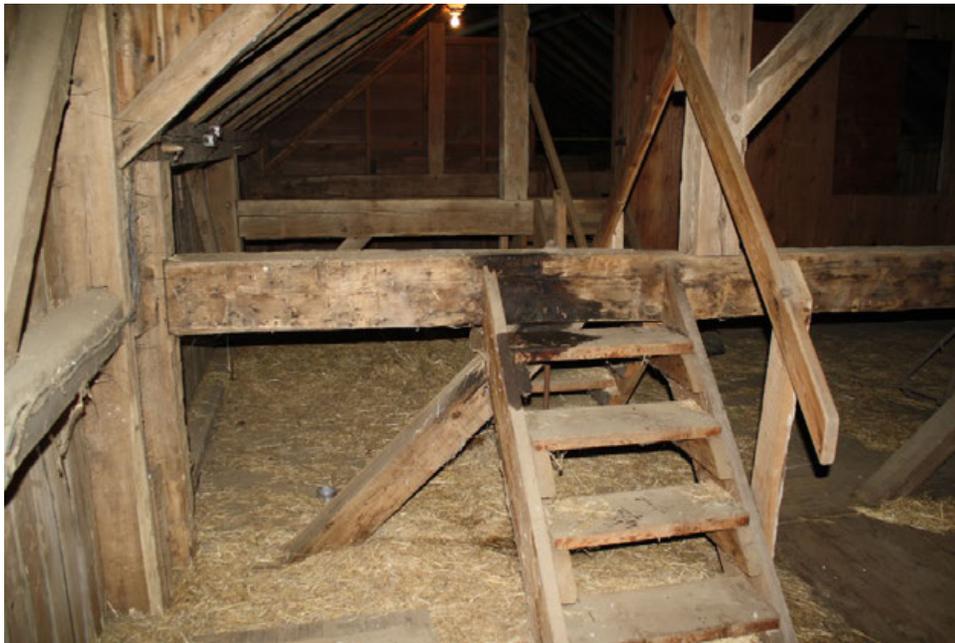
10. Interior view of Barn I loft level framing, camera facing east. This is the north wall of the barn, and shows the dropped tie-girts and queen posts.

The barn frame is a hand hewn square rule post and beam frame with mortise and tenon joinery. The bents have dropped tie-girts and queen posts support a pair of longitudinal purlin plates. Common rafters are hand hewn as well. A loft floor has been added approximately three feet below the tie-girts, to suit the layout of a ground level stable on the main level, and a series of steps, have been installed for ease of movement up and down over the tie-girts. In the northeast bay a stair down to the main level is flanked by a grain bin with chutes leading to below.

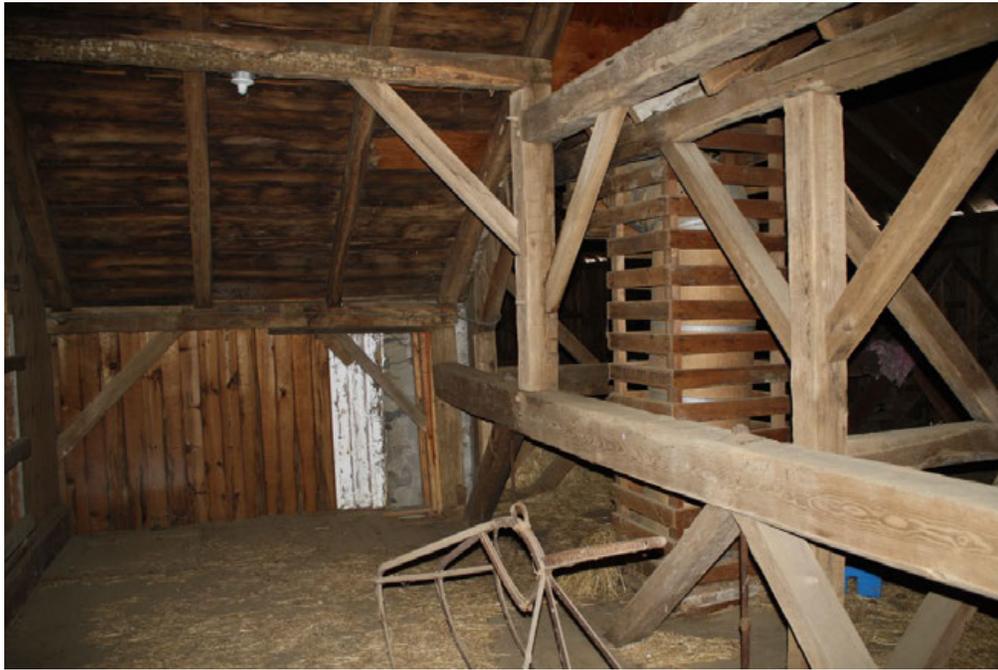
11. Interior view of Barn I loft level, camera facing south, showing the western bent with queen post, purlin plate, and hewn rafters. Below the tie-girt, a timber truss with iron tension rods has replaced the interior post, probably in order to provide a clear span at the ground level. Note the hay fork set on the loft floor.

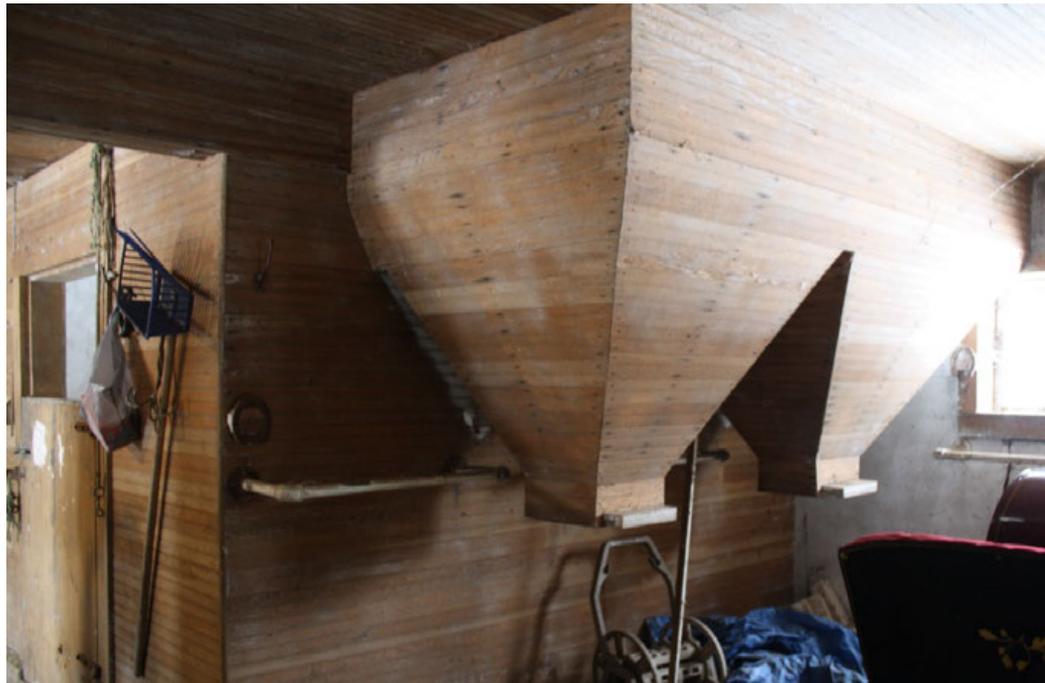
12. Interior view of Barn I, northeast corner, camera facing northwest, showing the grain chutes.

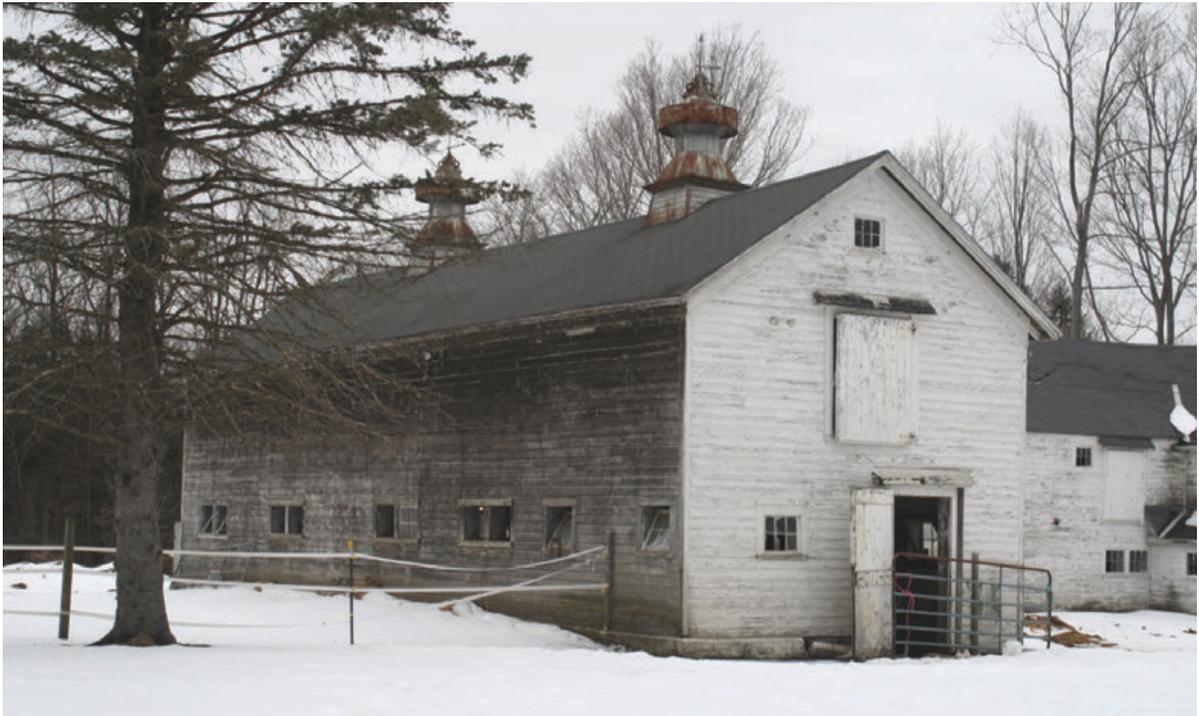
13. Southwest view of Barn II, camera facing northeast. The ground level dairy stable has been adapted for horses.

This structure is a 20' x 60' block with its ridge-line oriented north-south. It appears to be of late 19th-century construction, incorporating trusswork to frame the loft level with a clear span over the ground level stable below. The exterior has at the northern gable-end a livestock door at grade and a large hinged hay door and projecting hay hood above. The west side has a row of stable windows at the ground level. The south end has a sliding livestock door at grade and a sliding hay door above. The roof has two large metal ventilators with a decorative pressed metal faux shingle texture in the base, and finials with alternately a cow or horse weathervane.

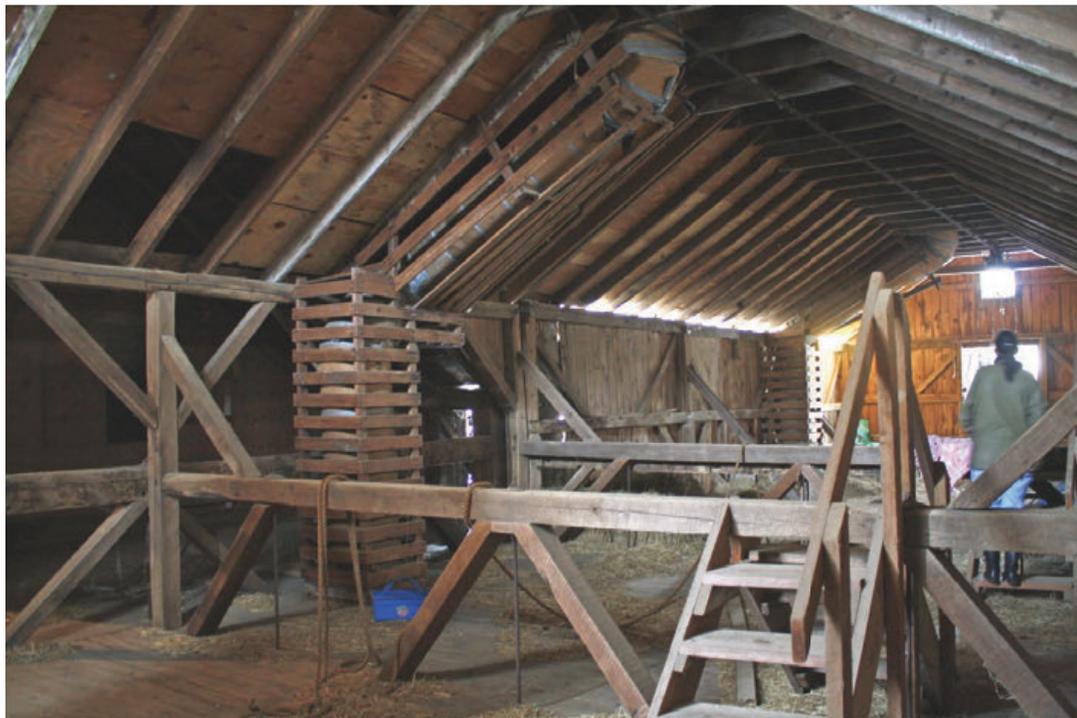
14. Interior view of Barn II, loft level, camera facing southeast, showing the timber trusses spanning the full width. The shaft to the ventilator can be seen. Beyond the ventilator shaft a double post signals where the far two bays appear to be a separately- framed structure with walls extended upward.

In the interior there are five bays; the northern two bays are a discrete frame from the southern three bays, as is indicated by the double posts at the joint between the two, visible in the loft level. The northern portion has timber trusses with iron tension rods joined to the full-height side-wall posts. The southern portion appears to have been adapted from a shorter structure by the addition of approximately six feet of additional wall height, indicated by the joints in the posts and diagonal bracing with wood angle braces and metal rods. The roof aligns across all five bays, and is framed with sawn dimension lumber.

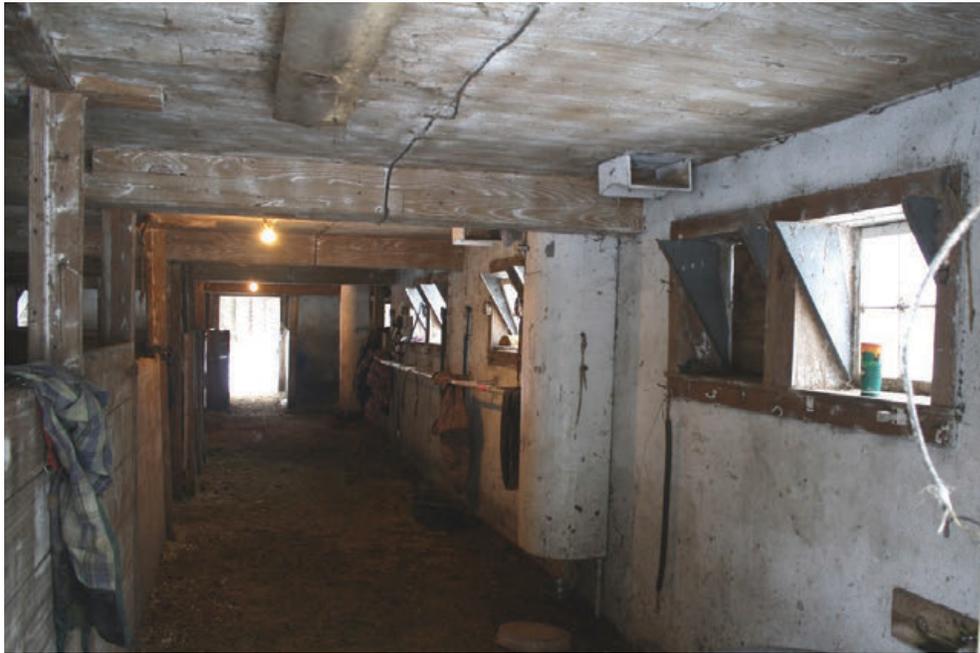
15. Interior view of Barn II, camera facing, showing typical hopper-type stable windows.

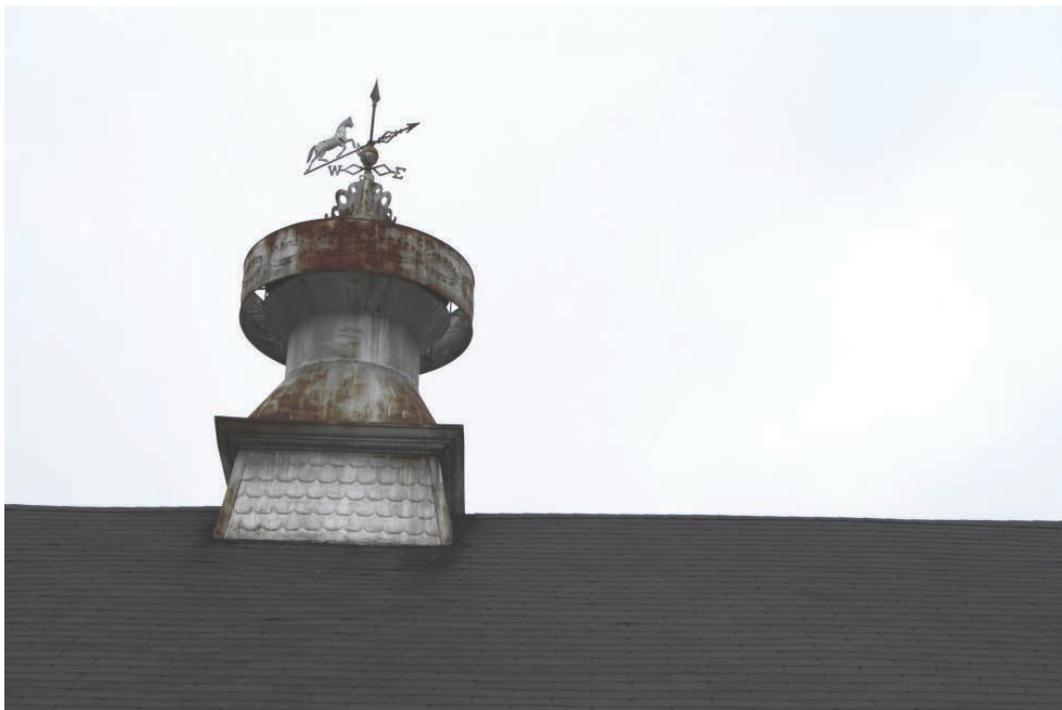
16. View of typical rooftop ventilator, camera facing west.

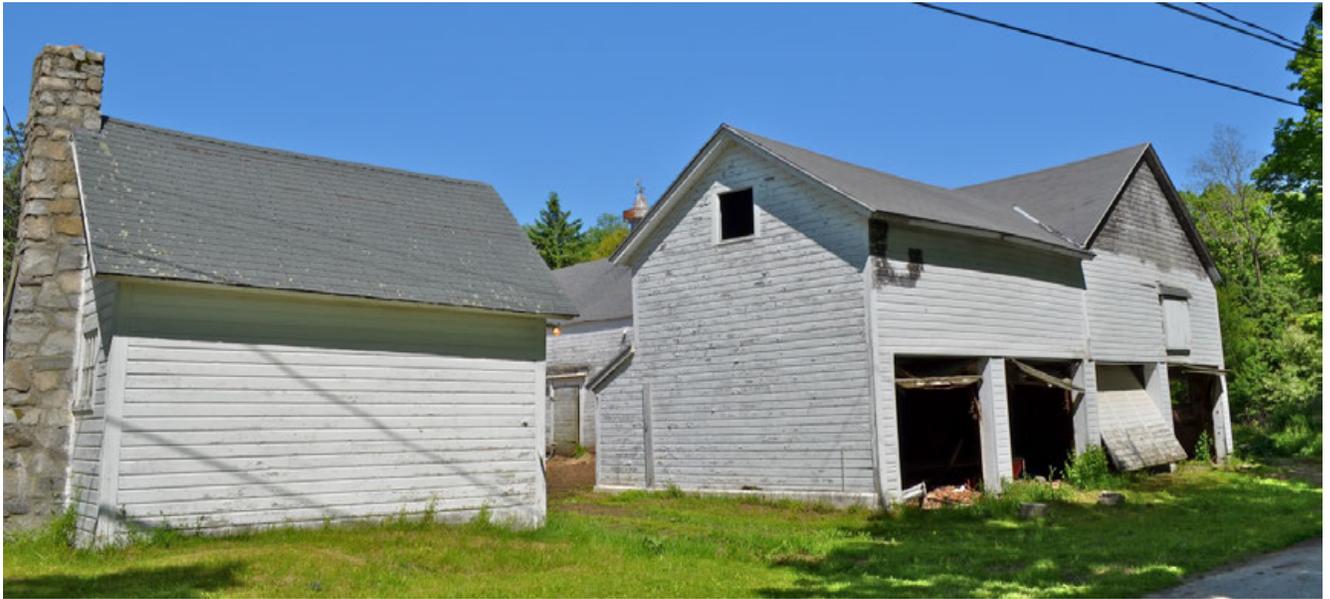
17. East view of Milk house and Barn III, camera facing northwest.

This structure is a two-bay 1 ½-story post and beam structure with some balloon framing and sawn rafters. It measures 16' x 24', and has a shed-roofed extension at the ground level, possibly to accommodate the extended length of vehicles garaged in it. The ridge-line runs north-south, butting into the side of the extension of Barn I, with the east walls aligned. The east side has two garage doors opening to the road. Siding is horizontal Dutch lap siding like the other components of the complex, and roofing is asphalt shingles.

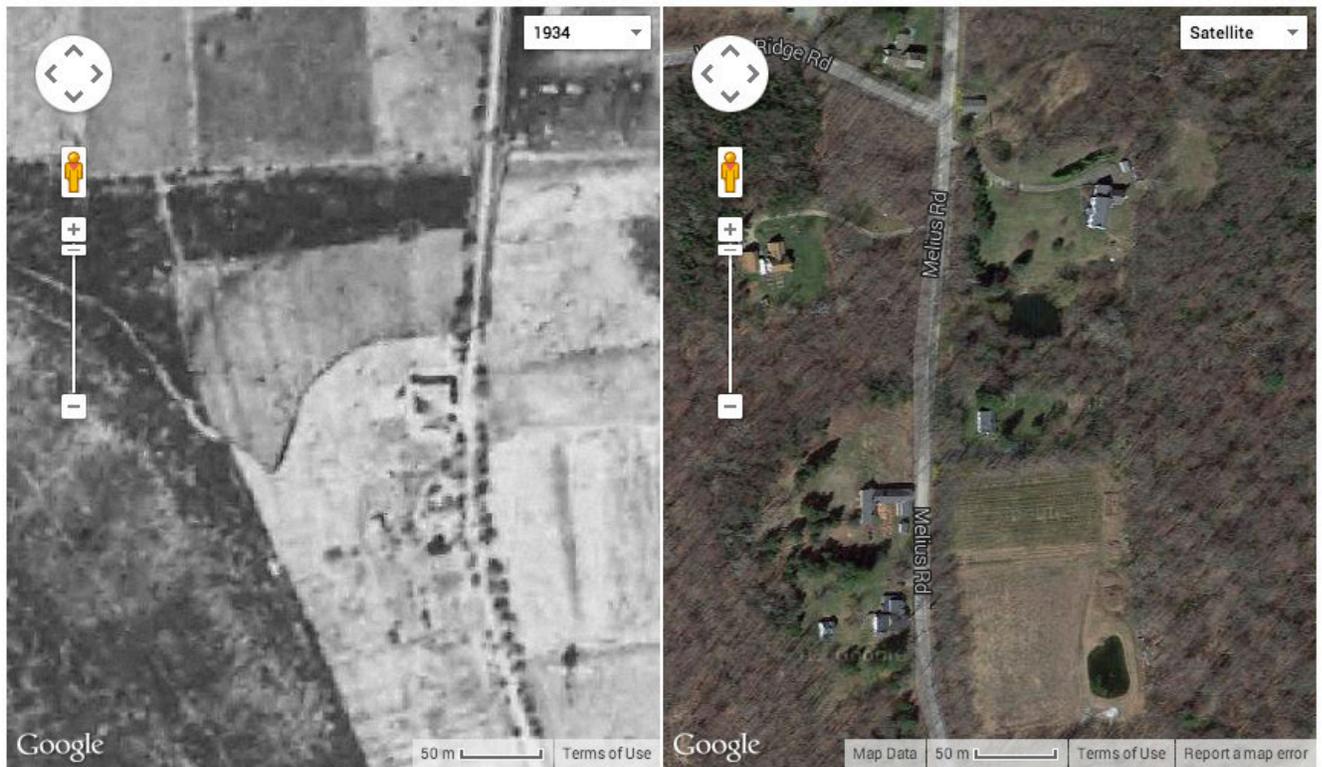
18. 1934 Fairchild aerial photograph (left) of the site compared with modern Google aerial view (right). In this area, many of the cleared fields of the 1930s have reverted to woodlands.
