HISTORIC RESOURCES INVENTORY - BUILDING AND STRUCTURES

Building Name (Common) Hart Castle Barn Record No. 8323
 Building Name (Historic) Euphrat, Theophileus, Barn
 Street Address or Location 34 Sammis Street
 Town/City Norwalk Village Rowayton County Fairfield
 Owner(s) Norwalk Land Trust, PO Box 34, Norwalk CT 06853 Public Private

34 Sammis Street, Norwalk CT

Record No. 8323

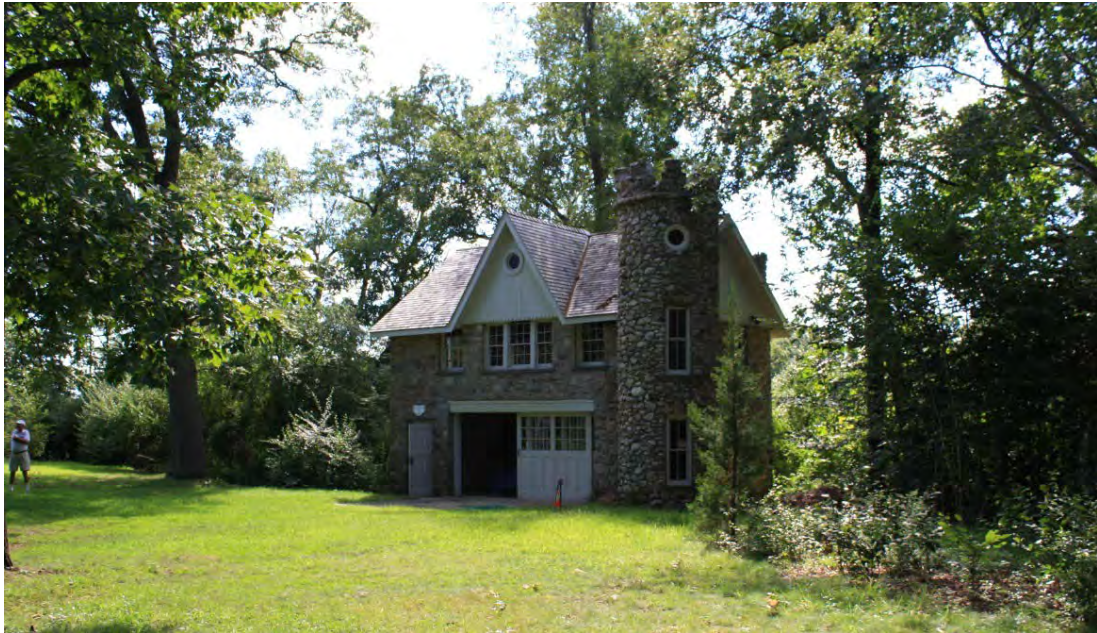
4. Northeast view of the carriage barn, camera facing southwest.

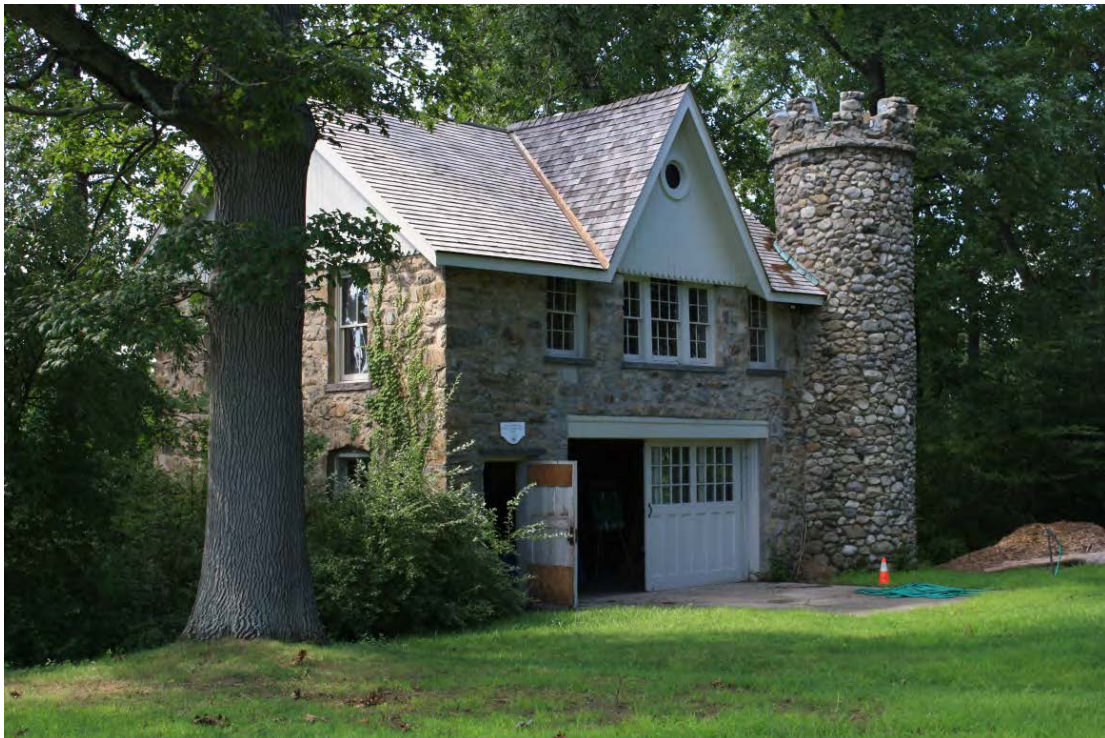
5. Southeast view of the carriage barn, camera facing northwest.

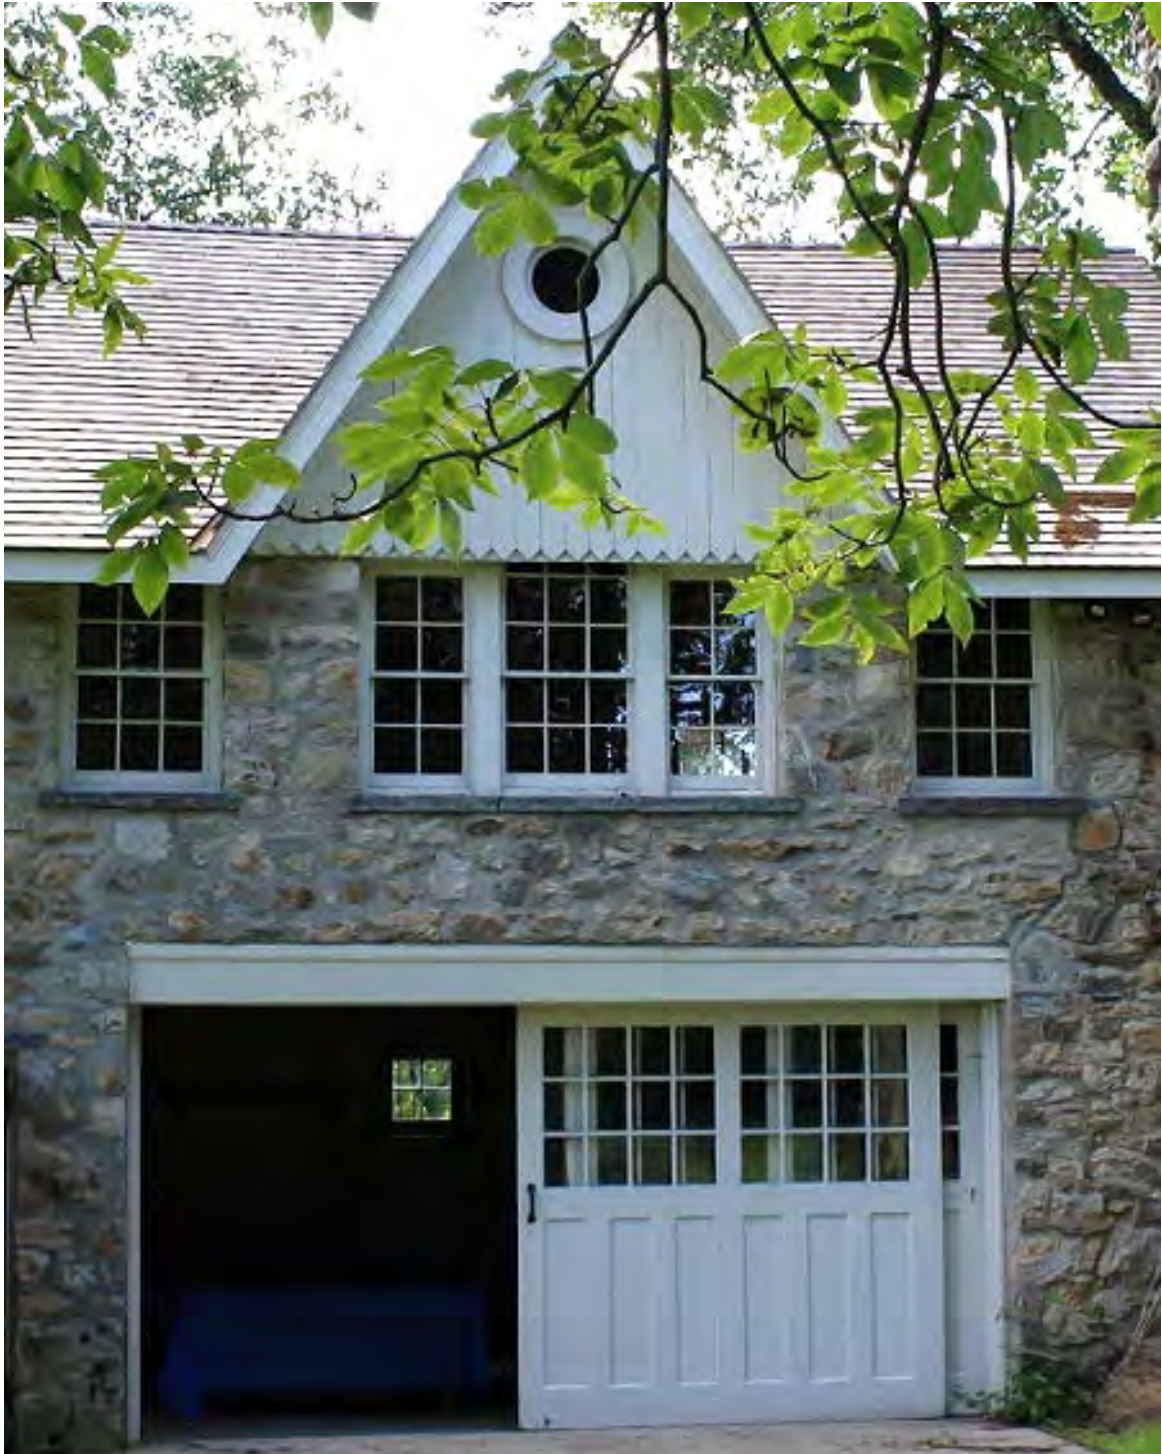
The main entry is centered in the east eave-façade of the carriage house and consists of a pair of interior-hung sliding doors with a wood hood. Each leaf has a pair of twelve-pane windows in the top half and six panels in the bottom half. On the south corner of the east eave-façade of the carriage house is a paneled pass-through door with a stone lintel. A white Rowayton Historical Society sign above the door has the following in black letters: The Theophile & Nellie E. Euphrat Barn c. 1907. At the north corner of the east eave-façade of the carriage house there is a 2 ½-story round cobblestone turret topped with crenellation.

6. East façade of the carriage barn, camera facing west.

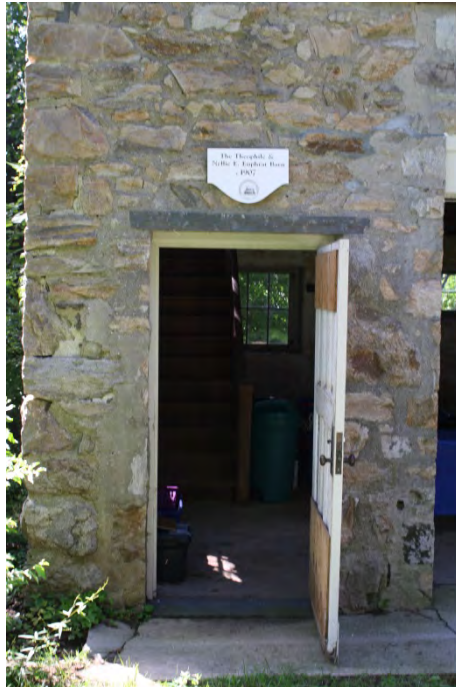
7. East façade of the carriage barn pass-through door at the south corner, camera facing west.

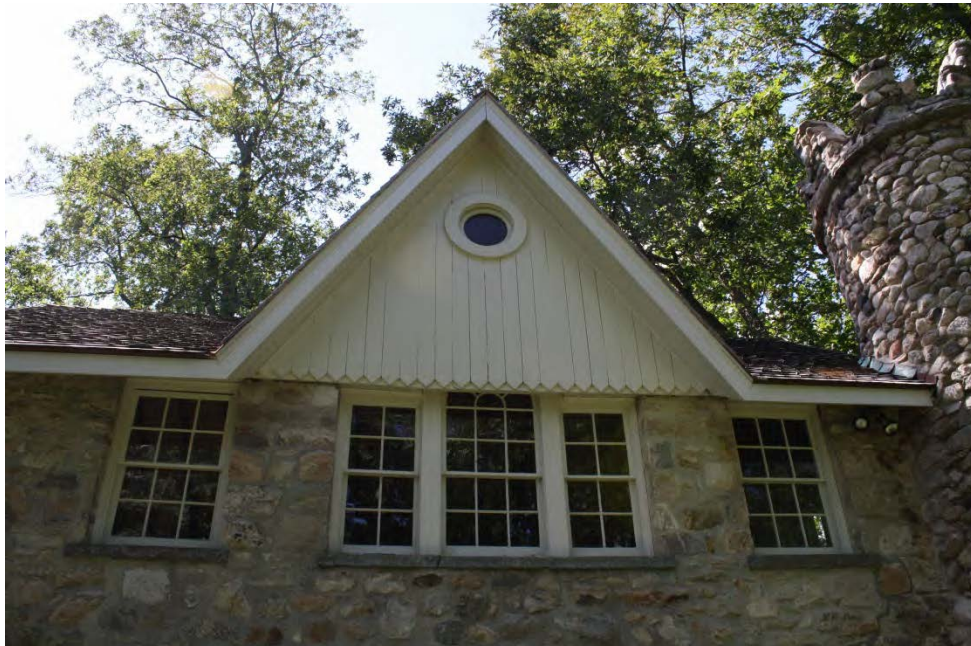
Centered above the main entry is a double-hung Palladian window with trim. Flanking the Palladian window just outside of the width of the wall dormer are six-over-six double-hung windows with trim. Centered above the Palladian window is a gable wall-dormer. Just beneath the apex of the gable wall-dormer is a rose tinted ocular window with trim. The girt line siding divide on the wall dormer has saw-tooth trim, which interestingly covers the arch of the Palladian window.

8. East façade of the carriage barn centered Palladian window and wall dormer, camera facing west.

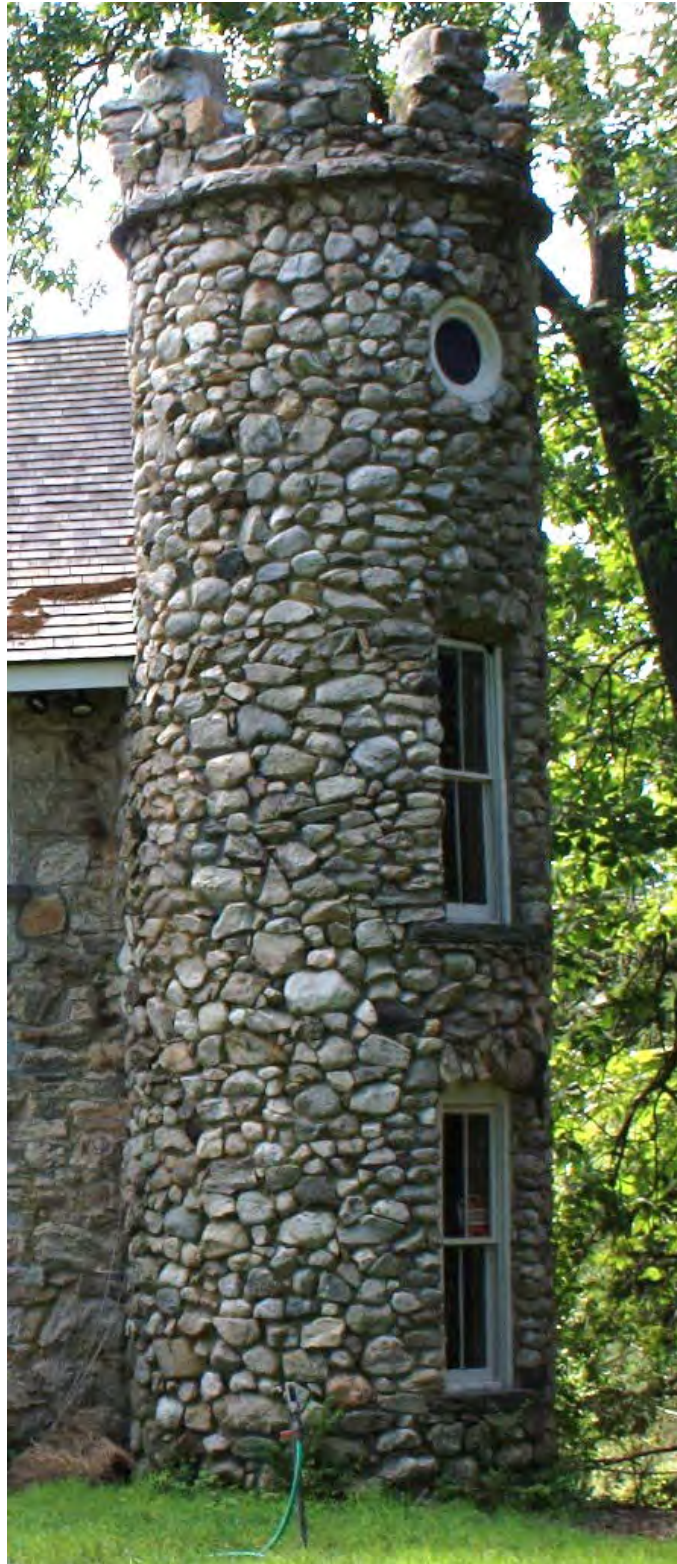
On the northeast side of the turret are three windows in a vertical line; two, two-over-two double-hung windows on the first and second level and a round window with trim just beneath the crenellation.

9. Northeast side of the turret, camera facing southwest.

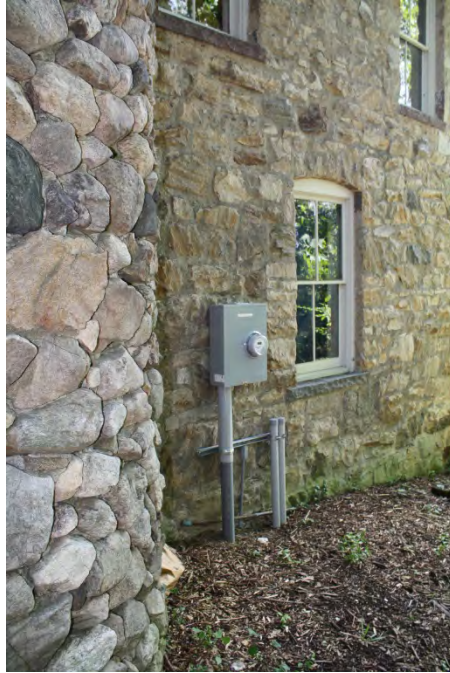
The north gable-end of the barn has three two-over-two double-hung windows with trim; one centered on the first level and two equally spaced on the second level. A rose tinted ocular window with trim is located just beneath the apex of the roof in the gable attic.

10. North gable-end of the carriage barn connected to the turret, camera facing south.

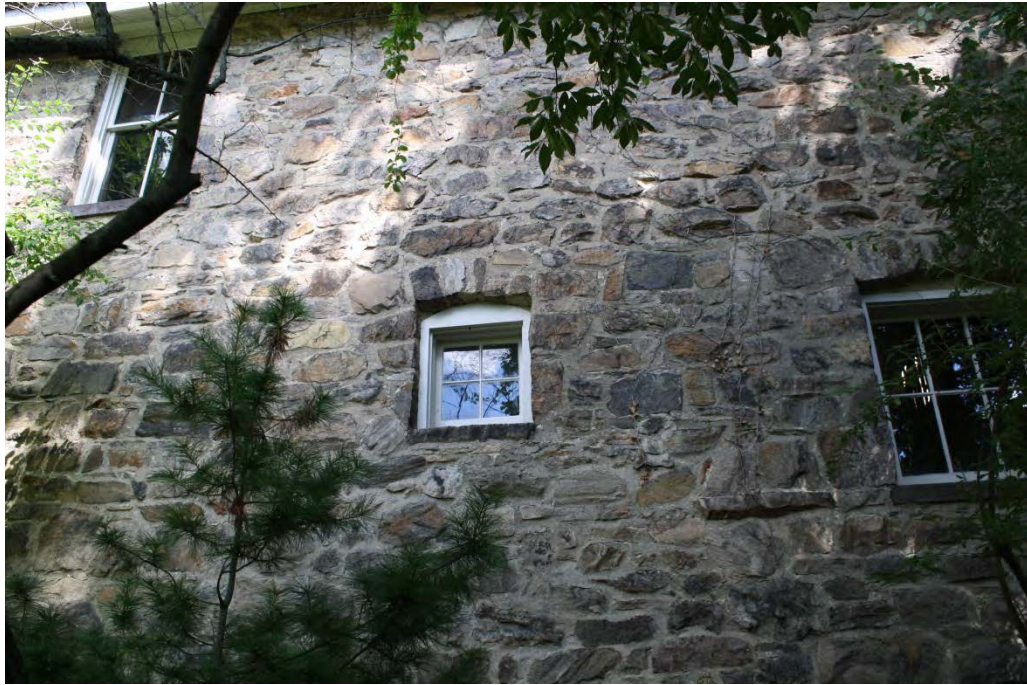
The west eave-side of the carriage barn has three windows, each one different. The main level has two windows; a small centered four-pane window with a stone arched head and a larger six-pane window under a stone arch in the south bay. The third window is a two-over-two double-hung window with trim in the north bay of the second level. Off-center to the south at ground level is a filled-in stone arch, spanning approximately four feet.

12. West eave-side of the carriage barn, camera facing east.

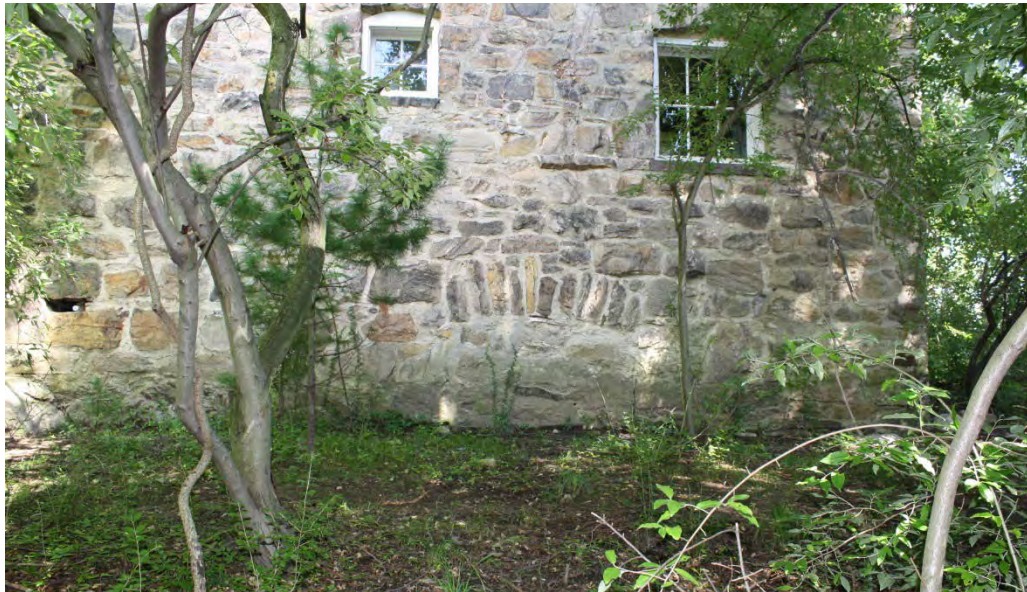
13. West eave-side of the carriage barn, filled-in arch, camera facing east.

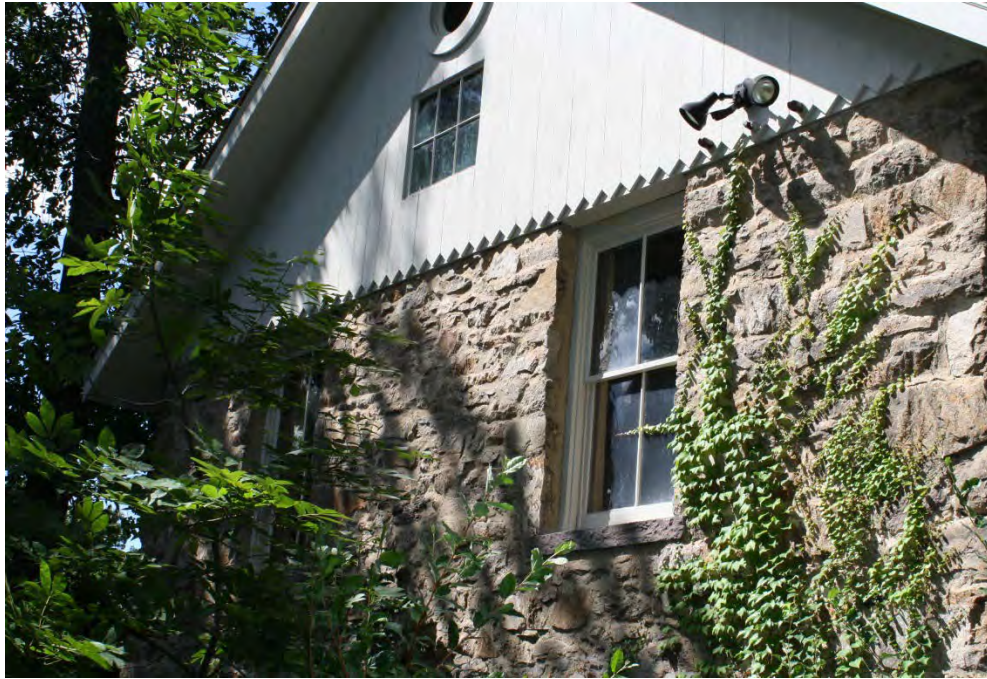
The south gable-end of the carriage barn has two equally spaced six-pane interior-swinging windows in arched openings on the first level and two, two-over-two double-hung windows with stone sills above in the second level. In the gable attic of the south gable-end of the barn are a six-pane fixed window above the girt line siding divide and a rose tinted ocular window with trim just below the apex of the roof. The girt line siding divide on all sides have saw-tooth trim.

14. South gable-end of the carriage barn, second level, camera facing northwest.

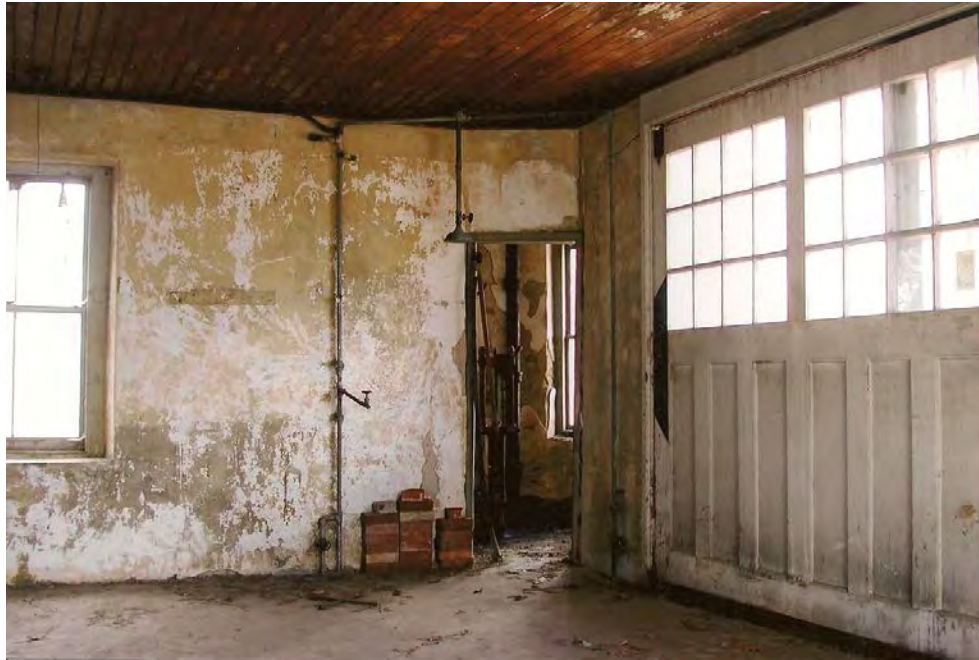
The main entry and the south pass-through door on the main façade access the main floor of the carriage barn, measuring approximately 22' x 28'. The floor and walls of the interior first level are concrete. The walls show signs of white and yellow paint, but much of it is faded and/or flaked off. The width of the walls is consistent throughout, roughly 20" wide. The floor is unpainted. Centered in the floor is a square metal drain. The ceiling of the first level is stained wood bead board. The northeast corner of the room is beveled and has a doorway that lead to the turret. Just west of the entrance to the turret is piping that runs from the floor to the ceiling, ending in a showerhead.

16. First level interior of barn, main entry and entry to turret, camera facing northeast.

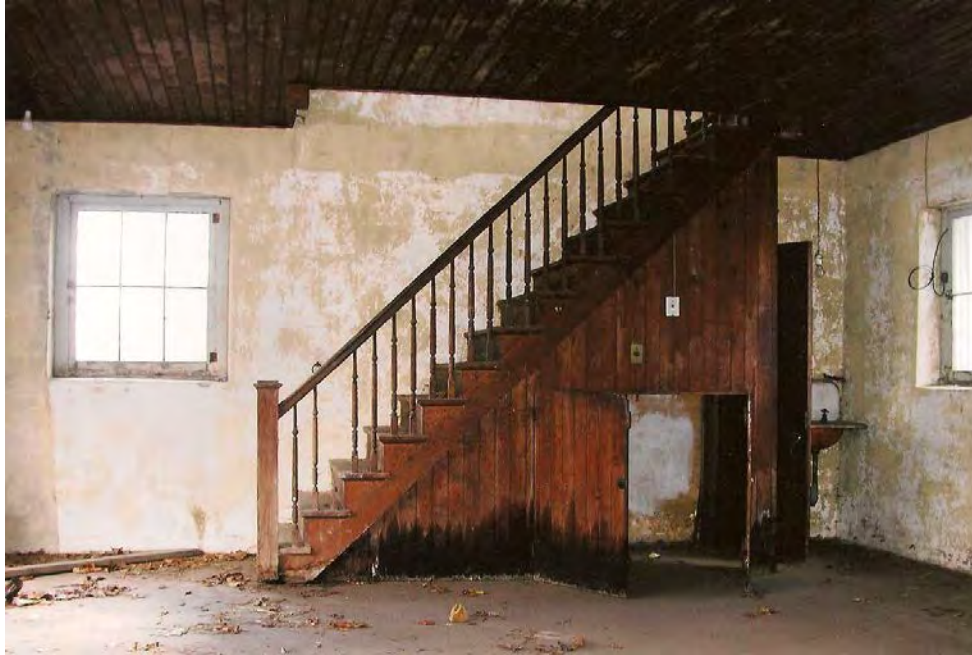
Against the south wall in the interior is a set of wood stairs that run east-west to the second level. The stair carriage is stained vertical wood bead board and has a pair of swinging hinged access door in the center at grade that open to the north. The stair case begins six feet from the south pass-through door and ends about six feet from the west wall. The resulting nook between the end of the staircase and the west wall has a stand-alone sink on the south wall. A full-sized door leads from the nook to the under area of the staircase. The turned spindle balustrade staircase has fourteen risers and ends at the southwest corner of the second level. The balustrade wraps around the stairway opening.

17. First level interior of barn, stairway to second level, camera facing south.

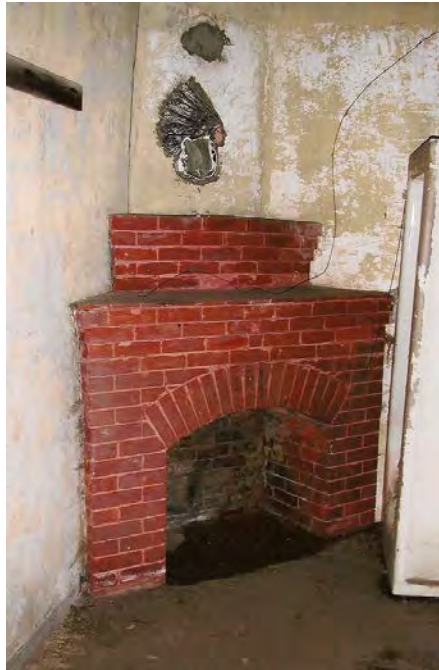
The northwest corner of the room is beveled and has a brick corner fireplace with a corbeled mantle. The fireplace spans halfway up the wall. Above the fireplace is a patched hole in the wall that appears to have been access through the wall to the exterior.

18. First level interior of barn, fireplace, camera facing northwest.

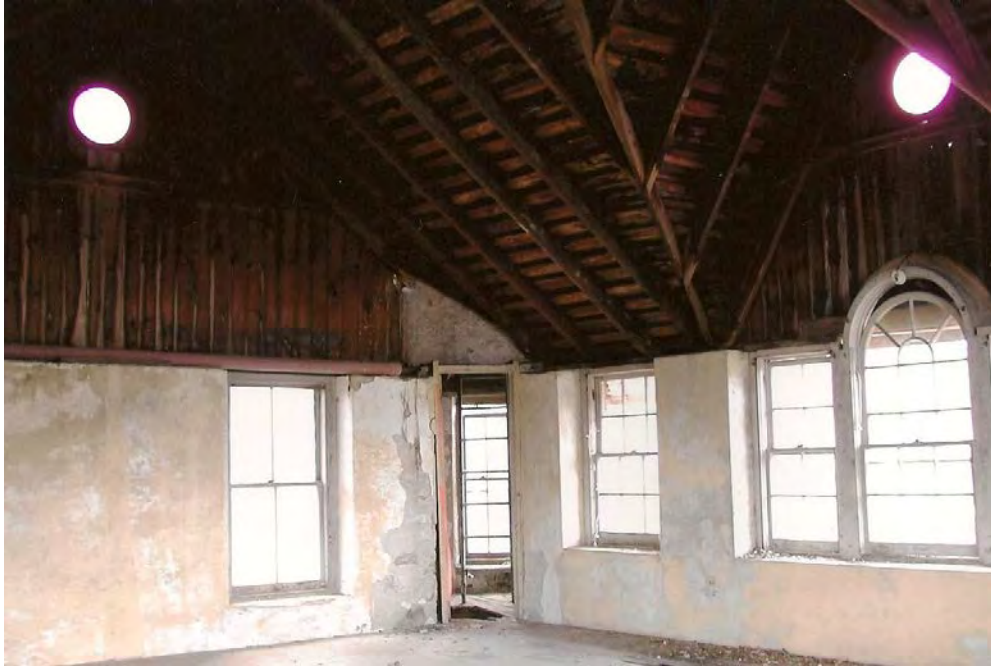
The interior of the turret has a ladder on the east side leading to the roof, which has a temporary repair of plywood. The roof is partially collapsed. There are two landings that the ladder once accessed; one adjacent to the second level and accessed by the second level entry (as well as the ladder), and the other just below the circular window on the northeast side of the turret. The interior condition of the concrete walls of the turret is poor and in need of immediate attention. A water main is in the north portion of the main level of the turret.

20. Second level interior of barn, entry to turret, camera facing northeast.

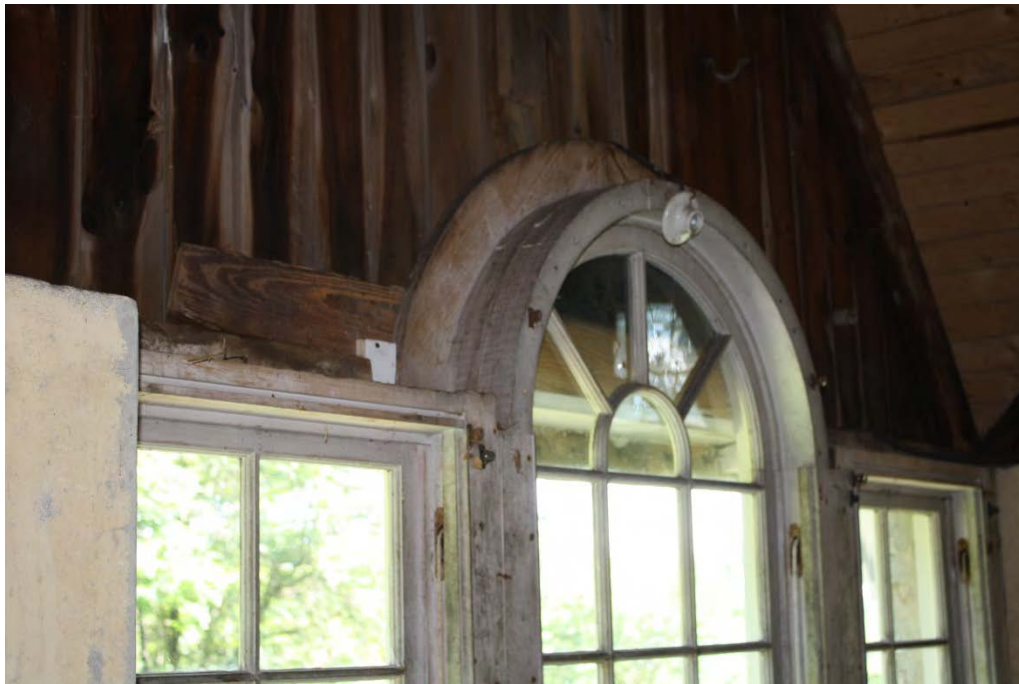
The second level of the carriage barn is a single open room, measuring approximately 18' x 28'. The floor is hardwood with the grain running north-south. The walls are plain concrete with faded and flaking white and yellow paint. The ceiling is the underside of the roof and includes rafters of sawn dimensional lumber and roof boards. The north wall in the northwest corner of the second level of the carriage barn has a portion of the brick chimney exposed. The chimney bumps out from the north wall about three inches. It was once covered with a thin layer of concrete and painted over, but portions of the concrete have failed, revealing the brick beneath. A section of a stove pipe extends out of the top of the exposed chimney above the eave that is secured with mortared fieldstone. The south wall of the southeast corner of the second level of the carriage house has an electrical box. The northeast corner of the carriage barn has a beveled corner with a door frame, sans door, leading to the turret. Above the door frame is exposed concrete of the turret. The interior gable-ends are the underside of the exterior vertical wood siding, unpainted. The gable-ends siding is supported by a horizontal plate and purlin below the ocular window, not with studs. The wall dormer Palladian window, partially covered by the exterior vertical siding, is fully revealed in the interior.

21. Second level interior of barn, detail of Palladian window, camera facing southeast.

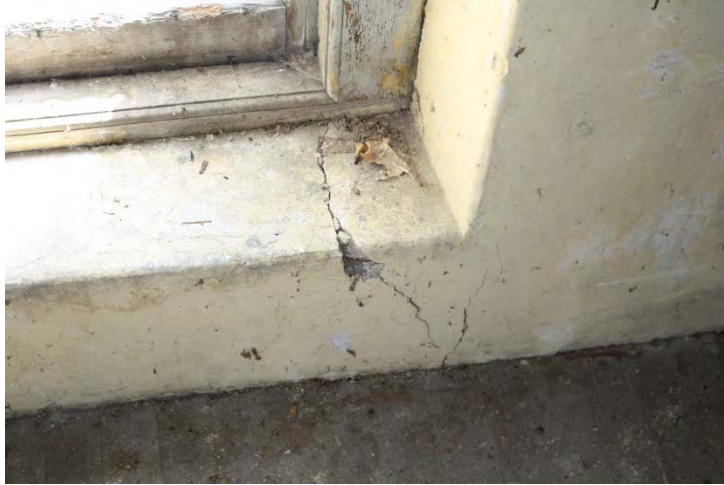
22. Second level interior of barn, detail of failing concrete.

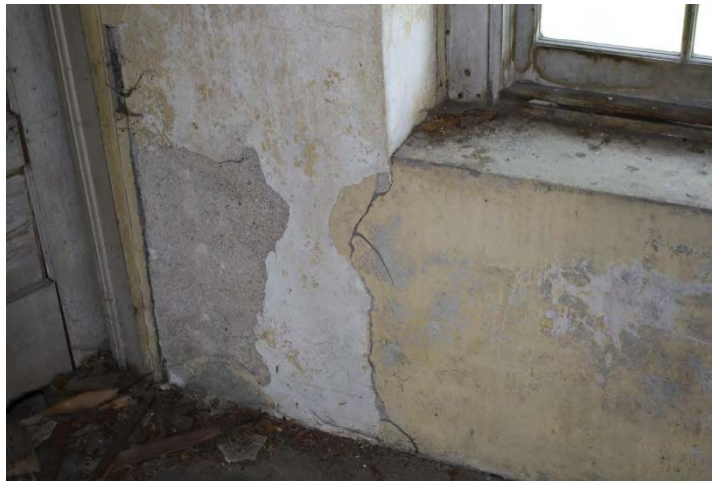
23. Second level interior of barn, detail of failing concrete.

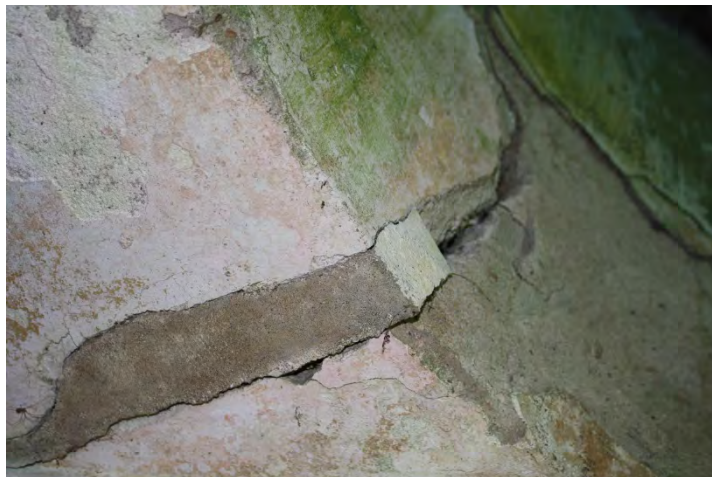
24. First level interior of barn, detail of failing concrete.
