HISTORIC RESOURCES INVENTORY - BUILDING AND STRUCTURES

Building Name (Common) Ames, Fredrick, Farmstead Record No. 33600
 Building Name (Historic) Ames, Fredrick, Farmstead
 Street Address or Location 157 Ames Hollow Road
 Town/City Portland Village _____ County Middlesex
 Owner(s) Judy and John Harper, 157 Ames Hollow Road, Portland CT 06480 Public Private

Tobacco shed:

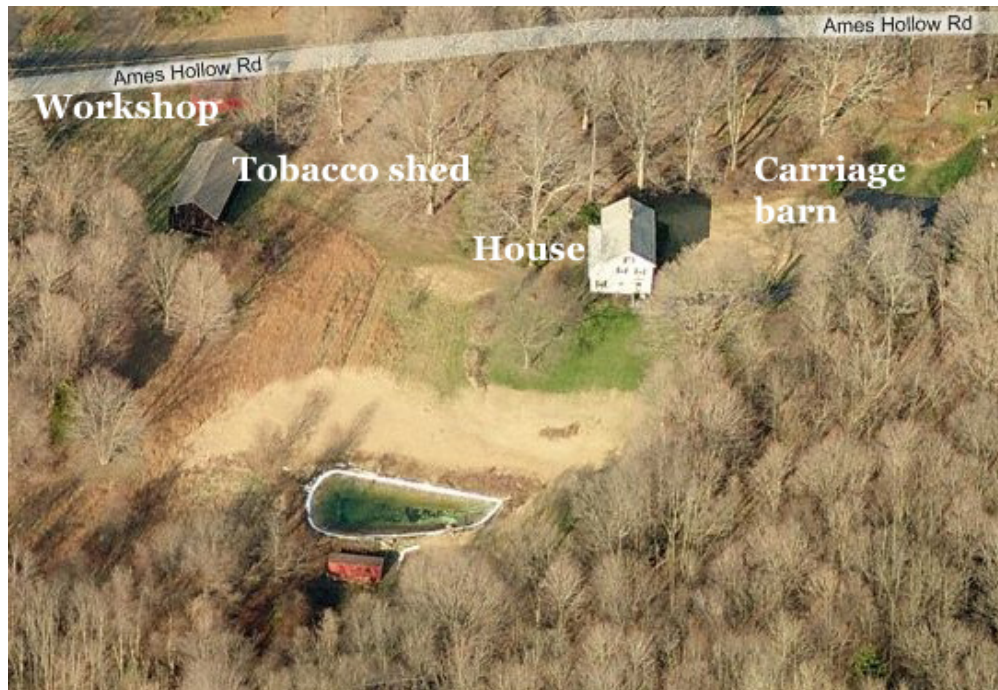
3. South view – aerial “bird’s-eye” map of 157 Ames Hollow Road, Portland, CT – <http://www.bing.com/maps> accessed 5/08/2012, showing contributing resources.

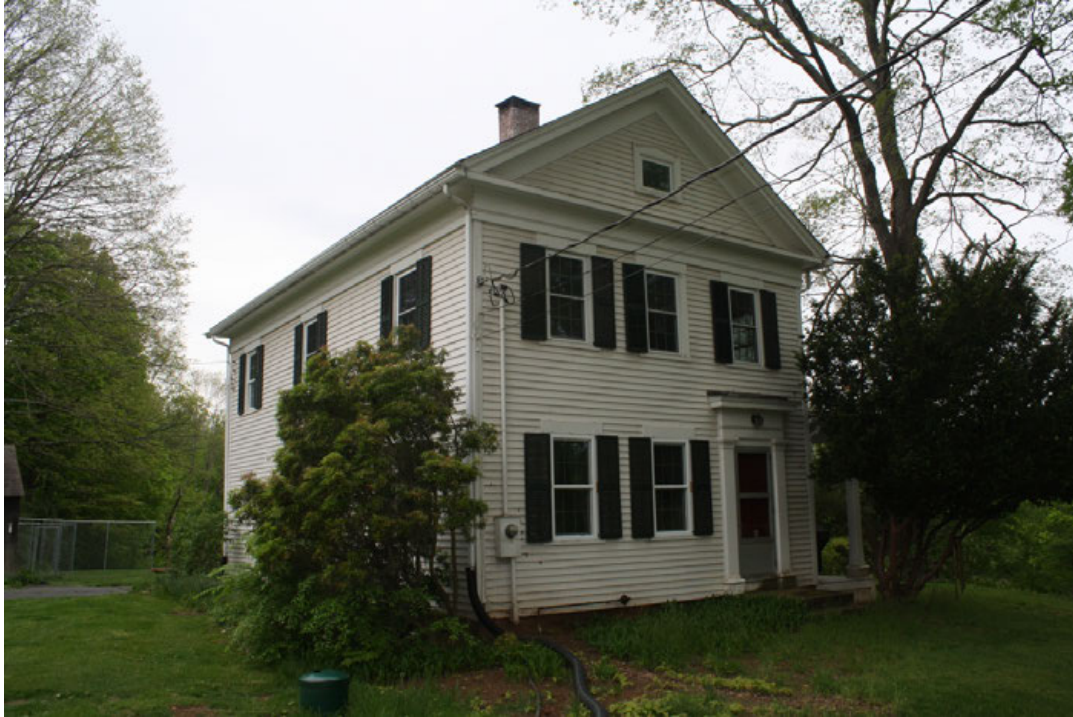
5. Northeast view of c. 1865 Greek Revival-style Farmhouse, camera facing southwest.

The 2 ½-story, three-bay, center chimney, side hall plan Farmhouse is an example of vernacular Greek Revival style. This wood-framed house has its north gable-end as the main façade; it rests on a granite block foundation and is sided in clapboards painted white. The building exhibits typical Greek Revival-style details including pilasters and high entablature around the front door, and pedimented gable-ends lit by small rectangular attic windows. A single story ell extends to the west of the house. The late 19th-century Carriage house is 24' x 30' and made of square rule, wood pegged mortise and tenon joinery of chestnut and oak. It originally had three horse stalls for plow horses for the farm. The gable-roofed workshop was used as a blacksmith shop, complete with forge and brick chimney. The pool house and modern sheds were built in the mid-20th century.

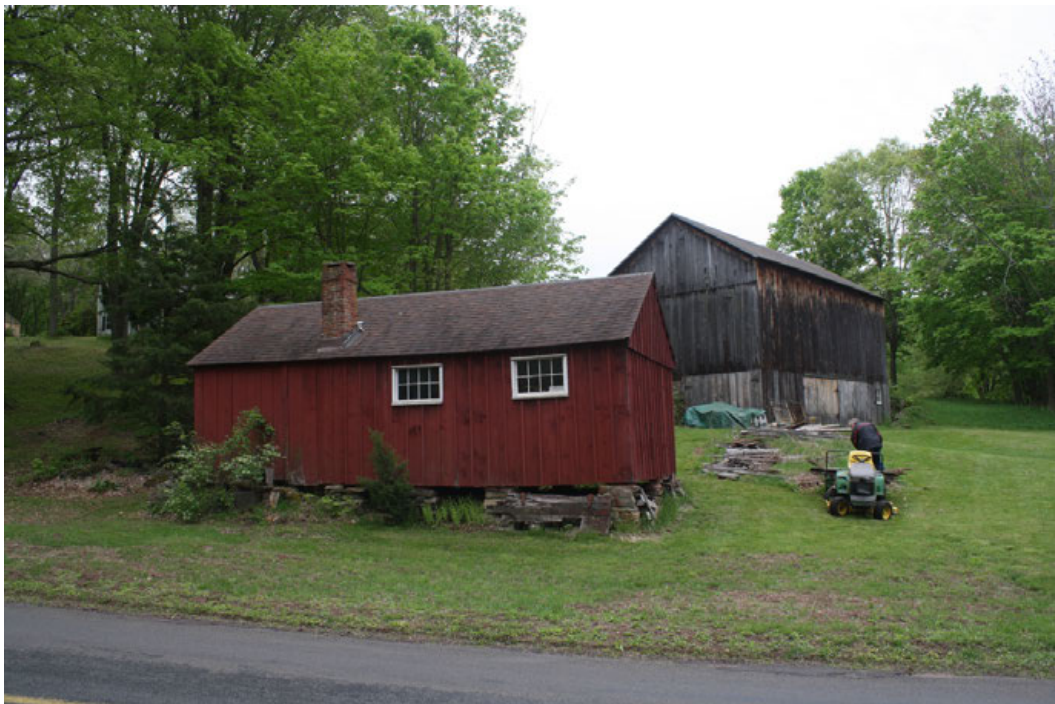
7. Northeast view of Tobacco shed, camera facing southwest.

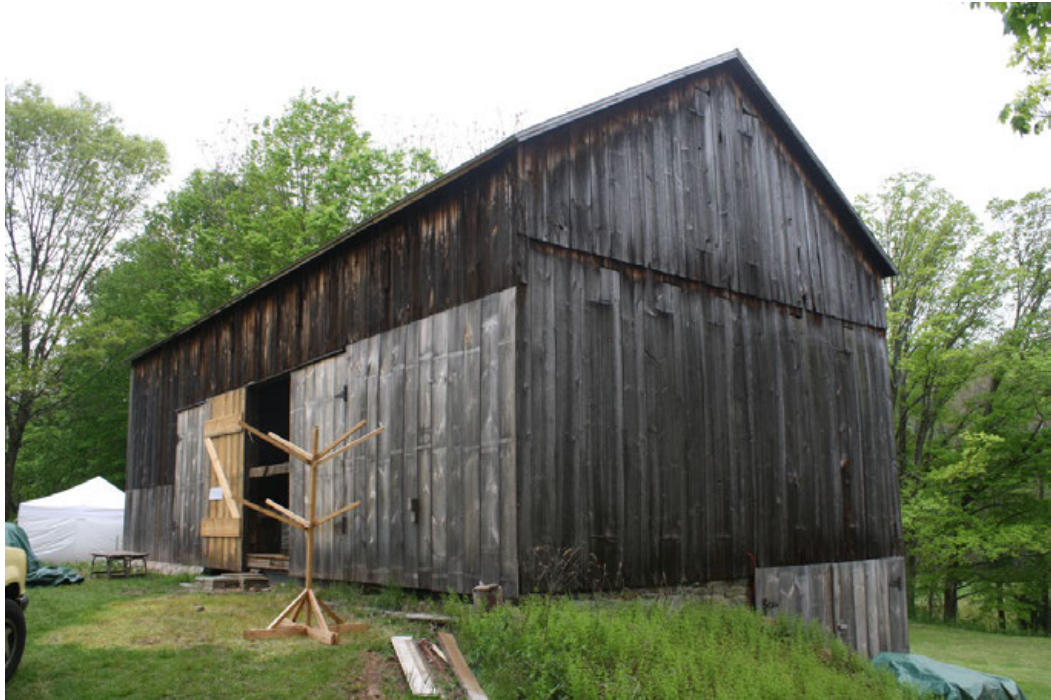
8. East view of Tobacco shed, camera facing west.

The main entries of the shed are on the east eave-side façade and consists of two pairs of Z-braced wagon doors in the center two bays. The rest of the facade is blank and there is no evidence of alternate venting other than the

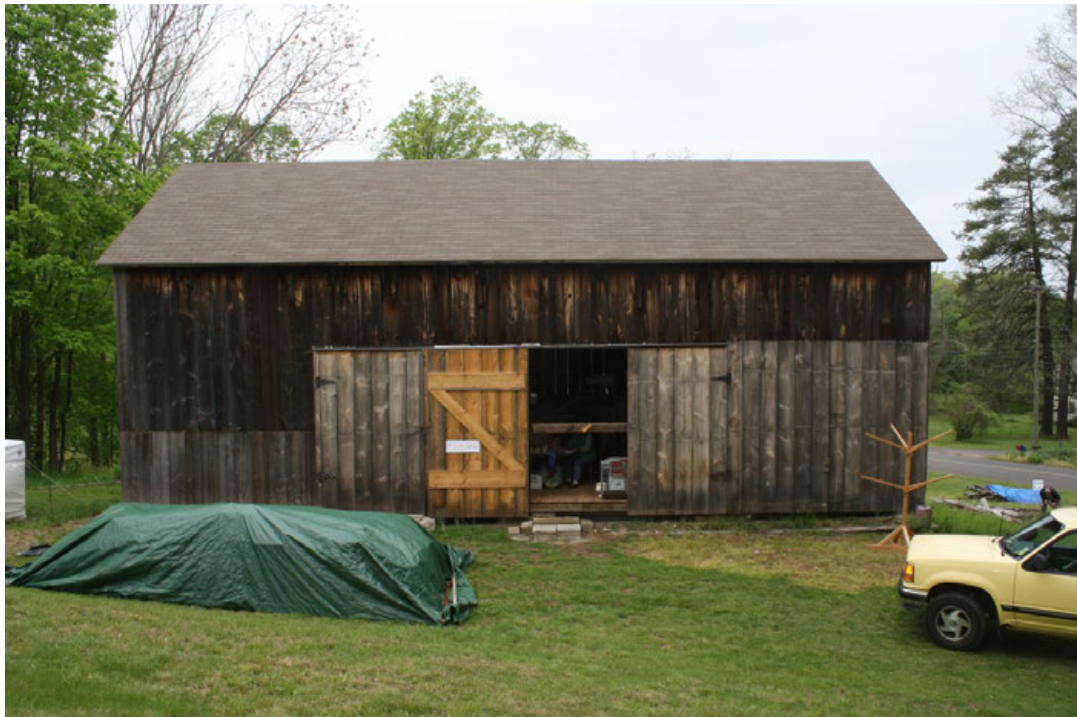
9. South view of Tobacco shed, camera facing north. Workshop is at left rear.

The west eave-side of the shed has a pair of bay-wide overlapping exterior sliding doors in the basement level, slightly off-center to the south. North of the doors is blank. South of the doors is a pass-through door and a fixed six-pane window. The main level of the west eave-side of the shed has a series of vertical wood board side-hinged vents. The grade at the south gable-end of the shed inclines sharply to the east and a stone retaining wall extends to the south from the southwest corner of the shed. The main level of the south gable-end of the shed has a pair of hinged doors in the east half. The rest of the gable-end is blank, although it originally had side-hinged vents. The shed was restored in 2010.

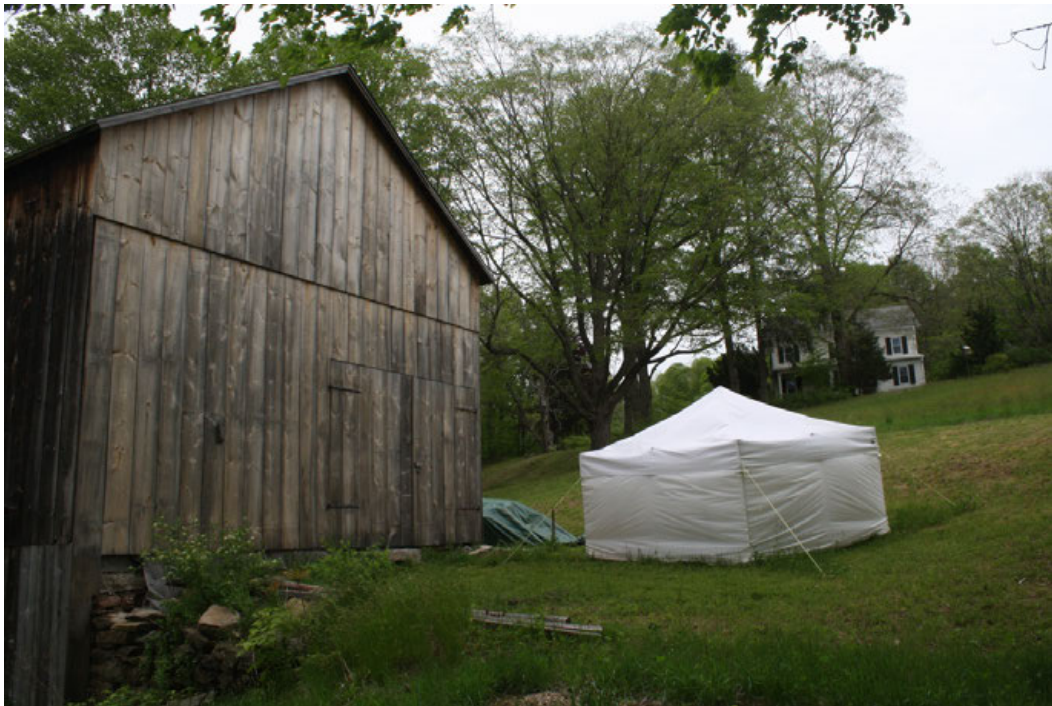
10. Southeast view of tobacco shed, camera facing northeast. Note farmhouse up the hill on the right.

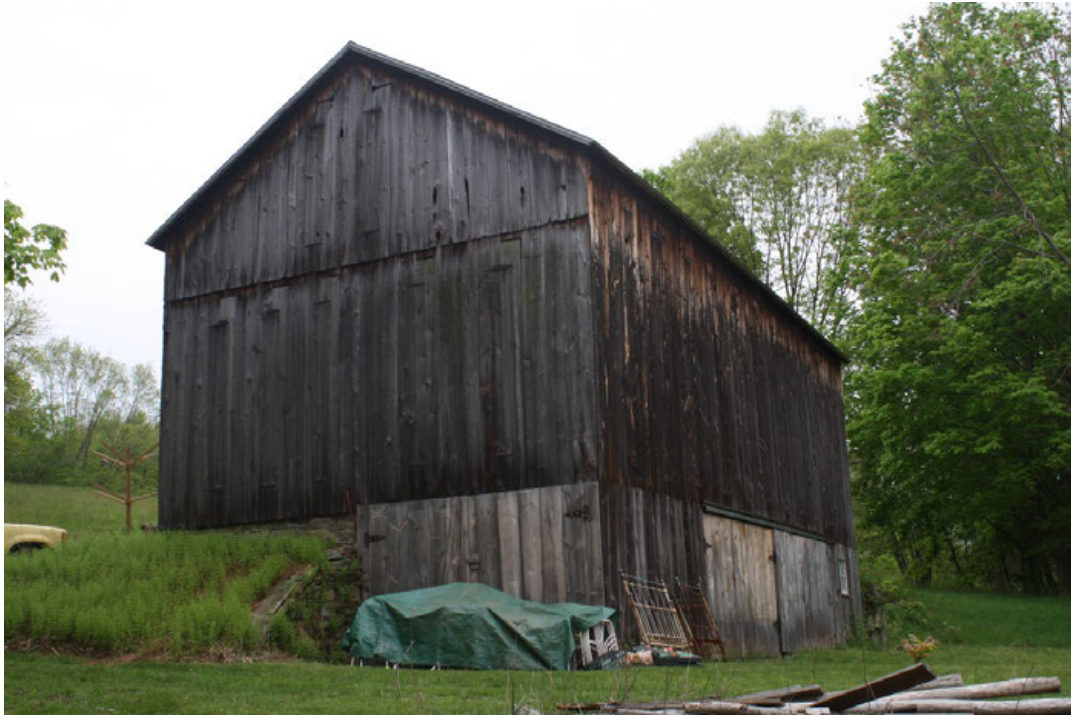
11. Northwest view of tobacco shed, camera facing southwest.

doors. The grade at the north gable-end of the shed declines from east to west, revealing a foundation and basement level. The western half of the basement level has a pair of hinged doors and the eastern half is the mortared fieldstone foundation. The main level of the north gable-end of the shed has a series of vertical wood board side-hinged vents, used for the curing of tobacco. The gable attic is separated from the main level by a dropped girt line siding divide. The gable attic has two side hinged vents.

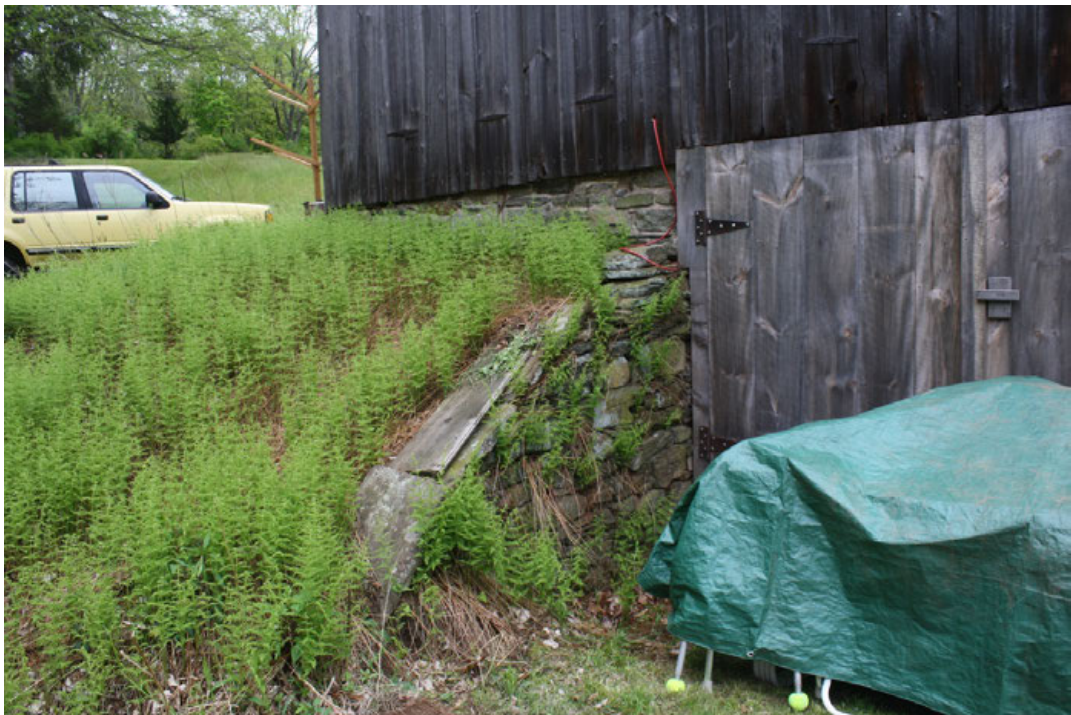
12. Detail of basement level north gable-end of tobacco shed and diminishing retaining wall, camera facing south.

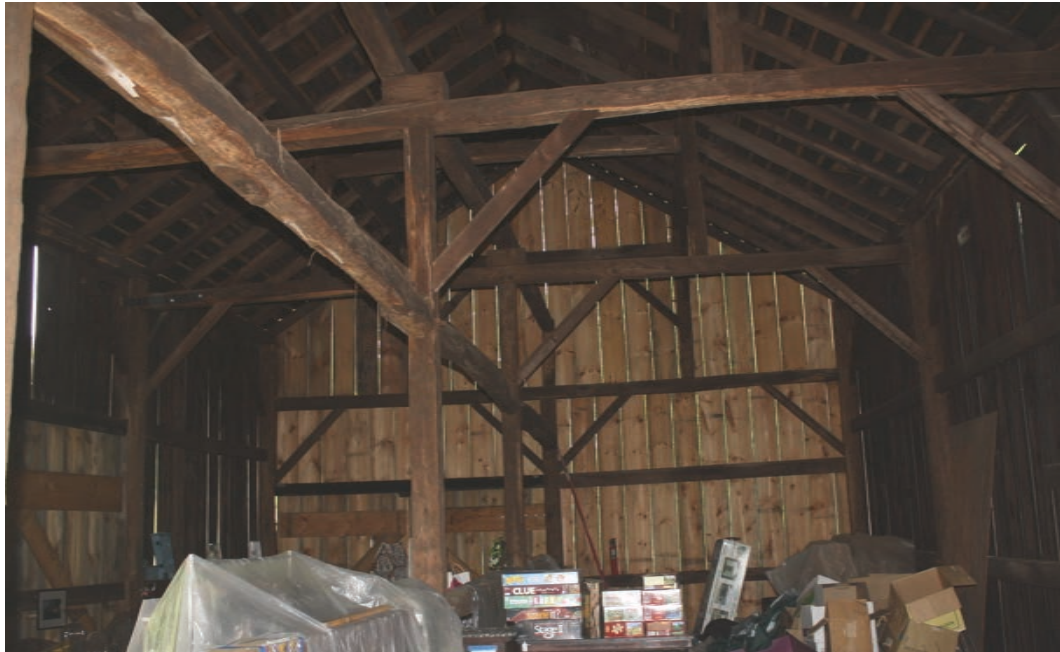
13. Interior view of Tobacco shed, camera facing south. Note new sheathing on the south gable-end.

The shed is built with square rule construction mortise and tenon joinery using primarily chestnut interspersed with oak posts and beams, queen trusses, oak pegs with hemlock diagonal bracing and dropped girts. The post and beams are hand-hewn except for the vertically sawn rafters, diagonal braces and nailing girts. The post and beams measure 7" x 7", the nailing girts measure 4" x 6", and the gable-ends dropped girts measure 6" x 6". The two main entries open into the middle two bays (of four). Each bay is 12' wide and 24' deep. The rafters are butted at the ridge without a ridge board. Original roof boards are evident, with new plywood over them. In 2010, renovations occurred that included resheathing the entire south gable-end, resulting in the removal of the original side-hinged vents. Other renovations include principal post repair, foundation repair and sheathing replacement where rotted.

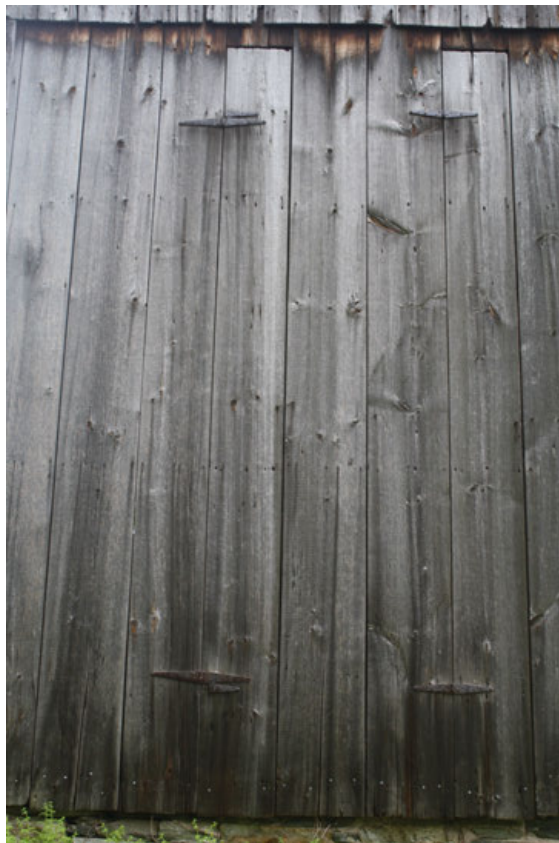
14. Detail of north gable-end of tobacco shed, side-hinged vents, camera facing south.

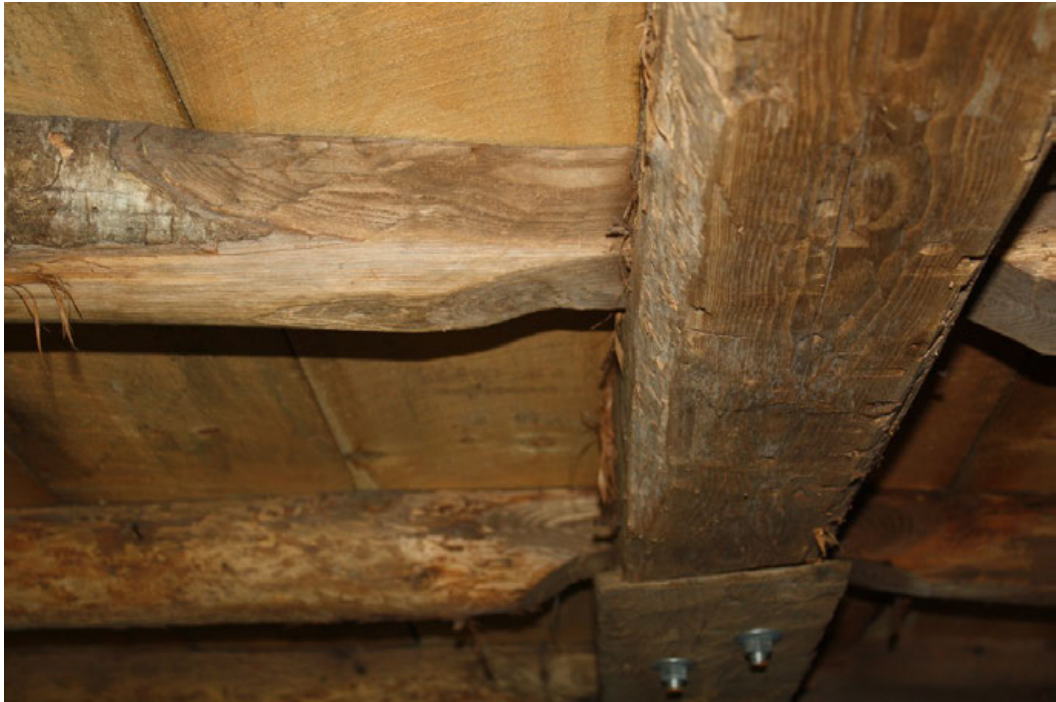
15. Interior basement detail of tobacco shed, camera facing east.

The basement level of the barn has unfinished square rule constructed ceiling beams, a concrete basement floor and exposed fieldstone foundation.

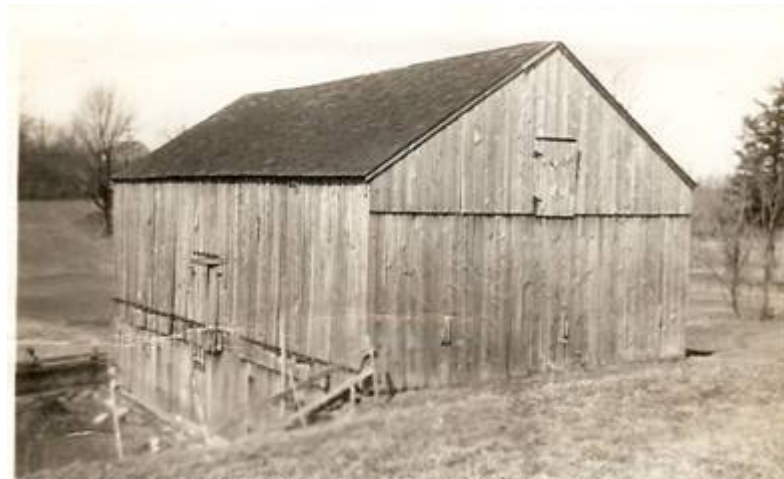
18. Historic photo from the 1950s of the English bank barn (hay barn), now gone.

The current site of 157 Ames Hollow Road originally had more outbuildings than today. A second tobacco shed was torn down in 1957. It was a contemporary of the extant shed and was to the west of it, near the road. A large English barn was disassembled in 1970s and some of the chestnut was used in the restoration of both the tobacco shed and the carriage barn. It was to the southwest of extant shed. Its unmortared fieldstone foundation can still be seen. There was originally a sheep barn to the south of the English barn, now gone as well.

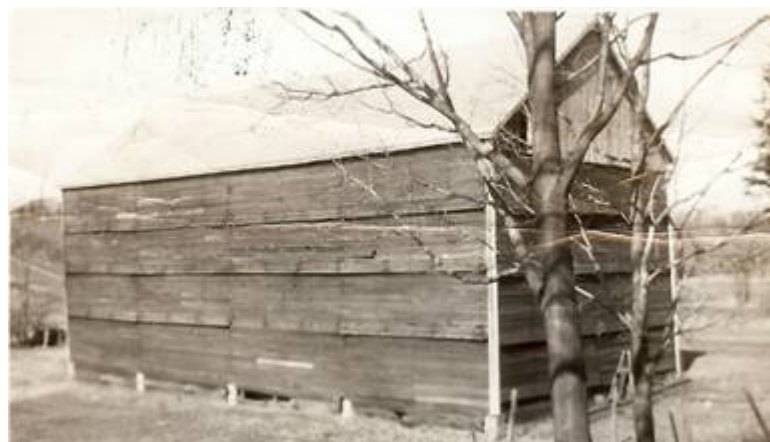
19. Historic photo from the 1950s of the second tobacco shed on the site, now gone.
