HISTORIC RESOURCES INVENTORY - BUILDING AND STRUCTURES

Building Name (Common) Gonzales, Roger, Antiques Record No. 39298
 Building Name (Historic) Swift, Henry, / Dunbar, Everett and Helen, Farmstead Barn
 Street Address or Location 99 Warren Hill Road
 Town/City Cornwall Village Cornwall Bridge County Litchfield
 Owner(s) Roger Gonzales, 99 Warren Hill Road, Cornwall Bridge CT 06754 Public Private

Present Use: Commerce/trade: professional; Domestic: single dwelling
 Historic Use: Agriculture/Subsistence: agricultural outbuilding
 Accessibility to public: Exterior visible from public road? Yes No
 Interior accessible? Yes No If yes, explain By appointment
 Style of building Extended English bank barn, Vernacular style Date of Construction c. 1780

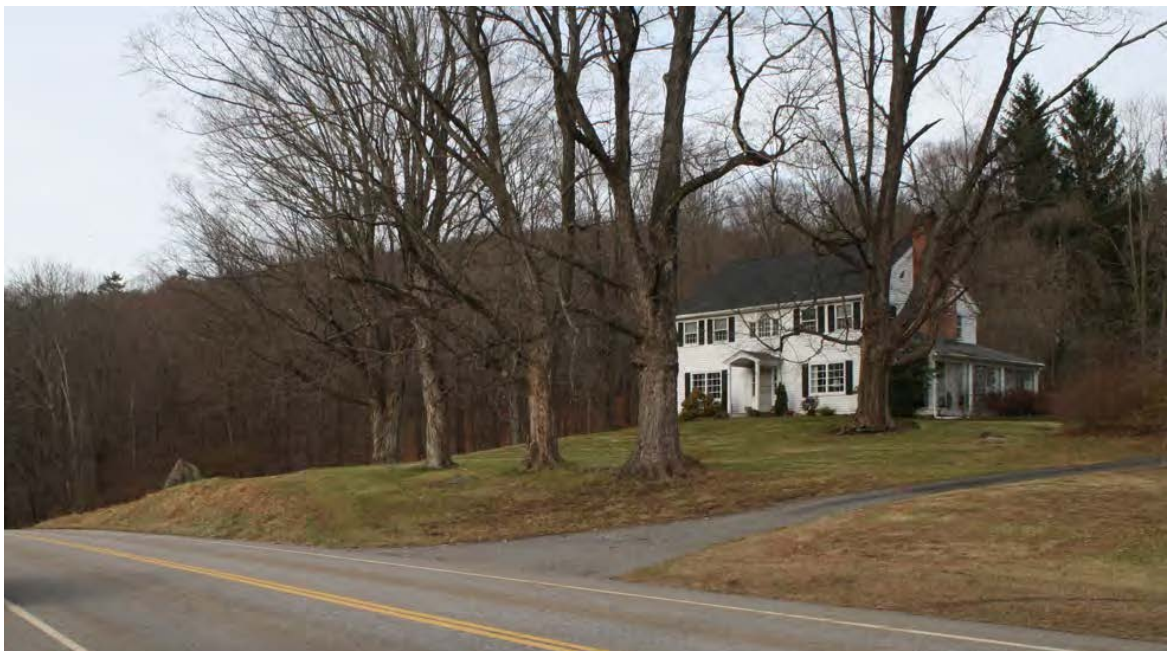
4. Southwest view of 98 Warren Hill Road, formerly associated with the Barn at 99 Warren Hill Road. Note the row of maple trees; prior to 1932, the road was aligned between trees and house. Camera facing northeast.

In 1932, the road realignment resulted in moving of the barn and installation of its new foundation. This may well have been the first time it had a basement, as the evidence suggests cows had been stabled on the main level. The Fairchild aerial photograph of the site shows the barn in its new location and the road re-aligned through the barn's former site. The track of the former road can be seen curving closer to the farmhouse.

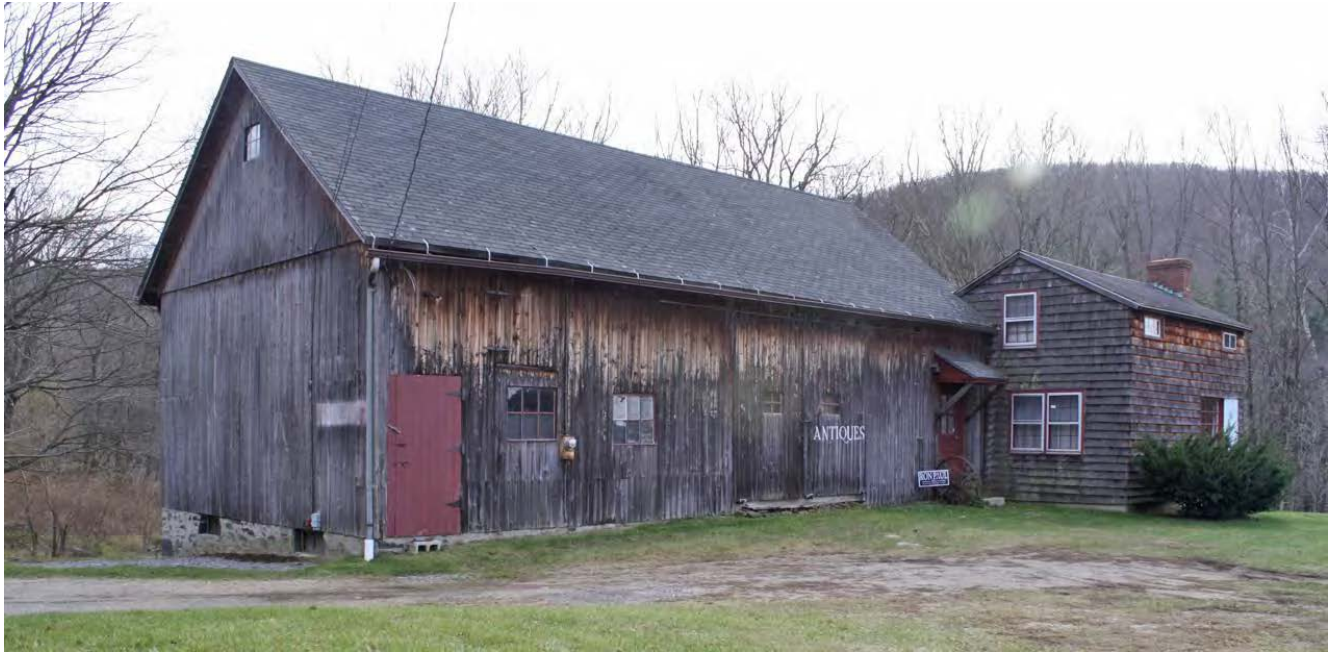
5. Northeast view of Barn and c. 1960 Residence, camera facing southwest.

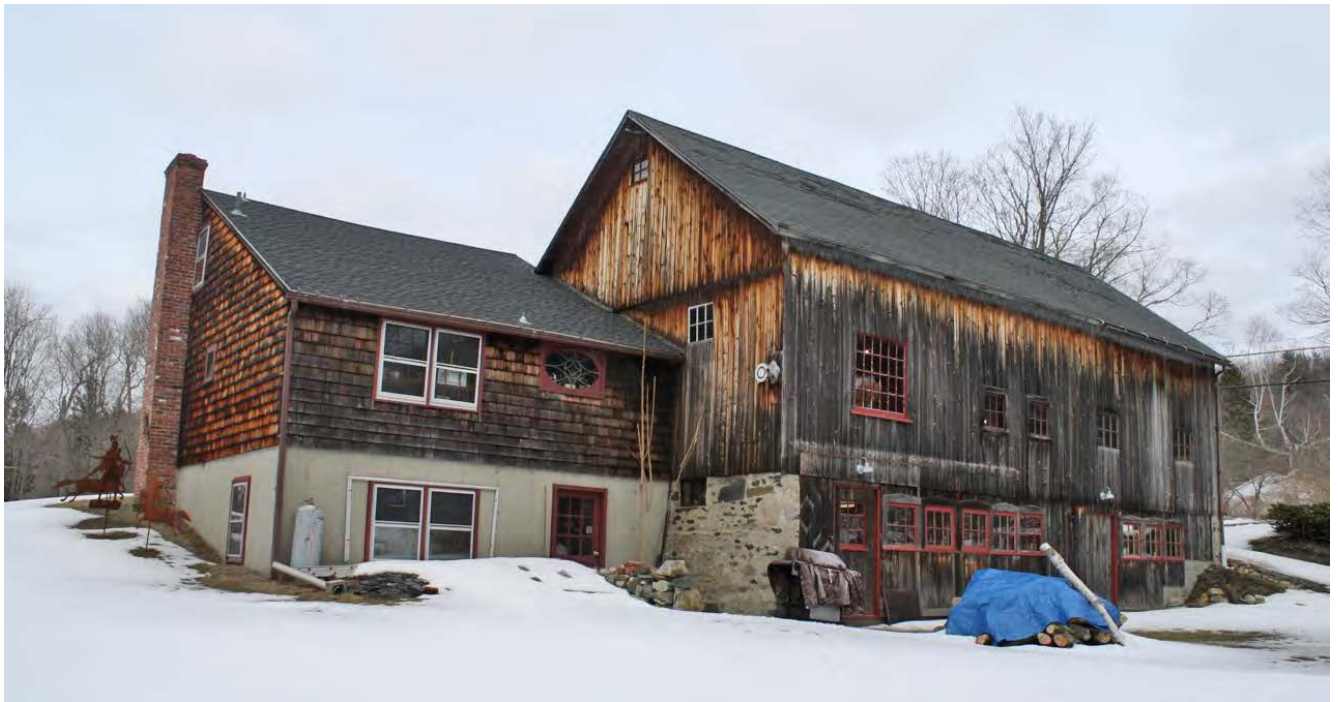
6. Southwest view of c. 1960 Residence and Barn, camera facing northeast. Compare with Figure 7 for recent alterations.

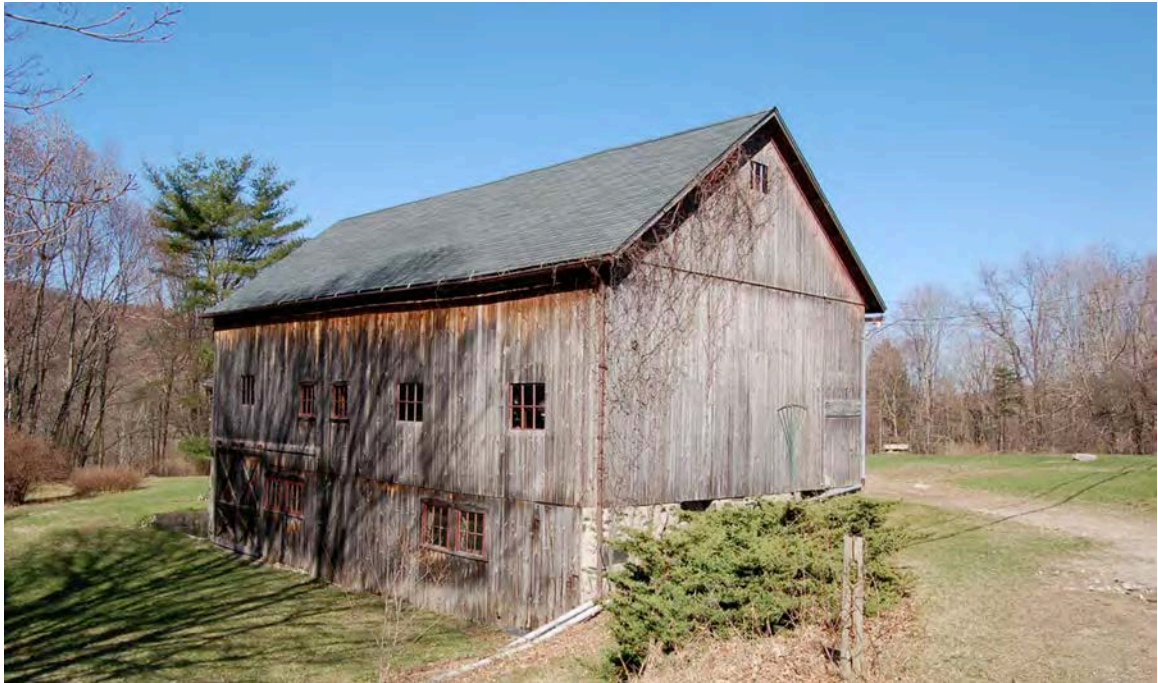
7. Southeast view of Barn, camera facing northwest. Photograph (taken about 2009) courtesy of Alec Frost; note the sliding barn door at the basement level, subsequently replaced by a pass-through door, and the stable window at the main level, replaced by a larger sash.

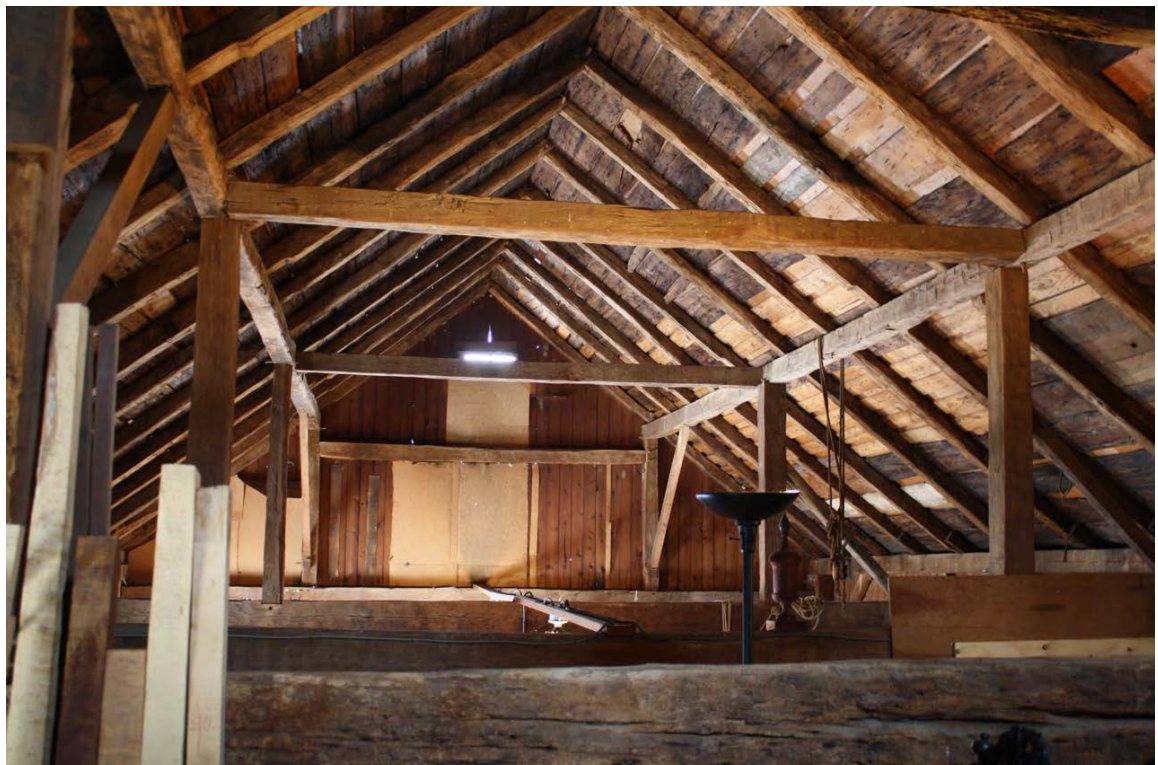
The interior consists of a four-bay post and beam frame with dropped tie-girts; the three western bays form a typical English barn frame, with the eastern bay a subsequent addition. The bents are designated from west to east, as 1-5. The two bents adjacent to the main door way (bents 2 and 3) span clear without a central interior post. Queen posts above the tie-girts support longitudinal purlin plates at the mid-span of the common rafters. The common rafters for the western three bays are hand hewn, and are half-lapped and pegged at the ridge, a common feature of early framing. Angle braces are at somewhat varied lengths and angles, an indication of early construction before square rule framing standardized the typical layout.

8. Interior view of Barn tie-girts and roof framing, camera facing west.

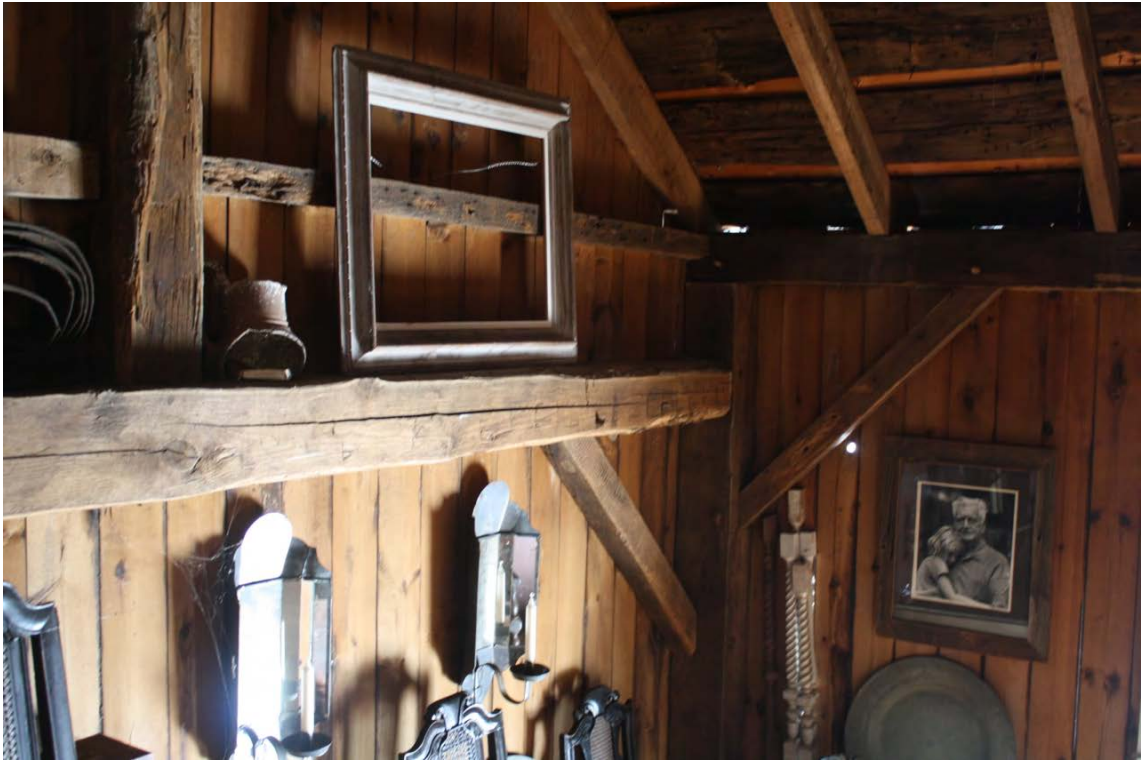
Rafters at the eastern bay are sawn dimension lumber. A slender wall girt at the eave line, above the dropped tie-girt, provides nailing for the exterior siding, resulting in the lack of a dropped siding divide as viewed from the outside. Timbers throughout are predominantly hand hewn, with some sash-sawn angle braces. Some joints show evidence of square rule framing, particularly the queen post connections to the tie-girts. Many of the angle braces in the western three bays are secured with a rare framing technique, using pegged shim blocks in the mortises.

9. Interior view of Barn southeast corner of added eastern bay, showing dropped tie-girt, sawn rafters, and wall girt at eave-line supporting exterior siding divide.

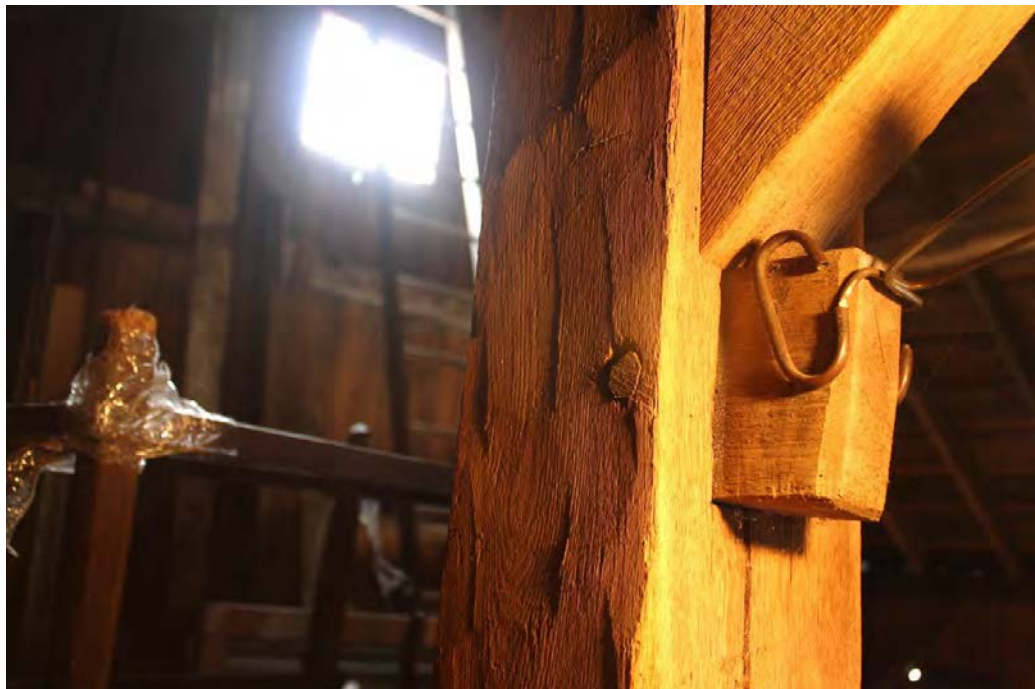
10. Interior view of Barn, showing post with pegged shim at angle brace joint; queen post at eastern interior bent (originally the eastern end bent). Camera is facing southeast.

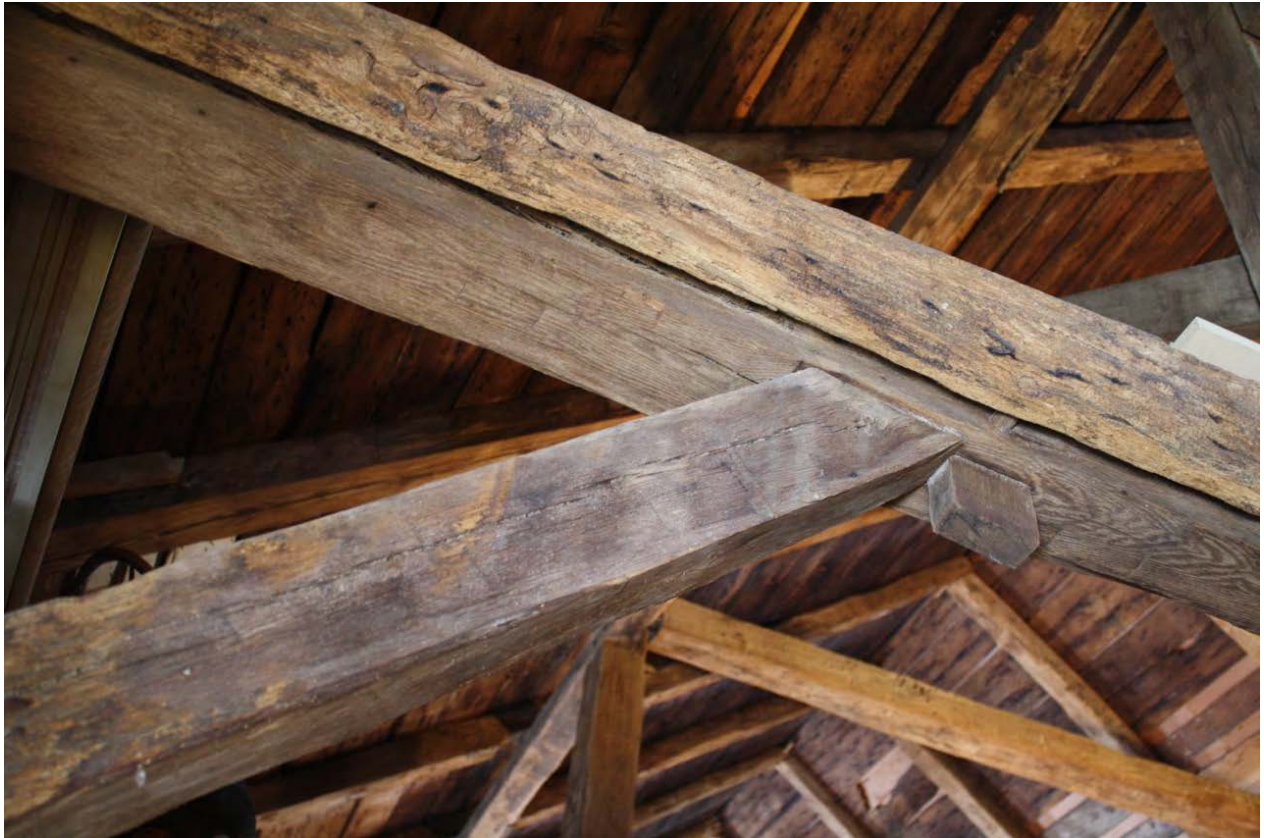
The easternmost bay is evidently an addition to the original three-bay structure, as the plates are discontinuous at the eastern interior bent, the posts are doubled to support the plates for the added bay, and the tie-girt of bent 4 has a rabbet in its lower face, as was traditionally cut to house the upper ends of the siding boards. This indicates its original function as the exterior end bent.

11. Interior view of Barn, camera facing west, showing the eastern interior bent (formerly the end bent) at tie-girt with pegged shim joint and rabbet to receive the top edge of siding boards.

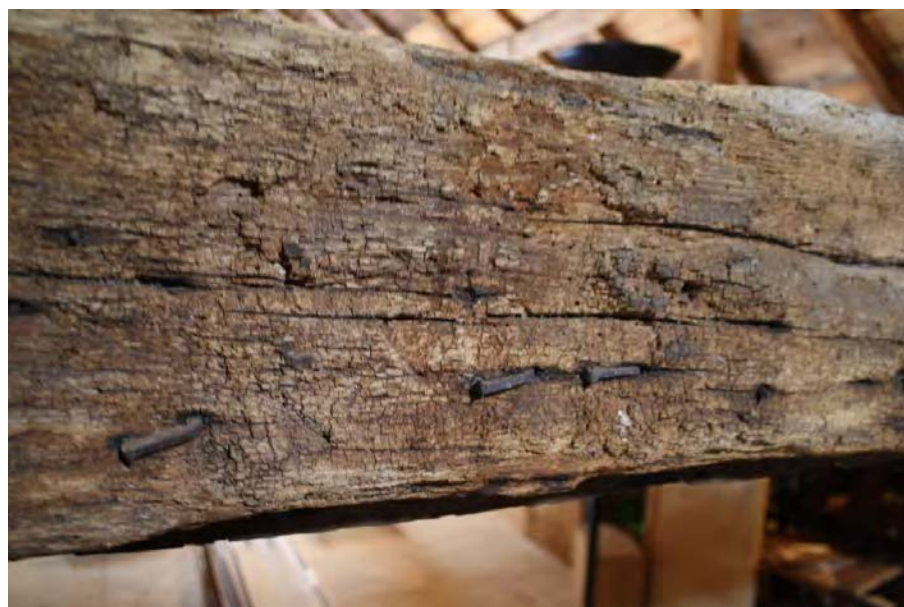
12. Interior view of Barn, camera facing west, showing the eastern interior bent (formerly the end bent) weathered surface and cut nails.

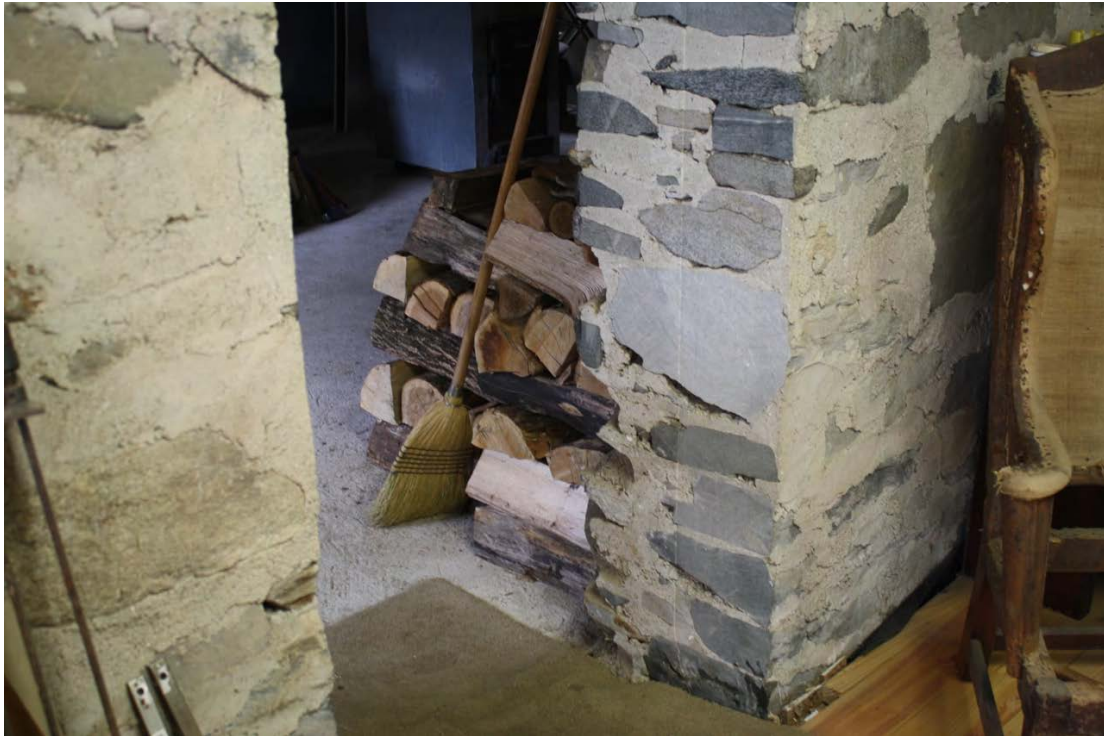
The basement, dating from the relocation of the barn in 1932, has a concrete slab floor. The joists supporting the main floor are of dimensional sawn lumber, also 20th-century. The south exterior wall of the basement level reflects use of the space for a cabinet workshop, with added insulation, doors, and windows. A doorway has been sawn through the west foundation wall to the basement of the residential structure.

13. Interior detail view of basement level of Barn, camera facing northwest; showing the 1932 west foundation wall where it has been saw-cut for an opening to the residential basement.

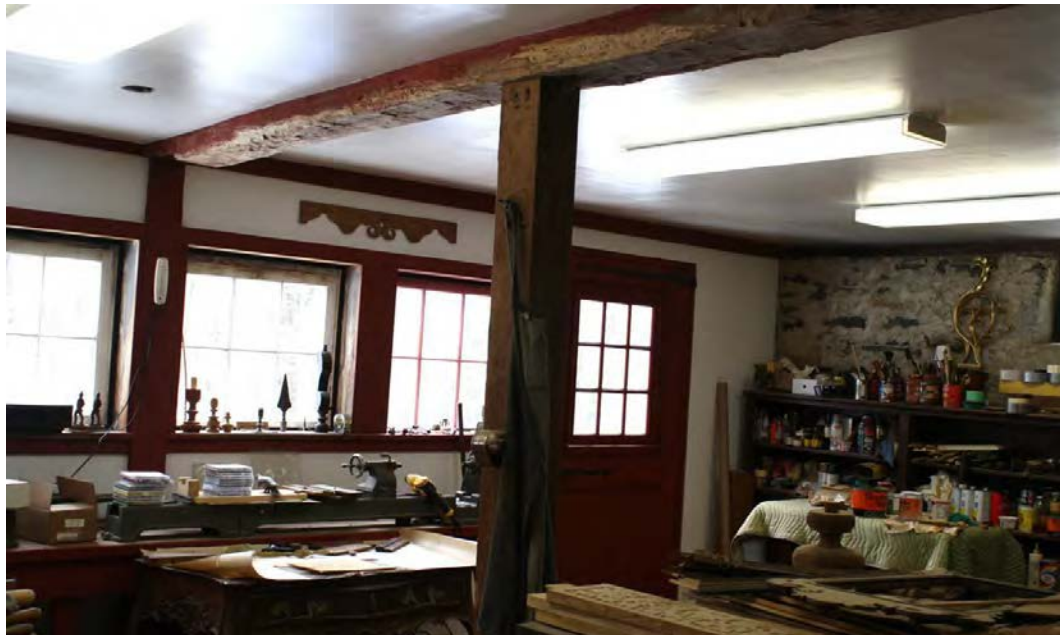
14. Interior view of Barn basement workshop, camera facing south.

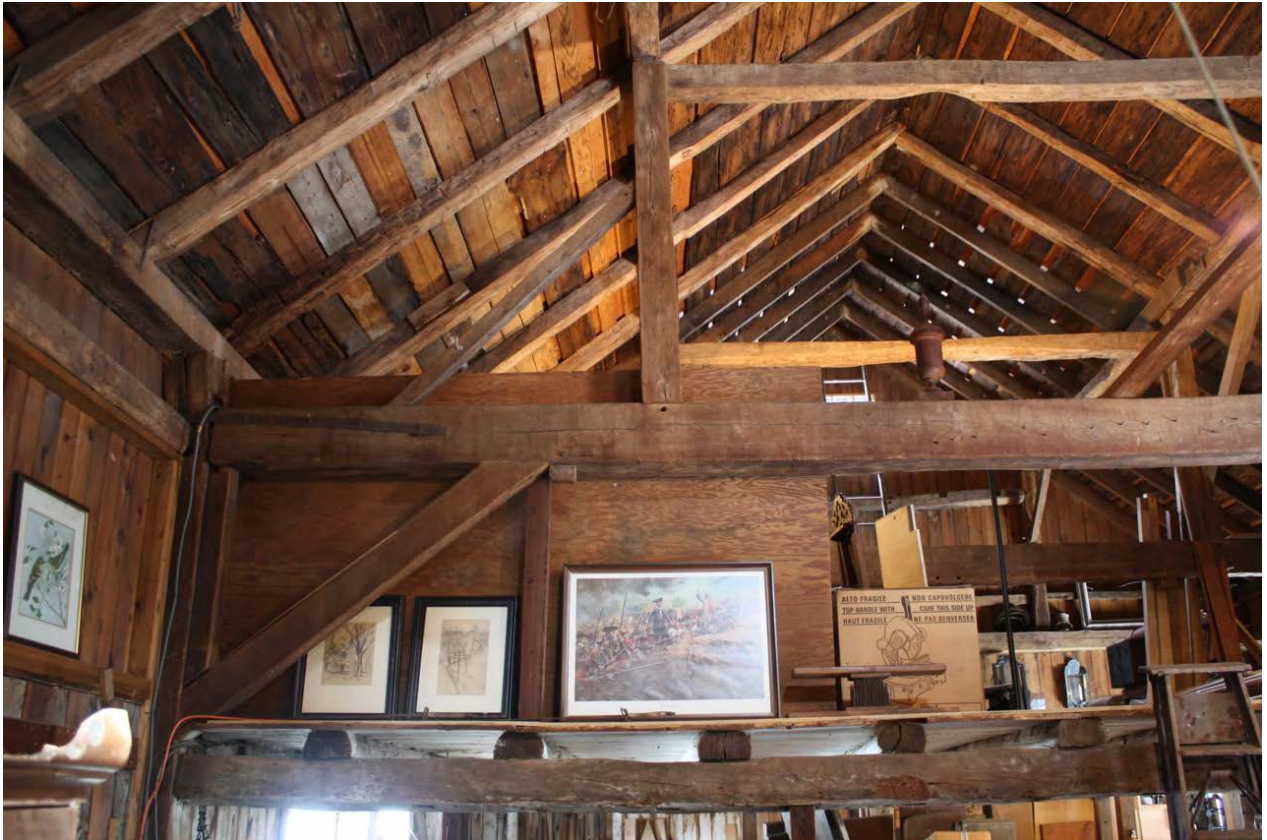
15. Interior view of Barn, camera facing east. Note iron repair strap at left end of tie-girt, pegged shim at angle brace joint, framing of loft with log joists, and rafters with half-lap pegged joints at ridge.

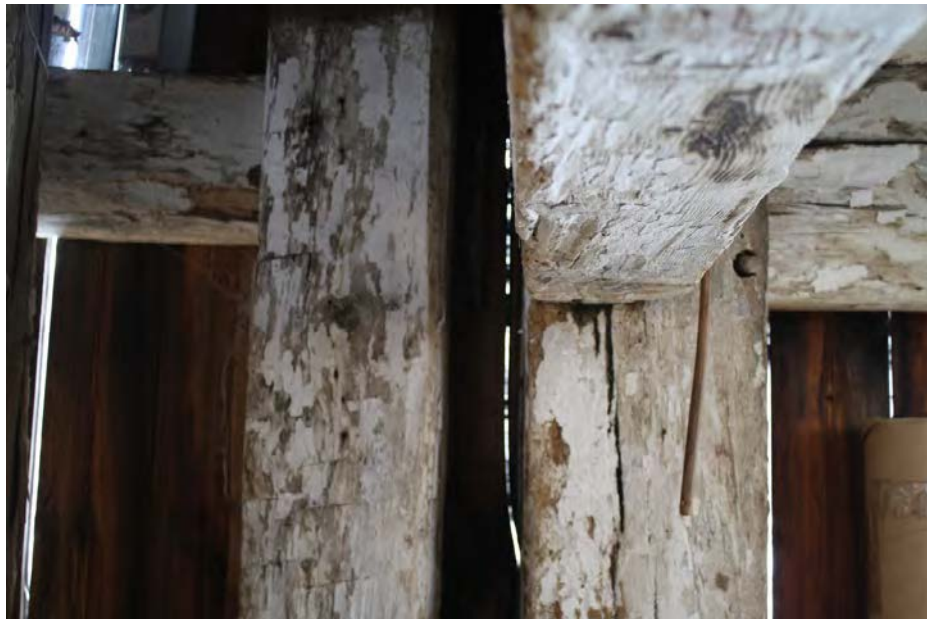
The two eastern bays have a loft floor level, now accessed by a modern stair. The underside of the framing has traces of whitewash, indicating use as a dairy stable at some time. Additional windows have been added by the present owner for use of the barn as an antique shop. In the west wall there is a door into the residential space.

16. Interior view of Barn, main level, camera facing south, showing the doubled posts at bent 4 and the whitewashed surfaces indicating former dairy stable use.

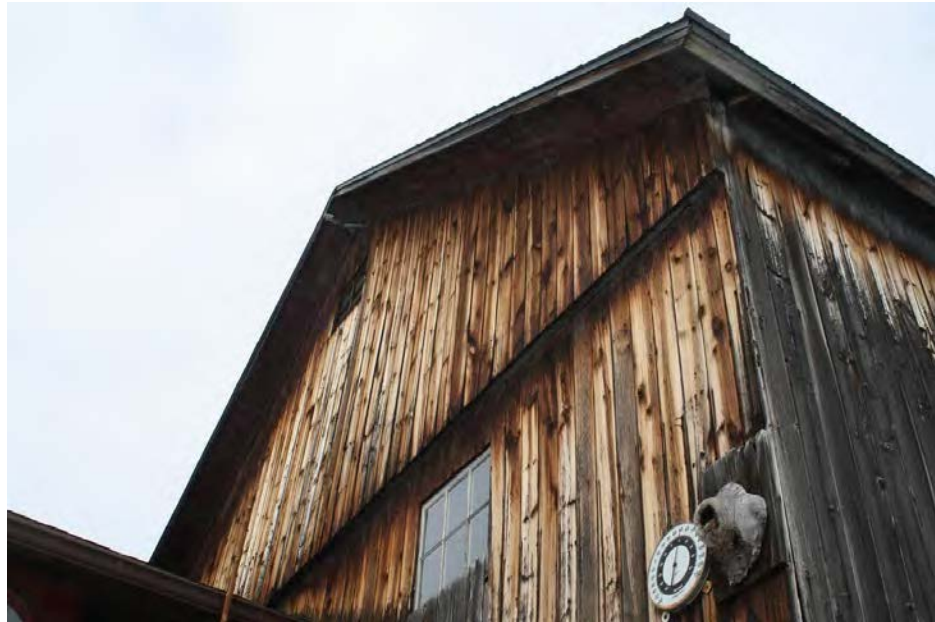
17. Southwest view of Barn, camera facing northeast. Note siding divide where the lower siding is seated in the rabbet on the lower face of the tie-girt.
