## HISTORIC RESOURCES INVENTORY - BUILDING AND STRUCTURES

Building Name (Common) Thompson-Dubicki Farmstead Record No. 14755  
 Building Name (Historic) Taylor, David, Farmstead  
 Street Address or Location 268 Main Street (Route 17)  
 Town/City Glastonbury Village South Glastonbury County Hartford  
 Owner(s) Lynn & Janet Thompson 268 Main St., Glastonbury, CT 06073  Public  Private

Style of building Tobacco shed, Vernacular style Date of Construction 19th c., moved in 1928

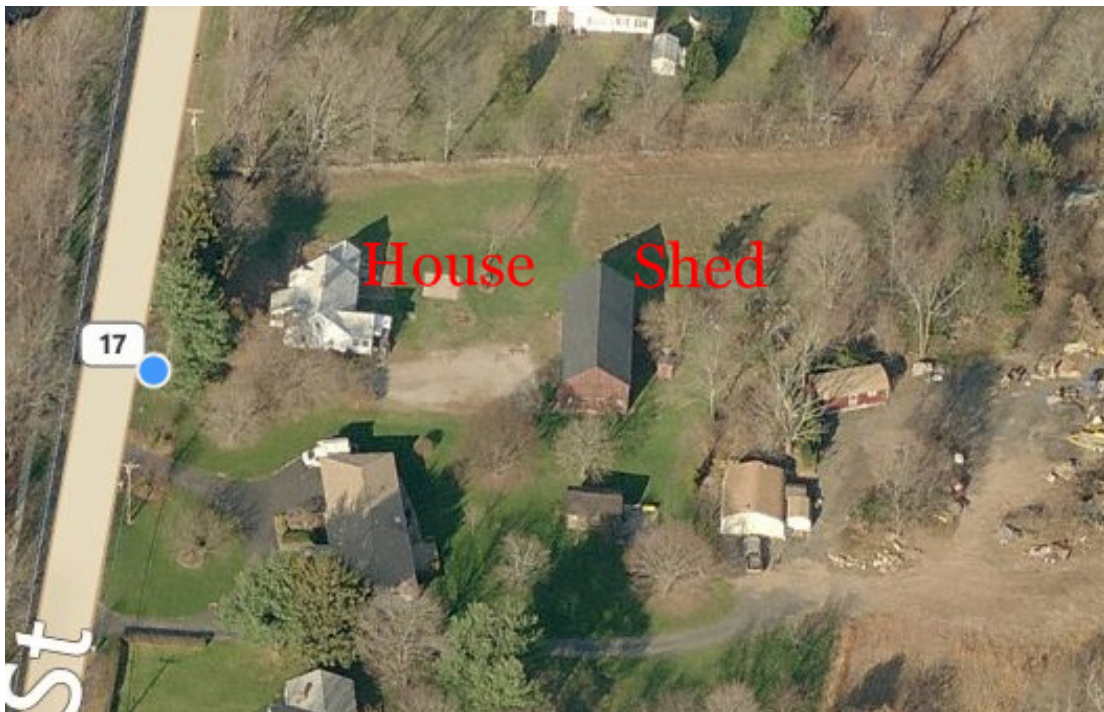
4. South view – aerial “bird’s-eye” detail site plan showing contributing resources, from <http://bing.com/maps>  
accessed 6/01/2012.

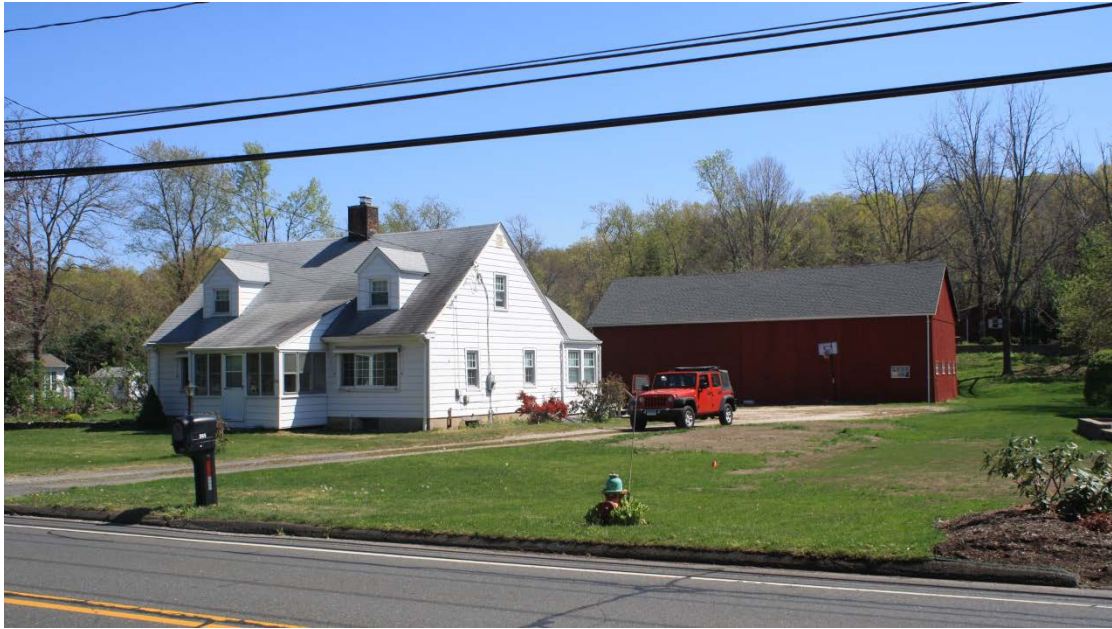
5. West view of 268 Main Street, Farmhouse and Tobacco shed, camera facing east.

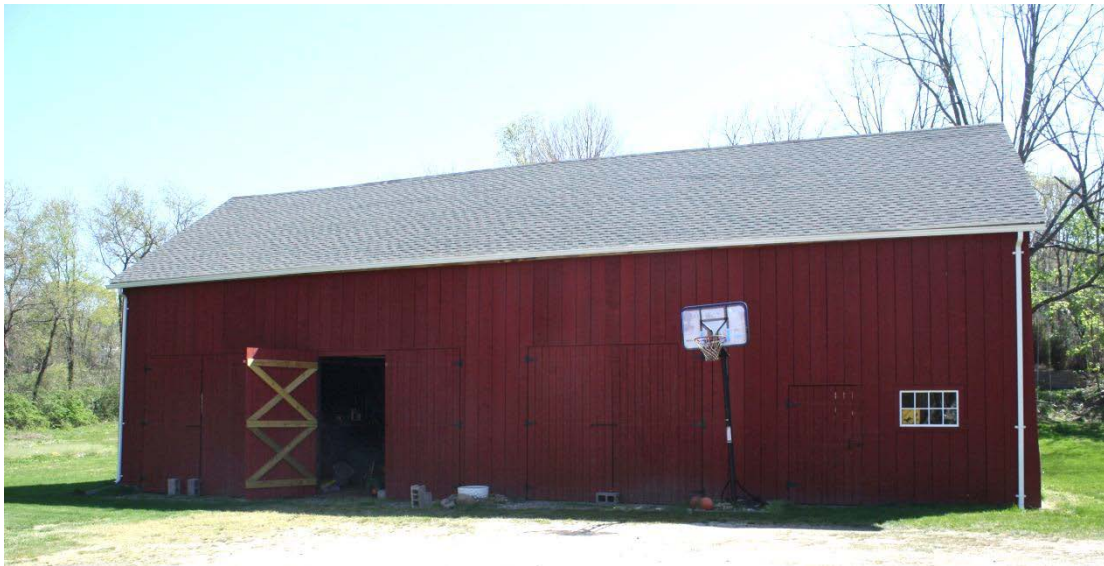
6. West eave-side facade of tobacco shed, camera facing east.

The main entries in the west eave-side of the shed are three pairs of X-braced hinged doors located in the north and middle bays; the southernmost bay has a pass-through door and fixed eight-pane window with trim. The south gable-end of the shed has four equally-spaced fixed eight-pane windows with trim. Just beneath the eave line is a dropped girt line siding divide. The east eave-side of the shed has a pass-through door and a single-pane window with trim in the southernmost bay. The rest of the side is blank. The north gable-end of the shed is identical to the south gable-end; four equally spaced fixed eight-pane windows with trim and a dropped girt line siding divide. The barn is covered with vertical wood siding painted red. The foundation is fieldstone. The roof has a projecting overhang and is covered with asphalt shingles. Both eave sides of the shed have modern gutters. The entire exterior was restored in 2010, including the roof and siding.

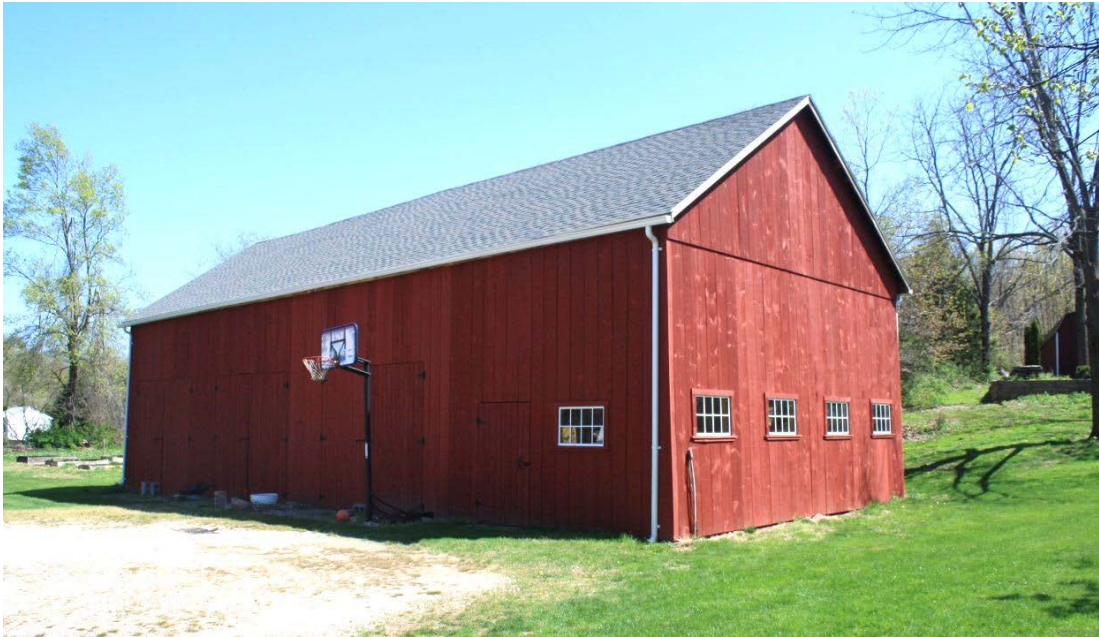
7. Southwest view of tobacco shed, camera facing northeast.

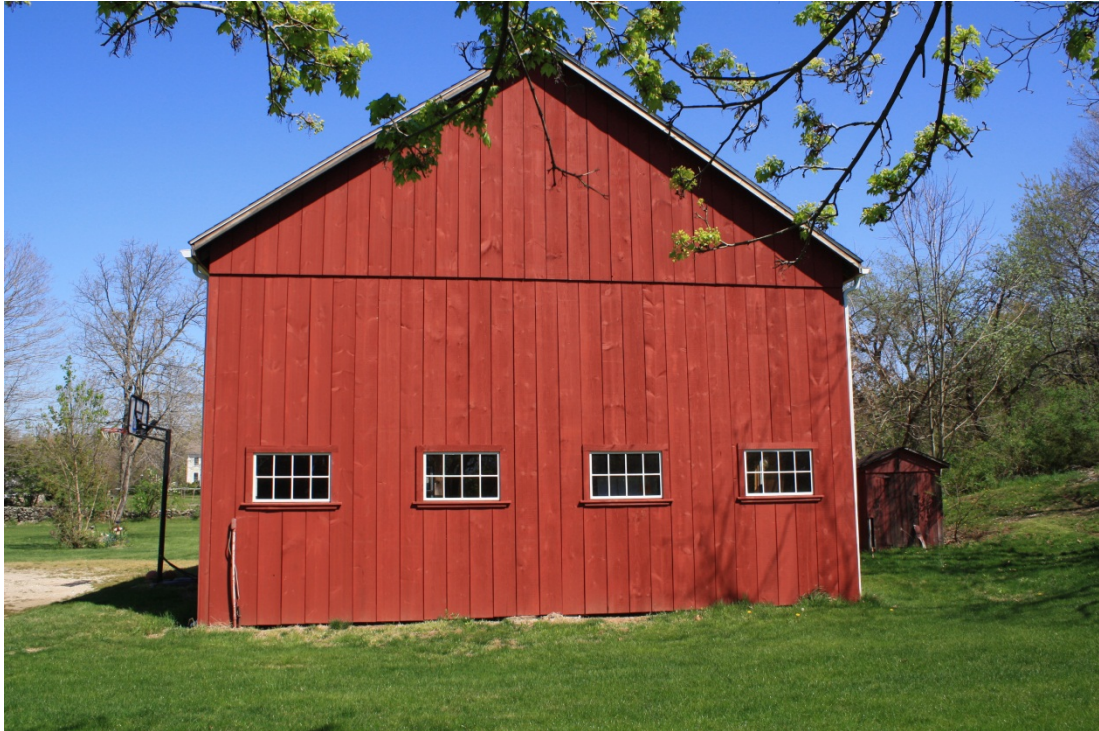
8. South gable-end of Tobacco shed, camera facing north. Note outhouse to the right.

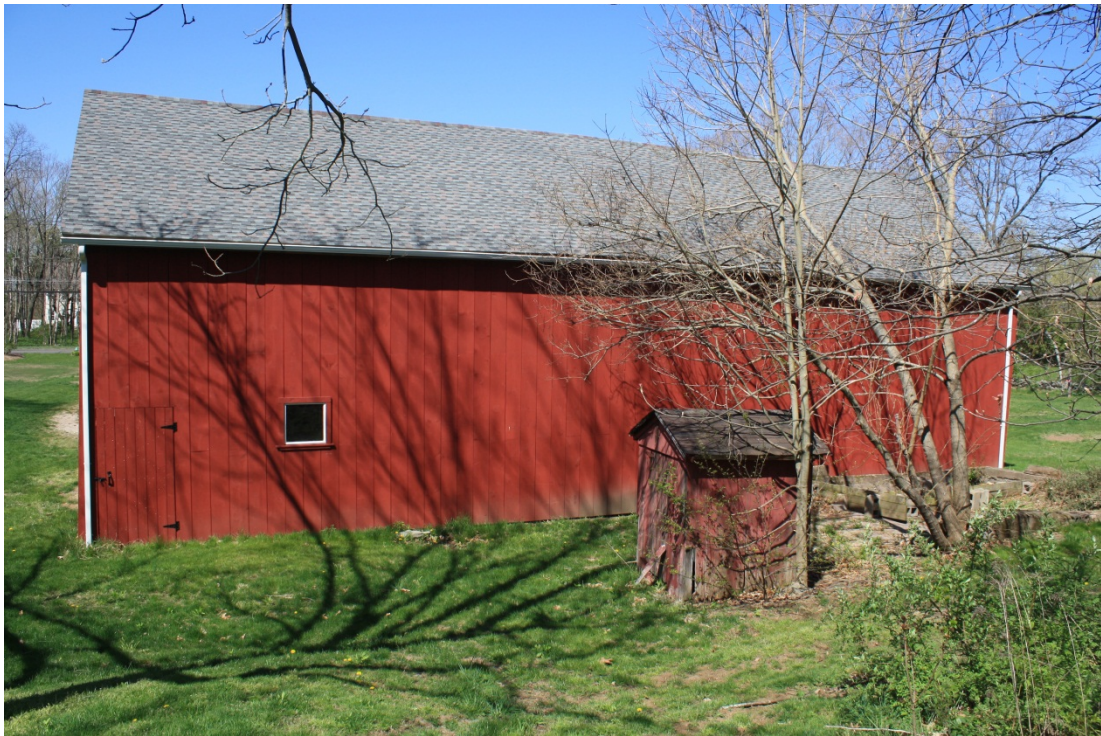
9. East eave-side of tobacco shed and outhouse, camera facing west.

The exterior skin of the shed at 268 Main Street has been altered with replacement siding and a number of windows. It appears to originally have had side-hinged vents on at least the east eave-side elevation and the north gable-end above the doors. At present the only remaining ventilation system is the series of hinged doors in the eave-side.

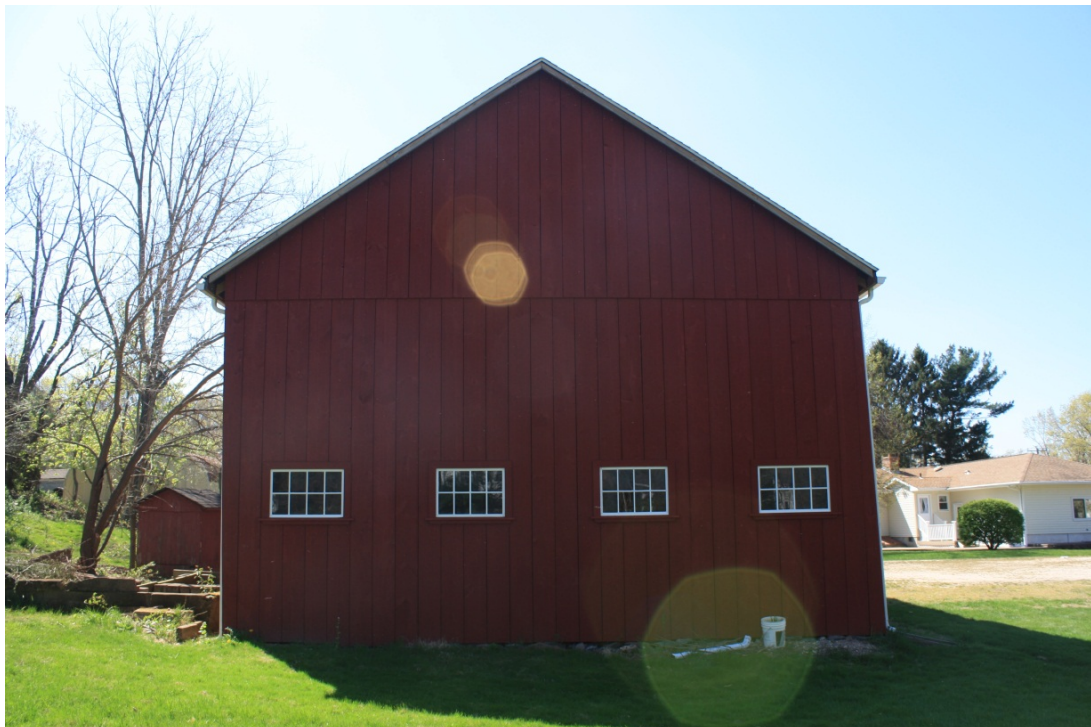
10. North gable-end of Tobacco shed, camera facing south.

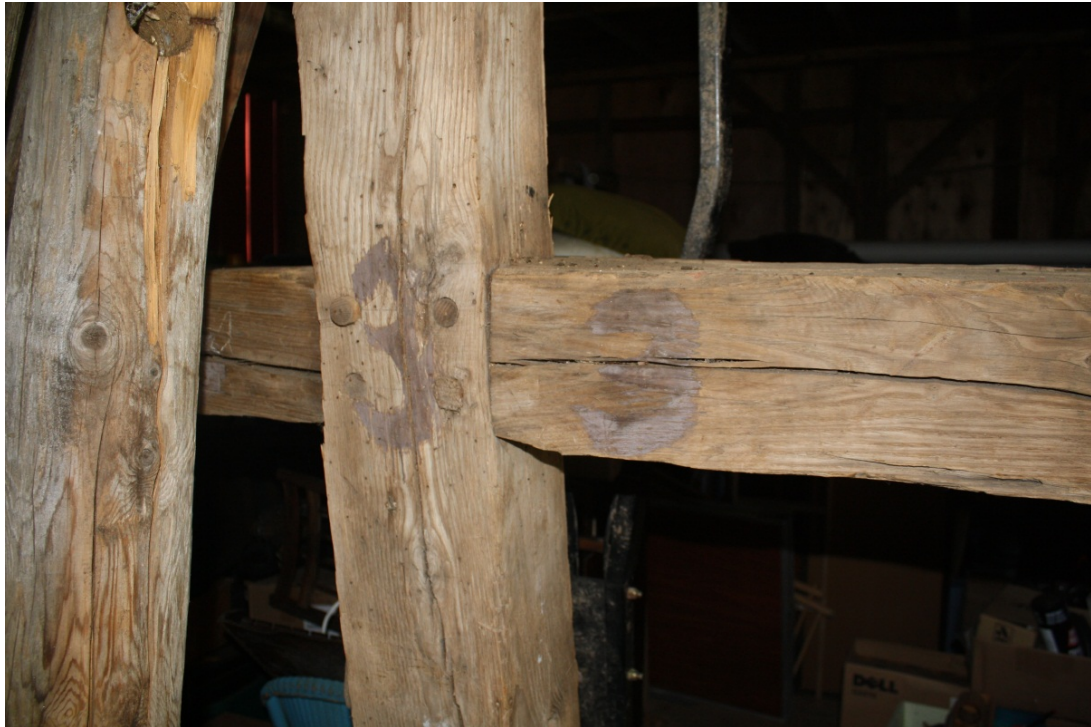
11. Interior of tobacco shed, detail of numbers at the square rule constructed timber frame joints, used for the rebuilding of the relocated shed in 1928, camera facing south.

The tobacco shed was relocated to 268 Main Street in 1928-30 from Portland, CT. The original barn or shed on this site had burned just prior to the relocation of the current shed. The land to the south and east up the hill were farmed for tobacco by the Dubicki family until the 1950s. At that time, the current owner's mother was given an acre at the southernmost portion of the site to build a house, now 238 Main Street. The Dubickis continued to farm tobacco until the 1970s, but off-site on land leased to them by a Mr. Daniel Andrews. From the time the Dubickis acquired the site in the 1920s through at least the 1930s, they also raised and sold chickens. They had a farm stand as early as the 1950s where they sold strawberries and vegetables. They continued to have gardens with cucumbers and strawberries up to and including today, although the farm stand is long gone. In the 1970s, the 2-acre lot between the 268 Main and 238 Main was given to a Dubicki nephew, and a house was built, now 256 Main Street.

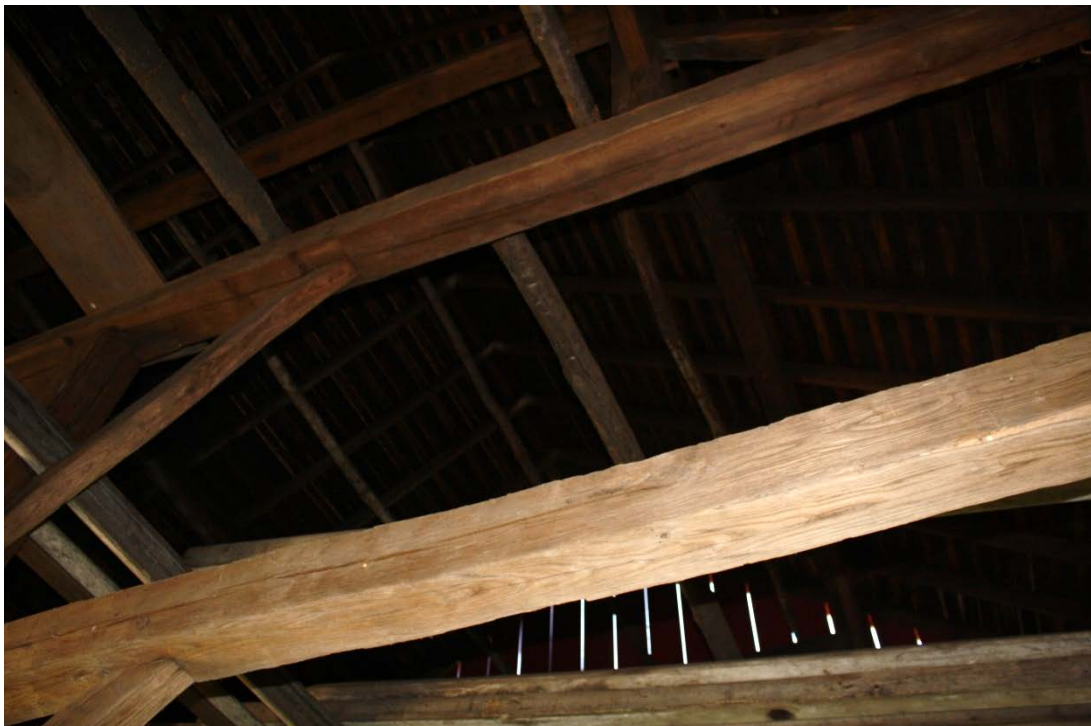
12. Interior of tobacco shed, detail of hand-hewn chestnut beams, camera facing south.

The west eave-side hinged doors and pass-through door access the interior of the shed, which is one large space, except for a workshop in the southernmost portion of the south bay. The shed has a dirt floor in the northernmost bay. The southernmost bay has a plywood floor. The two middle bays have a poured concrete floor. Each bent has hand-hewn 7" x 7" posts and beams, three 6" x 6" circular-sawn girts and 4" x 4" circular-sawn diagonal braces. At the gable-ends, from the sill to the first girt is 5 feet, another 5 feet between the first girt and second girt, and 6 feet from the second girt to the plate. The workshop in the south bay has a wall which runs east-west made up of plywood and nailed post and beams. A second wall divides the workshop into two rooms parallel to the ridgeline of the shed. Above the workshop is a bay-wide loft that runs the entire depth of the shed. Each bay is 16' wide and 28' feet deep. Extra horizontal rails have been added throughout the shed to assist in the support of tobacco bunches that are hung to cure; some of the rails are simply unfinished tree branches. The shed is made up of pegged square rule construction at each structural joint, although the extra rails are attached by nails. The roof has common rafters, a ridge board and purlin plates mid-span, supported by queen posts.

The shed is significant as an example of a hand-hewn structural post and beam frame in a tobacco shed. The use of hand-hewn post and beams is uncommon in extant tobacco sheds in Connecticut, as many sheds were lost in the Hurricane of 1938 and were rebuilt using sawn lumber and lighter framing.

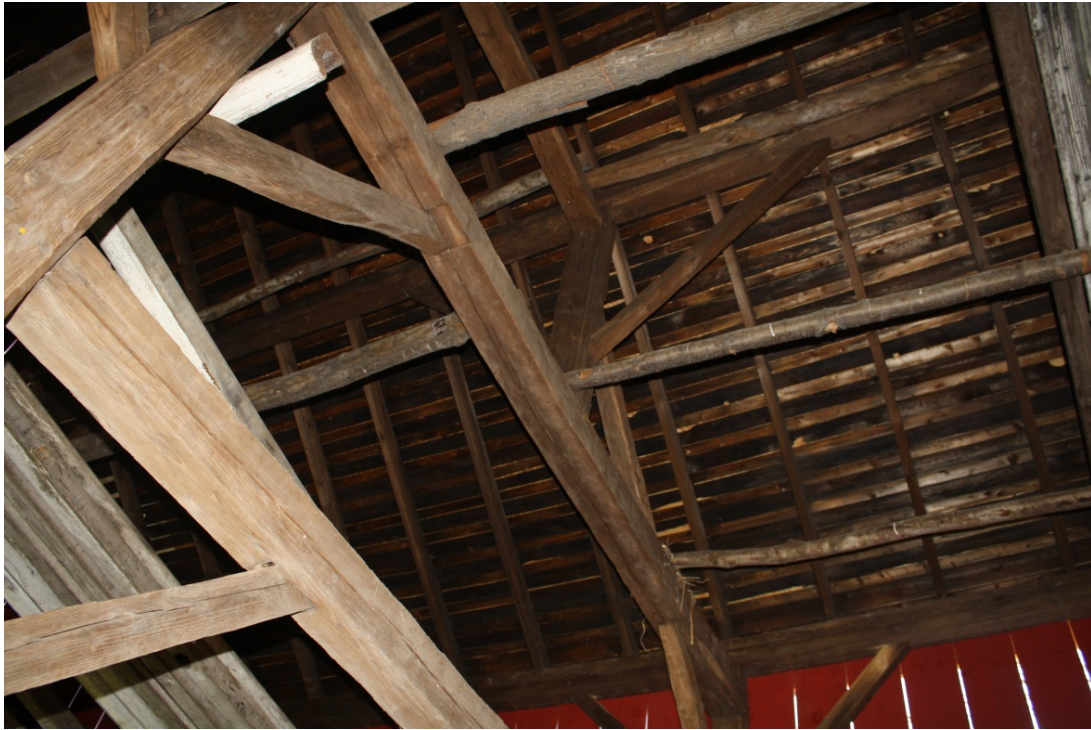
13. Interior of tobacco shed, detail of unfinished timber rails used to hang tobacco bunches as they were drying, camera facing west.

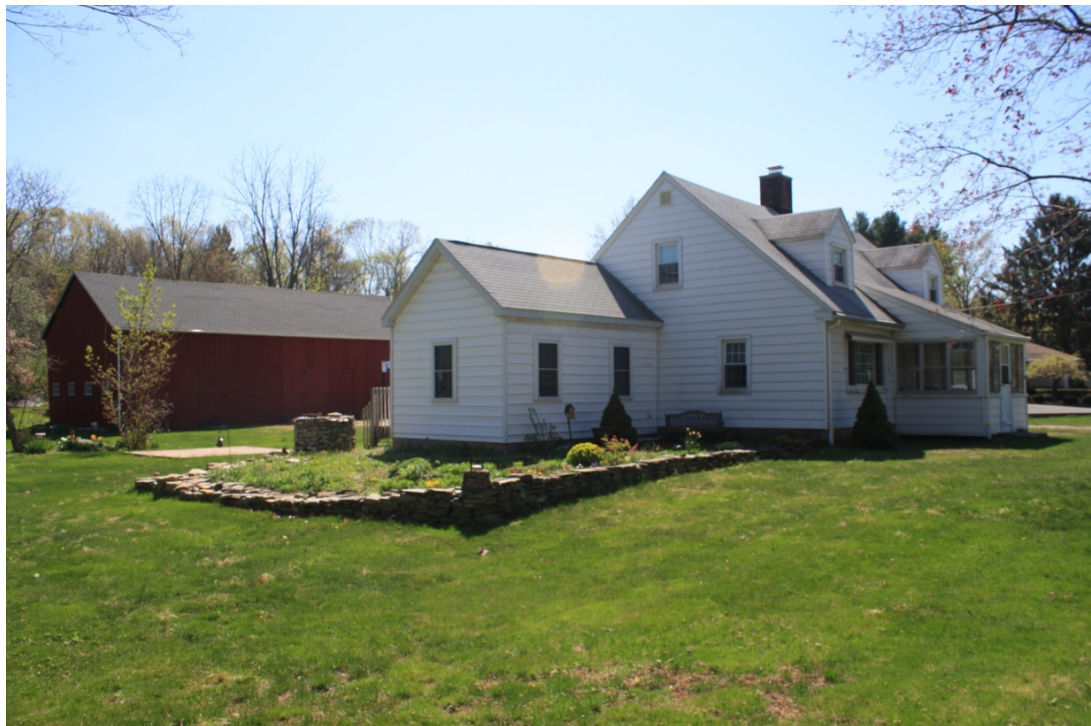
14. Northwest view of the house and Tobacco shed, camera facing southeast. Note the stone well to the left of the house.

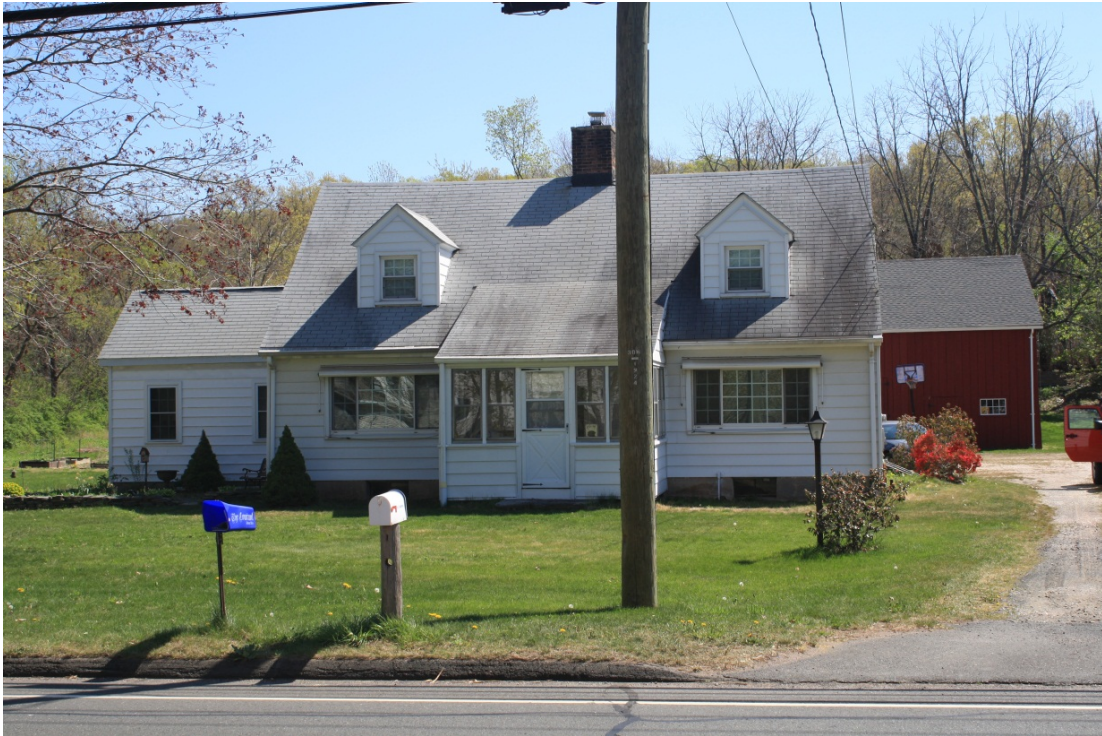
15. West eave-side of house and tobacco shed, camera facing east.

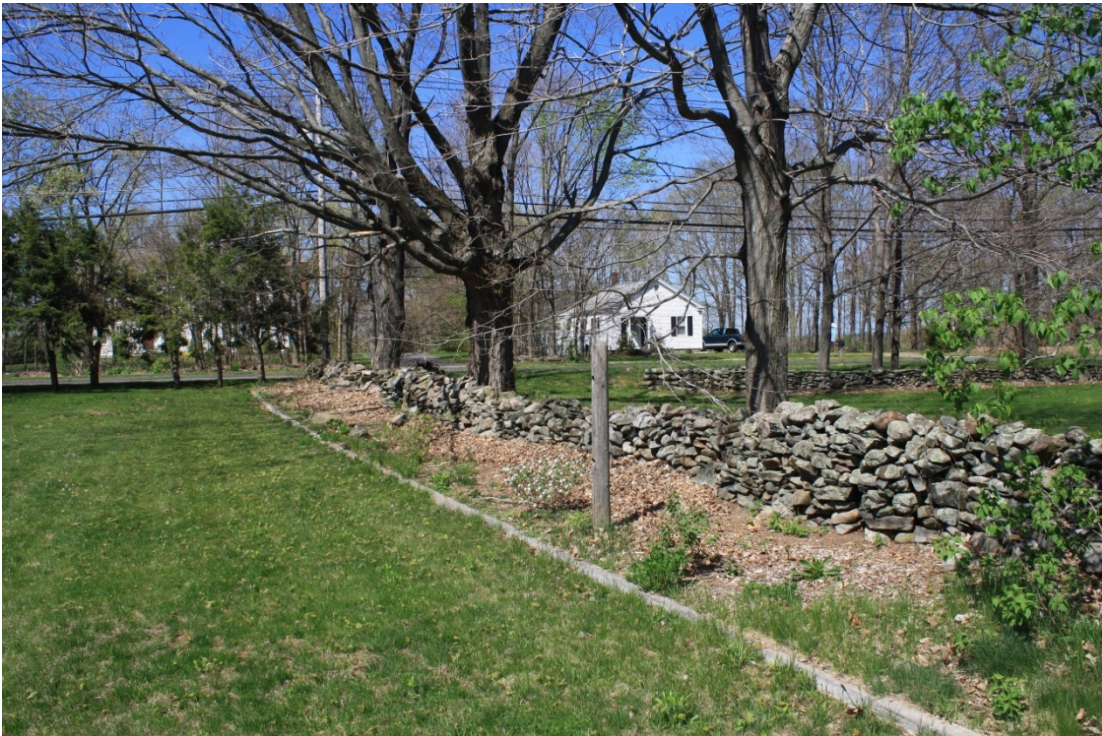
16. South view of stone wall at the north border of the site, camera facing northwest.

The site is mostly flat until east of the outhouse, where it inclines to the east into woodland. The site is demarcated to the west by Main Street, to the north by 280 Main Street, to the west by a tract of woodland that extends to Dayton Road and to the south by 256 Main Street. A stone wall runs east-west along the north property line. The area surrounding the site is residential and woodland.
