HISTORIC RESOURCES INVENTORY - BUILDING AND STRUCTURES

Building Name (Common) Freeman, Orrin, Farmstead Record No. 23840
 Building Name (Historic) Freeman, Orrin, Farmstead
 Street Address or Location 37 Maple Avenue
 Town/City Haddam Village Higganum County Middlesex
 Owner(s) Clark Gardner, 37 Maple Avenue, Higganum CT 06441 Public Private

HISTORIC RESOURCES INVENTORY FORM – BUILDING AND STRUCTURES continuation sheet

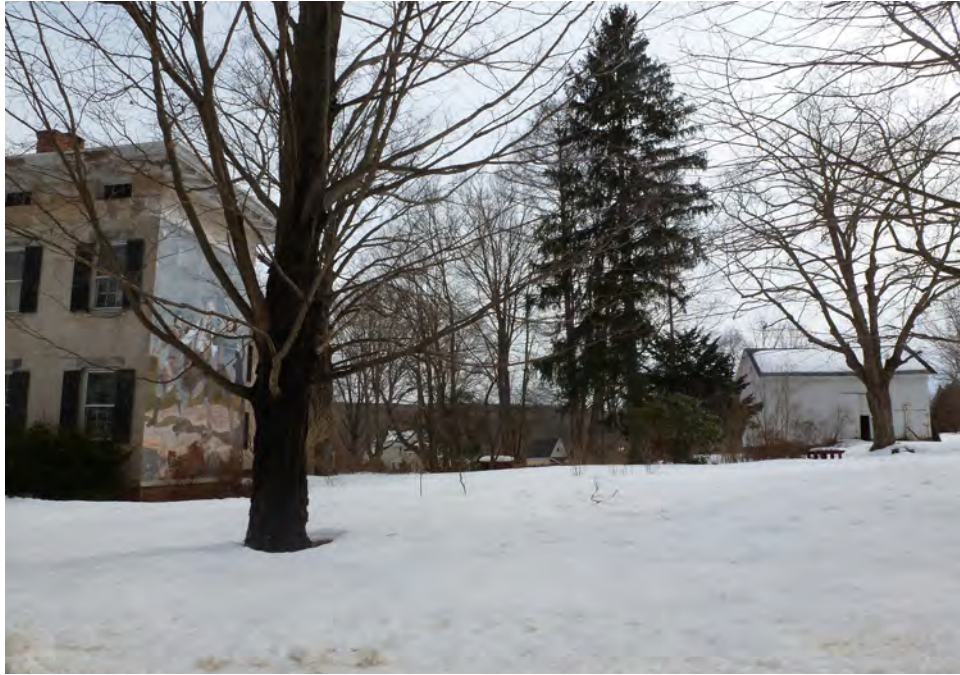
5. North context view of the House (at left) and Barn (at right). Camera facing south.

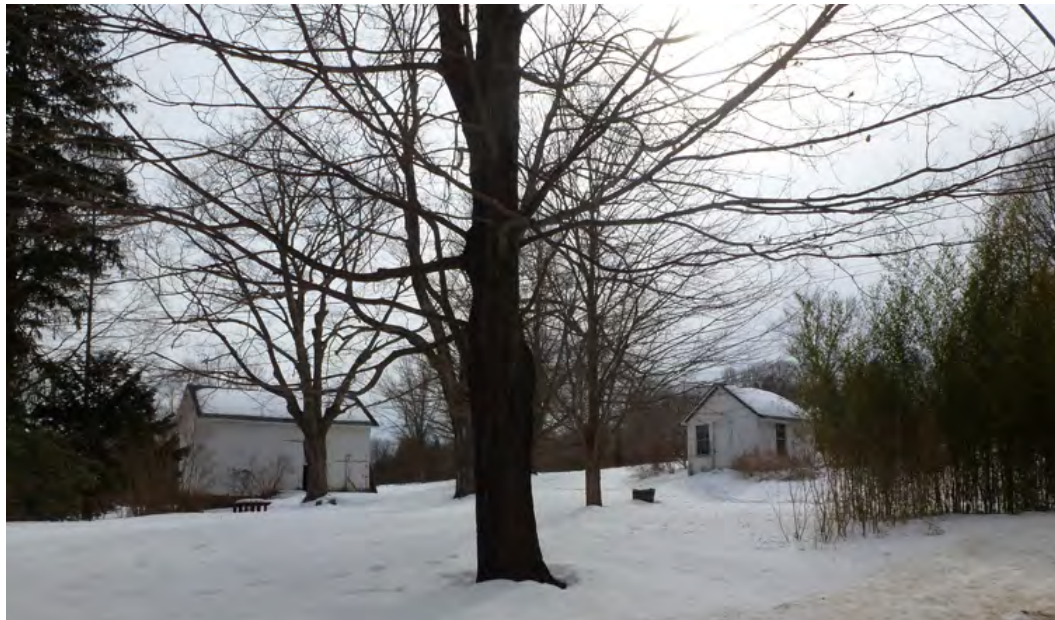
6. Northeast context view of the Barn (at left) and the Shed (at right). Camera facing southwest.

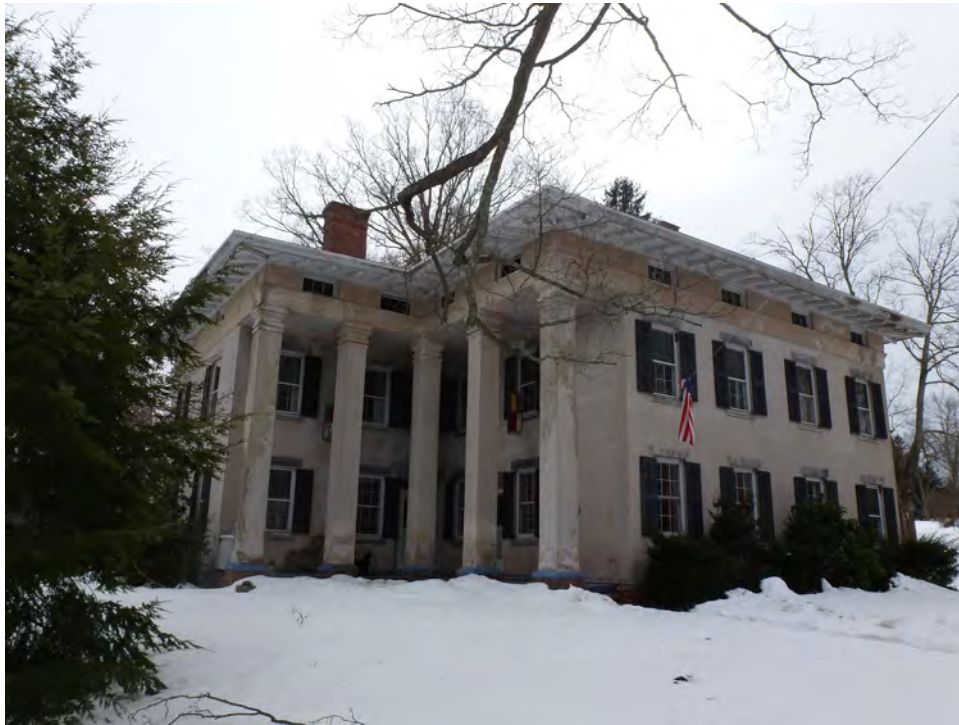
The House was built c. 1842, and faces approximately north. The main entry consists of a side-hinged door with paneling and a single-pane window in the top half. The hip roof is covered in asphalt shingles and has wide overhanging eaves. Some features of the house are as follows:

- Exposed rafters supporting overhanging eaves
- Greek-Revival-style entrance, recessed from front wing with sidelights and lintel
- Western elevation has no windows; decorated with full-color mural of the Spirit of '76
- Porch of connecting wings has five massive Tuscan order columns
- Wide friezeboard [sic] features 3-paned attic story windows
- Granite sills; lintels painted over stucco to simulate granite
- Six-over-six sash throughout
- South (rear) elevation exhibits the typical Greek-Revival-style 5 bay, center-hall configuration

7. Northeast view of the House. Camera facing southwest.

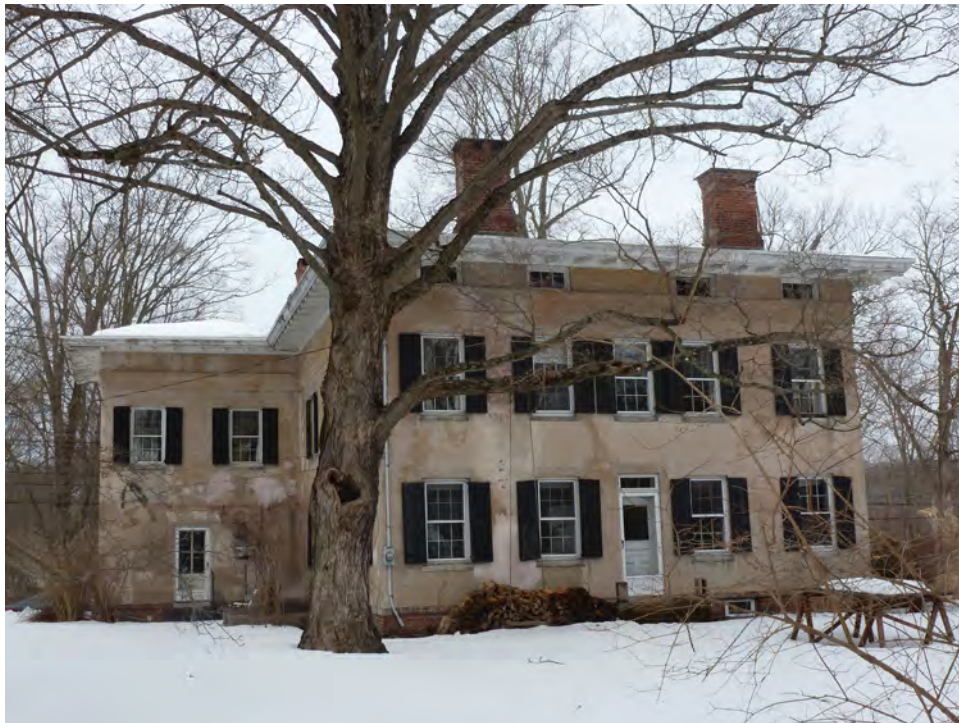
8. South view of the House. Camera facing north.

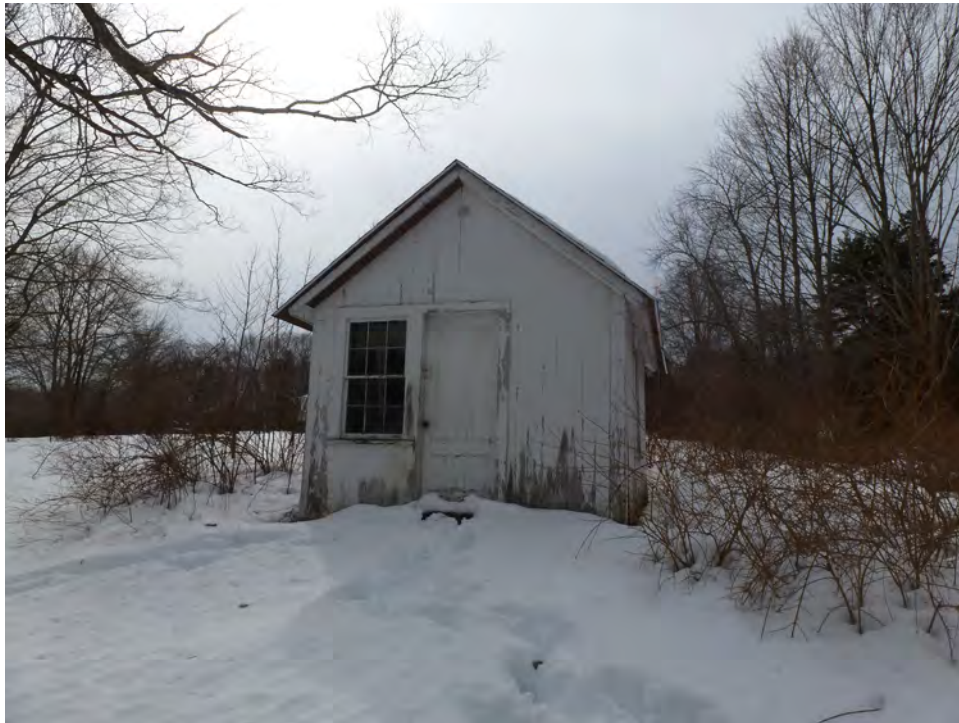
9. East gable-end of the Shed. Camera facing west.

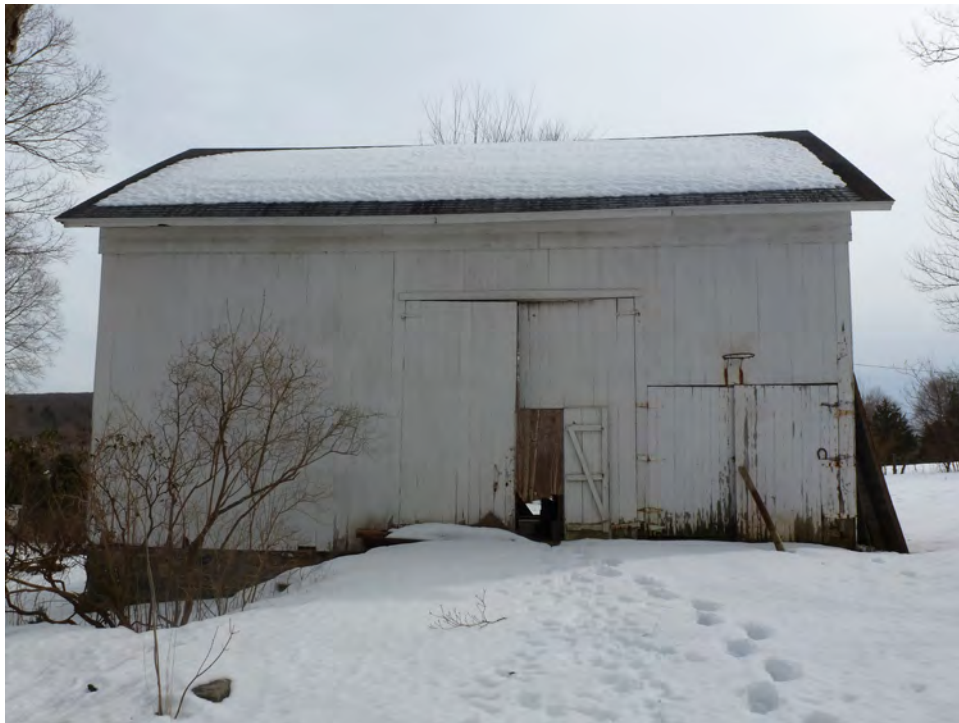
There are two entries found on the north eave-side of the barn. One of the entries consists of a pair of double-height side-hinged doors with a small weather door set within the west leaf. To the west of this is an entry that consists of a pair of side-hinged doors that lead into the west bay of the barn. The grade declines slightly towards the east, revealing the mortared fieldstone foundation.

10. North eave-side of the Barn. Camera facing south.

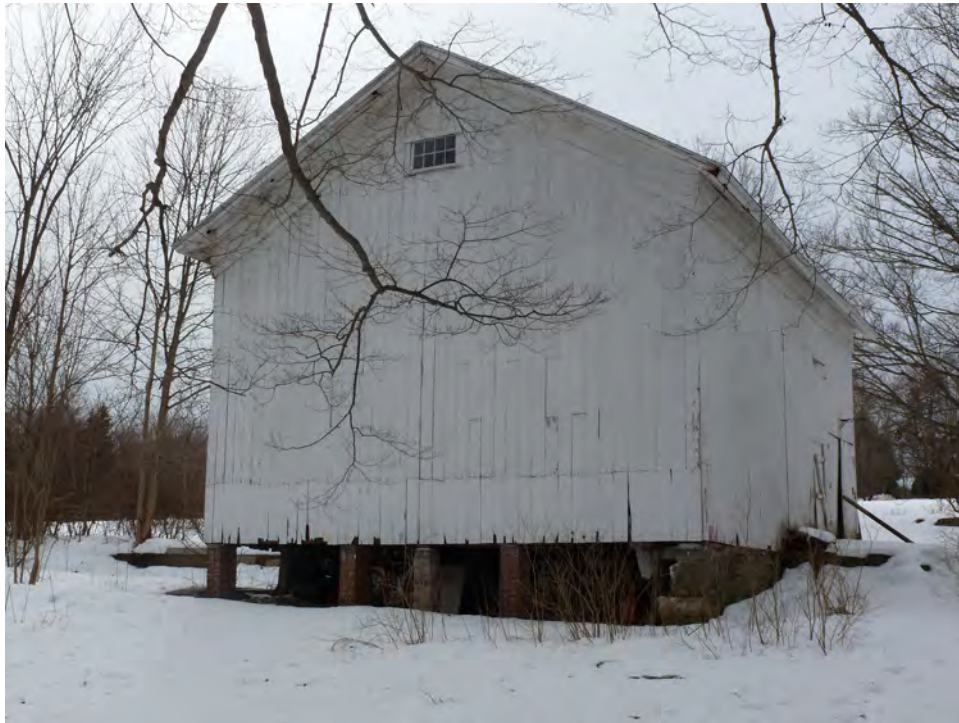
Visible along the east gable-end of the barn are the brick pillars on which the barn is raised, creating a crawl space. In the gable attic of the east gable-end is a horizontal eight-pane window with trim. There are no other features on this side. On the south eave-side of the barn are brick and concrete pillars on which the barn is raised. The grade rises slightly towards the west side of the south eave-side of the barn. The frame of the barn on the west end of this side is exposed where the siding is missing.

11. North eave-side and east gable-end of the Barn. Camera facing southwest.

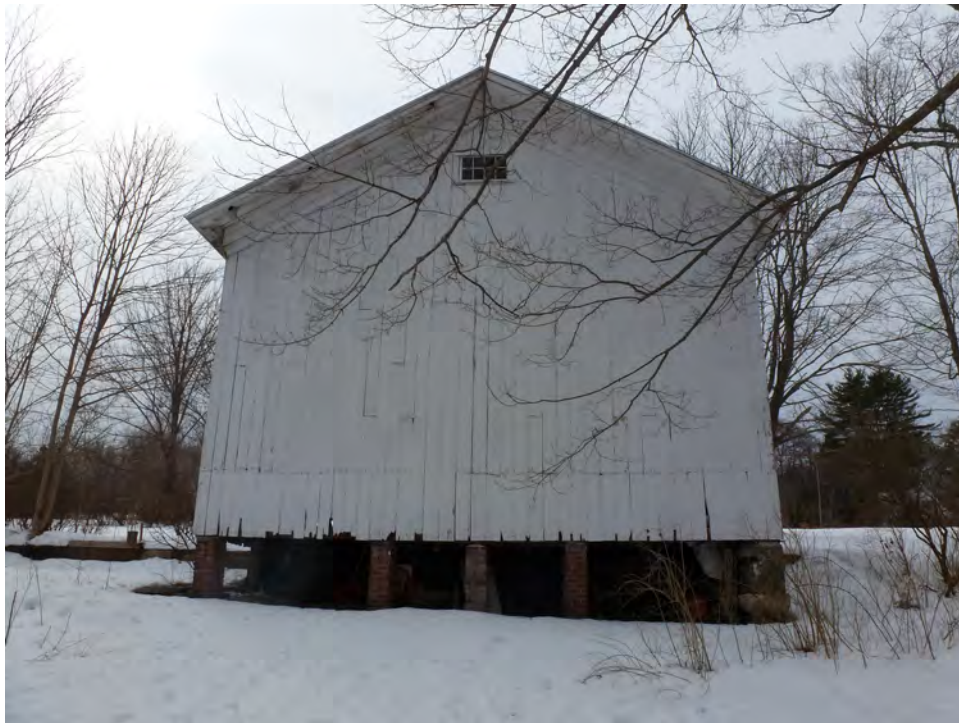
12. East gable-end of the Barn. Camera facing west.

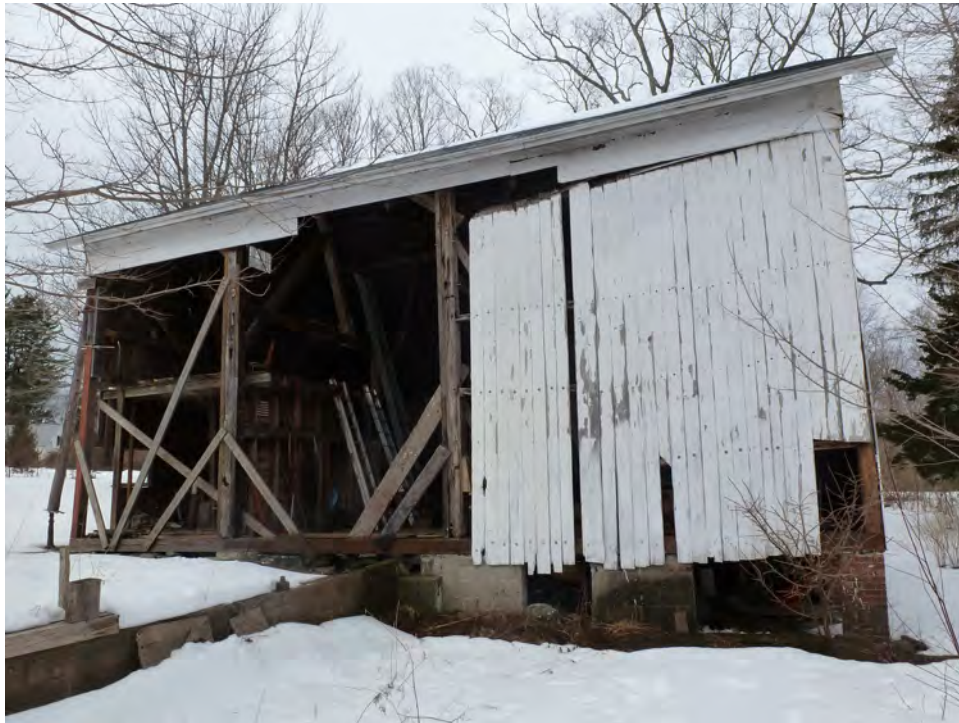
barn, came down and was never replaced. In 1957, Francis Wright Gardner, Jr. acquired the property after Eugene Orlando Burr died. During this time, Francis Wright Gardner, Jr. demolished an addition that had been attached to the south eave-side of the barn, due to its deteriorated state. Clark Gardner acquired the property in 2007, and remains the owner. Today the barn is used for storage.

13. South eave-side of the Barn. Camera facing north.

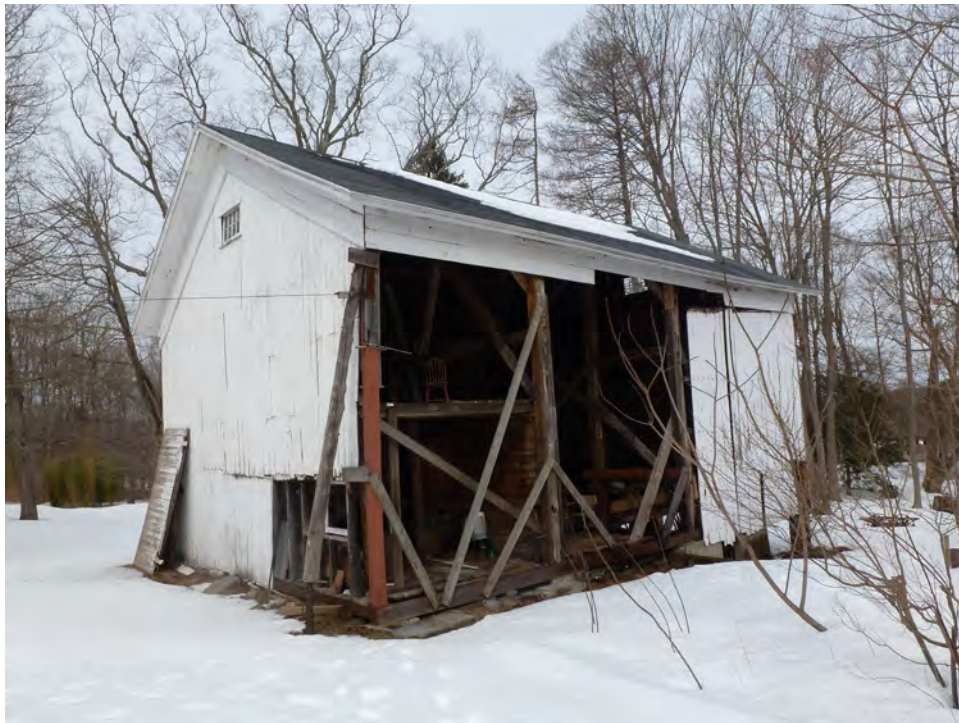
The frame in the southwest corner of the barn on the west gable-end is exposed where the siding is missing. Found in the gable attic of the west gable-end of the barn is a horizontal eight-pane window with trim. There are no other features on this side.

14. South eave-side and west gable-end of the Barn. Camera facing northeast.

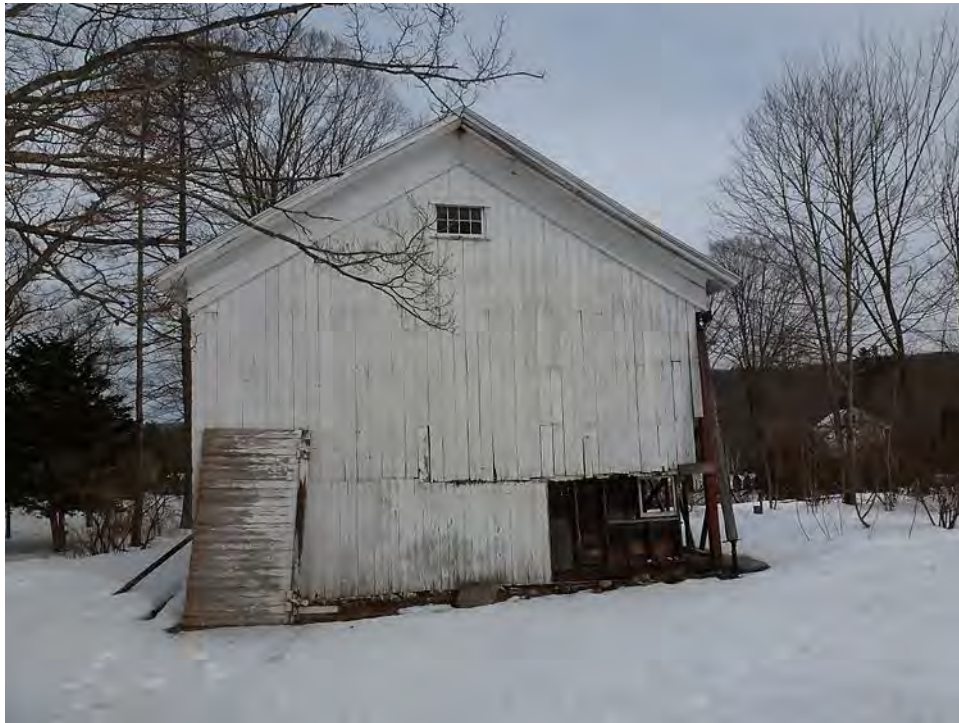
15. West gable-end of the Barn. Camera facing east.

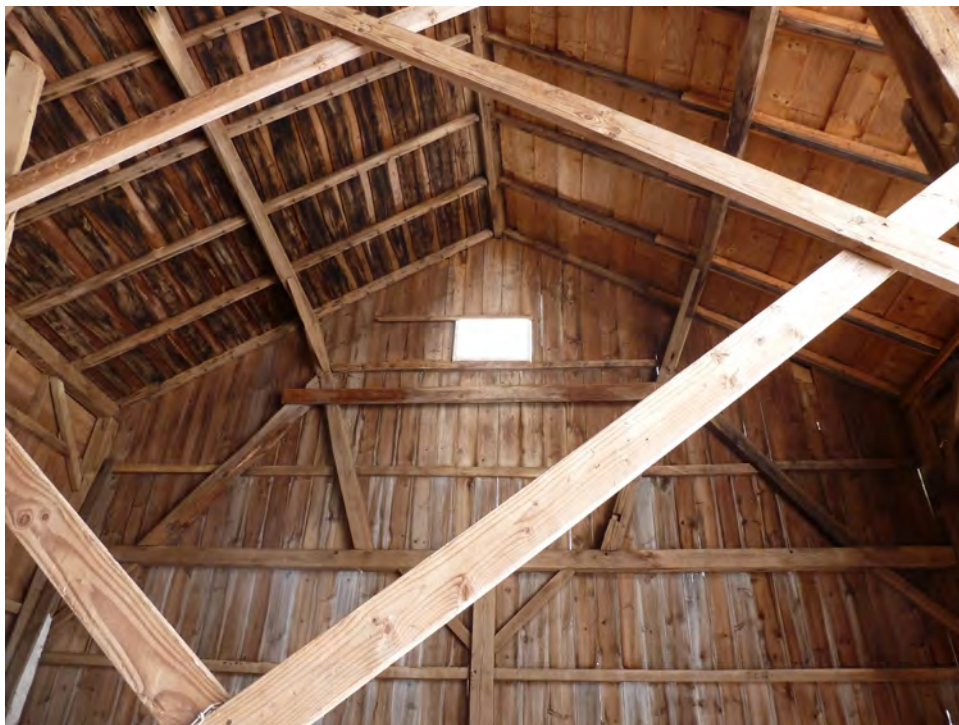
The interior of the barn is accessed by the pair of side-hinged doors on the north eave-side of the barn. It has a typical English barn layout with three bays, the middle of which was used for threshing. The middle bay of the barn once had doors in both the north and south eave-sides, enabling wind to blow through and help with the threshing process. The east gable-end of the barn is open to the roof while the west gable-end has a loft. Found on the interior is the square rule post-and-beam frame joined together by mortise and tenon joints with tree nails. The tie girts in the gable-ends of the barn are dropped and pegged together by mortise and tenon joints with tree nails. Canted queen posts with diagonal bracing toward the outside walls support purlin plates at the mid-span of the rafters. Common rafters spring from the plate and meet at the peak with a ridge-board, and the roof deck is made of wood planks. Hand hewn and sawn marks are found on the timbers throughout the barn. Extra support timbers have been added throughout to help stabilize the barn.

16. Interior view of the east gable-end of the barn. Note the canted queen posts. Camera facing east.

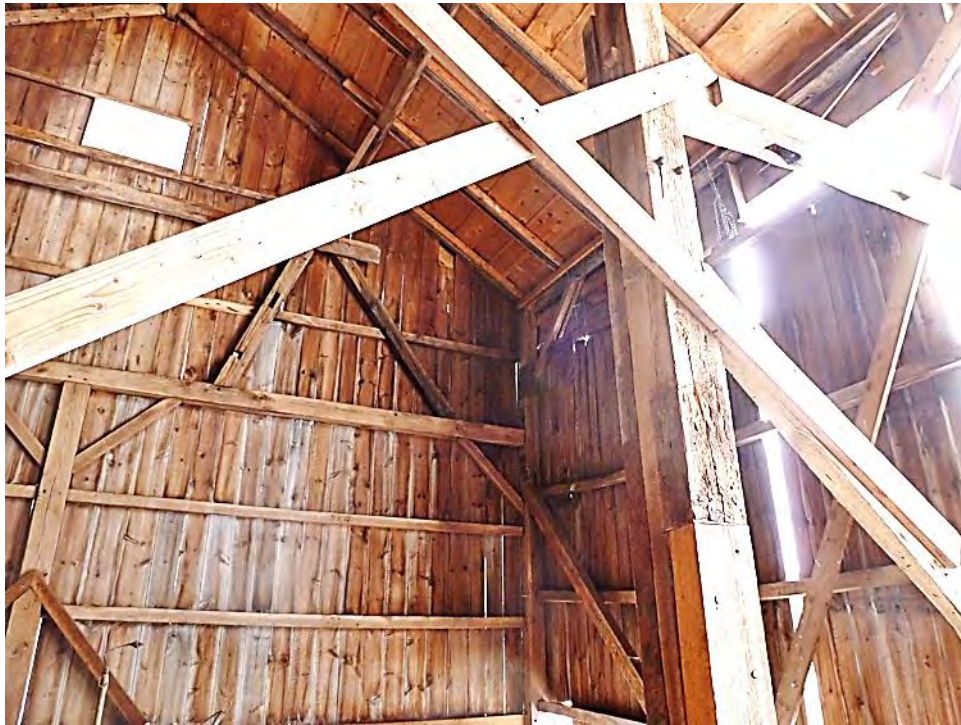
17. Interior view of the southeast corner of the barn. Note the dropped girtd that is attached to the post by the mortise and tenon joint. Camera facing southeast.

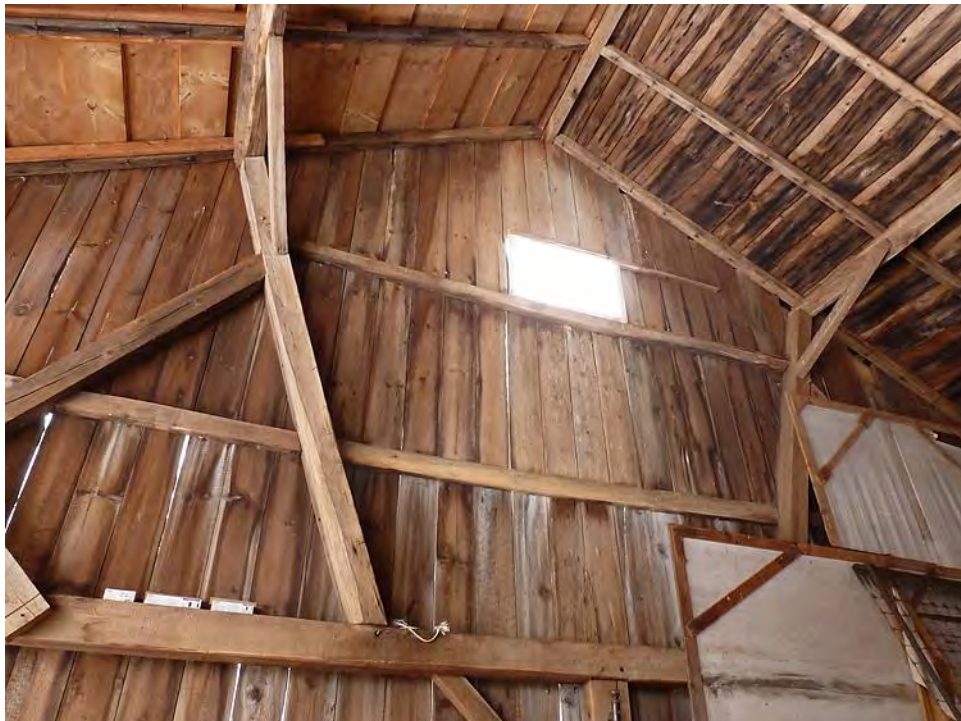
18. Interior view of the west gable-end of the barn. Note the canted queen posts and the common rafters meeting at the peak with a ridge-pole. Camera facing west.
