## HISTORIC RESOURCES INVENTORY - BUILDING AND STRUCTURES

Building Name (Common) Ellenberg, Louis and Clara, Farmstead Record No. 20842  
 Building Name (Historic) Greenberg, Louis and Sarah, Farmstead; Ellenberg, Louis and Clara, Farmstead  
 Street Address or Location 4 Old Colchester Road  
 Town/City Hebron Village Amston County Tolland  
 Owner(s) Kessler, Maurice and Diane, 635 Hicksville Road, Far Rockaway NY 11691  Public  Private

**Barn I:**

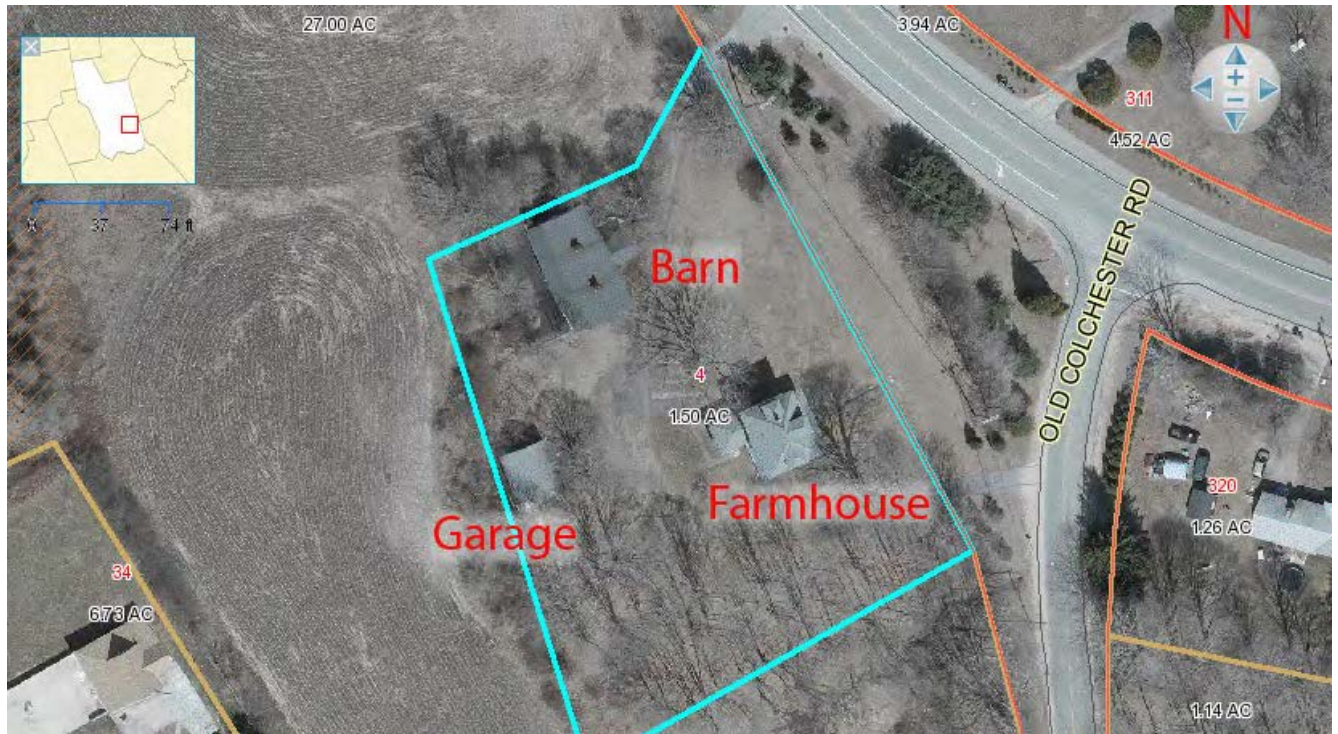
3. East view – aerial “bird’s-eye” map of 4 Old Colchester Road, Hebron CT – <http://www.bing.com/maps> accessed 8/11/2010.

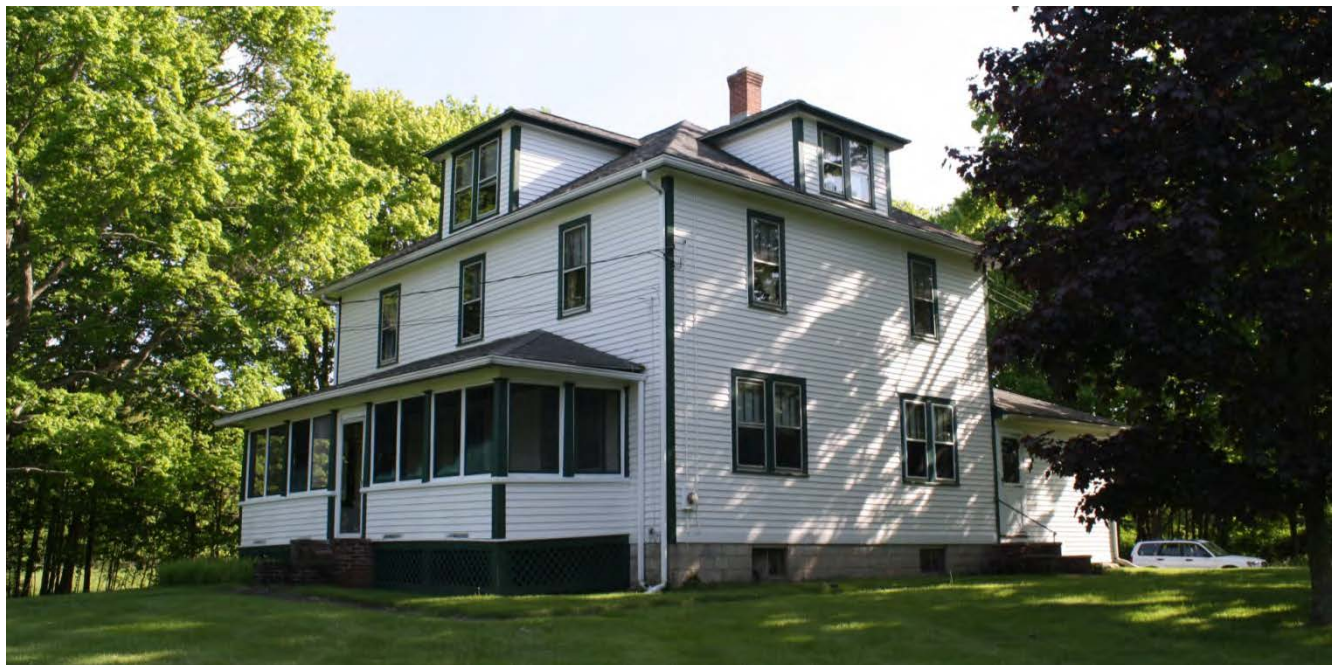
5. Northeast view of Farmhouse, camera facing southwest.

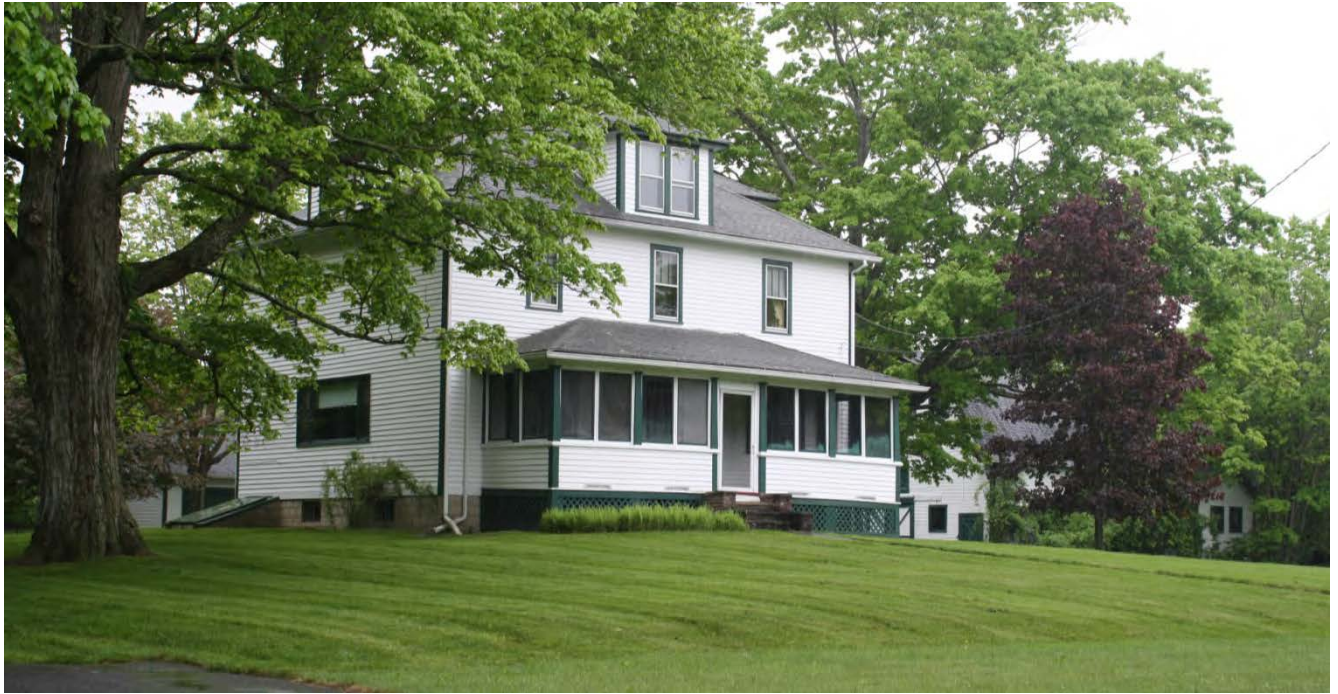
6. Southeast view of Farmhouse with barn at right rear, camera facing northwest.

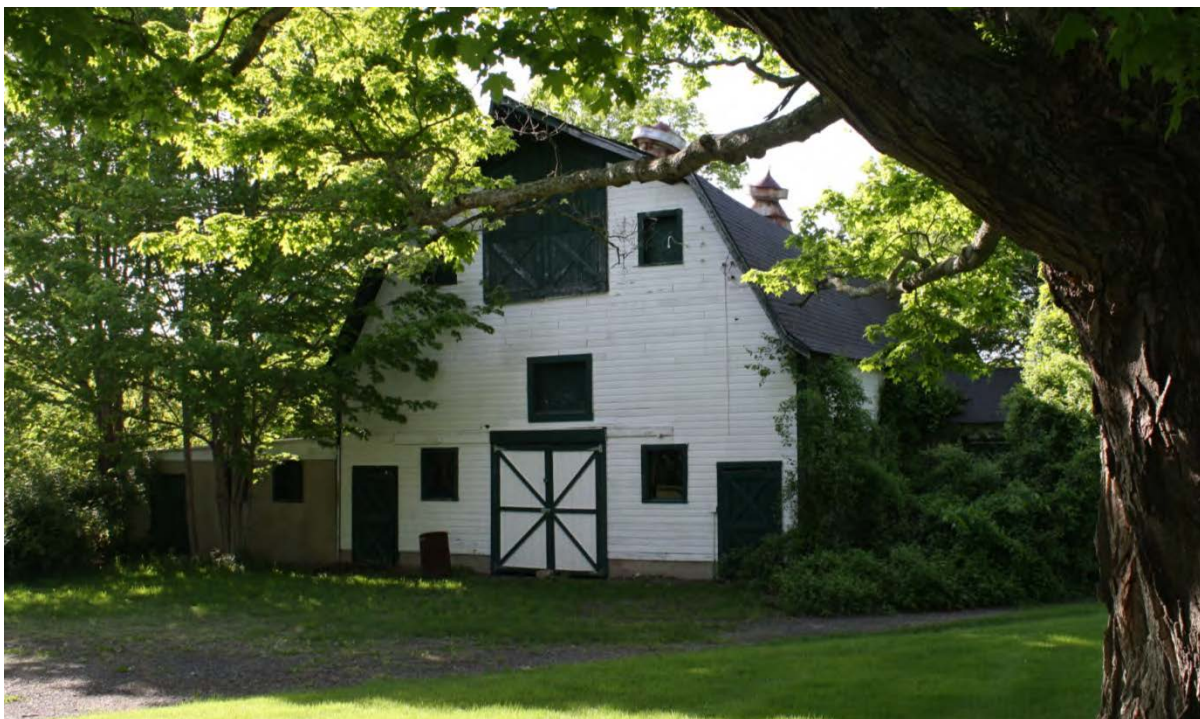
7. South view of the gable-end of the Barn, camera facing north. West addition is visible at far left.

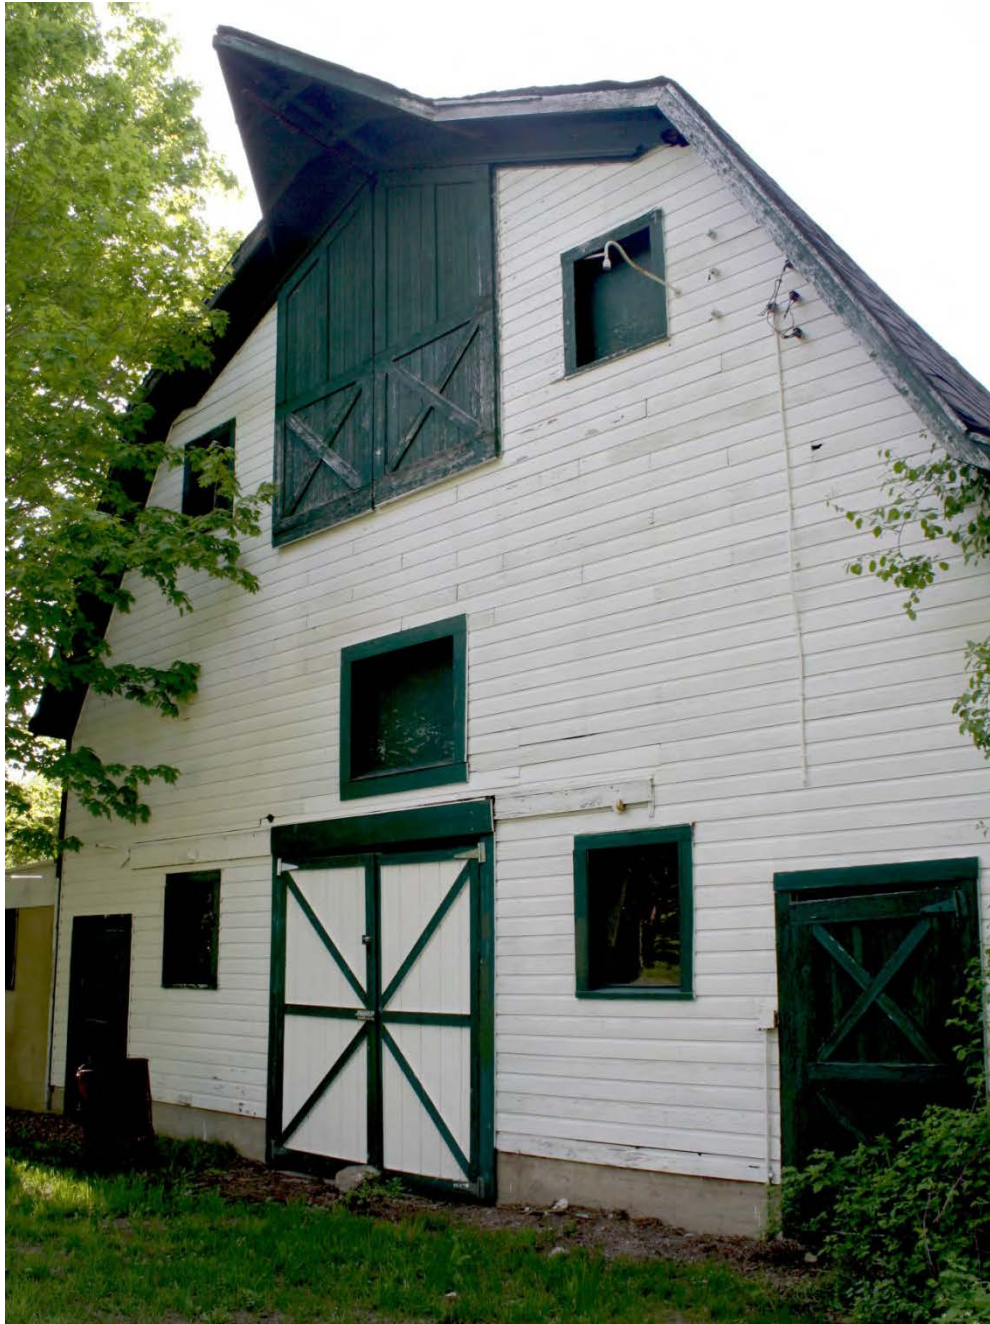
The main entrance in the south gable-end is a pair of hinged barn doors. These appear to have once been exterior sliding, as there are boards attached to the exterior in the location of a head track. The doors, with frames, z-bracing, and vertical board panels, are flanked by a stable-type window and a pass-through door on each side. Above in the loft and attic levels are hay mow doors, with the opening at the upper attic level being larger with a pair of doors with x-braced lower and rectangular upper panels. A projecting hay hood extends from the roof peak. Windows flank the upper hay door on both sides.

8. South view of Barn gable-end, camera facing north.

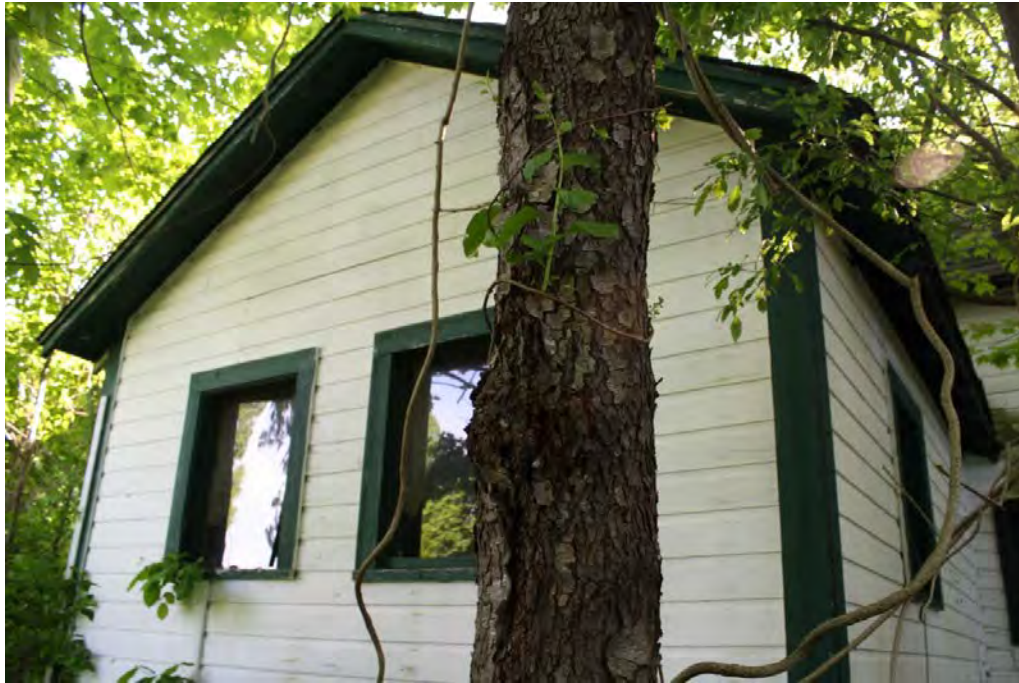
9. Northeast view of Milk room, camera facing southwest.

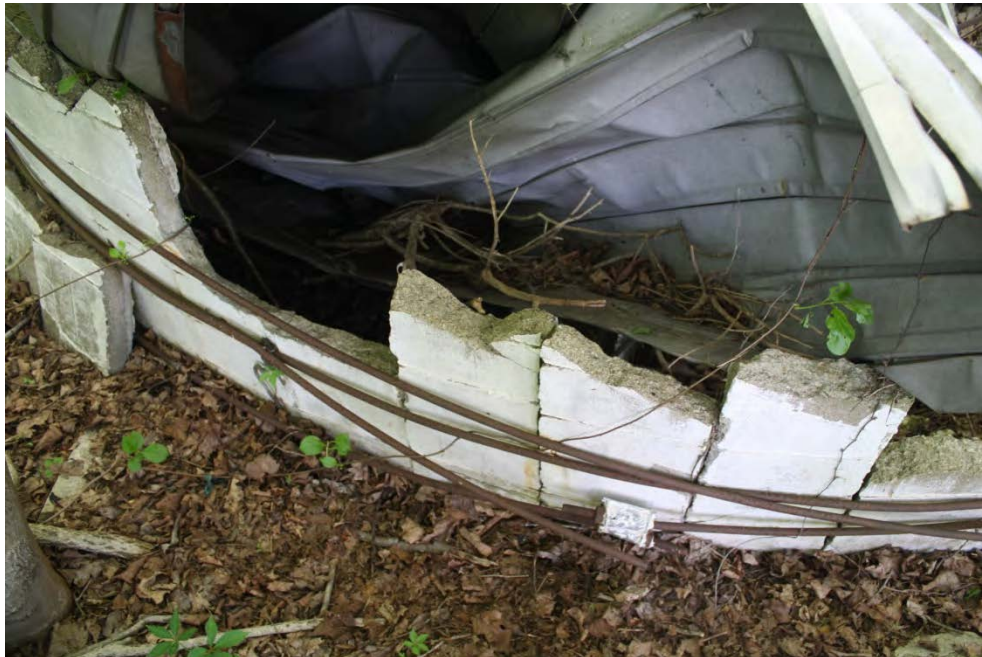
There were formerly additional buildings including a chicken coop and brooder house south of the garage, a horse barn between the garage and dairy barn, and a silo along the east side of the barn. As Diane tells the story, her uncle knocked it down to avoid paying taxes on it. The ruins of the silo are still lying on the ground next to the barn.

10. View of ruins of concrete stave silo, camera facing north.

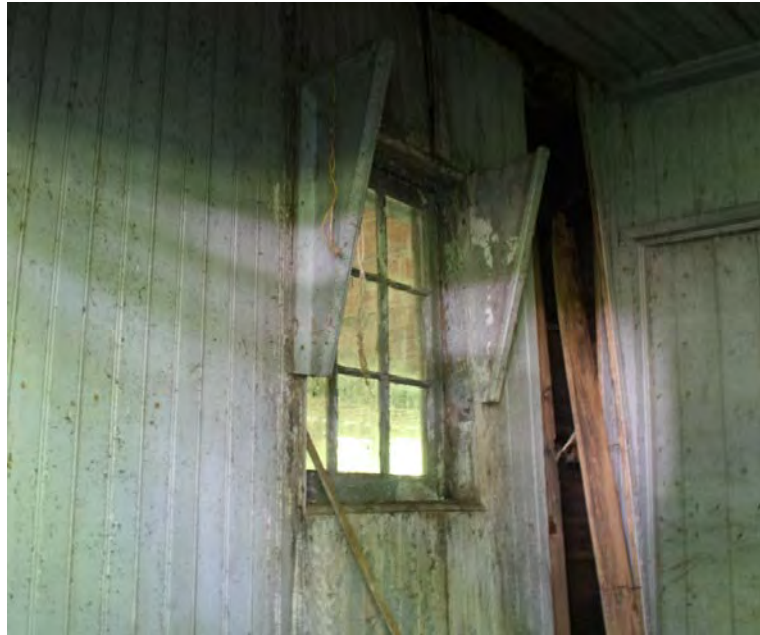
11. Interior view of extant original window located in feed room, camera facing west.

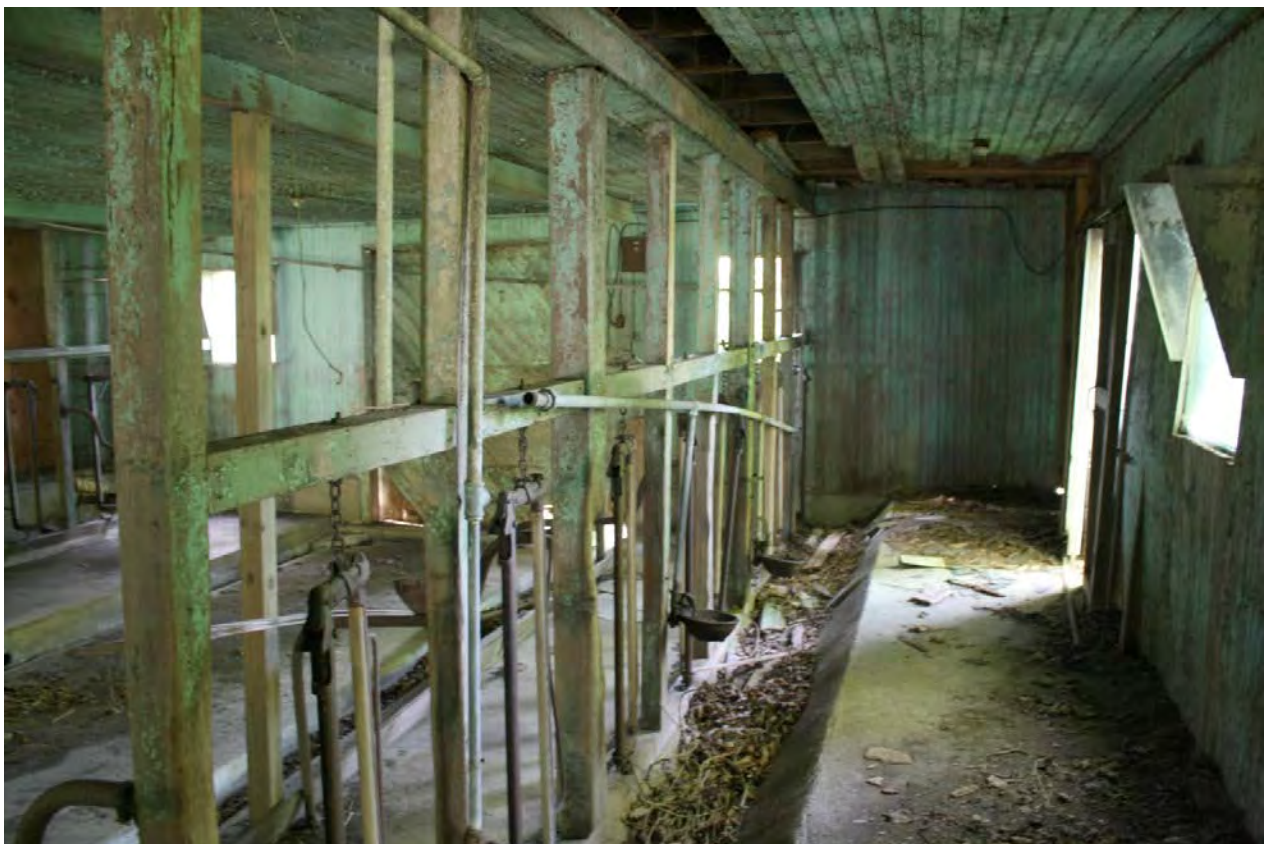
The interior of the ground floor is a stable barn layout with two rows of metal stanchions, some still in place, for cows to face outward. The concrete floor has unusual cast-in manure gutters which channel the waste around a series of turns to arrive at the north doorway rather than running straight through the wall. The water bowl and piping are extant at the outer face of the stanchions. The upper loft floor is supported by two longitudinal girders supported on posts in the line of the stanchions. These apparently were too widely spaced, as a third girder was added at the center line of the stable area, supported on metal lally columns, some replaced by wood posts. This girder is painted to match the adjacent surfaces, so appears to have been an early reinforcement. The aisles outboard of the feed troughs and adjacent to the exterior walls, is elevated several inches and accessed by two narrow ramps at the center of the barn's length. A milk room wing is reached through a door in the east wall. A feed room is enclosed in the southwest corner of the stable area; in this space one of the original nine-paned hopper windows is extant. The loft is accessed via two hatches in the ceiling just south of the center, with sliding covers mounted on the underside and ladders mounted on the walls. The walls and ceiling are paneled with tongue-and-groove boards painted light green, an unusually elaborate finish for this type of barn. An additional doorway in the east wall north of center leads to the ruins of the silo. The west wall is covered with plywood where originally windows matched the east side but subsequently a shed addition covered the exterior wall.

12. Interior view of ground level stable area, camera facing north. East wall with door opening to silo site is at right. Note stanchions, remains of automatic watering system, and feed trough formed into floor.

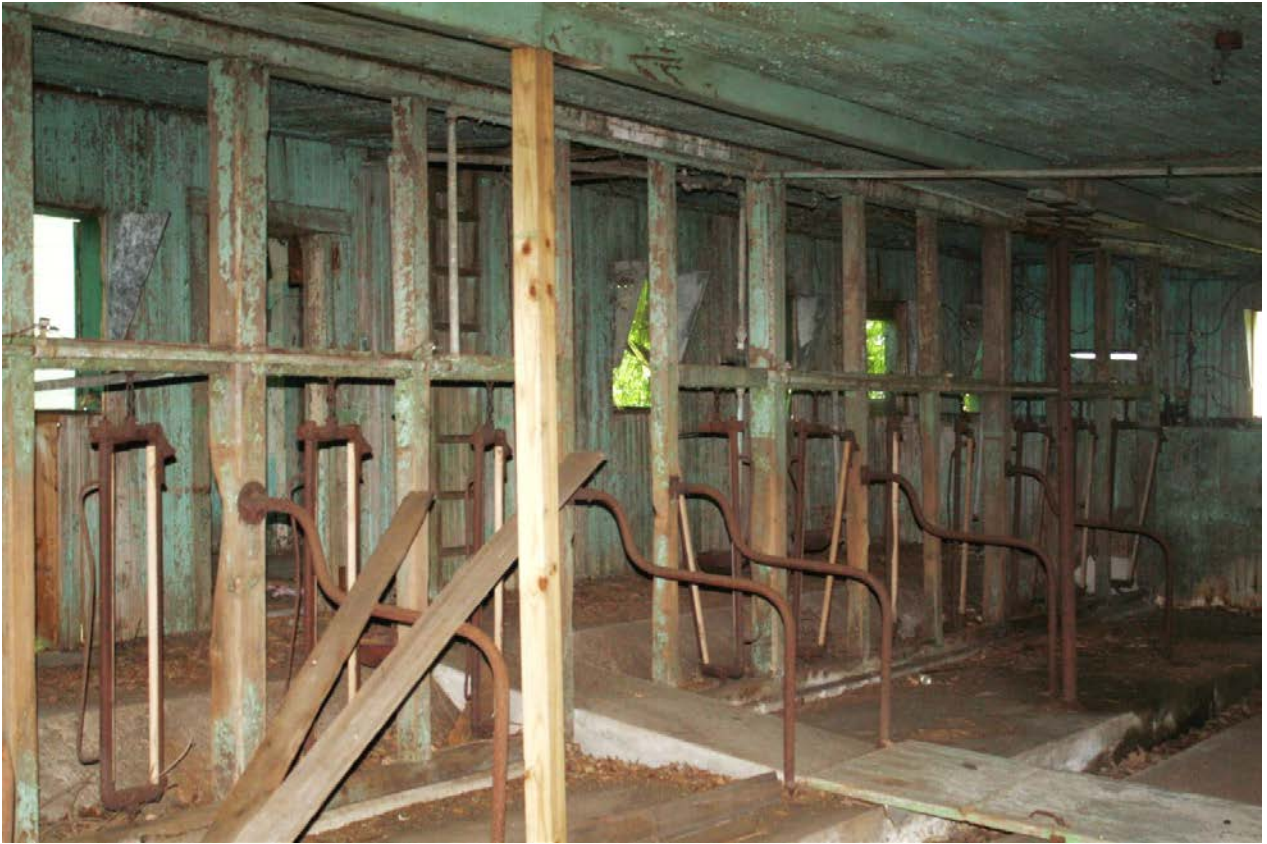
13. Interior view of ground level stable area, camera facing southeast. At left is the door to the Milk room, at right the typical stable windows and stanchions with stall dividers. Note the ramp transition from the walkway aisle near the outer wall to the manure aisle at center.

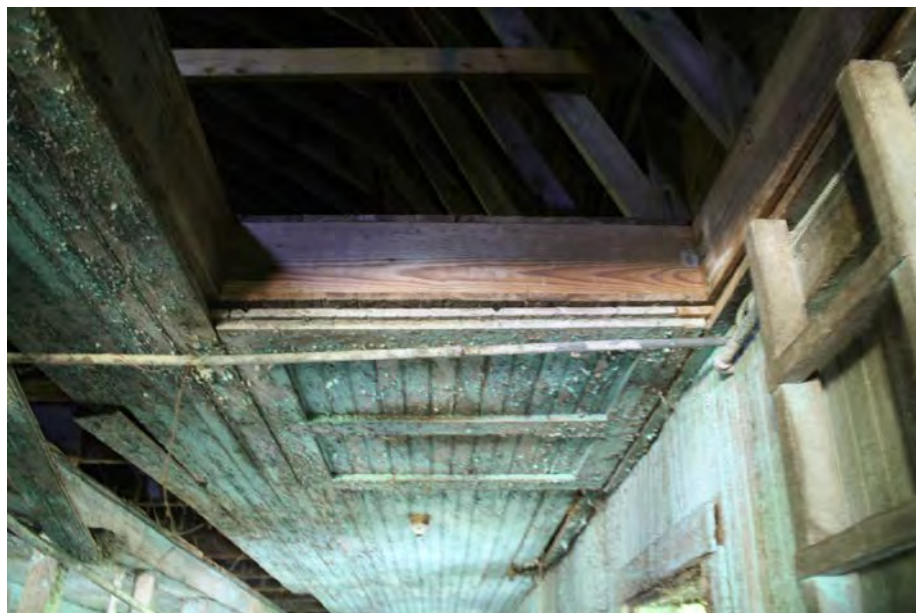
14. Interior detail view of sliding ceiling access hatch to hay loft, camera facing north.

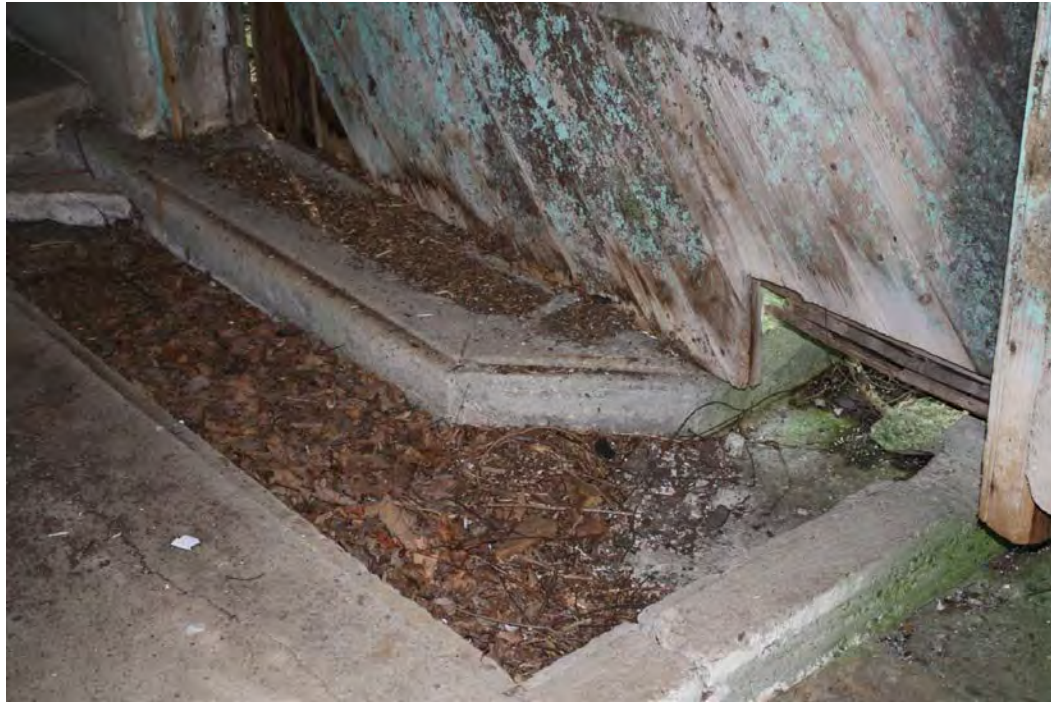
15. Interior detail view of floor slab at north door, camera facing north. Note the manure gutter exiting the building via a slot below the door, with an access panel cut into the door.

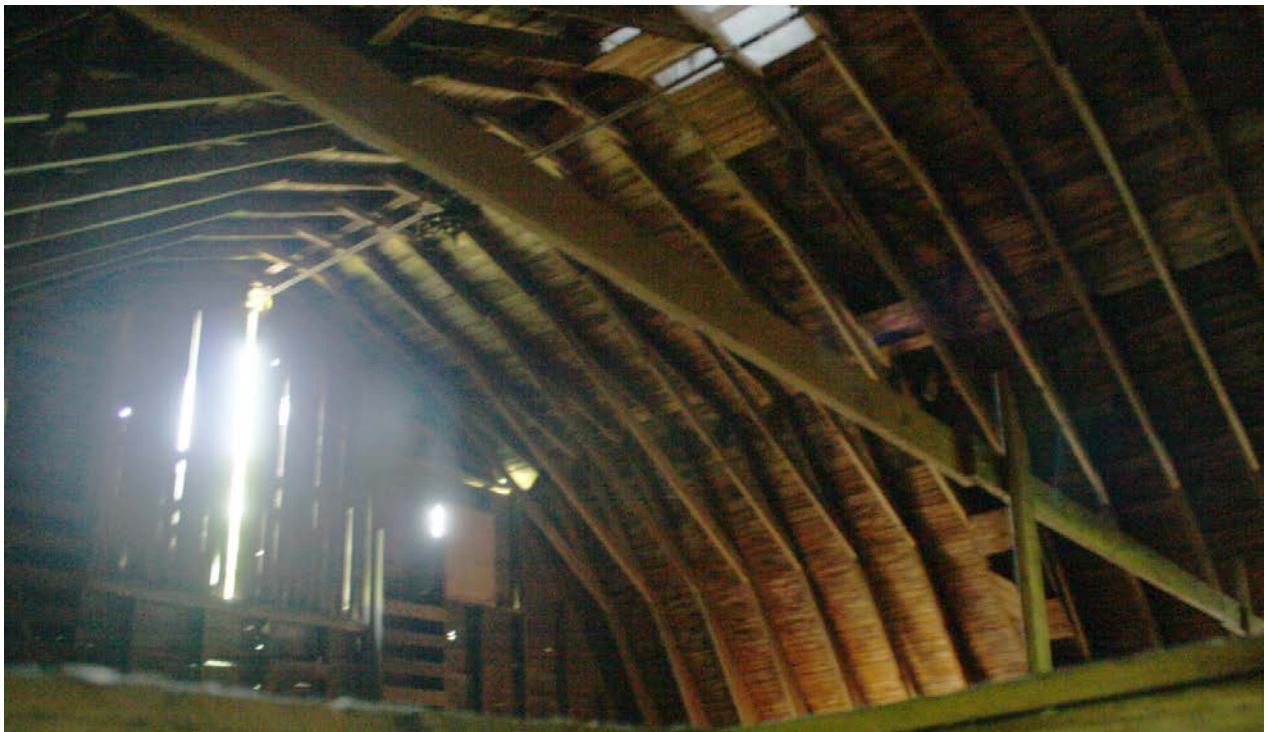
At the loft level, the roof is framed by dimension lumber scissor trusses which are somewhat unusually shallow and maximize the clear open space. Chases between the framing are enclosed leading from the lower level to the two roof-top ventilators. A hay track and hay fork are extant, suspended below the ridge. The large hay doors in the peak of the south elevation appear to be of the vertical sliding type, as no hinges are visible. Windows in the south gable-end flanking the hay doors are boarded shut.

16. Interior view of loft level of Barn, camera facing southwest.
