HISTORIC RESOURCES INVENTORY - BUILDING AND STRUCTURES

Building Name (Common) Randall, George and Louise, Farmstead Record No. 2481
 Building Name (Historic) Johnson, Ebenezer & Ruby, Old Johnson Homestead / Cinamella / Randall Farmstead
 Street Address or Location 1041 Exeter Road (Route 207)
 Town/City Lebanon Village _____ County New London
 Owner(s) Randall, Louise T., 1041 Exeter Road, Lebanon, CT 06249 Public Private

Style of building Extended English bank barn, Vernacular style Date of Construction Early 19th c.

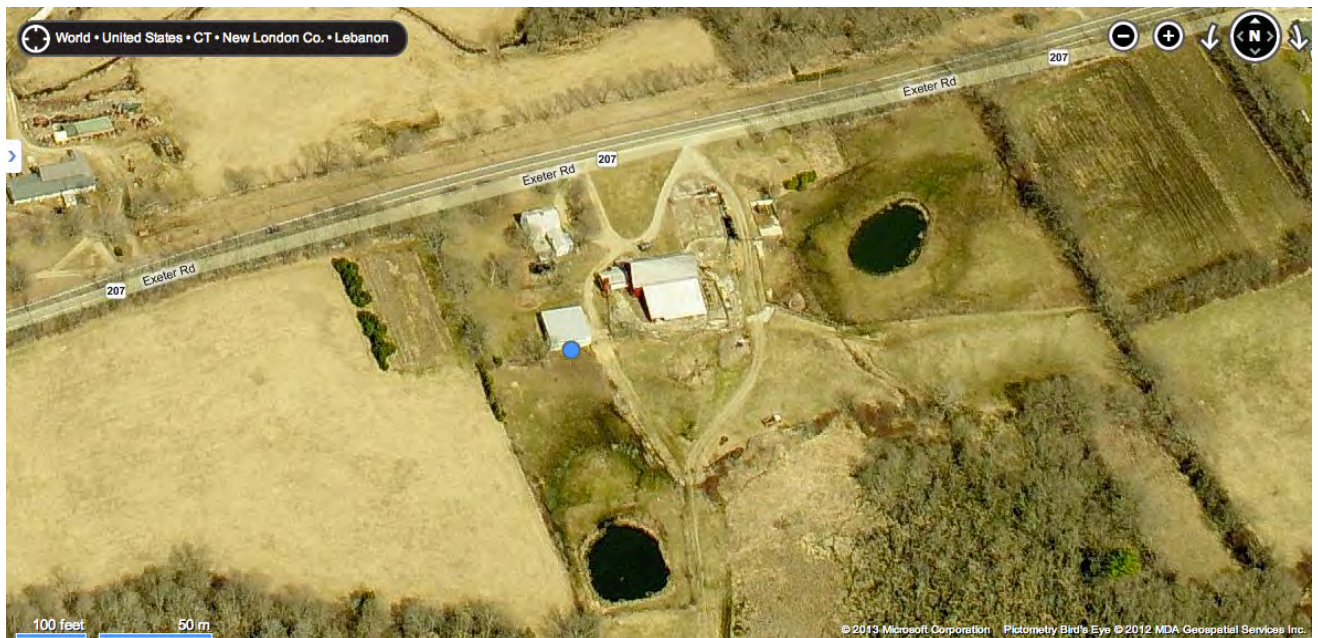
2. Southern view – aerial “bird’s-eye” map of 1041 Exeter Road, Lebanon, CT – <http://www.bing.com/maps> accessed 3/13/2013. Note: this photograph, from before 2011, shows the shed-roofed addition to the Barn.

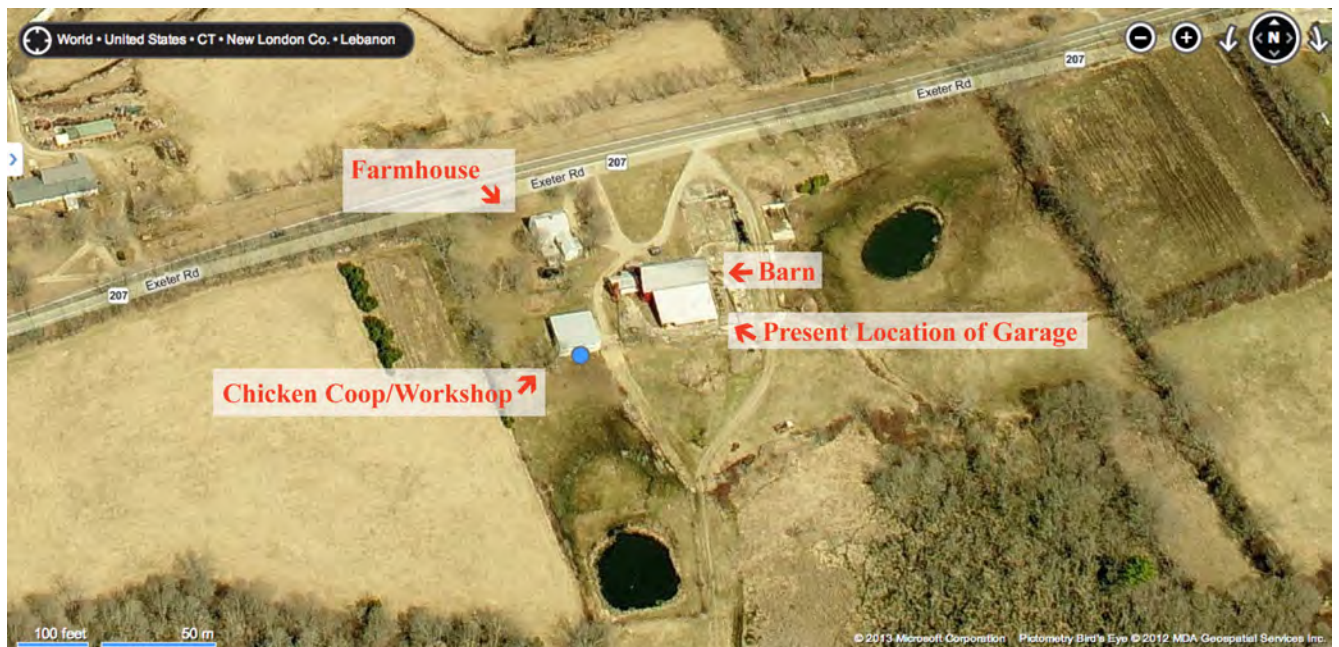
4. Site Plan Detail showing contributing and non-contributing resources. Base image from Bing Maps.

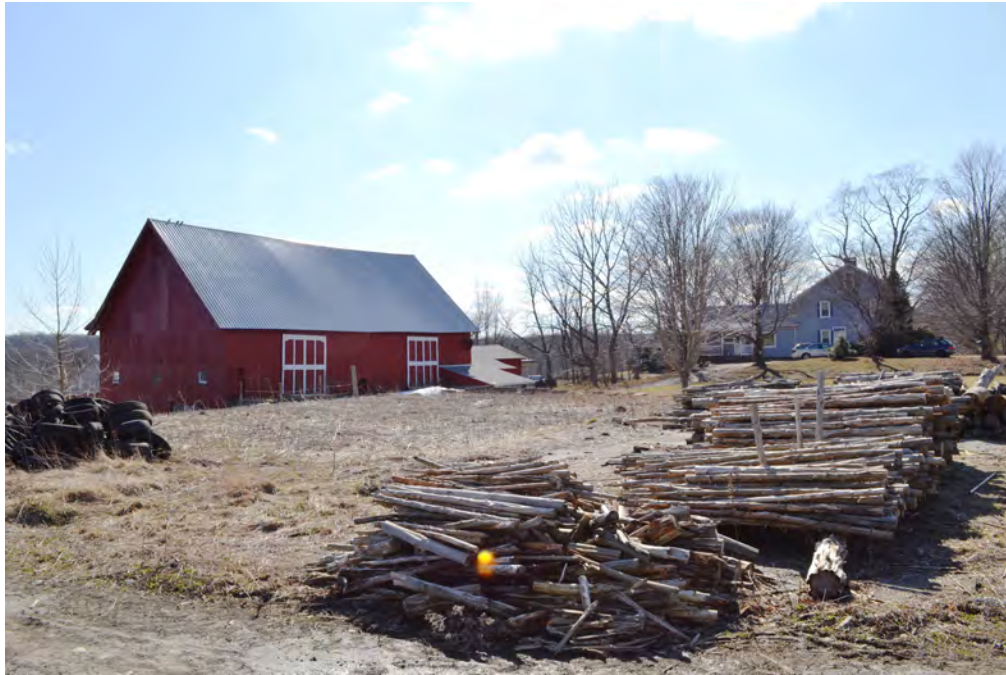
5. Northeast context view of 1041 Exeter Road, Lebanon, CT, camera facing southwest. Barn is at left, Farmhouse at right.

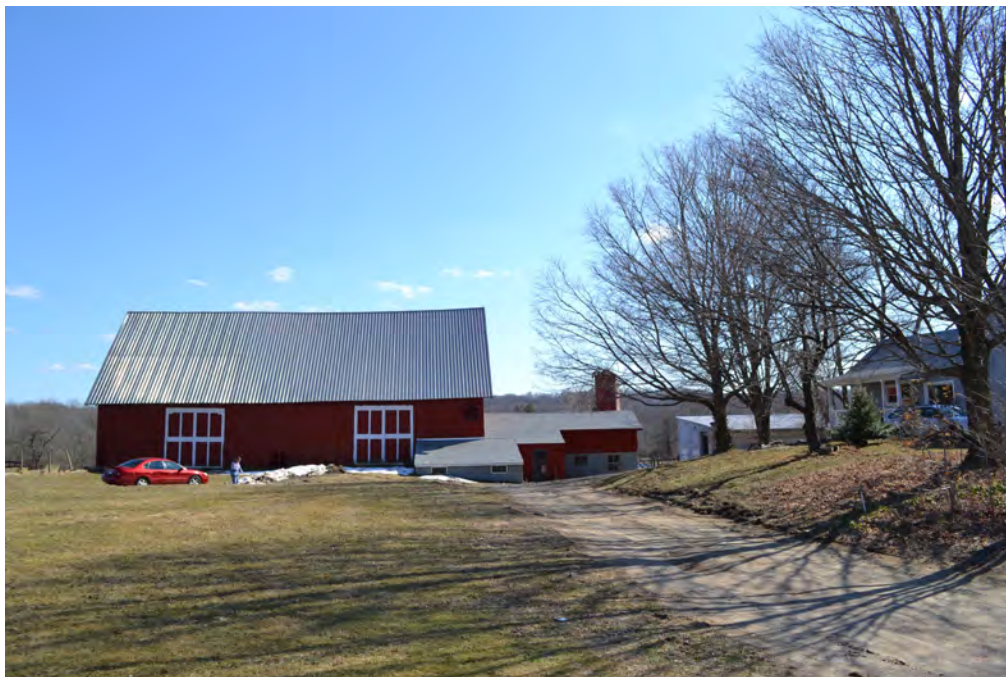
6. North context view of 1041 Exeter Road, Lebanon, CT, camera facing south. From left to right, Barn, Chicken coop, rear ell of Farmhouse.

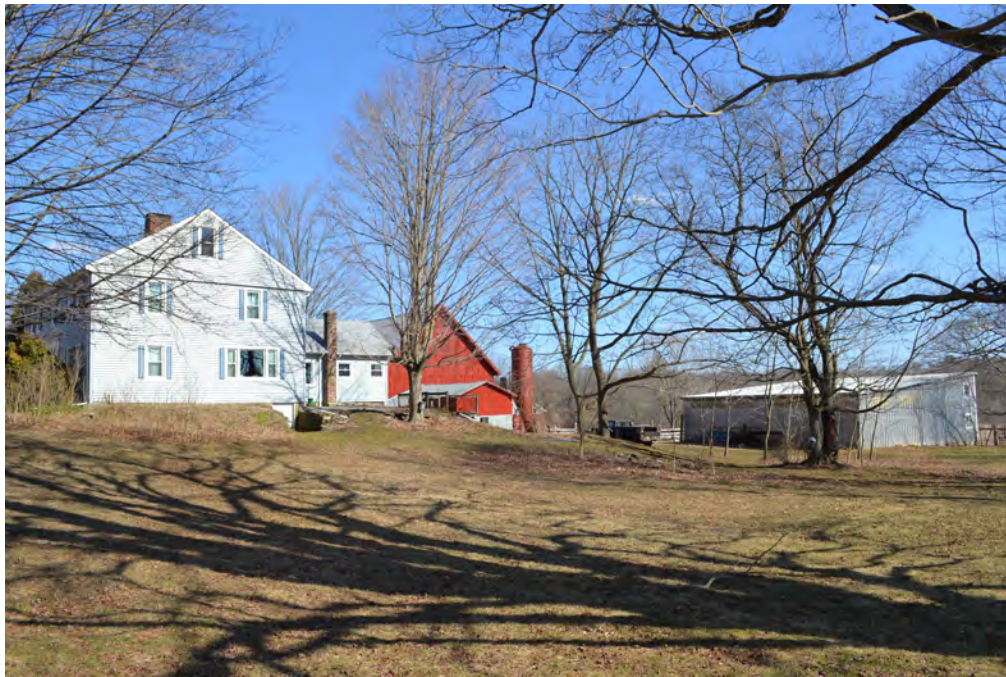
7. Northwest context view of 1041 Exeter Road, Lebanon, CT, camera facing southeast. From left to right, Farmhouse, Barn, Chicken Coop.

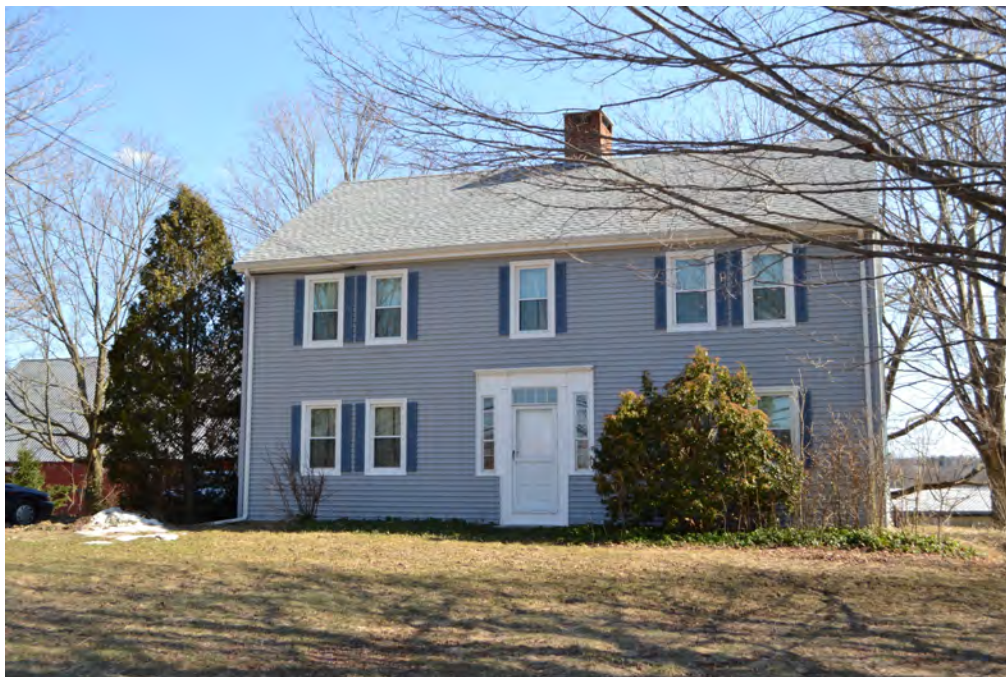
8. North eave-side of Farmhouse, camera facing south. Note Barn at rear left, Chicken coop at right rear.

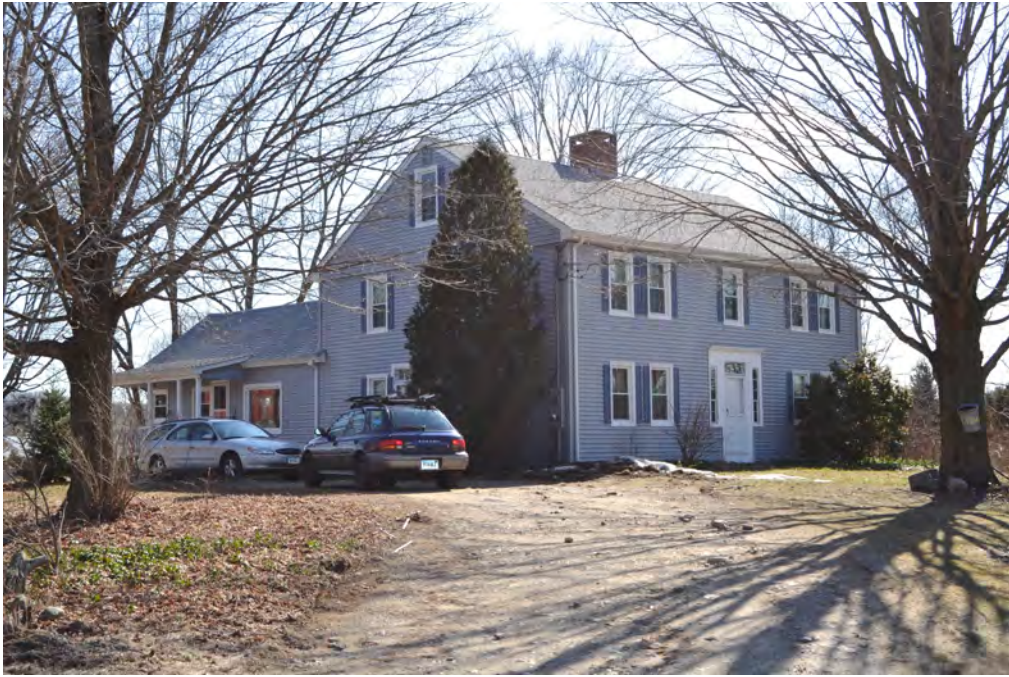
9. North eave-side and east gable-end of Farmhouse and west eave-side of rear ell, camera facing southwest.

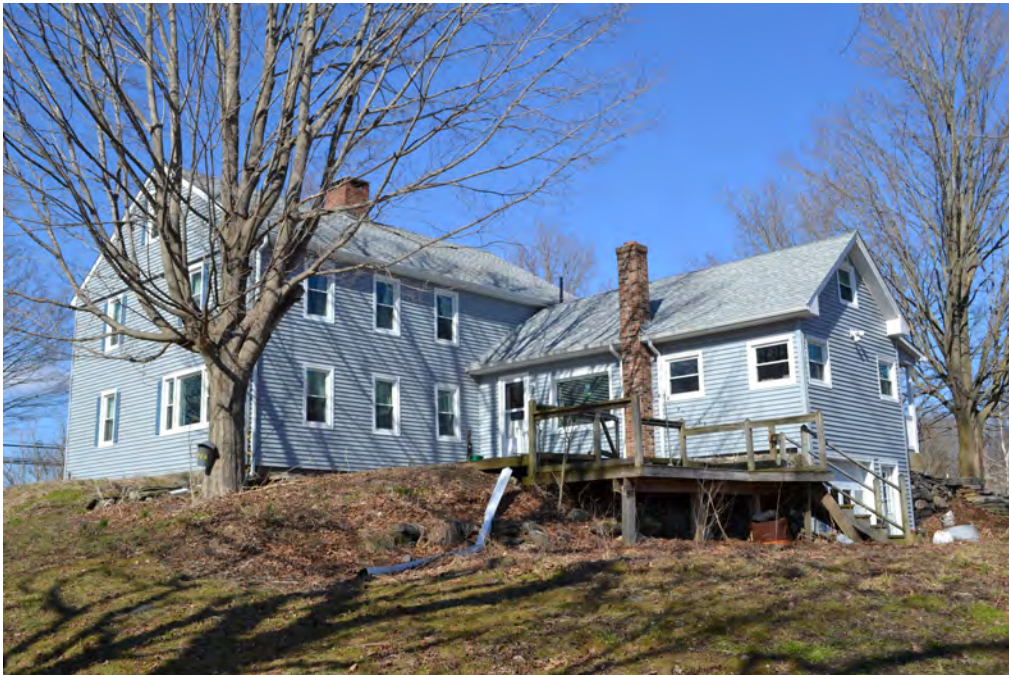
10. South eave-side and west gable-end of Farmhouse and west eave-side and south gable-end of rear ell, camera facing northeast.

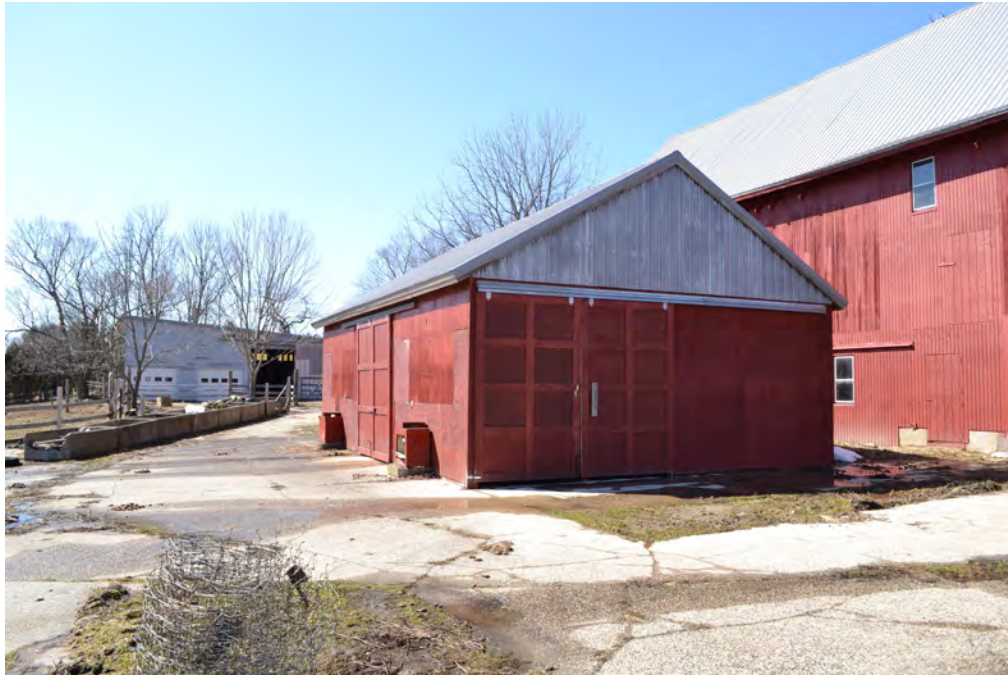
11. South eave-side and east gable-end of Garage, camera facing northwest. Note Chicken coop at left rear, south eave-side of Barn at right.

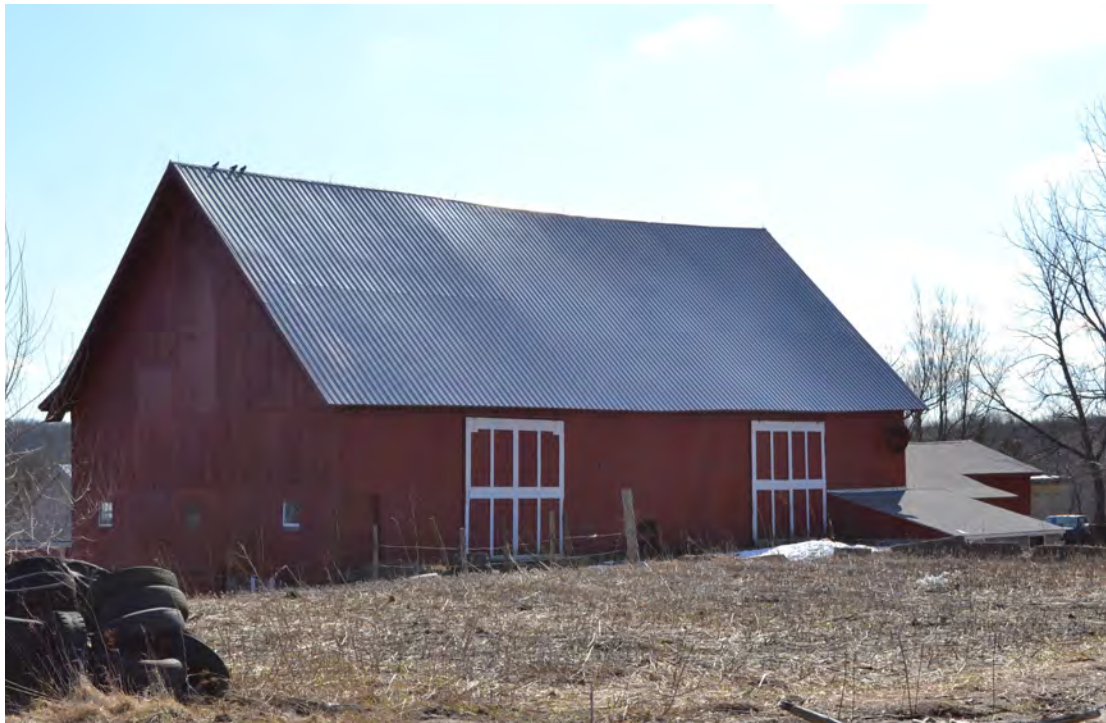
12. North eave-side and east gable-end of Barn, camera facing southwest.

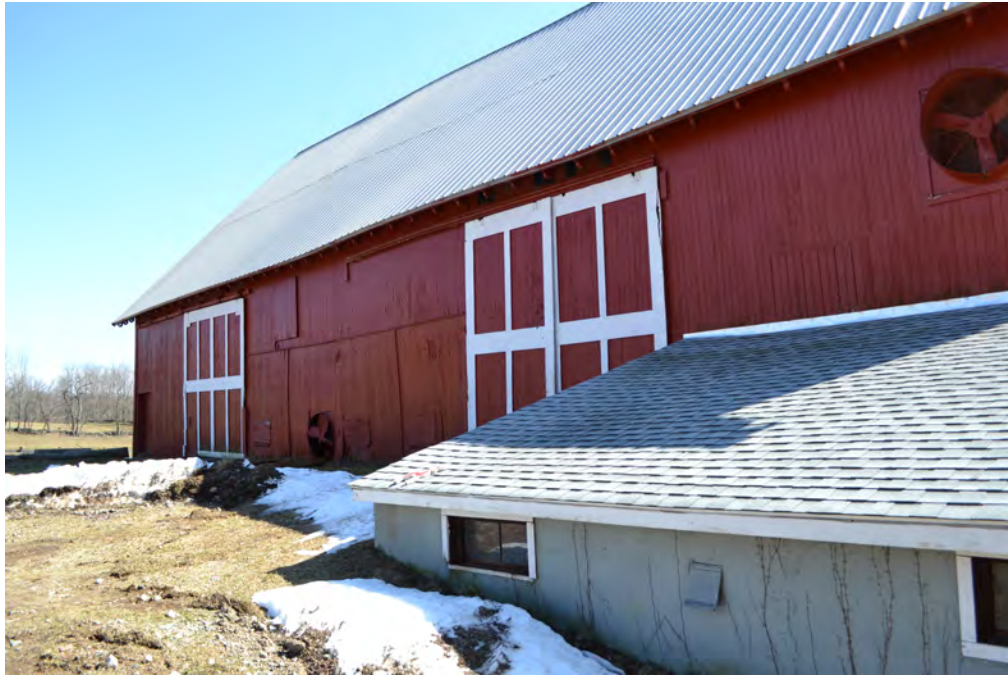
13. North eave-side of Barn and milk room, camera facing southeast. Note east and west sliding doors, center side-hinged doors, ventilator fans.

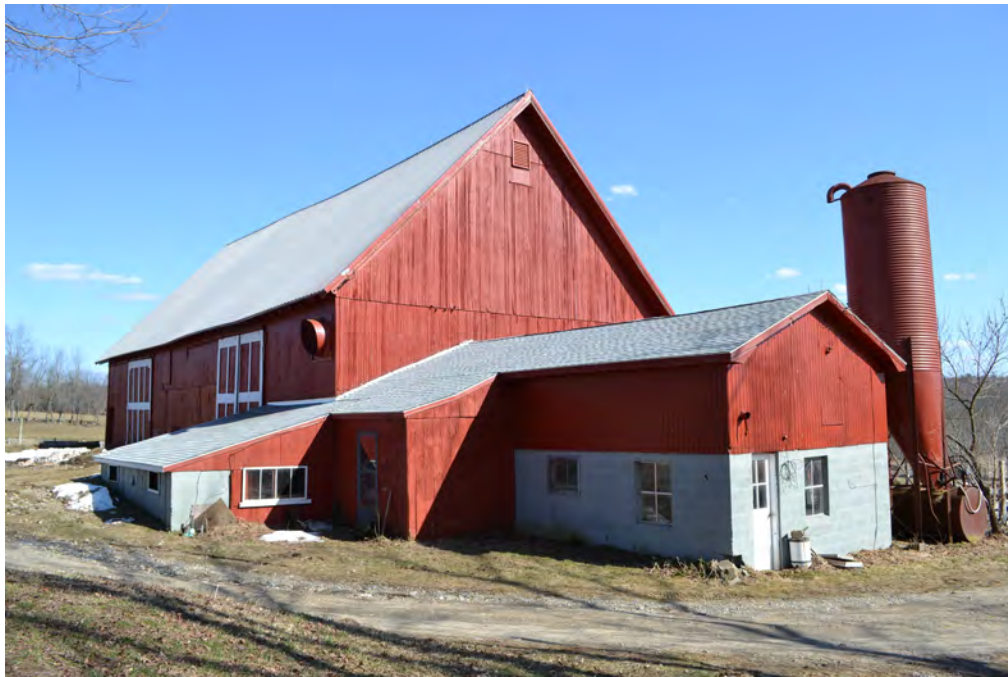
14. North eave-side and west gable-end of Barn, camera facing southeast. Note milk room and milking parlor/office additions, grain silo.

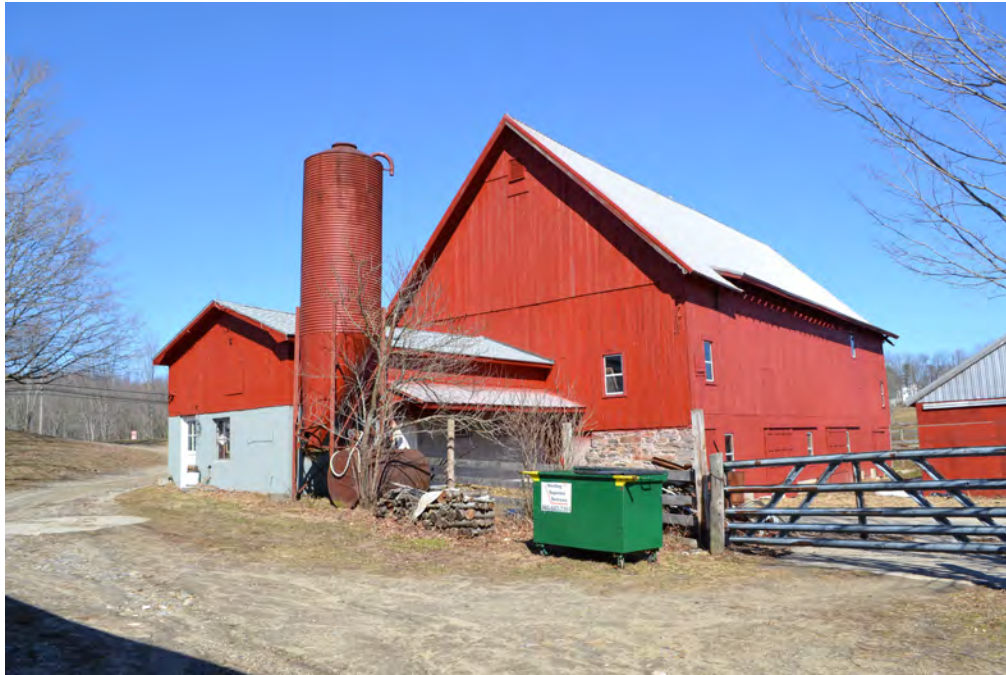
15. South eave-side and west gable-end of Barn, camera facing northeast. Note and milking parlor/office addition, and grain silo at left, Garage at far right.

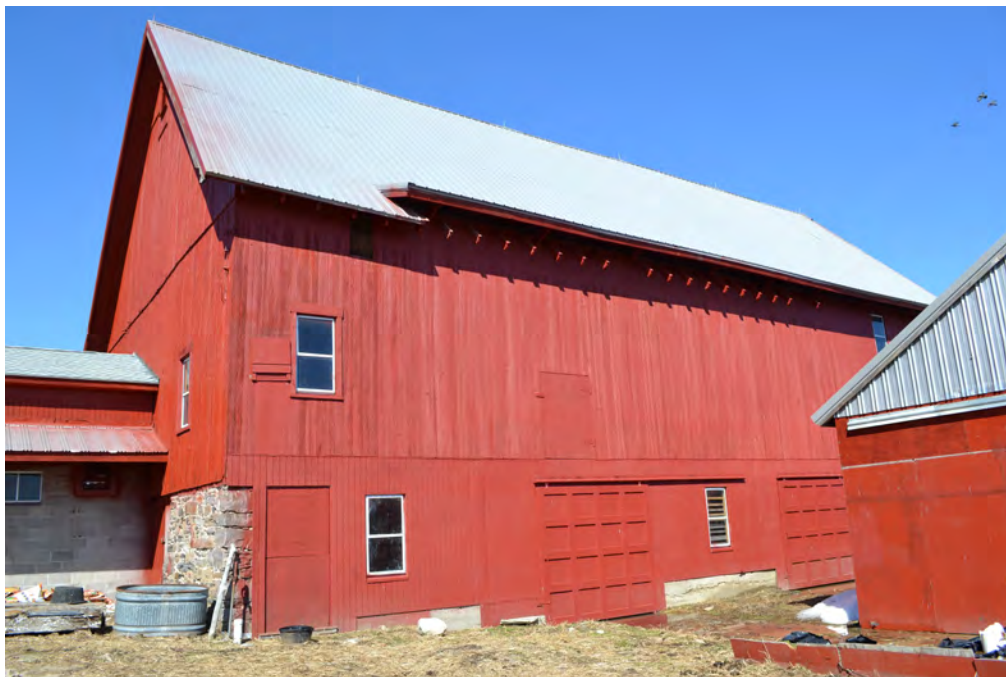
Until recently, the south eave-side of the barn had a modern shed-roofed pole barn addition that encompassed the majority of the façade and extended roughly 36' to the south. The addition was destroyed in a 2011 blizzard and has since been replaced by the freestanding Garage currently located south of the Barn. Removal of the pole barn has revealed the historic exterior of the south eave-side. In the basement level of the elevation there is – from west to east – a side-hinged pass-through door and three sliding doors, each of these alternating with a single one-over-one double-hung window. The sliding doors are mounted on exterior tracks running to the east. Above, in the main level of the barn, there are three one-over-one double-hung windows, these irregularly spaced throughout the elevation. A side-hinged hay door is located in the third bay from the western side of the barn. A shallower pitch in the roof-line running across all but the Barn's westernmost bay illustrates where the pole barn was once joined to the main block. The shaped rafter tails are still visible in situ.

16. South eave-side and west gable-end of Barn, camera facing northeast. Note sliding and pass-through doors on lower level, roof-line at junction with former free-stall barn addition, and extant sawn rafter tails.

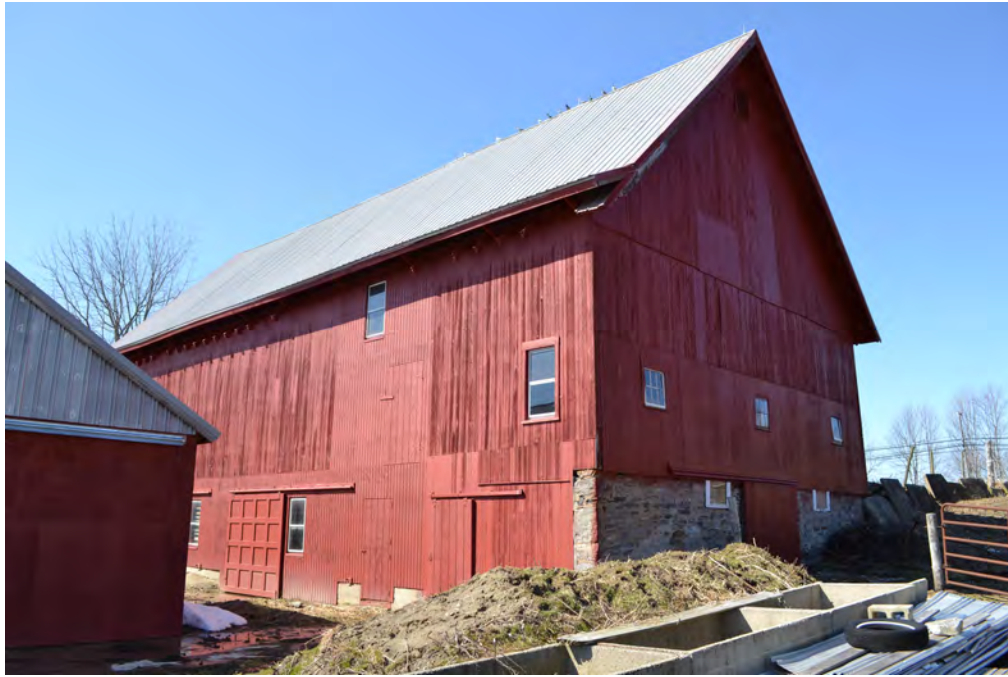
17. South eave-side and east gable-end of Barn, camera facing northwest. Note sliding door on east gable-end lower level, Garage at left.

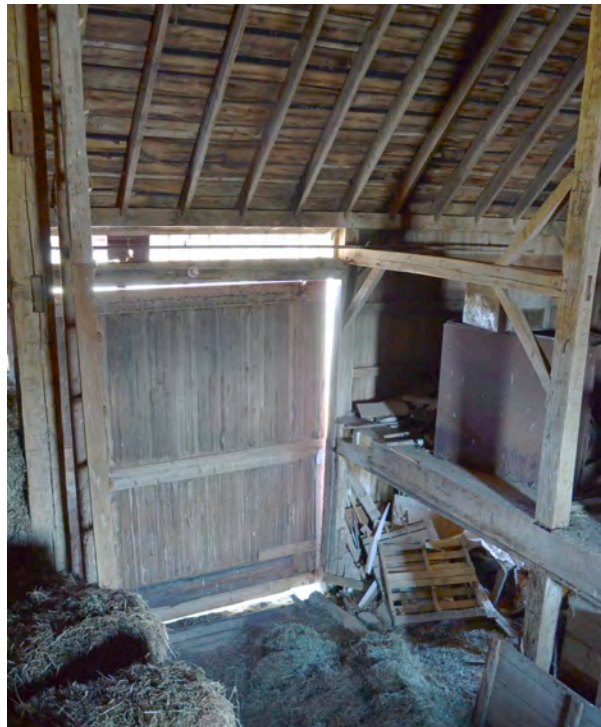
18. Interior view of Barn main and loft levels, showing framing details, camera facing southwest. Note mixed hand-hewn and sawn posts and girts, sawn braces, and north eave-side sliding door.

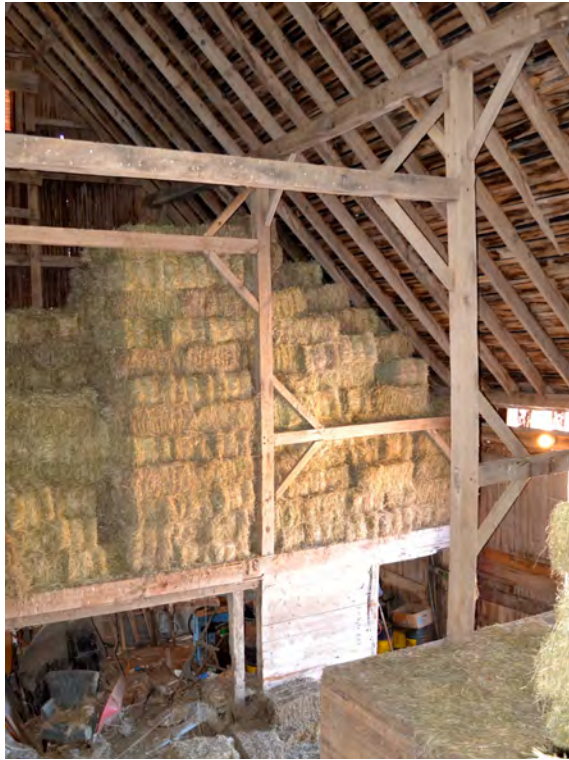
19. Interior view of Barn main and loft levels, showing framing details, camera facing northwest. Note mixed hand-hewn and sawn posts, girts, and purlin, sawn braces.

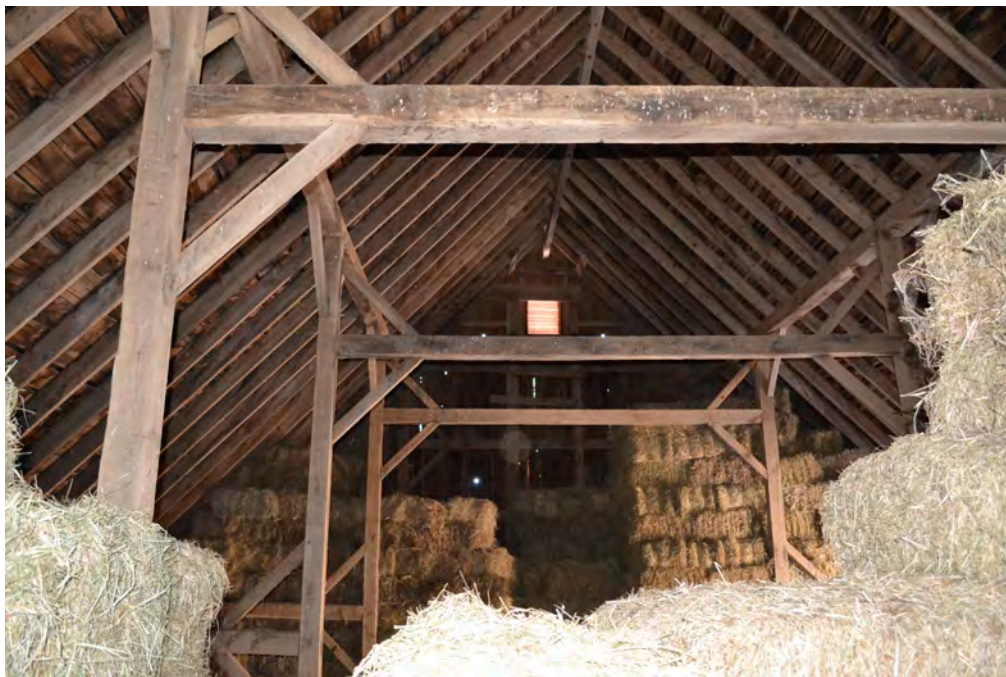
20. Interior view of Barn loft level, showing framing and roof details, camera facing west. Note mixed hand-hewn and sawn posts and girts, sawn braces.

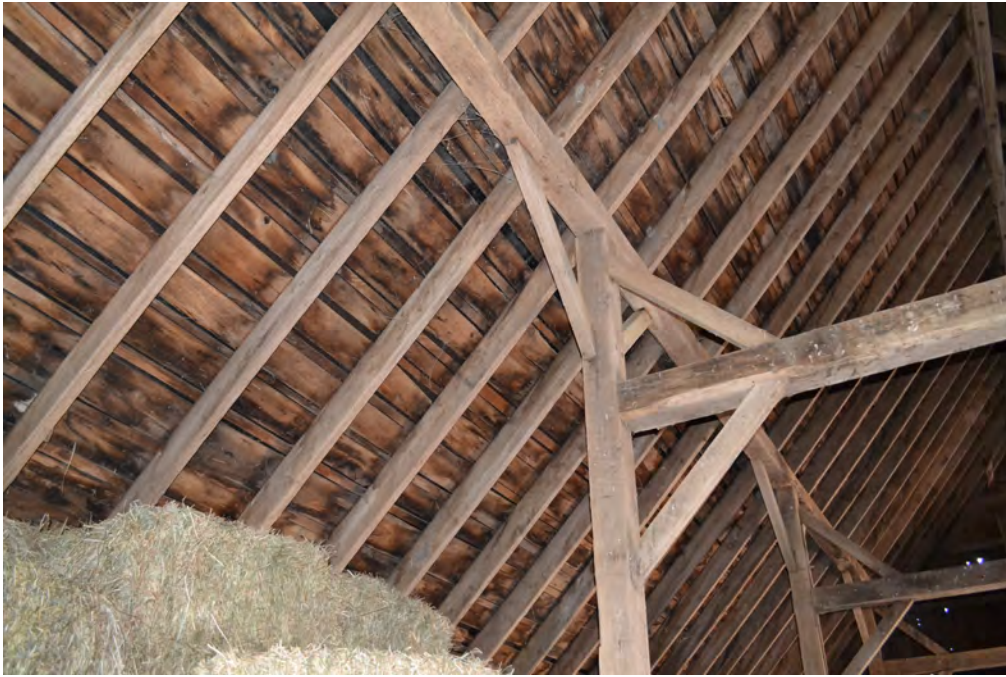
21. Interior view of Barn loft level, showing framing and roof details, camera facing southwest. Note mixed hand-hewn and sawn posts, girts, and purlin, sawn braces.

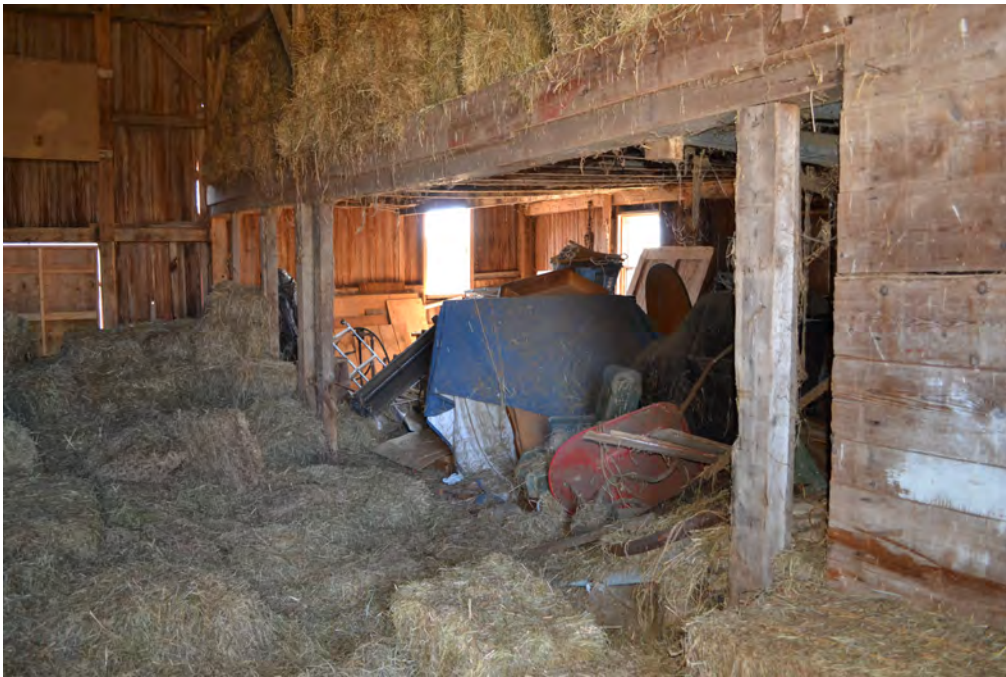
22. Interior view of Barn main level westernmost bay, showing framing details, camera facing southwest.

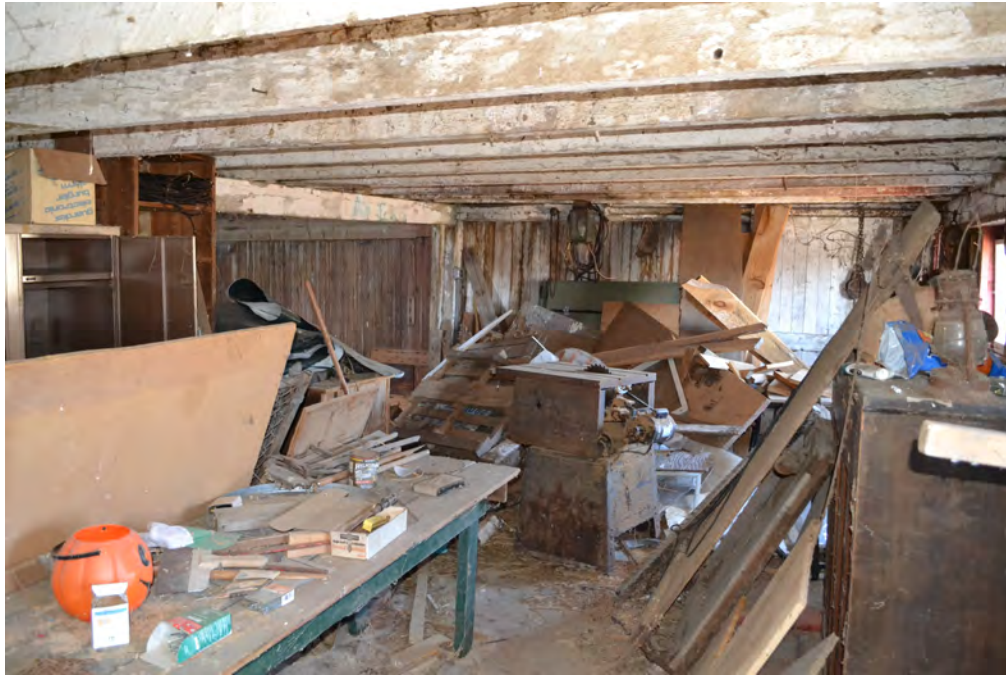
23. Interior view of Barn main level easternmost bay, showing interior details, camera facing north. Note whitewashed walls, floor joists above.

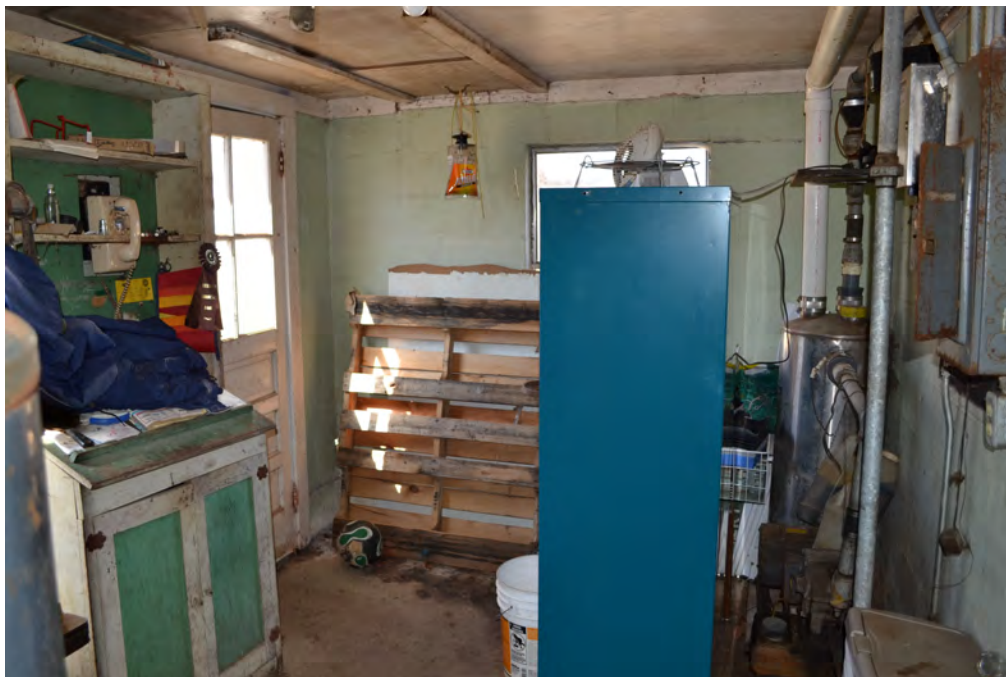
24. Interior view of Barn office, showing interior details, camera facing northwest.

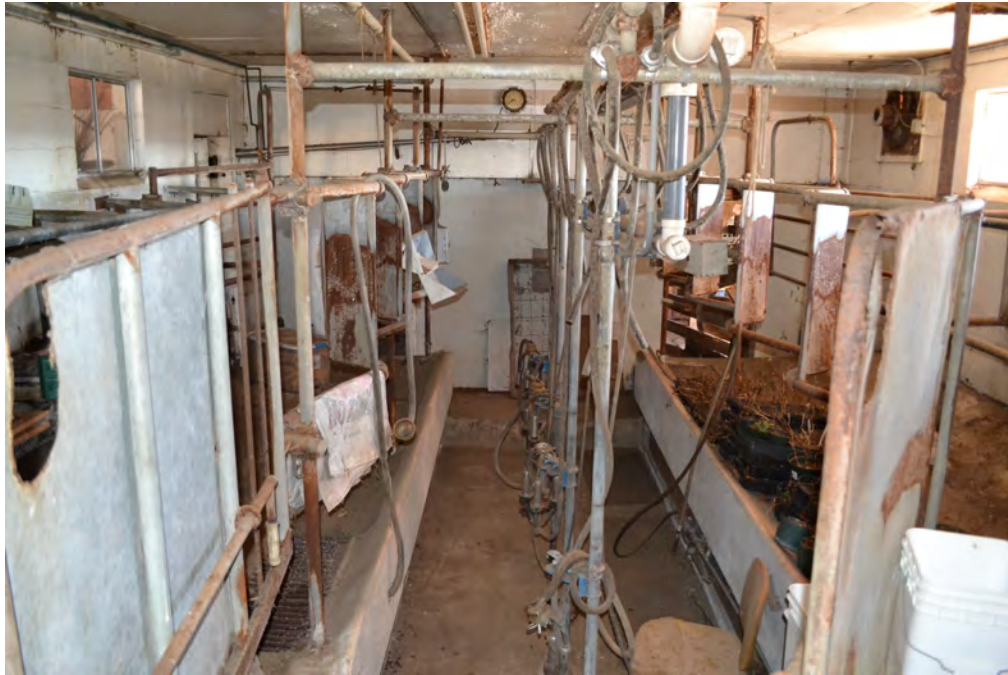
25. Interior view of Barn milking parlor, showing interior details, camera facing east. Note recessed milking station, milking equipment.

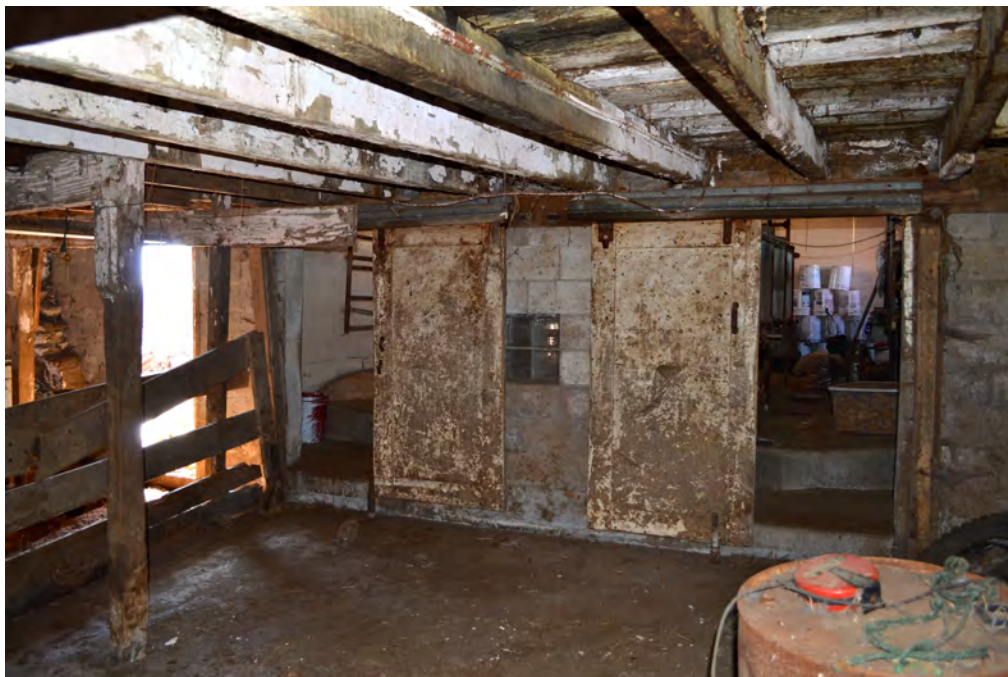
26. Interior view of Barn lower level, showing interior framing, camera facing west. Note sliding doors between milking parlor and barn.

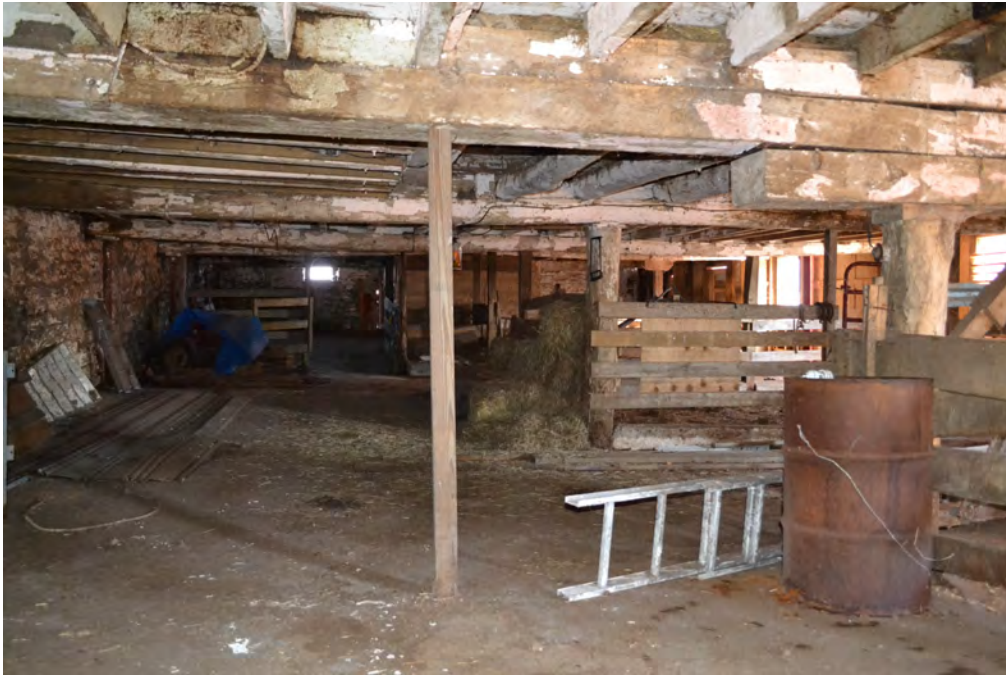
27. Interior view of Barn lower level, showing framing details, camera facing east. Note mixed hand hewn and sawn posts, girders, and joists.

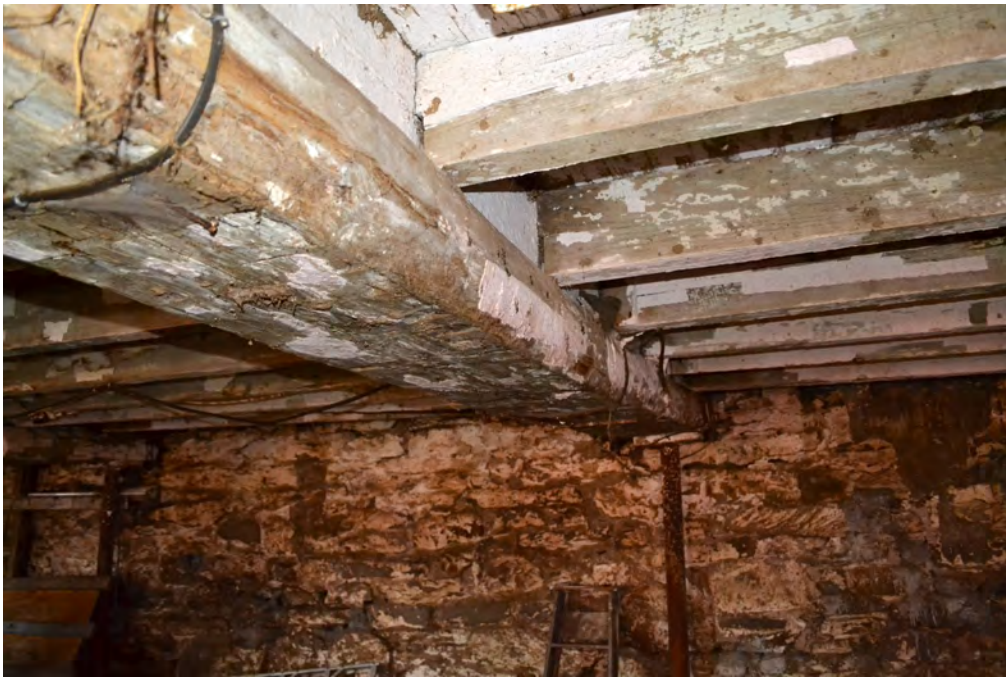
28. Interior view of Barn lower level, showing framing details, camera facing north. Note 18” hand-hewn girder, sawn joists, lally column.

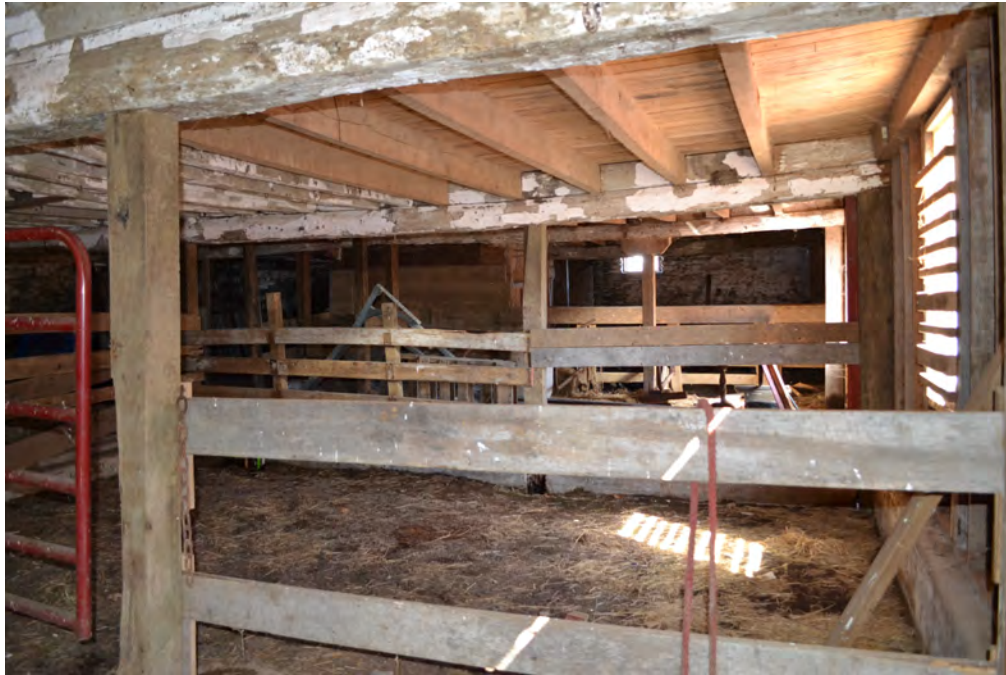
29. Interior view of Barn lower level, showing framing and interior details, camera facing east. Note birthing stall.

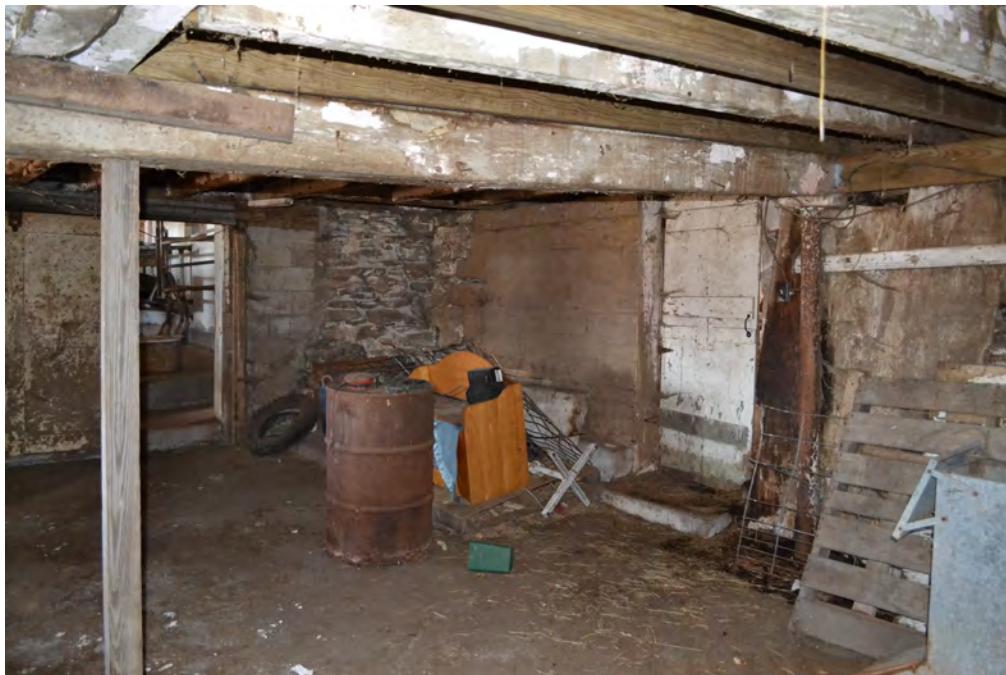
30. Interior view of Barn lower level, showing framing and interior details, camera facing northwest. Note sliding door to milking parlor at left, pass-through door to milk room at right.

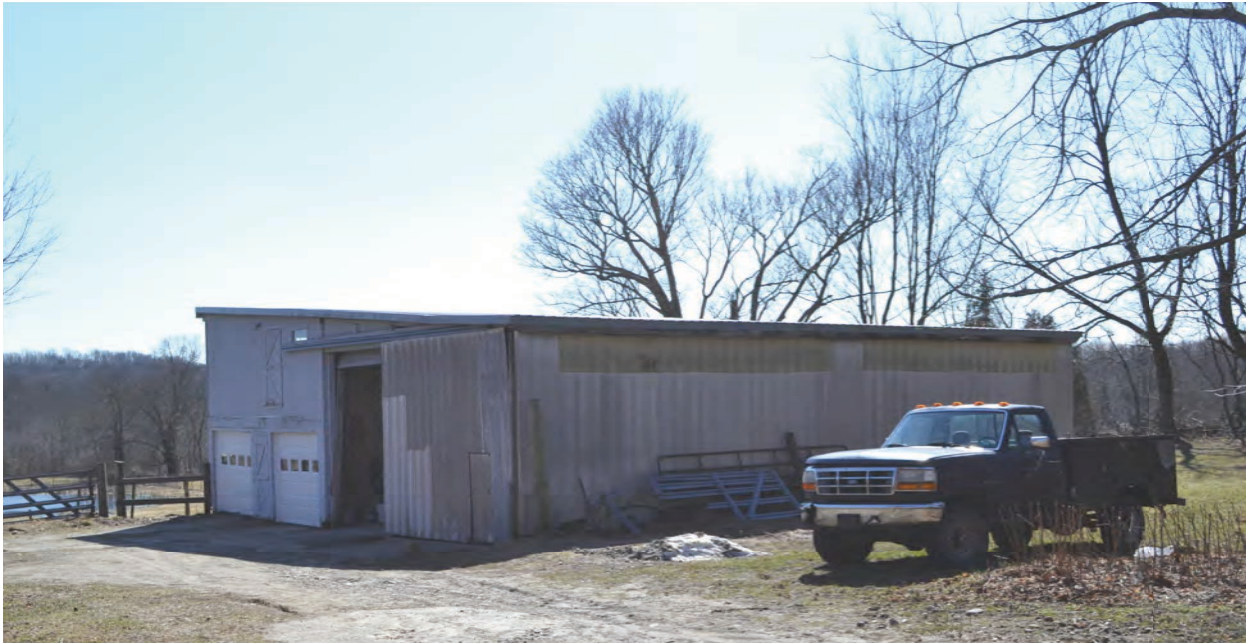
31. East gable-end and north eave-side of Chicken coop, camera facing southwest. Note workshop addition on north eave-side.

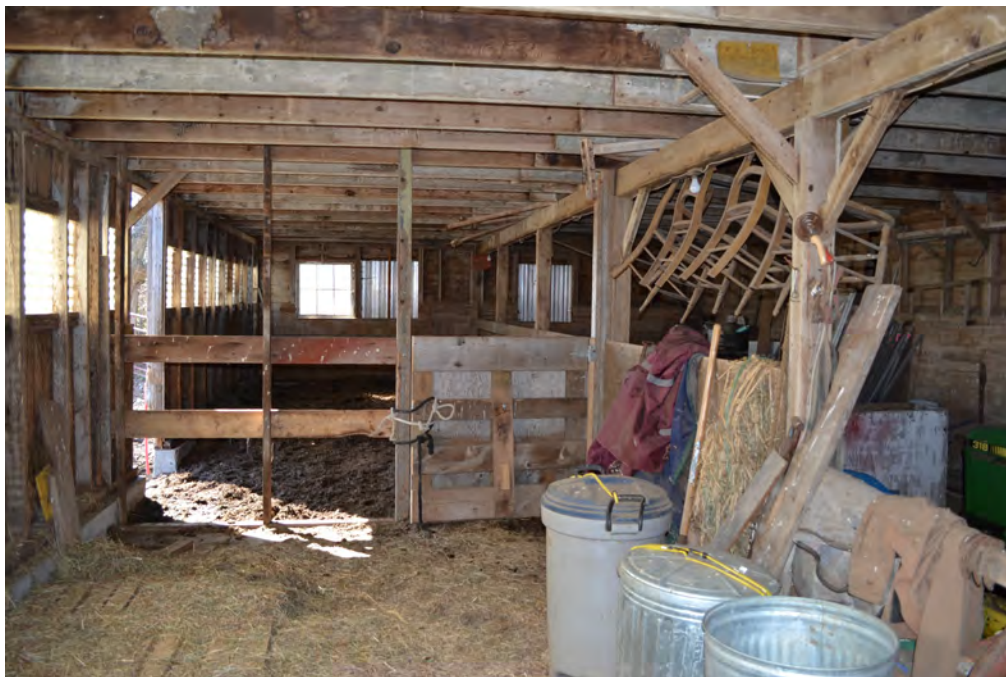
32. Interior view of Chicken coop lower level, showing framing and interior details, camera facing west. Note free stalls at left, storage area at right.

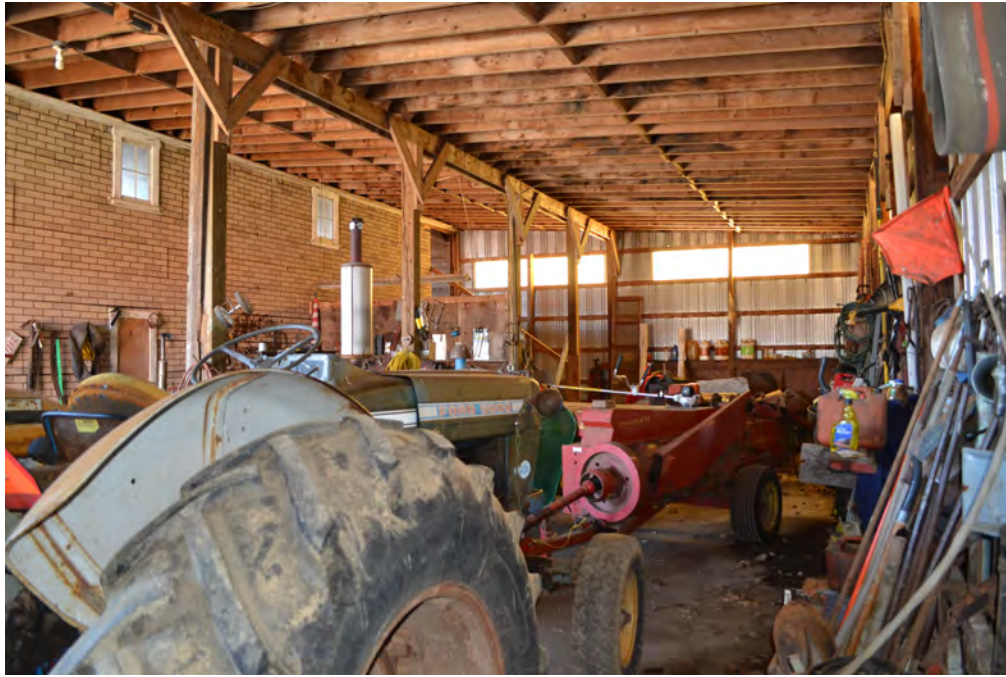
33. Interior view of Workshop addition to Chicken coop, showing framing and interior details, camera facing southwest. Note original north eave-side of Chicken coop at left, workshop area at right.
