HISTORIC RESOURCES INVENTORY - BUILDING AND STRUCTURES

Building Name (Common) Randall, George and Louise, Farmstead Record No. 2481
 Building Name (Historic) Johnson, Ebenezer & Ruby, Old Johnson Homestead / Cinamella / Randall Farmstead
 Street Address or Location 1041 Exeter Road (Route 207)
 Town/City Lebanon Village _____ County New London
 Owner(s) Randall, Louise T., 1041 Exeter Road, Lebanon, CT 06249 Public Private

Style of building Extended English bank barn, Vernacular style Date of Construction Early 19th c.

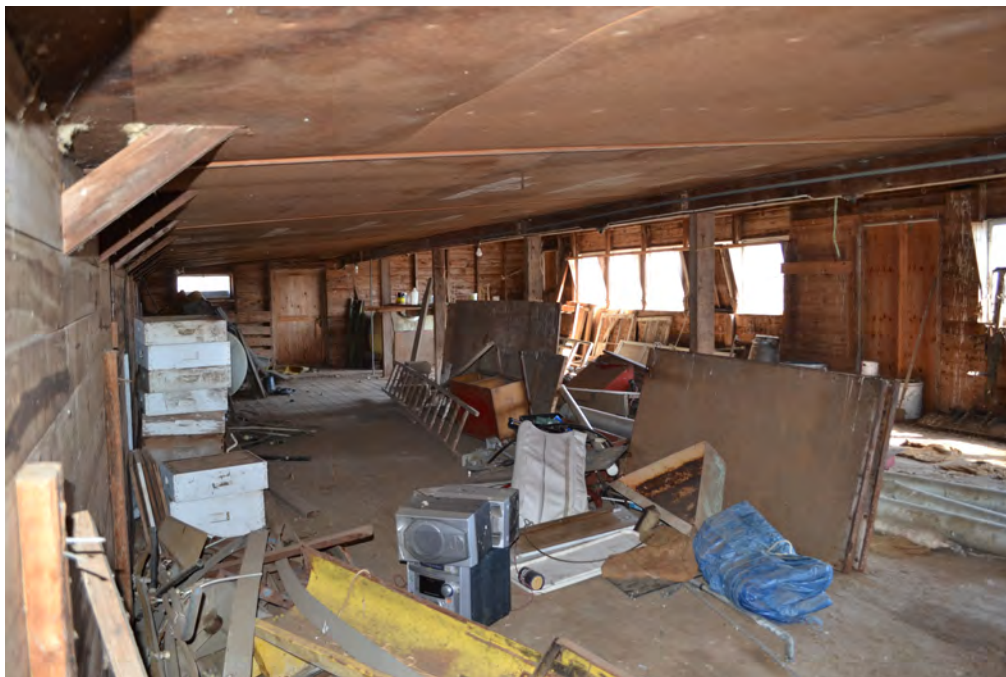
34. Interior view of Chicken coop upper level, showing framing and interior details, camera facing southeast.
