## HISTORIC RESOURCES INVENTORY - BUILDING AND STRUCTURES

Building Name (Common) Lebanon Hills Farm Record No. 53662  
 Building Name (Historic) Payne / Brown / Pokorny Farmstead  
 Street Address or Location 112 Kick Hill Road  
 Town/City Lebanon Village \_\_\_\_\_ County New London  
 Owner(s) Lebanon Hills Farm, LLC, 379 Goshen Hill Rd., Lebanon, CT 06249  Public  Private

Style of building English bank barn, Gambrel barn, Vernacular style Date of Construction 19th & 20th c.

112 Kick Hill Road, Lebanon, CT Record No. 53662

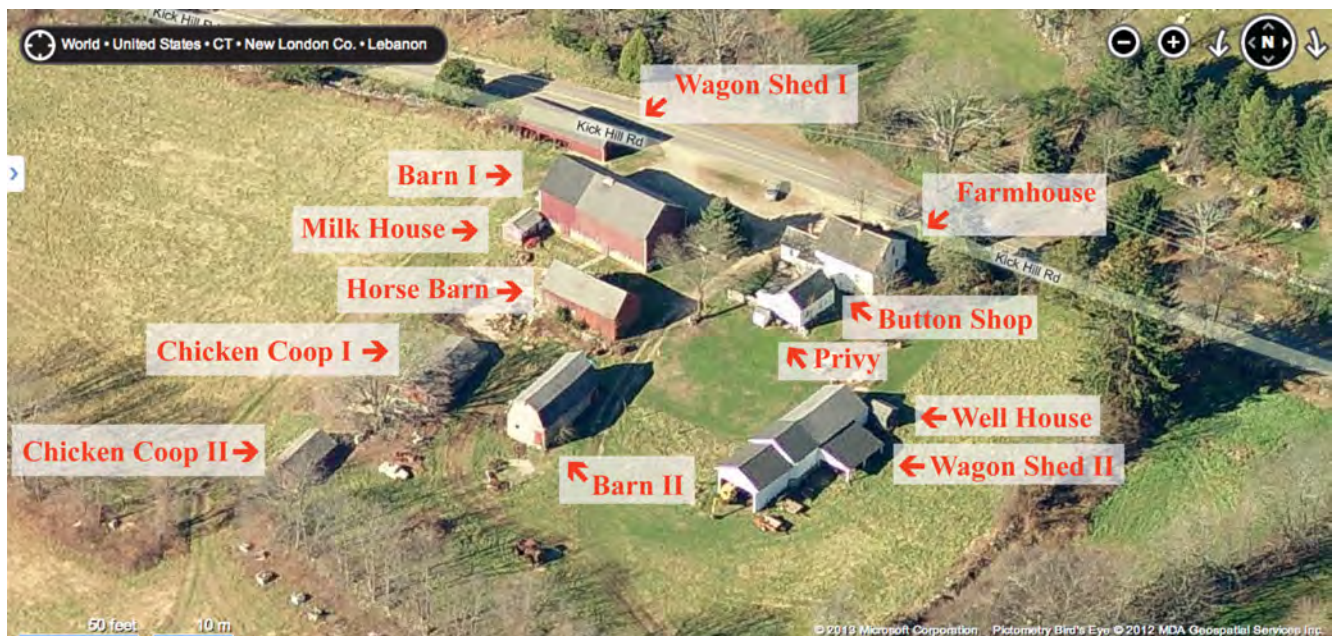
4. Detail Site Plan showing contributing resources – base image from Bing Maps.

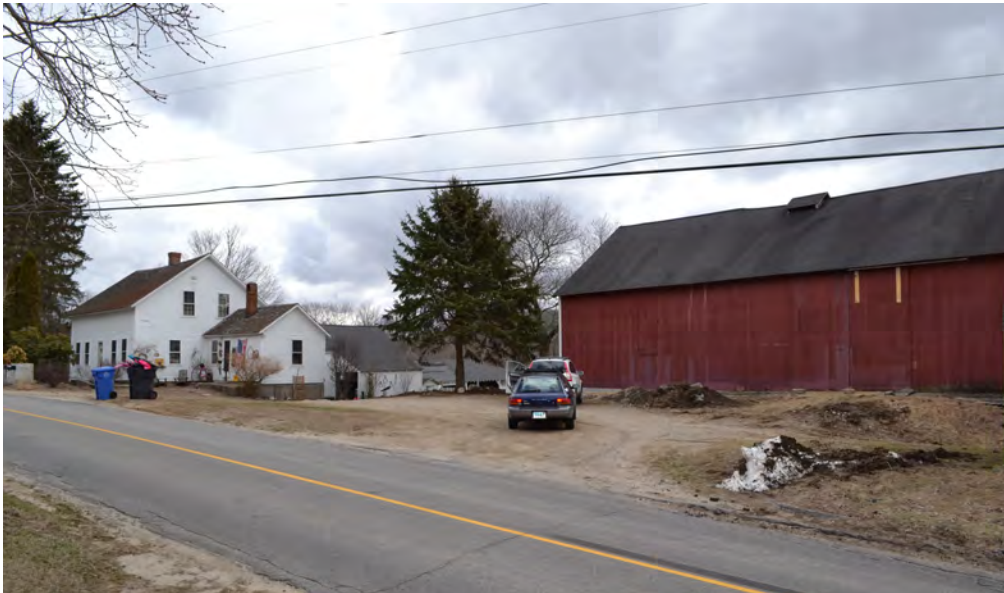
5. Northwest context view of 112 Kick Hill Road, Lebanon, CT, camera facing southeast. From right to left, Barn I, Button Shop, Farmhouse.

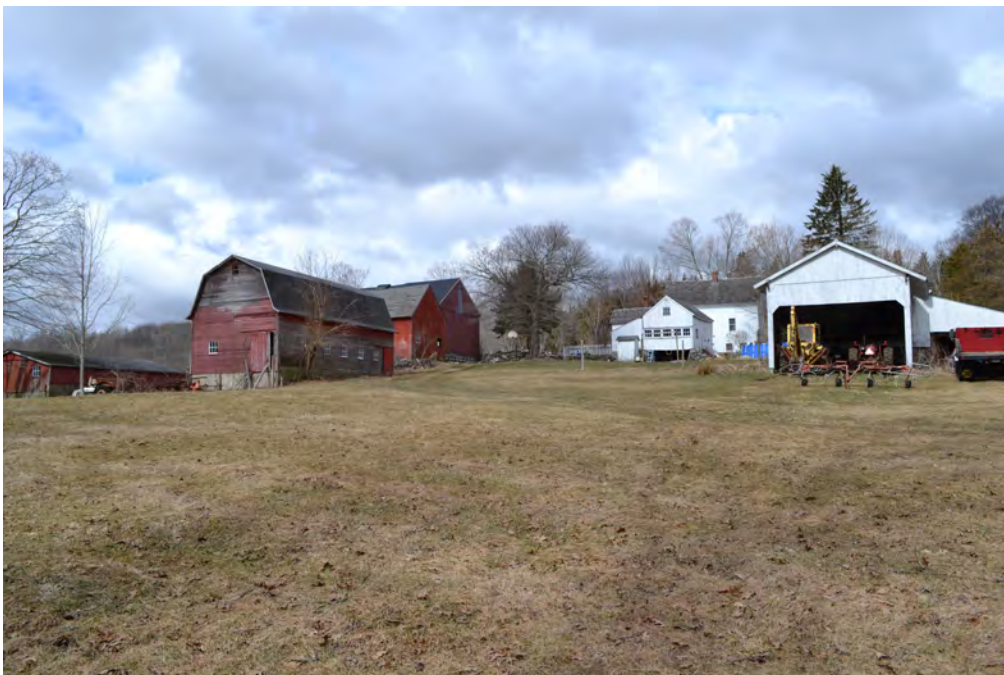
6. Southeast context view of 112 Kick Hill Road, Lebanon, CT, camera facing northwest. From left to right, Chicken coop I, Barn II, Horse barn, Barn I, Privy, Button shop, Farmhouse, Wagon shed II.

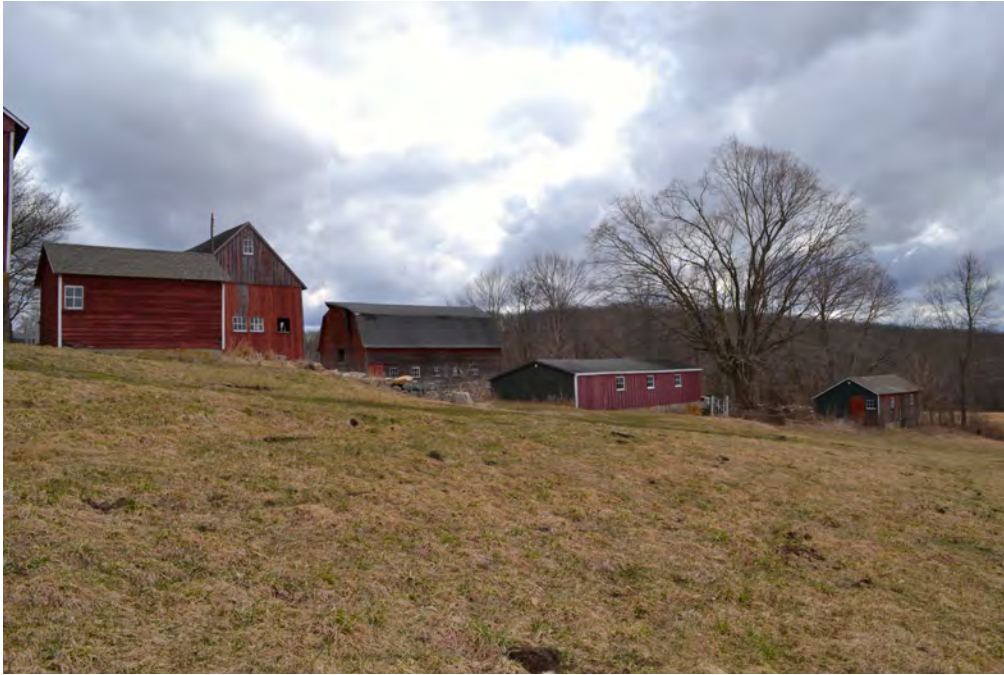
7. Northwest context view of 112 Kick Hill Road, Lebanon, CT, camera facing southeast. From left to right, Milk house, Horse barn, Barn II, Chicken coop I, Chicken coop II.

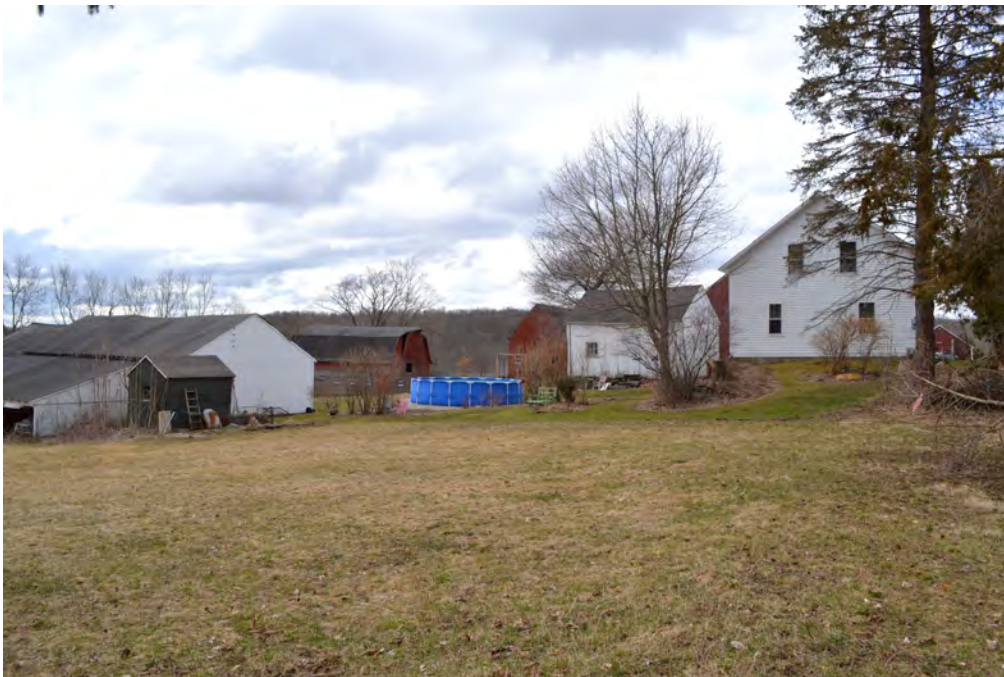
8. East context view of 112 Kick Hill Road, Lebanon, CT, camera facing west. From left to right, Well house, Wagon shed II, Barn II, Horse barn, Button shop, Barn I, Farmhouse, Wagon shed I.

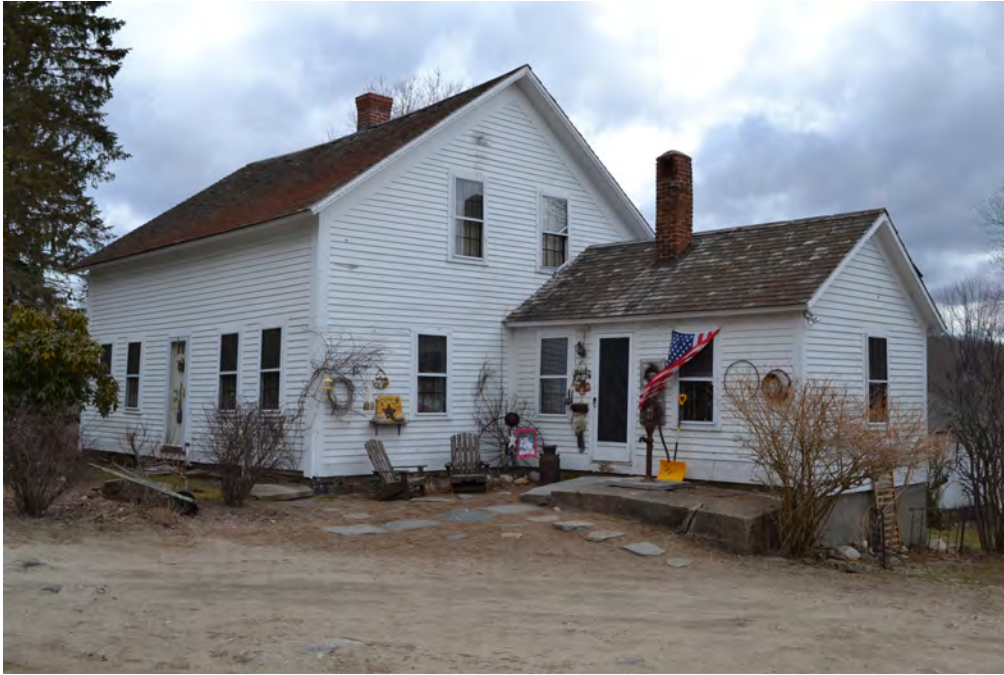
9. North eave-side and west gable-end of Farmhouse, camera facing southeast.

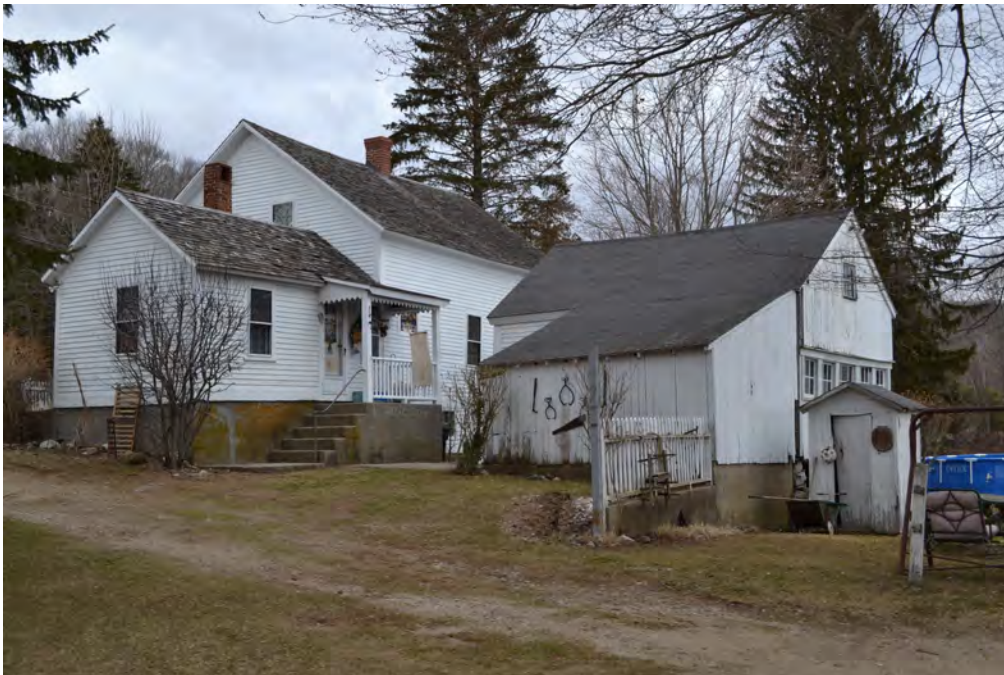
10. South eave-side and west gable-end of Farmhouse, west eave-sides and south gable-ends of Button shop, and west gable-end and south eave-side of Privy, camera facing northeast.

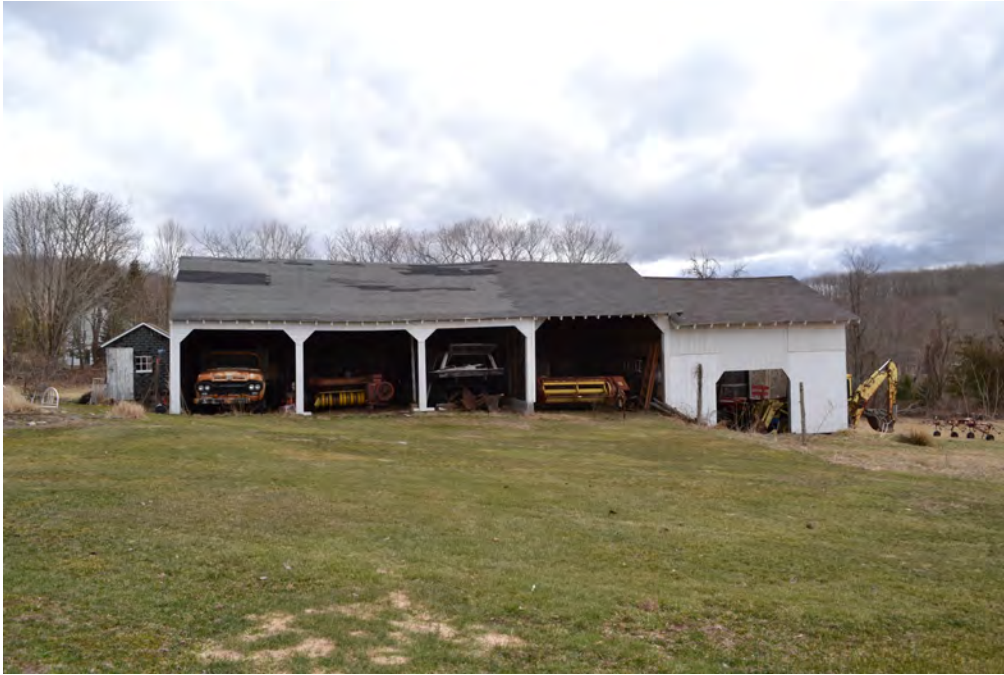
11. West gable-end of Well house and west eave-side of Wagon shed II, camera facing east.

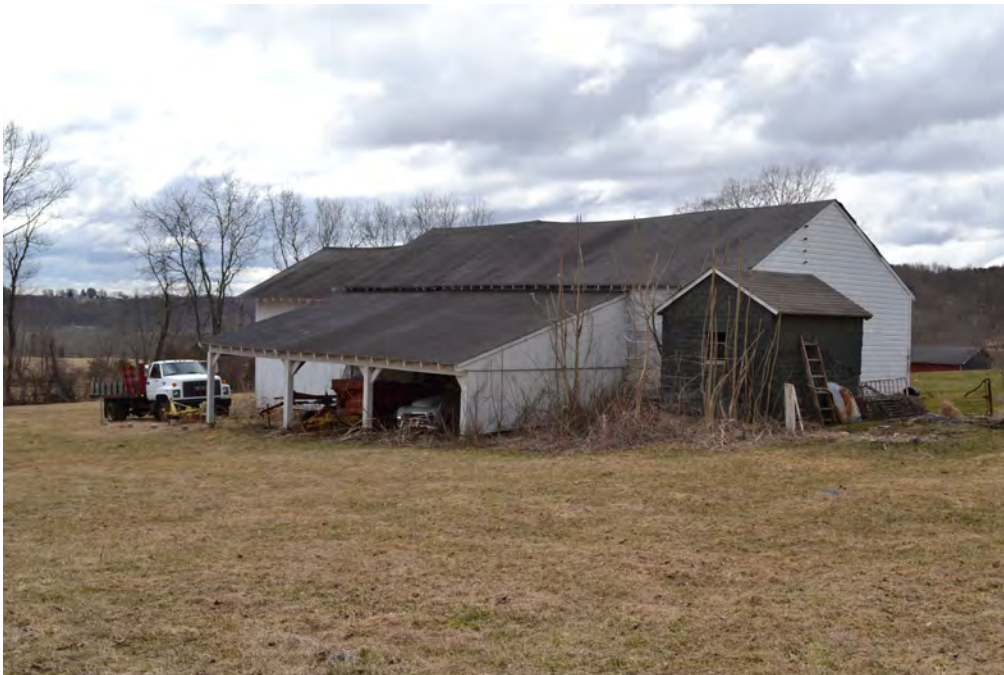
12. East gable-end and north eave-side of Well house and east eave-sides and north gable-ends of Wagon shed II, camera facing southwest.

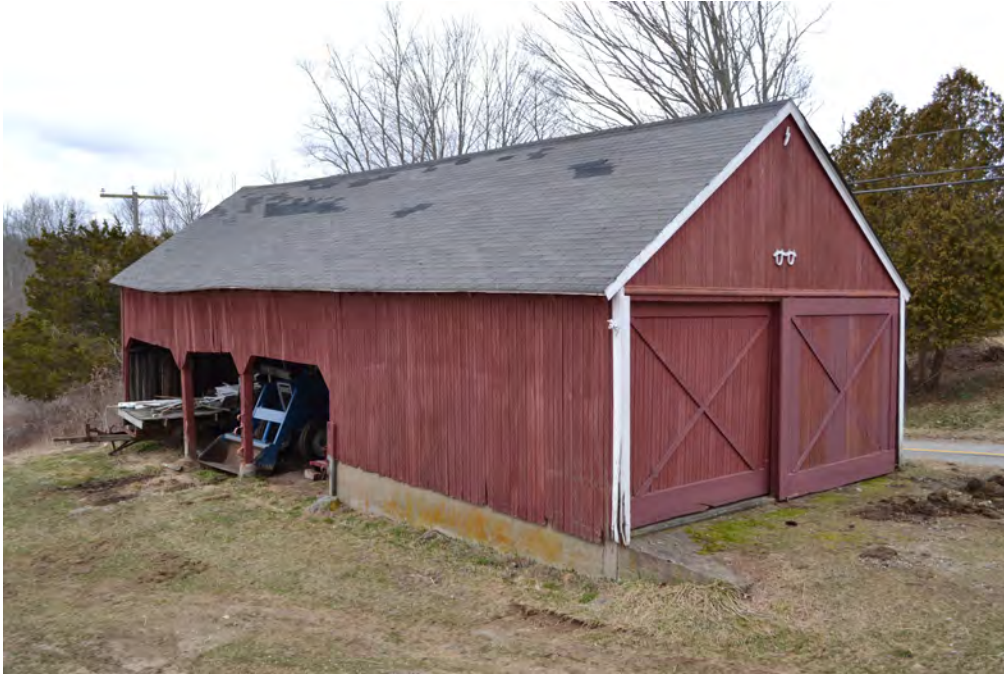
13. East gable-end and south eave-side of Wagon shed I, camera facing northwest.

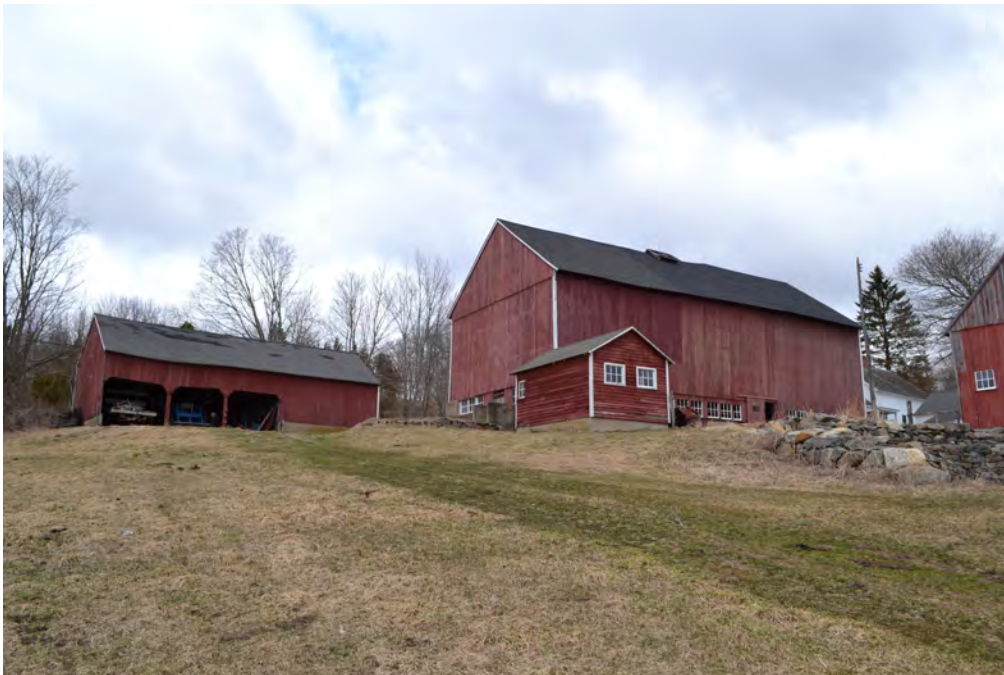
14. West gable-end and south eave-side of Wagon shed I, west eave-side and south gable-end of Milk house, and west gable-end and south eave-side of Barn I, camera facing northeast.

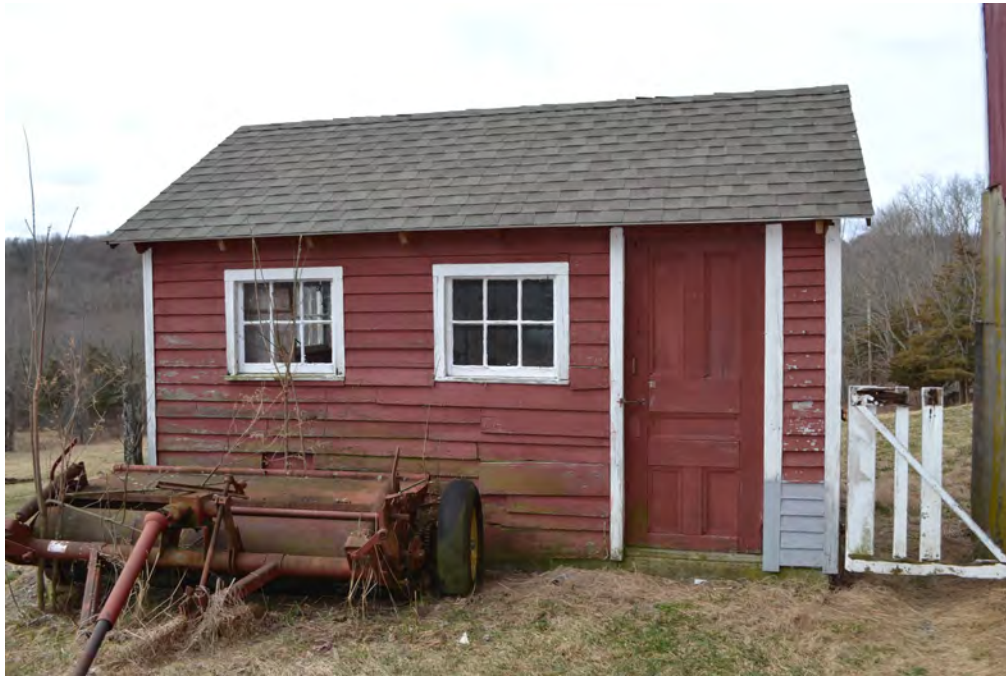
15. East eave-side of Milk house, camera facing west.

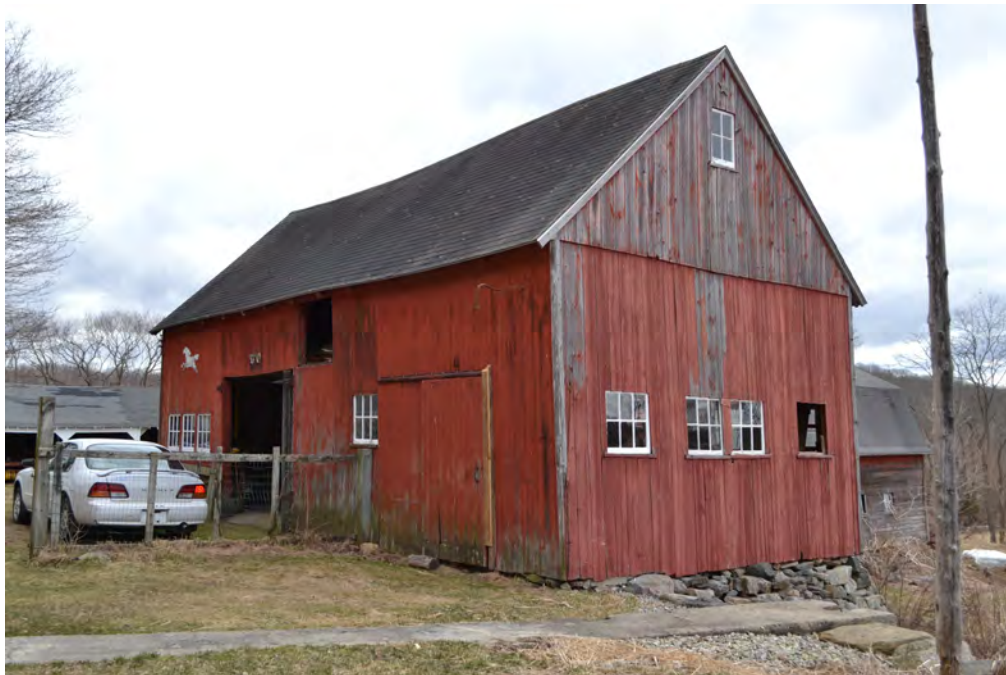
There is another frame outbuilding located 40' east of the Milk house, and 25' south of Barn I. Known as the Horse barn, the 40' x 20', 1 1/2-story building originally housed several horse stalls in its western bay and wagon storage in its two eastern bays. The stalls were later also used as calving pens while the wagon storage area has since been converted for use as a workshop. The Horse barn has a dry-laid fieldstone foundation, poured concrete floor, balloon frame, vertical board siding – painted dark red with white trim – and a gable roof oriented east-west parallel to Kick Hill Road. An exterior sliding door leads to the stable area, while side-hinged doors formerly enclosed the workshop. Fenestration primarily consists of fixed six-pane windows.

16. North eave-side and west gable-end of Horse barn, camera facing southeast. Note Wagon shed II at rear left, Barn II at rear right.

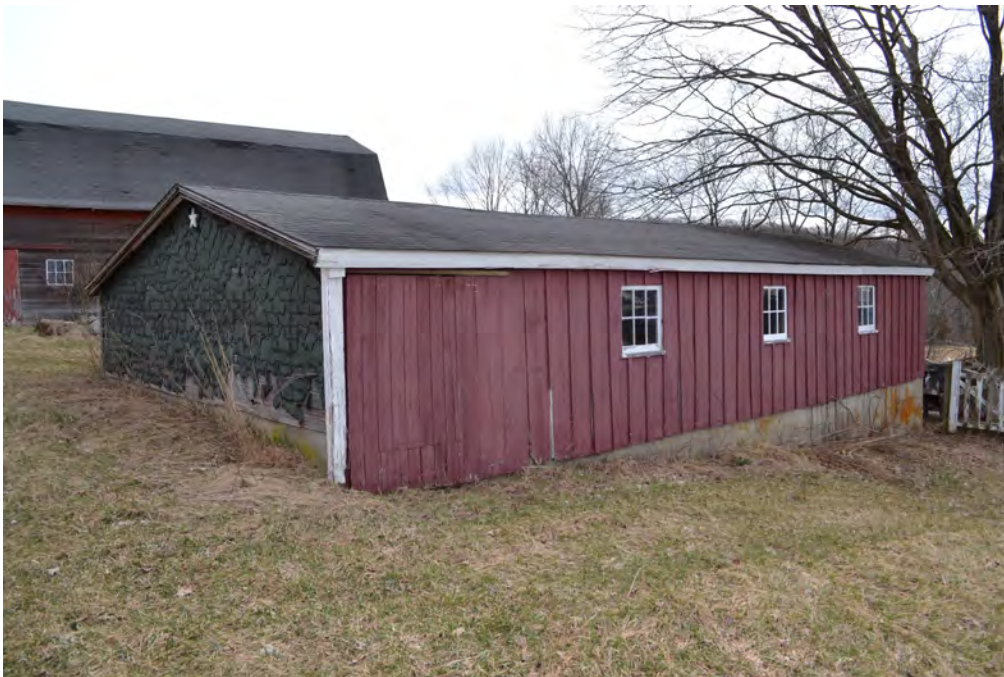
The last two secondary outbuildings on Lebanon Hills Farm are a pair of frame chicken coops located to the southeast of Barn I and southwest and south of Barn II. Chicken coops I and II are of similar design, both having poured concrete foundations, balloon frames, vertical board siding, fixed six-pane windows, and gable roofs with asphalt shingles. Chicken coop I is sited roughly 85' south of Barn I and 35' west of Barn II. It has a gable roof – oriented north-south – and its primary entry is an exterior sliding door on the northern end of its west eave-side. Chicken coop II is sited further to the south of Coop I. It has a front-facing roof oriented north-south – and its primary entry is a pass-through door just west of center on its north gable-end.

18. West eave-side and north gable-end of Chicken coop I, camera facing southeast. Note Barn II at rear left.

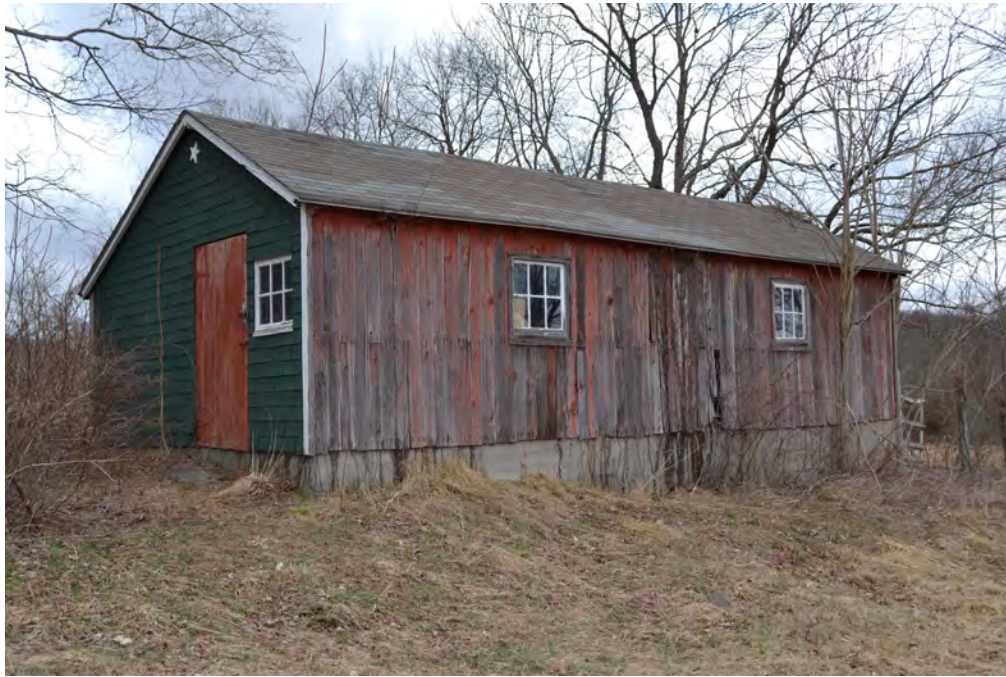
19. West eave-side and north gable-end of Chicken Coop II, camera facing southeast.

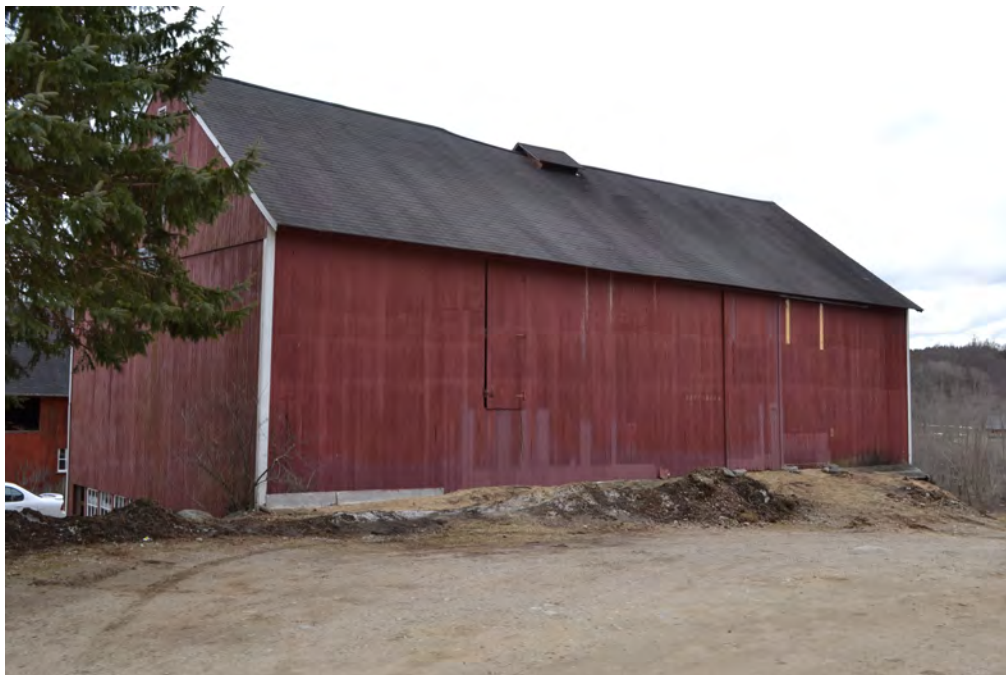
20. North eave-side and east gable-end of Barn I, camera facing southwest.

The main ground-level entry to the barn consists of a full-height sliding door located in what was originally the central bay on the north eave-side. The door is mounted on an exterior track, this running to the west. The remainder of the north eave-side is blank except for a side-hinged hay door centered on the interior section of the two-bay addition.

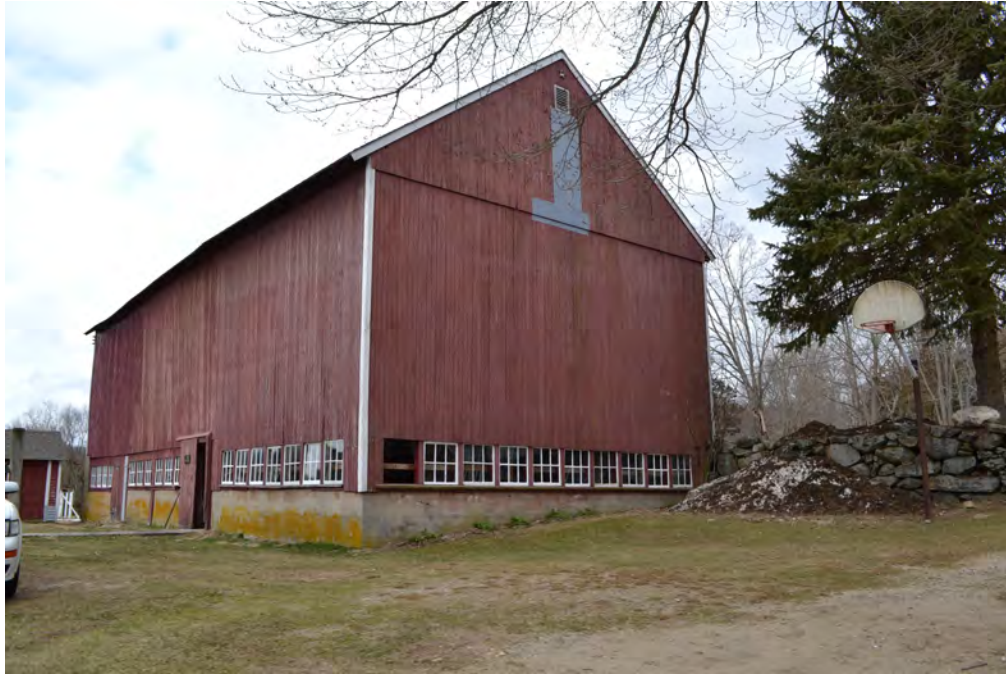
21. South eave-side and east gable-end of Barn I, camera facing northwest.

The grade at the south eave-side of the barn declines further, revealing a full basement level. A poured concrete half-wall runs the length of the elevation. There are two door openings on the south eave-side of the building. These include an exterior sliding door at what was the southeast corner of the original block and a side-hinged pass-through door roughly centered under the original center bay. There is a series of seven six-pane windows on the basement level of the 2-bay addition, six windows between the two door openings, and four windows west of the western pass-through door. The main level of the south eave-side of the barn is blank.

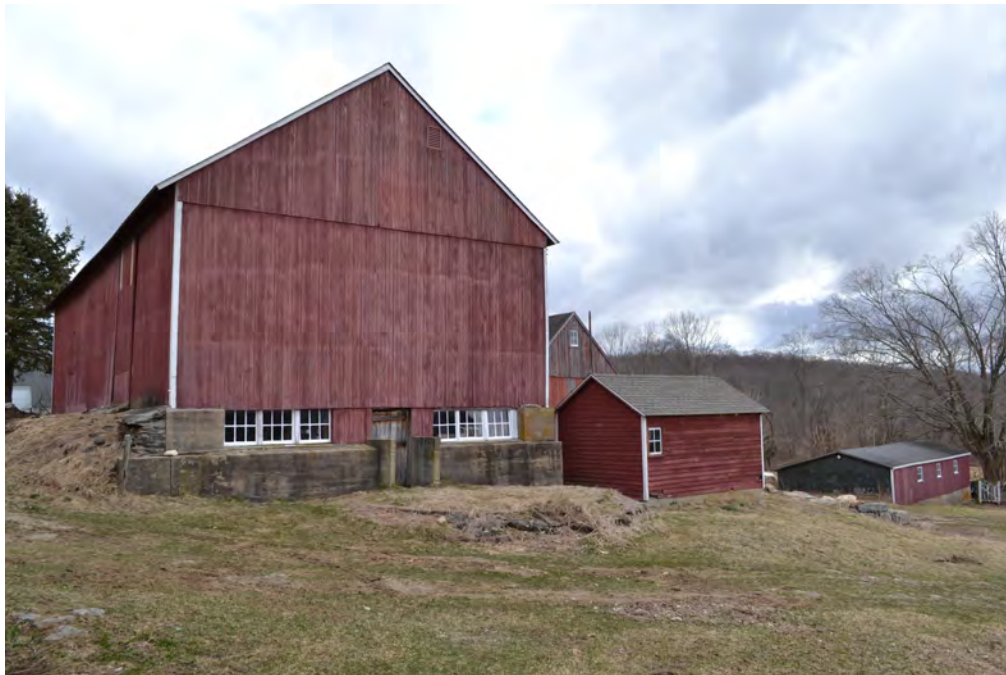
22. North eave-side and west gable-end of Barn I, camera facing southeast. Note silo foundation at center, Milk house, Horse barn, and Chicken coop I at right.

The grade at the west gable-end of the barn declines to the south, revealing the majority of the basement level. The basement level of the west gable-end has a poured concrete half-wall with centered opening that connected the barn to the silo formerly located on this side of the building. Three fixed six-pane sash are located on each side of the silo opening. The rest of the west gable-end is blank except for a girt line siding divide.

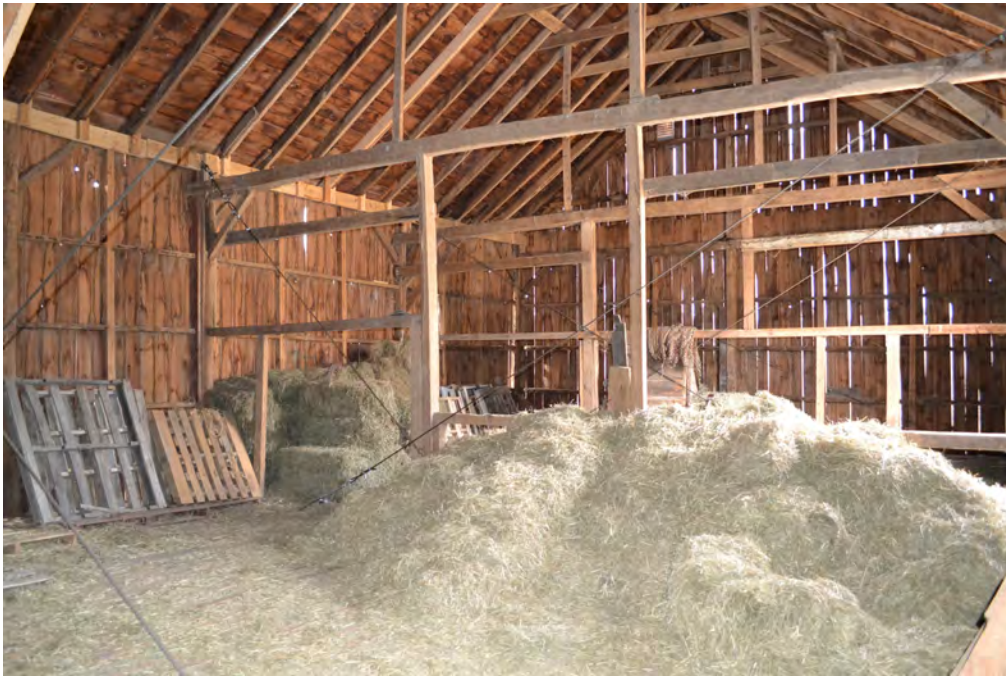
23. Interior view of Barn I main level, showing framing details, camera facing southwest. Note mixed hand-hewn and sawn posts and girts, sawn braces, and cable supports.

The interior of Barn I's main level reveals a four-bent, three-bay barn with a two-bay addition on its east gable-end. The original portion of the barn has square rule post and beam frame with diagonal bracing and a single post south of center in each bent. The original framing consists of an unusually lightly-framed mix of hand-hewn and sash-sawn primary timbers, these with pegged mortise and tenon joinery. The sash-sawn posts and diagonal bracing, and hand-hewn plates and tie-girts, are reinforced with an assortment of early 20<sup>th</sup>-century dimension lumber and crossed tension cables used to brace the bents within the original section of the barn. The additional (eastern) bays have balloon-frame exterior walls while the interior bents consist of sawn tie-girts, each with two evenly-spaced sawn posts. The roof appears to have been replaced when the barn was expanded. Its circular-sawn common rafters meet at a ridge board where they are nailed in place and then alternately joined with modern rafter ties. A hay track with intact pulley is suspended from the ridge-board running the length of the building. The original section of the barn has a lapped wide-board floor, while tongue-and-groove boards make up the floor within the eastern bays. A hay chute centered on the western side of the original center bay leads to the basement level.

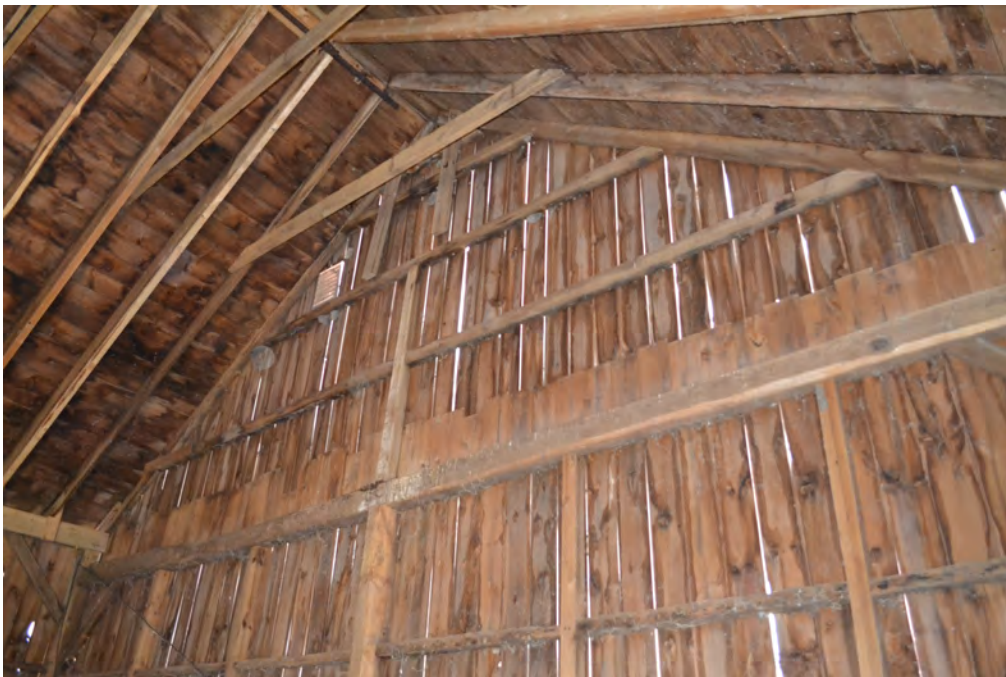
24. Interior view of Barn I main level, showing west gable-end framing details, camera facing southwest. Note mixed hand-hewn and sawn posts and girts, sawn braces, vertical board siding, horizontal board roof sheathing.

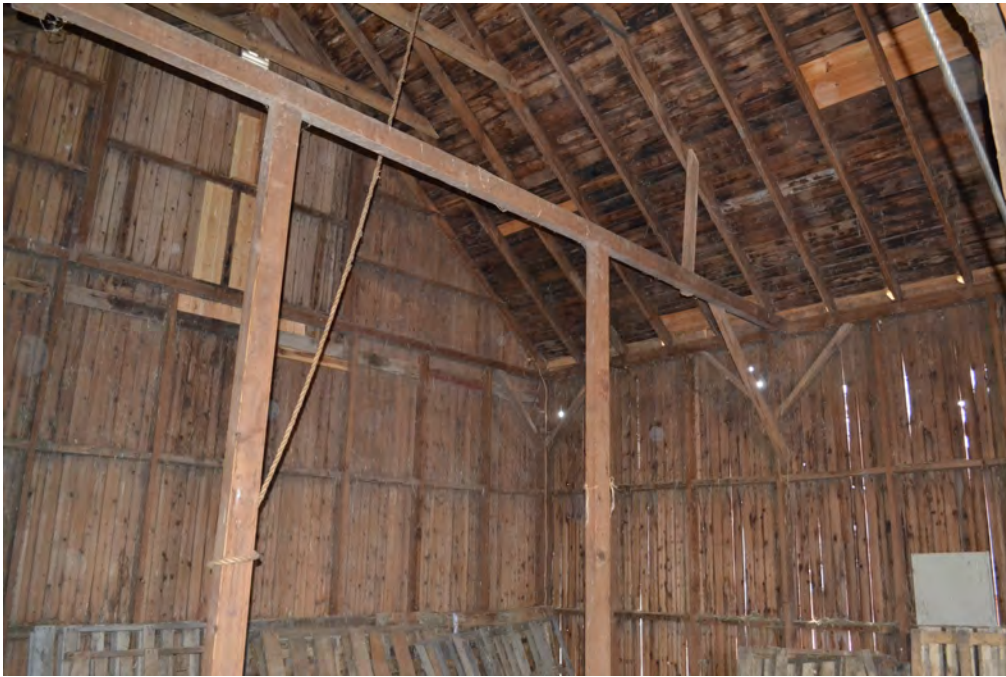
25. Interior view of Barn I main level, showing framing details of two-bay eastern addition, camera facing southeast. Note balloon frame construction with sawn timbers.

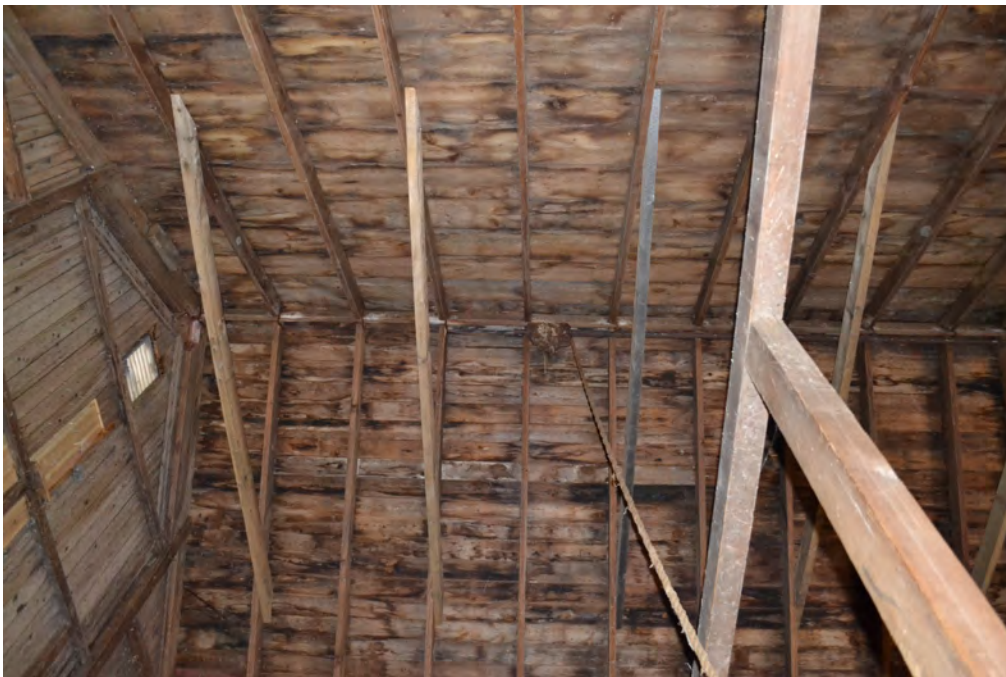
26. Interior view of Barn I main level, showing roof details of two-bay eastern addition, camera facing southeast. Note rope extending to hay track, later rater ties.

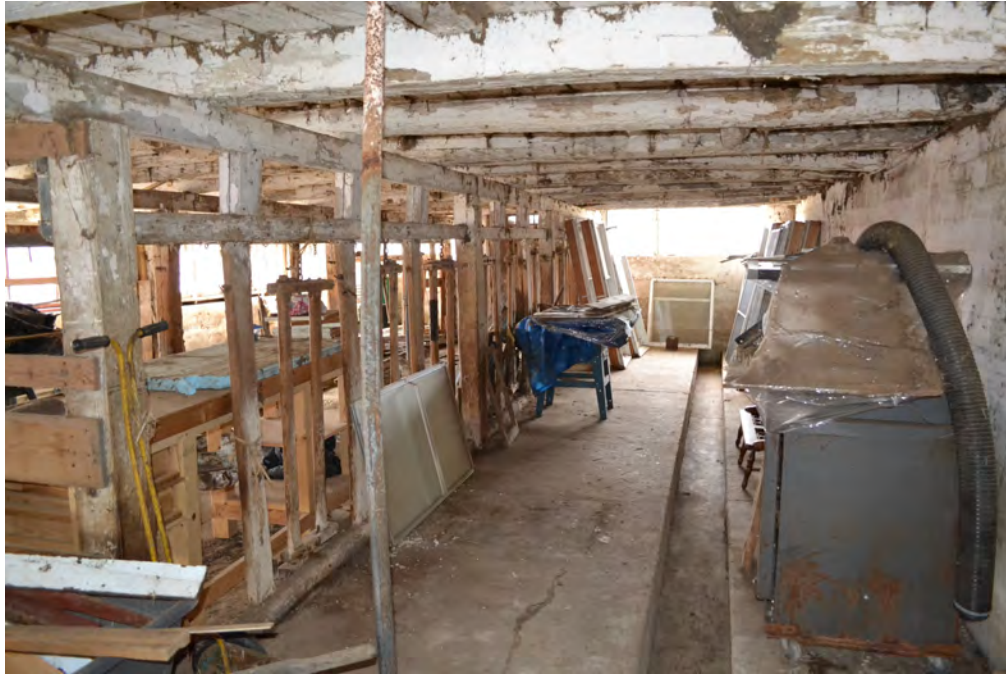
27. Interior view of Barn I lower level, showing framing and floor details, camera facing west. Note mixed hand-hewn and sawn posts, girders, and joists, frame stanchions, poured concrete floor with manure gutter.

The basement level extends under all five bays of the barn. Sawn posts support two longitudinal (east-west) girders. Floor joists run laterally (north-south) across and resting on the girders, the north eave-side foundation wall, and the south eave-side plate. The joists consist of a mix of half-round and squared timbers under the original portion of the barn, these, like the south eave-side plate, being heavy hand-hewn beams. The joists and framing in the southern bays consist of sawn dimension lumber.

Circa 1960, Barn I was lifted in order for its fieldstone foundation walls to be replaced with poured concrete. The floor throughout the barn is poured concrete, this predating the foundation walls and accommodating manure gutters running east-west along the north and south eave-sides of the barn. A central passageway formed by the interior posts and girders and flanked by inward-facing stanchion rows runs east-west for the length of the basement

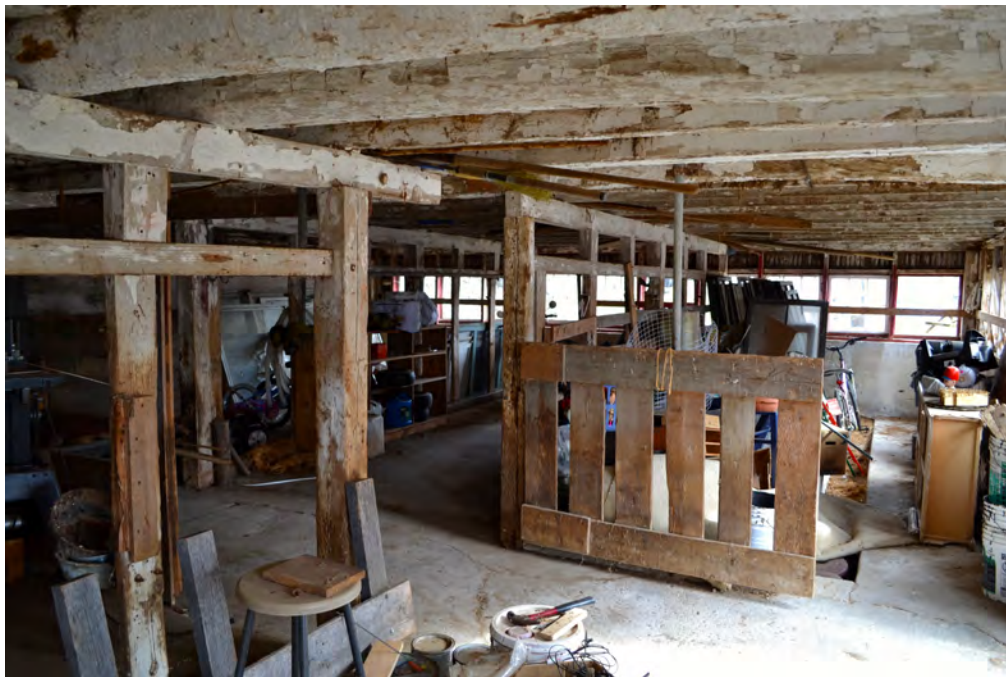
28. Interior view of Barn I lower level, showing framing and floor details, camera facing northeast. Note mixed hand-hewn and sawn posts, girders, and joists, poured concrete floor with manure gutter.

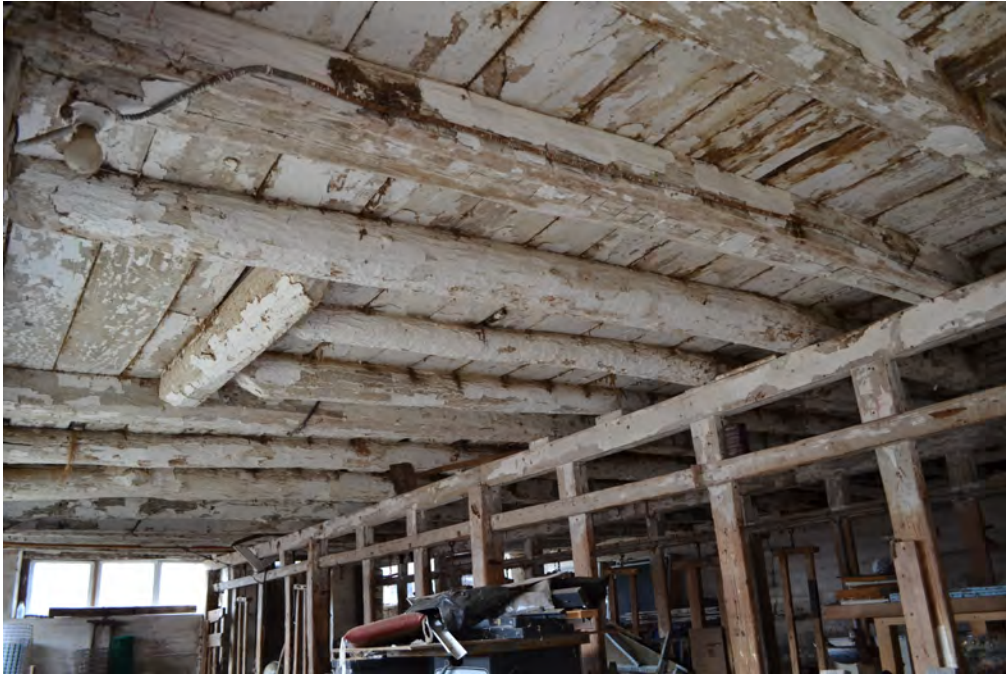
29. Interior view of Barn I lower level, showing framing details, camera facing northwest. Note sawn posts and girder, and hand-hewn joists.

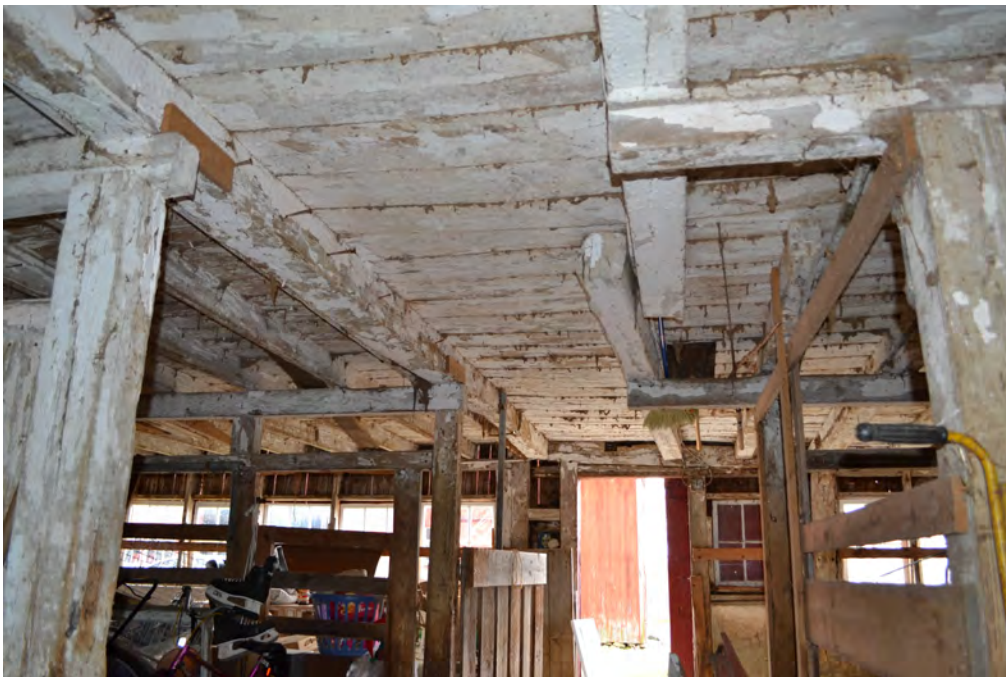
30. Interior view of Barn I lower level, showing framing details, camera facing south. Note framing alterations at junction of original portion and eastern addition to barn.

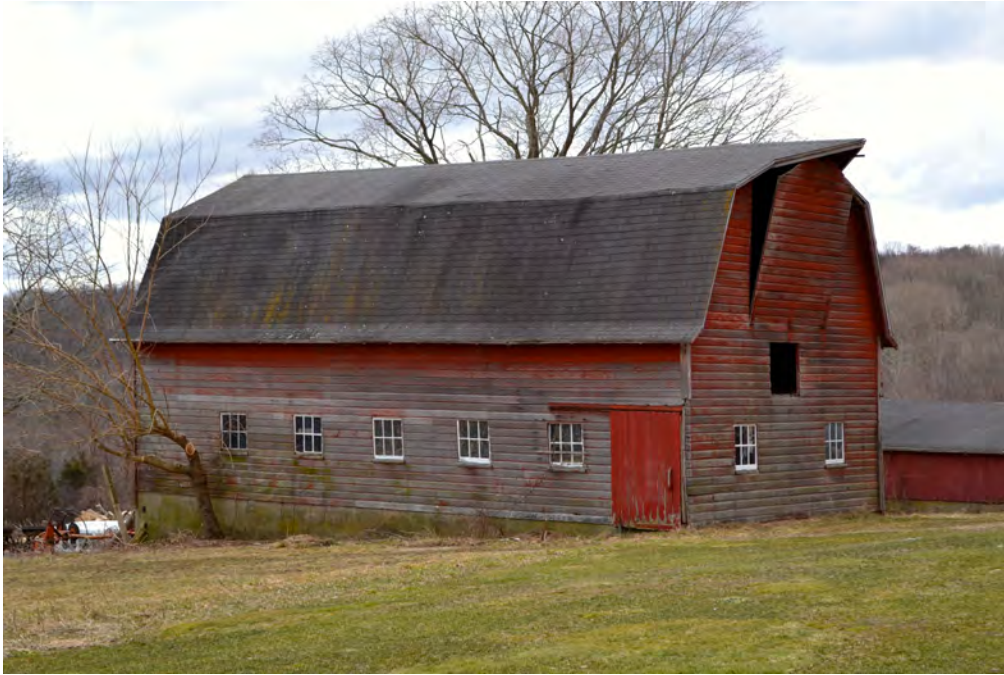
31. North gable-end and east eave-side of Barn II, camera facing southwest. Note hay door under projecting hood.

The grade on the east eave-side of Barn II declines to the south, revealing the foundation. As noted, an entry is located at the northeast corner of barn's east eave-side, this consisting of a partial-height sliding door. The door is mounted on an exterior track that runs to the south. A series of five, evenly spaced, six-pane windows run the length of the east eave-side.

The north gable-end of the barn has a pair of evenly spaced, fixed six-pane windows on its lower level and two hay doors above. The primary hay door is mounted with strap hinges located along its lower edge and drops open via a pulley mounted on the hay track slung beneath the barn's projecting hood. The second opening has lost its door but is located directly under the primary hay door.

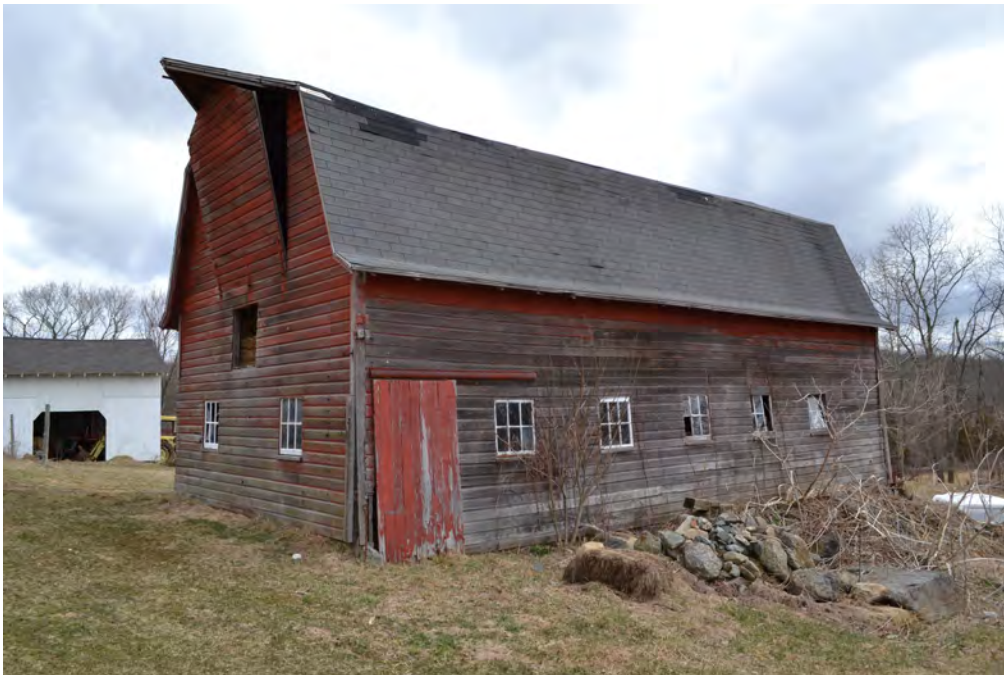
32. North gable-end and west eave-side of Barn II, camera facing southeast. Note hay door under projecting hood.

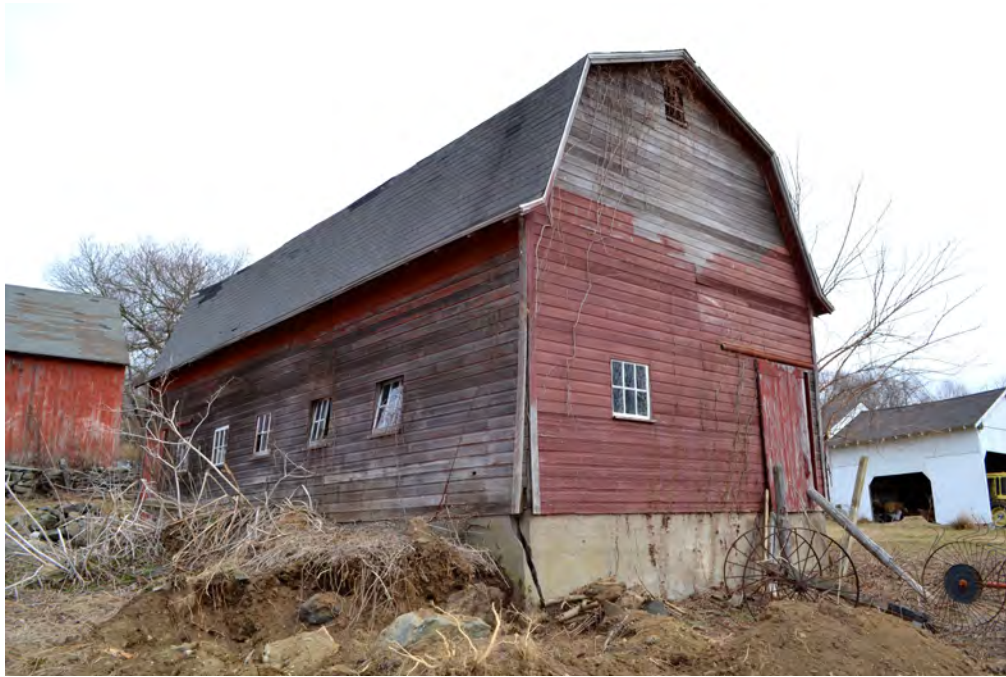
The west eave-side of Barn II is identical to the east eave-side, however, large rocks have been placed against the foundation in order to help shore up spreading deformation evidenced by a crack in its southwest corner. The foundation is fully exposed on the south gable-end of the building, above which there is a single sliding door and fixed six-pane window on the main level. The remainder of the elevation is blank except for a rectangular opening in the gable.

33. South gable-end and west eave-side of Barn II, camera facing northeast. Note foundation failure at southwest corner of building. Horse Barn at far left, Wagon Shed II at far right.
