## HISTORIC RESOURCES INVENTORY - BUILDING AND STRUCTURES

Building Name (Common) Lebanon Hills Farm Record No. 53662  
 Building Name (Historic) Payne / Brown / Pokorny Farmstead  
 Street Address or Location 112 Kick Hill Road  
 Town/City Lebanon Village \_\_\_\_\_ County New London  
 Owner(s) Lebanon Hills Farm, LLC, 379 Goshen Hill Rd., Lebanon, CT 06249  Public  Private

Style of building English bank barn, Gambrel barn, Vernacular style Date of Construction 19th & 20th c.

112 Kick Hill Road, Lebanon, CT Record No. 53662

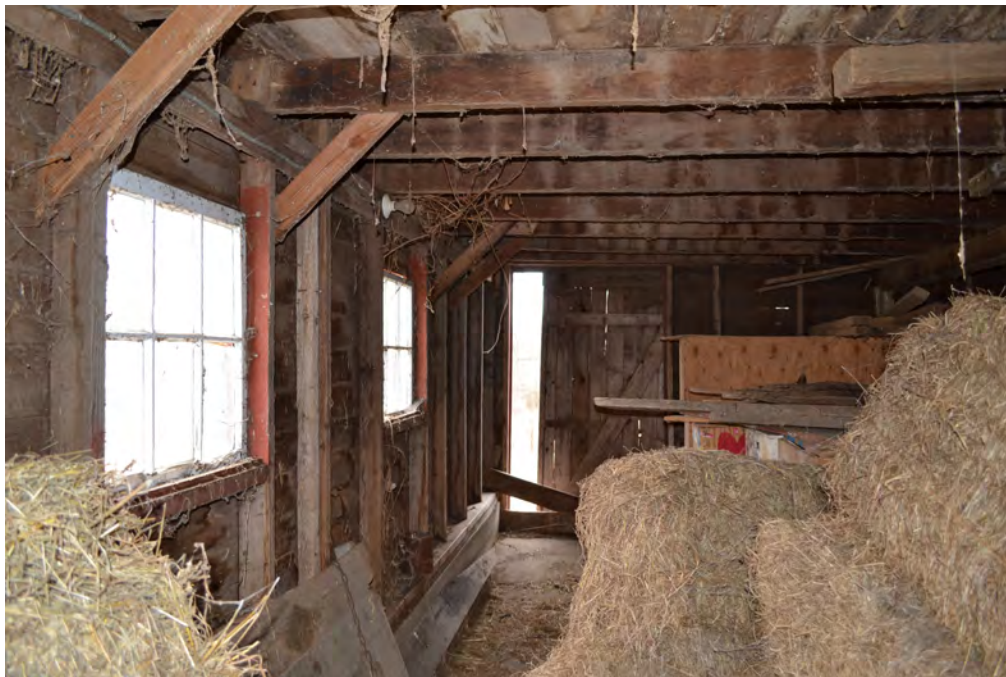
34. Interior view of Barn II lower level, showing framing details, camera facing south. Note sawn posts and girder, and hand-hewn joists.

The interior of the ground level of Barn II has a poured concrete floor and balloon framing. The lateral (southwest-northeast) joists are supported by a row of sawn posts and a single longitudinal (northwest-southeast) girder running down the center of the building. The barn's frame cow stanchions have been removed, however, evidence of the building's use as a heifer barn survives in the form of a manure gutter running the length of the eastern bay.

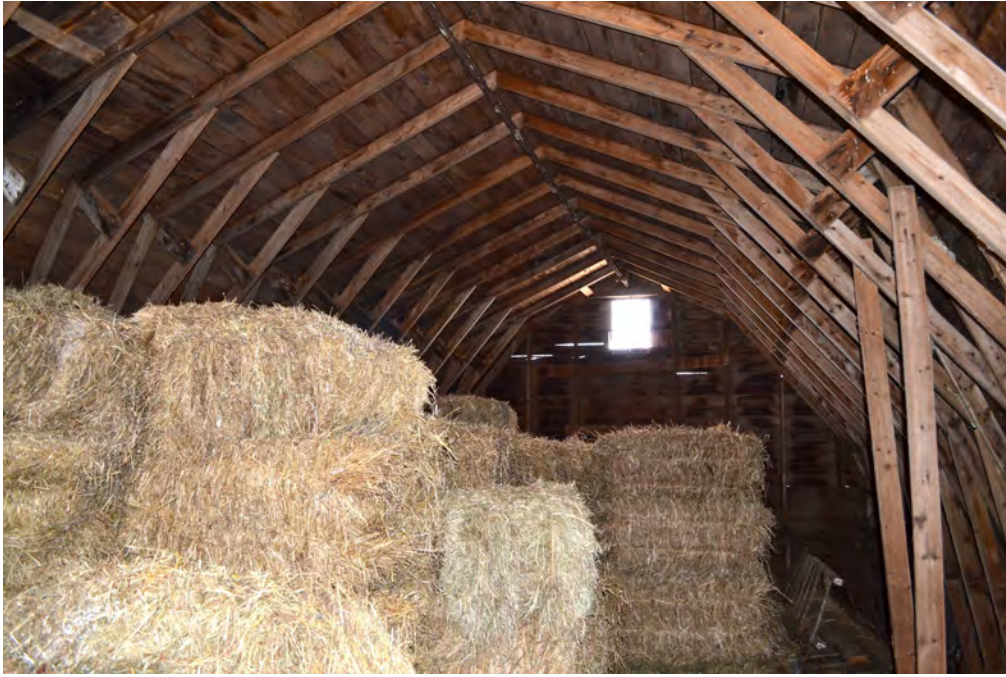
35. Interior view of Barn II loft level, showing framing details, camera facing south. Note balloon framing, hay track along ridge-line.

A hatch and ladder near the center of the barn's west eave-side leads into the loft level above. The hay loft is an open space with typical gambrel braced frame. The plates consist of two-by-fours, these resting on two-by-four studs forming low knee walls. The roof trusses are comprised of typical dimension lumber scissor trusses bracing the changes in roof pitch. The loft flooring consists of tongue-and-groove boards, these laid in line with the north-south orientation of the building.

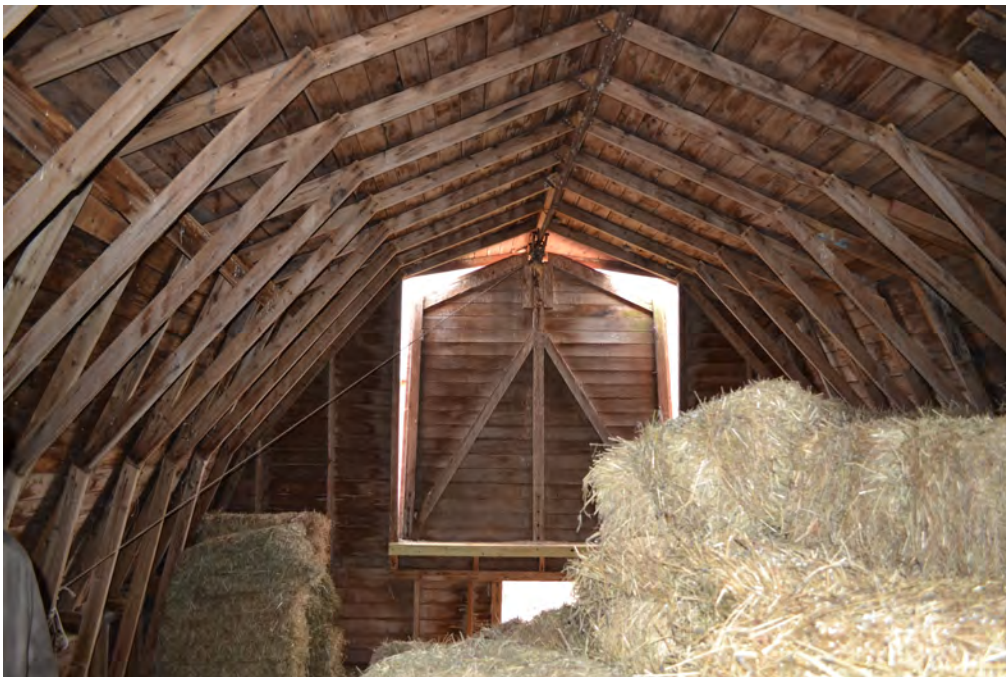
36. Interior view of Barn II loft level, showing framing and hay door details, camera facing north. Note balloon framing, hay track along ridge-line.
