HISTORIC RESOURCES INVENTORY - BUILDING AND STRUCTURES

Building Name (Common) Holmberg Orchards Record No. 15225
 Building Name (Historic) Avery, Edward, Farmstead / Holmberg, Adolf, Farmstead and Orchards
 Street Address or Location 12 Orchard Lane
 Town/City Ledyard Village Gales Ferry County New London
 Owner(s) Richard and Diane Holmberg, 4 Orchard Lane, Gales Ferry, CT 06339 Public Private

HISTORIC RESOURCES INVENTORY FORM – BUILDING AND STRUCTURES continuation sheet

12 Orchard Lane, Ledyard CT Record No. 15225

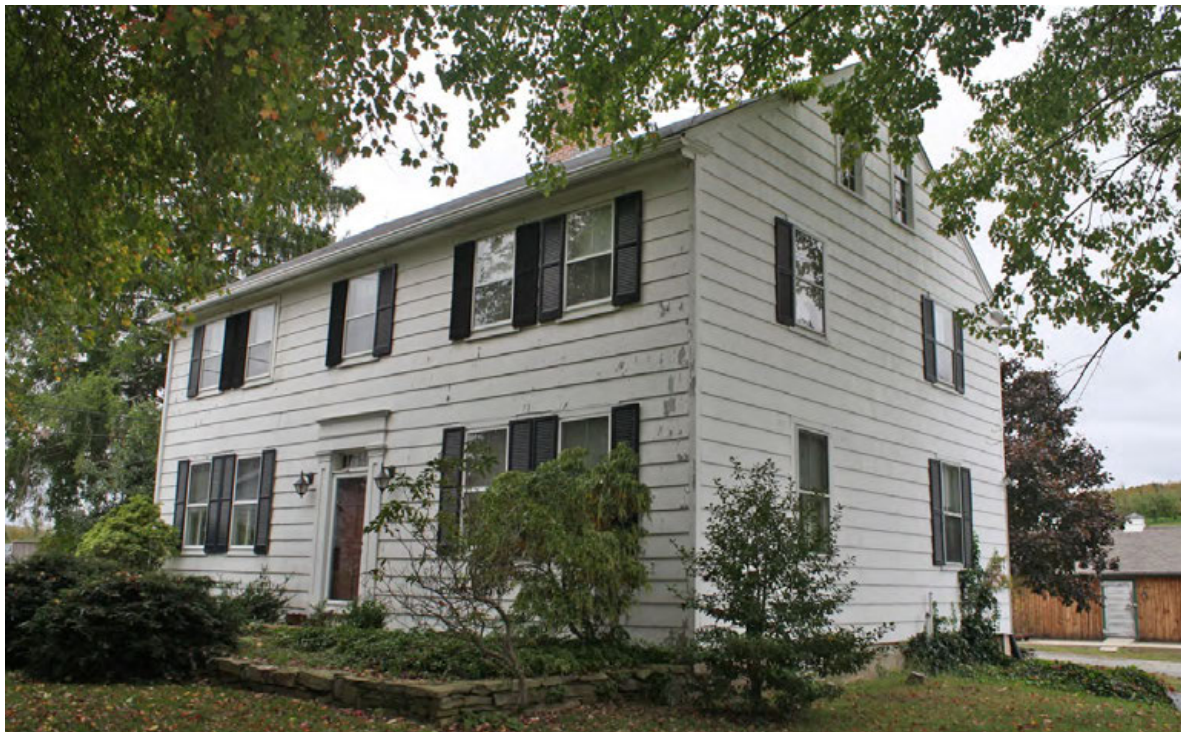
6. Southwest view of Farmhouse, camera facing northeast; Barn III at right rear.

The c. 1762 farmhouse, approximately 28' x 38', is prominently sited on the crest of the hill looking out westward toward the Thames River.

12 Orchard Drive [sic] is a two-story, gable-roofed Federal/Colonial house. There is a small shed-roofed ell at the north rear corner. The main entrance in the center of the five-bay façade is Federal in style. Its six-paneled, possibly original door is flanked by paneled pilasters. The six-light transom is surmounted by a high frieze with an unusual dentil course composed of small pegs. Most of the windows of the main block have replacement two-over-two sash except for the two in each gable peak which have six-over-nine sash. Those in the ell have six-over-six (Cunningham).

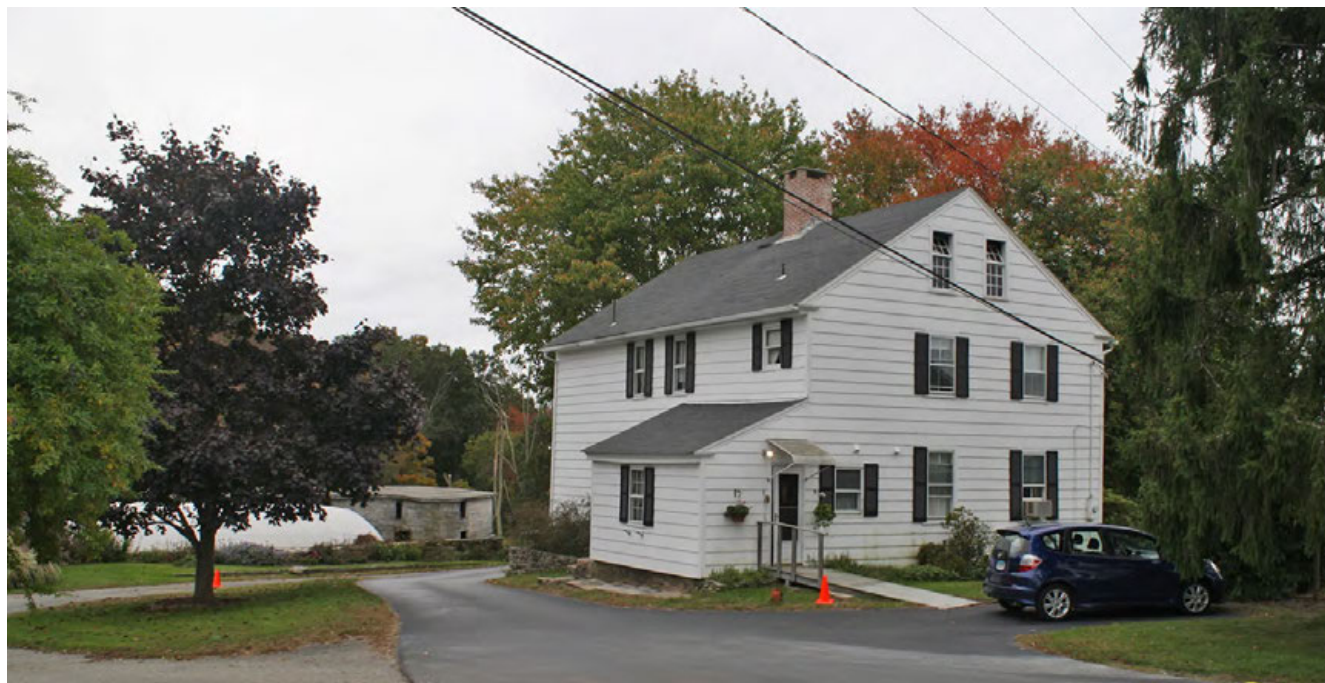
7. Northeast view of Farmhouse, camera facing southwest; Coop III at left rear. Note extant six-over-nine sash in attic windows, 19th-century two-over-two sash at lower floors.

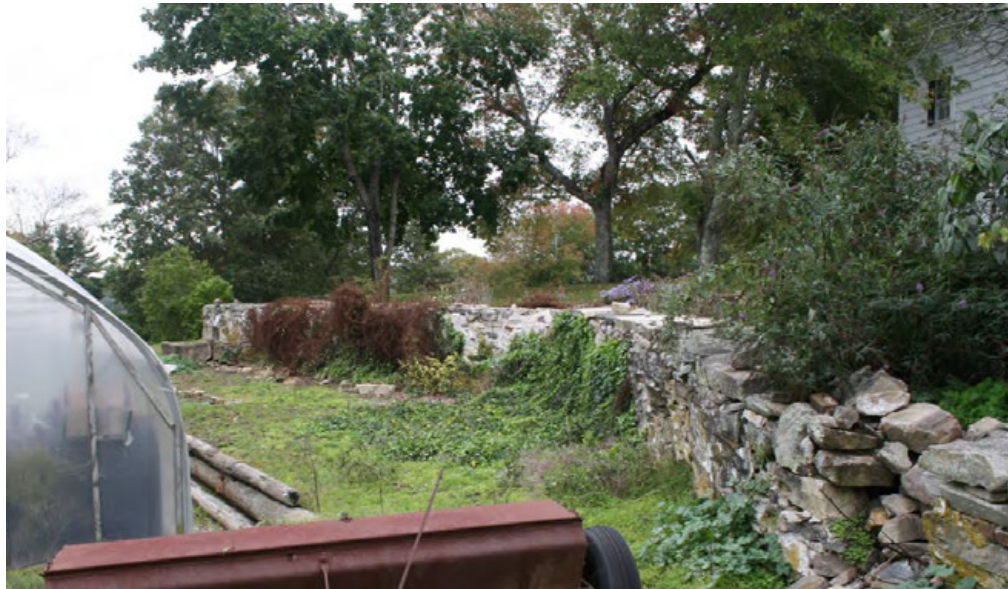
8. Southeast view of foundation wall of former greenhouse, camera facing northwest; Farmhouse at right rear.

A stone retaining wall to the east of the farmhouse formed the west wall of a banked glass greenhouse. Currently a plastic-covered hoop house occupies the flat area east of the wall. Another plastic-roofed hoop house sits to the south of Barn III, and a concrete masonry storage building is located east of the Coop I/apple storage building.

Just south of the farmhouse, a retaining wall is the remnant of a glass greenhouse which was banked into the hill. The Holmbergs raised flowers for some of the wealthy people of Norwich. The building now used for wine storage was built as a retail store. It proved unsuccessful up on the hill and so the current store is located right on Route 12.

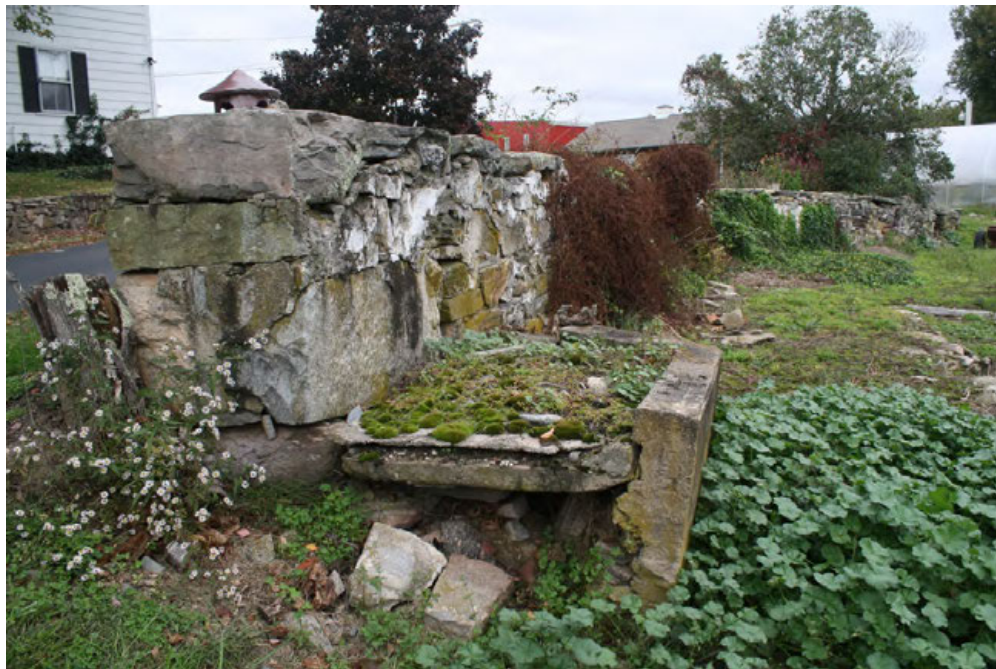
9. Southwest view of foundation wall of former greenhouse, camera facing northeast. Heating pipes ran underground along the north wall.

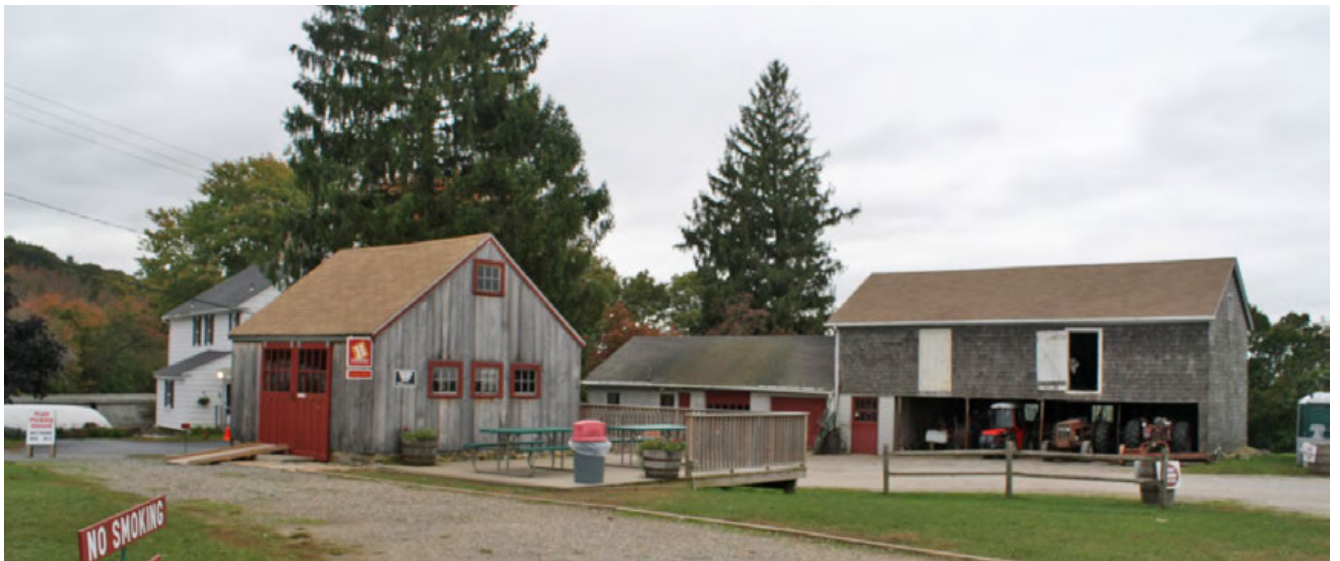
11. Northeast view of Barn I, camera facing southwest; rear (east) of Farmhouse at left, Barn II at right rear.

Barn I is a 1 ½ story 1-bay gable-roofed structure, 18' x 18', with its ridge-line oriented north-south. The east eave-side façade has a centered pair of sliding barn doors, the north gable-end has three six-pane stable-type windows, and the east eave-side has a single sliding door. The doors are reproductions matching the c. 1940 door extant on Barn II. The interior is a square rule post and beam structure with dropped end tie girts and round pole common rafters. New vertical siding has been installed over the original, which is visible at the interior. Siding is unpainted, roofing is asphalt shingles. Several courses of the un-mortared fieldstone foundation are visible. The original small barn, previously a cider mill, has been renovated for use as a wine tasting room. Renovations include new entrance and exit doors, ramp access via a deck on the west and north sides, new sills, climate control and lighting, and an interior serving counter. Renovation work used recycled period timbers for repairs and a tension rod between the rafter plates made from old iron.

The small barn (Barn I) is the oldest outbuilding. Various timbers were cut on up-down and circular saws, suggesting dates in the mid-19th century. To maintain the historical appearance of the interior, as much of the original siding as possible was left in place and new pine siding was placed on the exterior. This building had multiple past uses from fertilizer barn, to cider mill barn, to storing wood and tools. Its present use is as wine-tasting room.

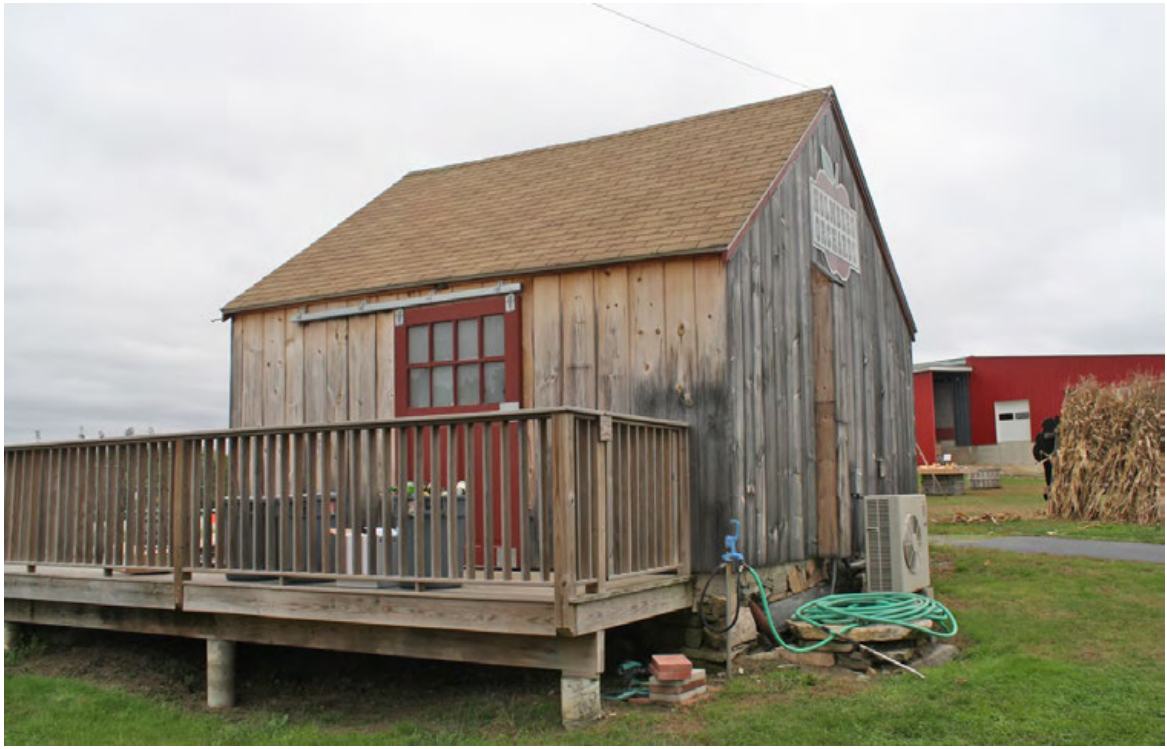
12. Southwest view of Barn I, camera facing northeast; Coop I / Apple storage is at right rear.

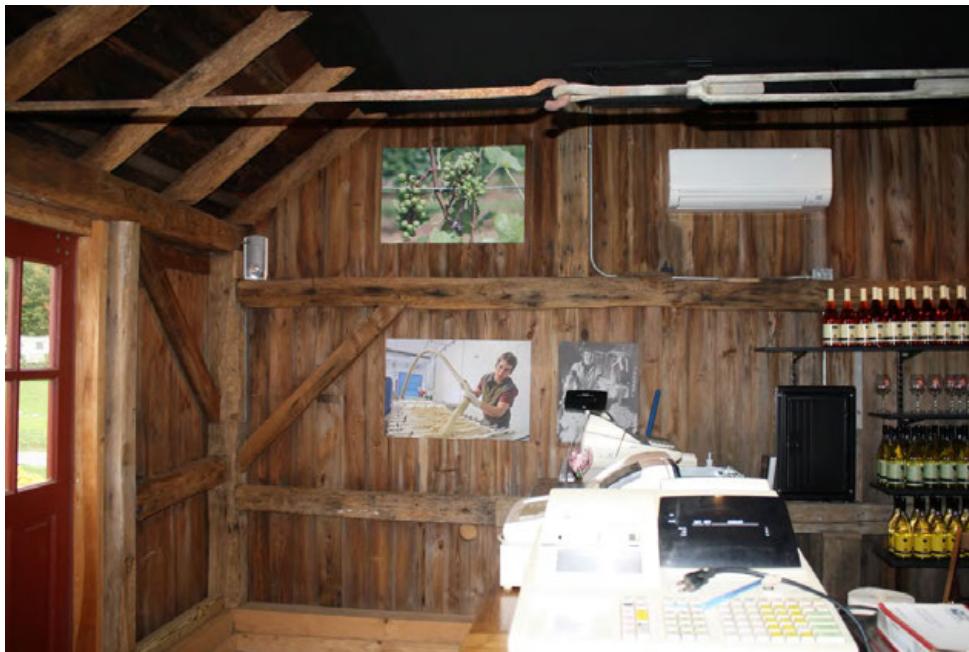
13. Interior view of Barn I, camera facing south.

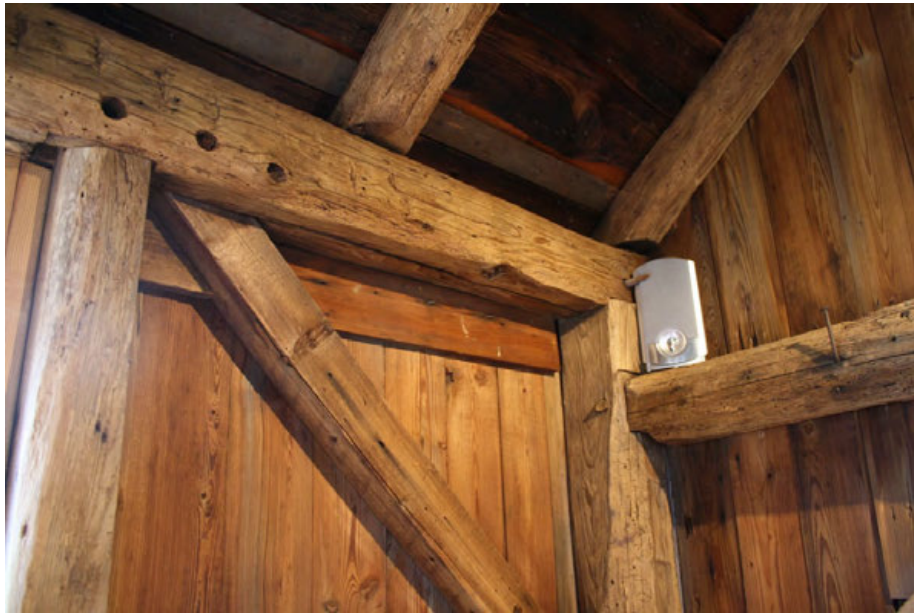
14. Interior detail view of Barn I framing, camera facing southeast.

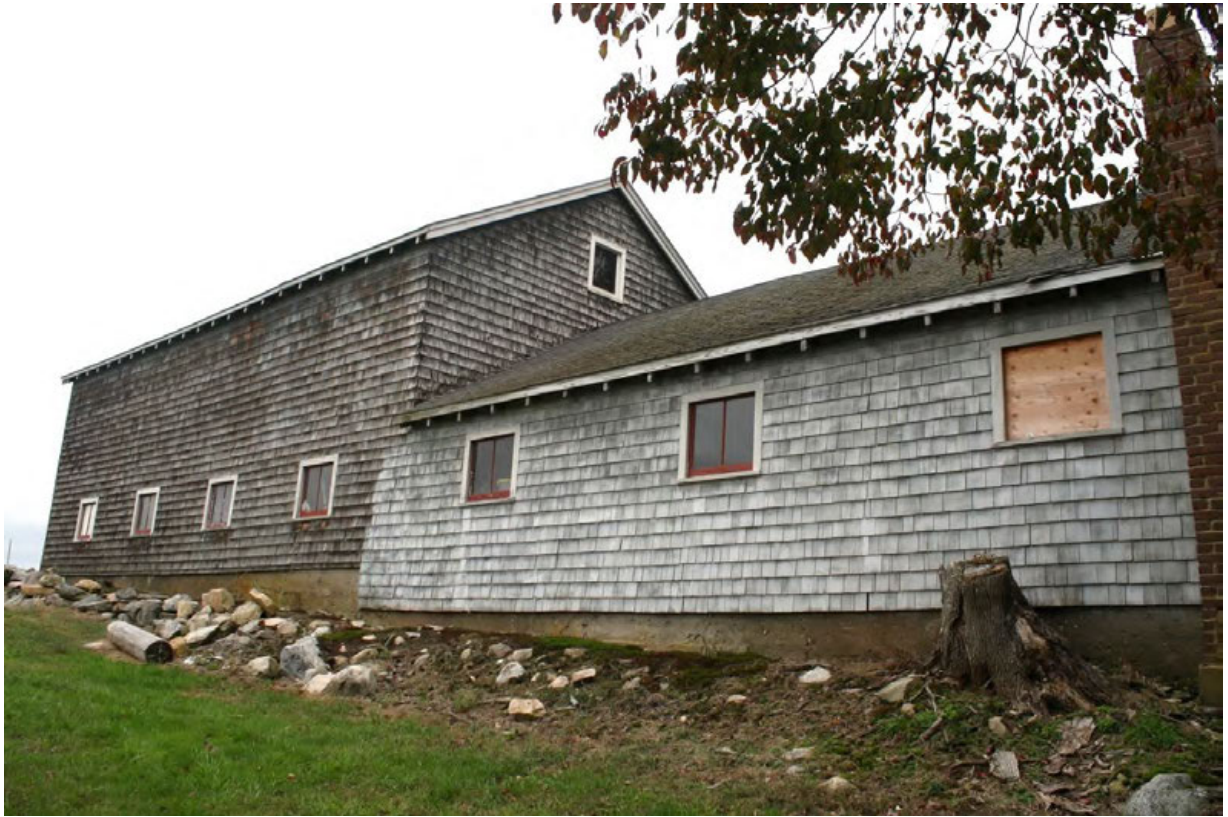
16. Southwest view of Barn II, camera facing northeast.

This building, 24' x 80', is a gable-roofed combination garage, wagon shed, and apple crate storage loft, built in 1939, oriented with its ridge-line north-south. It has a 2 ½-story portion with four open equipment bays facing east. Steel posts separate the bays. At the south end an enclosed bay has a paneled door with eight glazed panes above four panels, and a second floor loft level has two hay-type doors. A 1-story garage wing attached at the south end has two garage bays with overhead doors and at the left (south) end an enclosed bay with a pass-through door and to its left two multi-pane windows. The west side has a row of four stable-type windows in the ground floor of each of the main portion and the garage addition, which also has an exterior brick chimney at the right (south) enclosed portion. Walls are balloon framing with wood shingles and the roofs have exposed rafter tails and asphalt shingles. Foundations are cast-in-place concrete.

The wagon shed building west of the farmhouse, was built in 1939 using lumber harvested as salvage from a pine forest, near the former Norwich State Hospital, that blew down in the hurricane of 1938. The upper level was used for apple crate storage, the lower level for equipment.

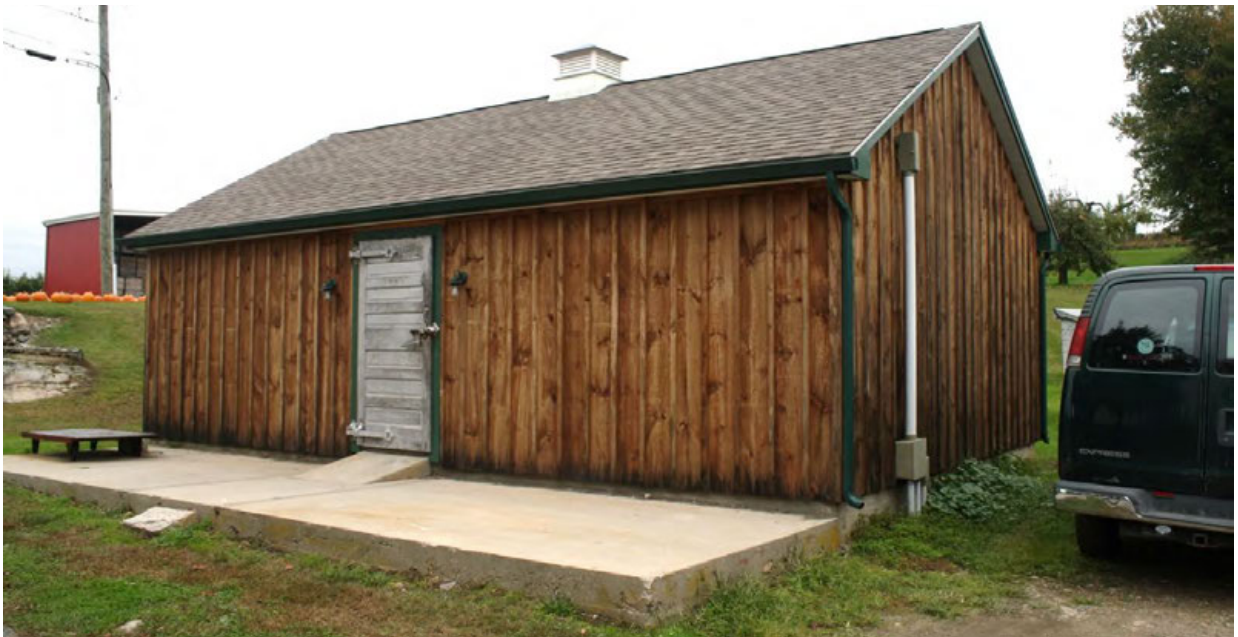
17. Southwest view of Barn III, camera facing northeast. During renovation for wine storage, the configuration of the original retail building was observed, with store windows in the west eave-side.

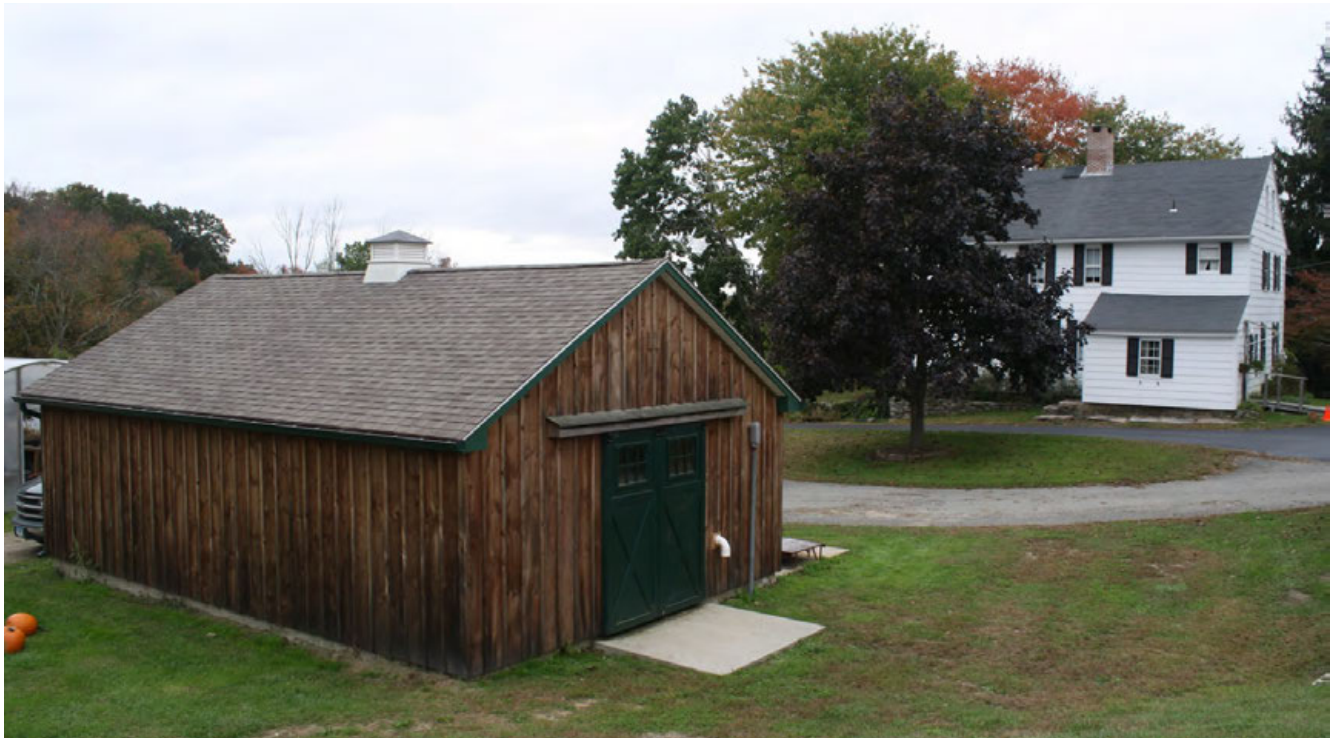
18. Northeast view of Barn III, camera facing southwest. Farmhouse is at right rear.

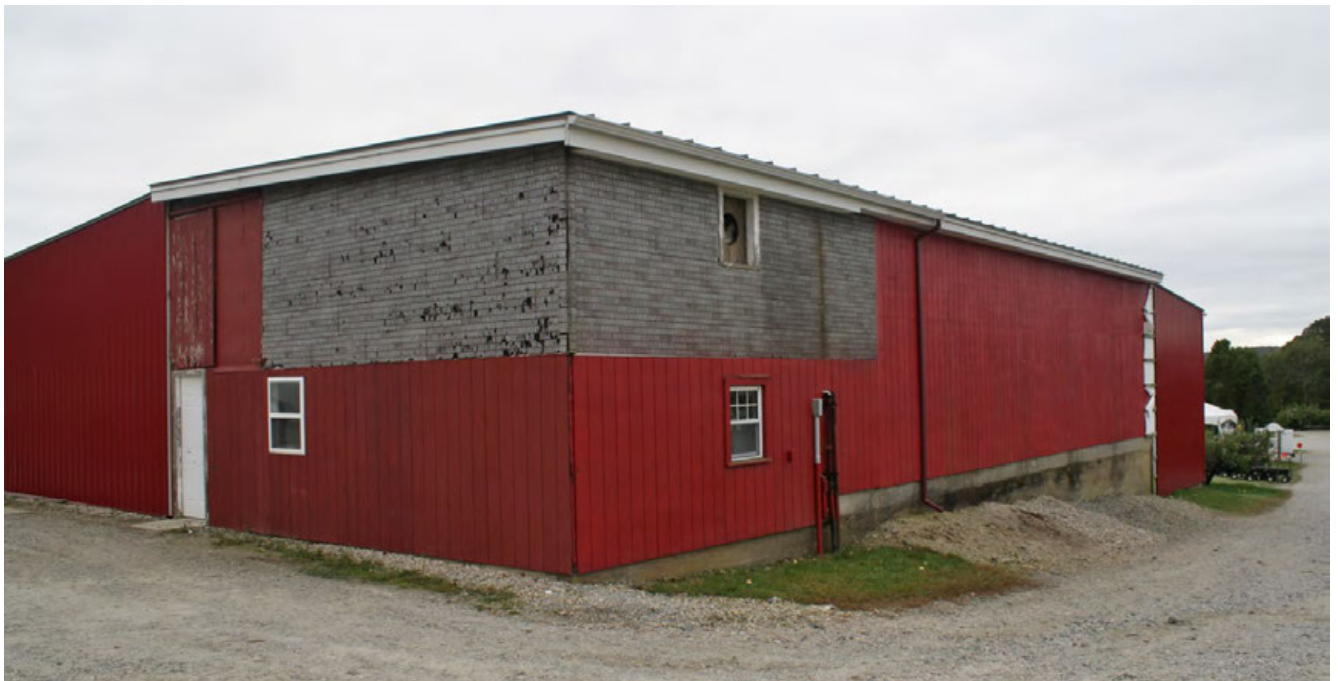
19. Northeast view of Coop I / Apple storage barn, camera facing southwest.

This structure, 70' x 75', consists of a northern portion, a narrow structure oriented east-west, which began as a chicken coop and was later converted to apple storage, and a southern addition which matches the length of the coop and extends southward. The roof is flat, pitched minimally to north and south from a high point at the south wall of the original coop structure. The north side reveals a concrete foundation, two small window openings near the east corner, and remnants of asphalt siding and plywood siding. The newer portion of the building has metal vertical panel siding, and the older coop portion is planned to have matching red metal siding installed.

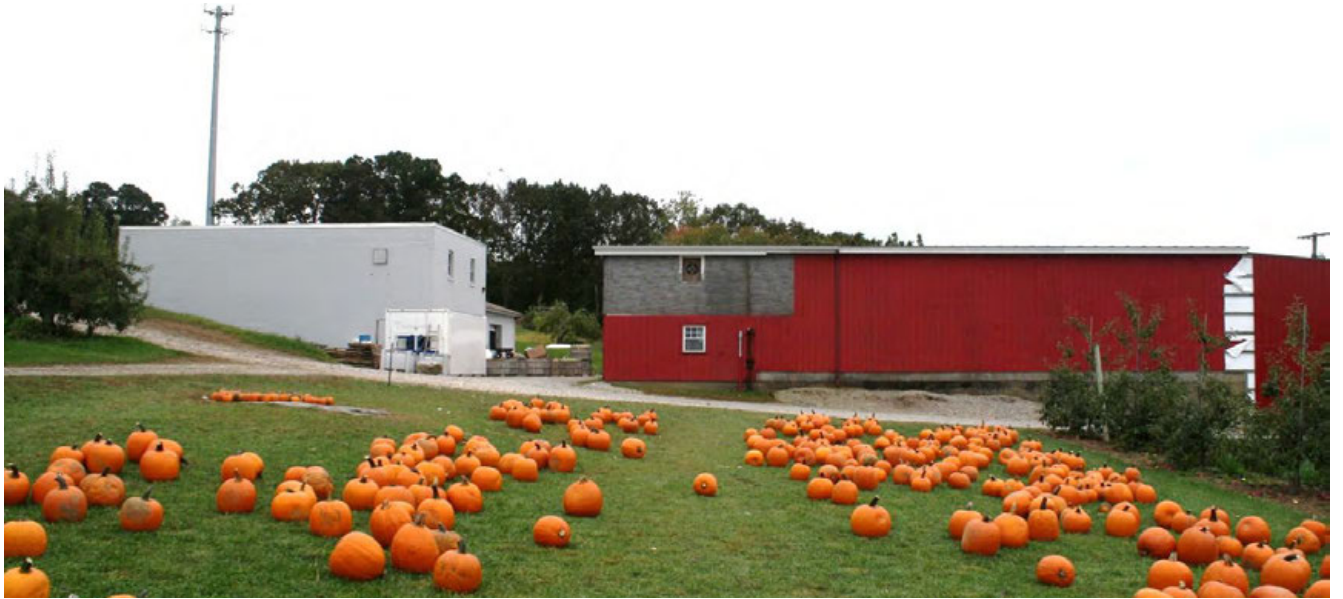
20. North view of Coop I / Apple storage barn, camera facing south. Storage building and cell phone tower at left.

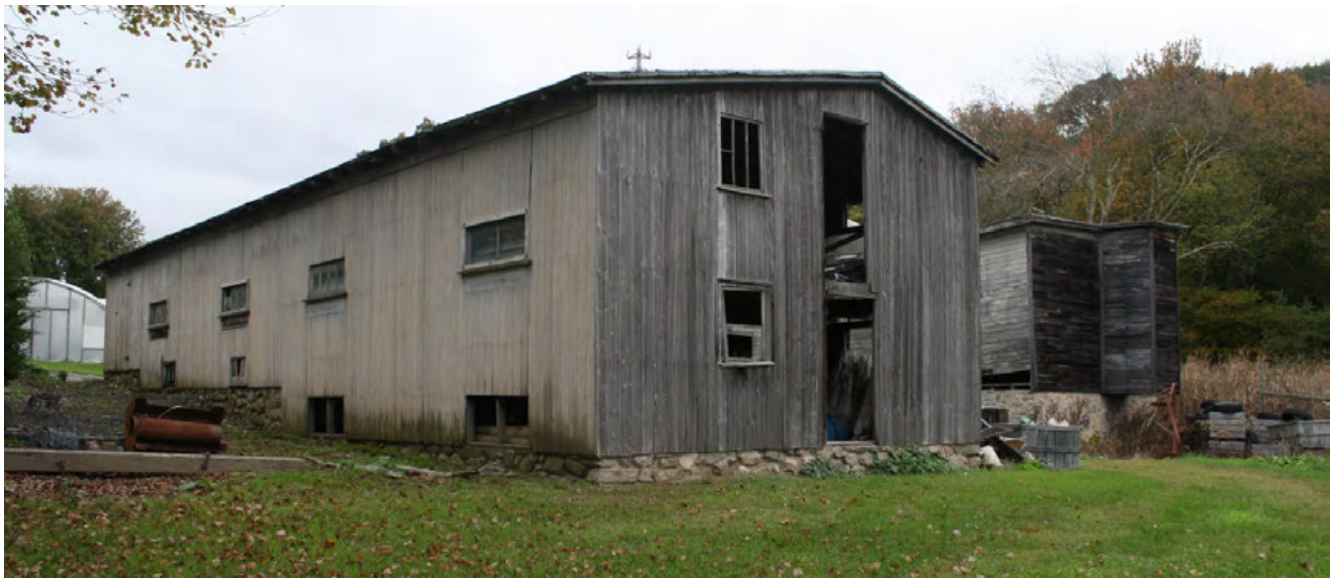
21. Northwest view of Coop II, camera facing southeast. Coop III is at right rear.

This is a very low-pitched gable-roofed two-story chicken coop building, 20' x 60', oriented east-west, with an unmortared fieldstone foundation and wood-framed walls with horizontal wood board siding. Along the north wall, the foundation steps down toward the west along the slope of the hill. There is a series of four widely spaced horizontal windows on both levels. The west wall has doorway openings at the center on both levels (for shoveling manure out of the building) and a six-pane window to the left (north) of the doorway. The south face has bands of poultry windows on both levels along the left (west) portion, and an open wall with a roofed porch area extending south along the remainder. Siding is vertical wood on the north and west, horizontal lap siding on the south, and plywood siding on the east. Roofing is built-up or roll roofing.

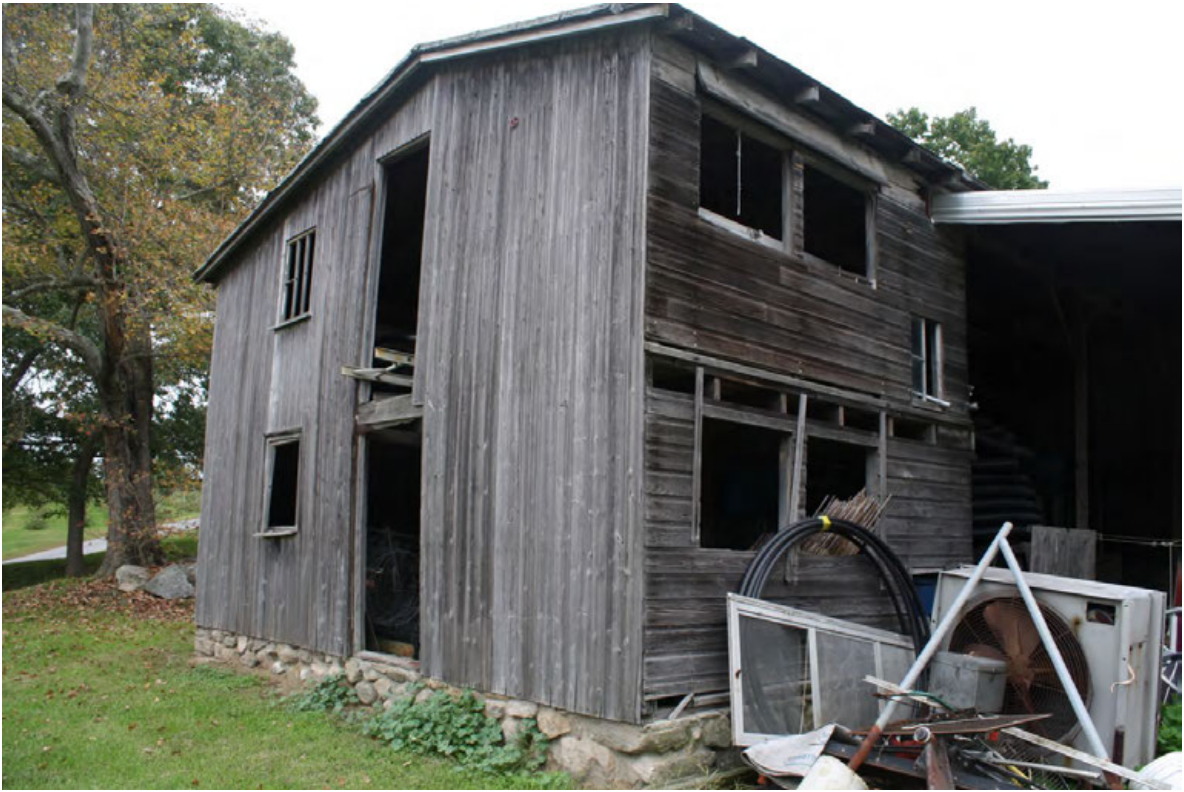
22. Southwest view of Coop II, camera facing northeast.

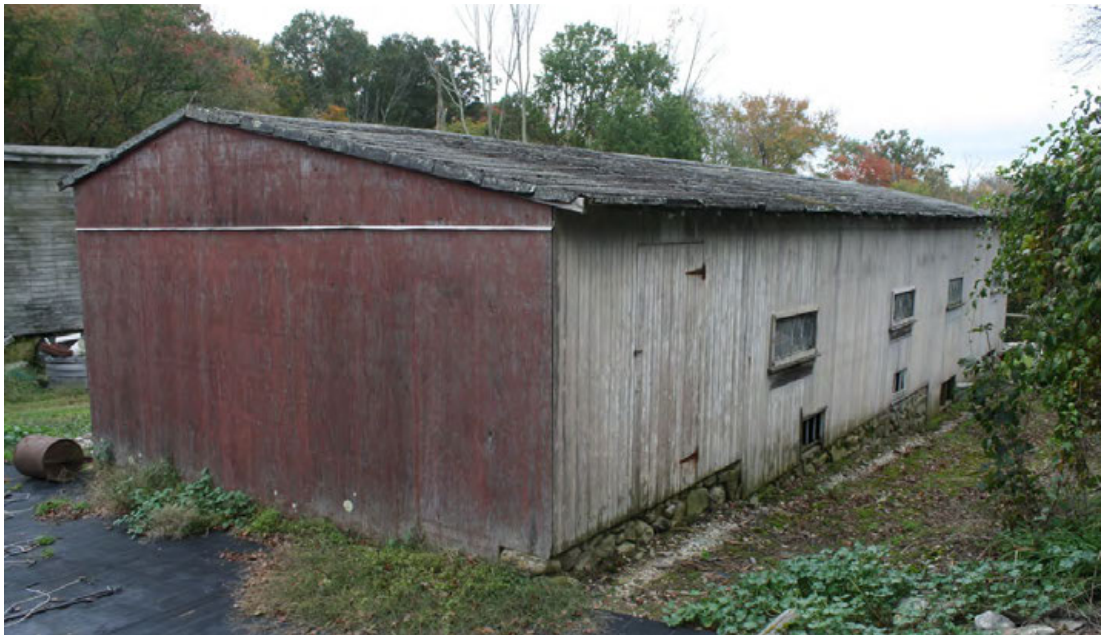
23. Northeast view of Coop II, camera facing southwest.

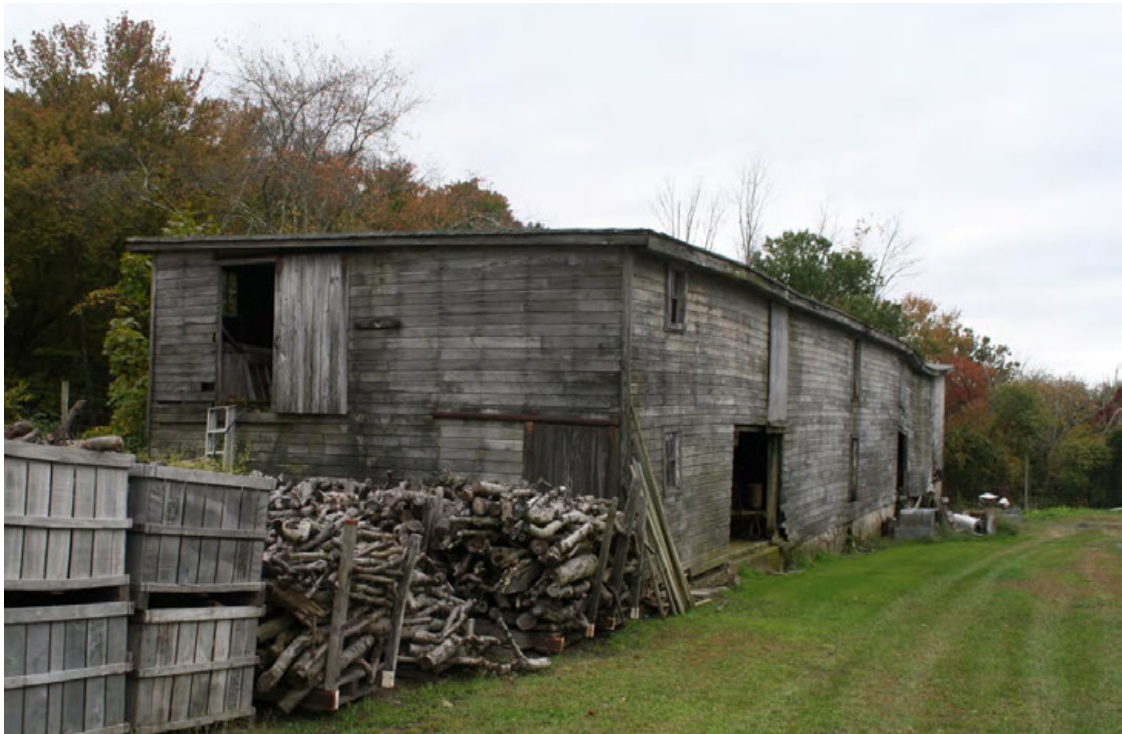
24. Northeast view of Barn II, camera facing northeast.

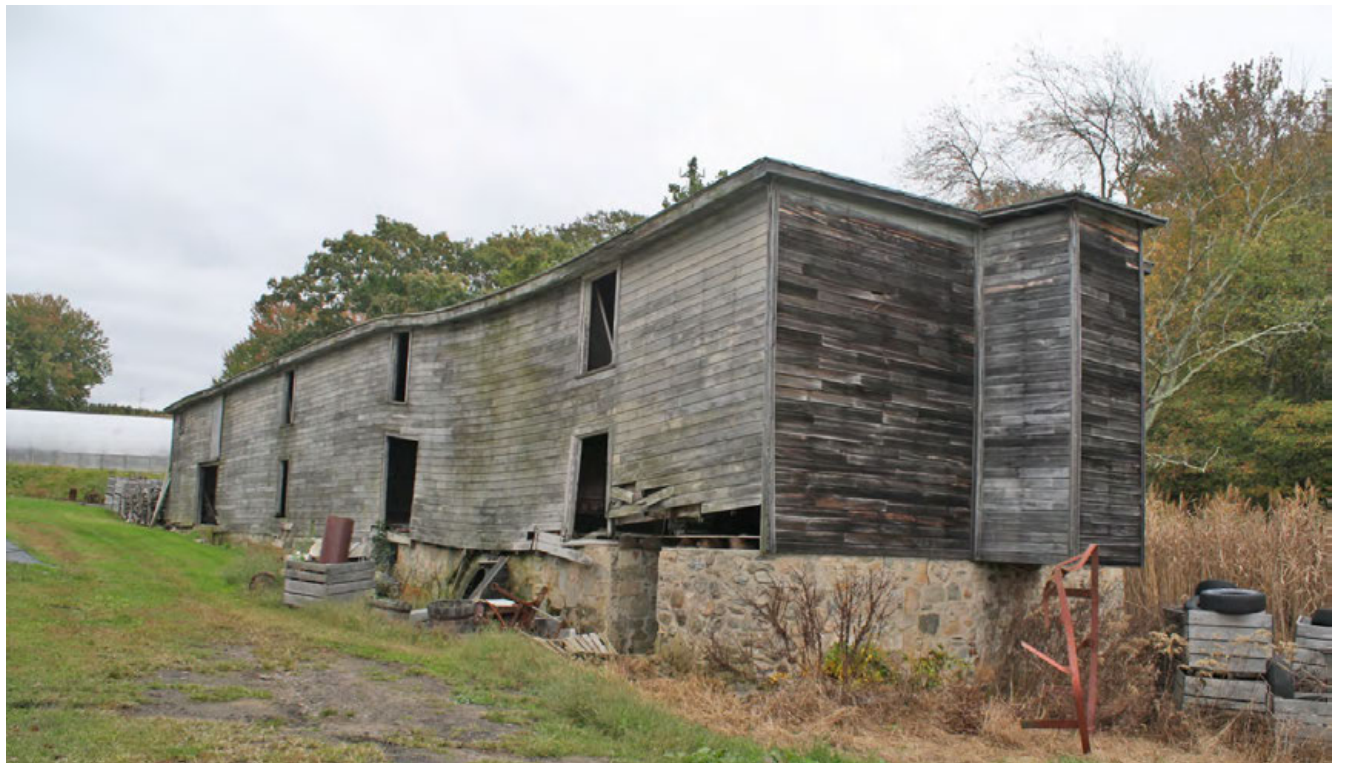
25. Northwest view of Barn II, camera facing southeast.

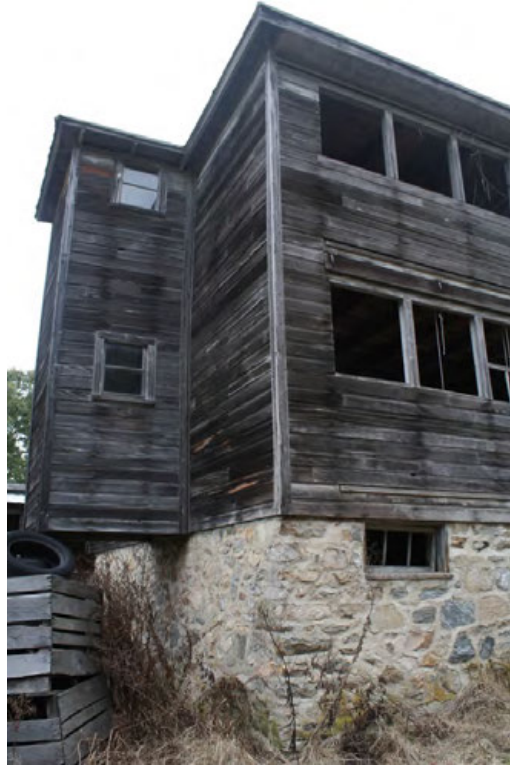
26. Southwest view of Coop III, west end; camera facing northeast.

This is a low-pitched two-story wood-framed shed-roofed chicken coop building, 26' x 110', oriented east-west with four doorway-sized openings spaced along the north facade. The south facade has bands of strip windows alternating with full-height openings (a few have twelve-pane glazing extant). The west gable-end facade has a projecting square shaft under which a wagon could be positioned to collect manure. The walls have horizontal wood lap siding and the roof is roll roofing. A foundation is visible as the grade slopes down toward the west, and consists of a hybrid concrete with fieldstones which were embedded in the formwork. The structure exhibits considerable deformation and is likely to be demolished in the near future.

When Adolph and Harold Holmberg first began farming here in the 1930s, they raised chickens for eggs and planted the orchards. It took a number of years for the trees to grow and the orchard to become profitable; during those years chickens were the main business. After the orchards were successful, chickens were phased out. One chicken coop is incorporated into the apple storage barn, although it has been substantially reconstructed over the years; the management of moisture and condensation is challenging in apple storage. Of the two remaining vacant coops, the long one is likely to be demolished, but the shorter one will be retained as equipment storage.

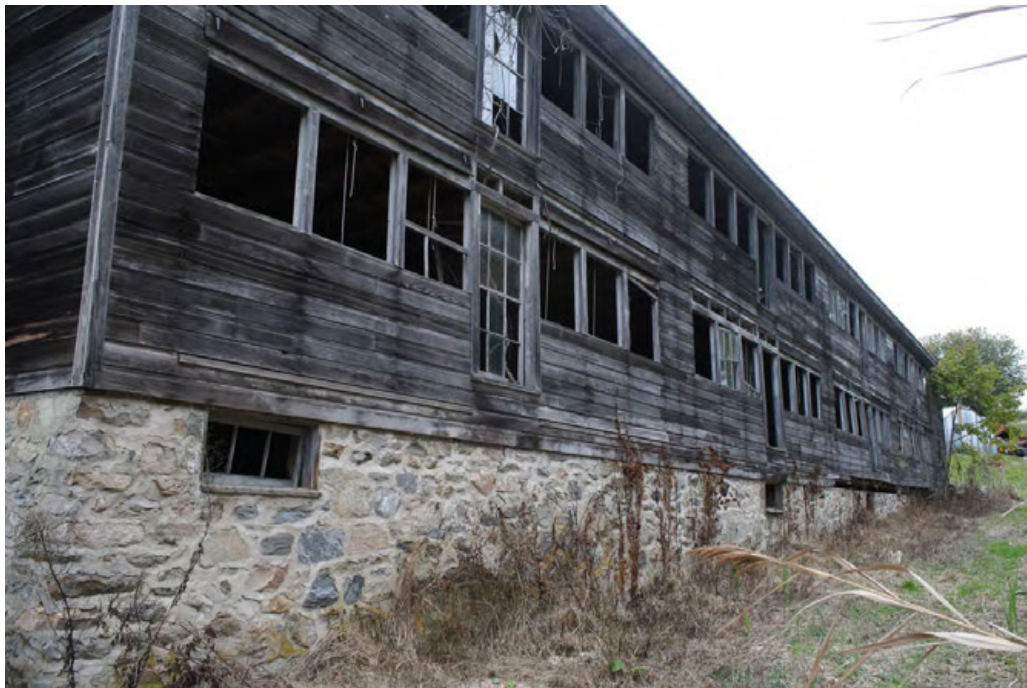
27. Southwest view of Coop III, south side; camera facing northeast.
