HISTORIC RESOURCES INVENTORY - BUILDING AND STRUCTURES

Building Name (Common) Brown's Turkey Farm Record No. 3151
 Building Name (Historic) Brown, George C. / Brown, Colonel James Franklin, Farmstead / Wychwood Farms
 Street Address or Location 254 Mystic Road
 Town/City North Stonington Village _____ County New London
 Owner(s) Wychwood Farms Ltd. Partnership, 456 Taugwonk Road, Stonington 06378 Public Private

Style of building Gambrel ground-level stable barn, Craftsman style Date of Construction 1936

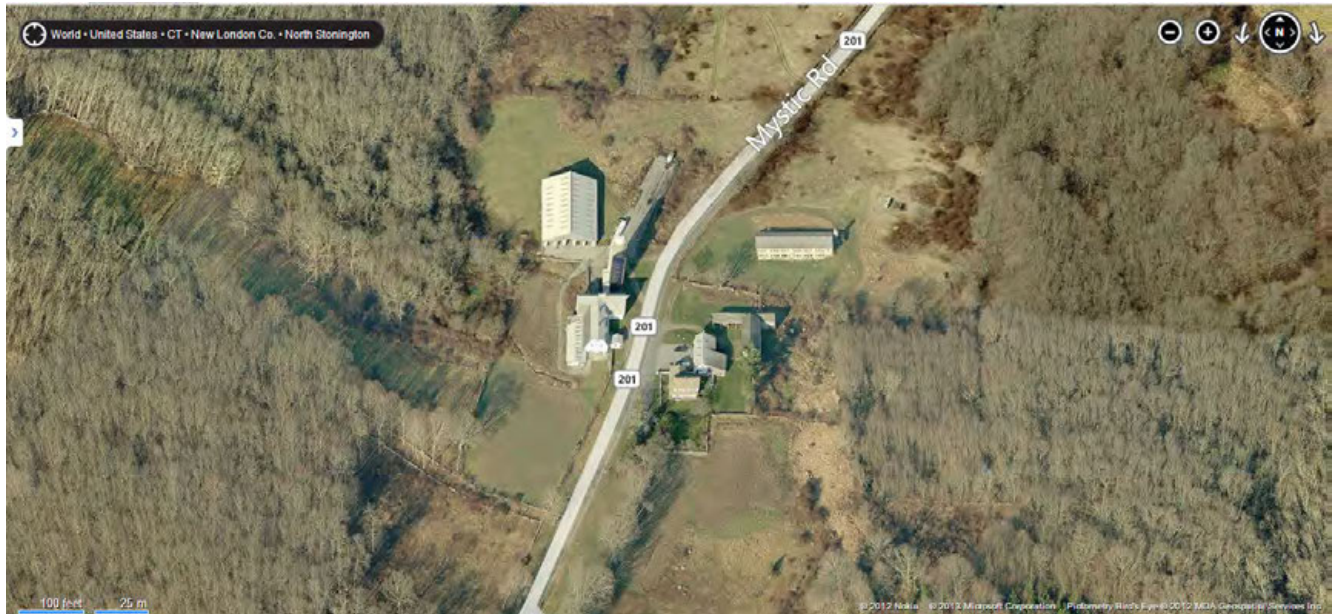
3. South view – aerial “bird’s-eye” view map of 254 Mystic Road, North Stonington, CT – from <http://www.bing.com/maps> - accessed 3/20/2013.

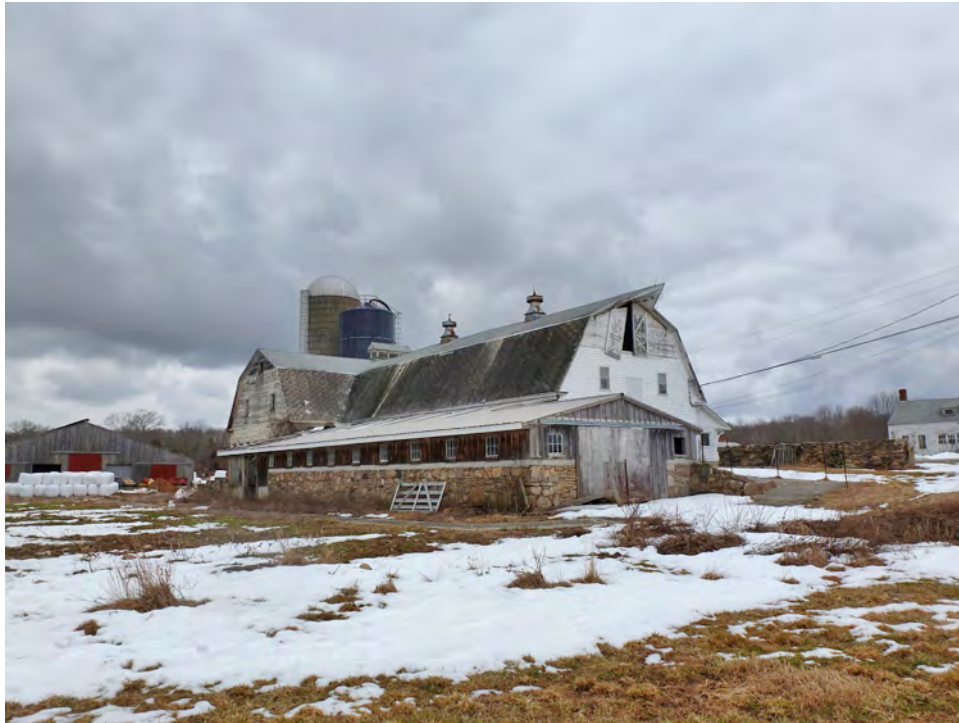
5. Southwest context view of Barn II (on the left), Barn I (in the middle) with its added west dairy stable wing, and a corner of Barn III (on the right). Camera facing northeast.

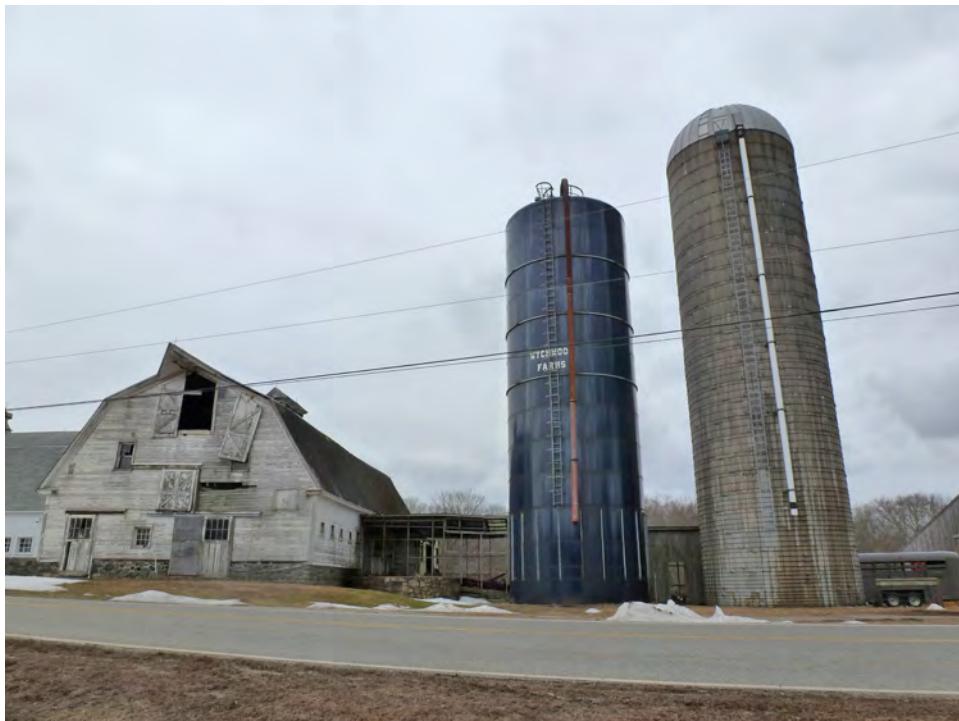
To the north of the Barn, linked by the metal-roofed addition, are two Silos. The northern Silo I is a concrete stave silo with a metal dome roof. The southern Silo II is a blue enameled steel Harvestore silo.

6. East context view of Barn I and the Silos I (right) and II. Camera facing west.

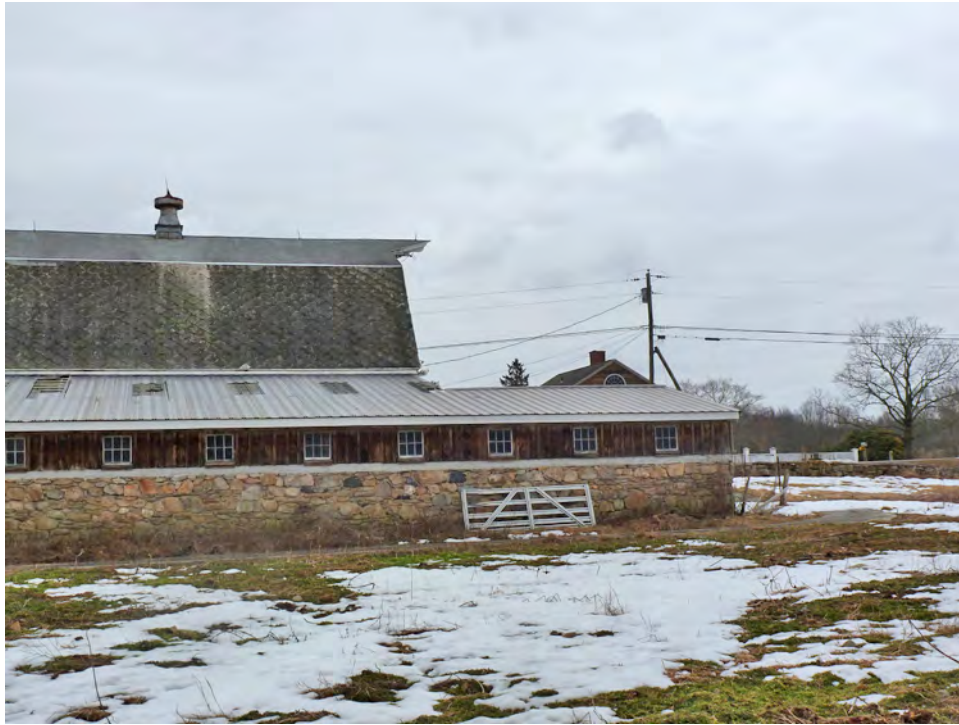
7. West view of Barn I (on the left) and the house (in the distance behind Barn I). Camera facing east.

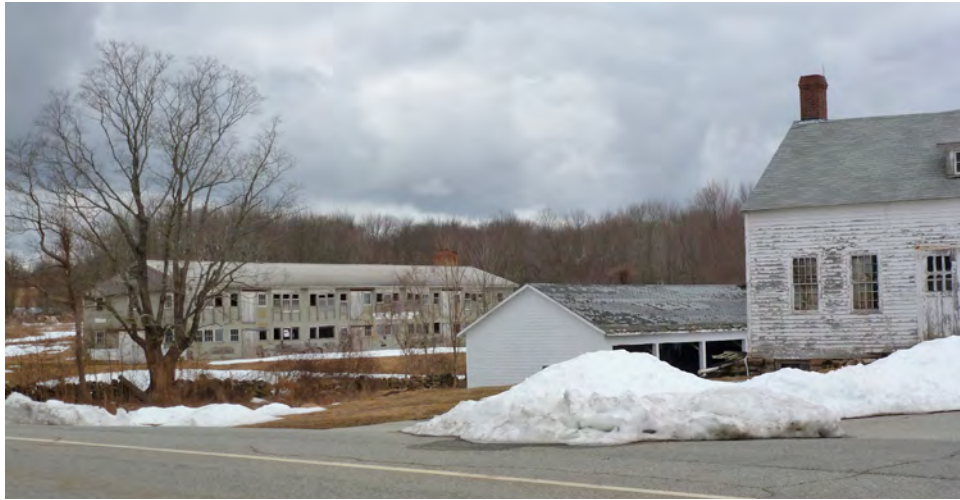
9. Southwest context view of the Poultry house (on the left), Barn IV (in the middle), and a corner of Barn III (on the right). Camera facing northeast.

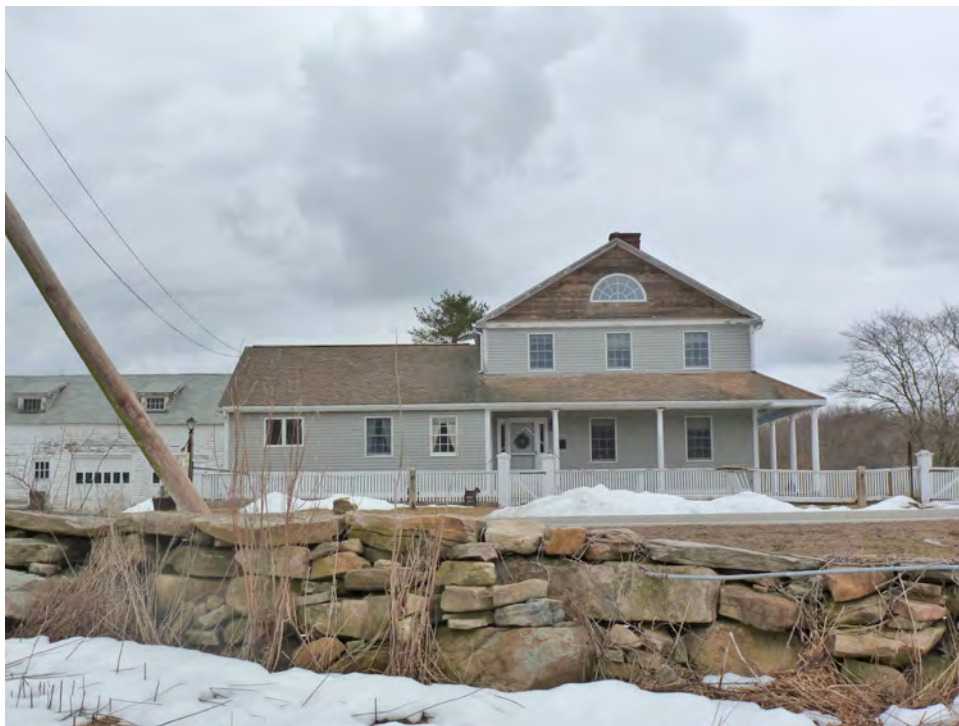
10. West side of the house. Note the stone walls on the west side of the road, along the east boundary of the property. Camera facing east.

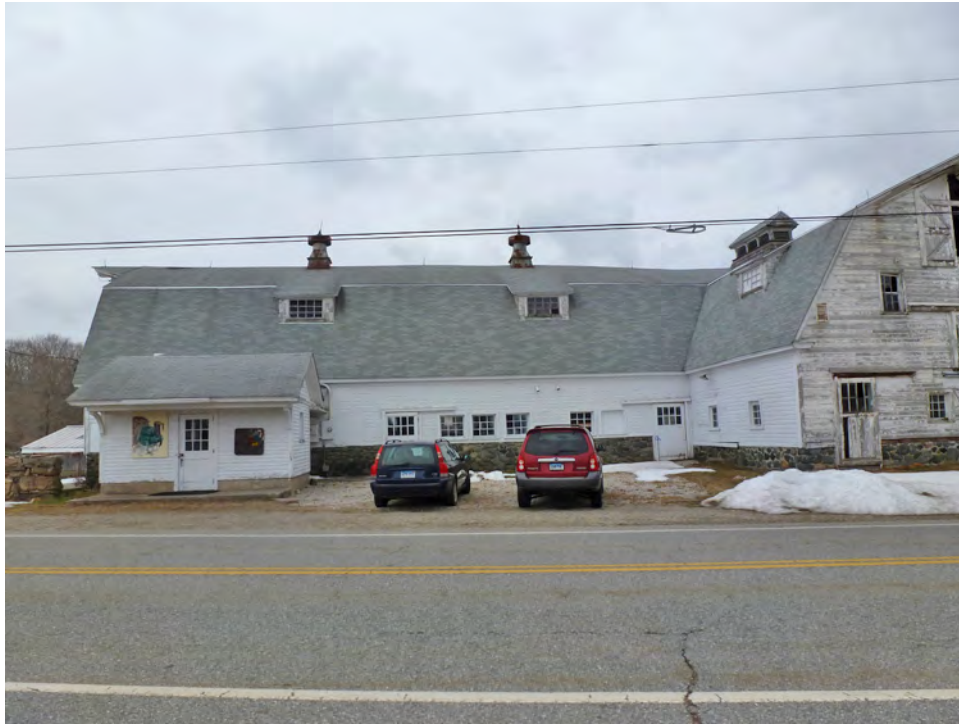
Extending off the east eave-side of the south block of Barn I, near the south corner, is a gable-roof addition, probably the milk room. This addition has horizontal board siding painted white, a concrete foundation, and asphalt shingles on the roof. To the north of the addition, and heading north, are as follows: an exterior-hung sliding door with an eight-pane window set within, four nine-pane windows, and another exterior-hung sliding door with an eight-pane window set within. Two shed-roof dormers with twelve-pane windows are found on the east slope of the roof.

11. East eave-side of the south section of Barn I. Camera facing west.

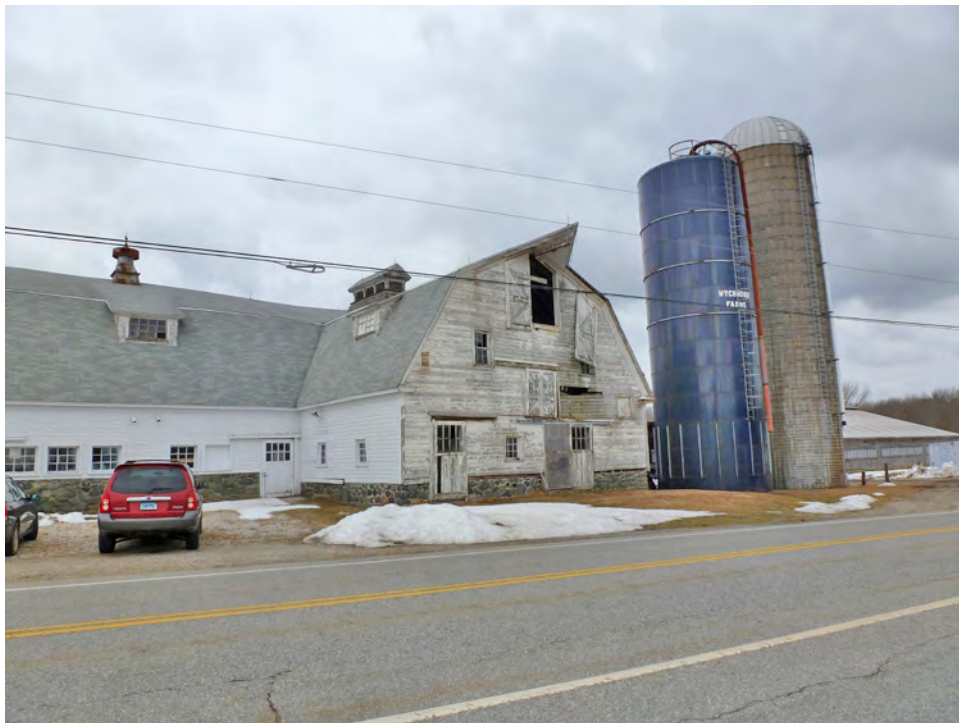
On the south eave-side of the north section of Barn I, there are two six-pane windows spaced evenly. Set within the roof is a shed-roof dormer with a twelve-pane window, now boarded.

12. South eave-side and east gable-end of the north section of Barn I. Camera facing northwest.

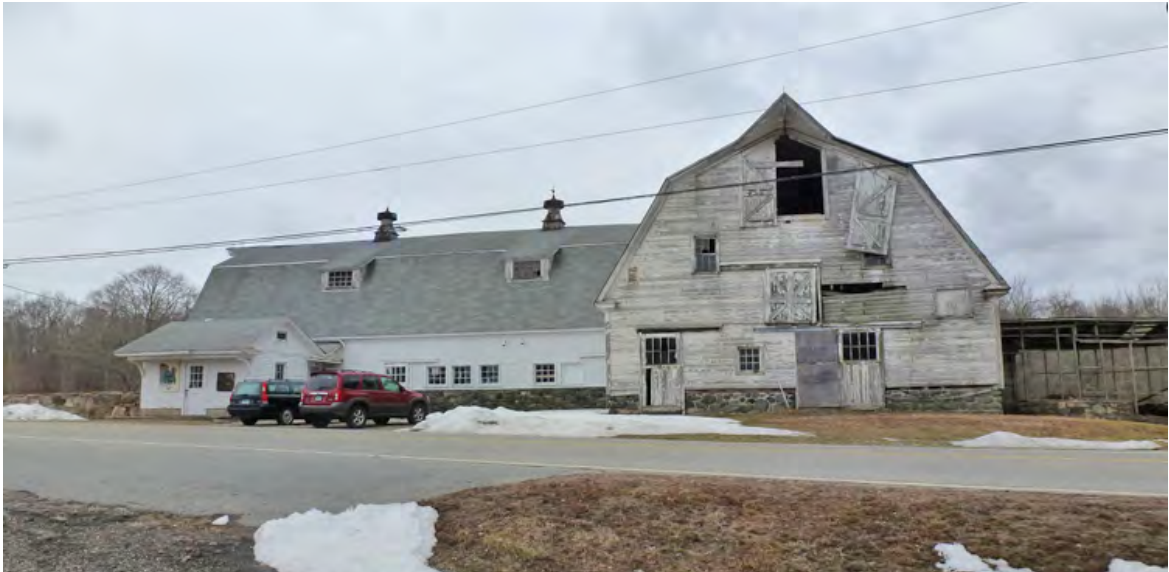
13. East eave-side of the south section and east gable-end of the north section of Barn I. Camera facing west.

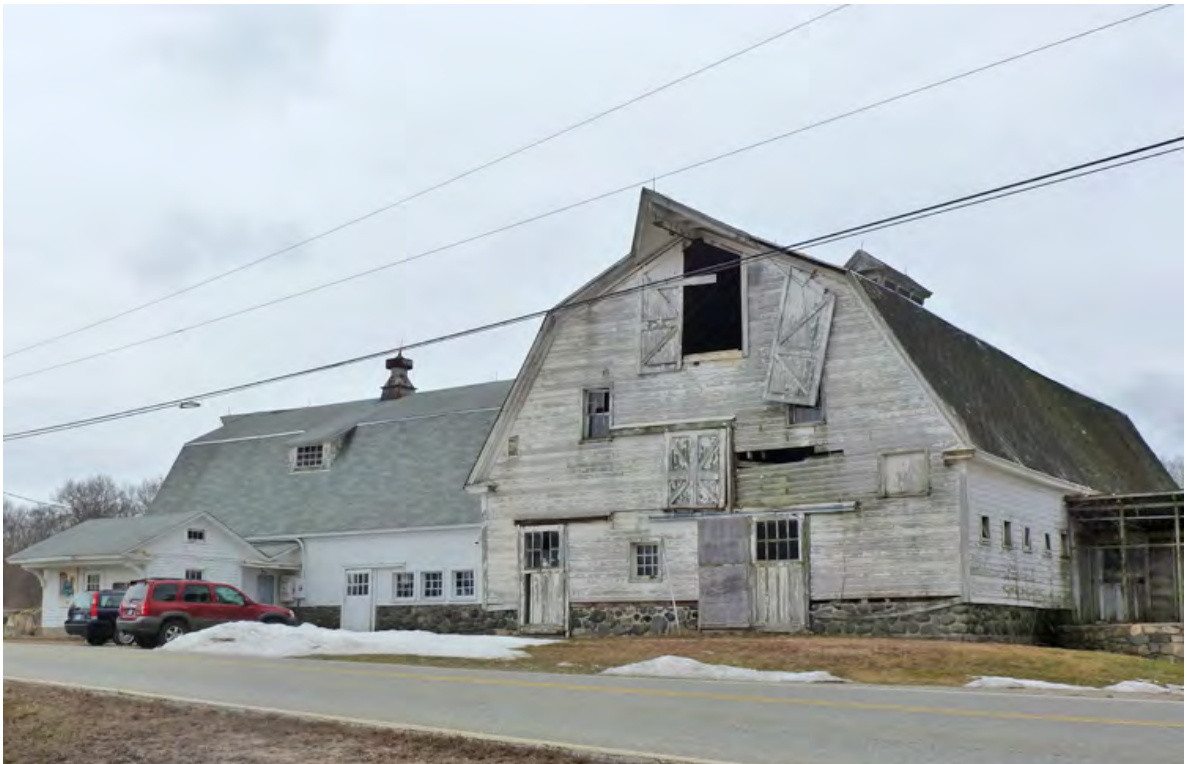
Near both the north and south corners of the east gable-end of the north section of Barn I are exterior-hung sliding doors with eight-pane windows set within. Between the doors is a nine-pane window. Above this is an exterior-hung sliding hay-door, and to the north is a window opening, now boarded. Two six-over-six double-hung windows are above the hay-door, and in the gable attic is an exterior-hung sliding hay-door. A hay hood extends from the peak of the roof, with a hay track protruding from the gable attic.

14. East eave-side of the south section, and east gable-end and north eave-side of the north section of Barn I. Camera facing southwest.

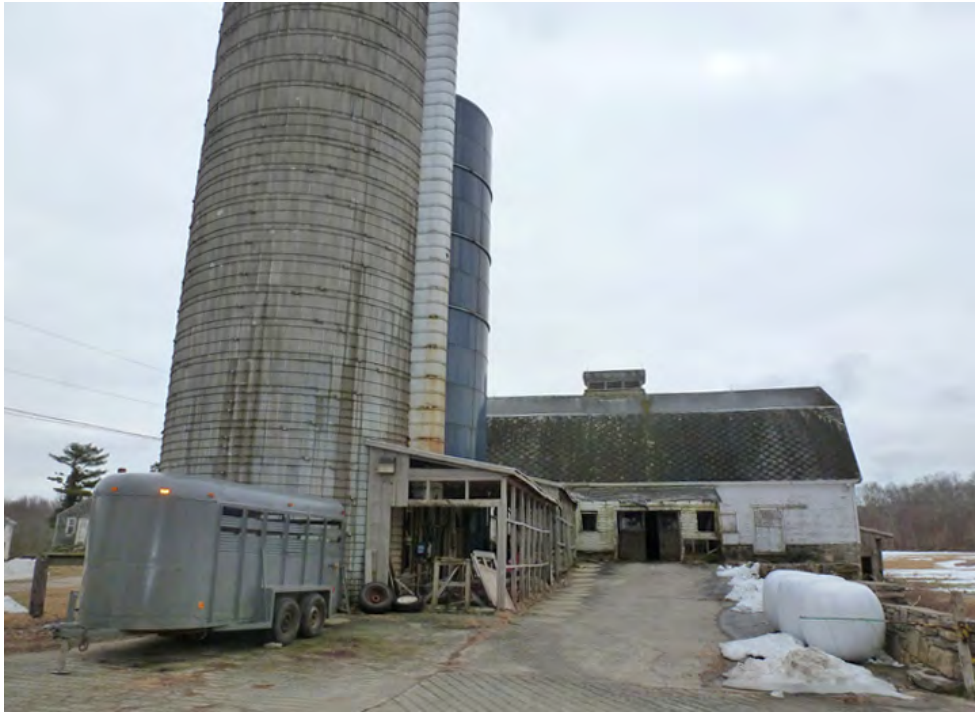
The grade inclines towards the north, and a mortared fieldstone retaining wall extends off the west corner of the north eave-side of the north block of Barn I. An exterior-hung sliding door and a window, now boarded, are near the west corner of the north eave-side. To the east is a pair of interior-hung sliding doors flanked by two windows. To the north of this, an open air shed-roof addition with a metal roof extends to the north. Five hopper windows are near the east corner of this side.

15. North eave-side of the north section of Barn I and Silos. Camera facing south.

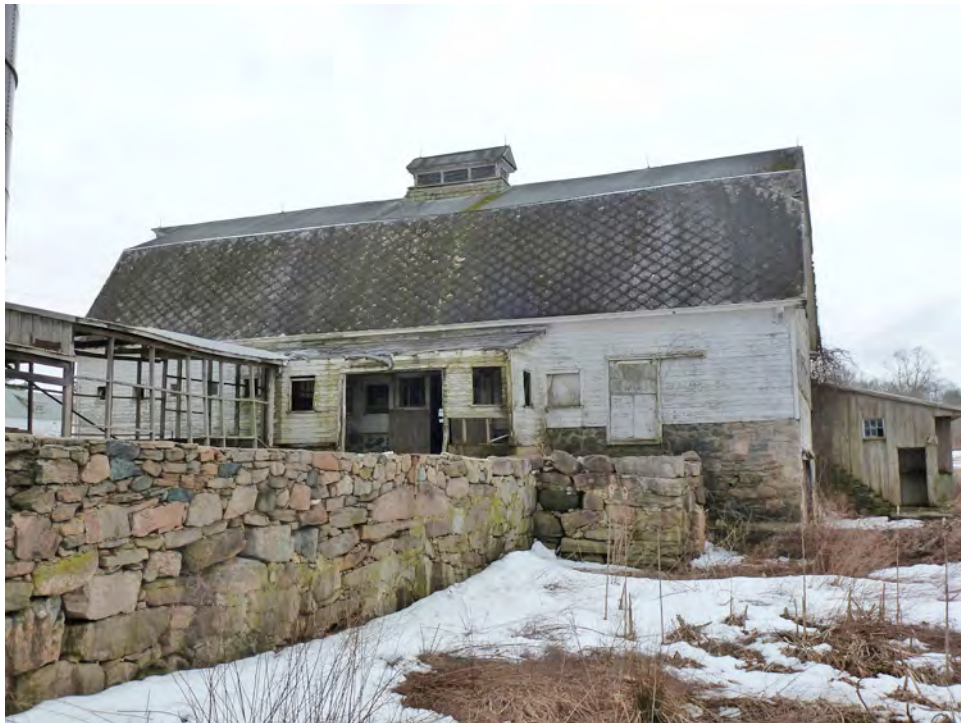
16. Close up of the north eave-side of the north section of Barn I. Camera facing south.

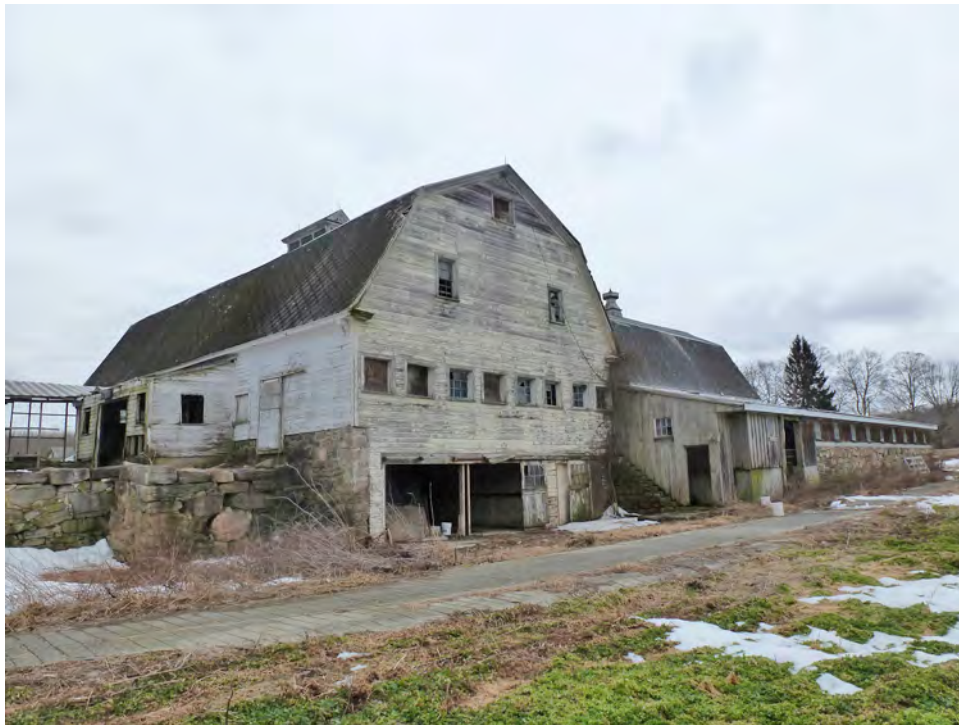
17. North eave-side and west gable-end of the north section of Barn I. Camera facing southeast. Note the partial banked basement.

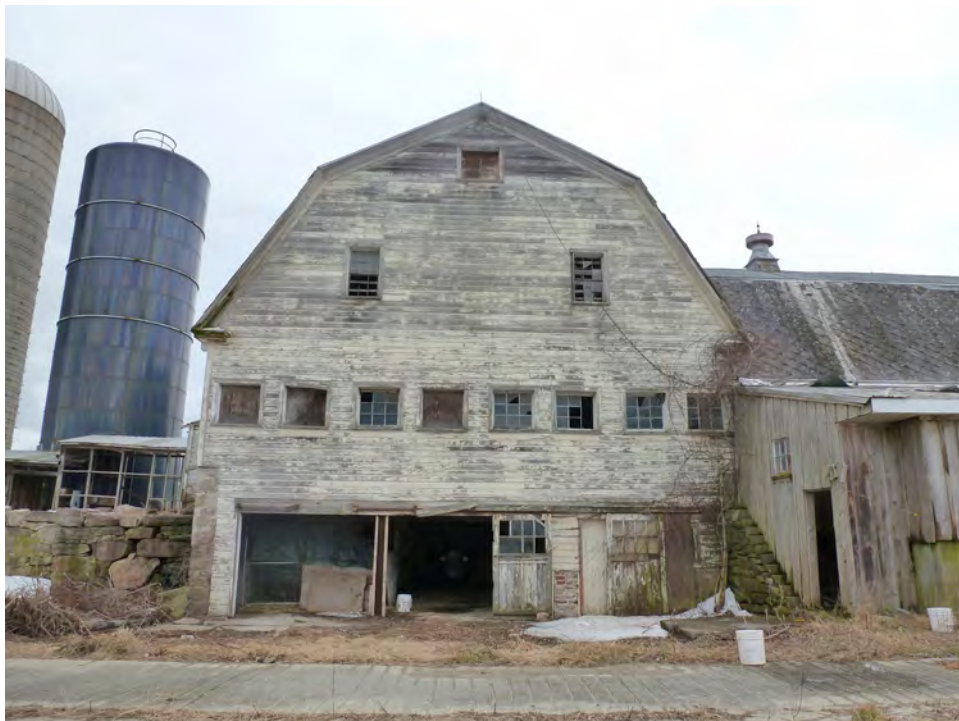
Found on the west gable-end of the north section of Barn I is a banked basement with a pair of door openings with remnants of a hooded track for exterior-hung sliding doors. Near the south corner are two leaves of an exterior-hung sliding door with eight-pane windows set within. This area may have been used to collect manure from the main stable level directly overhead. Above, on the main level of the barn, is a series of eight window openings, some are now boarded. In the upper level of the barn are two six-over-six double-hung windows, and found in the gable attic is a window opening that is now boarded.

18. West gable-end of the north section of Barn I. Camera facing east.

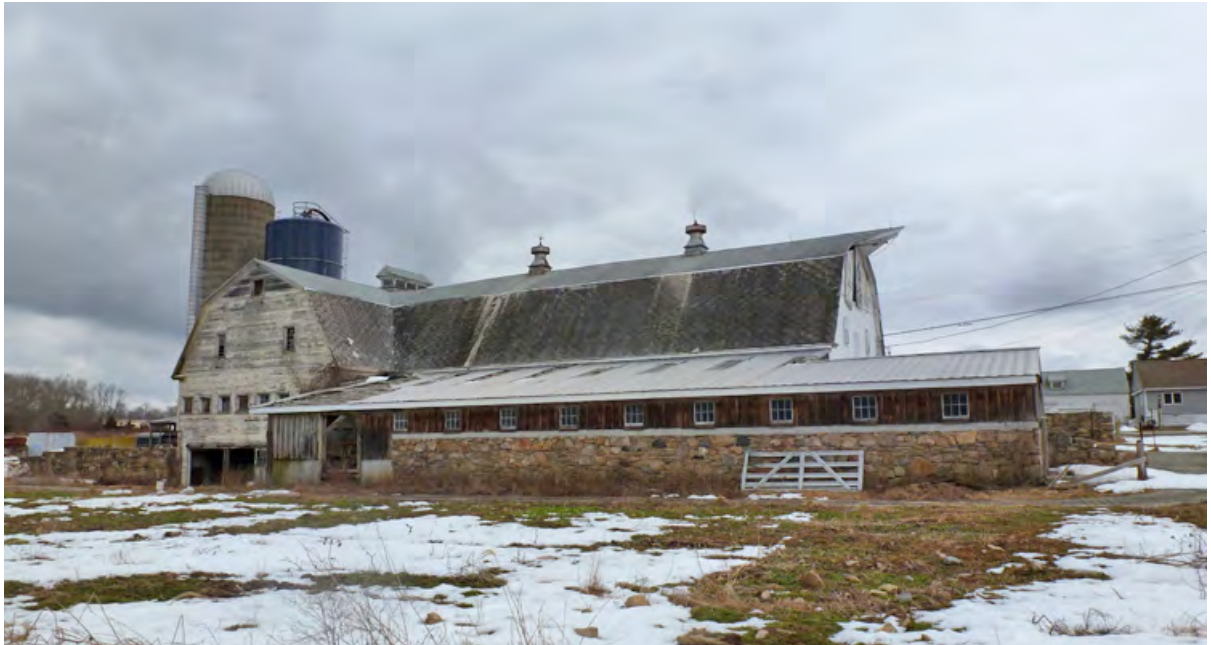
Attached to and encompassing the west eave-side of the south section of Barn I is a shed-roof addition which extends south of the main block as a gable roof. The shed-roof addition has a mortared fieldstone foundation, board-and-batten siding, and metal panels covering the roof. A long row of stable windows in the west eave side indicates use as a dairy stable.

19. West gable-end of the north section and west eave-side of the south section of Barn I. Camera facing east.

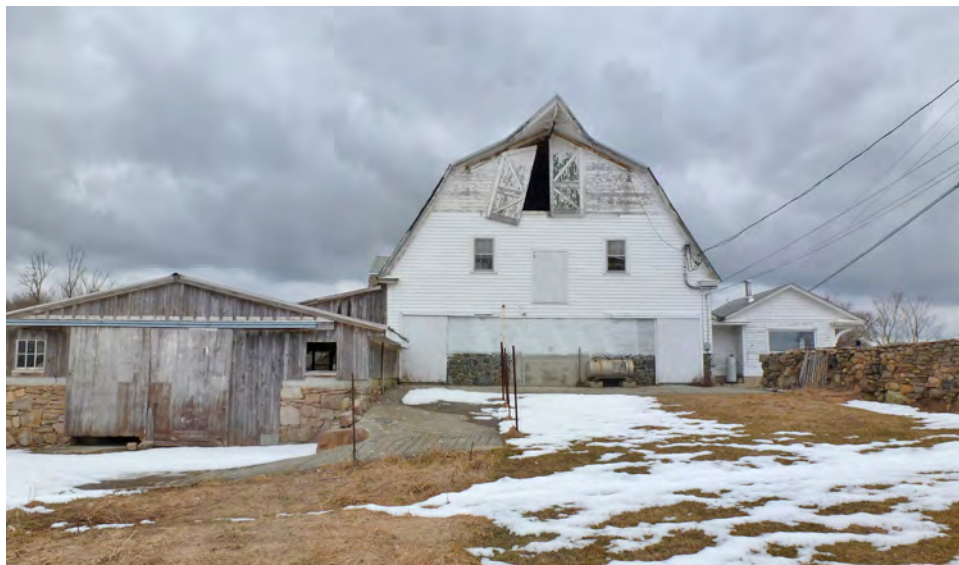
The south gable-end of the south section of Barn I has two exterior-hung sliding doors on both the east and west corners. A side-hinged hay-door is centered above the entries. Flanking the hay-door are six-over-six double-hung

windows with trim. Located in the gable attic is a pair of exterior-hung sliding hay- doors. A hay track protrudes from the apex of the south gable-end and a projecting hay hood from the peak of the roof.

20. South gable-end of the south section of Barn I and west dairy stable addition. Camera facing north.

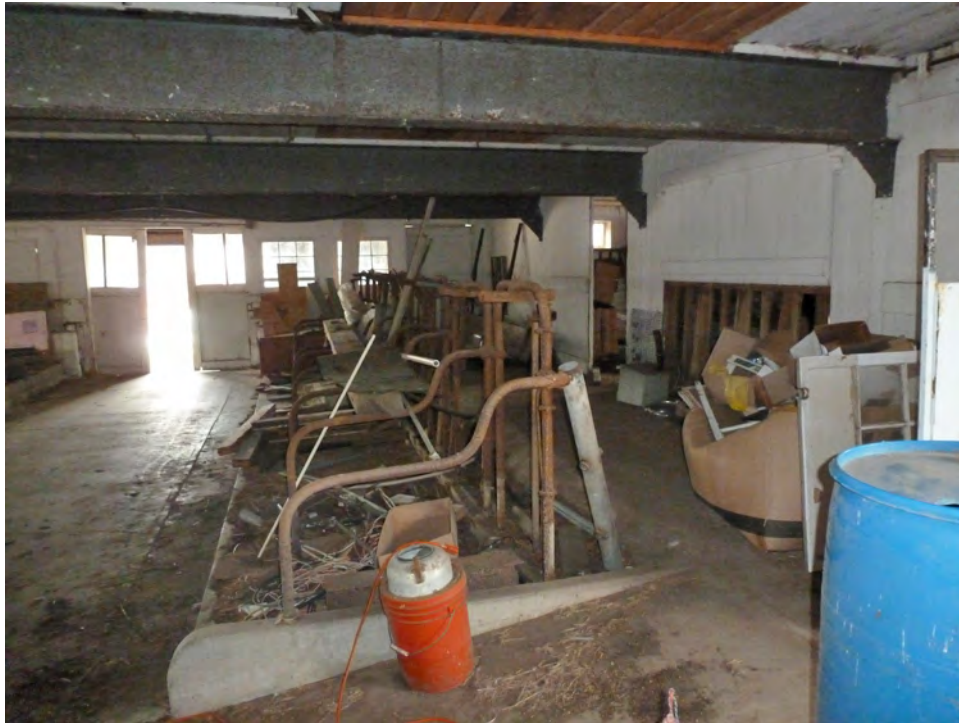
The entry on the east eave-side of the south section of the barn leads into an open space with concrete floors and white painted wood walls. In the south gable-end of the south section of the barn is the turkey processing area. A wall divides the south section of the barn from the north section. Found in the north section of the barn are cow stanchions along the east and west sides, forming a middle aisle with a layout for two rows of cows facing outward. The manure gutters are still visible, although they have been filled in with concrete. In the east gable-end of the north section of the barn are some stalls that once housed horses. A staircase in the east gable-end of the north section of the barn leads to the loft above.

21. Interior view of the cow stanchions in the first story of the north section of Barn I. Camera facing north. Note the use of steel beams to create a clear-span space.

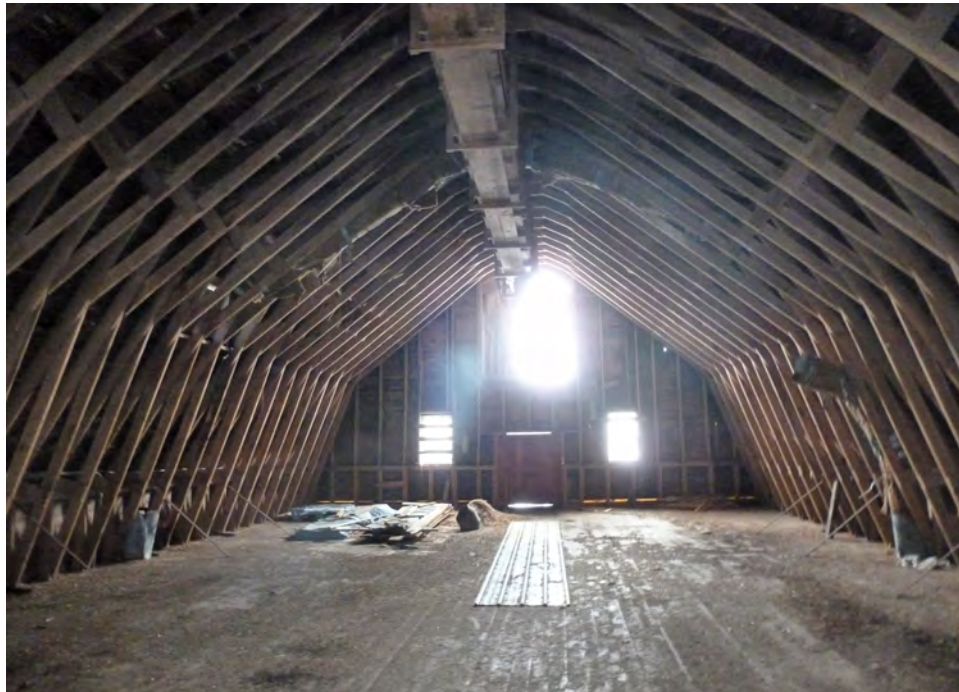
Wood plank floors and walls are found in the loft area. The balloon framing of the barn is visible in the loft and includes an approximately 2' high knee wall from which the rafters of the roof spring. Each rafter is constructed with trusses at each change of pitch, and a collar tie near the top of the roof. The rafters meet at the peak with a ridge-board. The roof deck is made of horizontal wood sheathing. A hay carrier track is still extant and extends to both the north and south sections of the barn, leading to all three gable-ends.

22. Interior view of the south gable-end of the south section of the loft of Barn I. Camera facing south. Note the typical scissor truss framing using sawn dimension lumber.

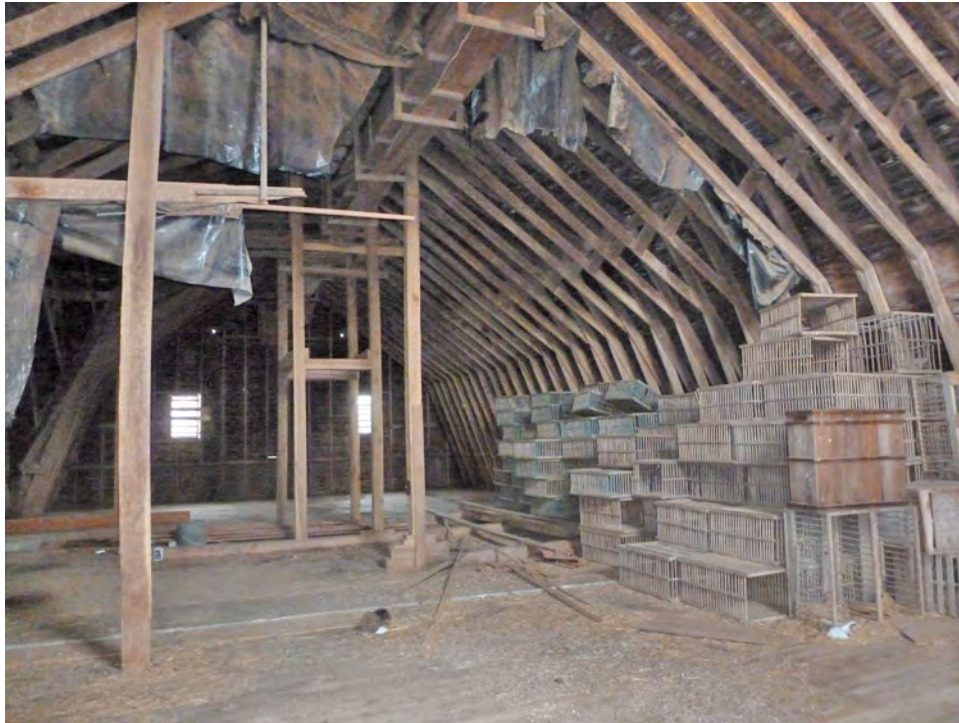
23. Interior view of the west gable-end of the north section of the loft of Barn I. Camera facing west.

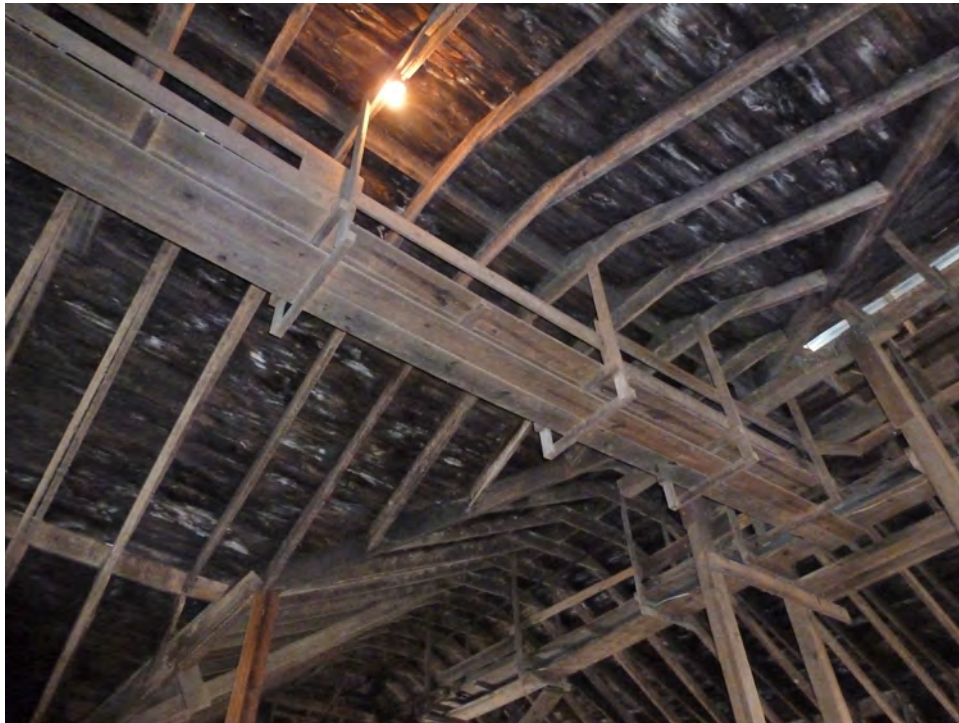
24. Interior view of the hay carrier track in the loft of Barn I. Note the ridge-board where the rafters meet. Camera facing north.
