## HISTORIC RESOURCES INVENTORY - BUILDING AND STRUCTURES

Building Name (Common) Treat Farm Record No. 4919  
 Building Name (Historic) Treat Farmstead  
 Street Address or Location 361 Old Tavern Road  
 Town/City Orange Village \_\_\_\_\_ County New Haven  
 Owner(s) Addie Associates LLC, 361 Old Tavern Road, Orange CT 06477  Public  Private

Style of building Extended English barn, Vernacular style Date of Construction c.1840

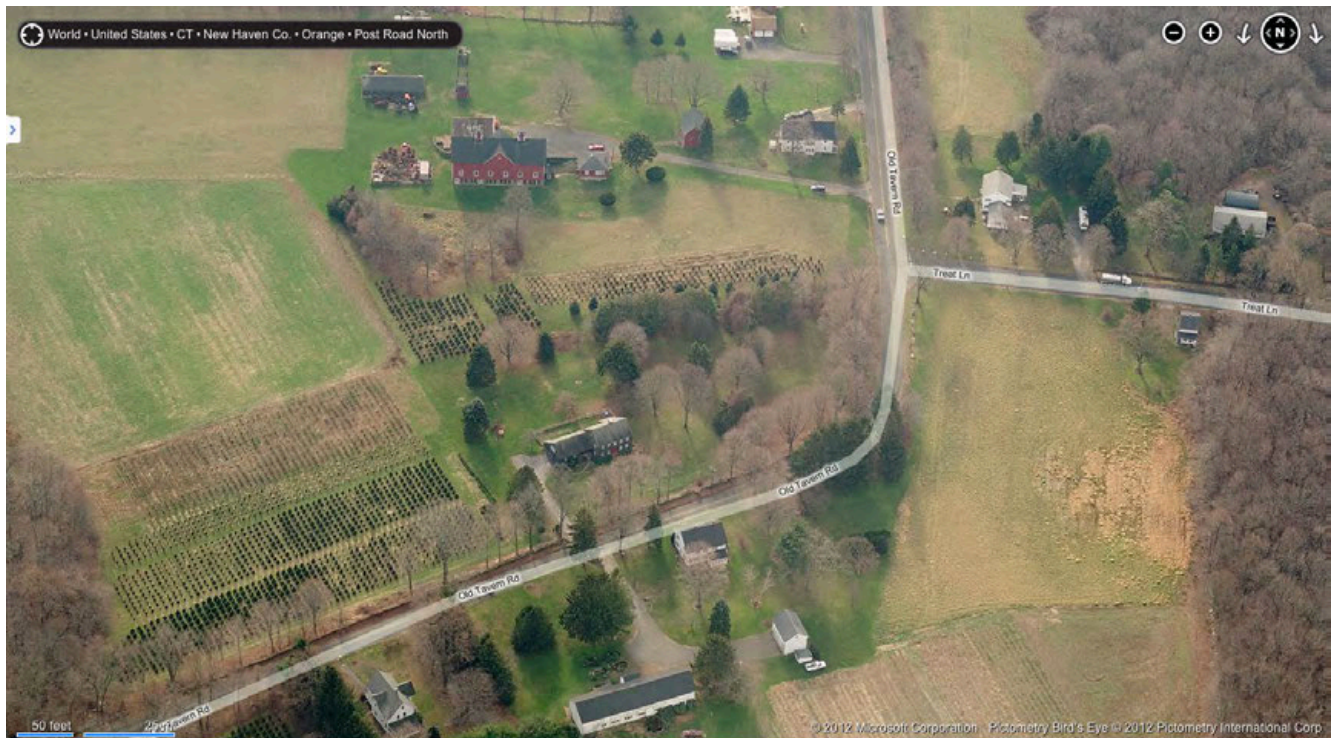
2. North view – aerial “bird’s-eye” map of 361 and 400-408 Old Tavern Road, Orange CT – <http://www.bing.com/maps> accessed 12/29/2012. Treat Farm is at the bottom (north) of the image with its long white barn, and Hayland Farm is at the top (south) of the image, with the large multi-story red barn.

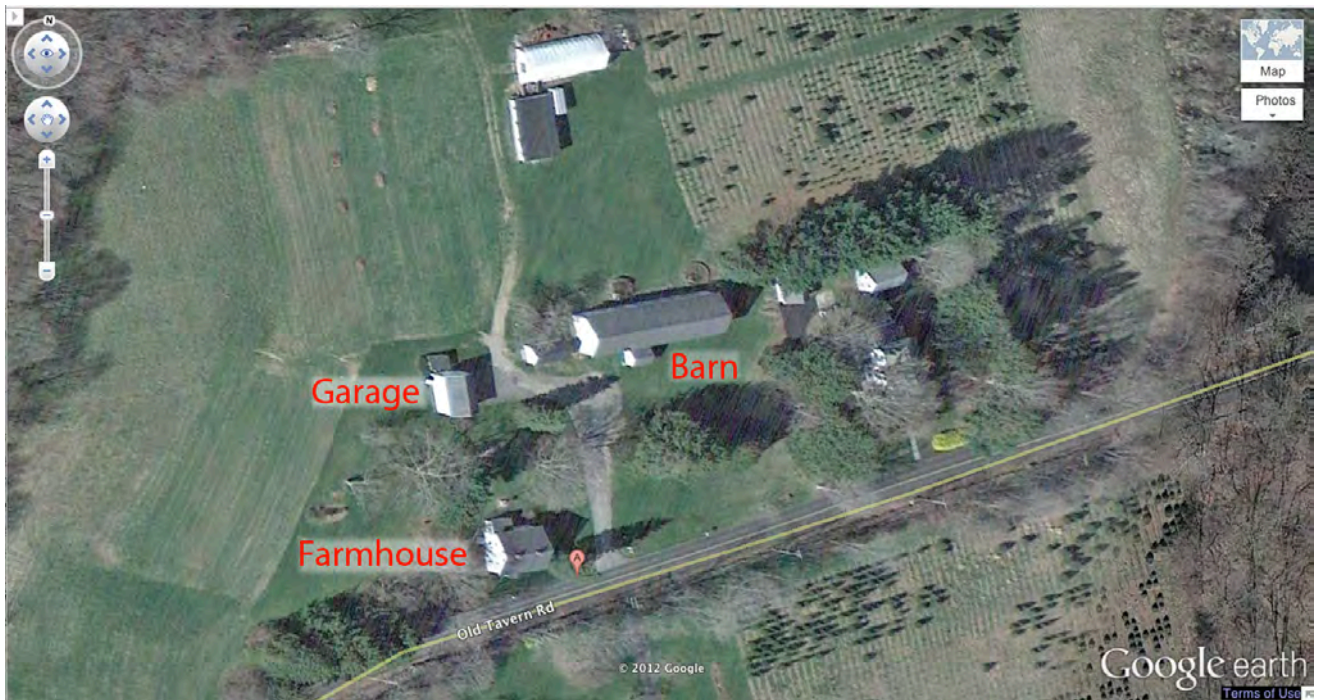
3. Detail Site Plan Sketch showing contributing resources – base image from Google Maps.

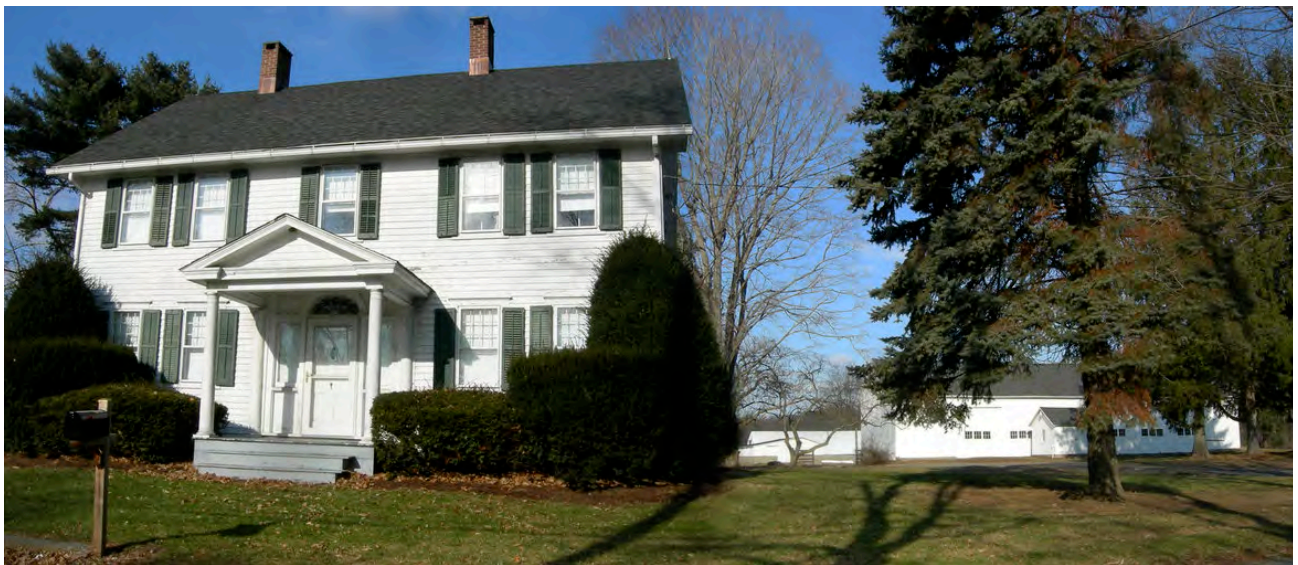
5. South view of Farmhouse, camera facing north, Barn is at right rear.

The Farmhouse is a 2 ½-story Colonial-style building, 30' x 36', with a five-bay façade and its ridge-line oriented east-west parallel to the road. The two chimneys and central doorway imply a center-hall plan. The entry doorway has a Federal-style fan light and side lights, and a gable-roofed porch, likely an early-20<sup>th</sup>-century addition. The door is flanked by two double-hung windows on each side; the second floor has five double-hung windows with two-over-one sash and shutters. Siding is wood clapboards painted white, and roofing is asphalt shingles.

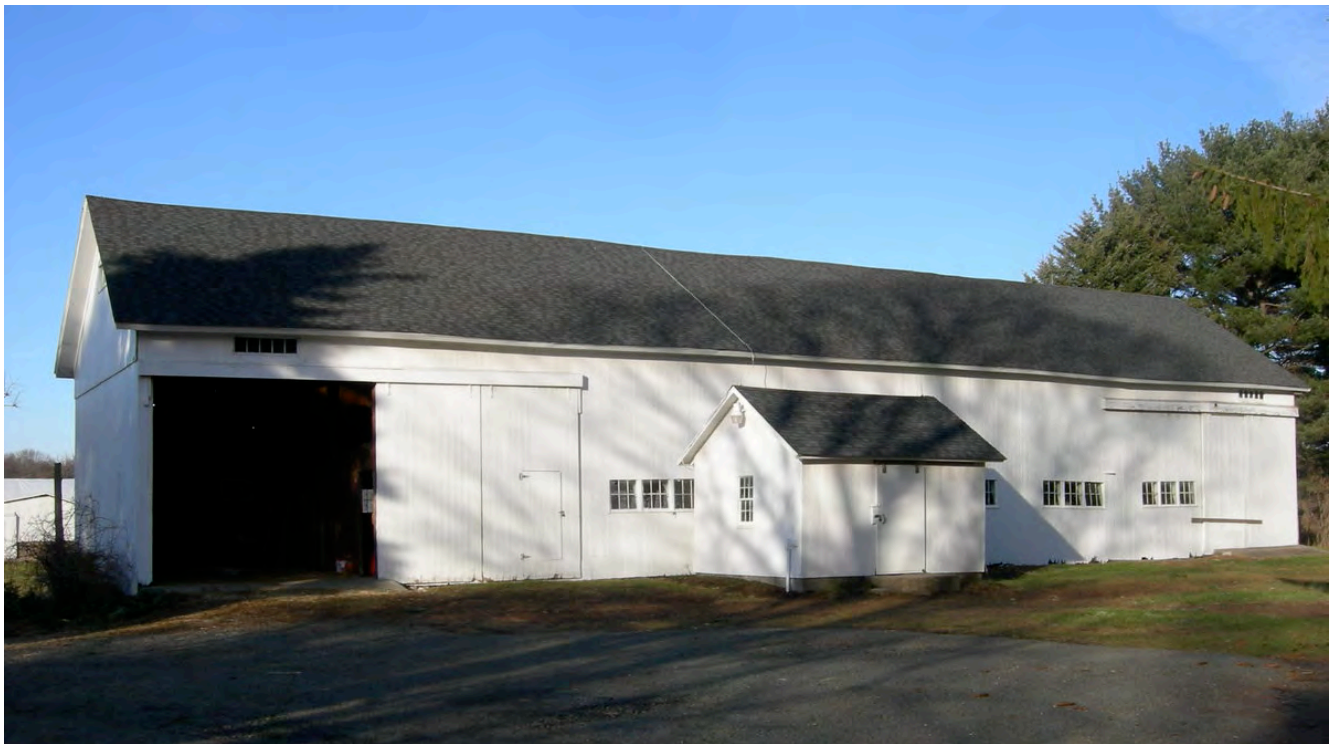
7. South view of Barn, camera facing north. Milk room is at center.

This is a 1 ½-story extended English barn, 30' x 104' with a gable roof oriented east-west, parallel to the road. The southern eave-side facing Old Tavern Road has the main entries. A small milk room is located just to the south of the barn, slightly off-center toward the west. It has a gable roof aligned parallel to the main barn, and is connected by a gable-roofed passage to the main structure.

The barn has eight bays with two hooded, exterior sliding doors in the south eave-side; one in the eastern-most bay and the other in the western-most bay. A series of three-panel six-pane stable windows are found in the intermediate bays. The entrance towards the west has a weather door insert. The sliding doors are each mounted under a single five-paned transom window.

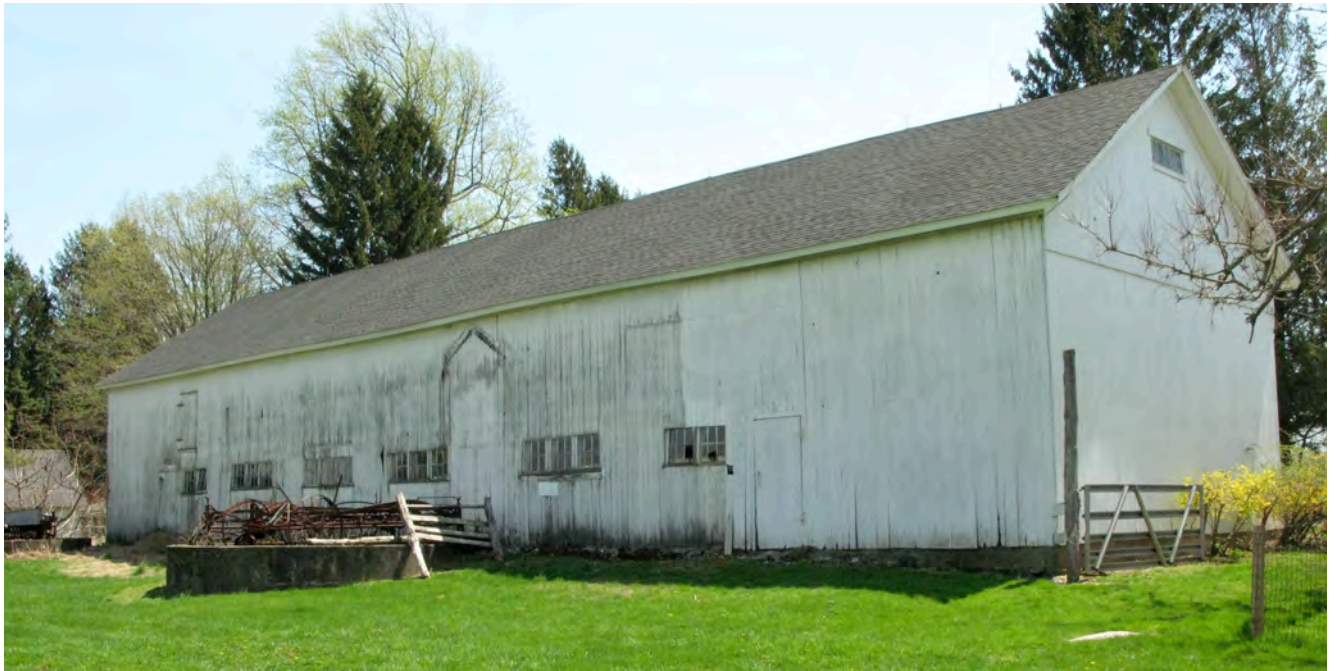
8. Northwest view of Barn, camera facing southeast. Note silo foundations (Gould photo).

The west gable-end has a five-paned attic window near the peak and is otherwise blank. The northern eave-façade of the barn has a row of stable windows similar to the south side, flanked by two single pass-through doors and a hay door in the upper wall of the seventh bay near the east end. The foundations of two silos remain adjacent to the north wall, and the marks of a connecting shed can be seen on the wall at the fourth bay. The second bay from the west shows joints in the siding indicating a former barn door location.

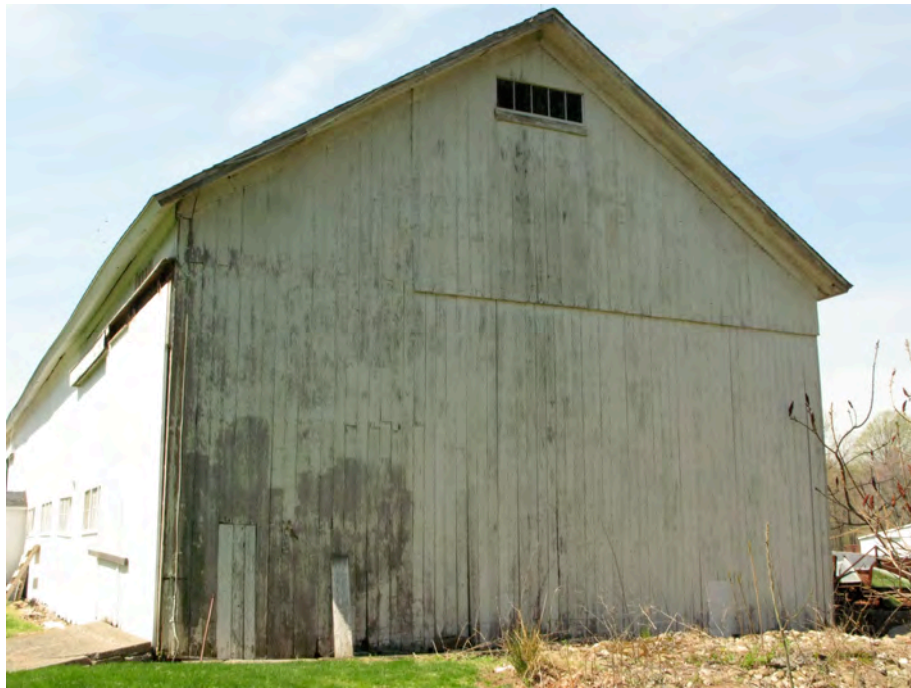
9. East view of Barn, camera facing west (Gould photo).

The east gable-end resembles the west, with a similar attic window. Siding repairs indicate where an addition was removed – relocated as the current garage.

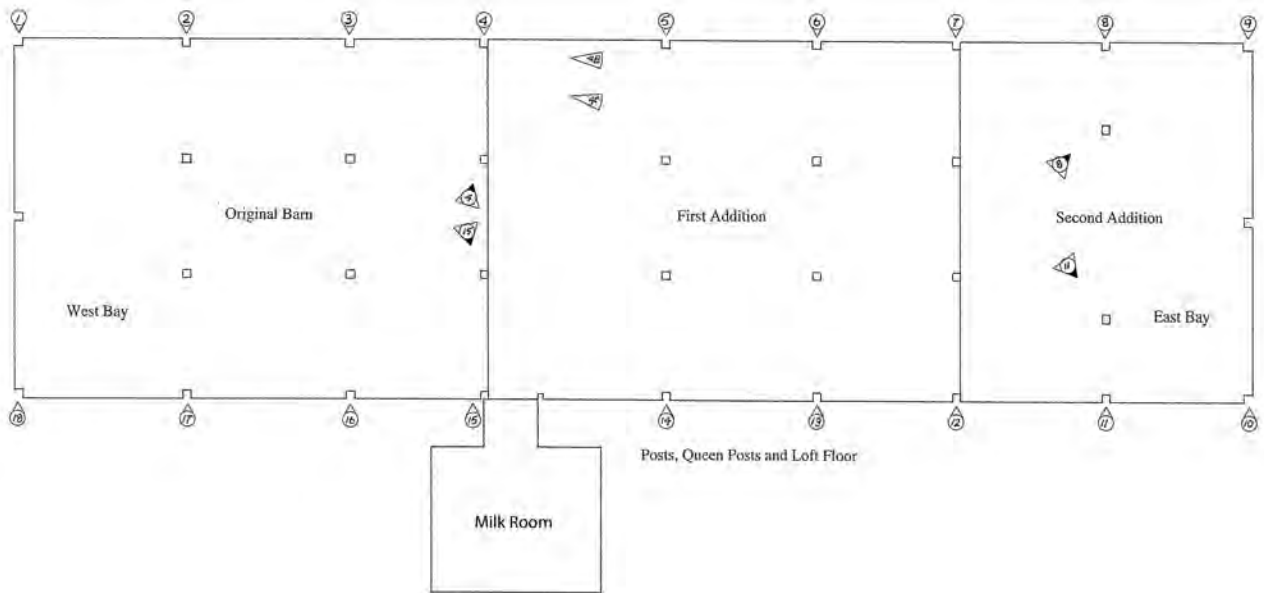
10. Plan diagram of Barn, indicating sequence of construction (Gould).

The next three bays, Bents 5-7, represent an addition not long after, as they exhibit the same construction details, including hewn white oak timbers, dropped tie-girts (though not all layouts exactly matching) and lower interior posts (one or two) offset from the upper queen posts.

The last two bays, Bents 8-9, are of circular-sawn chestnut, with full-height posts forming three aisles, the center aisle being open for ease of hay movement. These characteristics of material and layout are consistent with late 19<sup>th</sup>- or early 20<sup>th</sup>-century construction, implying another addition c. 1900. The rafters throughout are of sawn dimension lumber, probably replaced at the time of the eastern two-bay addition.

**Timber frame:** The original 30' x 40' foot barn frame, built in the first quarter of the 19<sup>th</sup> century, is made of hewn white oak. The first addition, probably later in the first quarter, is 30' x 40'6" is again made of hewn white oak. The last addition is 24' x 30' is made of circular sawn chestnut for total length of just over 104 1/2'. This portion could be as late as the early twentieth century. The new configuration, with end bays, was set-up with a track along the ridge and a hay grapple to lift hay from the wagons and move it into the center portions of the barn.

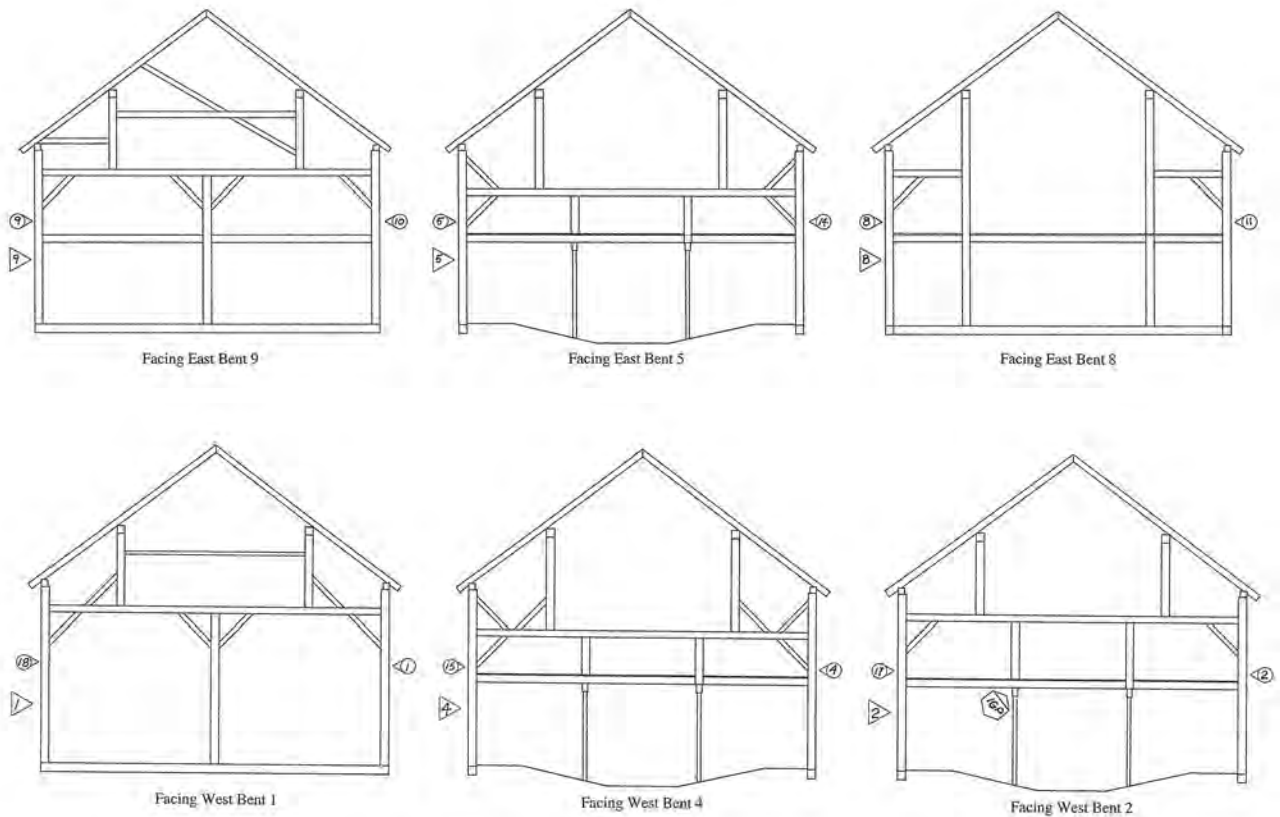
11. Elevation drawings of bents illustrating variations in construction (Gould).

The barn structure, exposed to the interior, is a square rule post and beam frame with pegged mortise and tenon joinery, consisting of nine bents forming eight bays. The bents are numbered for the purposes of documentation, from No. 1 at the west end wall to No. 9 at the east end wall. Per Gould's conditions assessment, Bents 1-4 comprise the three-bay English barn first constructed. The interior wall girt layout is consistent with the exterior evidence on the north side, of a former barn door opening in what would have been the center threshing bay.

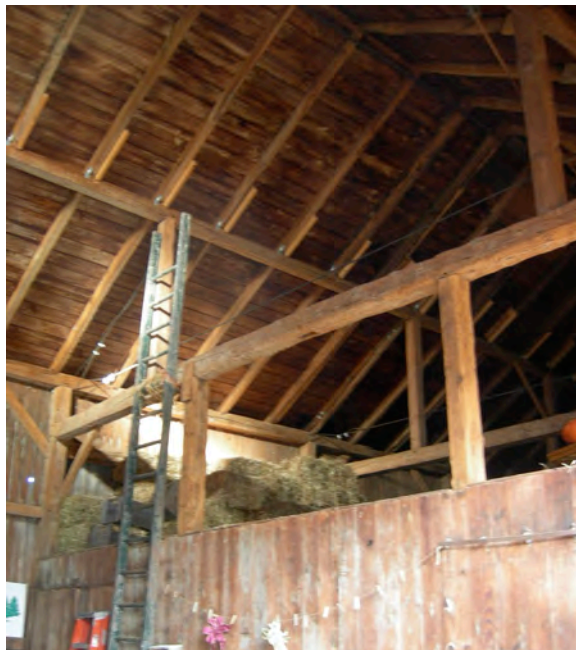
12. Interior view of Bent 2, camera facing northeast. Note the hand hewn oak timbers with dropped tie-girt and interior posts offset from the queen posts that support the purlin plates.

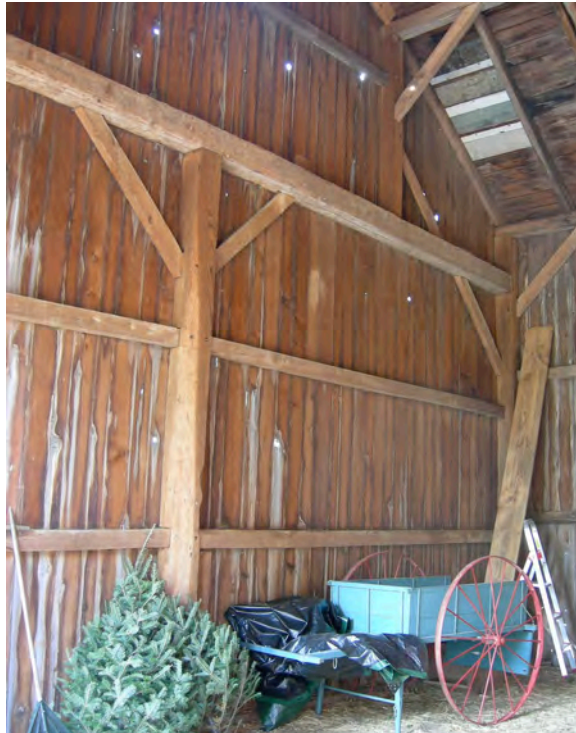
13. Interior view of Bent 1, the west end wall. Note the hand hewn oak timbers with a single interior post, dropped tie-girt and queen posts supporting purlin plates.

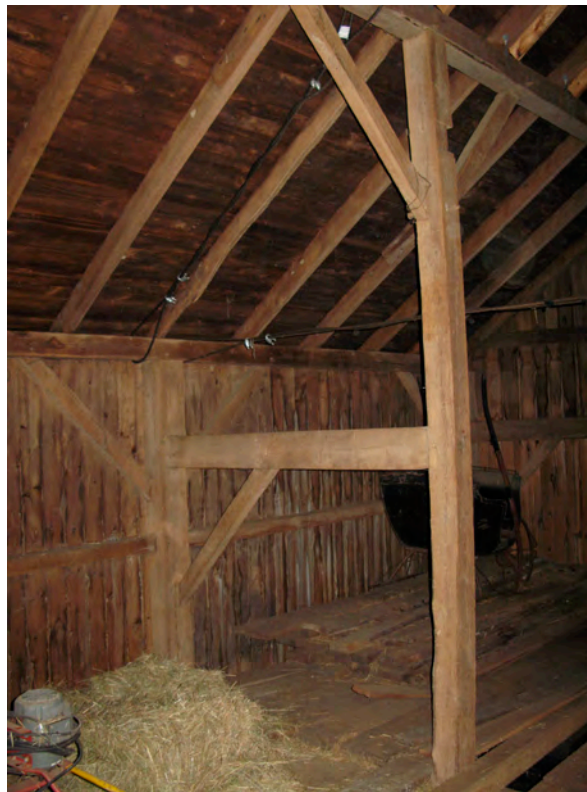
14. Interior view of Bent 8, camera facing northeast (Gould photo). Note the full-height post with bracing to the side wall but a clear center aisle.

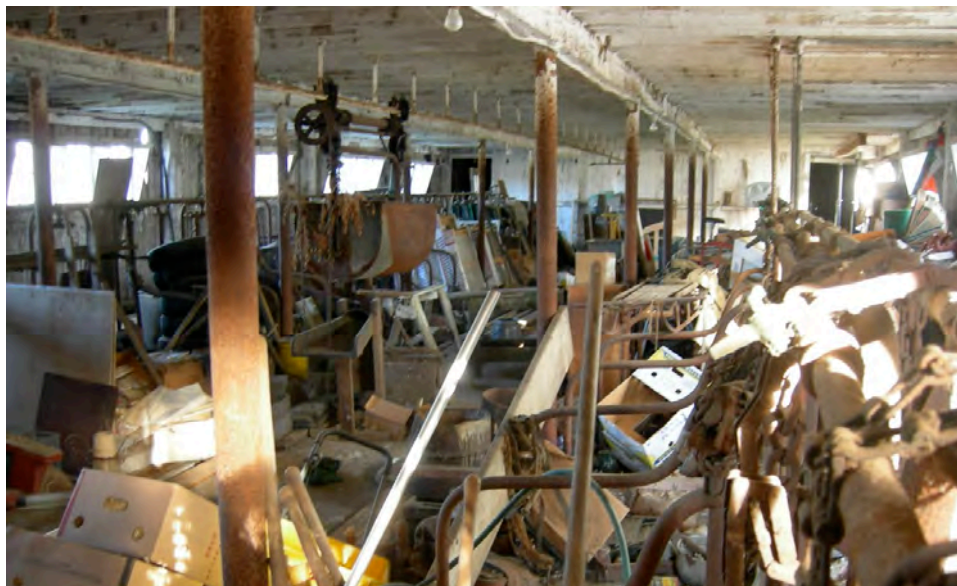
15. Interior view of ground level stable with stanchions, camera facing east. Note the Jamesway-type stanchions and manure trolley suspended on a track at the center aisle.

The westernmost and easternmost bays are open full height and have door openings in the south wall. The interior bays were remodeled to convert the barn to a stable barn with metal stanchions, including a concrete floor with a dropped center and raised outer lanes, for two rows of cows to face outward. Steel columns supporting a pair of longitudinal girders to carry loft floor joists and truncated timber posts, were installed at approximately 10-foot spacing, closer than the 12- to 14-foot spacing of the original timber frame. It may be noted that the 30-foot width of the barn was less than the optimal dimension of 36' for a double-loaded dairy stable. At the center aisle a ceiling-mounted track with manure trolley is extant (as of 2009); the track would have exited the barn, possible through a door in the north wall, to deposit manure in a collection area.

The flooring of the barn is concrete and it still houses the metal stanchions from the dairy operation, which were in use through the 1950s. The stable windows are of the hopper type, with the typical triangular side panels to secure them in the ventilating position. In the fourth bay south wall there is a doorway to the Milk room, a free-standing structure on a concrete foundation, to the south of the barn. Also in the fourth bay, north wall, there was a doorway to the silo, now no longer extant. The eastern silo was accessed from the easternmost eighth bay.

**Stanchion area frame:** Following World War II, many dairy operations expanded at a time when money was available and demand for milk increased. New farming methods were adopted including the housing and milking of dairy herds. This is evident at the Treat barn. The timber framing between the east and west bays, bents 2 through 8, was cut off 7' from the top of the sills. New 6' x 8' timbers were set under the cut off 8' x 8' queen posts. Four-inch concrete-filled pipe posts were placed every 10 1/2' with 4" x 6" timber posts at the east and west ends. Laid across the new carrying beams were 2" x 7" joists, 16" on center (Gould).
