HISTORIC RESOURCES INVENTORY - BUILDING AND STRUCTURES

Building Name (Common) The Inn at Mount Pleasant Record No. 24413
 Building Name (Historic) Hodges, Alpheus, Farmstead / Deming, Mason and Ruth: Mount Pleasant Farm
 Street Address or Location 505 University Drive
 Town/City Torrington Village Torrington Green County Litchfield
 Owner(s) Robert Bombardieri, 505 University Drive, Torrington CT 06790 Public Private

Style of building English bank barn, Vernacular style Date of Construction c. 1870

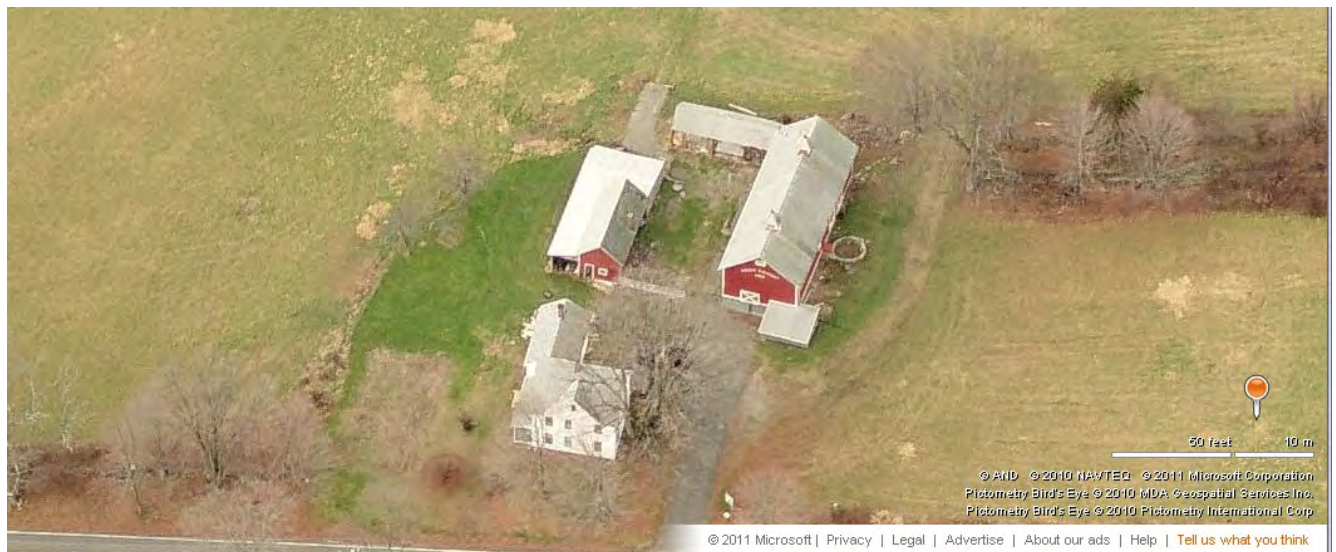
2. Southwest view – aerial “bird’s-eye” map of 505 University Drive, Torrington CT – <http://www.bing.com/maps> accessed 6/21/2011. View shows the farmstead prior to the demolition of the south and west structures. Note the circular silo foundation at right (north) side of the main barn.

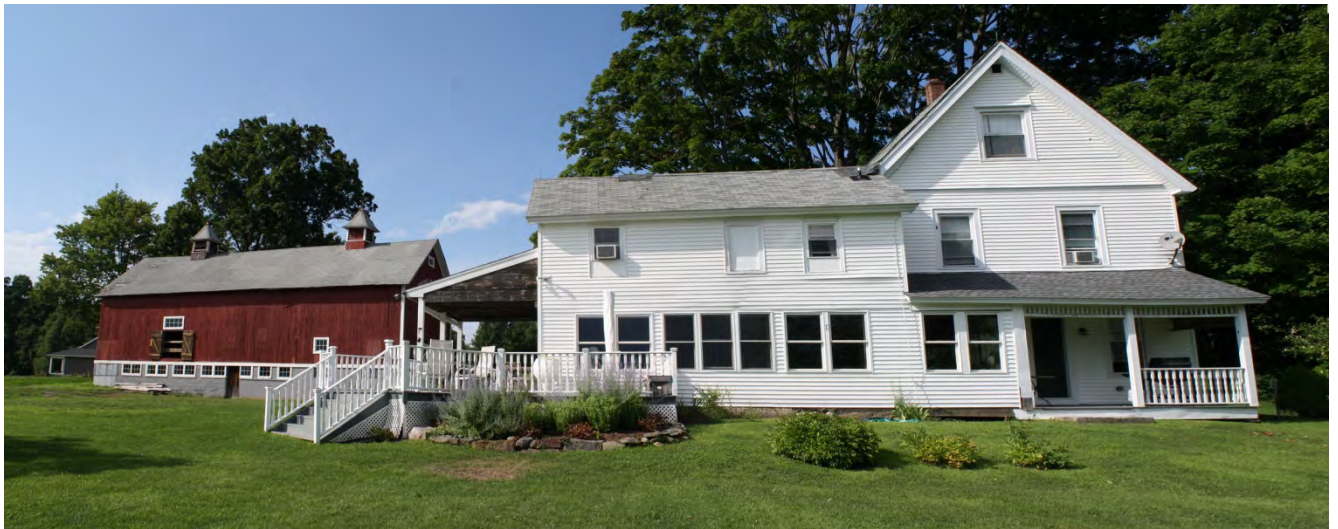
4. South view of Barn (left rear) and Farmhouse, camera facing north.

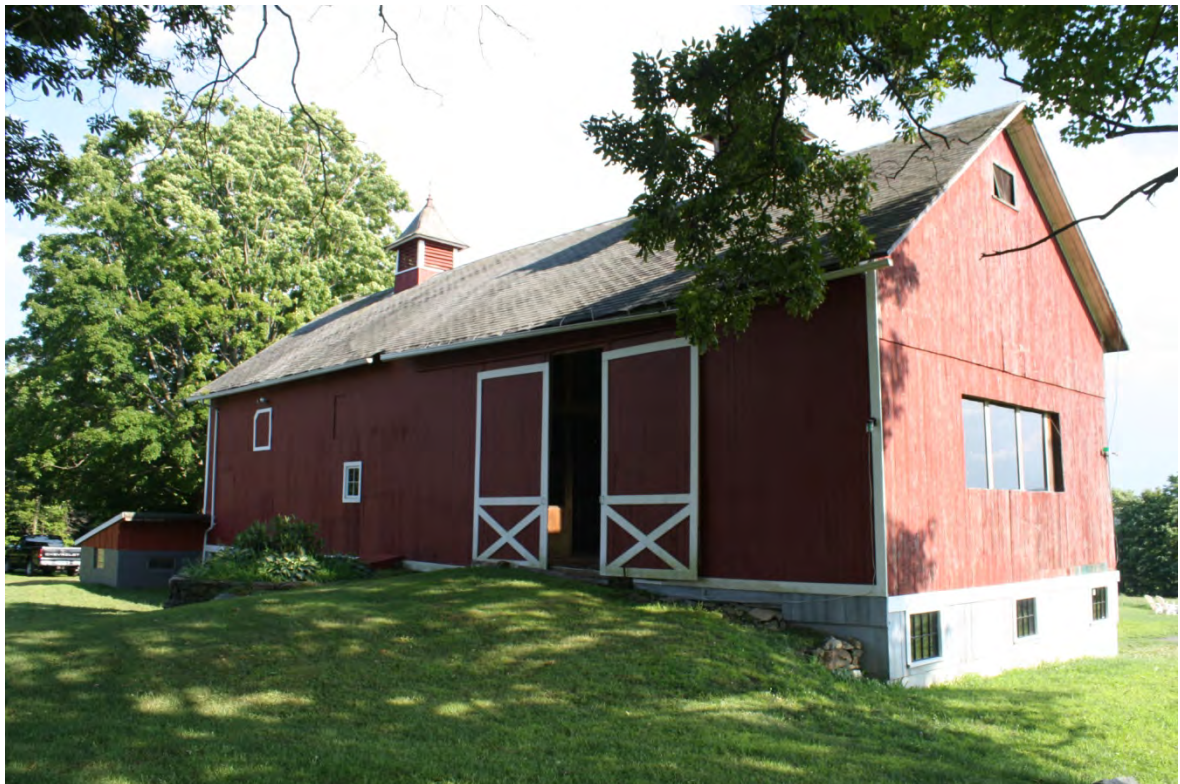
6. Northwest view of Barn, camera facing southeast.

The north eave-side has, from left (east) to right, a hinged door with no trim at the main level, a hay door with a chamfered upper left corner in the loft level, a hay door with no trim in the loft level above a four-pane stable window with trim in the main level, the oversized pair of sliding doors which have X-braces in the lower panels, and a blank bay to the right of the doors with the foundation partially visible as the grade slopes down toward the west. There are two basement windows near the left (east) corner, filled with glass block. A photograph prior to recent repairs shows that the doors did not originally have the x-bracing and there were marks of an attached shed at the location of an extant silo foundation at the center bay. A slightly pitched wood hatch cover is located on the ground adjacent to the north wall at this point.

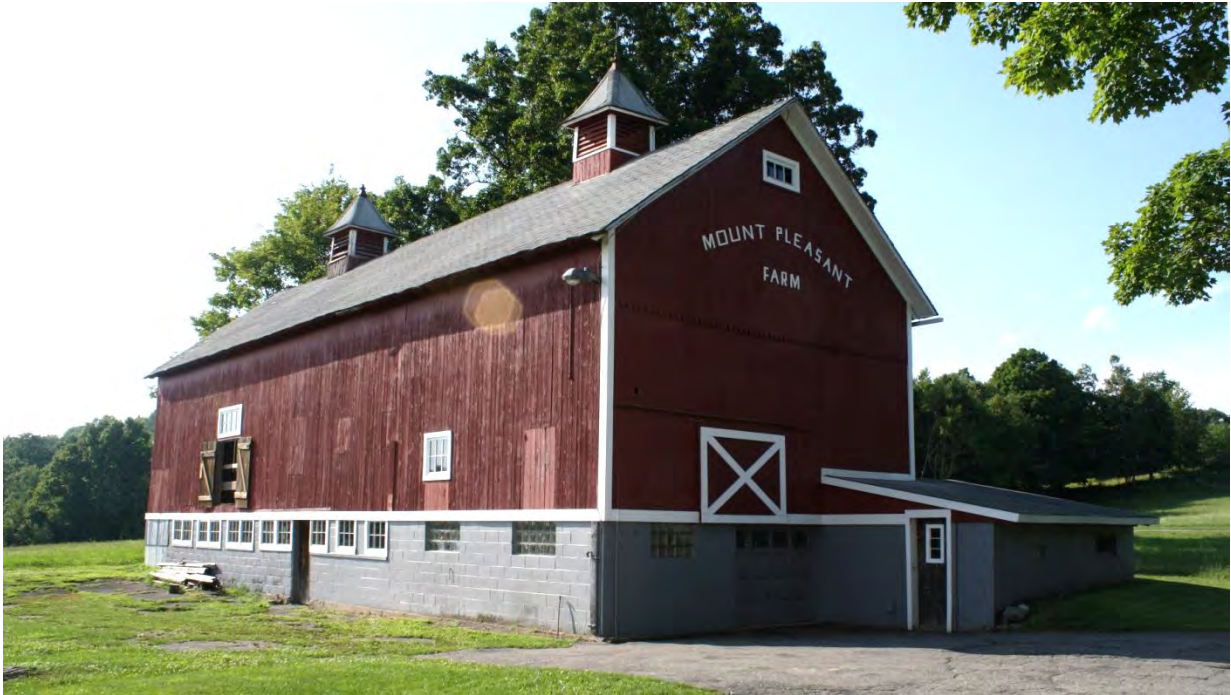
7. Southeast view of Barn, camera facing northwest.

The east gable-end, which faces the street, has a concrete block basement wall with a 3 x 5 unit glass block window near the left (south) corner, an overhead door at the center, and a 1-story shed-roofed concrete block milk room addition attached to the right portion, extending north beyond the corner of the main barn. This has a pass-through door in its south side, two small window openings in its east eave-side, and a glass block window in its north side. At the main level of the east gable-end, there is a sliding hay door off-center toward the left. The deeply dropped girt line siding divide features a saw-tooth pattern in the board ends. In the attic gable, the farm name "Mount Pleasant Farm" is written in applied letters and above near the peak is a three-pane window with trim.

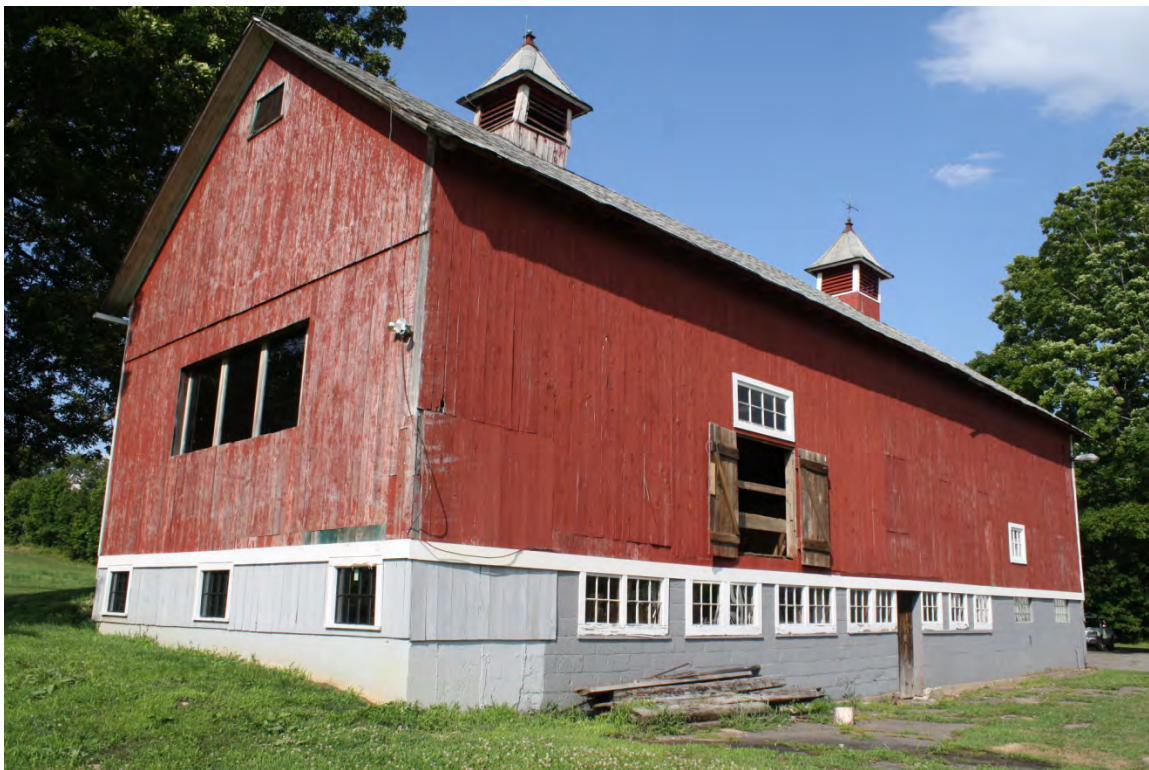
8. Southwest view of Barn, camera facing northeast.

The south eave-side has at the basement level, from left (west) to right, four pairs of six-pane stable windows, a pass-through door, three six-pane stable windows, and two window openings filled with glass block in a 3 x 5 unit pattern. Above at the main level the first bay at the left (west) is blank, the second bay has a pair of hinged hay doors under an eight-pane horizontal window, and the fifth bay has a six-pane stable window at the main level.

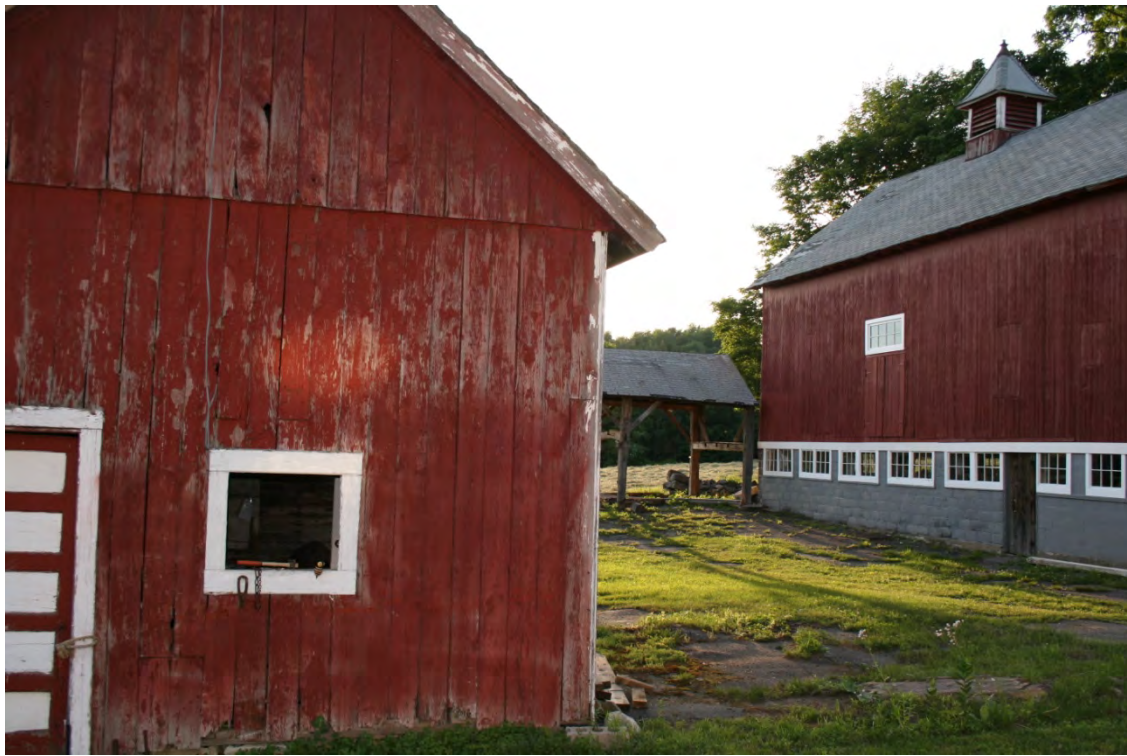
9. East view of barnyard prior to demolition of south and west structures and repair of main barn foundation, camera facing west.

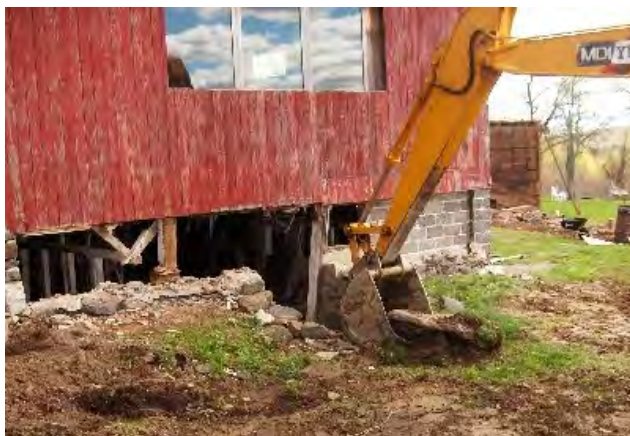
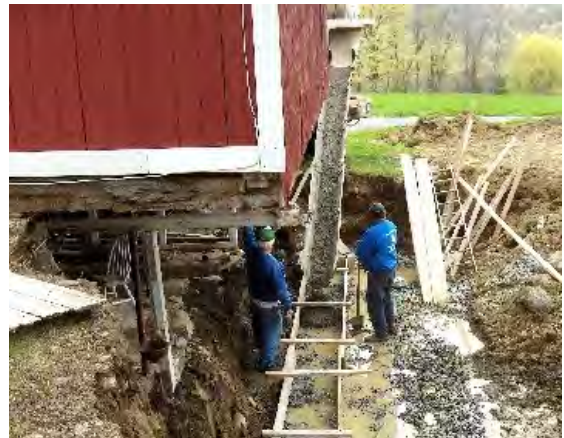
The west gable-end formerly had a concrete block foundation wall with an areaway leading down several steps into the lower level where there is a concrete slab floor configured for dairy cows. This was replaced in 2011 by a concrete foundation wall up to grade and a wood-framed knee wall with three eight-pane barn sash windows. Above at the main level is a recently-installed panel of three single-pane fixed windows. There is an attic window below the peak.

10a-b. Views of west end and northwest corner of Barn during foundation repair work. Note former areaway access to basement level at west side.

Robert Bombardieri has subdivided the property to create 15 home lots, reserving the farmhouse and barn as his own home, and deeding 16 acres to the local land trust as open space. Hay is still cut by Bruce Deming, nephew of Mason. The barn is protected by an easement granted to the City of Torrington. Bombardieri has rehabilitated the farmhouse as a bed and breakfast inn, and has made significant repairs to the barn foundation with the help of a matching grant administered by the Connecticut Trust for Historic Preservation.

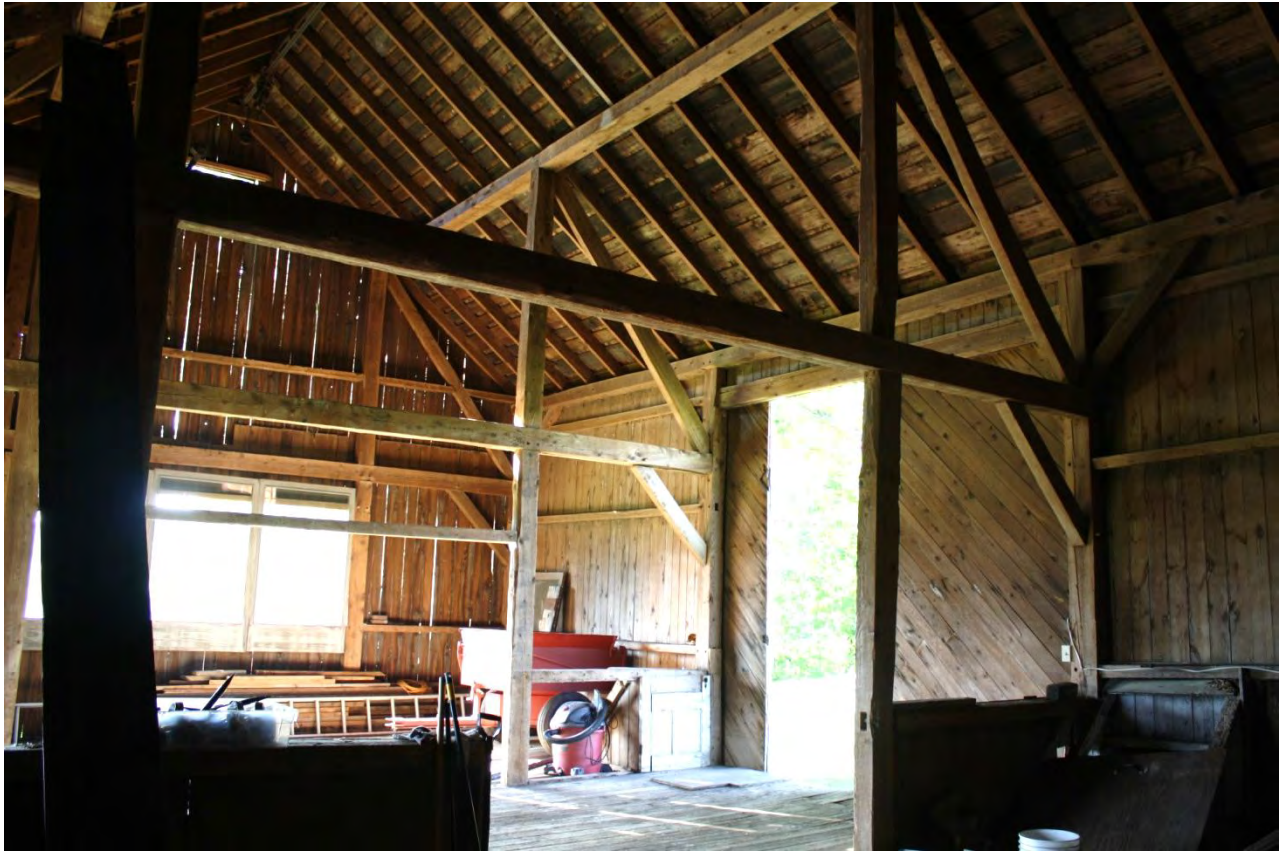
The interior construction is a square rule post and beam frame constructed with circular-sawn timbers and joined with wood pegs. The typical bents in the western three bays have two interior posts, deeply dropped tie-girts (roughly 4' below the plates), and vertical queen posts supporting longitudinal purlin plates at the mid-span of the common rafters. This three-aisle layout is typical of the New England barns of the last quarter of the 19th century, but is here combined with an eave-side entry in the second bay from the west end. The queen posts are braced down to the tie girts with massive diagonal braces, evidently a purposeful strategy to leave the upper center free for a hay track which is suspended under the ridge-board. The three western bays are 16' wide.

11. Interior view of western three bays, camera facing northwest.

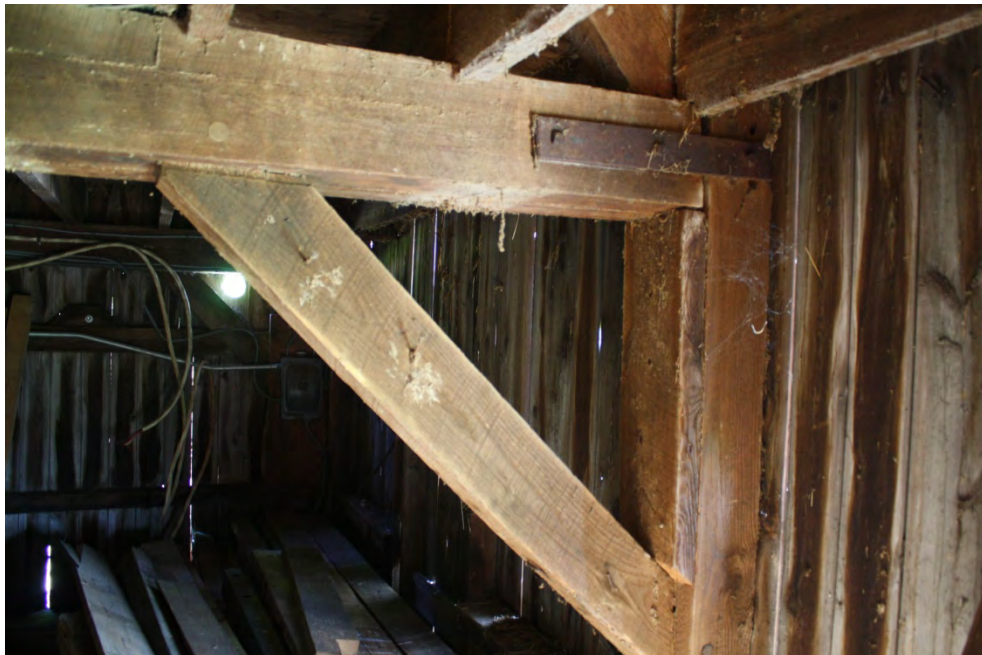
The eastern three bays are narrower, 10' and 12' wide, and have the tie girts about 6' below the plates. The girts support a loft floor. The first bent in from the east end has an unusual configuration; the two interior posts are truncated at about 7' above the loft floor and are carried by a wood and steel cable trapezoidal truss which allows the main level to have a clear span across the eastern two bays. It is unclear what function this low but wide clear area served, although there is a sliding door which would have allowed access to it. Possibly, prior to the insertion of

12. Interior detail view of eastern main level below loft, camera facing east. Note sawn timbers and floor joists. At upper right note the toe of one of the diagonal braces to the queen post.

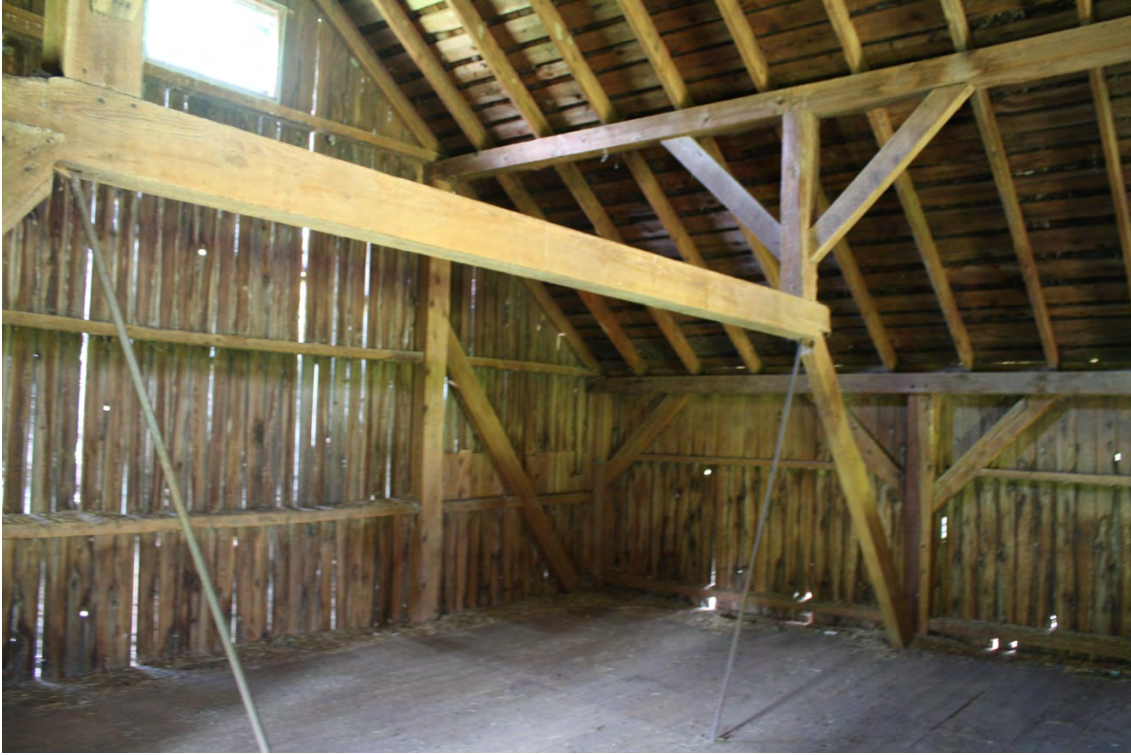
13. Interior view of truss at loft level, camera facing southeast.

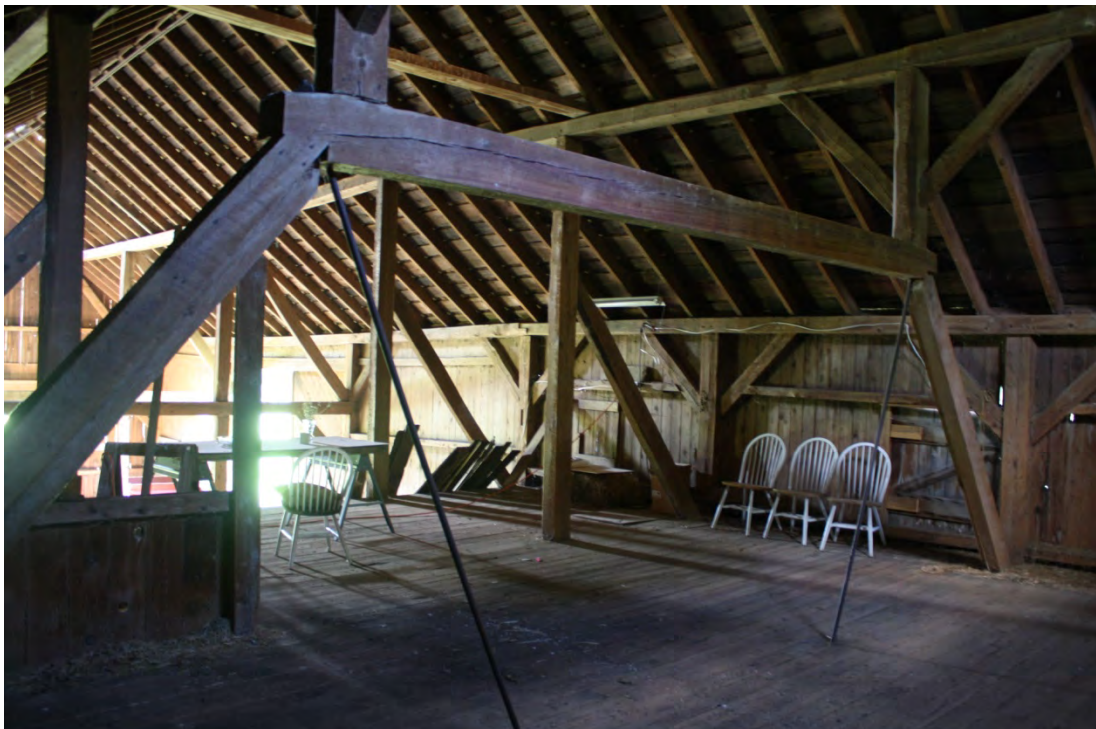
14. Interior view of truss at loft level, camera facing northwest.

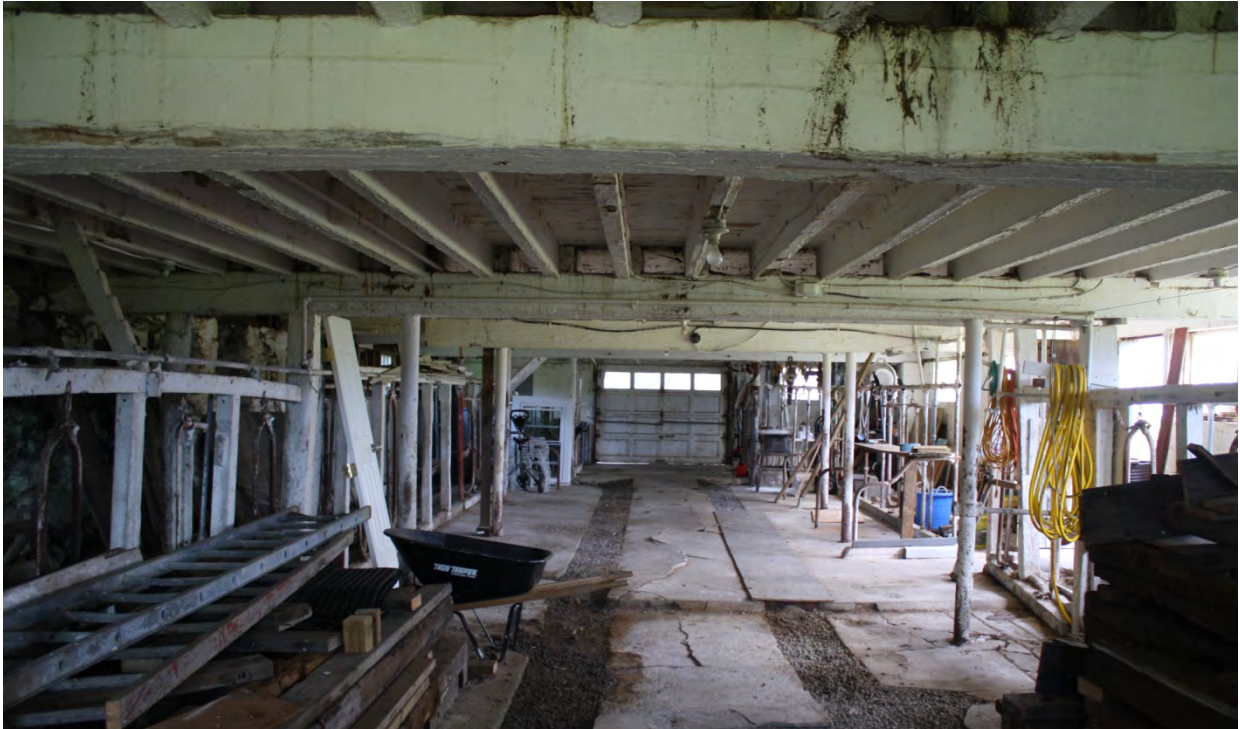
The basement level consists of a regular arrangement of wood and steel posts supporting heavy timber girders. Sawed wood joists run longitudinally to carry the main level floor planks. The basement is laid out for two rows of dairy cows with wood and metal stanchions, cows facing out and manure gutters along the center. The south side of the space is amply lit by the stable windows. At the southeast corner there is a metal bull- or calf-pen enclosure and the windows in this area are glass block. The original early 20th-century concrete “cinder” block walls below the window sills and the fieldstone north retaining wall, have been substantially replaced with cast concrete walls due to failure of the block masonry.

15. Interior view of basement stable area, camera facing east.

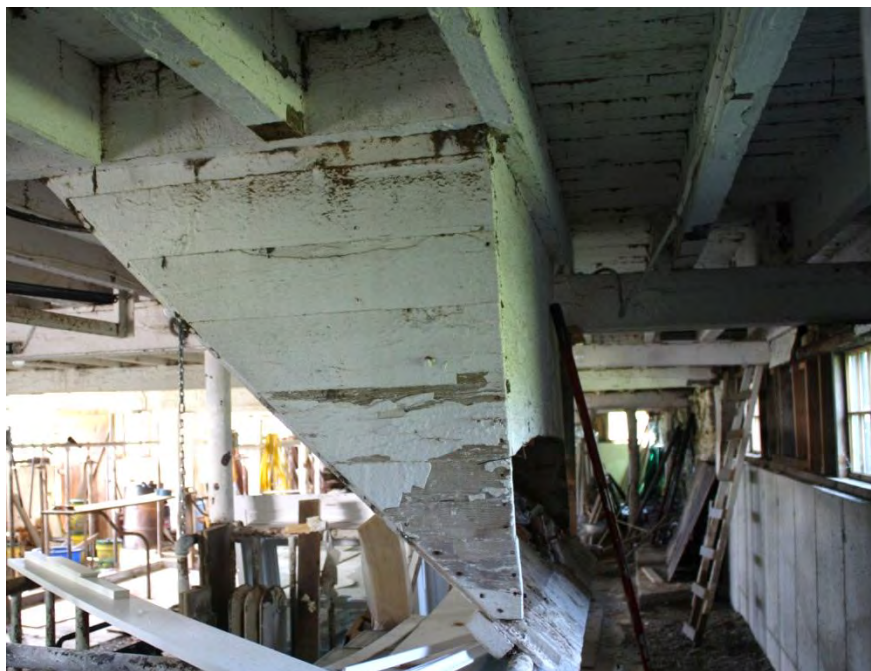
In the northeast corner of this area there is a grain bin with a hopper that feeds down to the stable area below.

16. Interior view of basement level, camera facing west, showing grain hopper from storage bin at main level above.

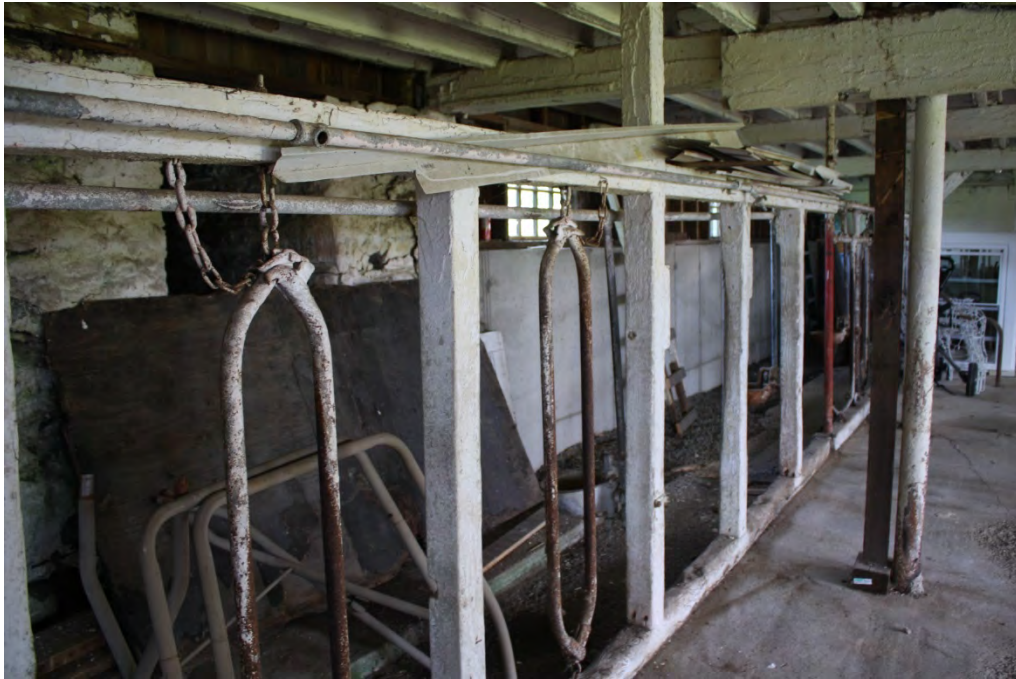
17. Interior view of basement cow stanchions, camera facing northeast. Note portion of original fieldstone north wall at left rear, new concrete wall at center rear.

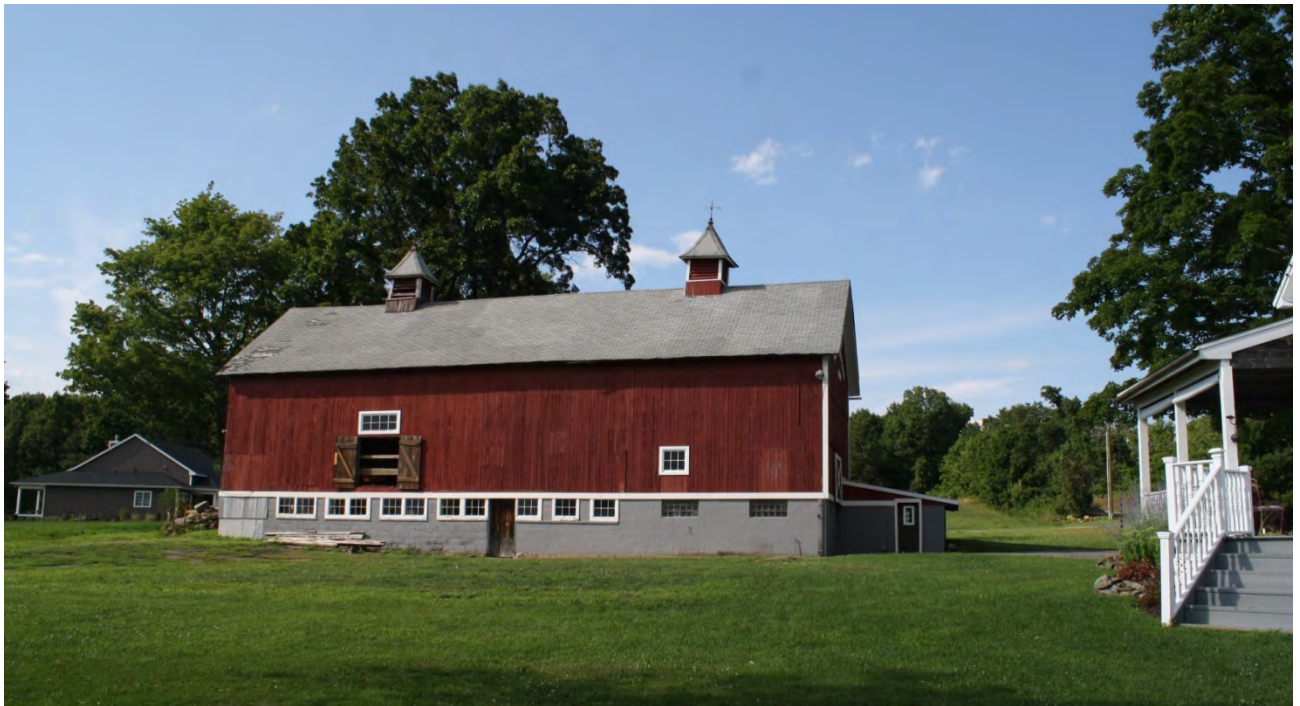
18. South view of barn, camera facing north. At left rear is a new home recently constructed on the adjacent lot; at right the western porch of the Farmhouse.
