## HISTORIC RESOURCES INVENTORY - BUILDING AND STRUCTURES

Building Name (Common) Gunther Farm, Hideaway Stables Record No. 22026  
 Building Name (Historic) Gunther, Frederick and Mary, Farmstead  
 Street Address or Location 80 Hyde Avenue  
 Town/City Vernon Village Rockville County Tolland  
 Owner(s) Gunther, Harriet, 80 Hyde Ave., Vernon, CT, 06066  Public  Private

**HISTORIC RESOURCES INVENTORY FORM – BUILDING AND STRUCTURES** continuation sheet

80 Hyde Avenue, Vernon, CT

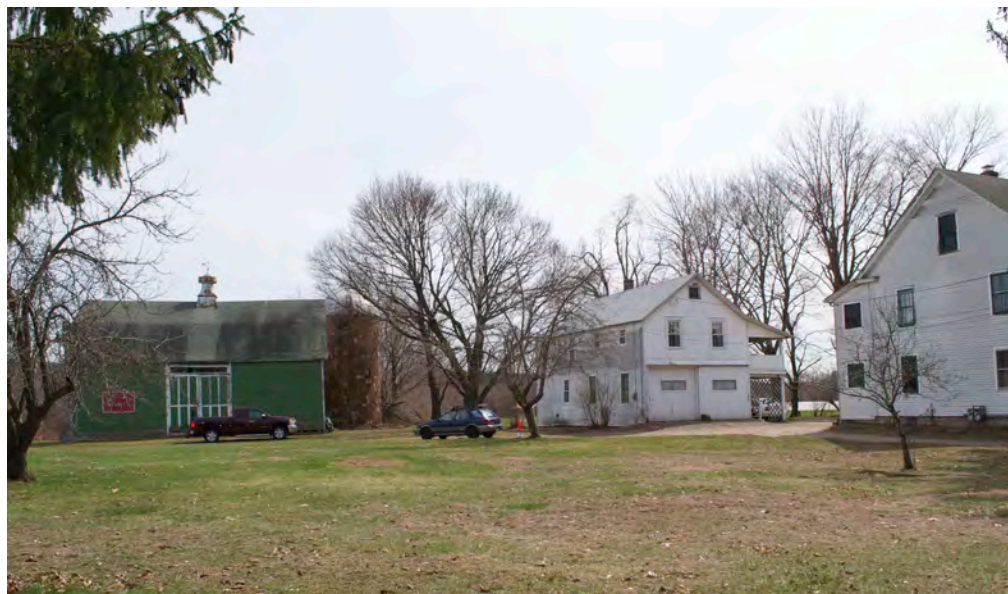
10. Southwest context view of Gunther Farm, camera facing northeast. From left to right, Farmhouse II, Farmhand housing, Farmhouse I, Barn, Silo.

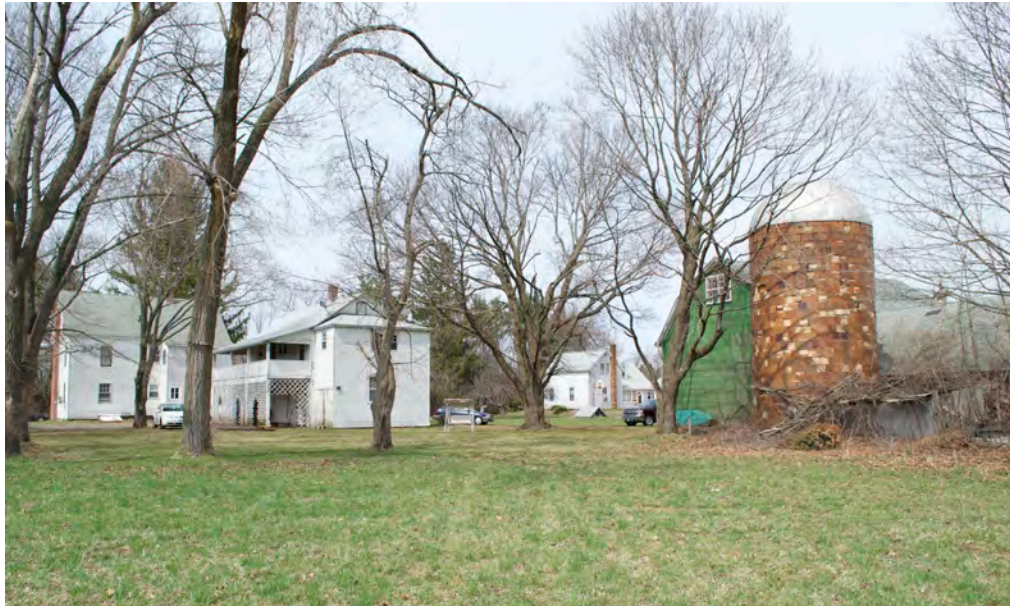
11. Southeast context view of Gunther Farm, camera facing northwest. From left to right, Barn, Pool and Pump House, Farmhouse I at rear right, Silo at rear left.

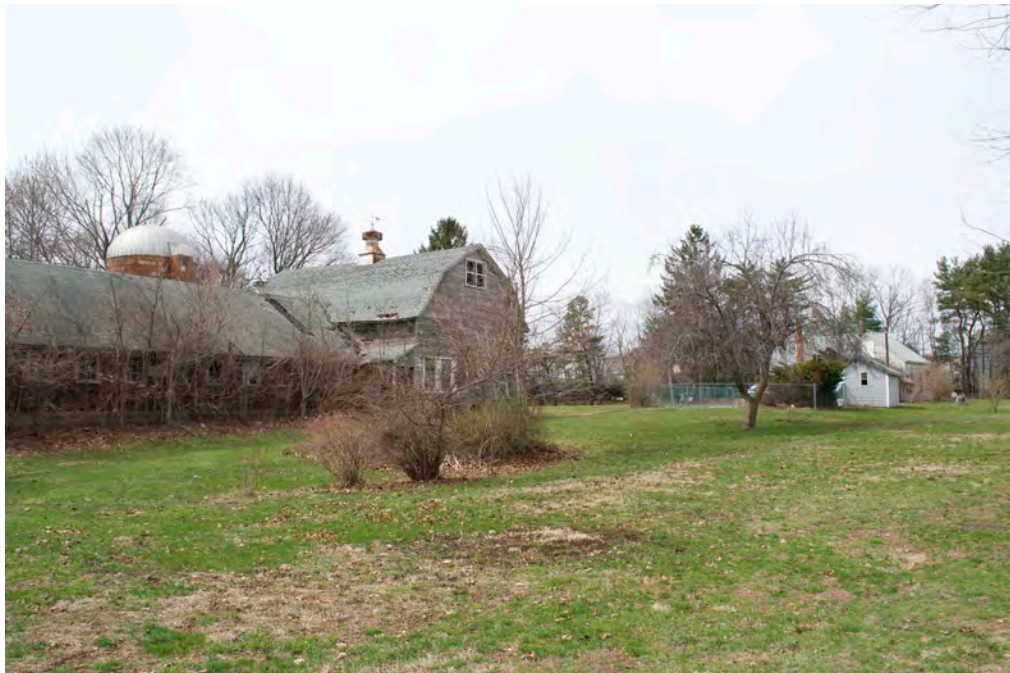
12. North and east view of Farmhouse I, camera facing southwest. Note Garage at left rear.

Farmhouse I is a vernacular frame residence consisting of two primary blocks. The earlier of the two portions consists of the 1 ½-story gable-roofed eastern block, this erected c. 1880. A 2 ½-story block with front-facing gable roof was likely constructed attached at the western side of the aforementioned house c. 1895. The roof-line of the c. 1895 block is oriented north-south perpendicular to Hyde Avenue, while that of the earlier portion of the house runs parallel to the road. The residence's western block measures 16' x 29', while that to the east measures 23' x 22'. A 1-story enclosed porch with shed roof is located on the south eave-side of the original eastern block of the house. The entirety of the house has a square-cut stone foundation, aluminum siding, and asphalt shingle roof. The primary entry is located on the north gable-end of the c. 1895 block, beneath a hipped-roof porch with Doric supports. Fenestration throughout consists of a mix of two-over-one and one-over-one double-hung sash.

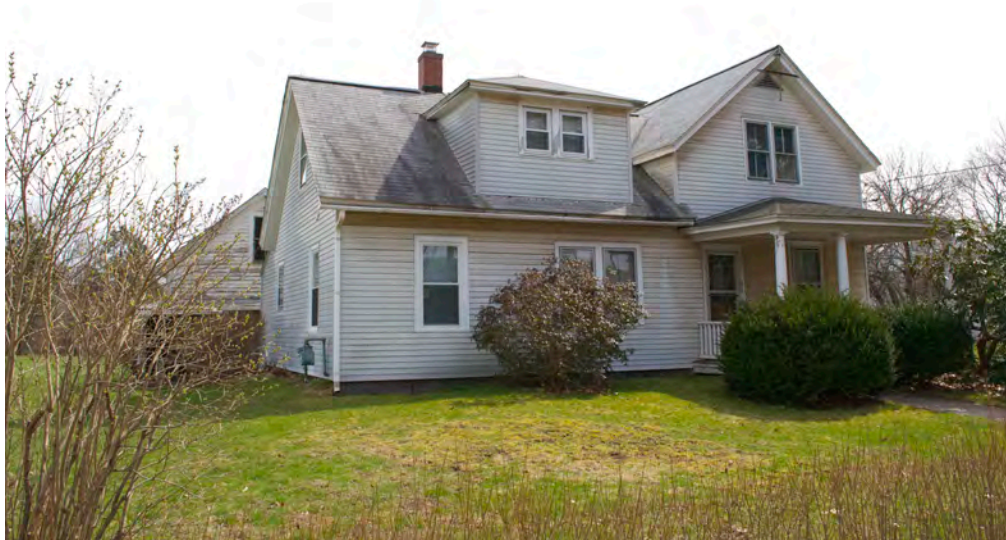
13. Southwest view of Farmhouse I, camera facing northeast. Note enclosed rear porch at center right, Garage at far right.

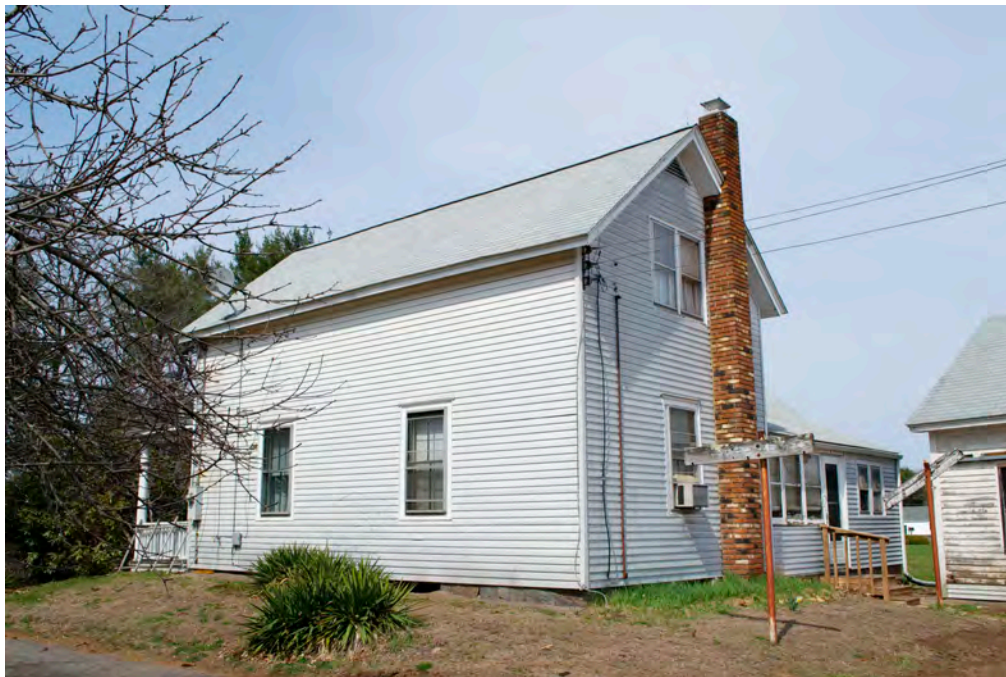
14. West eave-side and south gable-end of Garage, camera facing northeast. Note Farmhouse I rear porch at left, Bottling shed at right.

Directly south of Farmhouse I there is a 1 ½-story frame garage with gable roof oriented north-south perpendicular to Hyde Avenue. The Garage measures 21' x 19' and was likely constructed c. 1895. The building has a wood frame, horizontal board siding, and asphalt shingle roof. An exterior sliding door is located on its west eave-side, this flanked by a two-over-two double-hung window. The building is painted white.

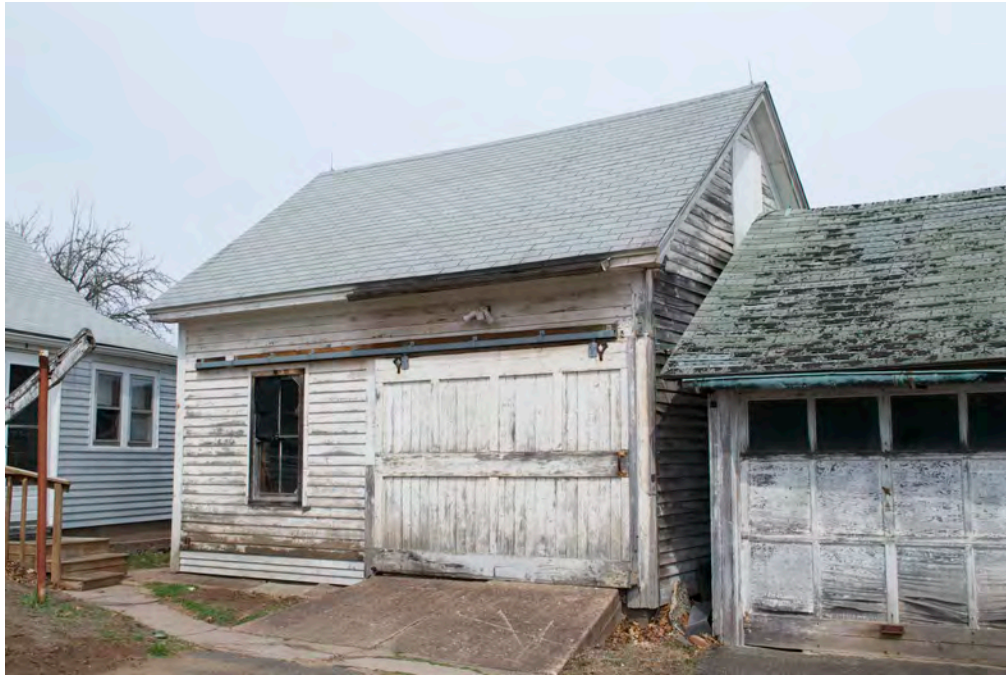
15. West eave-side and south gable-end of Bottling shed, camera facing northeast. Note Garage at left.

Directly south of the Garage there is a second frame outbuilding with side-gabled roof oriented perpendicular to the road. Built c. 1940 as a shed for bottling milk, the building measures 26' x 18' and is 1-story in height. The Bottling shed has a poured concrete foundation, balloon frame, vertical board siding, and asphalt shingle roof. Its primary entry, a frame pass-through door, is roughly centered on the west eave-side and is flanked by fixed six-pane windows. A one-bay, roll-up garage style door is located on the northern end of the west eave-side. A frame Well house with a gable roof and in-ground swimming pool with pump house are located south of the Bottling shed.

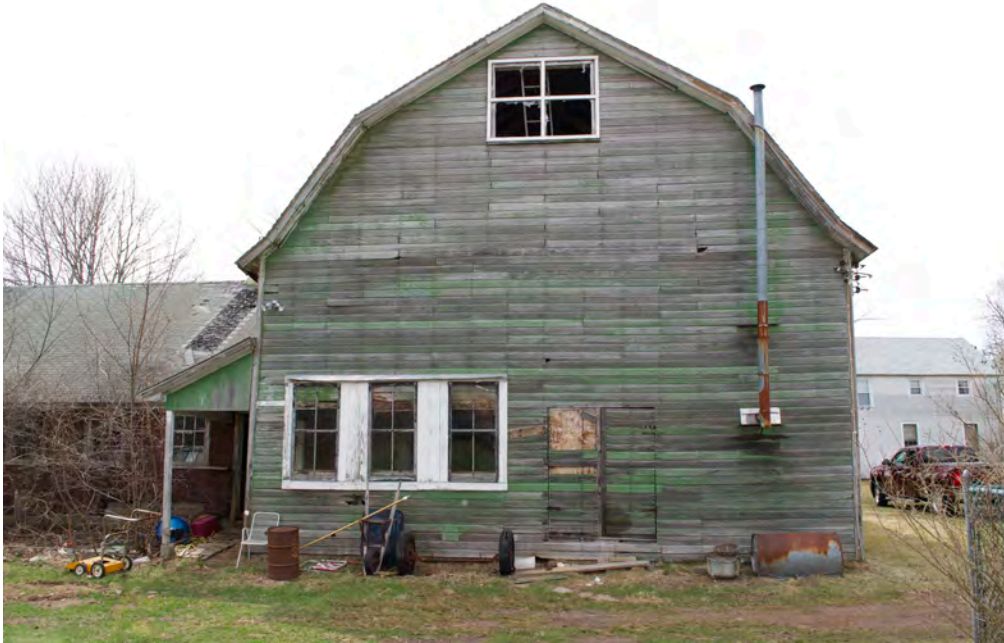
23. East gable-end and eave-side of Barn, camera facing northwest. Note Silo at center rear.

A 1-story shed-roofed porch on the southeast corner shelters two pass-through doors, one leading into the main block and one leading into the rear ell. The rear ell's poured concrete foundation is visible along this side of the building as the grade drops slightly to the south. In addition to the pass-through door at its northern end, the east eave-side of the rear ell consists of eleven evenly-spaced nine-pane hopper windows.

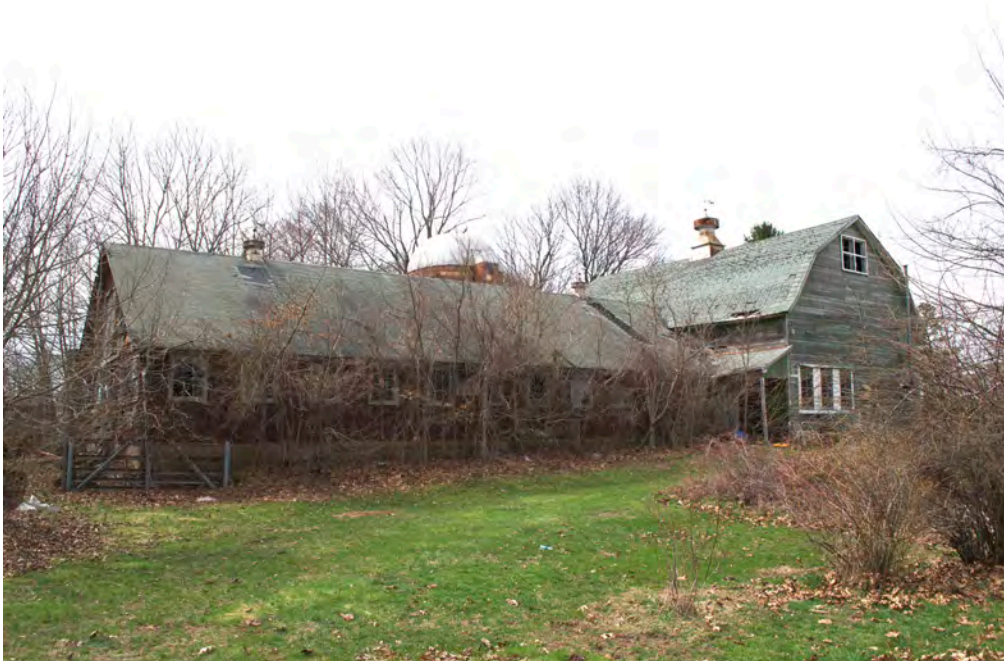
24. South gable-end of Barn, camera facing northwest. Note earthen ramp leading to centered entry doors, hay doors above.

An earthen ramp leads to a door opening centered on the rear ell's south gable-end. The entry consists of a pair of sliding doors mounted on an exterior track. The doors open to the east and west and are flanked on each side by three six-pane hopper windows. A pair of hay doors flanked by a single window on each side is located directly above the entry. The hay doors are mounted with side-hinges and open outwards.

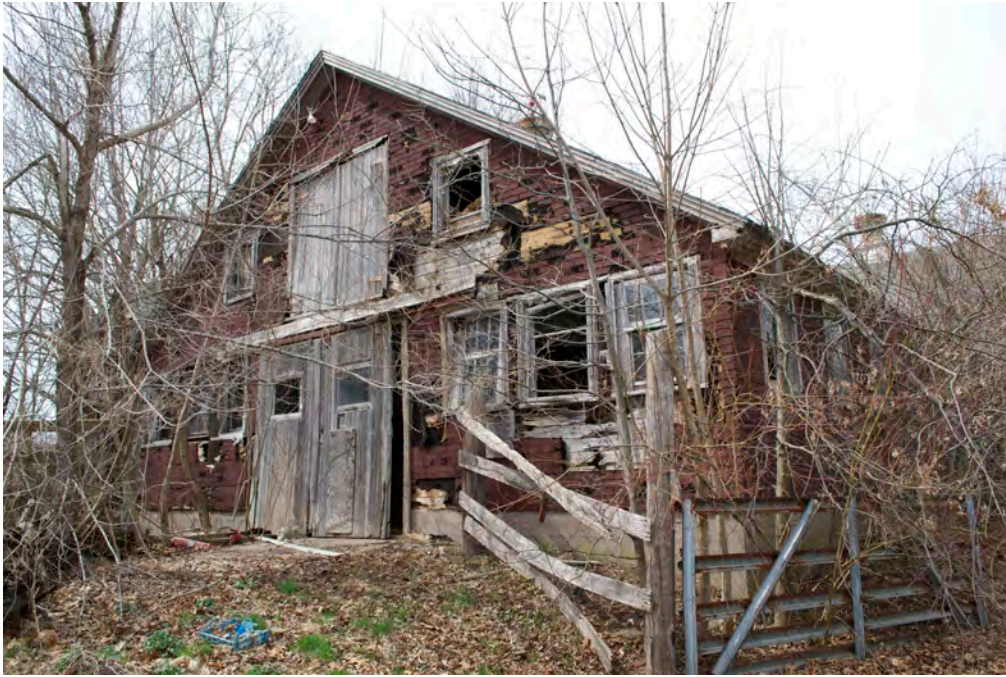
25. North eave-side and west gable-end of Barn, camera facing southeast. Note Silo at right.

The rear ell's west eave-side is identical to its eastern elevation except that it is partially obscured by the clay tile Silo, which is located at its northern end just behind the barn's main block. It is connected to the rear ell by a narrow frame corridor.

The west gable-end of the main block is blank except for a window opening in the attic gable. The window consists of a pair of six-over-six double-hung sash, these with a single 16-pane storm window.

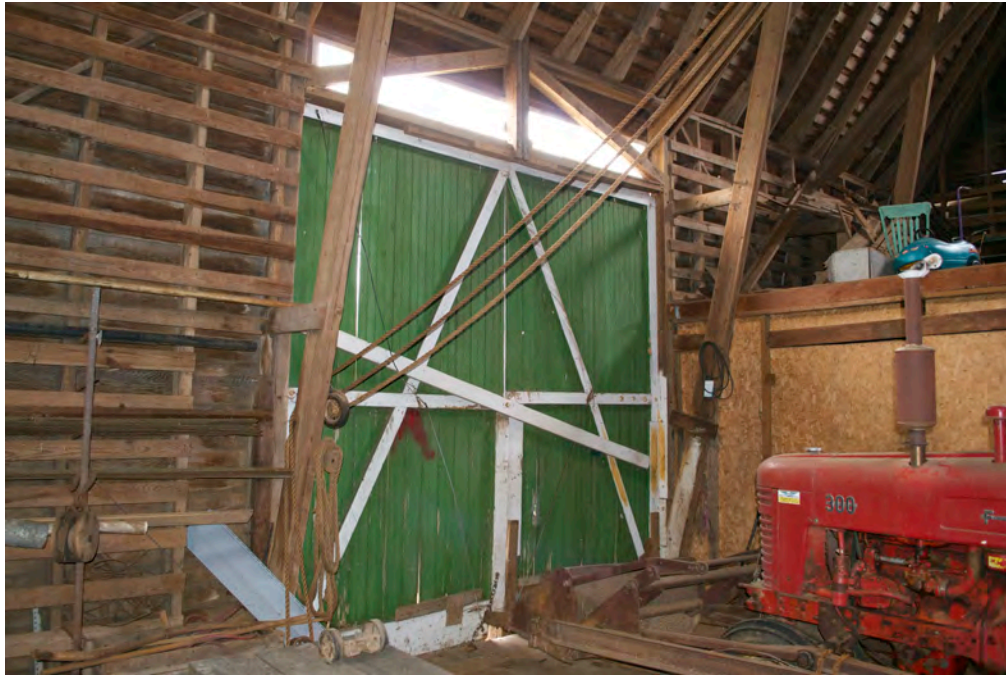
27. Interior of Barn main block, showing interior details, camera facing east. Note scissor trusses.

The interior of the Barn's main block reveals a largely open space with trussed balloon framing. The flooring consists of wood boards, these laid perpendicular to the ridge-line in the center drive aisle and parallel elsewhere. The interior walls have been partially finished with widely spaced horizontal lathe, this to allow air to circulate around the loose hay that originally filled the majority of the space. The plates of the frame consist of two-by-sixes, sistered and resting on two-by-six studs. Four interior trussed ribs support the roof, these being scissor trusses tilted on end and meeting at the ridge (see 664 Rimmon Hill Road, Beacon Falls and 312 Litchfield Turnpike, Bethany for similar structures). Two-by-four common rafters meet at a ridge board where they are nailed in place and each pair braced by a two-by-four tie. A hay track with intact pulley runs the length of the ridge-line, however, the original hay doors have been replaced with windows at each gable-end.

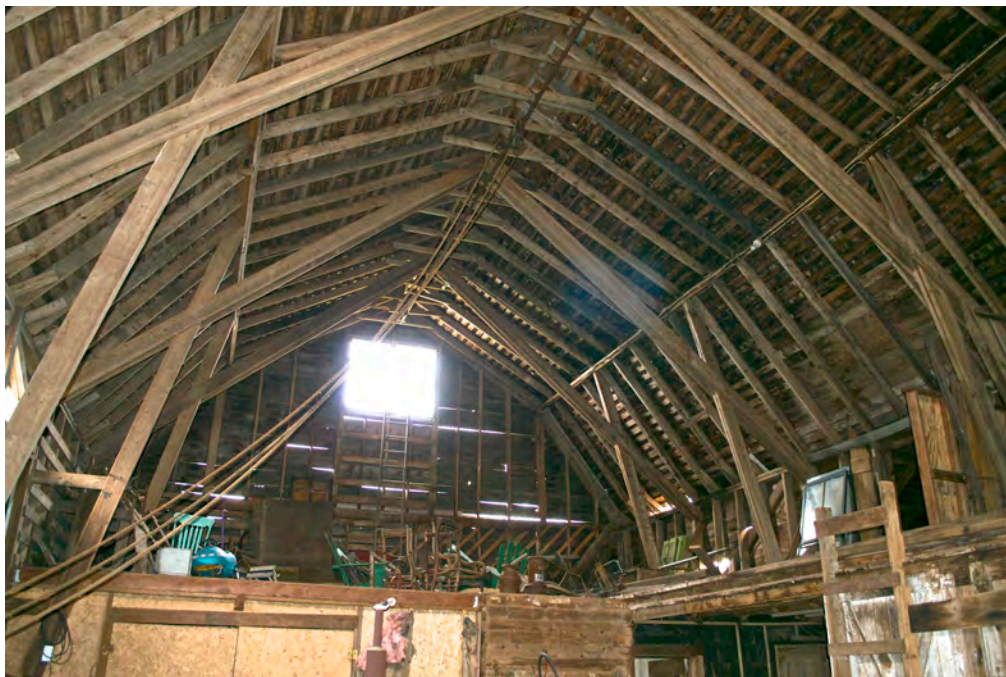
28. Interior of Barn main block, showing sliding door between main block and rear ell, camera facing southeast. Storage area behind wall at right, workshop at far left.

The lower level of the eastern third of the main block has been framed out to house two small workshops and an interior granary, all with storage above. The granary's metal lining has since been removed and replaced with a frame stair leading to the loft level. A roughly ten-foot deep portion of the western two-thirds of the barn, this extending north from the south eave-side of the main block, has likewise been framed off to create a storage room. This has space for storage above, accessed by a vertical wood ladder.

A frame sliding door divides the barn's main block from the rear ell. The interior of the rear ell's ground level is laid out as a ground level stable barn for two rows of cows facing outward. It has a poured concrete floor, balloon framing, and fiberboard walls and ceiling. Two longitudinal (northwest-southeast) girders running down the interior of the building create a center aisle. Each girder is supported by five evenly spaced steel columns, and lateral (southwest-northeast) joists support the hay loft floor above. All but one of the barn's cow stanchions have been removed and replaced with horse stalls, however, additional evidence of the building's use as a dairy barn survives in the form of a pair of manure gutters running nearly in line with each of the girders and a bull pen with metal enclosure at the northwest corner of the rear ell. The horse stalls have board floors and vertical board walls and doors.

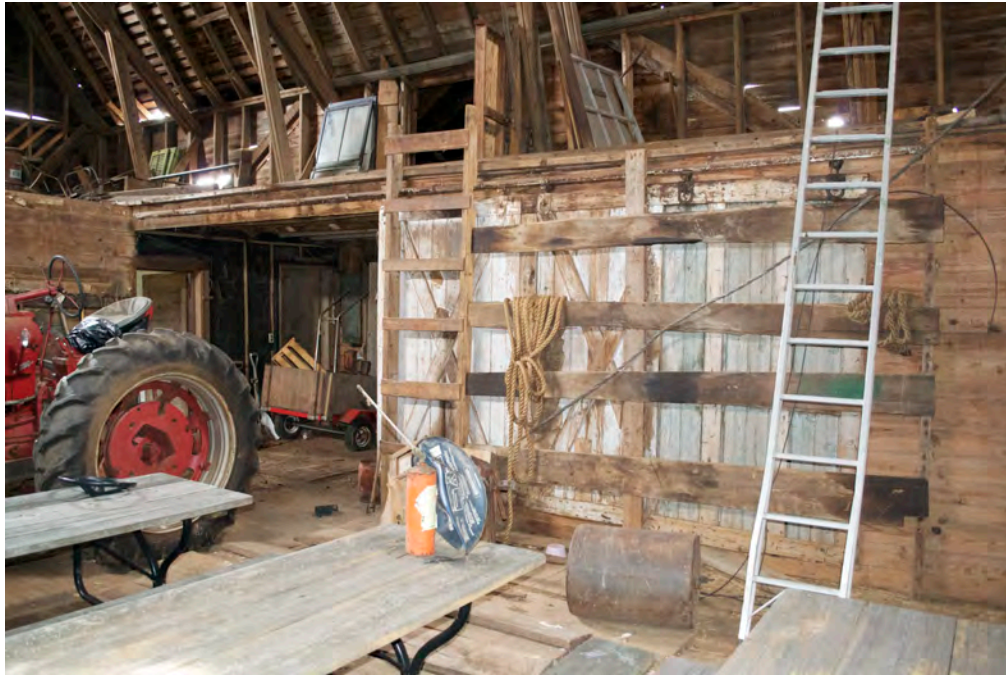
29. Interior of Barn main block, showing storage area at southwest corner of main block, camera facing west.
