HISTORIC RESOURCES INVENTORY - BUILDING AND STRUCTURES

Building Name (Common) Luddy/Taylor Tobacco Museum & Archives, Northwest Park Record No. 53463
 Building Name (Historic) Lang, Jacob and Dona, Farmstead
 Street Address or Location 135 Lang Road (Tobacco museum), 145 Lang Road (Northwest Park)
 Town/City Windsor Village Rainbow County Hartford
 Owner(s) Town of Windsor, 275 Broad Street Windsor, CT 06095 (continued page 2) Public Private

Present Use: Agriculture/Subsistence: agricultural outbuilding; Domestic: single dwelling
 Historic Use: Agriculture/Subsistence: agricultural outbuilding; Domestic: single dwelling
 Accessibility to public: Exterior visible from public road? Yes No
 Interior accessible? Yes No If yes, explain Museum and nature center during public hours
 Style of building Tobacco sheds, Vernacular style Date of Construction Early 20th c.

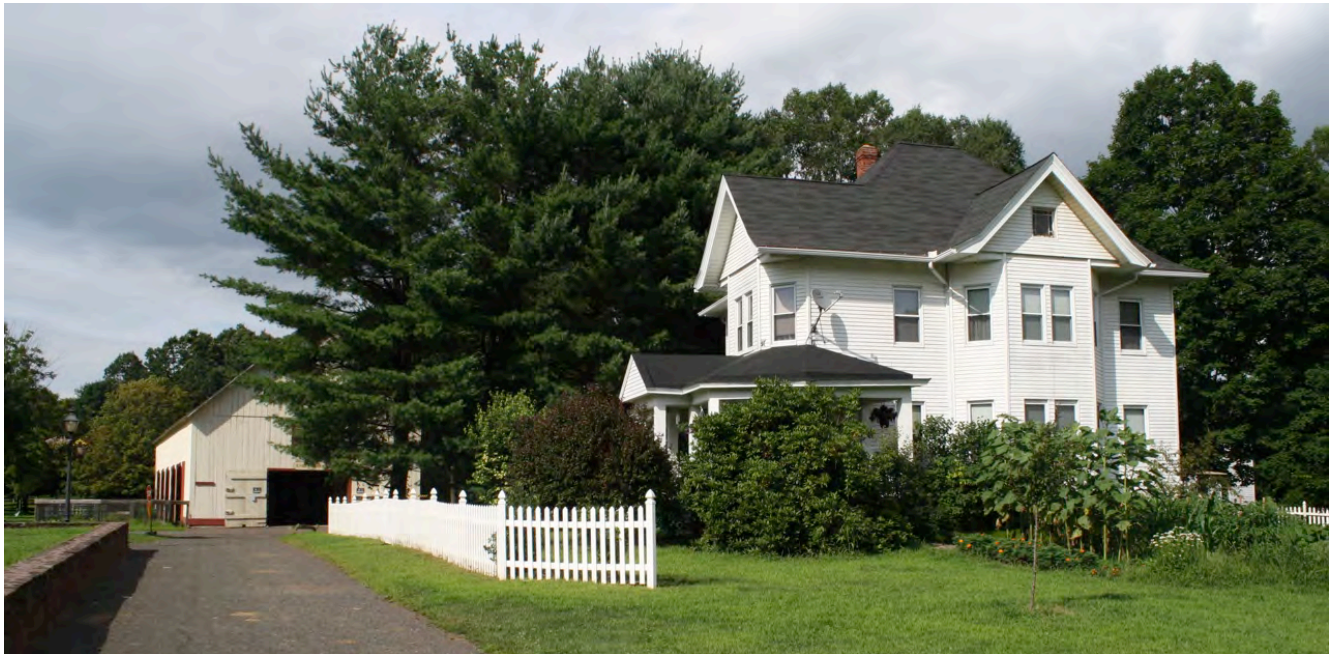
6. South view of Farmhouse, camera facing north. Animal barn is at left rear.

The Farmhouse is a 2 ½-story vernacular Queen Anne-style building with a steeply-pitched hip roof and projecting gable-roofed bays on the west and south sides. A wrap-around porch shelters the entry on the west side. Lang Road formerly ran along the south and west sides of the house, ending as a farm road extending northward. It has been re-routed around the east and north sides, so that today the west front façade faces a green space forming a courtyard for the nature center and museum. The Farmhouse has been re-sided with vinyl siding, and is used as staff housing.

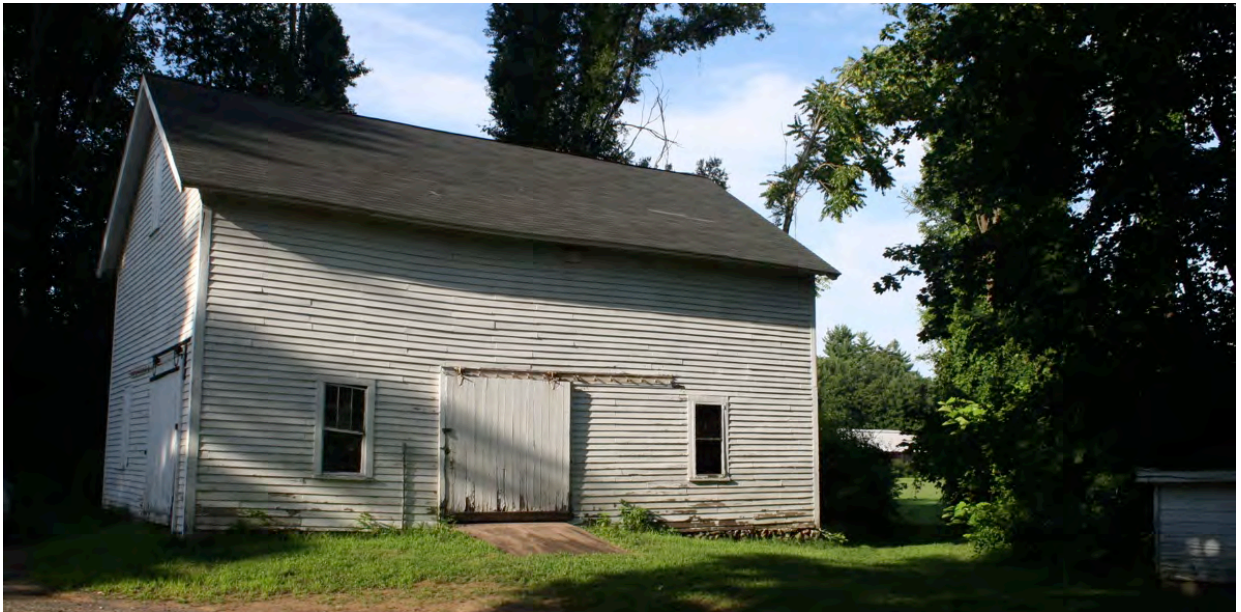
8. Southwest view of Horse barn, camera facing north. Field barn I (Tobacco shed) is partially visible at right rear. A small structure, possibly a springhouse, is at the far right.

Northeast of the Farmhouse is an English barn which appears to have been a horse barn or carriage barn for the farm family. It is a 1 ½-story three-bay gable-roofed structure with its ridge-line oriented east-west. A sliding door in the center bay of the south side is typical for an English barn. Another sliding door is off-center to the right (south) in the west gable-end. There is a pass-through door in the east gable-end and several window openings which appear to have had double-hung sash. Siding is wood clapboards with corner board trim, roofing is asphalt shingles, and the foundation is cobblestone masonry. To the southeast is a small low hip-roofed structure that appears to have been a springhouse. North of the Farmhouse and west of the English horse barn is the modern maple sugar house, a gable-roofed board-and-batten structure.

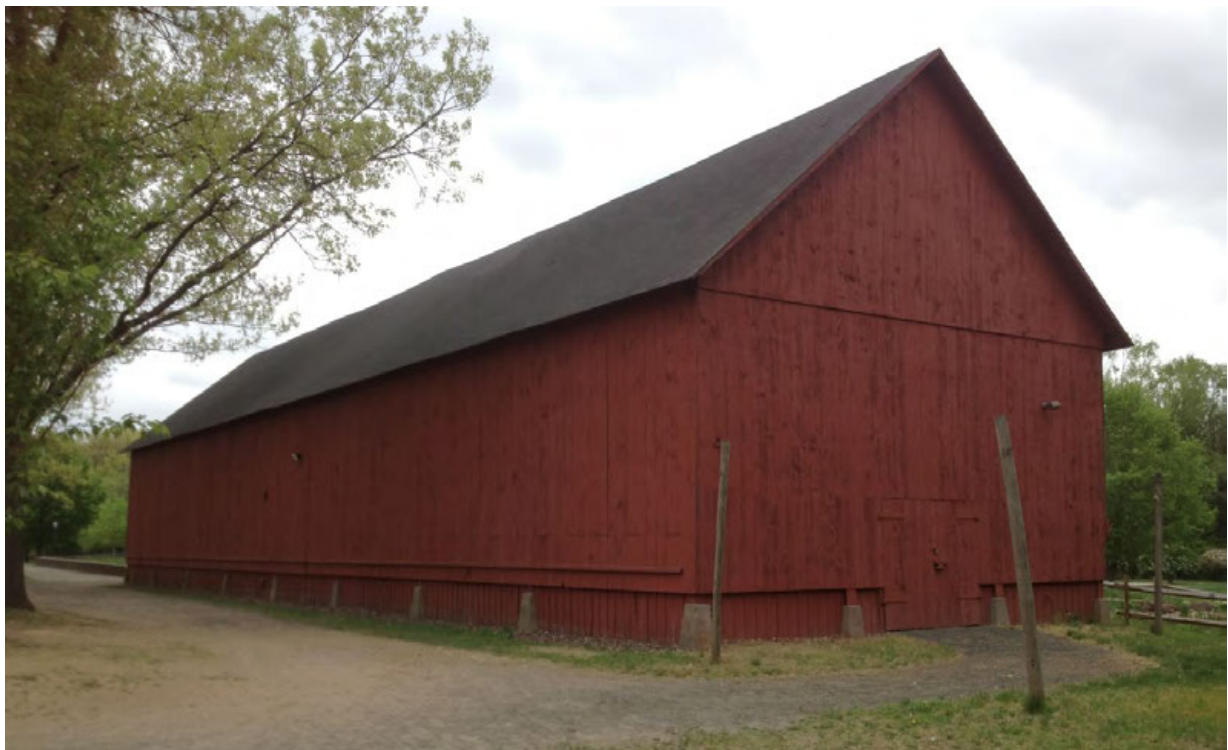
11. Southwest view of Taylor Tobacco museum, camera facing northeast.

This shed is an eight-bay three-aisle gable-roofed structure with its ridge-line oriented north-south. It has been converted to a seasonal museum displaying exhibits on historical tobacco farming. The vertical wood siding has been replaced and secured, but the long iron hook and eye fasteners and the horizontal battens for tilting open groups of alternate boards to ventilate the shed, have been re-installed. Along the lower edge between the truncated pyramidal concrete foundation piers, narrow vertical siding has been infilled for weather-tightness where originally the spaces would have been open or had top-hinged shutters. In each of the north and south gable-ends a pair of hinged doors provides access to the museum, and is similar to the original type of wagon doors, though not as wide or tall. Siding is painted red. Roofing is asphalt shingles.

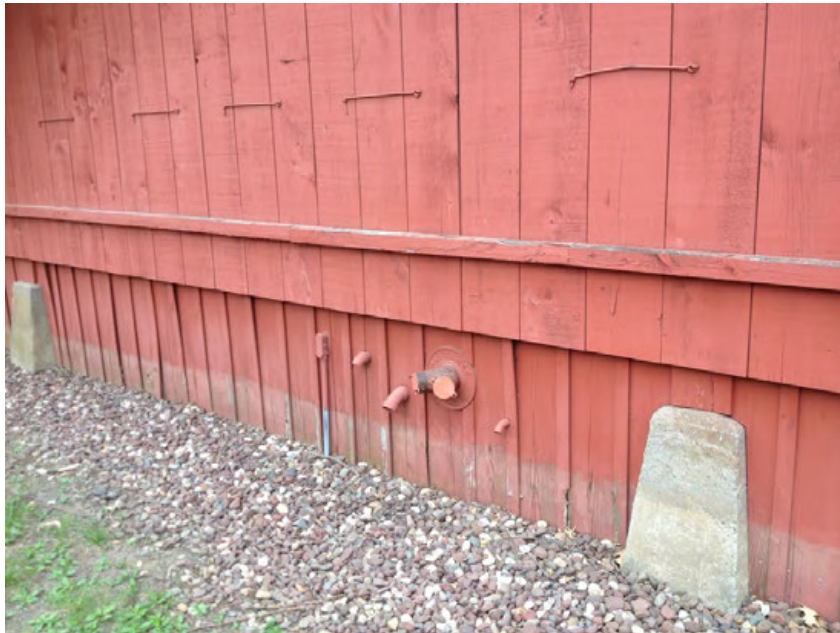
12. West detail view of Taylor Tobacco museum, camera facing northeast. Note horizontal battens for operating vents, and hooks for closing vents.

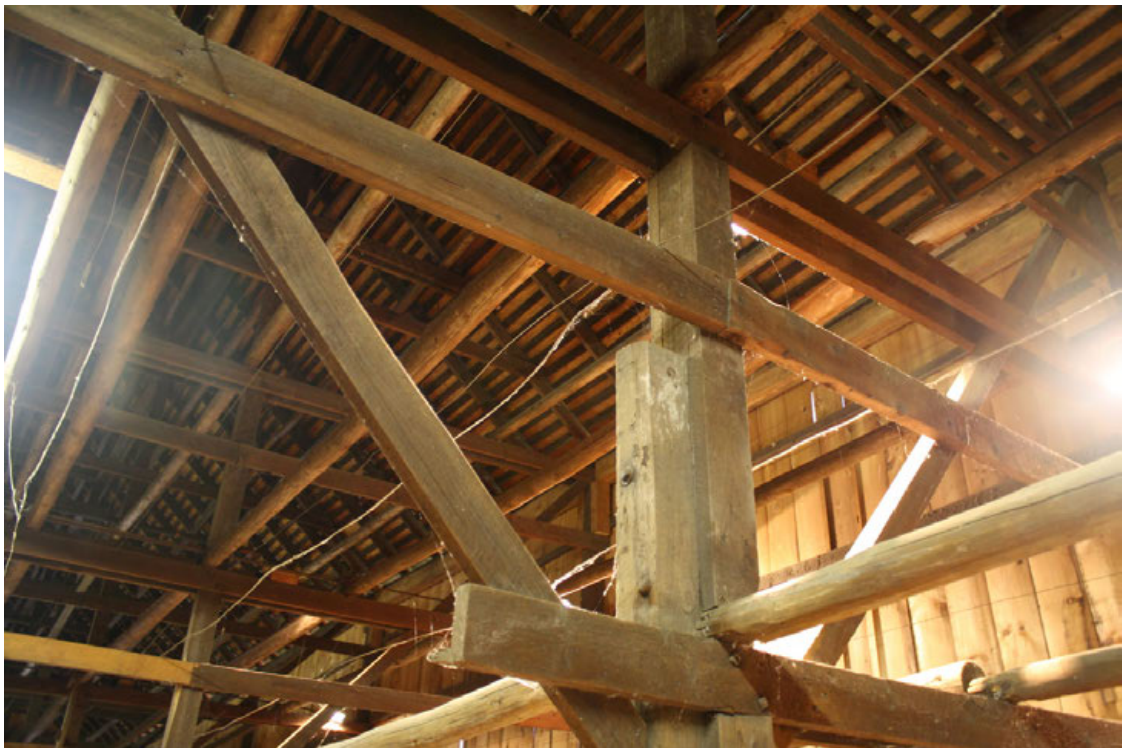
13. Interior detail view of Taylor Tobacco museum, showing nailed and bolted connections.

The interior is a typical early 20th-century type of timber frame structure with two interior posts at each bent and a network of tie-girts and diagonal braces of dimension lumber secured with bolted or nailed connections. The multiple horizontal ties also function as supports for the rails upon which the tobacco leaves were hung to cure. Lighting and a concrete slab floor have been installed for the display area.

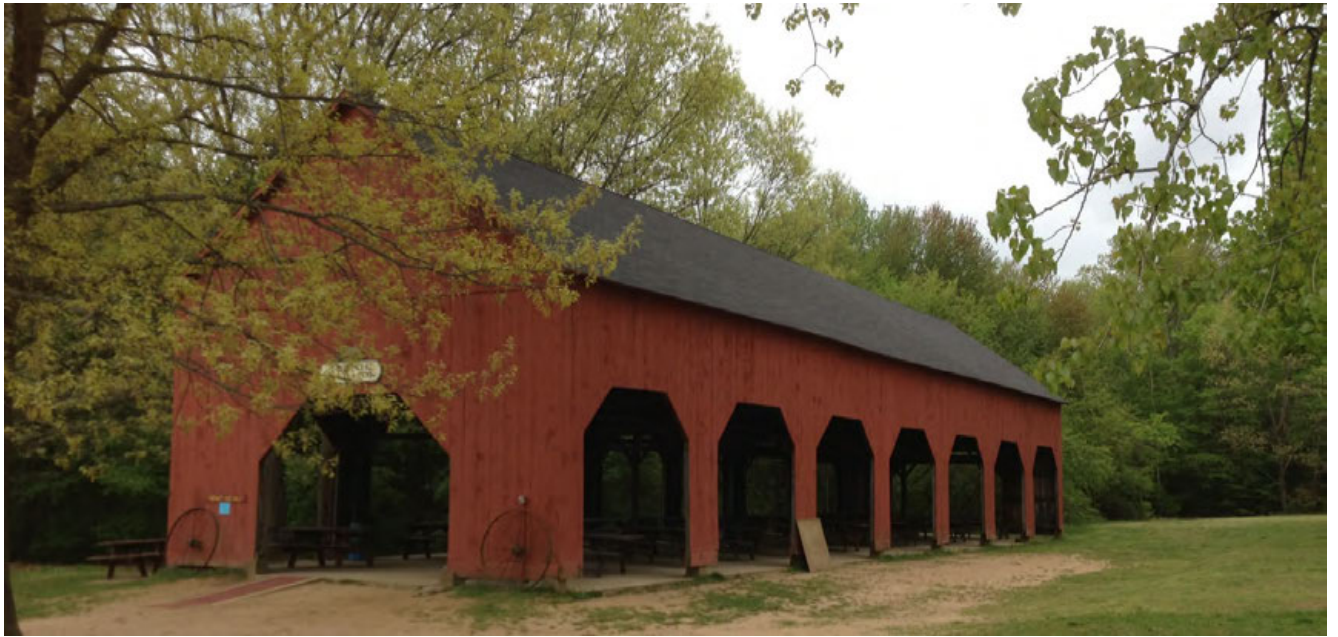
16. Northwest view of Picnic pavilion, camera facing southeast.

This shed, located south of the Museum, is a seven-bay three-aisle tobacco shed structure with its gable roof oriented north-south and with truncated pyramid concrete foundation piers. The typical structure is similar to the museum shed. The side walls have openings cut into each bay with chamfered top corners, forming an open-sided picnic shelter. Similar openings at the gable-ends have taken the place of doors. Siding is vertical boards painted red and roofing is asphalt shingles.

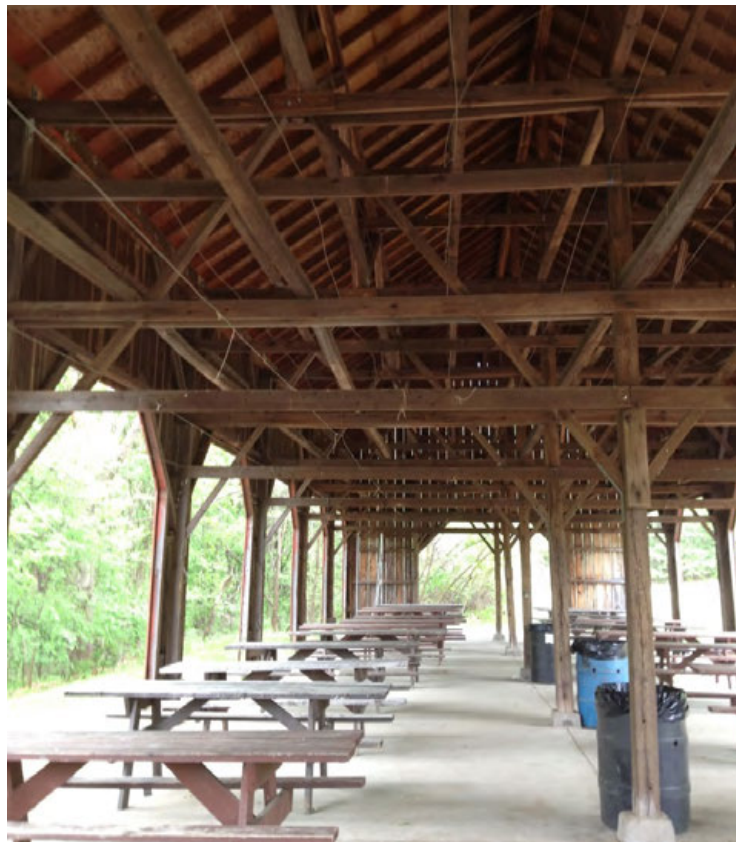
17. Interior view of Picnic pavilion, camera facing south.

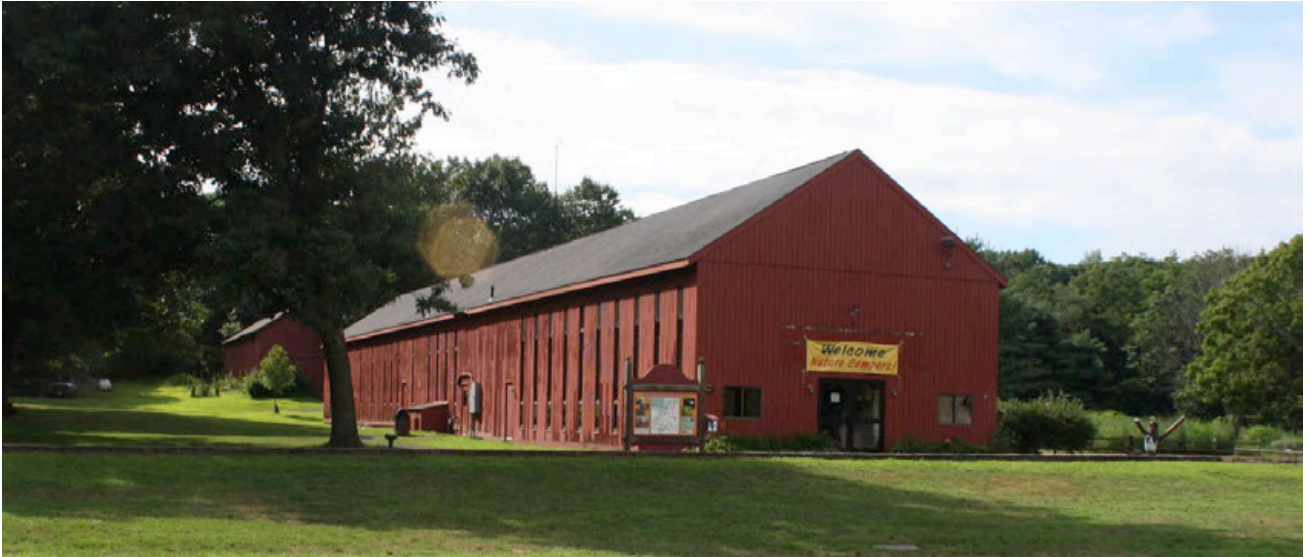
18. Southeast view of Nature center, camera facing northwest.

This shed, converted to a fully finished building, is oriented east-west, and has a modern glazed entry in the east gable-end. Along the eave-sides, tall narrow glazing panels are reminiscent of the narrow vent panels of the historic tobacco sheds. Vertical wood siding is painted red. Roofing is asphalt shingles.

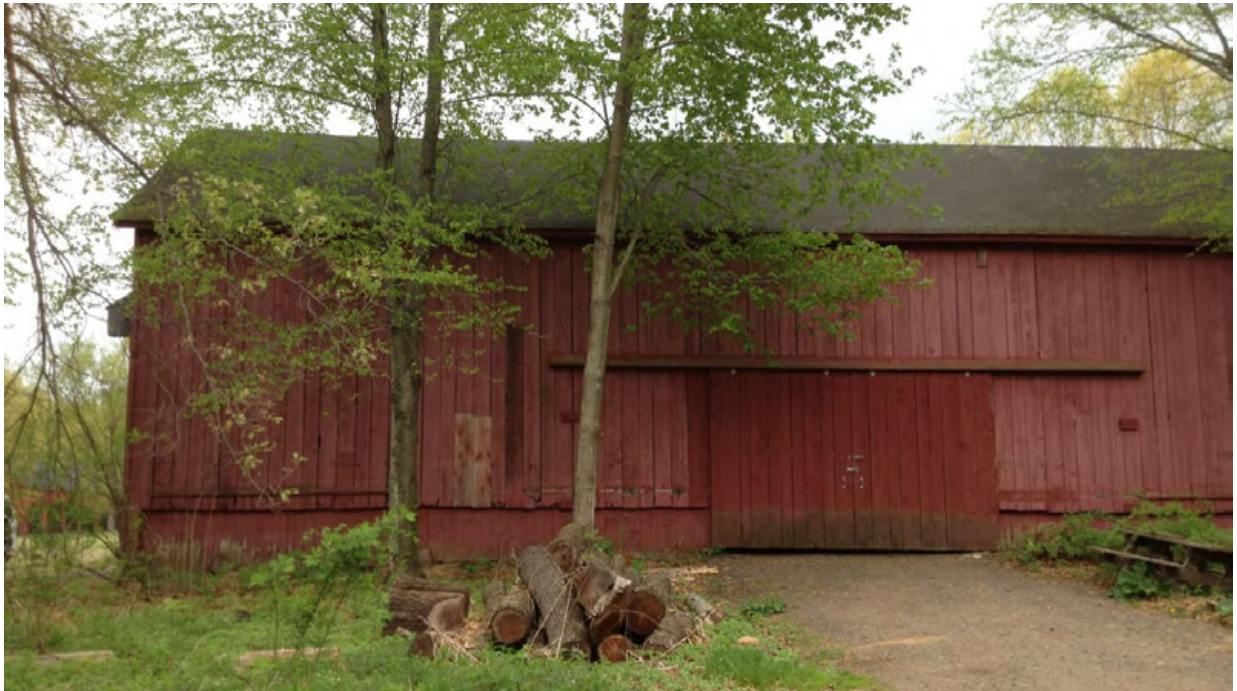
19. North view of Maintenance shed, camera facing south.

This shed is located west of the Nature center and is a six-bay three-aisle shed structure with its ridge-line oriented east-west. The structural elements are typical, similar to the Museum shed. The lower skirt below the siding has been filled in with vertical board siding; the upper siding has been partially replaced but in some areas the original horizontal battens for opening the vents are still in place. The main entry to the shed is a sliding door in the north

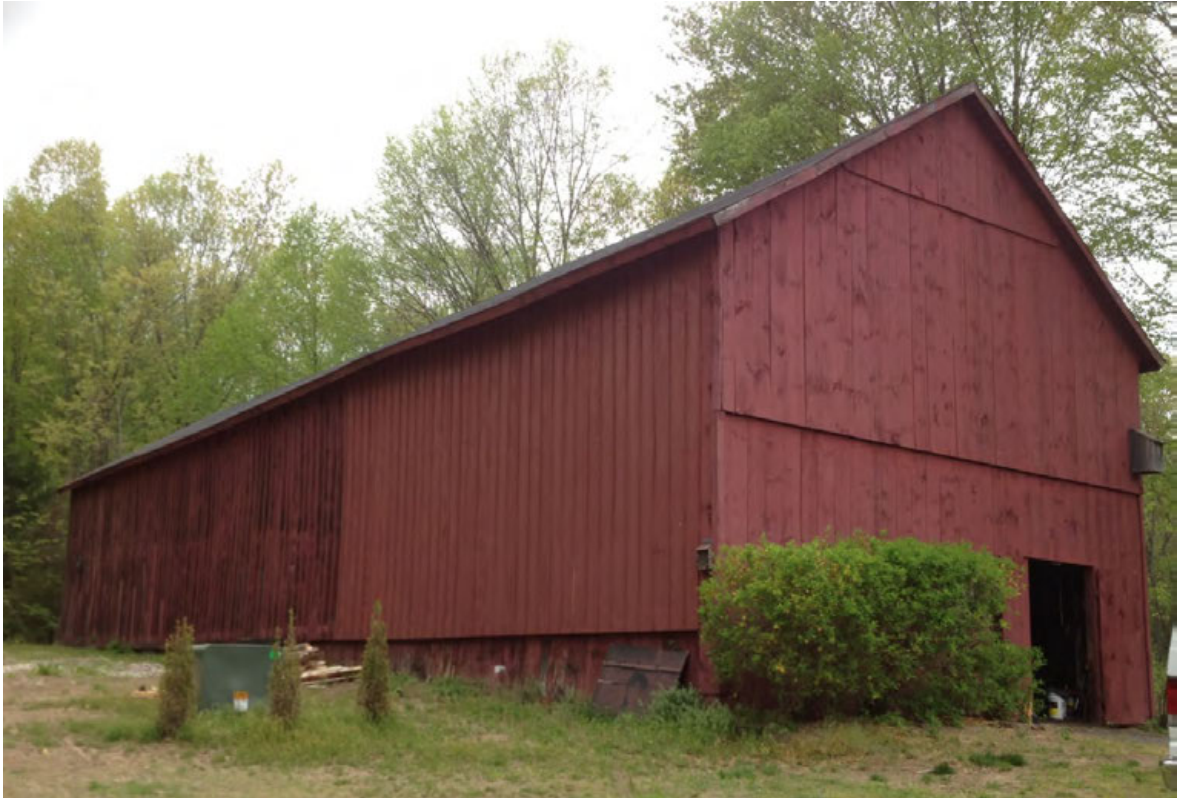
19. Southeast view of Maintenance shed, camera facing northwest.

side. A secondary doorway is in the east gable-end, off-center toward the right (north). This shed has asphalt shingle roofing and the siding is painted red. The interior floor is gravel.

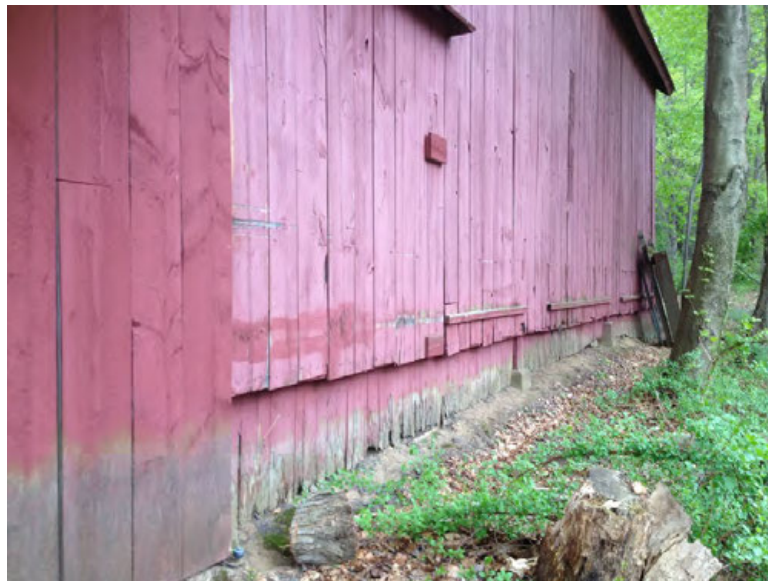
20. North detail view of Maintenance shed, camera facing southwest.

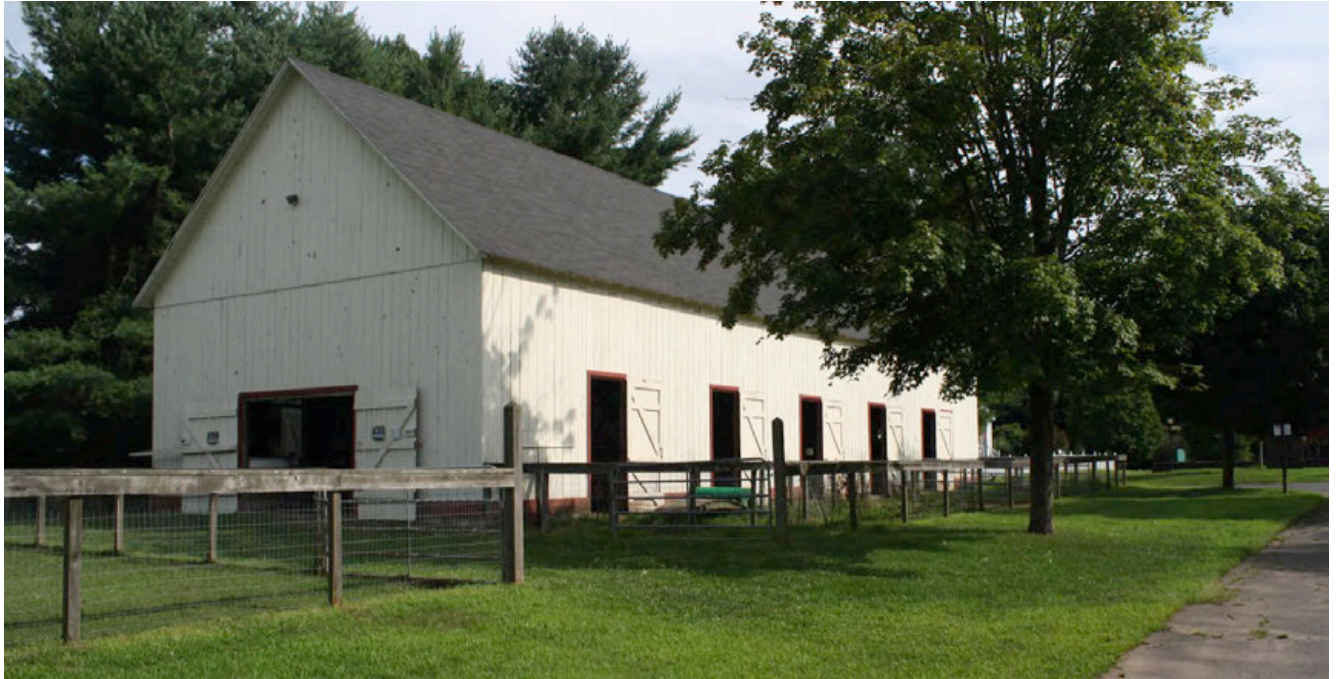
21. Northwest view of Animal barn, camera facing southeast.

This is a six-bay three-aisle gable-roofed shed with its ridge-line oriented north-south, and it is located north of the Farmhouse. The eave-side walls have been modified with five tall hinged doors in each side corresponding to livestock stalls inside and pens outside. The north and south gable-ends have pairs of hinged doors the full width of the center aisle. The south end has a hay door above, with a pointed top. The shed structure is standard and similar to the other sheds. The center aisle has a concrete slab floor. Several bays near the south end are enclosed for storage. The exterior is painted cream with barn red trim. The roof is asphalt shingles.

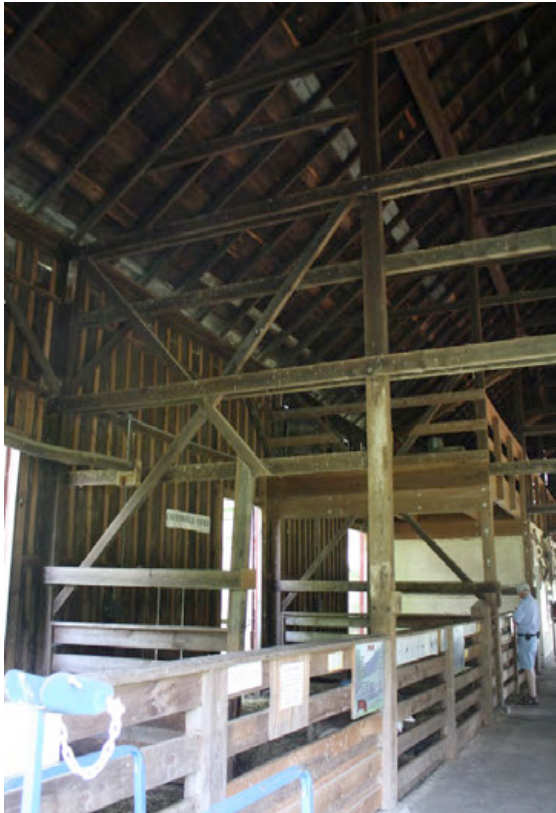
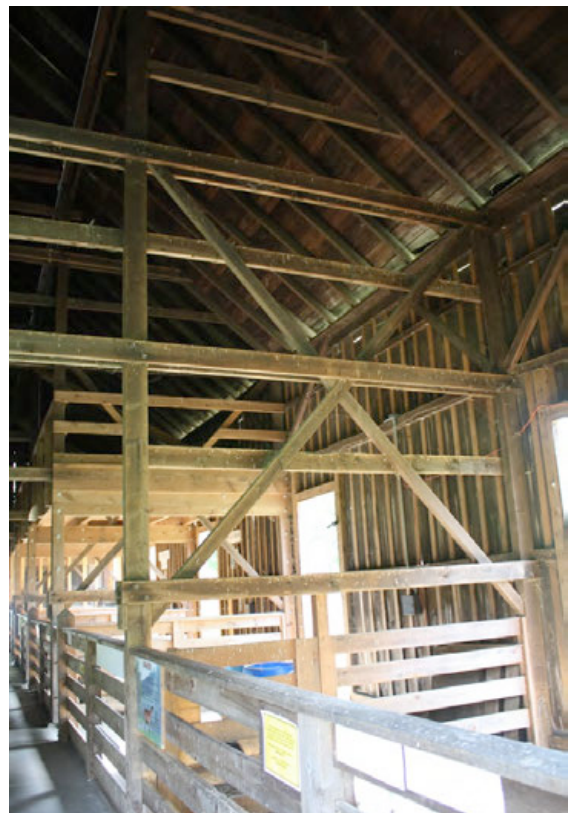
22a-b. Interior views of Animal barn, camera facing south.

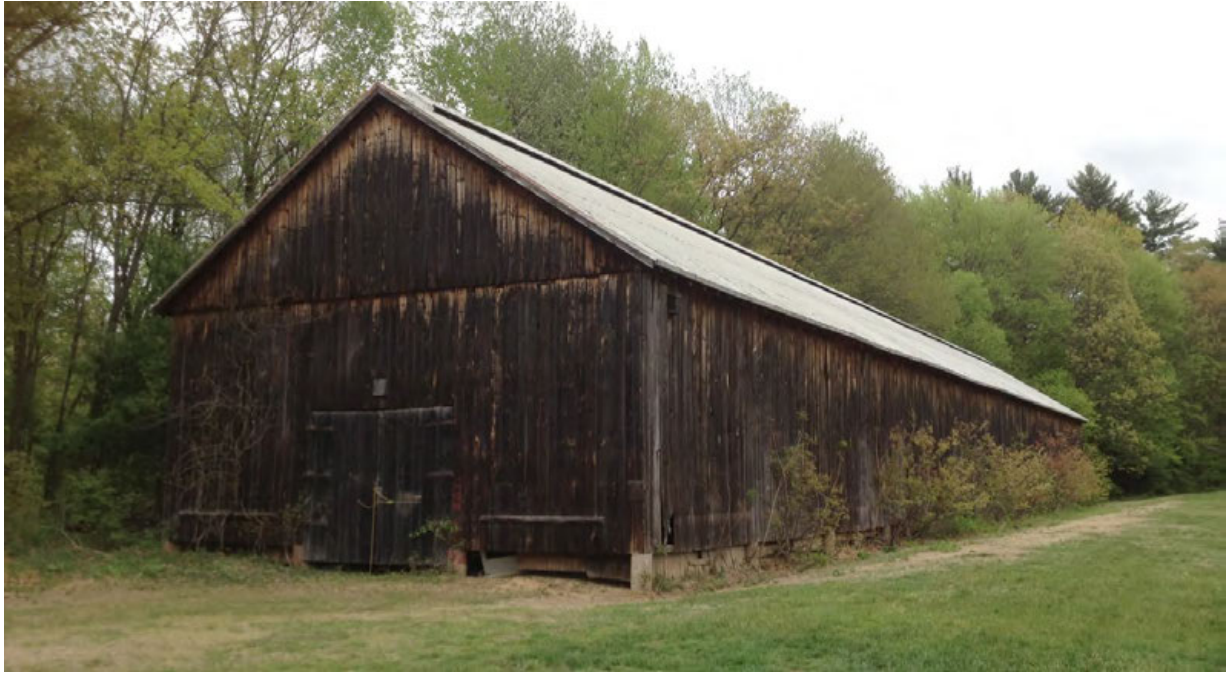
23. Southwest view of Field barn I (Tobacco shed), camera facing northeast. Note the metal roof with continuous ridge ventilator.

This shed, located along the north edge of the soccer field, is a 12-bay three-aisle gable-roofed tobacco shed with its ridge-line oriented east-west. Its concrete foundation piers are cylindrical, suggesting construction using cardboard tube formwork which may indicate a later date of construction than the other sheds. The frame is typical, similar to the Museum shed. A pair of hinged doors with iron strap hinges is in each gable-end. Roofing is metal panels. The interior floor is dirt.

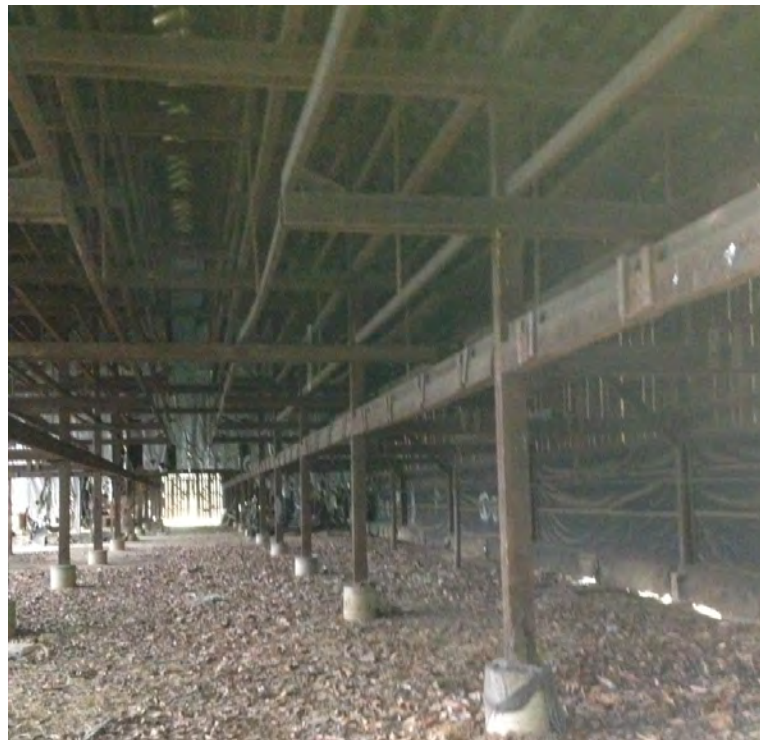
24. Interior view of Field barn I, camera facing west.

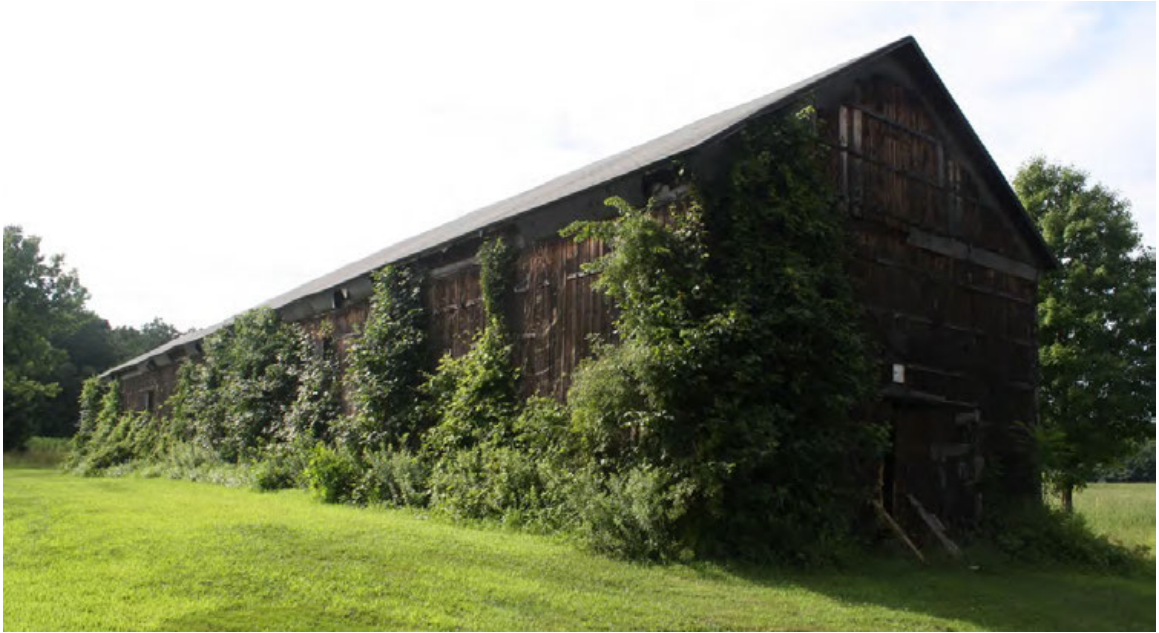
25. Southeast view of Field barn II, camera facing northwest.

This shed is located in a mowed field (formerly a tobacco field) along the northern extension of Land Road, near the Brookside trailhead, and has its ridge-line oriented east-west. It is a ten-bay two-aisle shed, with a single interior post at each bent. A pair of hinged doors is located in each gable-end. Roofing is asphalt shingles. The vertical wood siding and eaves have been covered with tar-paper or a similar sheet material; this has mostly worn away. The interior floor is dirt.

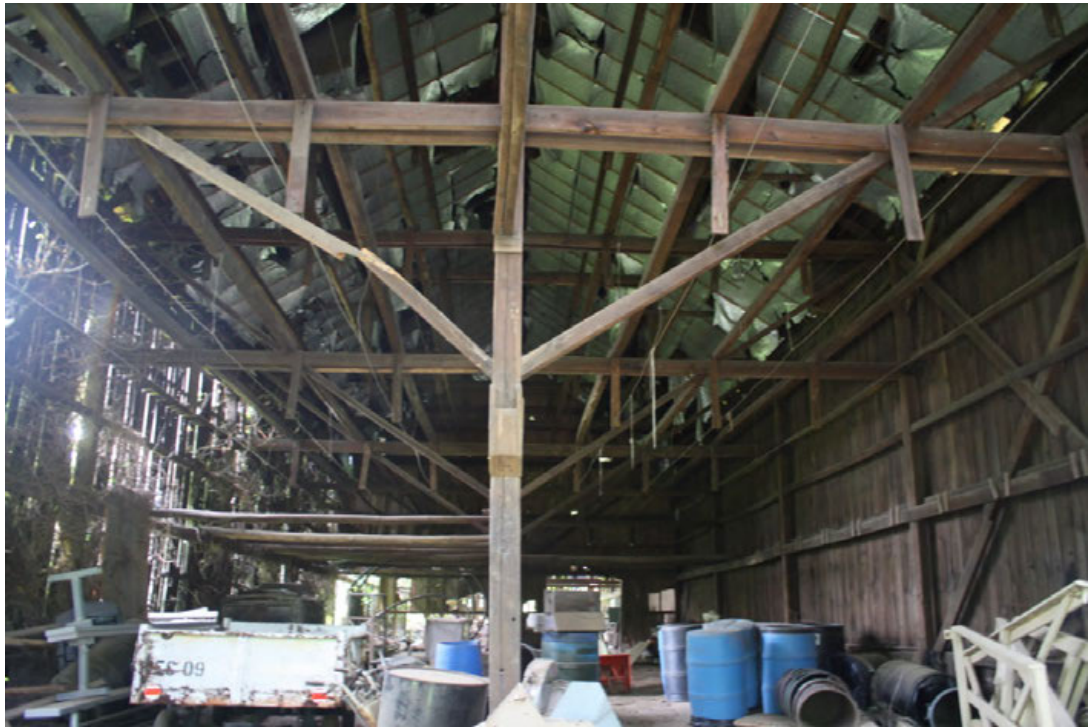
27. Interior view of Field barn II, camera facing west.

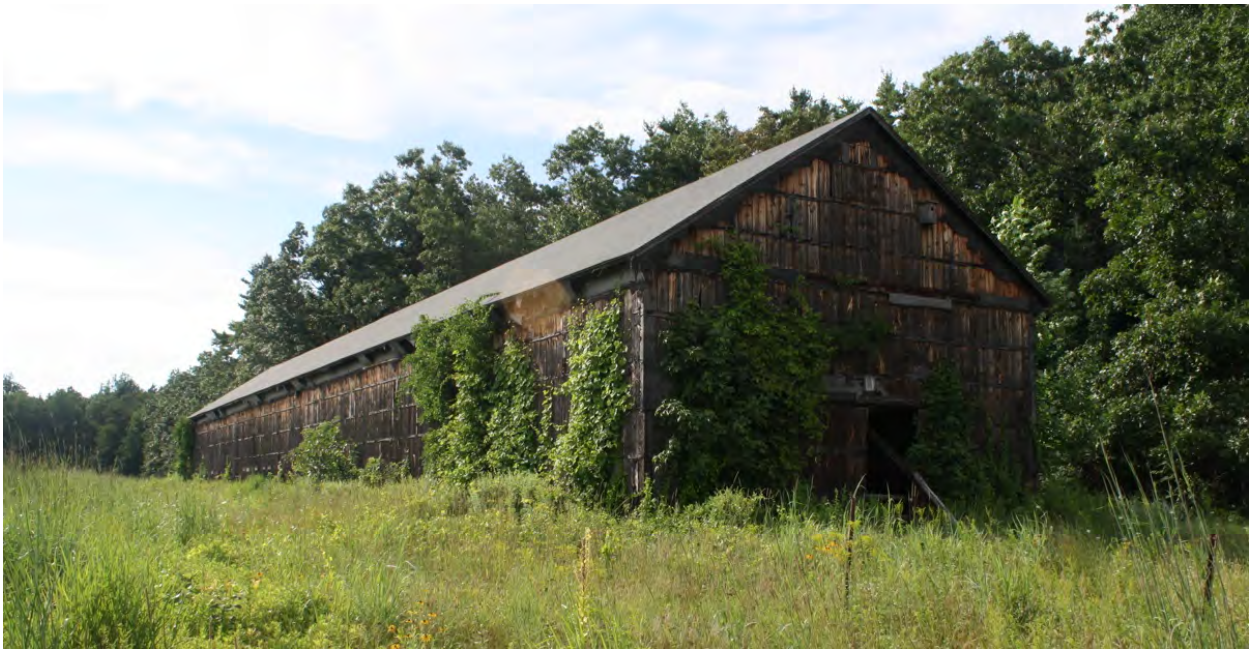
28. Southeast view of Field barn III, camera facing northwest.

This shed is located in a mowed field (formerly a tobacco field) along the northern extension of Land Road, near the Softwood trailhead, and has its ridge-line oriented east-west. It is a twelve-bay two-aisle shed, with a single interior post at each bent. A pair of hinged doors is located in each gable-end. Roofing is asphalt shingles. The vertical wood siding and eaves have been covered with tar-paper or a similar sheet material; this has mostly worn away. The interior floor is dirt.

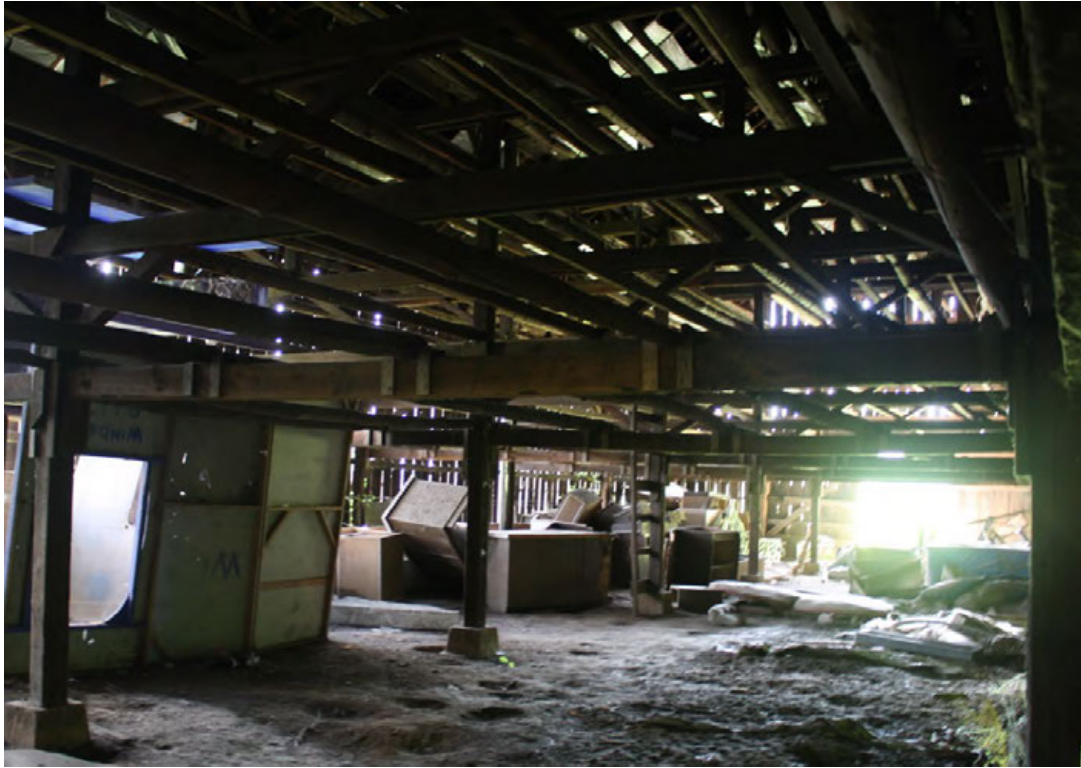
29. Interior view of Field barn III, camera facing southwest.

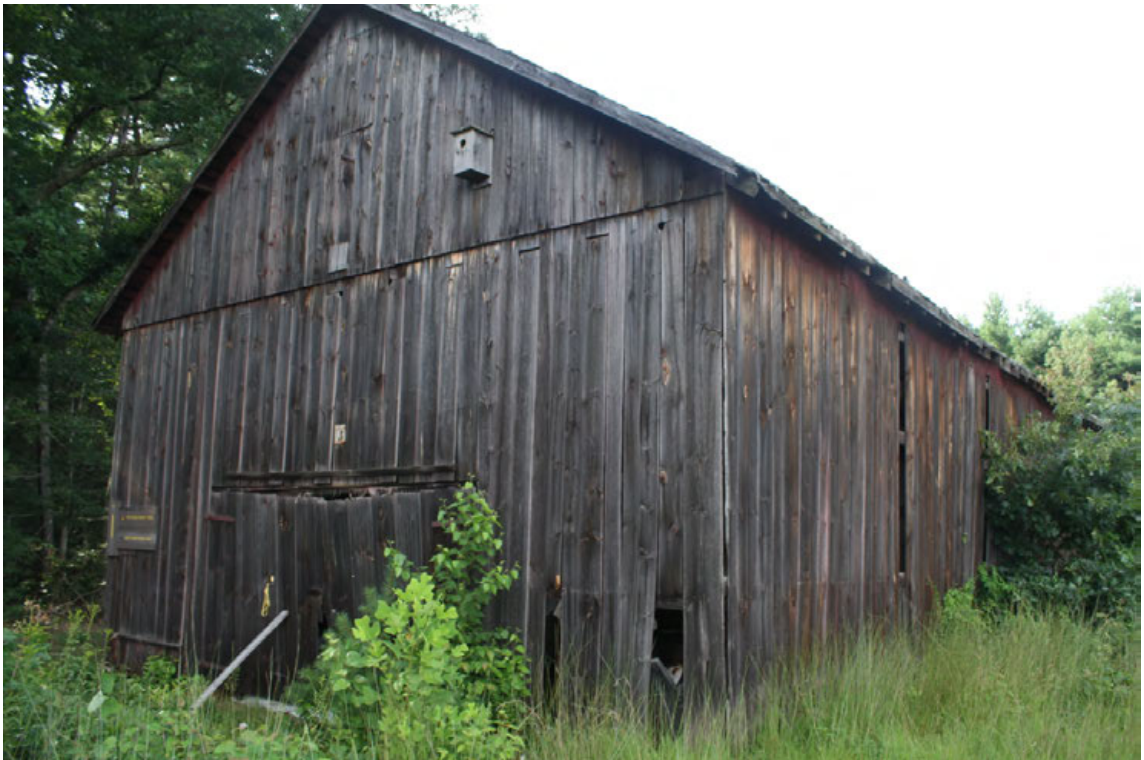
30. Southeast view of Field barn IV, camera facing northwest.

This shed is located further north of the previous pair and sits with its ridge-line oriented north-south at the edge of a wooded area so the east eave-side faces an open field and the west and north sides are adjacent to woods. It is an eleven-bay two-aisle shed structure with truncated pyramidal concrete foundation piers. The framing is typical. Large openings in the east side and the north gable-end no longer have doors extant. The vertical wood siding, formerly painted but faded except for traces of paint on the west side, has extant hinges and fasteners for its venting system, of the top-hinged vertical slat type. Roofing is an old type of interlocking asphalt shingle, with some missing sections. The interior floor is dirt.

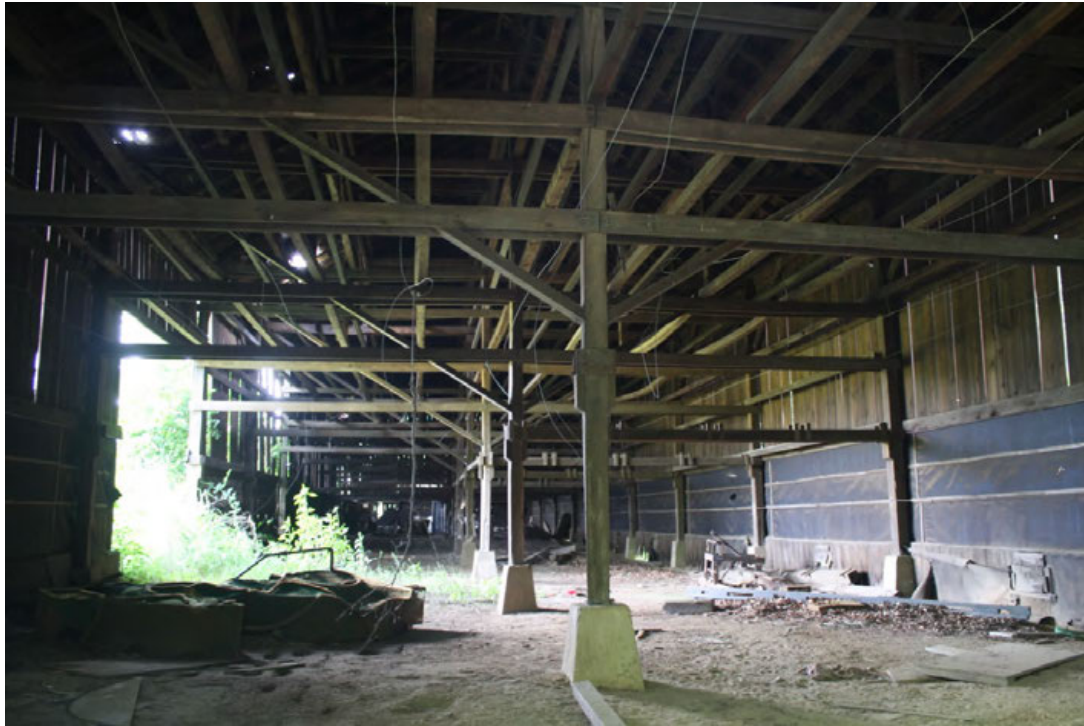
31. Interior view of Field barn IV, camera facing south.

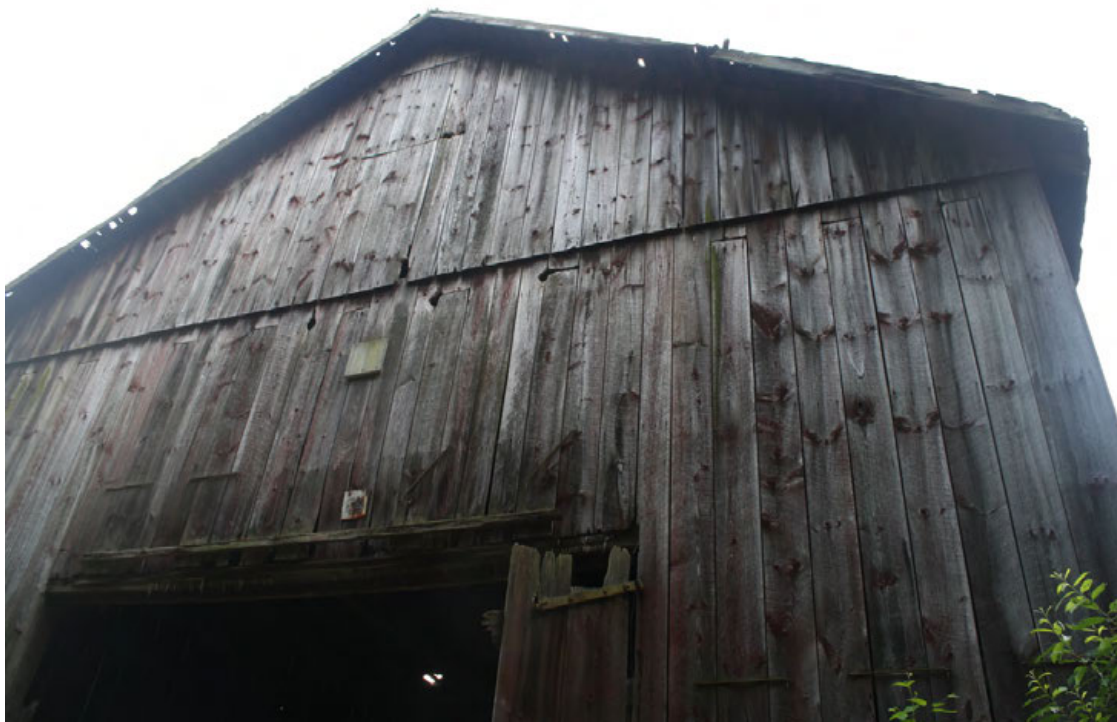
32. North view of Field barn IV, camera facing south.

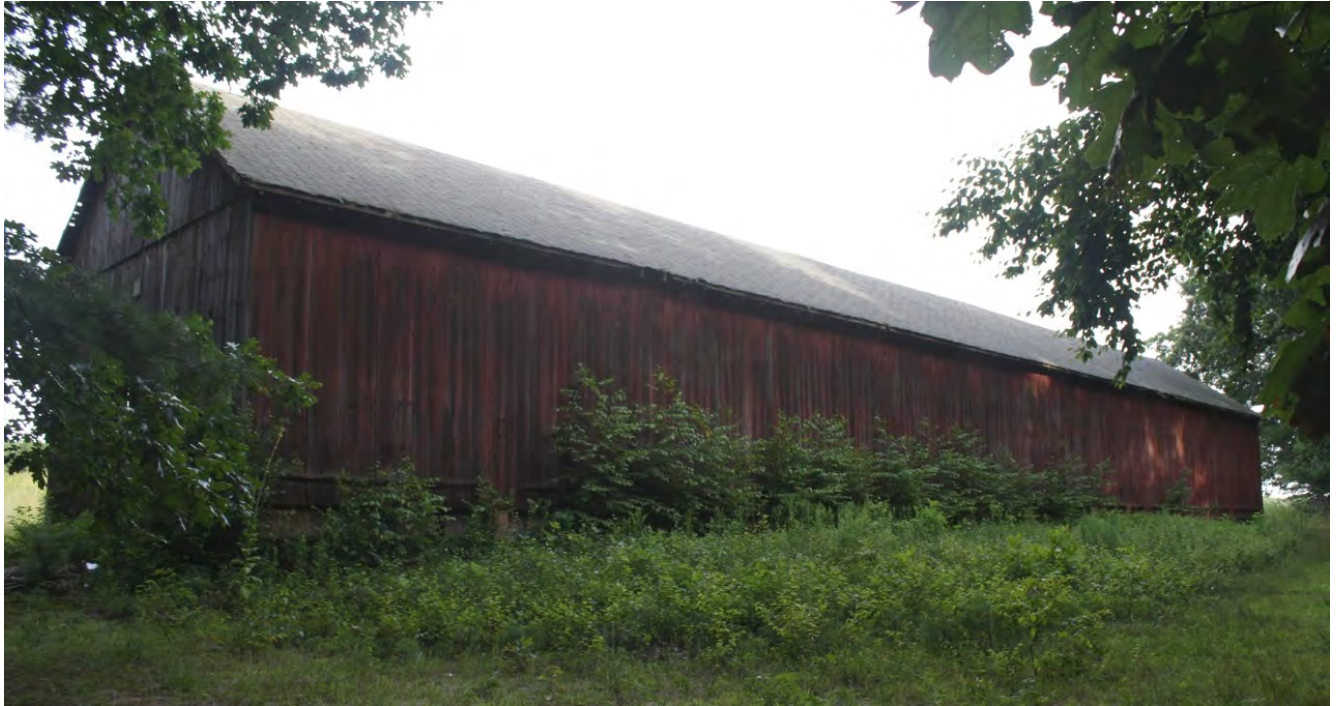
33. Northwest view of Field barn IV, camera facing southeast.

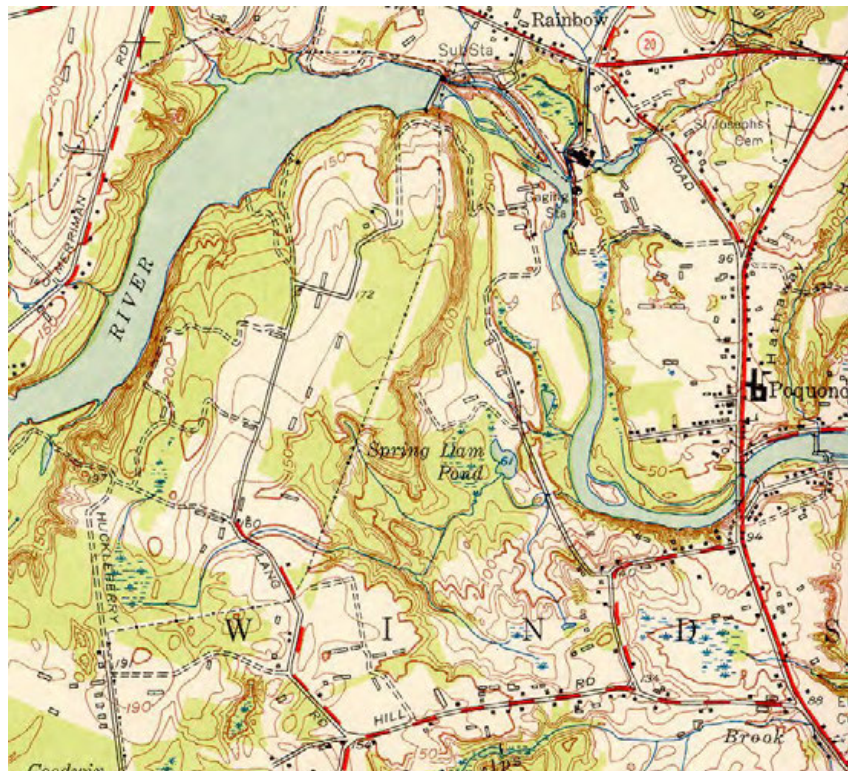
34. Detail from 1953 USGS map; note the tobacco sheds shown by open rectangles. Five sheds shown are no longer extant, while nine are still standing.
