HISTORIC RESOURCES

BUILDING AND STRUCTURES

Building Name (Common) Greaser, John & Kay Page, Family Barn Record No. 10257
 Building Name (Historic) Wilder, Family / Guernsey, Joseph, Farmstead
 Street Address or Location 143 Center Hill Road (Route 181)
 Town/City Barkhamsted Village Barkhamsted Center County Litchfield
 Owner(s) Greaser, John & Kay Page, 143 Center Hill Rd, Barkhamsted, CT 06063 Public Private

143 Center Hill Road, Barkhamsted, CT Record No. 10257

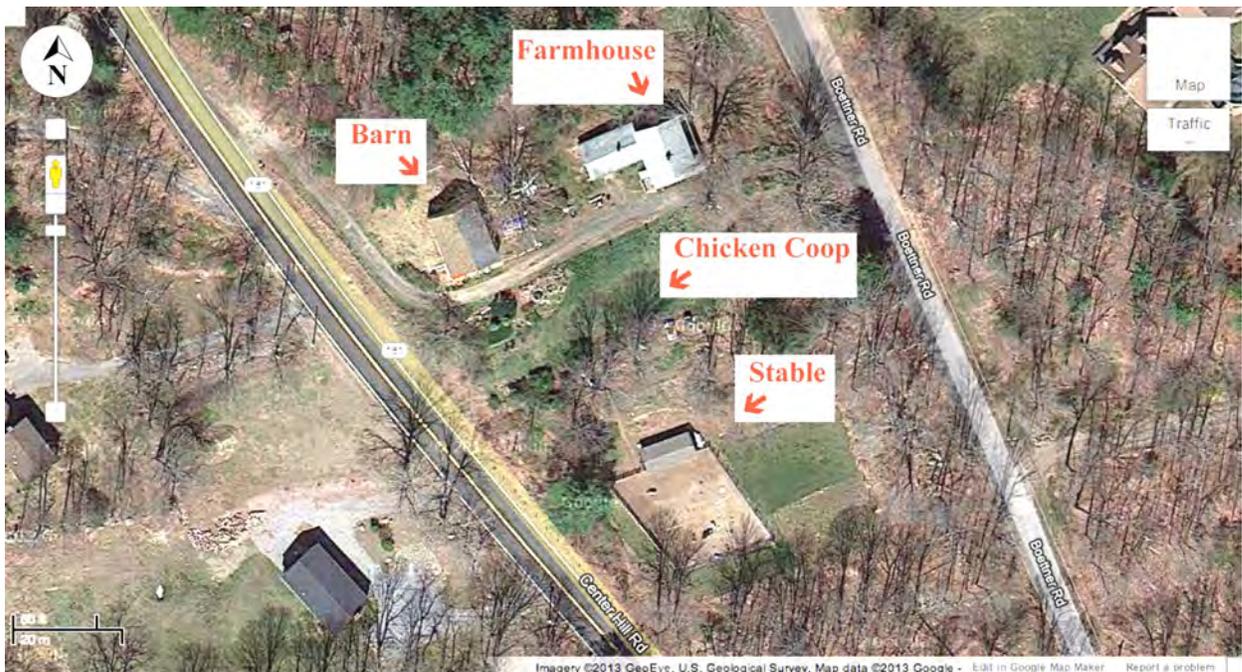
4. Detail Site Plan Sketch showing contributing resources, base image from Google Maps.

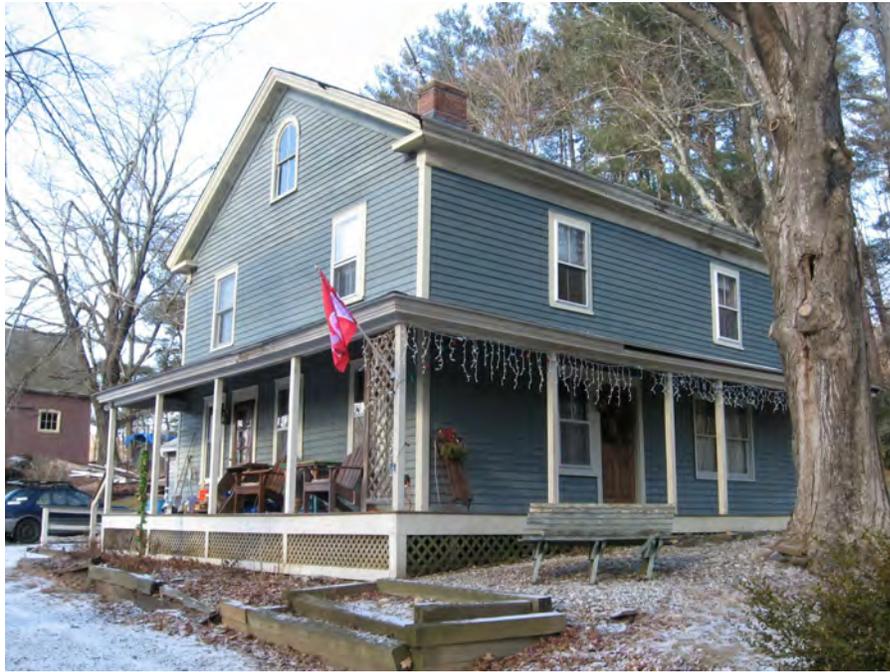
7. East eave-side and south gable-end of Farmhouse, camera facing northwest. Note arched window in gable, a feature of the late 19th-c. second-story expansion.

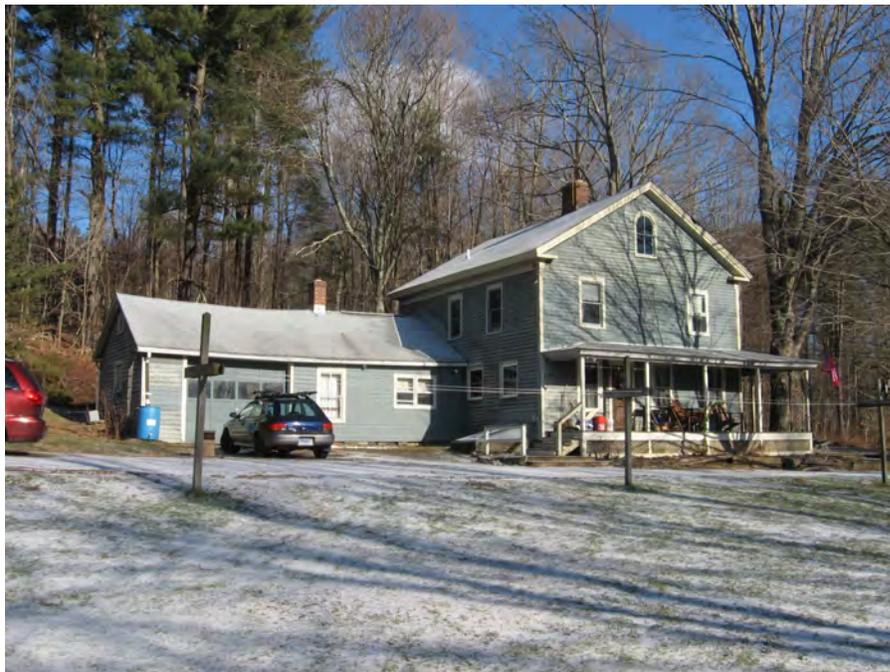
8. South gable-end and west eave-side of Farmhouse and south eave-side of rear ell, camera facing northeast.

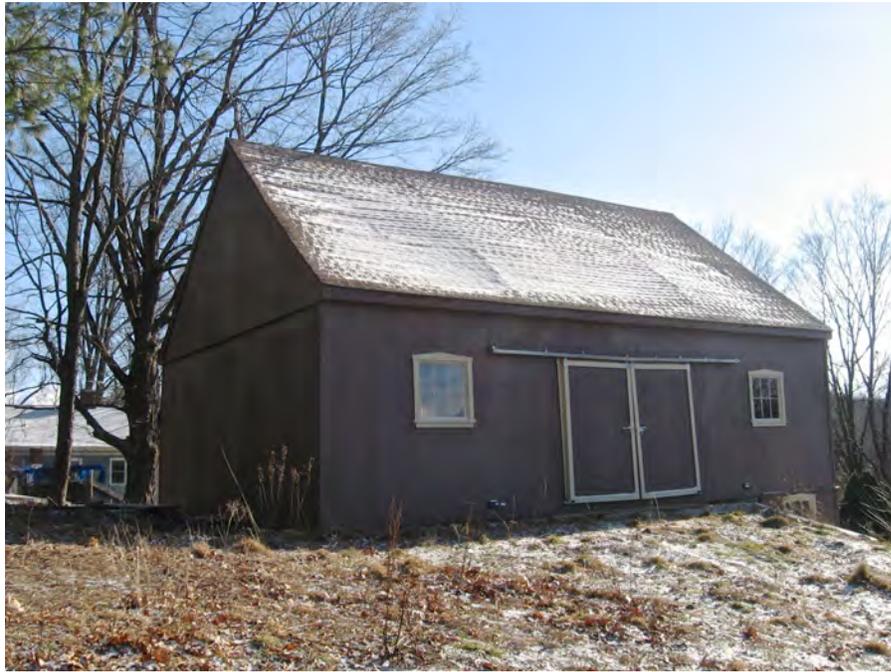
9. West eave-side and north gable-end of Barn, camera facing southeast.

The main entry is a pair of exterior sliding doors in the center bay of the west eave-side of the building. The doors are mounted on a metal track and slide to the north and south revealing the entry. The slope of the bank runs almost all the way up to the sill, leaving just a few inches of the foundation exposed below the entry. The batten-style doors are framed on the interior with three narrow horizontal boards and are secured to the track with metal hardware. Each of the side bays has a single, fixed, six-pane window with wood sill and trim. The basement level, exposed at the right (south) corner, has a six-pane window.

The north gable-end has no openings. The fieldstone foundation is partially exposed and the poured concrete foundation remains of a round silo are centered roughly 3' north of the elevation. A narrow concrete channel leads to an opening in the barn's foundation. The vertical board siding forms a girt-line siding divide at the eave line.

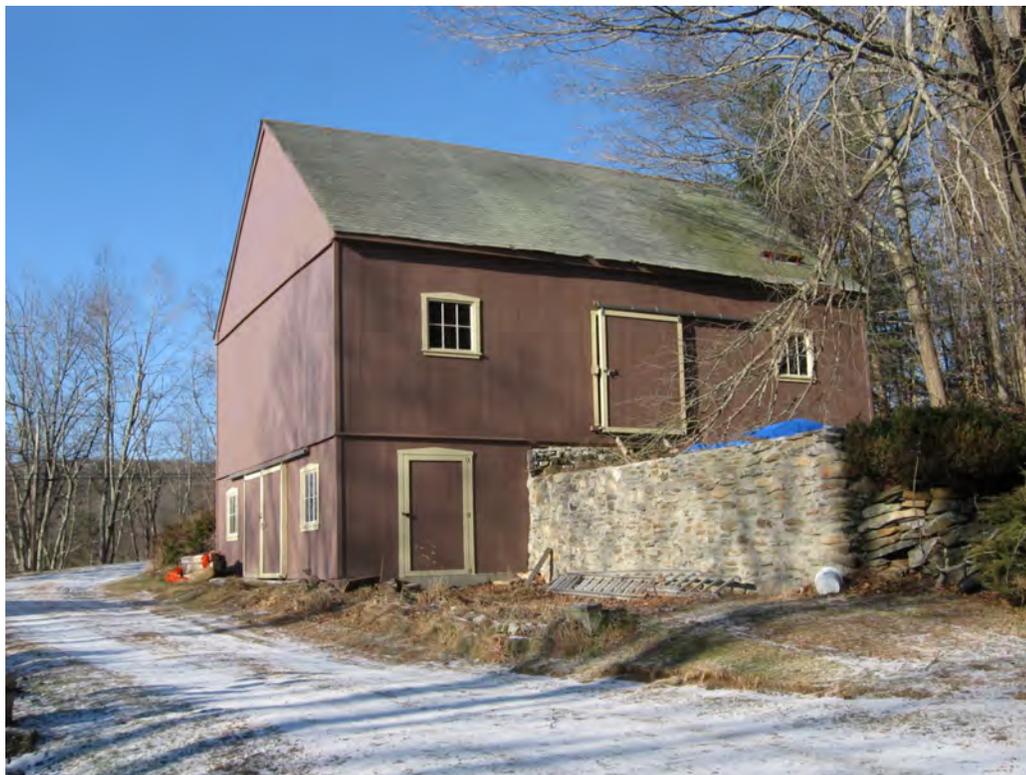
10. East eave-side and south gable-end of Barn, camera facing northwest.

The south gable-end has no openings on the main level or in the gable, however, the vertical board siding forms a girt-line siding divide at the eave line and at the main level sills. A pair of exterior sliding doors is centered on the basement level. The doors are mounted on a metal track and slide to the east and west revealing the entry. There is a single, fixed, six-pane window with wood sill and trim on each side of the entry.

The details of the east eave-side are identical to those on the west, except the main level entry has only one door and there is a basement-level entry door at the left (south) corner of the building. Here the fieldstone retaining wall is offset from the southern plane of the building, providing access to a batten pass-through door with wood trim.

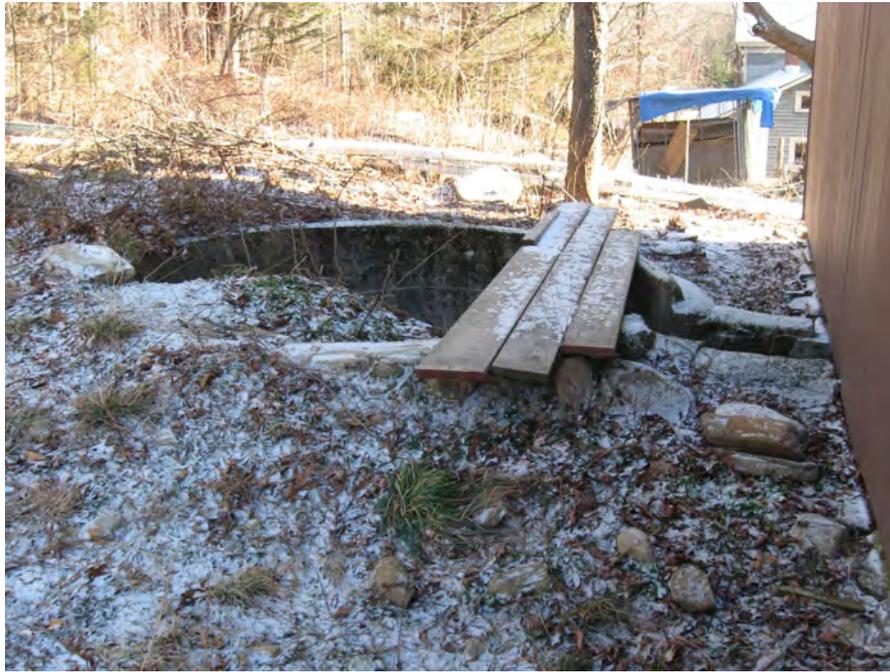
11. Detail of silo foundation, north of north gable-end of Barn, camera facing east.

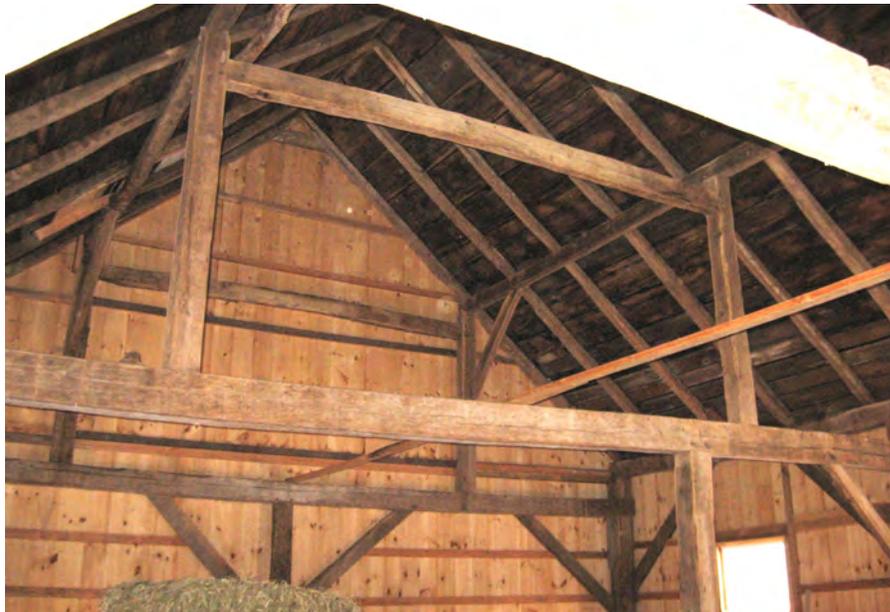
12. Interior view of Barn main level, showing framing, camera facing northeast. Note dropped tie-girts, diagonal bracing, queen posts, and purlins with intact upper ties.

The interior of the main level consists of a three-bay, four-bent, scribe rule post and beam frame with dropped tie-girts, diagonal bracing, and a single post at the center of each exterior bent and east of center along the interior bents. The center and north bays each measure roughly 13' wide, while the southern bay is 14' wide. The original framing is primarily hand hewn timbers, these with pegged mortise and tenon joinery. Several sash and circular sawn supporting timbers are also present. Queen posts rise from all four bents to purlin plates running the length of the building. Unusual extant upper tie-girts are located slightly below the heads of the queen posts – these are in many barns removed for installation of hay tracks. The common rafters are hand hewn and butted at the ridge. In general, the majority of the main level framing appears to be of original construction, however, the current owners recently replaced the exterior siding and added new floor boards after a later addition (likely early-20th century) to the barn collapsed in 2011.

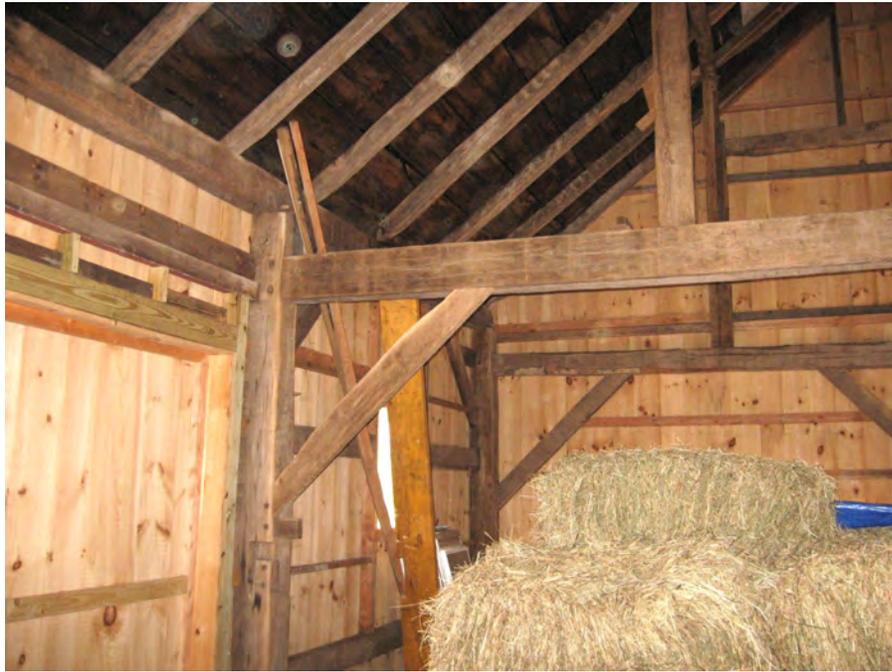
13. Interior view of Barn main level, showing framing detail, camera facing northwest. Note dropped tie-girts, diagonal bracing, hewn rafters.

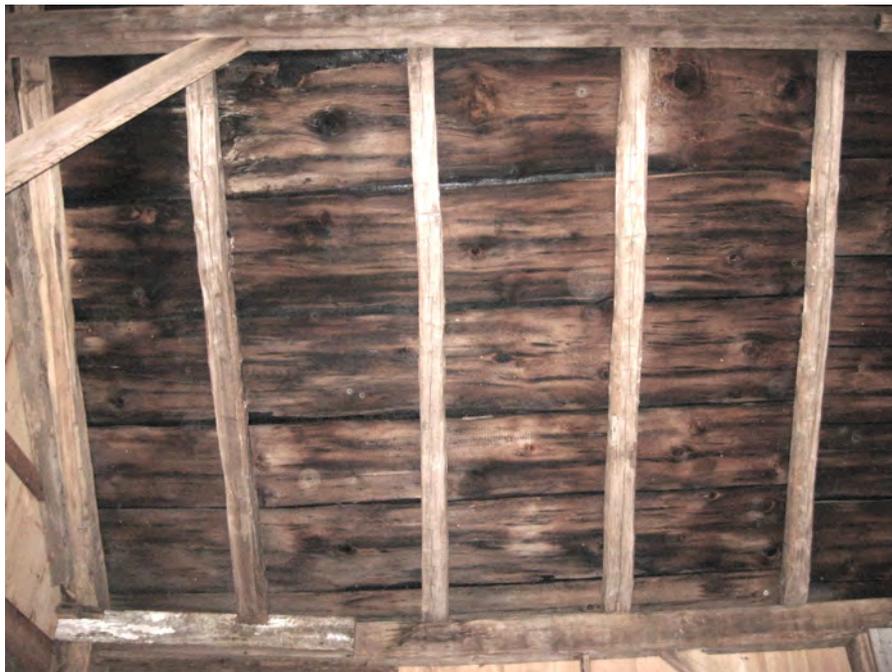
14. Interior view of Barn main level, showing roof detail, camera facing west. Note hewn rafters, rough sawn board sheathing.

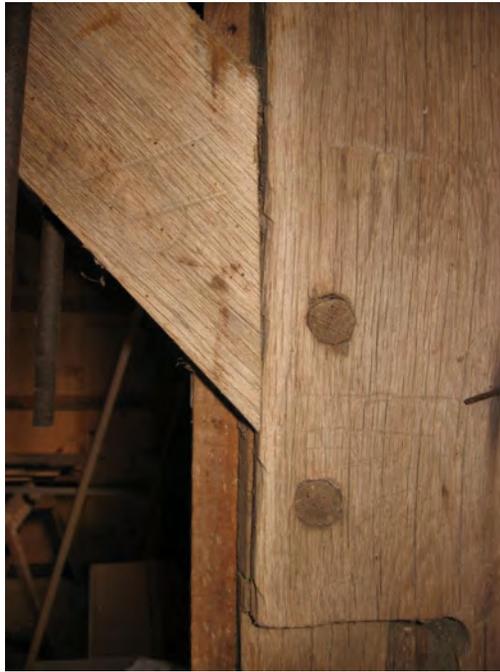
15. Interior view of Barn main level, showing detail of scribed marriage marks, camera facing northeast. Note mark consisting of two parallel lines, one intersecting a circle stamped with a gouge.

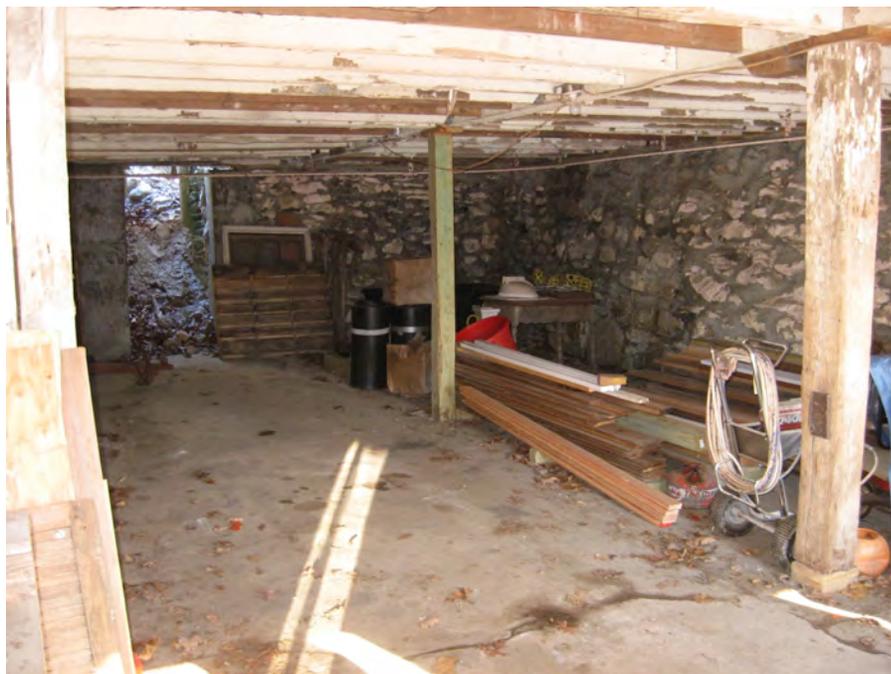
16. Interior view of Barn basement level, showing foundation and framing details, camera facing northeast. Note concrete floor, whitewashed interior, foundation opening to silo on north (upper left) foundation wall.

The basement level extends under all three bays. Circular sawn posts support longitudinal (north-south) girders running the length of the building and intermediate girders running laterally (east-west) in the plane of the main bents at the upper level. The floor joists run laterally (east-west) and are nailed to the longitudinal girders. The basement level has mortared fieldstone walls on its north, east, and south elevations. A poured concrete floor, this with a builder's mark reading "1925-30-OCT/A. PRANKA," has been installed within the entirety of the basement level and a poured concrete foundation wall has recently been added on the west elevation in order to shore up a sagging foundation on that side of the building. The basement level shows indications of use as a dairy stable. The foundation walls, posts, floor joists, and underside of the main level flooring are whitewashed and the remains of a steel manure trolley track hangs from the ceiling along the north and east sides of the basement level. The opening to the exterior silo is visible on the north gable-end foundation wall.

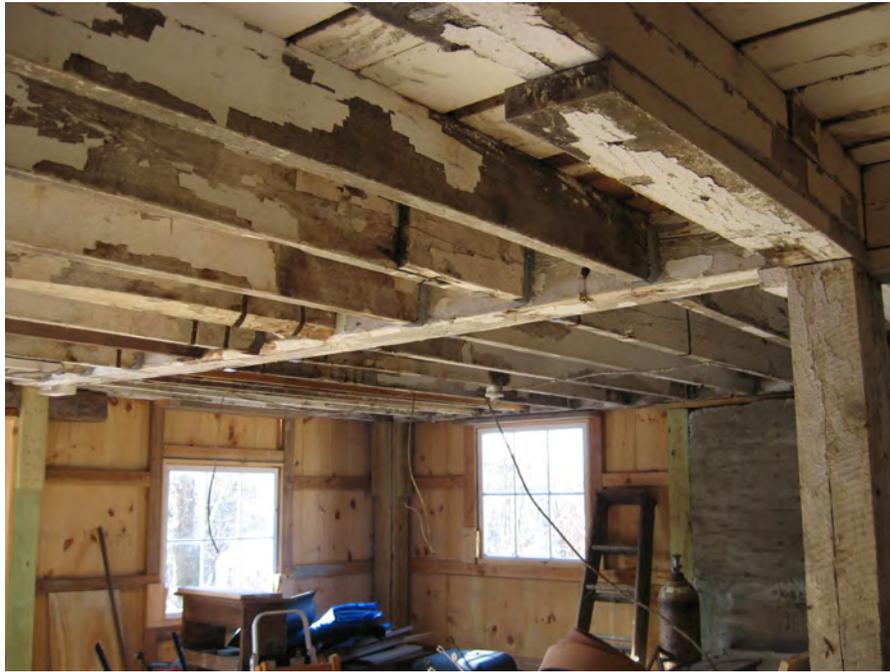
17. Interior view of Barn basement level, showing framing detail, camera facing southwest.

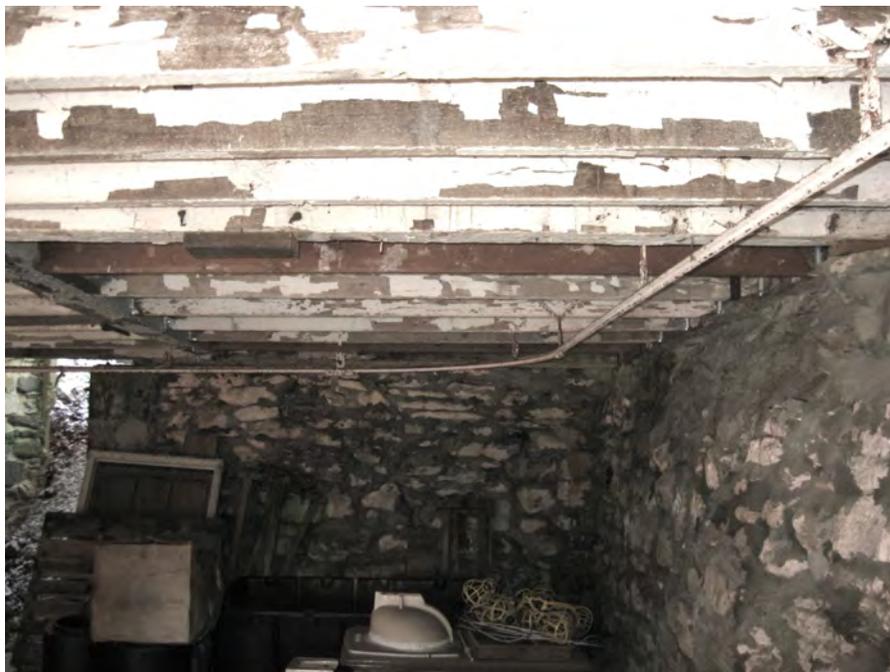
18. Interior view of Barn basement level, showing detail of manure trolley track, camera facing north.

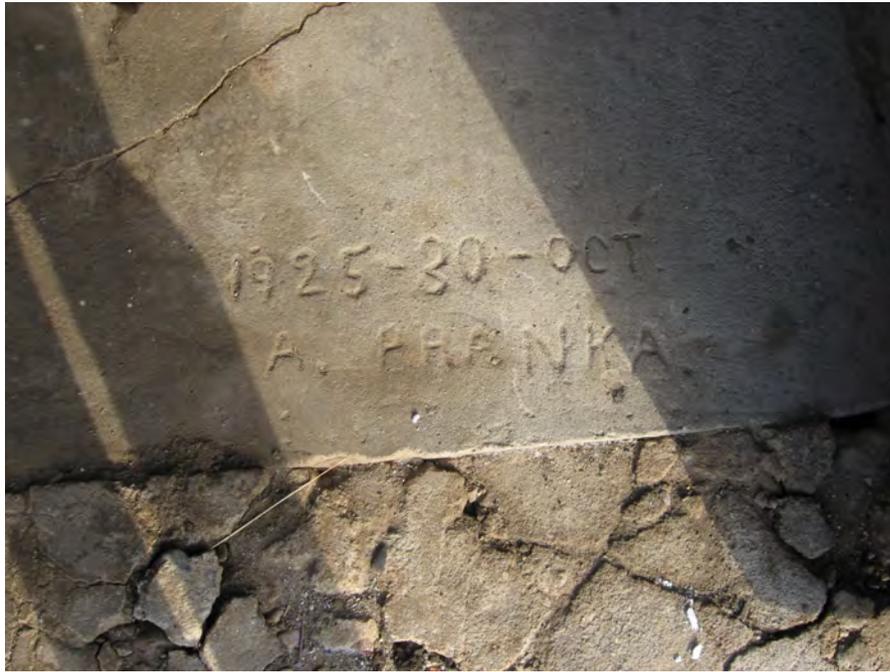
19. Interior view of Barn basement level, showing concrete detail, camera facing north. Note builder's mark reading "1925-30-OCT/A. PRANKA."

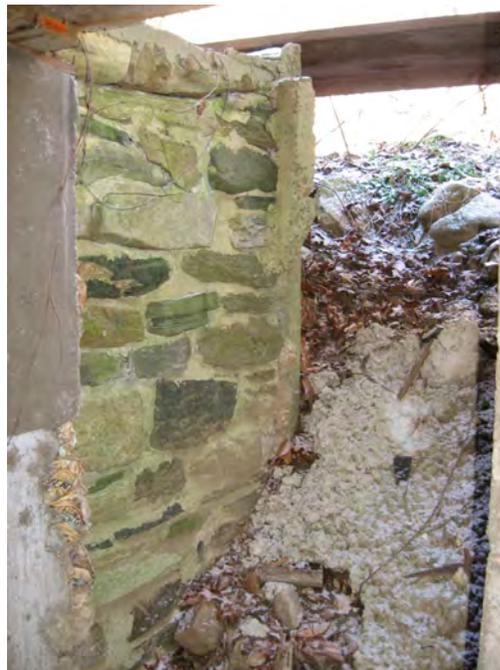
20. Interior view of Barn basement level, showing silo access detail, camera facing northwest.

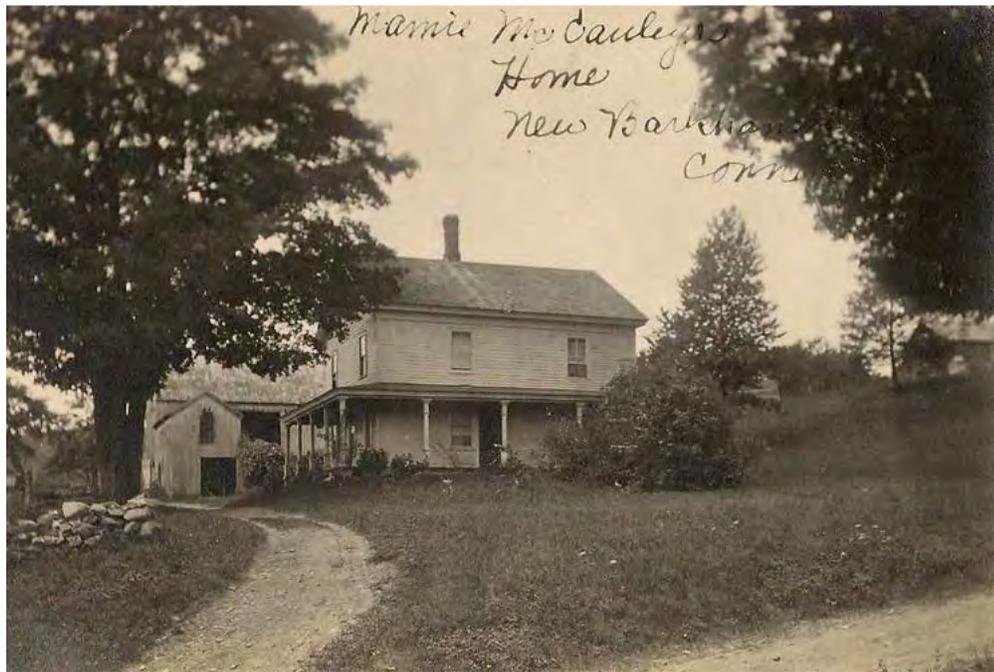
21. Circa 1908 photograph of the east eave-side and south gable-end of the Farmhouse, and east eave-side of Barn, camera facing northwest. Note 1-story ell on east eave-side of barn, collapsed 2/13/2011. Photograph courtesy of Paul Hart.

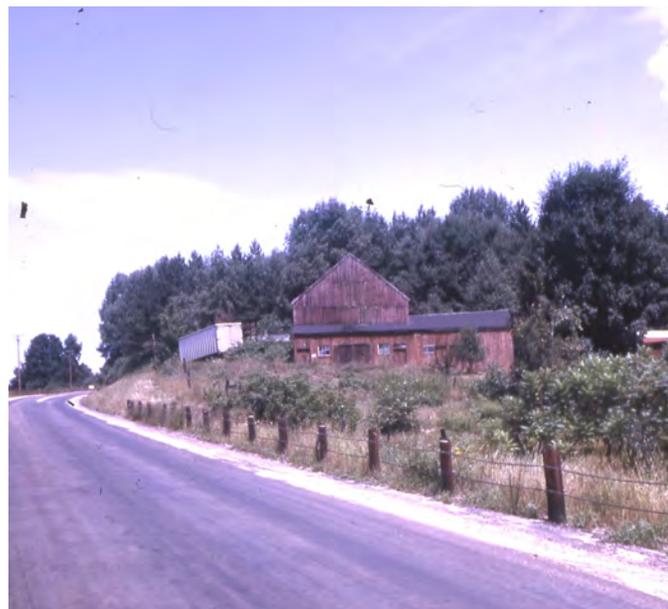
21. Circa 1970 photograph of the south gable-end of the Barn, camera facing north. Note 1-story ell on south gable-end of barn, collapsed 2/13/2011. Photograph courtesy of Paul Hart.

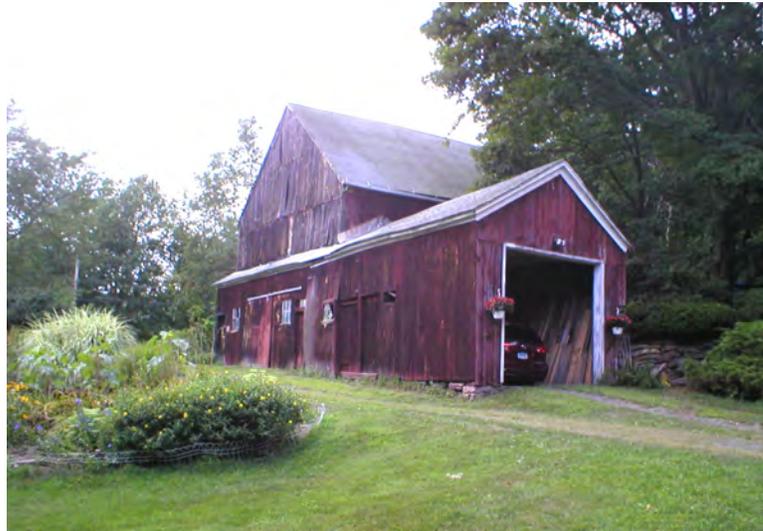
21. Circa 2010 photograph of the east eave-side and south gable-end of the Barn, camera facing northwest. Note 1-story ell on south gable-end of barn, collapsed 2/13/2011. Courtesy of John and Kay Page Greaser.

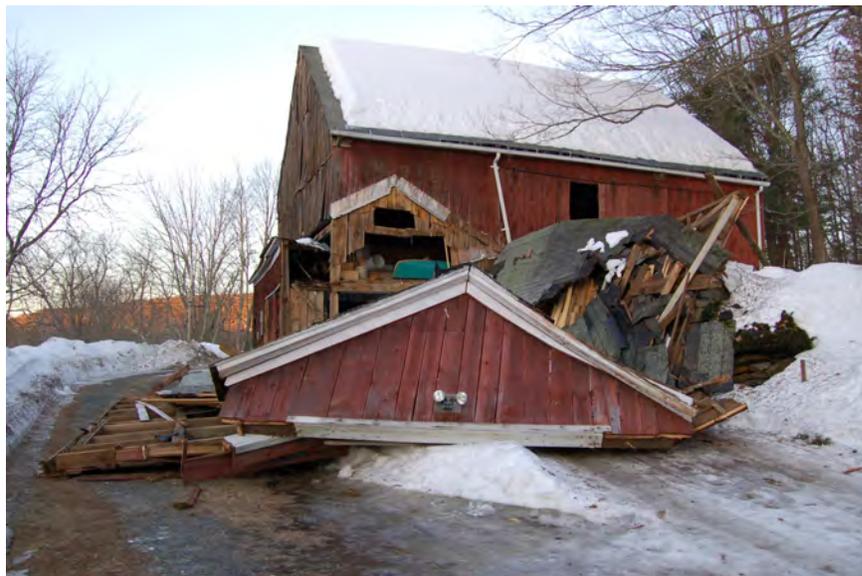
22. February 2011 photograph of the east eave-side and south gable-end of the Barn, showing 2/13/2011 collapse of 1-story ell, camera facing northwest. Photograph courtesy of John and Kay Page Greaser.
