HISTORIC RESOURCES

BUILDING AND STRUCTURES

Building Name (Common) Fish Family Farm and Dairy Store Record No. 20987
 Building Name (Historic) White, Jabez Loomis, Farmstead
 Street Address or Location 20 Dimock Lane
 Town/City Bolton Village _____ County Tolland
 Owner(s) Donald Fish, 10 Dimock Lane, Bolton, CT 06043 Public Private

Style of building Gambrel ground level stable barn, Vernacular style Date of Construction 1938

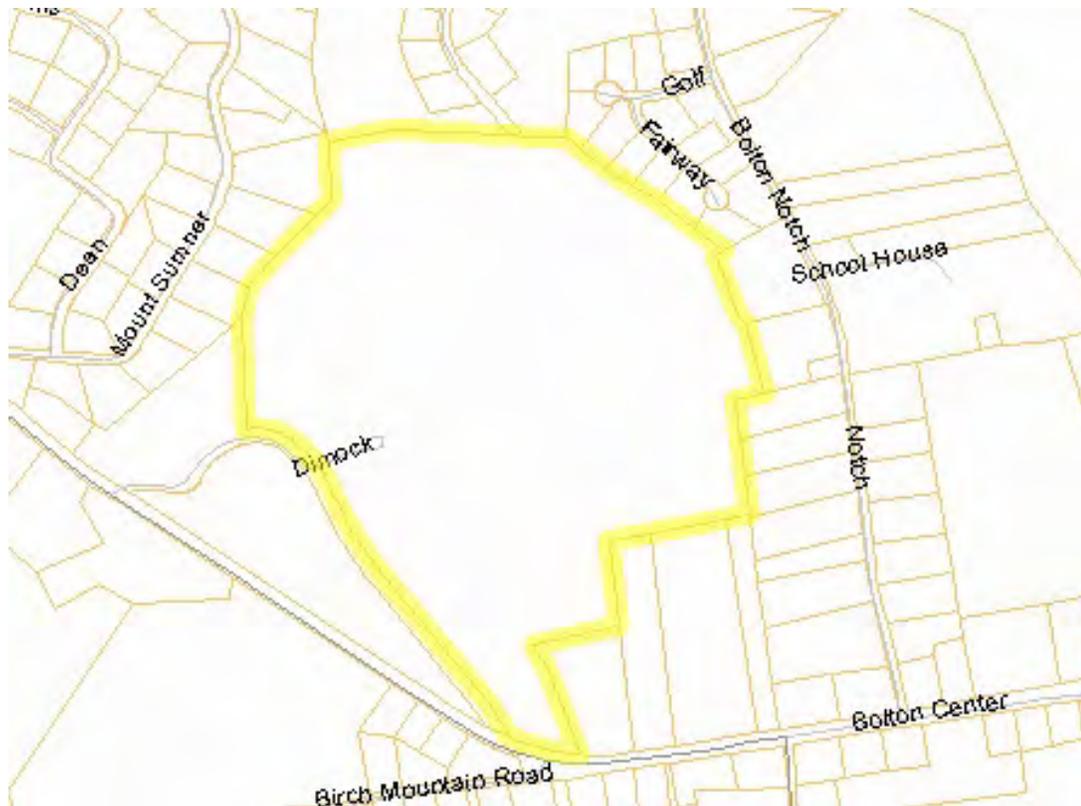
2. Parcel map of 20 Dimock Lane, Bolton, CT – from Bolton GIS Viewer <http://www.crcog.org/gissearch/> accessed 7/01/2012.

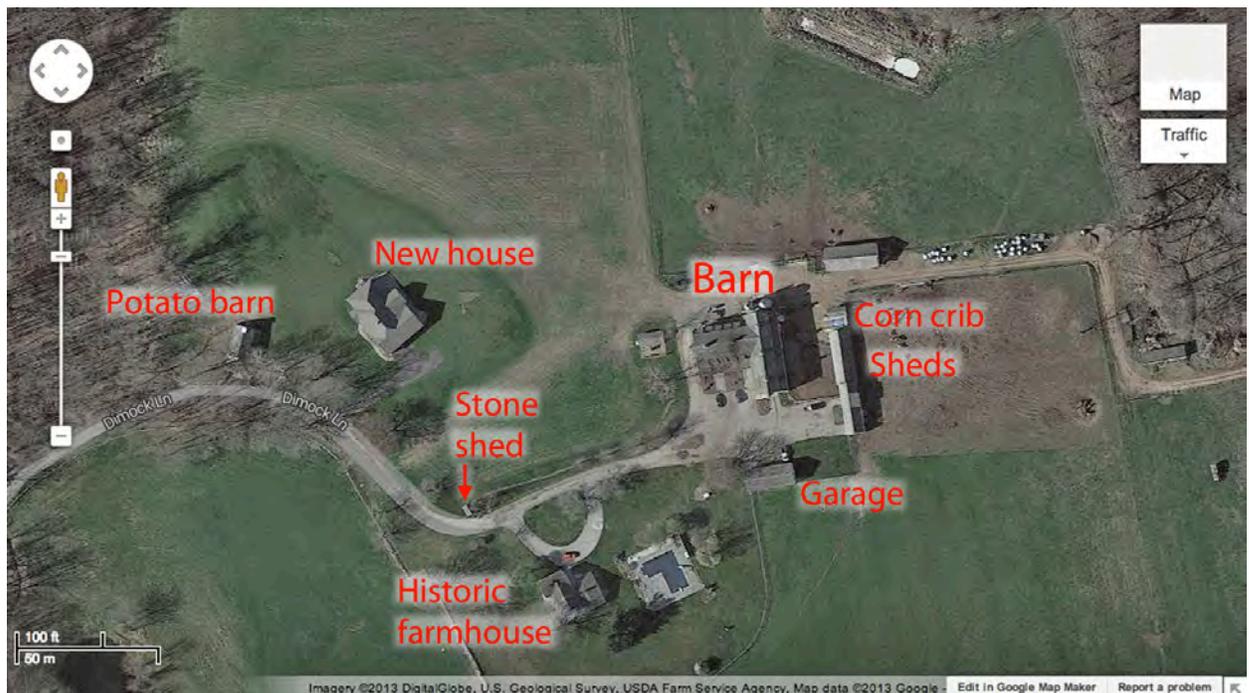
4. Detail map view of 20 Dimock Lane, Bolton, CT showing contributing and non-contributing resources – base image from <https://maps.google.com/>, accessed 9/09/2013.

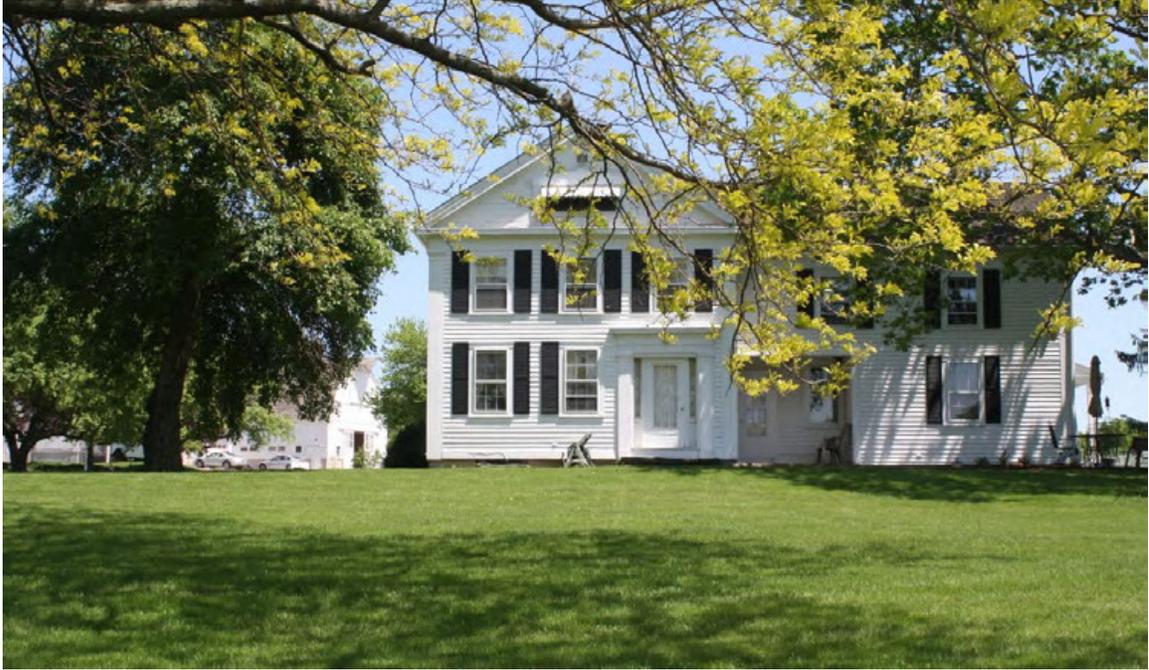
5. West view of Jabez Loomis White house, camera facing east. Note barn on left behind house.

The house associated with this site, the Jabez Loomis White house, is the first deed recorded in town history, found on Page one, Volume one of the Bolton Land Records and dated 1718. According to an O. W. Gray Tolland County map, the site appears to have been owned by a Mrs. White in 1869. A property owned by J. L. White is adjacent to Mrs. White property, but west of the current site. Dr. Charles F. Sumner occupied the house from 1834 through the beginning of the 20th century, at least until 1905. The current Greek Revival-style building appears from its form and ornament to date from the Sumner period, although the south block of the house could represent an older Colonial structure with its eave-front facing the old road.

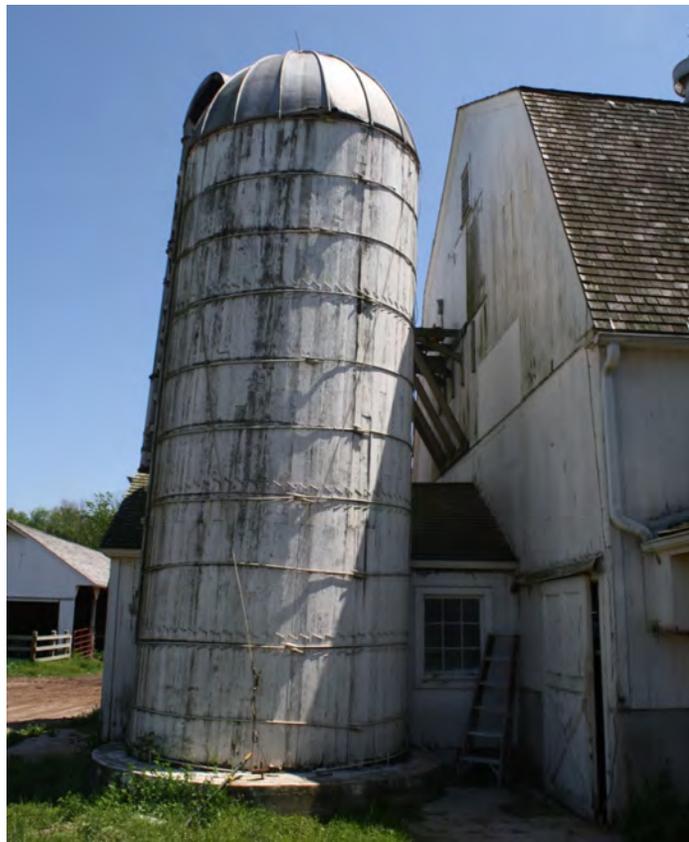
6. West side of silo, camera facing east. Note cleats holding the vertical boards of the silo together.

D. W. Fish, the current owner, acquired the site in 1981. In 1988 he added the large gambrel-roofed addition. The cleats on the silos were added by Amish workers in 1990 and the silos were used until 2009. A new hay fork and hay

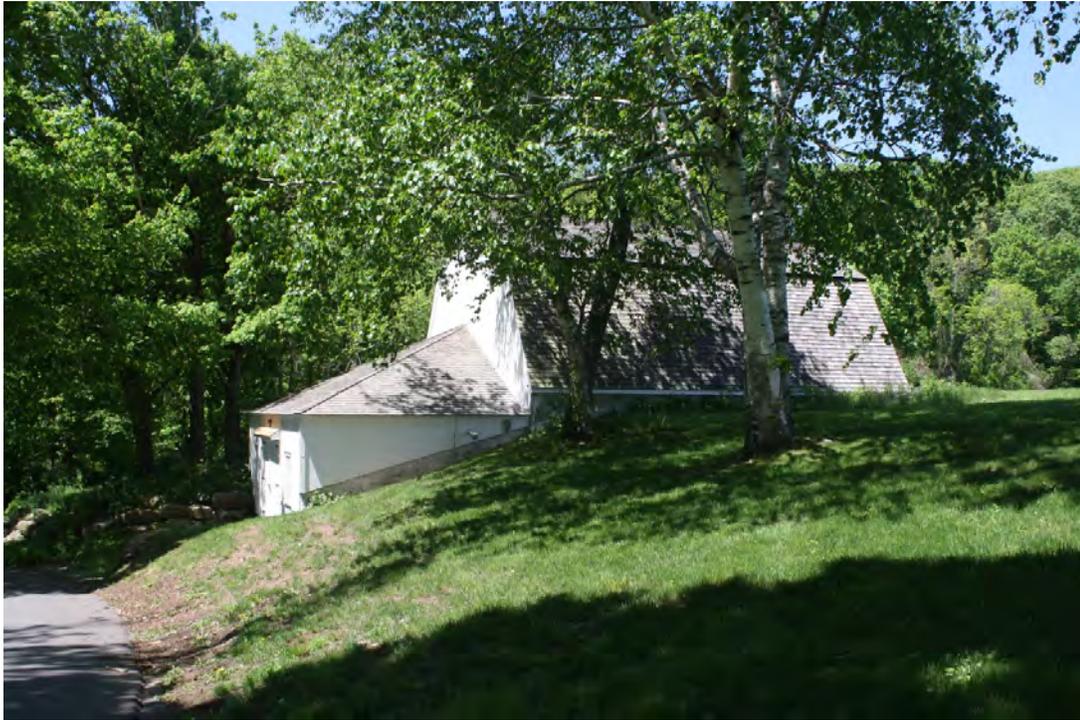
7. East side of gambrel-roofed potato barn, camera facing west. Note the hipped-roof entrance to the potato barn and the semi-subterranean arrangement.

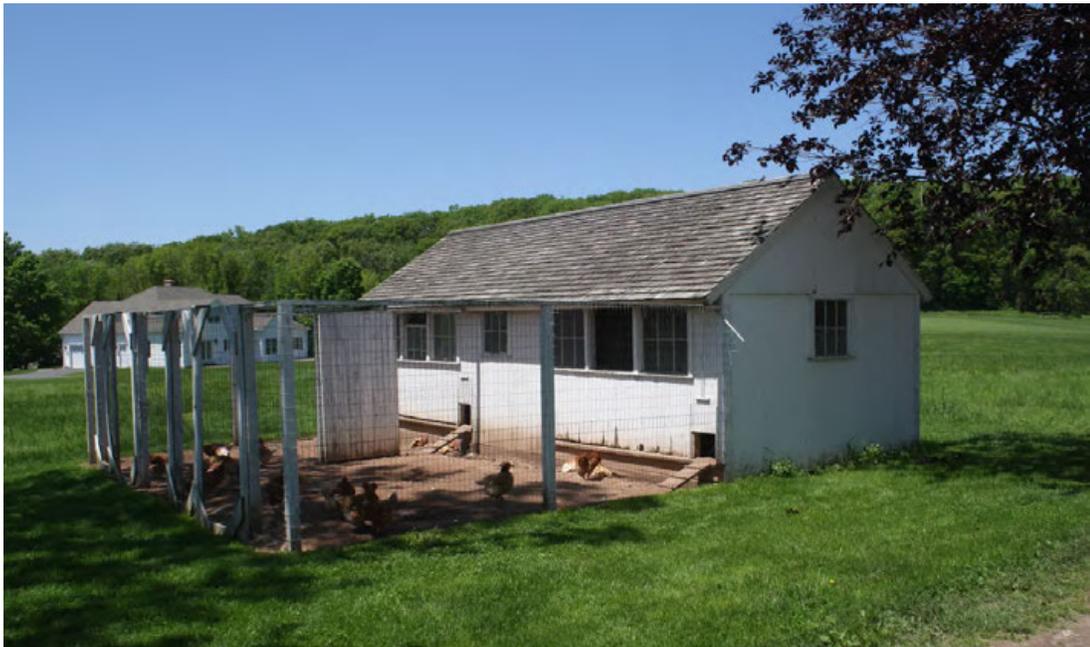
8. Southeast corner of the chicken coop, relocated to site from an area east of the barn to this location in 2010, camera facing northwest. Note the modern house built in 2011 to the left.

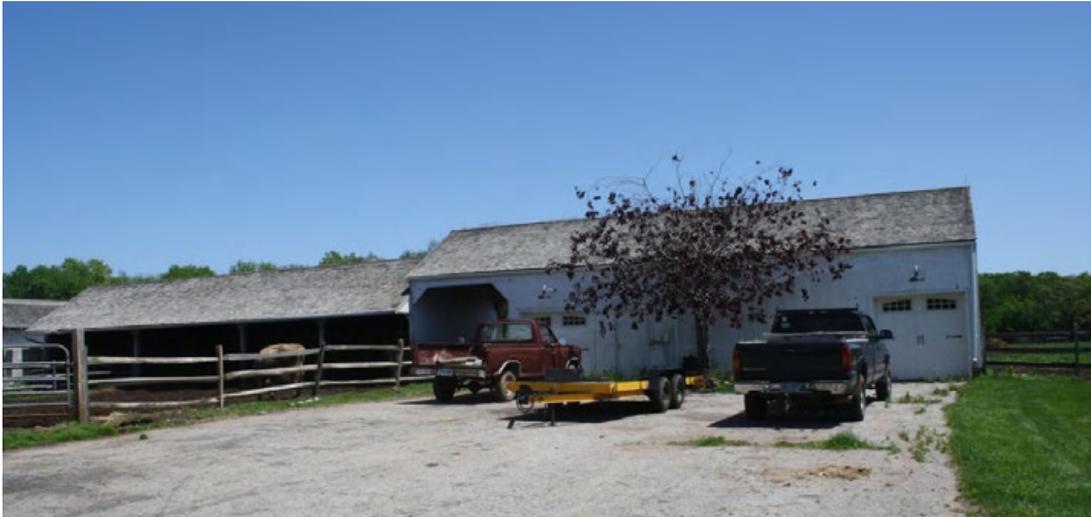
9. East side of sheds to the east of the barn. The south shed is for apple storage and the north section has a four bay for wagons, now used for storage and farming equipment.

A five-car garage faces the south gable-end of the barn across Dimock Lane with its ridgeline running east-west. To the east are two sheds arranged in a line gable-to-gable with their ridge-lines running north-south. The south shed has two sets of hinged doors and a covered passageway in the northernmost bay, originally used as an apple barn. The north wagon shed has open bays on the west eave-side and is used as a shelter for cattle. To the north are two agricultural outbuildings with their ridge-lines running east-west; a corn crib and further north an equipment shed with open bays on the south eave-side.

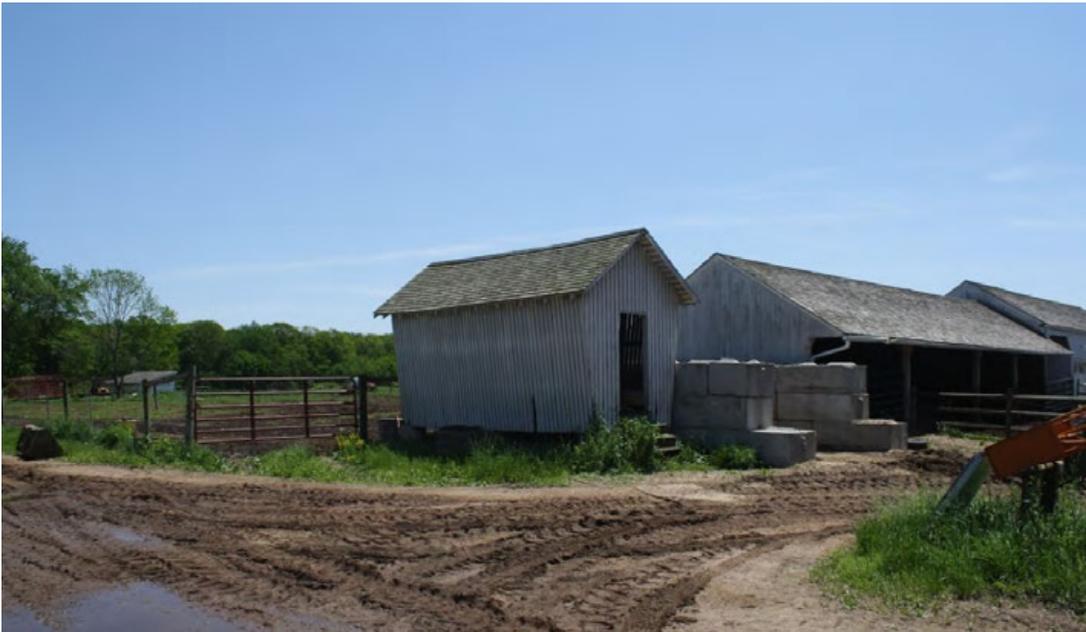
10. Northwest corner of corn crib, camera facing southeast. Note the wagon shed to the right.

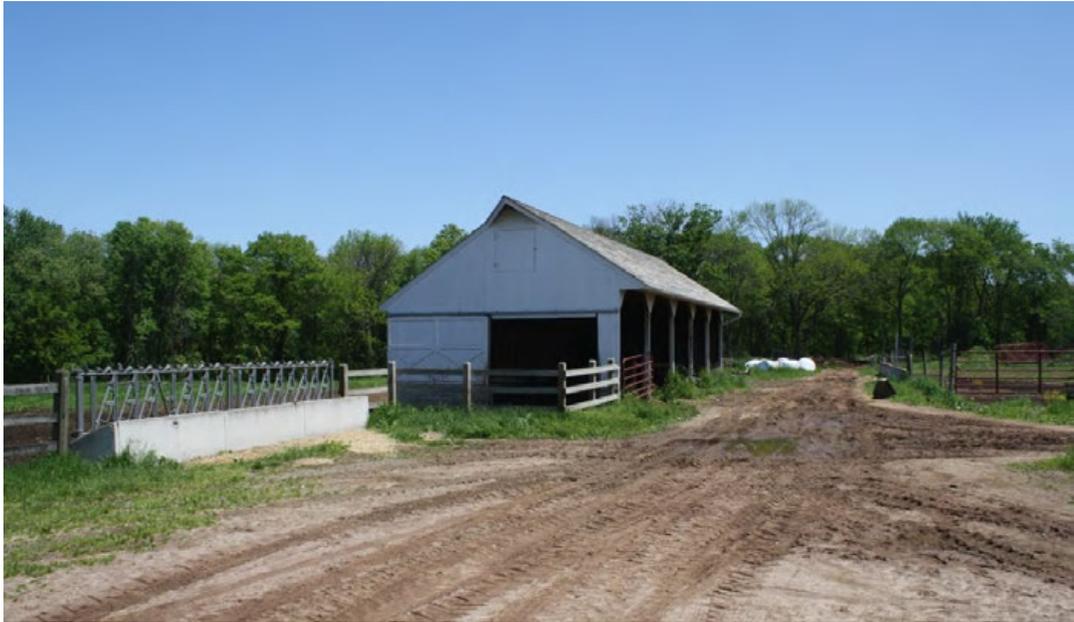
11. West gable-end of six-bay wagon shed, camera facing east.

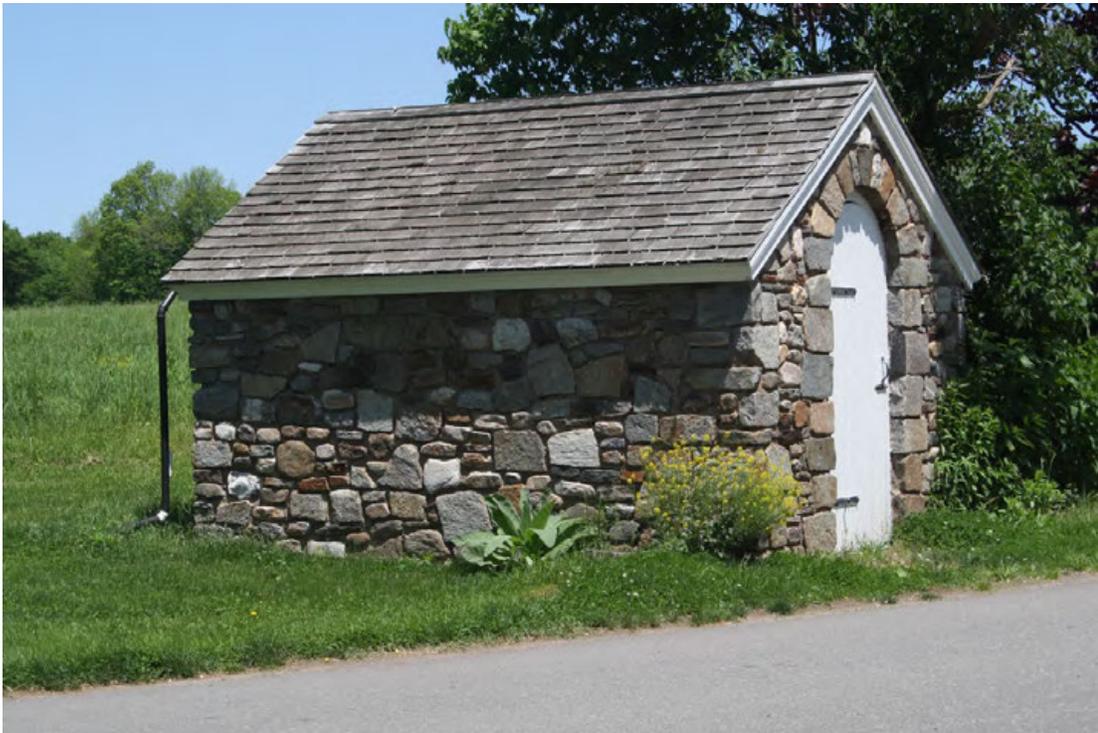
12. Stone shed, camera facing north.

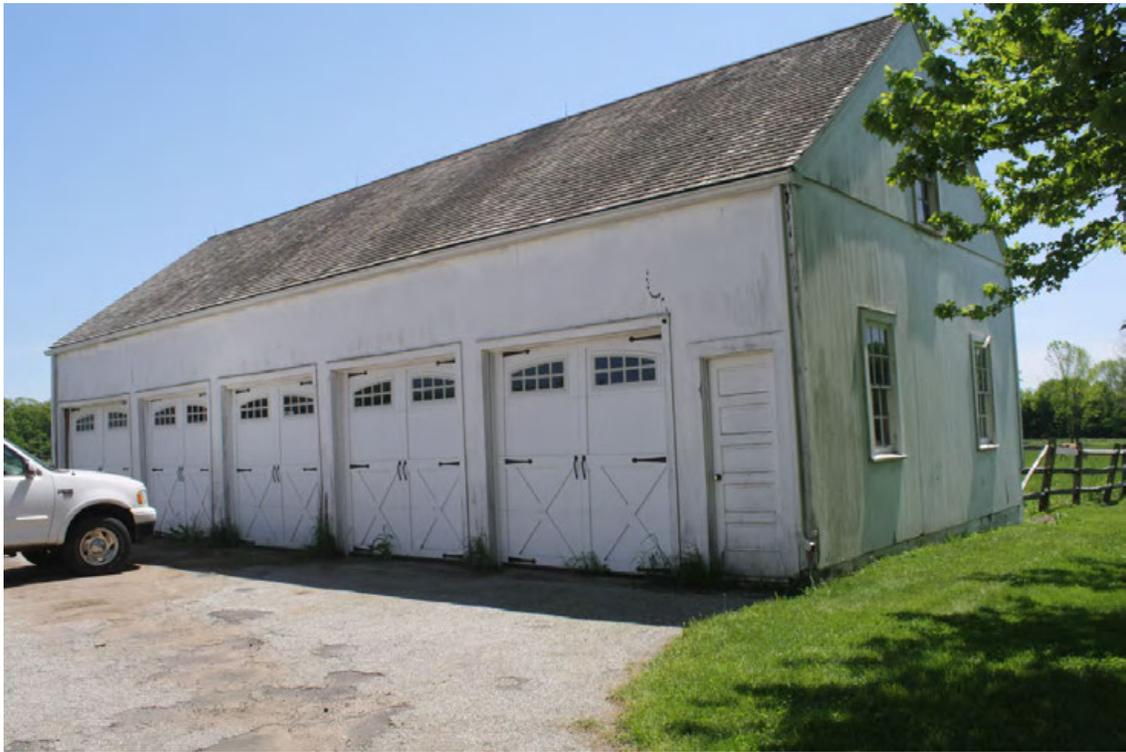
13. North eave-side of the five-bay garage, camera facing south.

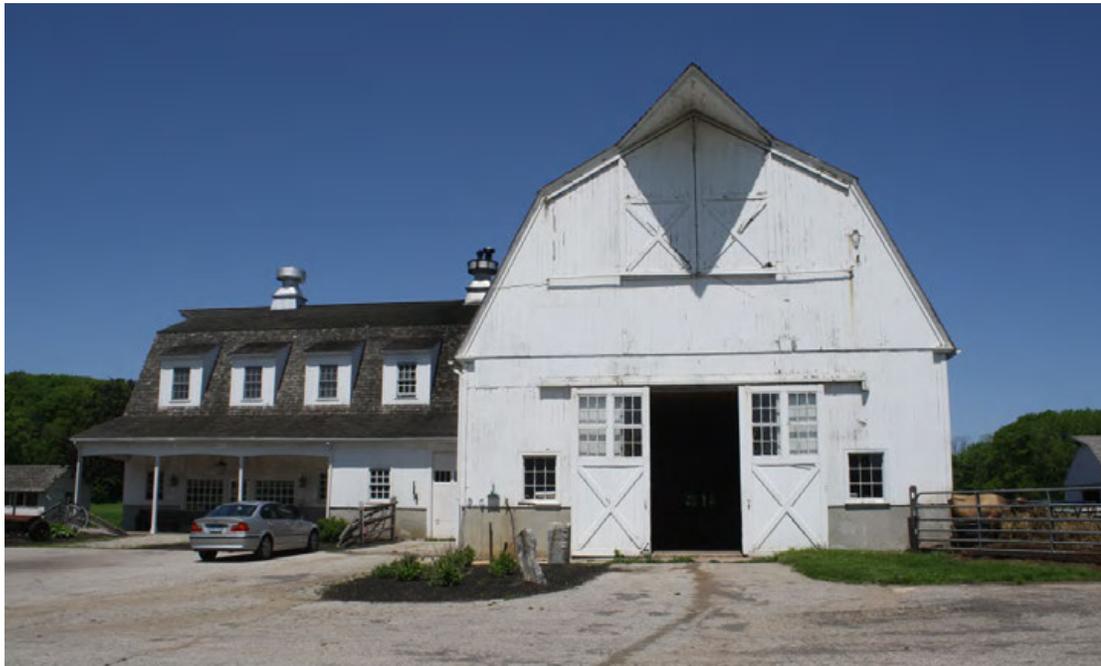
15. South gable-end of barn and addition, camera facing north. Note original diagonal sliding hay doors.

The main entry of the ground-level stable barn is a pair of exterior sliding doors in the center of the south gable-end. The top halves of the doors each have four sets of inset nine-pane windows while the lower halves are X-braced. Flanking the main entry are nine-pane windows with trim. The gable-end has small cornice returns at the eave line. The attic gable has a pair of centered, sliding hay doors. They are on an exterior track which follows the pitch of the roof. At the apex of the roof extending south is a hay hood.

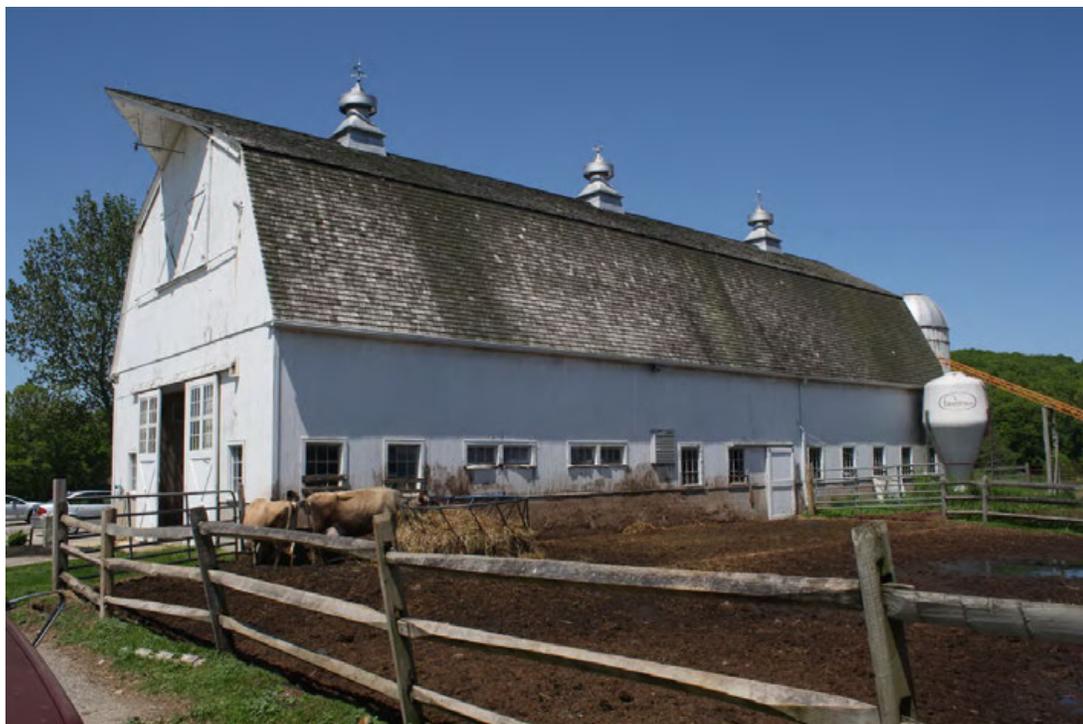
16. Southeast corner of barn, camera facing northwest.

The east eave-side of the ground-level stable barn has eleven sets of windows; the first two closest to the south corner are nine-pane windows with trim; the next two are sets of two-pane windows with trim; the rest are nine-pane windows. Between the fourth and fifth window is a metal louvered vent. Between the sixth and seventh window from the south is a sliding pass-through door. A small water tower is near the north corner.

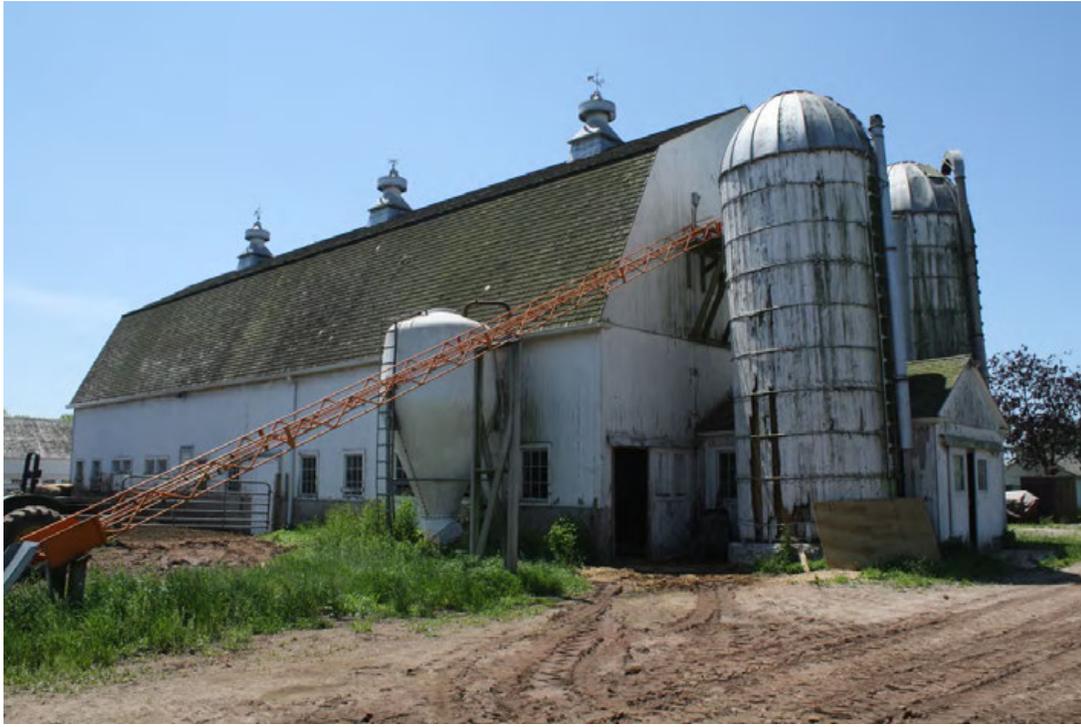
17. Northeast corner of barn and silos, camera facing southwest.

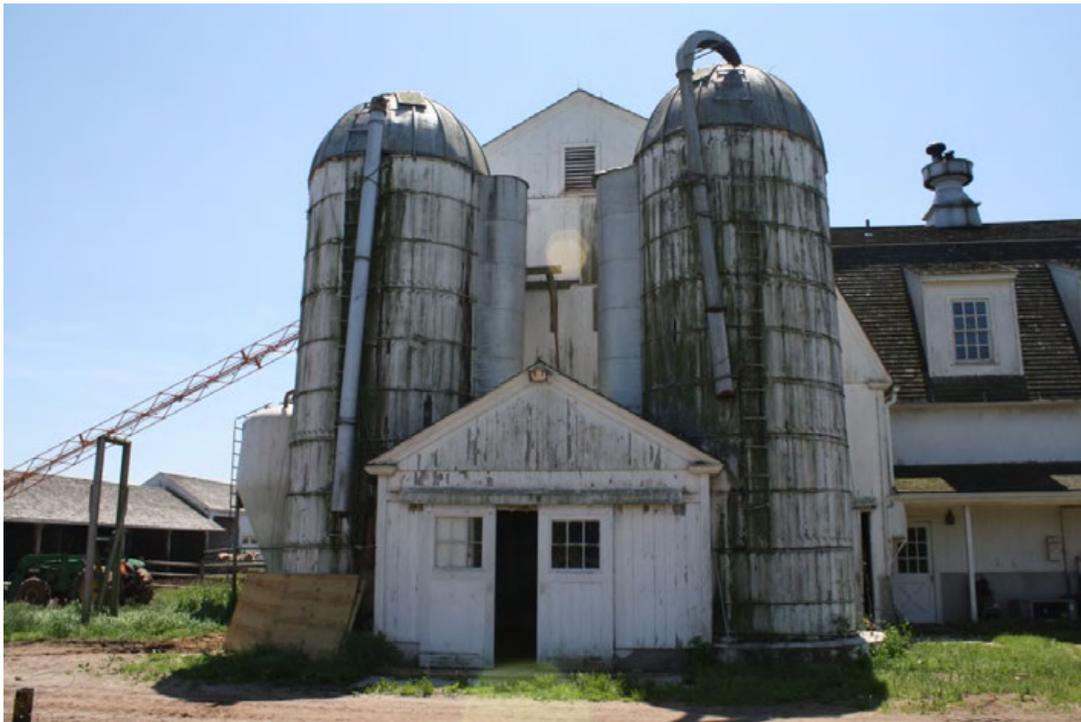
18. North gable-end of barn and silos, camera facing south.

The north gable-end of the barn has a centered gable-roof addition that is the entry into the barn and accesses the two silos, each one built partially into the east and west side of the addition. The north gable-end of the addition has a hooded, centered pair of exterior sliding doors. The addition has returning eaves and corner board trim. The silos are of vertical wood staves with iron hoops. In the 1990s, staples were added to the silos to aid in keeping the boards together. The eave-sides of the addition each have a nine-pane window with trim between the silos and the main block of the barn. The main gable-end of the barn has x-braced sliding doors towards the corners. Centered in the gable attic is a pair of hinged hay doors. Just beneath the roof peak is a louvered vent.

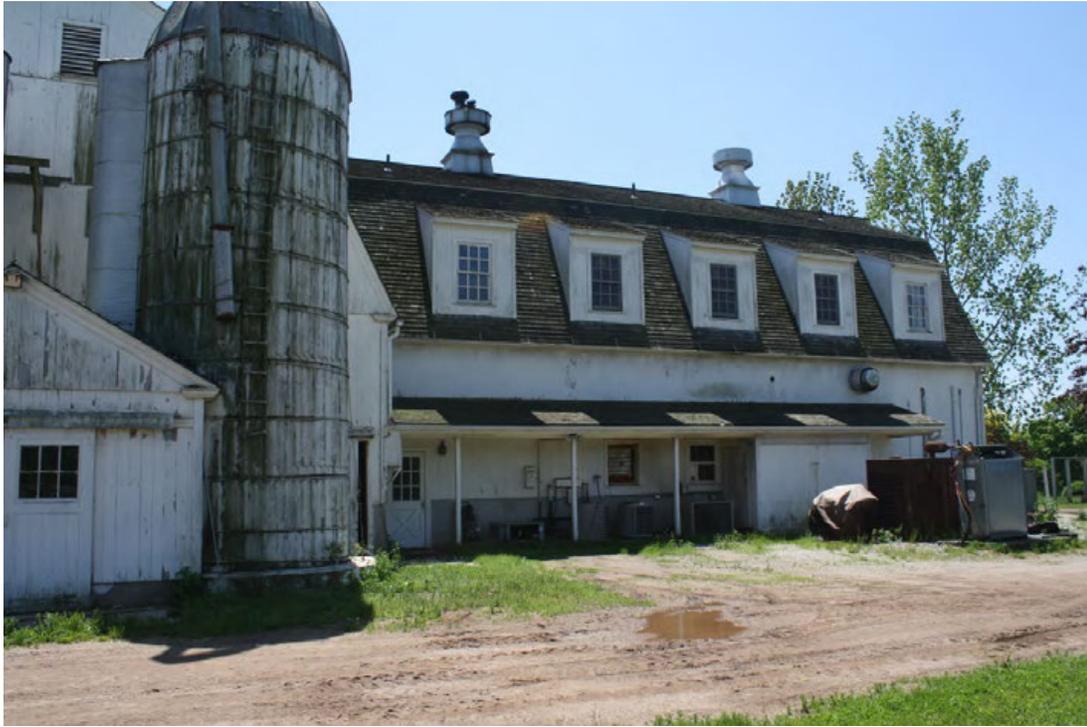
19. North eave-side of addition, camera facing south.

The gambrel-roofed addition is similar in appearance to the main block, although its ridgeline runs east-west instead of north-south. The north eave-side of the addition has a shed-roofed porch that extends to the north which encompasses most of the side. Beneath the leanto is a pass-through door, a louvered metal vent, a two-over-two double-hung window, a six-over-six double-hung window and an enclosed utility shed. Set in the lower pitch of the gambrel roof are four shed-roofed dormers, each with a centered six-over-six double-hung window.

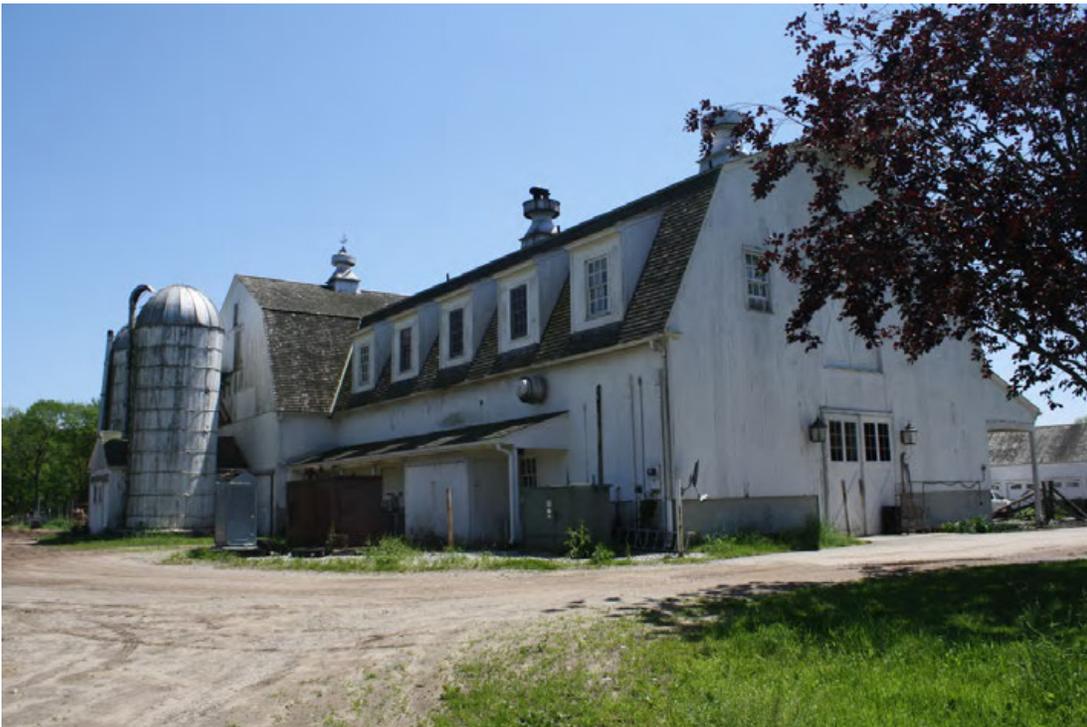
20. Northwest corner of addition, camera facing southeast.

This is a 2-story gambrel-roofed, ground level stable barn with its ridge-line oriented north-south. Extending west from the north half of the west eave-side of the barn is a gambrel-roofed addition which is used as retail and milk processing on the first floor and storage on the second. The barn measures 36' wide x 90' long. The main façade is the south gable-end of the barn. The barn is sheathed with vertical wood siding painted white. A three-foot-high poured concrete foundation is exposed around the entire barn as well as the addition. Atop the ridge of the roof are three metal ventilators. Atop the ridge of the addition are two metal ventilators.

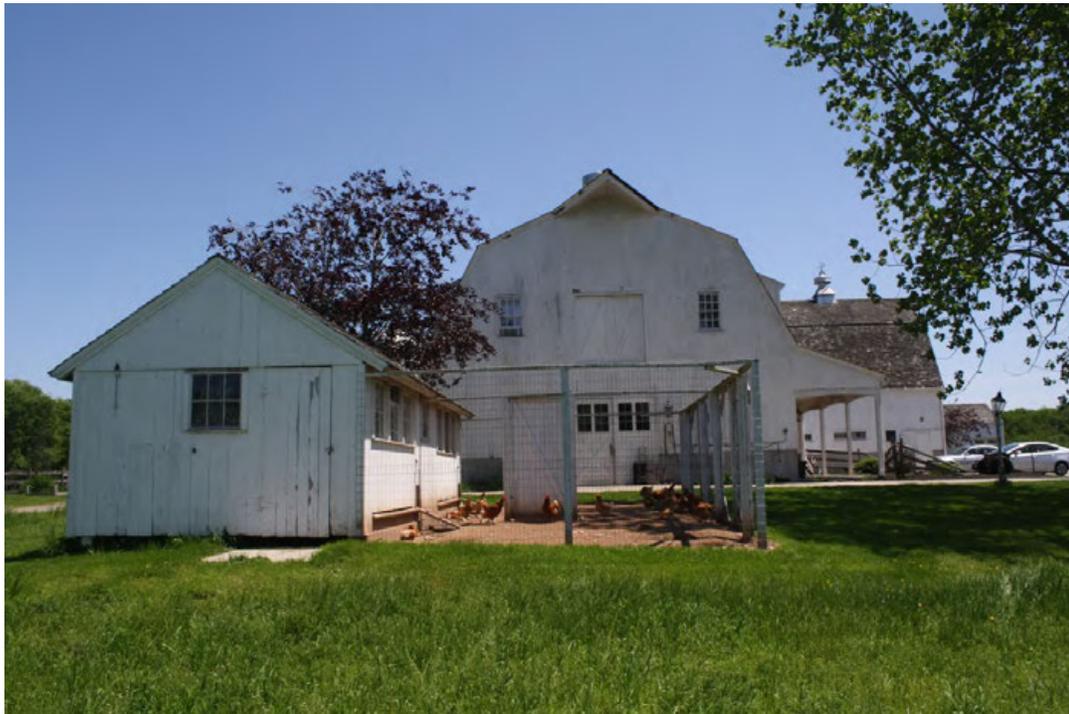
21. East gable-end of addition and Hen house, camera facing east.

The east gable-end of the addition has a centered pair of swinging hinged doors with x-braces, each with two inset eight-pane windows. Centered above in the gable attic is a pair of interior sliding x-braced hay doors. Flanking the hay doors are six-over-six double-hung windows. The roof has a hay hood and cornice returns at the eaves.

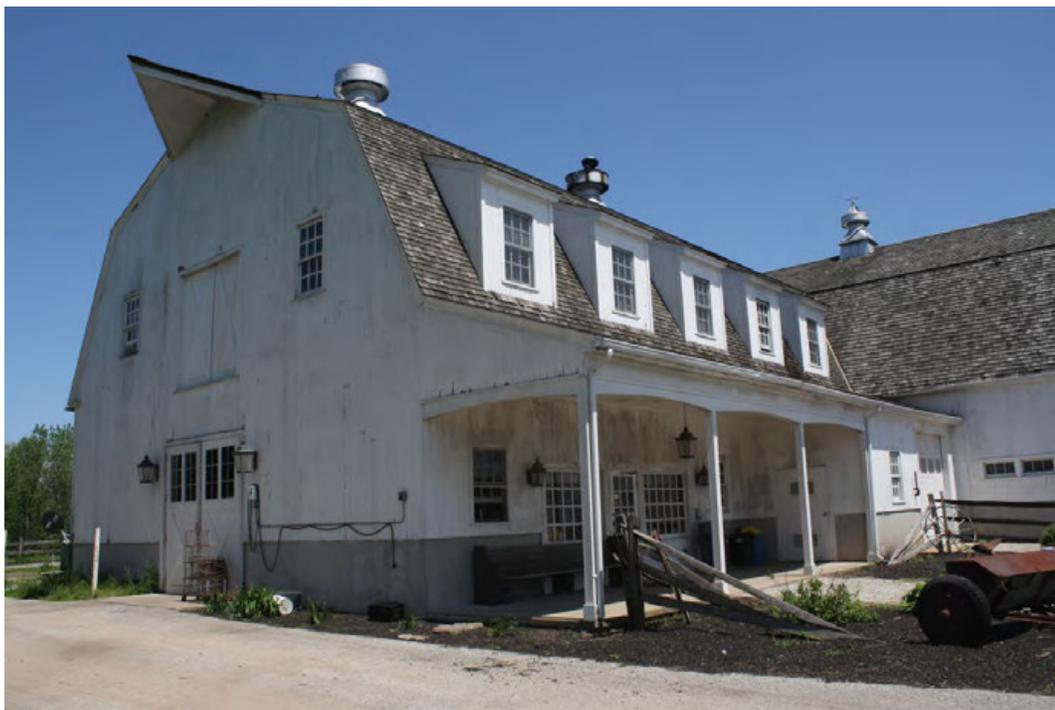
22. Southwest corner of addition, camera facing northeast.

Extending south from the south eave-side of the addition is a covered porch, partially enclosed to the east. The open portion is supported by three square posts. Beneath the roof is a centered pass-through door flanked by multi-panes windows. On both sides of the multi-pane windows are six-over-six double-hung windows. The enclosed area has a six-over-six double-hung window and a modern overhead garage. Set in the lower pitch of the gambrel roof are four shed-roofed dormers, each with a centered six-over-six double-hung window.

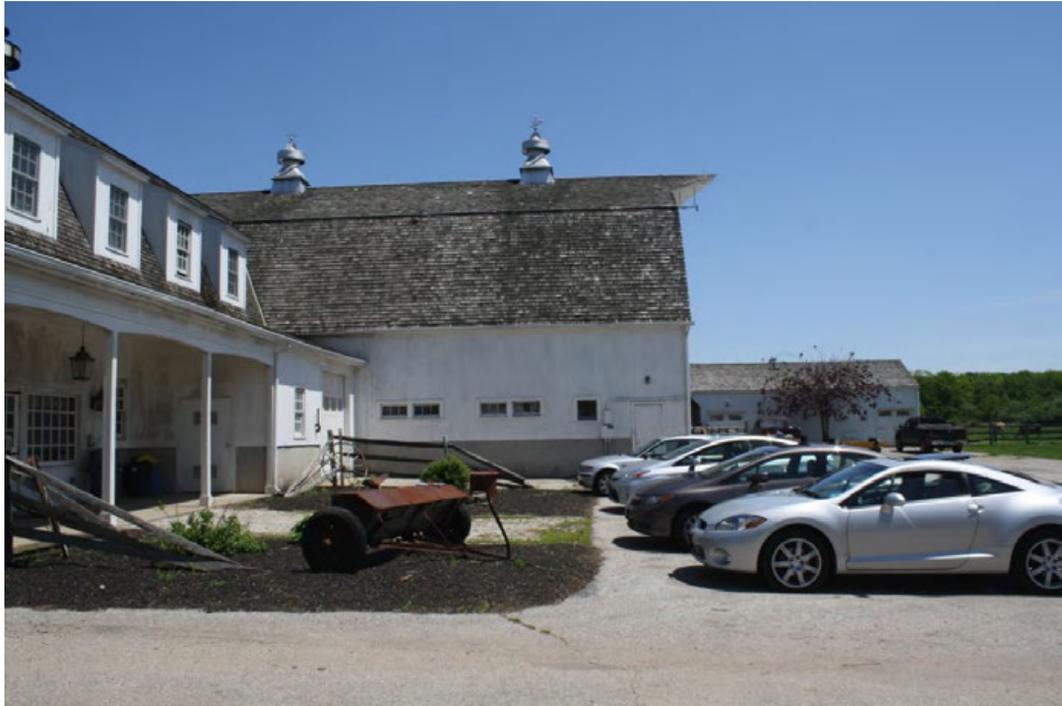
23. West eave-side of barn, camera facing east.

The north half of the west eave-side of the ground-level stable barn is encompassed by a gambrel-roofed addition extending to the west. The south half of the west eave-side of the barn has two sets of two windows, each with three horizontal sashes with trim, a square window with trim and a pass-through door at the southwest corner.

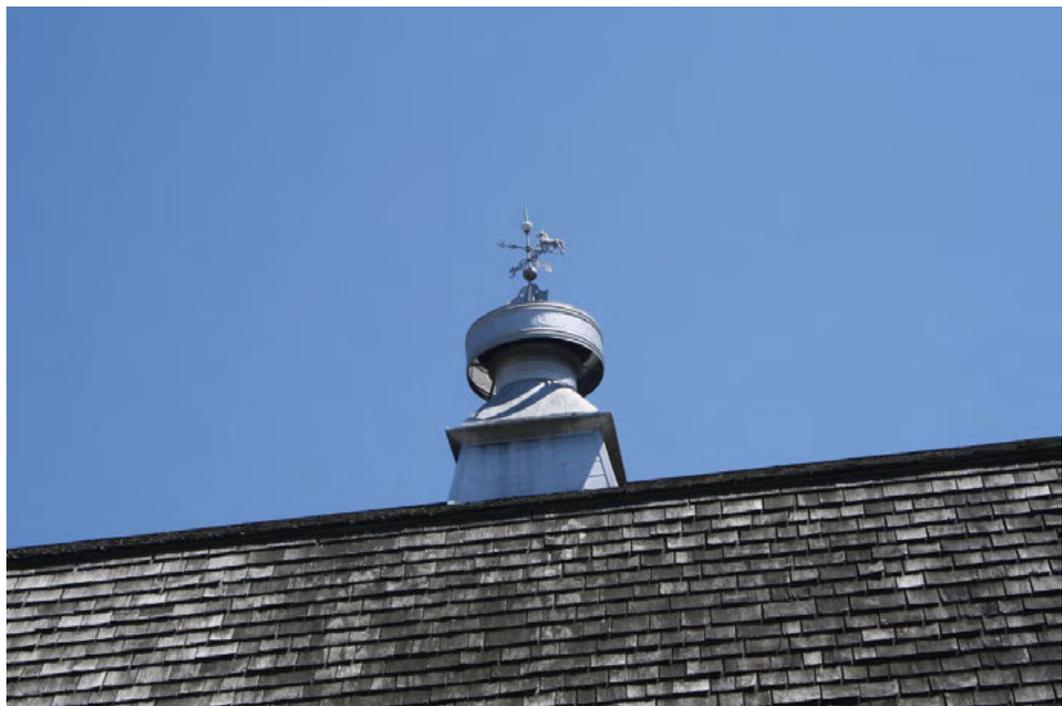
24. Detail of barn metal ventilator, camera facing east.

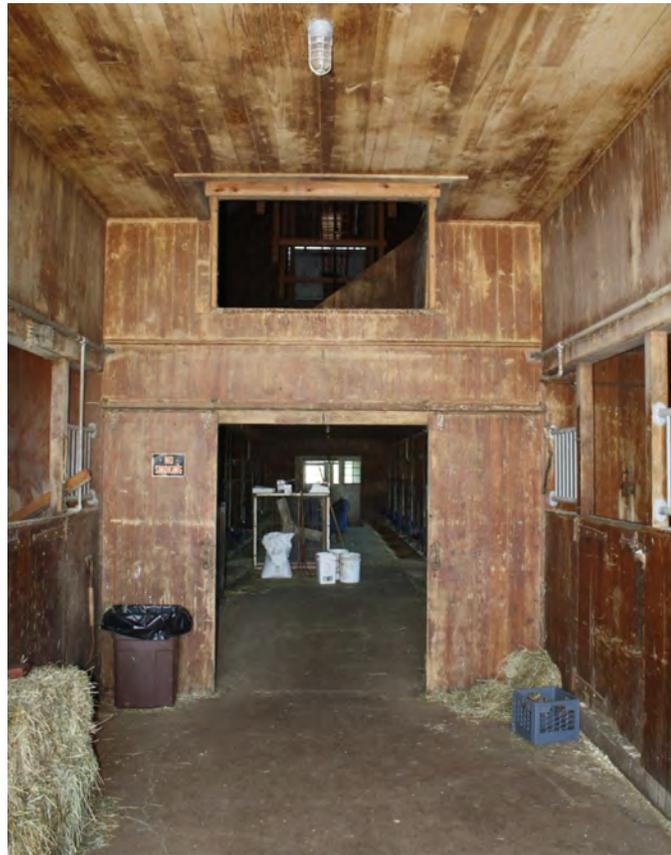
25. Interior of barn entry, camera facing north.

The main entry of the barn in the south gable-end opens into an eleven-foot-wide concrete-floored corridor flanked by a series of utility rooms and box stalls, terminating approximately thirty feet away at a set of sliding wood doors with a set of swinging hinged hay doors above, that access the gable attic. Along the west wall are an 11' x 6' tool room, 11' x 6' feed room and two box stalls, each measuring 11' x 10'. Along the east wall are 11' x 12' office and

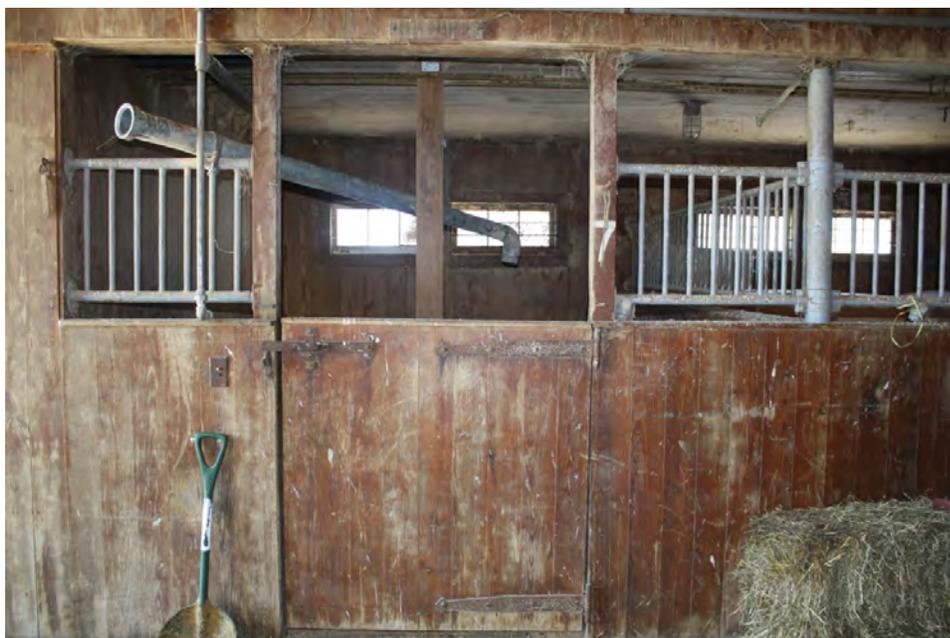
26. Detail of interior box stall, camera facing west.

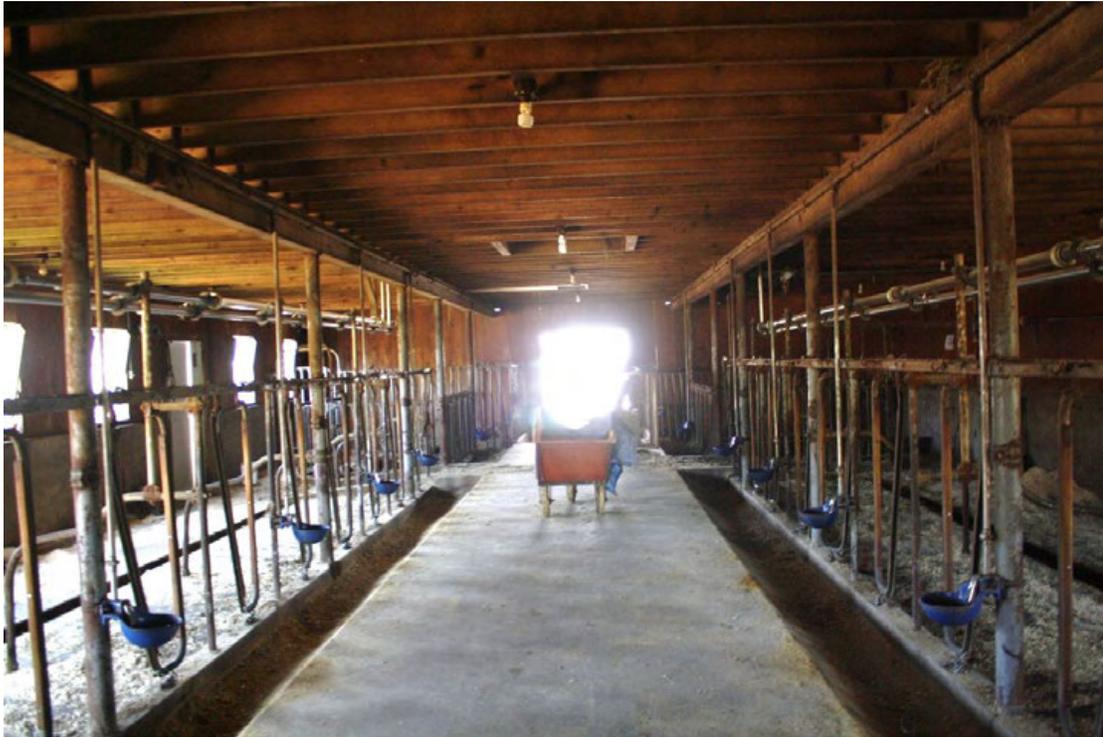
27. Interior of dairy stable with stanchions and center aisle, camera facing south.

The center aisle, 7' wide, runs to the north gable-end of the barn and is used as a feeding alley and is supported by 10" x 6" longitudinal girders. To the east and west of the alley are four 8' x 9' calf pens, two on each side. Further east and west are 4'-wide litter alleys between the pens and the exterior walls, which also run the entire length of the barn. Between the north wall and the calf pens are two rows of ten stanchions, one on each side. The concrete floor declines slightly to the north. Centered in the north wall is a wide sliding door that opens to the west. A small room, which has access to the silos, is beyond. The hopper windows have window shields. At the west corner of the cow stable is a doorway that leads to a stairway to the attic loft of the barn and to the addition.

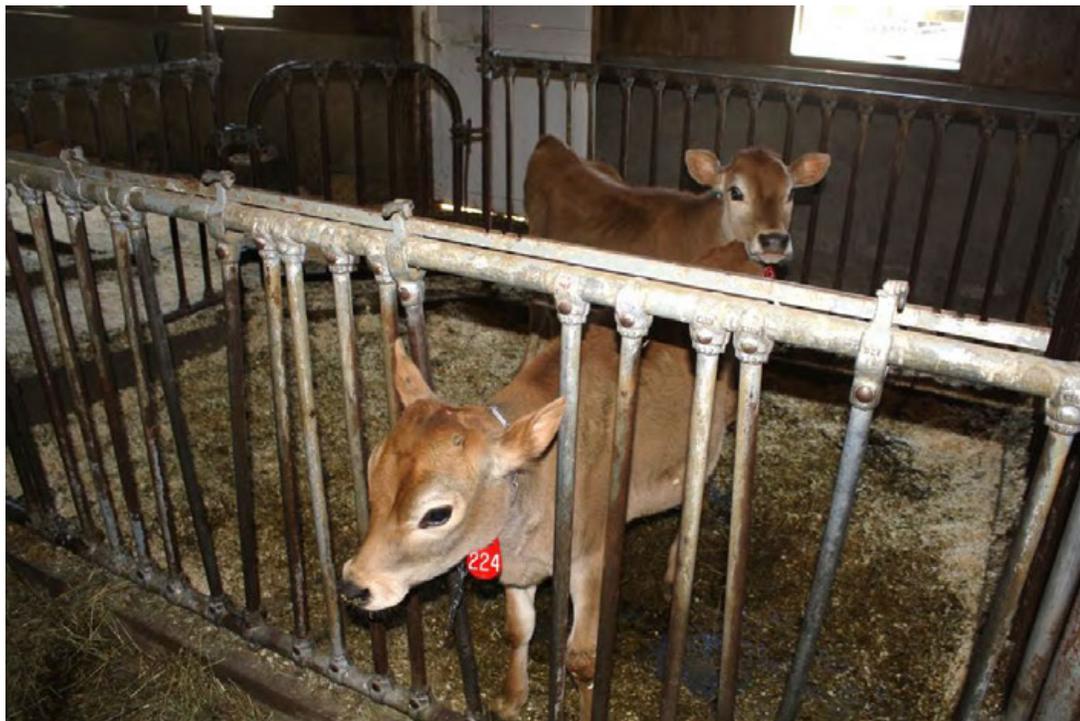
28. Detail of interior calf pen, camera facing east.

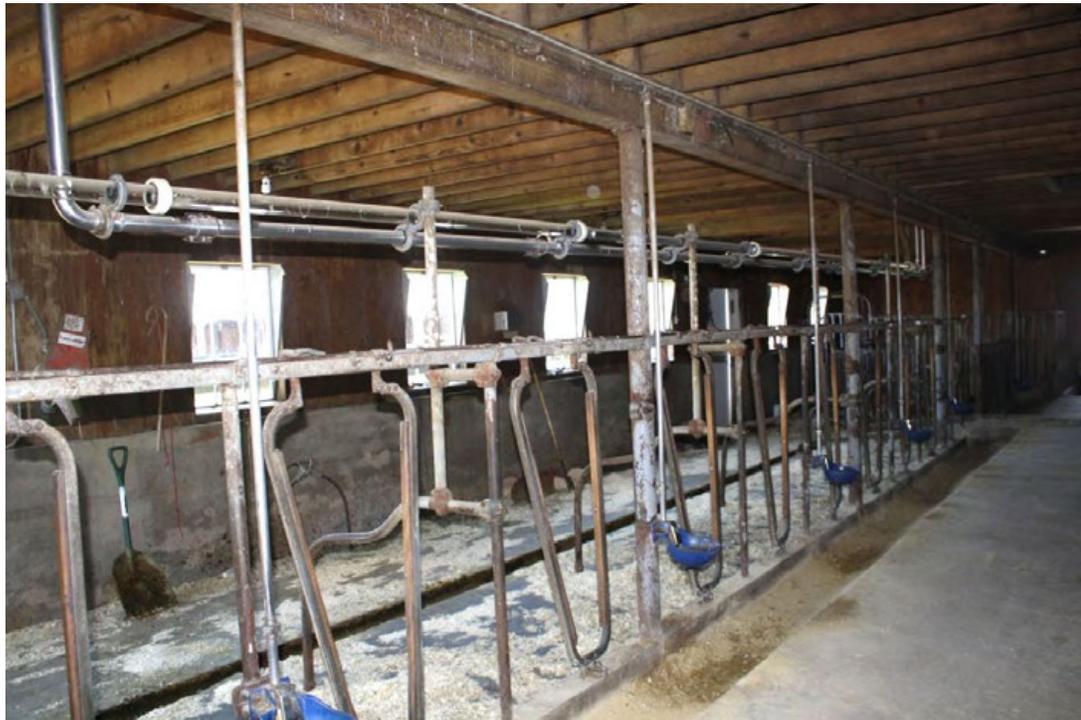
29. Interior detail view of stanchions, camera facing northwest.

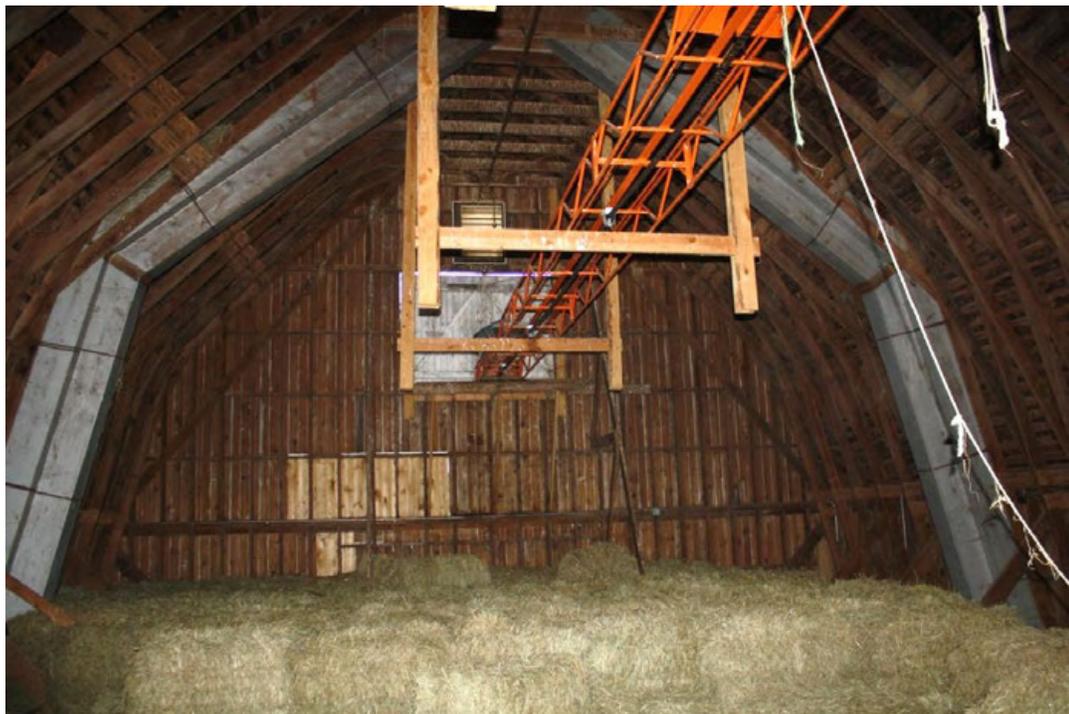
30. Interior detail view of attic loft, camera facing north.

The hay loft of the barn has two sets of two boxed wood vents that run along the wall and ceiling to the metal ventilators atop the ridge of the roof. The middle ventilator is open to the attic loft. The structure is made up of dimensional lumber and wire nails. The gambrel roof is made up of common rafters and a trussed roof, with a truss attached to each rafter. A large mechanical hay track extends the entire length of the barn.
