HISTORIC RESOURCES

BUILDING AND STRUCTURES

Building Name (Common) Fish Family Farm and Dairy Store Record No. 20987
 Building Name (Historic) White, Jabez Loomis, Farmstead
 Street Address or Location 20 Dimock Lane
 Town/City Bolton Village _____ County Tolland
 Owner(s) Donald Fish, 10 Dimock Lane, Bolton, CT 06043 Public Private

Style of building Gambrel ground level stable barn, Vernacular style Date of Construction 1938

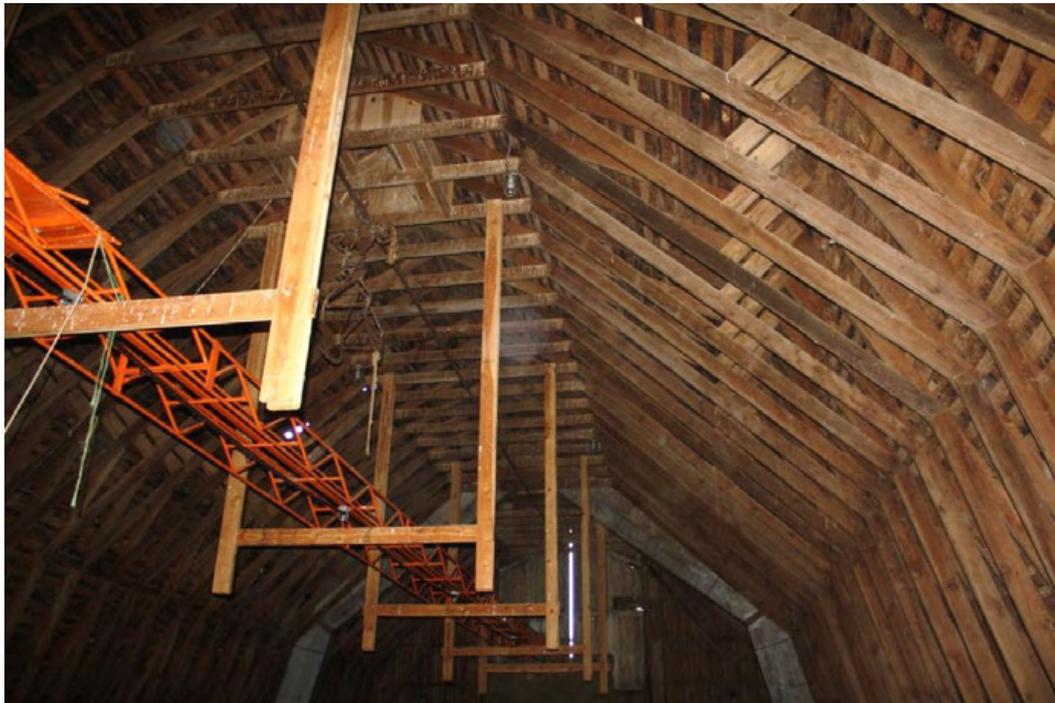
31. Interior detail view of attic loft, camera facing south.

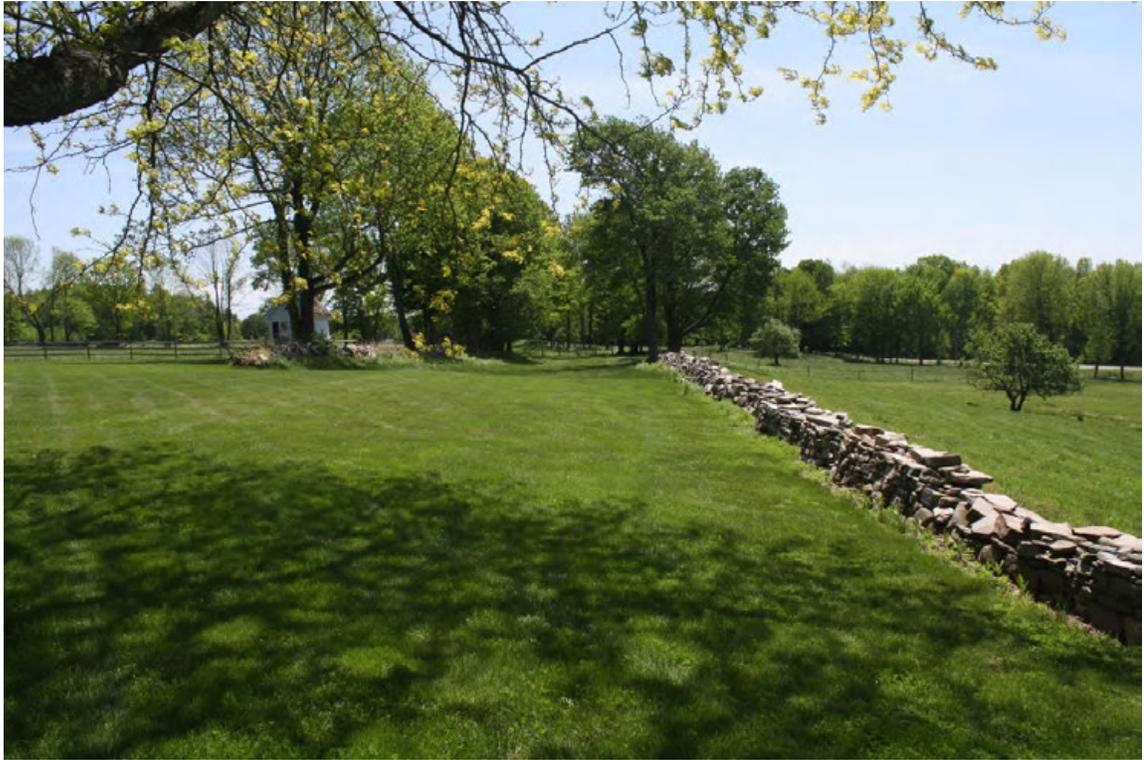
32. Revolutionary War period road lined with stone walls, camera facing south.

The original route of the road, dating to the Revolutionary War period, can be identified on site, bordered by stone walls (see photo), just south of the house, running toward the southeast. A historic map from 1892 shows how the road looped north to follow the contours of the land. By 1944 the main road, a state route, had been straightened, leaving Dimock Lane as a local side loop, and later the southern portion was abandoned. The west gable-end façade of the house faces toward the old route.

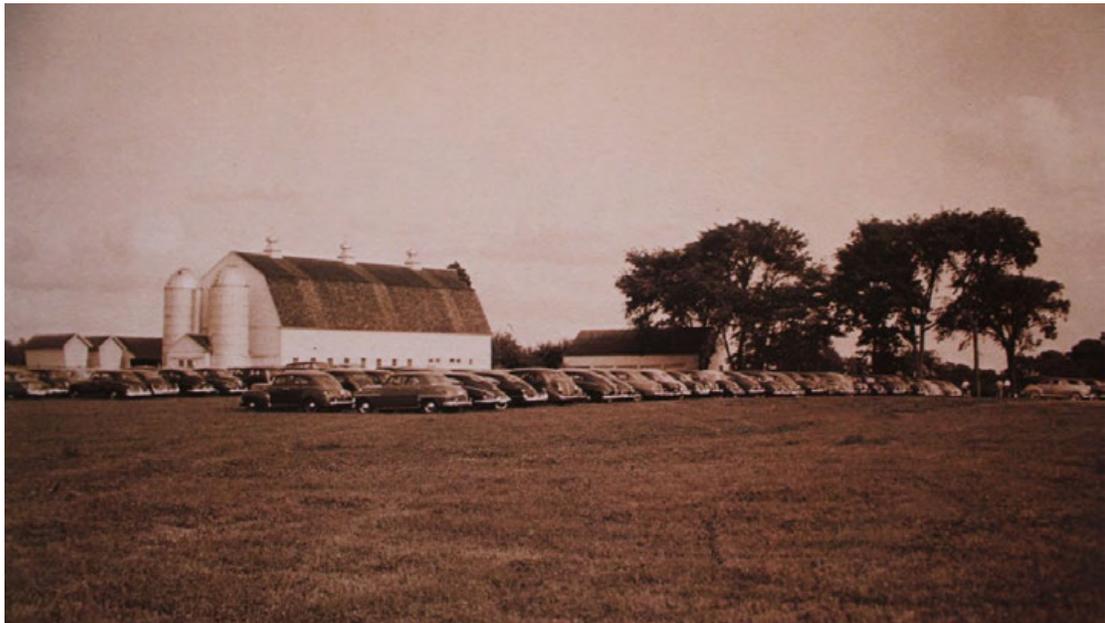
33. Historic photograph, courtesy of Bob Fish, circa 1950s. Northwest view of main barn prior to construction of the addition.
