HISTORIC RESOURCES **BUILDING AND STRUCTURES**

Building Name (Common) South Farms Record No. 42767
 Building Name (Historic) Feldsher, Aaron and Bernard, Farmstead
 Street Address or Location 131 South Street
 Town/City Morris Village _____ County Litchfield
 Owner(s) Erica & Corey Matthews, 131 South Street, Morris 06763 Public Private

HISTORIC RESOURCES INVENTORY FORM – BUILDING AND STRUCTURES continuation sheet

131 South Street, Morris CT

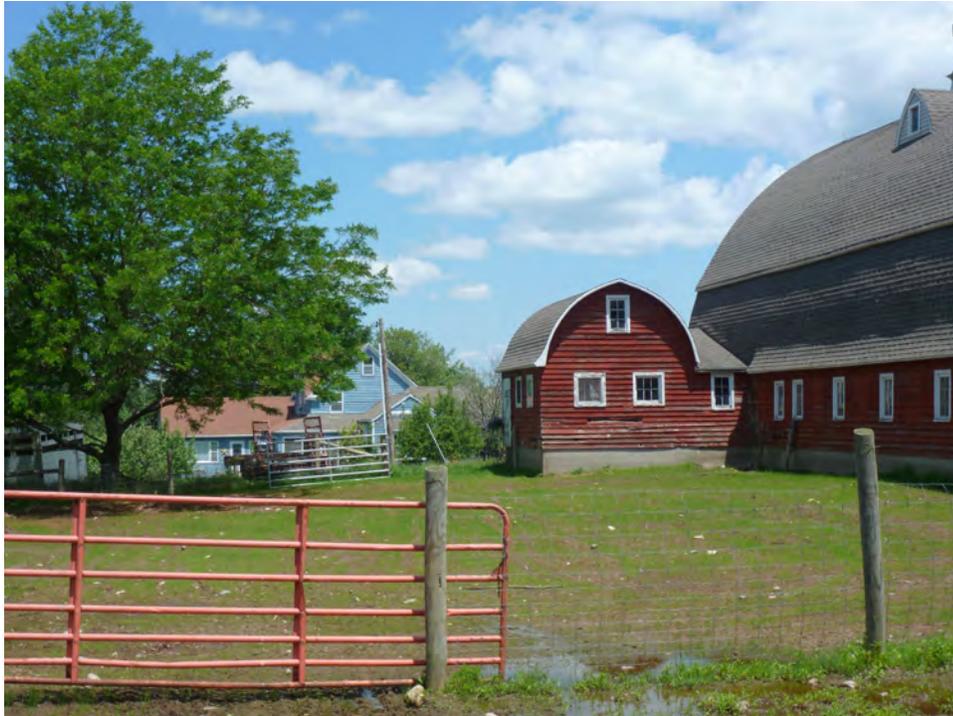
8. South context view of the Farmhouse (in the distance on the left) and the Barn (on the right) with the Milk room addition. Camera facing north.

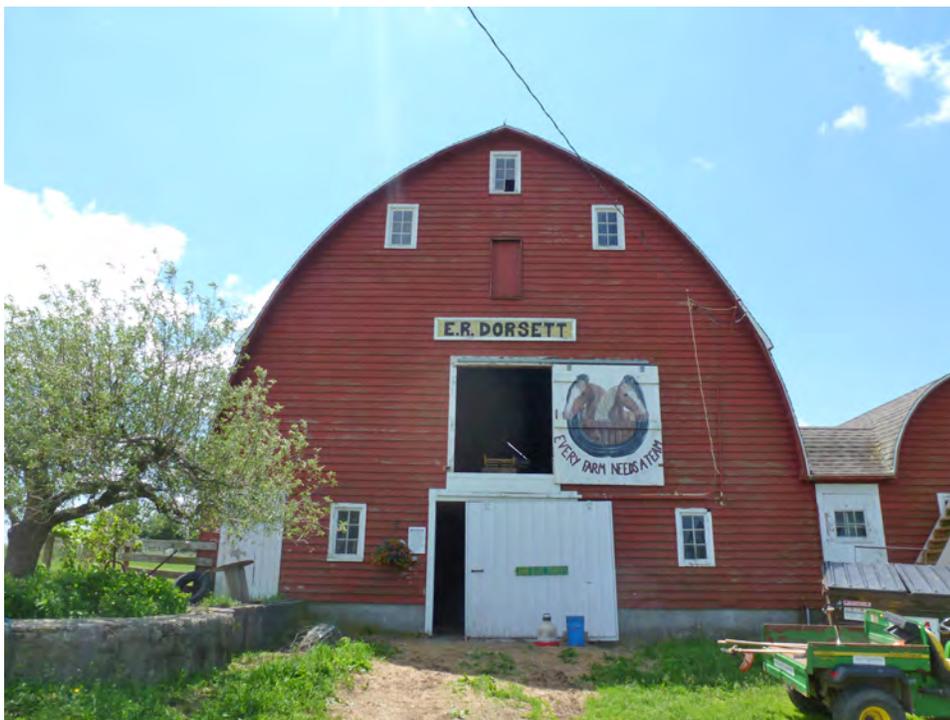
16. North gable-end of the Barn. Camera facing south.

The north gable-end of the barn has an centered exterior-hung sliding-door at grade. It is flanked by two six-pane windows with trim. Just above the entryway is an exterior-hung sliding-hay door with a mural painting of horses. A sign reading "E. R. Dorsett" hangs above the hay door. A small rectangular hay door is just above the sign and three

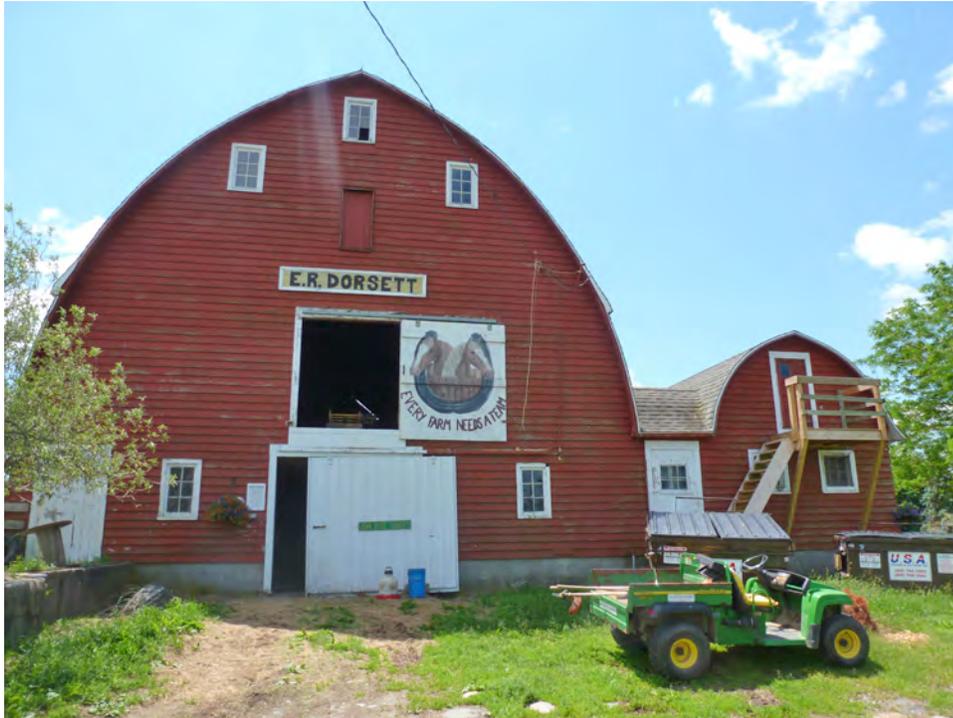
17. North gable-end of the Barn and north gable-end of the Milk room addition. Note the connector with the pass-through door. Camera facing southwest.

six-pane windows with trim are in the gable attic. Near the east corner, at grade, is a concrete retaining wall extending to the north. A pass-through door is on the east corner of the north gable-end of the barn.

A series of ten six-pane windows with trim run along the west eave-side of the barn. Two Gothic-roof dormers with single-pane windows are located on the slope of the roof on the west eave-side of the barn. On the north corner of this side is the addition, presumed to have been the milk room. This structure has a miniature Gothic roof with its ridge-line oriented north-south, parallel to the main barn. It has four six-pane windows with trim on the south side. Two six-pane windows and a pass-through door are on the west side. On the north side of the addition are two six-pane windows and a pass-through door that is reached by a wooden staircase. A pass-through door is in the passageway that connects the milk house with the barn. This connector is a 1-story structure with an asymmetrical gable roof, the south pitch being shallower than the north.

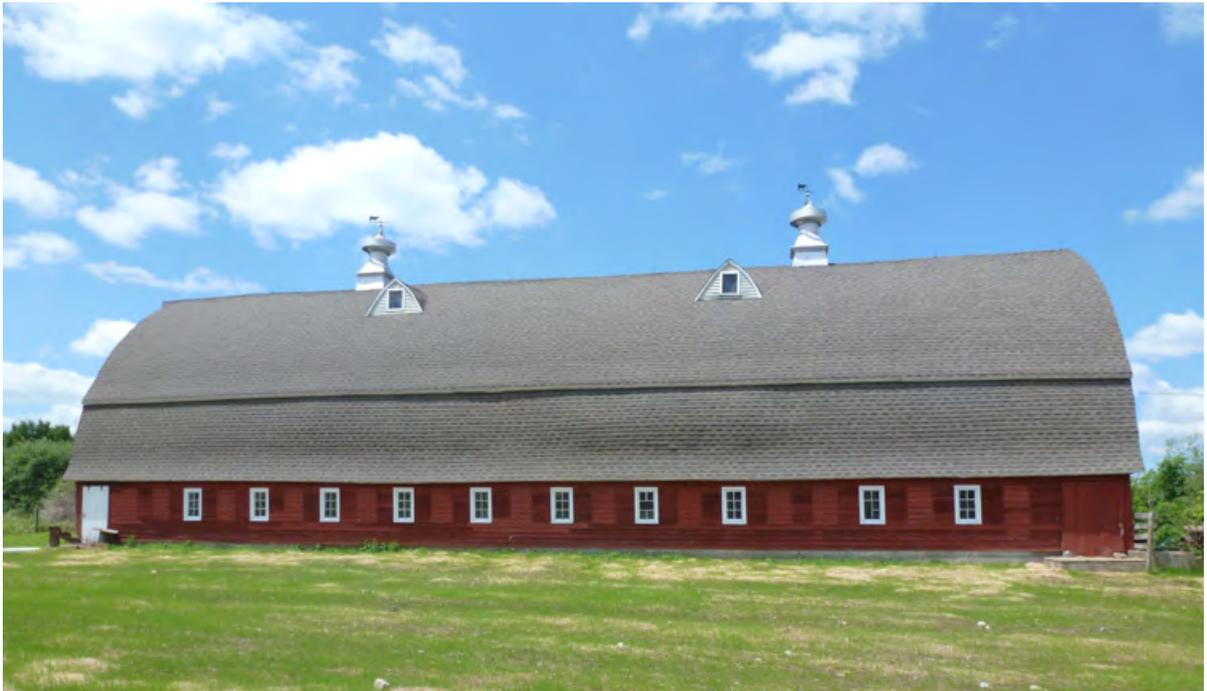
18. East eave-side of the Barn. Camera facing west.

An exterior-hung sliding-door is on the north corner of the east eave-side of the barn. A series of ten six-pane hopper windows with trim run along this side. An exterior-hung sliding pass-through door is on the south corner of the east eave-side of the barn. On the slope of the roof are two gothic-roof dormers with a single-pane window in each.

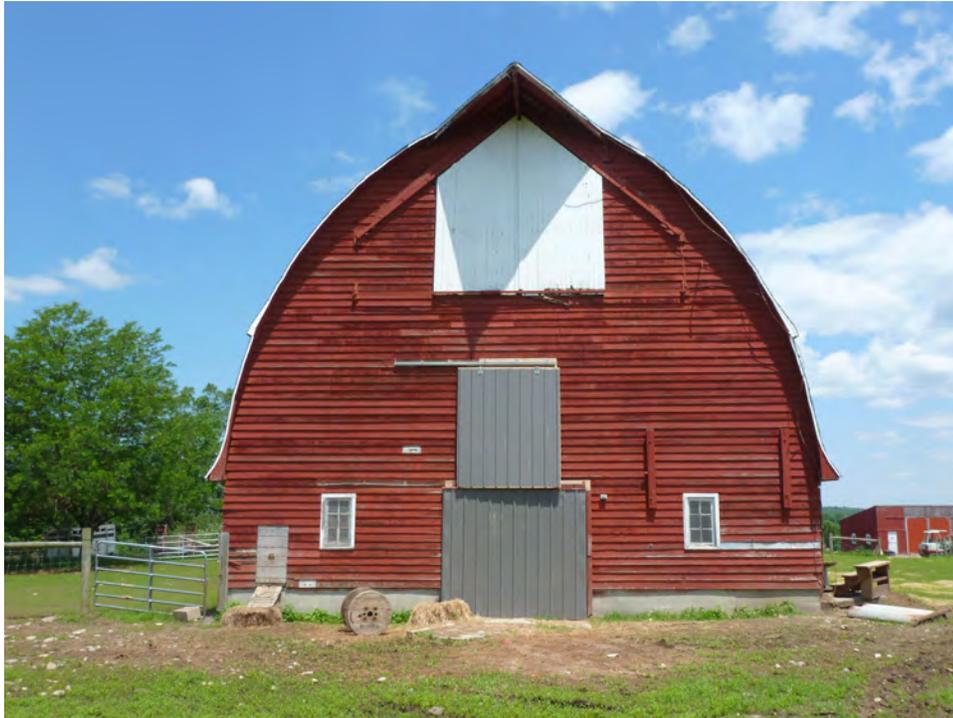
19. South gable-end of the barn. Camera facing north.

An exterior-hung sliding door is centered on the south gable-end of the barn. Flanking this entryway are two six-pane windows with trim. Just above the entry is an exterior-hung sliding hay door. In the gable attic is a pair of exterior-hung sliding hay doors that slide diagonally down and outward.

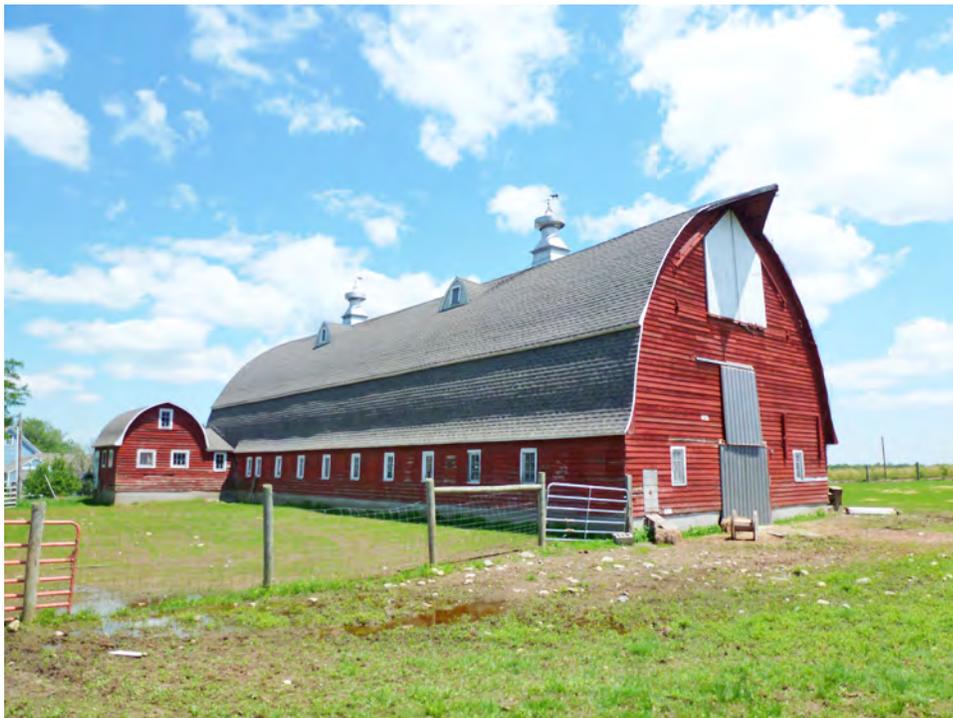
20. South gable-end and west eave-side of the Barn, and south gable-end of the Milk room addition. Camera facing northeast.

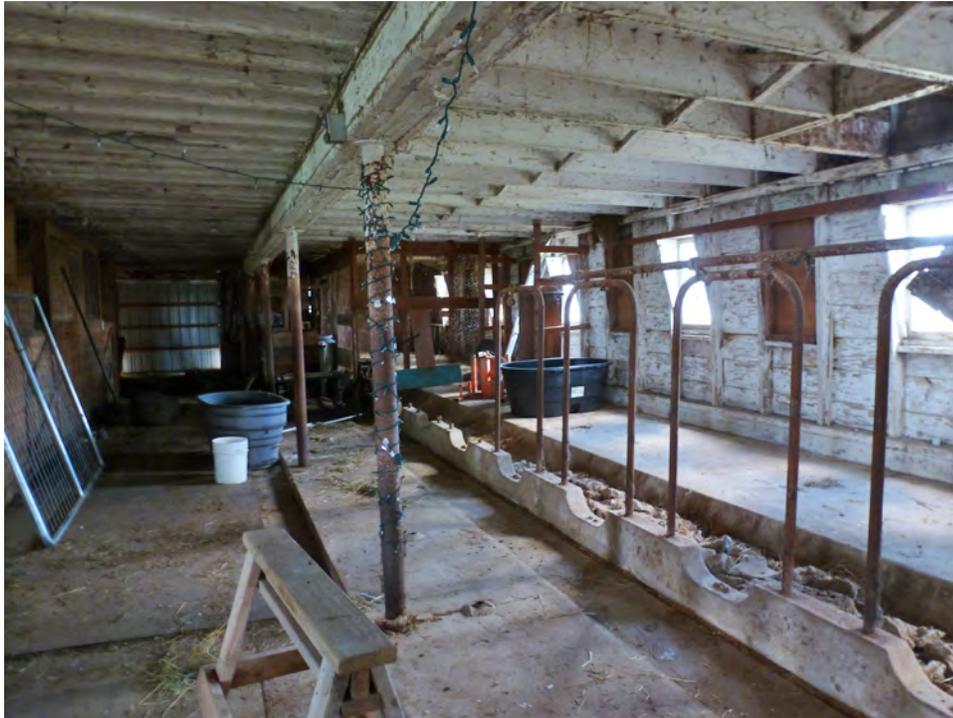
21. Interior view of the east side of the south end of the Barn ground level. Note the cow stanchions and hopper windows. Camera facing southeast.

The barn is accessed by the entryway in the north gable-end of the barn. The interior has concrete floors and wood plank walls. Two rows of steel columns support two longitudinal (north-south) girders. The wood joists supporting the loft level run laterally (east-west) and are carried on the girders and the exterior walls. Cow stanchions and a manure trough are still extant along the east eave-side of the barn, laid out for two rows of dairy cows facing outward. The interior walls and ceiling are unfinished and whitewashed. Horse stalls were added later to the south half of the west eave-side of the barn.

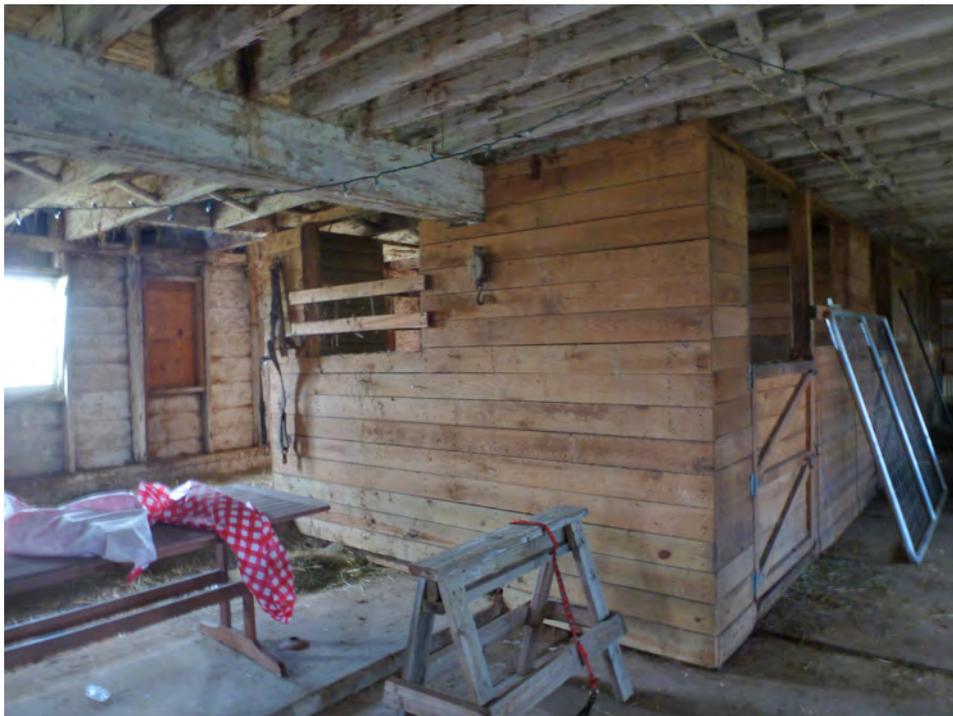
22. Interior view of the west side of the south end of the Barn. Note the horse stalls. Camera facing southwest.

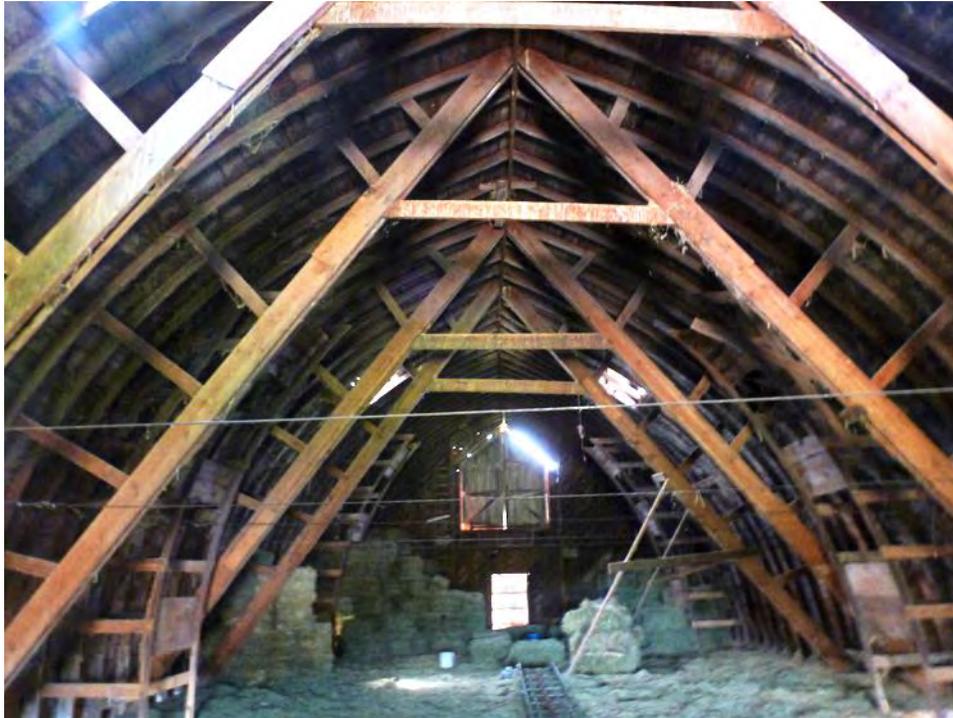
23. Interior view of the south gable-end of the upper loft level of the barn. Note the large A-frames helping to stabilize the barn, and the curved wood rafter arches. Camera facing south.

The upper level of the barn was originally used for loose hay but about two years after the barn was built, the owners switched to baling their hay instead of storing it loose. The balloon frame is visible in the upper level. Long curved wood rafters spring from the wood plank floor and meet at the peak. These rafters are constructed of laminated wood, meaning they are constructed of many thin layers of curved wood glued together. Large A-frame supports were added some time before 1975 to help stabilize the barn because the arched rafters were failing. Large ventilator shafts run along each eave-side of the barn. See the nomination for 78 Bill Hill Road, Lyme, for a similar structure.

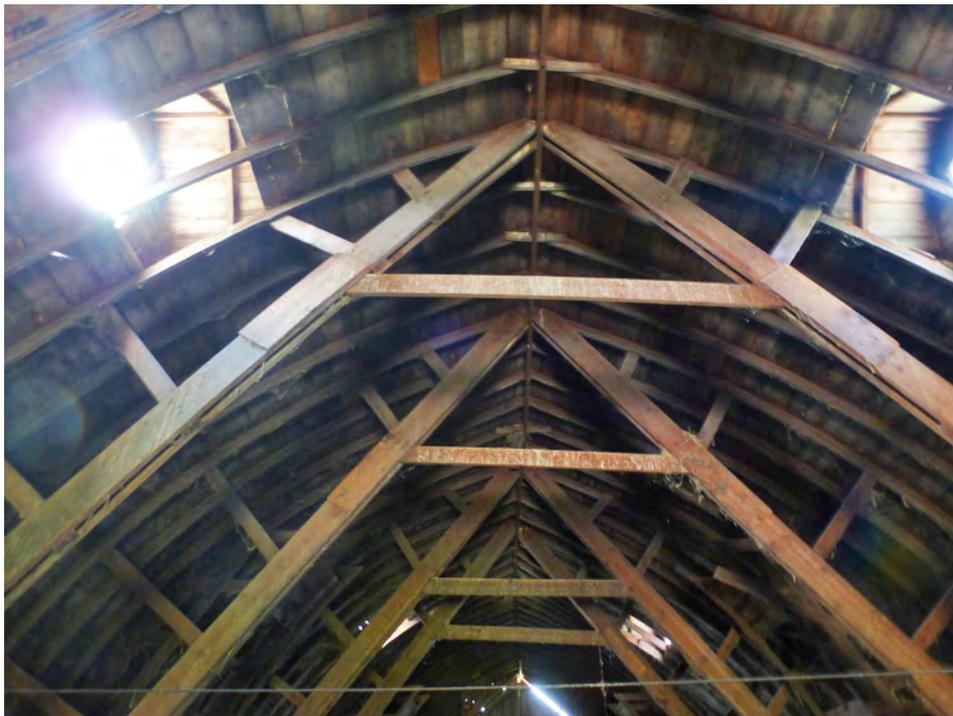
24. Interior view of the upper level of the barn. Note the curved wood rafters meeting at the peak with a hay track. Camera facing south.

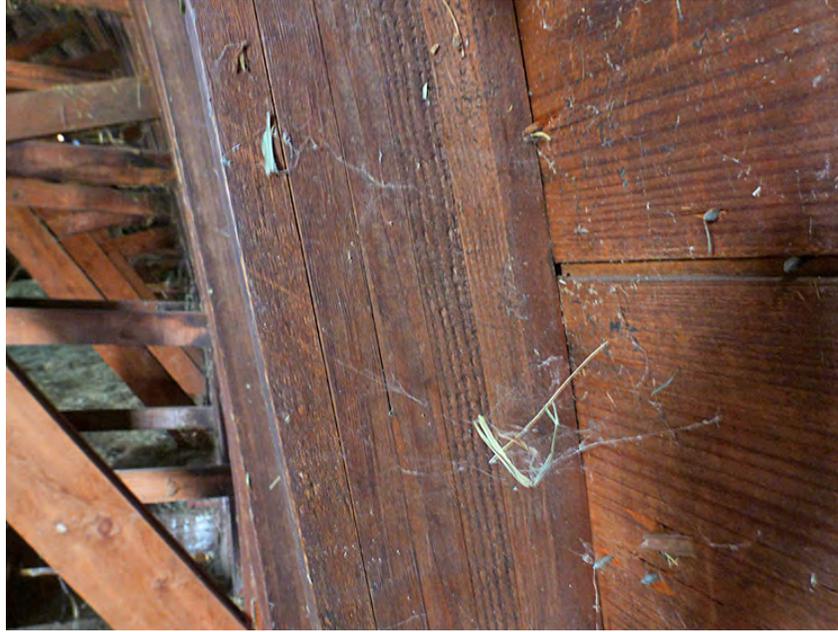
25. Interior detail view of a laminated arched rafter. Note the many thin layers of wood that are glued together to make the rafter.
