**HISTORIC RESOURCES**

Building Name (Common) Gambino, Robert and Kathy, Farmstead/Red Tobacco Barn Record No. 10160  
 Building Name (Historic) Morehouse, Seymour / Reynolds, Susan / Benedict, Jennie and William, Farmstead  
 Street Address or Location 4 Old Mill Road  
 Town/City New Milford Village Northville County Litchfield  
 Owner(s) Robert & Kathy Gambino, 4 Old Mill Road, New Milford CT 06776  Public  Private

Style of building Tobacco shed bank barn, Vernacular style Date of Construction c. 1880

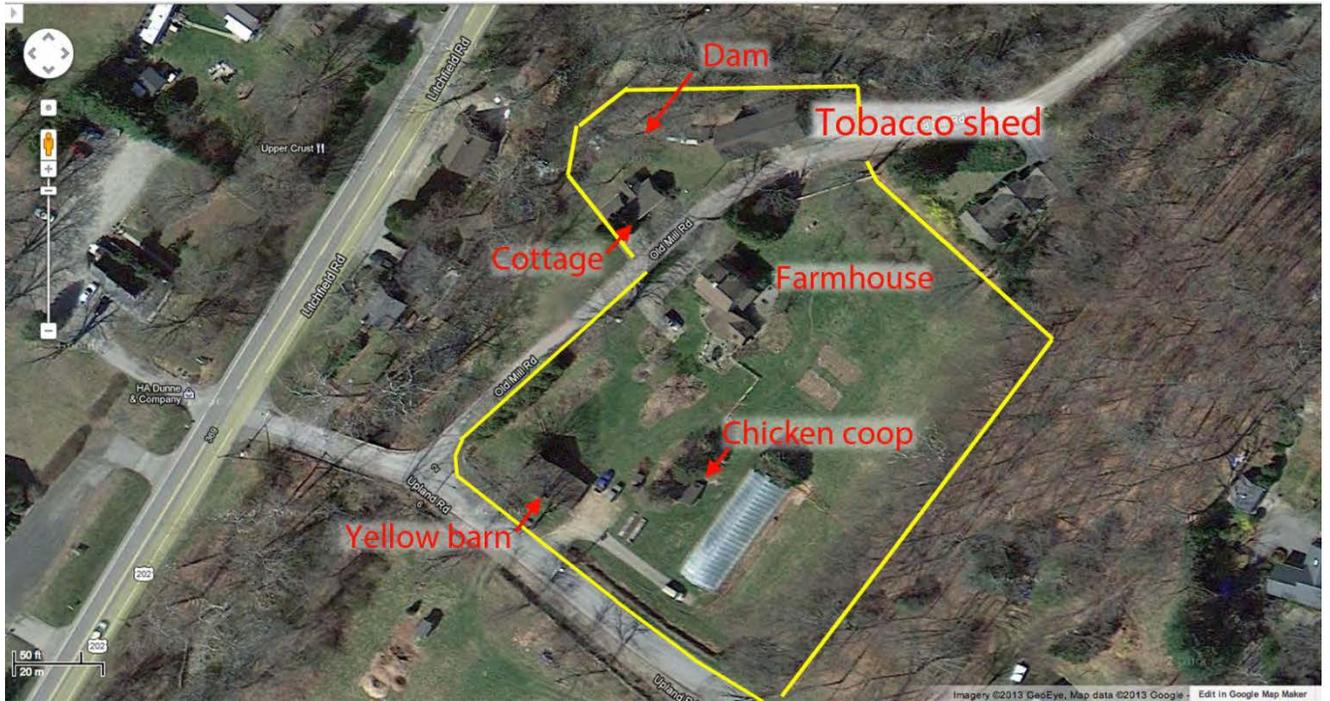
3. Site Plan Sketch showing contributing resources.

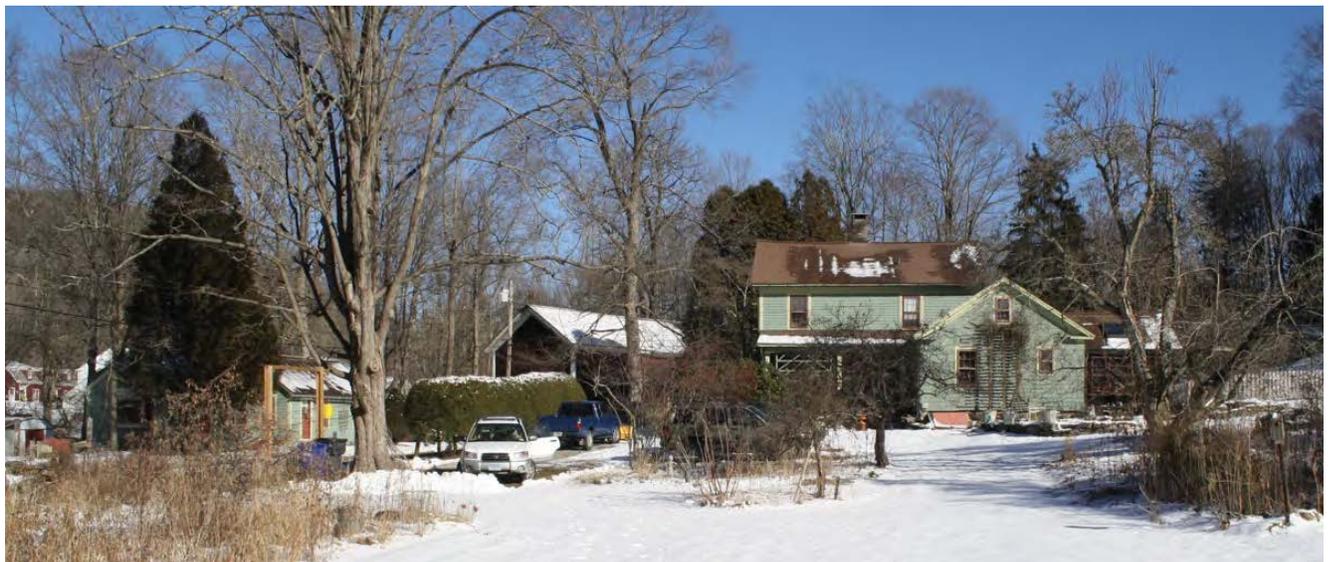
4. South context view, camera facing north. From left to right: the Cottage, Tobacco shed, and Farmhouse.

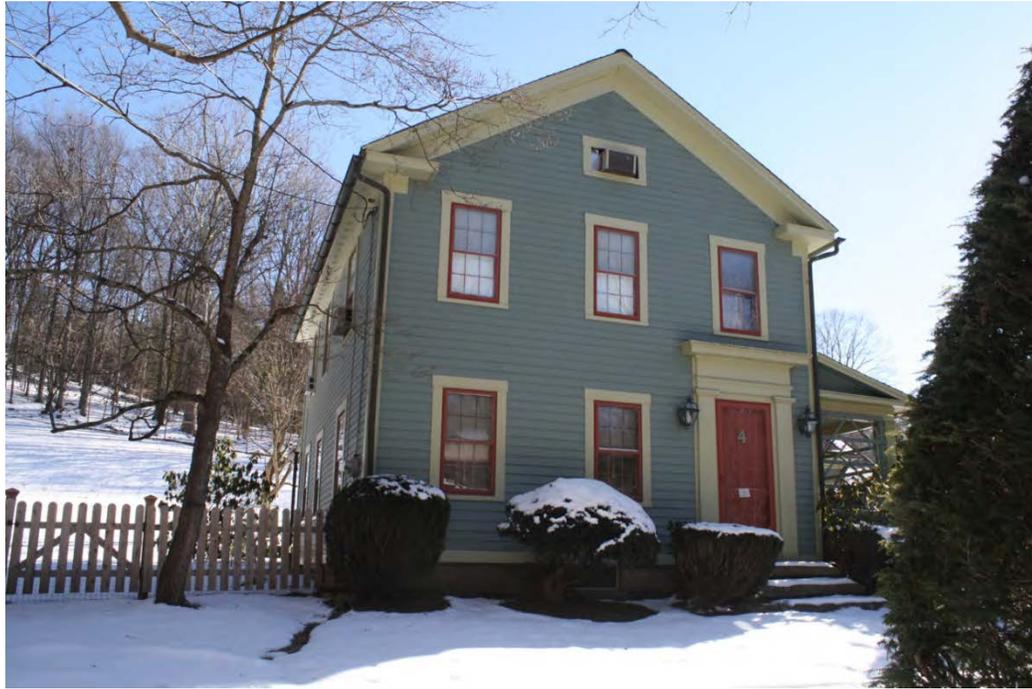
5. West view of Farmhouse, camera facing east.

The c. 1860 farmhouse at 4 Old Mill Lane is on the east side of the road, with its ridge-line oriented east-west and its west gable-end facing the road. The house is a 2 ½-story three-bay side-hall plan structure with its entry door in the right (south) bay. The doorway has a Greek Revival-style surround with pilasters, lintel, and a projecting cornice. Windows at the first and second floor levels are six-over-six double-hung; a rectangular attic window appears to be of Greek Revival style but has an air conditioner unit in the opening. The roof has overhangs at the rake and eaves with closed soffits, short cornice returns on the west façade, and simple molded trim and frieze boards. Siding is wood clapboards with corner board trim. There is a 1-story late 19<sup>th</sup>-century porch along the south eave-side and a 1-story ell projecting southward off the southeast corner. Roofing is asphalt shingles.

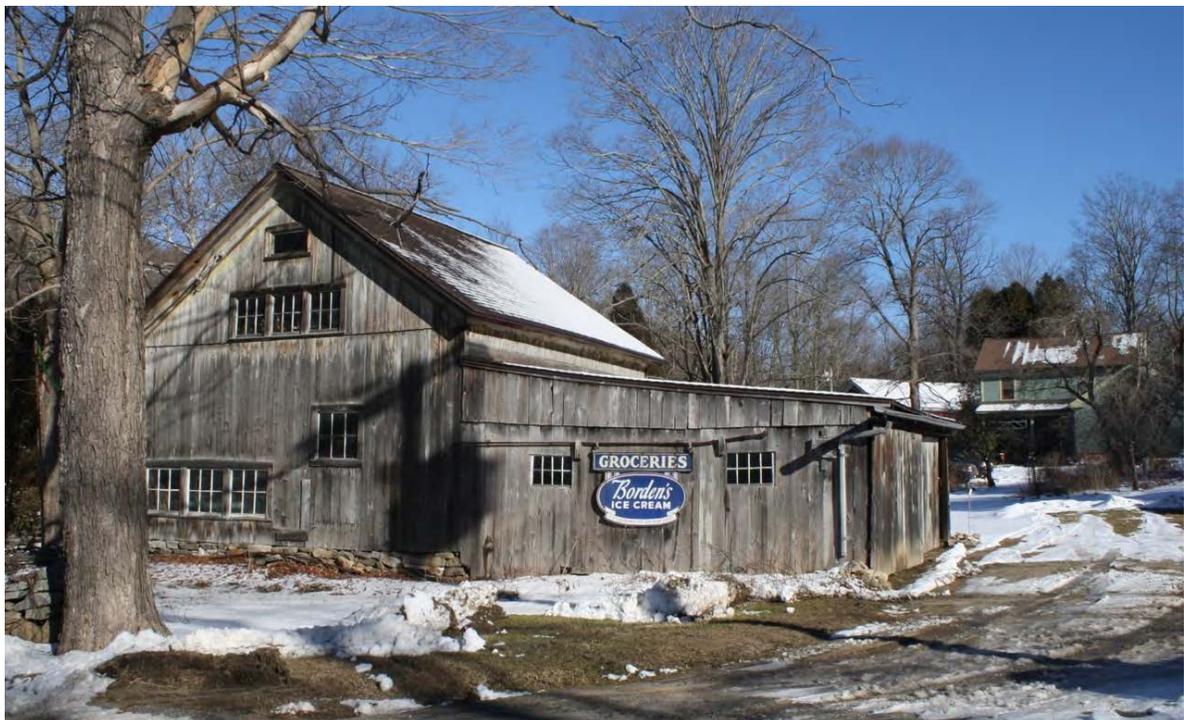
6. South view of Yellow barn, camera facing north.

To the south is an open field and a 1 ½-story two-bay gable-roofed barn, 22’ x 24’, known as the “Yellow Barn” (now faded) which is thought by the owner to have been built on the foundation of an earlier house. This barn has its ridge-line oriented north-south, a pair of sliding doors in the north gable-end, and is used for equipment storage. Three-unit panels of six-pane windows in the ground floor and attic of the south gable-end indicate a former use for poultry. There is a two-bay shed-roofed addition attached on the east side with sliding doors in the east eave-side. The barn interior has some elements of post and beam framing, mixed with sawn lumber elements including rafters and balloon-framed partitions. A small chicken coop and an outhouse are located to the northeast of the barn and a modern hoop-house-style greenhouse is at the southeast corner of the property.

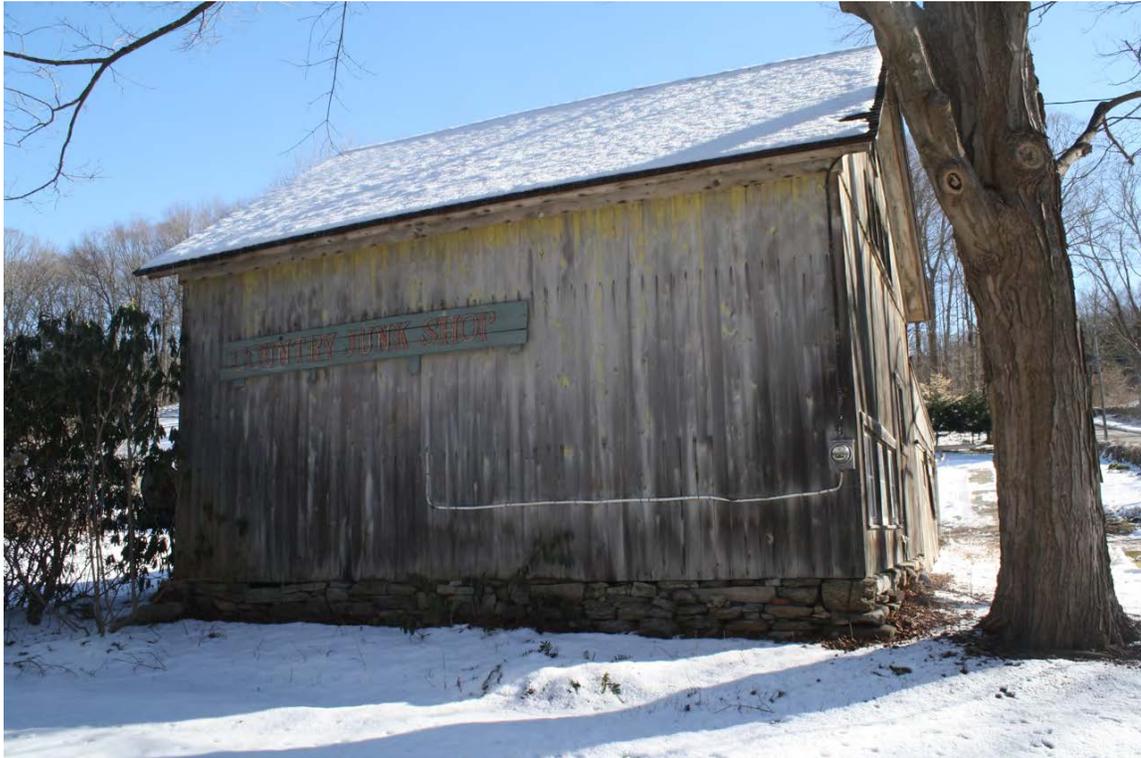
7. West view of Yellow barn, camera facing east.

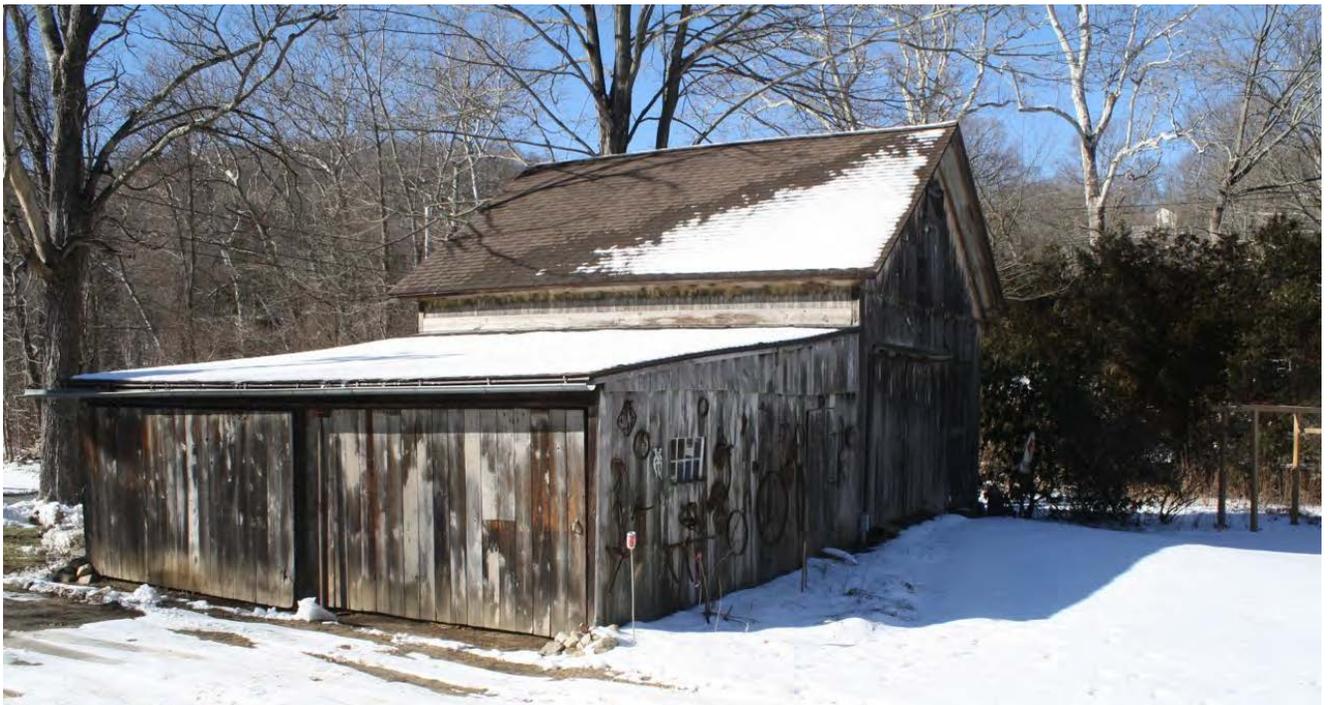
8. Northeast view of Yellow barn, camera facing southwest.

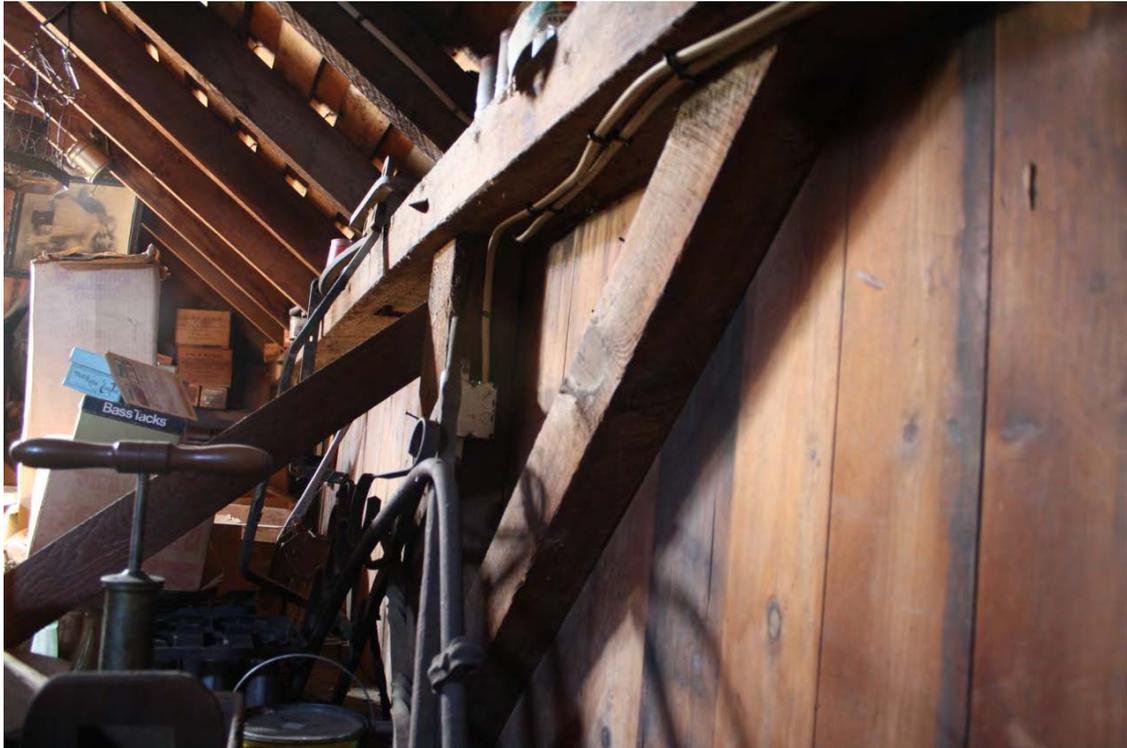
9. Interior view of Yellow barn loft level and roof framing, camera facing south.

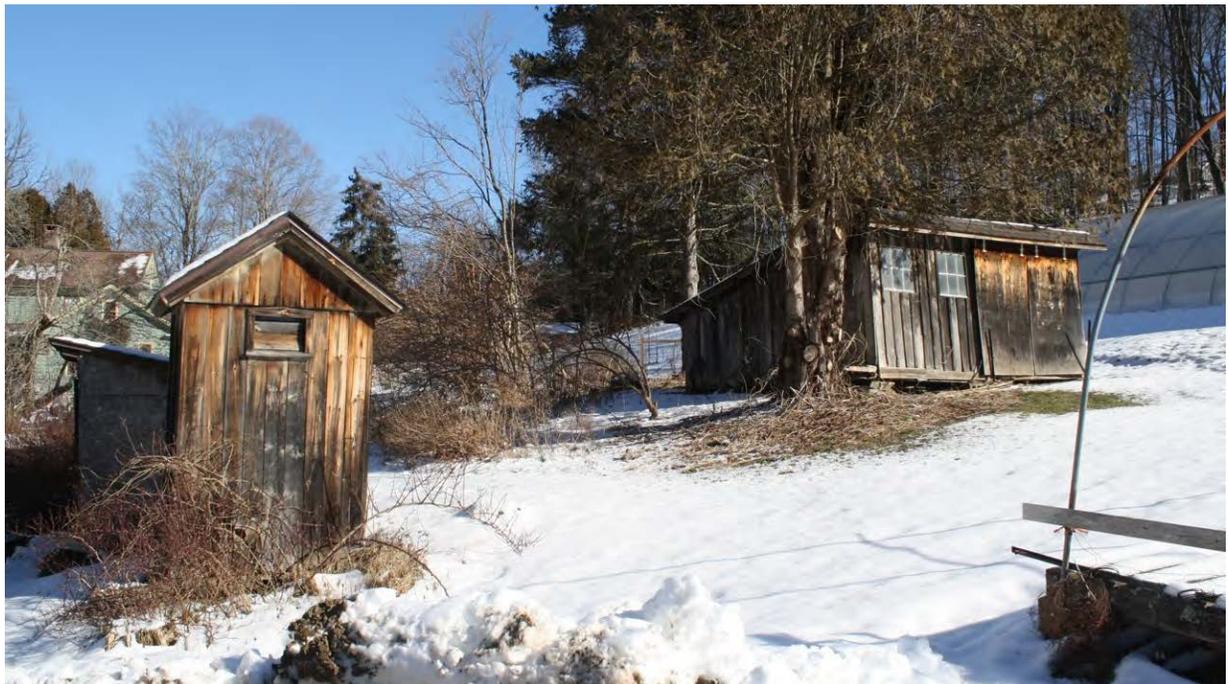
10. South view of Outhouse (left) and Chicken coop (right), camera facing north. Farmhouse is a far left rear.

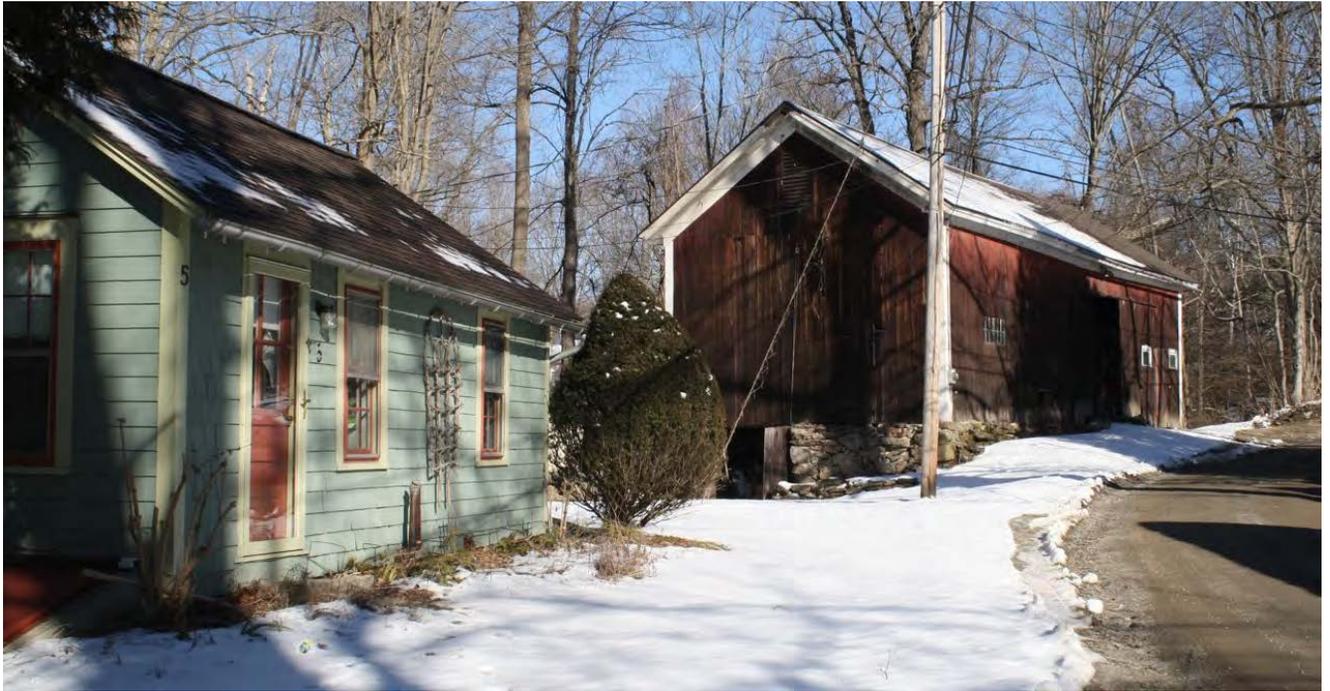
11. Southeast view of Cottage and Tobacco shed, camera facing north.

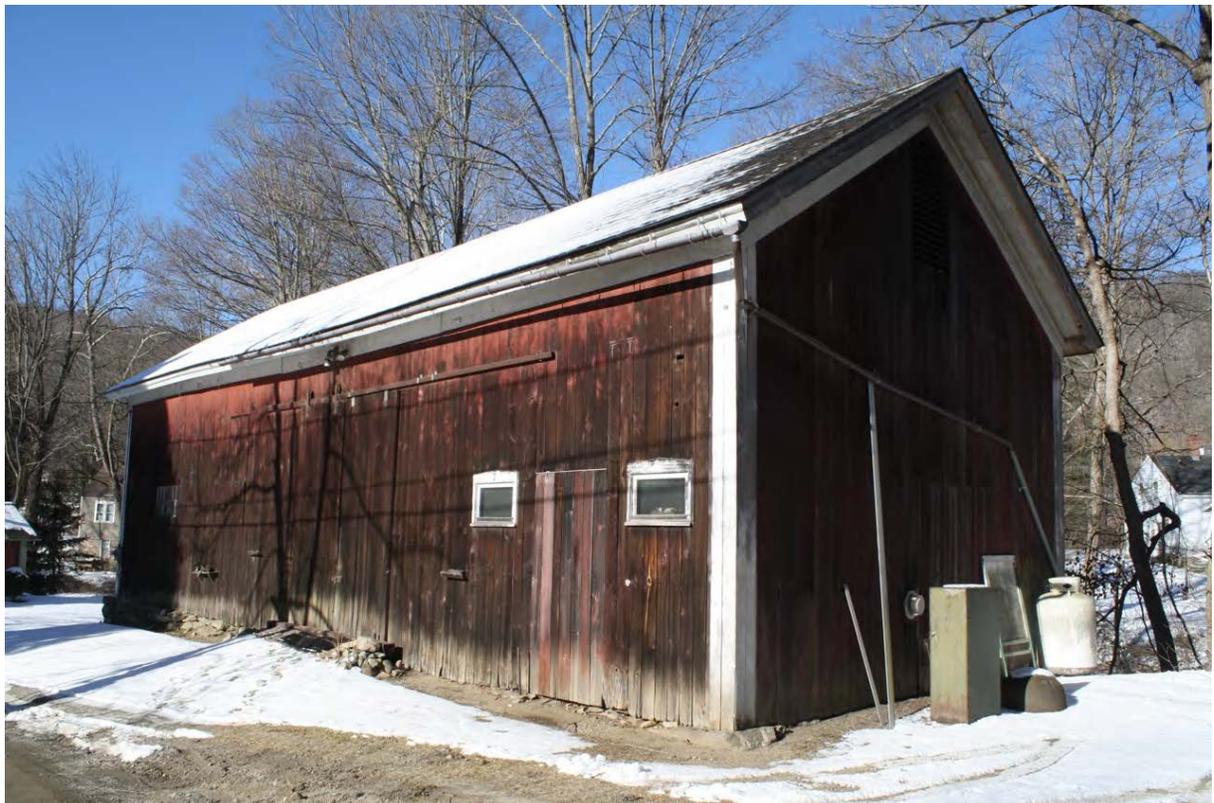
12. Northeast view of Tobacco shed, camera facing southwest. Note faux corner boards in white trim paint.

This is a 1 ½-story eave-entry bank barn tobacco shed. The ridge-line is parallel to Old Mill Road which meanders but at this point will be considered as north-south. The shed is a 24' x 60' four-bay five-bent structure erected on a fieldstone foundation forming a shallow banked basement accessed from the south gable-end. The bays are here identified as 1 through 4, from south to north. Siding is vertical boards with a wide frieze board under the eaves. The roof overhangs have sloped soffits with simple molding trim on the fascias, typical of late 19<sup>th</sup>-century vernacular design. The location of the interior bents is identifiable by iron strap ties at the dropped girt elevations; these protrude through cut-outs in the frieze board and are visible on the exterior. Siding is faded but has remains of a red stain; trim is painted white.

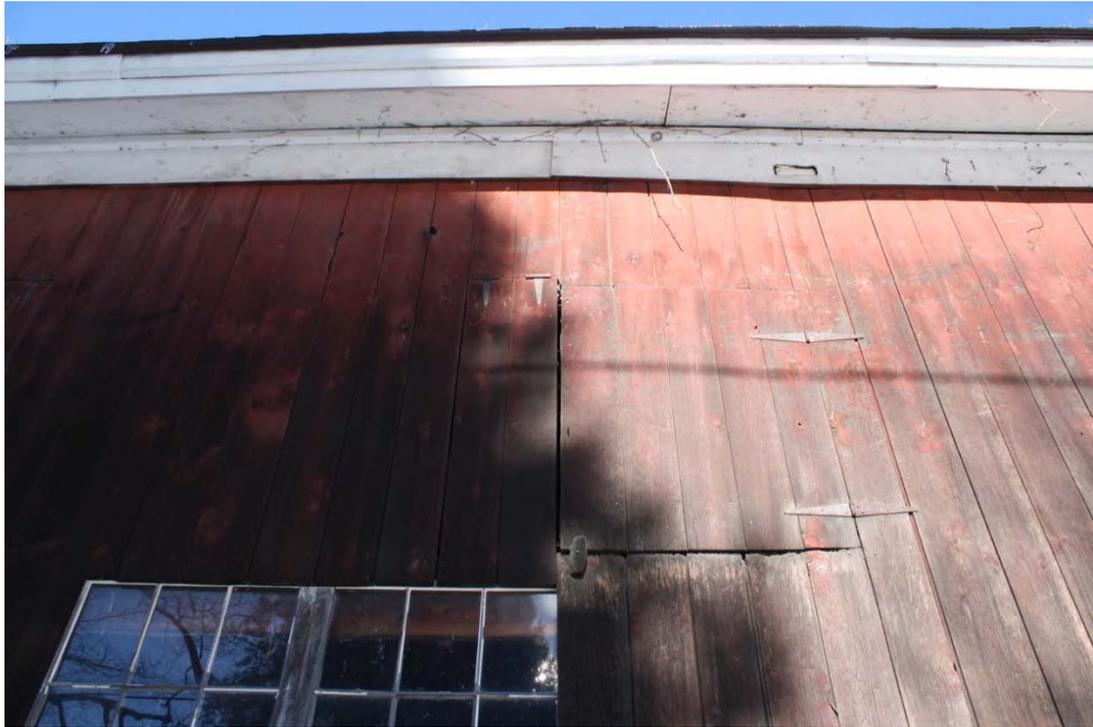
13. Detail view of east eave-side, camera facing west at Bay 1, showing top-hinged vent above the window, side-hinged vent to the right, and iron strap protruding through the frieze board, at top above the hinges.

The main entry in the east eave-side is a pair of exterior sliding doors in Bay 3. The left leaf has what appear to be original track hardware, while the right leaf has more modern hardware. The entry is accessed by a short ramp; the grade declines to the sides of the ramp, revealing an un-mortared fieldstone foundation. In Bay 1 is a pair of six-pane windows set near the center of the wall height. To the right of the windows and again in Bay 2 there is a top-hinged venting panel two boards wide and a rectangular side-hinged panel similar to a hay door high in the wall. In Bay 4 are two single-pane windows with beveled head trim. Between the windows are top-hinged vents two boards wide and between these a door opening which has been sealed shut.

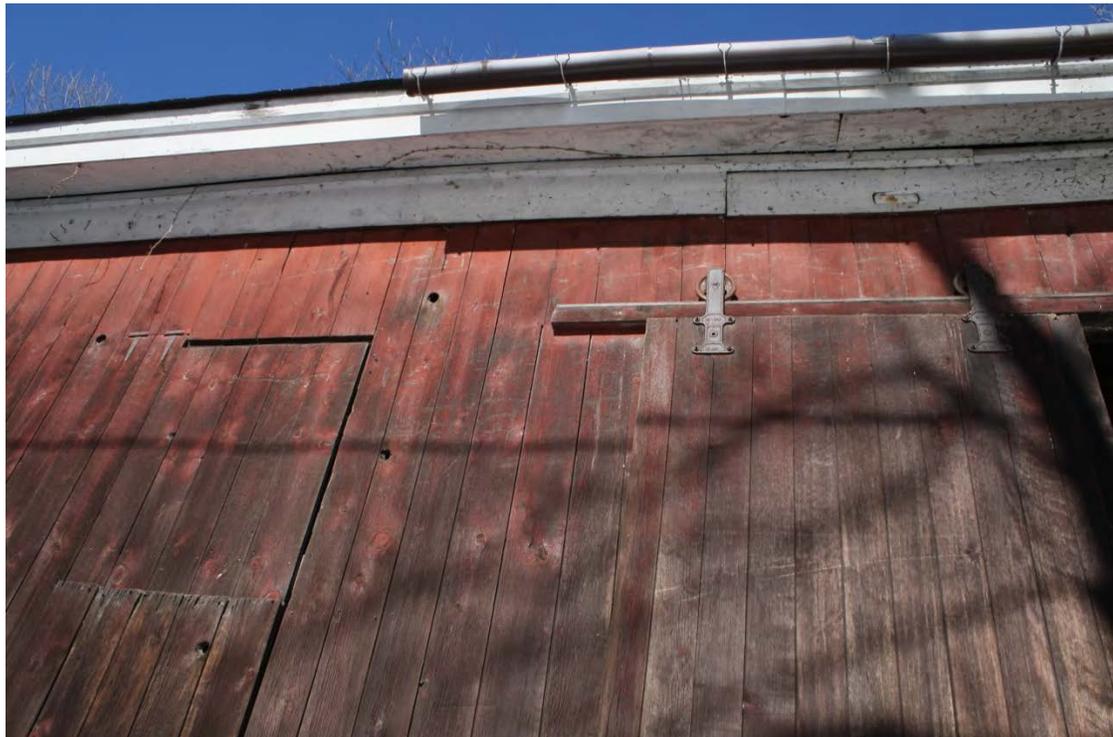
14. Detail view of east eave-side at Bays 2-3, camera facing west, showing vents (top- and side-hinged) and sliding door hardware. Note also the iron strap protruding through the frieze board above the sliding door hangers.

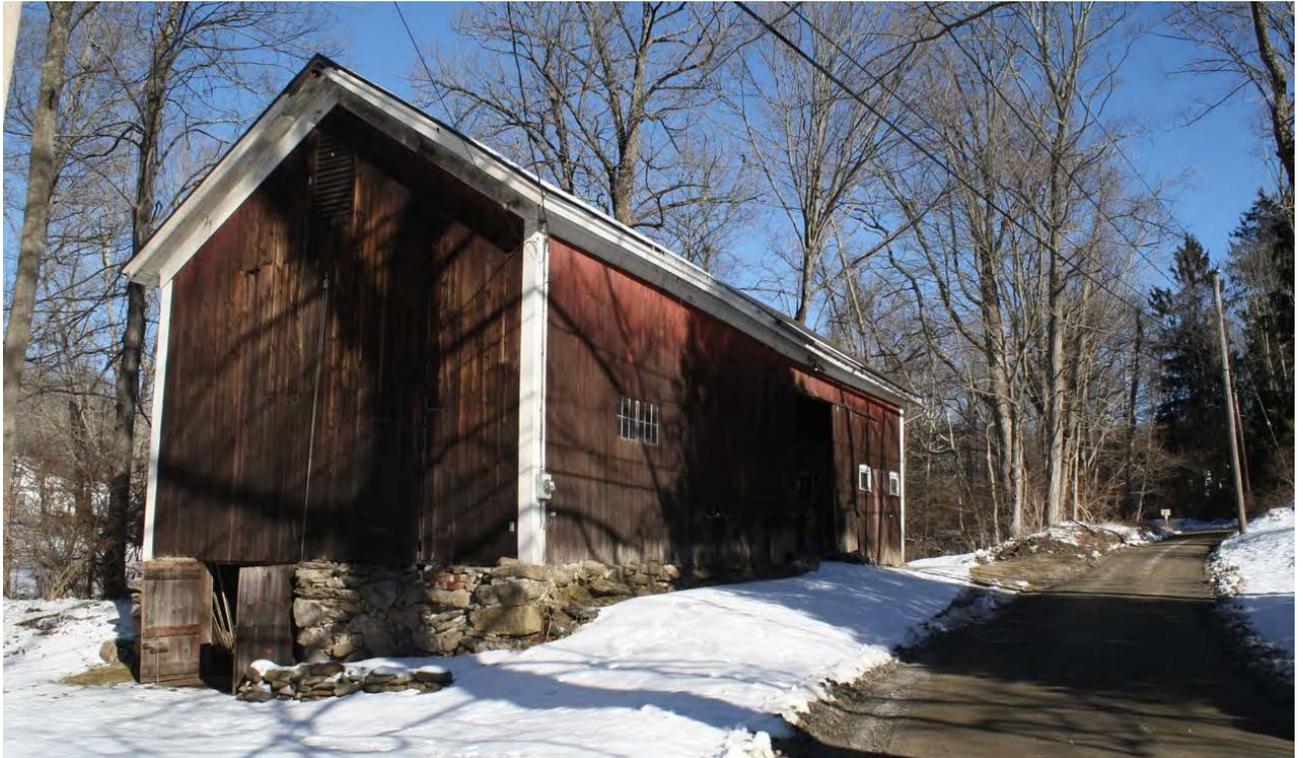
15. Southeast view of Tobacco shed, camera facing north, showing south gable-end with banked basement entry.

The grade at the south gable-end of the shed declines further, revealing a basement level. In the basement level in the west half is a pair of hinged doors; the rest of the basement level is un-mortared fieldstone. The main level of the south gable-end is blank except for top-hinged vents and one side-hinged vent off-center toward the right (east). Beneath the apex of the roof is an arched louvered vent.

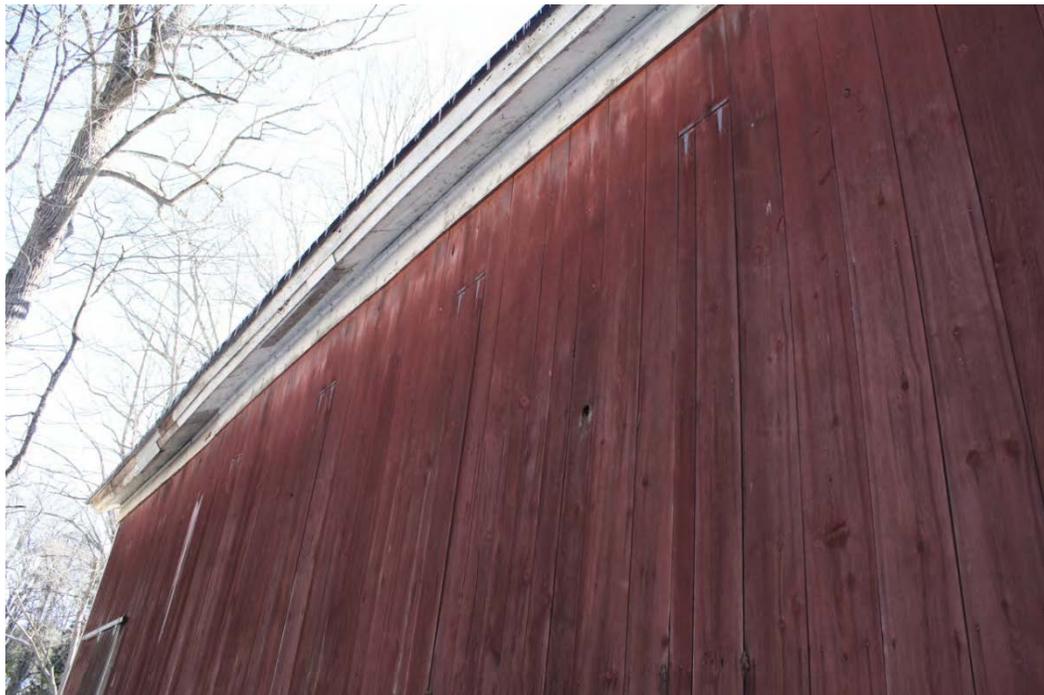
16. West detail view of Tobacco shed, camera facing northeast, showing top-hinged venting system.

The grade at the west eave-side inclines slightly. The west eave-side has a sliding door at the left (north) corner and a series of top hinged vents. The north gable-end of the shed has an arched louvered vent beneath the apex of the roof and two top-hinged vents.

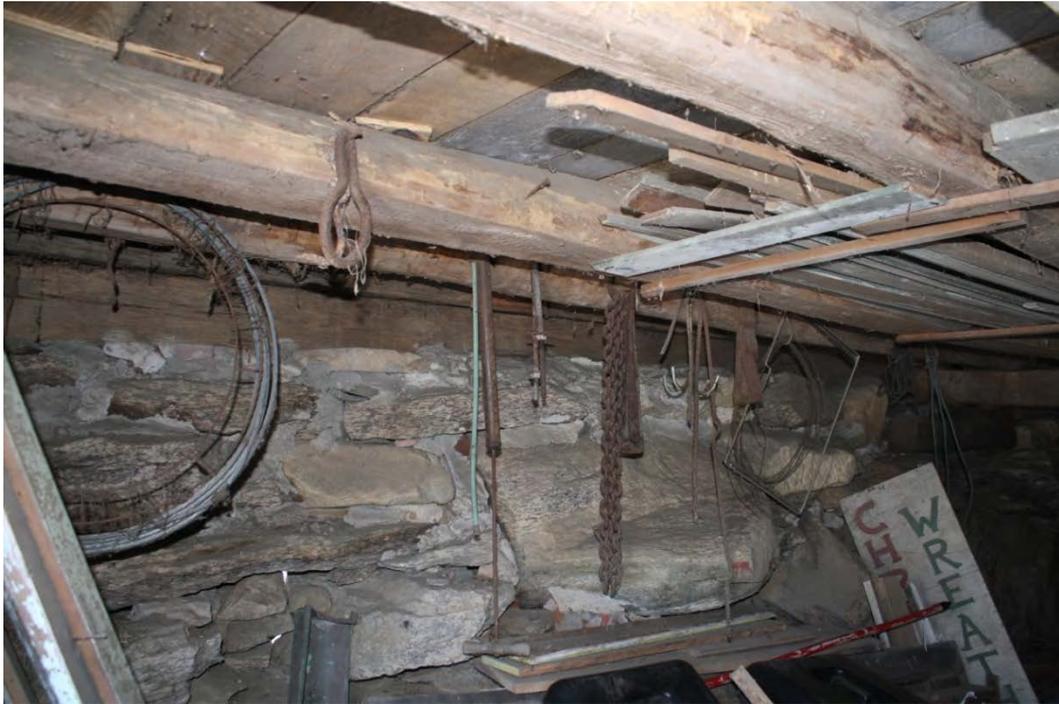
17. Interior view of Tobacco shed basement, camera facing northwest, showing fieldstone retaining wall and joist framing of floor above.

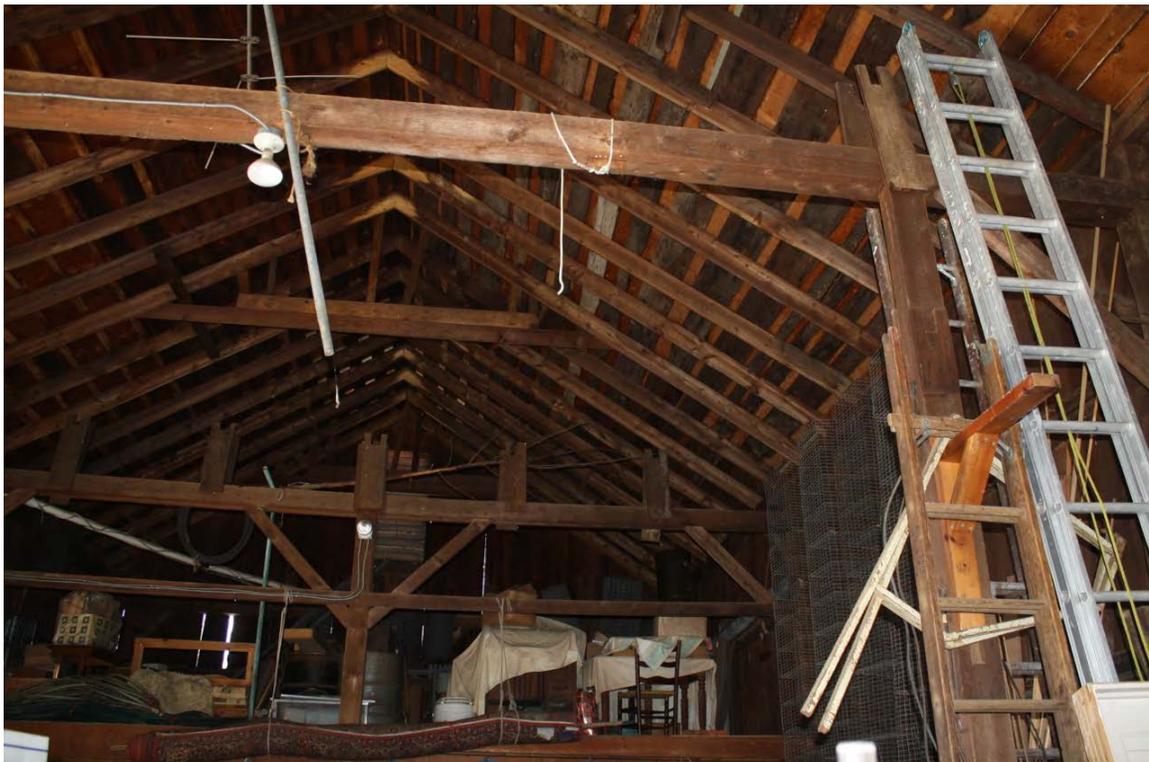
18. Interior view of Tobacco shed, camera facing south, showing two-aisle post and beam frame.

The interior reveals a square rule post and beam frame of circular sawn timbers. Each of the five bents has a center interior post forming two aisles, and a dropped tie-girt. The sawn common rafters are butted at the ridge and have no intermediate supports. A distinctive feature is the iron straps at the tie-girts, which wrap around the outside of the vertical posts and protrude through the frieze trim at the exterior, being visible through cut-outs in the boards. Also on the tie-girts, a series of short vertical boards with notches in their upper ends provided supports for the pole on which tobacco leaves were hung to dry.

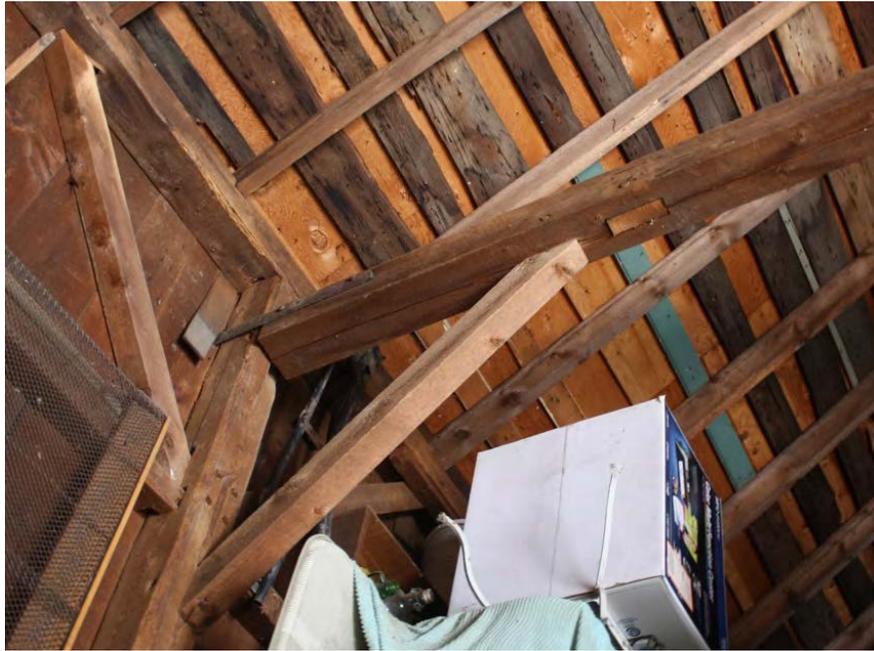
19. Interior detail view of Tobacco shed, camera facing south, showing dropped tie-girt and plate framing. Note the typical iron strap which wraps around the outside of the vertical post and is visible on the exterior.

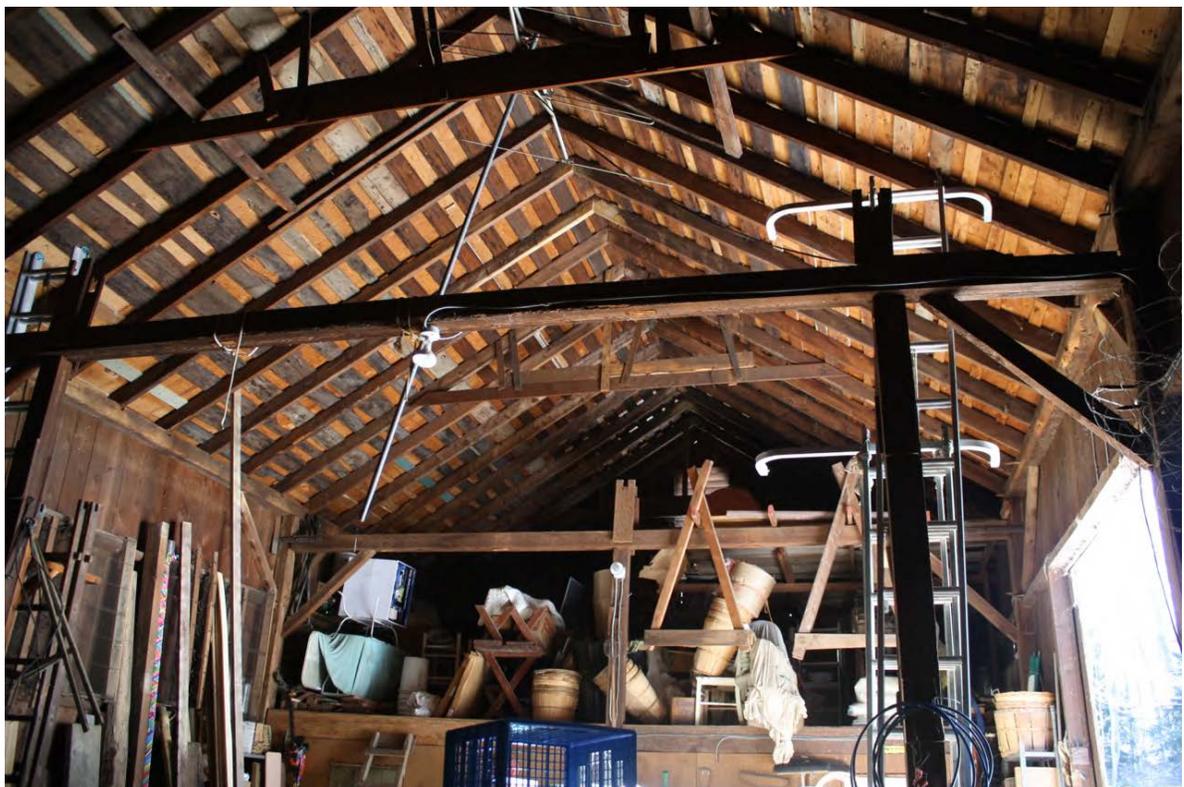
20. Interior detail view of Tobacco shed, camera facing north, showing dropped tie-girt and plate framing.
