**HISTORIC RESOURCES**

**BUILDING AND STRUCTURES**

Building Name (Common) Sullivan Farm Record No. 49768  
 Building Name (Historic) Sullivan, William Adolphus and Sally Ann, Farmstead / Greatbrook Farm  
 Street Address or Location 140 Park Lane Road (US Route 202)  
 Town/City New Milford Village Park Lane County Litchfield  
 Owner(s) Town of New Milford, 10 Main Street, New Milford CT 06776  Public  Private

140 Park Lane Road, New Milford CT

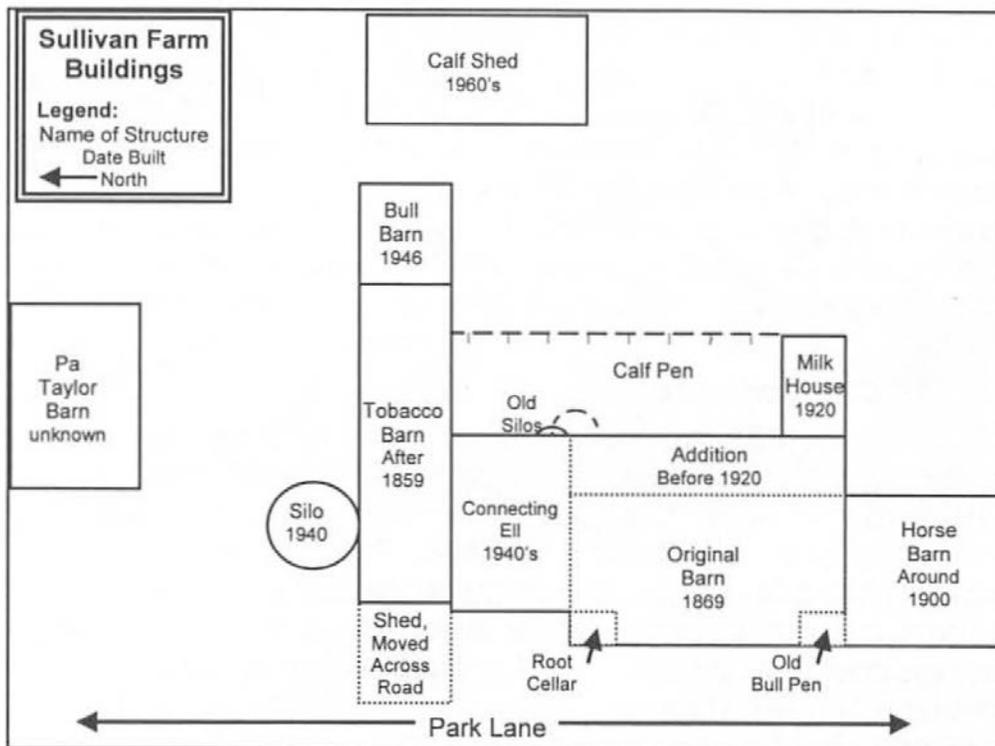
3. Plan Sketch showing sequence of barn construction (Note: North is left) - image courtesy of Sharon Sullivan Racis (p. 6).

The main barn consists of a central core and a number of additions. The core structure is a 30' x 52' English bank barn dating from c. 1869. Its ridge-line is oriented north-south parallel to the road, and the barn is located close to the edge of the modern roadway (when constructed, it was a narrower dirt road). The barn was extended southward another 30' c. 1900 for a horse barn addition which continues the same roofline. The east side was later expanded for a wider basement dairy stable, a connector was built to join the tobacco barn to the main structure, and a small

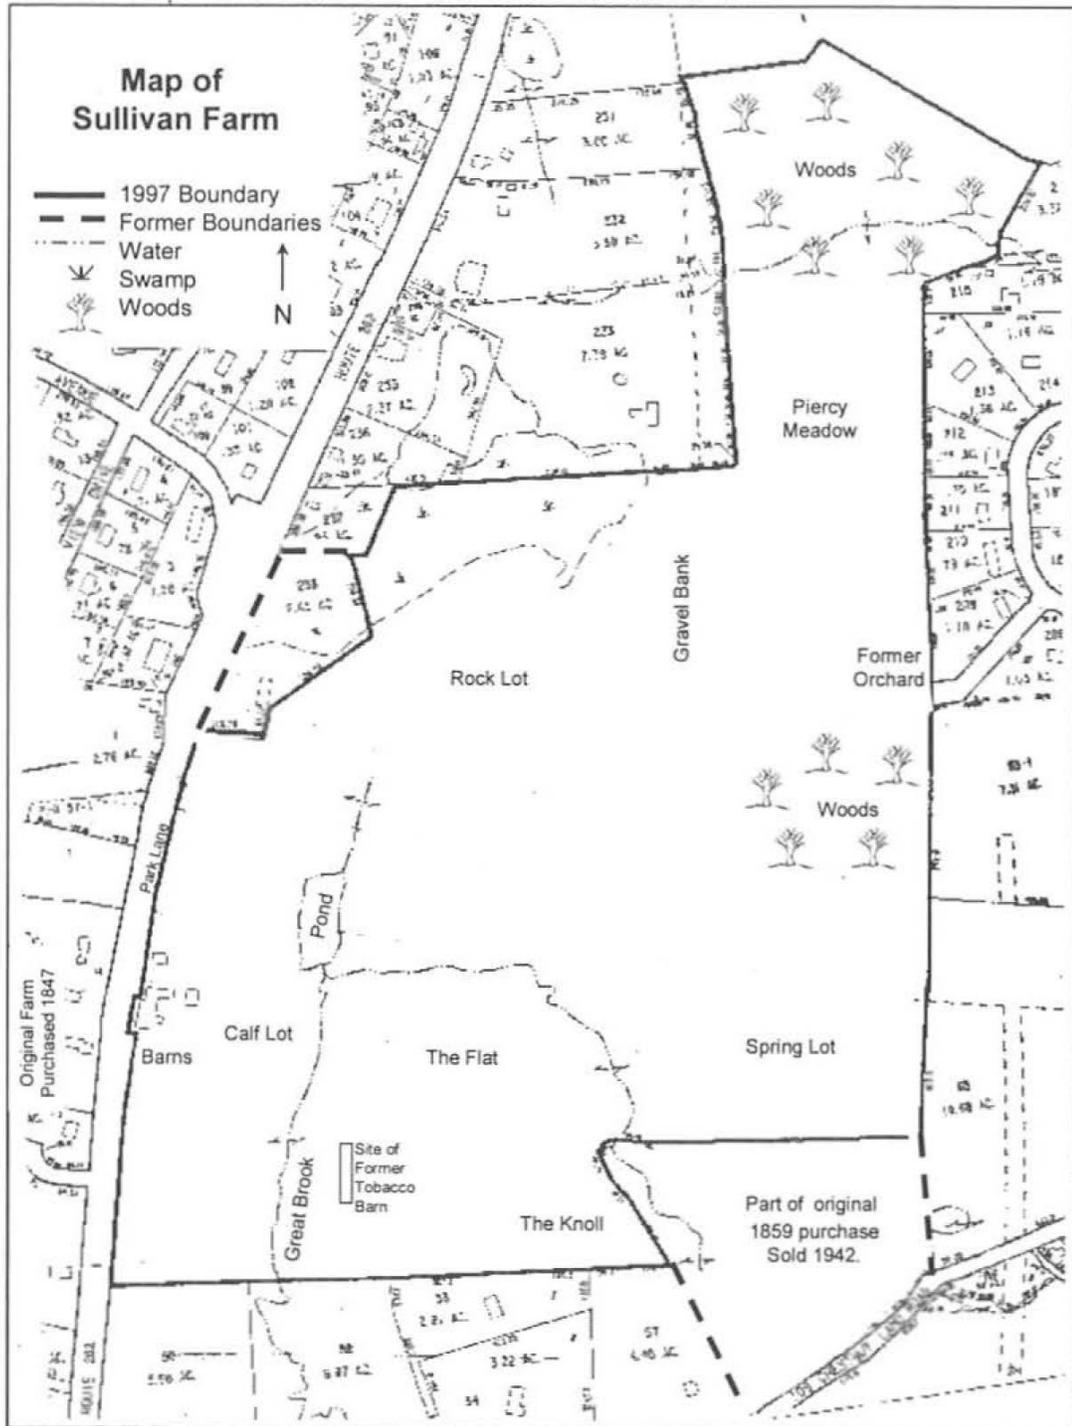
4. Site plan of Sullivan Farm – image courtesy of Sharon Sullivan Racis (p. 9). Note the notch in the right-of-way taken by the Connecticut Department of Transportation in the 1931 road widening; the barn was allowed to remain and the right-of-way jogs around it.

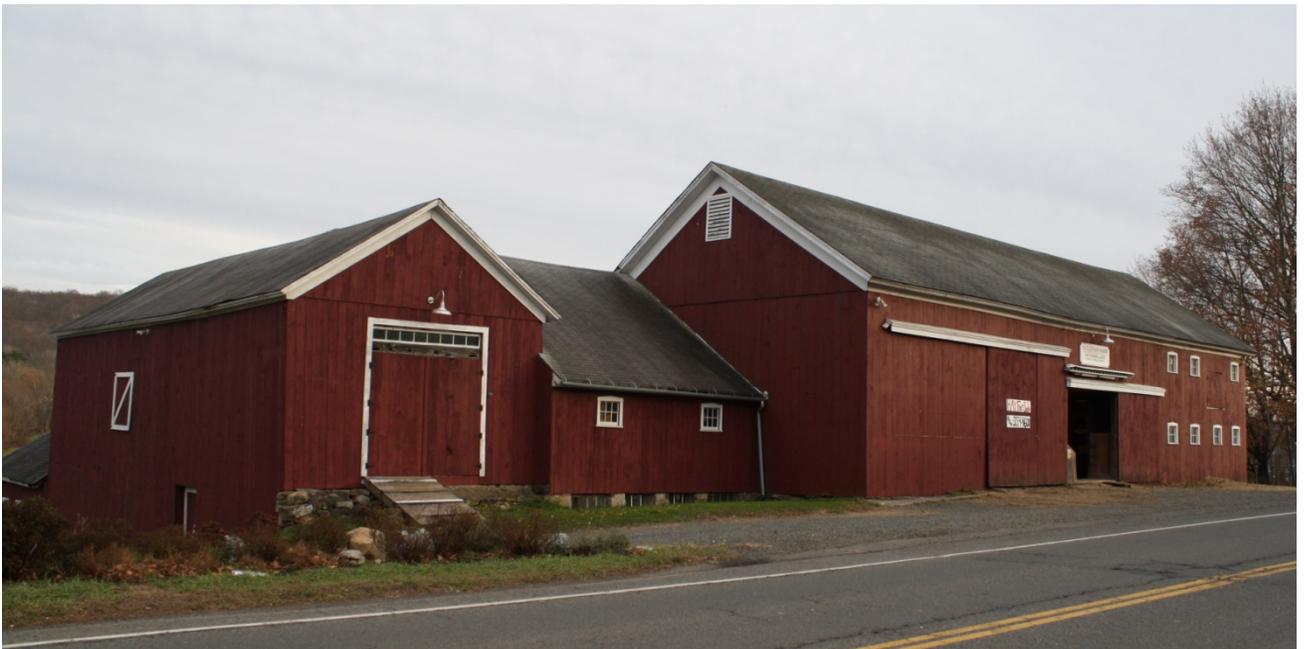
6. Northwest view of Main barn (right) and Tobacco barn (left), camera facing southeast.

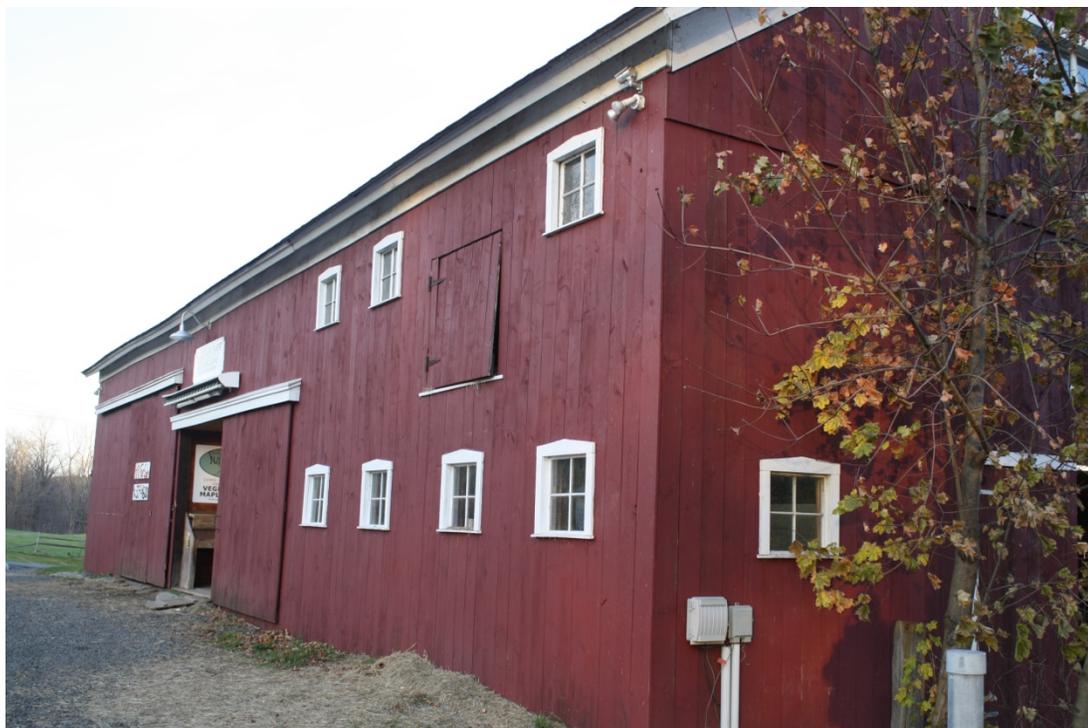
10. West view of Main barn – at left the earliest three-bay section, at right the horse barn addition with stable windows; camera facing northeast.

The core structure, a three-bay English bank barn, has its main entry doors in the center bay of the west eave-side facing the road. The main doors are a pair of tall single sliding doors hung on an exterior track with a shallow hood, both sliding to the left (north). A shorter sliding door is in the right (south) bay, with the modern farm stand located inside this bay. To the right (south) is the horse barn extension, which has a row of four-pane stable windows in the ground level. Above at the loft level there are four-pane windows, and a hay door.

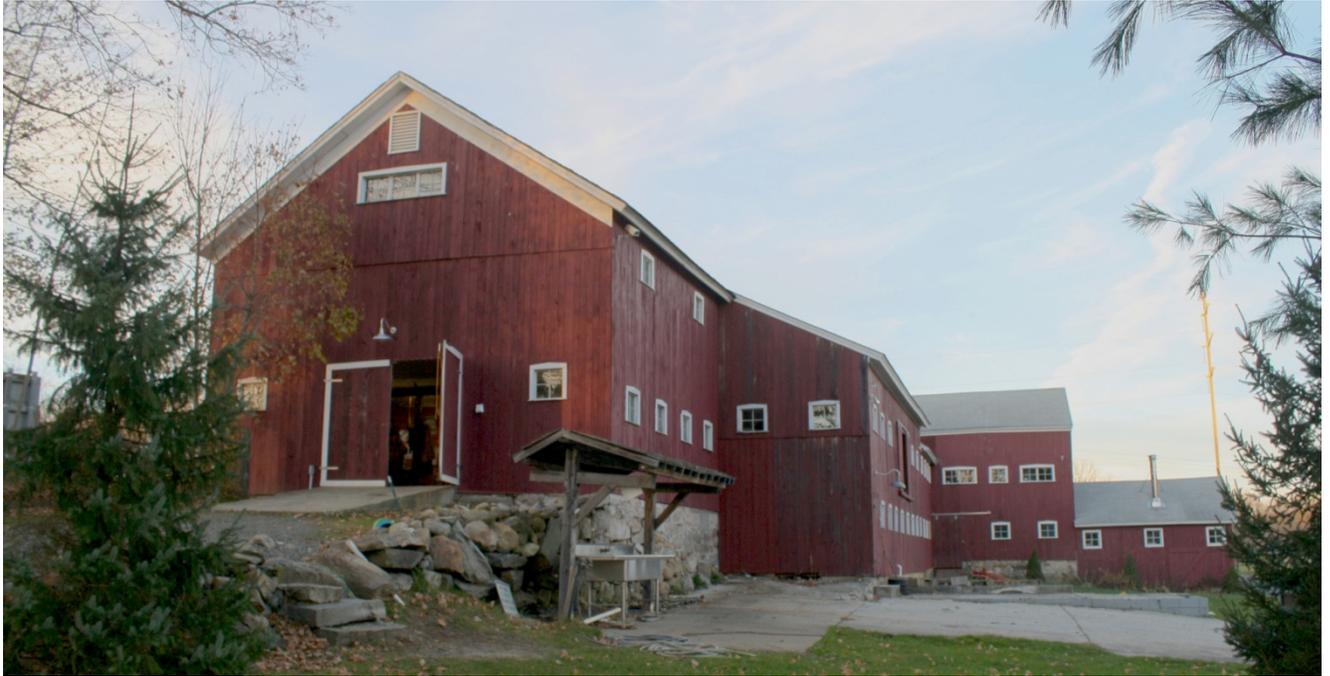
11. Southeast view of the Main barn showing the south gable-end, camera facing north. At right foreground is the foundation slab of the former Milk room, and behind are the cow barn addition, the Tobacco barn at rear, and the Bull barn at right rear.

At the south gable-end of the horse barn where the natural grade slopes down toward the east, grading has formed a level entry terrace with a fieldstone retaining wall along its eastern edge. In the gable-end is a centered doorway with a pair of hinged doors flanked by four-pane stable windows. In the attic there is a horizontal window with three four-pane sash, and a louvered vent above at the peak.

At the southeast corner of the Main barn, a concrete slab represents the location of a Milk room from the 1920s. The south wall of the Main barn addition likely had openings connecting to the Milk room.

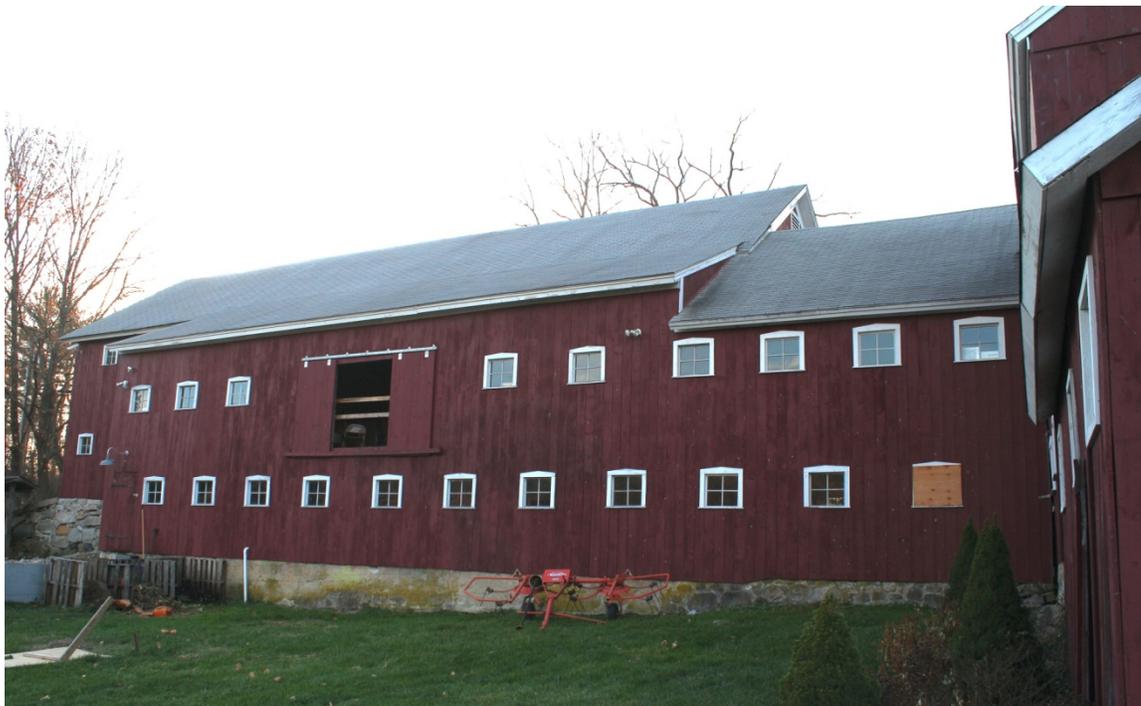
12. East view of the Main barn, showing the dairy barn addition (left) and the connecting ell (right); camera facing west. At the far right is the south side of the Tobacco shed.

The east side of the barn has a fully exposed basement level. Along the left (south) wall of the horse barn a fieldstone foundation wall is exposed at the basement level; at the main level is a row of four four-pane stable windows, and in the loft level are two four-pane windows. Along the length of the core block a 2-story shed-roofed addition (built before 1920) extends the width of the barn east by about ten feet. The exterior is wood siding with a concrete foundation wall exposed below. The basement level has a row of four-pane stable windows. The main level has a large double sliding hay door, corresponding to the center bay of the core block, flanked by rows of stable windows on both sides.

An infill addition built c. 1945 connects the main barn with the Tobacco barn (see below). This addition has a gable roof oriented north-south, lower than the main roof. The east eave-side wall is flush with the east side of the main barn, while the west eave-side wall is set back about ten feet from the face of the main barn's west side. On the east, the rows of stable windows continue across this addition at both the basement and main levels. On the west there are two stable windows spaced close to the corners.

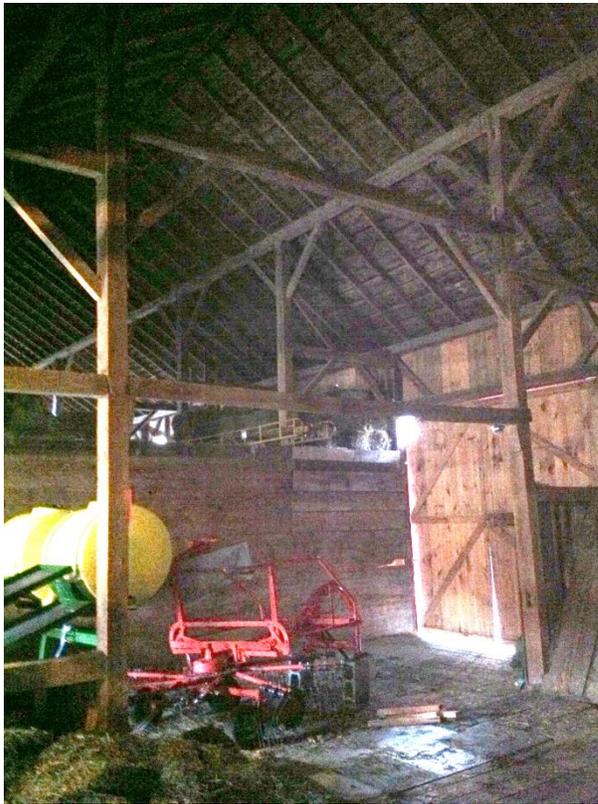
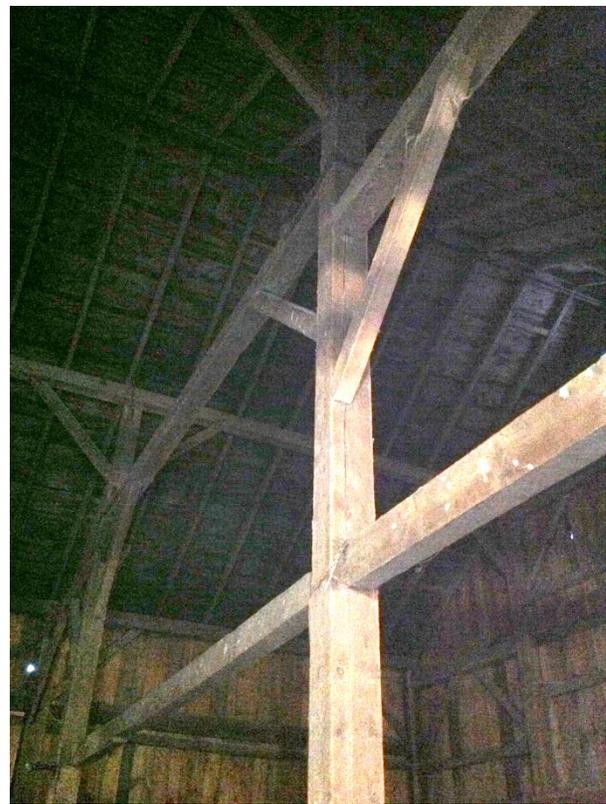
14. Interior of the Main barn, camera facing southwest.

15. Interior of the Main barn, camera facing northwest.

The interior of the Main barn is a square rule post and beam structure. The typical bent has two interior posts rising full-height to a pair of purlin plates at the mid-span of the common rafters. Cross-ties in the side aisles are dropped below the plates and braced with angle braces. An upper cross tie-girt at the center aisle is low enough to accommodate a hay track mounted below the ridge. The center and north bays are open full height to the roof, and the barn is open to the northern connector addition and to the eastern extension. The south bay and the horse barn section have a loft floor above the ground level. In the basement level there were originally a root cellar in the northwest corner and a bull pen in the southwest corner.

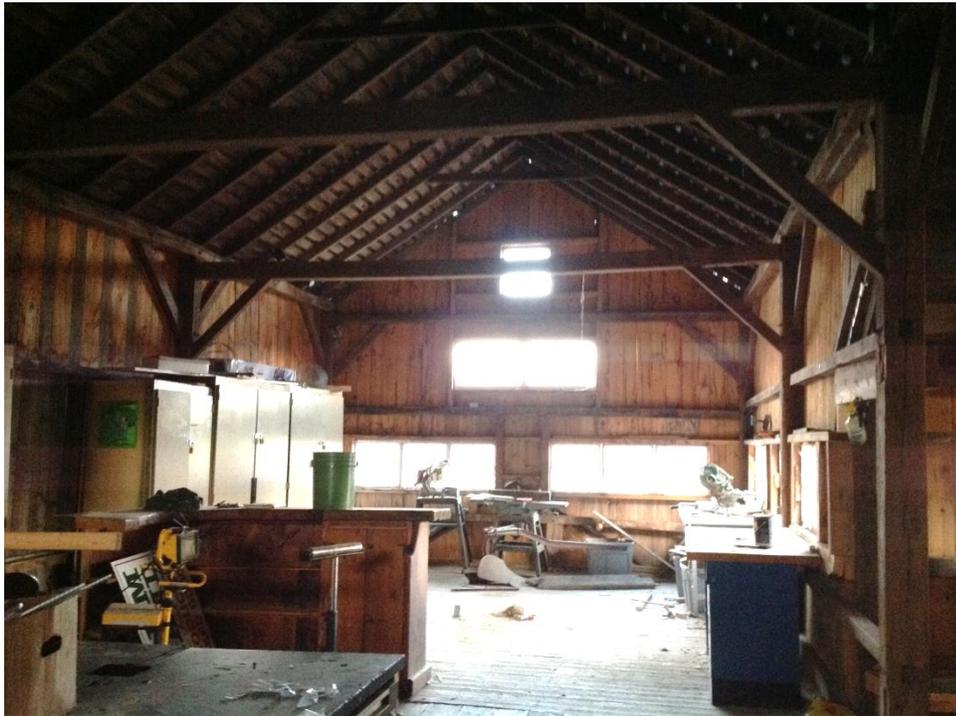
16. Interior view of the Tobacco barn upper level, camera facing east.

The extant frame is a five-bay six-bent post and beam frame with dropped tie-girts. The bents have no interior posts and the common rafters span from the side wall plates to the ridge. The floor is wood planks.

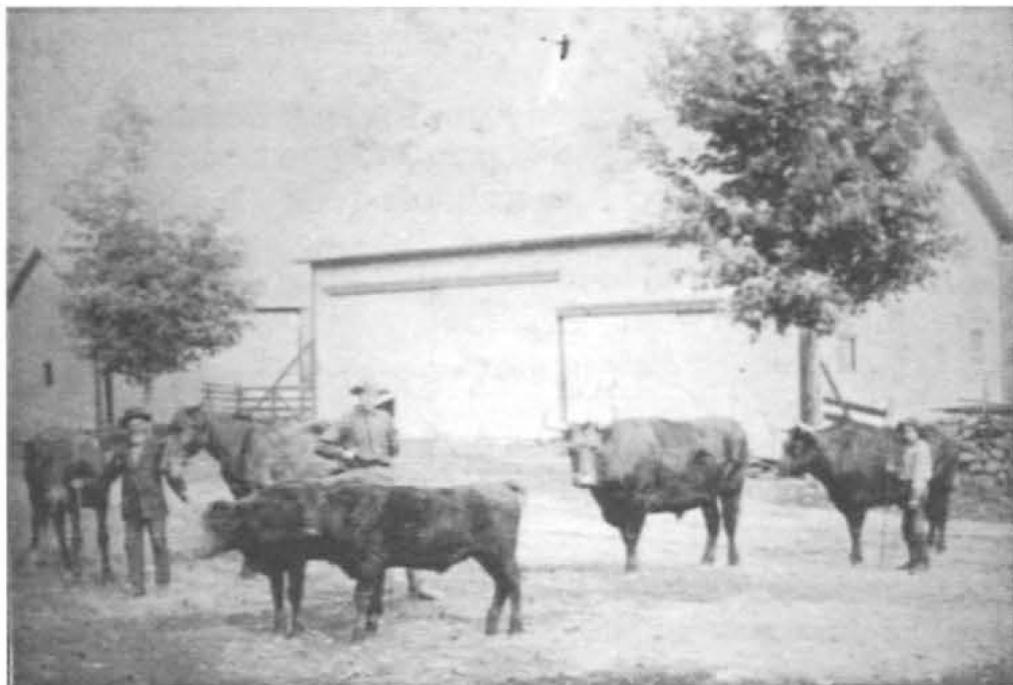
17. Historic photograph: west view of the Main barn (right) and Tobacco barn (left) before 1900, camera facing east; photograph courtesy of Sharon Sullivan Racis. The man at the far left is thought to be William Sullivan. The cows are standing in what is now the middle of US Route 202 (Park Lane Road).

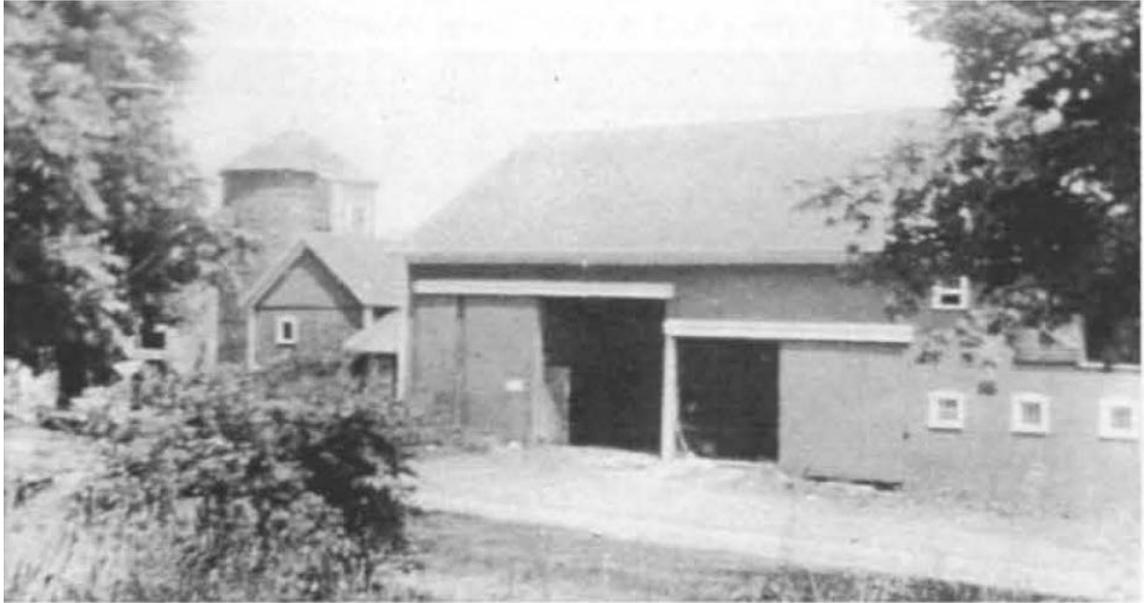
18. Historic photograph: west view of the Main barn (right) and Tobacco barn (left) after 1940, camera facing east; photograph courtesy of Sharon Sullivan Racis. Note the silo to the north of the Tobacco barn.

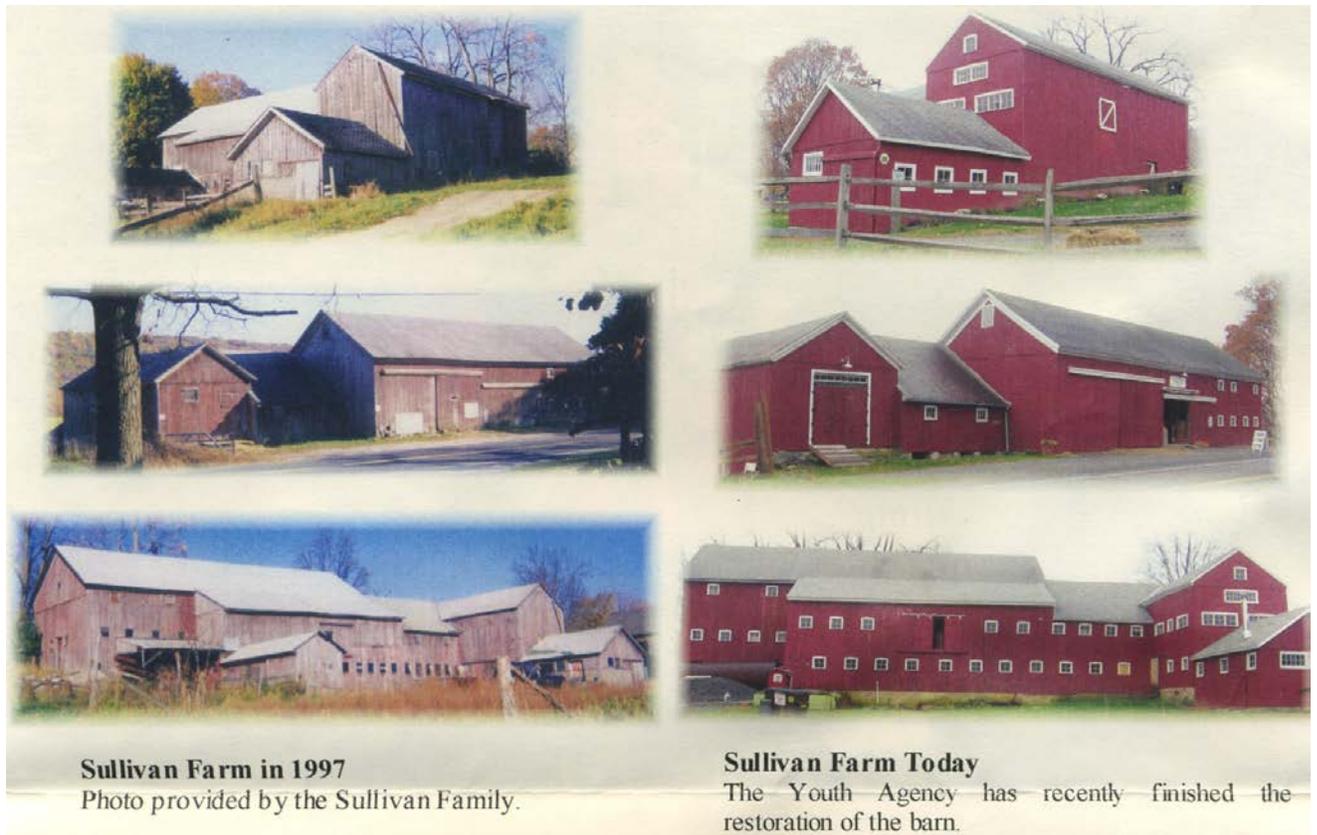
19. “Before and After” photographs, courtesy of Mark Mankin.

**Sullivan Farm in 1997**

**Sullivan Farm Today**

The Youth Agency has recently finished the restoration of the barn.

In 1997 the 104 acres east of Park Lane Road were purchased by the Town of New Milford. The farm was managed for about ten years by the town's Youth Agency under the direction of Mark Mankin. During that time, the Main barn was rehabilitated by Mark and his brother John Mankin. The Sugar house was erected on the site over the two-year period of 2001-2; both projects were educational experiences for crews of high school students. Since 2011, the
