Agricultural Heritage Multiple Property Submission - State Register

BUILDING AND STRUCTURES

Building Name (Common) Hayden Farmstead

HISTORIC RESOURCES INVENTORY FORM – BUILDING AND STRUCTURES continuation sheet

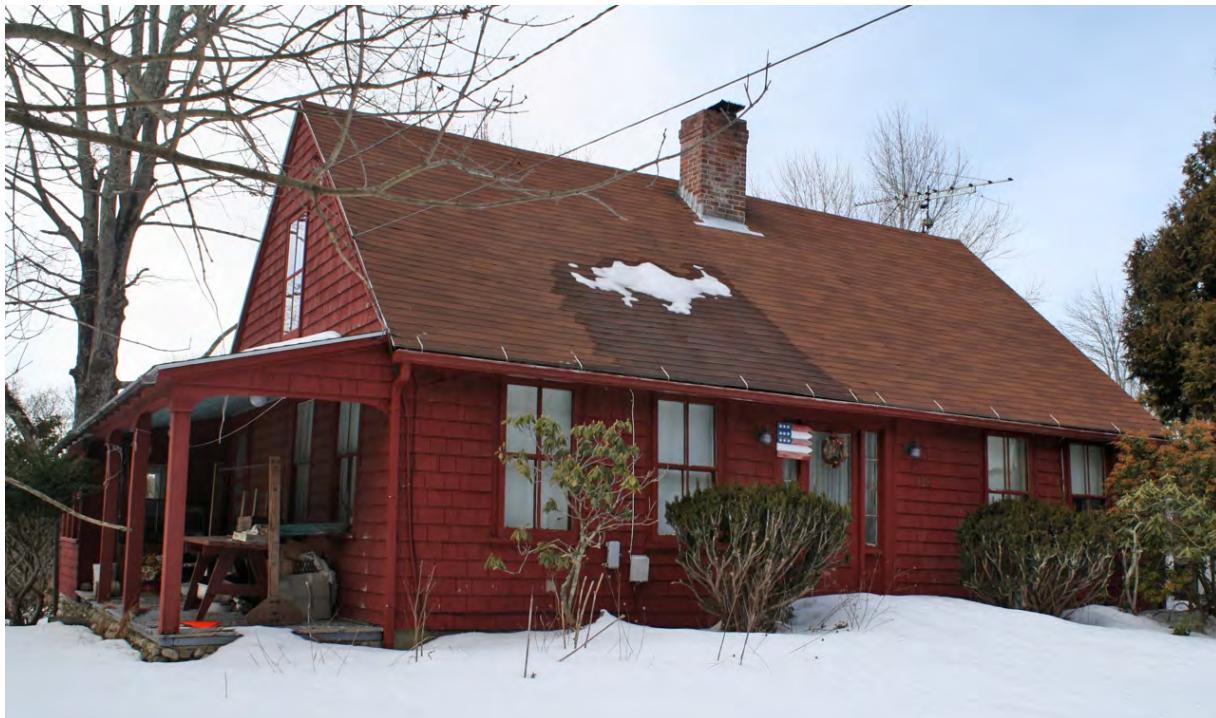
5. Southeast view of the Farmhouse, camera facing northwest.

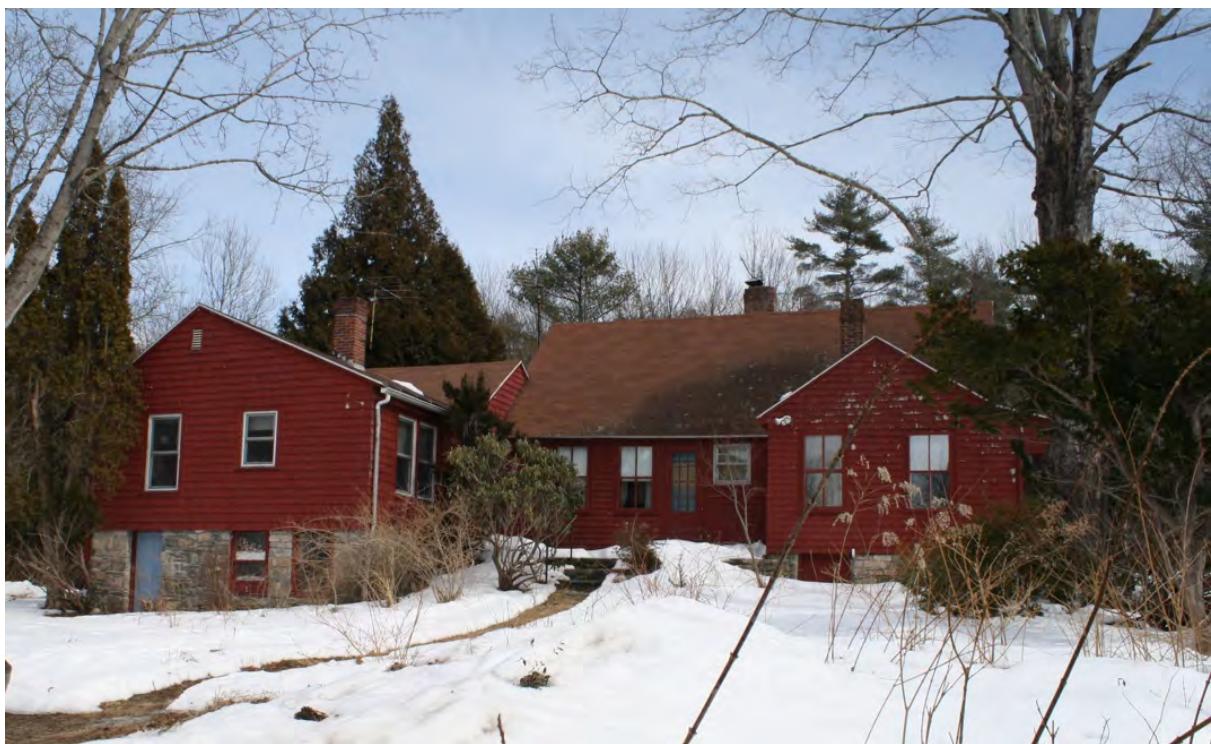
6. West view of the Farmhouse, camera facing east.

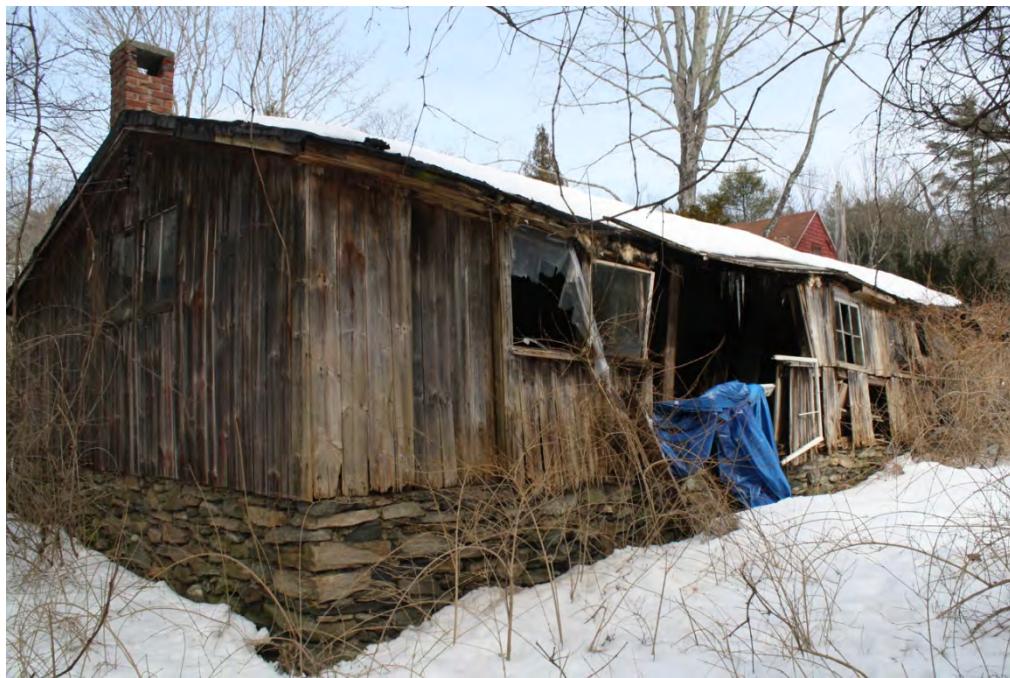
The Chicken coop is a 1-story gable-roofed structure oriented east-west, in deteriorated condition. It has a field-stone foundation, a band of multi-pane windows facing south, three six-pane windows in the north side, and brick chimneys at the gable-ends. A metal and glass greenhouse with a concrete foundation is attached to the east gable-end; most of its glazing is missing. The Barn is oriented with its ridge-line east-west. Formerly attached at the west end was a c. 1945 gable-roofed sheep shed which collapsed in the February storms of 2011. This was used for sheep during the 1950s. A dirt track runs along the north side of the barn toward the open field below the buildings, where crops were raised and where there is the foundation of a 19th century grist and saw mill; a mill pond formerly provided water power.

8. Southwest view of the Chicken coop, camera facing northeast.

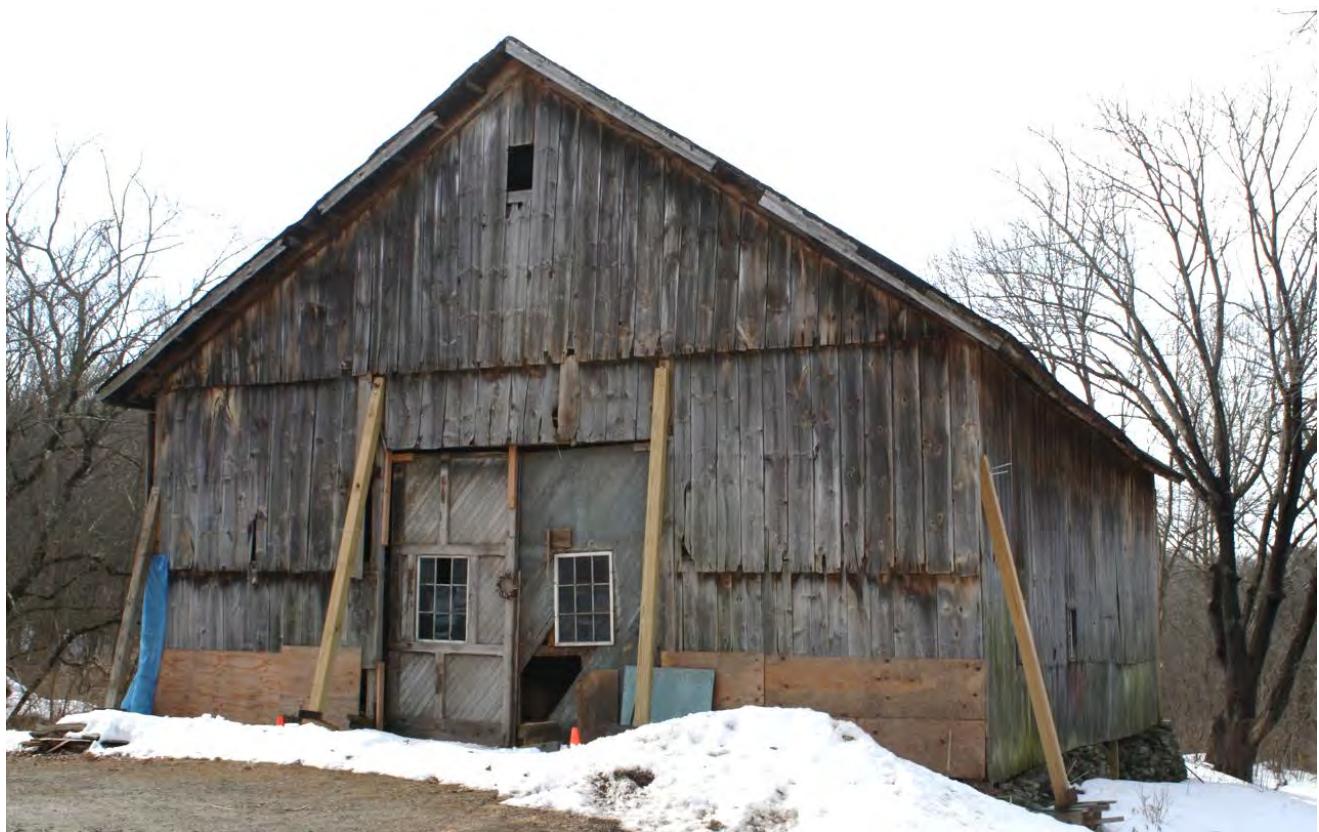
The main entry is a pair of tall interior sliding doors centered in the east gable-facade. The doors are constructed with frame and panels, a mid- to late-19th-century style of detail. The sliding front barn doors measure 13'-6" in width and 11'-6" in height. The two door panels are decorative as well as functional, in that they incorporate multi-pane window inserts and chamfered frames with diagonal board paneling. The rest of the east gable-end is blank except for a small vent opening beneath the apex of the roof. The vertical wood siding on this east end has two siding divides, the upper at the eave-line and a second divide at the mid-height of the main level.

10. East view of the Barn, camera facing west.

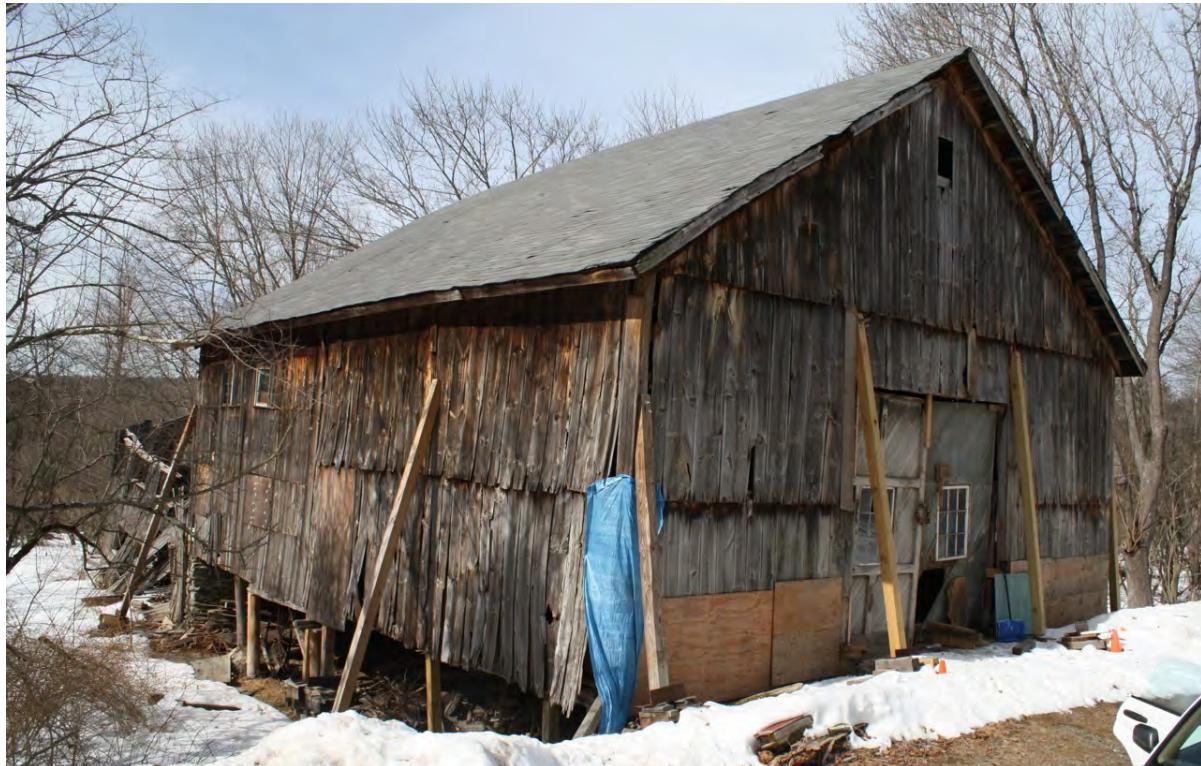
The south eave-side of the barn has its basement level open to a dropped grade. The ends of the fieldstone foundation walls are exposed at the west and east corners, while wood posts support the upper framing along the middle bays. The eastern two bays of the main level have siding similar to the east gable-end, with a lapped siding divide at mid-height. The western bays have boarded-up stable windows at the main level and two un-matching windows at an upper loft level.

11. Southeast view of the Barn, camera facing northwest.

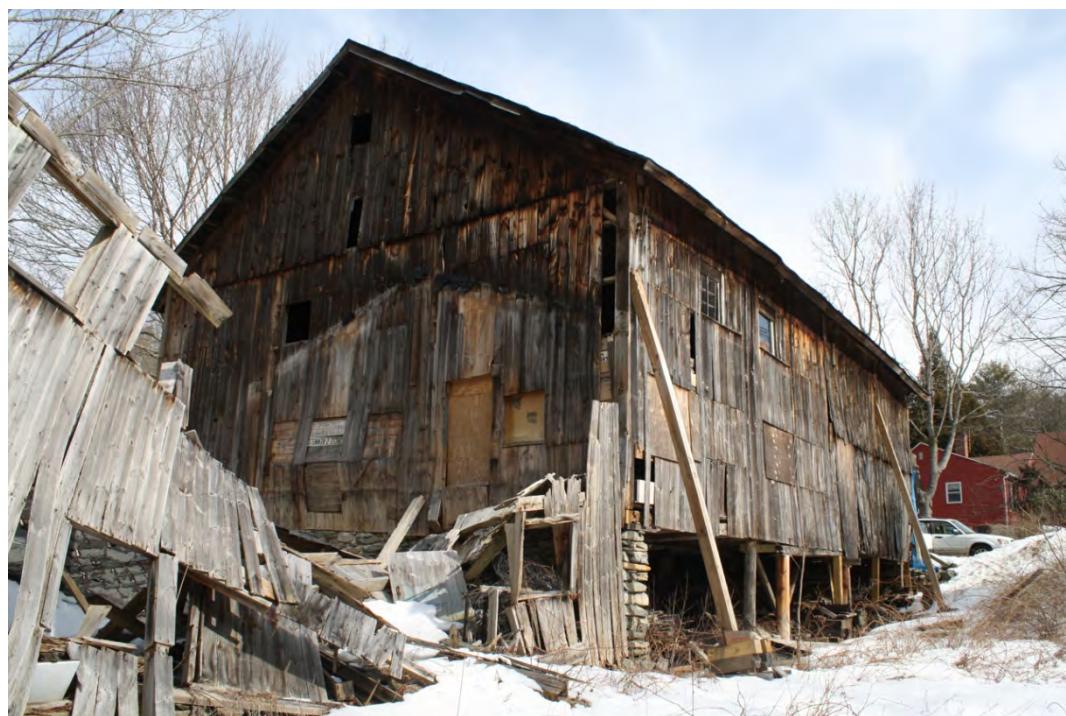
The west gable-end of the barn formerly had the attached 25' x 30' c. 1950 gable-roofed sheep shed addition extending west; it encompassed much of the west gable-end of the main barn block, with its south wall flush with the main block. The ruins of this addition are to be removed. The bermed grade declines toward the north, exposing the rubble fieldstone concrete foundations.

12. Southwest view of the Barn, camera facing northeast. Ruins of collapsed sheep shed are at left.

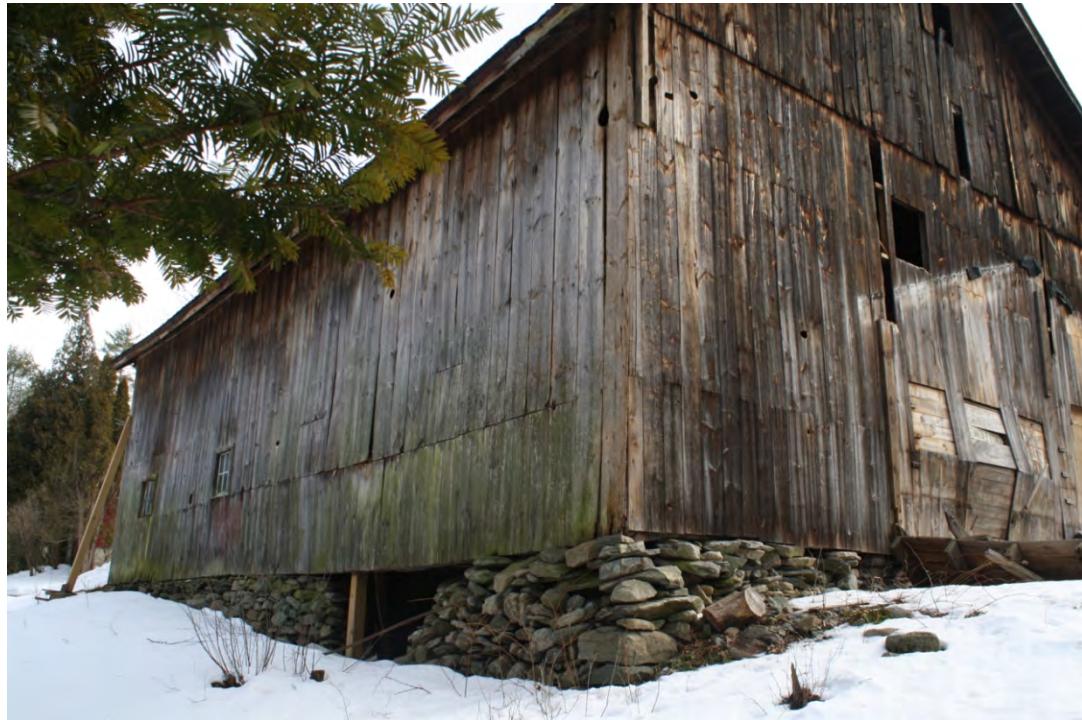
The north eave-side grade declines gently from east to west, partially exposing the foundation wall, which has collapsed below the third bay; a temporary post supports the timber frame above. On this side, a six-bay stable window is located in each of bays one and two. Patching in the siding suggests similar former openings in the remaining bays. Siding has been replaced below the sill level of the windows.

13. North eave-side and west gable-end view of the Barn, camera facing southeast.

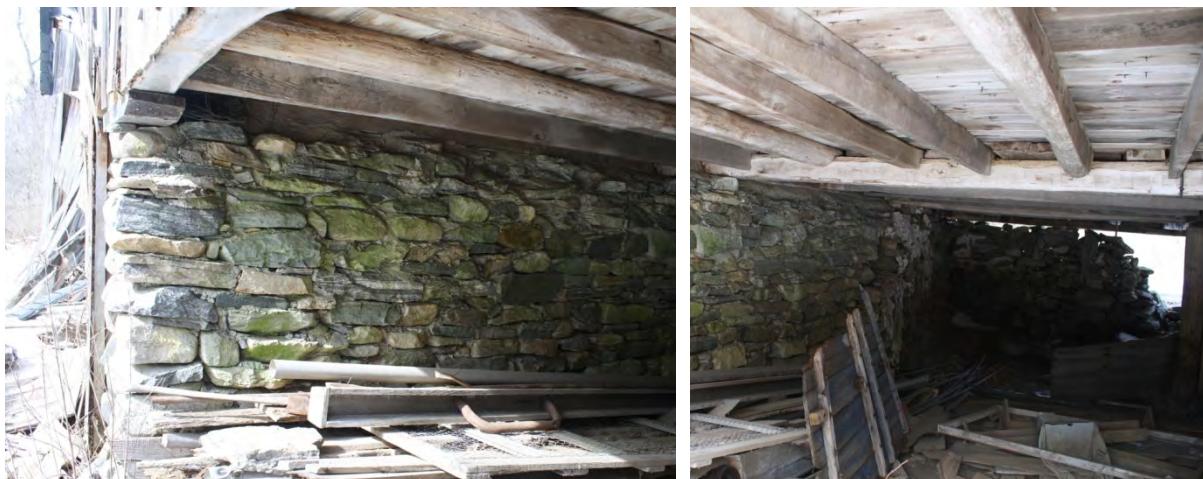
The foundation is dry laid fieldstone with wood posts supporting the upper barn framing. The foundation extends around the west, north, and east walls, with the south side open at the basement level.

14. Interior view of the Barn basement west wall and main level floor framing, camera facing west.

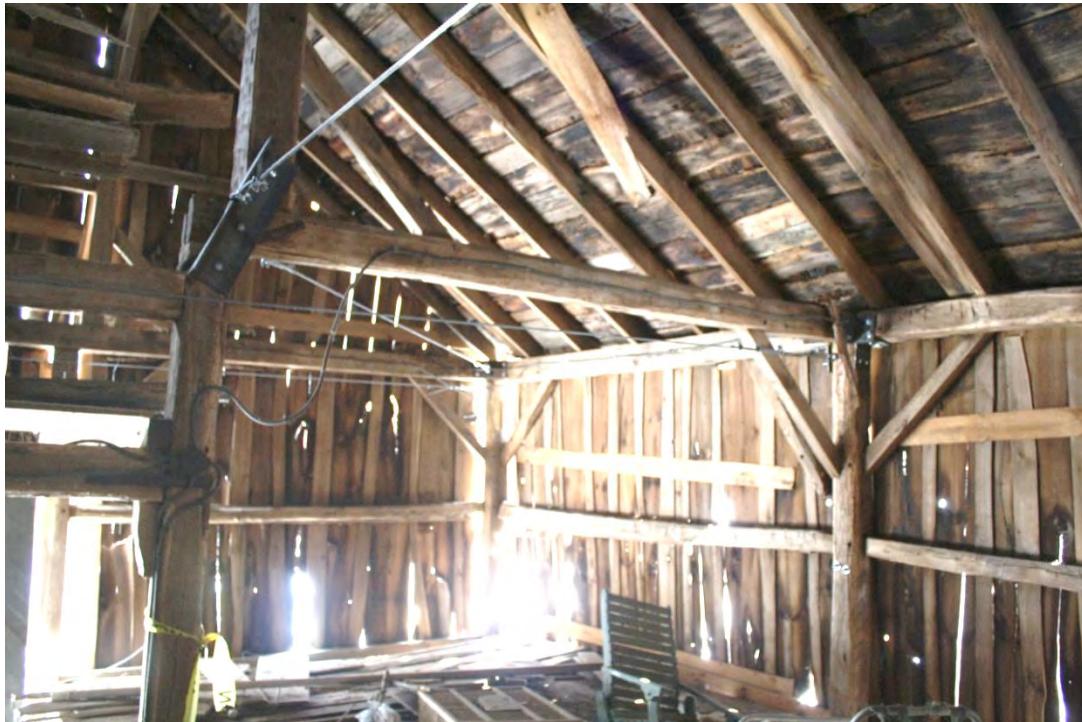
The interior frame is a square rule post and beam frame of mixed hewn and sawn timbers. The frame has three aisles running longitudinally. In each bent, there are two interior posts extending from the main floor to lateral tie-girts which are joined to the outer walls at the rafter plates. In general, the tie-girts appear to have been designed to continue across the full width of the barn. However at the bent between bays 1 and 2, the tie-girt is truncated at the interior face of the post, possibly to allow a higher aisle or for a hay track which is extant at the peak. Between bays 2 and 3, the tie-girt is cut but has been replaced, anchored with iron strap ties.

15. Interior view of Barn – southeast corner, upper level, camera facing southeast, showing bay 1 and 2. Note the truncated tie-girt at the interior bent in foreground. Tie-girts meet the rafter plates at the plate elevation.

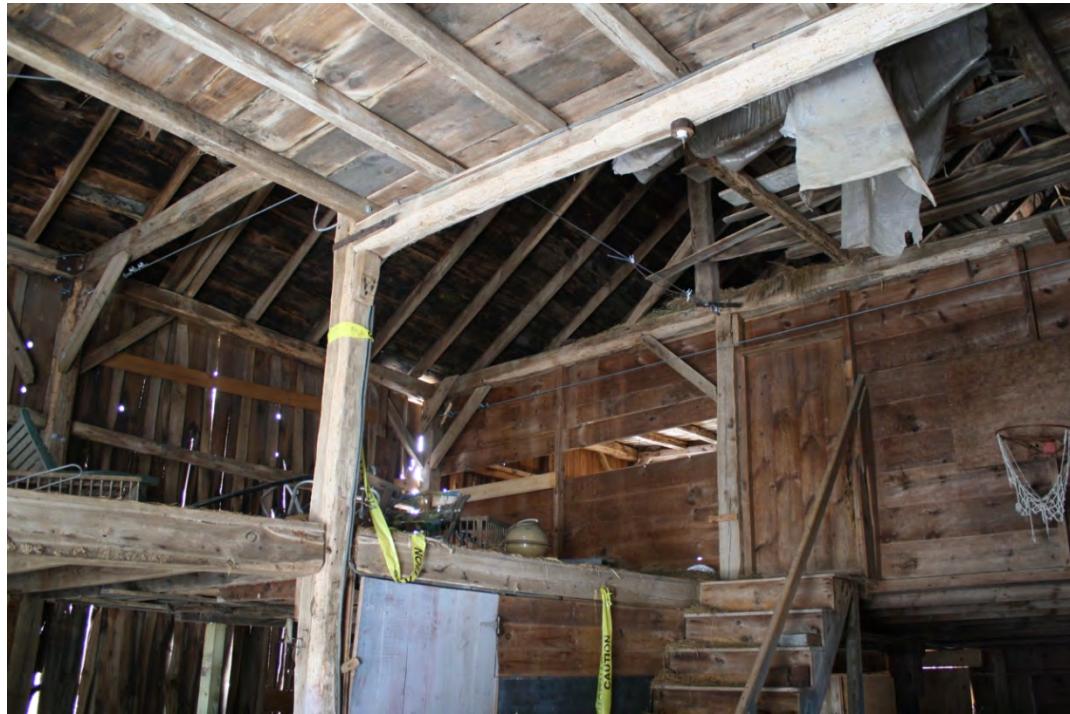
16. Interior view of Barn showing bay 1 (left) and 2, camera facing southwest. Note the bent at rear has a tie-girt which has been sawn and replaced, with an iron strap repair.

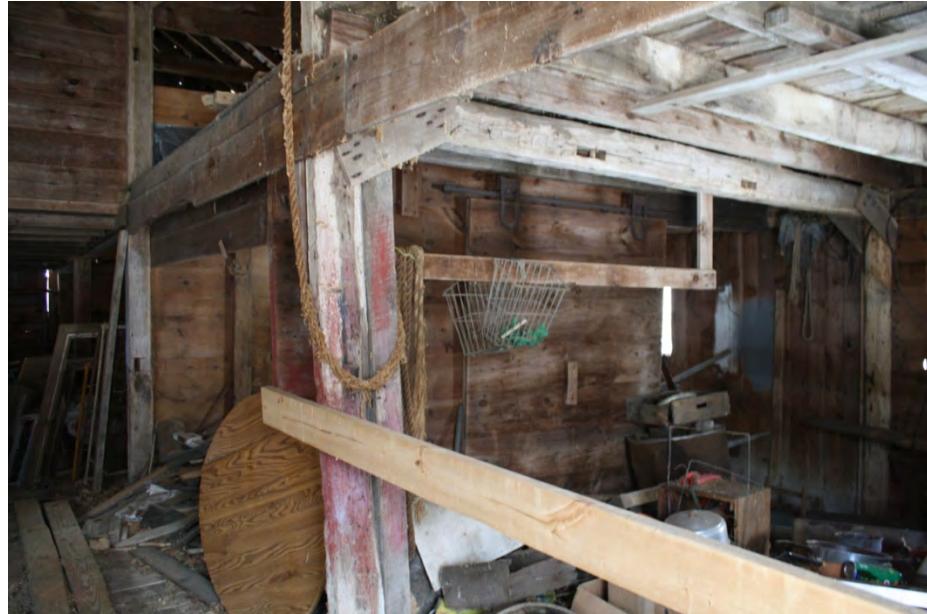
The outer aisles of bays 1 and 2 appear to have been fitted out as horse stalls at one time; sliding and hinged stall doors remain. The outer aisles and also the center aisle, have in places an upper loft floor level framed with sawn dimension lumber. In some areas a second upper loft floor exists as well, with some hand hewn joists and some

17. Interior view of Barn north aisle bay 2 (left) and 1 (right), camera facing northwest. Note the sliding door of a horse stall. The loft floor joist in front of the sliding door is detailed in Fig. 18.

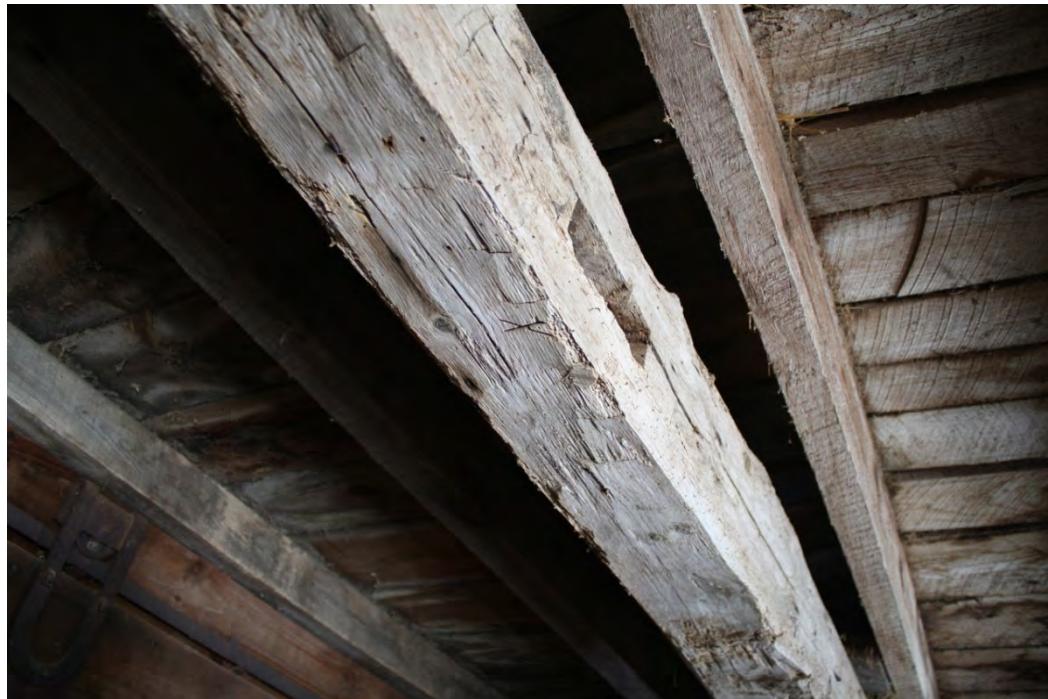
The majority of the original timber framing appears to be chestnut. Some of the post and beam framing shows evidence of having been used in earlier structures, as mortises are visible that do not relate to the existing framing pattern, and there is at least one instance of scribe rule marriage marking adjacent to an empty mortise. Many posts and beams on the lower- and mid-level are round logs, while others have been milled on two sides.

18. Interior detail view of joist (Fig. 17) – note the Roman numeral X mark adjacent to an empty mortise; evidence of old major timbers re-used in a different capacity.

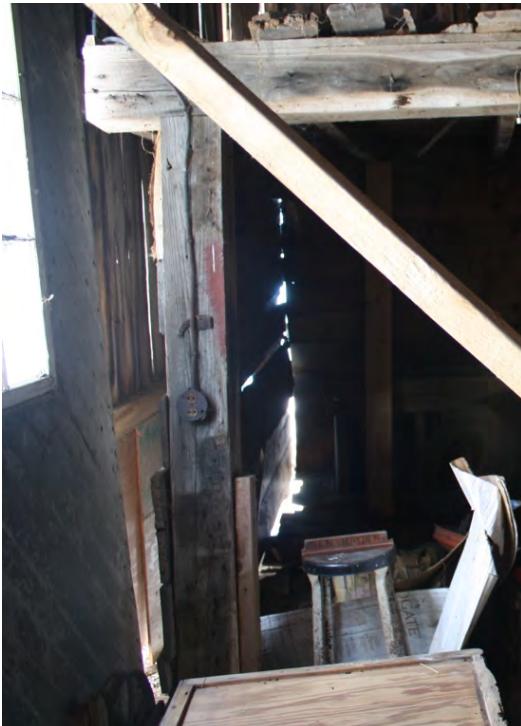
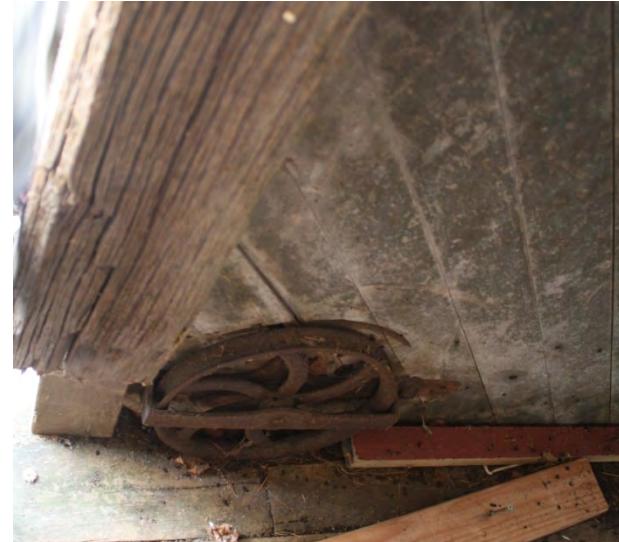
19. Interior details of sliding door in east gable-end. Note special pocket on the outside face of wall framing.

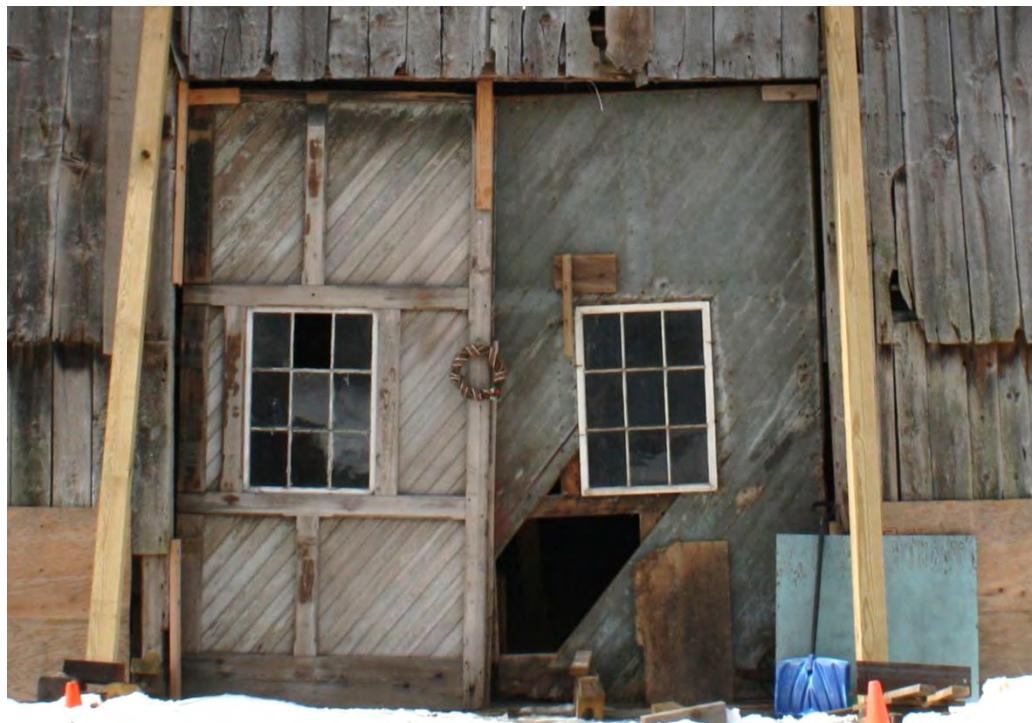
20. Detail view of sliding doors in east gable-end (right leaf temporarily installed reversed).

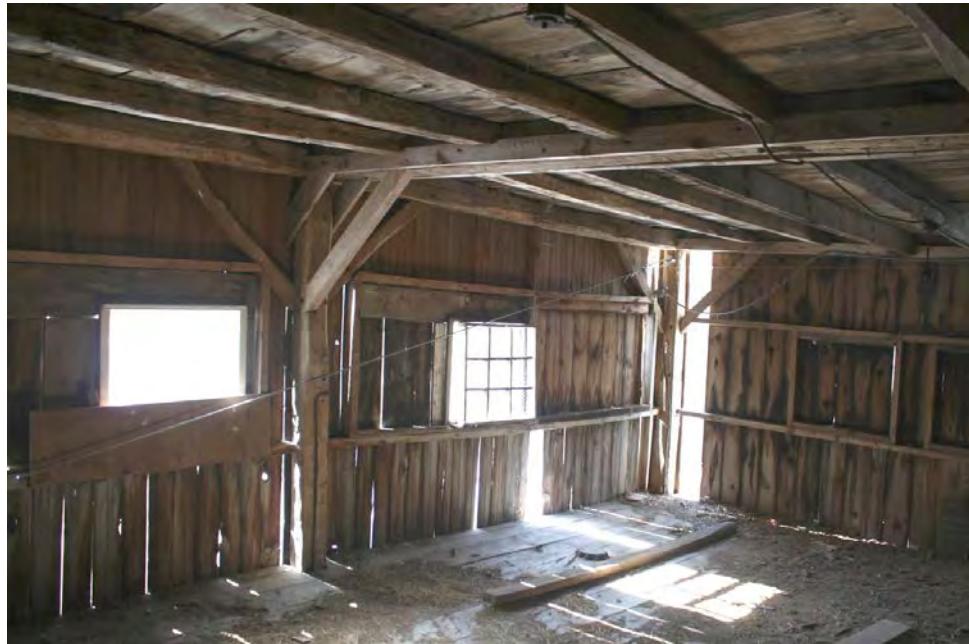
sawn. A stair leads up from the center aisle in bay 2 to access the upper level. Window openings in the south side on the main and upper levels indicate conversion to use for poultry.

21. Interior view of upper level of Barn, camera facing southwest, showing windows added for poultry.

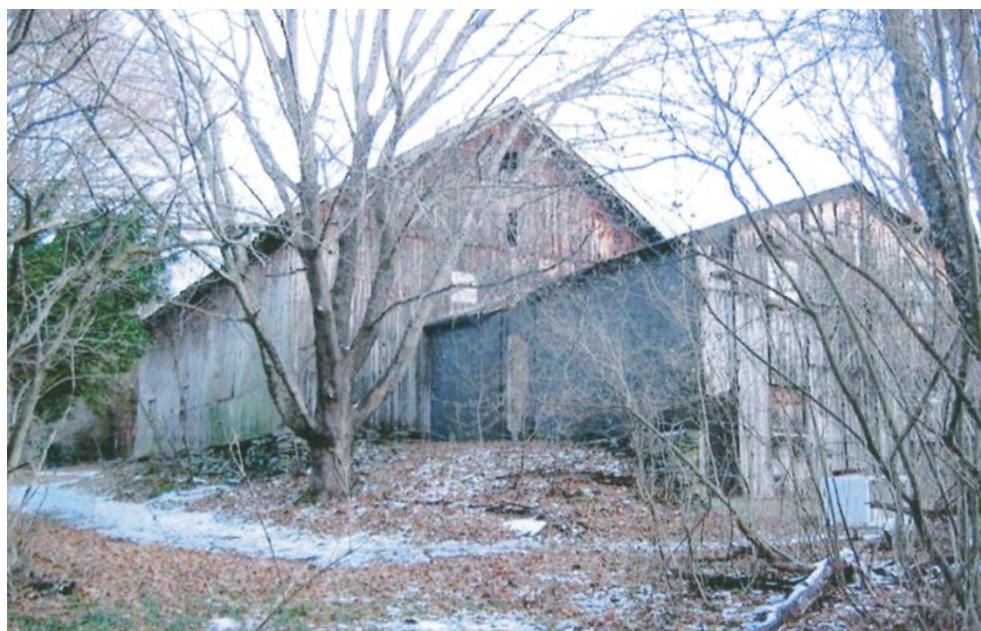
26. Northwest view of Barn and Sheep shed, 2010, photograph by Elizabeth Hayden.
