Agricultural Heritage Multiple Property Submission - State Register

Building Name (Common) Ellsworth Hill Orchard & Berry Farm Record No. 52419
 Building Name (Historic) Lord-Dunbar Farmstead
 Street Address or Location 461 Cornwall Bridge Road (CT Route 4)
 Town/City Sharon Village Ellsworth County Litchfield
 Owner(s) Bozzi Realty LLC, 461 Cornwall Bridge Road, Sharon CT 06069 Public Private

Present Use: Agriculture/Subsistence: agricultural outbuilding; Domestic: single dwelling
 Historic Use: Agriculture/Subsistence: agricultural outbuilding; Domestic: single dwelling
 Accessibility to public: Exterior visible from public road? Yes No
 Interior accessible? Yes No If yes, explain Some areas during retail store hours
 Style of building High-drive hybrid English bank barn, Vernacular style Date of Construction 18th-20th c.

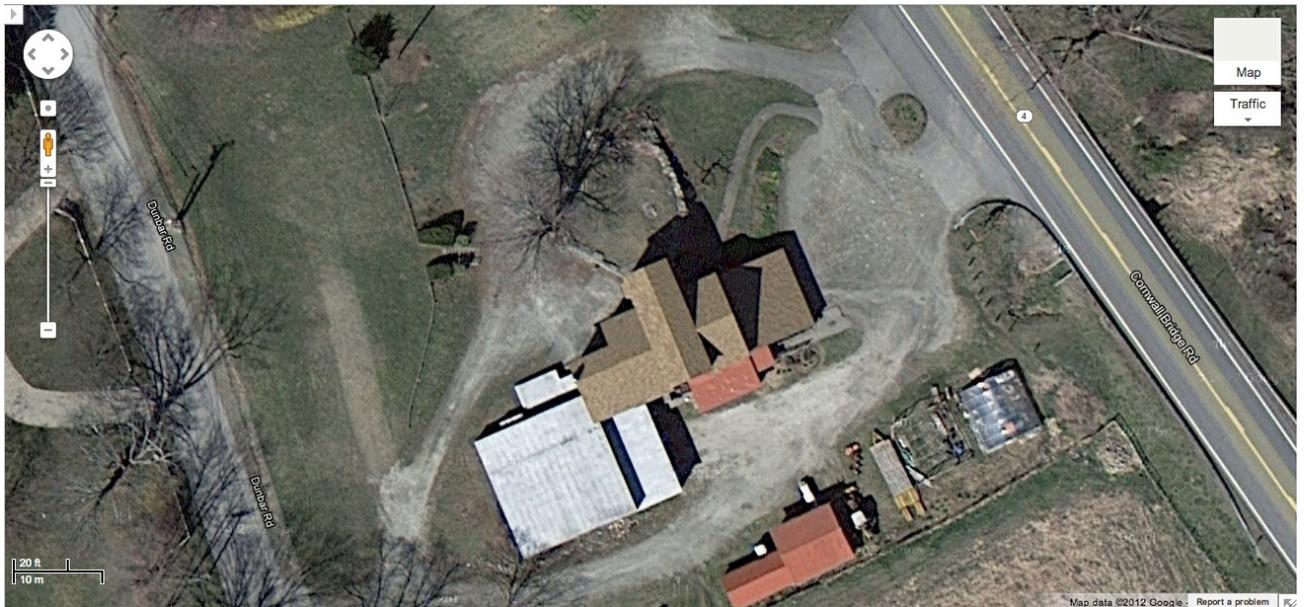
3. Detail Site Plan – base image from Google Maps. The brown shingle roofed building is the barn, with the white flat-roofed apple storage warehouse at the southwest corner.

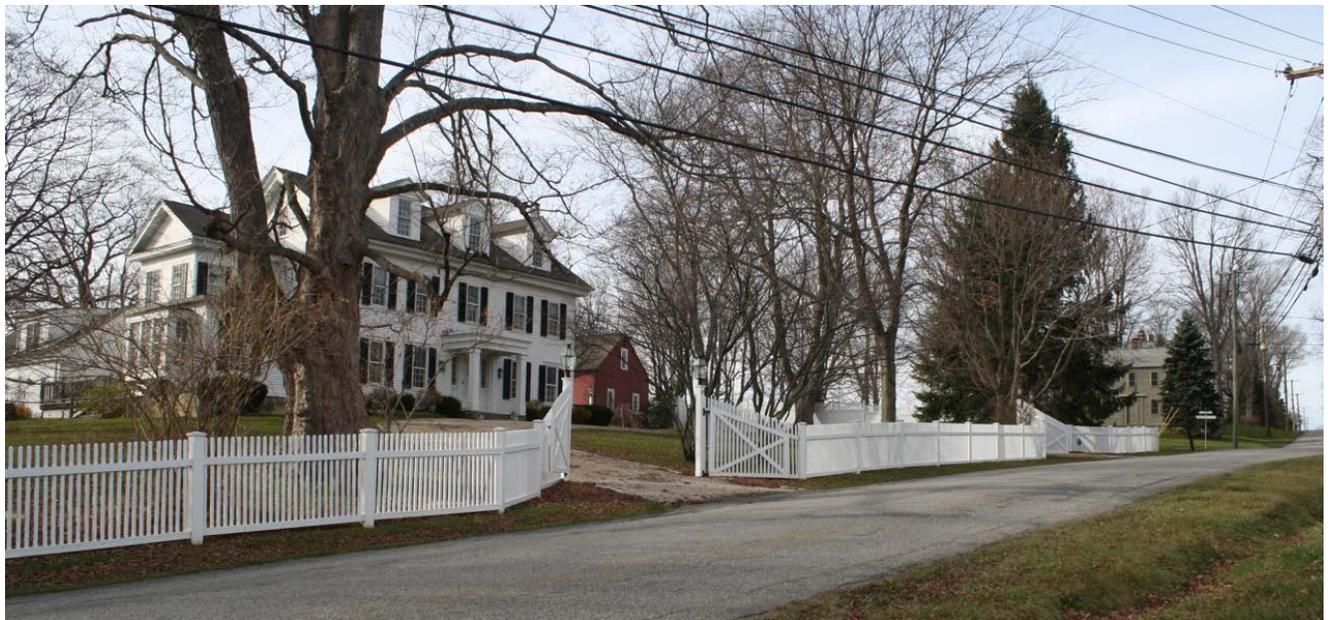
4. Southeast view of 13 Dunbar Road, historically home to the Dunbar family, now under separate ownership; camera facing northwest.

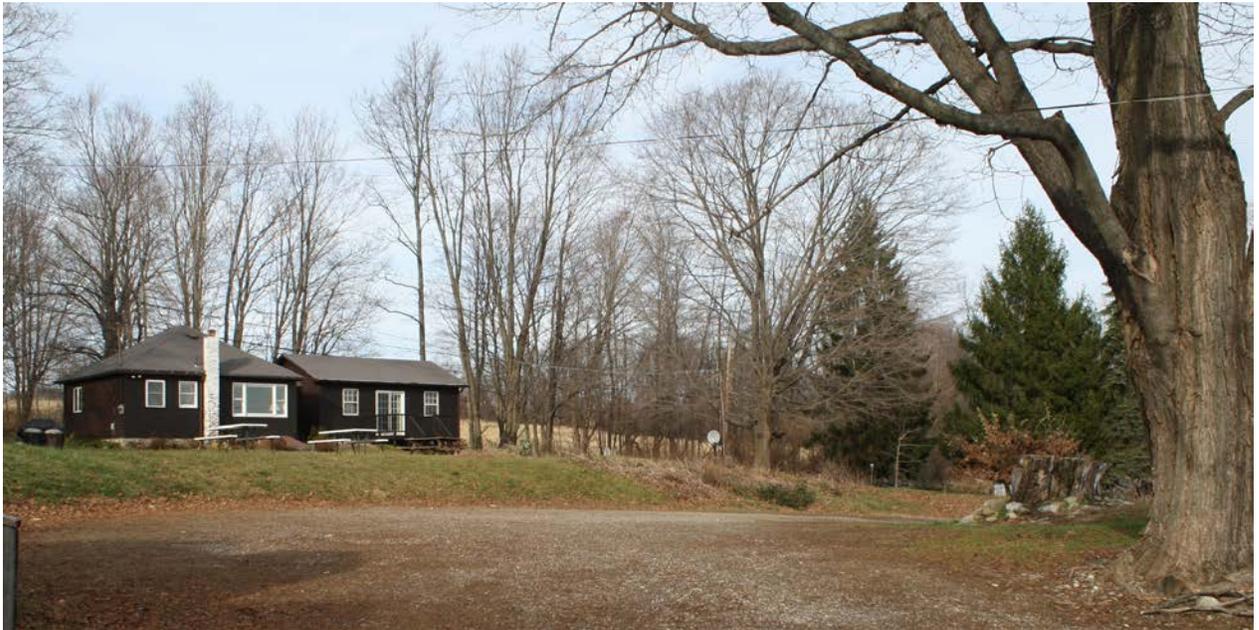
In addition to the barn/store, the site includes a small 1-story gable-roofed bungalow residence to the north, facing Cemetery Road, and a hip-roofed structure connected to the bungalow. This appears likely to have been a milk room for the dairy farm, based on its size and shape.

5. South view of 1 Cemetery Road, building at left is possibly the former milk room; camera facing north.

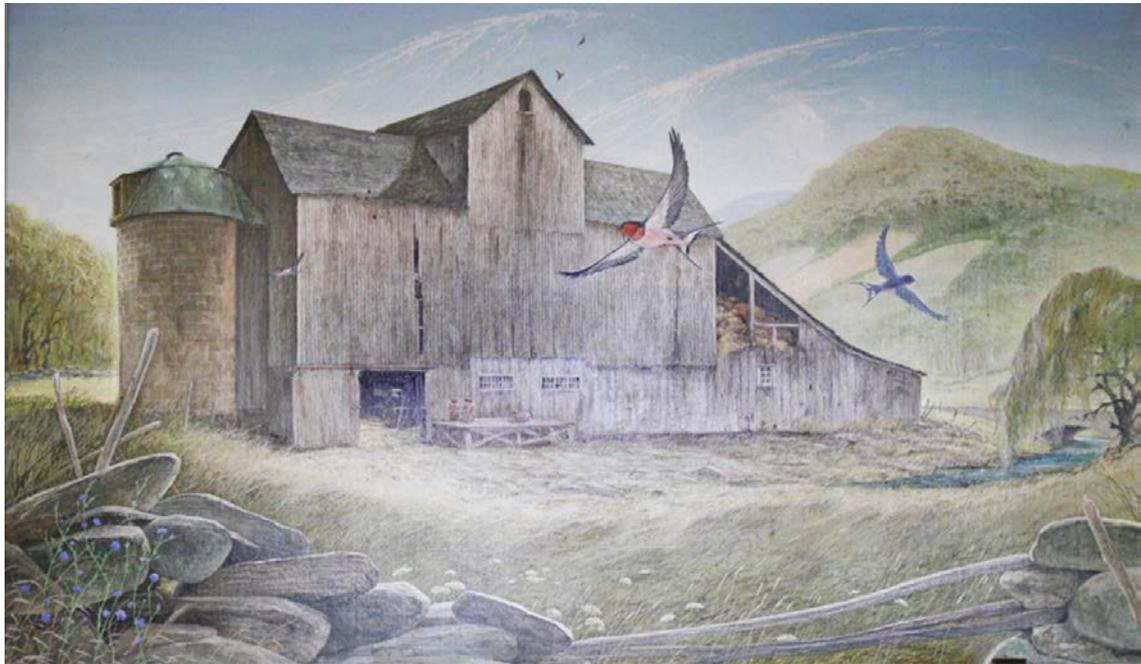
6. Painting showing the barn from the southwest, prior to remodeling; courtesy of the Bozzi family.

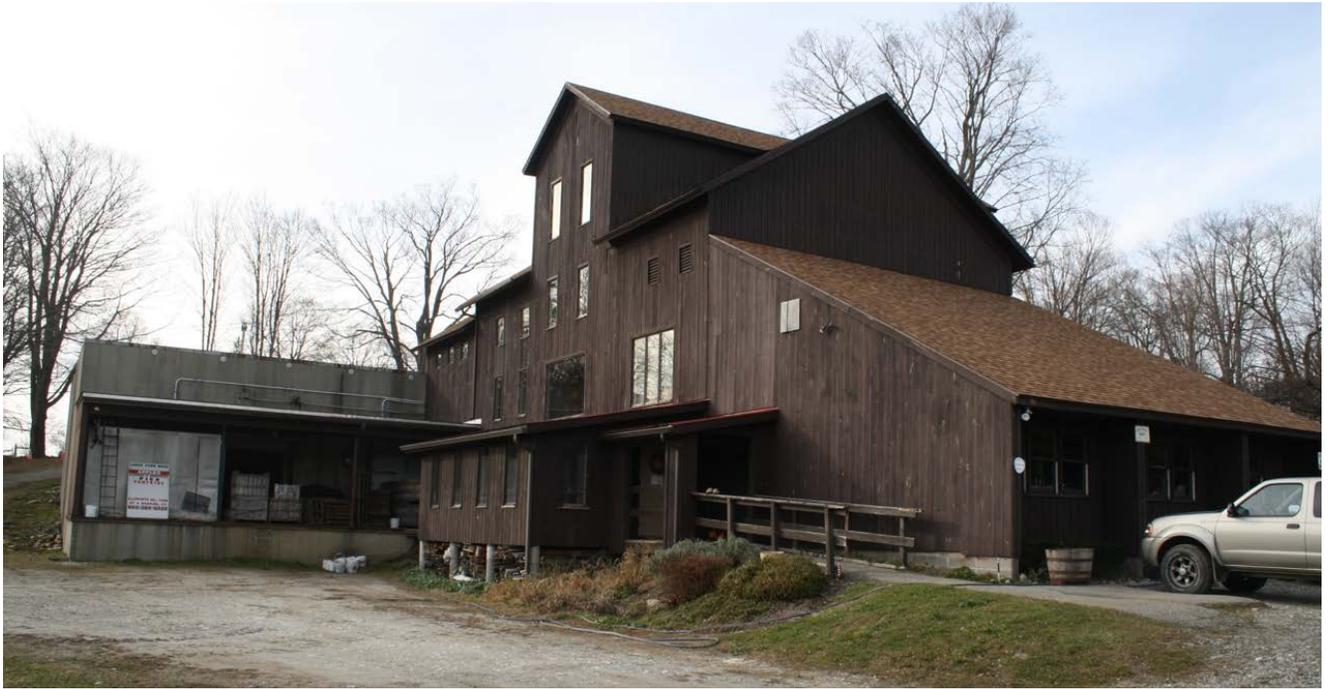
The core frame of the barn was most likely a 30' x 45' English barn with three equal bays. Over the years remodeling appears to have altered it into a high-drive bank barn with an unusual cross-gable structure oriented north-south above the center bay. The gable roof of this structure sits higher than the main ridge-line; its north end projects 12' north of the main barn to form an enclosure for what may have been a high-drive access to the upper hay loft. The current entry into the store is under the high drive, an area that may have been an open passage accessing the center bay of the barn. The south gable-end of the high roof is flush with the south eave-side of the main block, forming the effect of a large wall dormer.

A shed-roofed addition on the east end spans the full width of the east gable-end and its sweeping roof attaches high on the main barn's east gable-end and then slopes down to a basement level wall to the east. This wing now houses the cider mill in the basement level.

A gable-roofed extension continues the roof line of the main block toward the west. A modern concrete apple storage block is attached at the southwest corner and has a flat roof.

7. Southeast view of barn with the east shed wing at right, the main barn at center rear, and the apple storage warehouse at left rear, camera facing northwest.

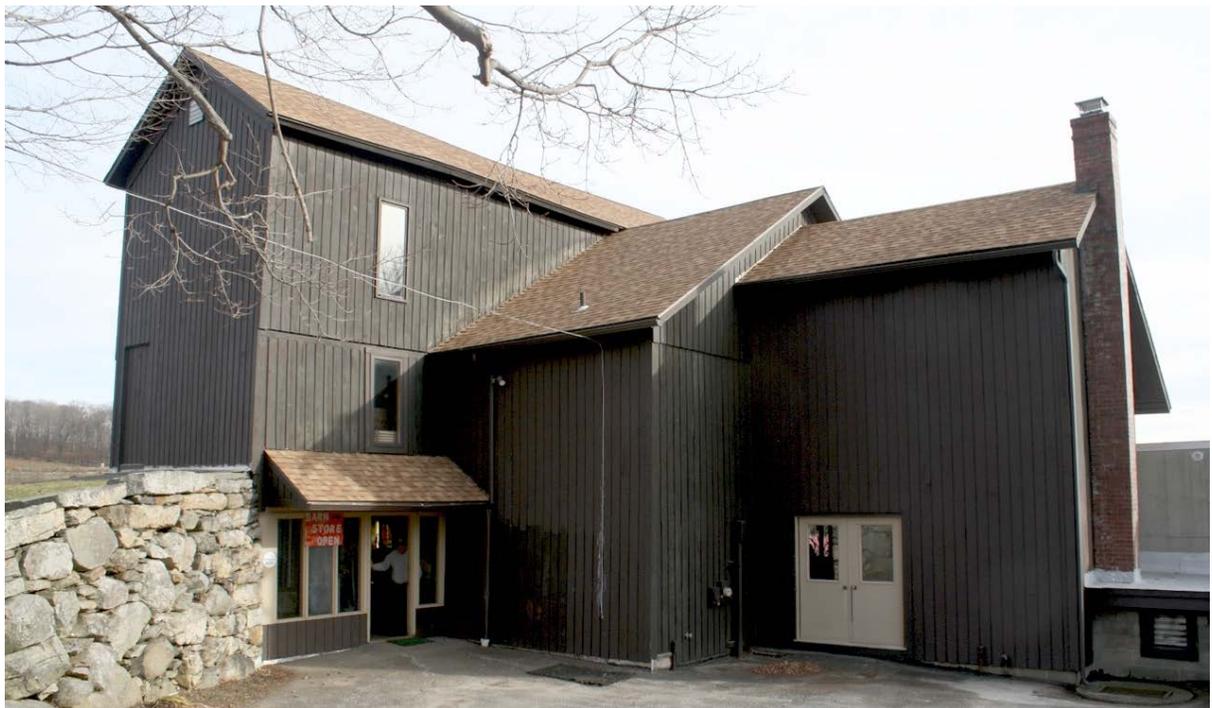
This is a 2 ½-story plus basement hybrid type barn, 30' x 70', with entries into various locations on its four levels. The gable roof has its main ridge-line oriented east-west perpendicular to Dunbar and Cornwall Bridge Roads. Siding is vertical boards stained dark brown. Windows are a mixture of casement and picture windows, installed in the early 1980s when the barn was remodeled for use as a store and office space. A large 47' x 60' apple storage warehouse with a flat roof is attached at the west gable-end and extends to the south of the barn footprint.

8. Northwest view of barn showing the main level entry to the retail store, with the high drive entrance to the upper loft level at left, camera facing southeast.

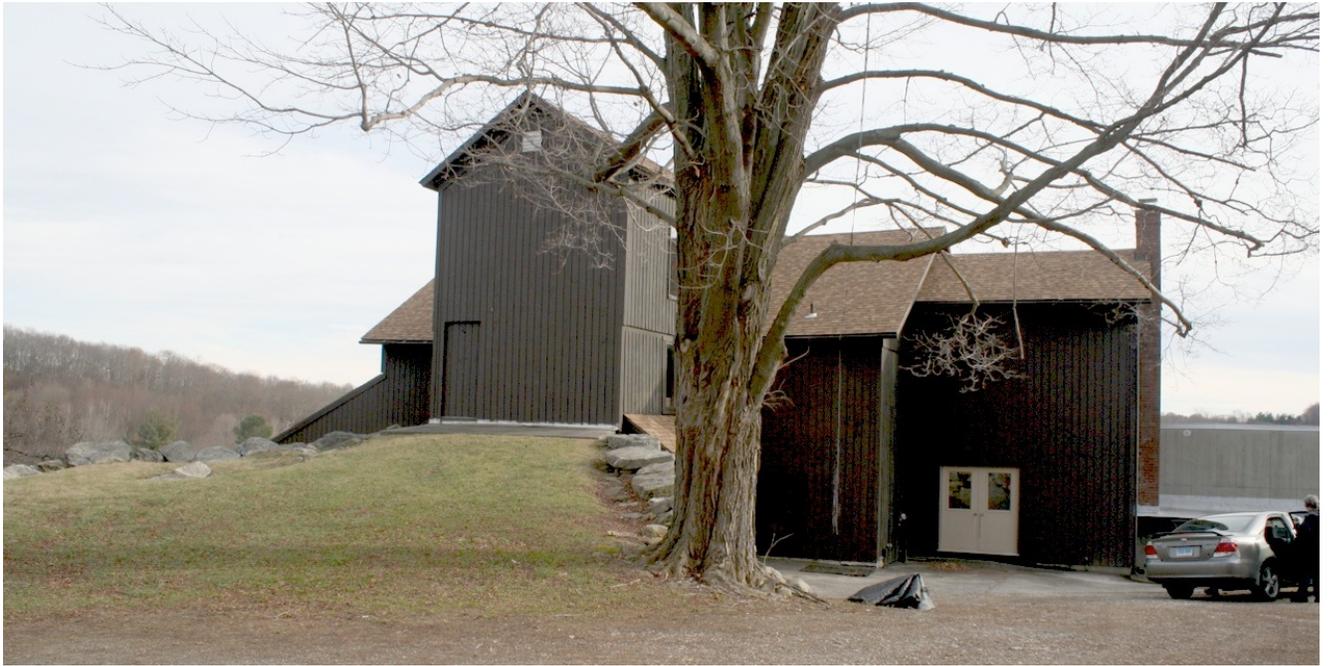
12. North view of barn showing the high drive ramp to the upper loft level at left, camera facing south.
