HISTORIC RESOURCES

BUILDING AND STRUCTURES

Building Name (Common) Tomlinson Farmstead Record No. 43539
 Building Name (Historic) Tomlinson, David / Gideon, Farmstead
 Street Address or Location 181 Meadow Street
 Town/City Shelton Village Lower White Hills County Fairfield
 Owner(s) Paula Anthony, 181 Meadow Street, Shelton CT 06484 Public Private

Style of building Gambrel bank barn, Vernacular style Date of Construction 1931

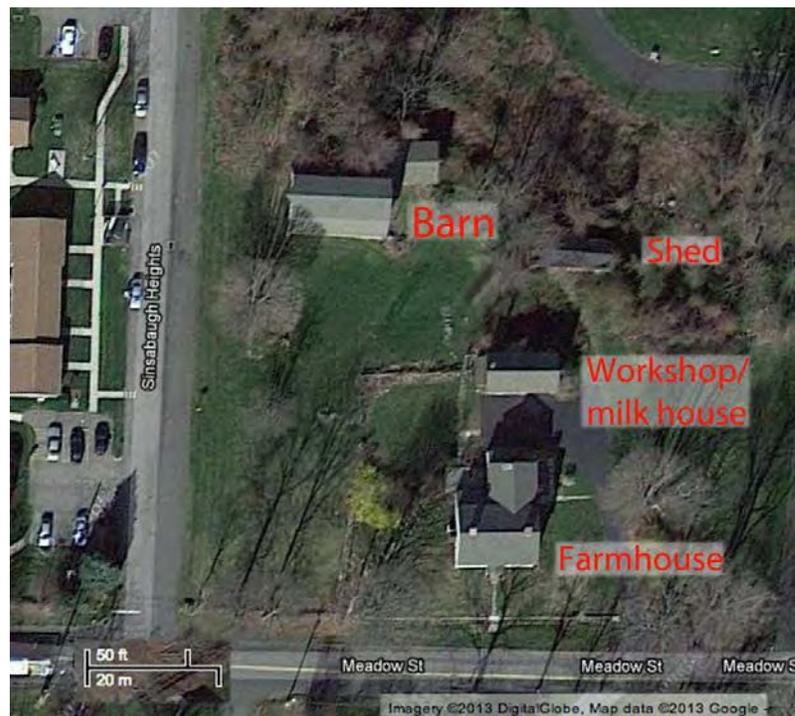
4. Site Plan showing resources – all are contributing (historic) except the Shed – base image from Google Maps.

Farmhouse	c. 1810	C
Gambrel barn	1931	C
Milk House/Garage	20 th c.	C
Shed/Barn	20 th c.	NC

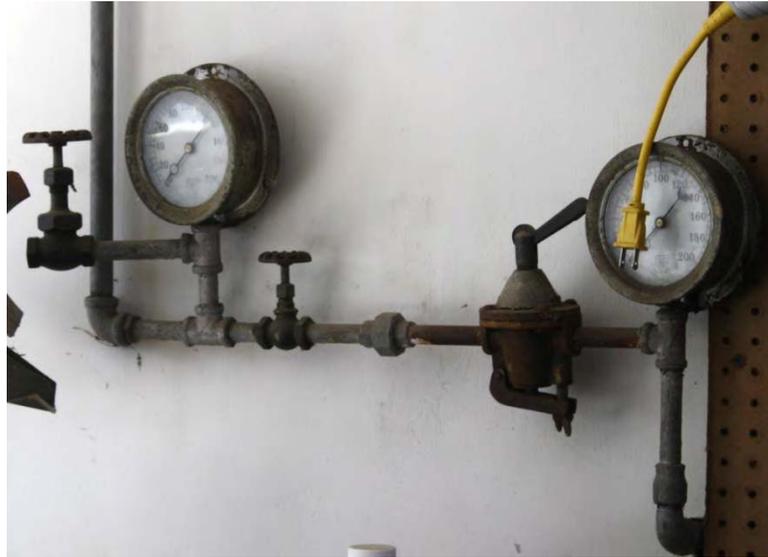
14. Interior view of milk processing area showing valves and gauges, camera facing west.

A second outbuilding is a 2-story workshop or milk house building, 18' x 23', located north of the Farmhouse. It is a three-bay structure with some heavy timber framing mixed with balloon framed studs and dimension lumber rafters. The western bay is enclosed and the interior finished; this was a milk processing facility during the farmstead's mid-20th century dairy farming period. The south eave-side, facing the rear of the Farmhouse, has in its west (left) bay an entry door with four-pane glazed panel over three solid panels. Flanking this are six-over-six double-hung windows with trim including beveled lintels, one on each side. To the right (east) are two modern overhead garage doors. The upper floor level has three six-pane windows tucked in a knee-wall under the eaves. The west gable-end has one six-over-six double-hung window with trim in the upper level. A brick chimney rises in the upper floor and through the roof, off-center toward the north. The north eave-side has a pair of six-over-six double-hung windows in the western bay. The remainder of the north side has a projecting enclosure for the stair that provides interior access to the upper floor, and a projecting shed addition installed to allow for garaging the owner's Cadillacs in the 1960s and 1970s. The east gable-end has a loading door at the upper level, flanked by six-pane windows with trim. The building has horizontal Dutch lap wood siding, painted red, and white trim. The roof is asphalt shingles and the foundation is concrete.

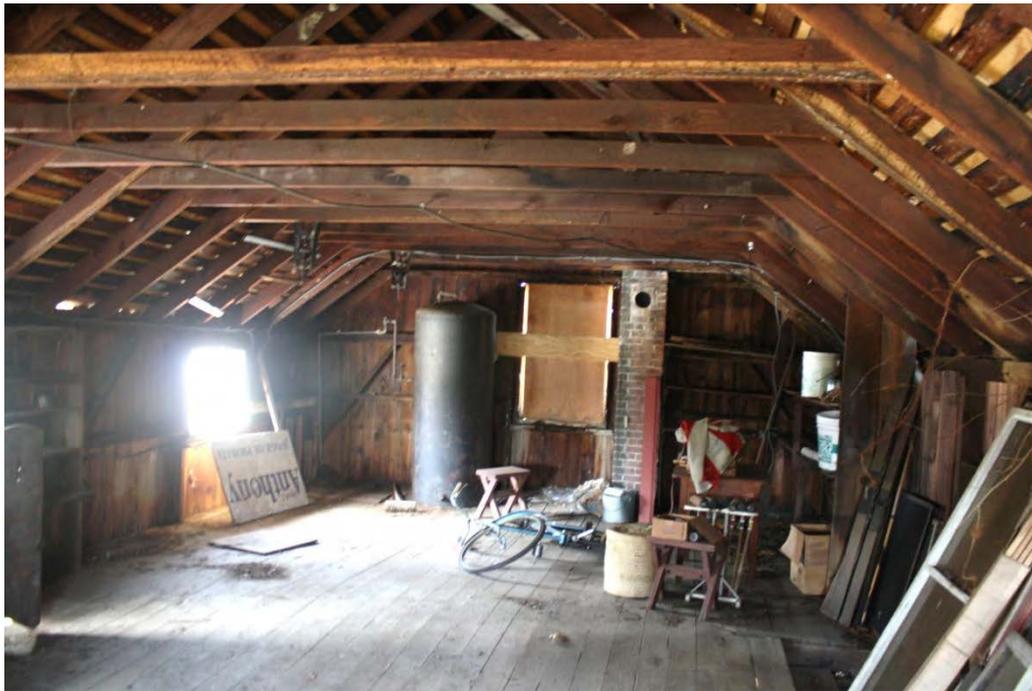
15. Interior view of upper level of Workshop/milk house showing tank and chimney, camera facing west.

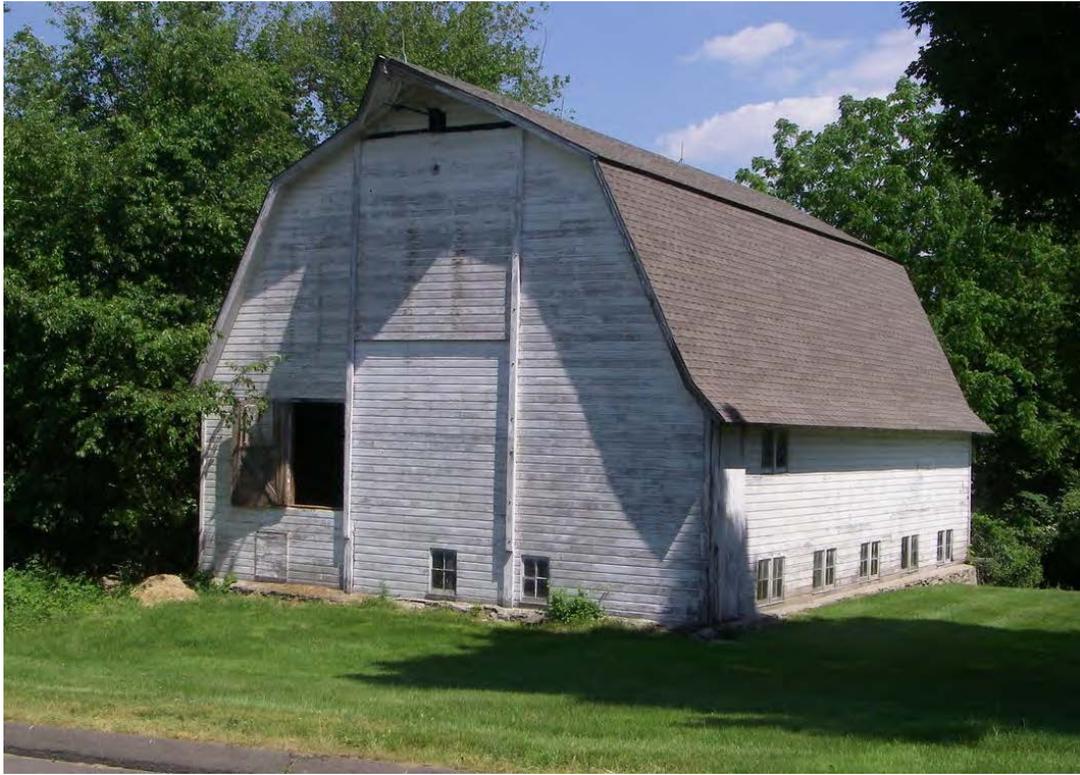
16. Southwest view of Gambrel barn, camera facing northeast. Note the hay door which operates by sliding down.

The west gable-end of the barn has a projecting hay hood at the peak of the roof. Below this a hay track projects through the wall over a large vertical sliding hay door on side-mounted tracks which extend down to the ground. There is a side-hinged hay door at the floor level of the hay loft, to the left (north) of center. This has interior X-bracing, siding on the exterior to match the adjacent wall, and a six-pane vertically-set window sash in the upper part. Two four-pane stable windows and one closed opening are located close to grade, just above the fieldstone foundation which has a few courses exposed on this side.

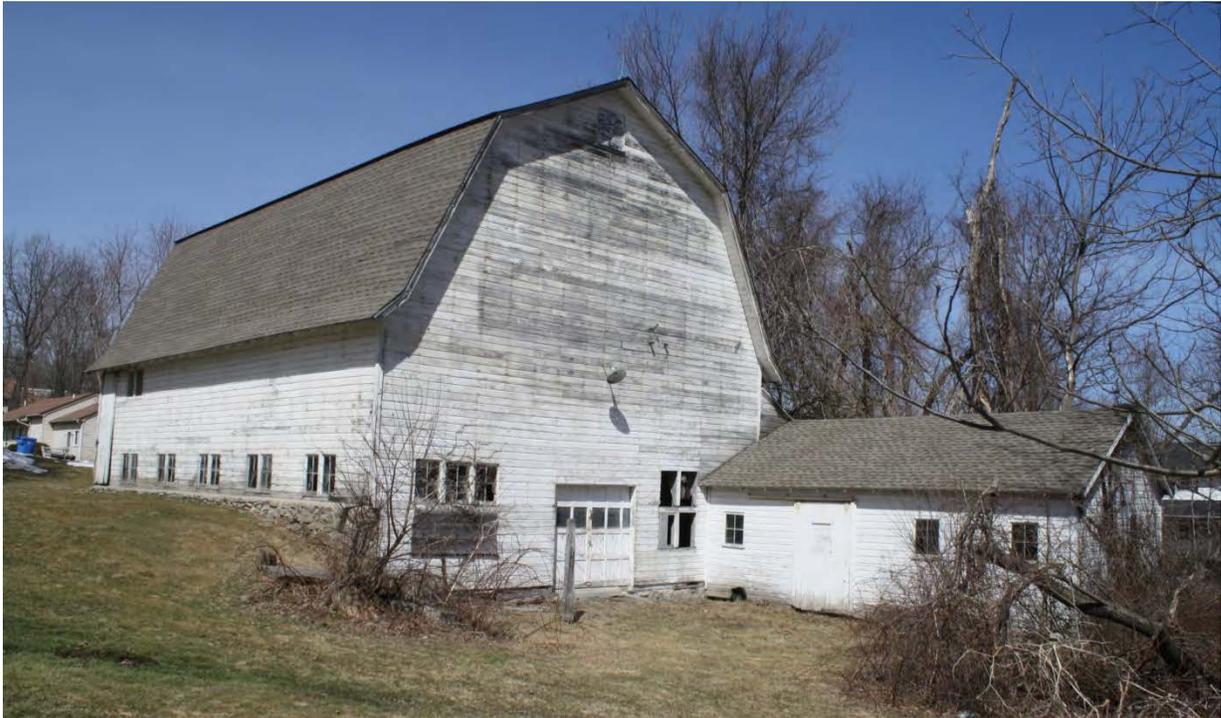
18. Southeast view of Gambrel barn, camera facing northwest, with addition at right.

The grade drops abruptly near the southeast corner to fully expose the east gable-end. At the lower stable level there is a centered overhead door flanked by a group of three four-pane windows on the left and two on the right. Additional openings below these are partially boarded up. The right (north) portion of the wall is overlapped by an attached 1-story gable-roofed addition. The south eave-side of this addition has a sliding door off-center toward the left (west) flanked by one four-pane window on the left and two on the right. The east gable-end of the addition has two four-pane windows. The north side of the addition wraps around the north wall of the main barn and has a door at the northwest corner and several window openings. The door was used for moving manure on an overhead manure trolley, still extant.

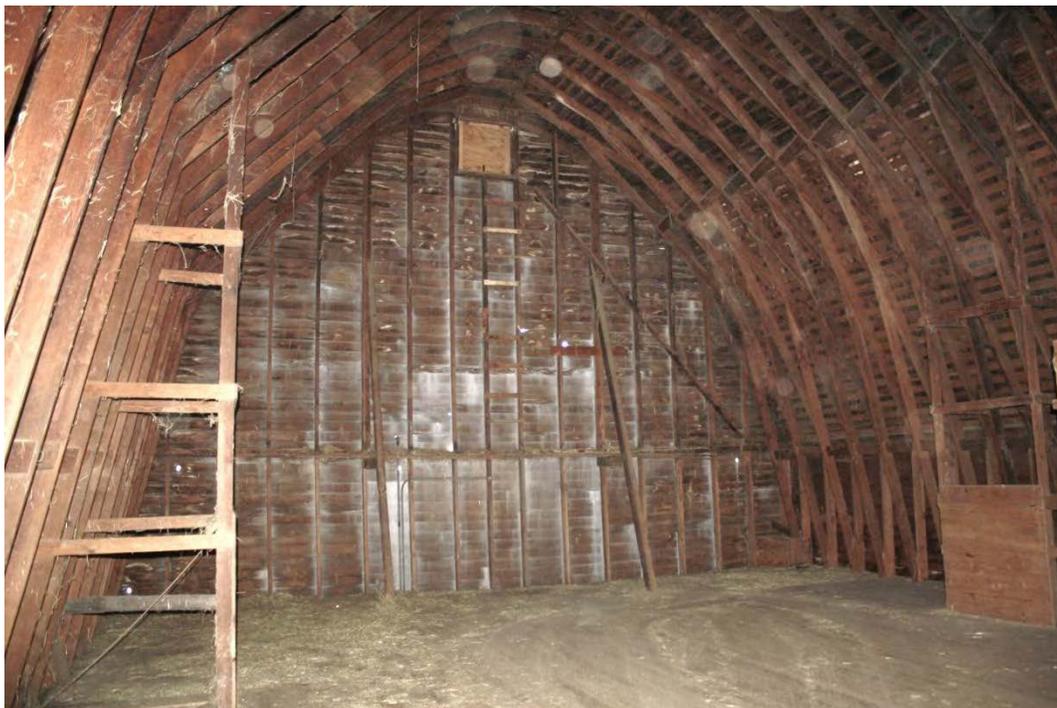
19. Interior view of barn hayloft level, camera facing east. Note the triangular trusses bracing the gable-end wall, a sign of high quality construction, and the barriers protecting the hay trap doors to the lower level.

The loft level is a large clear span space framed by scissor trusses at the changes of wall and roof pitch. A knee wall approximately five feet high along the outer walls transitions to the steep roof pitch by means of a series of trusses at each rafter, composed of sawn dimension lumber. Similar trusses brace the transition from the lower steep roof pitch to the upper shallow pitch. Collar ties near the peak support a hay track. An enclosure at the southwest corner separates the grain bin and stair from the hay mow. Two hatches along the outer walls provide for pitching hay down to the stable. The end walls are braced by triangular trusswork anchored to the floor.

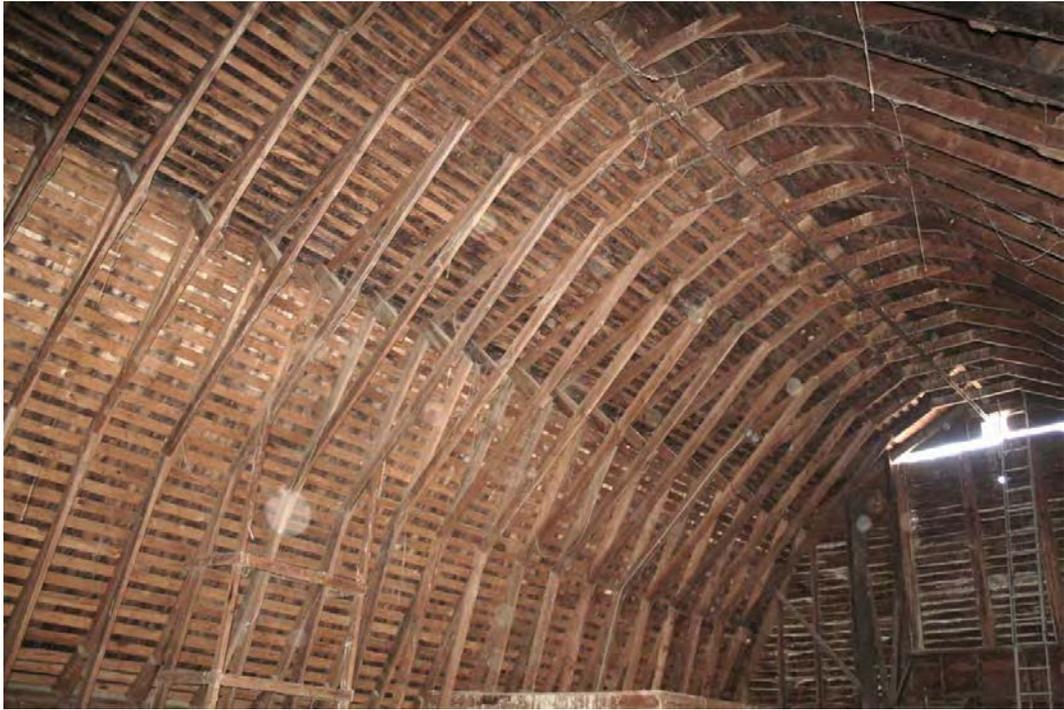
20. Interior view of barn hayloft level, camera facing west. Note the inside view of the vertical sliding hay door and the hay track suspended at the peak.

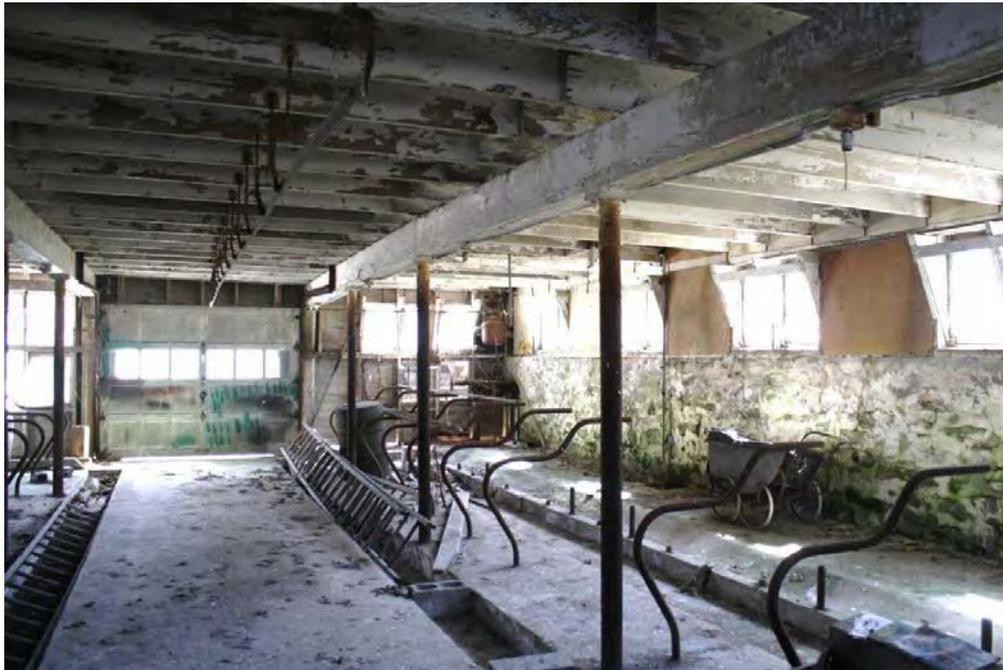
21. Interior view of barn ground level stable, camera facing east. The east end opens to grade while the south wall at right is partially banked. Note the typical ground level dairy layout with the remains of metal stanchions, manure gutters, and the track overhead for a manure trolley system. Windows have typical hopper opening function with side panels.

The ground level has mortared fieldstone walls up to the window sills. Two lines of steel pipe columns support longitudinal wood girders made up of multiple timbers of sawn dimension lumber. Lateral joists of sawn dimension lumber support the loft floor above. The concrete slab floor is formed with a center aisle containing two manure gutters, two rows of stanchions facing out, curved mangers, and access aisles slightly raised along the outside walls.

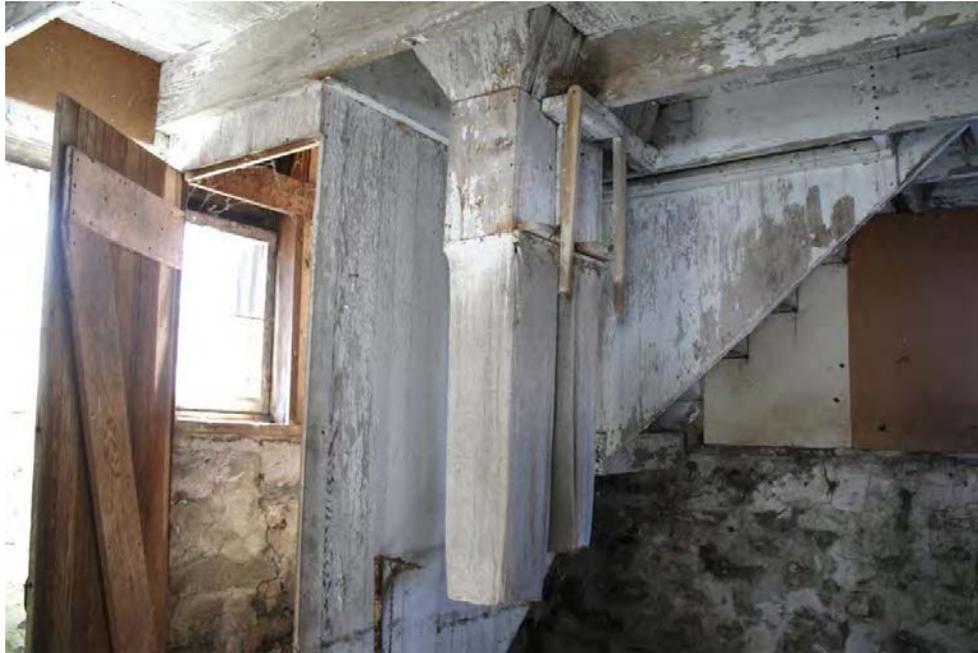
22. Interior view of barn stable level, camera facing southwest, showing the entry from grade a half-level above and the grain chutes from the grain bin above.

At the southwest corner, an enclosure contains steps up to a landing and exist door, with continuing steps up to the loft level. Adjacent to the stair are grain chutes leading down from grain bins at the loft level.

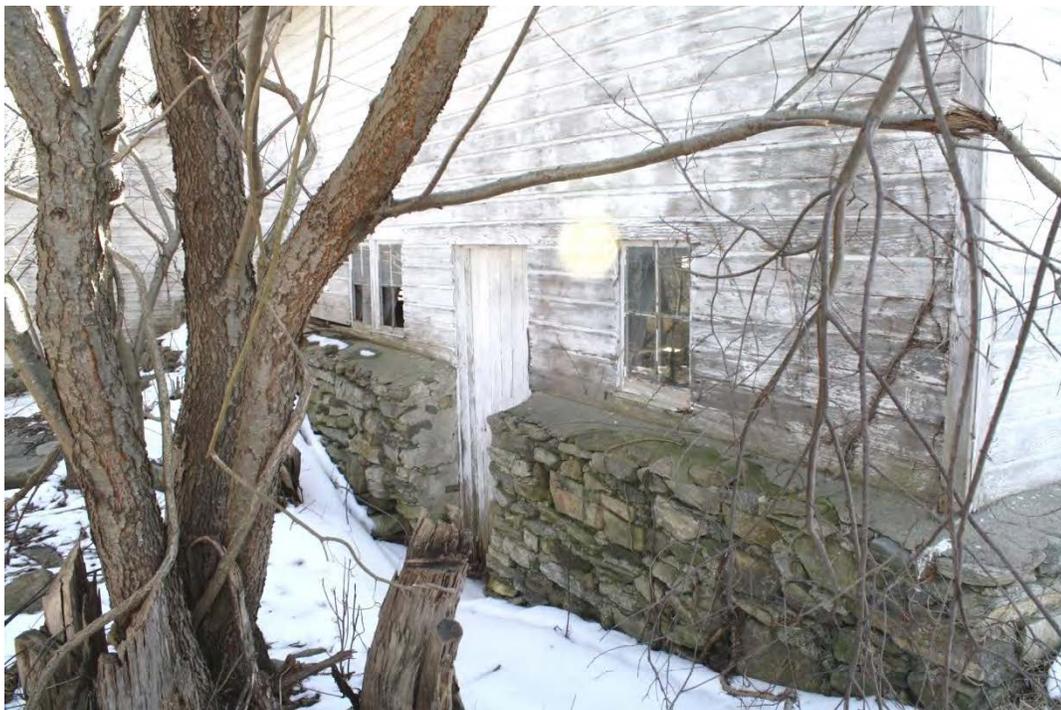
23. North view of Barn, camera facing southeast, showing the north side exposed foundation wall. The door was access to the silo, which stood immediately north of the barn wall.

The north eave-side of the barn is similar to the south, with the addition of a doorway leading to the location of the former silo, whose foundation stones are still visible.
