**HISTORIC RESOURCES**

**BUILDING AND STRUCTURES**

Building Name (Common) White Silo Farm and Winery Record No. 10153  
 Building Name (Historic) Barnes, Albert, Farmstead / Osborns' Upland Pastures Farm (South parcel)  
 Street Address or Location 32 Route 37 East  
 Town/City Sherman Village \_\_\_\_\_ County Fairfield  
 Owner(s) Ralph Gorman, 32 CT Route 37 E, Sherman CT 06784  Public  Private

**HISTORIC RESOURCES INVENTORY FORM – BUILDING AND STRUCTURES continuation sheet**

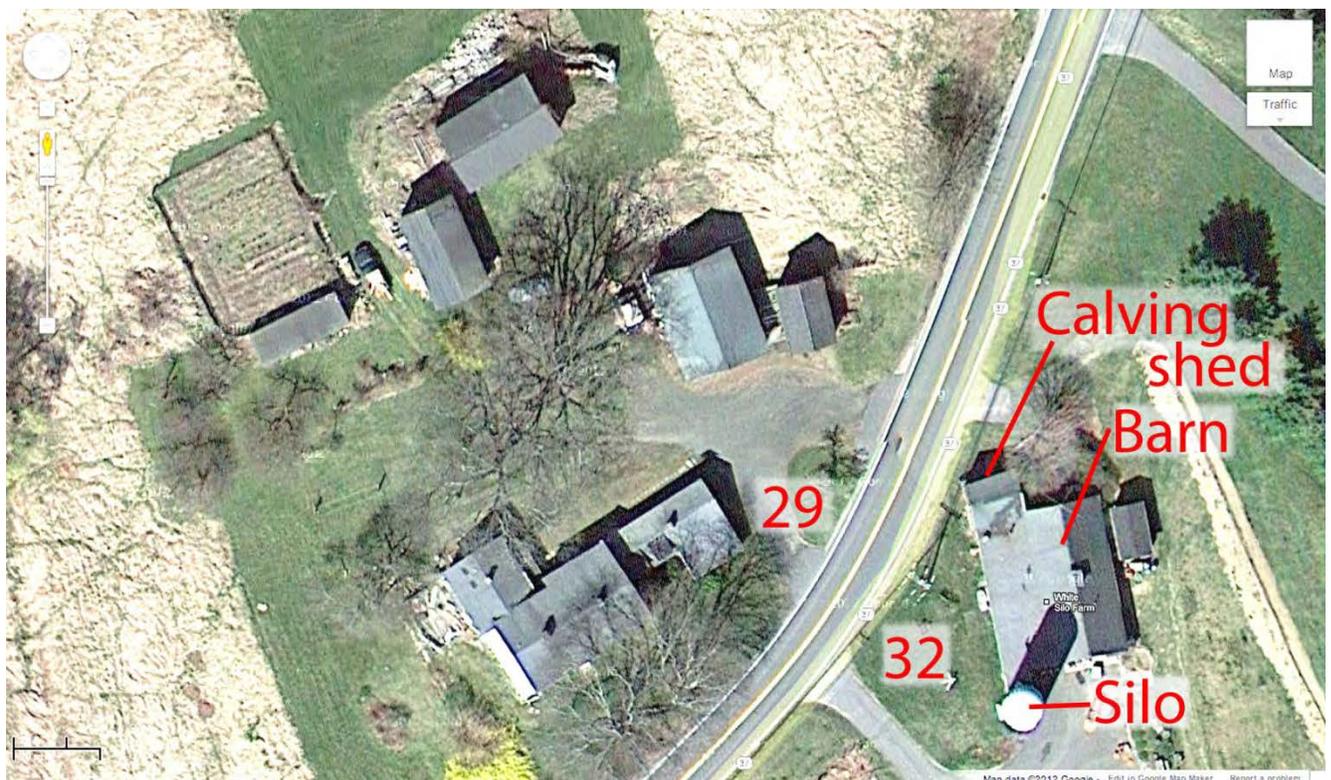
4. Detail Site Plan Sketch showing contributing resources, including the Main barn, Calving shed, and Silo. On the north side of the road, 29 Route 37 East is the Barnes-Osborn Farm house and outbuildings.

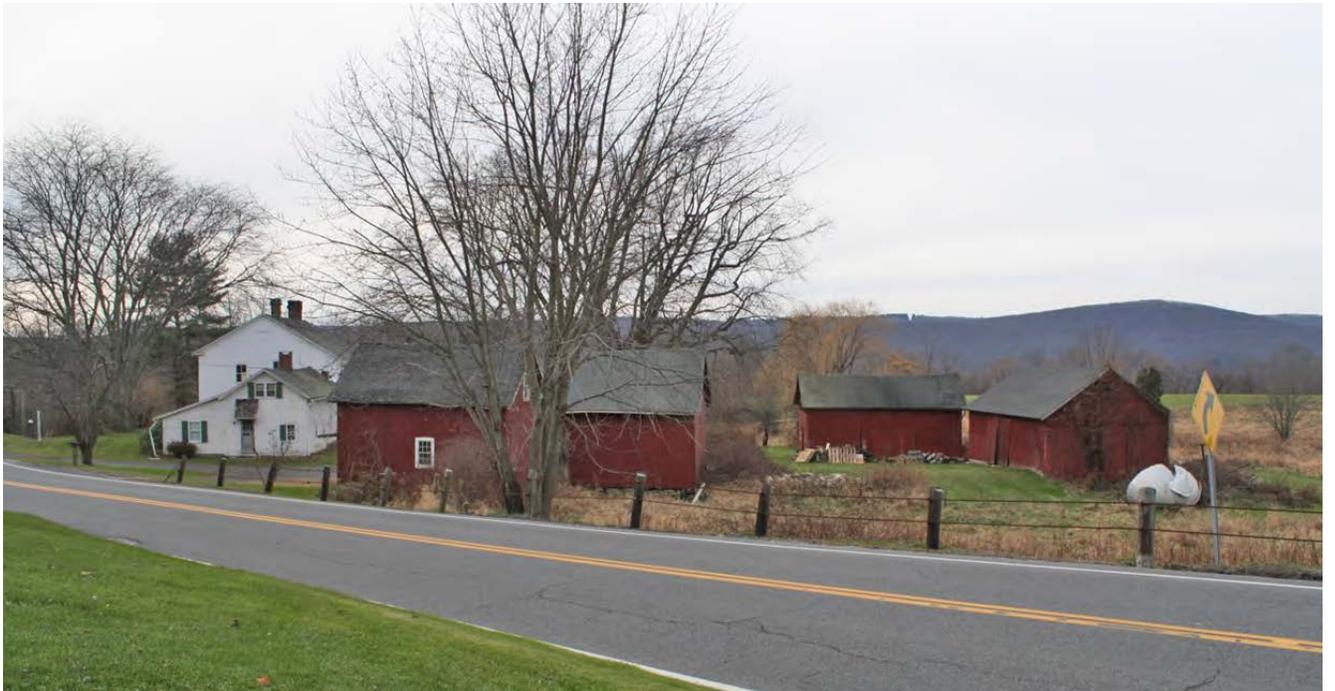
6. East view of the north side of the road, the Albert Barnes House at left and outbuildings at right, camera facing west. Note the remains of the collapsed silo at far right.

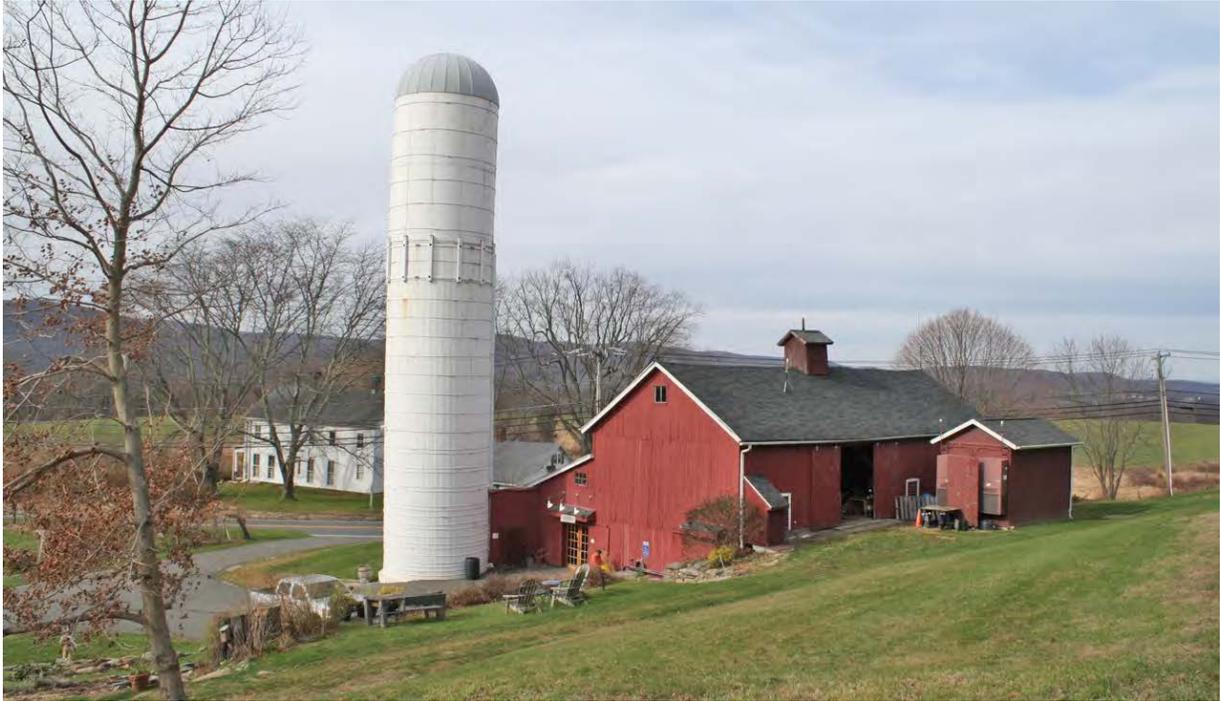
The Silo is a concrete stave silo on a concrete foundation, all painted white. Formerly a second silo stood adjacent to the east. In recent years the silo has been converted to a telecommunications tower by the addition of a fiberglass extension which has extended the height and altered the proportions of the silo.

7. Southeast context view, camera facing northwest. Main barn is at center with the Silo. Barnes House is at left rear across the road. The small shed at right is a new structure for telecommunications equipment, as is the upper part of the silo.

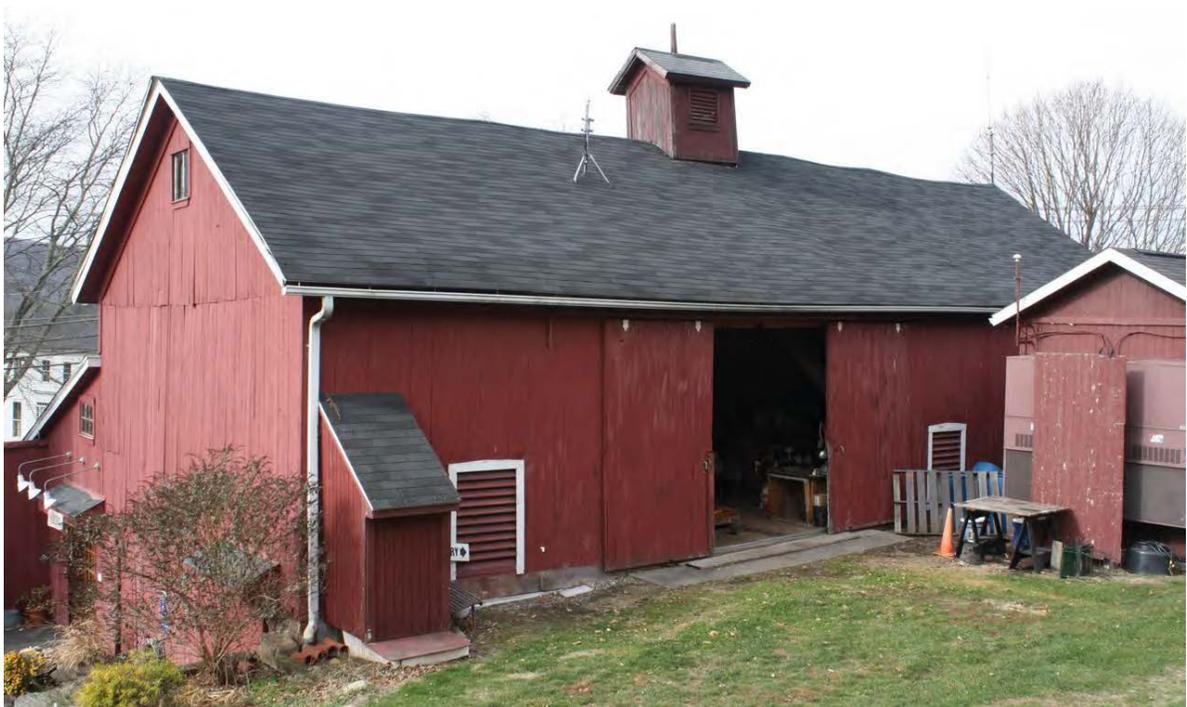
The main entry is in the east eave-side of the barn, and is in the second bay from the south end. It consists of a pair of exterior hung sliding doors. Located just north and south of the entryway are louvered openings with trim, venting the basement stable via an enclosed shaft at the interior. Near the north corner of the east eave-façade are two window openings with trim, lighting the basement via enclosed shafts. On the south corner of the east eave-façade is a small shed-roof extension, extending to the east.

8. Southeast view of the Main barn, camera facing northwest. Note the louvers in the wall which connect to ventilation shafts from the basement stable level.

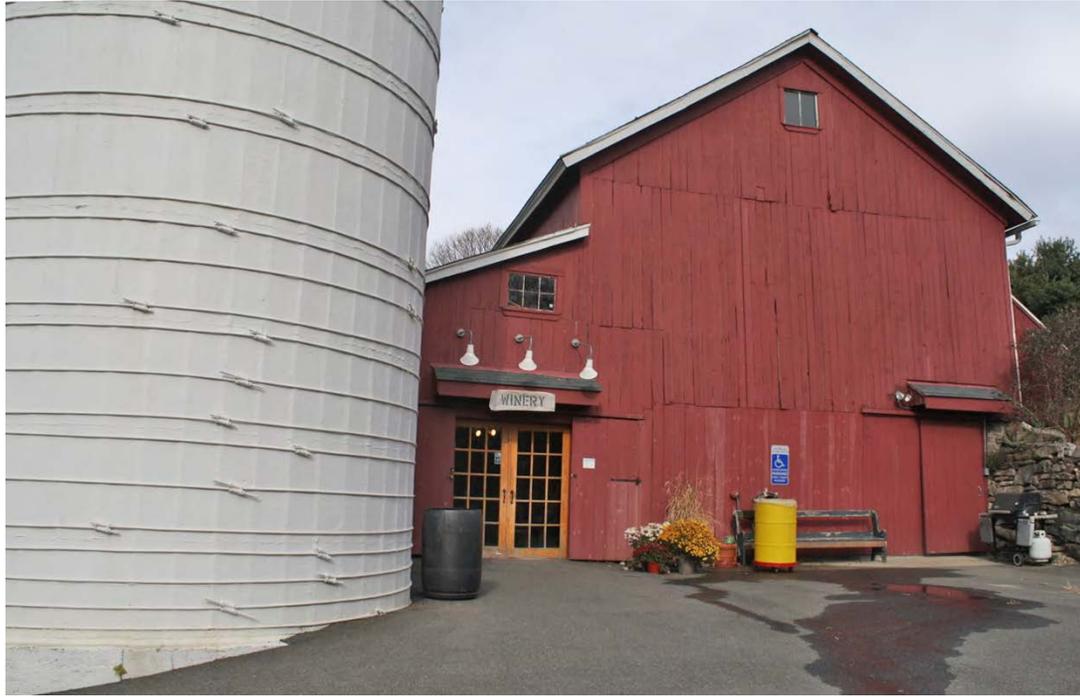
The grade drops dramatically towards the west across the south gable-end of the barn, with a stone retaining wall making the transition, revealing a full basement level. Near the south corner is an exterior sliding door with a shed-roof hood above. At the left corner under the shed roof of an attached addition, there is a pair of French doors providing the entry to the wine-tasting room. A six-pane window is above the doors and in the gable-attic of the is a two-pane window.

9. South view of the Main barn and Silo, camera facing north.

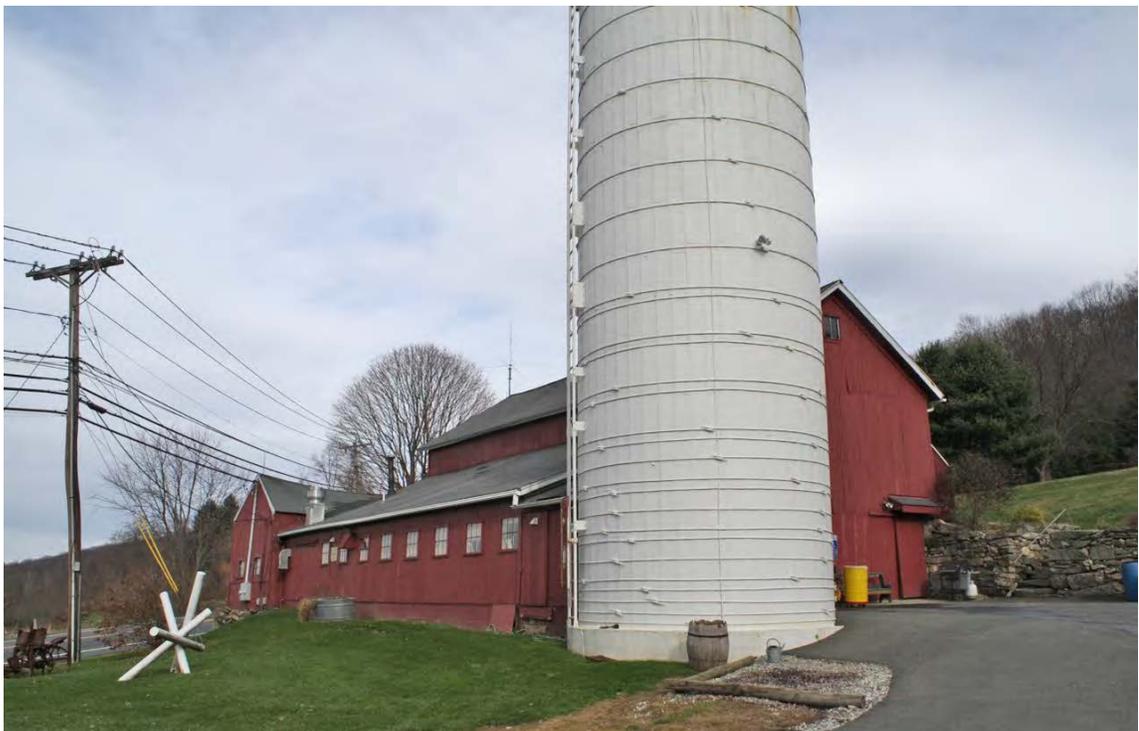
Attached to the west eave-side of the barn and extending to the west is a shed-roof addition. This addition encompasses the entire lower wall of the west eave-side of the barn. A six-pane window is found high up just below the eave, off-center toward the south, on the west eave-side of the main block of the barn. The west side of the addition has a row of eight six-pane windows with trim, spaced evenly except near the north corner where there is a pair of hinged doors. At the right (south) corner a 1-story gable-roofed shed connector links the barn to the Silo and has a sliding door in the west side.

Attached to the north end of the shed addition and flush with the west wall, is the 1-story gable-roofed Calving shed with its ridge-line oriented east-west. A fieldstone foundation is visible on the west gable-end and a concrete foundation on the north eave-side. Two six-pane windows are in the west gable-end. There are no openings along the north or east sides of the addition.

10. Southwest view of the Main barn and Silo, with the Calving shed at the left rear, camera facing northeast.

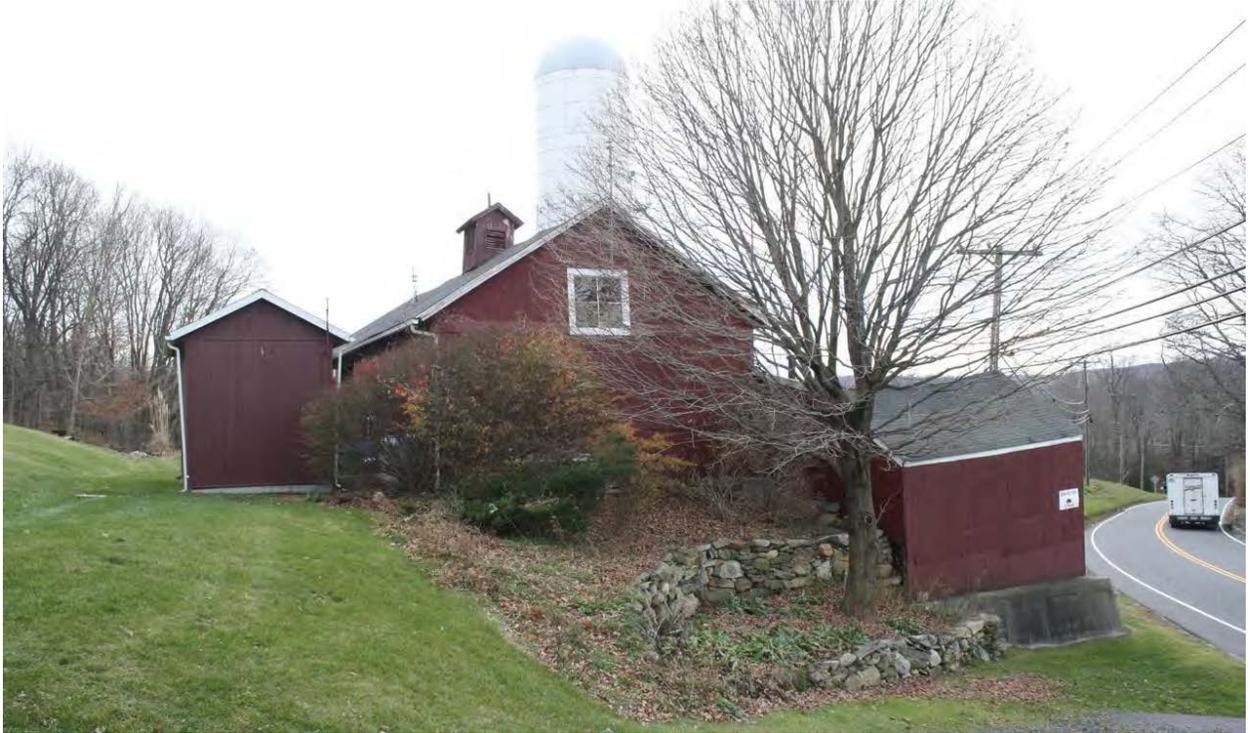
11. North view of the Main barn and Calving shed at right, camera facing south. Shed at left is a new telecommunications structure.

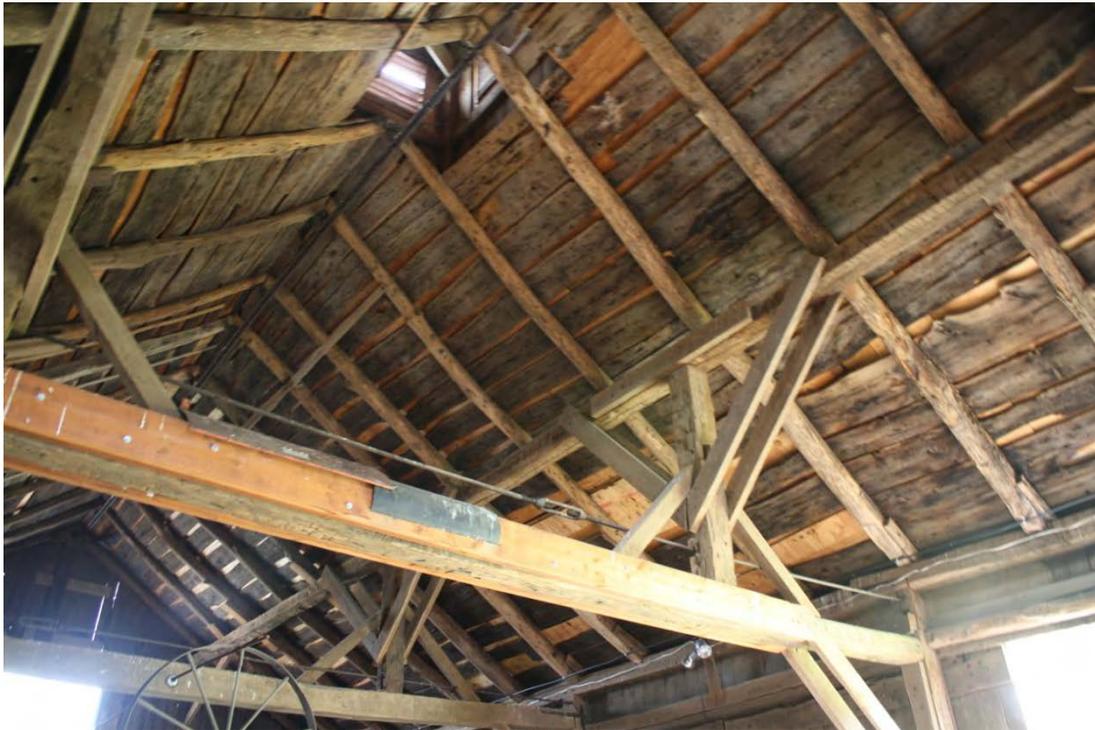
The interior of the main level is a four-bay, five-bent square rule post and beam frame with dropped tie-girts and queen posts supporting longitudinal purlin plates which carry the common rafters at mid-span. The southernmost interior bent has a center post, while the other three interior bents do not. The southern bent has experienced failure of the tie-girt at the center over the post. One of the tie-girts has been repaired with sistered lumber members, while all have tension cables installed across the width of the barn. Numerous other repairs are visible, both sistered reinforcing and added diagonal braces. The rafters are un-planed poles butted at the peak, with random-width board decking overlaid with plywood for a new roof. A hay track and horse fork are extant, suspended below the ridge. The west side wall is open to the shed roof extension which encompasses the entire west side. The east wall has slope-topped enclosures for vents and windows connecting to the basement stable level below. The floor is a plywood layer installed over insulation above the original plank floor, which forms the exposed ceiling of the basement level.

The White Silo Farm barn on the south side appears to be an early- to mid-19<sup>th</sup>-century structure, though possibly rebuilt or re-arranged, as evidenced by the four-bay arrangement with un-matching bents. Its original pole rafters and wide board roof sheathing are indications of an early 19<sup>th</sup>-century date. As was often the case, the early timber frame may have been jacked up and the dairy stable level inserted beneath, to adapt to the needs of a commercial dairy operation of the early 1900s.

13. Interior view of Barn main level roof framing, camera facing north, showing two north bays. Note lap joint in plate over the tie-girt, and indication of possible construction in two sections.

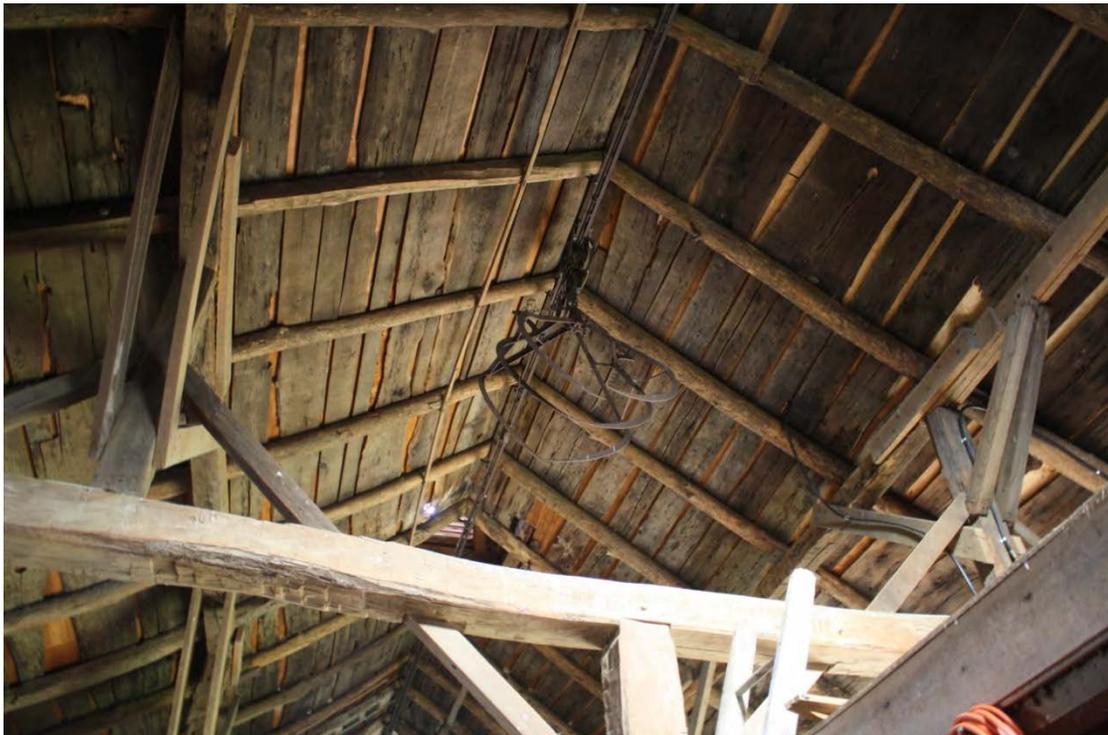
14. Interior view from south bay looking north. Note the hay track and horse fork, bent with interior center post.

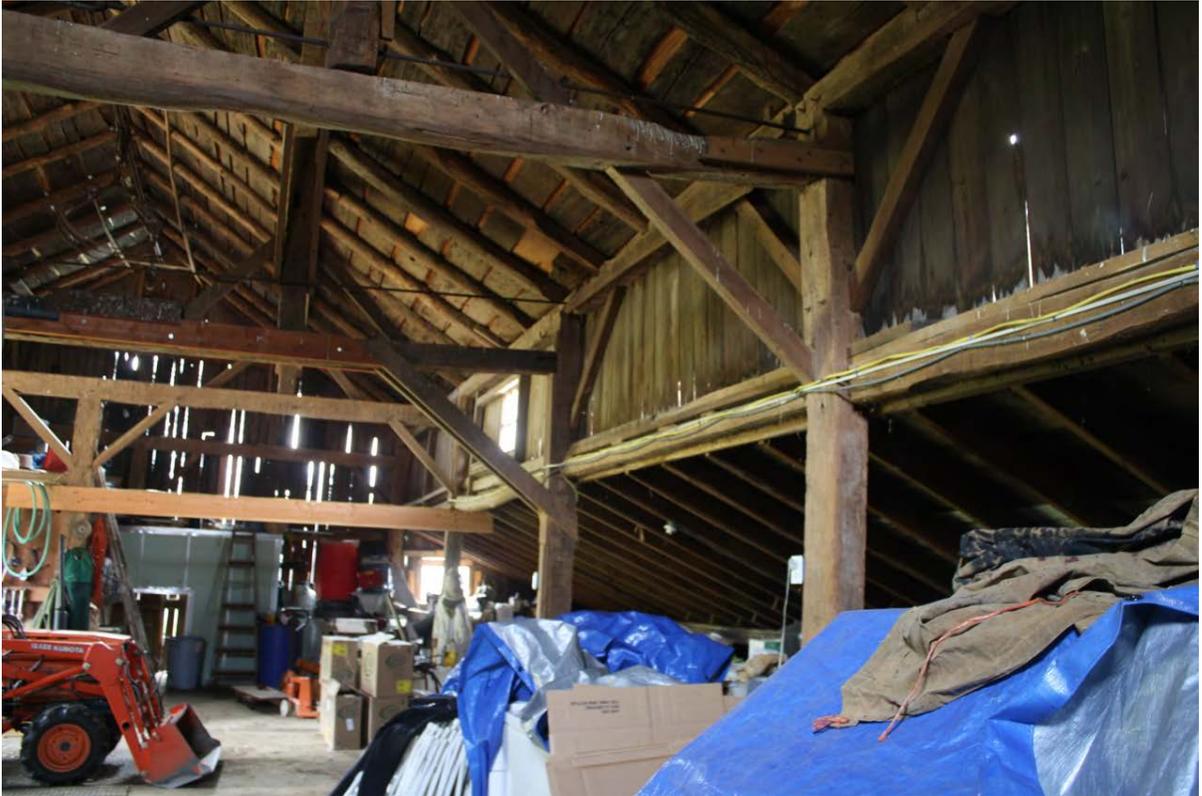
15. Interior view, camera facing south. Note the shed roof framing of the western addition at right.

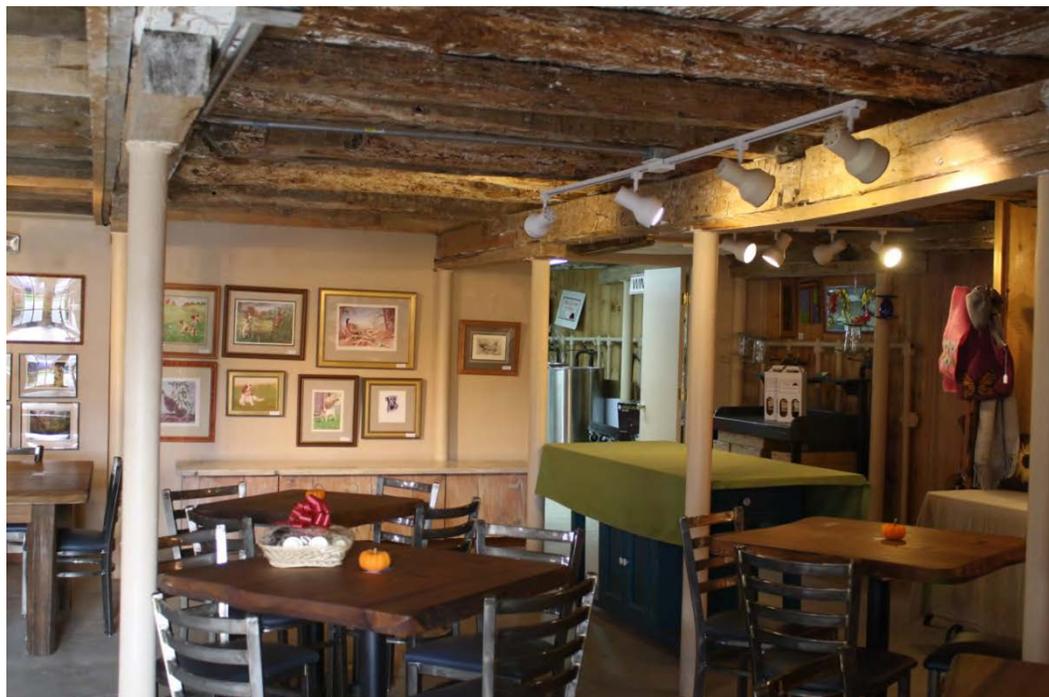
The basement grade level, formerly the dairy stable, has been converted to a winery, kitchen, and sales and tasting room. The structure supporting the barn above is exposed timber, with traces of whitewash. Three longitudinal girders carried on rows of steel columns, support the lateral joists of the main level. Joists vary, from hand hewn and mortised into the girders below the main loft, to dimension lumber at the shed addition area. A new concrete floor has been poured and display cabinets have been created from recycled barn wood. Accessible toilet facilities have been installed and there is a commercial kitchen in conjunction with the wine-making rooms. The tasting room doubles as a gallery with rotating art exhibits.

16. Interior view of basement level wine tasting room, camera facing northeast. Girder at left is the line of the west wall of the upper loft level; to left is the shed addition. Doorway at right rear opens to wine-making area.

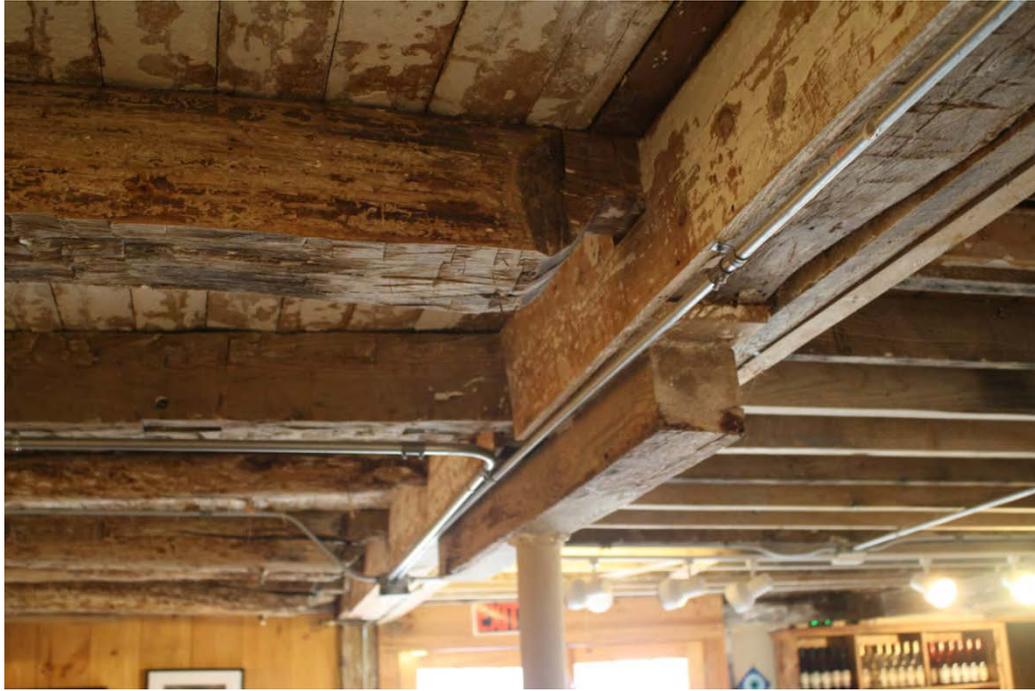
17. Interior view of basement level wine tasting room, camera facing south. Girder is the line of the west wall of the upper loft level; to right is the shed addition. Note hand hewn mortised framing in the left, older portion.

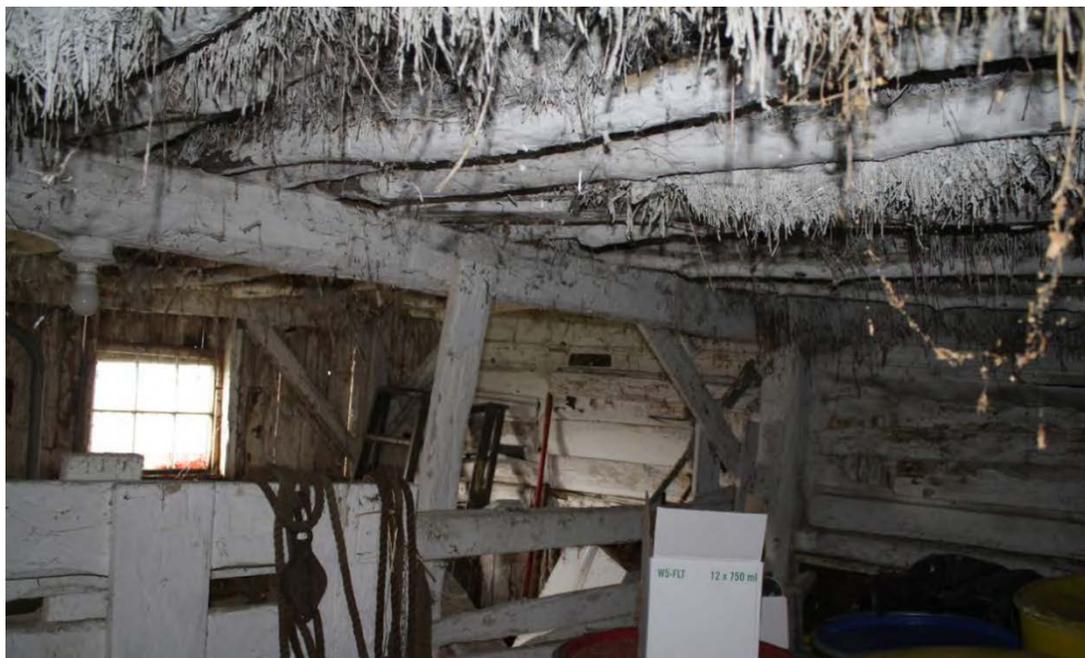
The interior of the Calving Shed is still in its original condition, with hand hewn post and beam framing and cattle pens. The ceiling is insulated with straw.

18. Interior view of Calving shed, camera facing northwest.

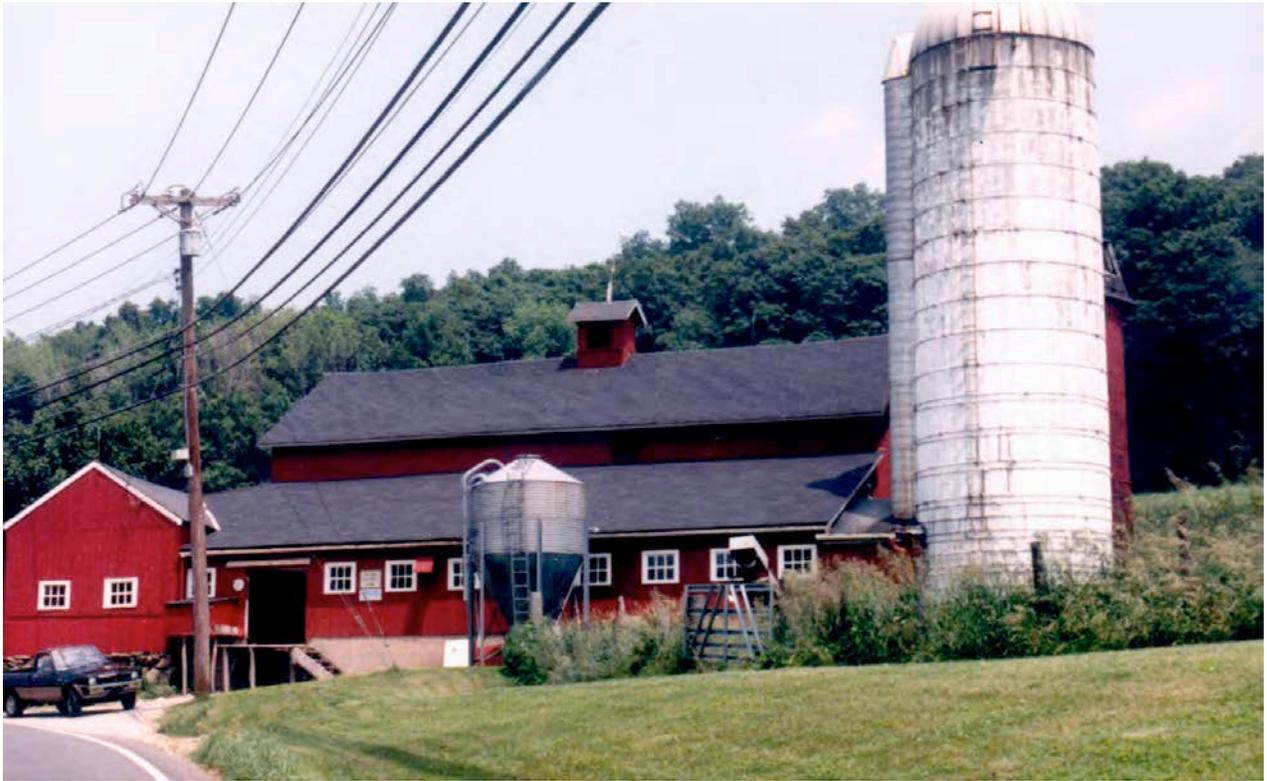
19. West view of barn and silo taken in 1985, while still a working dairy farm, camera facing east, photograph courtesy of Robin Szendy.

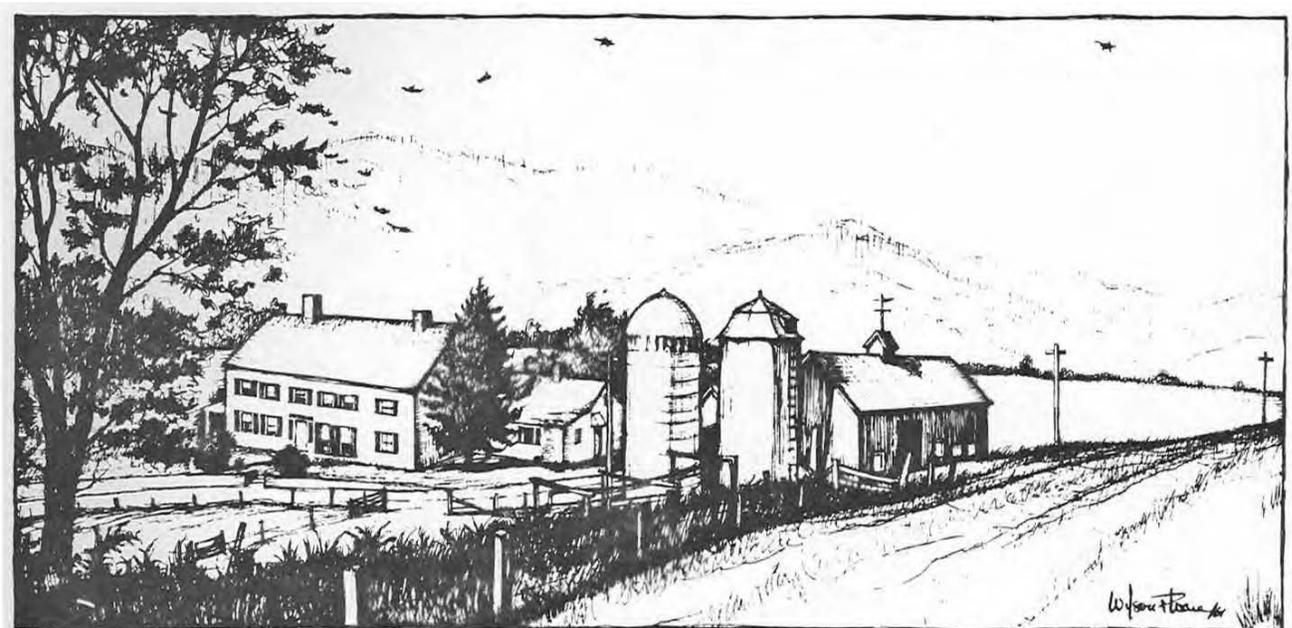
The Osborn Farm -- November 1961

20. South view of the Osborn Farm in 1961, drawing by Wilson Ware (*Sherman Sentinel Houses*); note two silos at south end of the barn.
