**HISTORIC RESOURCES**

**BUILDING AND STRUCTURES**

Building Name (Common) Woodbury Sugar Shed, Inc. Record No. 7366  
 Building Name (Historic) Mitchell Farmstead  
 Street Address or Location 41 Washington Road (Route 47)  
 Town/City Woodbury Village North Woodbury County Litchfield  
 Owner(s) Louis S & Carol A Berecz, 41 Washington Road, Woodbury CT 06798  Public  Private

HISTORIC RESOURCES INVENTORY FORM – BUILDING AND STRUCTURES continuation sheet

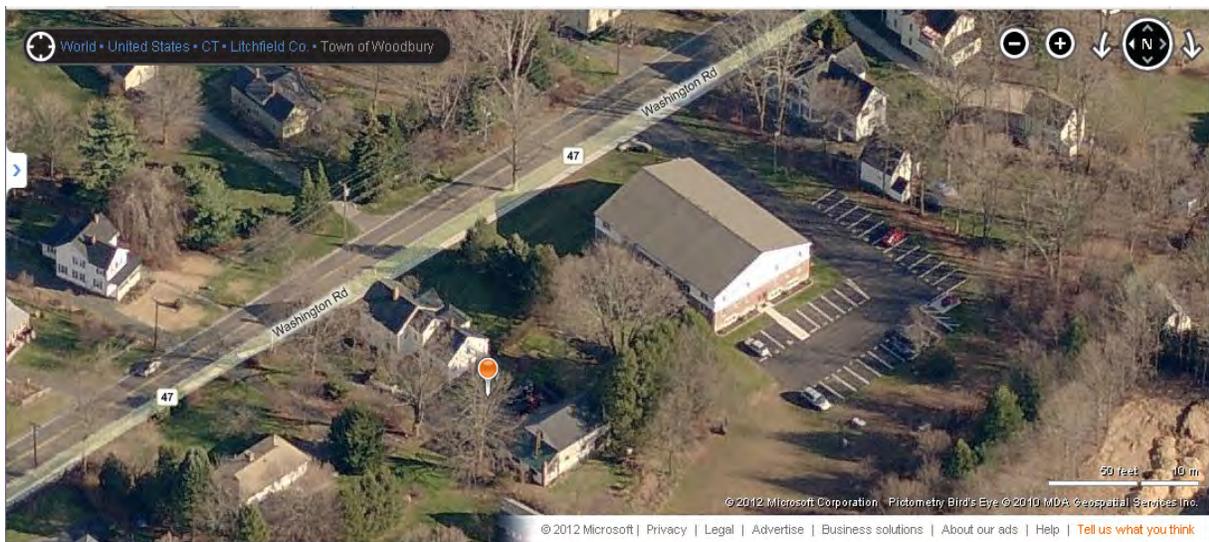
2. West view – aerial “bird’s-eye” map of 41 Washington Road, Woodbury CT –<http://www.bing.com/maps> accessed 2/10/2012. The map “pin” indicates No. 41. To the right (south) of the boxy recent apartment building is No. 31.

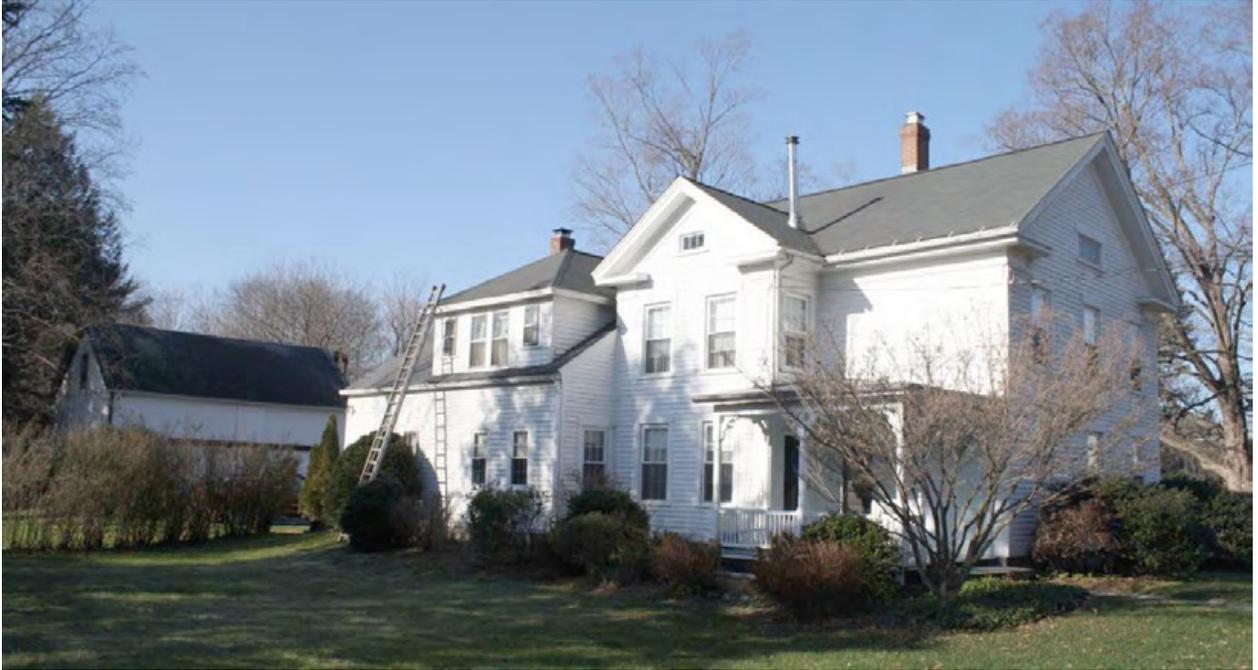
4. Southeast view of farmhouse, camera facing northwest. Barn is at left rear. Oldest structure is the 1 1/2 –story wing at left with later hip-roofed dormer. Right front structure is the mid-19<sup>th</sup>-century portion of the house.

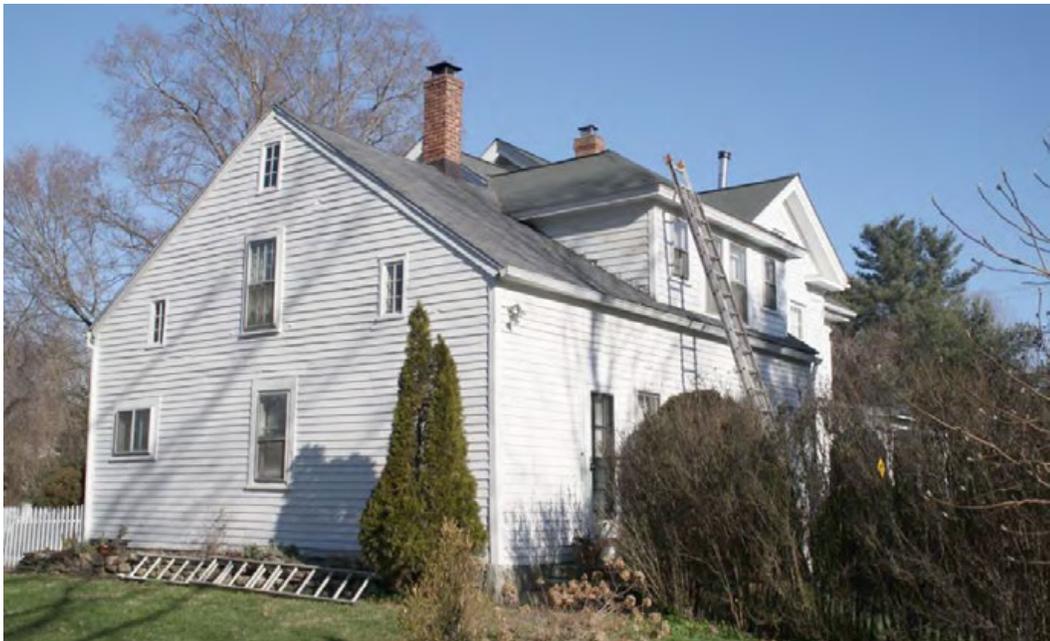
5. Southwest view of farmhouse, camera facing northeast, showing the oldest portion of the building with a later dormer addition.

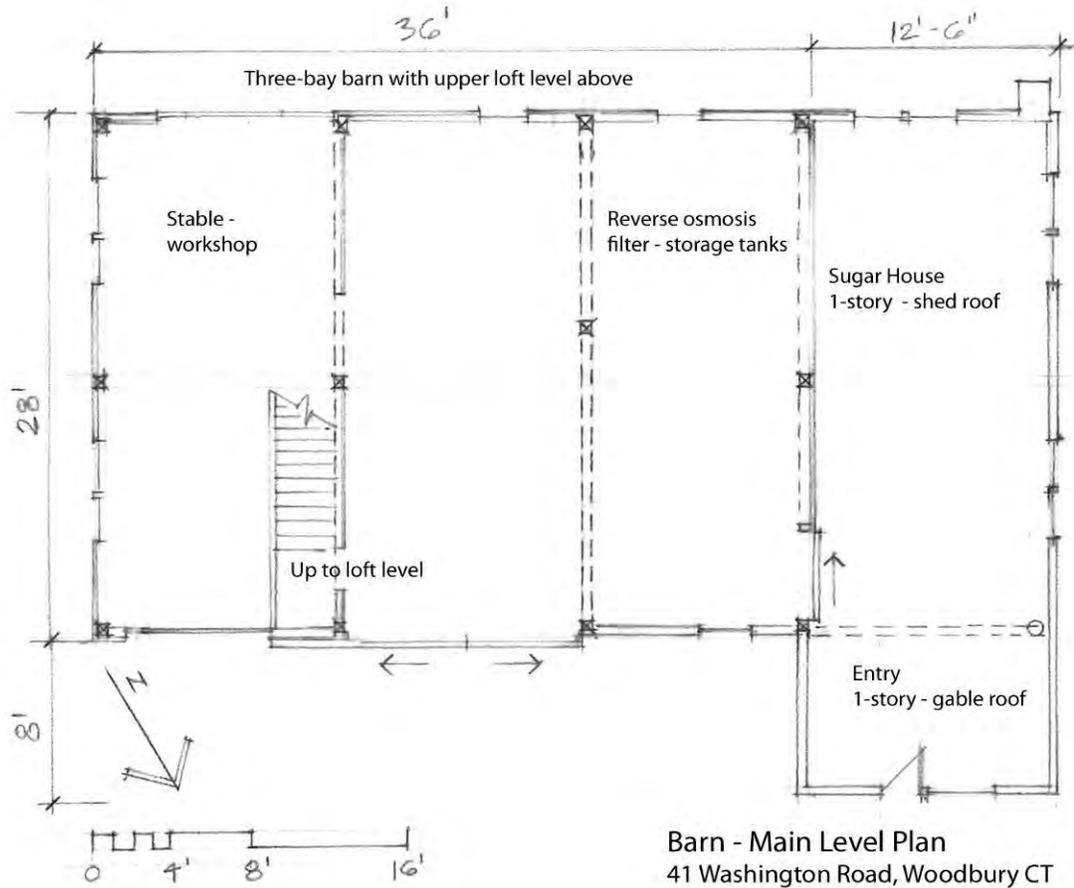
6. Plan Sketch – main (ground) level of barn.

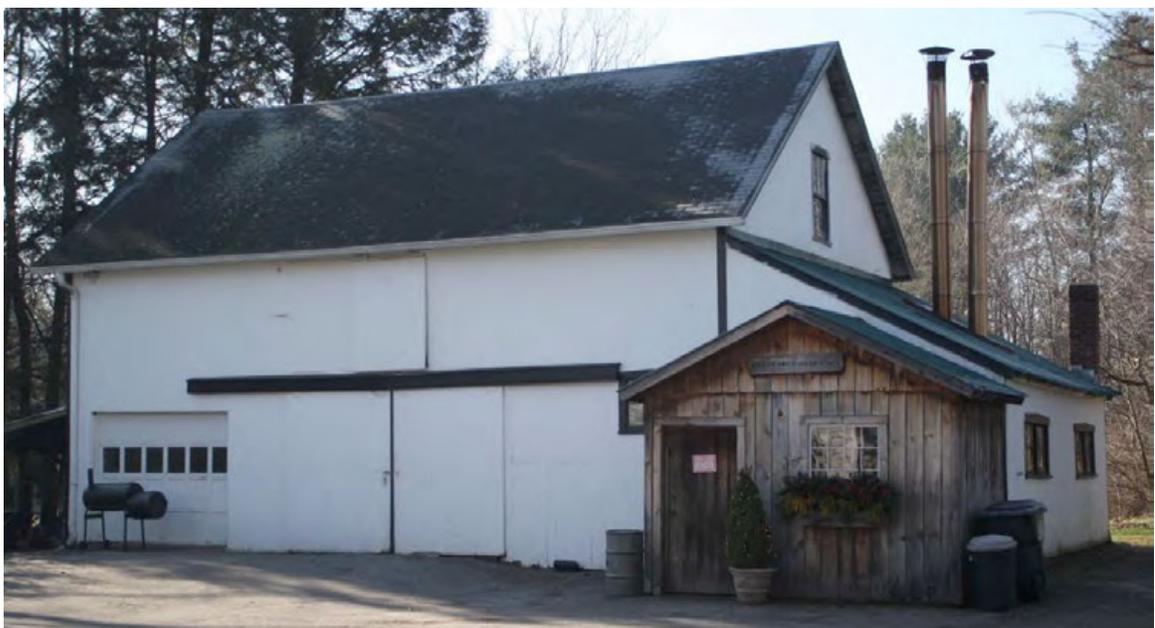
The primary entrance façade is the east eave-side, which has a pair of exterior-mounted sliding barn doors in the center of three bays. The door height corresponds to the ground floor level; a shallow hood protects the head track and hardware. Centered above is a single sliding hay door giving access to the loft level. To the left (south) in the ground level is a door opening with an overhead garage door. In the right (north) bay of the ground level, off-center to the right, is a six-pane stable window with trim including a beveled lintel trim board, typical throughout the barn and the north shed addition. The vestibule addition covers the end of the shed addition, and has a gable-end facing east with a pass-through door to the left and a twelve-pane window to the right. A wood sign in the peak of the gable is lettered "Woodbury Sugar Shed."

7. Northeast view of barn, camera facing southwest, showing east eave-side, north shed addition, and vestibule.

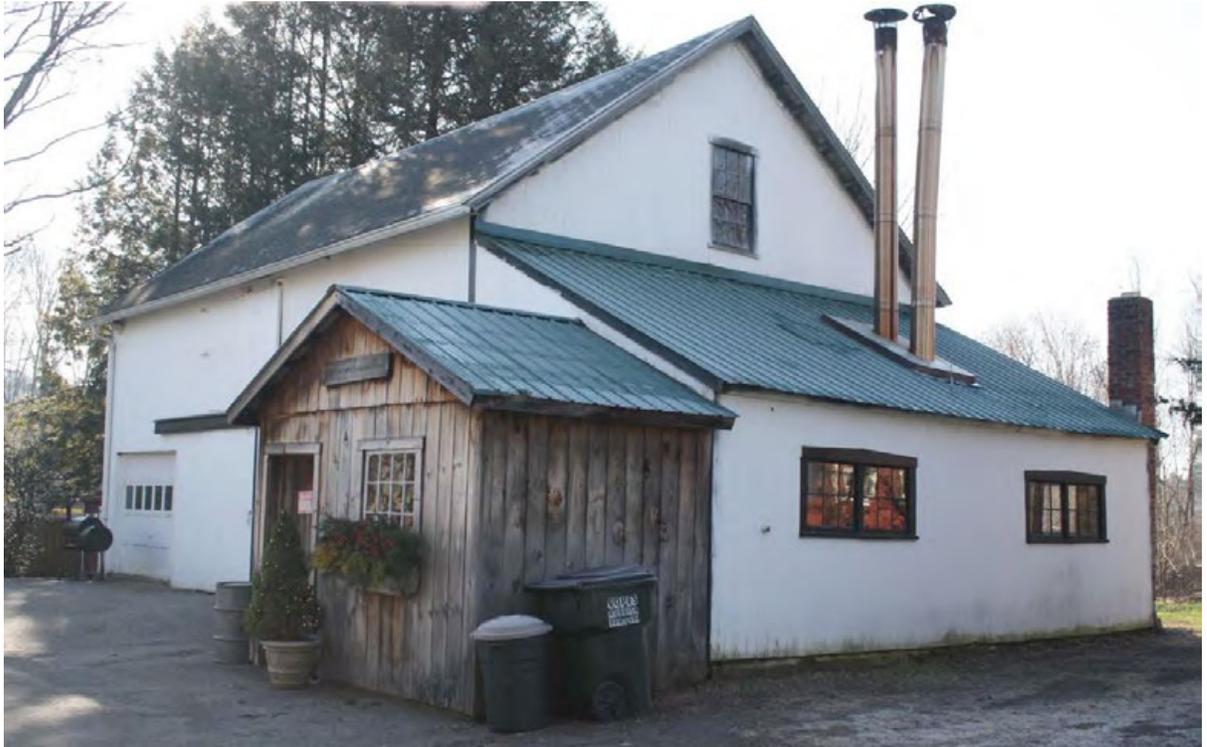
The north gable-end of the barn above the shed-roofed addition has a six-over-six double-hung window with trim. Outriggers are visible at the rake edge of the roof, the ends covered by a fascia with a simple molding. The north eave-side wall of the addition has two pairs of six-pane stable windows with trim. Two tall metal flue pipes project through the shed roof, venting the maple syrup evaporator housed within.

8. Northeast view showing north gable-end of barn, camera facing south.

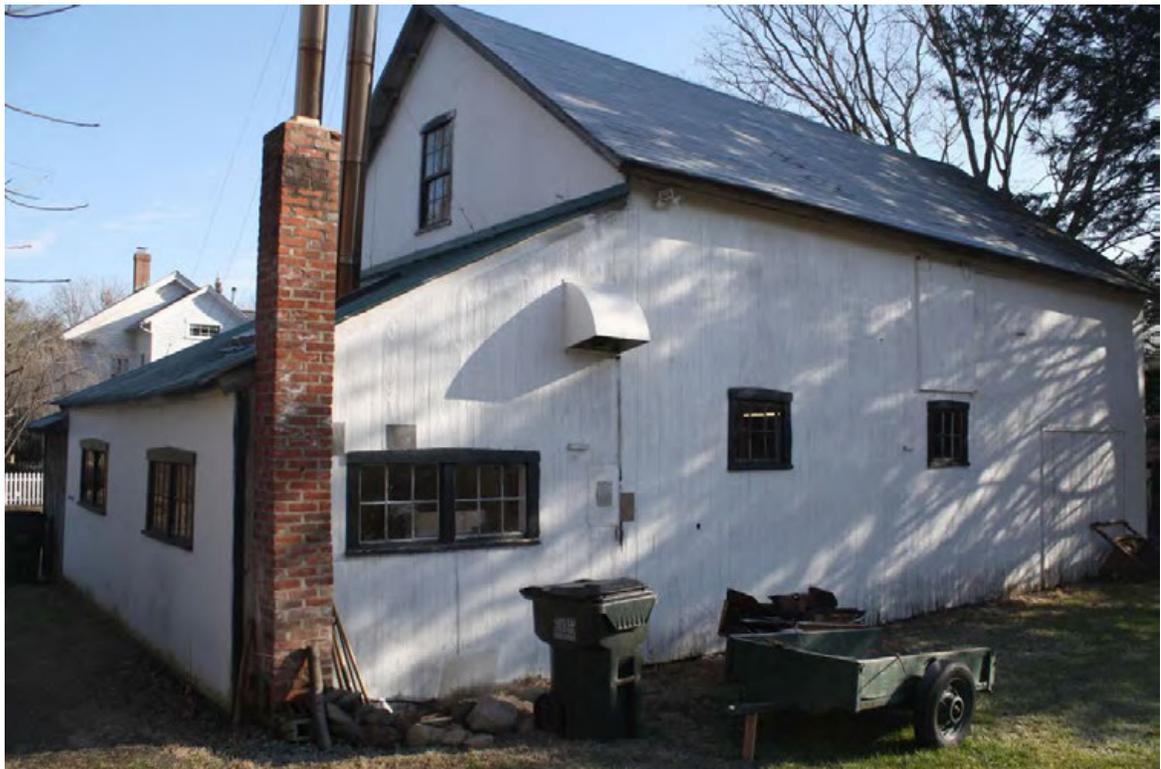
The west eave-side of the barn has, from left (north) to right (south): a brick chimney abutting the exterior wall; a pair of six-pane stable windows in the end wall of the addition, matching the north side; an exhaust hood high in the wall of the addition; a six-pane stable window in each of the north and center bays of the main block; a hay door in the upper level of the center bay; and a former garage door opening in the south bay, now boarded shut. One course of a fieldstone foundation wall is visible below the wood siding.

9. Northwest view showing west eave-side and north gable-end of barn, camera facing southeast.

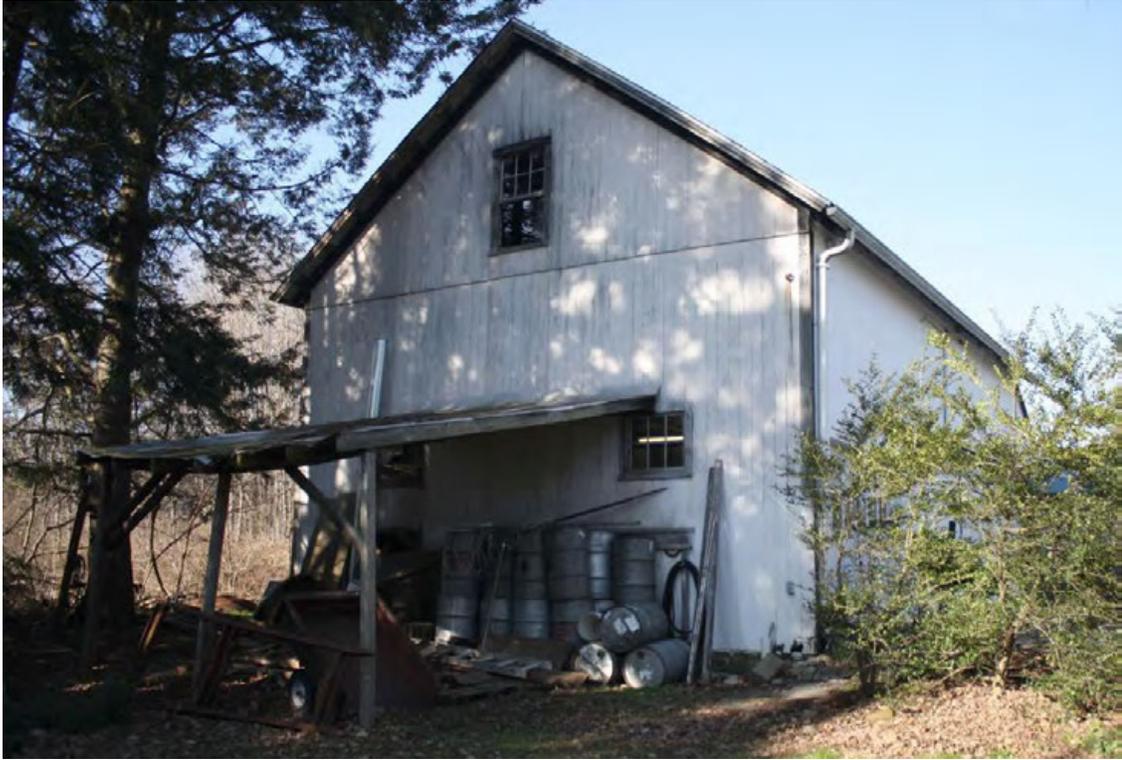
The south gable-end of the main barn has a six-over-one double-hung window in the attic and two six-pane stable windows near the corners in the ground level. An open-sided shed-roofed shelter is attached along the south side.

10. Southeast view showing south gable-end of barn, camera facing northwest.

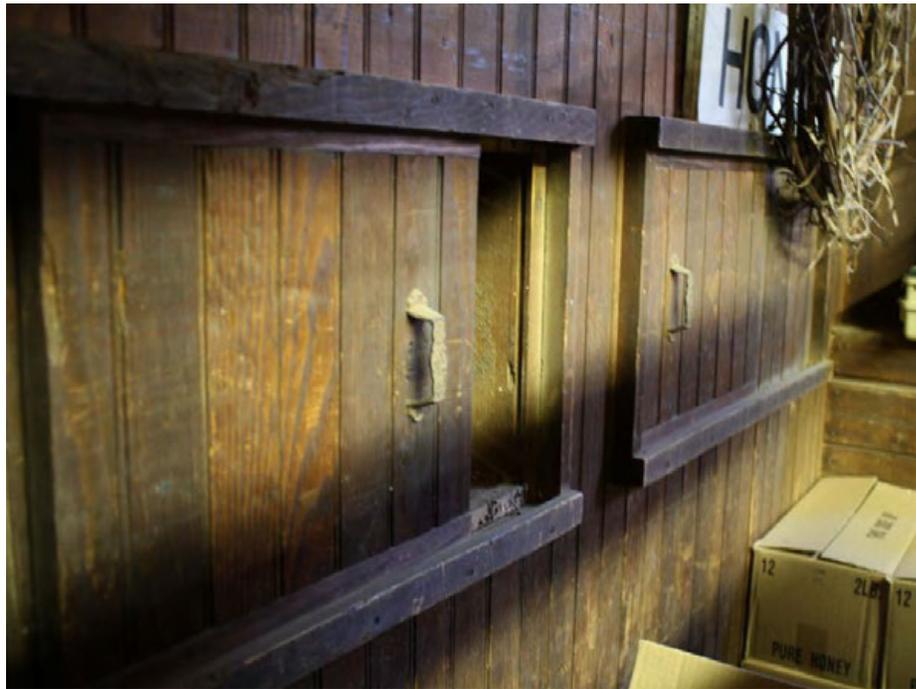
The south bay, accessed by an overhead door, has been equipped as a workshop with power tools and tool storage along the walls. The walls and ceiling have interior bead board surfaces. At the northeast corner a stair leads to the upper loft level, accessed from the adjacent center bay. Along the interior wall abutting the center bay there are several small square openings with sliding shutters, apparently remaining from an earlier use as stable space for horses.

11. Interior view of the partition between the south and center bays showing sliding partitions, camera facing southwest, showing stable openings with period hardware.

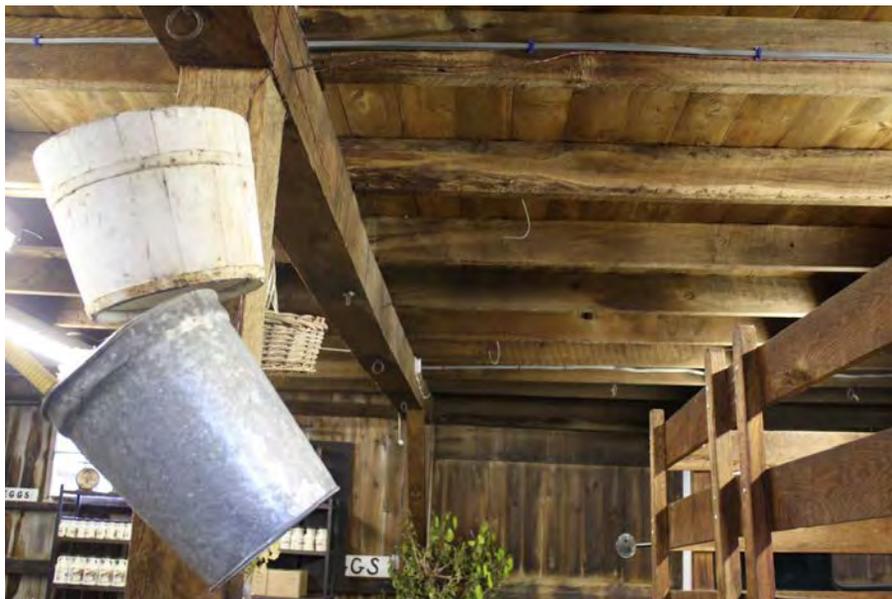
The center and north bays have exposed timber framing, where circular saw marks are visible. Joints have wood pegs. Some metal tension rods from the upper level can be seen protruding from the tie girders. The center bay is currently garage space for a vintage pickup truck. The north bay houses equipment for the maple sugar operation including two large sap tanks and a reverse osmosis filter.

13. Interior view of girder line between center and north bays, camera facing west.

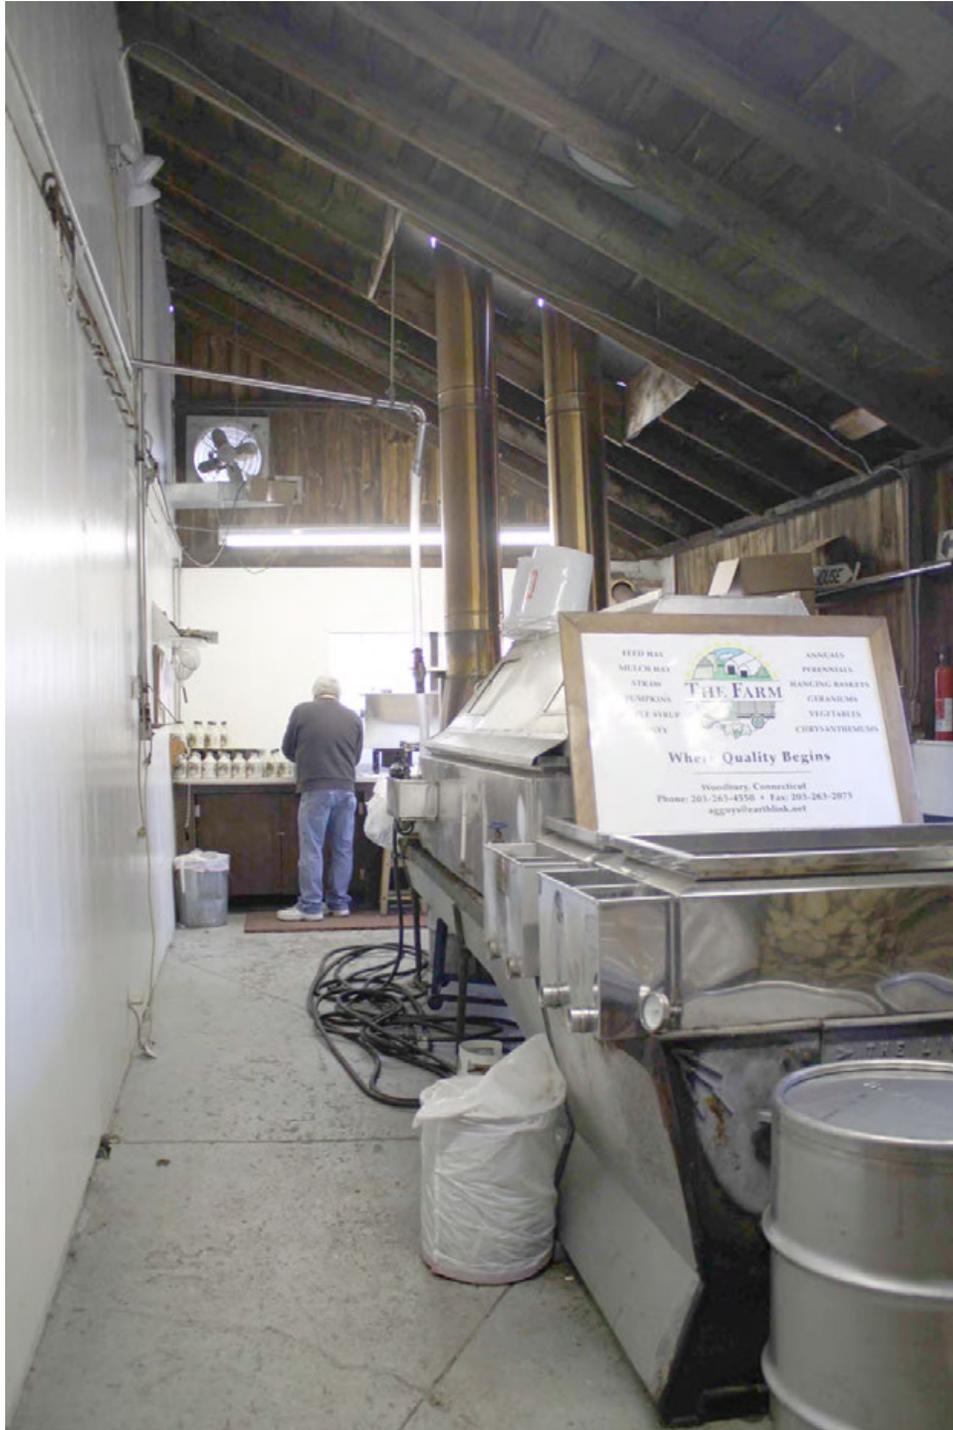
The attached shed on the north end appears, from its window configuration, to have been stable space for horses. The exterior wall of the main block with its vertical siding and a sliding door near the east corner, indicates that the shed-roofed portion was an addition after the initial construction of the three-bay barn. At present this area houses the wood-fired maple syrup evaporator, along with a small wood stove for space heating. The vestibule attached to the northeast corner serves as an entry space to the sugaring area.

14. Interior view of north addition, camera facing west. At left is the north gable-end wall of the main block; at right the wood-fired evaporator.

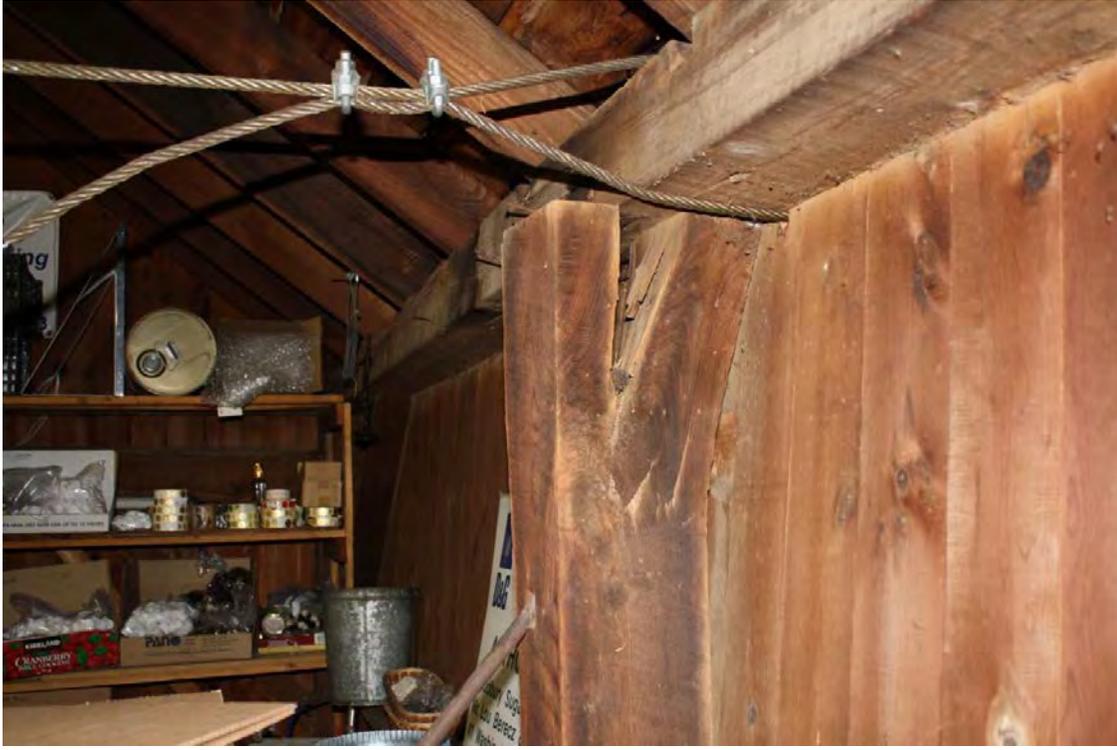
The upper level loft was formerly hay and feed storage and retains a grain bin with a chute to the lower main level. In spite of metal tension cables, some deformation is visible, in which the main plate on the east eave wall is moving outward, splitting the tops of the vertical posts. The roof is framed with dimension lumber and uniform sawn spaced deck boards support what must have been originally a wood shingle roof.

The timber framing of this barn reflects the increasingly light construction technique of the time. Instead of hewing massive over-scaled members as was done earlier, these sawn timbers were likely engineered to be just sufficient for their purpose. The incidences of failure in this structure and the need for steel tie rod reinforcement, are evidence of this trend.

15. Interior view of the east wall of the loft level, camera facing northeast, showing structural failure of the post and beam framing at the plate.

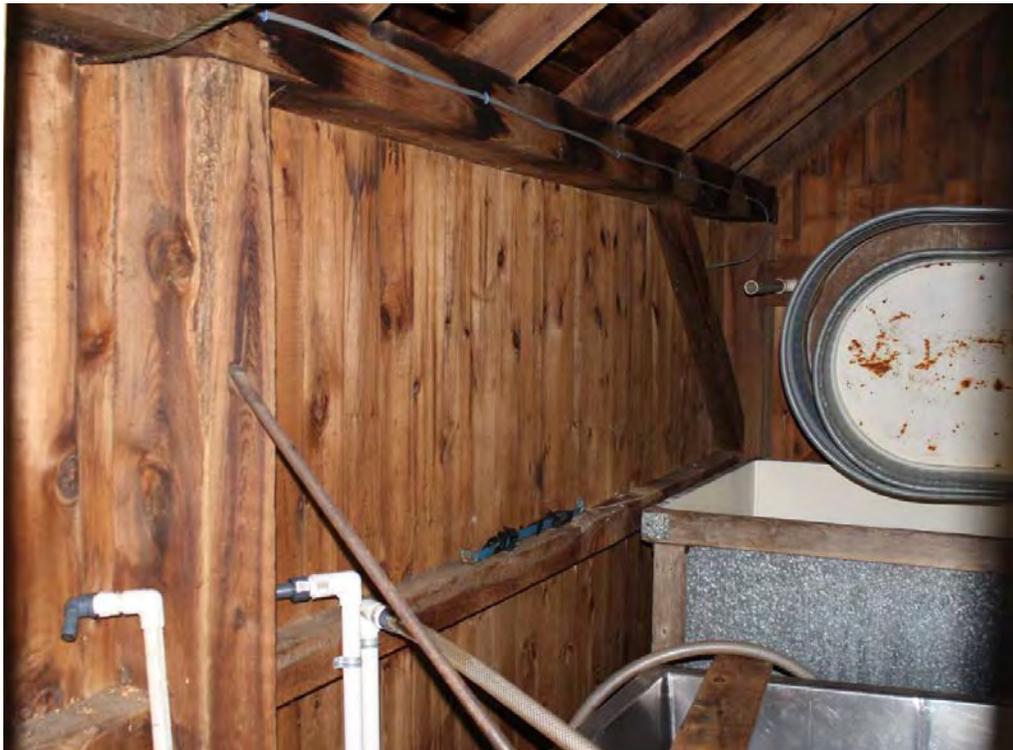
16. Interior view of the loft level, east wall and southeast corner, camera facing southeast.
