## HISTORIC RESOURCES INVENTORY - BUILDING AND STRUCTURES

Building Name (Common) Mead Farmstead, Clover Farm Record No. 10556  
 Building Name (Historic) Mead, Silas Edward and Cornelia M. Wilcox, Farmstead  
 Street Address or Location 215 John Street  
 Town/City Greenwich Village \_\_\_\_\_ County Fairfield  
 Owner(s) Mike and Genevieve Howe, 215 John Street, Greenwich 06831  Public  Private

215 John Street, Greenwich, CT

Record No. 10556

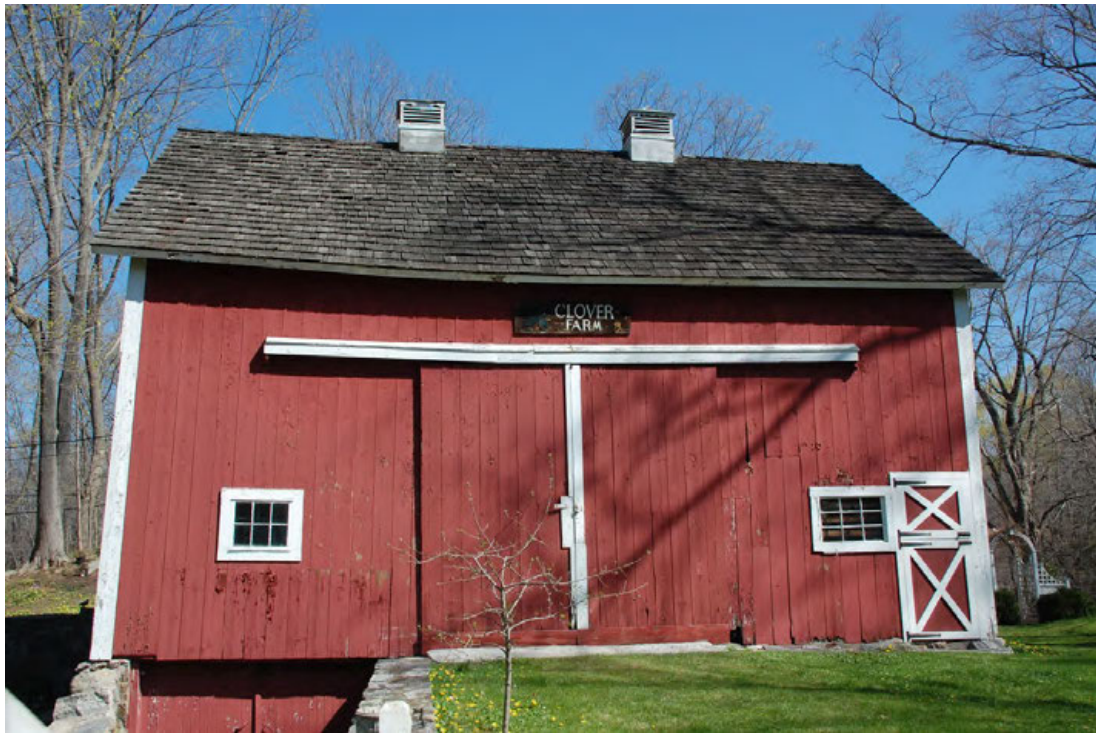
9. South eave-side of the Barn. Camera facing north.

The south eave-side of the barn faces the house and John Street. The entryway consists of a pair of double-height, exterior-hung sliding doors with a hooded track, centered on this side. An earthen ramp leads to the entryway. Above the doors is a sign reading "Clover Farm." To the east are a six-pane window with trim and a Dutch door with trim and X-bracing. To the west is a small six-pane window with trim. Extending to the south off the west side of the doorway is a stone retaining wall. The grade drops at this wall revealing a full basement at the westernmost

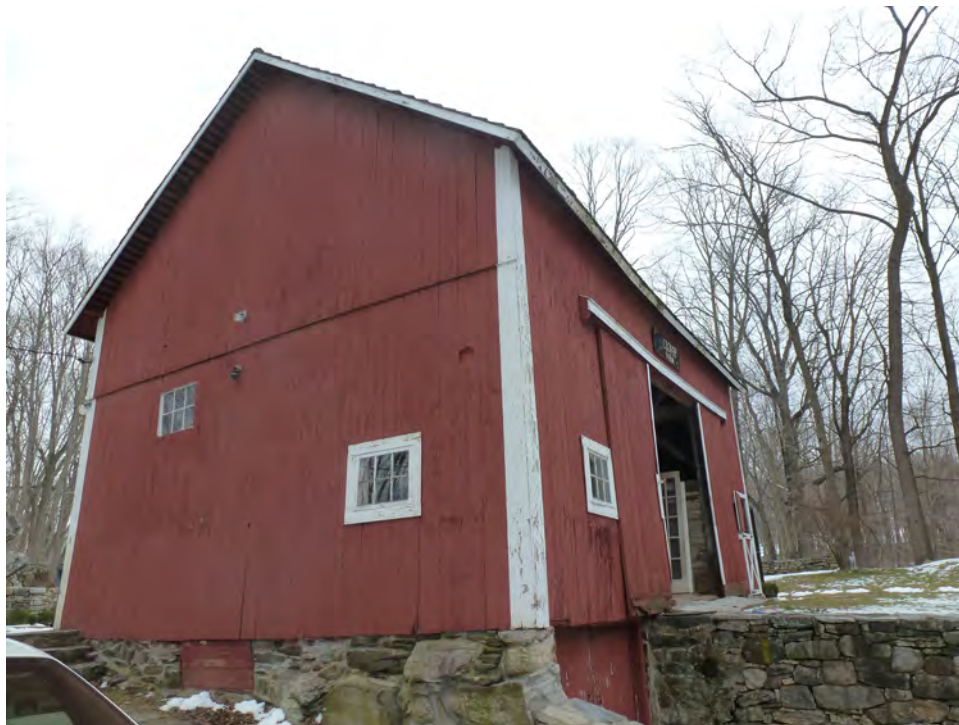
10. South eave-side and west gable-end of the Barn. Camera facing northeast.

The grade rises slightly along the west gable-end of the barn; however, the mortared fieldstone foundation is visible on this side. Set within the foundation is an opening, which is now boarded. A six-pane window with trim is near the south corner and near the north corner is a six-pane window set high in the wall just below a dropped siding divide.

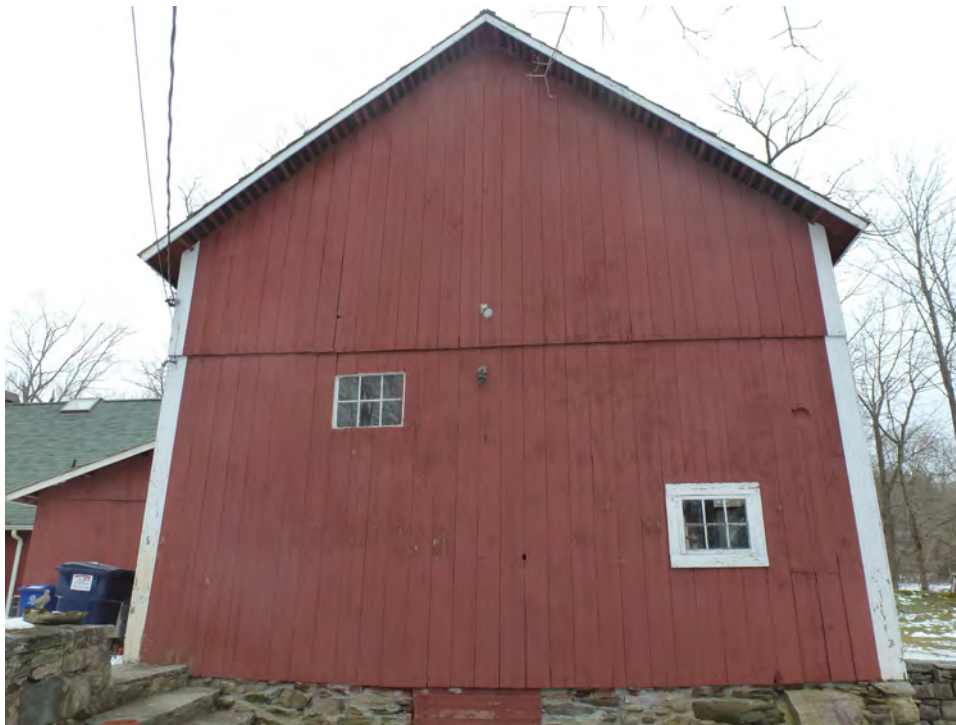
11. West gable-end of the Barn. Camera facing north.

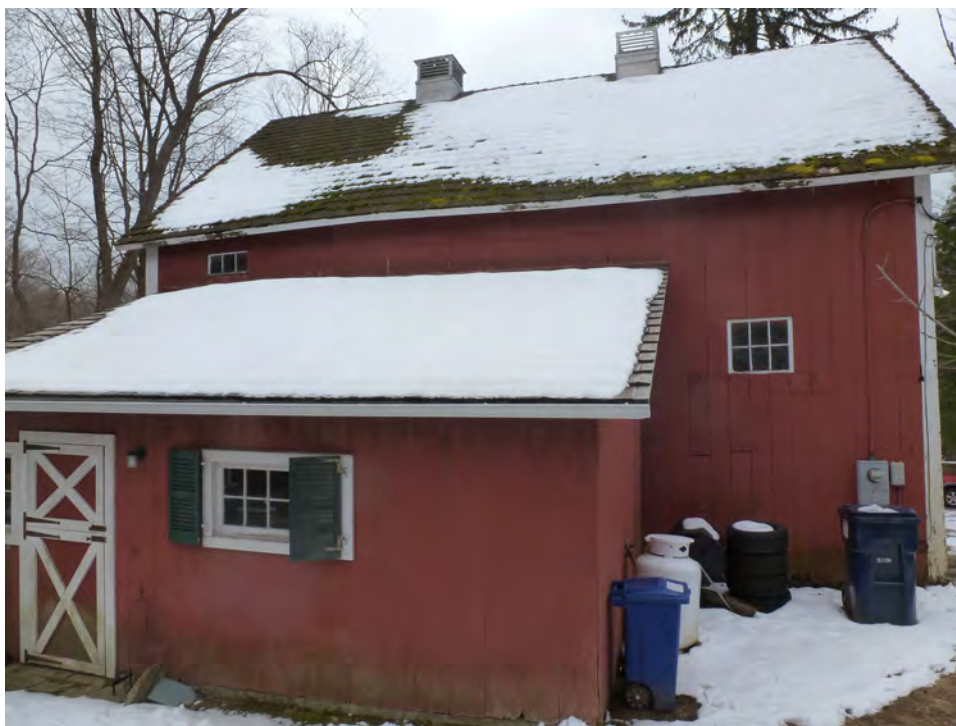
12. North eave-side of the Barn and north eave-side of shed-roof addition. Camera facing south.

The grade continues to rise toward the north so the foundation is no longer visible along the north eave-side of the barn. A high six-pane window is near the west corner of the north eave-side. The shed-roof addition is attached to this side of the barn. Just above the addition, near the east corner is a rectangular three-pane window. Extending to the north, the shed-roof addition encompasses the east and middle bays of the barn. There are no features on the west side, but on the north side starting at the west and heading east are as follows: a rectangular ten-pane window with trim and shutters, a Dutch door with trim and X-bracing, and a six-pane window with trim. A stone retaining wall extends to the east off the northeast corner of the addition. On the east side of the addition is a pair of side-hinged doors.

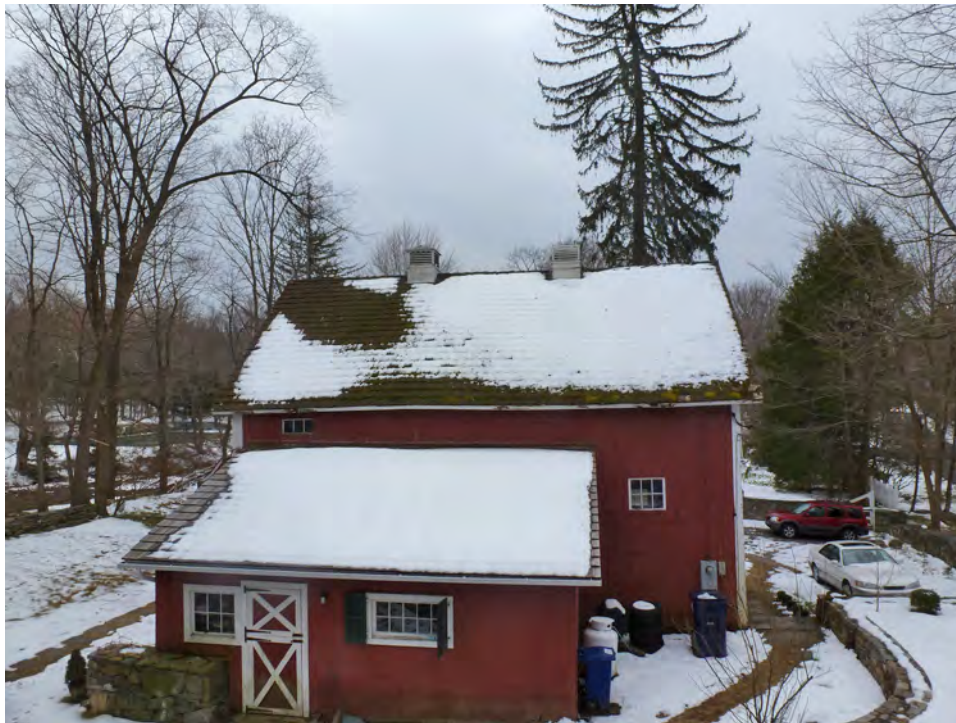
13. North eave-side of the Barn and shed-roof addition. Camera facing south.

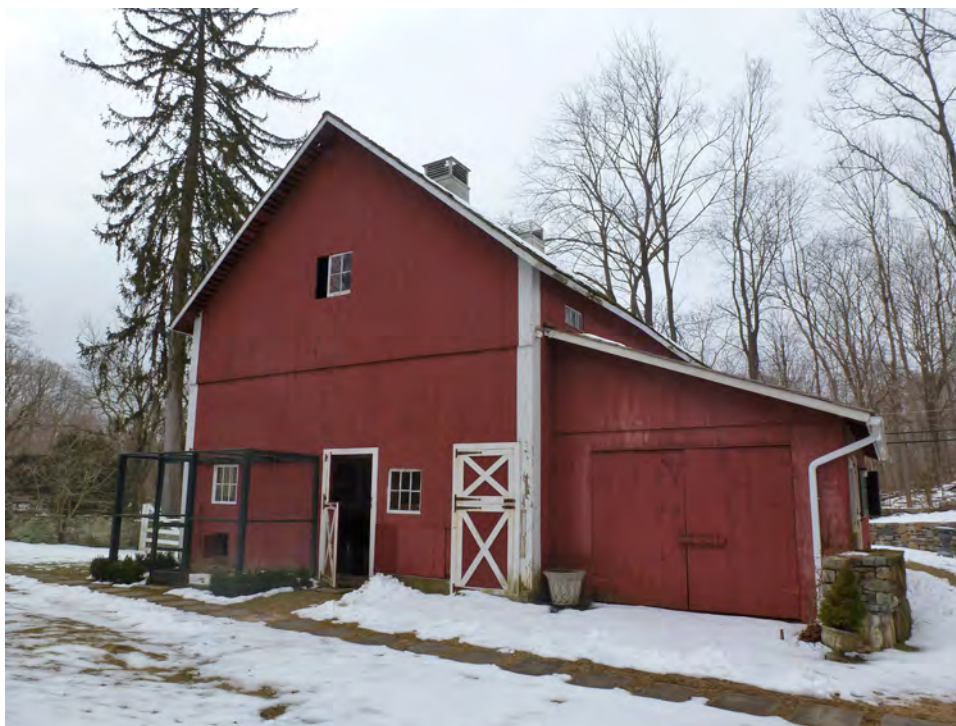
14. East gable-end of the Barn and shed-roof addition. Camera facing west.

Starting at the north corner and proceeding south along the east gable-end of the barn are as follows: A Dutch door with trim and X-bracing, a six-pane window, another Dutch door with trim and X-bracing, and a six-pane window with trim. A chicken pen extends off the barn on the south half of the east gable-end. A small side-hinged chicken door is below the six-pane window near the south corner. In the gable attic is a six-pane window.

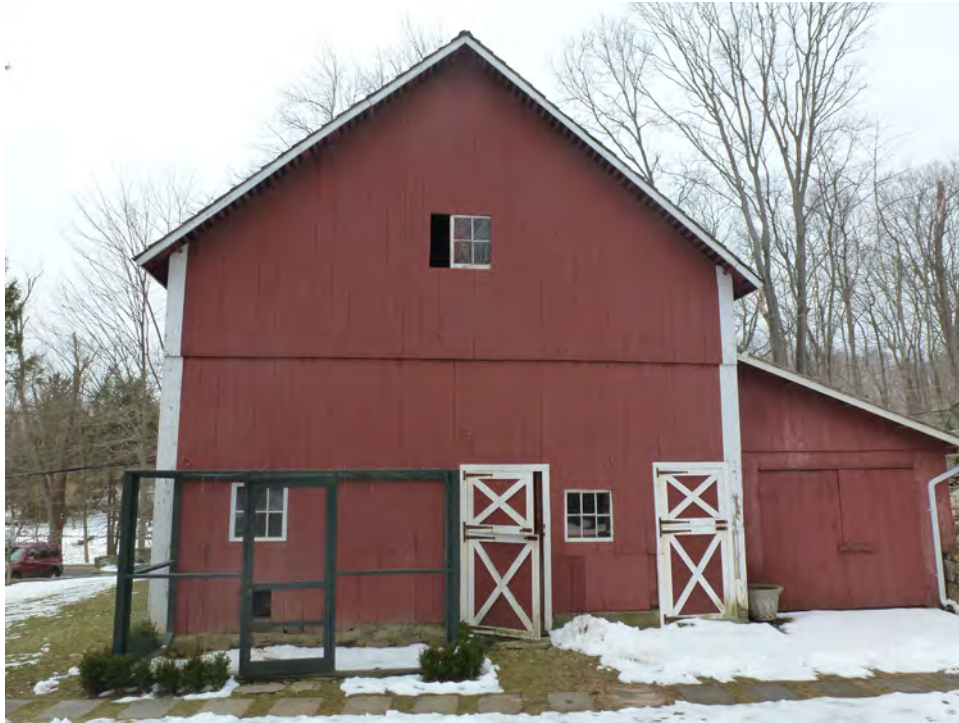
15. East gable-end of the Barn and shed-roof addition. Camera facing west.

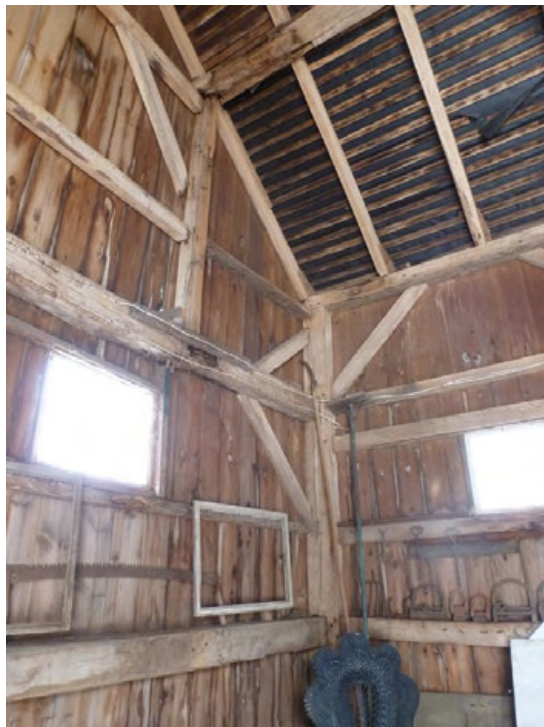
16. Interior view of the northwest corner of the Barn and the post-and-beam frame. Note the dropped tie girt. Camera facing northwest.

The interior is accessed by the doors on the south eave-side of the barn that open into a typical English barn layout with three bays and four bents. The middle bay would traditionally have been used for threshing and the two outer bays were used for storage of hay and to house livestock. The flooring and walls are of wood planks. A pair of double-height, side-hinged doors are visible on the interior of the north eave-side wall, but are no longer operable. The square rule post-and-beam frame is connected by mortise and tenon joints with tree nails. Hand hewn marks are seen on the timbers throughout the barn, indicating a mid-19<sup>th</sup>-century construction date. Some modern support braces have been added in recent years. Charred timbers are still extant in the barn from a fire in the 1950s. The typical bent has one interior post at the center. The tie-girts are dropped and attached to the corner posts by mortise and tenon joints with tree nails. The east bay currently houses chickens, but feeding troughs are still extant from when sheep were housed in this section of the barn. The west bay is open to the peak, while the east bay has a loft reached by a built-in ladder. Queen posts support plates at the mid-span of the rafters. The common rafters spring from the plate and meet at the peak with no ridge-board and half-lapped joints, and the roof deck is made of narrow wood planks evenly spaced, typical of late 19<sup>th</sup>-century construction.

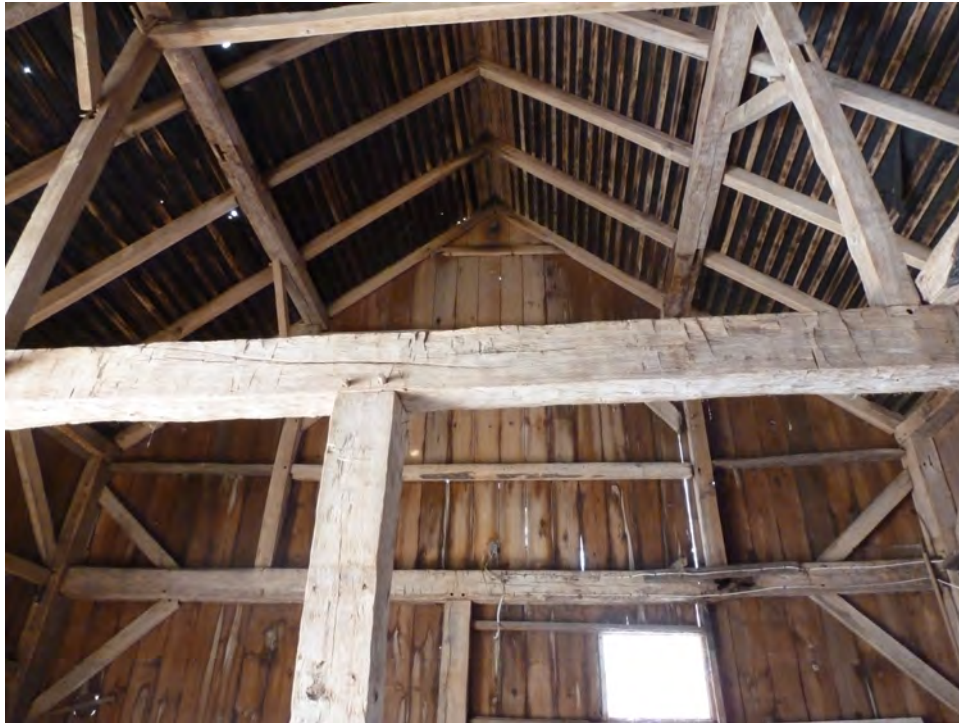
17. Interior view of the west gable-end of the Barn. Note the hand hewn marks on the timbers. Camera facing west.

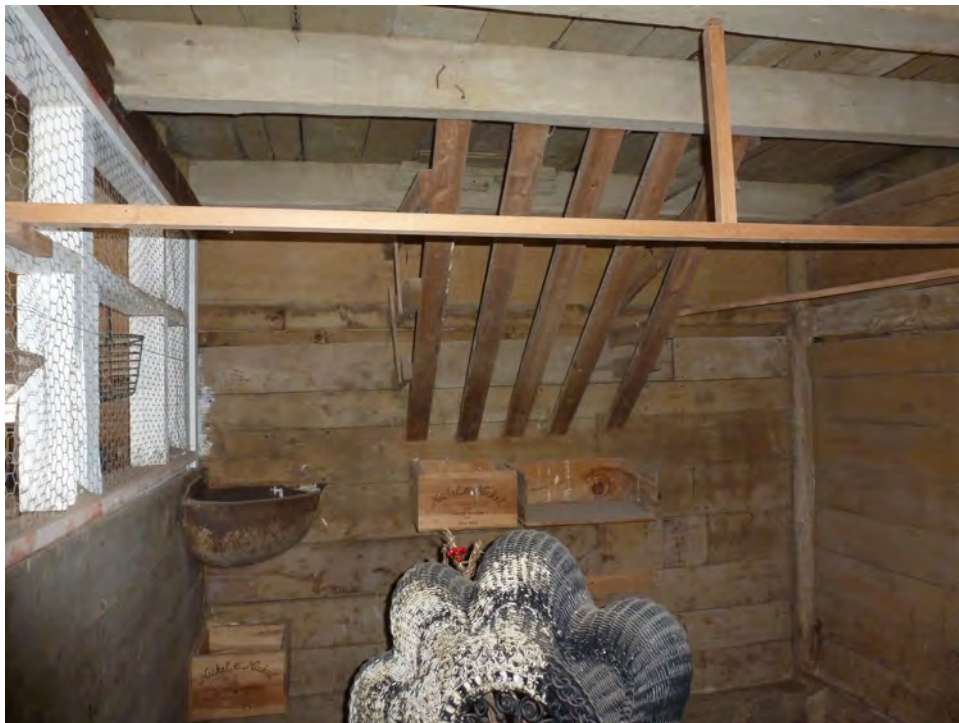
18. Interior view of the extant manger in the east gable-end of the Barn. Camera facing west.

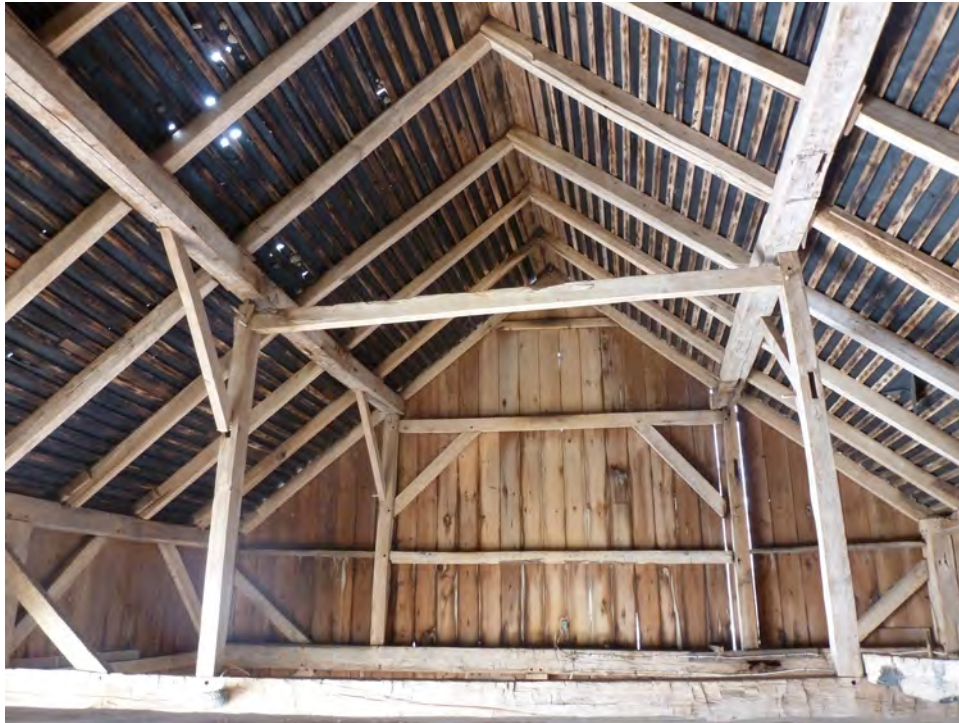
19. Interior view of the west gable-end of the Barn. Note the rafters meeting at the peak with no ridge-board and half-lap joints. Camera facing west.

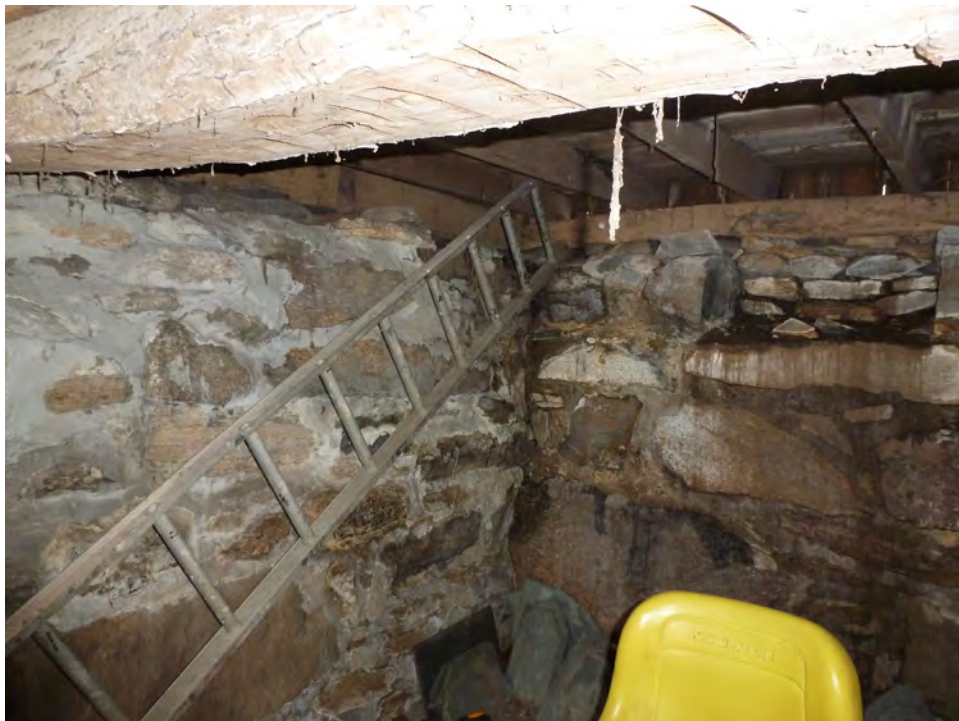
20. Interior view of the northwest corner of the basement. Note the mortared fieldstone walls. Camera facing northwest.

The basement of the barn is accessed by the doors on the west corner of the south eave-side of the barn and consists of a large open space with dirt floors and mortared fieldstone walls. The floor joists are hand hewn and still include bark. Whitewash is extant indicating dairy cows were once housed here, although this basement has little natural light from windows.
