## HISTORIC RESOURCES INVENTORY - BUILDING AND STRUCTURES

Building Name (Common) Allen-Thompson Homestead Record No. 14483  
 Building Name (Historic) Spicer, Benjamin, Farmstead  
 Street Address or Location 7 Allen Road  
 Town/City Lisbon Village \_\_\_\_\_ County New London  
 Owner(s) Wayne and Elizabeth Thompson, 7 Allen Road, Lisbon CT 06330  Public  Private

Style of building English bank barn, vernacular style Date of Construction c.1880

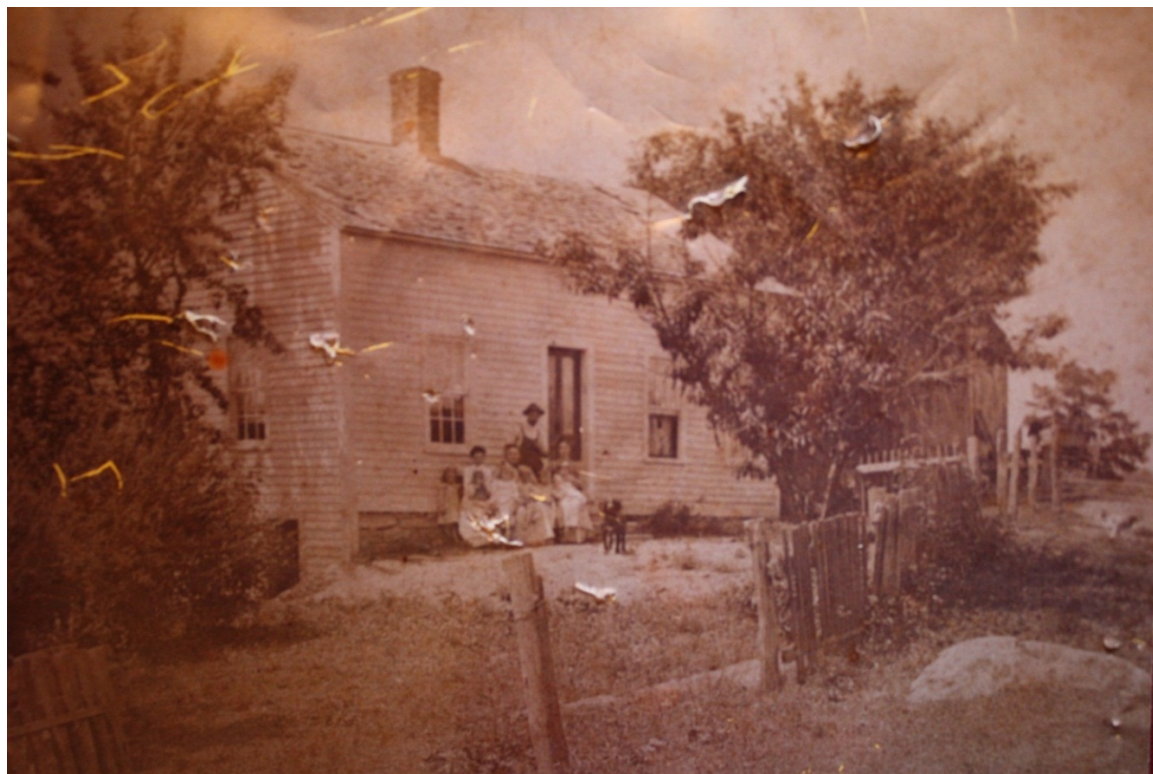
2. Historic photo of original house and workshop barn (to the right), camera facing northwest.

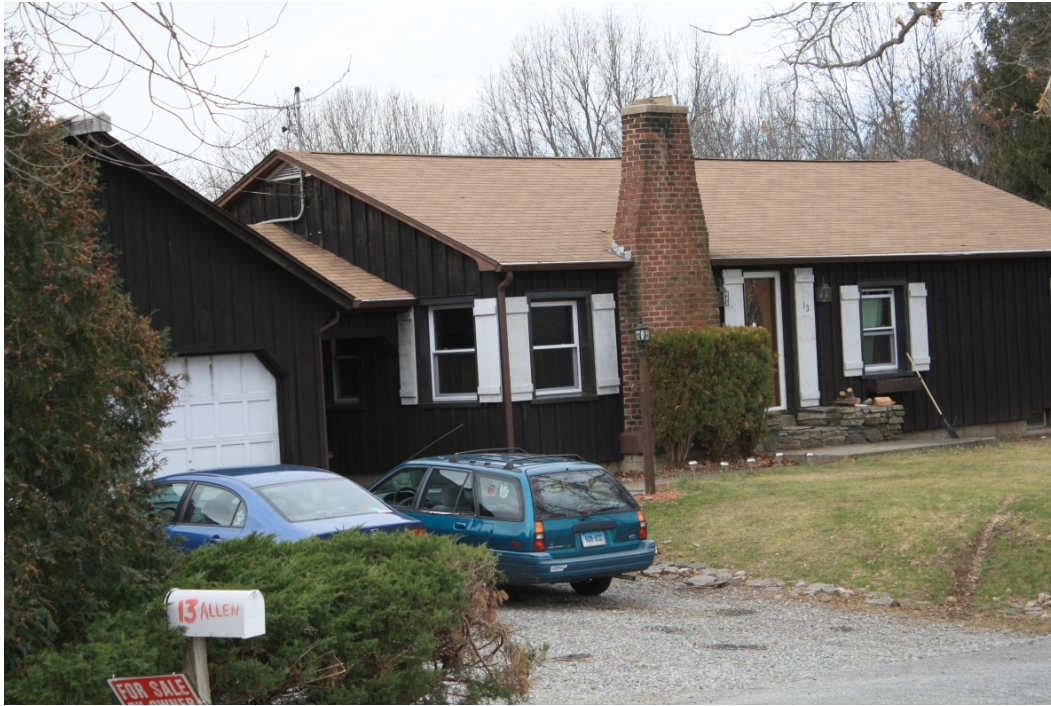
17. Lot to the north of site, 13 Allen Road. Note the garage and house have the same exterior board-and-batten and were built by the same owner.
