HISTORIC RESOURCES INVENTORY - BUILDING AND STRUCTURES

Building Name (Common) The Dudley Farm Museum Record No. 8721
 Building Name (Historic) Dudley Farmstead / Dudley, Nathan C., House
 Street Address or Location 2351 Durham Road (Route 77)
 Town/City Guilford Village North Guilford County New Haven
 Owner(s) The Dudley Foundation, Inc., 2351 Durham Road, Guilford CT 06437 Public Private

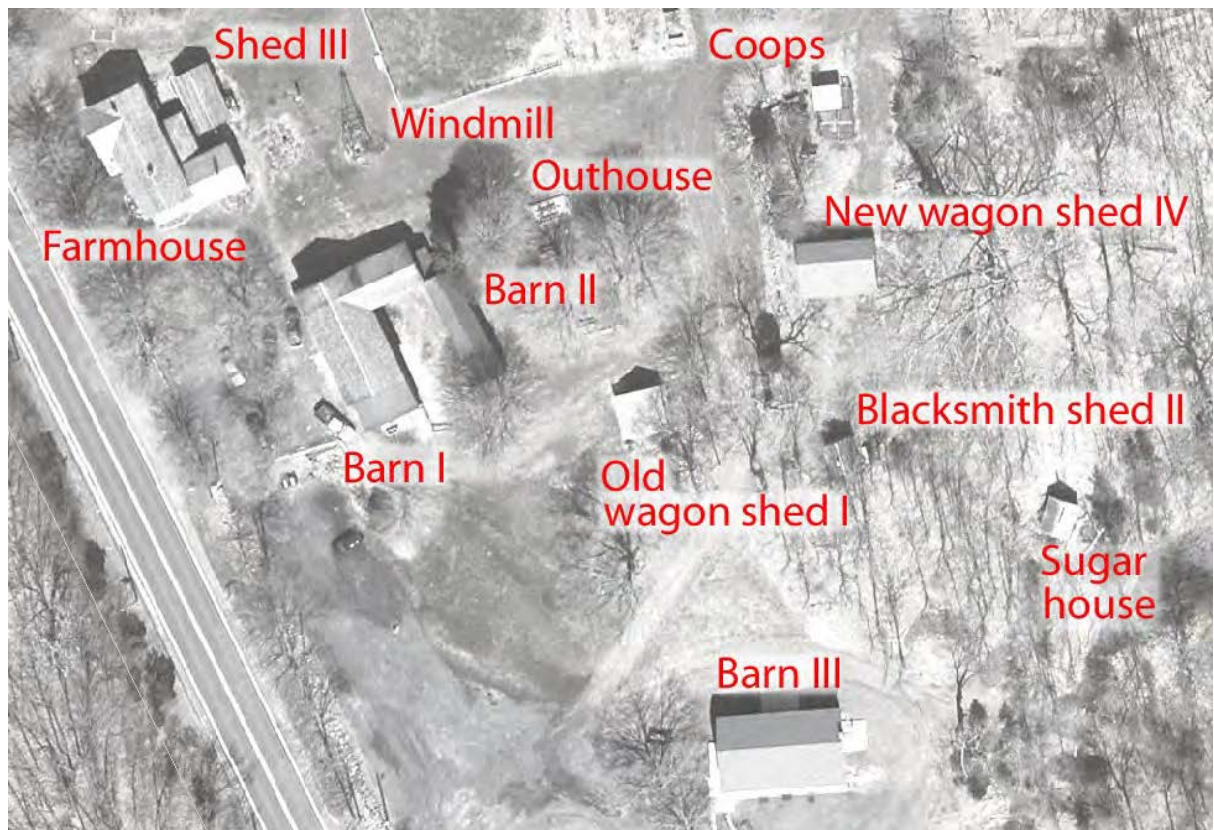
4. Site Plan Detail showing contributing resources, base image from <http://www.guilfordgis.com/mapsearch.asp>

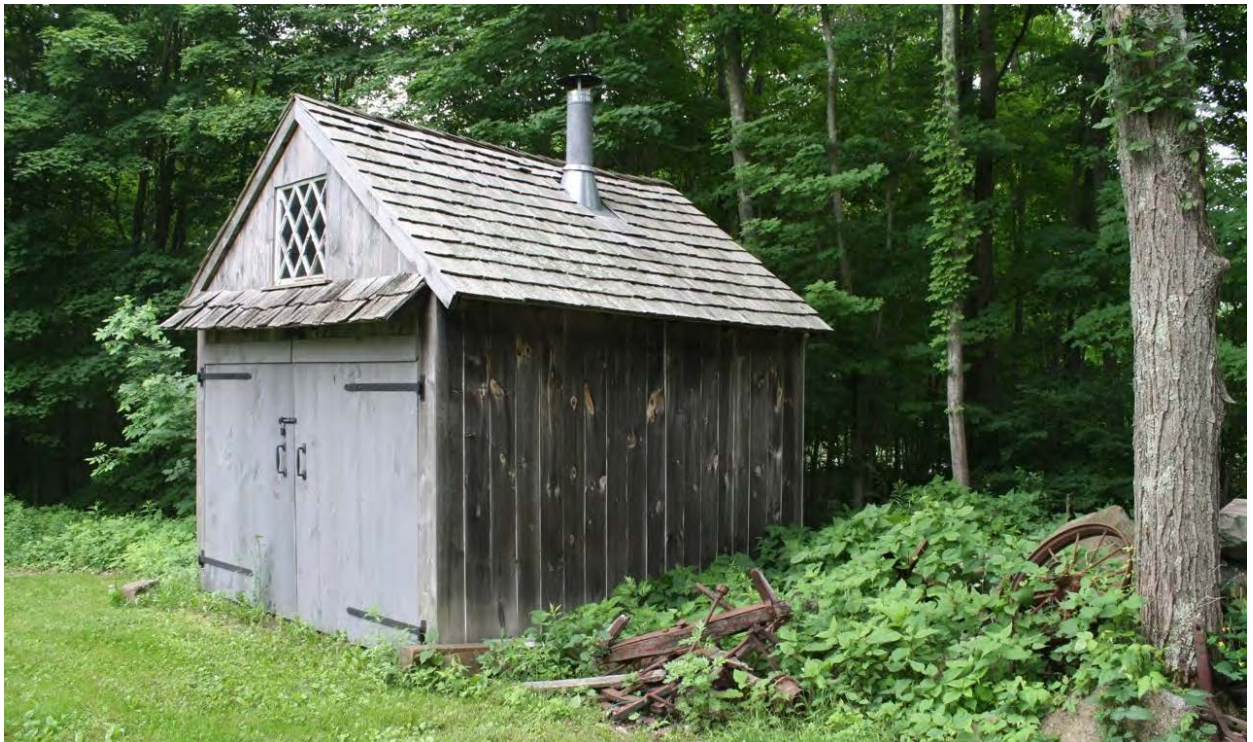
16. Northwest view of Blacksmith shed II, camera facing southeast.

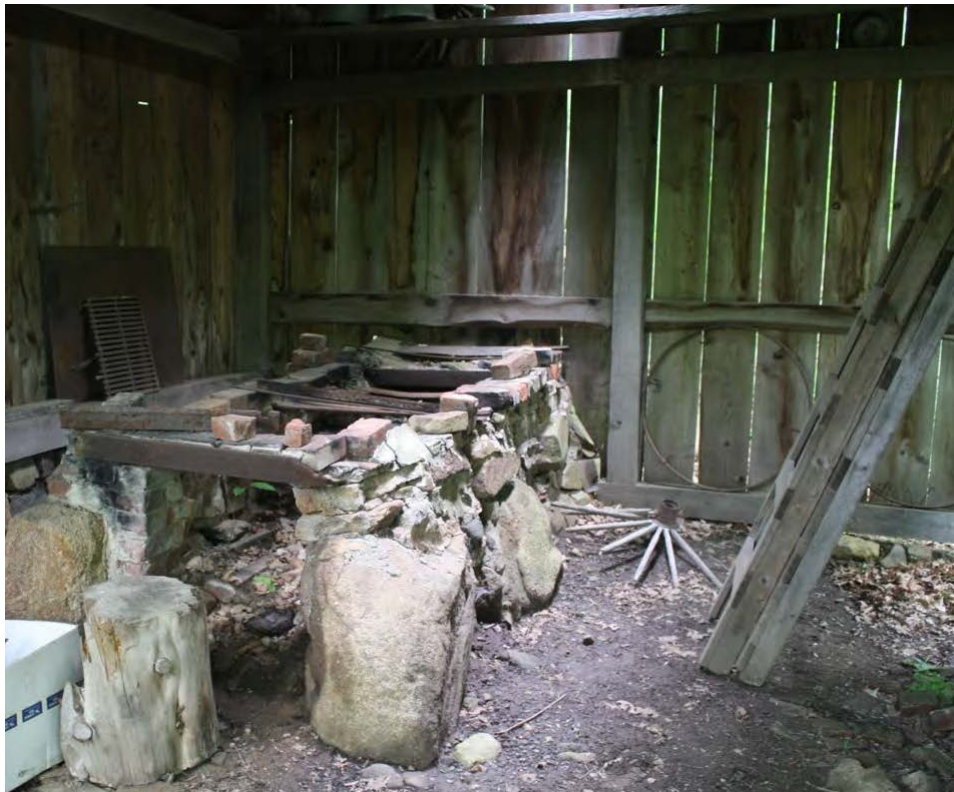
18. Interior view of Sugar house showing firebox, camera facing north

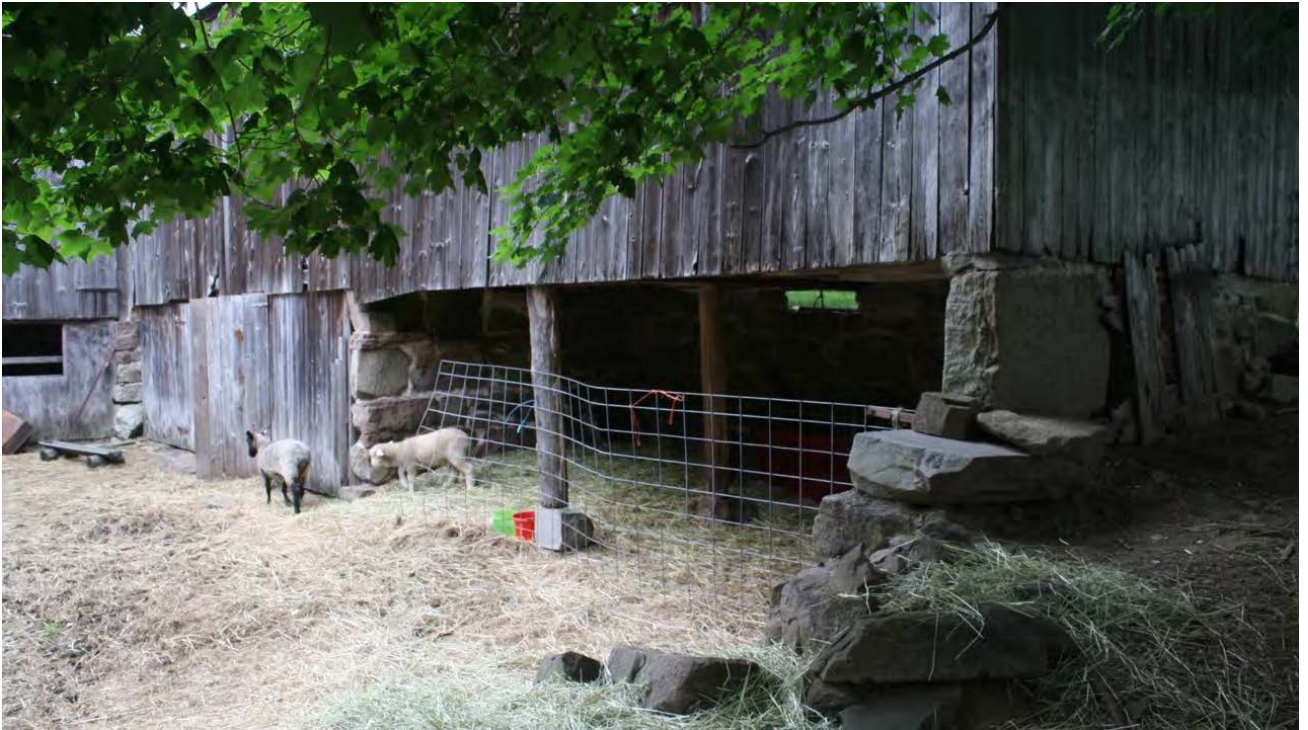
23. Southwest view of Barn II, camera facing northeast, showing basement foundation walls.

The south gable-end has a six-pane attic window, a blank main level, and mortared stone foundation incorporating very large stones. Grade rises toward the east along this wall. The east eave-side has several openings in the foundation allowing light to the basement level, a pass-through door in the left (south) bay and a six-pane stable window in the bay to the right. The north gable-end is partially covered by the sleigh shed attached to Barn I, and has a pass-through door at the left (east) corner. There are two attic windows above.

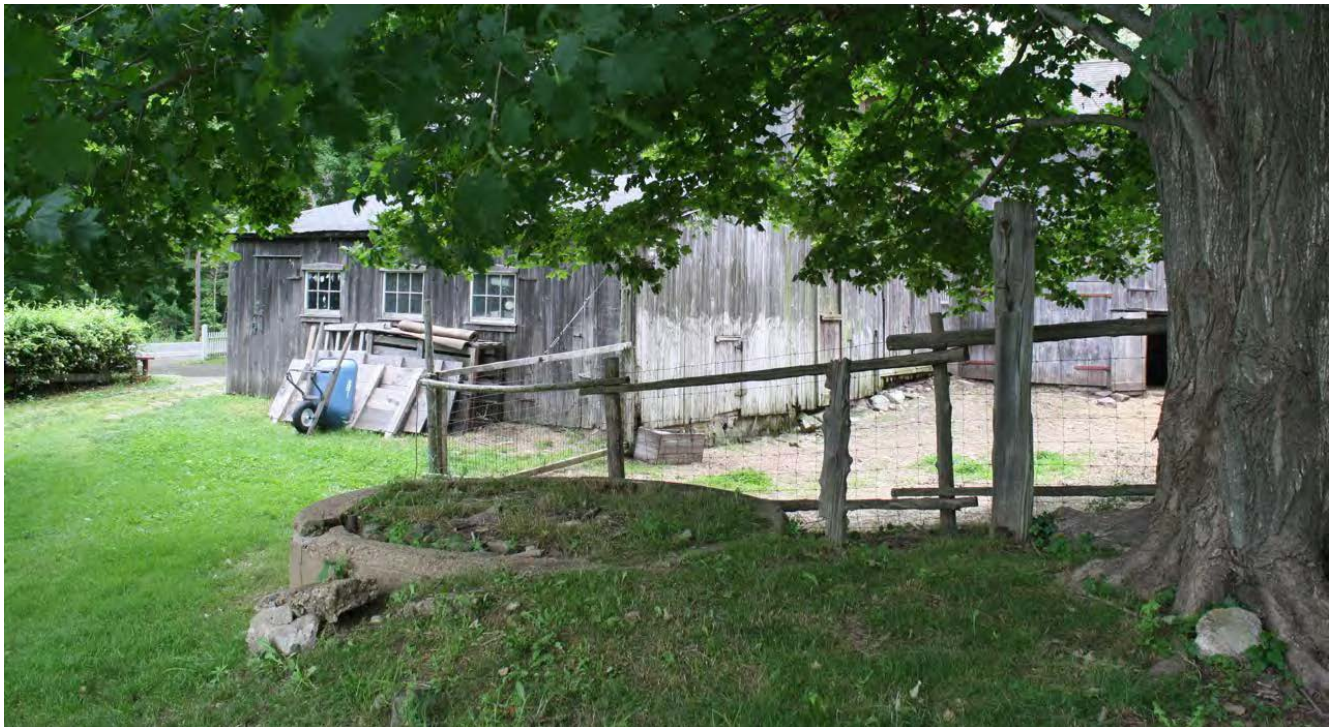
24. Silo foundation south of Barns I and II, camera facing northwest.

Northeast of the house and barn complex is a large garden and open space for livestock and the metal framework of a Windmill base. Southeast of the Farmhouse is a barn complex. Barn I and Barn II, two parallel structures oriented north-south and connected at the north ends, form a sheltered barnyard open to the south. The foundation of a silo is near the south end of Barn II.

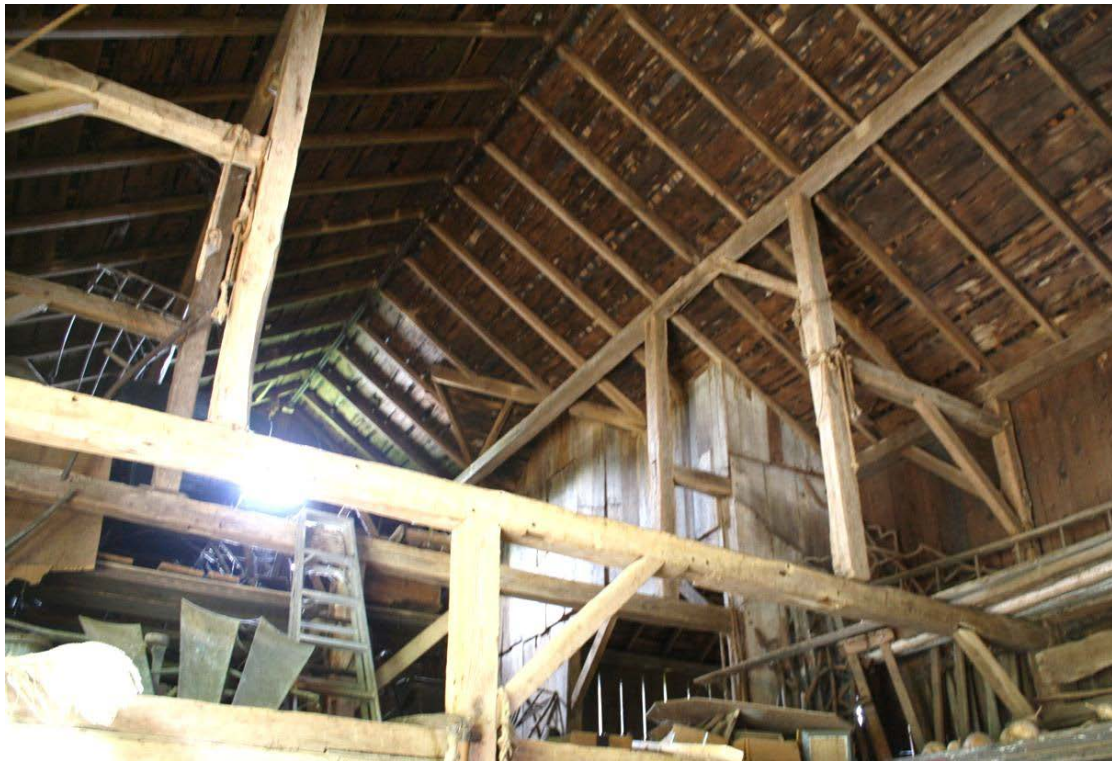
26. Interior view of Barn I, camera facing northeast from the threshing bay. Note the posts of the narrow bay set close together.

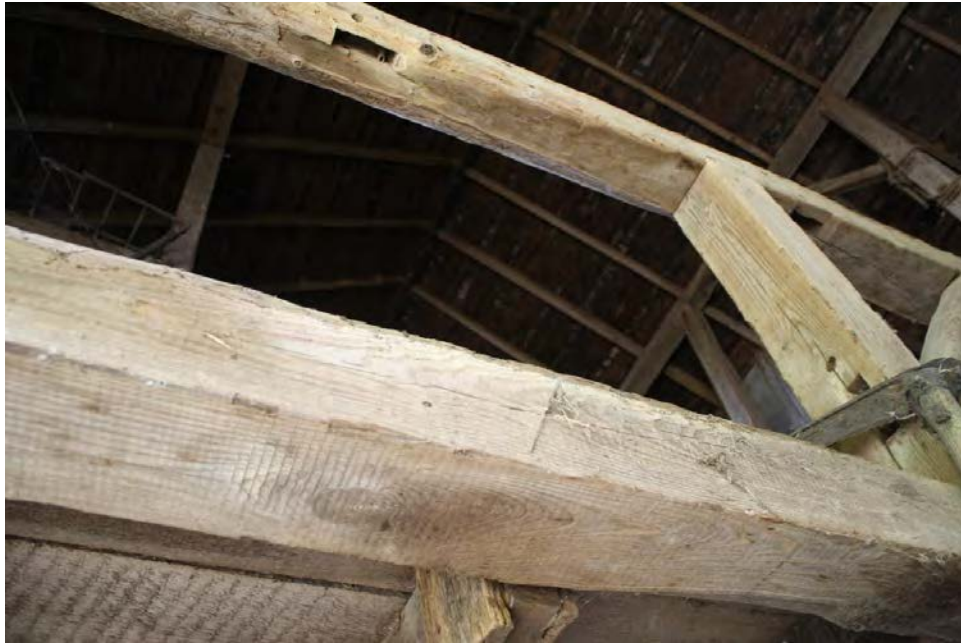
27. Interior view of Barn I, camera facing south from threshing bay. Note straight saw kerf marks on girt.

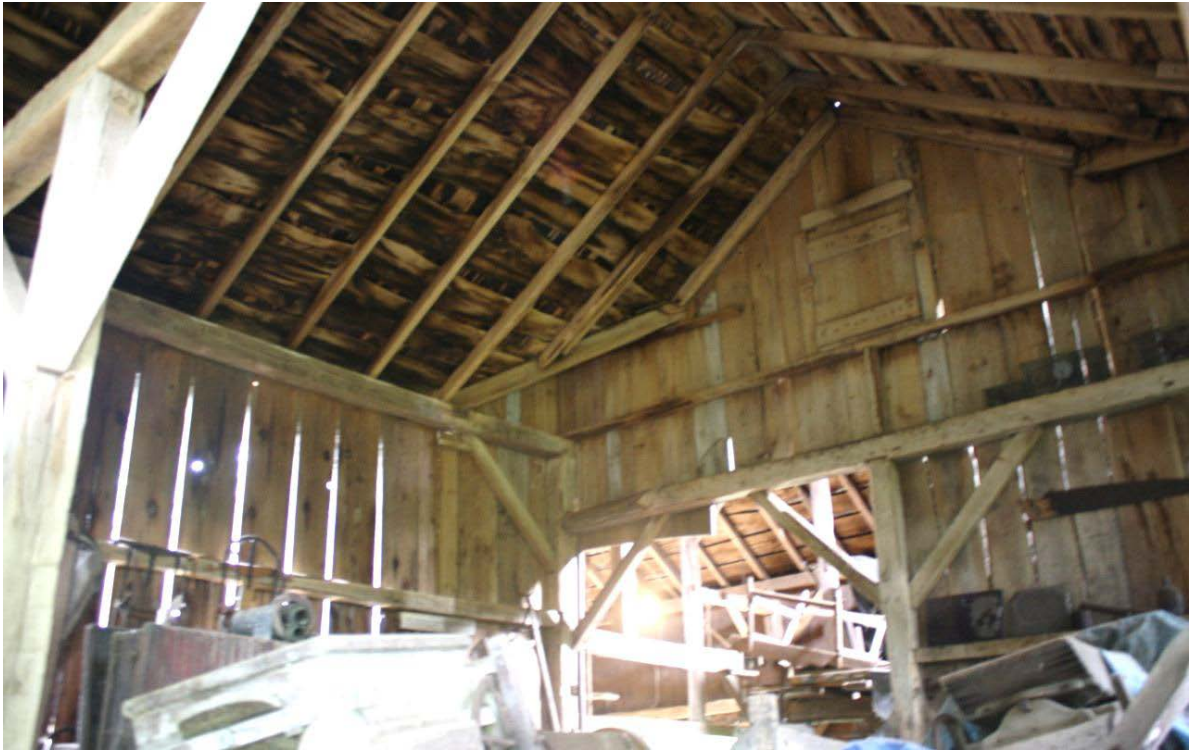
29. Interior view of Barn I east wing, camera facing southwest into main block. Note valley rafter at intersection of eave and gable sides, where the west gable-end wall is inside the foot print of Barn I. Siding on the far side of the gable-end bent suggest that the east wing may have been a free-standing structure later connected to Barn I.

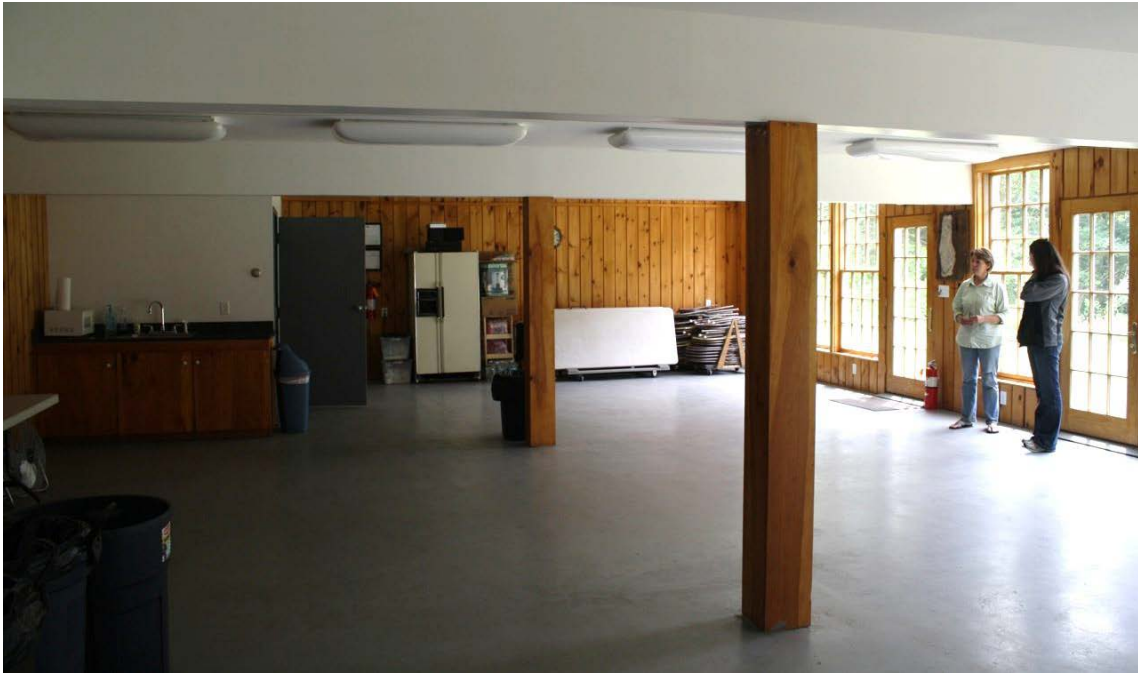
33. Interior view of Barn III basement level, camera facing southeast.

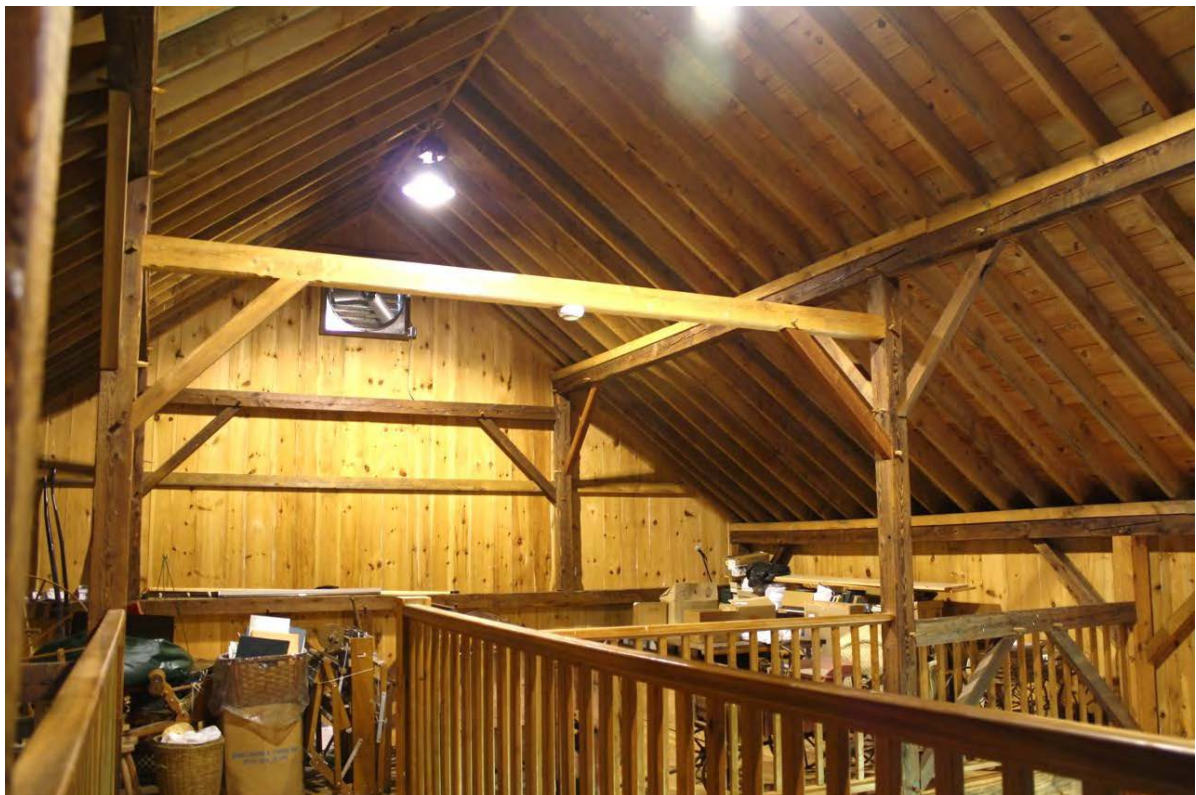
34. Interior view of Barn III loft level, camera facing east; in foreground is the "bridge" over the center bay.

This is a 1 ½-story three-bay English bank barn. The main upper level entry facade faces north and the ridge-line is oriented east-west. The barn has been dismantled at its original location and re-assembled here on a new foundation.
